ENVIRONMENTAL RESTORATION PROGRAM

**FOURTH CERCLA FIVE-YEAR REVIEW
REPORT**

JBER-ELMENDORF, ALASKA

**FINAL
MARCH 2014**

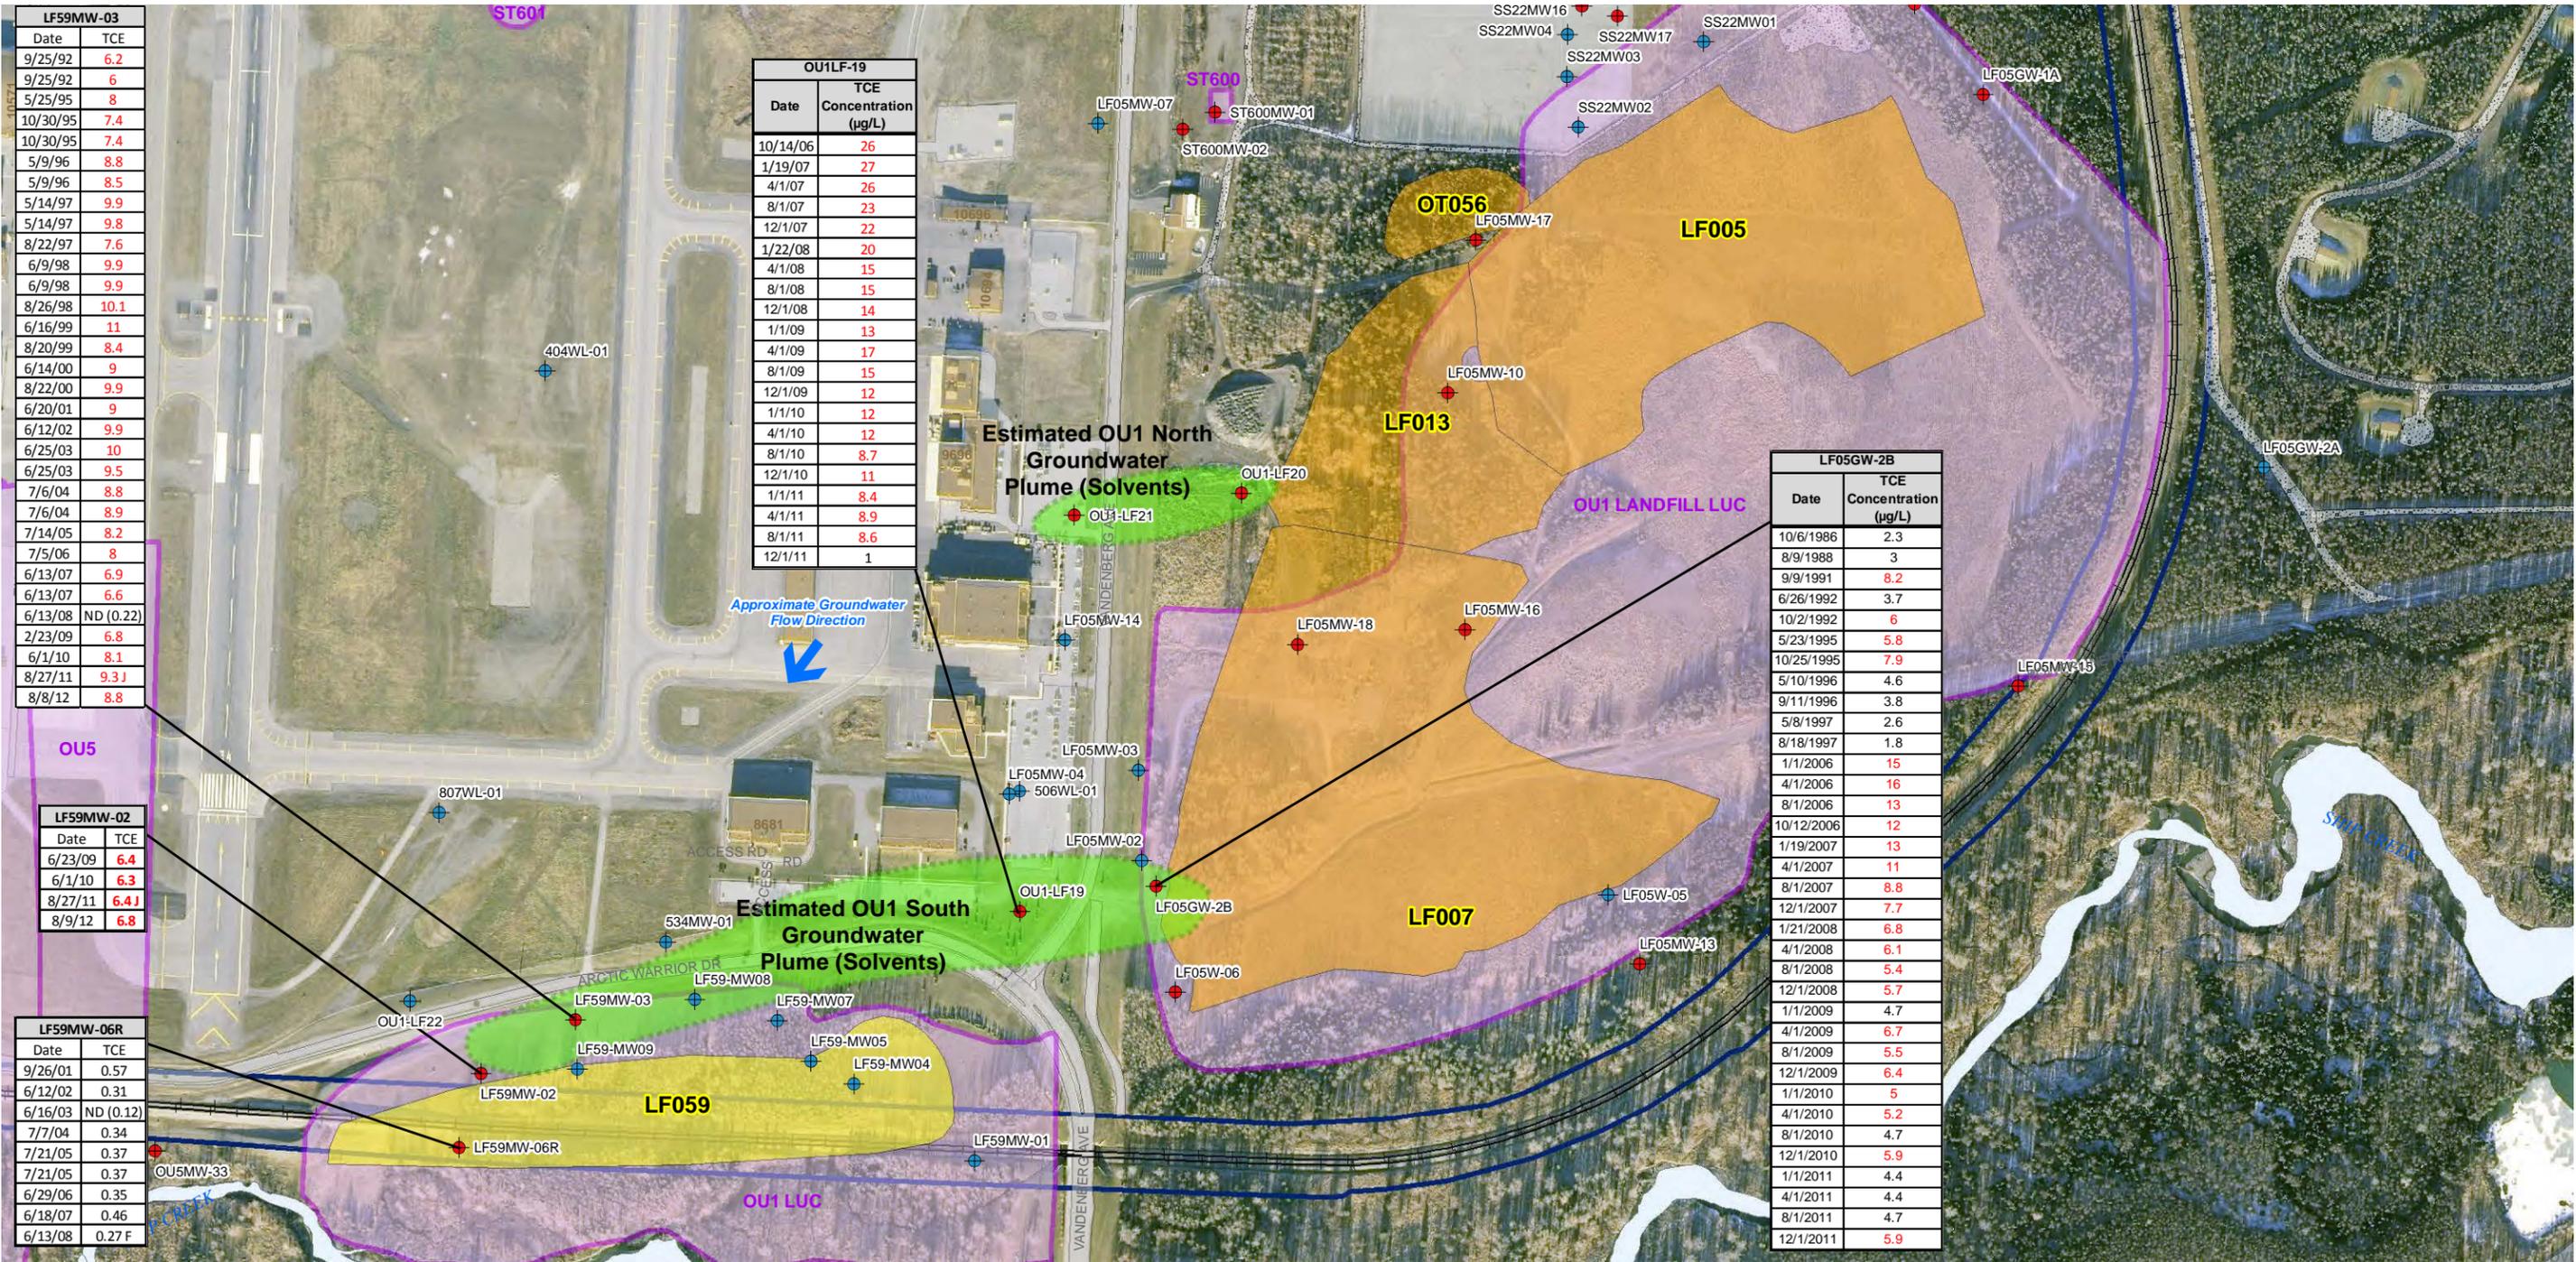
LF059 SITE MAP WITH HISTORICAL DATA			
JOINT BASE ELMENDORF-RICHARDSON, ALASKA			
JACOBS	DATE: 11 MAR 2014	PROJECT MANAGER: K. MAHER	FIGURE NO: C-1

Notes:
 1. All groundwater results are in micrograms/liter [µ/L].
 2. Red results exceed cleanup criteria.
 TCE = Trichloroethylene
 Cleanup Criteria = [5 µ/L]
 ND = Not Detected (Detection Limit)
 FLAGS:
 F - Result in between the method detection limit and the reporting limit.
 J - Analyte was positively identified, but result is

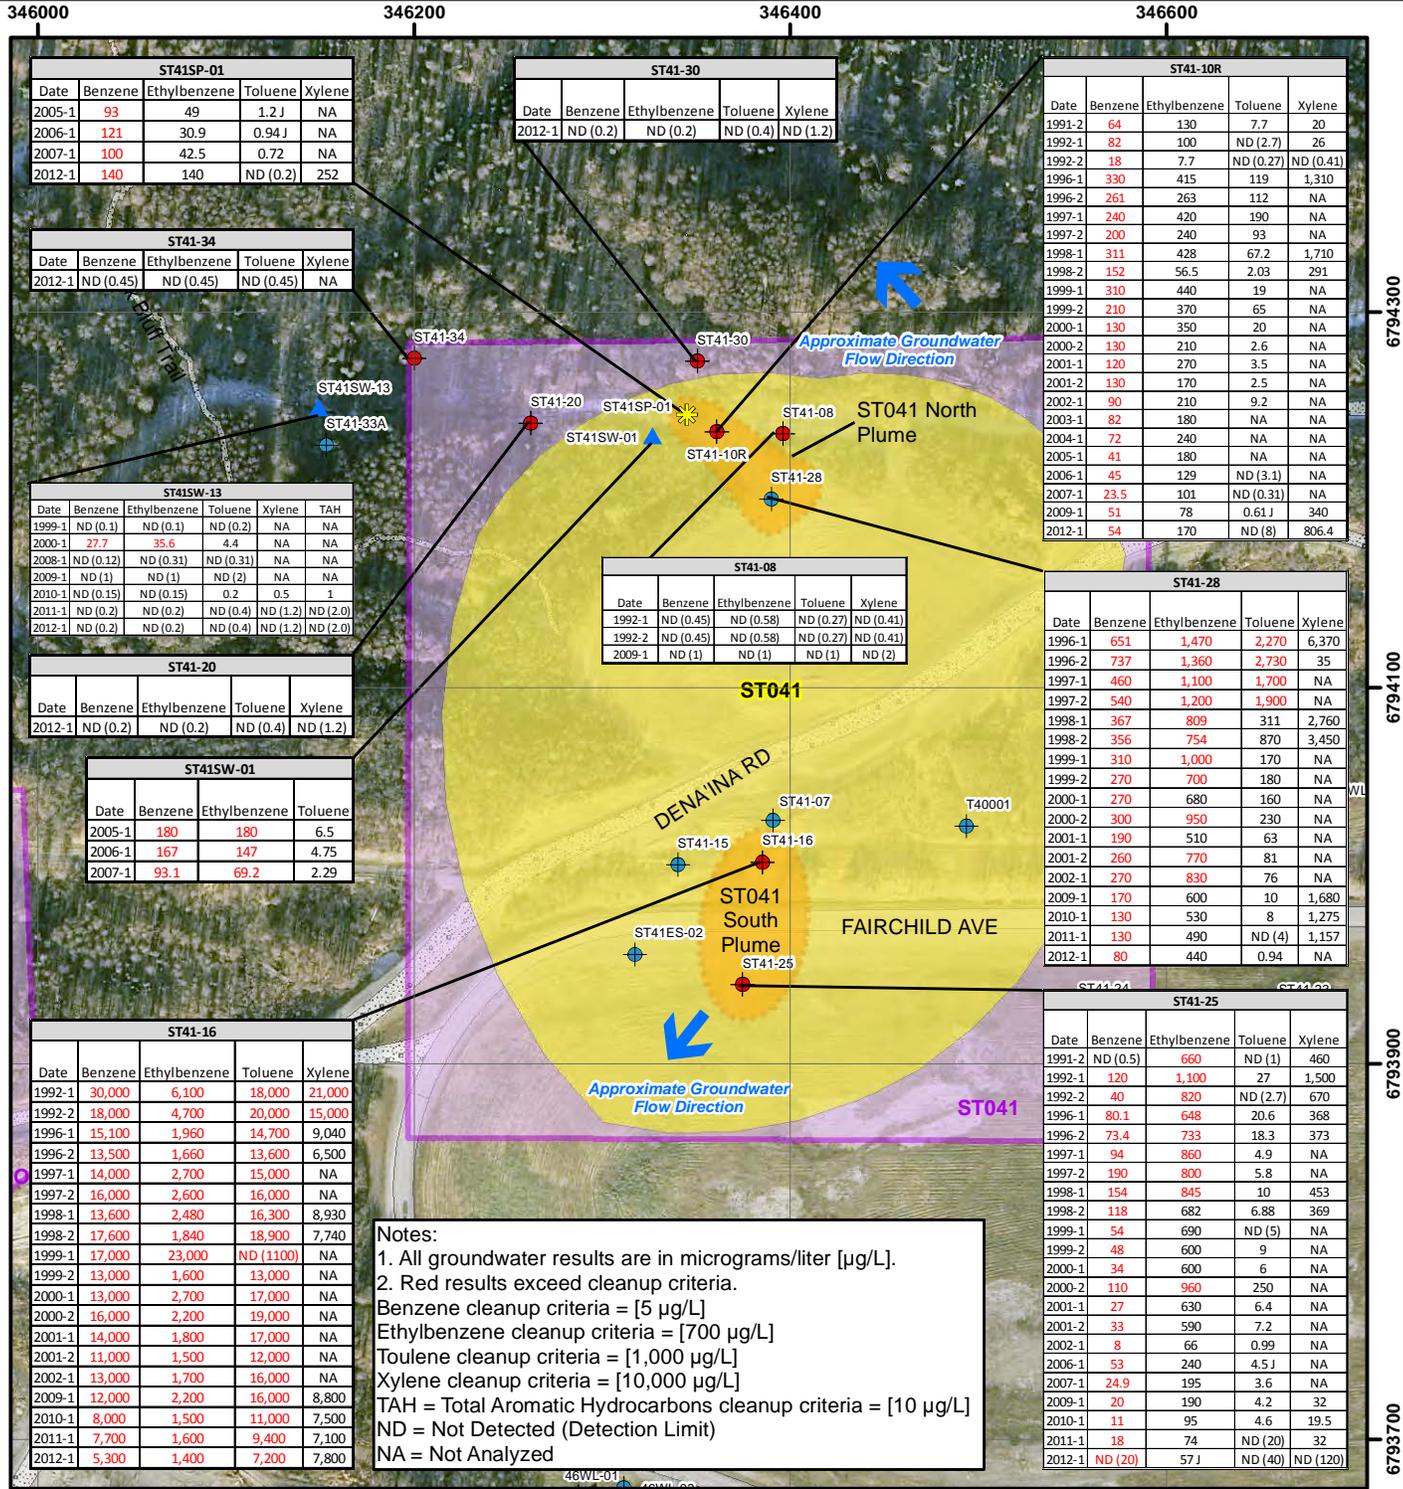
JACOBS	DATE: 05 MAR 2014	PROJECT MANAGER: K. MAHER	FIGURE NO: C-2
---------------	----------------------	------------------------------	-------------------

Notes:
 1. All groundwater results are in micrograms/liter [µg/L].
 2. Red results exceed cleanup criteria.
 Benzene cleanup criteria = [5 µg/L]
 Ethylbenzene cleanup criteria = [700 µg/L]
 Toluene cleanup criteria = [1,000 µg/L]
 Xylene cleanup criteria = [10,000 µg/L]
 TAH = Total Aromatic Hydrocarbons cleanup criteria = [10 µg/L]
 ND = Not Detected (Detection Limit)
 NA = Not Analyzed

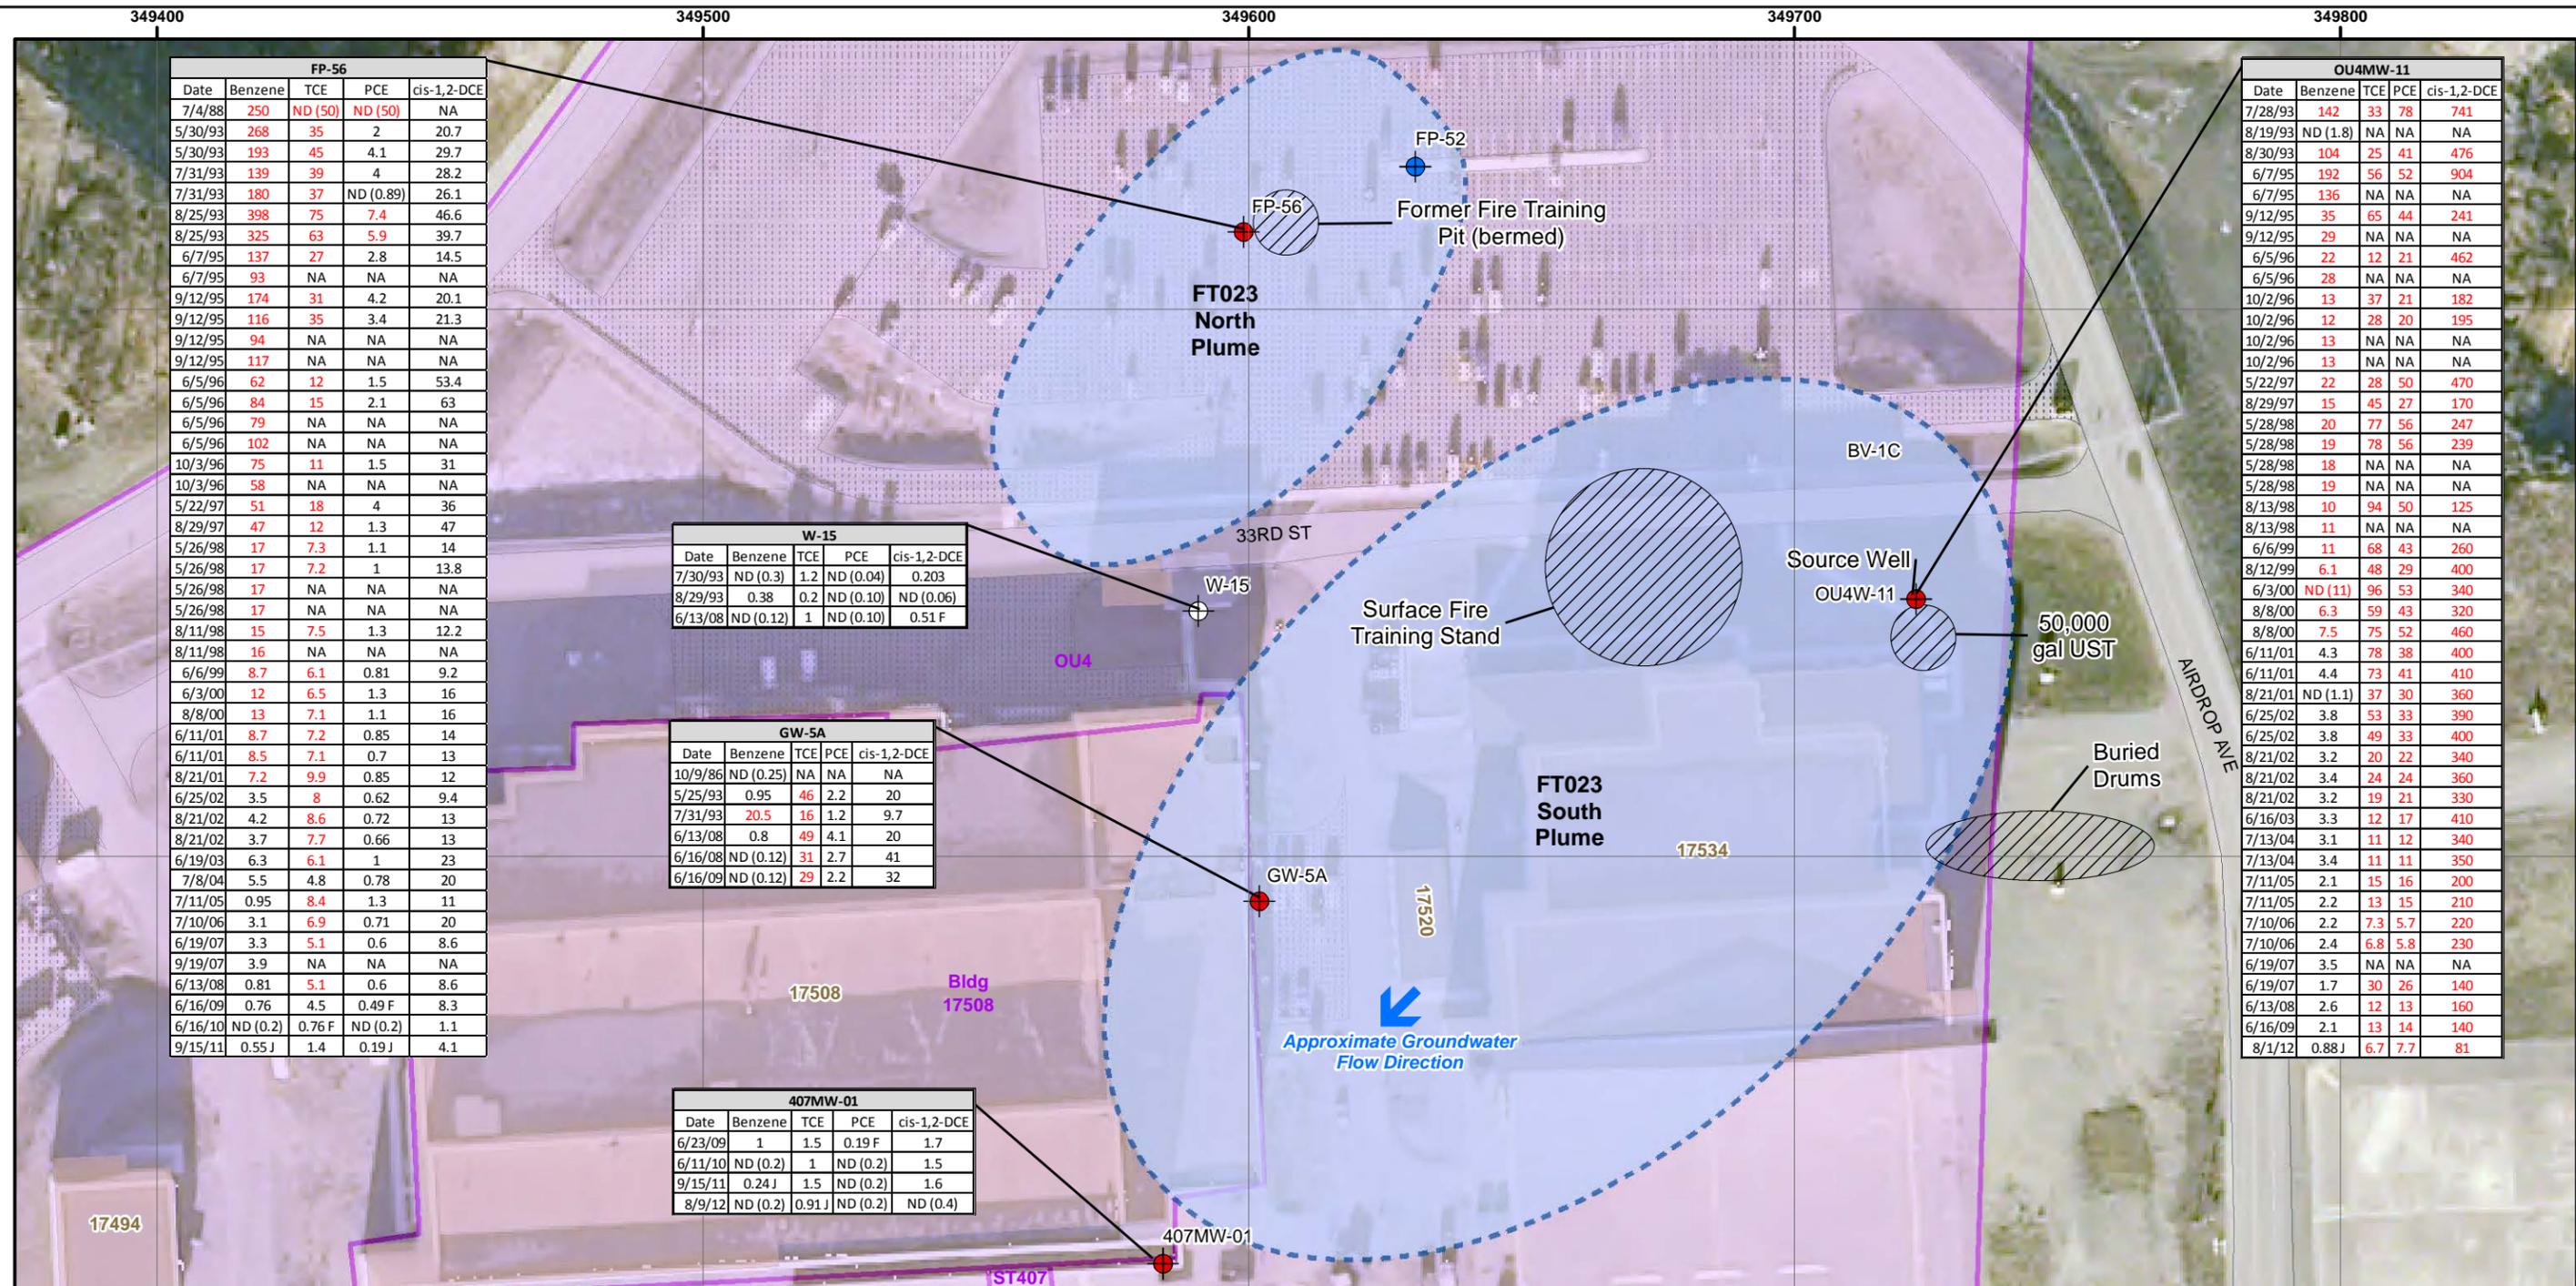
DATE: 05 MAR 2014	PROJECT MANAGER: K. MAHER	FIGURE NO: C-3
--	-------------------	---------------------------	----------------

Notes:
 1. All groundwater results are in micrograms/liter [µg/L].
 2. Red results exceed cleanup criteria.
 Benzene cleanup criteria = [5 µg/L]
 TCE (Trichloroethene) cleanup criteria = [5 µg/L]
 PCE (Tetrachloroethene) cleanup criteria = [5 µg/L]
 cis-1,2 Dichloroethene cleanup criteria = [70 µg/L]
 ND = Not Detected (Detection Limit)
 NA = Not Analyzed

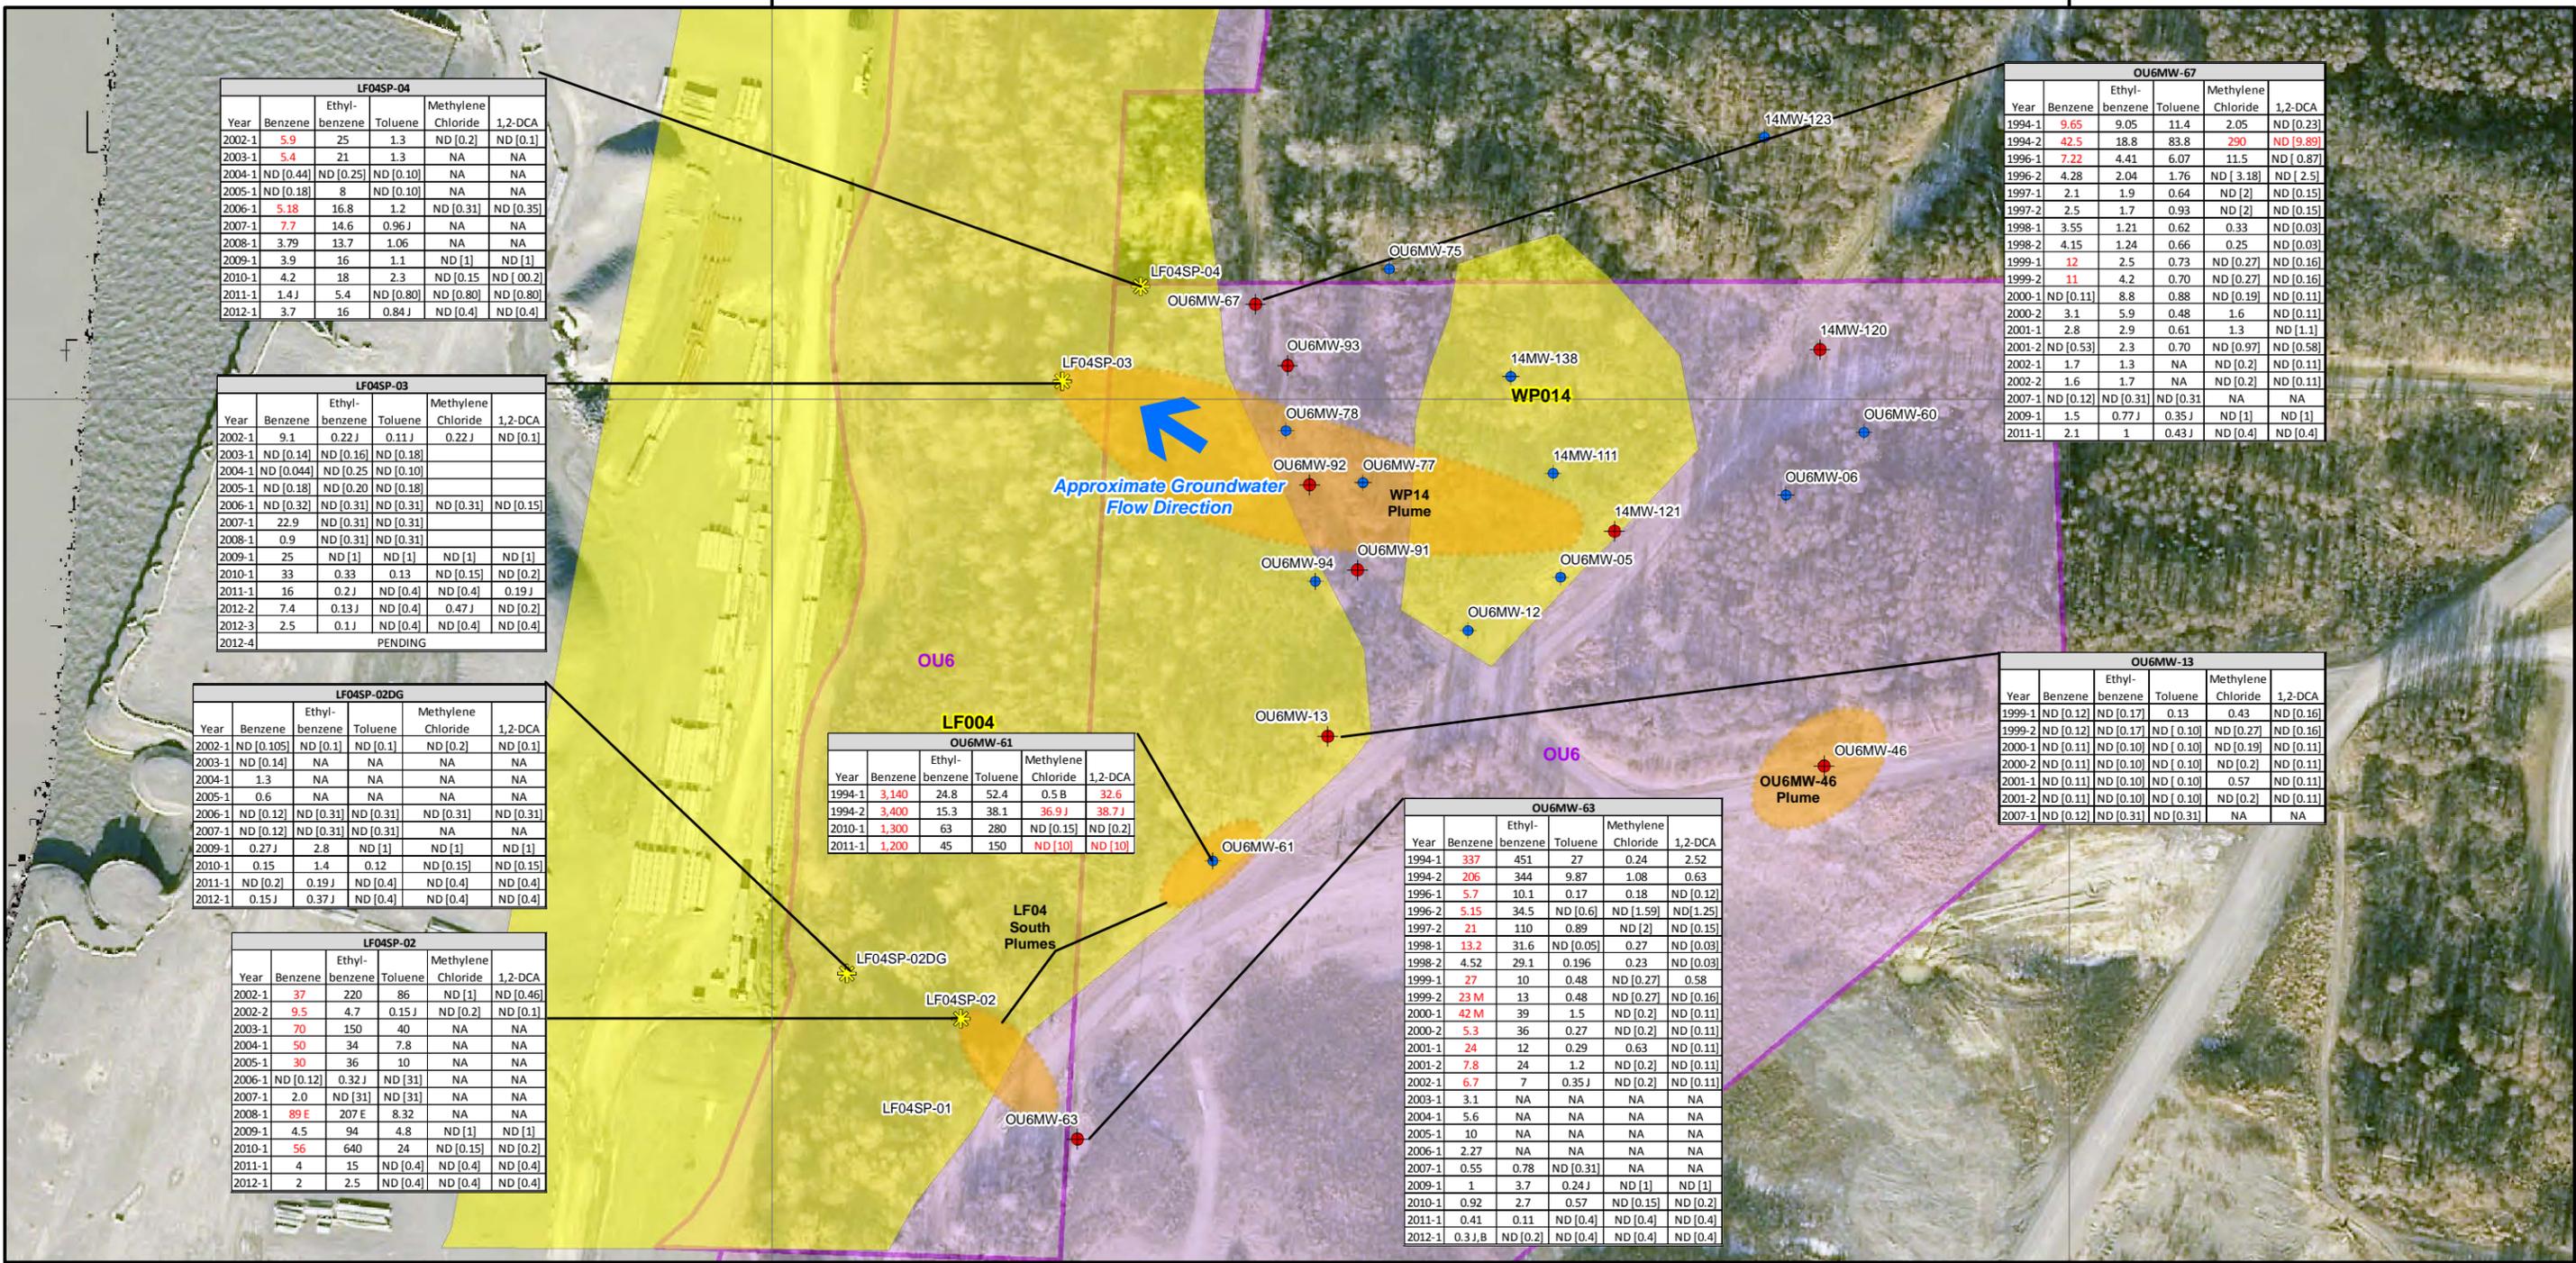
LF004 SOUTH SITE MAP AND HISTORICAL DATA			
JOINT BASE ELMENDORF-RICHARDSON, ALASKA			
JACOBS	DATE: 11 MAR 2014	PROJECT MANAGER: K. MAHER	FIGURE NO: C-19

- Seep Sample Location
- Program Monitoring Well
- Non-Program Monitoring Well
- Abandoned Monitoring Well
- Inferred Plume Boundary (Fuels)
- CERCLA Site Boundary
- Land Use Control Boundary

NOTES:
 1. All groundwater results are in micrograms per liter (ug/L).
 2. Red italicized results exceed cleanup criteria.

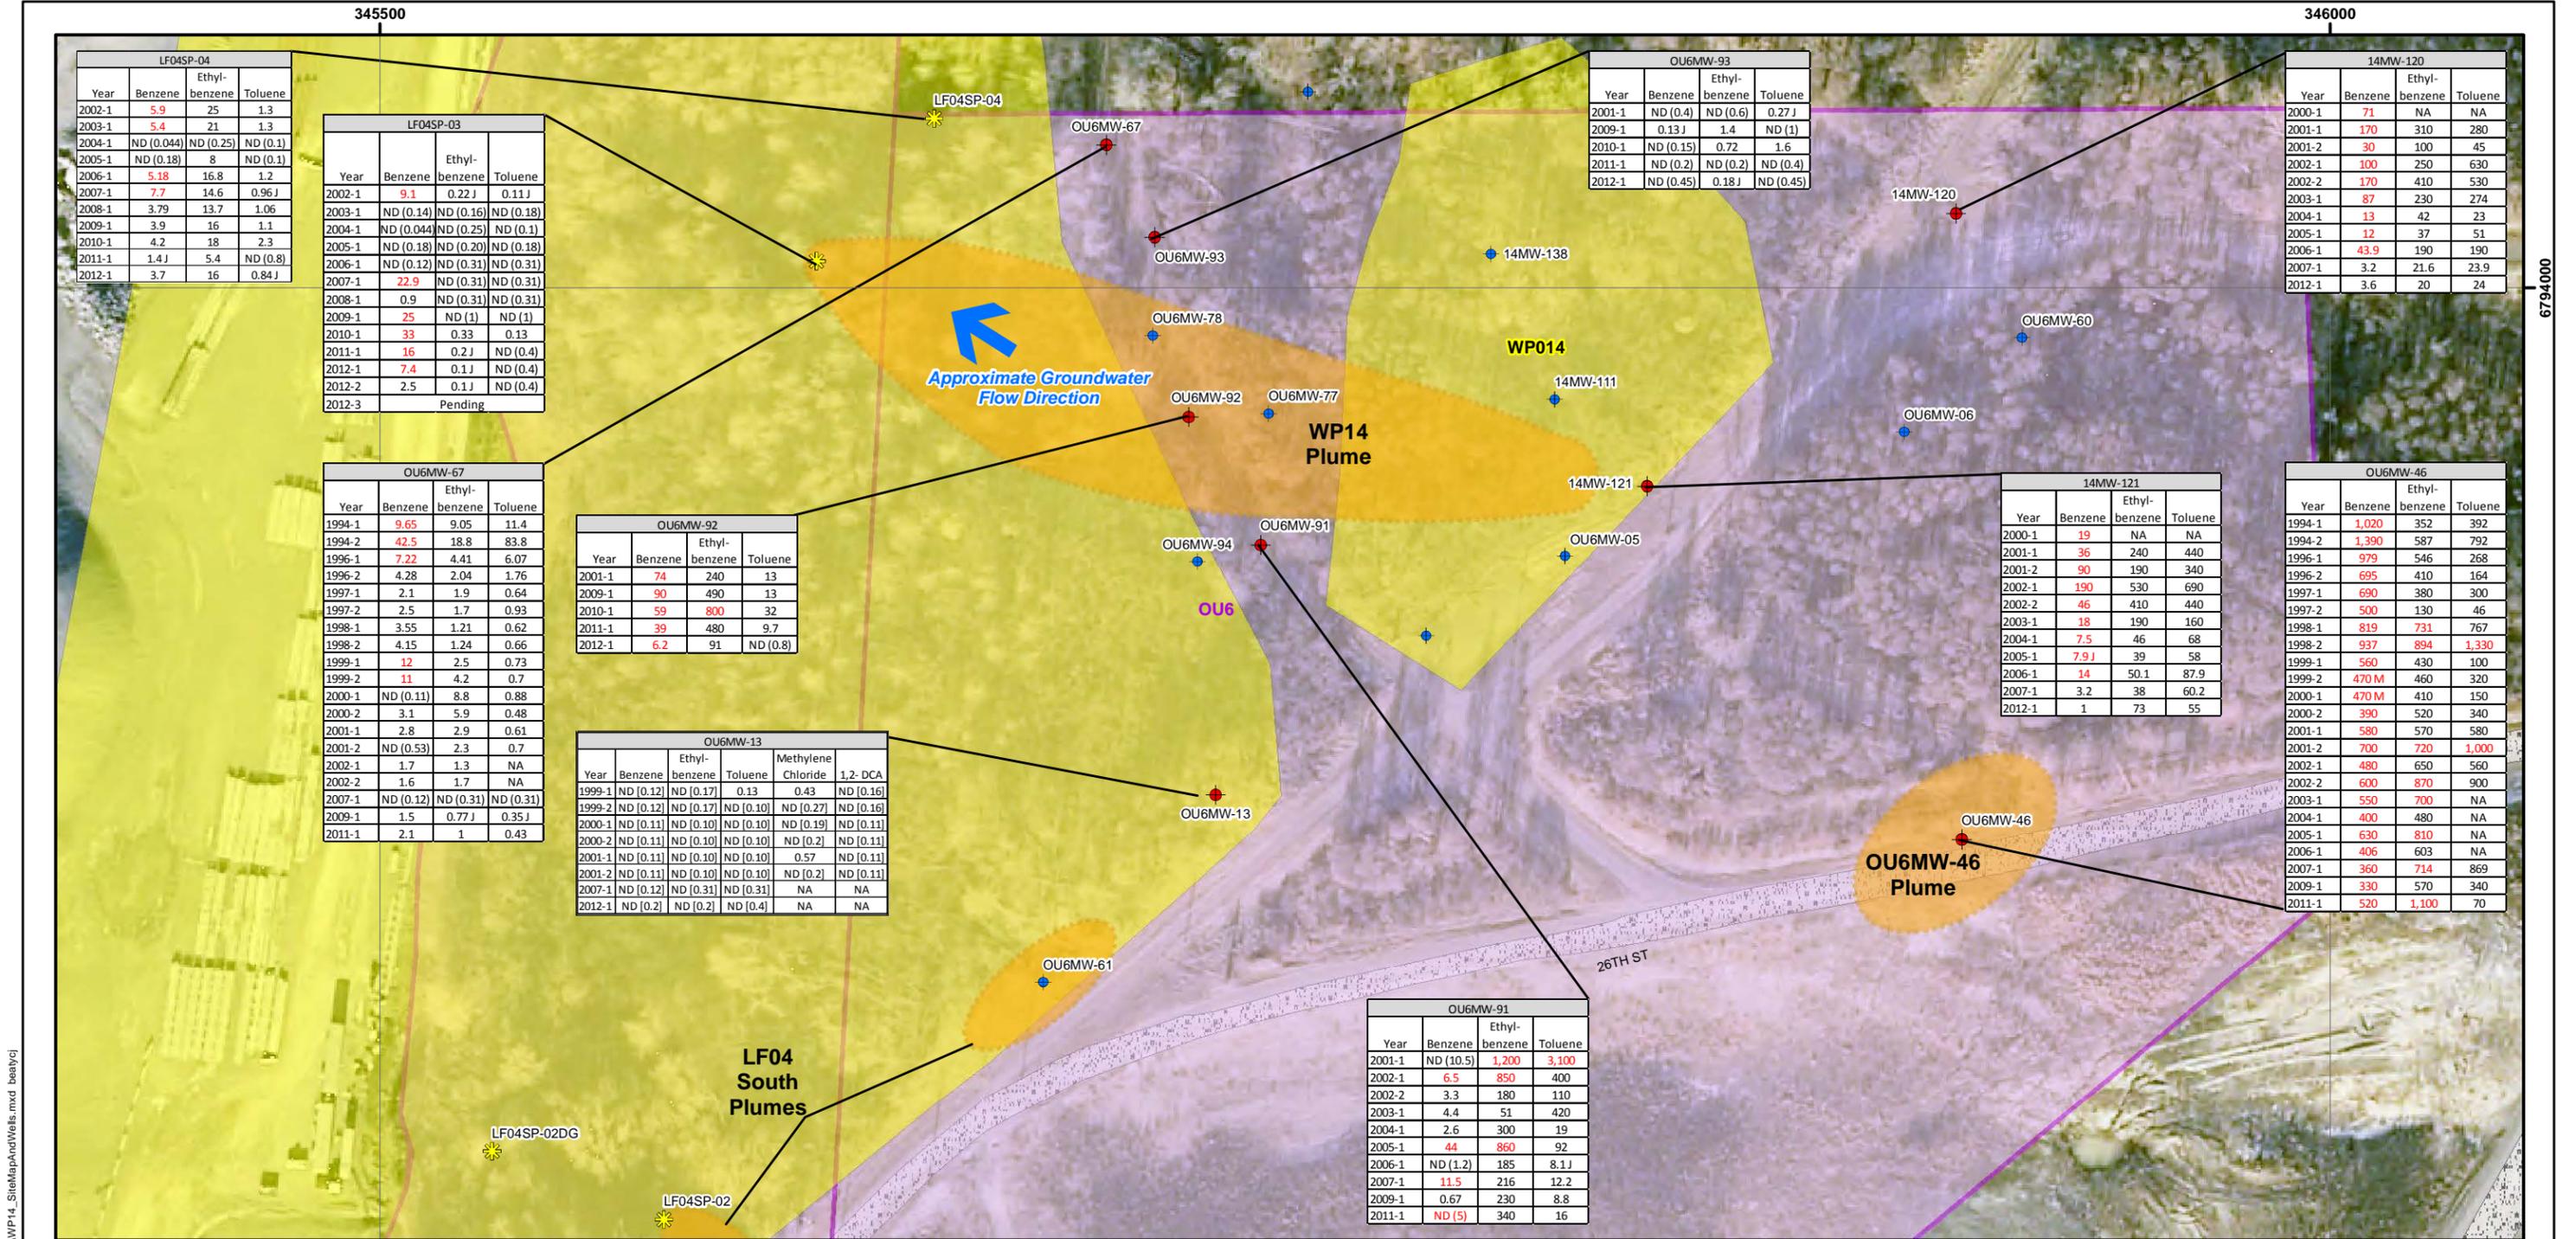
WP014 SITE MAP AND HISTORICAL DATA			
JOINT BASE ELMENDORF-RICHARDSON, ALASKA			
JACOBS	DATE: 11 MAR 2014	PROJECT MANAGER: K. MAHER	FIGURE NO: C-20

- Seep Sample Location
- Program Monitoring Well
- Non-Program Monitoring Well
- Abandoned Monitoring Well
- Inferred Plume Boundary (Fuels)
- CERCLA Site Boundary
- Land Use Control Boundary

NOTES:
 1. All groundwater results are in micrograms per liter (ug/L).
 2. Red italicized results exceed cleanup criteria.

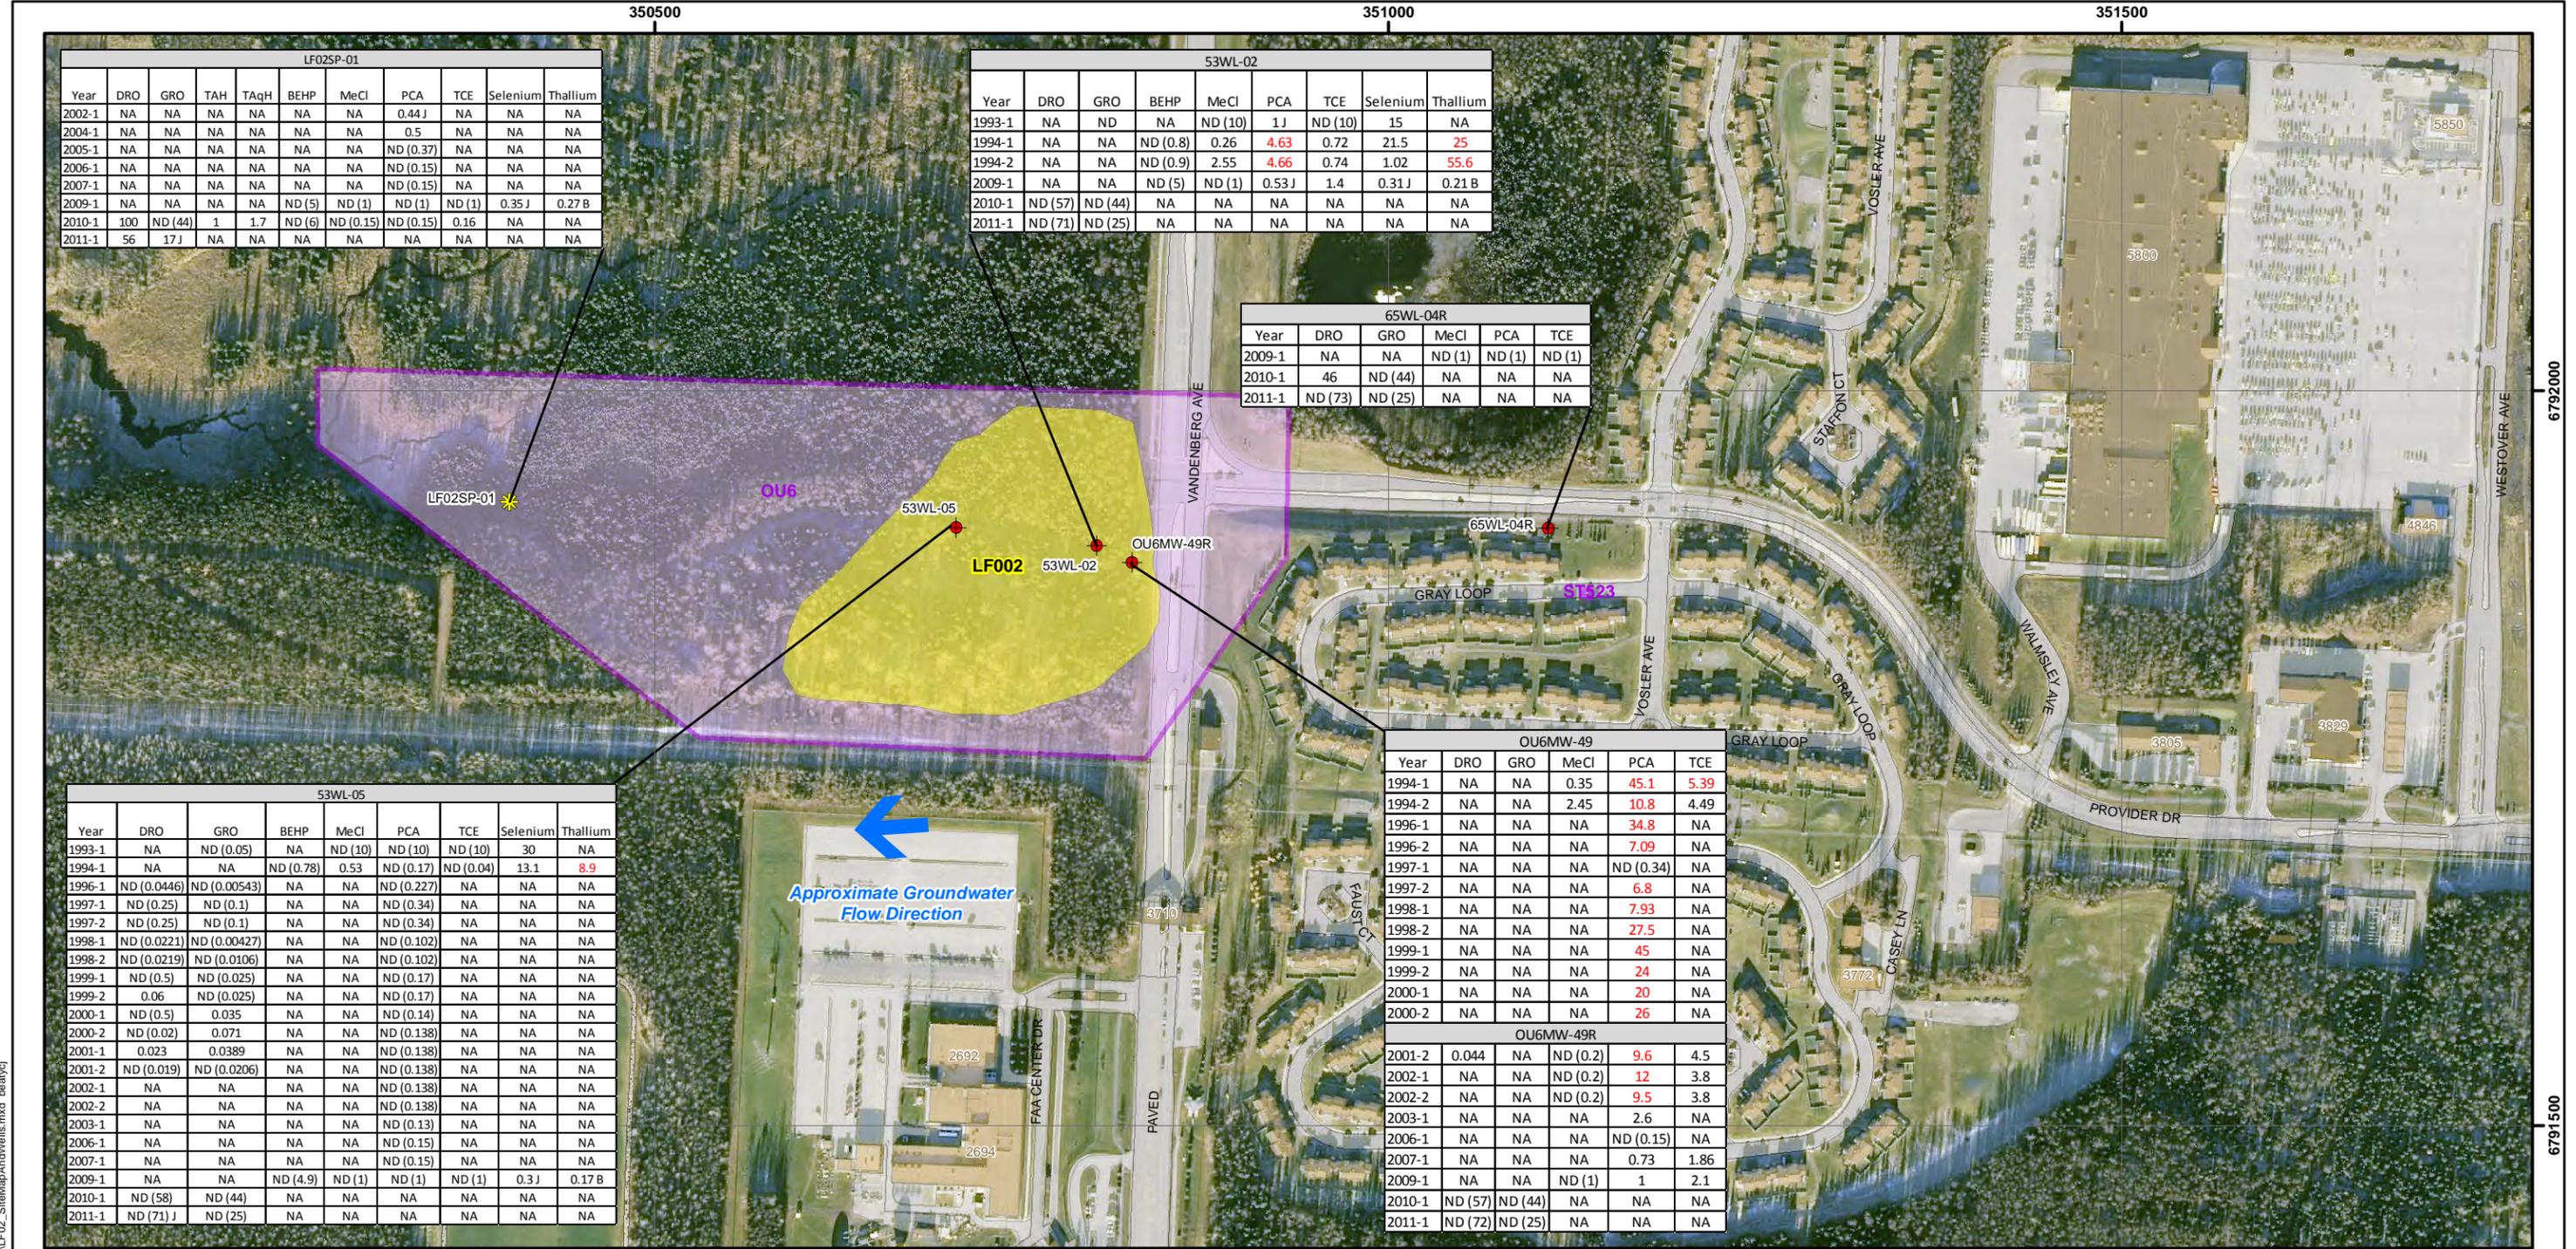
LF002 SITE MAP AND HISTORICAL DATA			
JOINT BASE ELMENDORF-RICHARDSON, ALASKA			
JACOBS	DATE: 11 MAR 2014	PROJECT MANAGER: K. MAHER	FIGURE NO: C-21

LF02SP-01										
Year	DRO	GRO	TAH	TAqH	BEHP	MeCl	PCA	TCE	Selenium	Thallium
2002-1	NA	NA	NA	NA	NA	NA	0.44J	NA	NA	NA
2004-1	NA	NA	NA	NA	NA	NA	0.5	NA	NA	NA
2005-1	NA	NA	NA	NA	NA	NA	ND (0.37)	NA	NA	NA
2006-1	NA	NA	NA	NA	NA	NA	ND (0.15)	NA	NA	NA
2007-1	NA	NA	NA	NA	NA	NA	ND (0.15)	NA	NA	NA
2009-1	NA	NA	NA	NA	ND (5)	ND (1)	ND (1)	ND (1)	0.35J	0.27B
2010-1	100	ND (44)	1	1.7	ND (6)	ND (0.15)	ND (0.15)	0.16	NA	NA
2011-1	56	17J	NA	NA	NA	NA	NA	NA	NA	NA

- Seep Sample Location
- Program Monitoring Well
- Non-Program Monitoring Well
- Abandoned Monitoring Well
- CERCLA Site Boundary
- Land Use Control Boundary

NOTES:
 1. All groundwater results are in micrograms per liter (ug/L).
 2. Red italicized results exceed cleanup criteria.

LF002 meets the ROD-specified cleanup levels; therefore, a “Response Complete” determination with continued implementation of LUCs is recommended for the site.

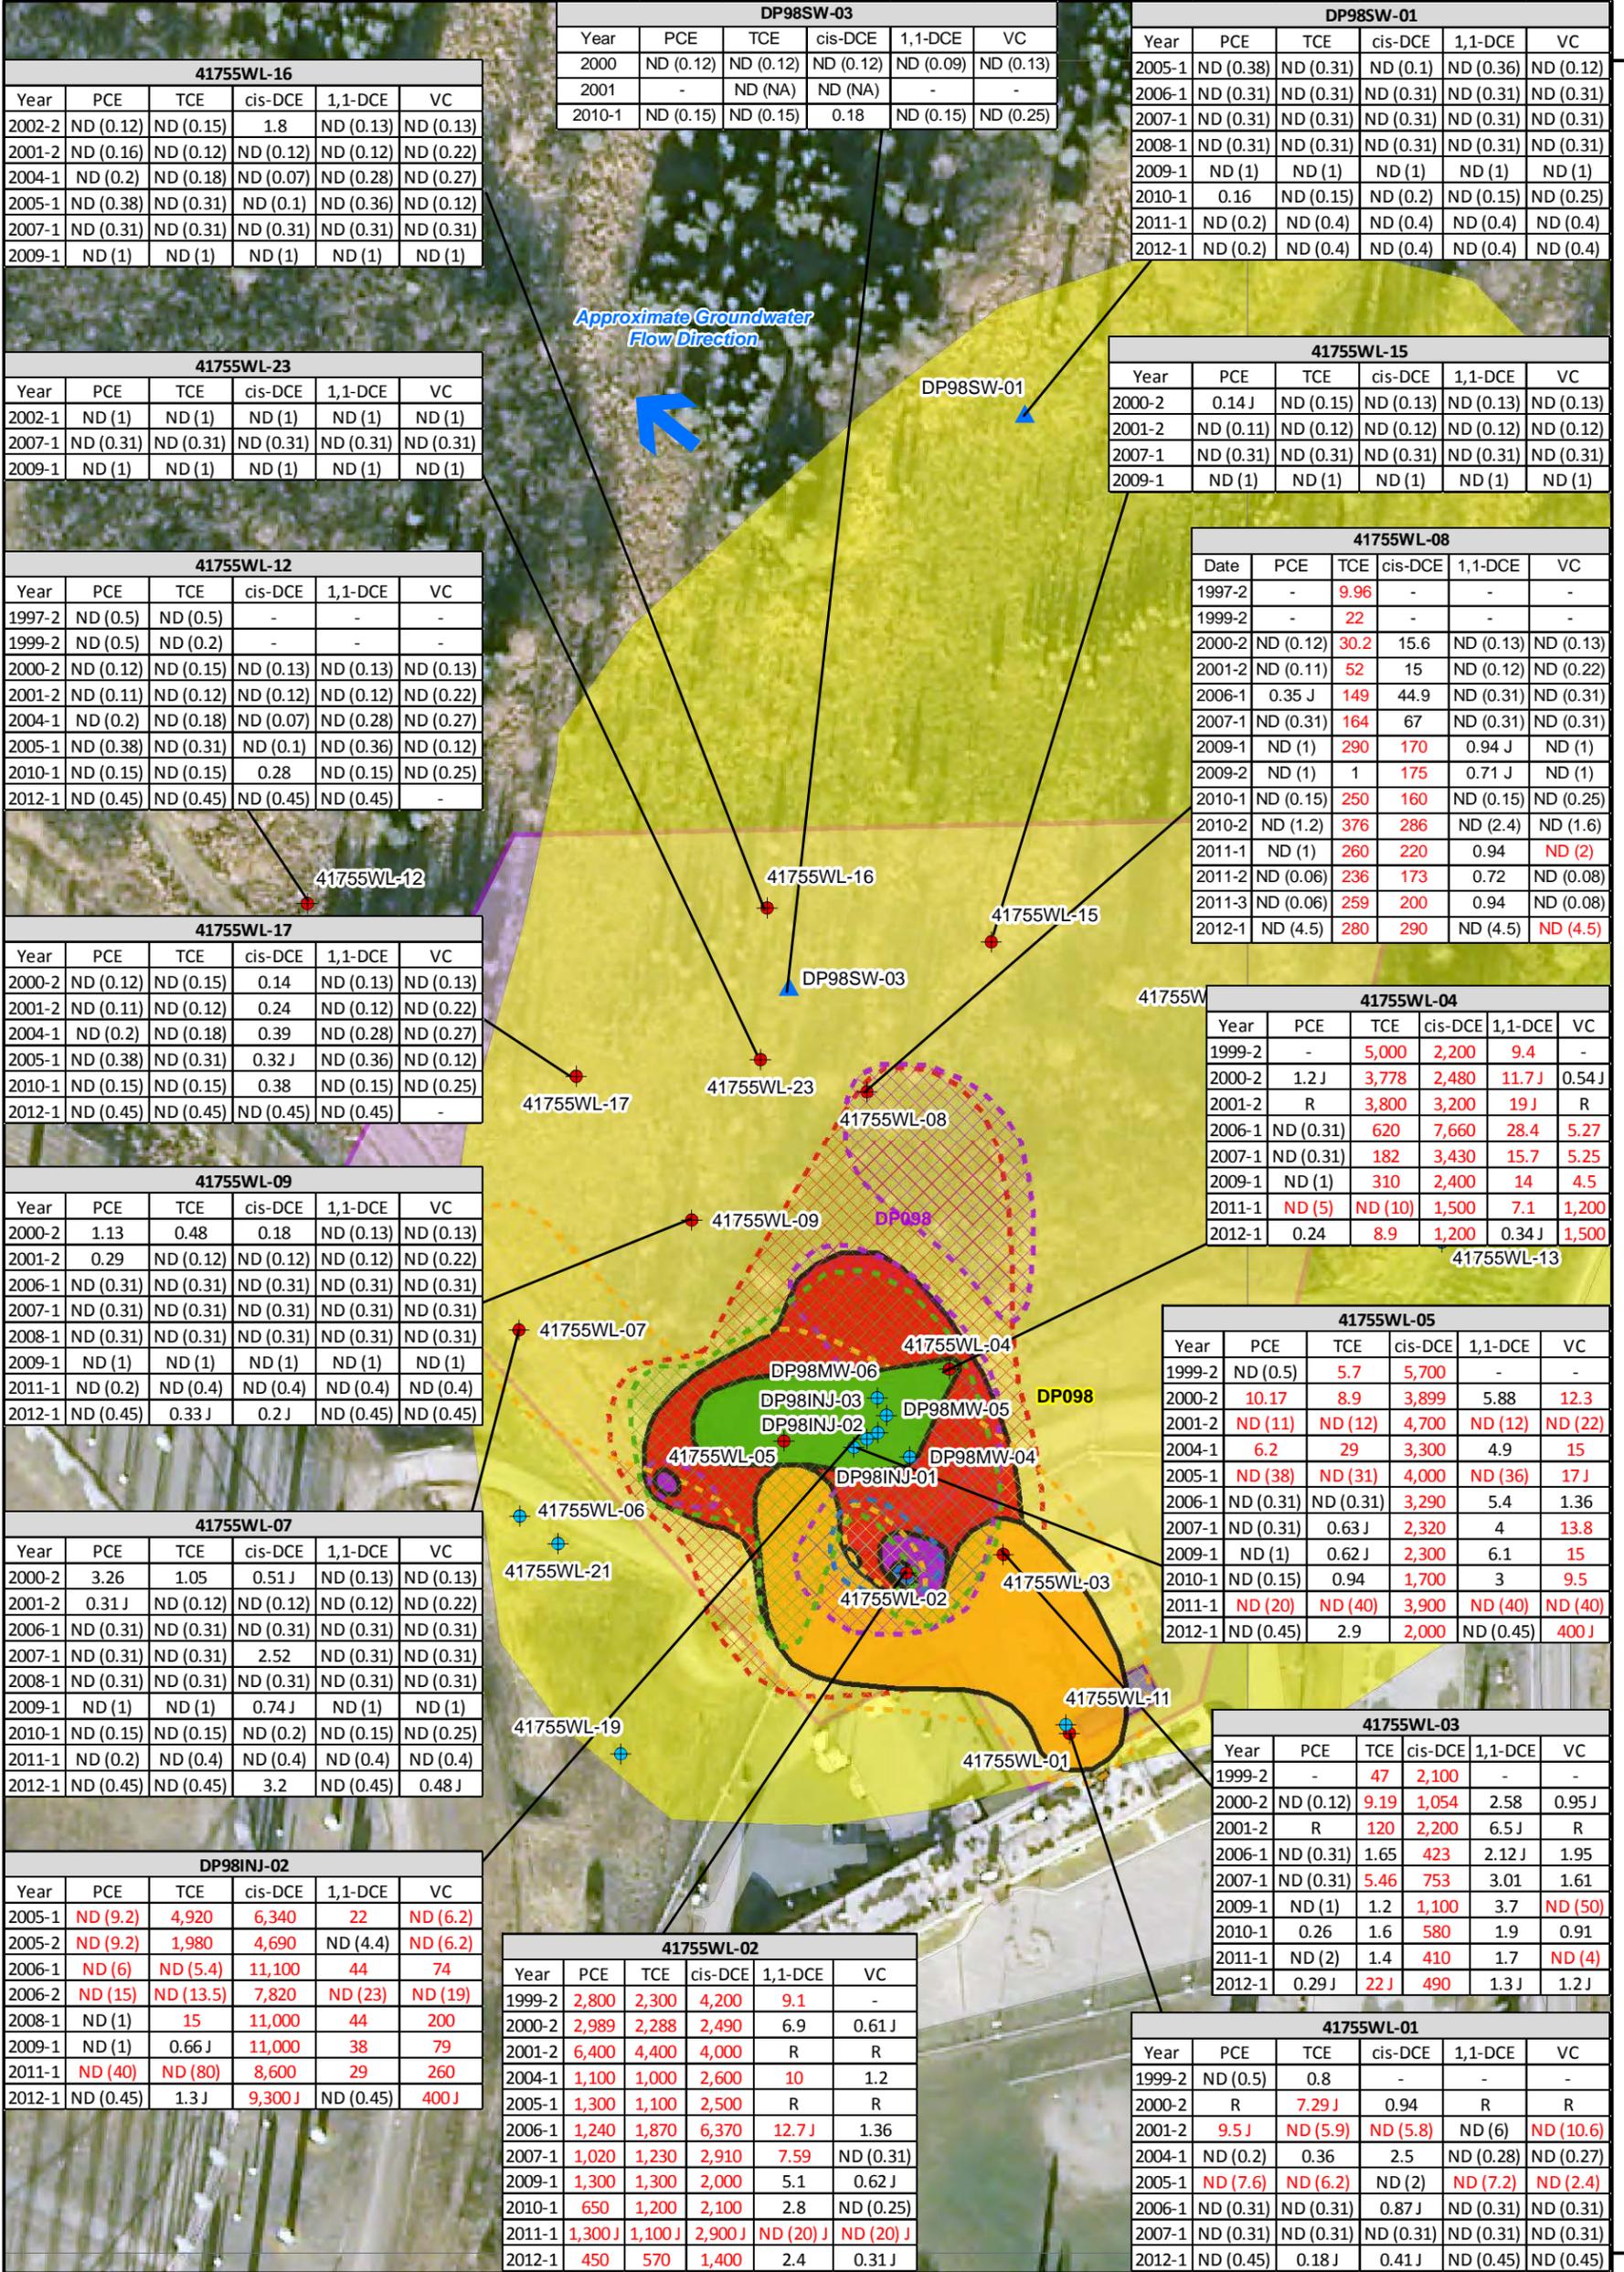
DP098 SITE MAP
 AND HISTORICAL DATA
 JOINT BASE ELMENDORF-RICHARDSON, ALASKA

NOTES:
 1. All groundwater results are in micrograms/liter [µg/L].
 2. Red results exceed cleanup criteria.
 TCE (Trichloroethene) (5 µg/L*)
 PCE (Tetrachloroethene) (5 µg/L*)
 cis-DCE (Dichloroethene) (70 µg/L*)
 1,1 DCE (Dichloroethene) (7 µg/L*)
 VC (Vinyl Chloride) (2 µg/L*)
 ND = Not Detected (Detection Limit)
 NA = Not Analyzed
 * Analyte Cleanup Criteria
 FLAGS:
 J - Analyte was positively identified, but result is estimated.
 R - The result was rejected.
