ENVIRONMENTAL RESTORATION PROGRAM

**FOURTH CERCLA FIVE-YEAR REVIEW
REPORT**

JBER-ELMENDORF, ALASKA

**FINAL
MARCH 2014**

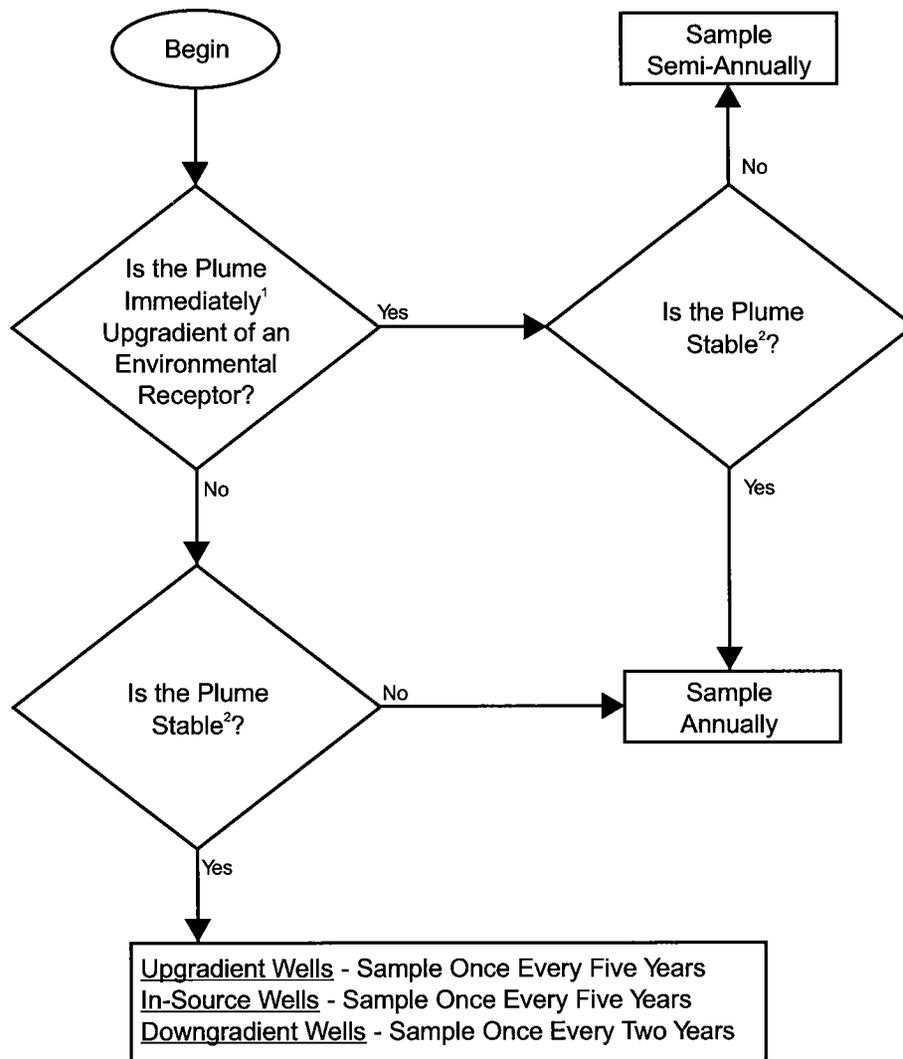
FIGURE F-1
Basewide Monitoring Program
Well Sampling Frequency Decision Guide as Adapted for OU 4, 5, and 6

¹ Immediately Upgradient: Means within a two-year warning line, similar to that generated for OU 5.

1. Seep are sampled annually, unless they exceed cleanup levels in which case they are sampled quarterly.
2. Wells with historical free product will be monitored annually for free product occurrence. Active product recovery will continue in wells with recoverable free product.
3. Sampling frequencies can be modified as needed to support site closure or modeling results.
4. Surface water sampling at OU 5 (Ship Creek) will be performed annually.

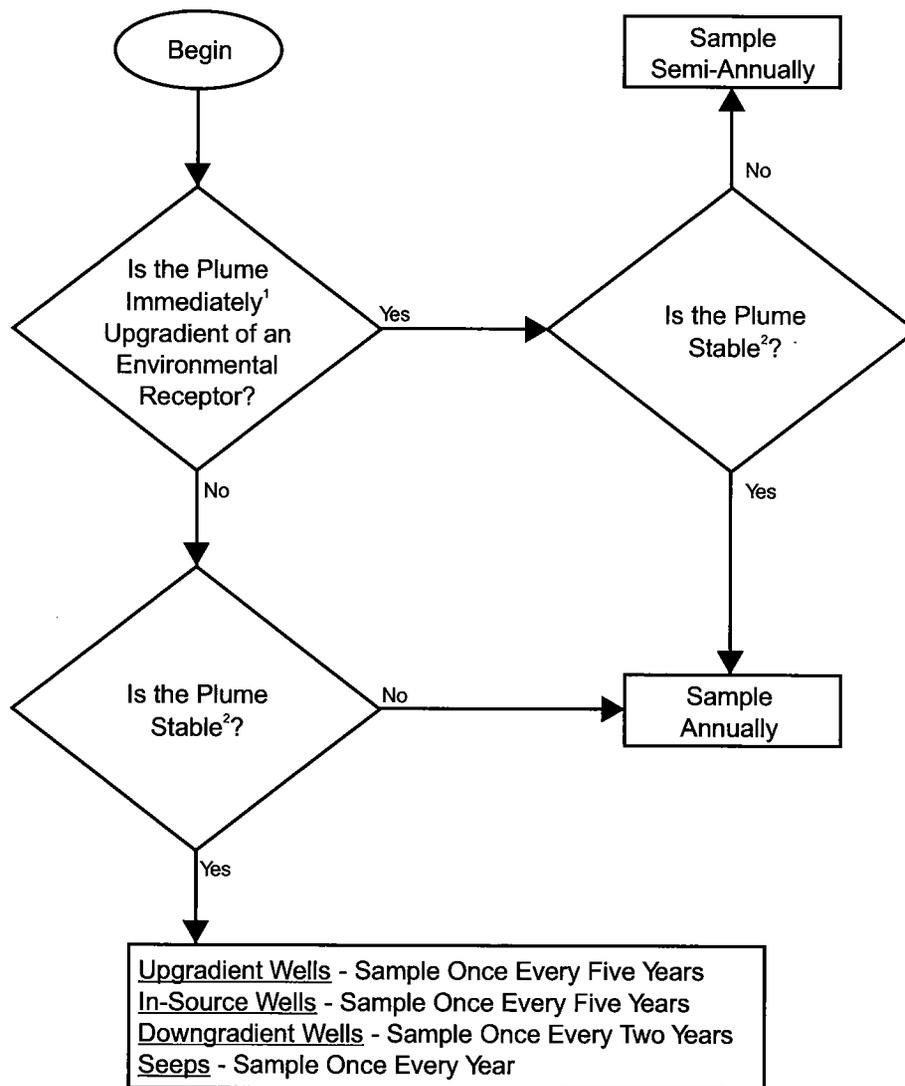
FIGURE F-2
Basewide Monitoring Program
Well Sampling Frequency Decision Guide as Adapted for DP98

¹ **Immediately Upgradient:** Within a two-year warning line. The warning line is defined as the distance groundwater travels in two years, ignoring retardation processes, and measure from a receptor (i.e. the kettle pond).

² **Stable Plume:** A stable plume has defined boundaries with stable or decreasing contaminant concentrations.

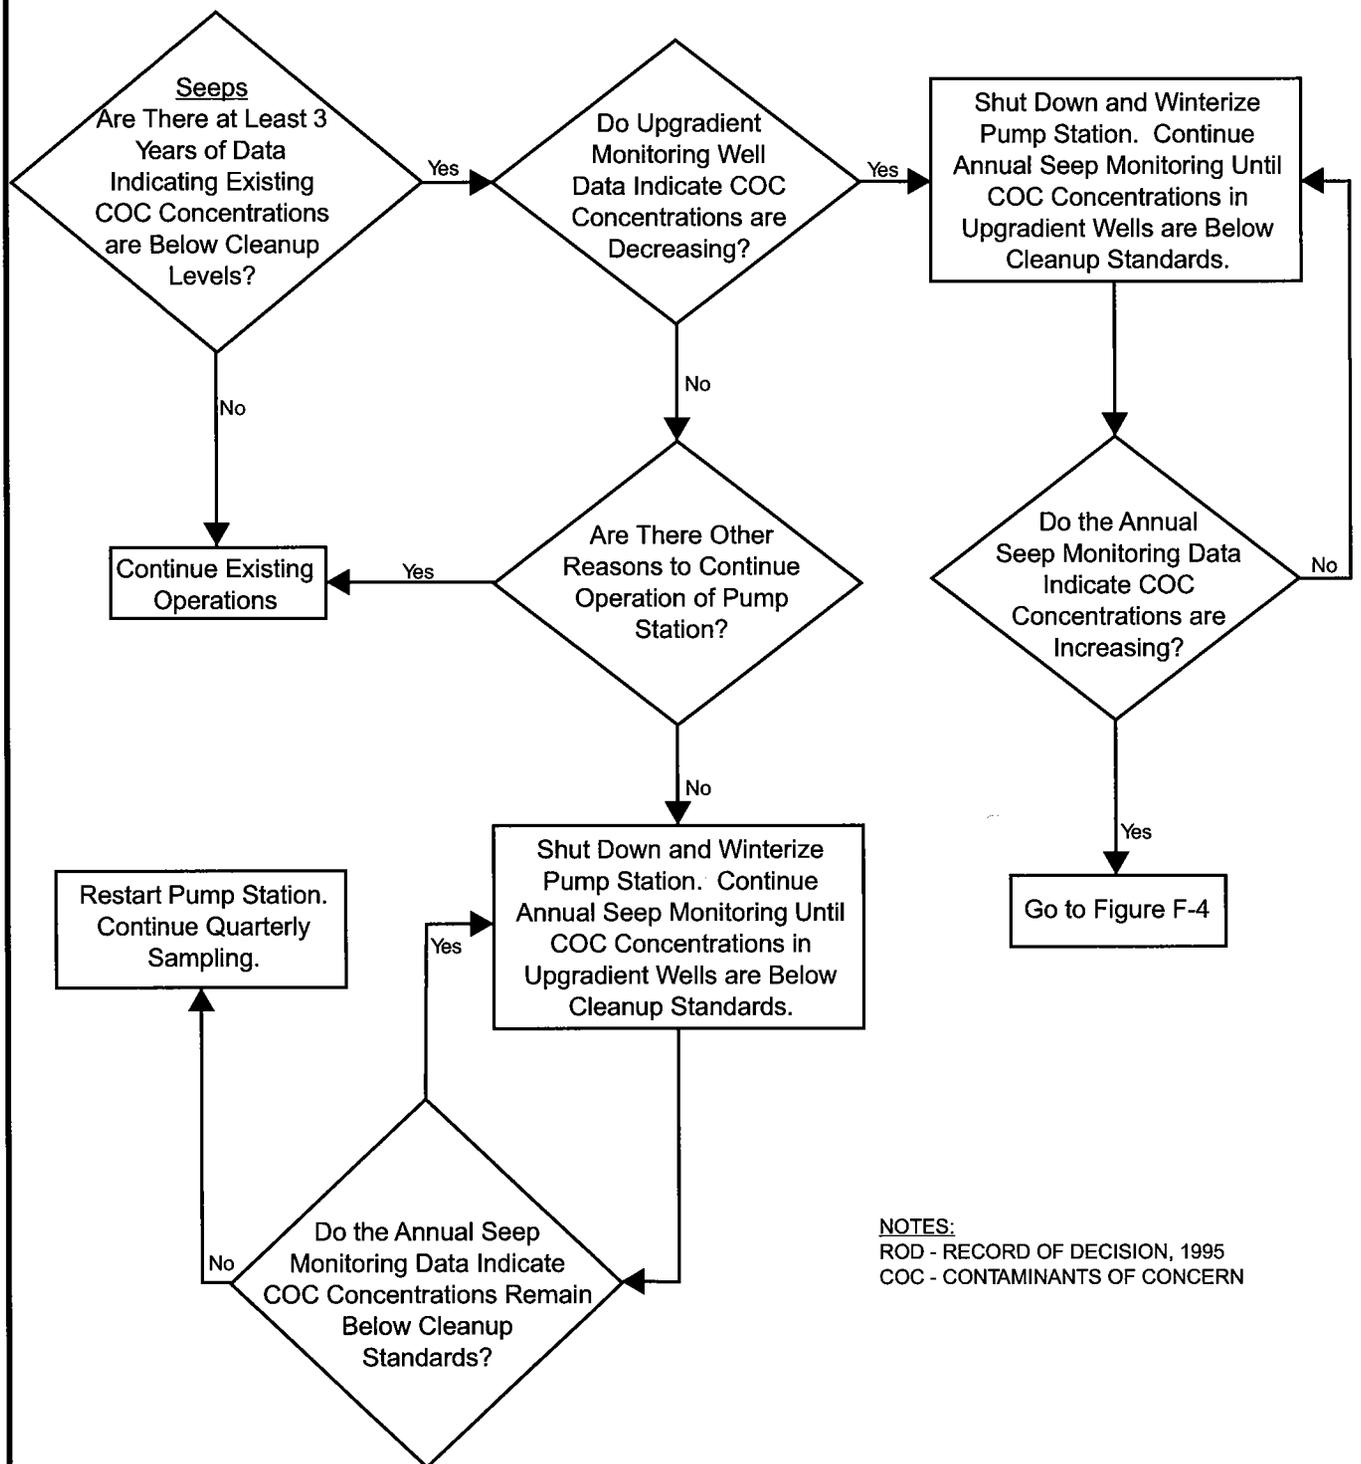
**FIGURE F-3
Decision Guide for
Shutting Down Pump Stations at OU5**

NOTES:
ROD - RECORD OF DECISION, 1995
COC - CONTAMINANTS OF CONCERN

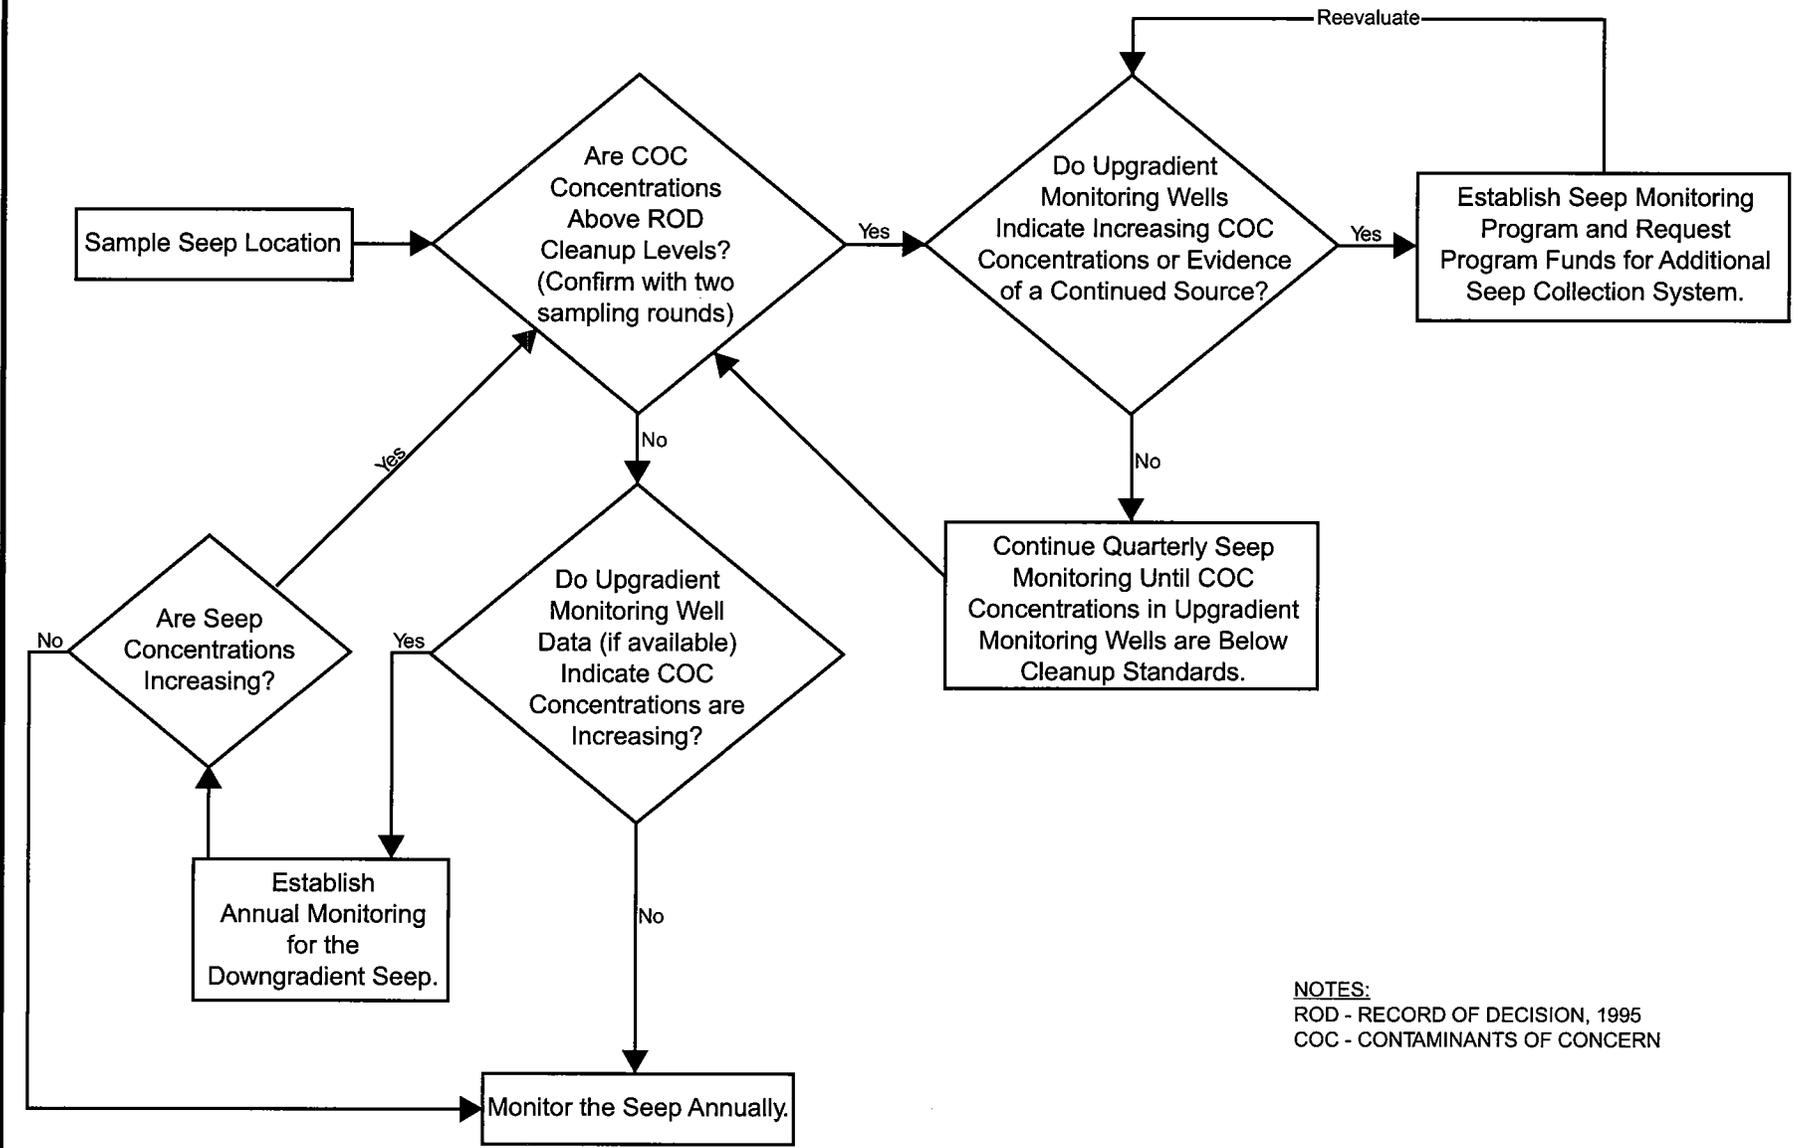
FIGURE F-4
Decision Guide for Restarting an Existing Seep Collection Area or
Adding a New Seep Collection Area for Treatment at OU5

NOTES:
 ROD - RECORD OF DECISION, 1995
 COC - CONTAMINANTS OF CONCERN

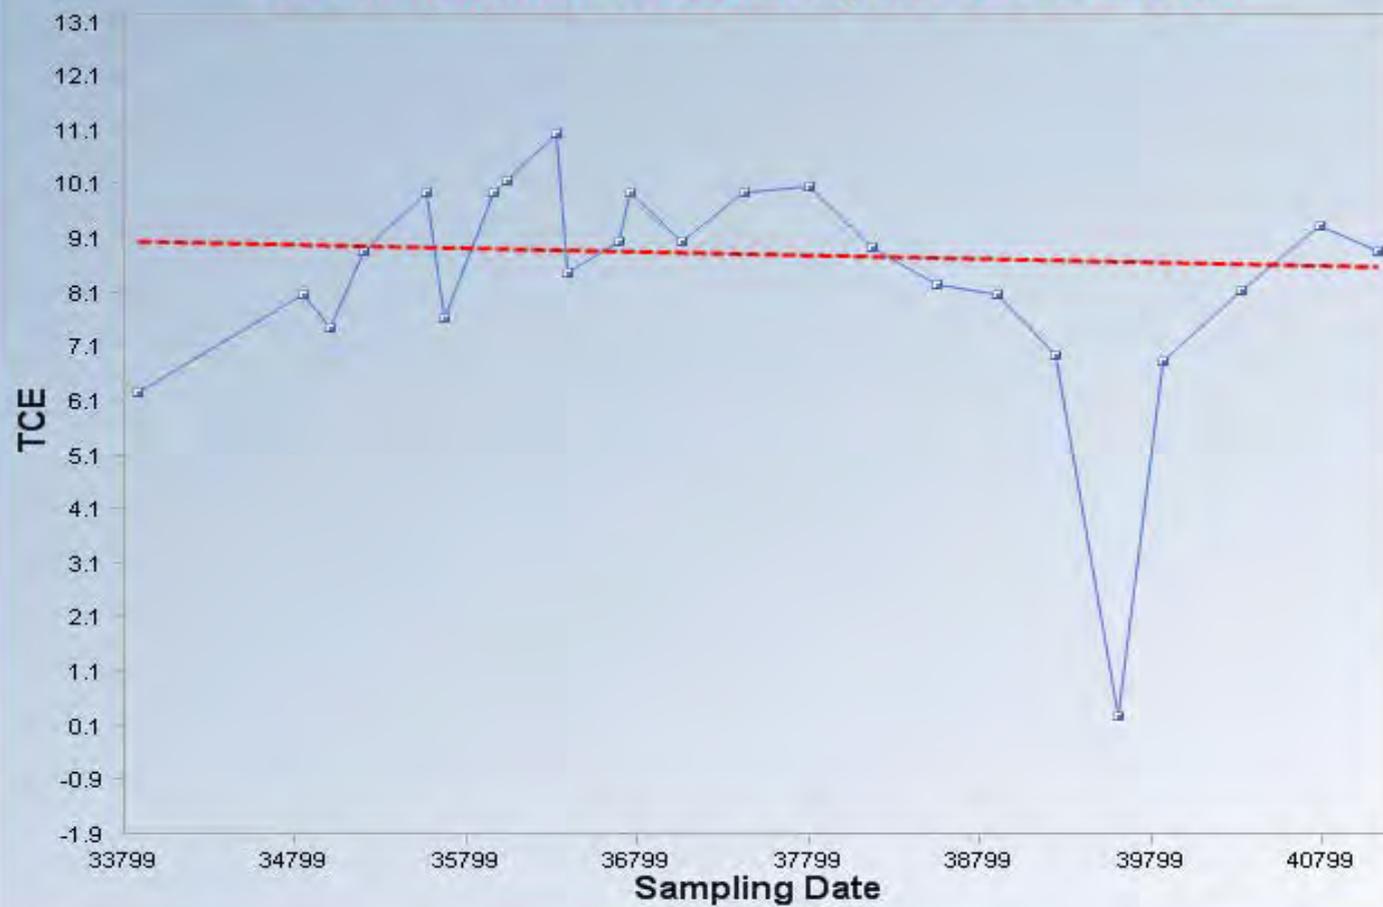
Mann-Kendall Trend Analysis - LF59MW-03

n	24.0000
Confidence Coefficient	0.9500
Level of Significance	0.0500
Test Value (S)	-19
Critical Value (0.05)	-1.6449
Standard Deviation of S	40.1705
Standardized Value of S	-0.4481
Approximate p-value	0.3270

Insufficient evidence to identify a significant trend at the specified level of significance.

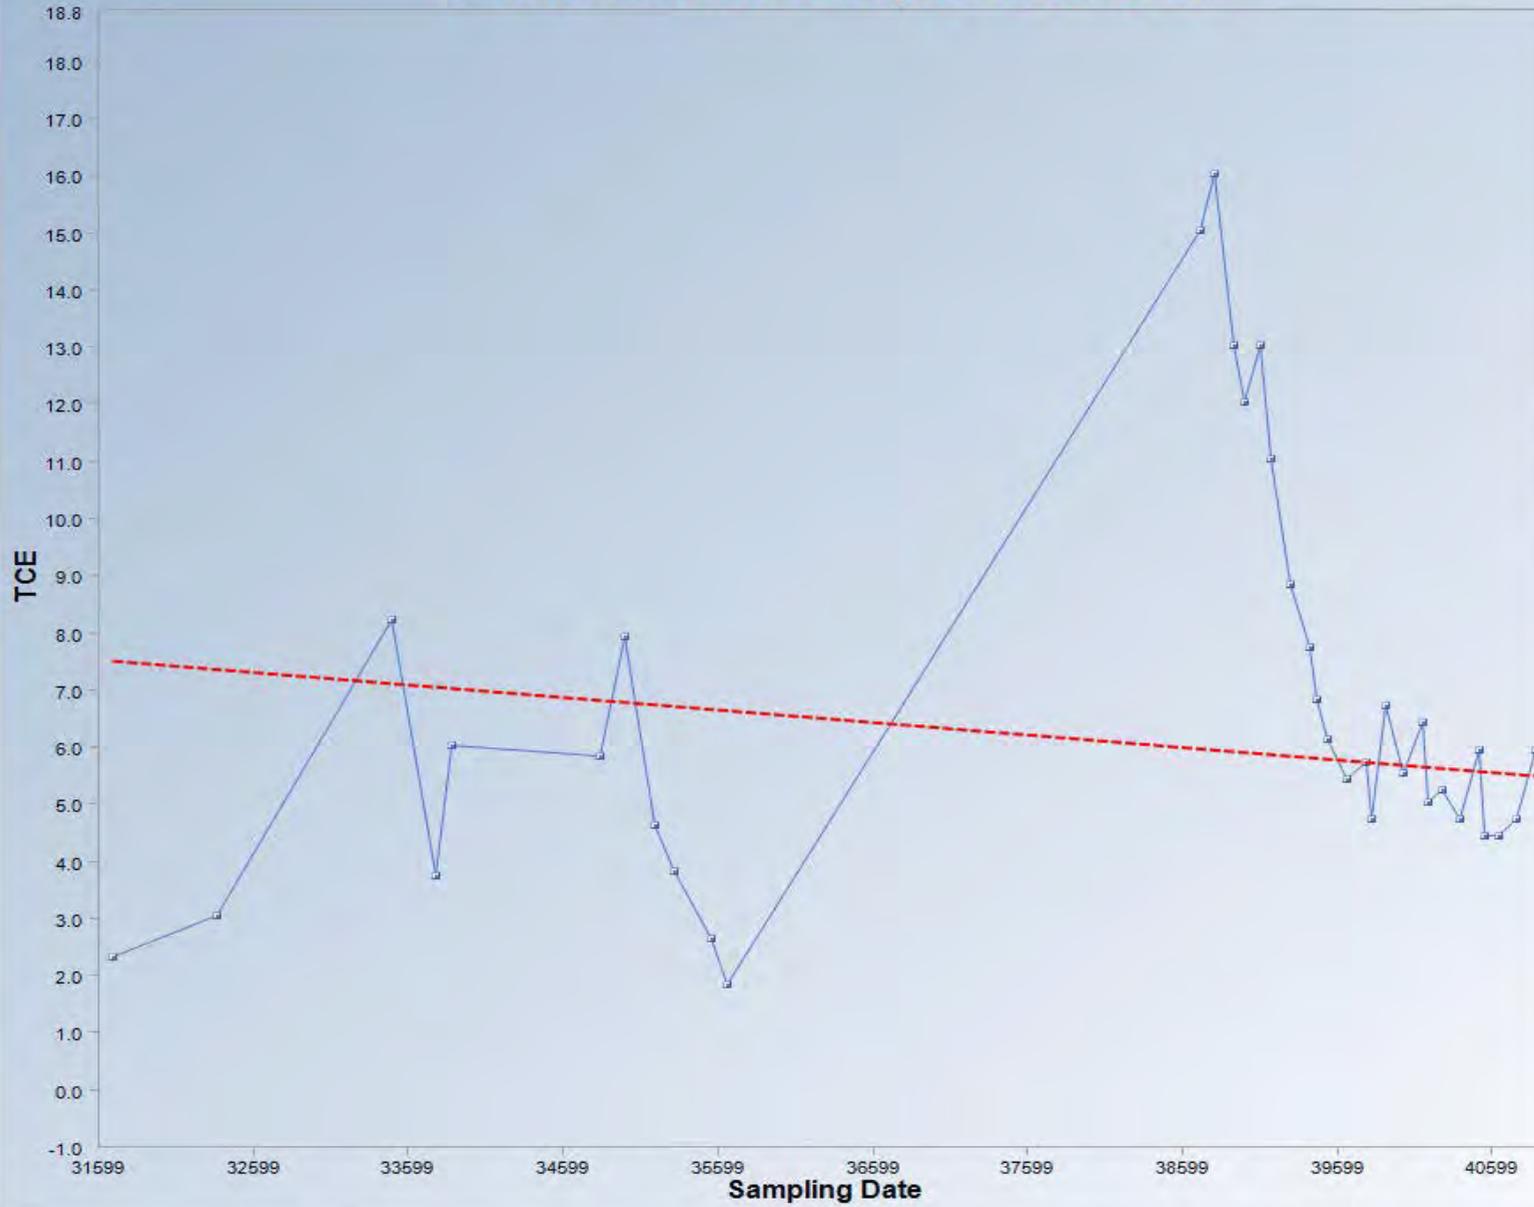
Mann-Kendall Trend Analysis - LF05GW-2B

n	35.0000
Confidence Coefficient	0.9500
Level of Significance	0.0500
Test Value (S)	-59
Critical Value (0.05)	-1.6449
Standard Deviation of S	70.3681
Standardized Value of S	-0.8242
Approximate p-value	0.2049

Insufficient evidence to identify a significant

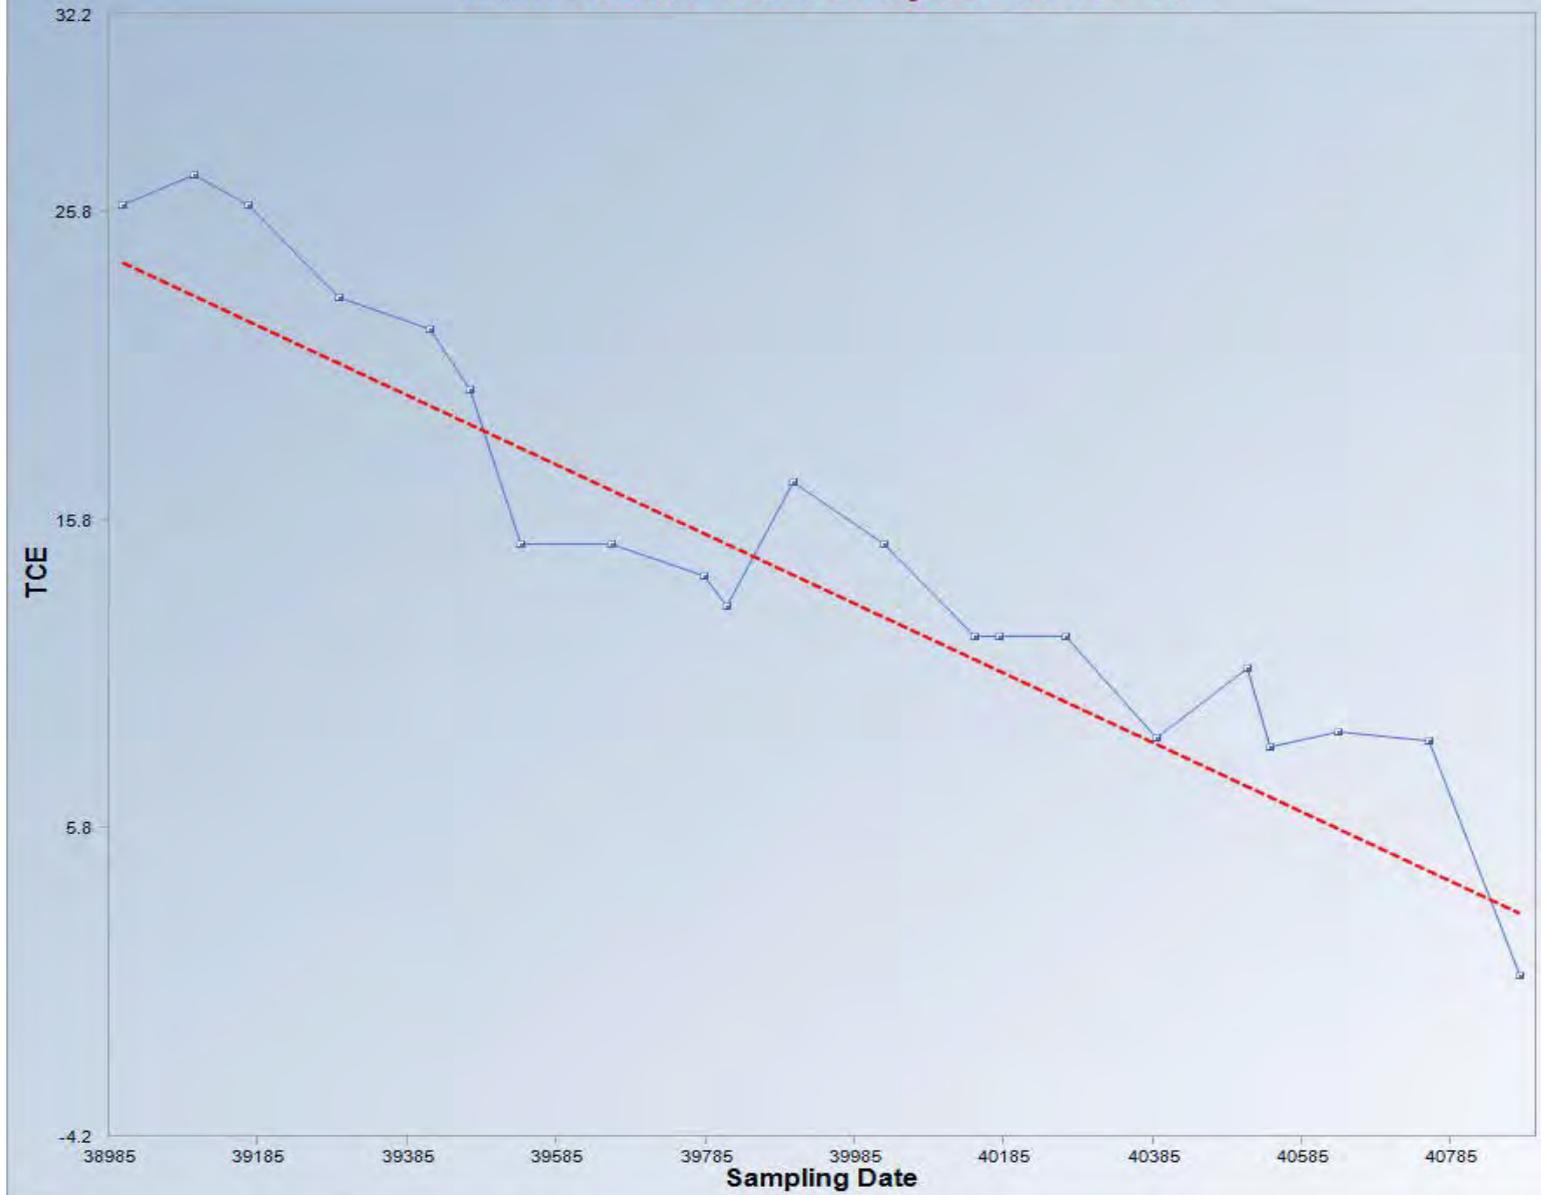
Mann-Kendall Trend Analysis - OU1LF-19

Mann-Kendall Trend Analysis	
n	21.0000
Confidence Coefficient	0.9500
Level of Significance	0.0500
Test Value (S)	-181
Tabulated p-value	0.0000
Standard Deviation of S	32.9899
Standardized Value of S	-5.4562
Approximate p-value	0.0000

Theil-Sen Trend Line = Red	
Theil-Sen Slope	-0.0113
Theil-Sen Intercept	464.3532

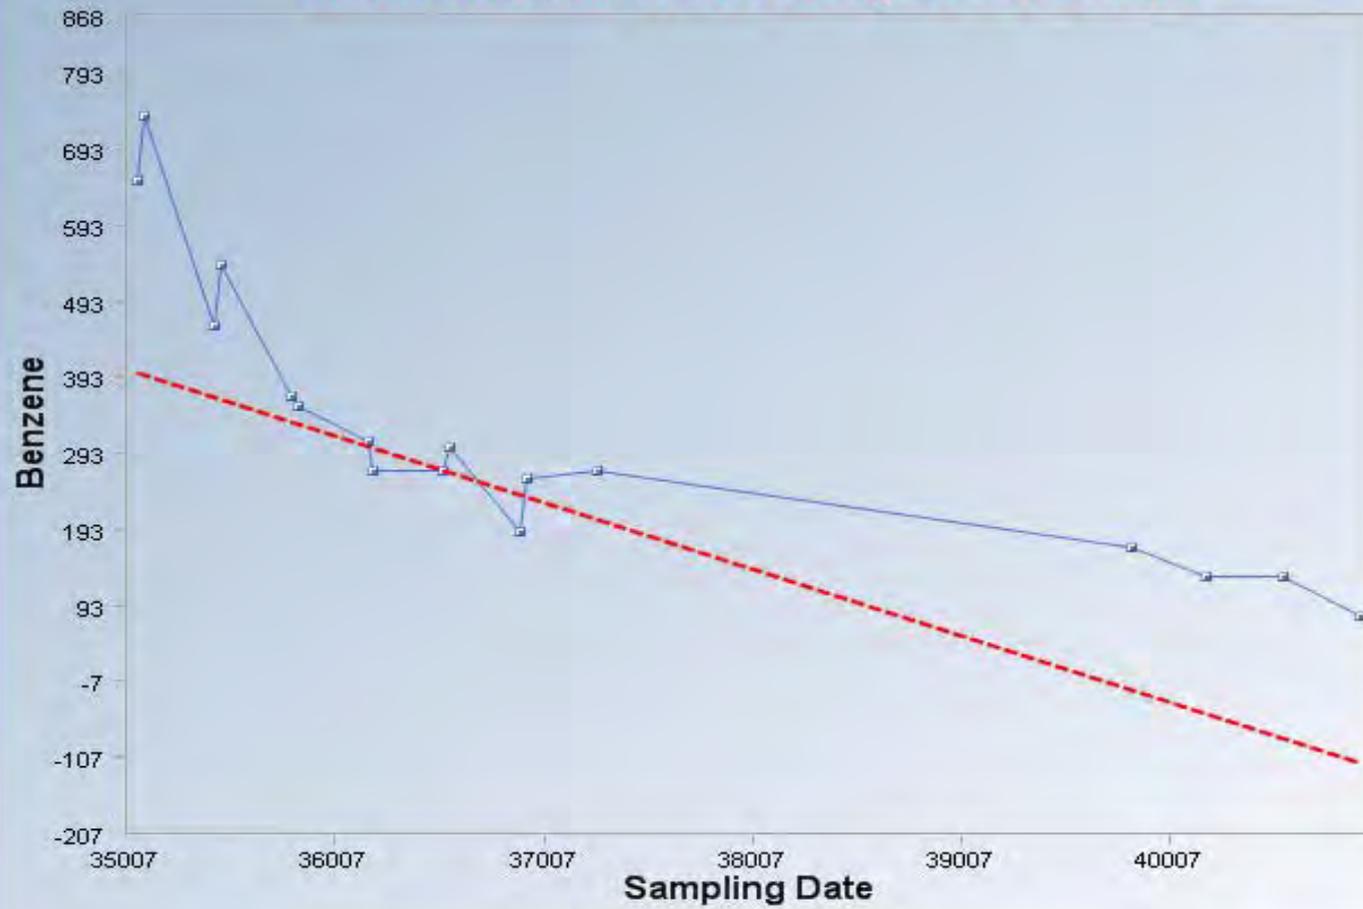
Mann-Kendall Trend Analysis - ST41-28

n	17.0000
Confidence Coefficient	0.9500
Level of Significance	0.0500
Test Value (S)	-118
Tabulated p-value	0.0000
Standard Deviation of S	24.1799
Standardized Value of S	-4.8387
Approximate p-value	0.0000

Statistically significant evidence of a decreasing trend at the specified level of significance.

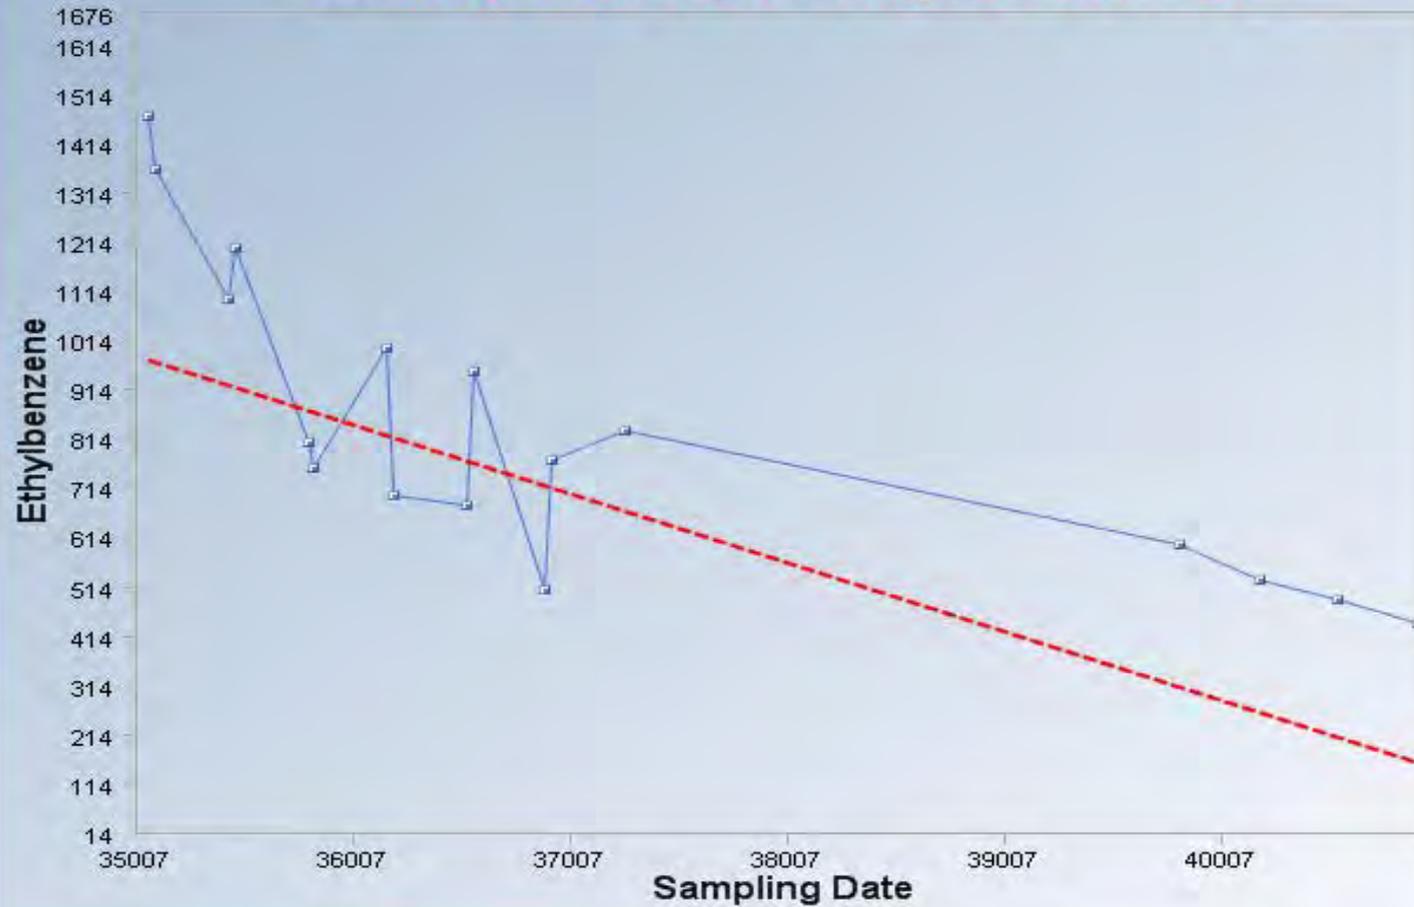
Mann-Kendall Trend Analysis - ST41-28

n	17.0000
Confidence Coefficient	0.9500
Level of Significance	0.0500
Test Value (S)	-98
Tabulated p-value	0.0000
Standard Deviation of S	24.2762
Standardized Value of S	-3.9957
Approximate p-value	0.0000

Mann-Kendall Test
Test Value (S) -98
Tabulated p-value 0
Standard Deviation of S 24.28
Standardized Value of S -3.996
Approximate p-value 3.23E-05

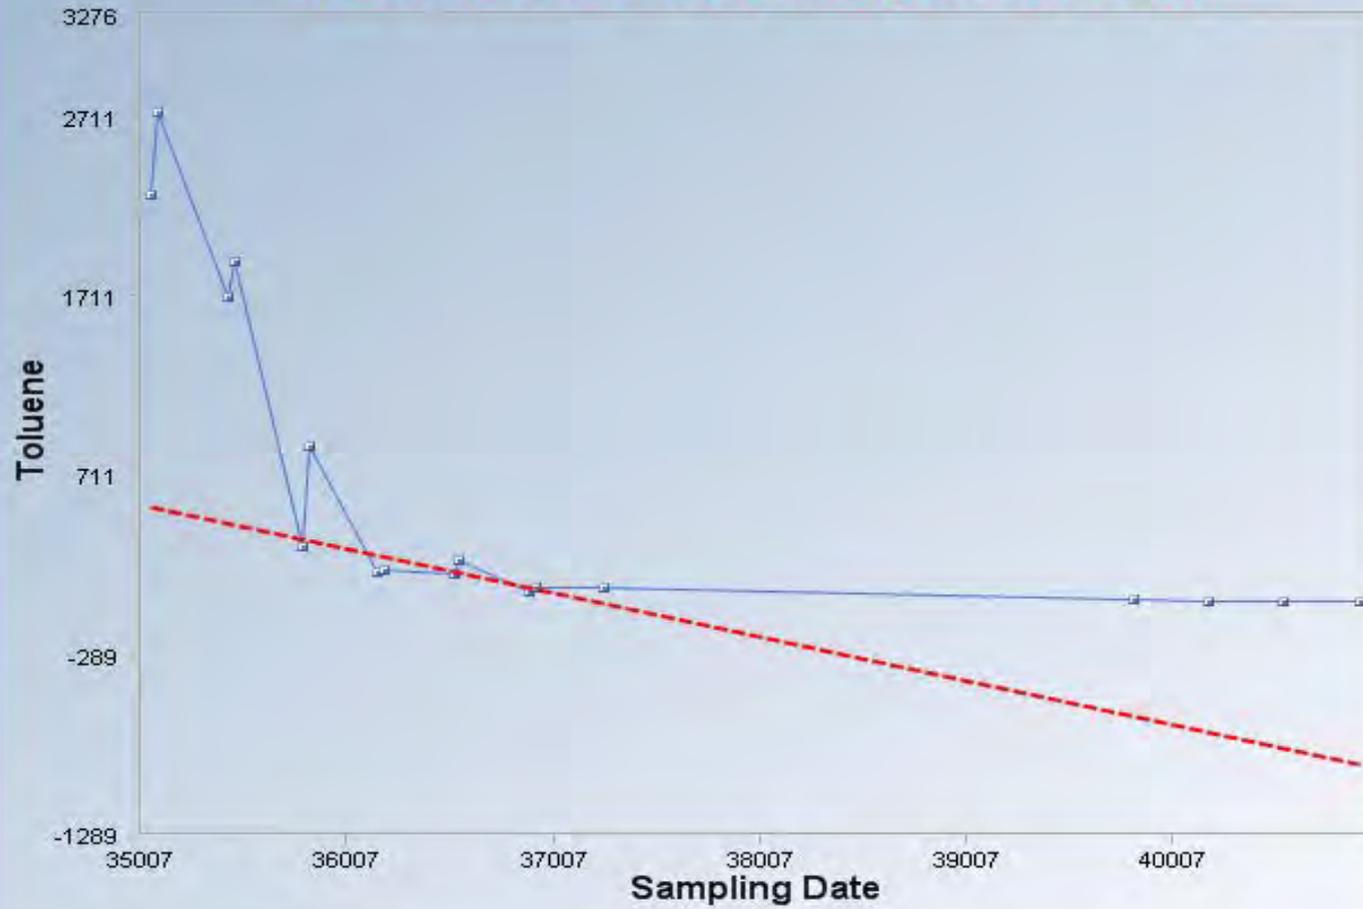
Mann-Kendall Trend Analysis - ST41-28

Mann-Kendall Trend Analysis	
n	17.0000
Confidence Coefficient	0.9500
Level of Significance	0.0500
Test Value (S)	-118
Tabulated p-value	0.0000
Standard Deviation of S	24.2762
Standardized Value of S	-4.8195
Approximate p-value	0.0000

Theil-Sen Trend Line = Red	
Theil-Sen Slope	-0.2457
Theil-Sen Intercept	9,142.6976

Statistically significant evidence of a decreasing trend at the specified level of significance.

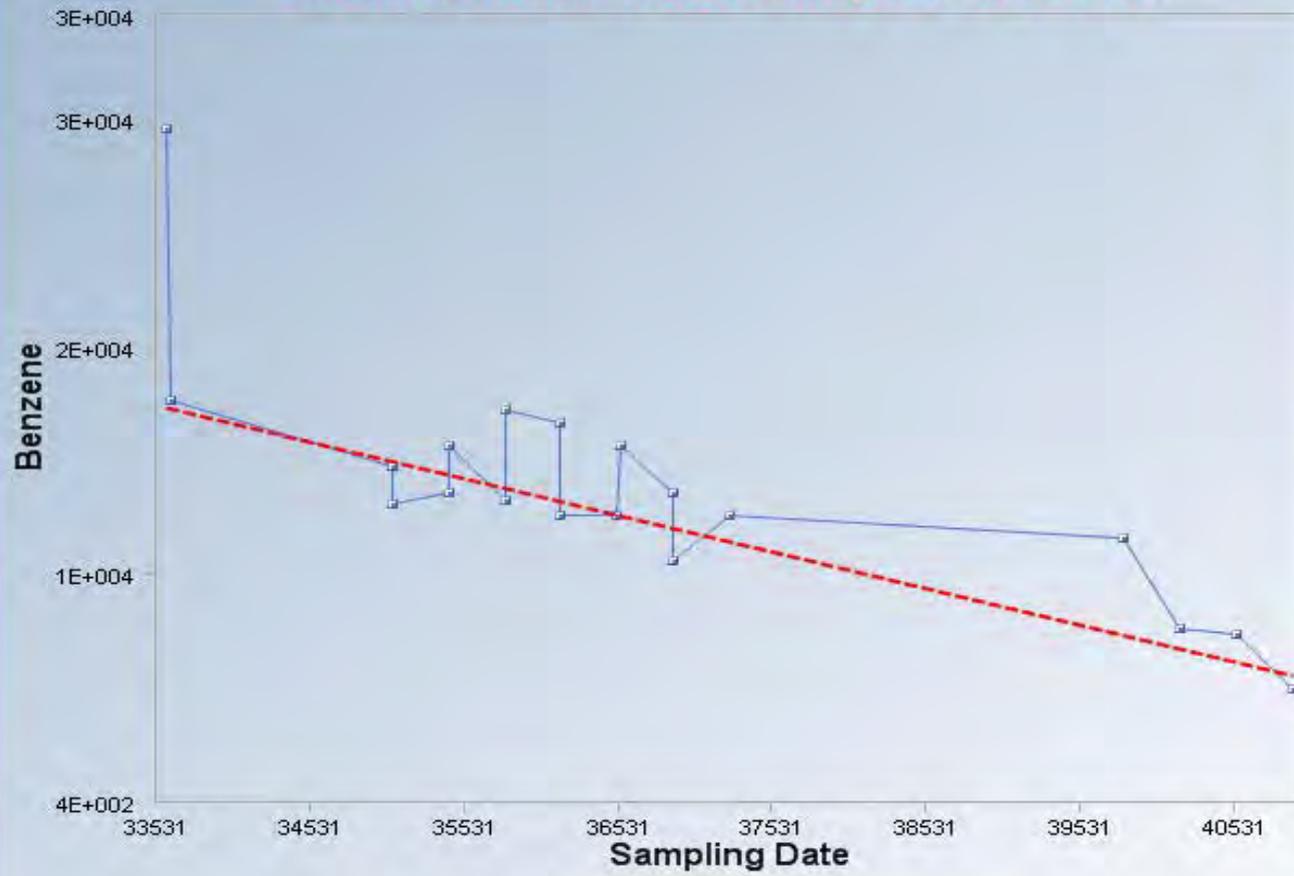
Mann-Kendall Trend Analysis - ST41-16

Mann-Kendall Trend Analysis	
n	19.0000
Confidence Coefficient	0.9500
Level of Significance	0.0500
Test Value (S)	-112
Tabulated p-value	0.0000
Standard Deviation of S	28.4839
Standardized Value of S	-3.8969
Approximate p-value	0.0000

Theil-Sen Trend Line = Red	
Theil-Sen Slope	-1.6124
Theil-Sen Intercept	71,908.0621

Statistically significant evidence of a decreasing trend at the specified level of significance.

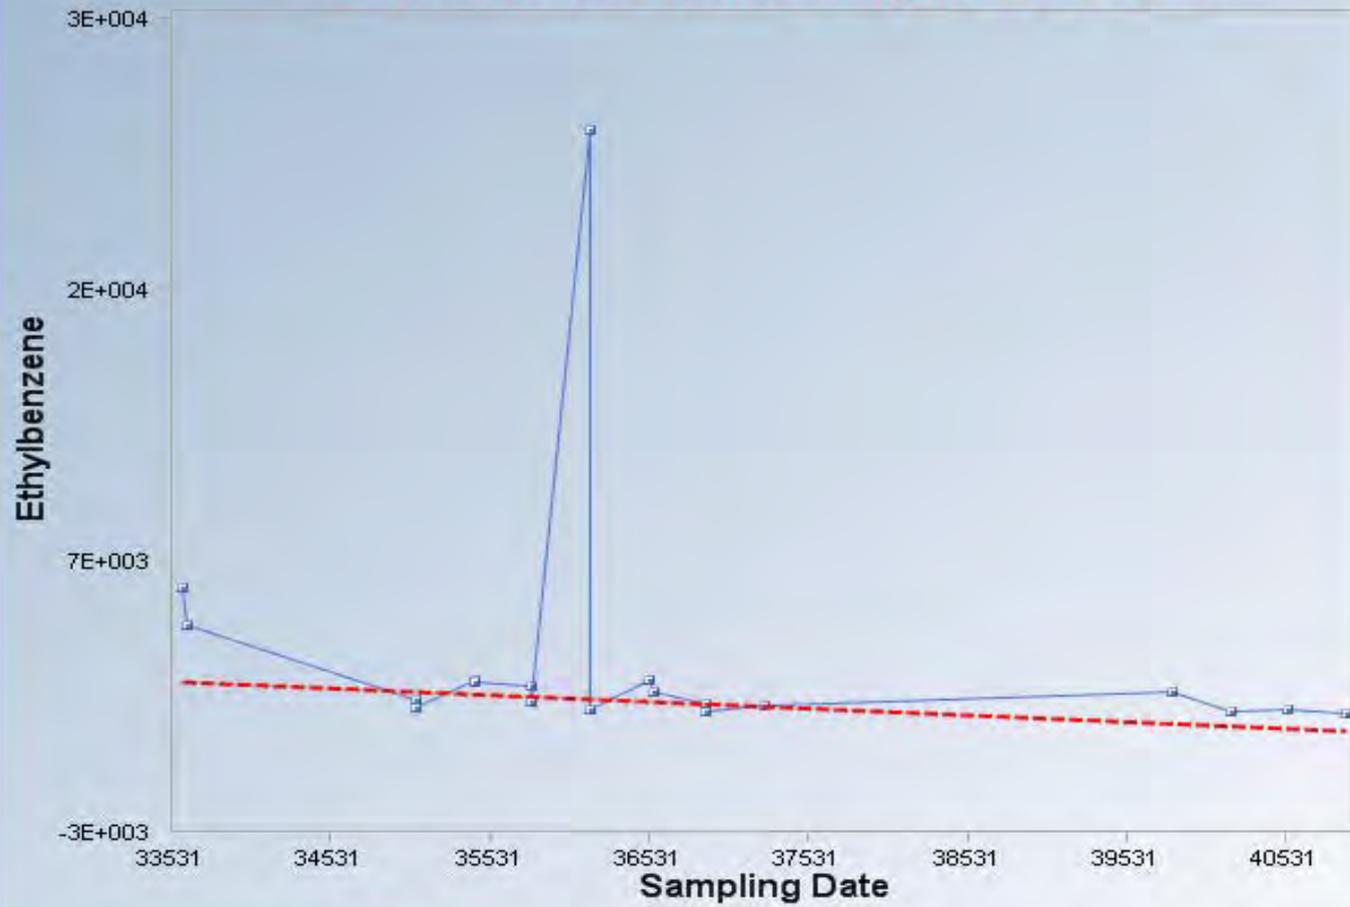
Mann-Kendall Trend Analysis - ST41-16

n	19.0000
Confidence Coefficient	0.9500
Level of Significance	0.0500
Test Value (S)	-89
Tabulated p-value	0.0010
Standard Deviation of S	28.5132
Standardized Value of S	-3.0863
Approximate p-value	0.0010

Statistically significant evidence of a decreasing trend at the specified level of significance.

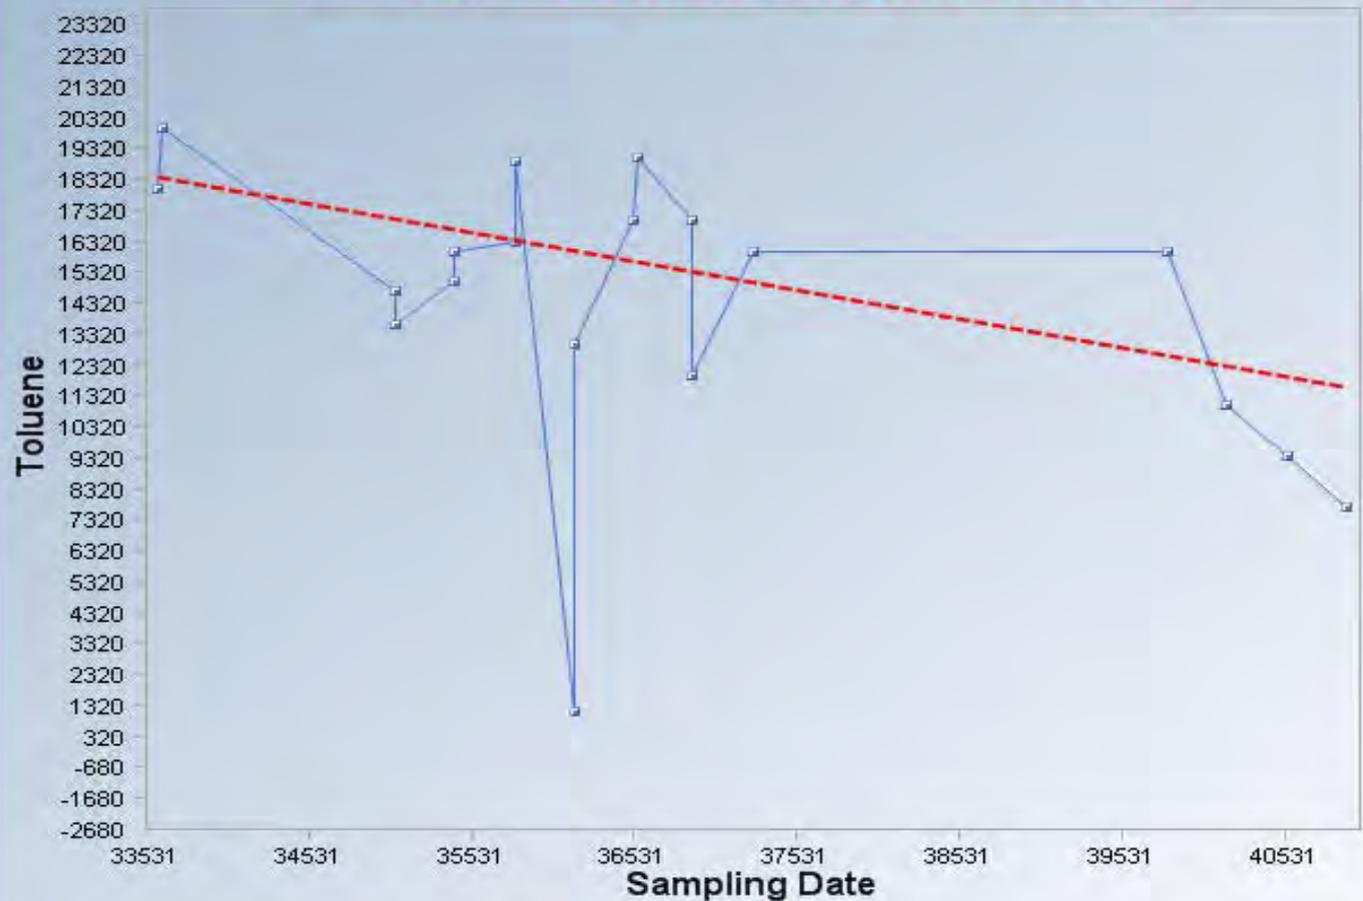
Mann-Kendall Trend Analysis - ST41-16

Mann-Kendall Trend Analysis	
n	19.0000
Confidence Coefficient	0.9500
Level of Significance	0.0500
Test Value (S)	-53
Tabulated p-value	0.0340
Standard Deviation of S	28.5015
Standardized Value of S	-1.8245
Approximate p-value	0.0340

Theil-Sen Trend Line = Red	
Theil-Sen Slope	-0.9211
Theil-Sen Intercept	49,308.5662

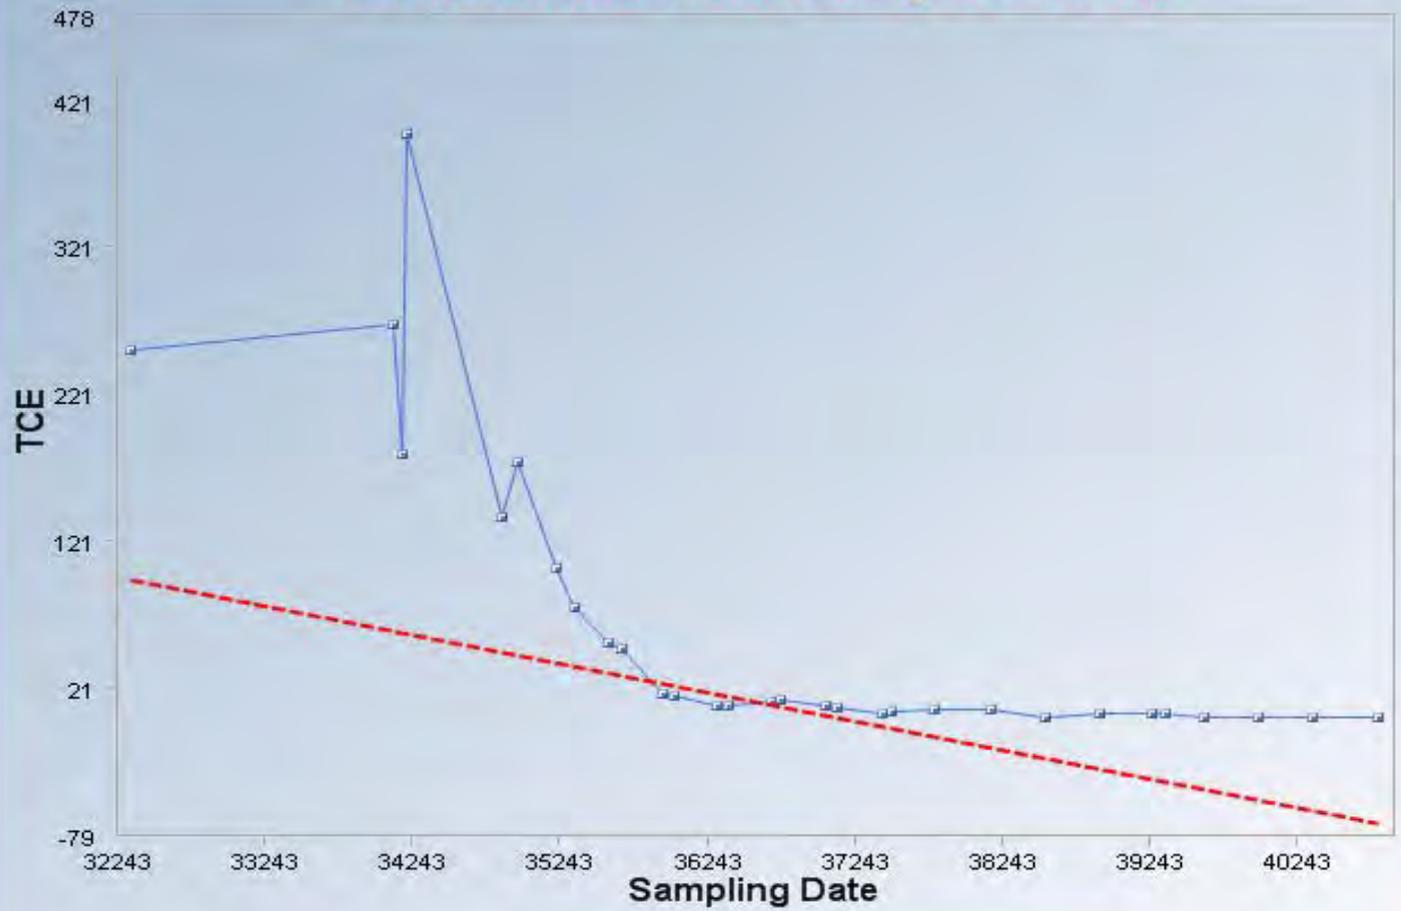
Mann-Kendall Trend Analysis - FP-56

Mann-Kendall Trend Analysis	
n	30.0000
Confidence Coefficient	0.9500
Level of Significance	0.0500
Test Value (S)	-386
Critical Value (0.05)	-1.6449
Standard Deviation of S	56.0417
Standardized Value of S	-6.8699
Approximate p-value	0.0000

Theil-Sen Trend Line = Red	
Theil-Sen Slope	-0.0195
Theil-Sen Intercept	724.6451

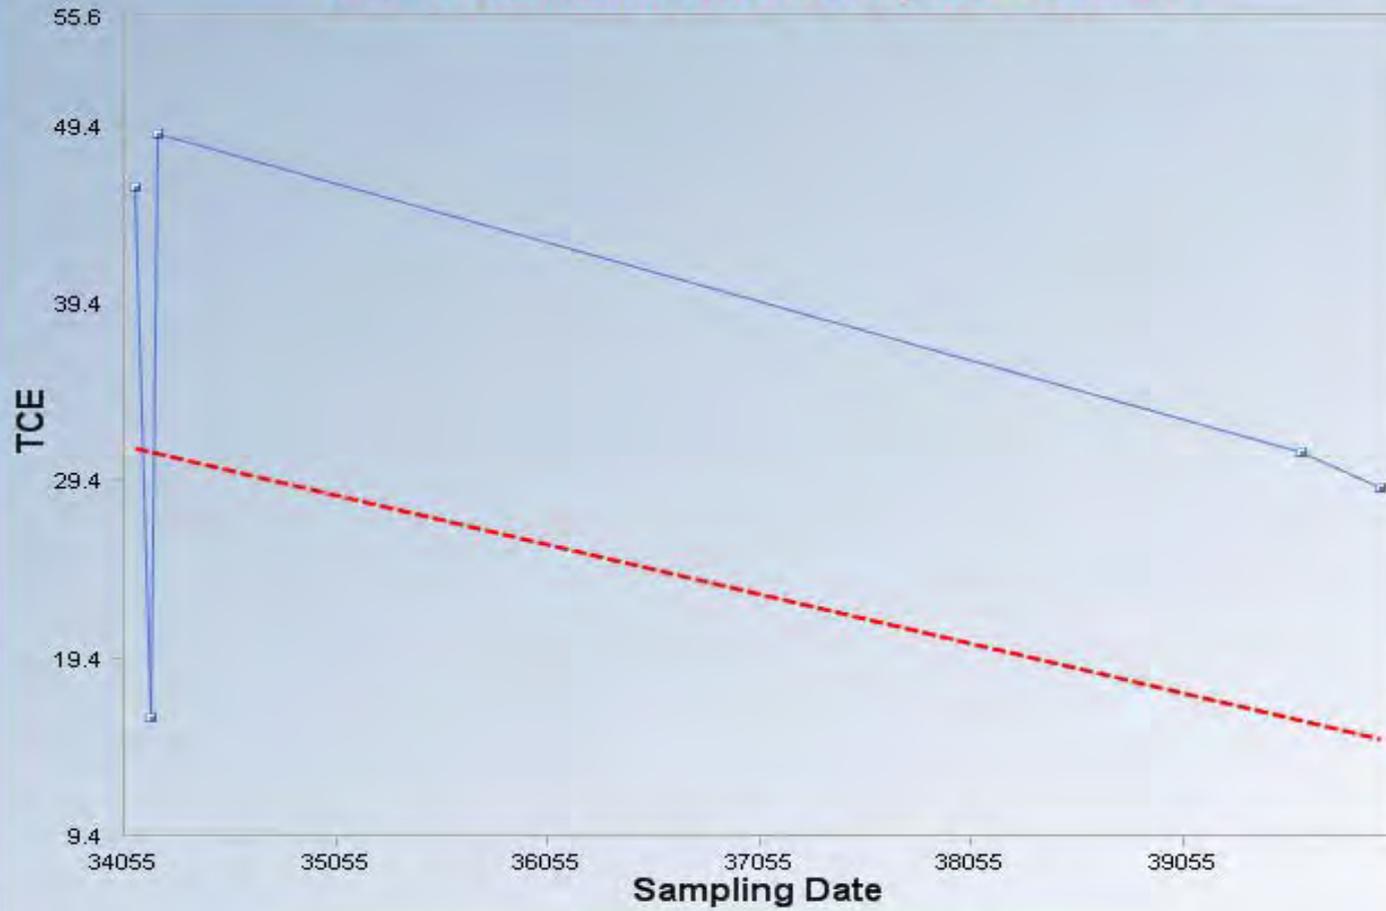
Mann-Kendall Trend Analysis - GW-5A

Mann-Kendall Trend Analysis

n	5.0000
Confidence Coefficient	0.9500
Level of Significance	0.0500
Test Value (S)	-2
Tabulated p-value	0.4080
Standard Deviation of S	4.0825
Standardized Value of S	-0.2449
Approximate p-value	0.4032
