ENVIRONMENTAL RESTORATION PROGRAM

**FOURTH CERCLA FIVE-YEAR REVIEW
REPORT**

JBER-ELMENDORF, ALASKA

**FINAL
MARCH 2014**

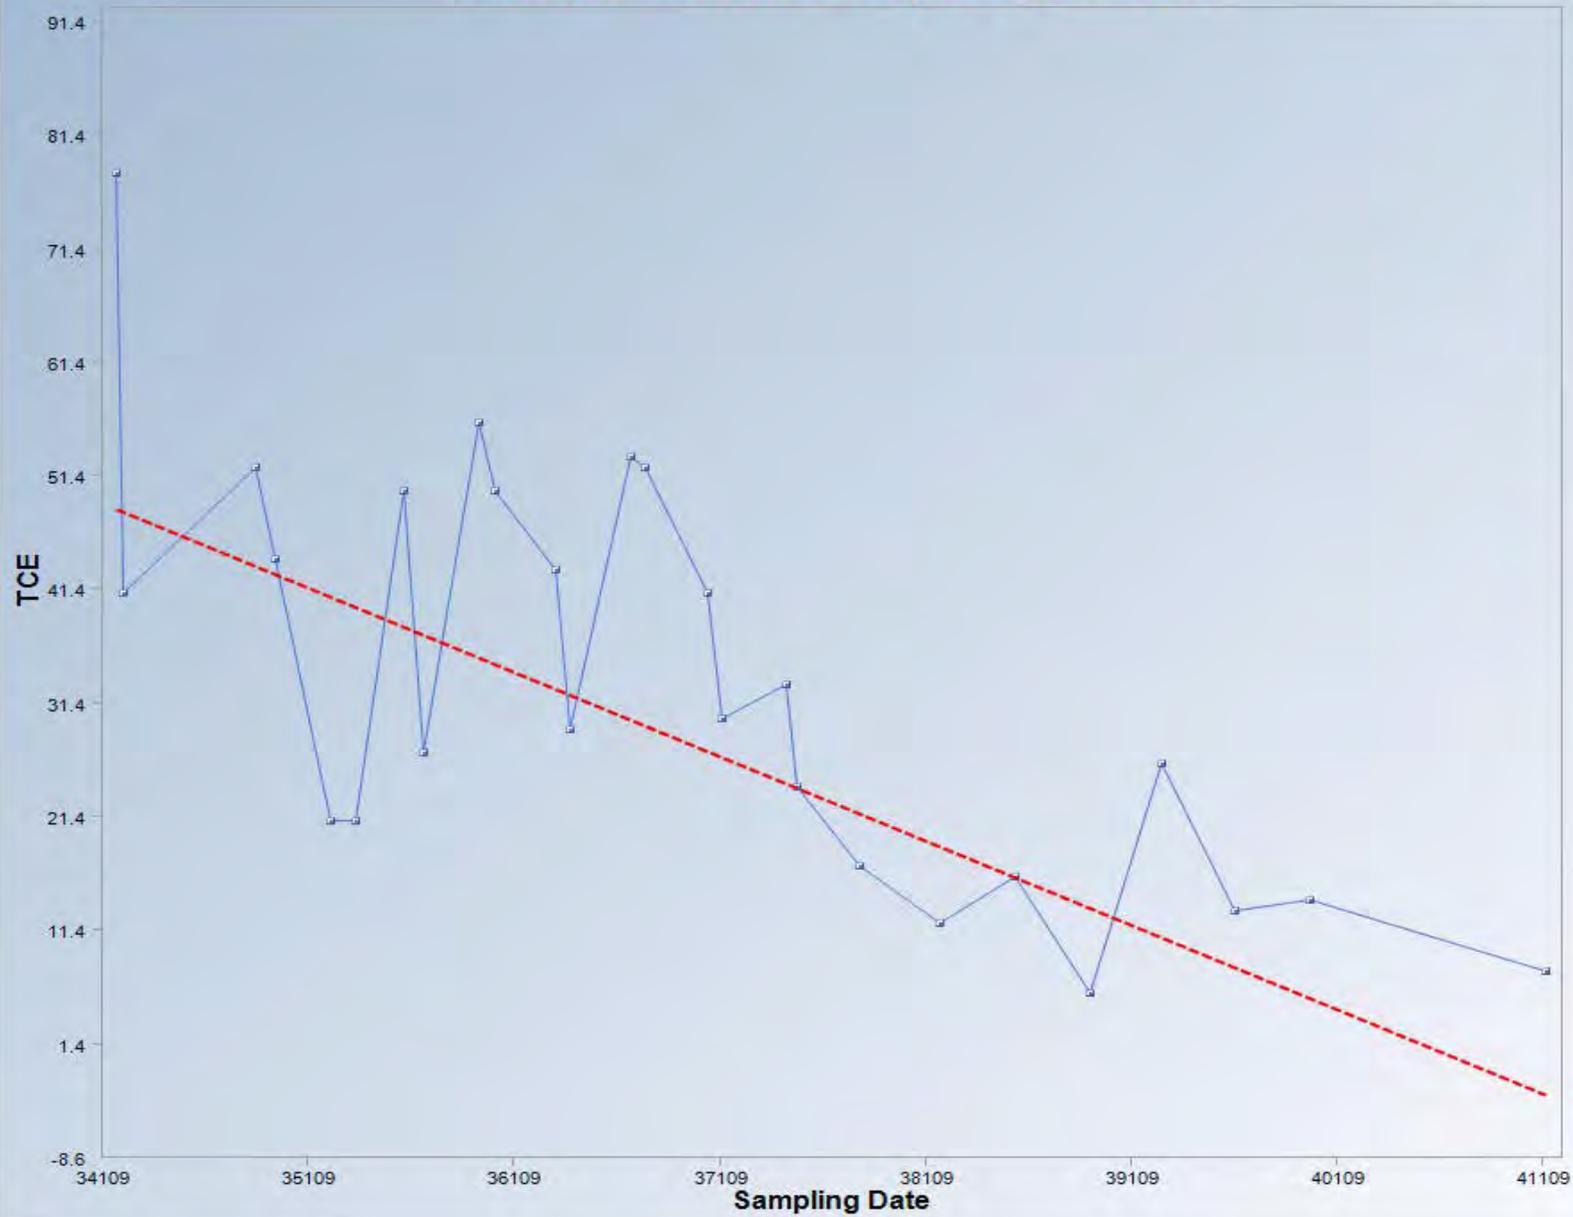
Mann-Kendall Trend Analysis - OU4MW-11

Mann-Kendall Trend Analysis	
n	26.0000
Confidence Coefficient	0.9600
Level of Significance	0.0500
Test Value (S)	-171
Critical Value (0.05)	-1.6449
Standard Deviation of S	45.3248
Standardized Value of S	-3.7507
Approximate p-value	0.0001

Theil-Sen Trend Line = Red	
Theil-Sen Slope	-0.0074
Theil-Sen Intercept	302.1213

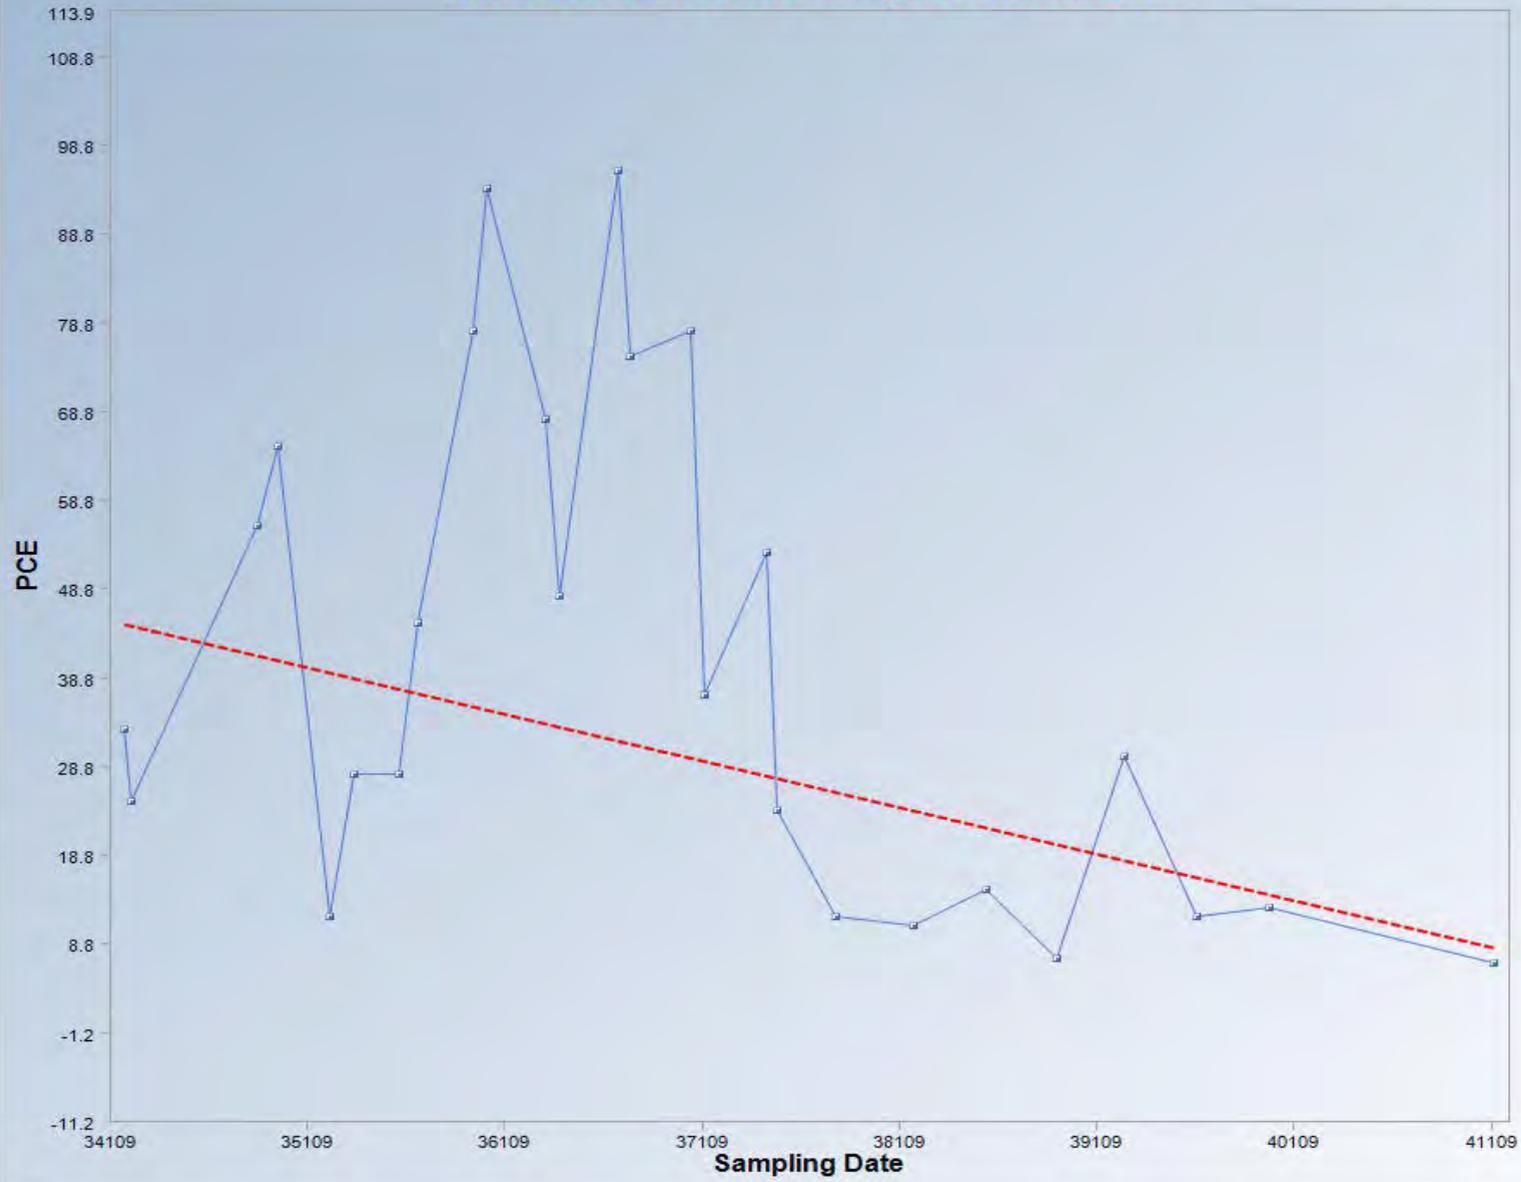
Mann-Kendall Trend Analysis - OU4MW-11

Mann-Kendall Trend Analysis

n	26.0000
Confidence Coefficient	0.9500
Level of Significance	0.0500
Test Value (S)	-98
Critical Value (0.05)	-1.6449
Standard Deviation of S	45.3064
Standardized Value of S	-2.1410
Approximate p-value	0.0161

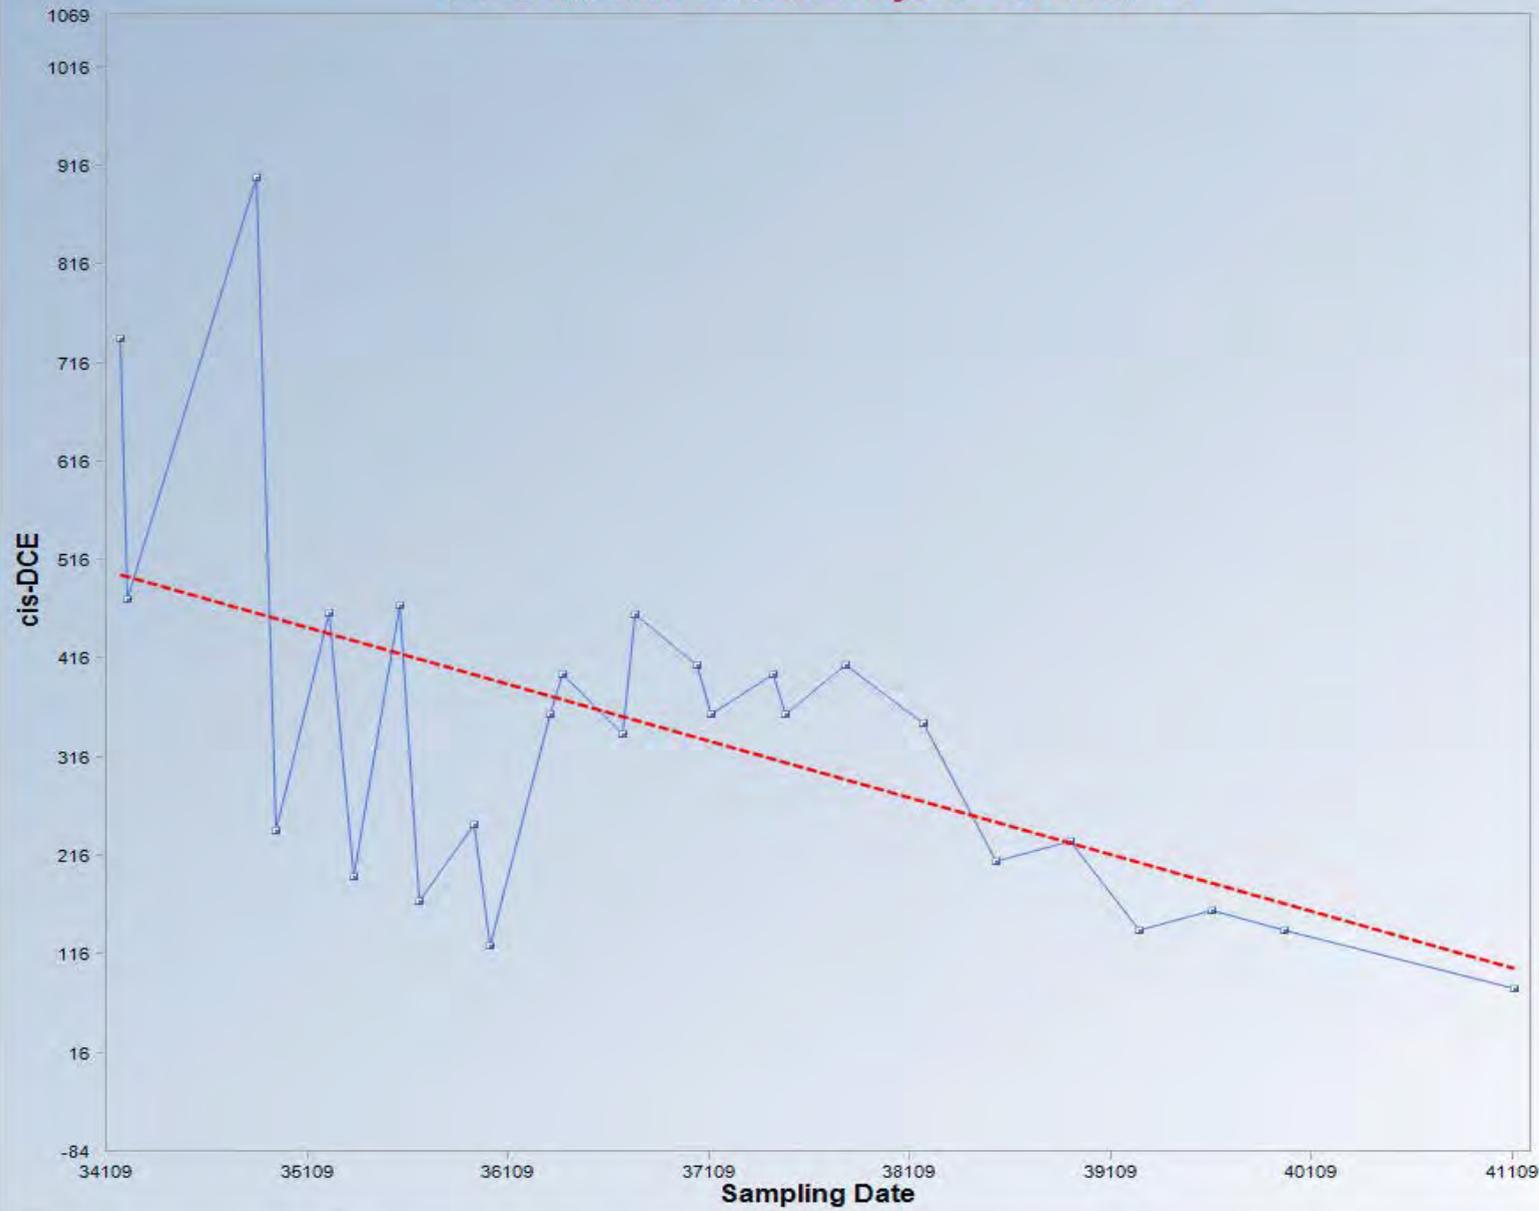
Mann-Kendall Trend Analysis - OU4MW-11

Mann-Kendall Trend Analysis	
n	26.0000
Confidence Coefficient	0.9500
Level of Significance	0.0500
Test Value (S)	-141
Critical Value (0.05)	-1.6449
Standard Deviation of S	45.2953
Standardized Value of S	-3.0908
Approximate p-value	0.0010

Theil-Sen Trend Line = Red	
Theil-Sen Slope	-0.0574
Theil-Sen Intercept	2,461.6406

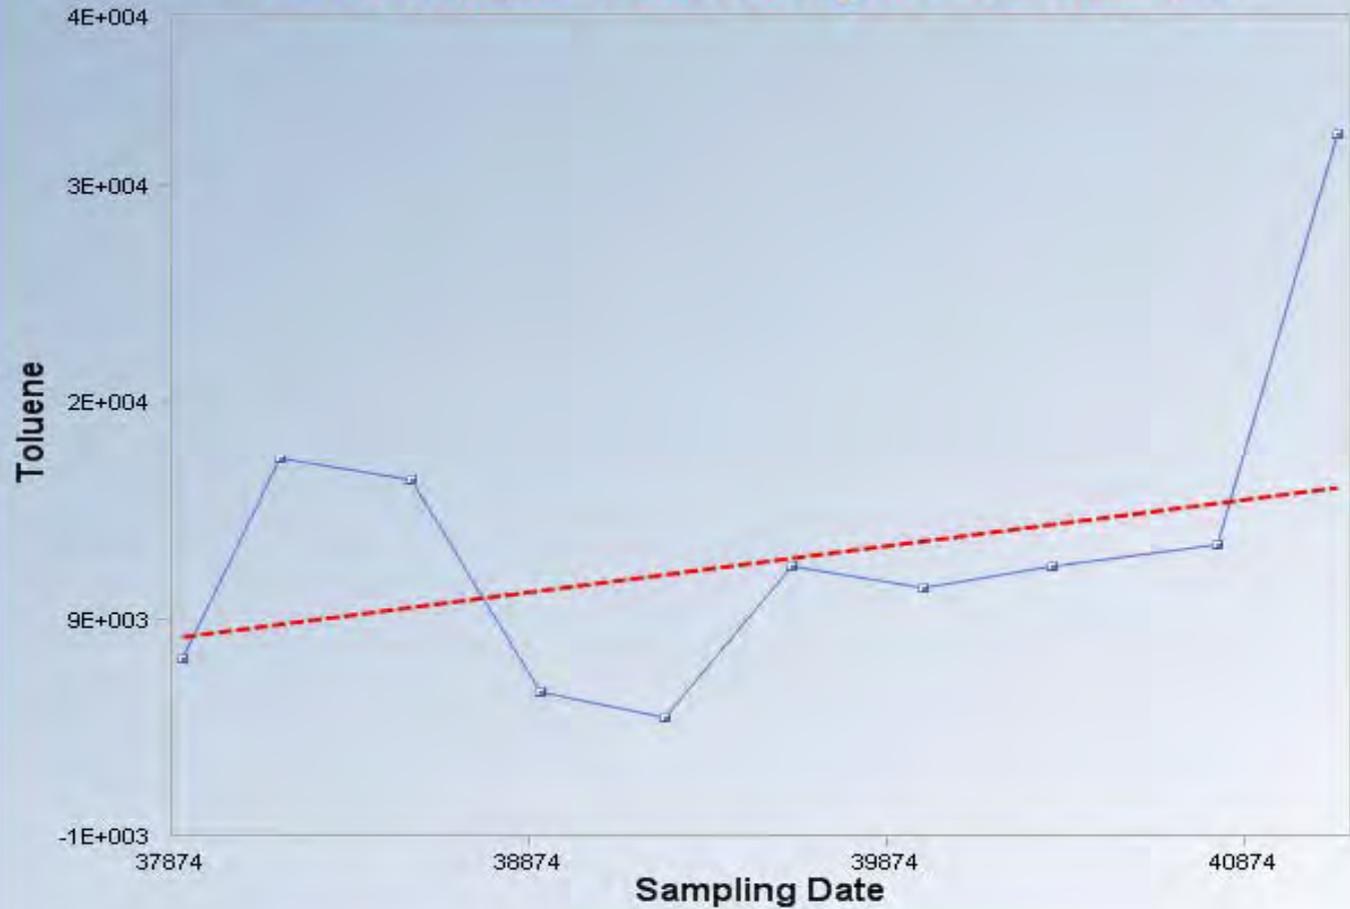
Mann-Kendall Trend Analysis - OU4MW-08R

Mann-Kendall Trend Analysis

n	10.0000
Confidence Coefficient	0.9500
Level of Significance	0.0500
Test Value (S)	10
Tabulated p-value	0.1900
Standard Deviation of S	11.1355
Standardized Value of S	0.8082
Approximate p-value	0.2095

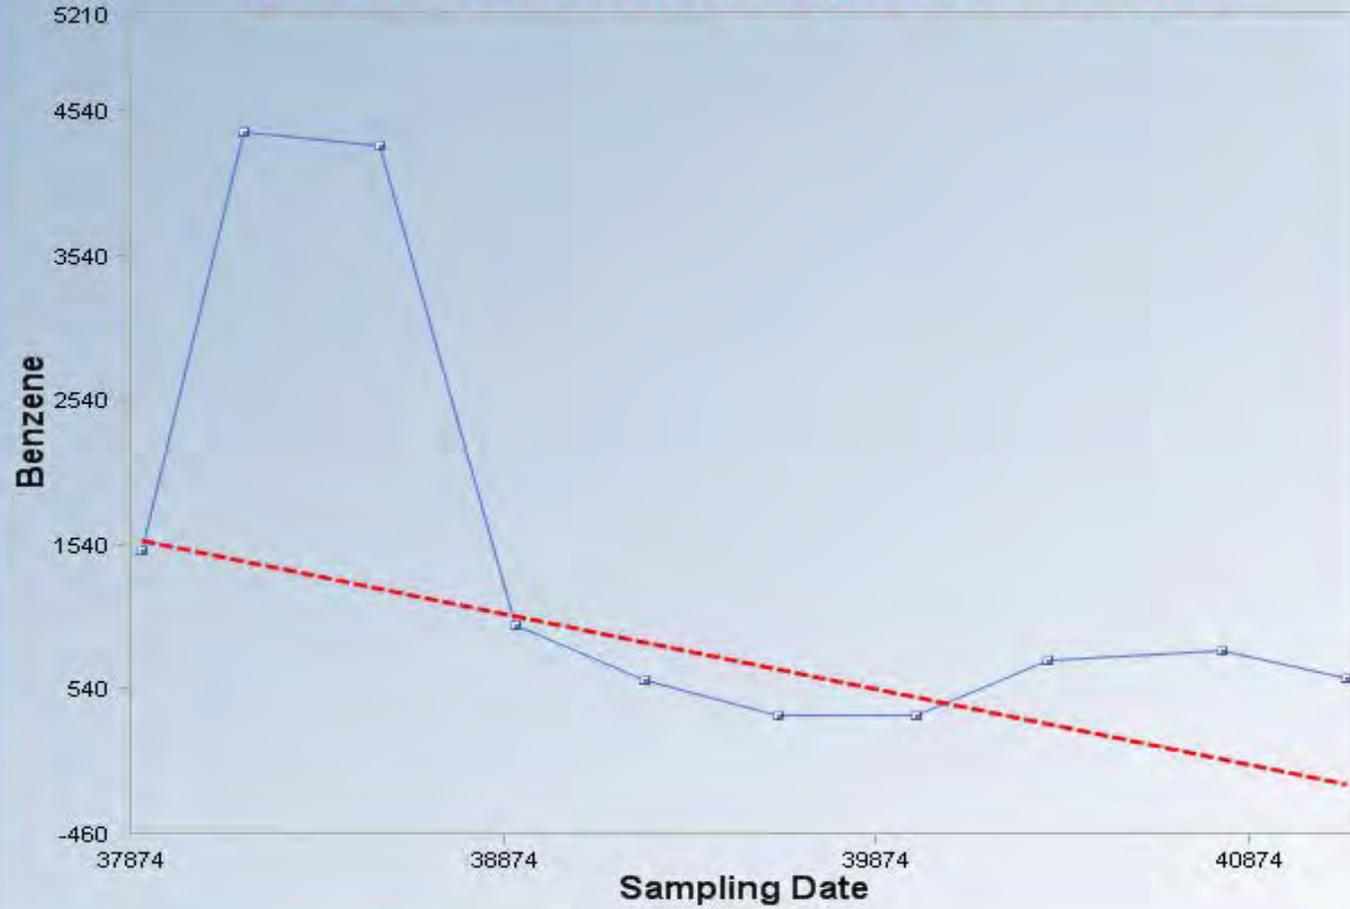
Mann-Kendall Trend Analysis - OU4MW-08R

Mann-Kendall Trend Analysis

n	10.0000
Confidence Coefficient	0.9500
Level of Significance	0.0500
Test Value (S)	-19
Tabulated p-value	0.0540
Standard Deviation of S	11.1803
Standardized Value of S	-1.6100
Approximate p-value	0.0537

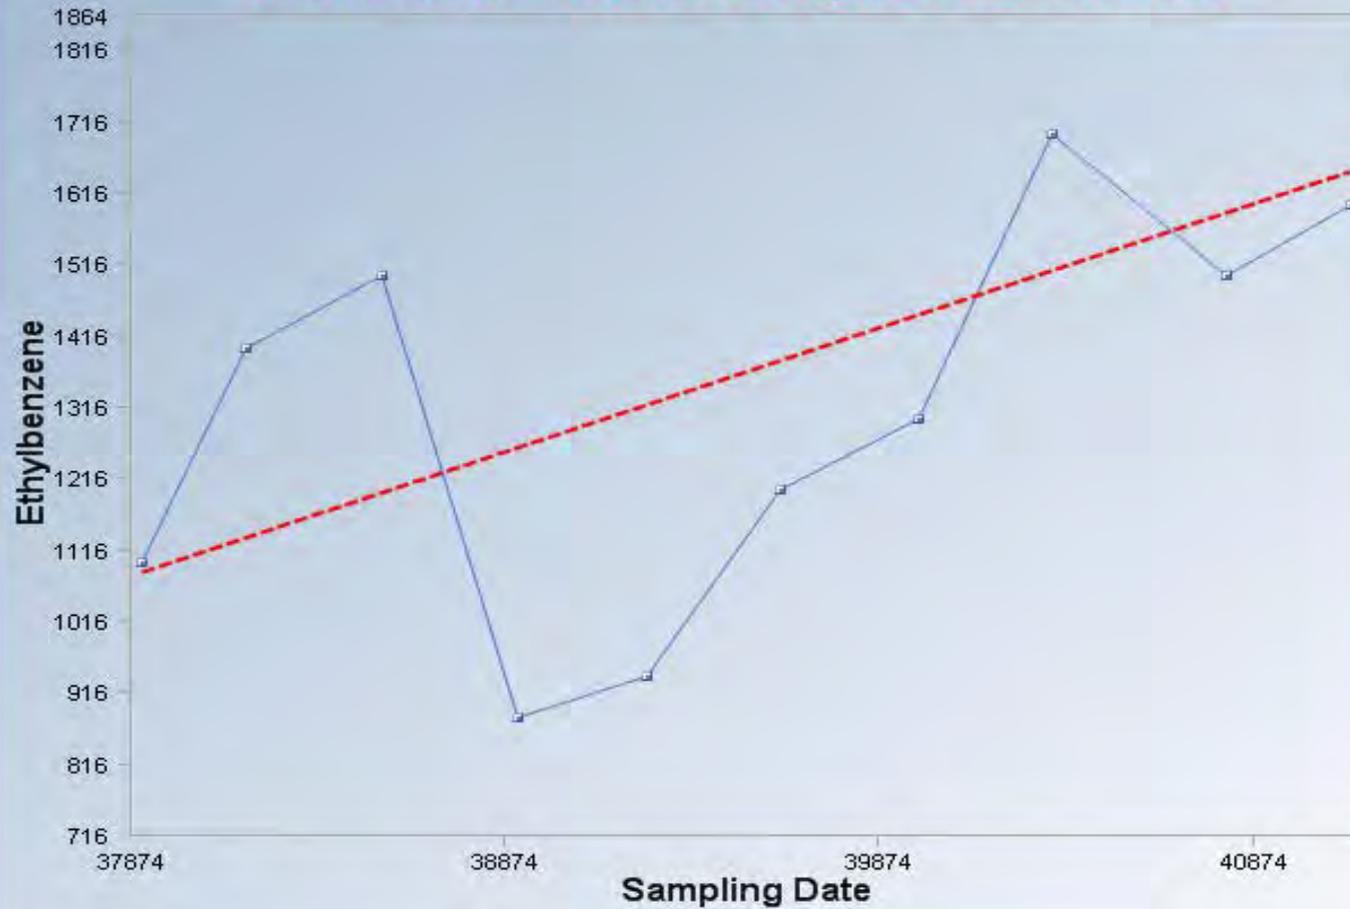
Mann-Kendall Trend Analysis - OU4MW-08R

Mann-Kendall Trend Analysis

n	10.0000
Confidence Coefficient	0.9500
Level of Significance	0.0500
Test Value (S)	20
Tabulated p-value	0.0360
Standard Deviation of S	11.1355
Standardized Value of S	1.7063
Approximate p-value	0.0440

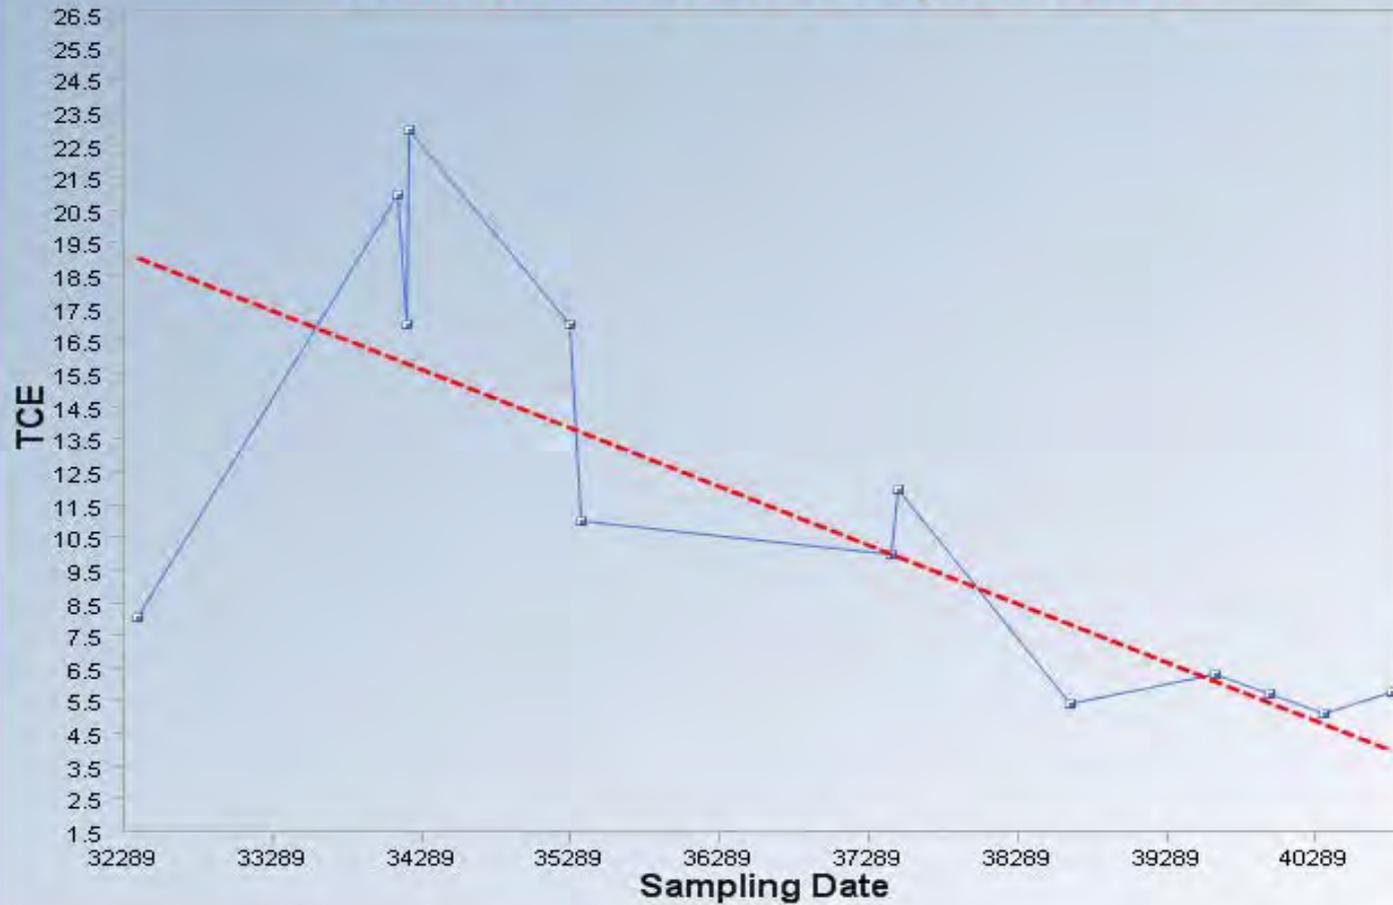
Mann-Kendall Trend Analysis - IS6-01

Mann-Kendall Trend Analysis

n	13.0000
Confidence Coefficient	0.9500
Level of Significance	0.0500
Test Value (S)	-45
Tabulated p-value	0.0030
Standard Deviation of S	16.3605
Standardized Value of S	-2.6894
Approximate p-value	0.0036

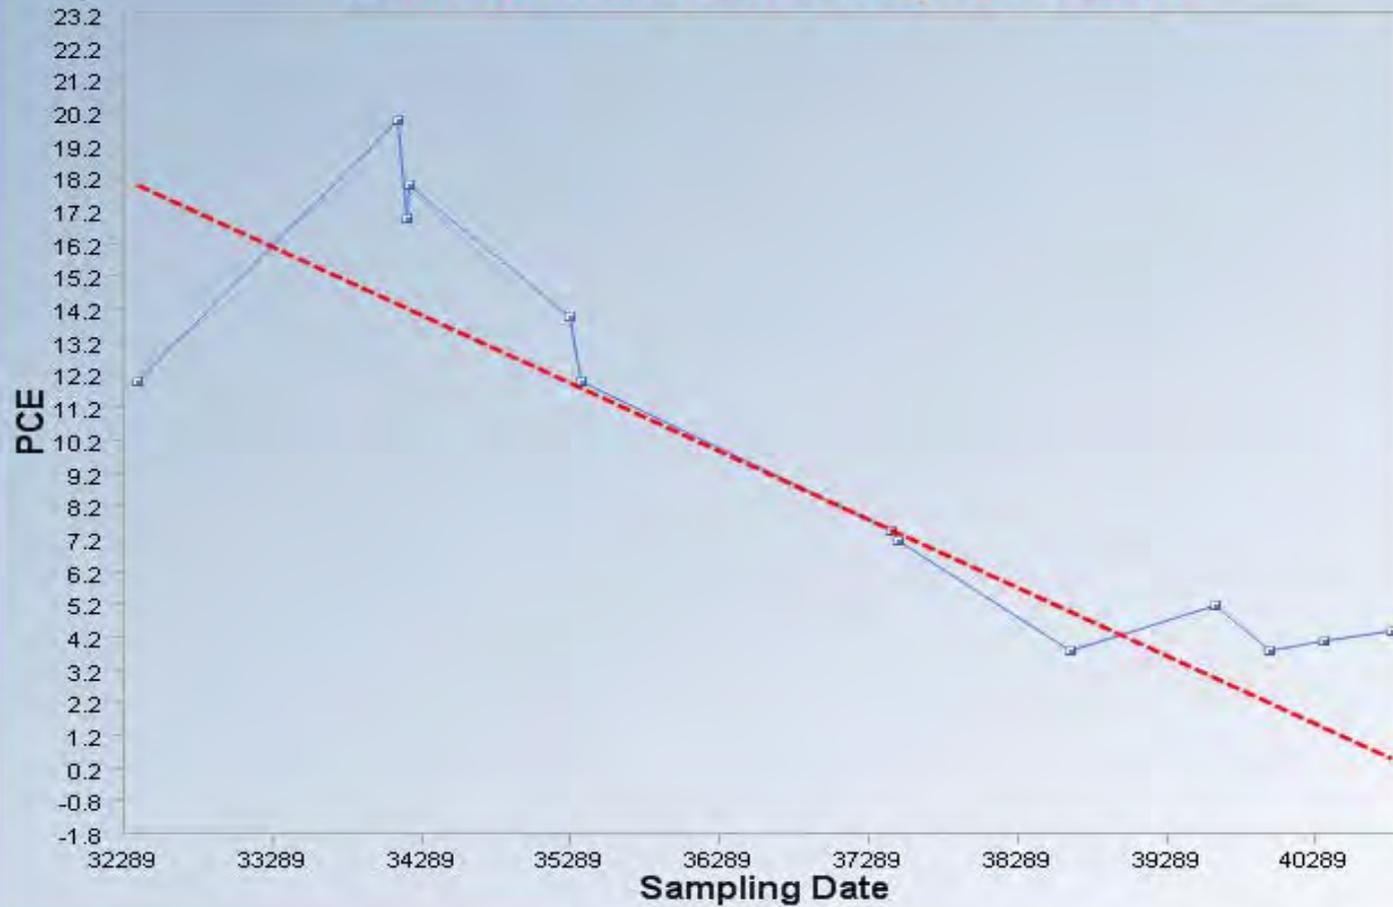
Mann-Kendall Trend Analysis - IS6-01

Mann-Kendall Trend Analysis

n	13.0000
Confidence Coefficient	0.9500
Level of Significance	0.0500
Test Value (S)	-54
Tabulated p-value	0.0000
Standard Deviation of S	16.3299
Standardized Value of S	-3.2456
Approximate p-value	0.0006

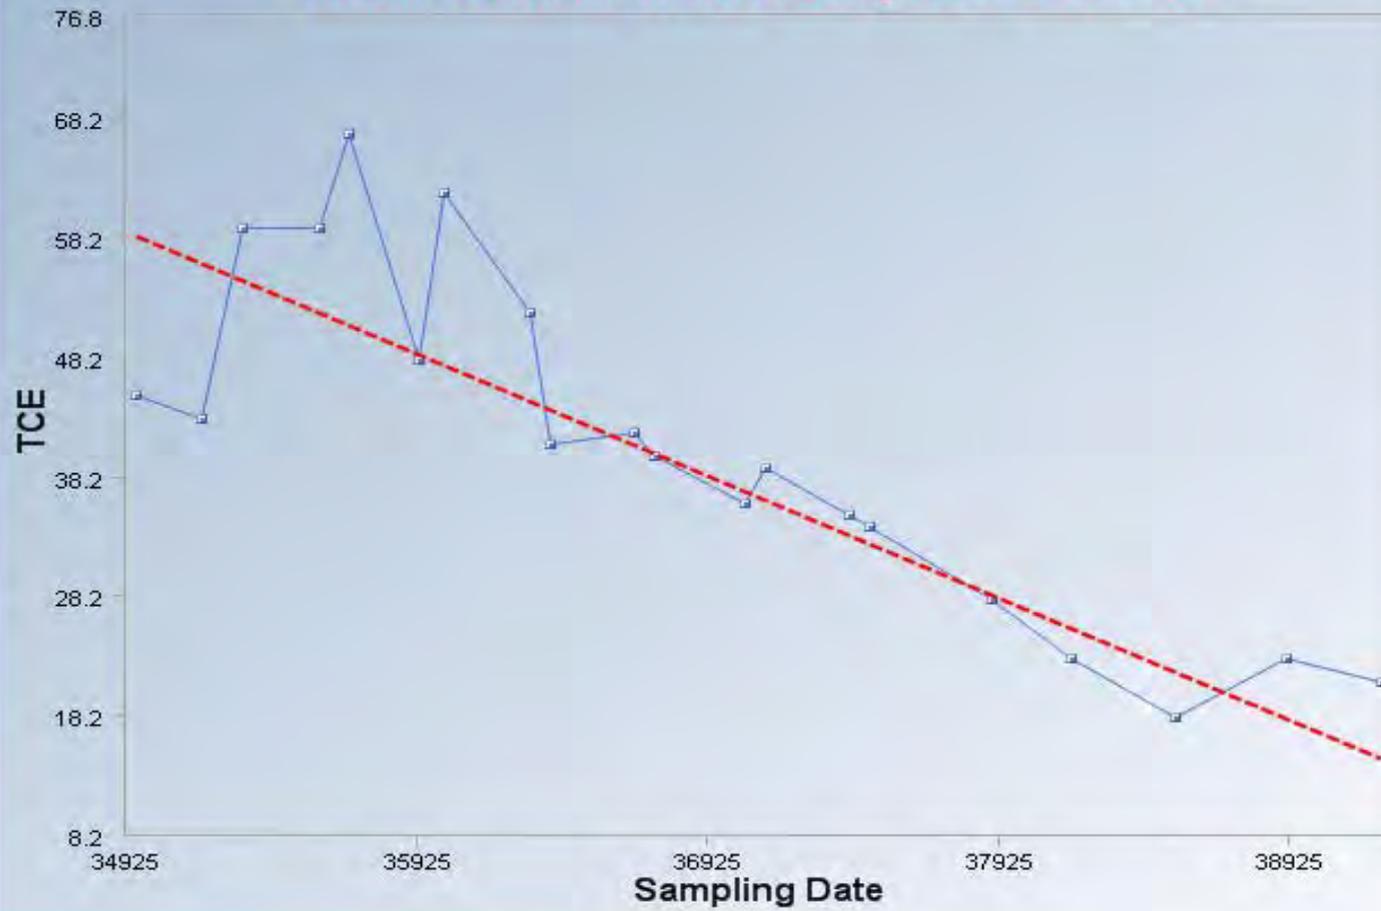
Mann-Kendall Trend Analysis - 49WL-01

Mann-Kendall Trend Analysis

n	20.0000
Confidence Coefficient	0.9500
Level of Significance	0.0500
Test Value (S)	-144
Tabulated p-value	0.0000
Standard Deviation of S	30.7896
Standardized Value of S	-4.6444
Approximate p-value	0.0000

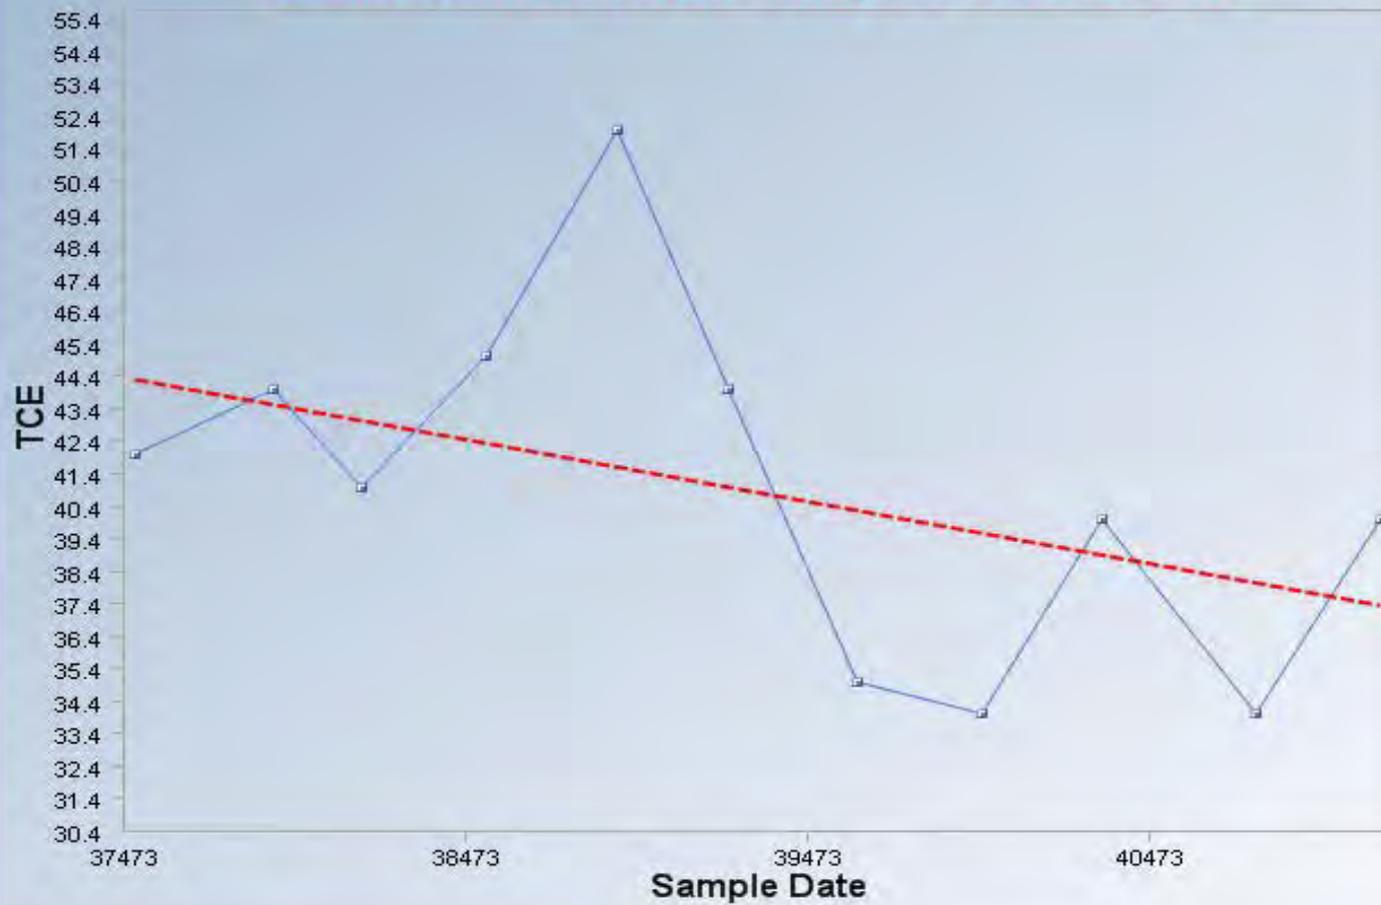
Mann-Kendall Trend Analysis - OU5MW-34

Mann-Kendall Trend Analysis

n	11.0000
Confidence Coefficient	0.9500
Level of Significance	0.0500
Test Value (S)	-22
Tabulated p-value	0.0430
Standard Deviation of S	12.7279
Standardized Value of S	-1.6499
Approximate p-value	0.0495

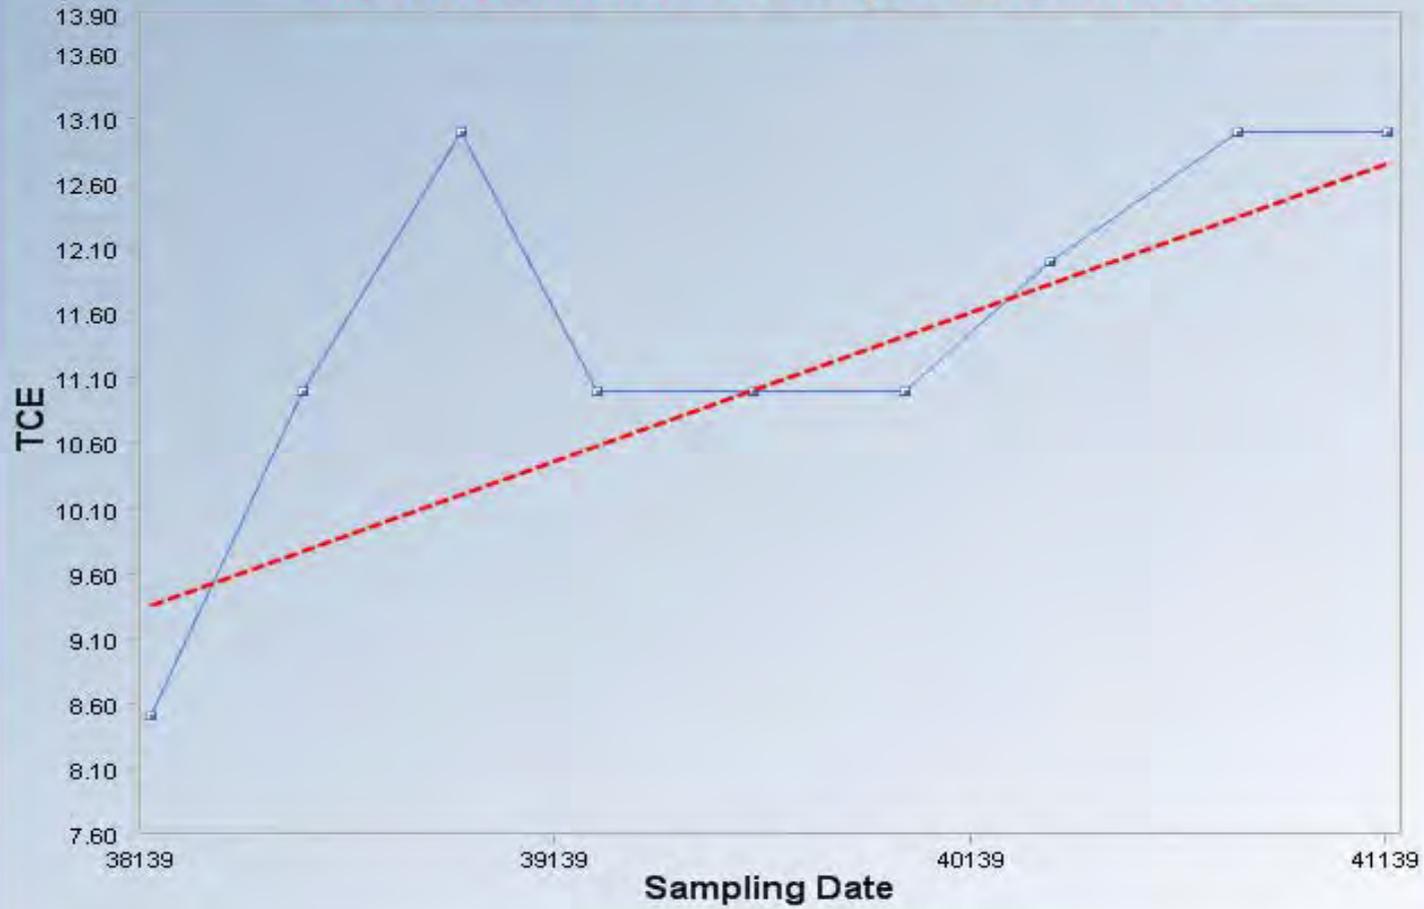
Mann-Kendall Trend Analysis - OU5MW-38

Mann-Kendall Trend Analysis

n	9.0000
Confidence Coefficient	0.9500
Level of Significance	0.0500
Test Value (S)	19
Tabulated p-value	0.0380
Standard Deviation of S	8.9256
Standardized Value of S	2.0167
Approximate p-value	0.0219

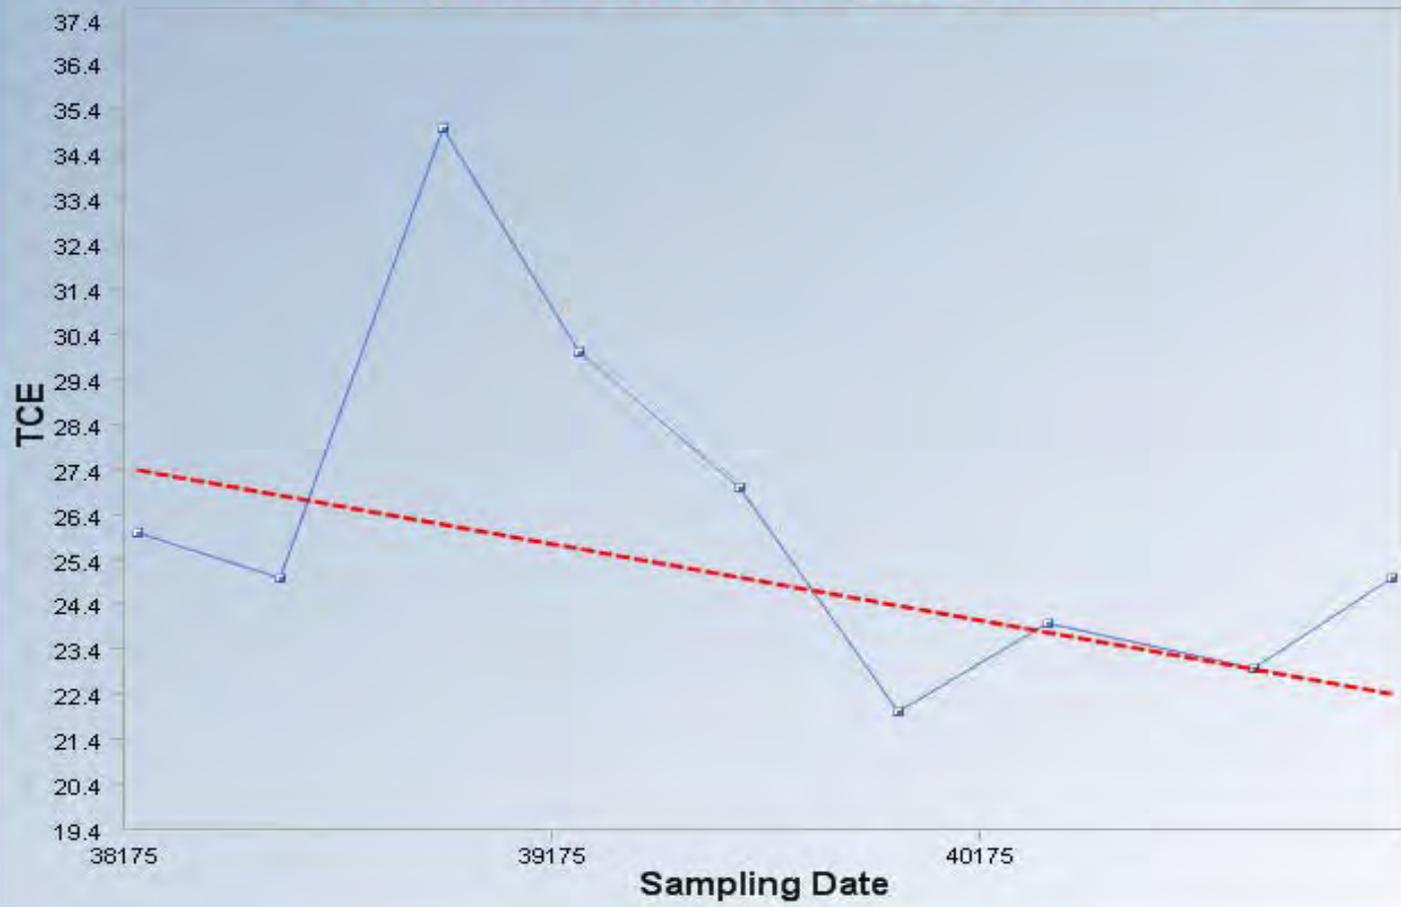
Mann-Kendall Trend Analysis - OU5MW-44

Mann-Kendall Trend Analysis

n	9.0000
Confidence Coefficient	0.9500
Level of Significance	0.0500
Test Value (S)	-13
Tabulated p-value	0.1300
Standard Deviation of S	9.5394
Standardized Value of S	-1.2579
Approximate p-value	0.1042

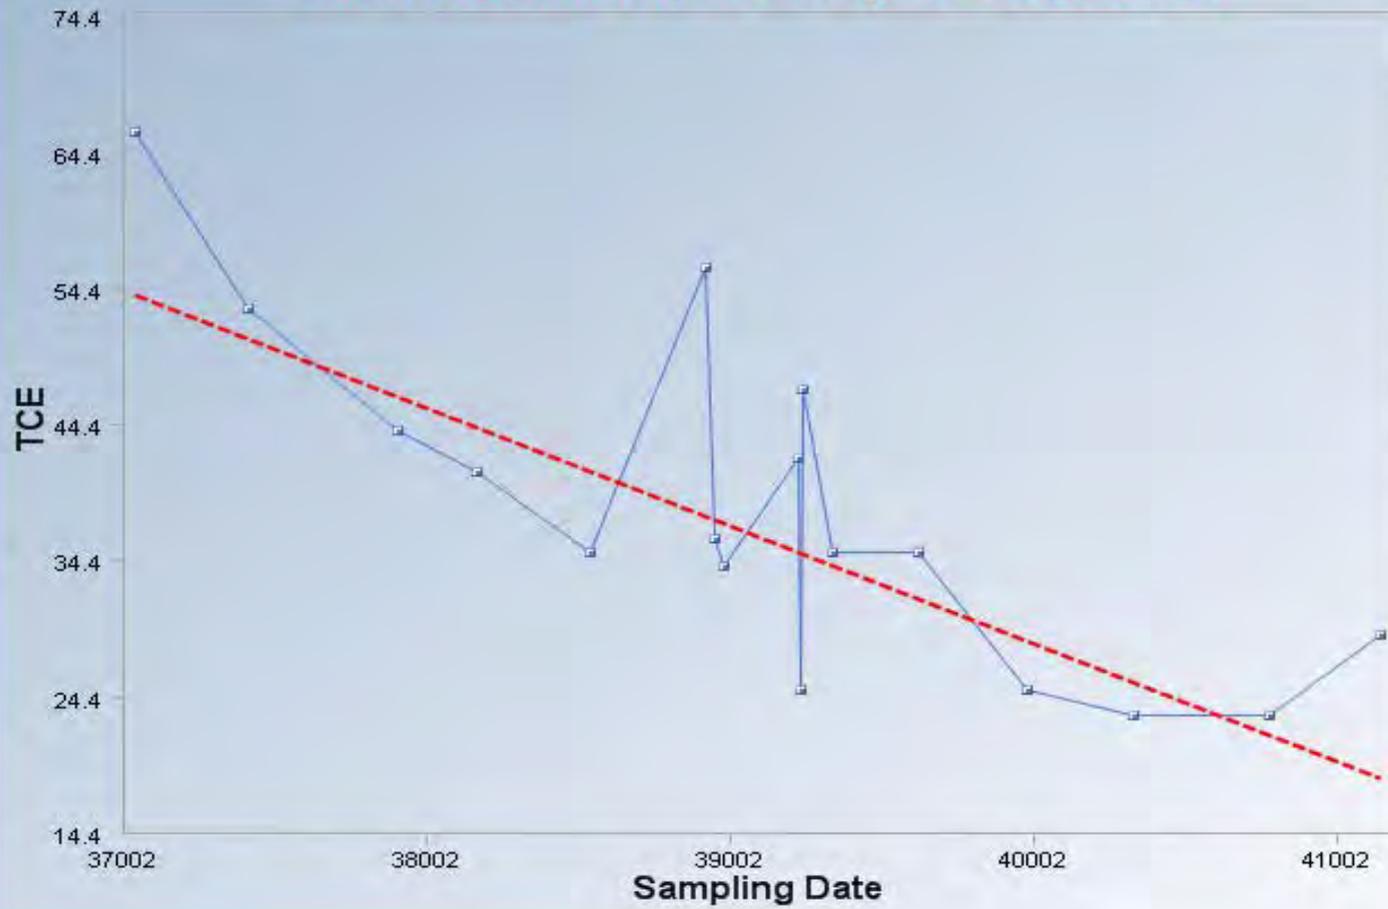
Mann-Kendall Trend Analysis - 403WL-01

Mann-Kendall Trend Analysis

n	17.0000
Confidence Coefficient	0.9500
Level of Significance	0.0500
Test Value (S)	-83
Tabulated p-value	0.0000
Standard Deviation of S	24.1592
Standardized Value of S	-3.3942
Approximate p-value	0.0003

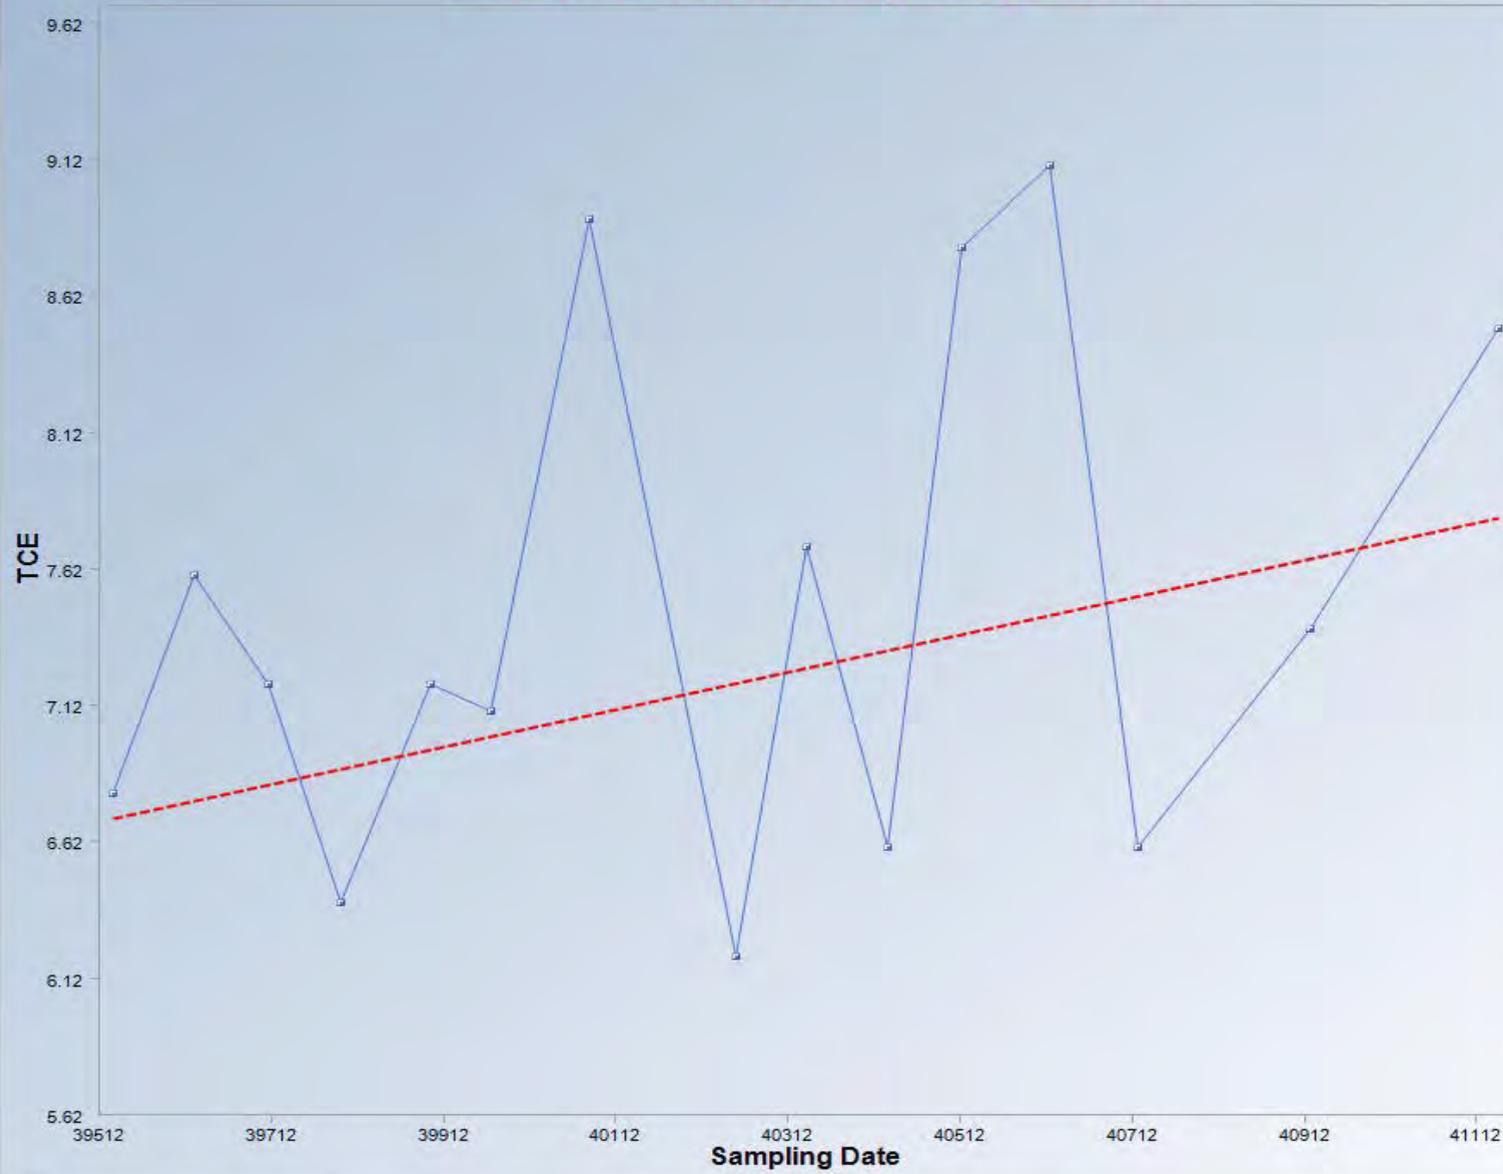
Mann-Kendall Trend Analysis - OU5SP-10

Mann-Kendall Trend Analysis	
n	15.0000
Confidence Coefficient	0.9500
Level of Significance	0.0500
Test Value (S)	21
Tabulated p-value	0.1640
Standard Deviation of S	20.1577
Standardized Value of S	0.9922
Approximate p-value	0.1606

Theil-Sen Trend Line = Red	
Theil-Sen Slope	0.0007
Theil-Sen Intercept	-20.3699

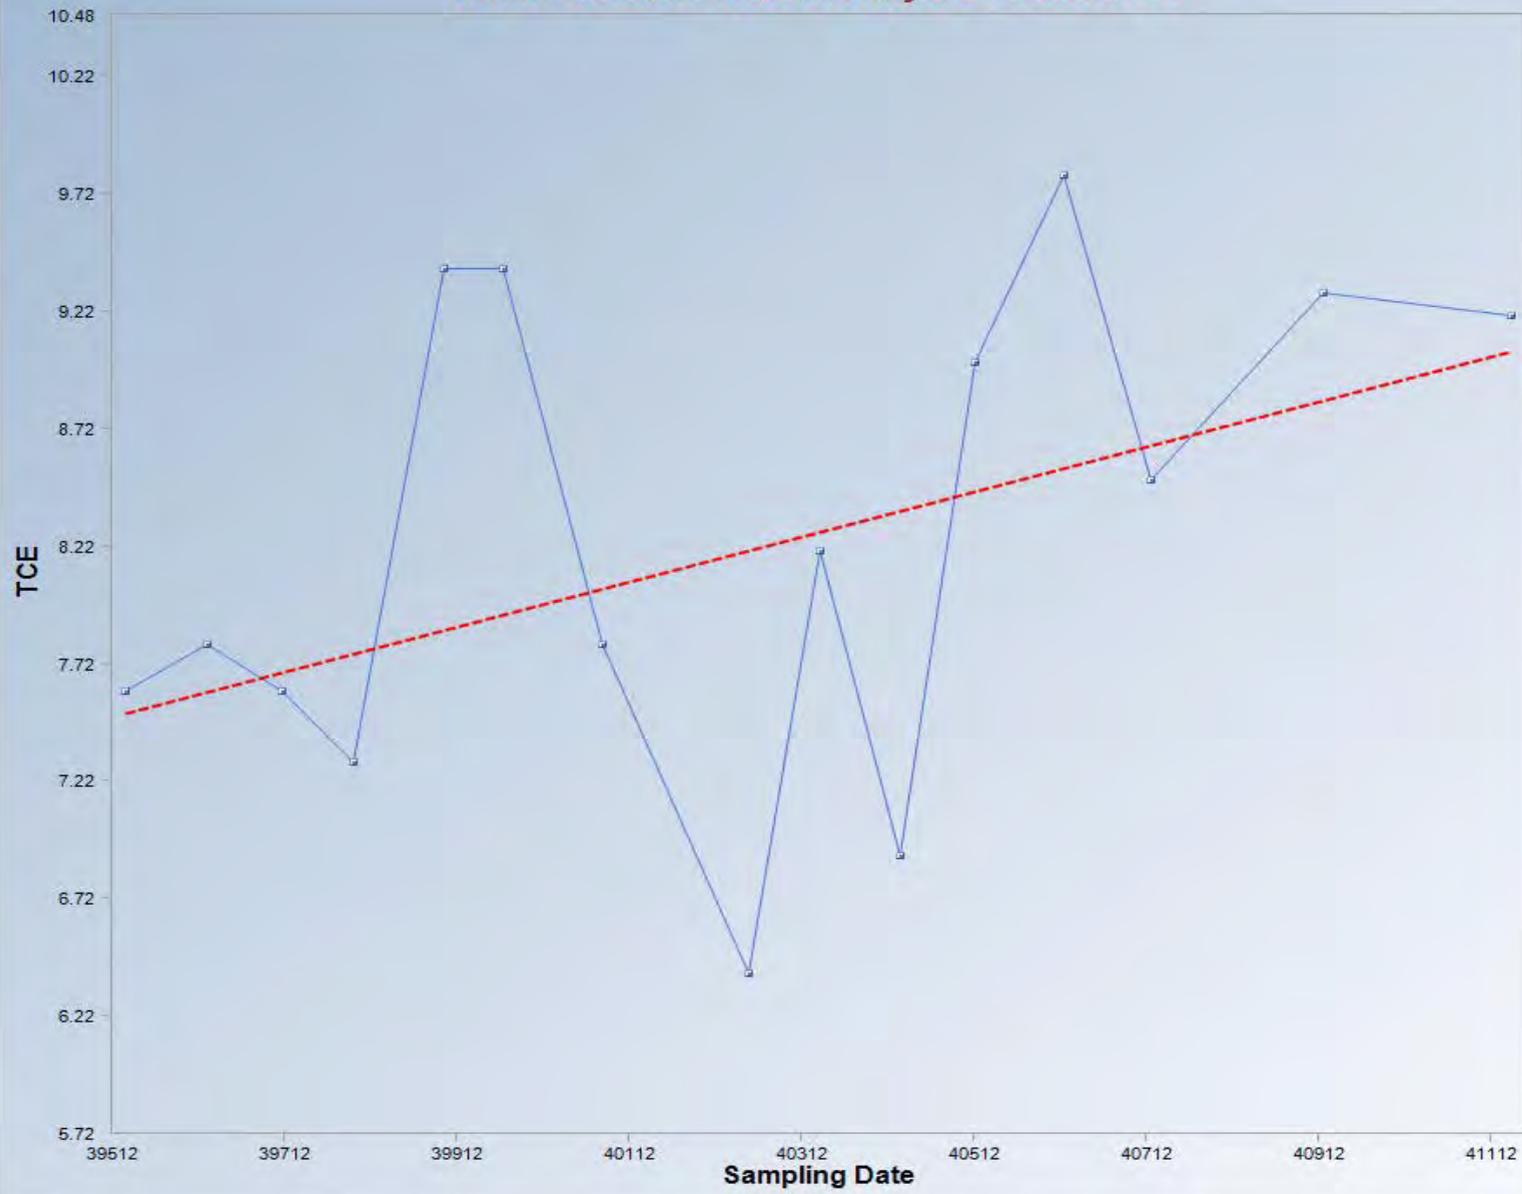
Mann-Kendall Trend Analysis - OU5SP-11

Mann-Kendall Trend Analysis	
n	15.0000
Confidence Coefficient	0.9500
Level of Significance	0.0500
Test Value (S)	30
Tabulated p-value	0.0700
Standard Deviation of S	20.1329
Standardized Value of S	1.4404
Approximate p-value	0.0749

Theil-Sen Trend Line = Red	
Theil-Sen Slope	0.0010
Theil-Sen Intercept	-30.4419
