ENVIRONMENTAL RESTORATION PROGRAM

**FOURTH CERCLA FIVE-YEAR REVIEW
REPORT**

JBER-ELMENDORF, ALASKA

**FINAL
MARCH 2014**

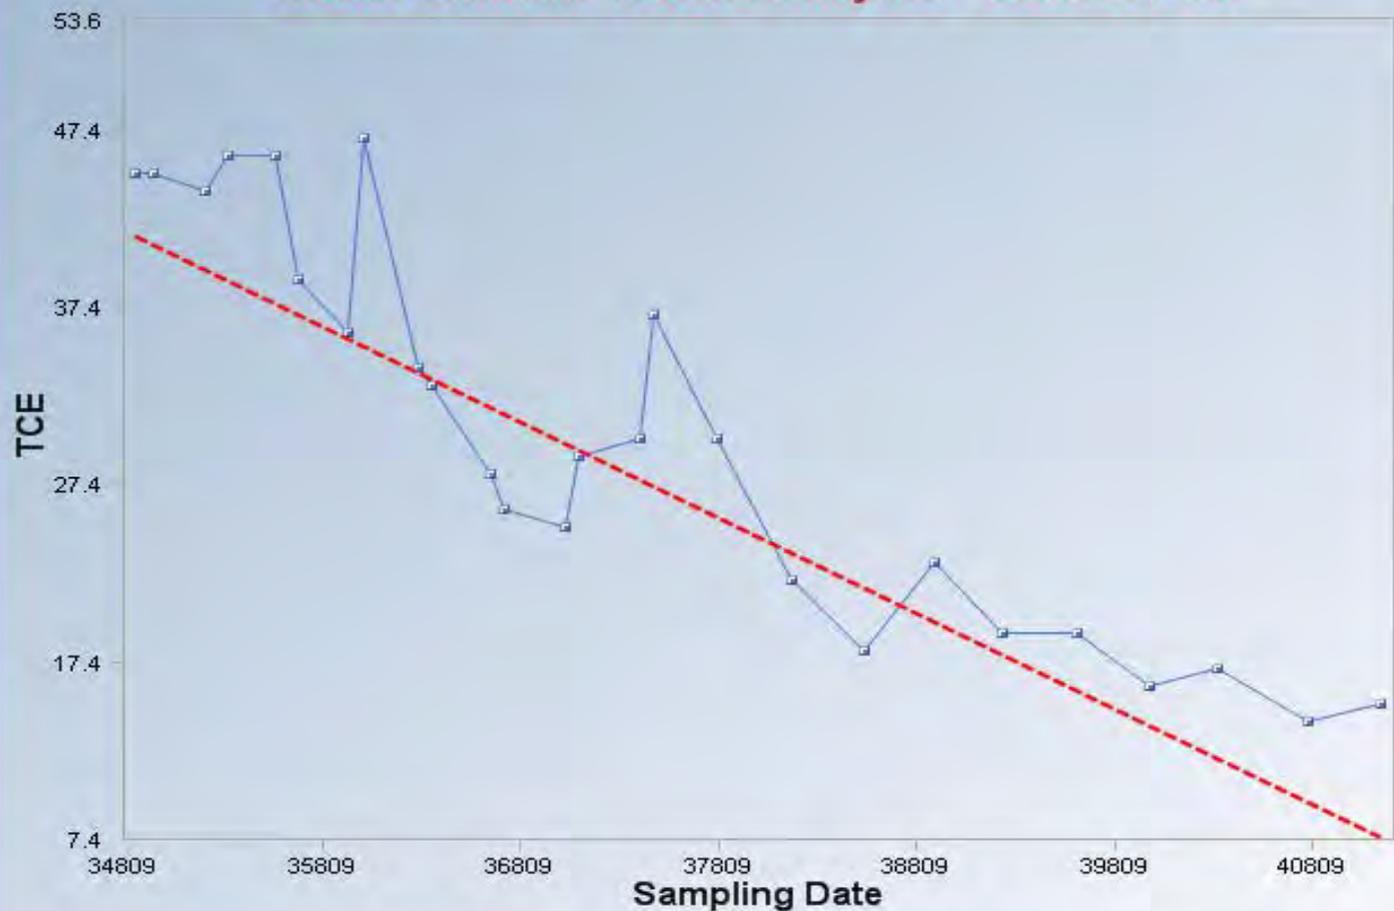
Mann-Kendall Trend Analysis - OU5MW-06

Mann-Kendall Trend Analysis	
n	26.0000
Confidence Coefficient	0.9500
Level of Significance	0.0500
Test Value (S)	-245
Critical Value (0.05)	-1.6449
Standard Deviation of S	45.3248
Standardized Value of S	-5.3834
Approximate p-value	0.0000

Theil-Sen Trend Line = Red	
Theil-Sen Slope	-0.0054
Theil-Sen Intercept	229.4209

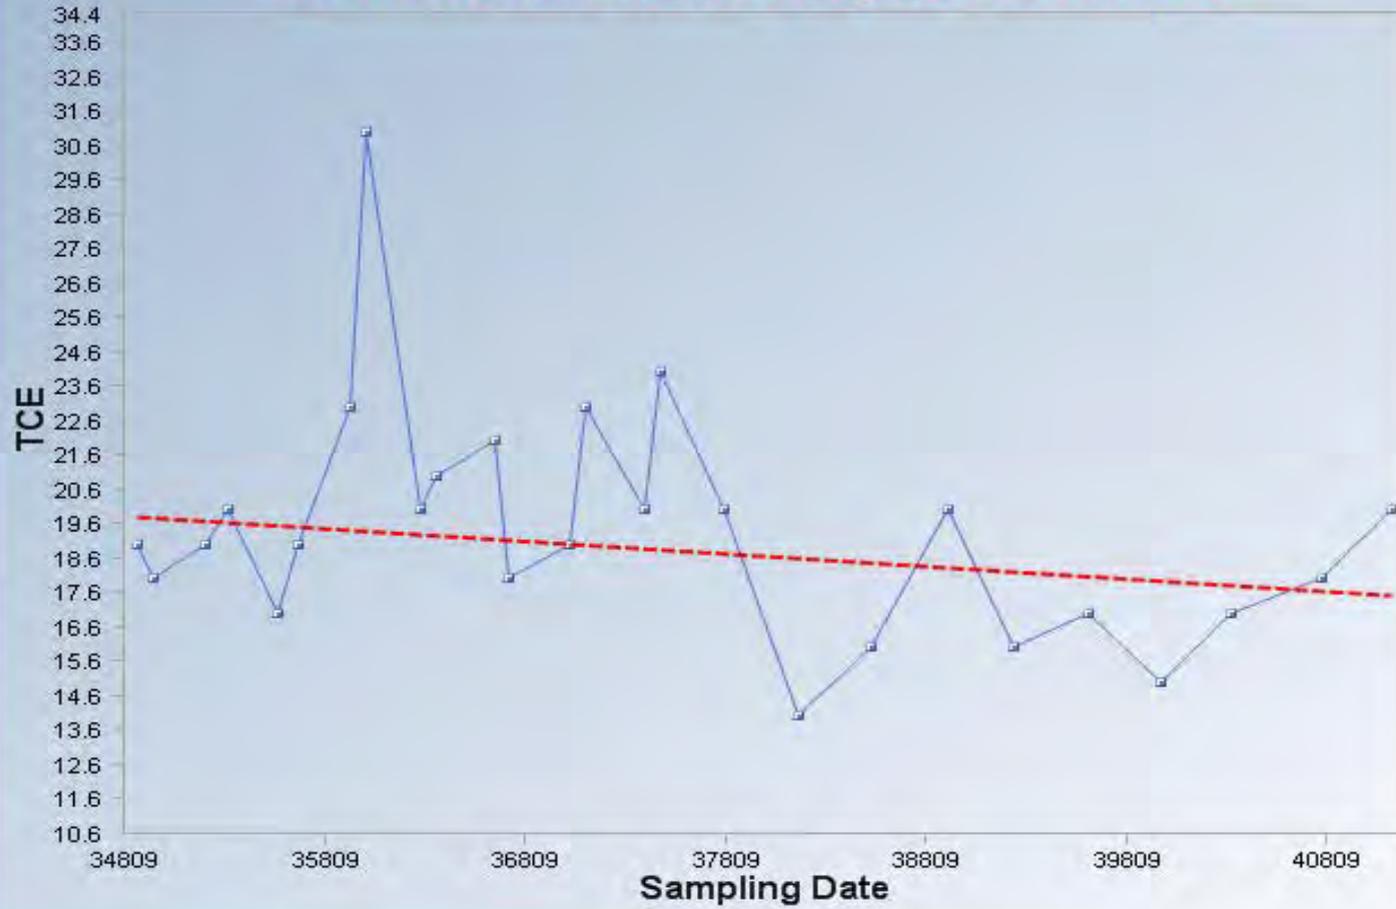
Mann-Kendall Trend Analysis - OU5MW-07

Mann-Kendall Trend Analysis

n	26.0000
Confidence Coefficient	0.9500
Level of Significance	0.0500
Test Value (S)	-52
Critical Value (0.05)	-1.6449
Standard Deviation of S	44.8553
Standardized Value of S	-1.1370
Approximate p-value	0.1278

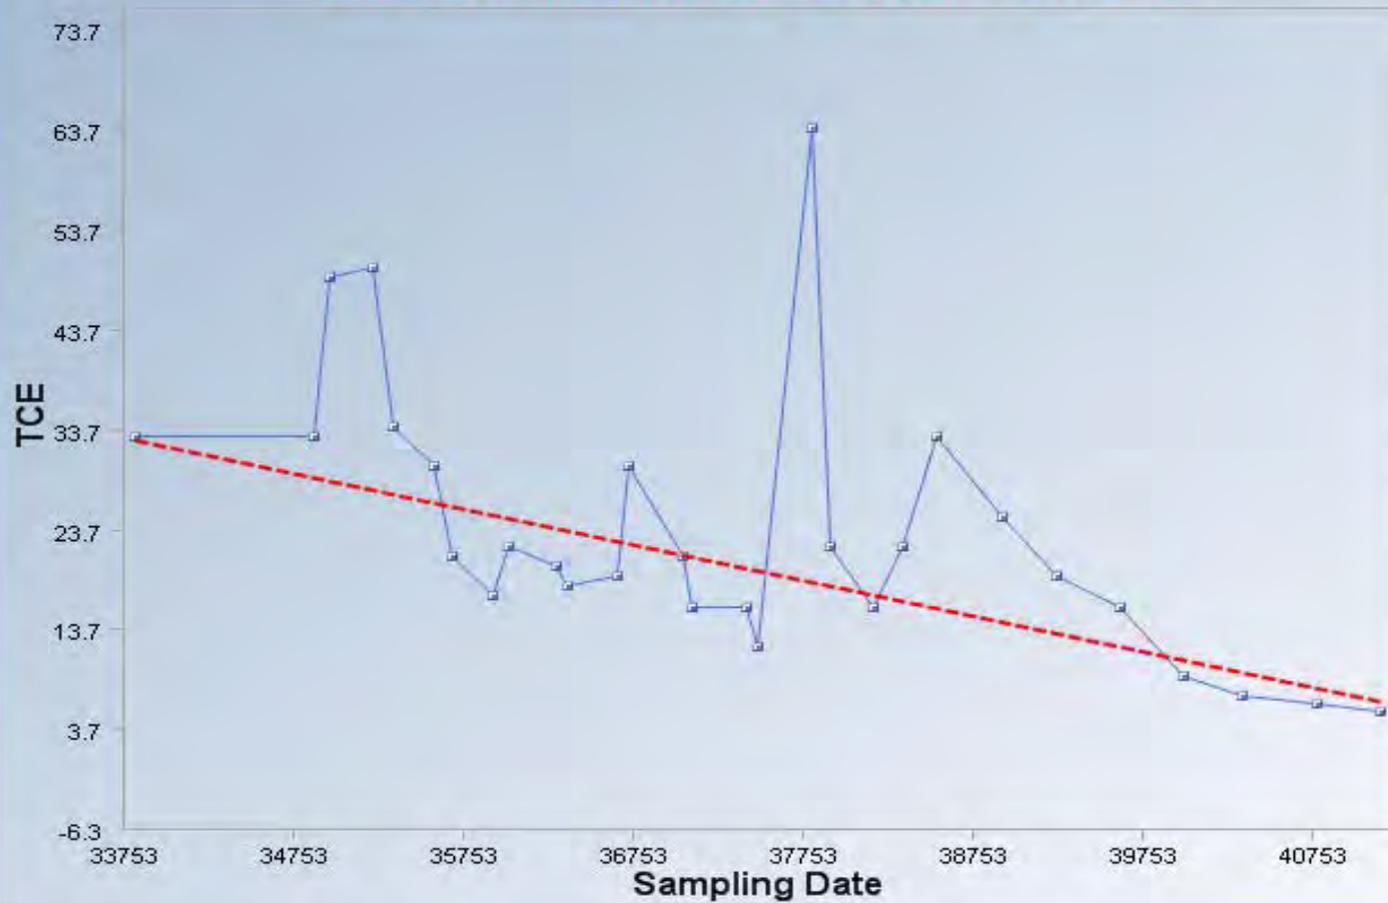
Mann-Kendall Trend Analysis - SP1-02

Mann-Kendall Trend Analysis

n	29.0000
Confidence Coefficient	0.9500
Level of Significance	0.0500
Test Value (S)	-201
Critical Value (0.05)	-1.6449
Standard Deviation of S	53.1319
Standardized Value of S	-3.7642
Approximate p-value	0.0001

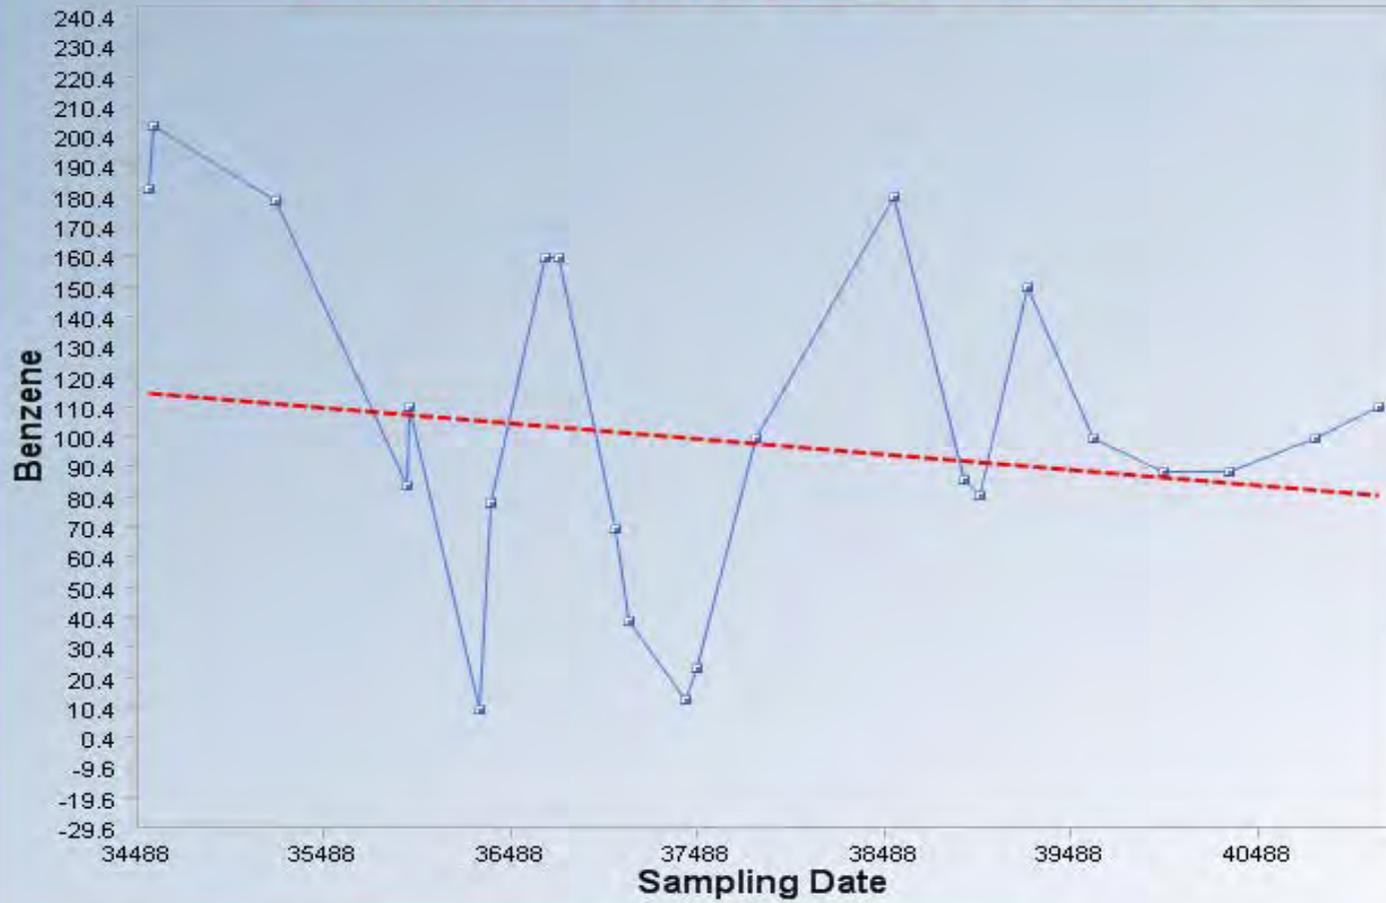
Mann-Kendall Trend Analysis - OU6MW-17

Mann-Kendall Trend Analysis

n	23.0000
Confidence Coefficient	0.9500
Level of Significance	0.0500
Test Value (S)	-25
Critical Value (0.05)	-1.6449
Standard Deviation of S	37.7757
Standardized Value of S	-0.6353
Approximate p-value	0.2626

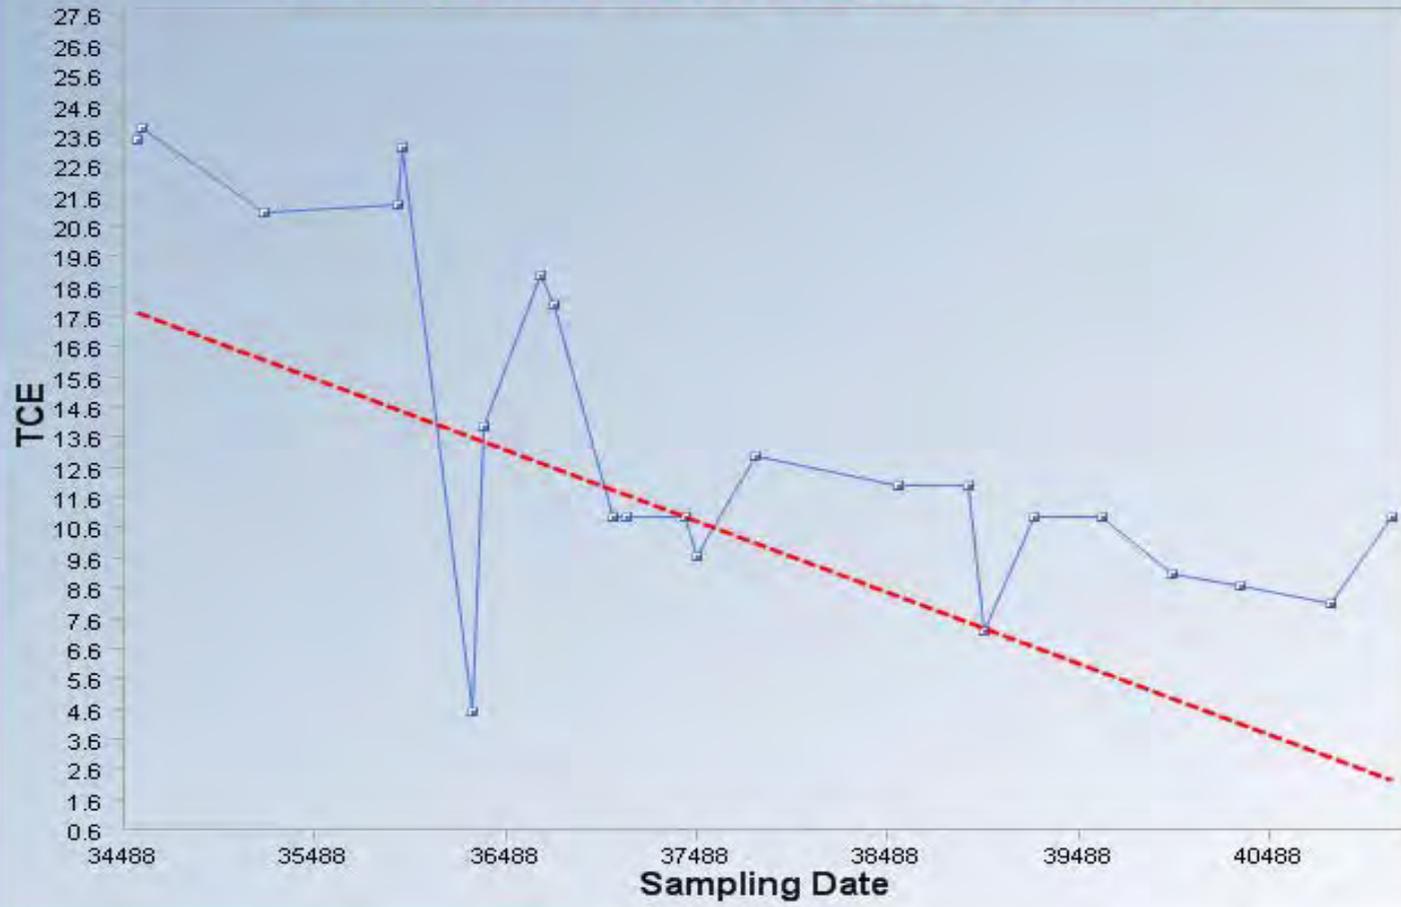
Mann-Kendall Trend Analysis - OU6MW-17

Mann-Kendall Trend Analysis

n	23.0000
Confidence Coefficient	0.9500
Level of Significance	0.0500
Test Value (S)	-143
Critical Value (0.05)	-1.6449
Standard Deviation of S	37.4744
Standardized Value of S	-3.7892
Approximate p-value	0.0001

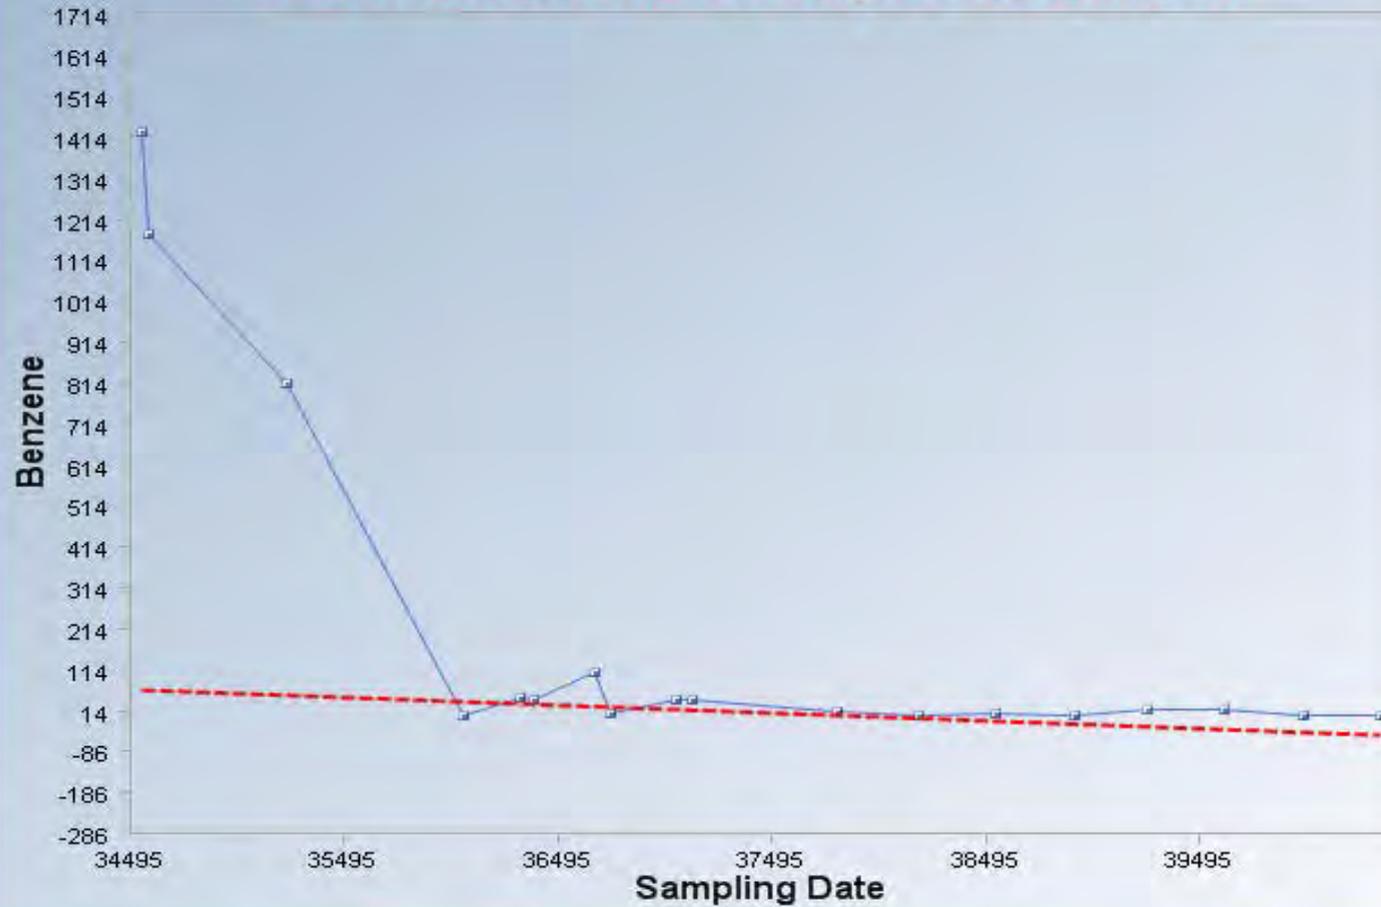
Mann-Kendall Trend Analysis - OU6MW-18

Mann-Kendall Trend Analysis

n	18.0000
Confidence Coefficient	0.9500
Level of Significance	0.0500
Test Value (S)	-82
Tabulated p-value	0.0010
Standard Deviation of S	26.3818
Standardized Value of S	-3.0703
Approximate p-value	0.0011

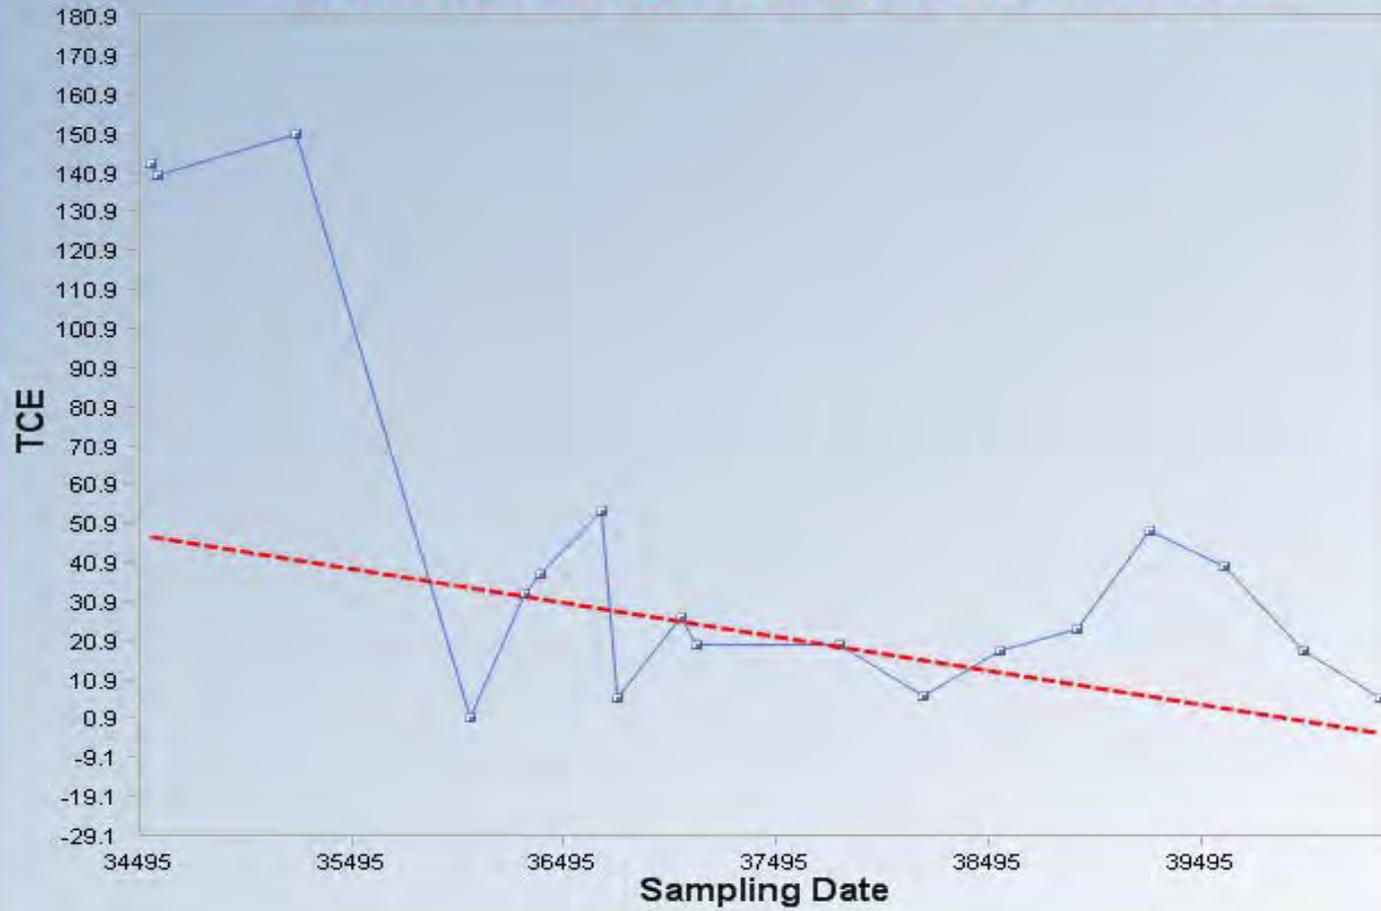
Mann-Kendall Trend Analysis - OU6MW-18

Mann-Kendall Trend Analysis

n	18.0000
Confidence Coefficient	0.9500
Level of Significance	0.0500
Test Value (S)	-51
Tabulated p-value	0.0290
Standard Deviation of S	26.3629
Standardized Value of S	-1.8966
Approximate p-value	0.0289

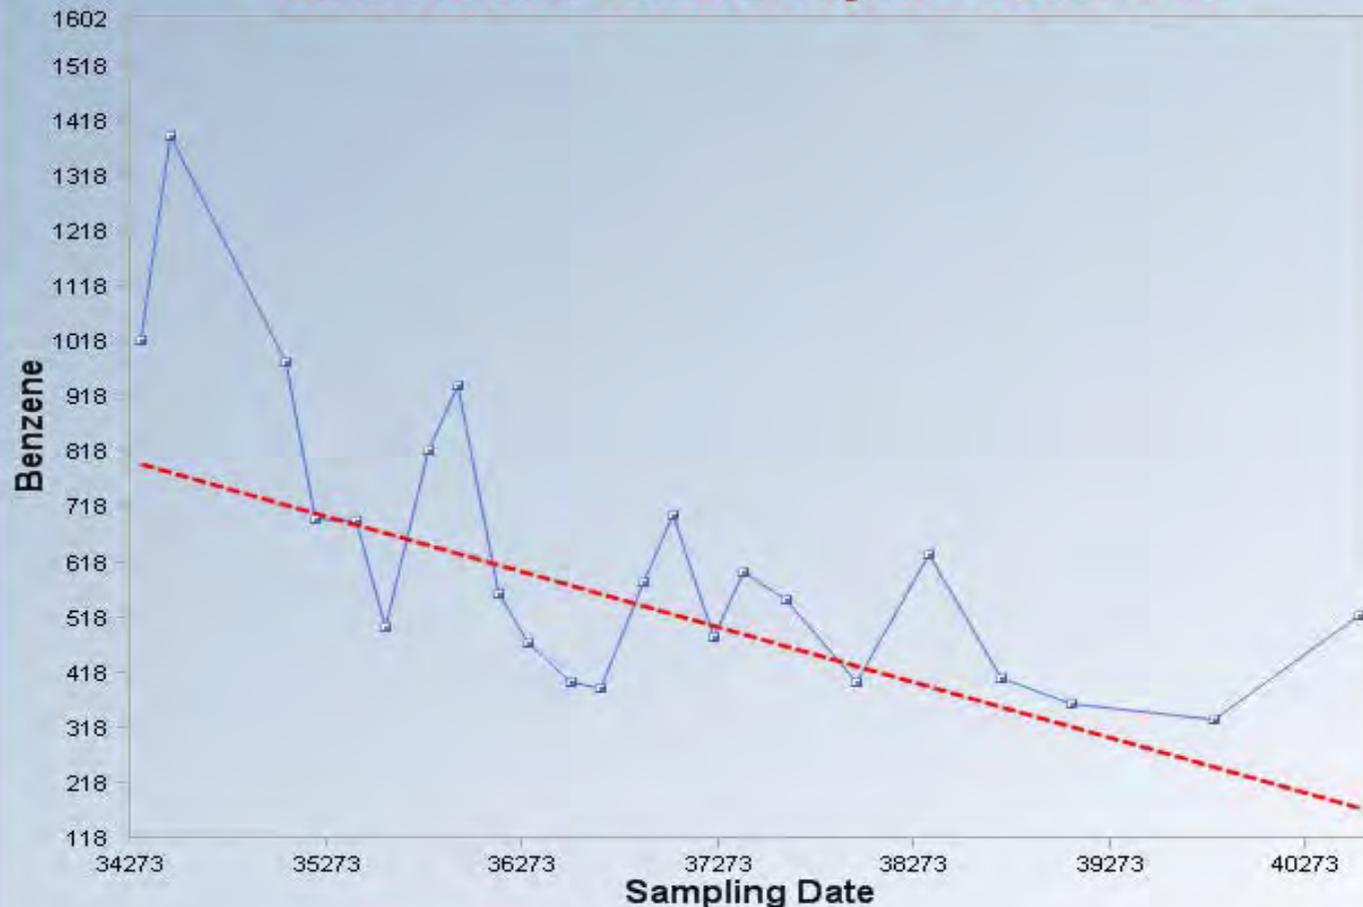
Mann-Kendall Trend Analysis - OU6MW-46

Mann-Kendall Trend Analysis

n	23.0000
Confidence Coefficient	0.9500
Level of Significance	0.0500
Test Value (S)	-132
Critical Value (0.05)	-1.6449
Standard Deviation of S	37.8506
Standardized Value of S	-3.4610
Approximate p-value	0.0003

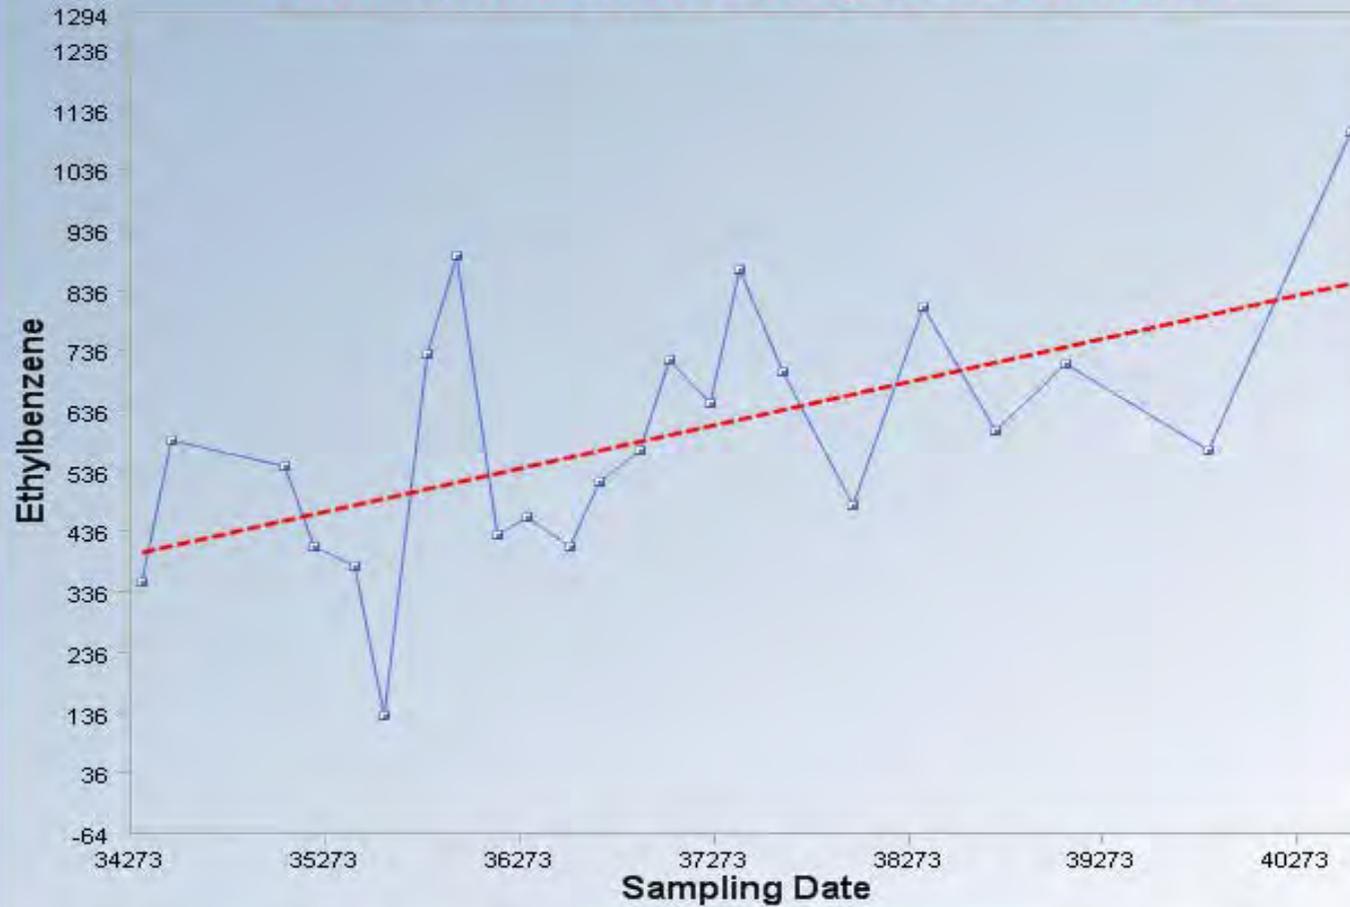
Mann-Kendall Trend Analysis - OU6MW-46

Mann-Kendall Trend Analysis

n	23.0000
Confidence Coefficient	0.9500
Level of Significance	0.0500
Test Value (S)	99
Critical Value (0.05)	1.6449
Standard Deviation of S	37.8374
Standardized Value of S	2.5900
Approximate p-value	0.0048

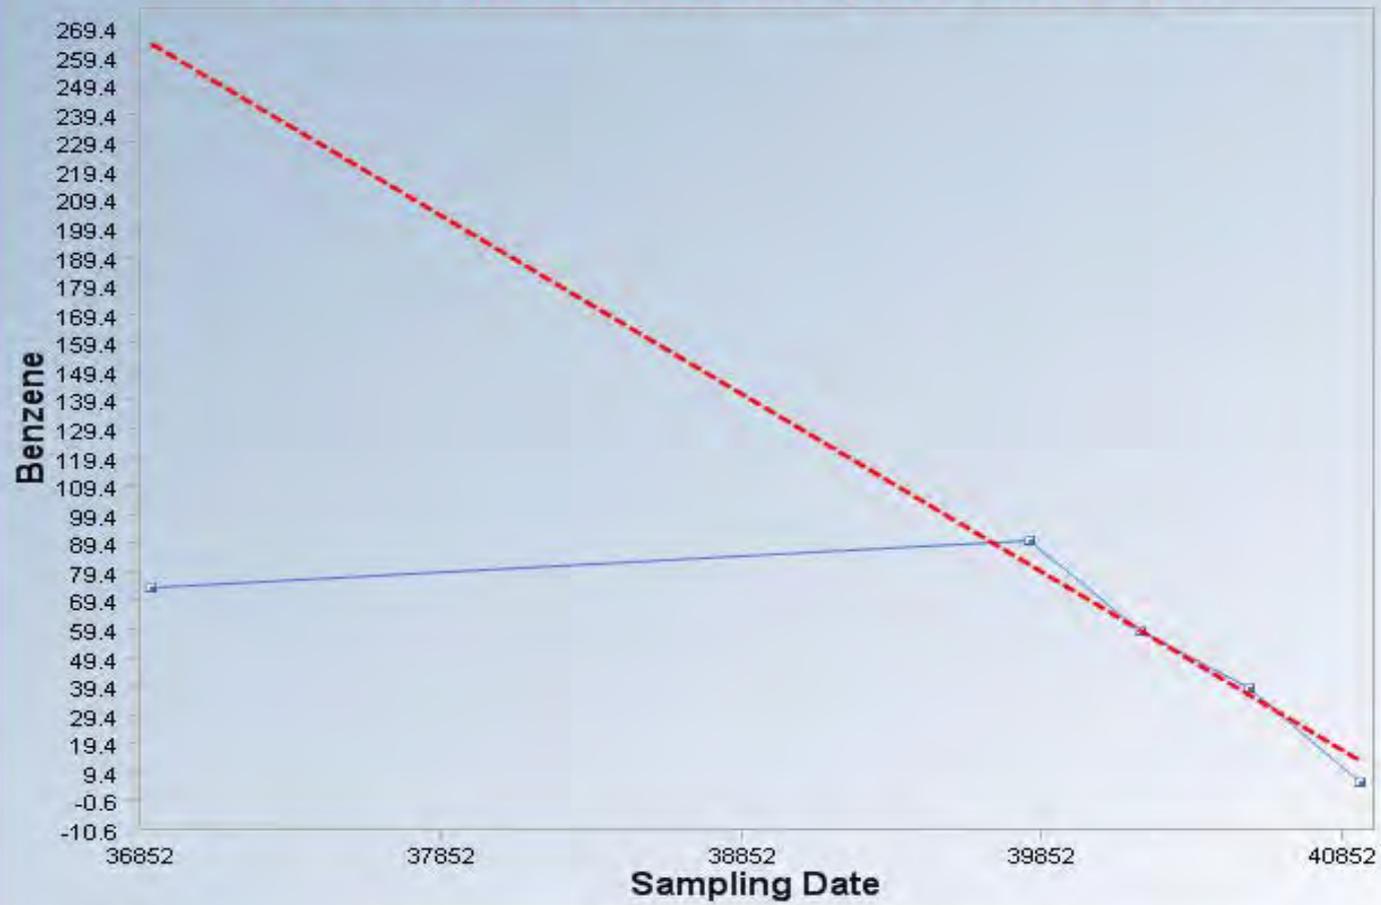
Mann-Kendall Trend Analysis - OU6MW-92

Mann-Kendall Trend Analysis

n	5.0000
Confidence Coefficient	0.9500
Level of Significance	0.0500
Test Value (S)	-8
Tabulated p-value	0.0420
Standard Deviation of S	4.0825
Standardized Value of S	-1.7146
Approximate p-value	0.0432

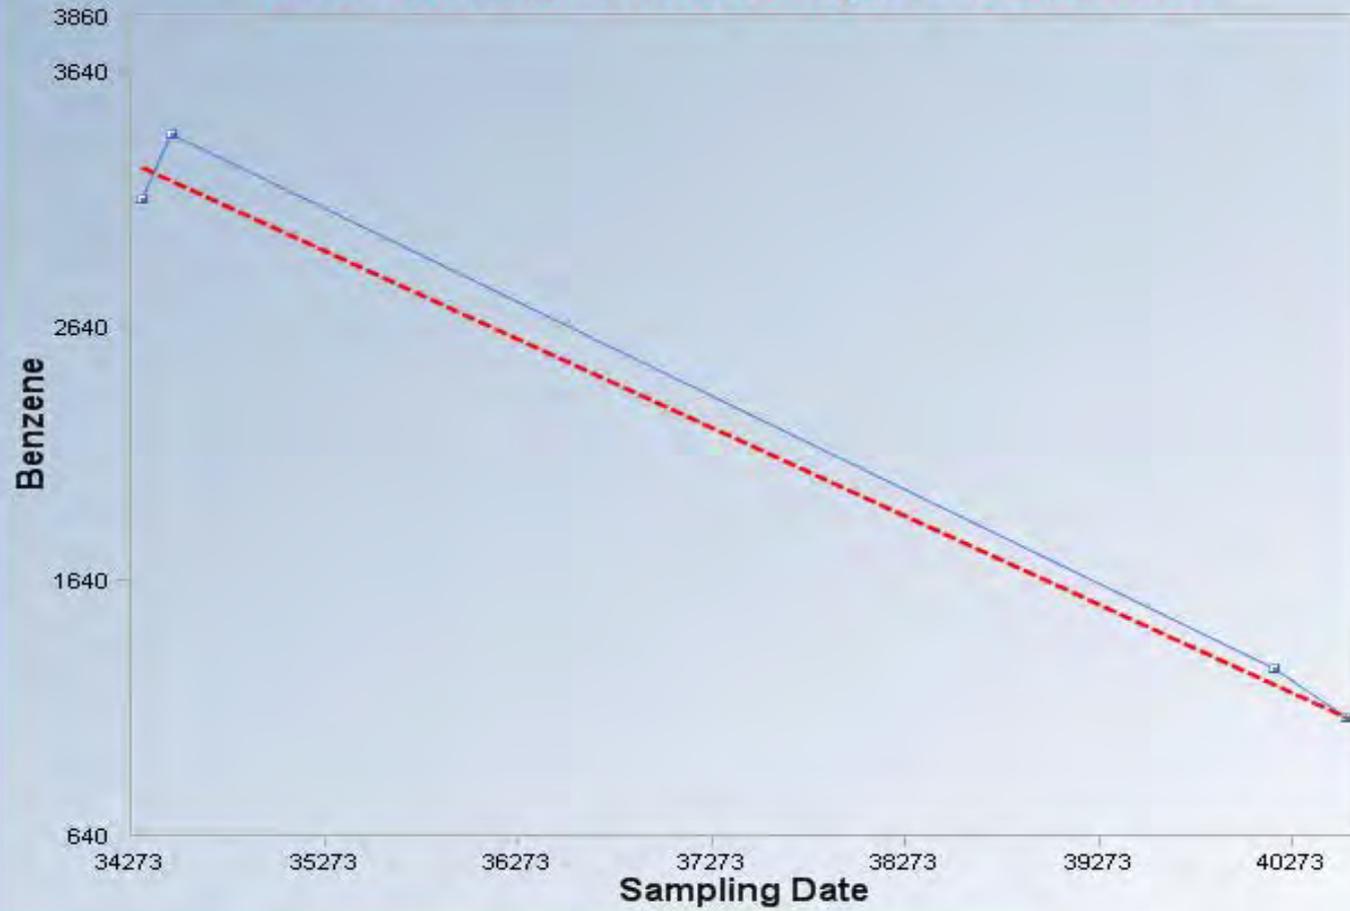
Mann-Kendall Trend Analysis - OU6MW-61

Mann-Kendall Trend Analysis

n	4.0000
Confidence Coefficient	0.9500
Level of Significance	0.0500
Test Value (S)	-4
Tabulated p-value	0.1670
Standard Deviation of S	2.9439
Standardized Value of S	-1.0190
Approximate p-value	0.1541

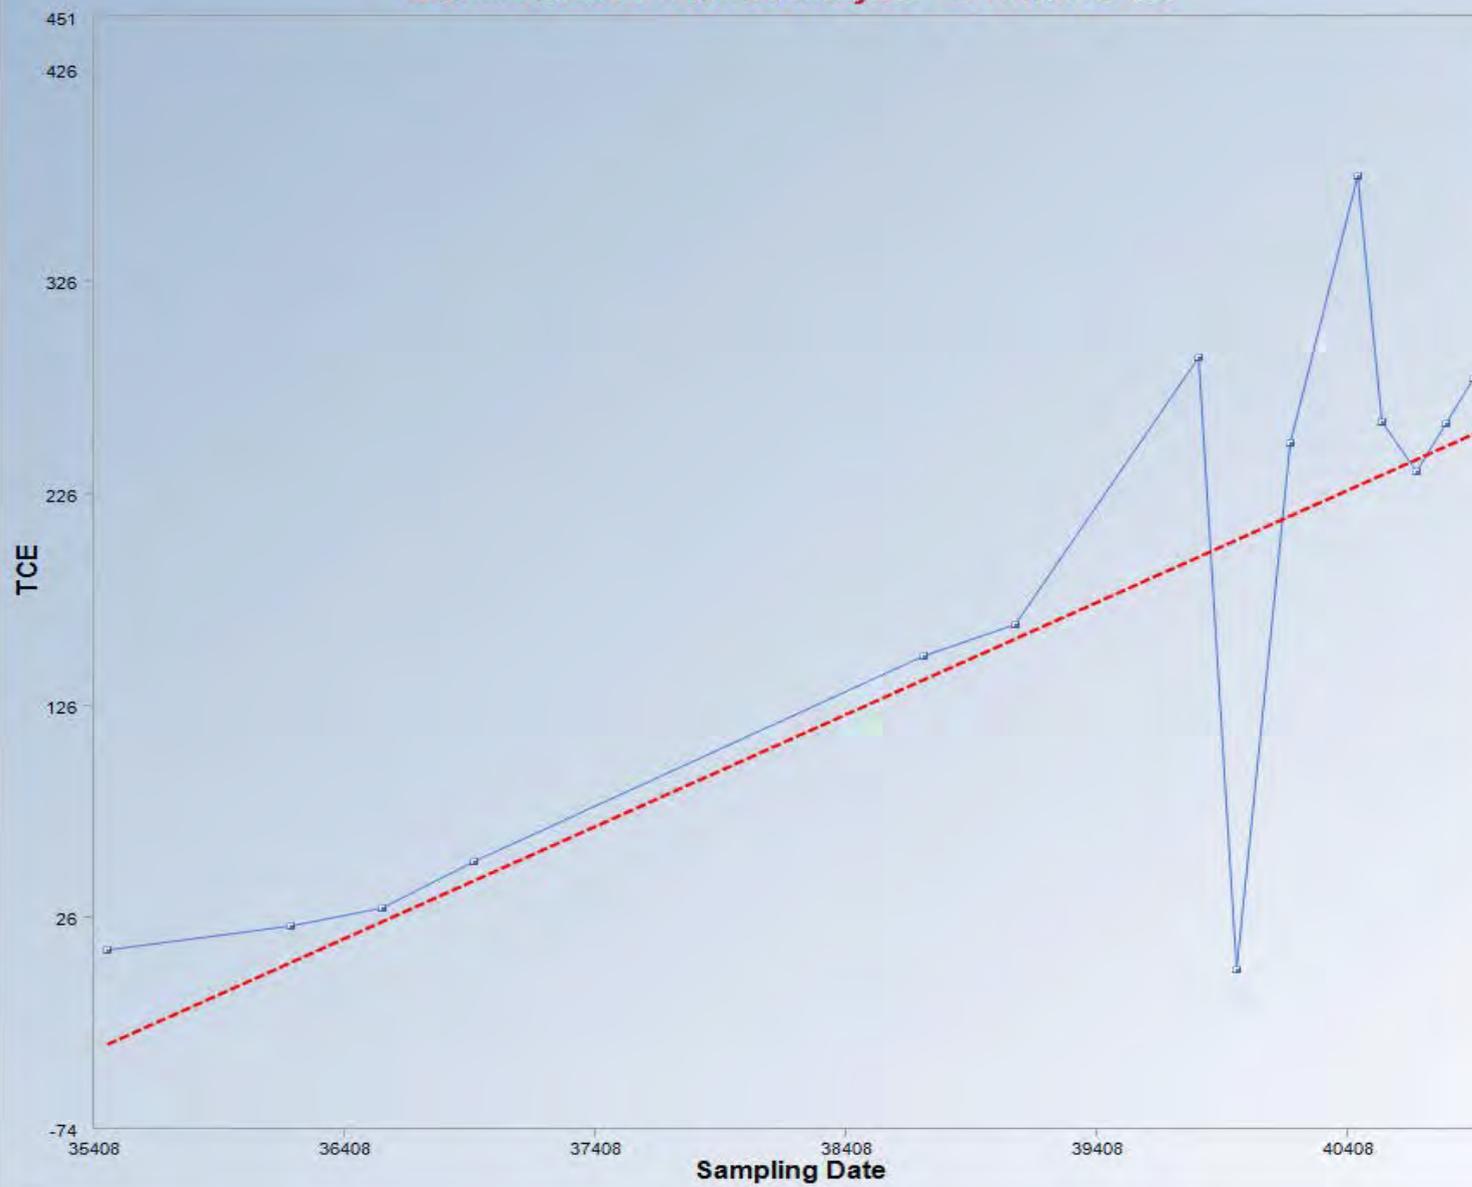
Mann-Kendall Trend Analysis - 41755WL-08

Mann-Kendall Trend Analysis	
n	14.0000
Confidence Coefficient	0.9500
Level of Significance	0.0500
Test Value (S)	53
Tabulated p-value	0.0020
Standard Deviation of S	18.2665
Standardized Value of S	2.8467
Approximate p-value	0.0022

Theil-Sen Trend Line = Red	
Theil-Sen Slope	0.0530
Theil-Sen Intercept	-1,912.9118

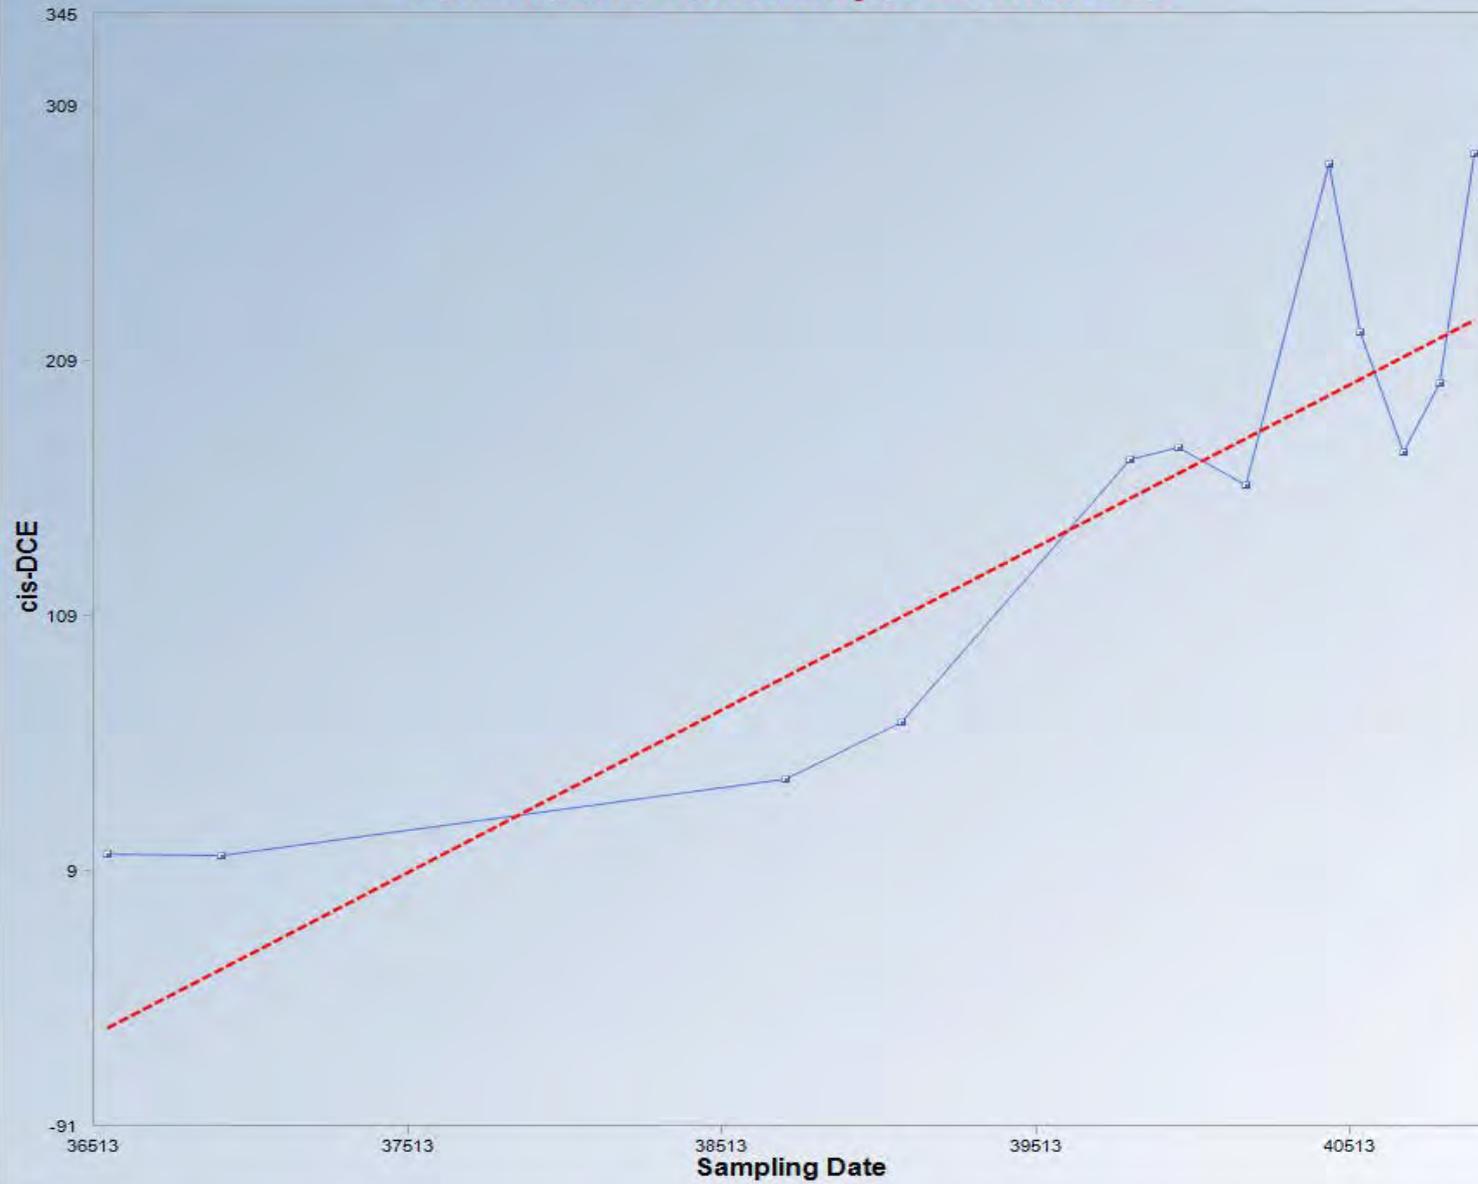
Mann-Kendall Trend Analysis - 41755WL-08

Mann-Kendall Trend Analysis	
n	12.0000
Confidence Coefficient	0.9500
Level of Significance	0.0500
Test Value (S)	48
Tabulated p-value	0.0000
Standard Deviation of S	14.5831
Standardized Value of S	3.2229
Approximate p-value	0.0006

Theil-Sen Trend Line = Red	
Theil-Sen Slope	0.0637
Theil-Sen Intercept	-2.382.3629

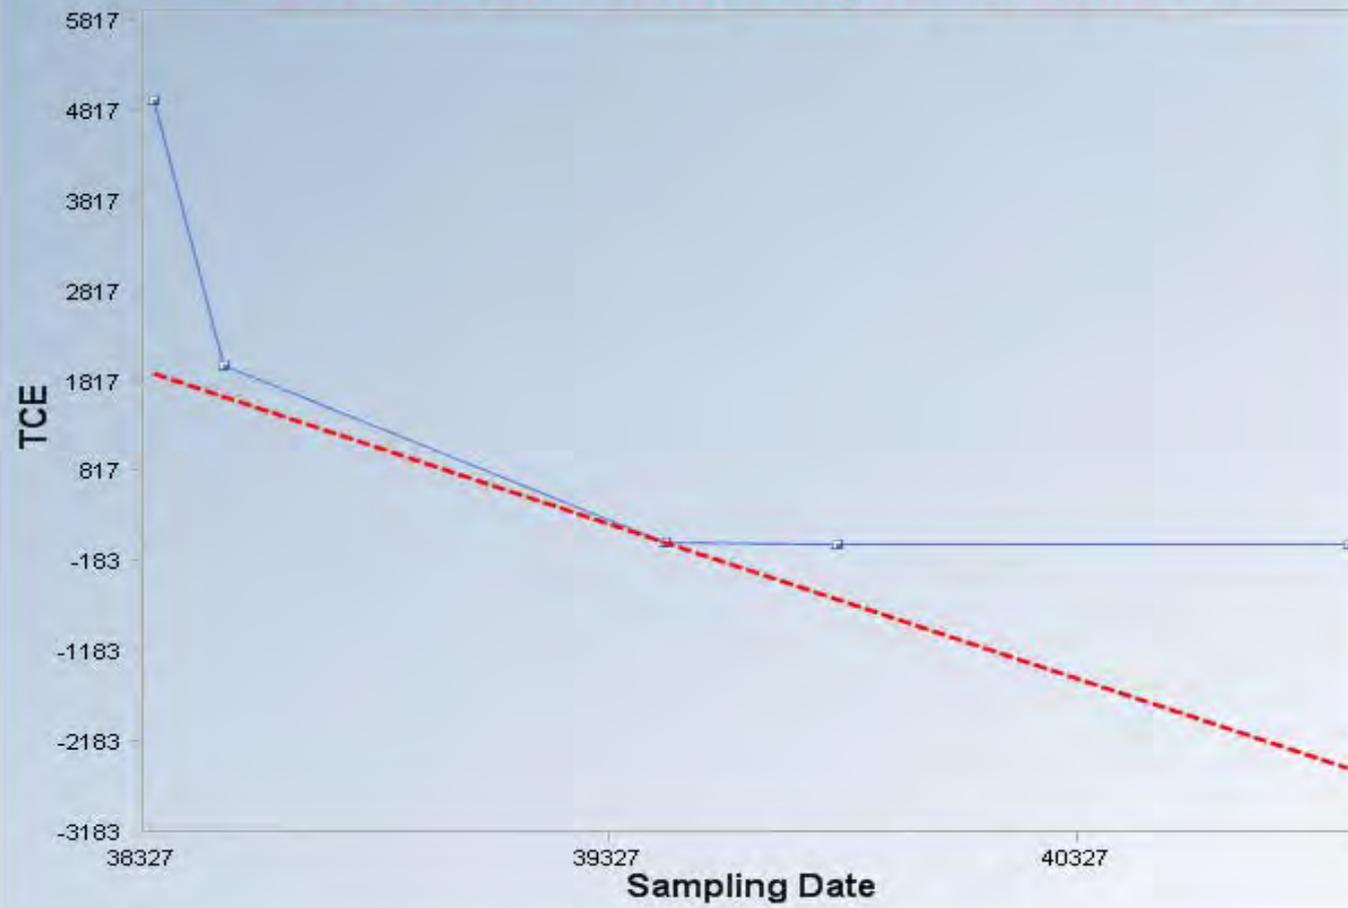
Mann-Kendall Trend Analysis - DP98INJ-02

Mann-Kendall Trend Analysis

n	5.0000
Confidence Coefficient	0.9500
Level of Significance	0.0500
Test Value (S)	-8
Tabulated p-value	0.0420
Standard Deviation of S	4.0825
Standardized Value of S	-1.7146
Approximate p-value	0.0432

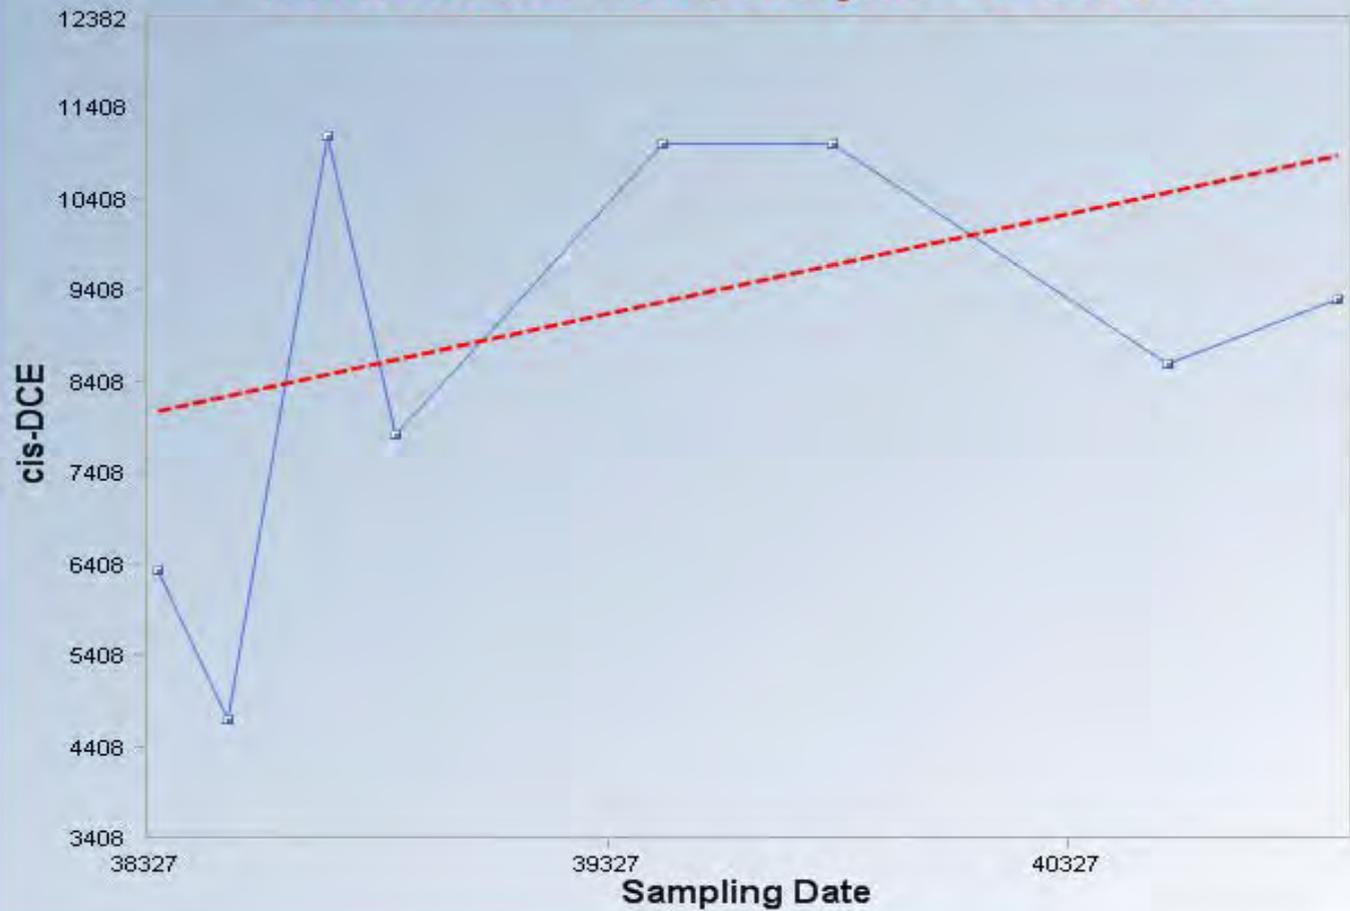
Mann-Kendall Trend Analysis - DP98INJ-02

Mann-Kendall Trend Analysis

n	8.0000
Confidence Coefficient	0.9500
Level of Significance	0.0500
Test Value (S)	7
Tabulated p-value	0.2740
Standard Deviation of S	8.0208
Standardized Value of S	0.7481
Approximate p-value	0.2272

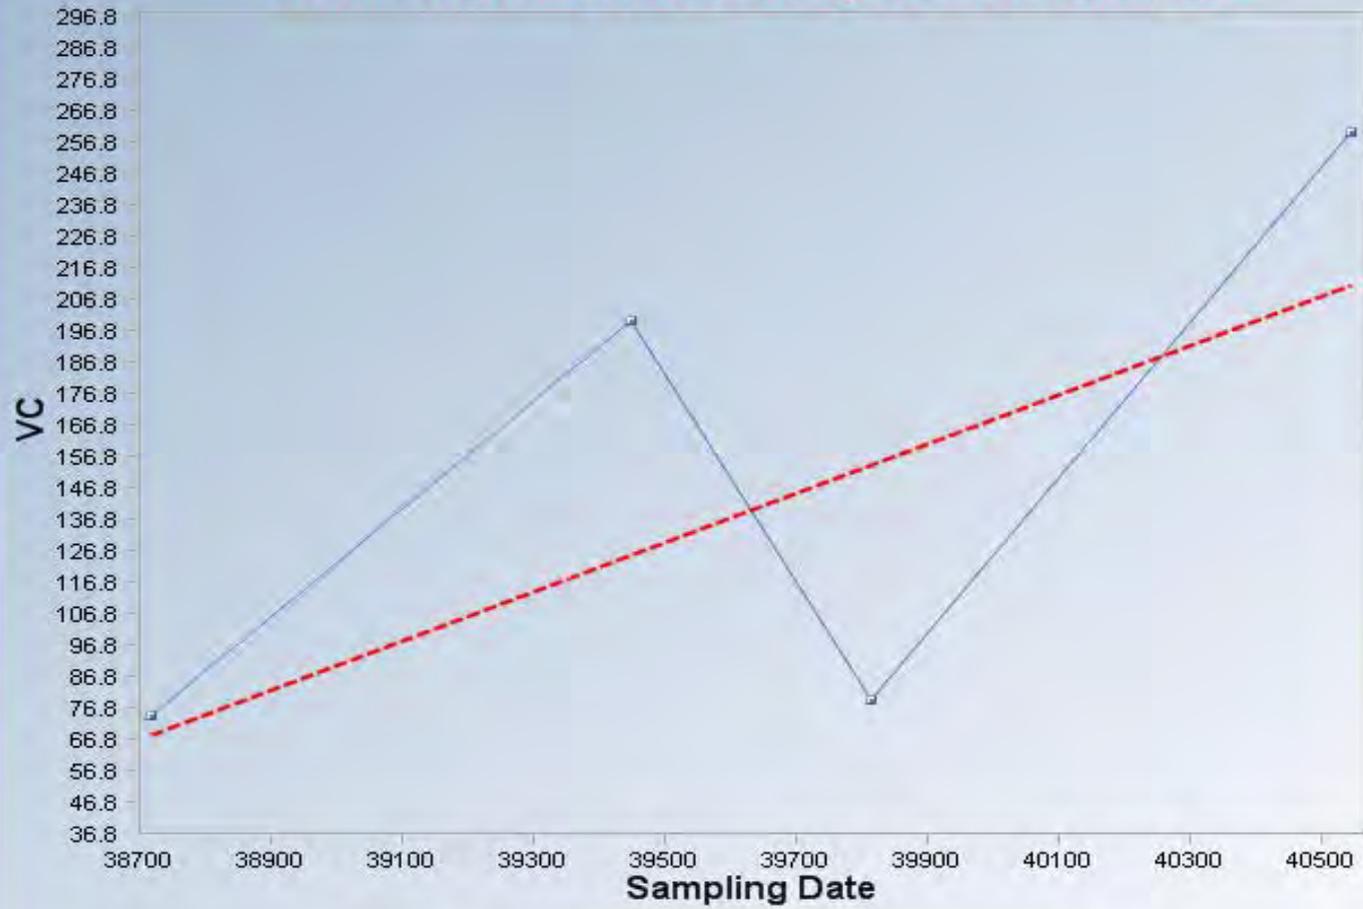
Mann-Kendall Trend Analysis - DP98INJ-02

Mann-Kendall Trend Analysis

n	4.0000
Confidence Coefficient	0.9500
Level of Significance	0.0500
Test Value (S)	4
Tabulated p-value	0.1670
Standard Deviation of S	2.9439
Standardized Value of S	1.0190
Approximate p-value	0.1541
