ENVIRONMENTAL RESTORATION PROGRAM

**FOURTH CERCLA FIVE-YEAR REVIEW
REPORT**

JBER-ELMENDORF, ALASKA

**FINAL
MARCH 2014**

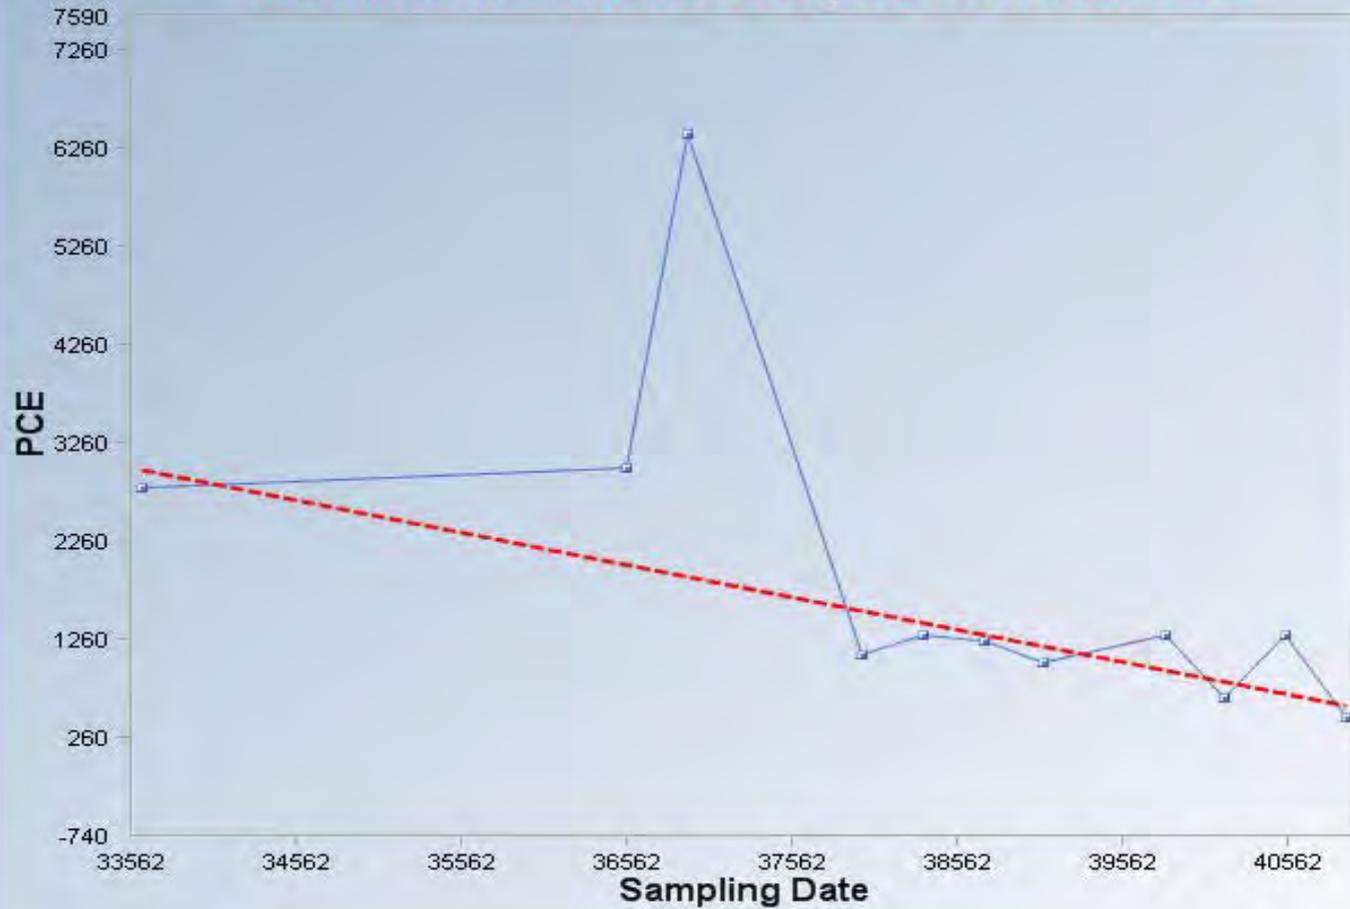
Mann-Kendall Trend Analysis - 41755WL-02

Mann-Kendall Trend Analysis

n	11.0000
Confidence Coefficient	0.9500
Level of Significance	0.0500
Test Value (S)	-28
Tabulated p-value	0.0130
Standard Deviation of S	12.7017
Standardized Value of S	-2.1257
Approximate p-value	0.0168

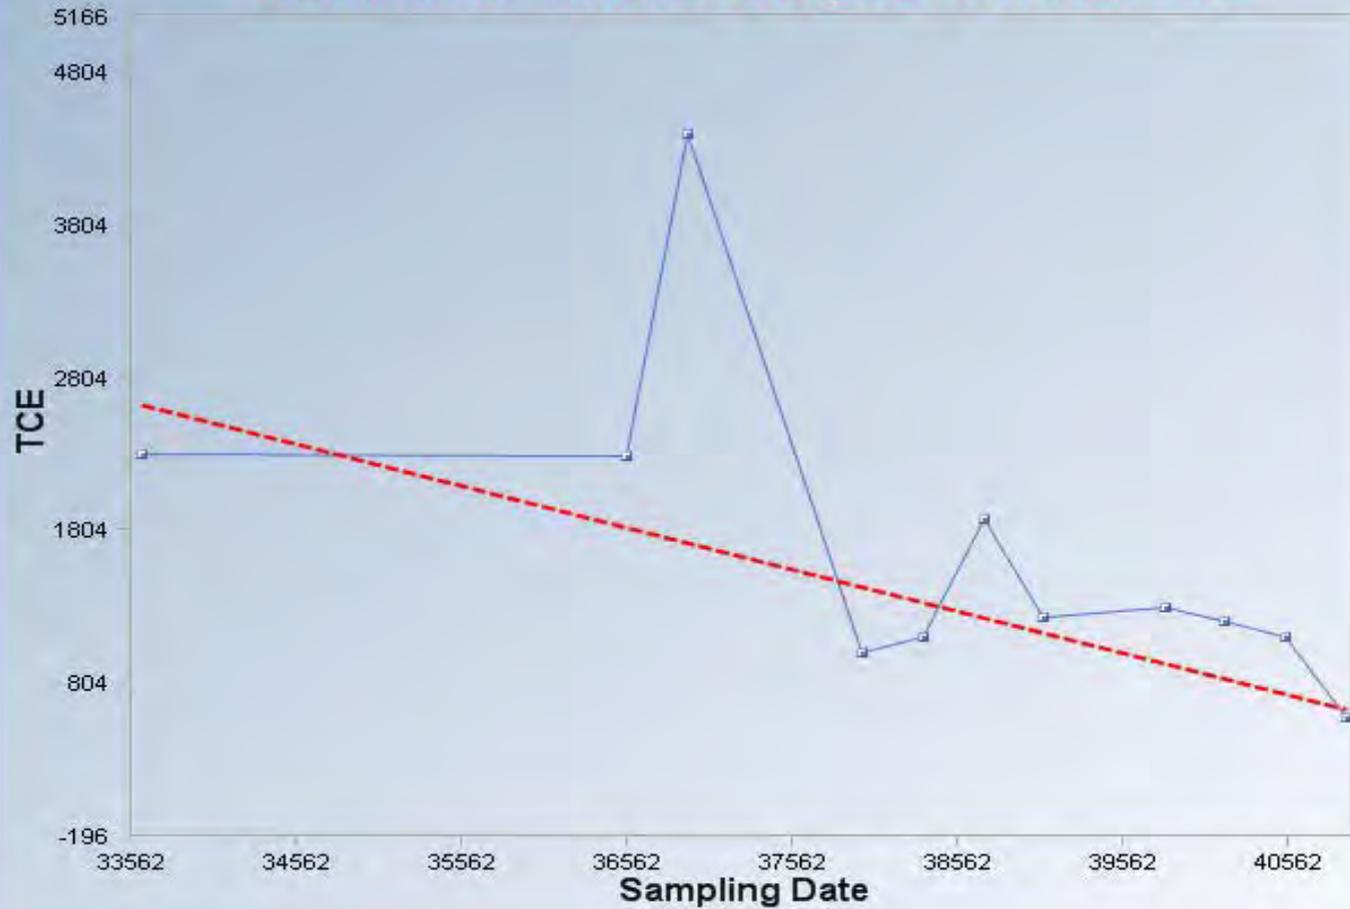
Mann-Kendall Trend Analysis - 41755WL-02

Mann-Kendall Trend Analysis

n	11.0000
Confidence Coefficient	0.9500
Level of Significance	0.0500
Test Value (S)	-28
Tabulated p-value	0.0130
Standard Deviation of S	12.8062
Standardized Value of S	-2.1083
Approximate p-value	0.0175

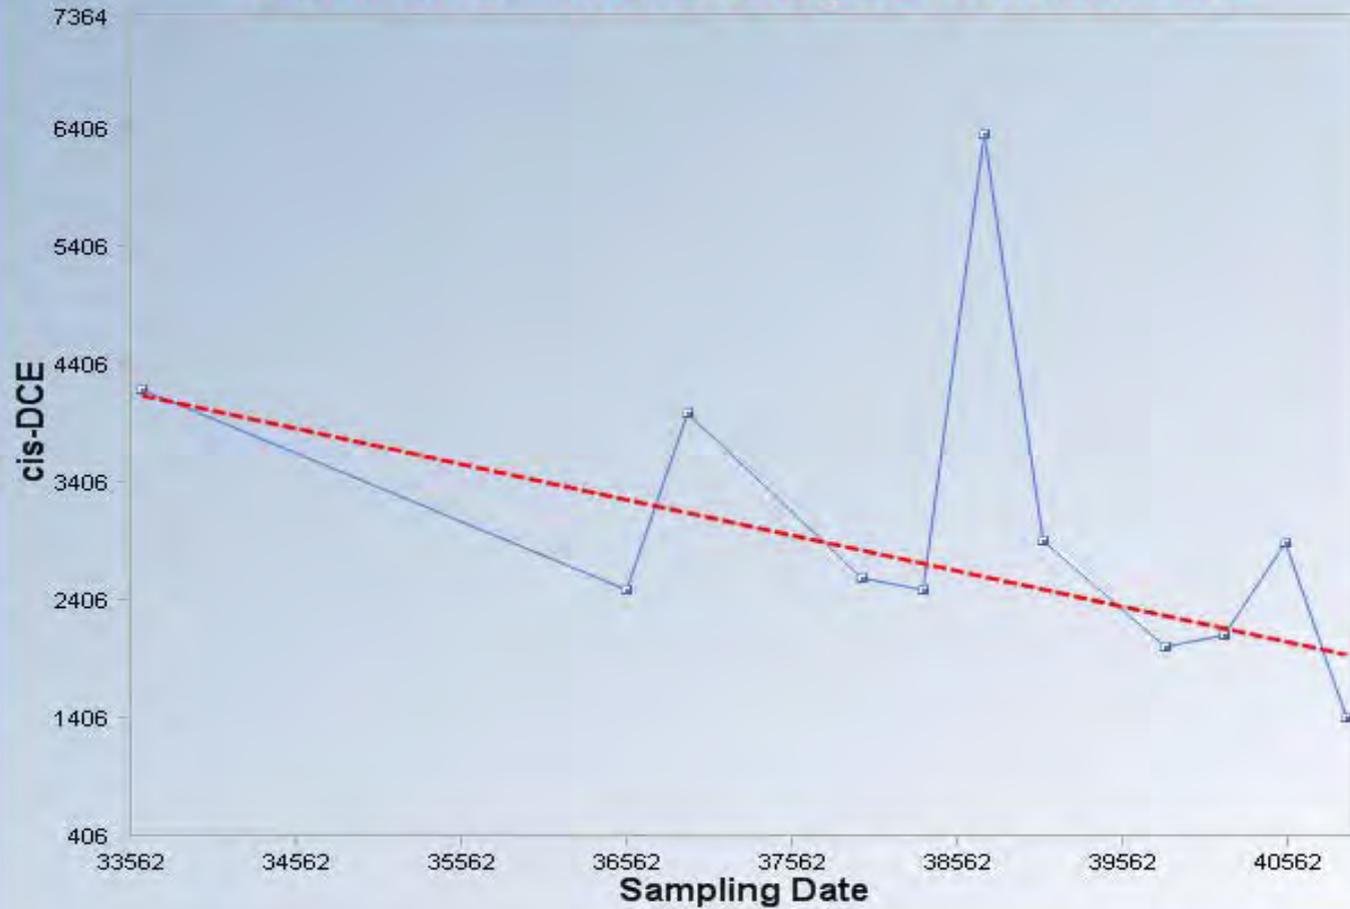
Mann-Kendall Trend Analysis - 41755WL-02

Statistically significant evidence of a decreasing trend at the specified level of significance.

Mann-Kendall Trend Analysis

n	11.0000
Confidence Coefficient	0.9500
Level of Significance	0.0500
Test Value (S)	-21
Tabulated p-value	0.0600
Standard Deviation of S	12.8452
Standardized Value of S	-1.5570
Approximate p-value	0.0597
