**PRE-DESIGN INVESTIGATION REPORT  
PROPOSED SOLAR REDEVELOPMENT PROJECT  
FORMER BAUXITE RESIDUE DISPOSAL AREAS  
Operable Unit 1, North Alcoa Site**

East St. Louis, Illinois

**Restoration Land Development Company, LLC**  
Wellesley, MA

**AMEC Environment & Infrastructure, Inc.**  
800 N. Bell Avenue, Suite 200  
Pittsburgh, Pennsylvania 15106  
(412) 279-6661

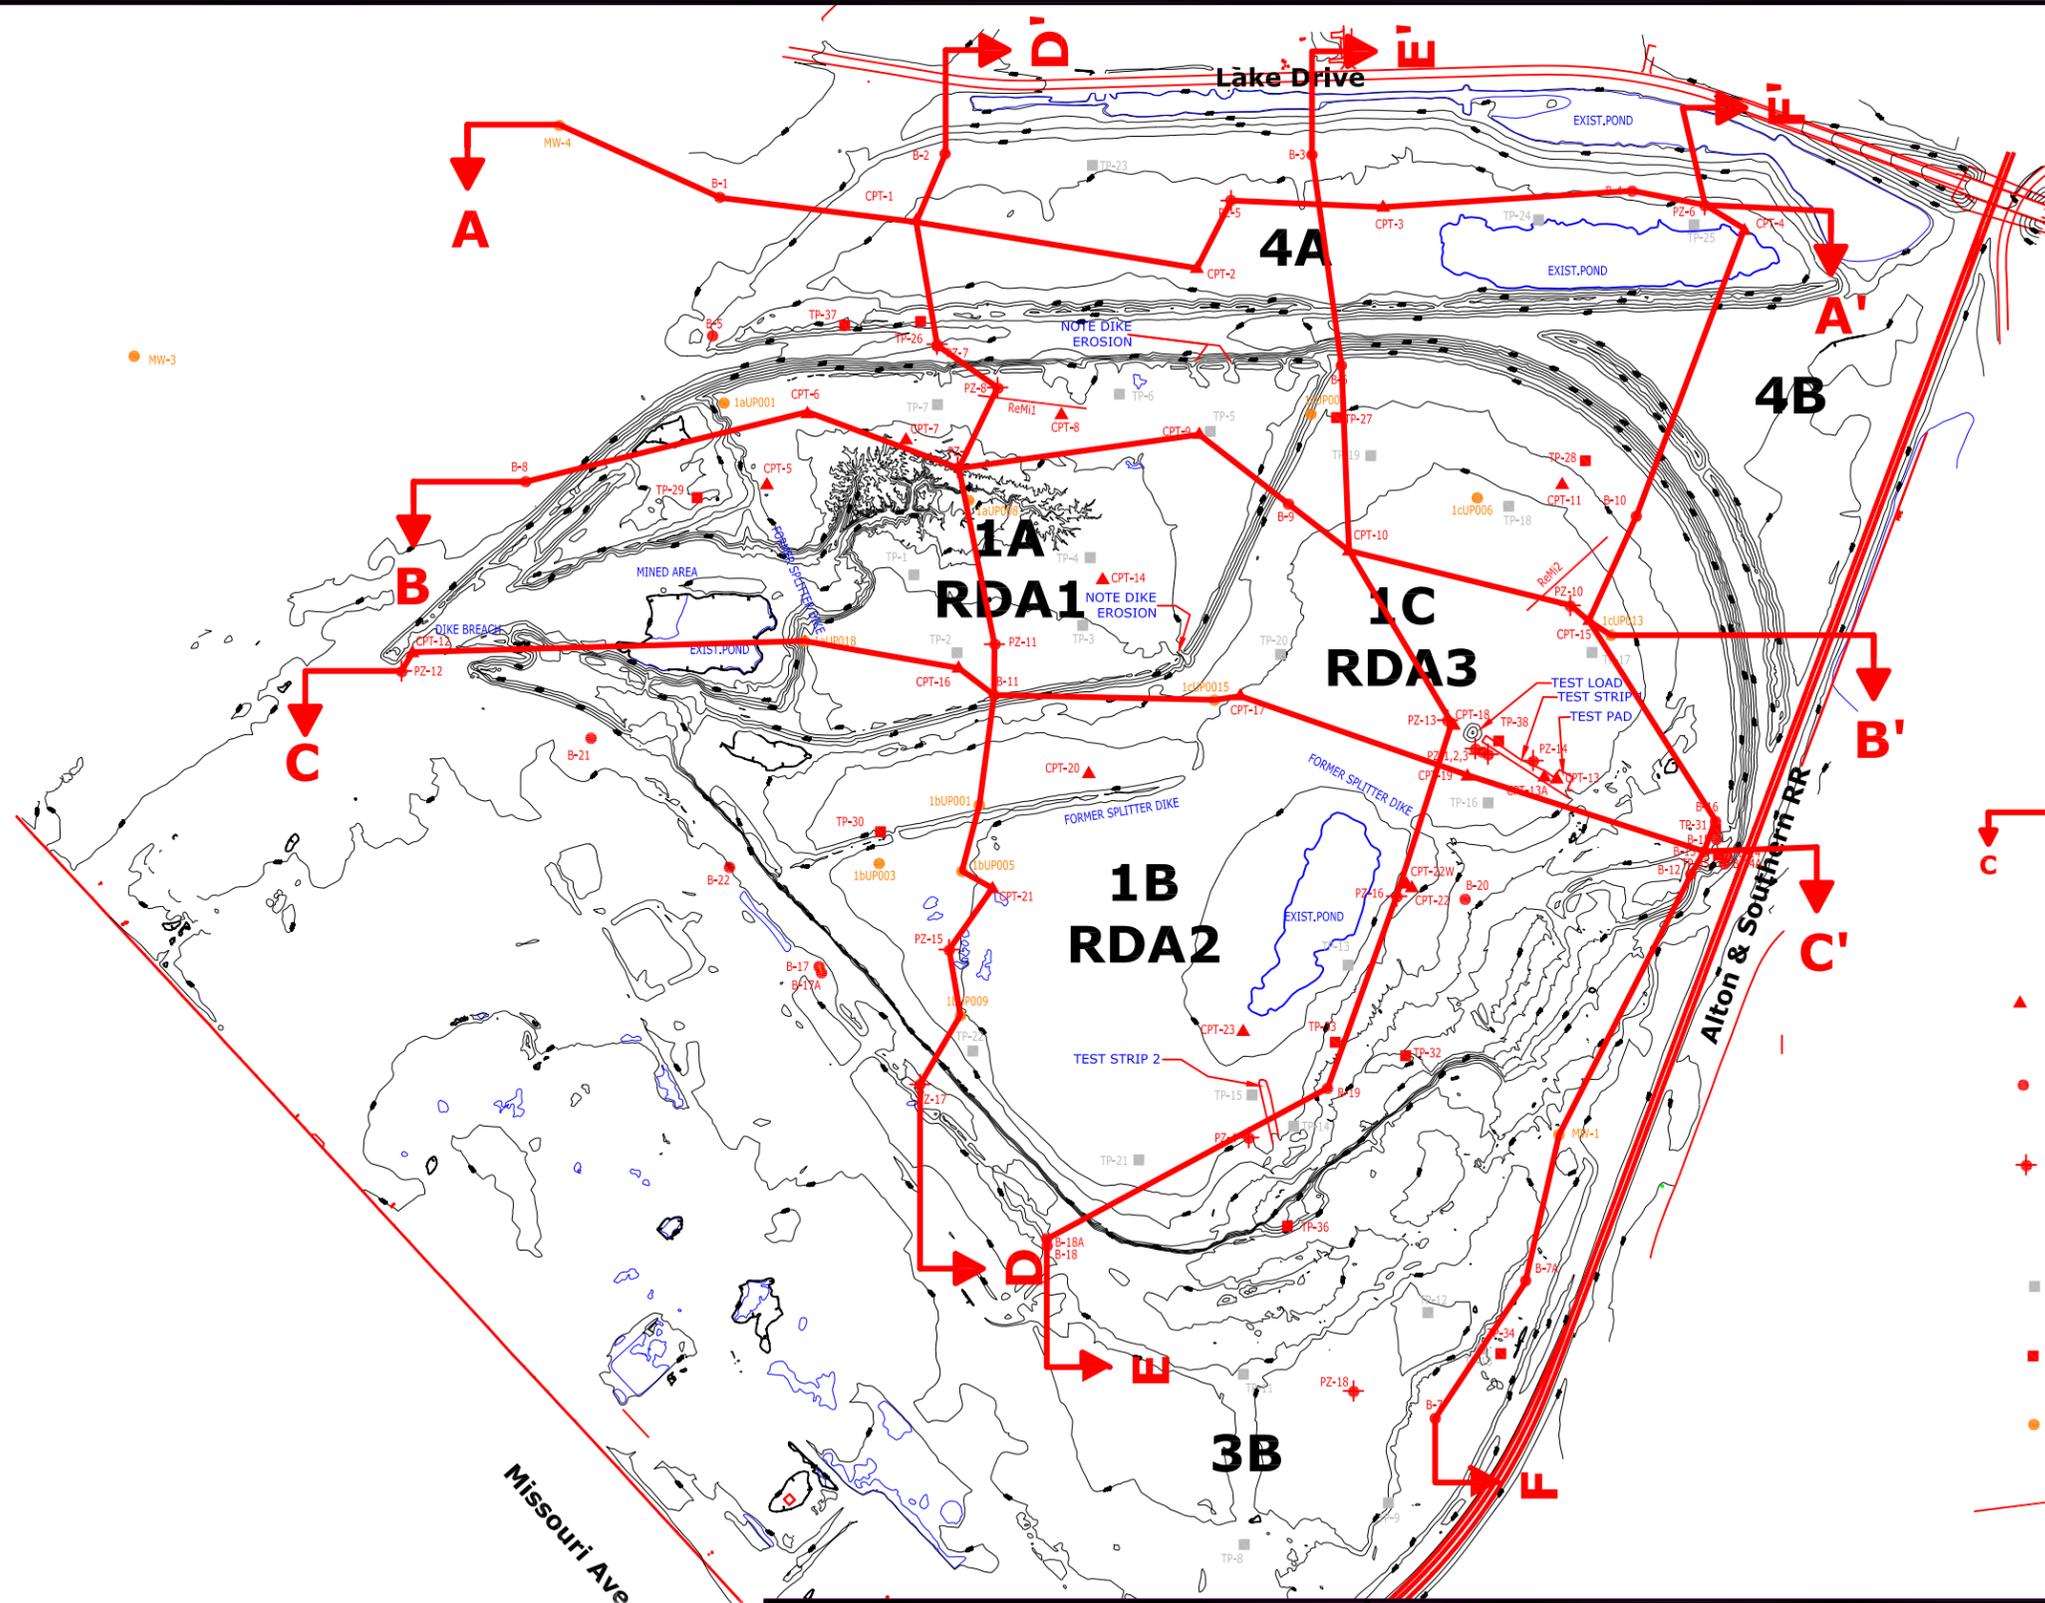
JOB NO. 3410-10-0782.9.2      FIGURE 2

- Subsurface Section
- APPROX. SCALE IN FEET
- CPT PROBE (CPT-1 THRU CPT-23)
- SPT BORING (B-1 THRU B-22)
- SPT BORING WITH PIEZOMETER (PZ-5 THRU PZ-18)
- TEST PIT (2010)
- TEST PIT WITH HEAVY TRACKHOE (2011)
- WELLS/BORINGS FROM RIR
- ReMi Traverse

The OU-1 Site is located near the eastern edge of East St. Louis. It is a roughly triangular shaped parcel, bounded on the southeast by the Alton and Southern Railroad (an active double track line), on the southwest by outparcels along Missouri Avenue (SR 15) formerly occupied by the Alcoa Plant, on the northwest by parcels fronting on North 29<sup>th</sup> Street, and on the north by Lake Drive. The general area is relatively level at elevations ranging around 415 to 420 feet. The Site is characterized by a large central mound comprising the three Residue Disposal Areas RDAs and stockpiles of gypsum of generally lesser size. A topographic site/exploratory location plan is provided as **Figure 1**. **Figures 2-8** provide subsurface cross sections that are based on data generated during this investigation.

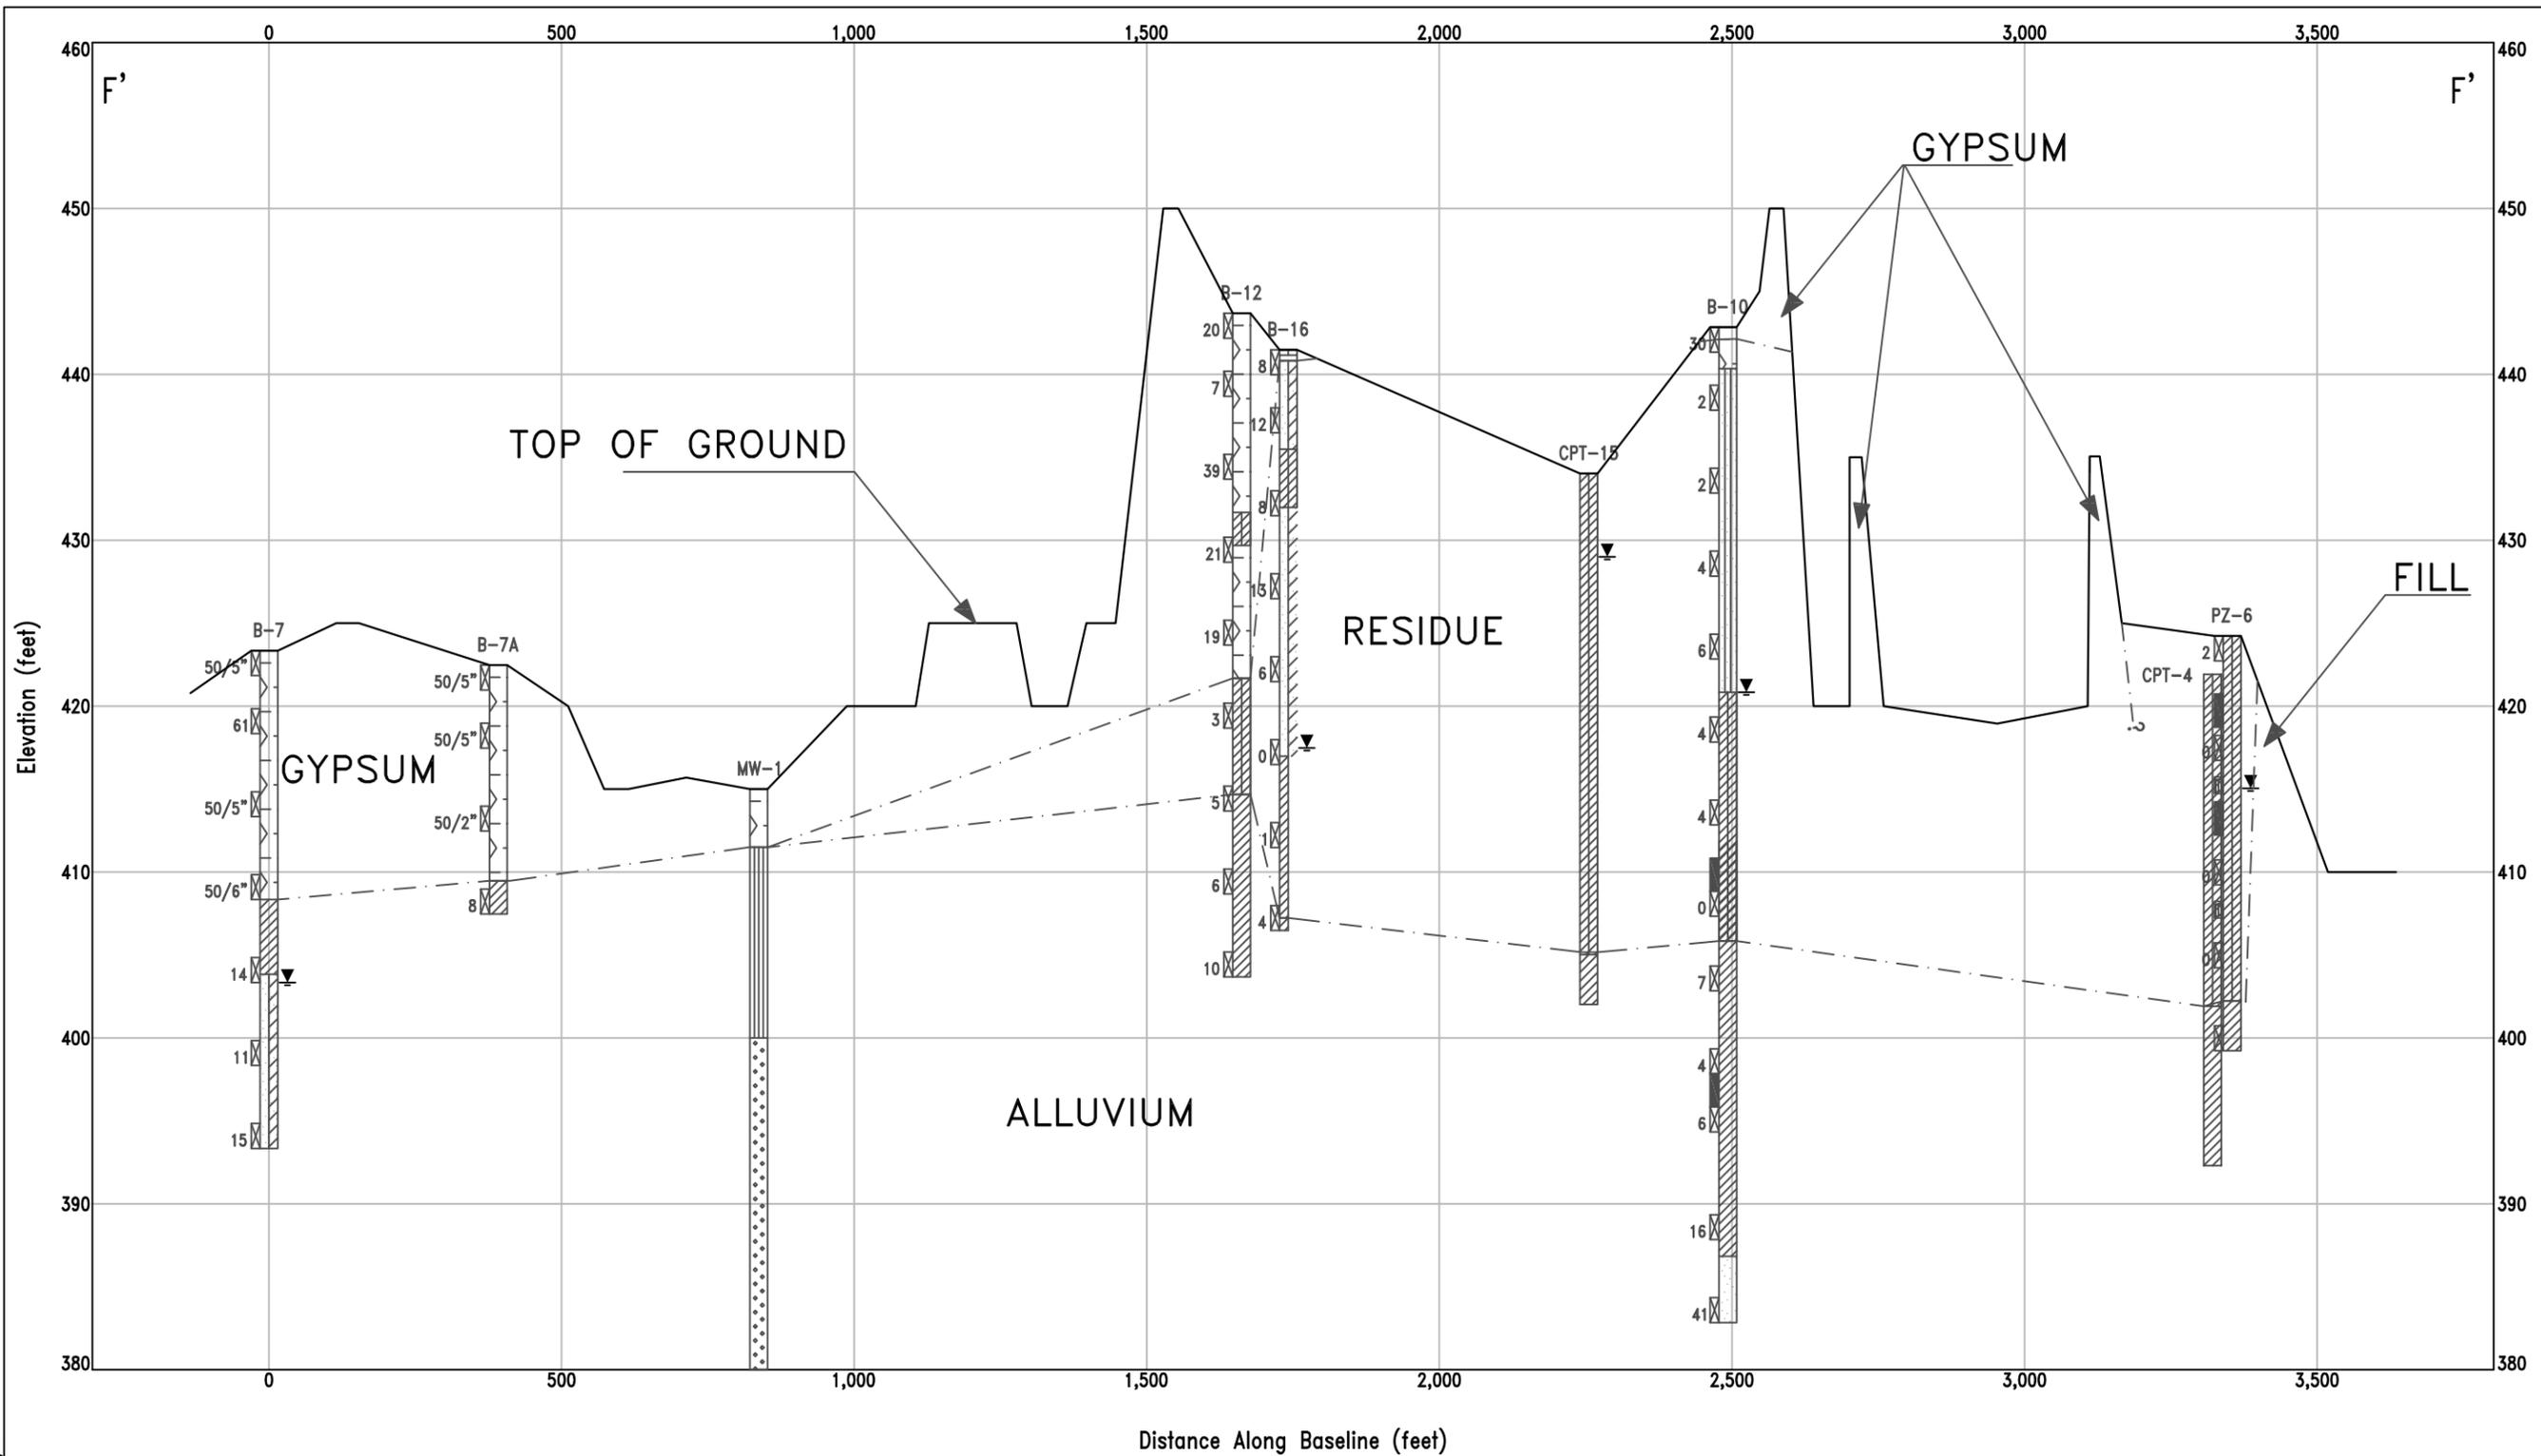
Gypsum, Rocksalt, etc.		USCS Silty Sand		AR Auger Refusal
	USCS Low Plasticity Silty Clay		USCS Low Plasticity Clay		BT Boring Terminated
	USCS Poorly-graded Sand		USCS Poorly-graded Sand with Clay		Standard Penetration Test
	USCS Silt		USCS Well-graded Sand		Undisturbed Sample
					Groundwater Level At Time Of Boring
					Groundwater Level After 24 Hours

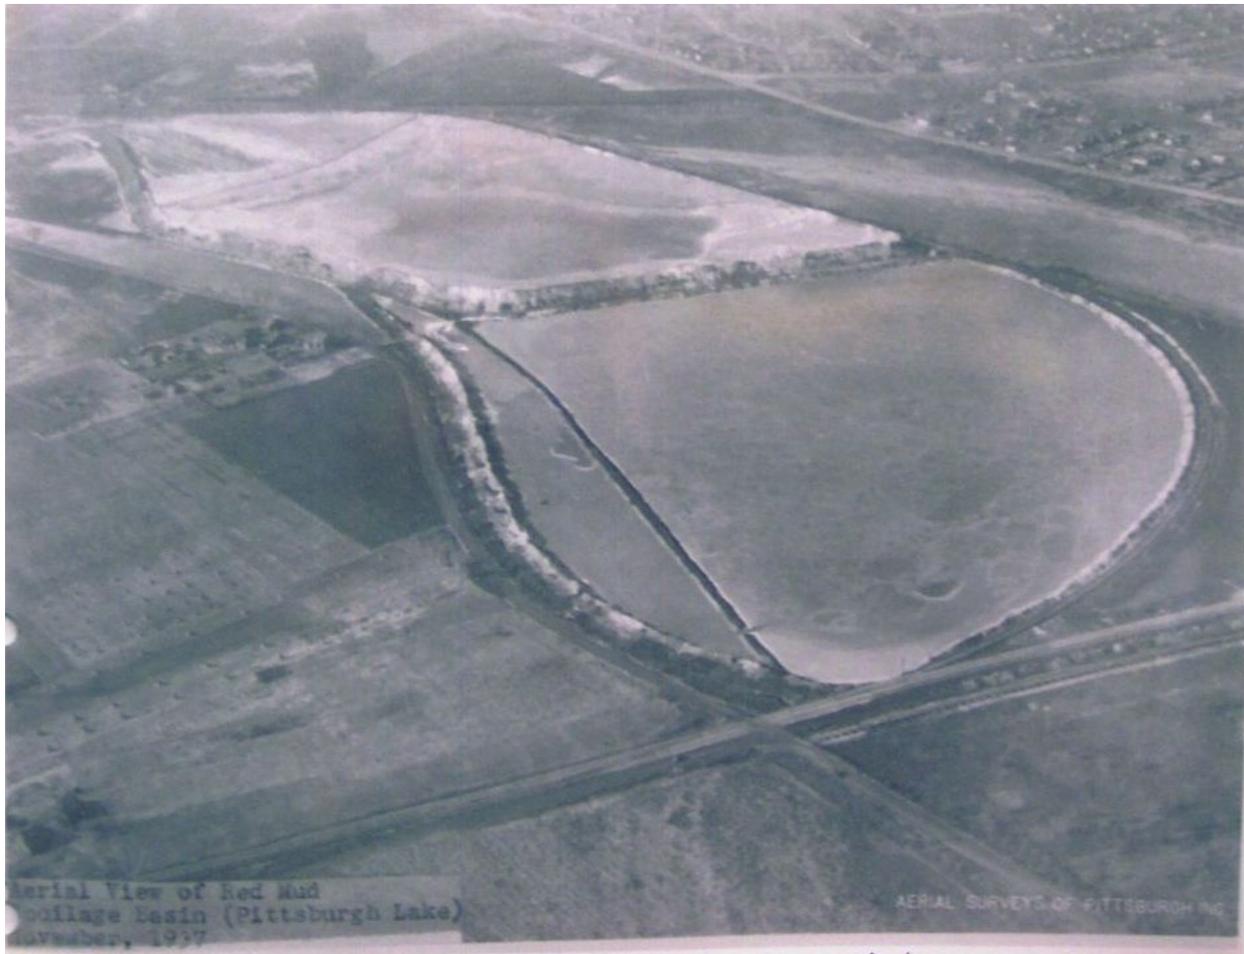
Fig 2-11

2811 RDA IN 3/10/1937

By the 1930's, RDA 1 had been defined, again probably starting with lower dikes. The eastern portion of RDA 1 was probably still in use for residue placement and storage. Photographs from 1937 and 1940 (see **Figures 9 and 10**) suggest that there was an interior dike running approximately southeast to northwest along the east end of the mined area. Based on current exposures and exploration in the area, this interior dike appears to have been constructed of residue. The RDA 1 area east of this still appears to be depressed and holding liquor/residue in the late 1930's aerial photographs. Mining of residue from southwestern portion of RDA 1 appears to have commenced in a circa 1930 photograph and been near the existing extent by the 1937 photograph.

The southeast corner of the RDA 3 dike appears to be closely impinging, if not overlying, the railroad right of way. Historic aerial photographs indicate that the dike was constructed in approximately this condition (see **Figures 9 and 10**). The final design will include moving the dike toe back to or slightly behind the railroad right of way line and then excavating and flattening the slope to at least 3 horizontal to 1 vertical. Test pits (TP-31 and TP-35) and borings (B-12 through B-16) atop and behind the existing dike suggest that excavation of this slope will encounter mostly gypsum materials, though some residue materials may be encountered in the top or westernmost portion of this cut. After clearing of this area, we recommend careful surveying of the area to indicate the top of cut slope. Additional test pits should be conducted in this area prior to beginning the cut to determine if and to what extent residue will be encountered in the cut. If the cut is expected to encounter significant residue, which would present stability issues with the finished slope, one or more trenches could be excavated along the back of the slope to remove the residue and replace it with gypsum fill. Test pits behind the planned cut area demonstrate that temporary excavation trenches can be made to depths up to about 15 feet. Gypsum fill in such a case would be placed in thin lifts and compacted remotely, using the backhoe bucket, as personnel entry into the trench would not be feasible.

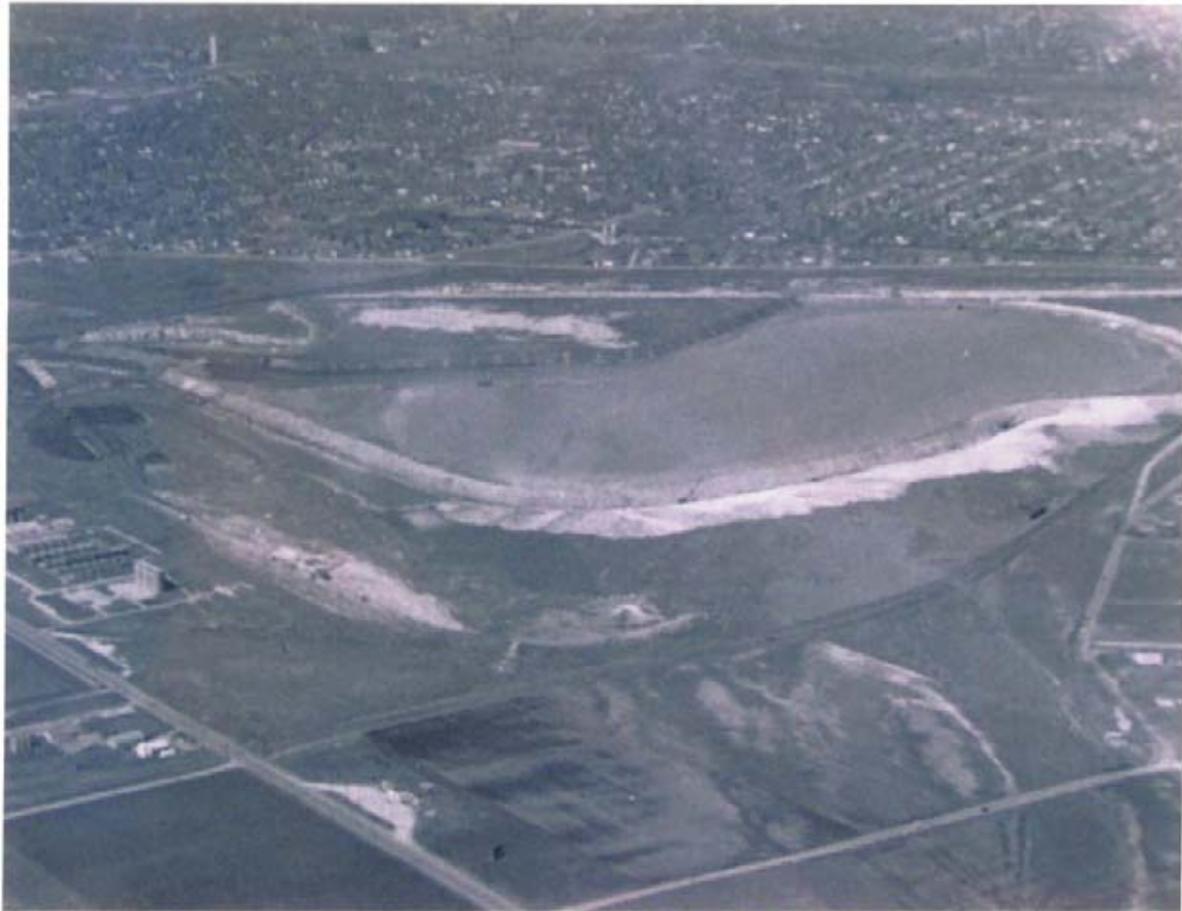
**Figure 11: Aerial Photo 1955 Oblique From SE**

Fig 15 RDA aerial 1955

By 1955 (See **Figure 11**), RDA 1A had apparently filled and erosion of the central portion toward the southwest appears to have begun. RDA 2 and RDA 3 appeared to be operational, with the edges beginning to fill with residue.

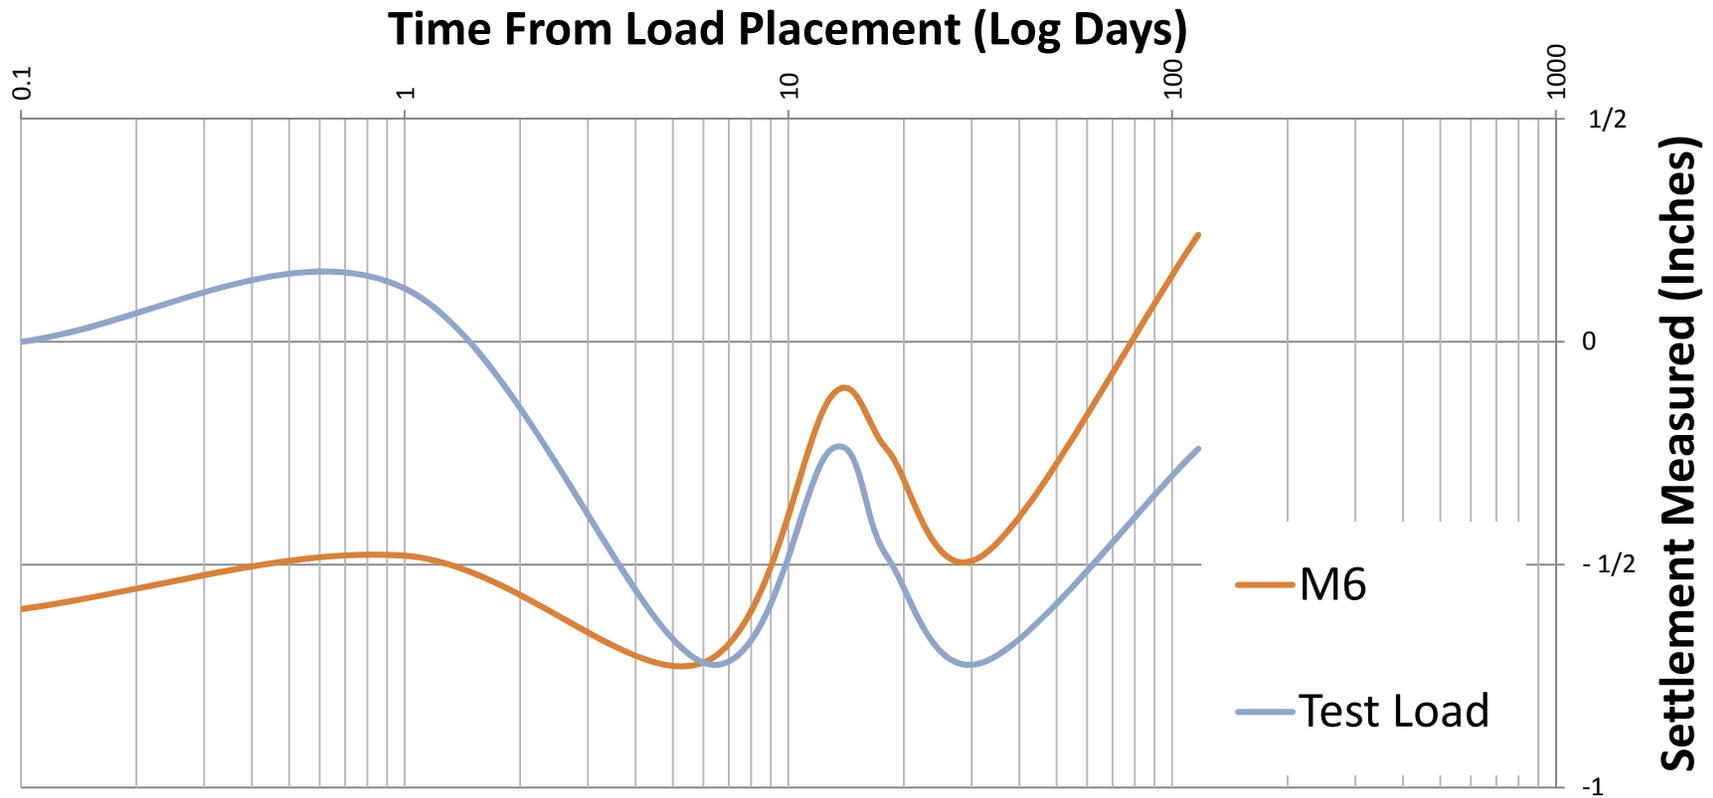
# Figure 12: Test Load Settlement

1. Potential Survey Error about 1/2 Inch, based on Data Scatter
2. Sudden decline could indicate load rod was disturbed by Surveyor Climbing on Load

A test load was installed during the test strip program. The test load is a conical pile of soil approximately 15 feet high with 2 horizontal to 1 vertical side slopes. It has a volume of about 500 cubic yards and weighs approximately 800 tons. Settlement measurements were taken of the loaded area from prior to placement and periodically since that time. Additional measurements will be taken until the test load material is spread into the bridge lift during remedial construction. Interpreted settlement measurements for the test load are shown in **Figure 12**.

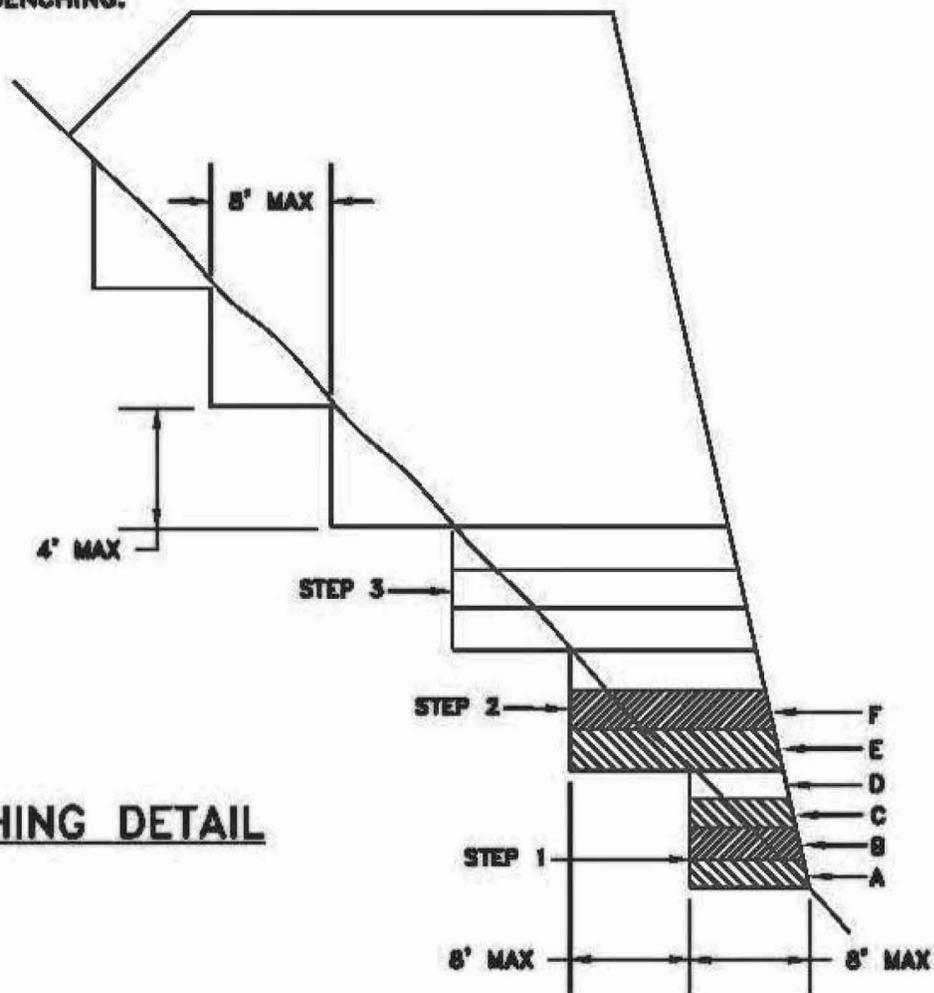
**BENCHING DETAIL**

2. THE DIAGRAM SHOWS THAT BEFORE LAYER "A" IS PLACED THE FIRST STEP (1) IS CUT INTO THE SLOPE A MAXIMUM DISTANCE OF ABOUT 8' (ABOUT 3/4 THE WIDTH OF THE USUAL D-8 BULLDOZER BLADE). SUCCESSIVE LAYER "E" IS PLACED, THE SECOND STEP IS CUT 8' INTO THE SLOPE AND SUCCESSIVE LAYERS ARE AGAIN PLACED. IF IT IS ANTICIPATED THAT THE VERTICAL PART OF THE STEP WILL EXCEED 4' IF AN 8' HORIZONTAL CUT IS MADE, THEN THE ACTUAL CUT STOPS WHEN THE VERTICAL PART REACHES A MAXIMUM OF 4' ALLOWING THE HORIZONTAL DISTANCE TO VARY.

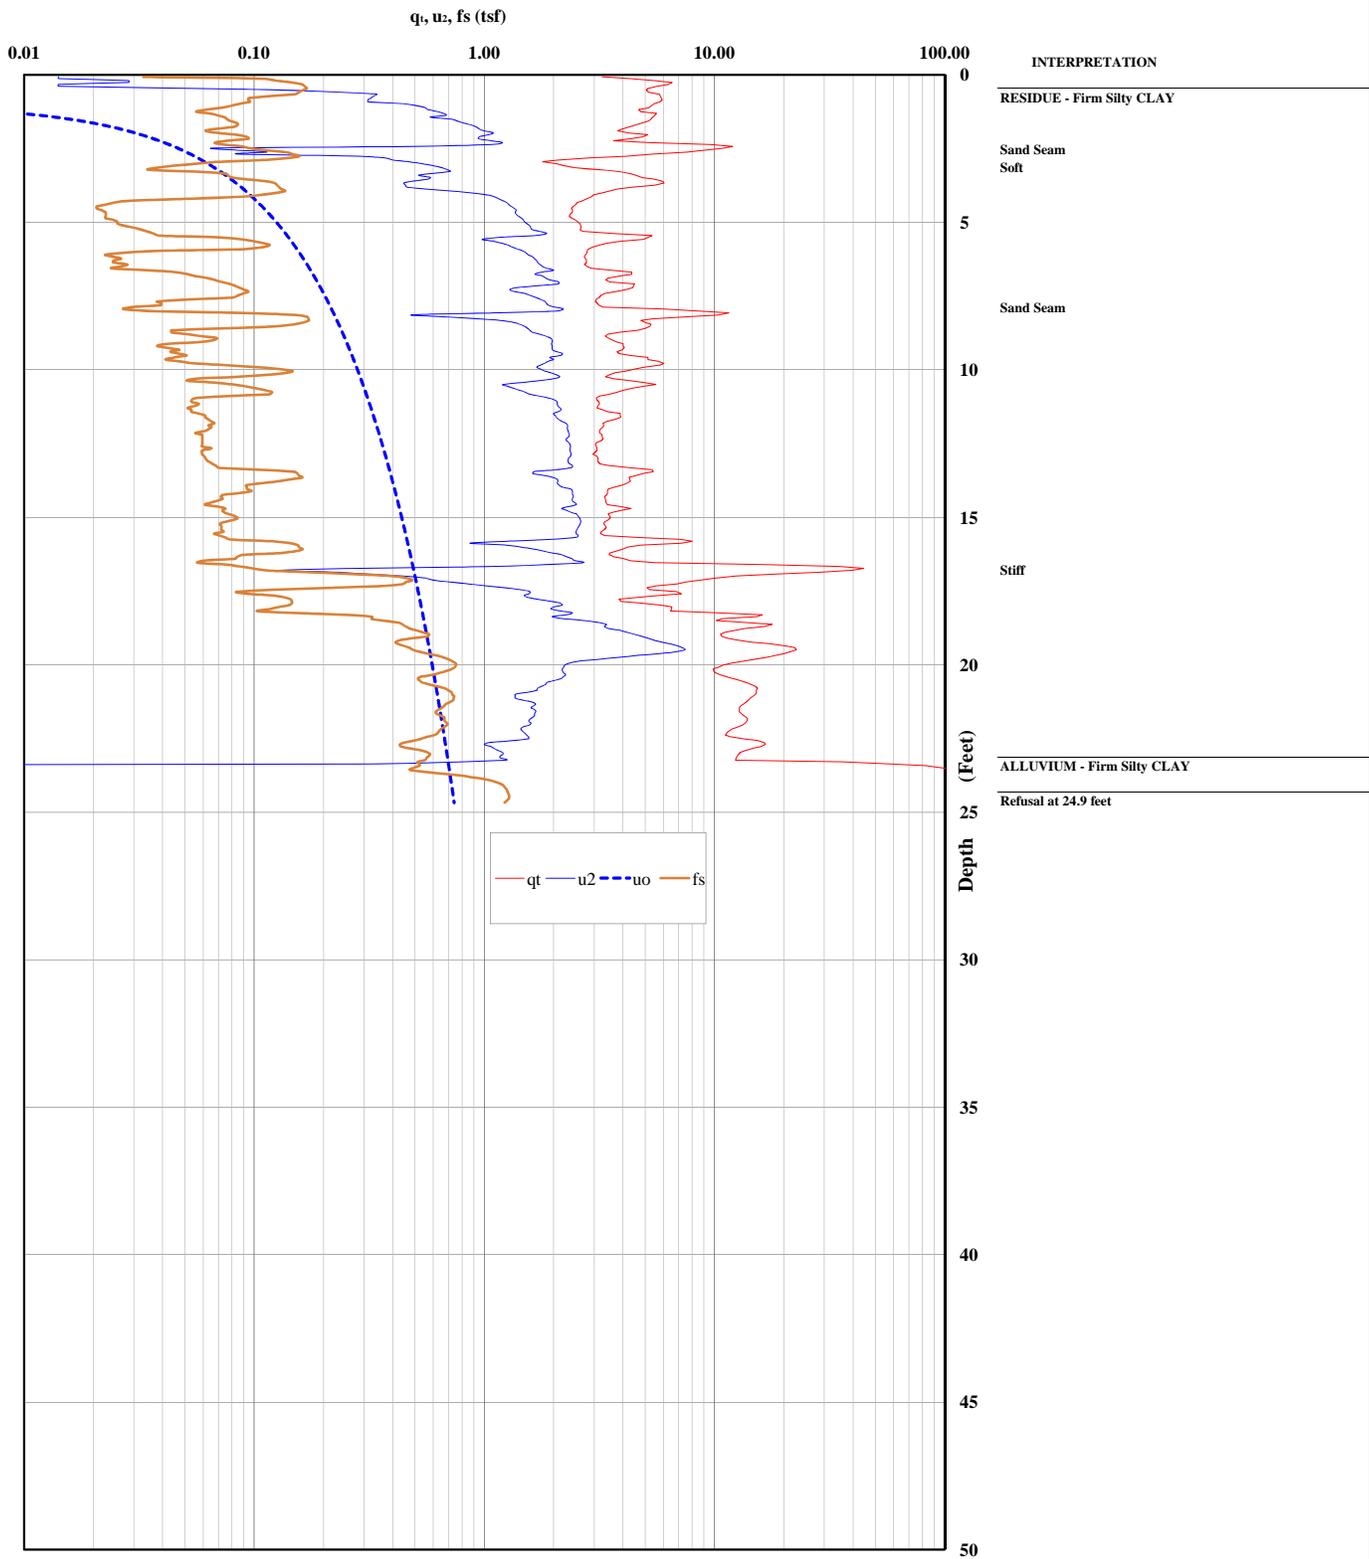
PROJECT: FAESLOU1  
 PROJECT NUMBER: 3410-10-0782 10.2  
 PROBE ID: CPT-01  
 DATE: 12/4/11  
 SURFACE ELEVATION: 424 Feet  
 PUSHED BY: Fugro (20 Ton Track)  
 PREPARED BY: AAW  
 CHECKED BY: PDP

CPT does not provide a direct measurement of groundwater levels. The pore pressure measurement is a dynamic pressure measured as the cone is advanced. In clean sands, this may approach the hydrostatic pressure at the depth. However, in soft soils with significant fines, the dynamic pressure is typically greater than hydrostatic in soft soils. In stiff clays or silts, suction may develop at the cone shoulder where the pore pressure measurements are taken, creating low or negative pore pressure readings. The pore pressure transducer may become clogged or drained by suction, so that some data is lost; typically this is indicated by relatively straight lines on the pore pressure plots.

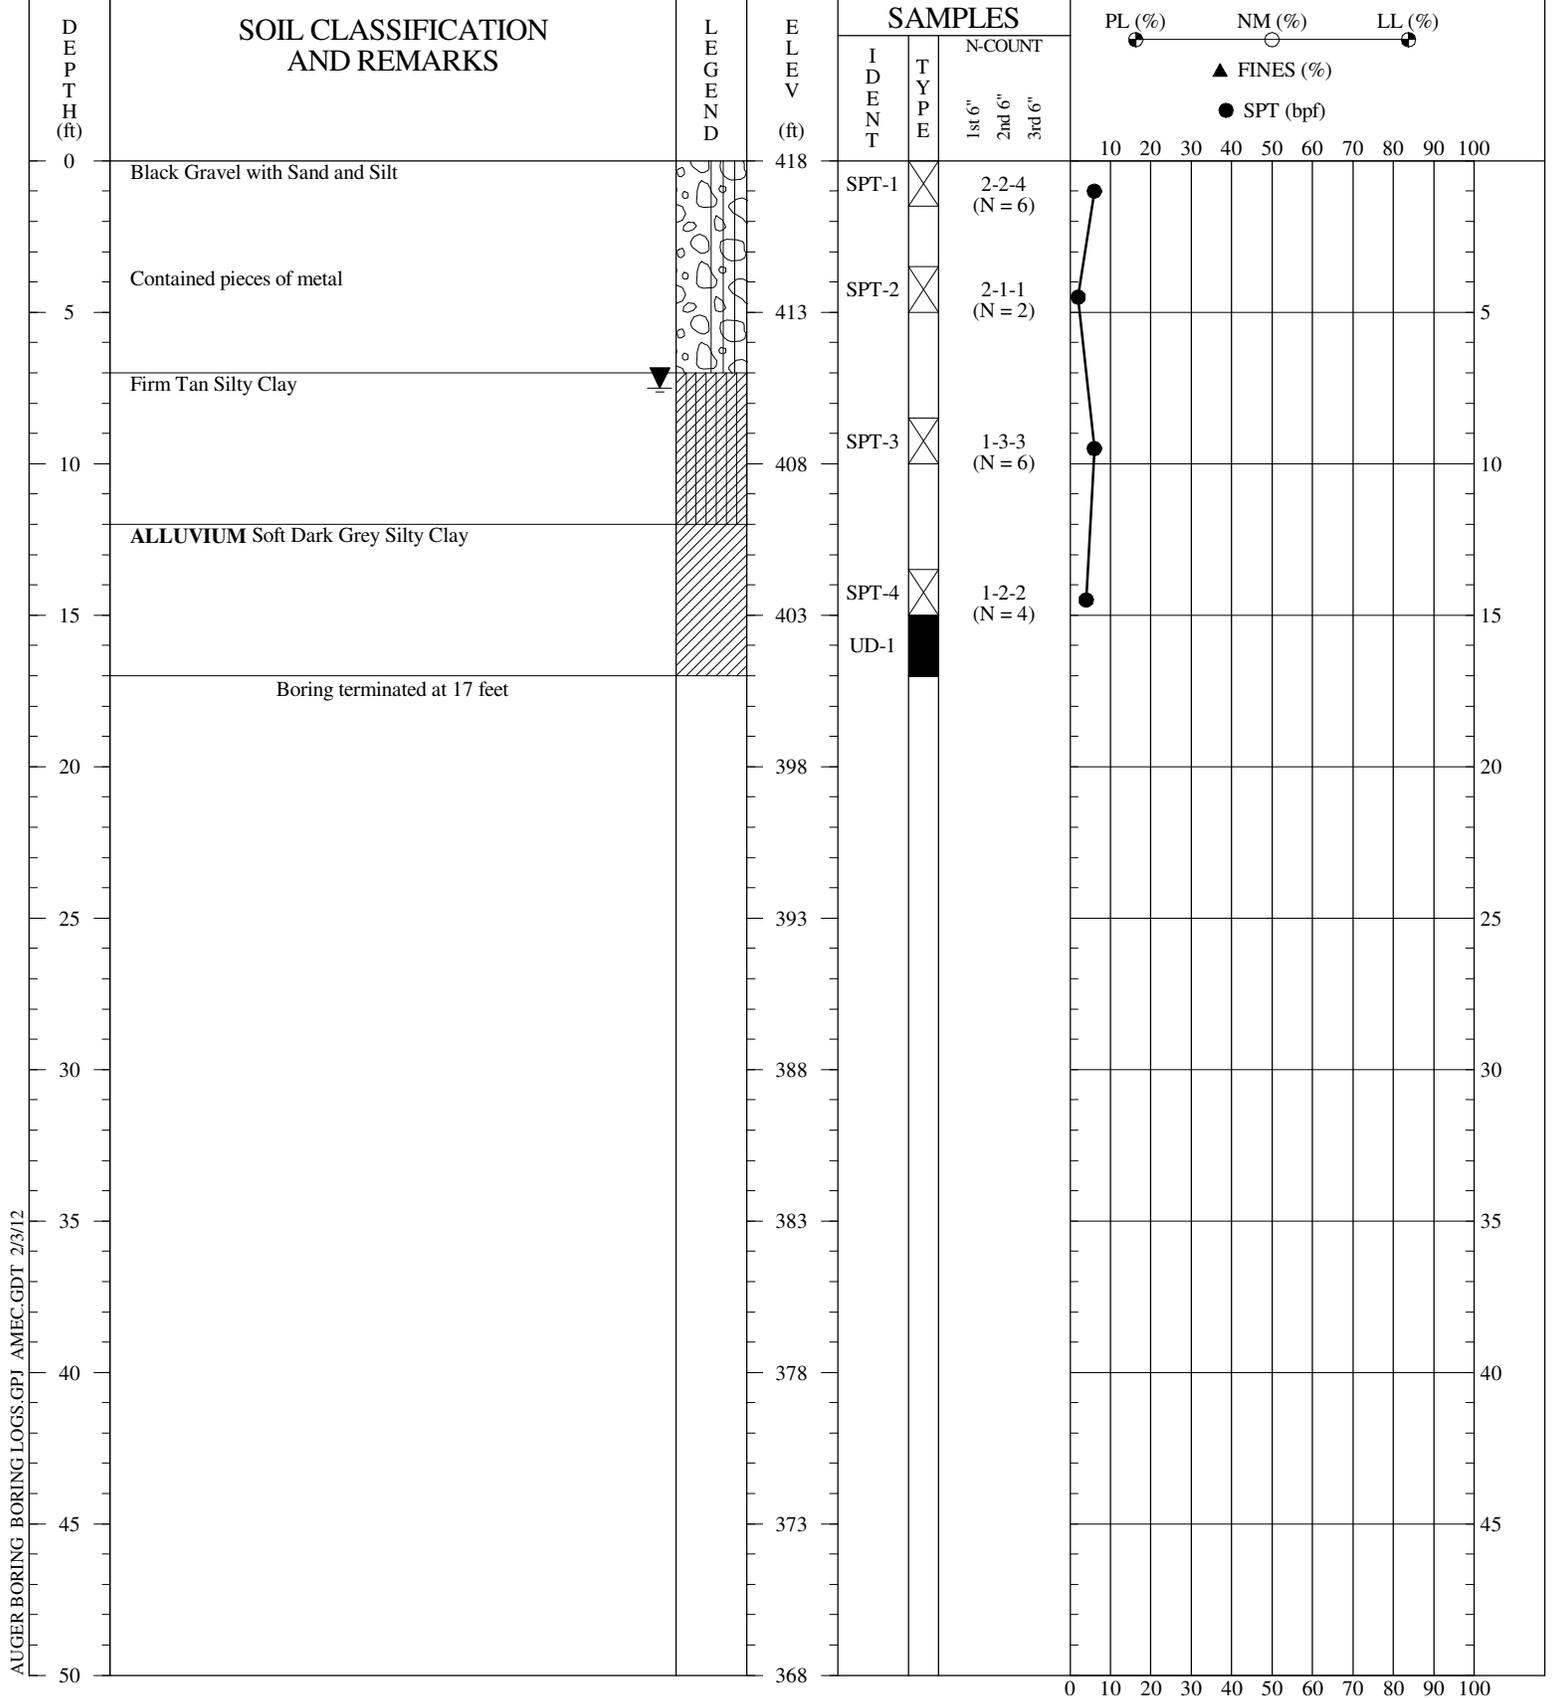
**DRILLER:** R. Landeros (AMEC)  
**EQUIPMENT:** CME-550 (Auto-Hammer)  
**METHOD:** Rotary Wash with Mud  
**HOLE DIA.:** 6 inches  
**REMARKS:** Boring caved at 14 feet.

Twenty six soil test borings designated B-1 through B-22, B-7A, B-14A, B-17A, and B-18A, were advanced at the approximate locations indicated on the Subsurface Exploration Location Plan (**Figure 1**). Borings were advanced to depths ranging from 15 to 65 feet below existing grades. Borings were generally terminated in natural alluvial clay soils. If borings penetrated into natural alluvial sand, boreholes were grouted to reduce the potential for infiltration into the natural sands. Otherwise, boreholes were backfilled with drill cuttings.

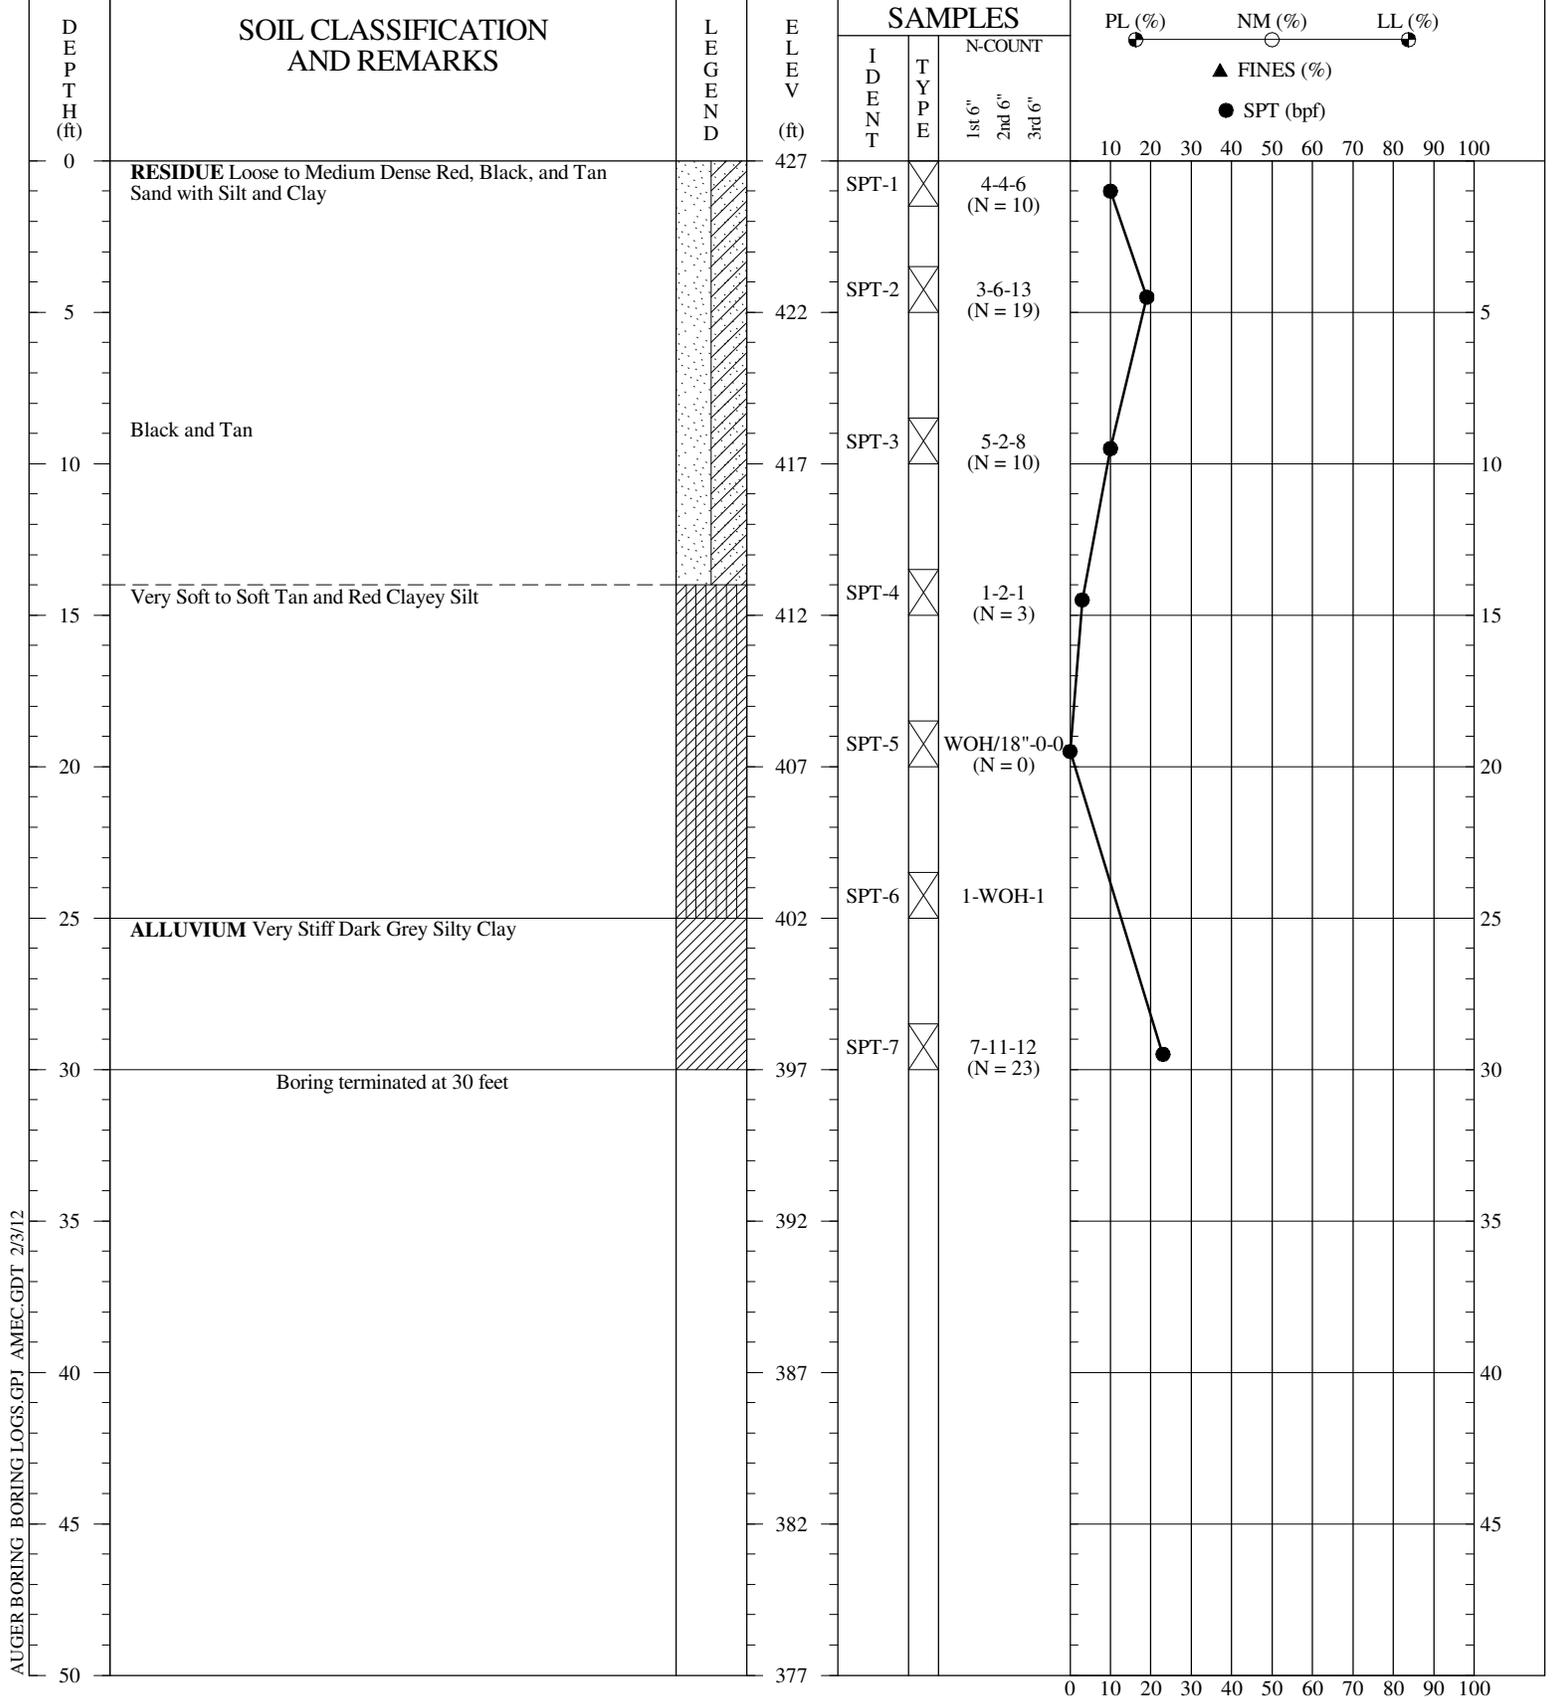
**DRILLER:** R. Landeros (AMEC)  
**EQUIPMENT:** CME-550 (Auto-Hammer)  
**METHOD:** Rotary Wash with Mud  
**HOLE DIA.:** 6 inches  
**REMARKS:** Dry, boring caved at 16 feet. Boring performed on the crest of the dike.
