**PRE-DESIGN INVESTIGATION REPORT  
PROPOSED SOLAR REDEVELOPMENT PROJECT  
FORMER BAUXITE RESIDUE DISPOSAL AREAS  
Operable Unit 1, North Alcoa Site**

East St. Louis, Illinois

**Restoration Land Development Company, LLC**  
Wellesley, MA

**AMEC Environment & Infrastructure, Inc.**  
800 N. Bell Avenue, Suite 200  
Pittsburgh, Pennsylvania 15106  
(412) 279-6661

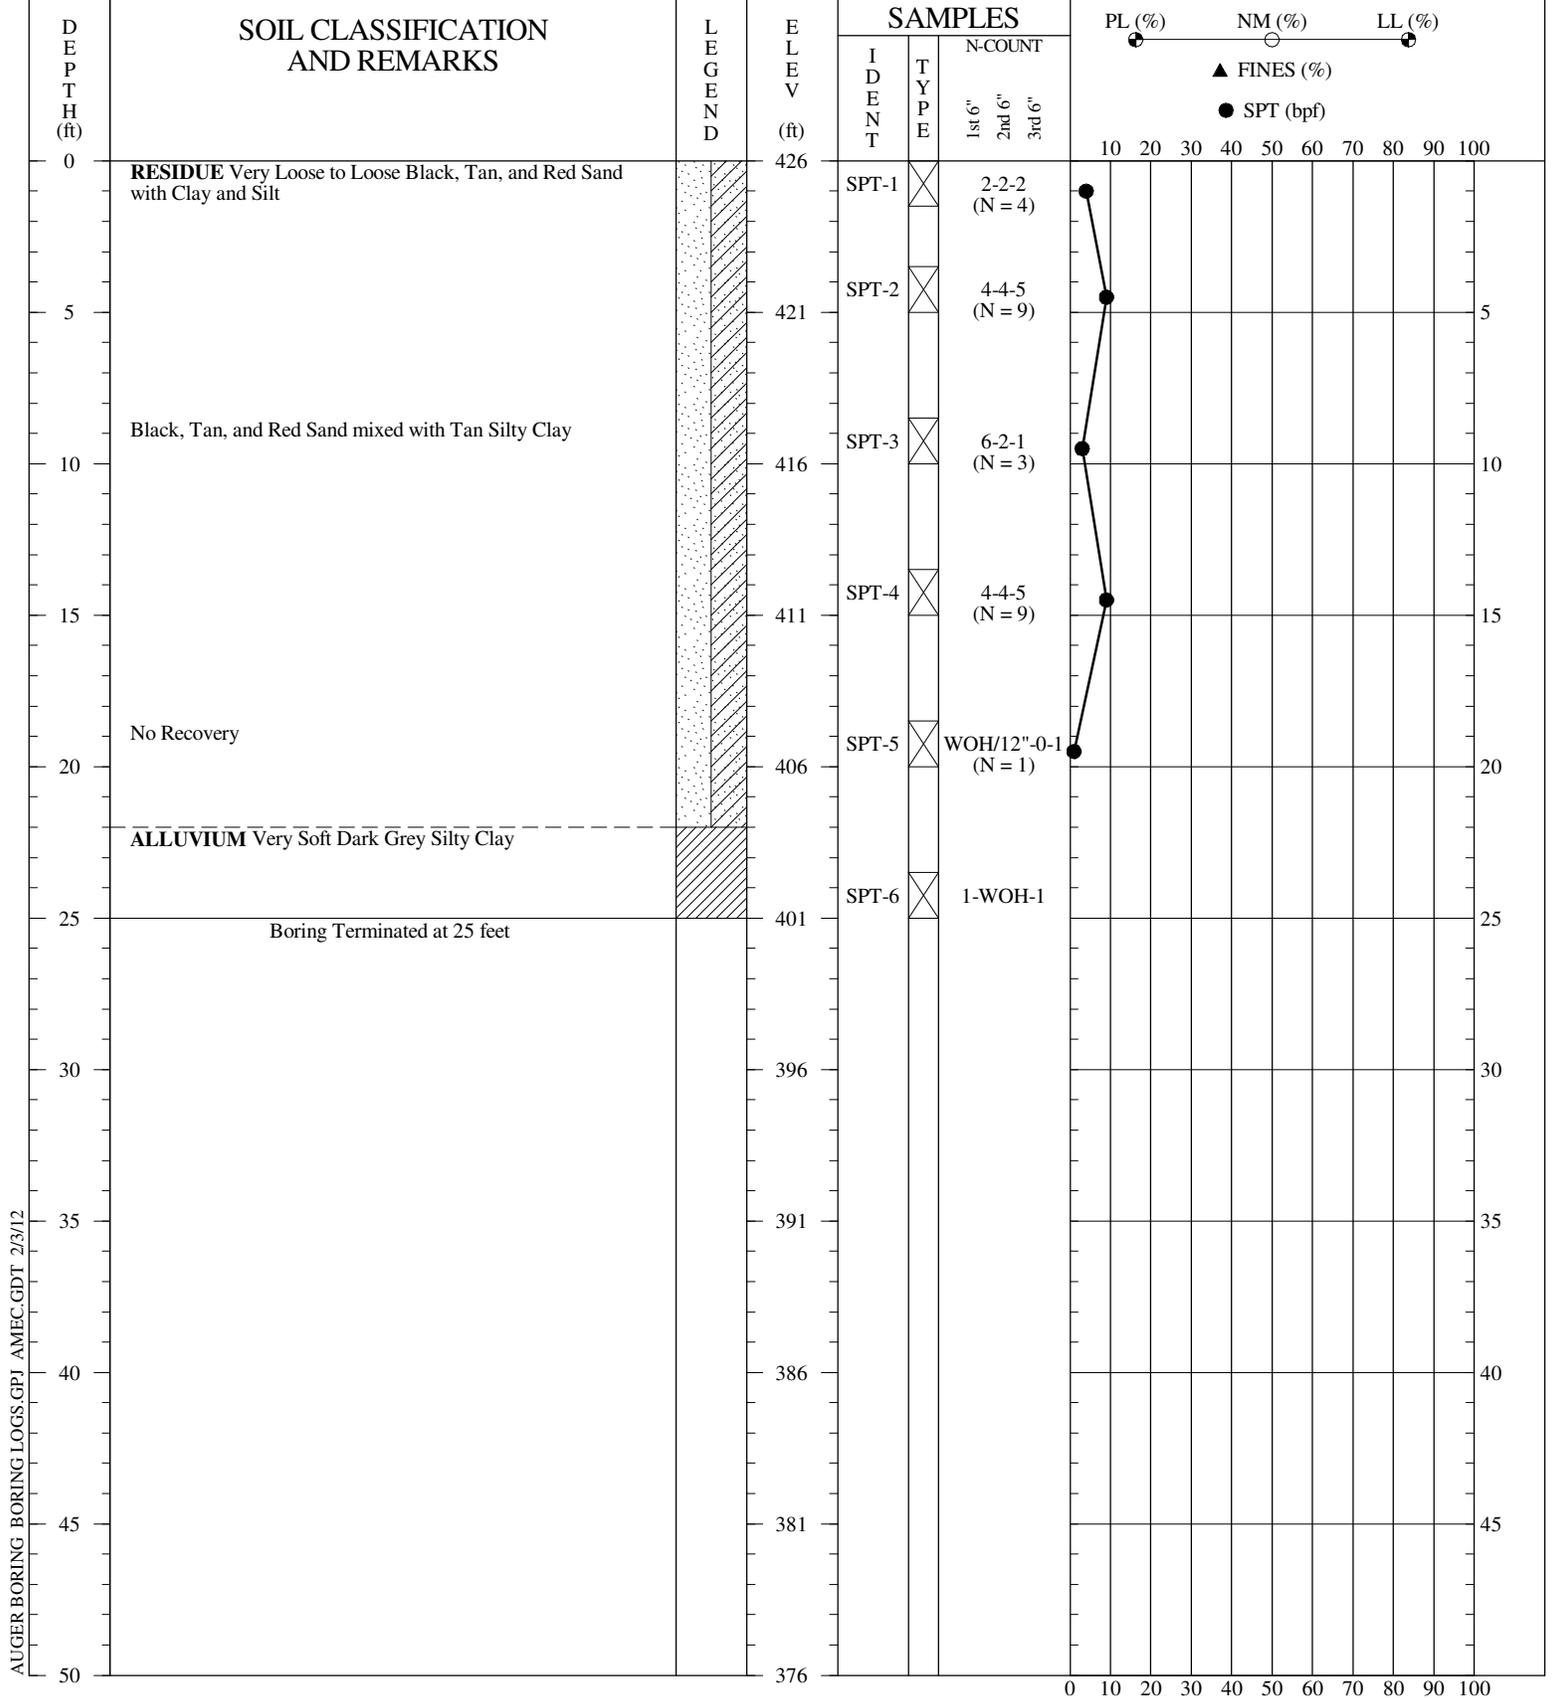
**DRILLER:** R. Landeros (AMEC)  
**EQUIPMENT:** CME-550 (Auto-Hammer)  
**METHOD:** Rotary Wash with Mud  
**HOLE DIA.:** 6 inches  
**REMARKS:** Dry, boring caved at 16 feet. Boring performed 20 feet south of the dike crest.

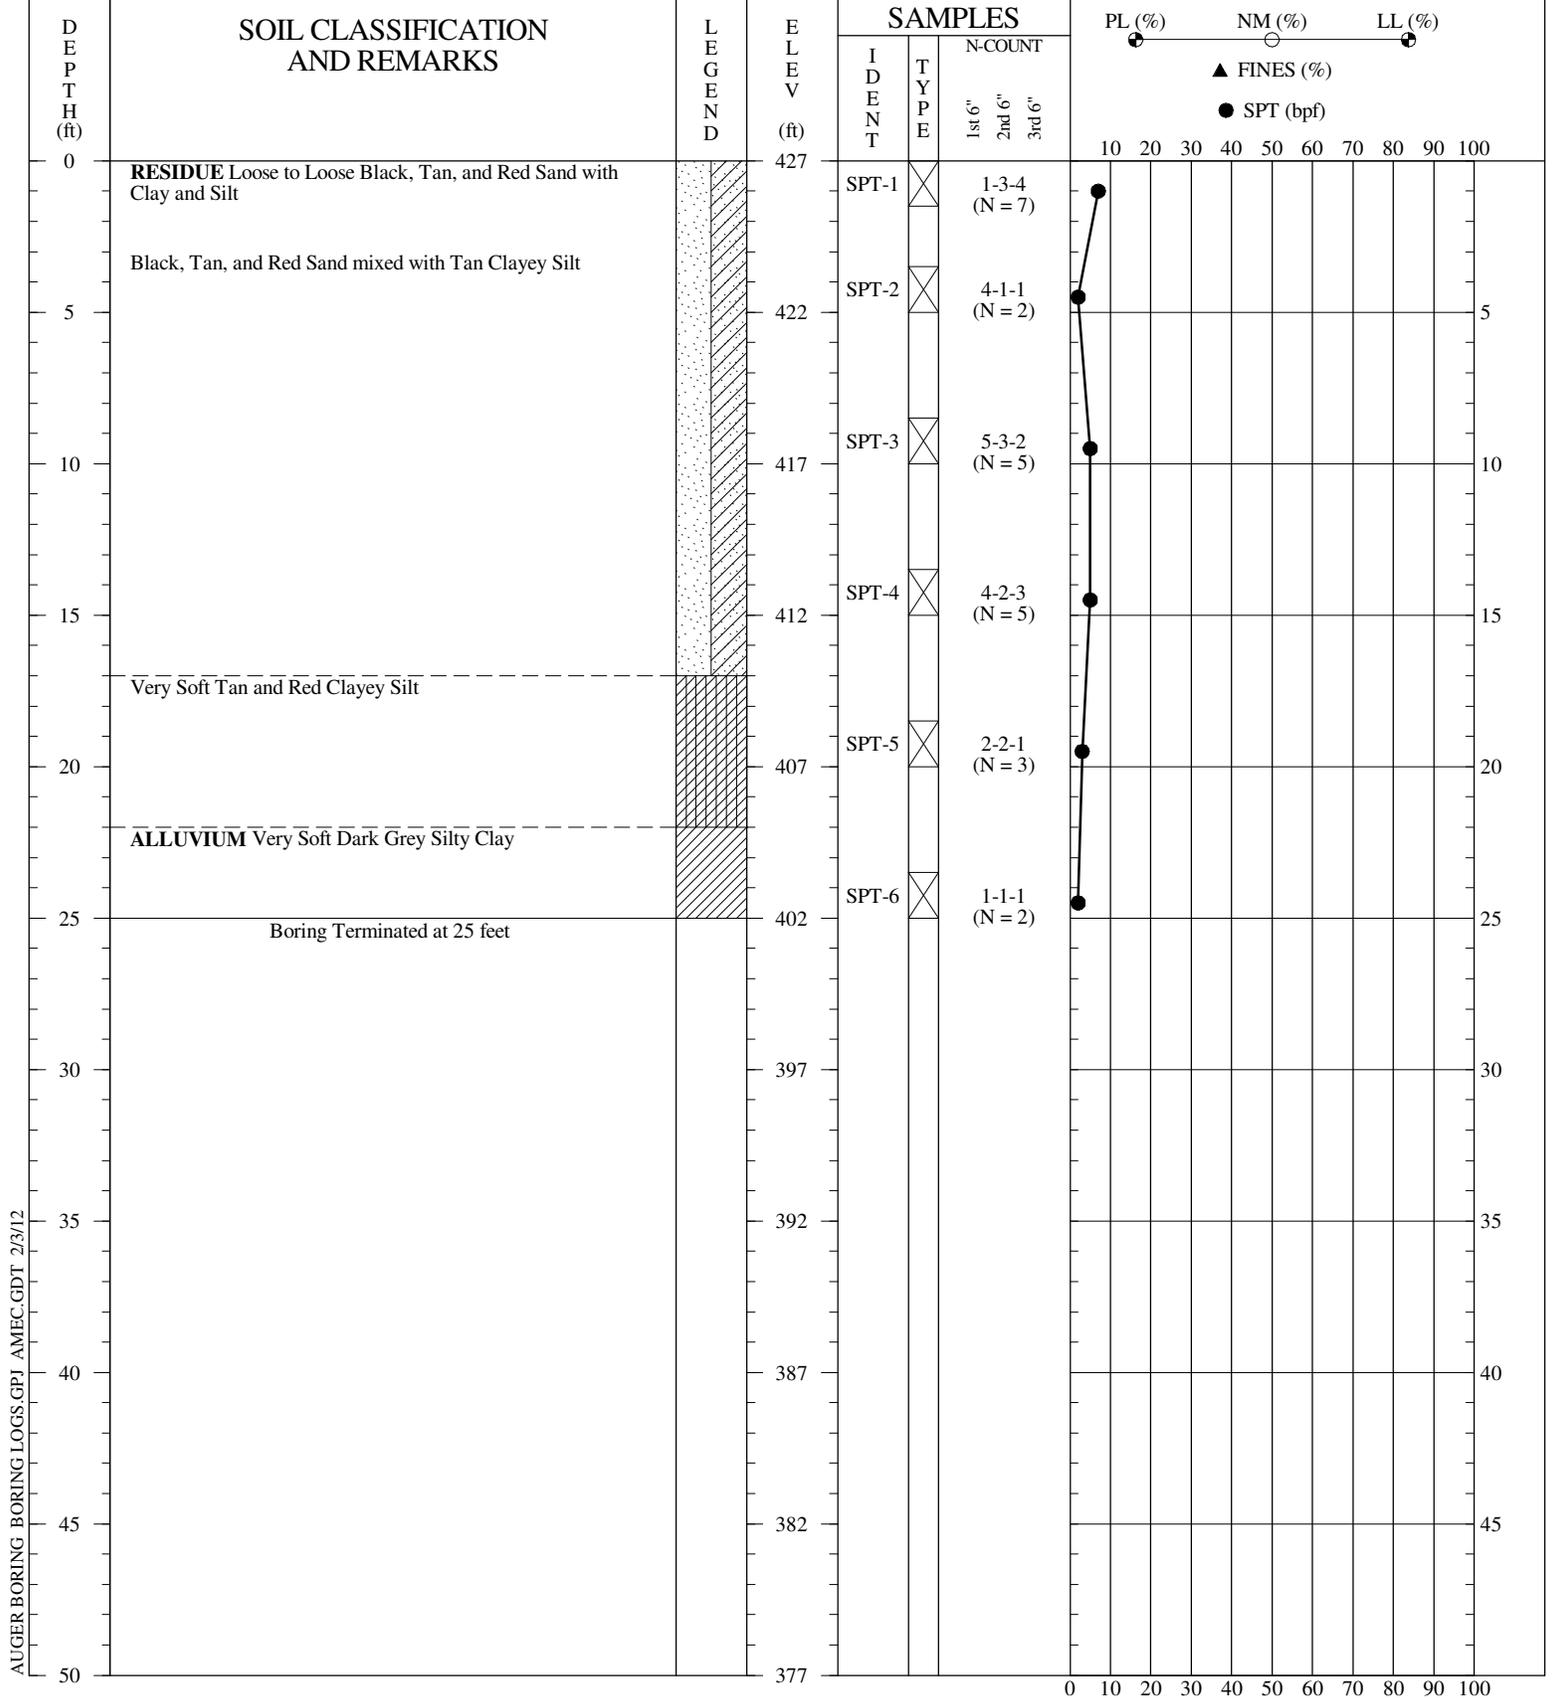
**DRILLER:** R. Landeros (AMEC)  
**EQUIPMENT:** CME-550 (Auto-Hammer)  
**METHOD:** Rotary Wash with Mud  
**HOLE DIA.:** 6 inches  
**REMARKS:** Dry, boring caved at 13.5 feet. Boring performed 5 feet south of the dike crest.

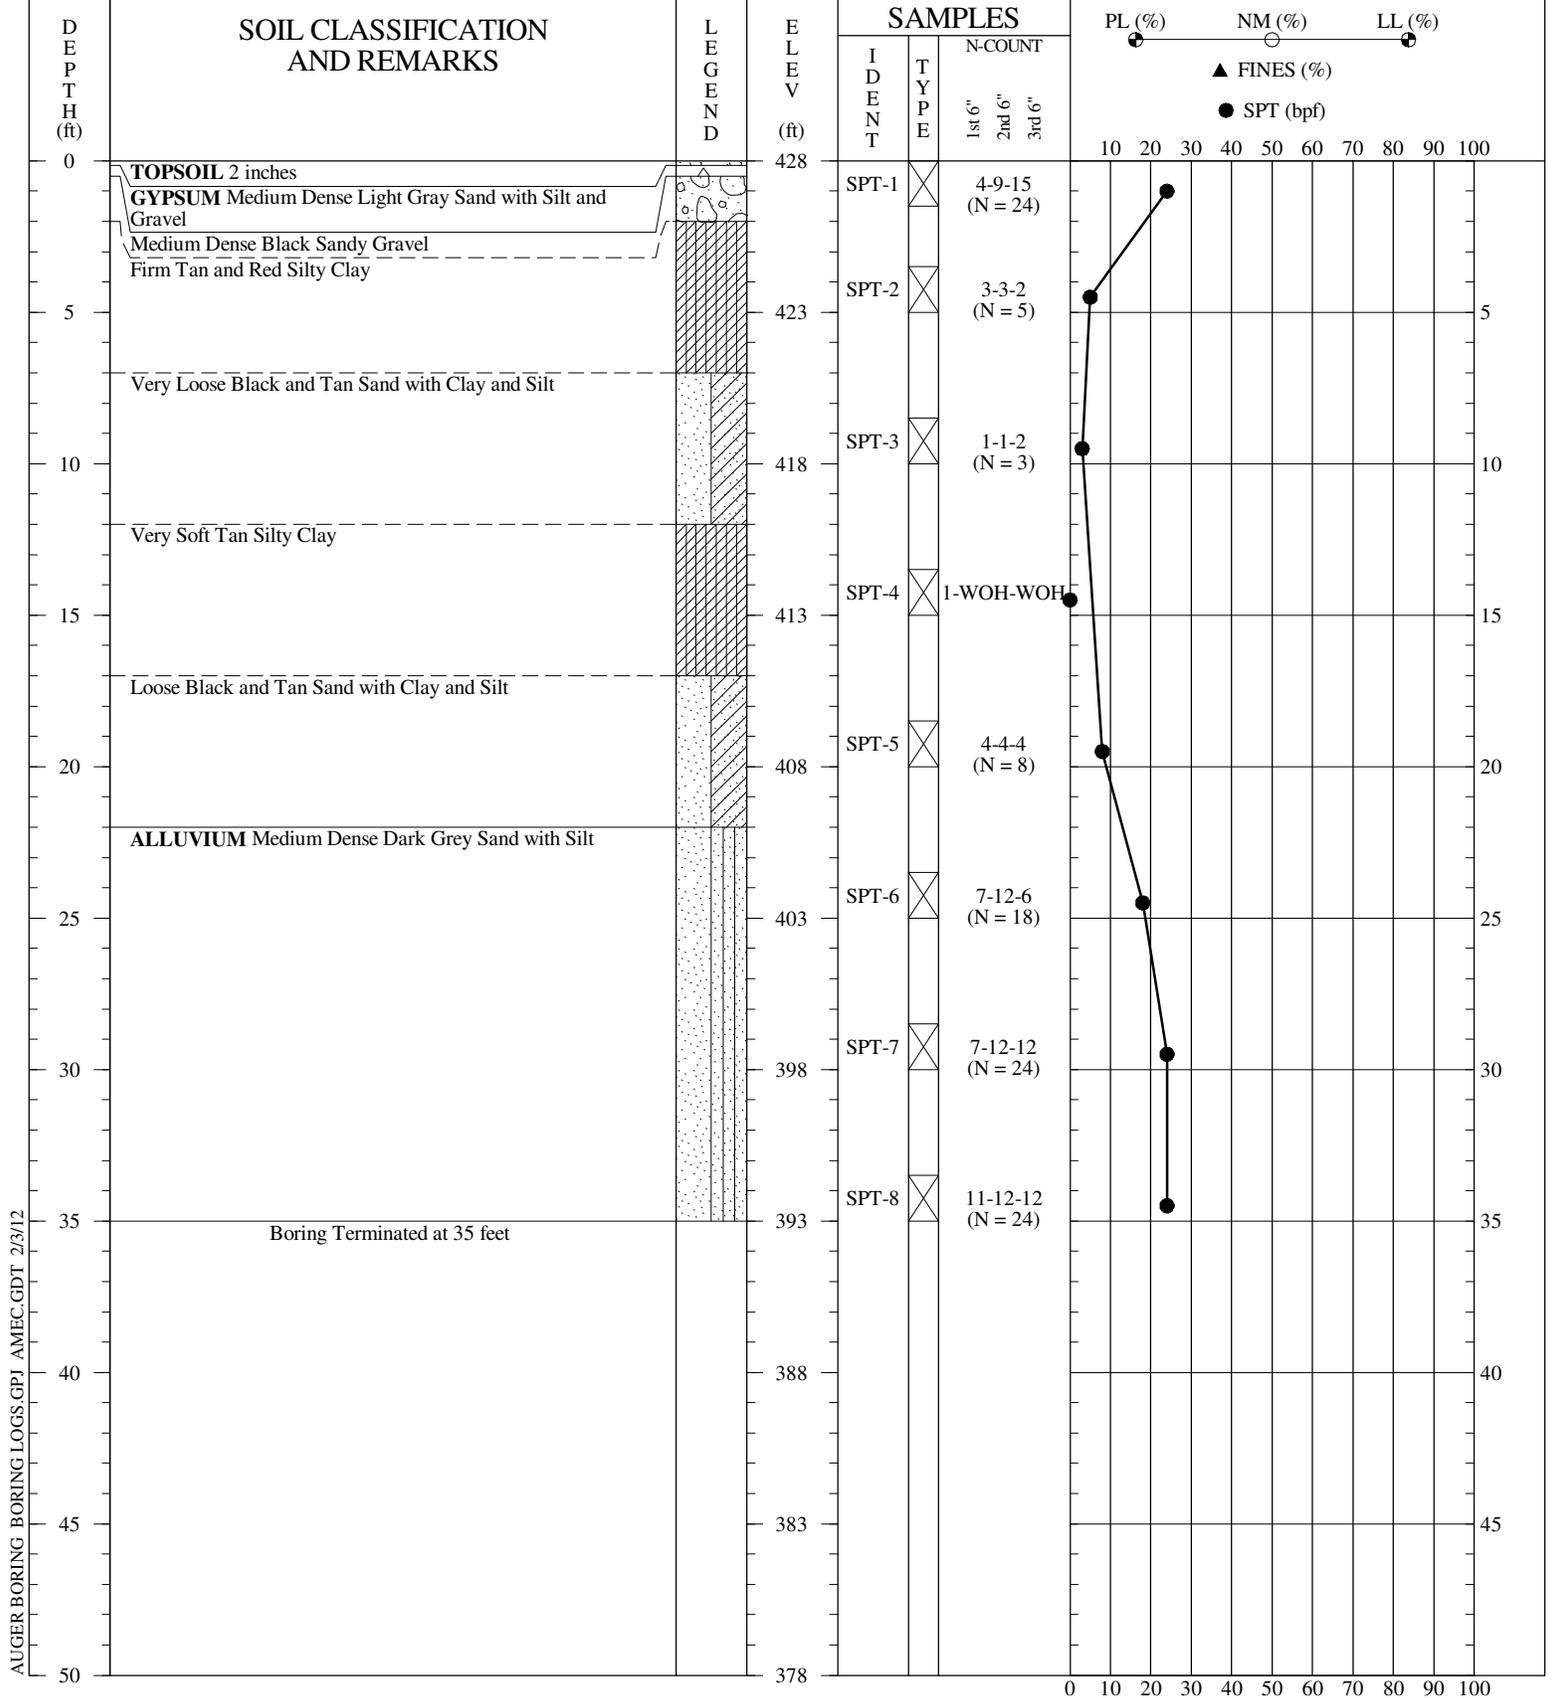
**DRILLER:** R. Landeros (AMEC)  
**EQUIPMENT:** CME-550 (Auto-Hammer)  
**METHOD:** Rotary Wash with Mud  
**HOLE DIA.:** 6 inches  
**REMARKS:** Dry, boring caved at 18 feet.

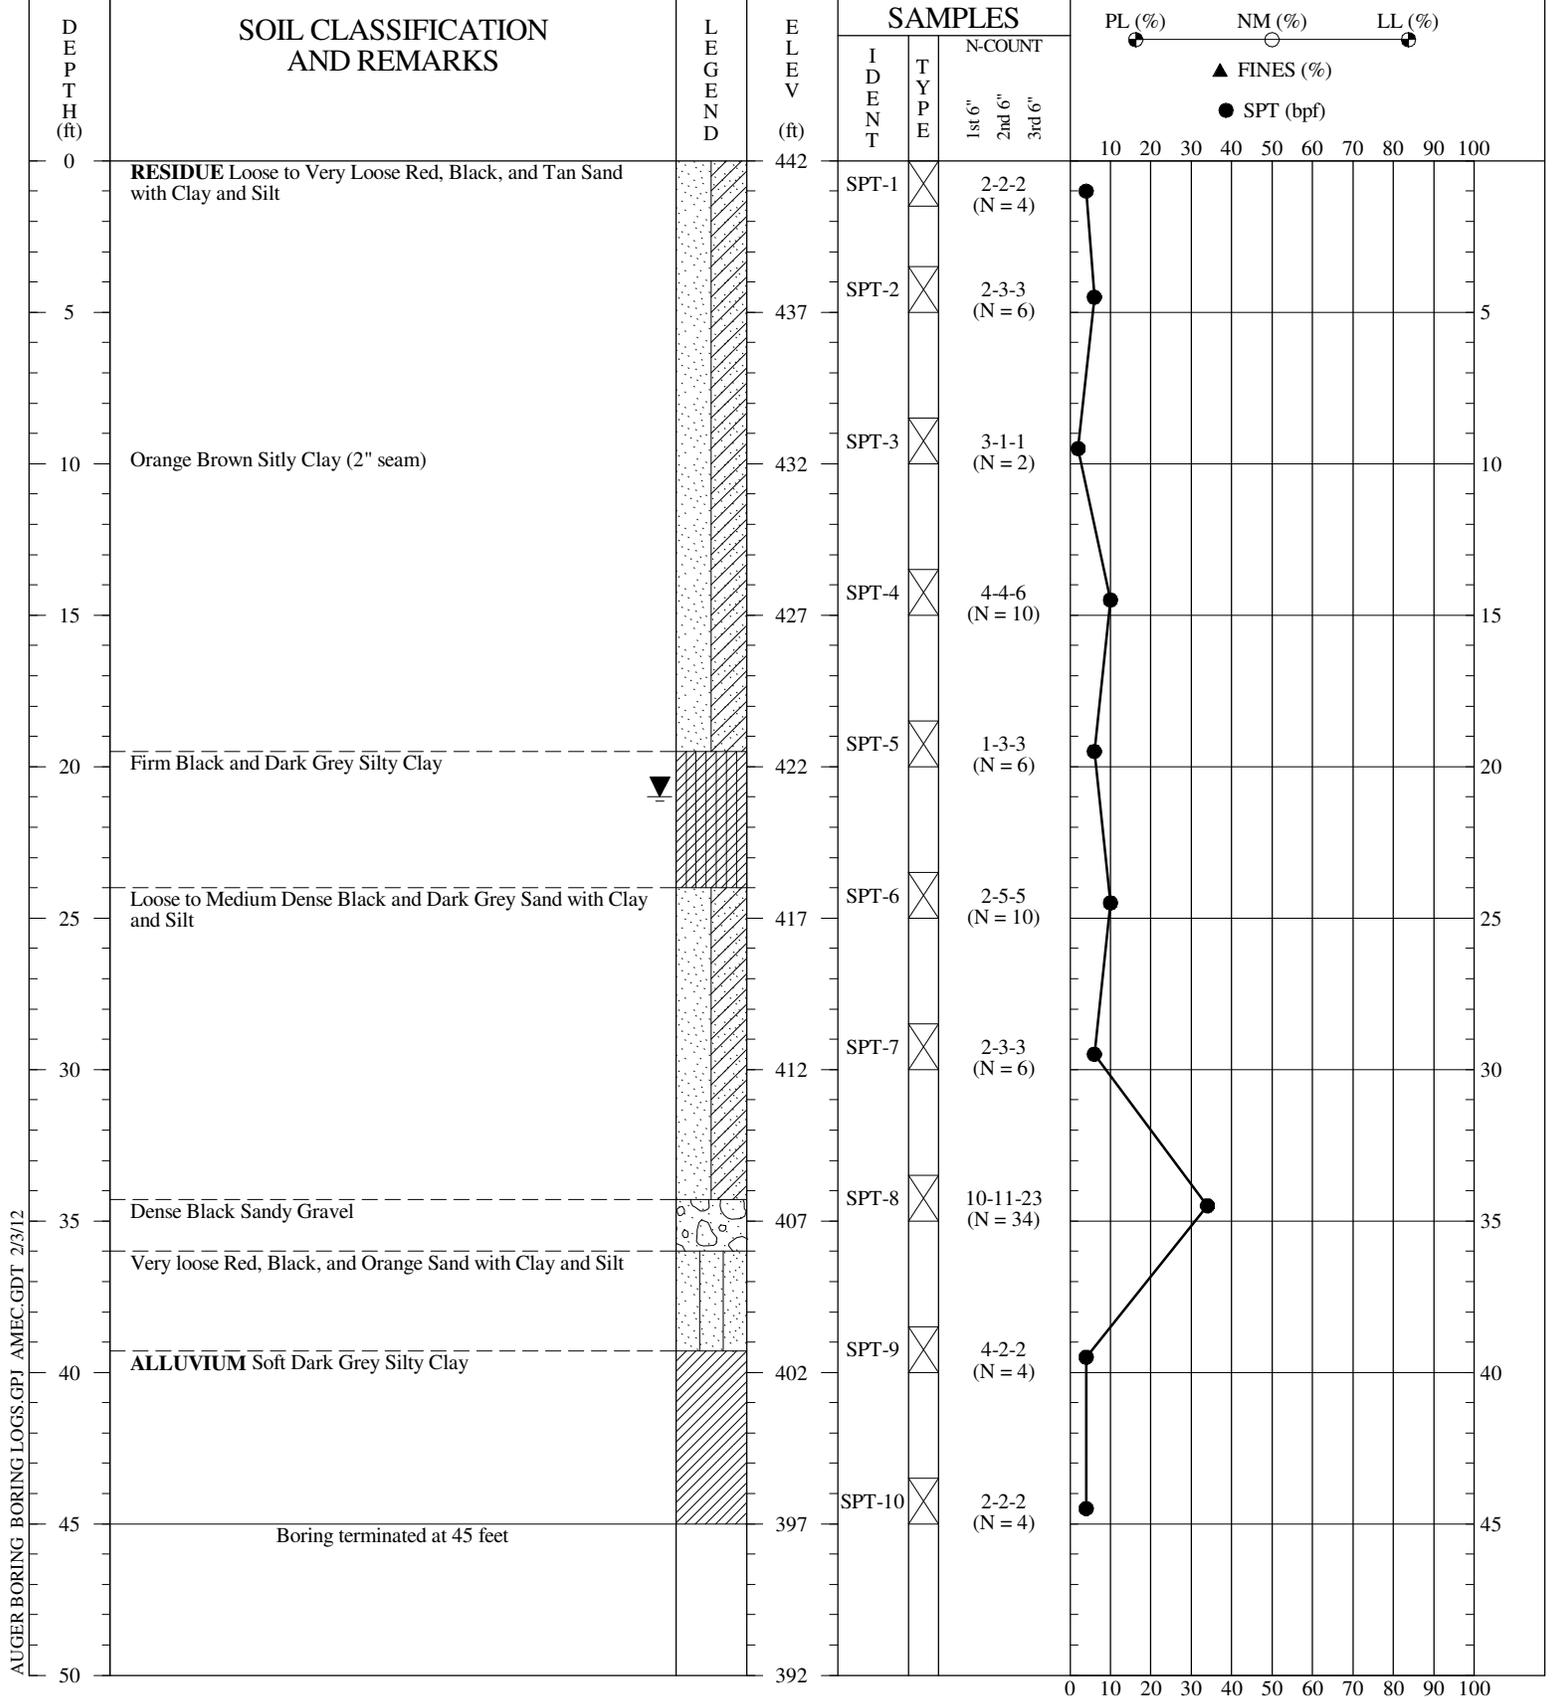
**DRILLER:** R. Landeros (AMEC)  
**EQUIPMENT:** CME-550 (Auto-Hammer)  
**METHOD:** Rotary Wash with Mud  
**HOLE DIA.:** 6 inches  
**REMARKS:** Boring caved at 40.5 feet.

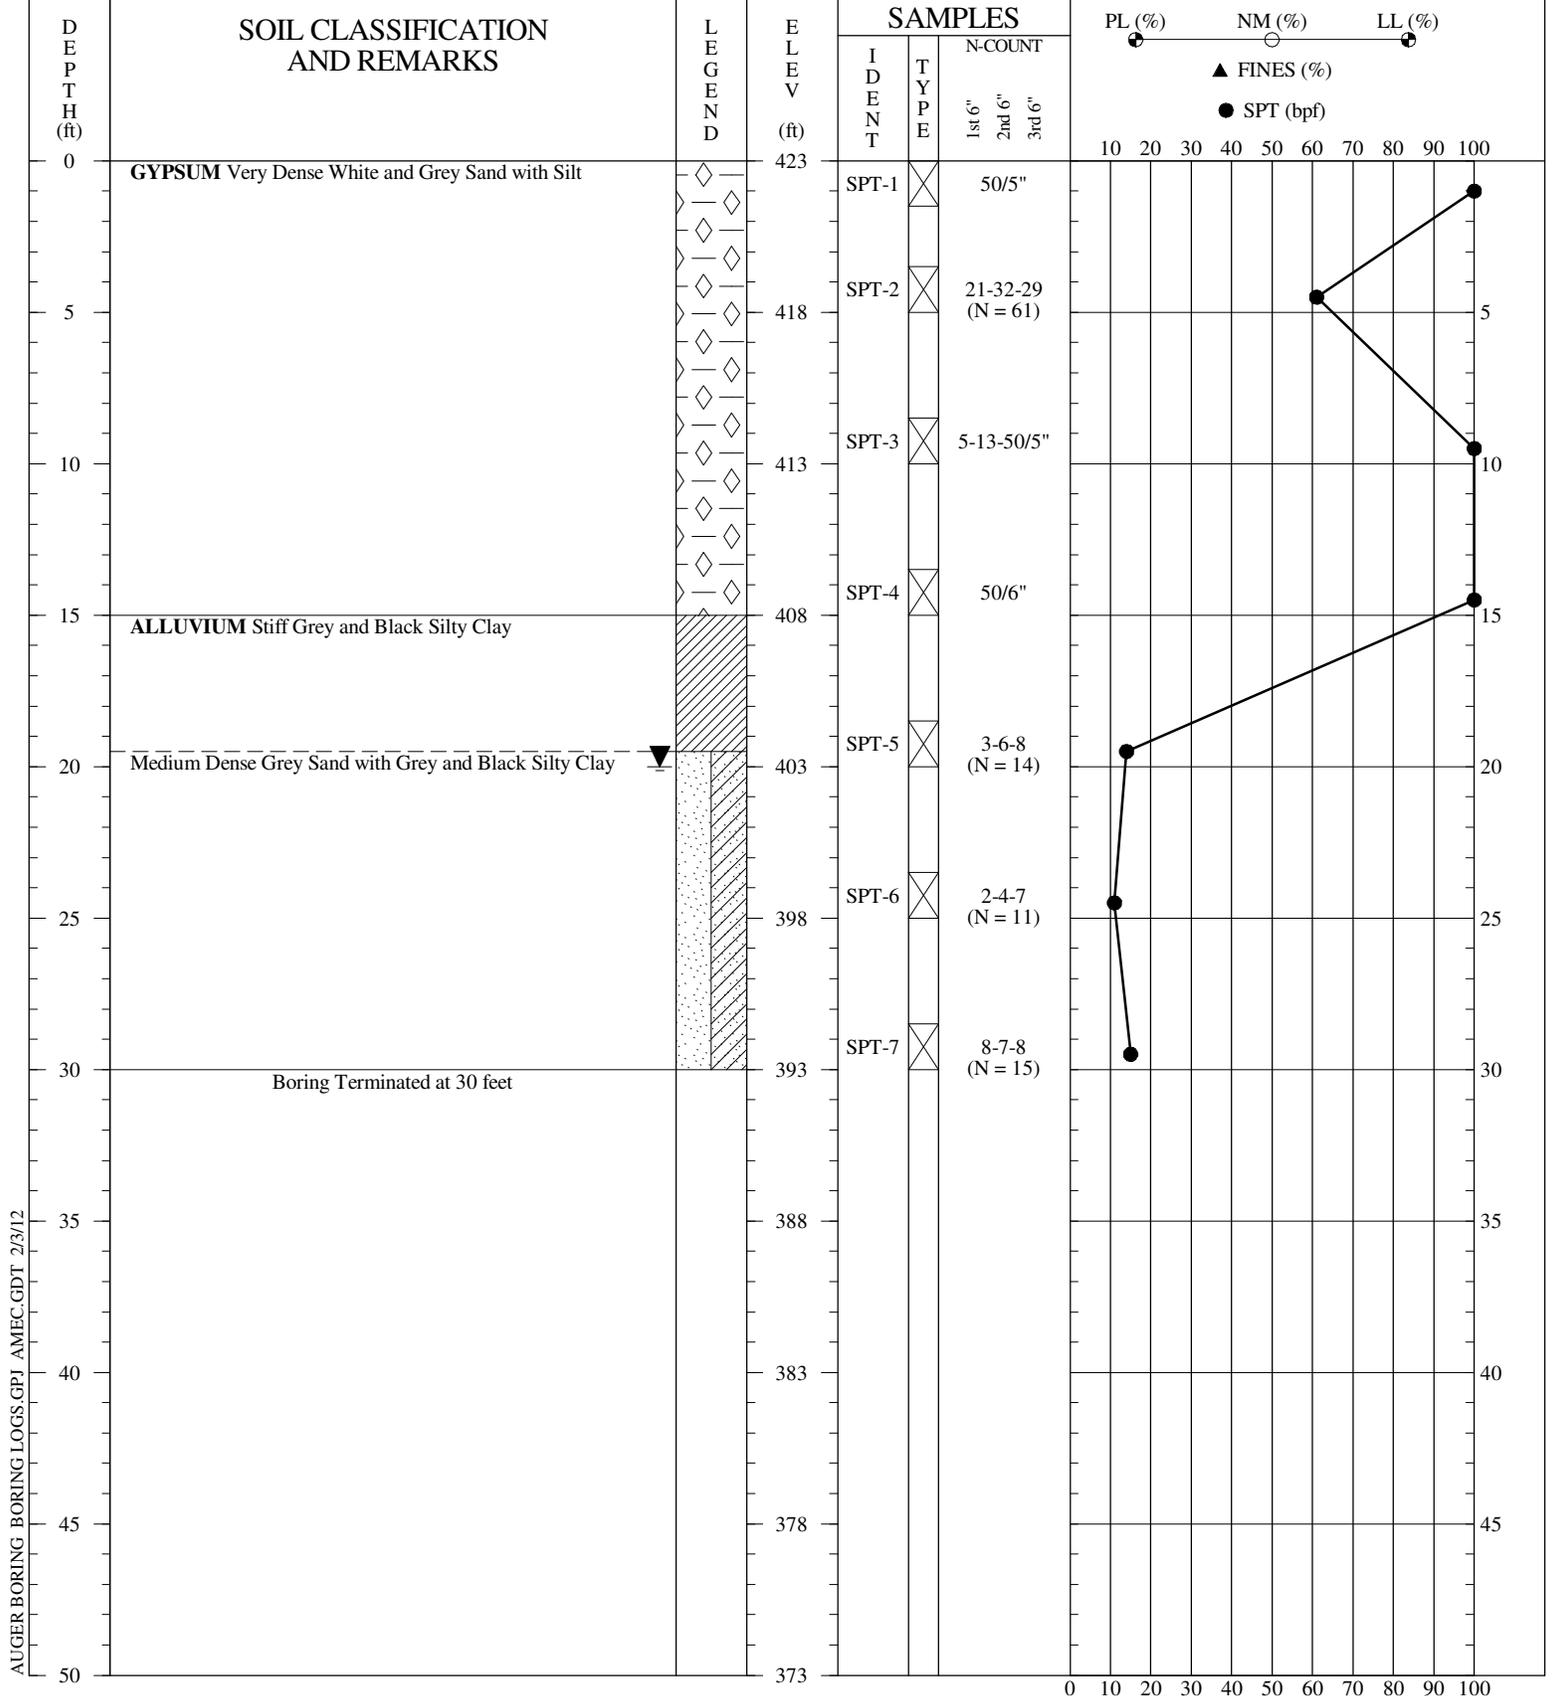
**DRILLER:** R. Landeros (AMEC)  
**EQUIPMENT:** CME-550 (Auto-Hammer)  
**METHOD:** 3 1/4" HSA  
**HOLE DIA.:** 6 inches  
**REMARKS:** Boring caved at 7 feet.

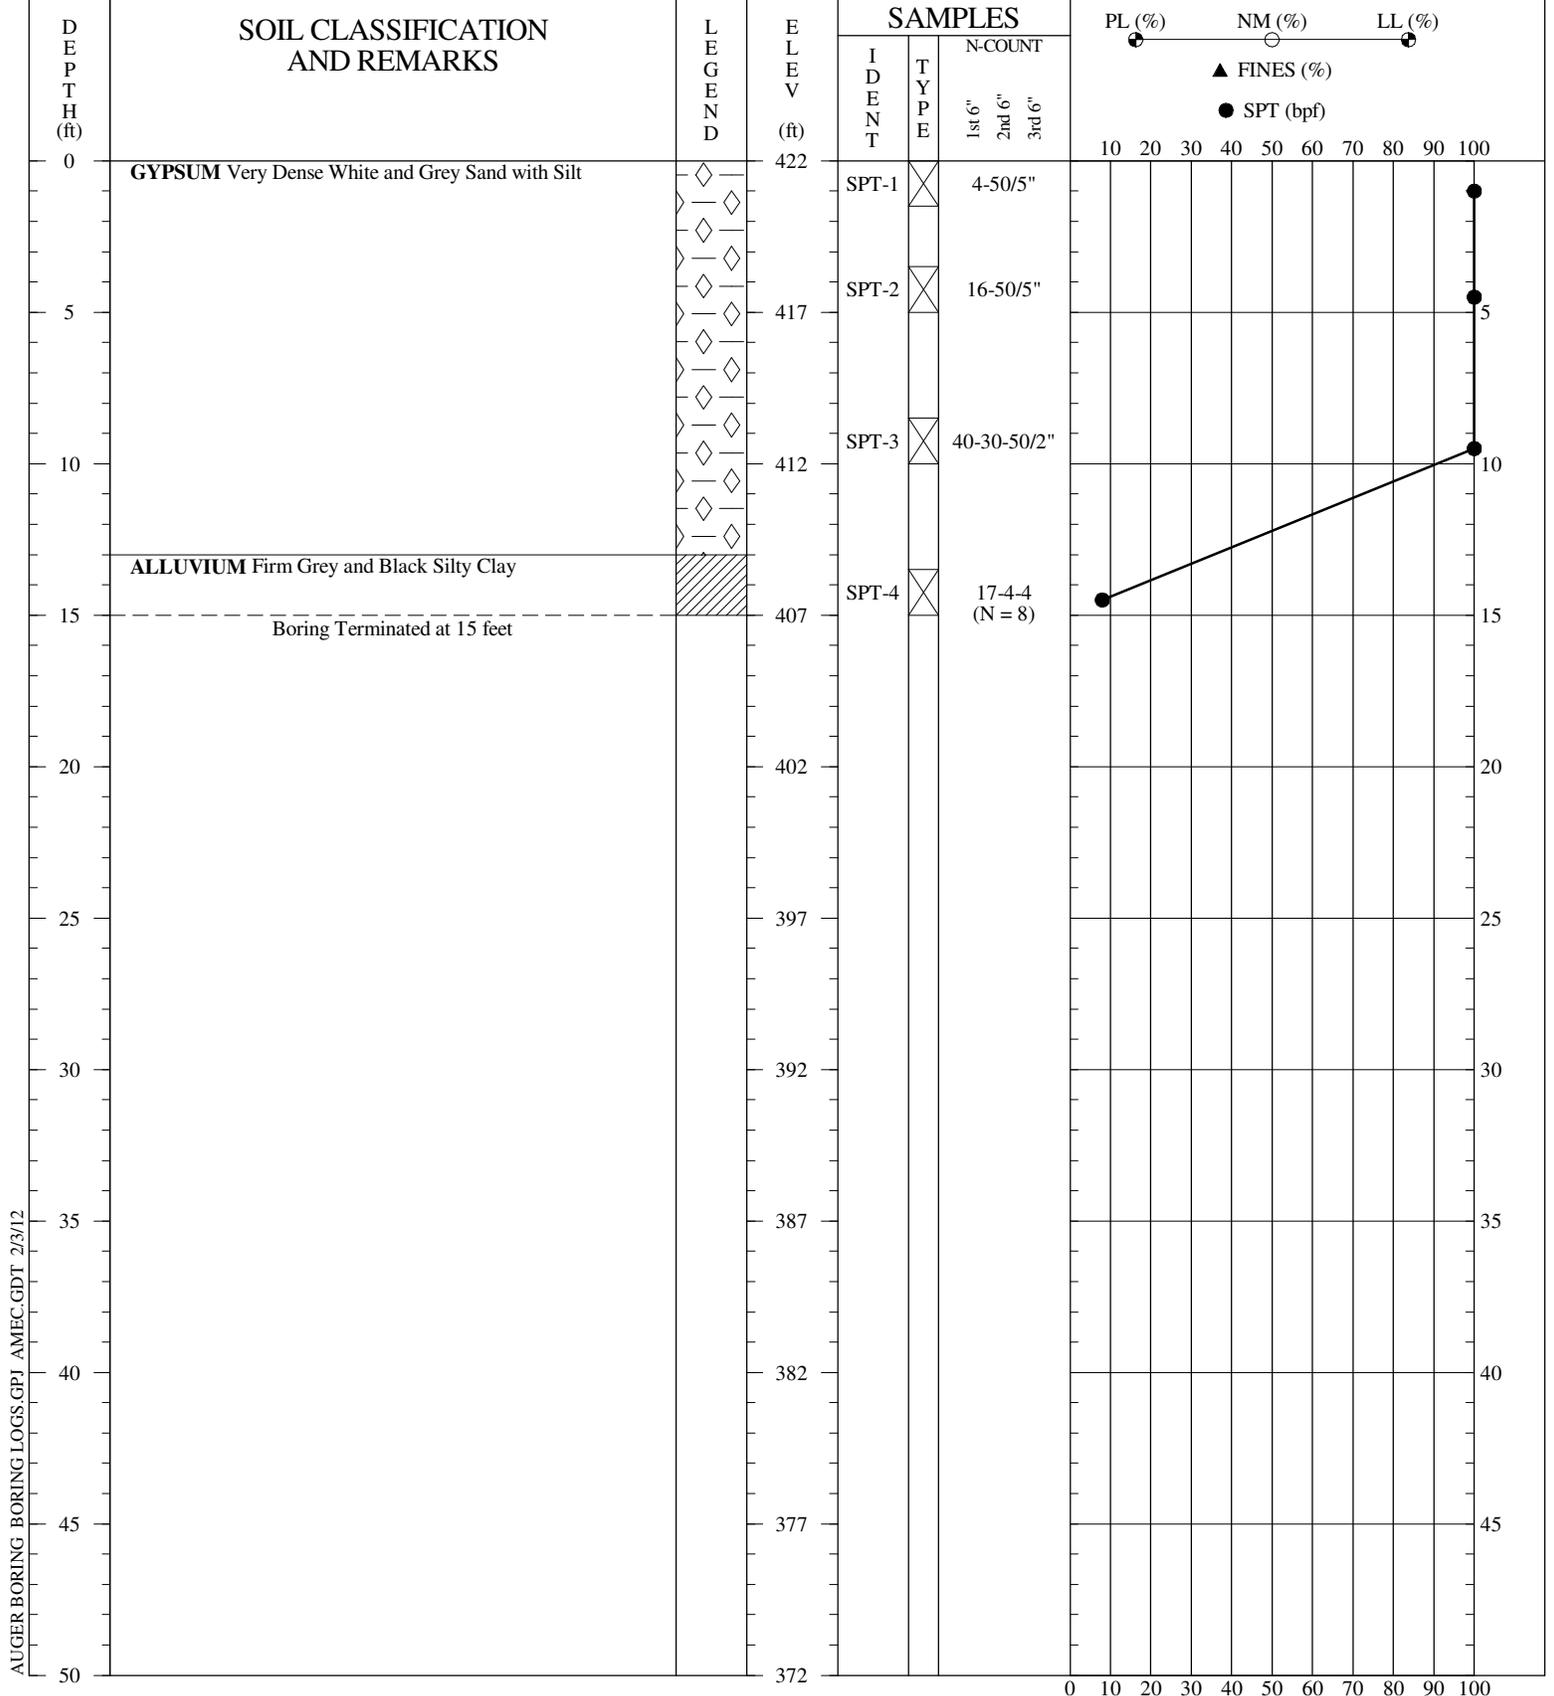
DRILLER: R. Landeros (AMEC)  
 EQUIPMENT: CME-550 (Auto-Hammer)  
 METHOD: 3 1/4" HSA  
 HOLE DIA.: 6 inches  
 REMARKS: Dry, boring caved at 7 feet.

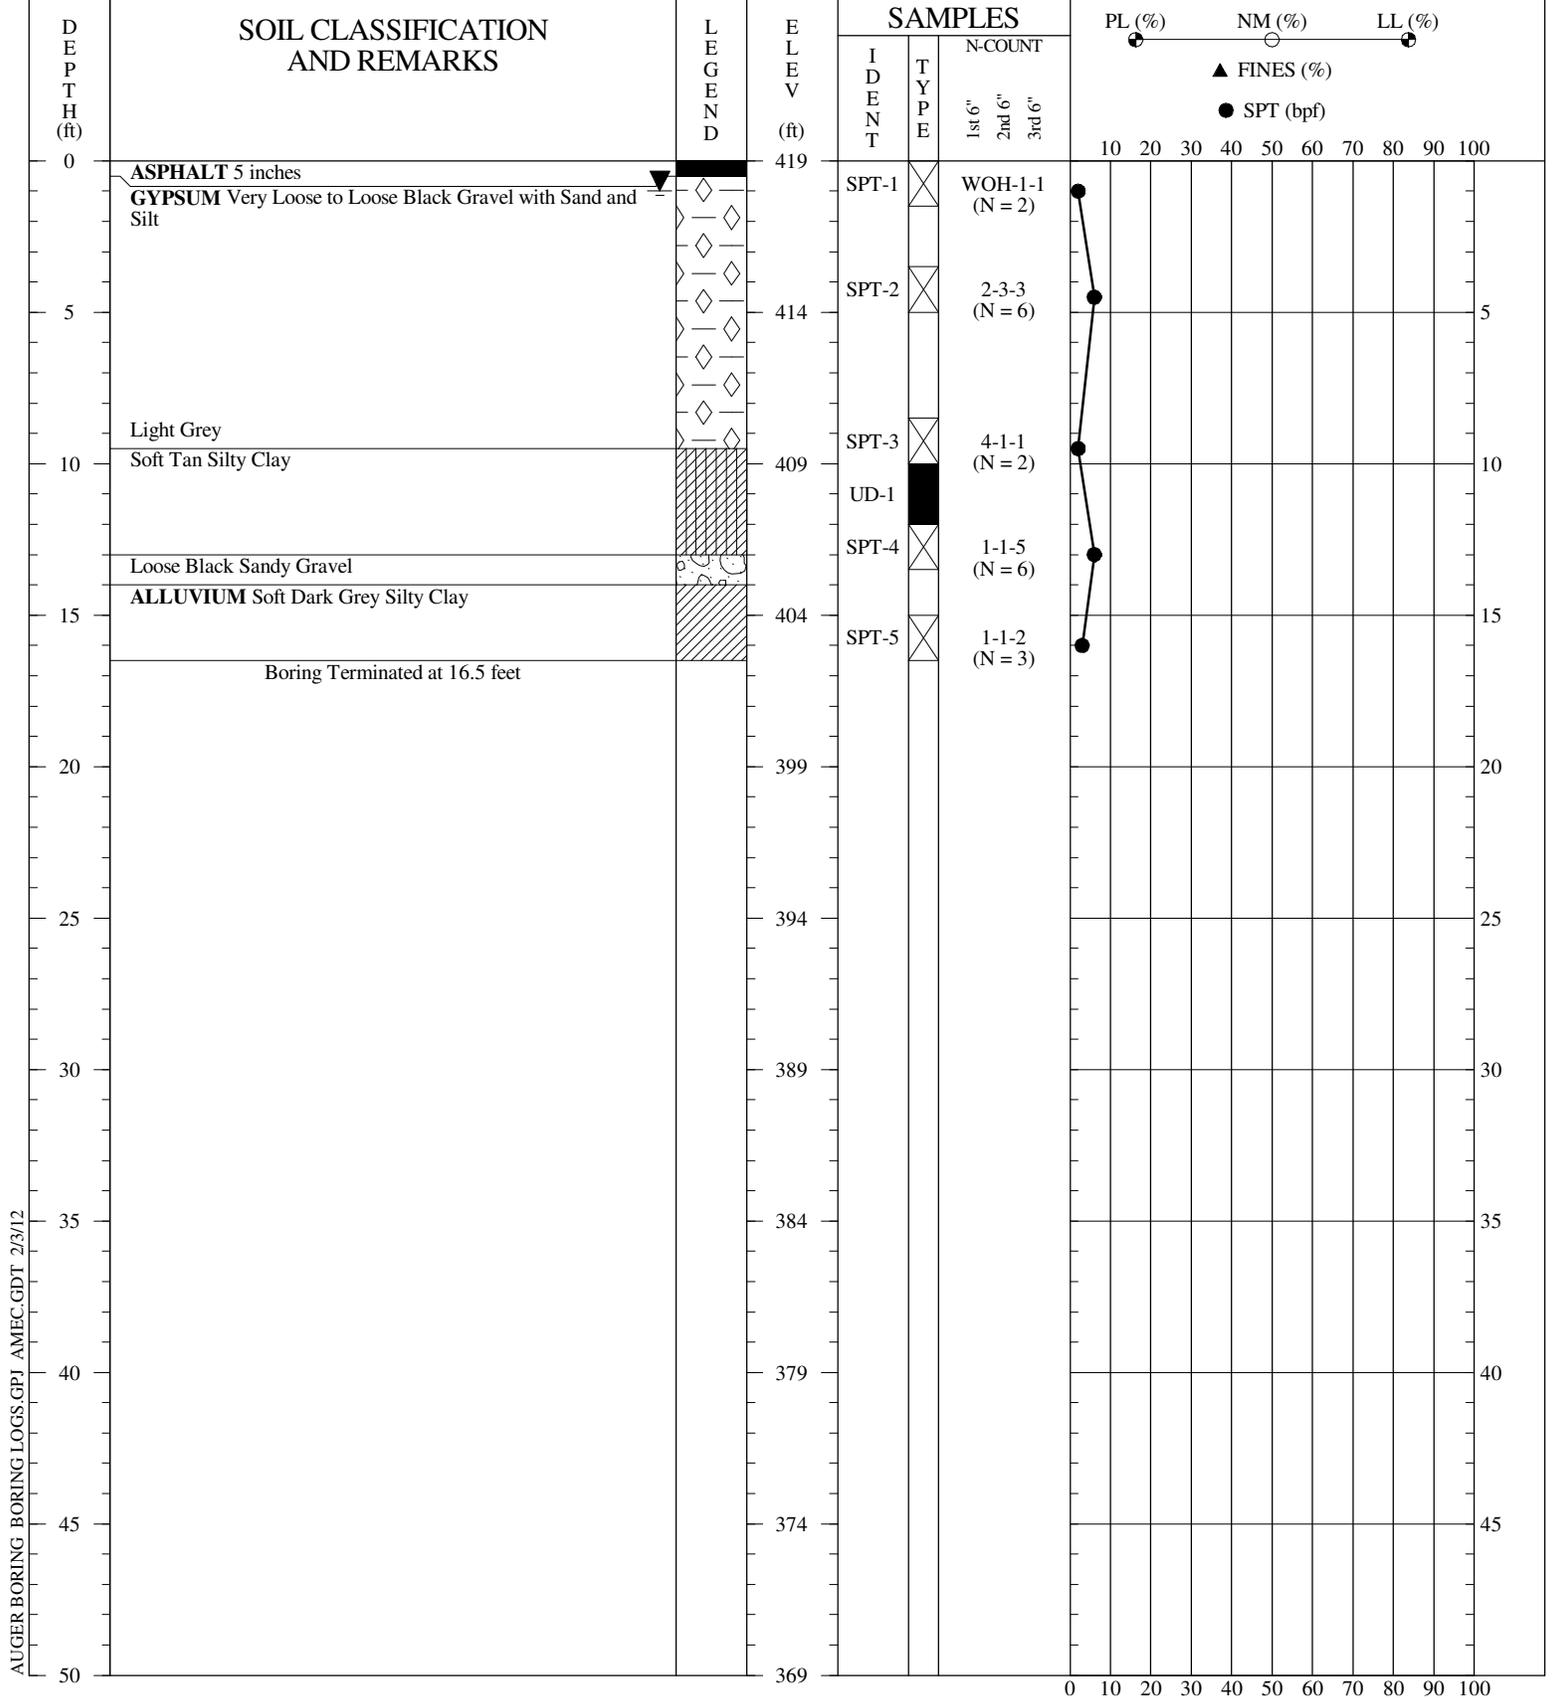
**DRILLER:** R. Landeros (AMEC)  
**EQUIPMENT:** CME-550 (Auto-Hammer)  
**METHOD:** Rotary Wash with Mud  
**HOLE DIA.:** 6 inches  
**REMARKS:** Boring caved at 6.5 feet.

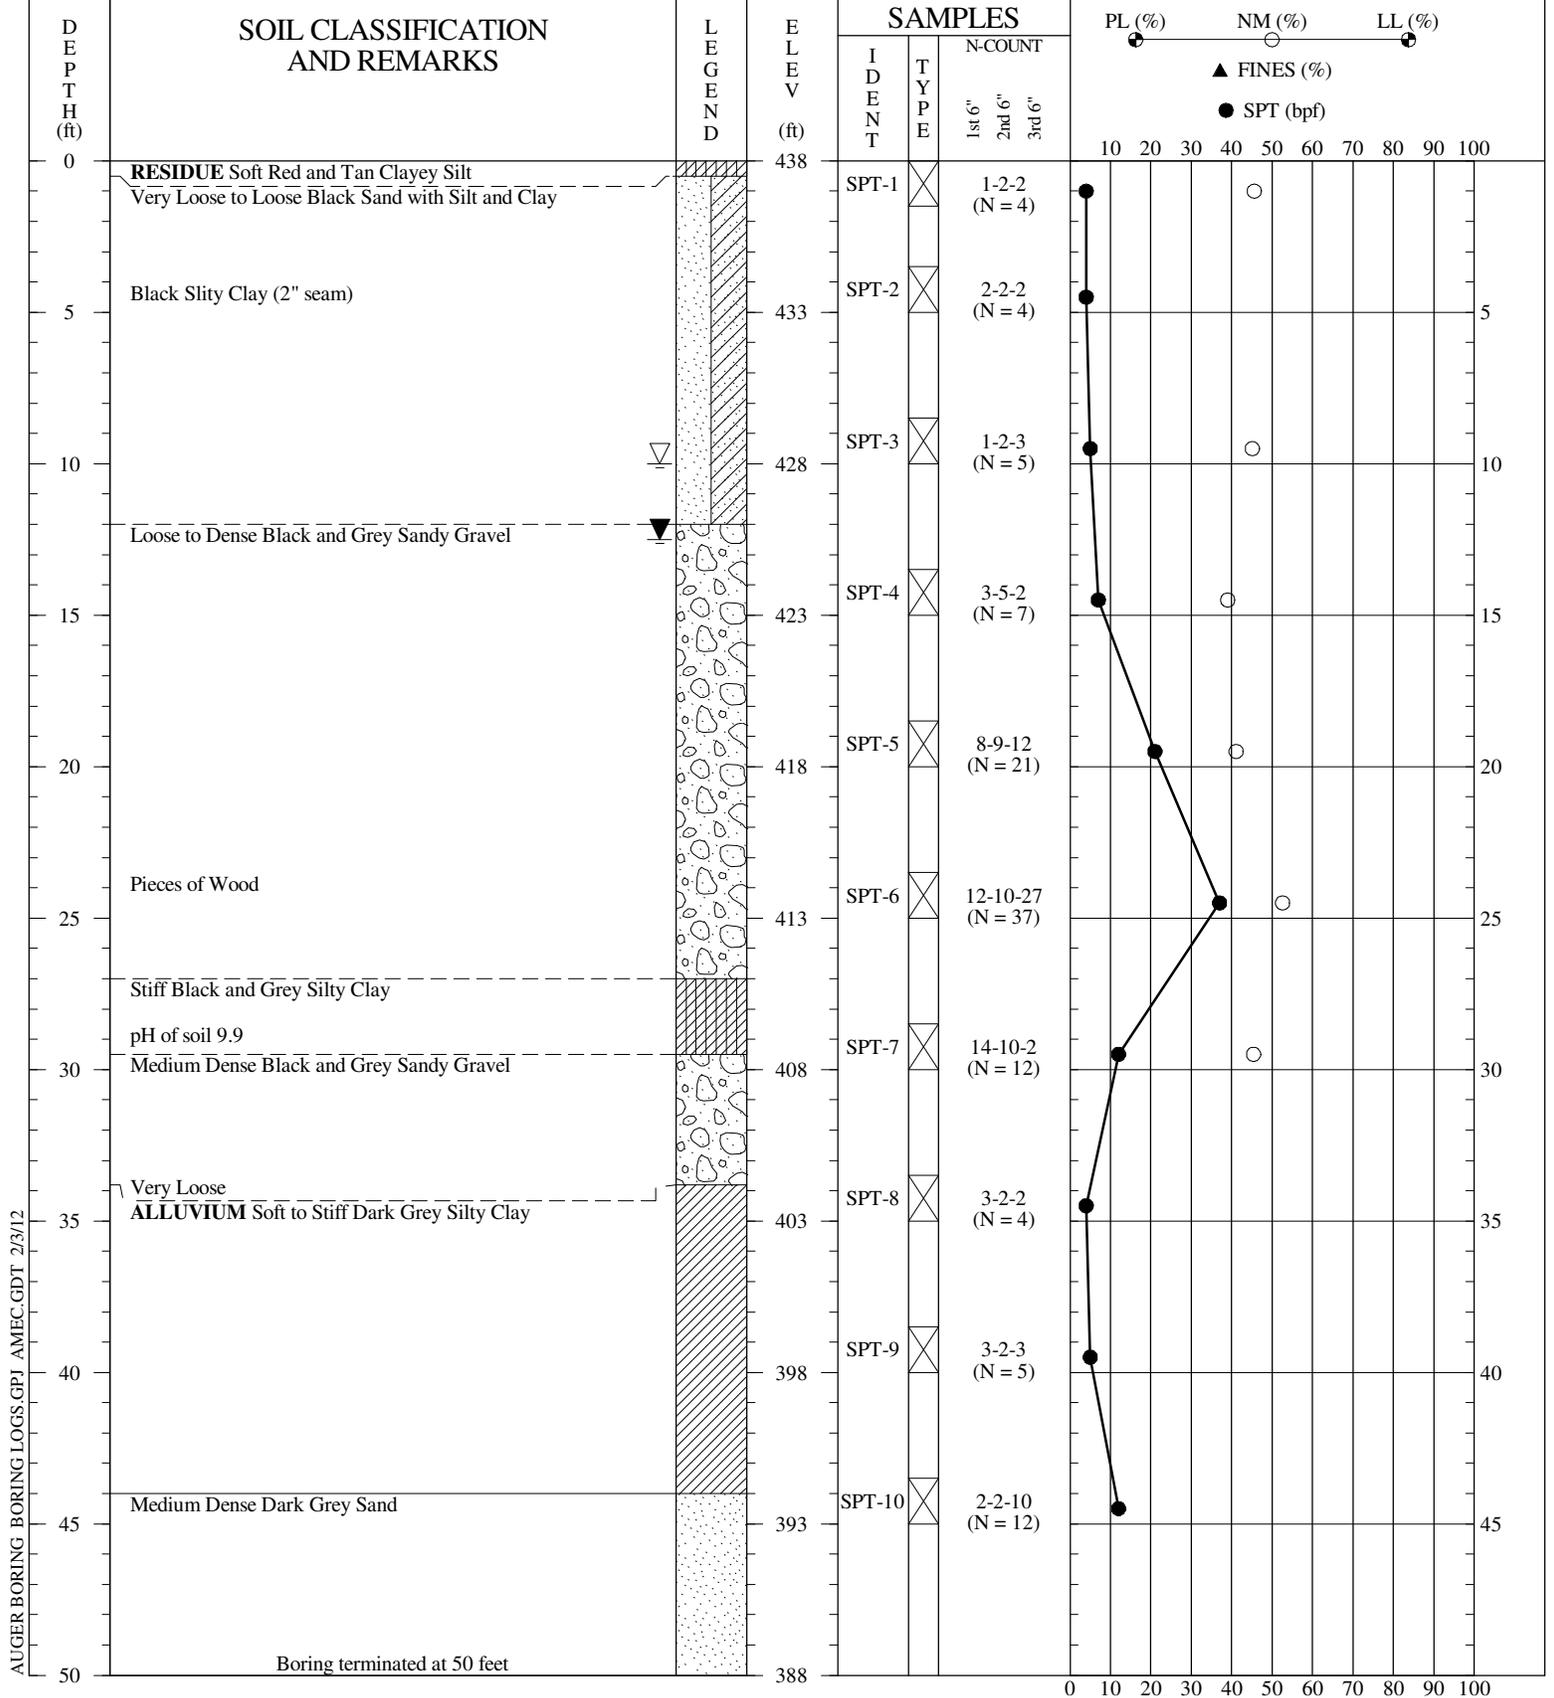
DRILLER: R. Landeros (AMEC)  
 EQUIPMENT: CME-550 (Auto-Hammer)  
 METHOD: Rotary Wash with Mud  
 HOLE DIA.: 6 inches  
 REMARKS: Boring caved at 37 feet.
