**PRE-DESIGN INVESTIGATION REPORT  
PROPOSED SOLAR REDEVELOPMENT PROJECT  
FORMER BAUXITE RESIDUE DISPOSAL AREAS  
Operable Unit 1, North Alcoa Site**

East St. Louis, Illinois

**Restoration Land Development Company, LLC**  
Wellesley, MA

**AMEC Environment & Infrastructure, Inc.**  
800 N. Bell Avenue, Suite 200  
Pittsburgh, Pennsylvania 15106  
(412) 279-6661

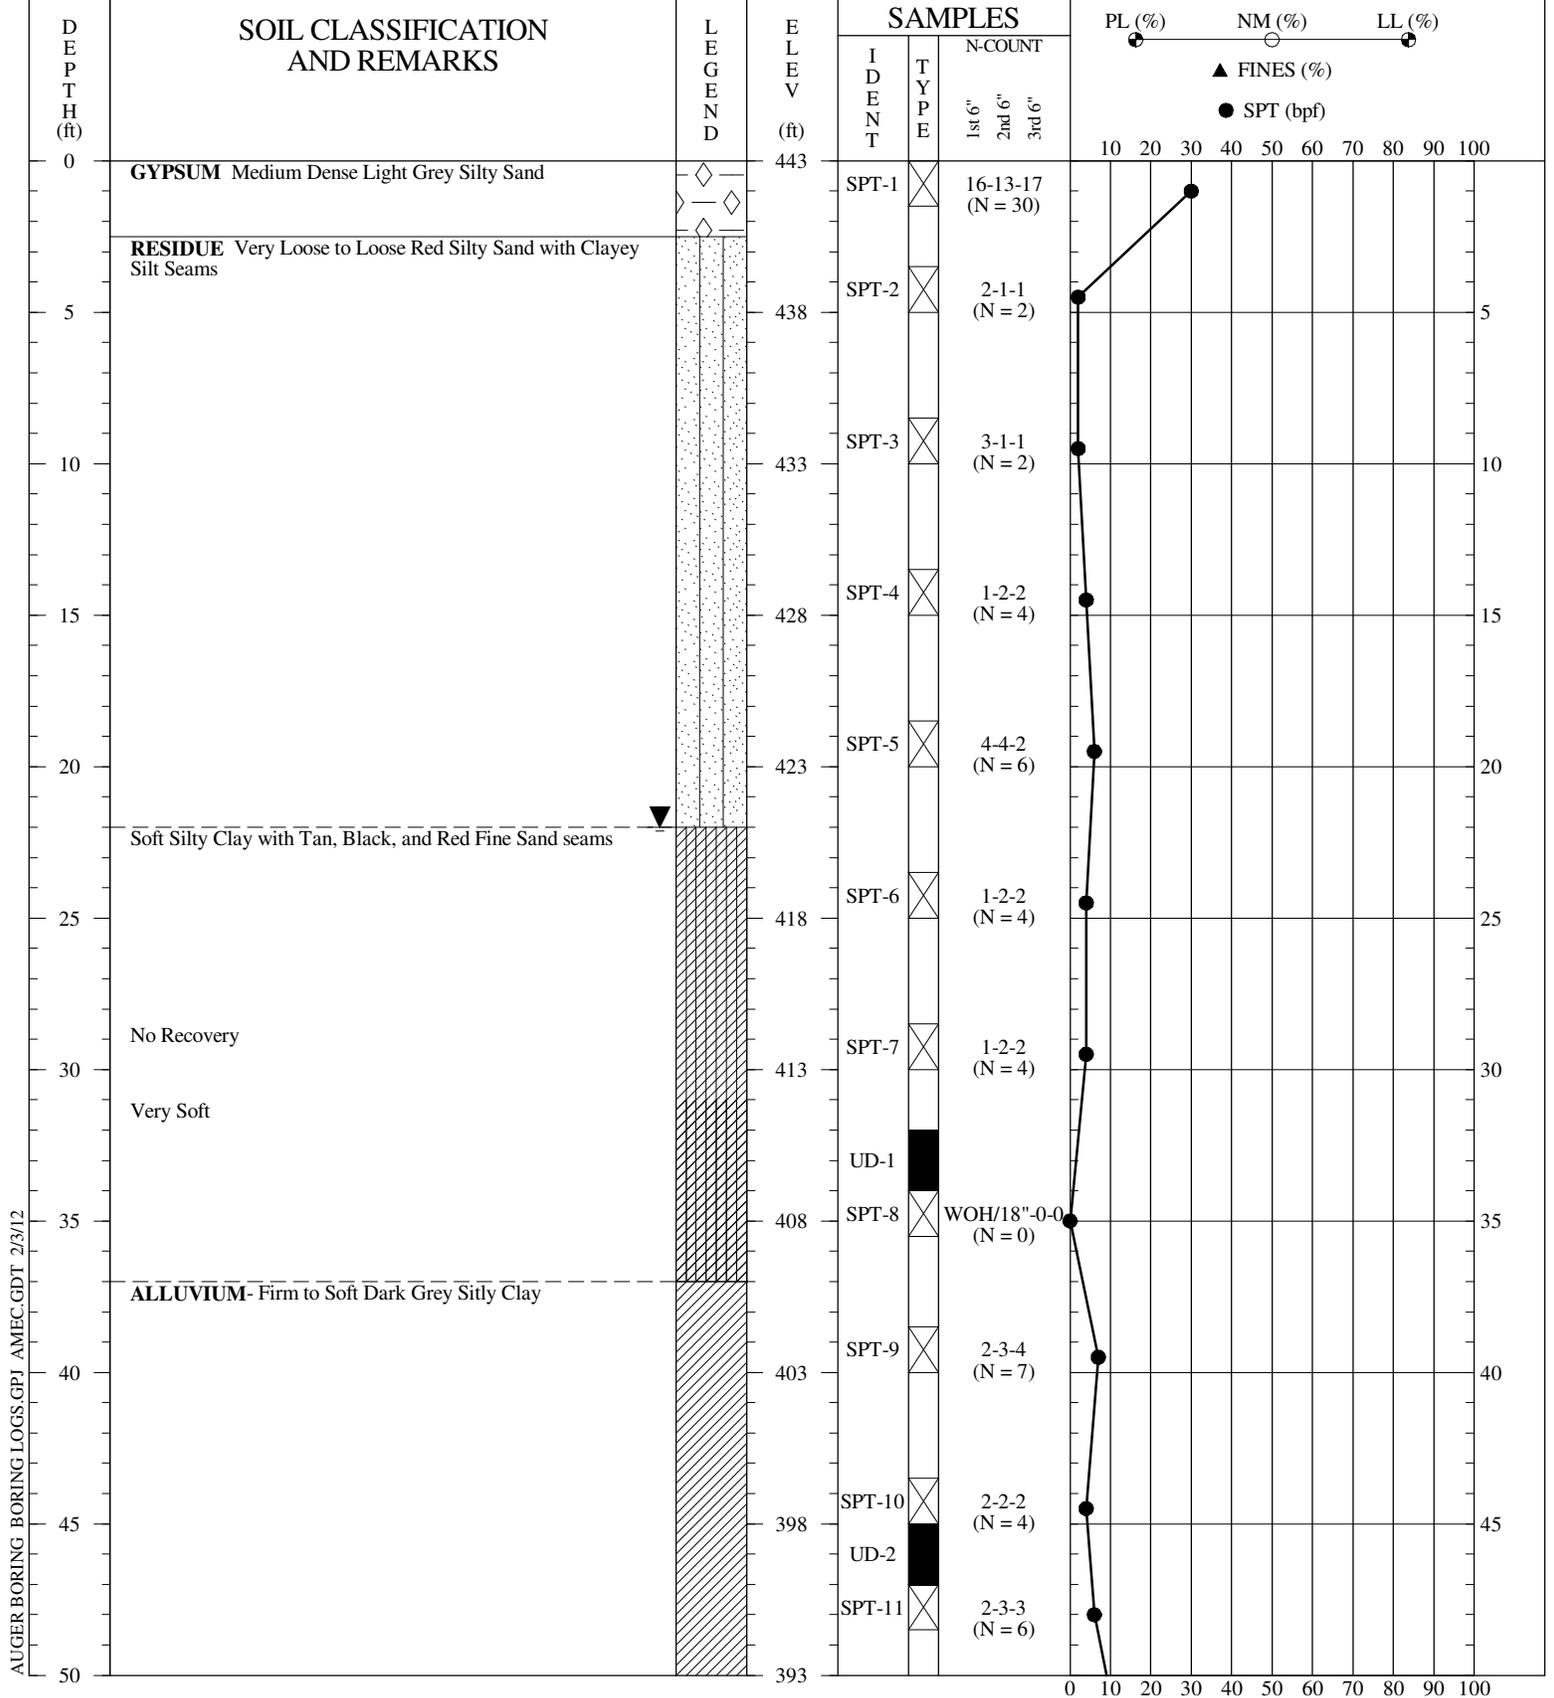
**DRILLER:** R. Landeros (AMEC)  
**EQUIPMENT:** CME-550 (Auto-Hammer)  
**METHOD:** Rotary Wash with Mud  
**HOLE DIA.:** 6 inches  
**REMARKS:** Boring caved at 28 feet.

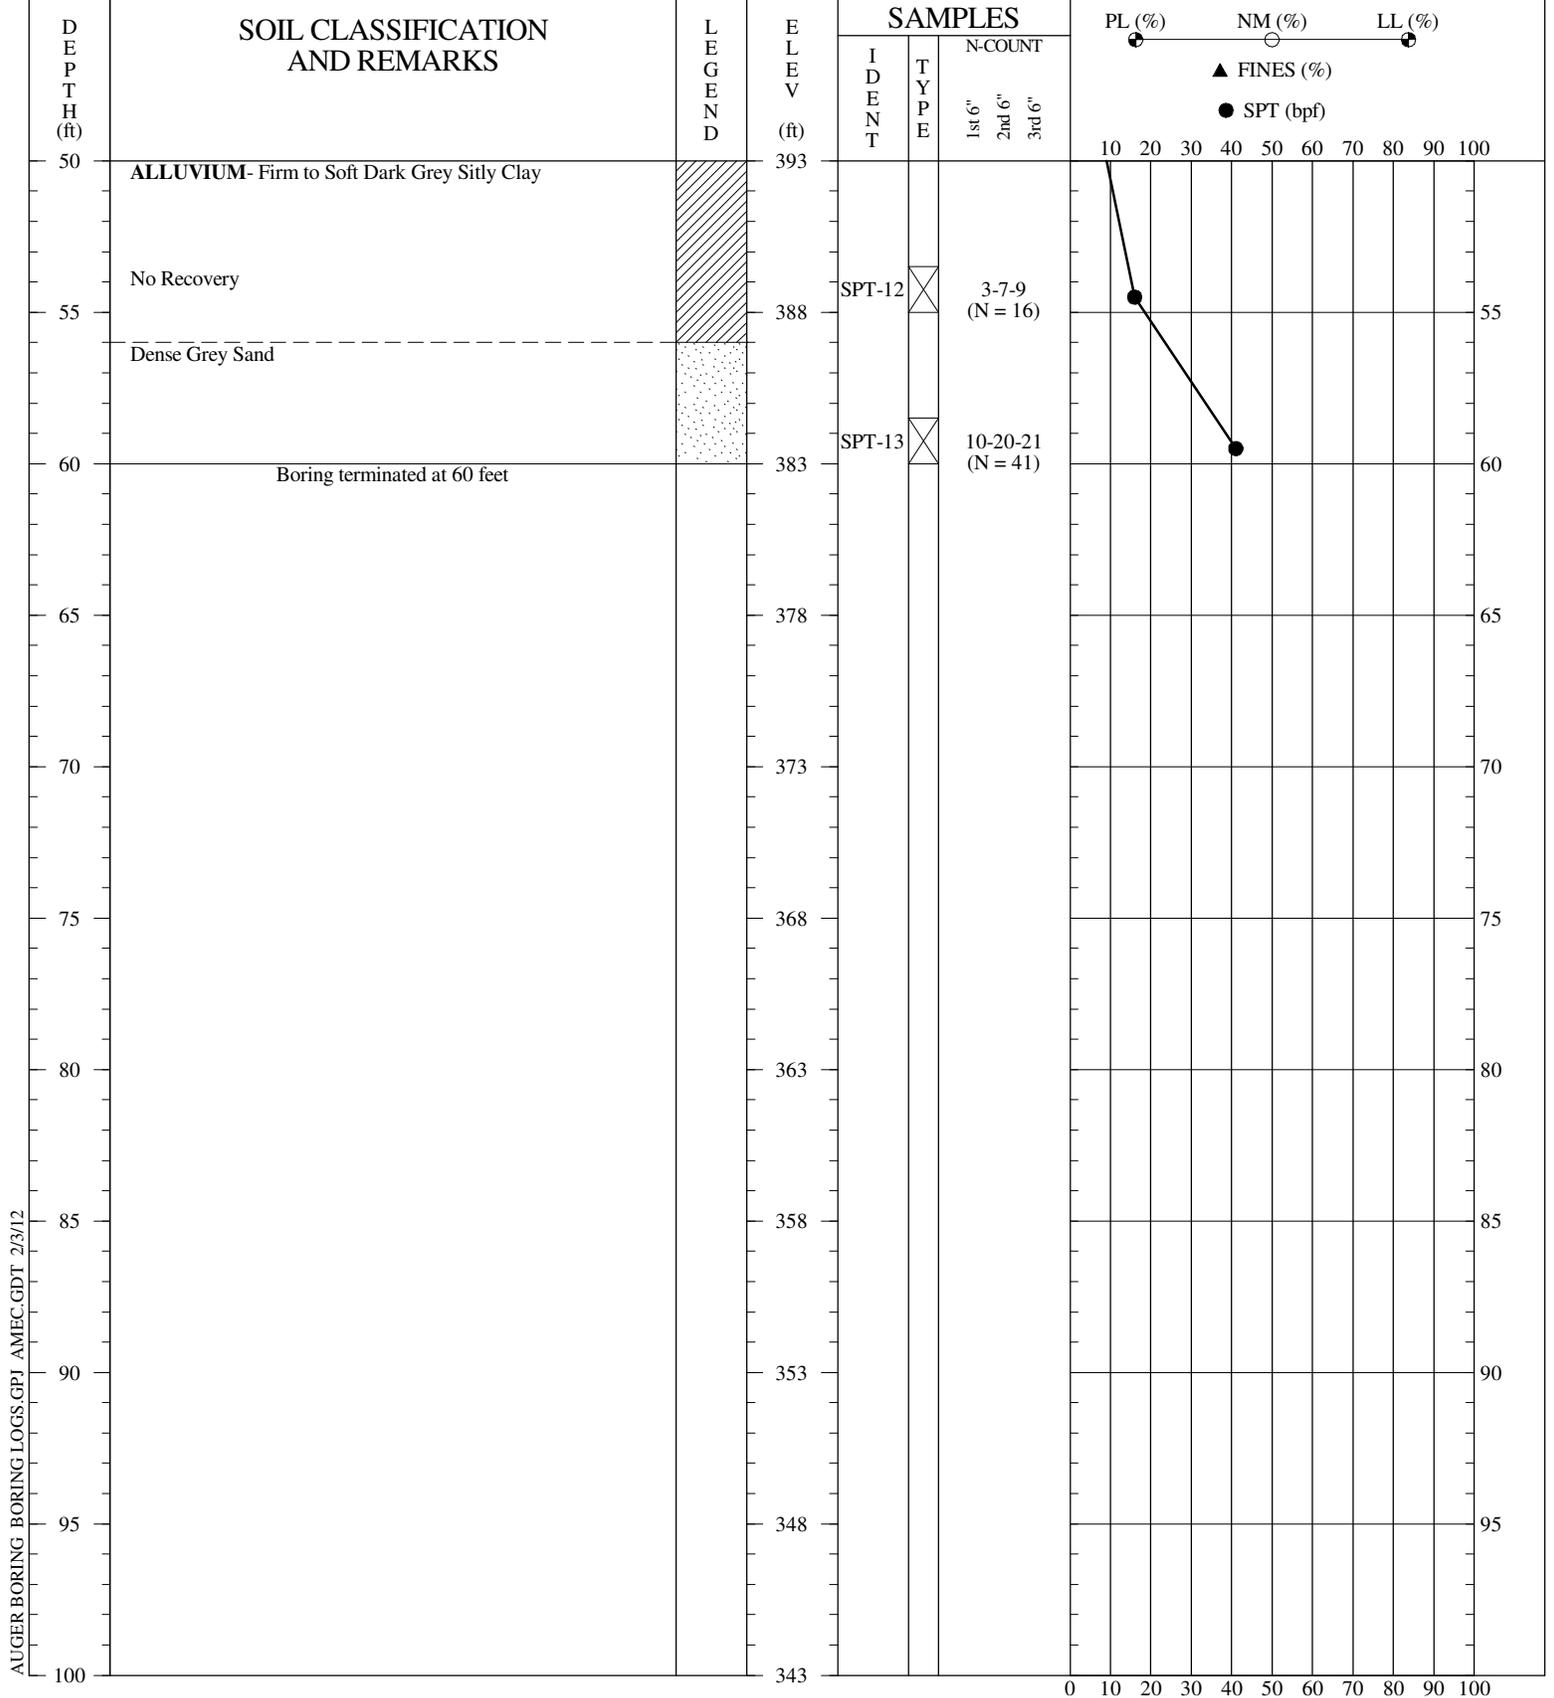
**DRILLER:** R. Landeros (AMEC)  
**EQUIPMENT:** CME-550 (Auto-Hammer)  
**METHOD:** Rotary Wash with Mud  
**HOLE DIA.:** 6 inches  
**REMARKS:** Boring caved at 28 feet.

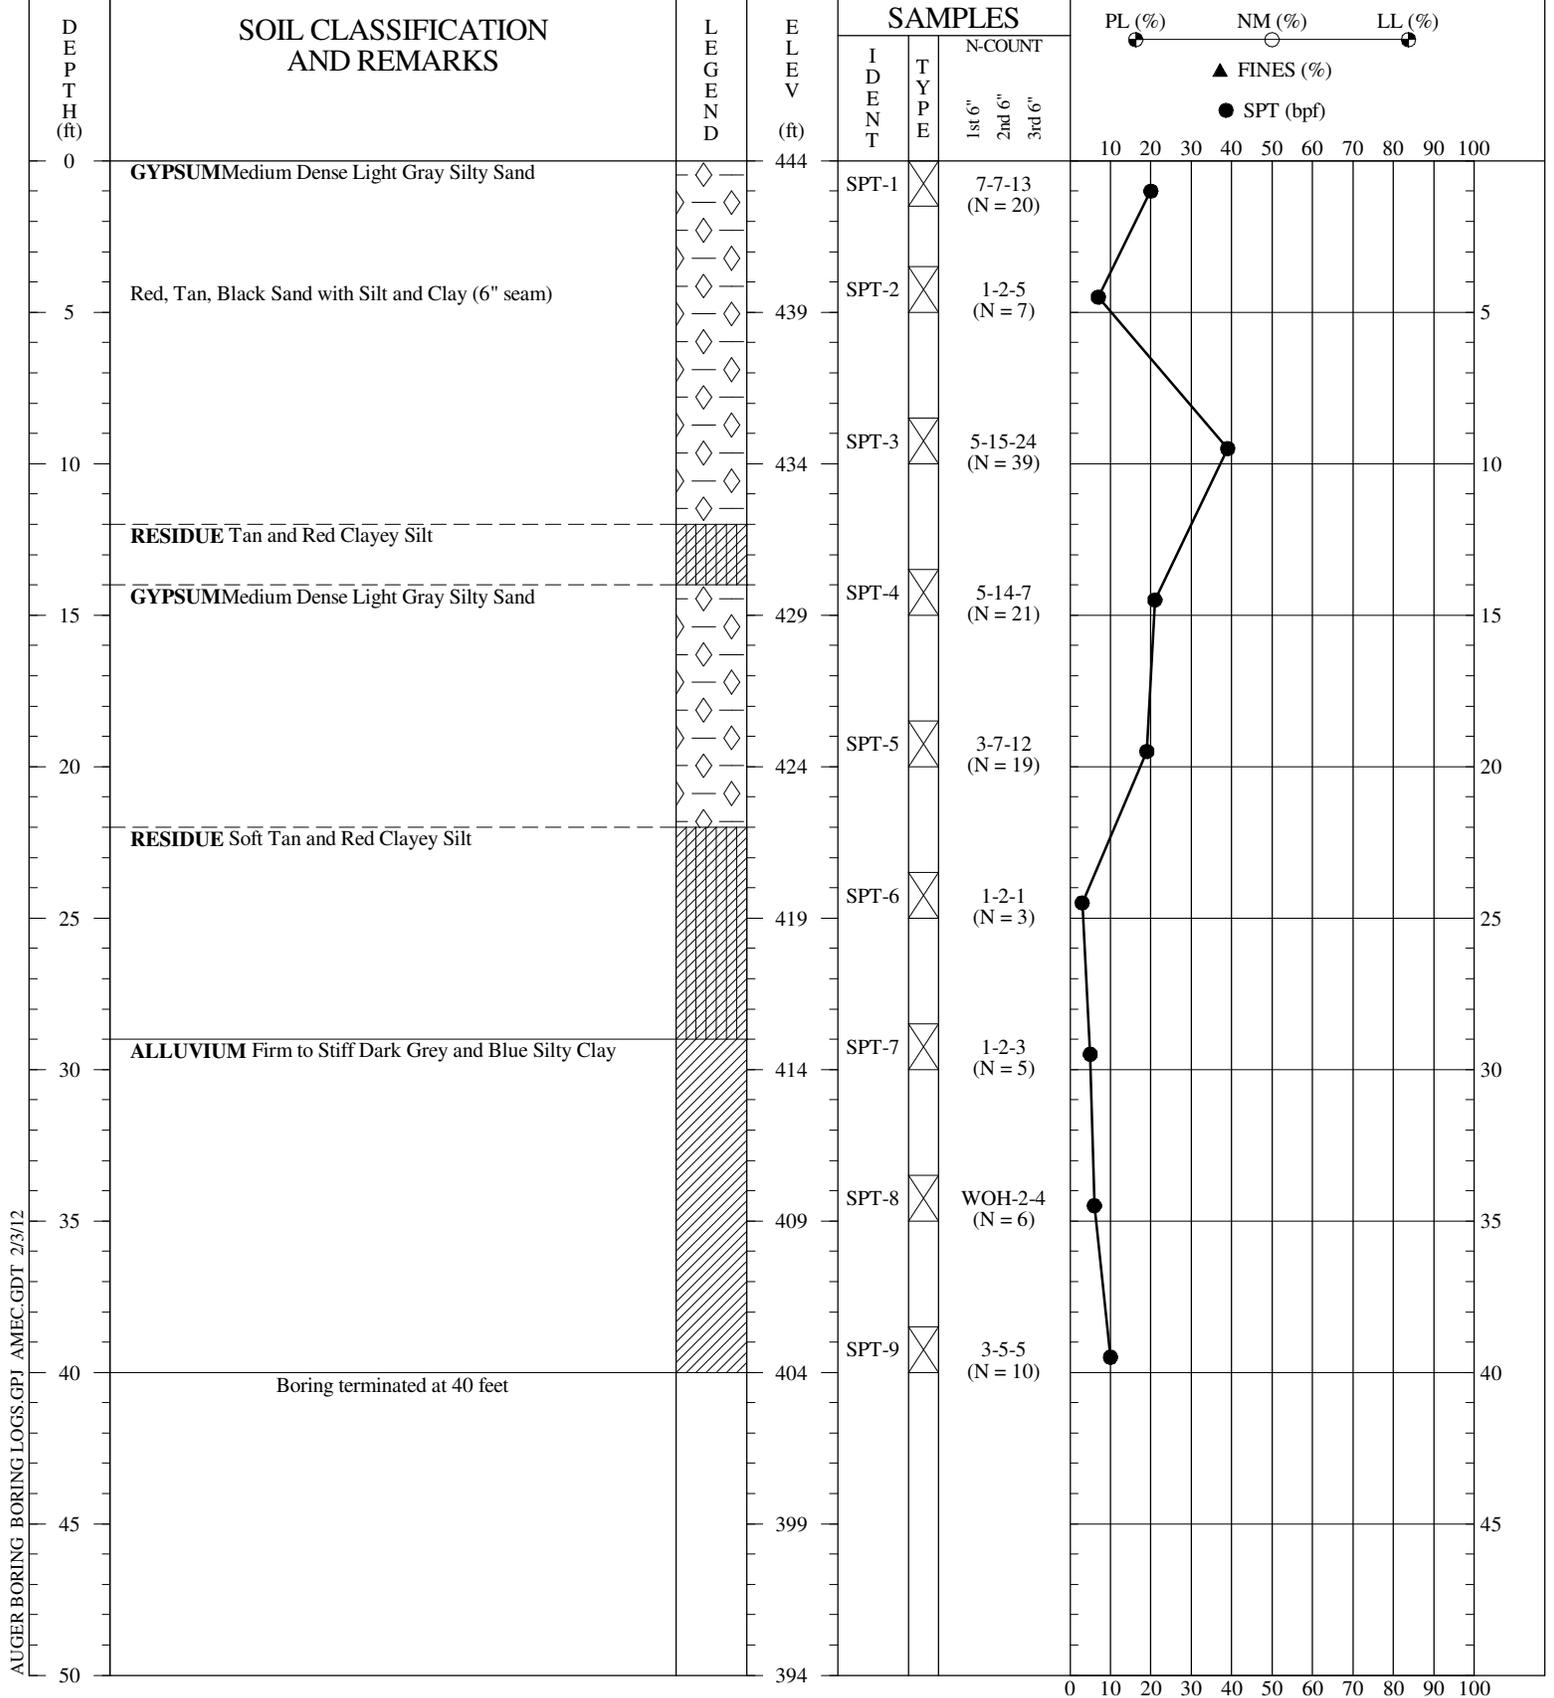
**DRILLER:** R. Landeros (AMEC)  
**EQUIPMENT:** CME-550 (Auto-Hammer)  
**METHOD:** 3 1/4" HSA  
**HOLE DIA.:** 6 inches  
**REMARKS:** Dry, boring caved at 12 feet.

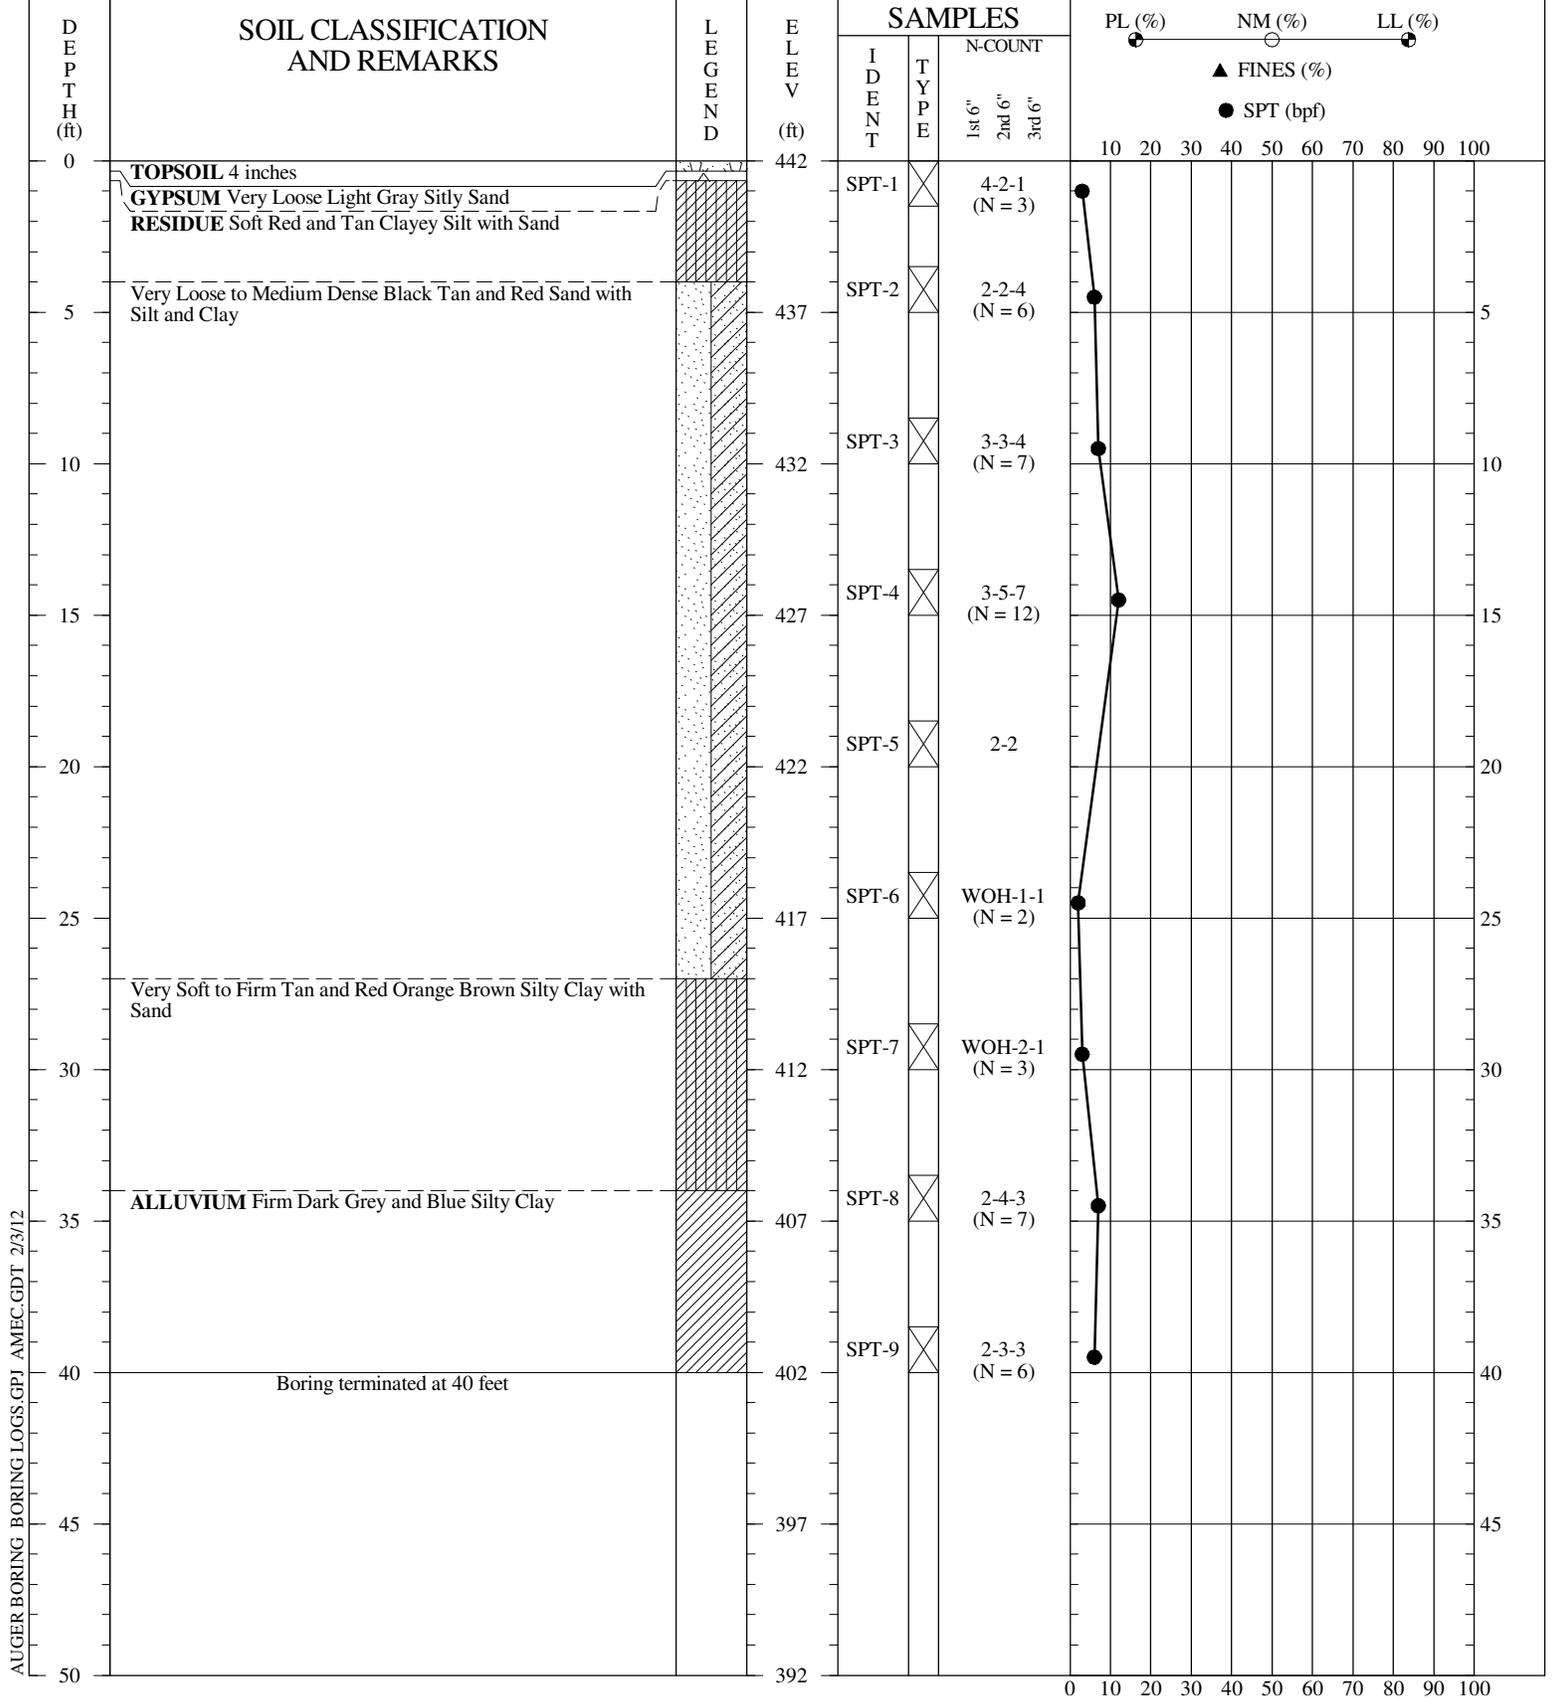
**DRILLER:** R. Landeros (AMEC)  
**EQUIPMENT:** CME-550 (Auto-Hammer)  
**METHOD:** 3 1/4" HSA  
**HOLE DIA.:** 6 inches  
**REMARKS:** Dry, boring caved at 17 feet.

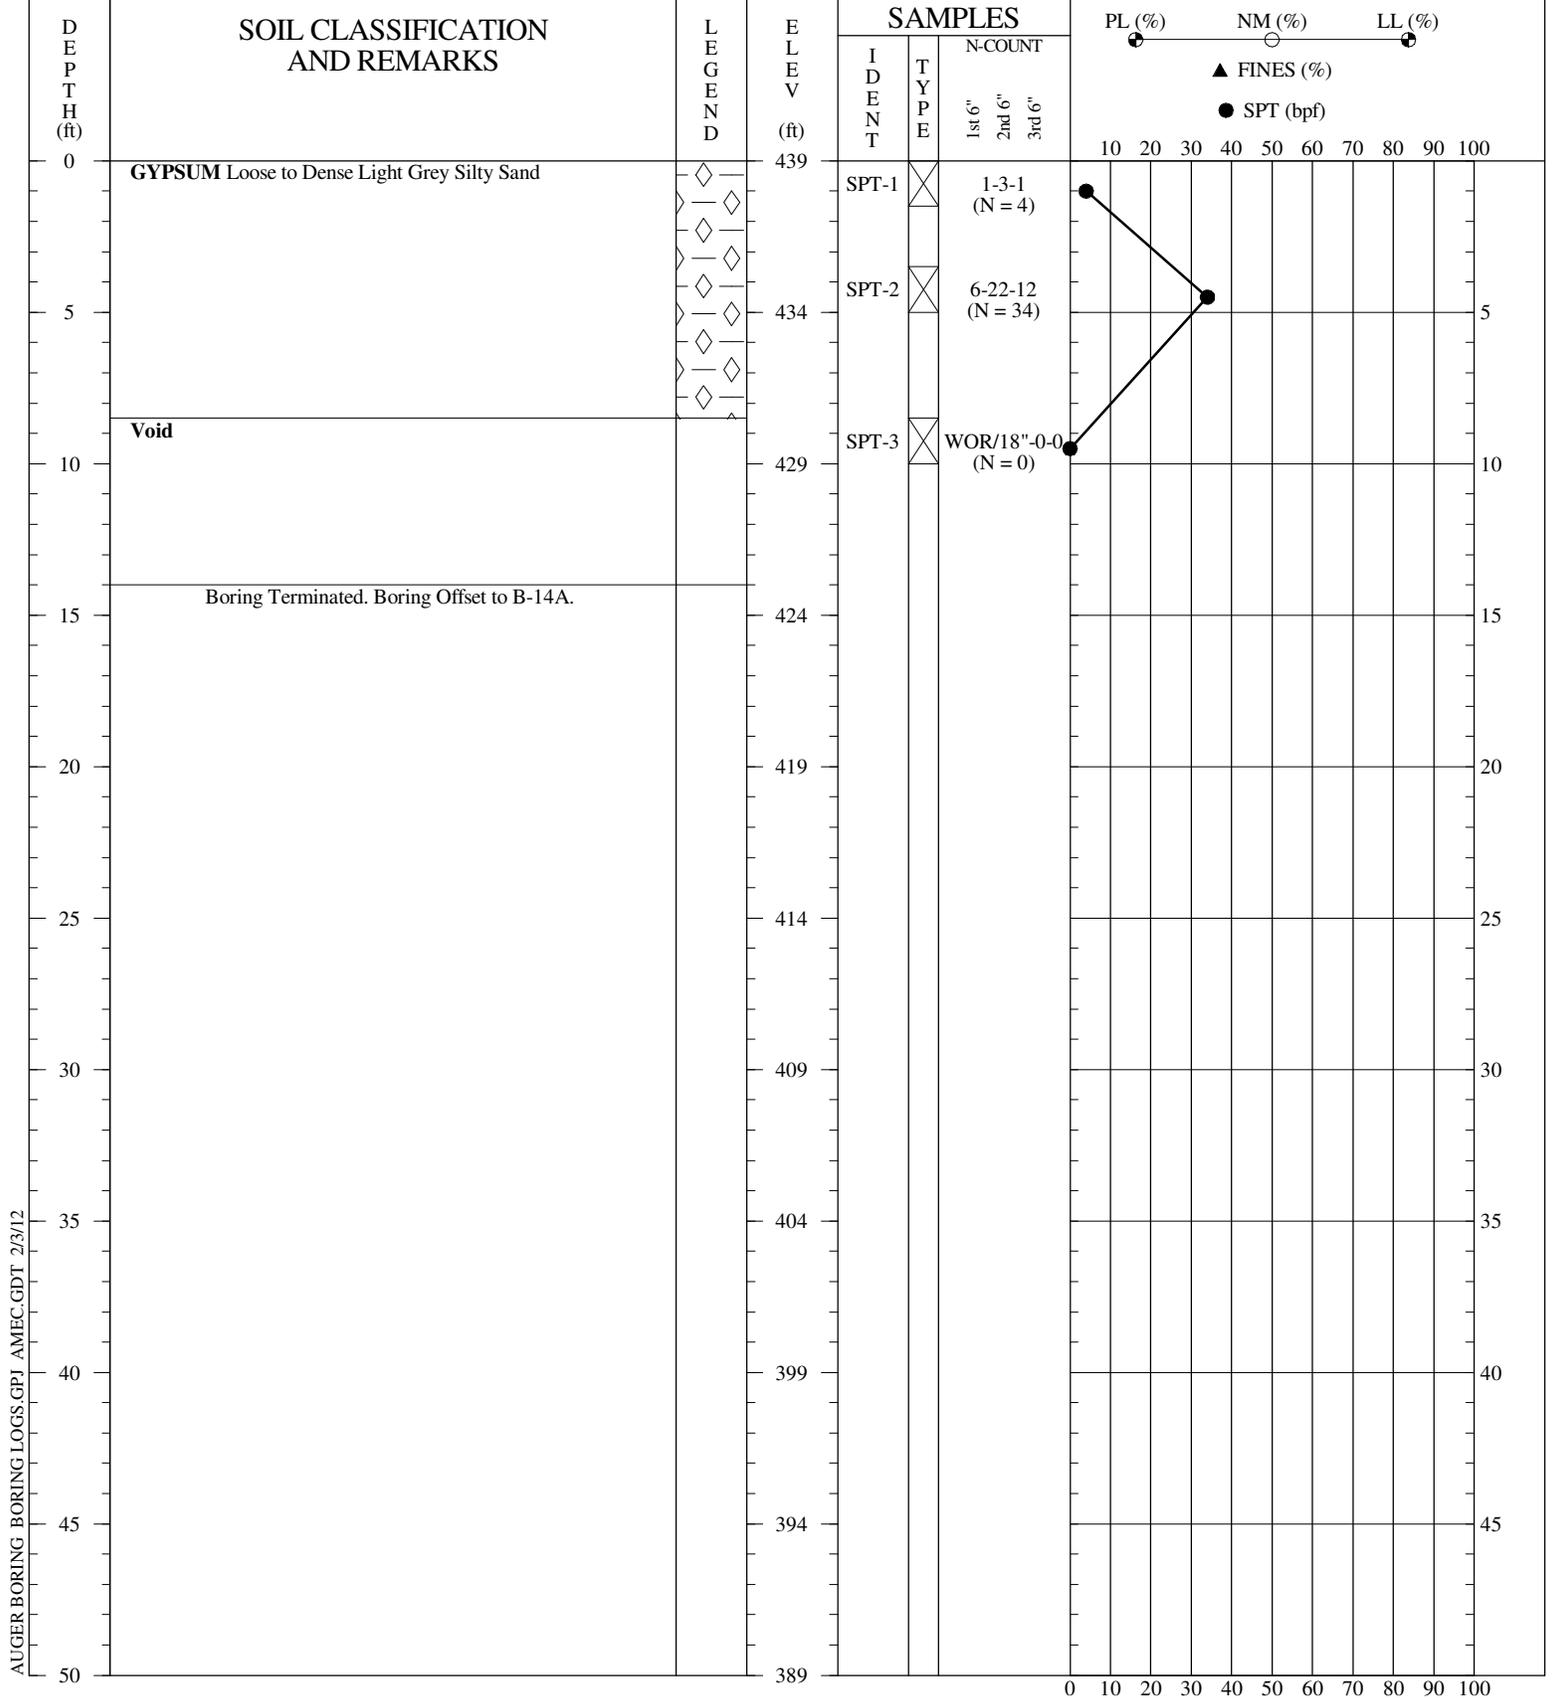
**DRILLER:** R. Landeros (AMEC)  
**EQUIPMENT:** CME-550 (Auto-Hammer)  
**METHOD:** 3 1/4" HSA  
**HOLE DIA.:** 6 inches  
**REMARKS:** Groundwater not encountered at TOD.

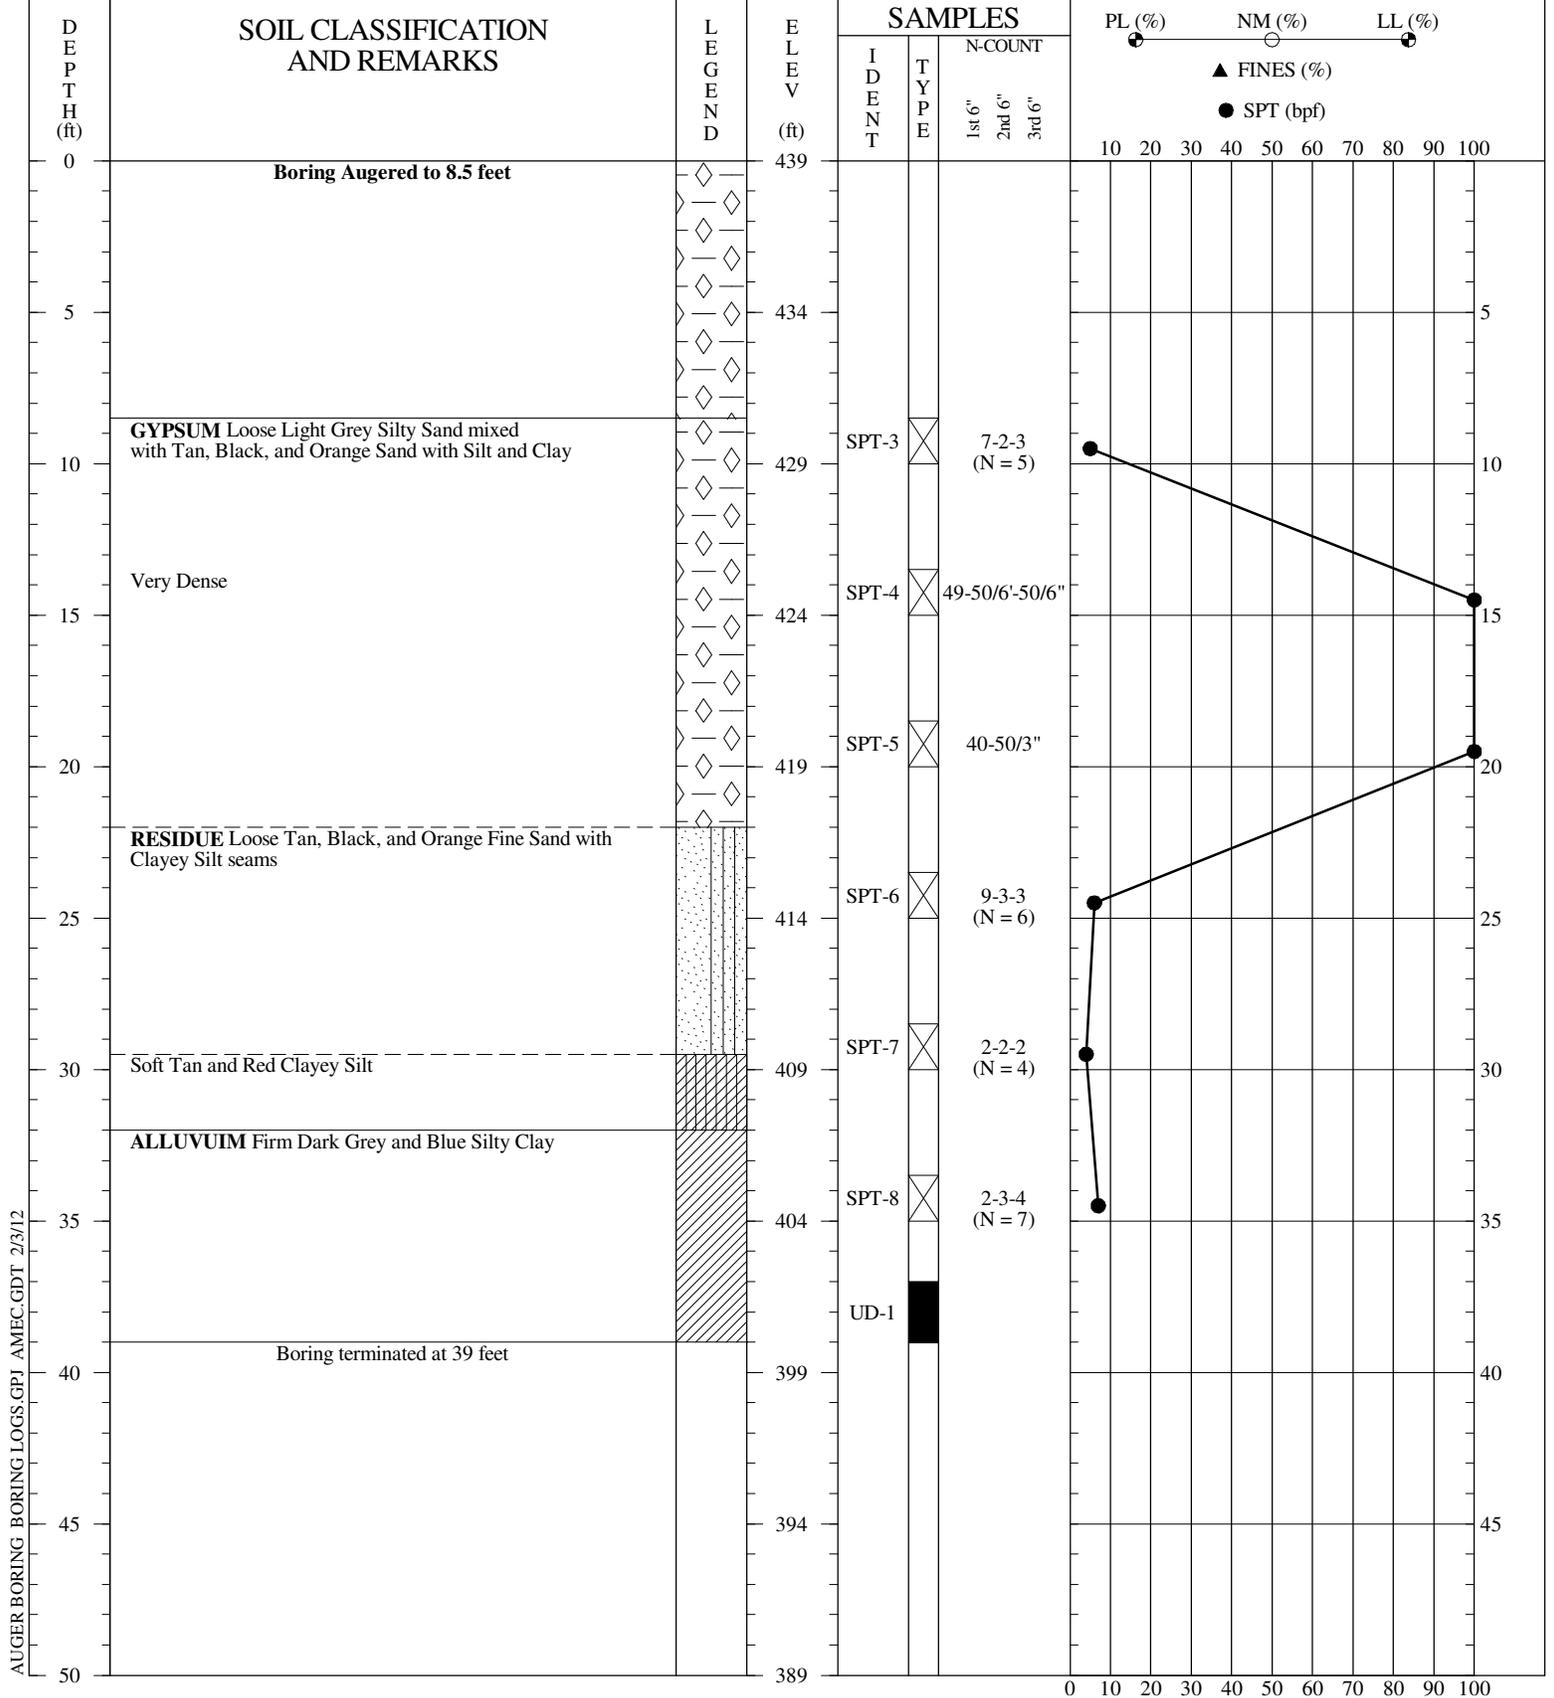
**DRILLER:** R. Landeros (AMEC)  
**EQUIPMENT:** CME-550 (Auto-Hammer)  
**METHOD:** 3 1/4" HSA  
**HOLE DIA.:** 6 inches  
**REMARKS:** Groundwater not encountered at TOD.

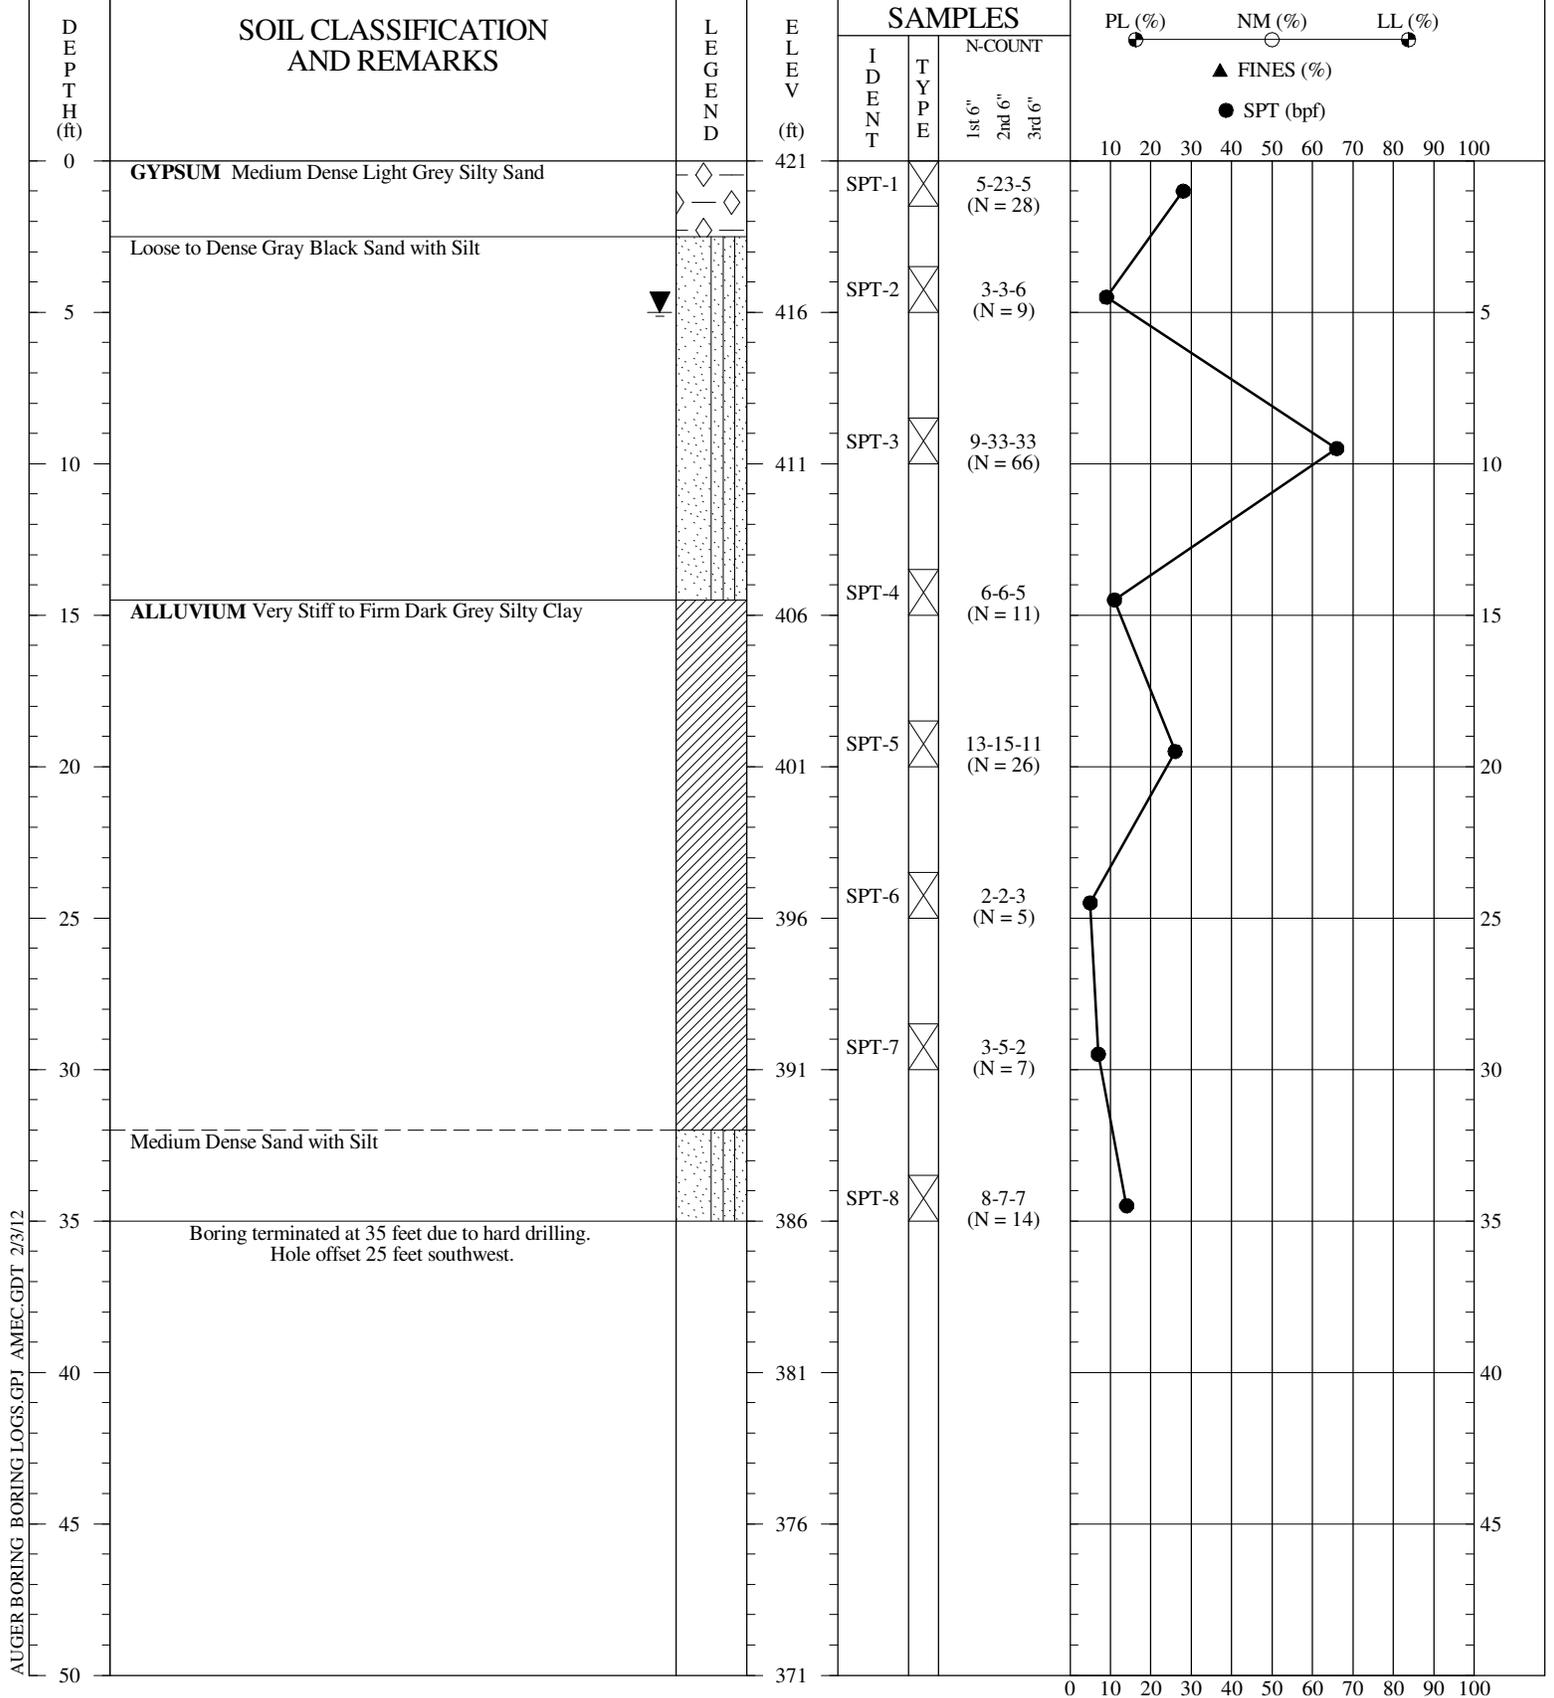
**DRILLER:** R. Landeros (AMEC)  
**EQUIPMENT:** CME-550 (Auto-Hammer)  
**METHOD:** 3 1/4" HSA  
**HOLE DIA.:** 6 inches  
**REMARKS:** Boring caved at 12 feet.

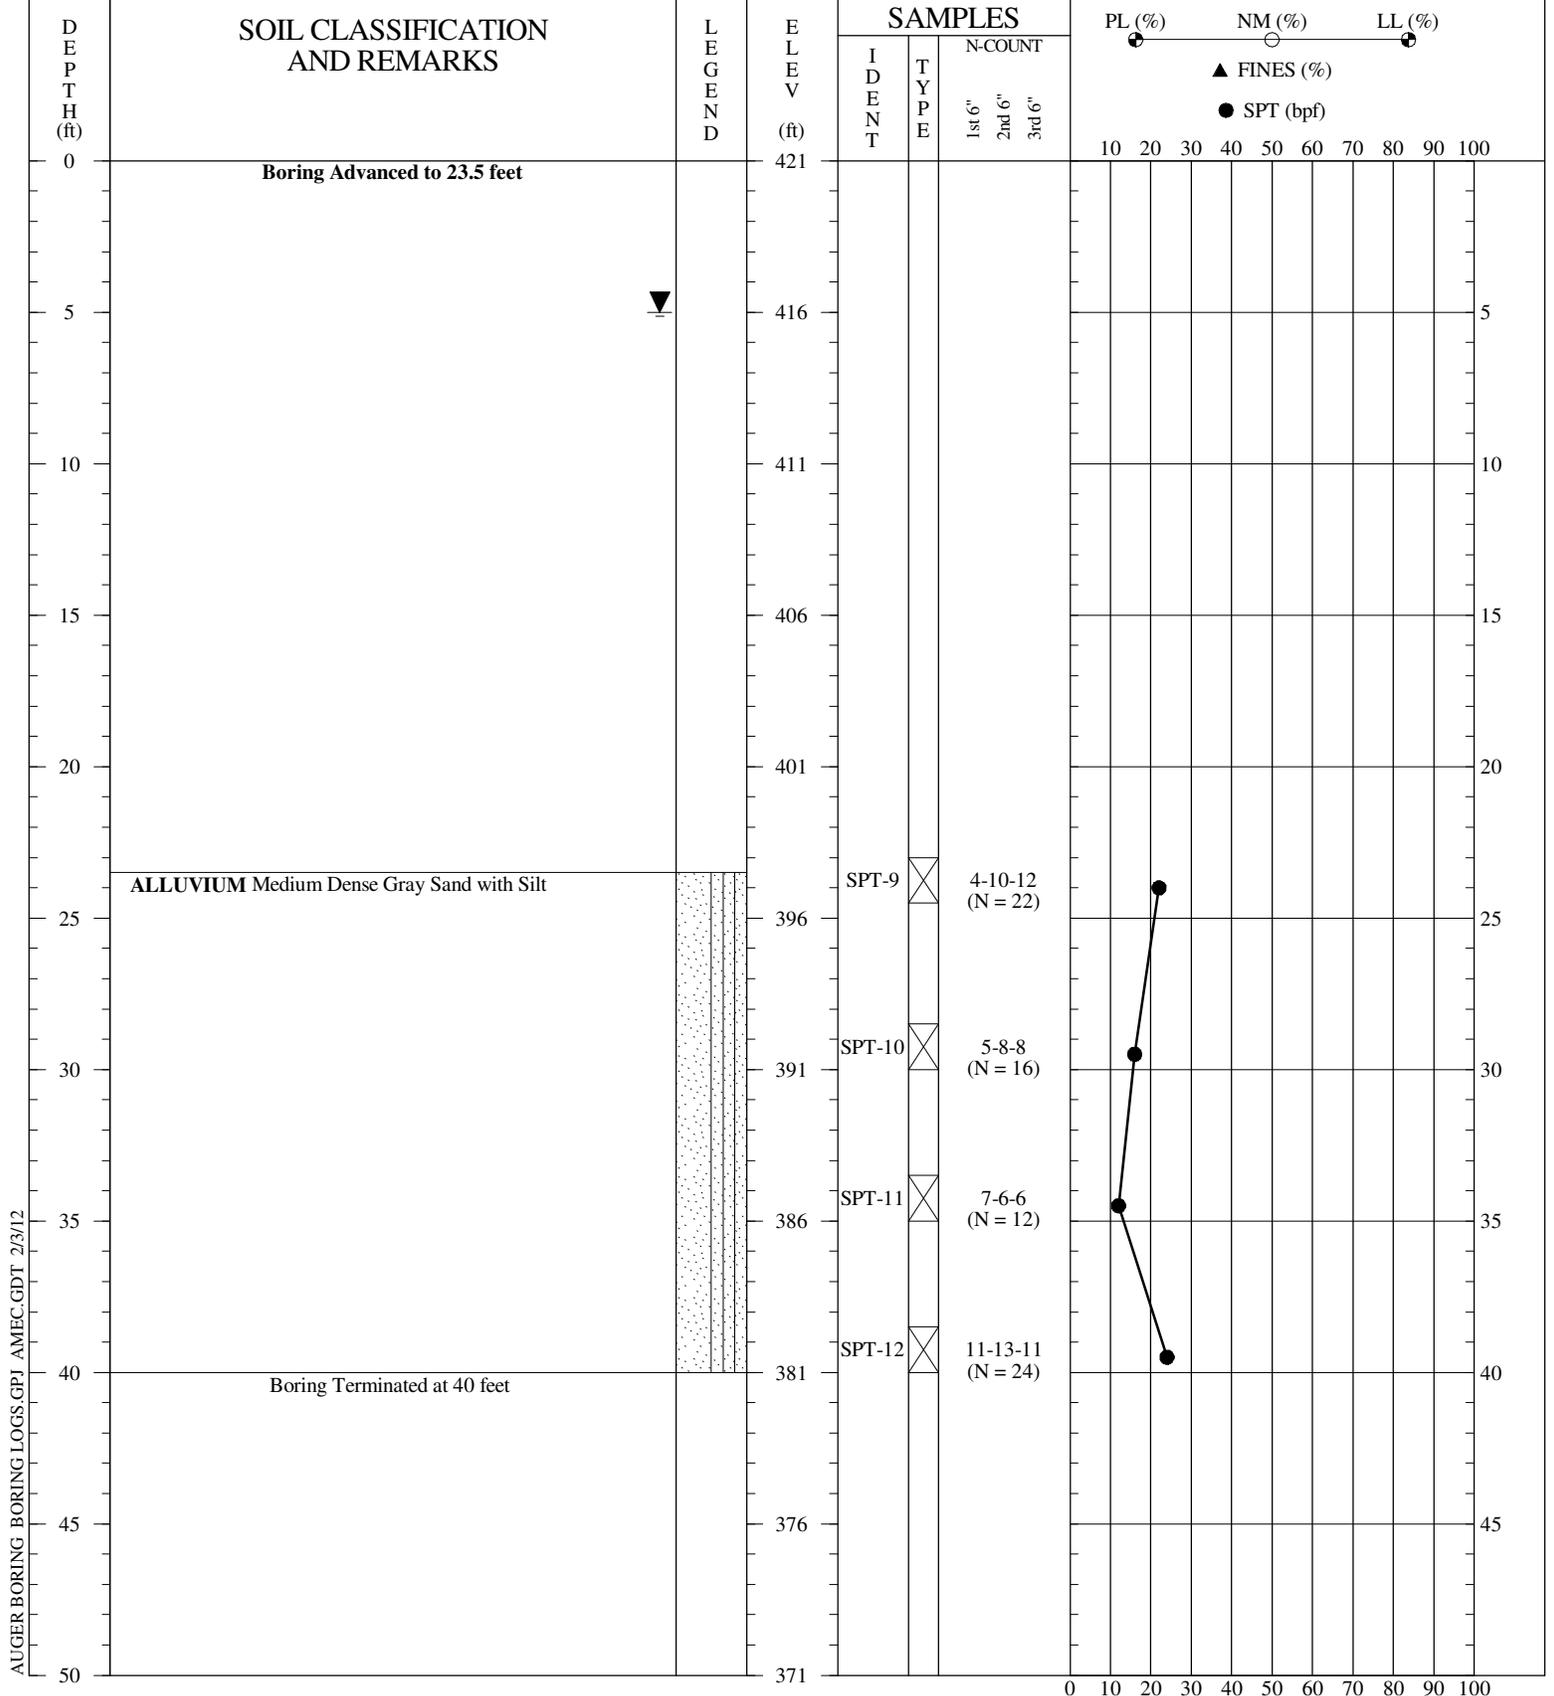
DRILLER: R. Landeros (AMEC)  
 EQUIPMENT: CME-550 (Auto-Hammer)  
 METHOD: Rotary Wash with Mud  
 HOLE DIA.: 6 inches  
 REMARKS: Boring caved at 7 feet.
