**PRE-DESIGN INVESTIGATION REPORT  
PROPOSED SOLAR REDEVELOPMENT PROJECT  
FORMER BAUXITE RESIDUE DISPOSAL AREAS  
Operable Unit 1, North Alcoa Site**

East St. Louis, Illinois

**Restoration Land Development Company, LLC**  
Wellesley, MA

**AMEC Environment & Infrastructure, Inc.**  
800 N. Bell Avenue, Suite 200  
Pittsburgh, Pennsylvania 15106  
(412) 279-6661

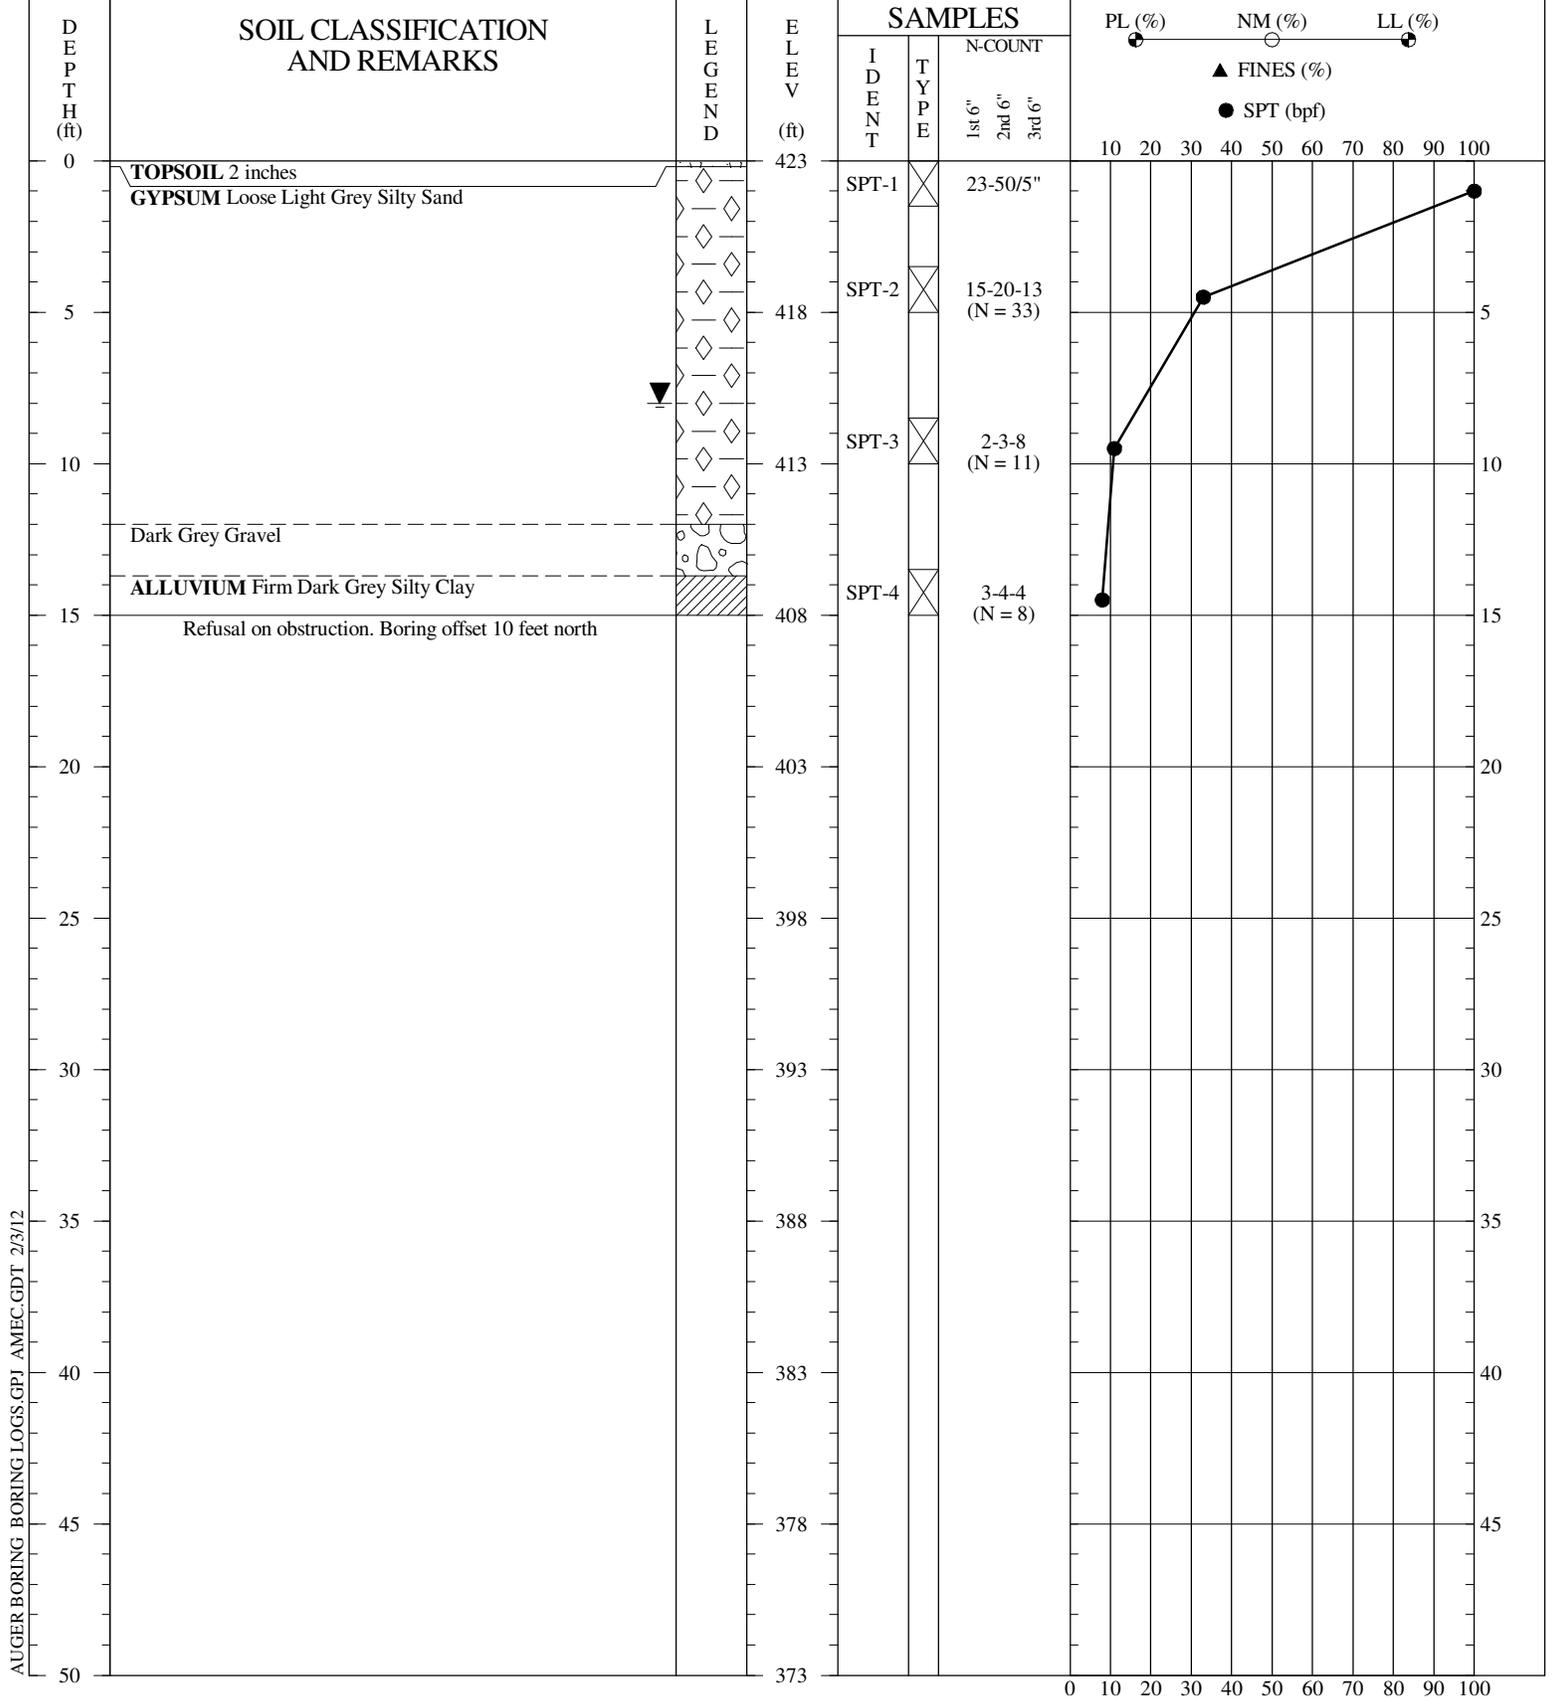
**DRILLER:** R. Landeros (AMEC)  
**EQUIPMENT:** CME-550 (Auto-Hammer)  
**METHOD:** Rotary Wash with Mud  
**HOLE DIA.:** 6 inches  
**REMARKS:** Boring caved at 1 foot.

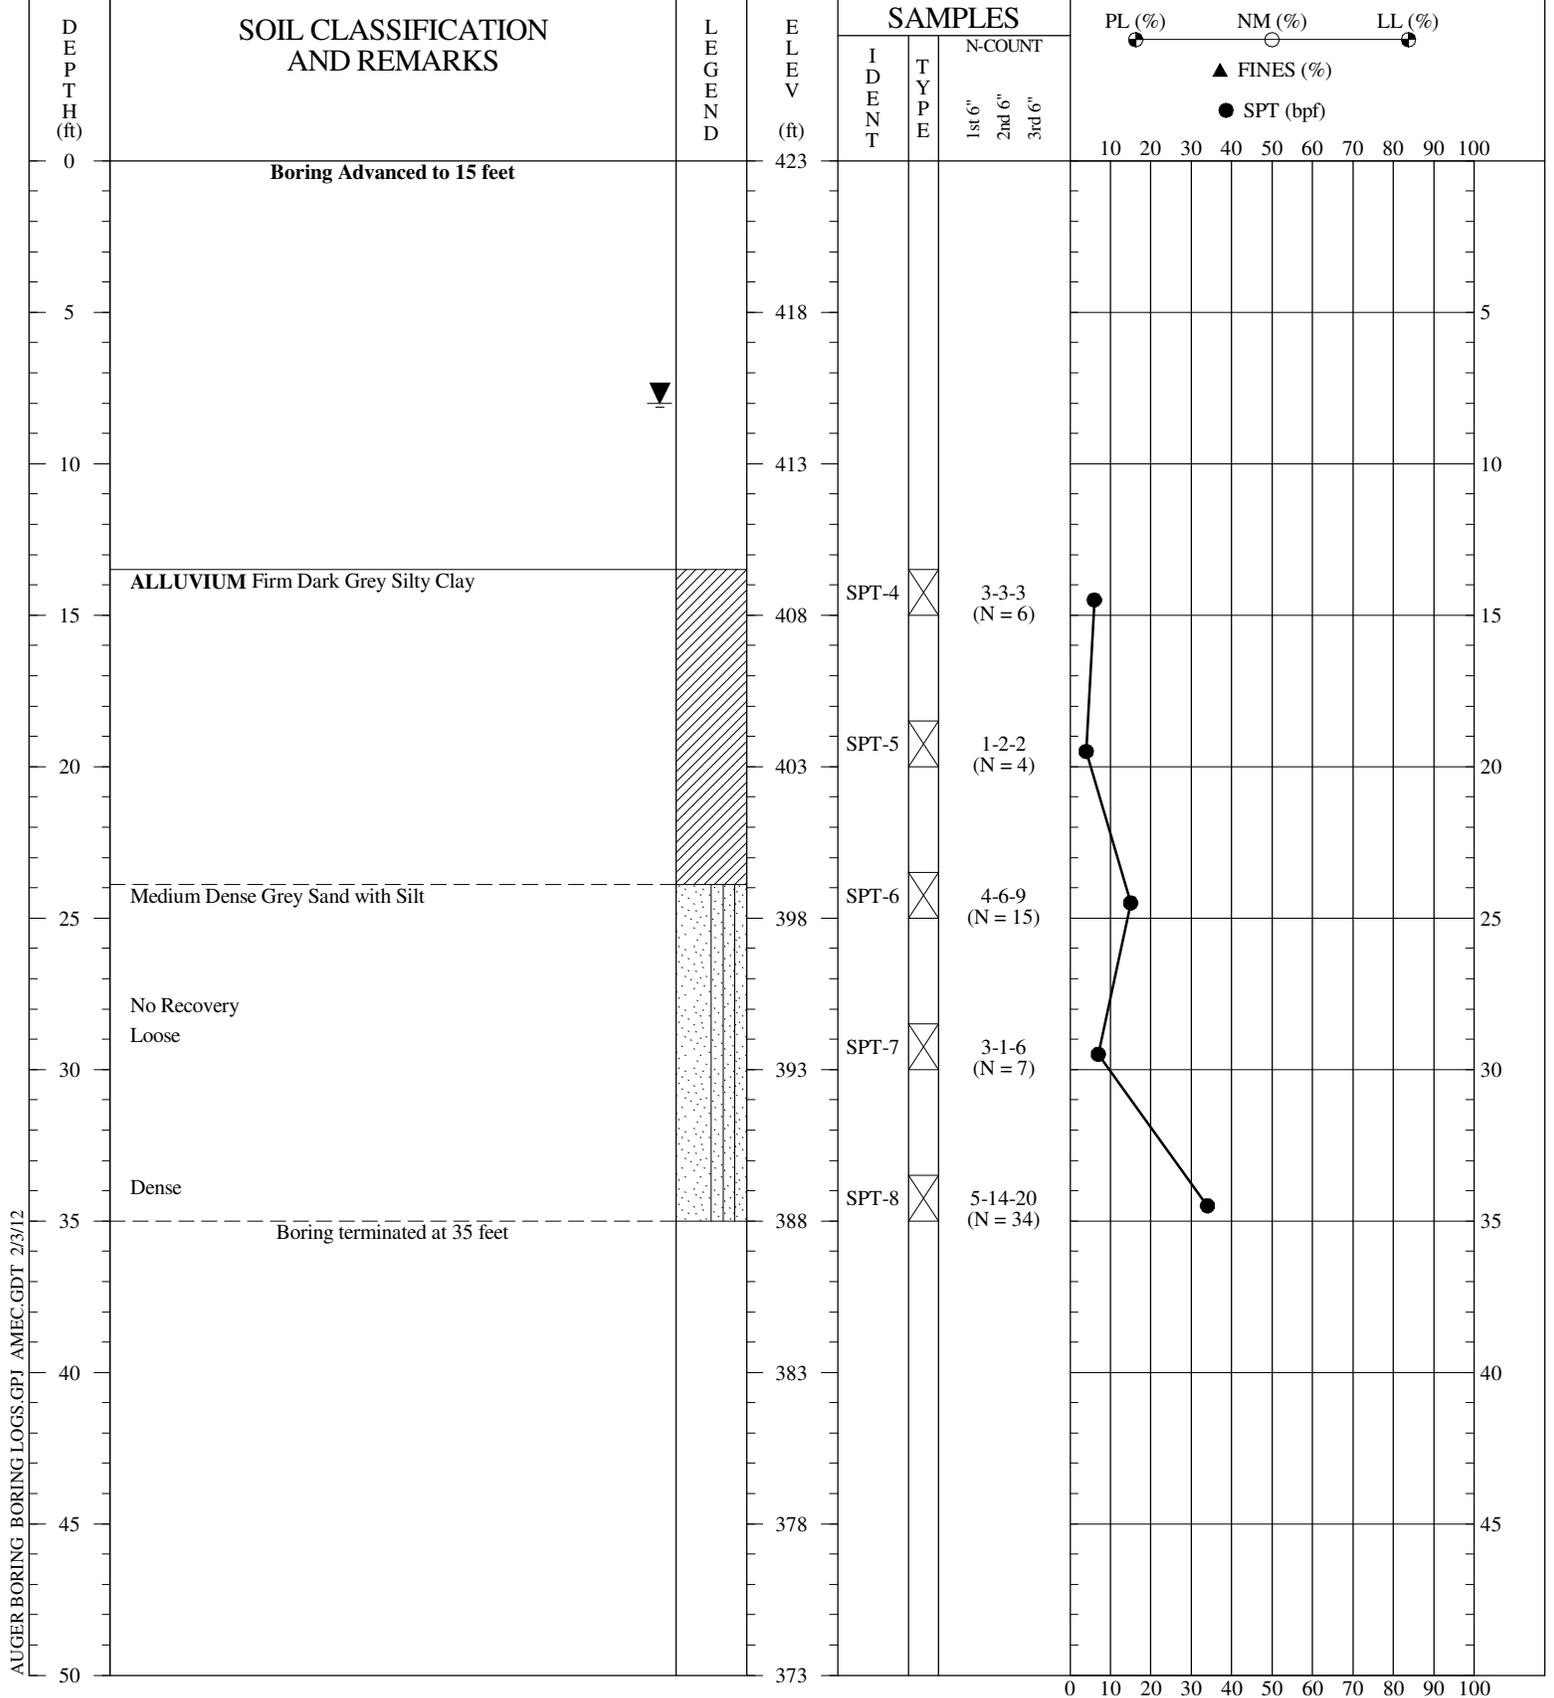
**DRILLER:** R. Landeros (AMEC)  
**EQUIPMENT:** CME-550 (Auto-Hammer)  
**METHOD:** Rotary Wash with Mud  
**HOLE DIA.:** 6 inches  
**REMARKS:** Boring caved at 27 feet.

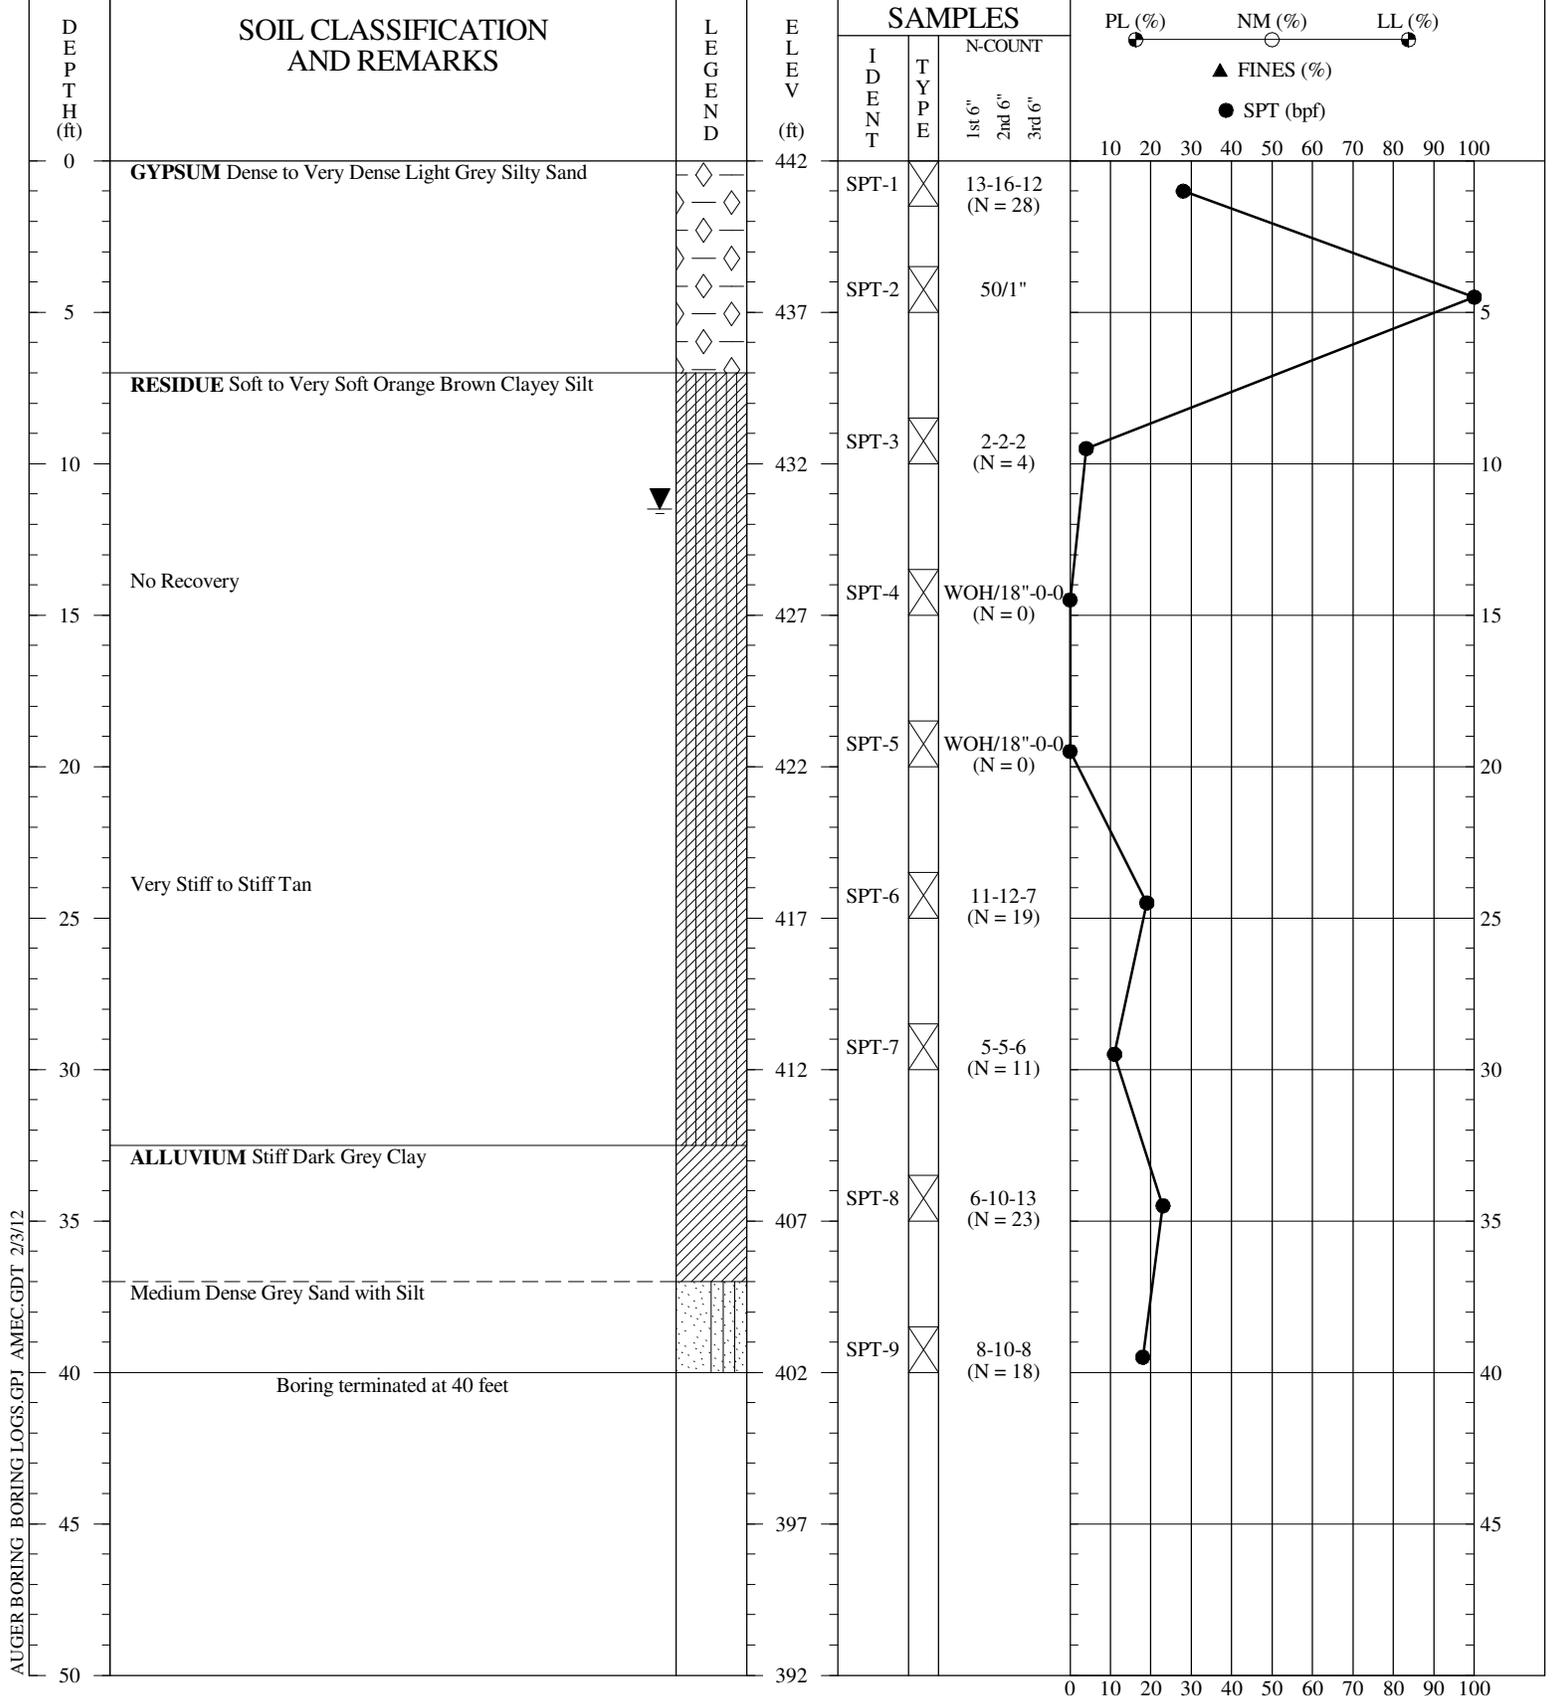
**DRILLER:** R. Landeros (AMEC)  
**EQUIPMENT:** CME-550 (Auto-Hammer)  
**METHOD:** Rotary Wash with Mud  
**HOLE DIA.:** 6 inches  
**REMARKS:** Boring caved at 18 feet.

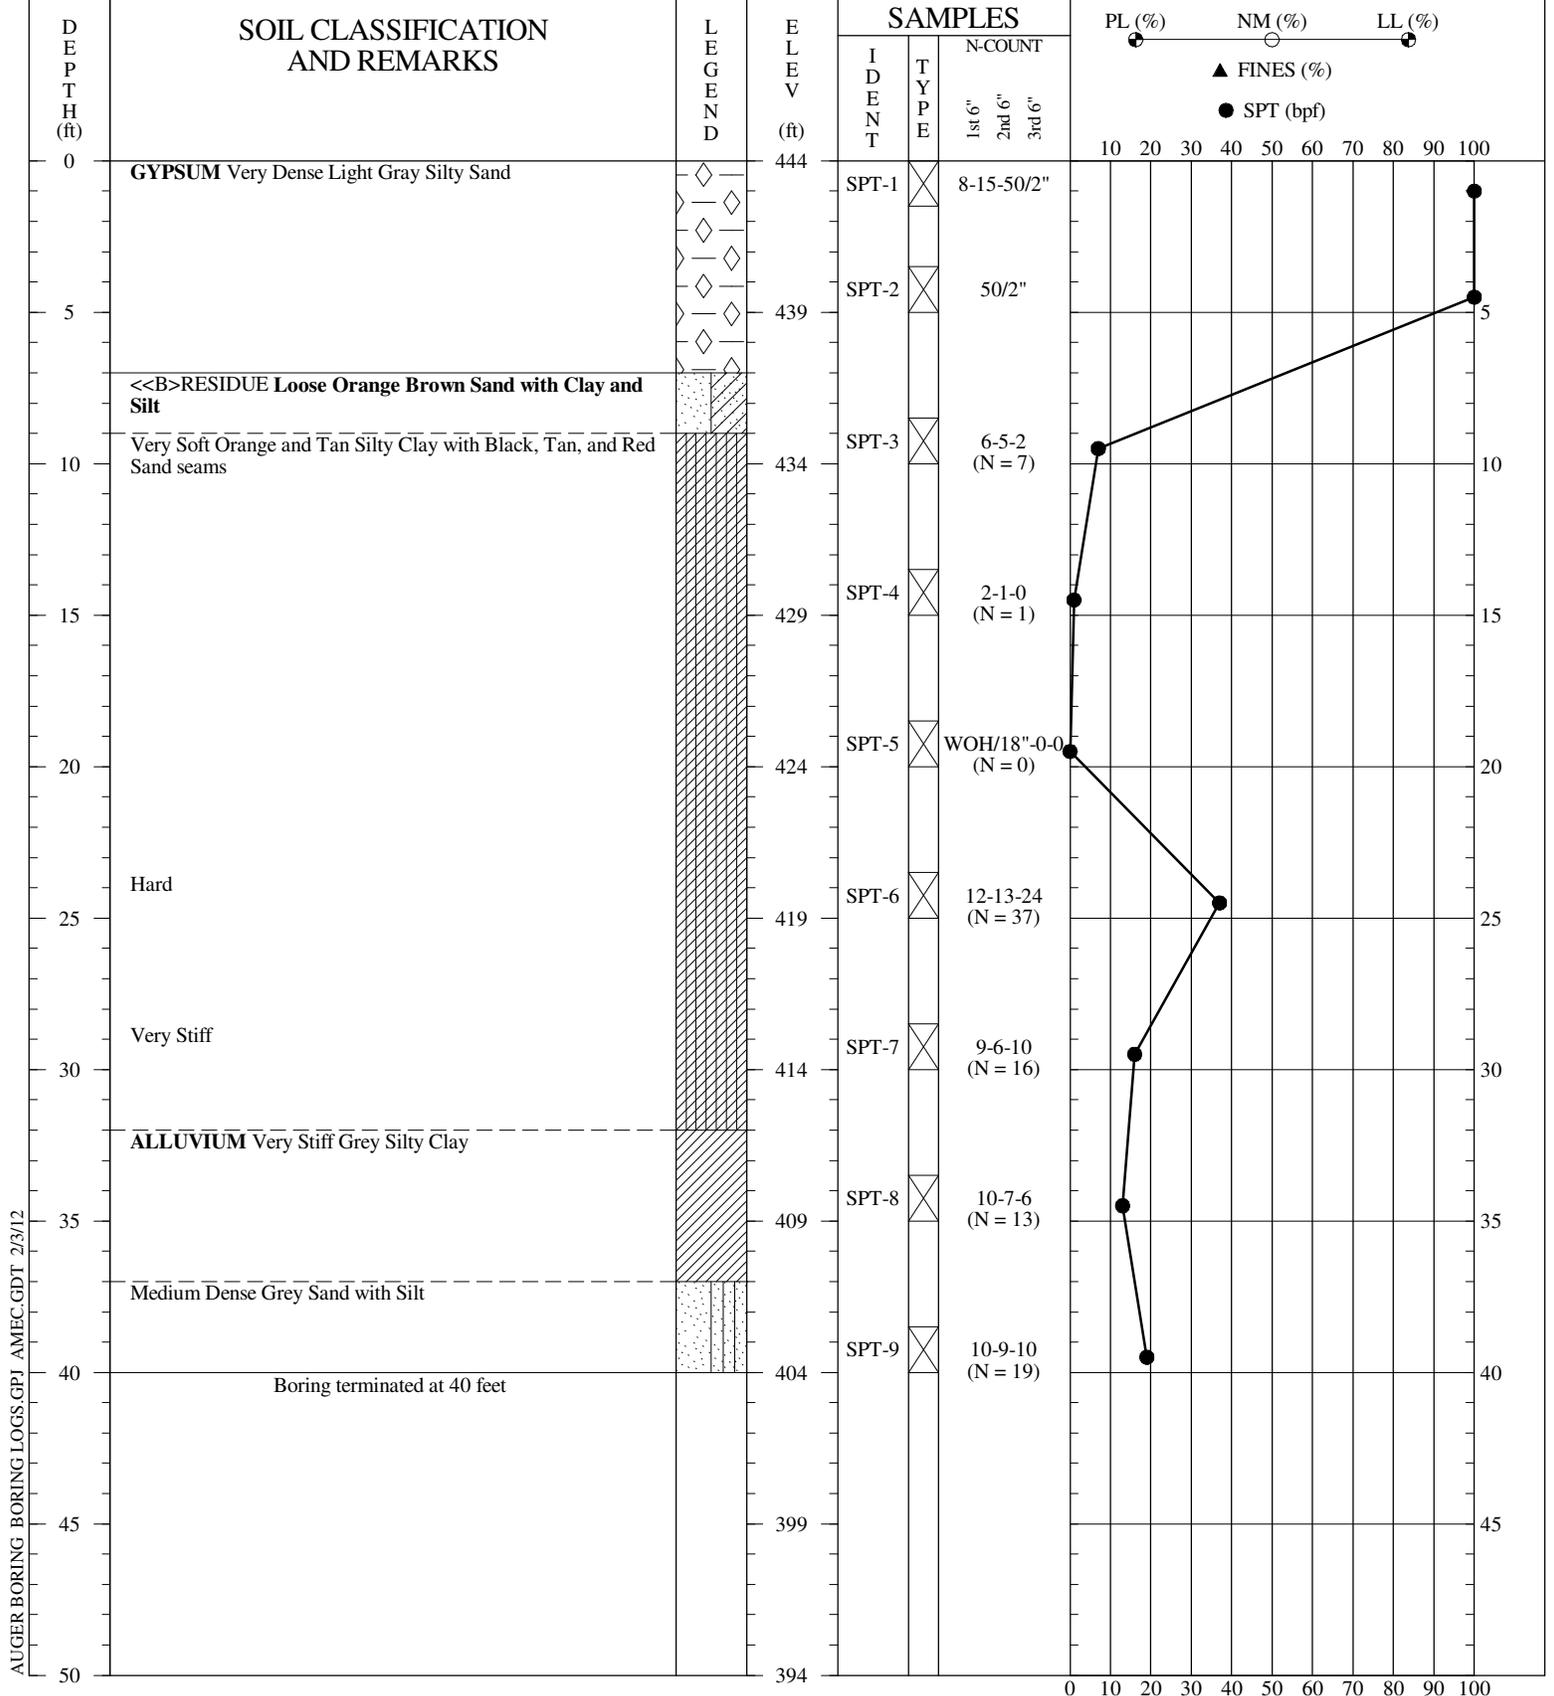
**DRILLER:** R. Landeros (AMEC)  
**EQUIPMENT:** CME-550 (Auto-Hammer)  
**METHOD:** Rotary Wash with Mud  
**HOLE DIA.:** 6 inches  
**REMARKS:** Dry, boring caved at 17 feet.

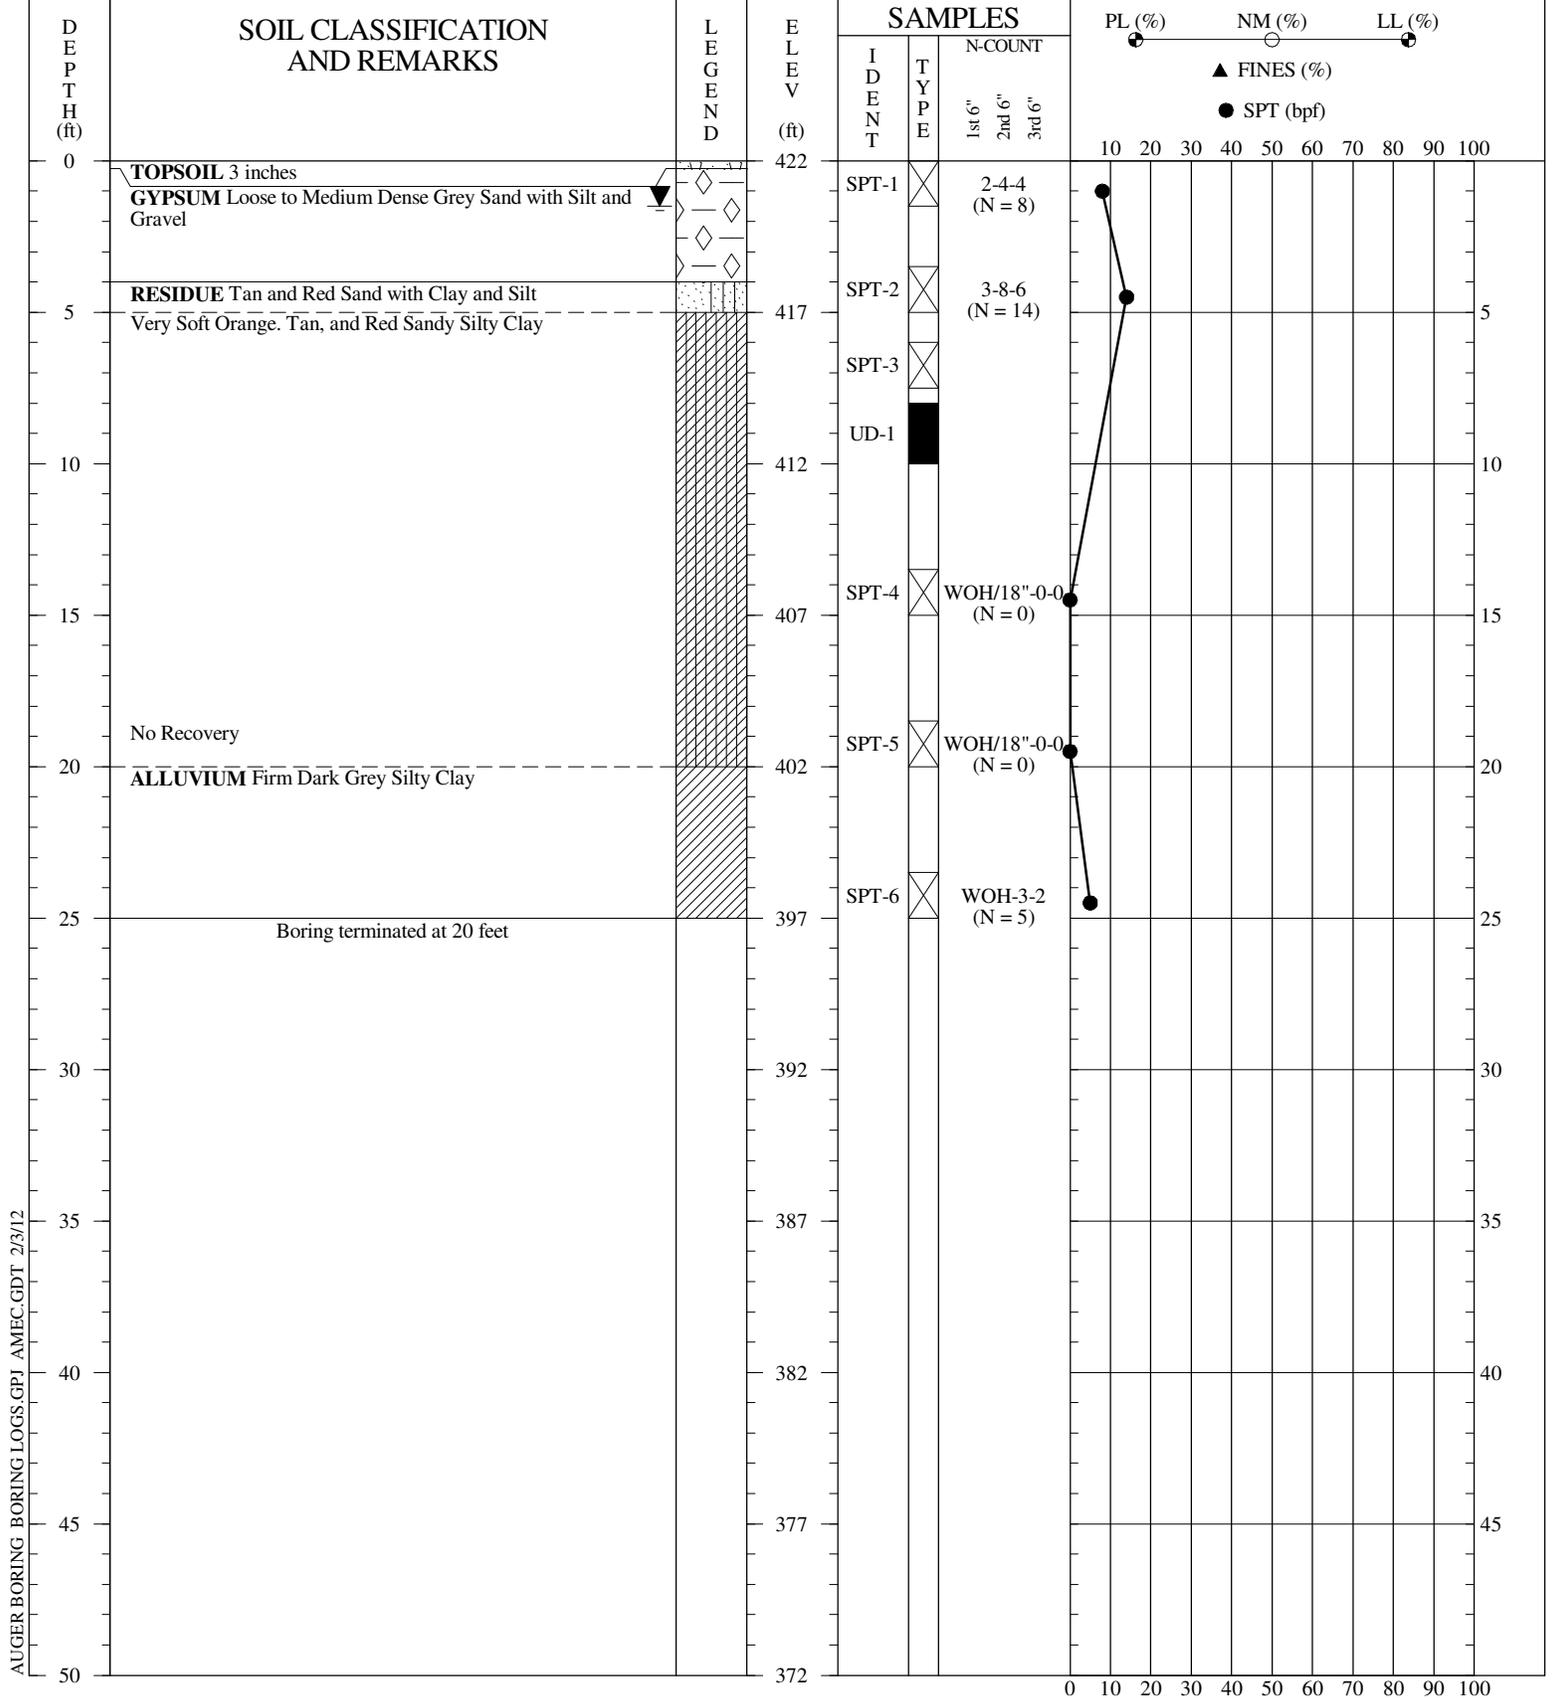
**DRILLER:** R. Landeros (AMEC)  
**EQUIPMENT:** CME-550 (Auto-Hammer)  
**METHOD:** Rotary Wash with Mud  
**HOLE DIA.:** 6 inches  
**REMARKS:** Boring caved at 13 feet.

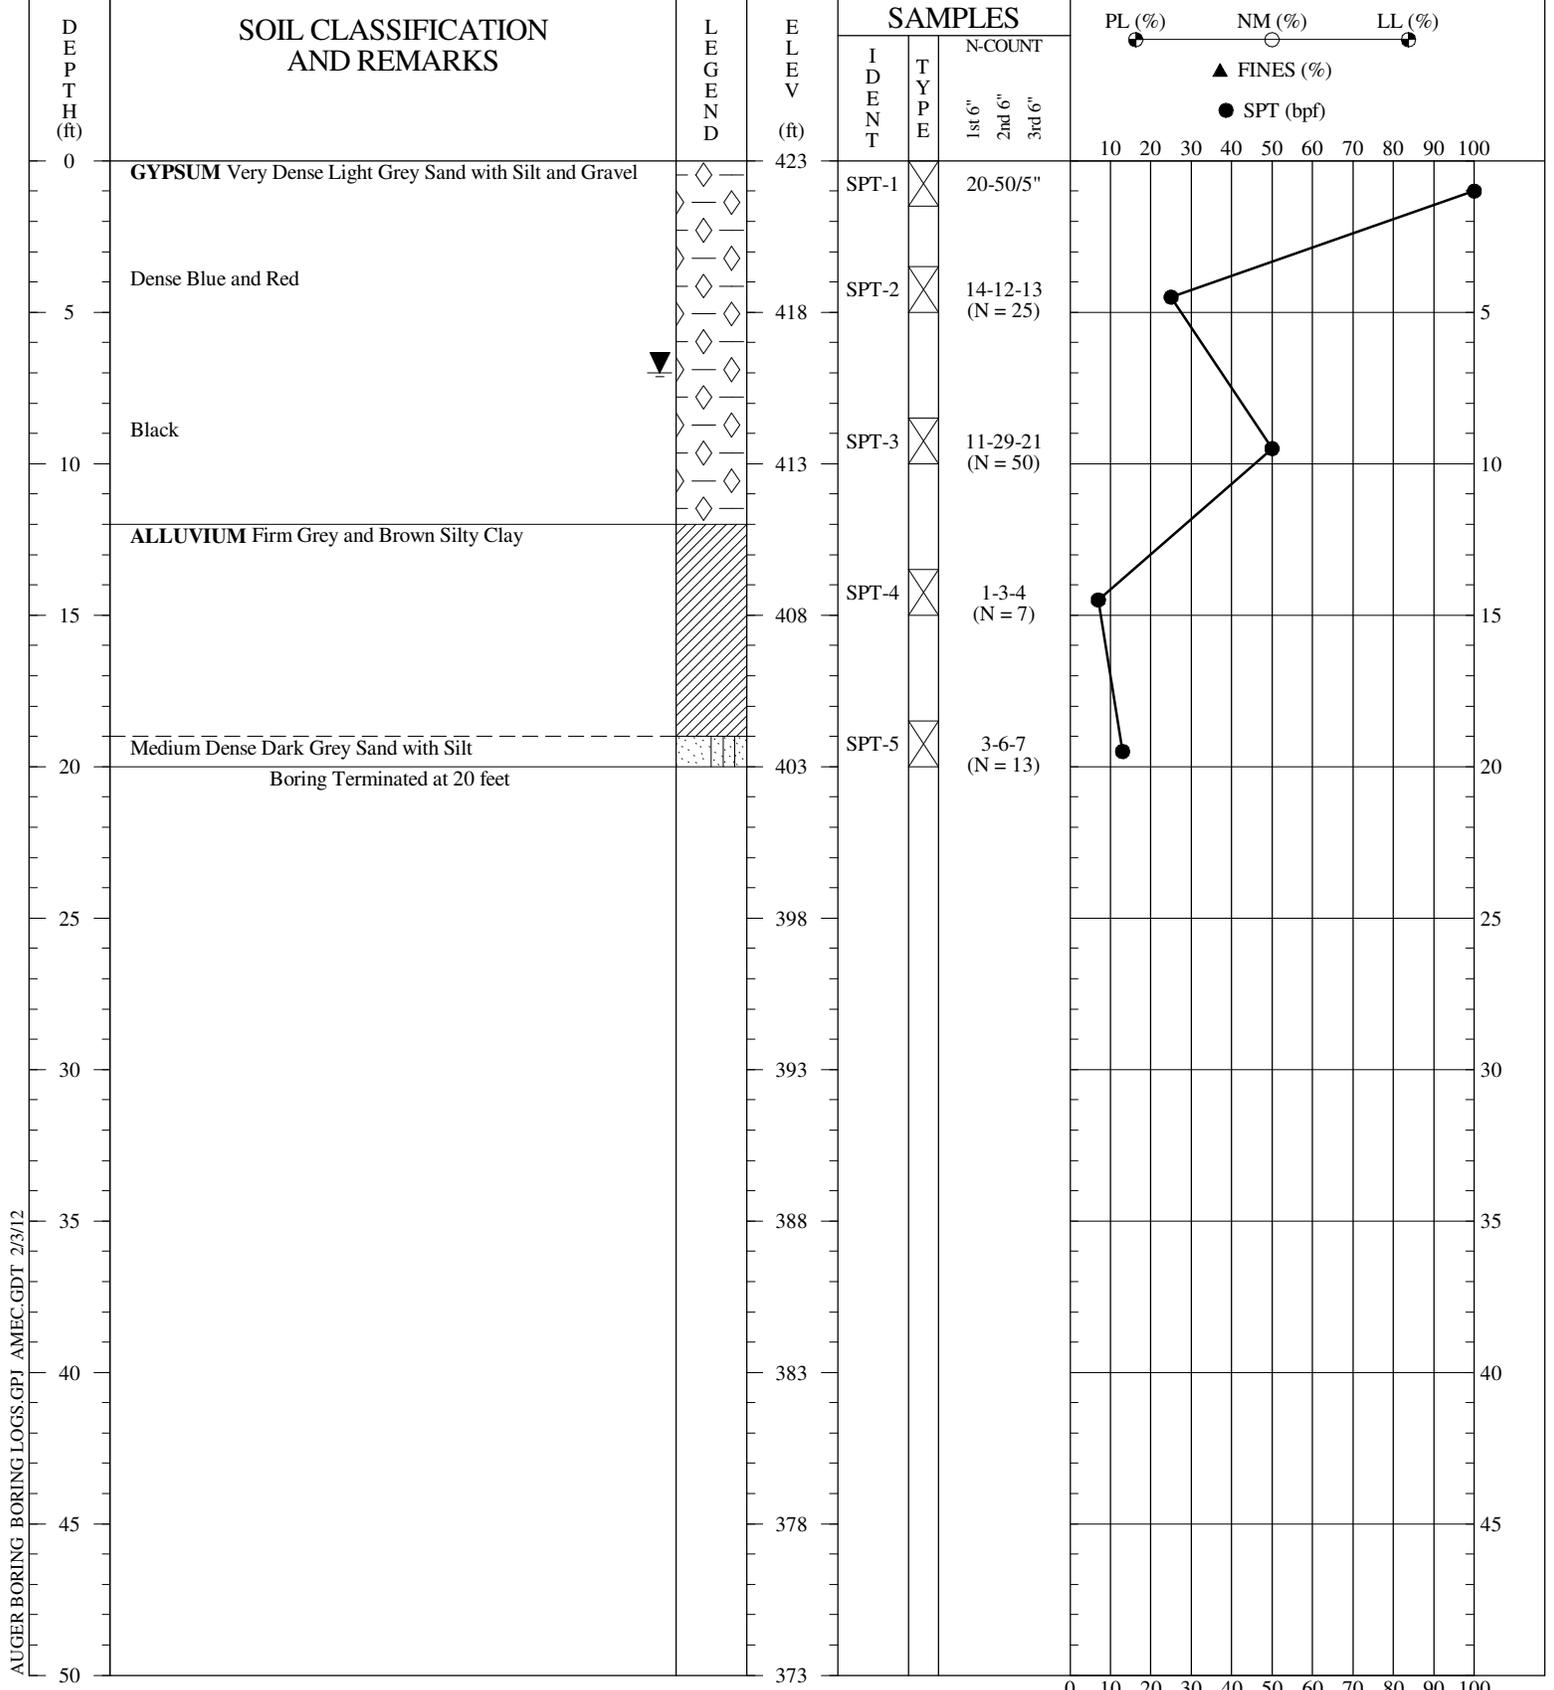
**DRILLER:** R. Landeros (AMEC)  
**EQUIPMENT:** CME-550 (Auto-Hammer)  
**METHOD:** Rotary Wash with Mud  
**HOLE DIA.:** 6 inches  
**REMARKS:** Boring caved at 12 feet.

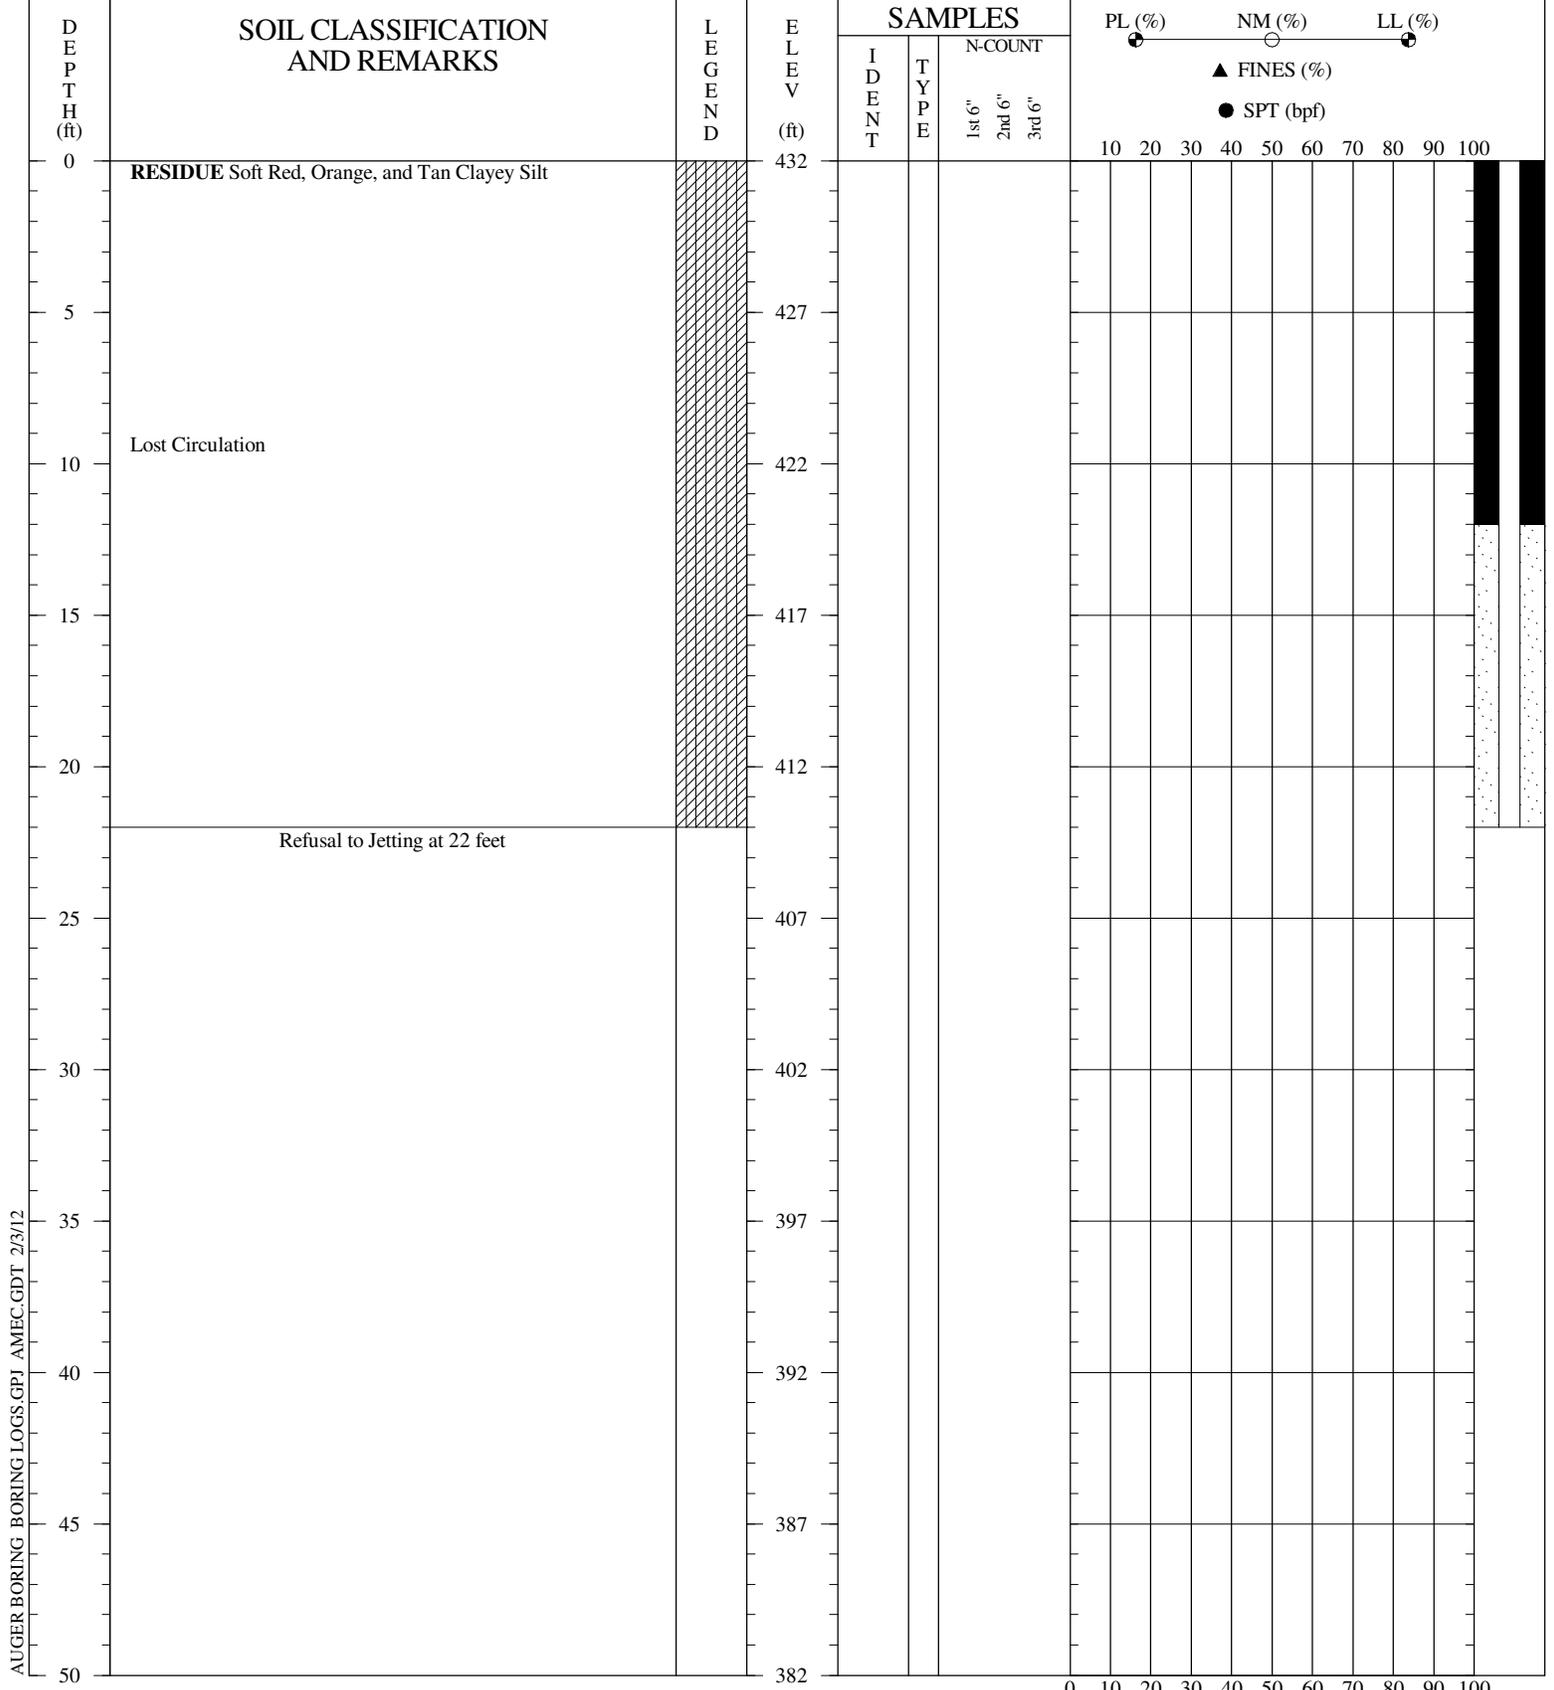
**DRILLER:** Piet DePree (AMEC)  
**EQUIPMENT:** Pump  
**METHOD:** Advanced by Hand with Jetting Water with 1 inch PVC  
**HOLE DIA.:** pipe  
**REMARKS:** 1.5 inches  
 No Sampling.

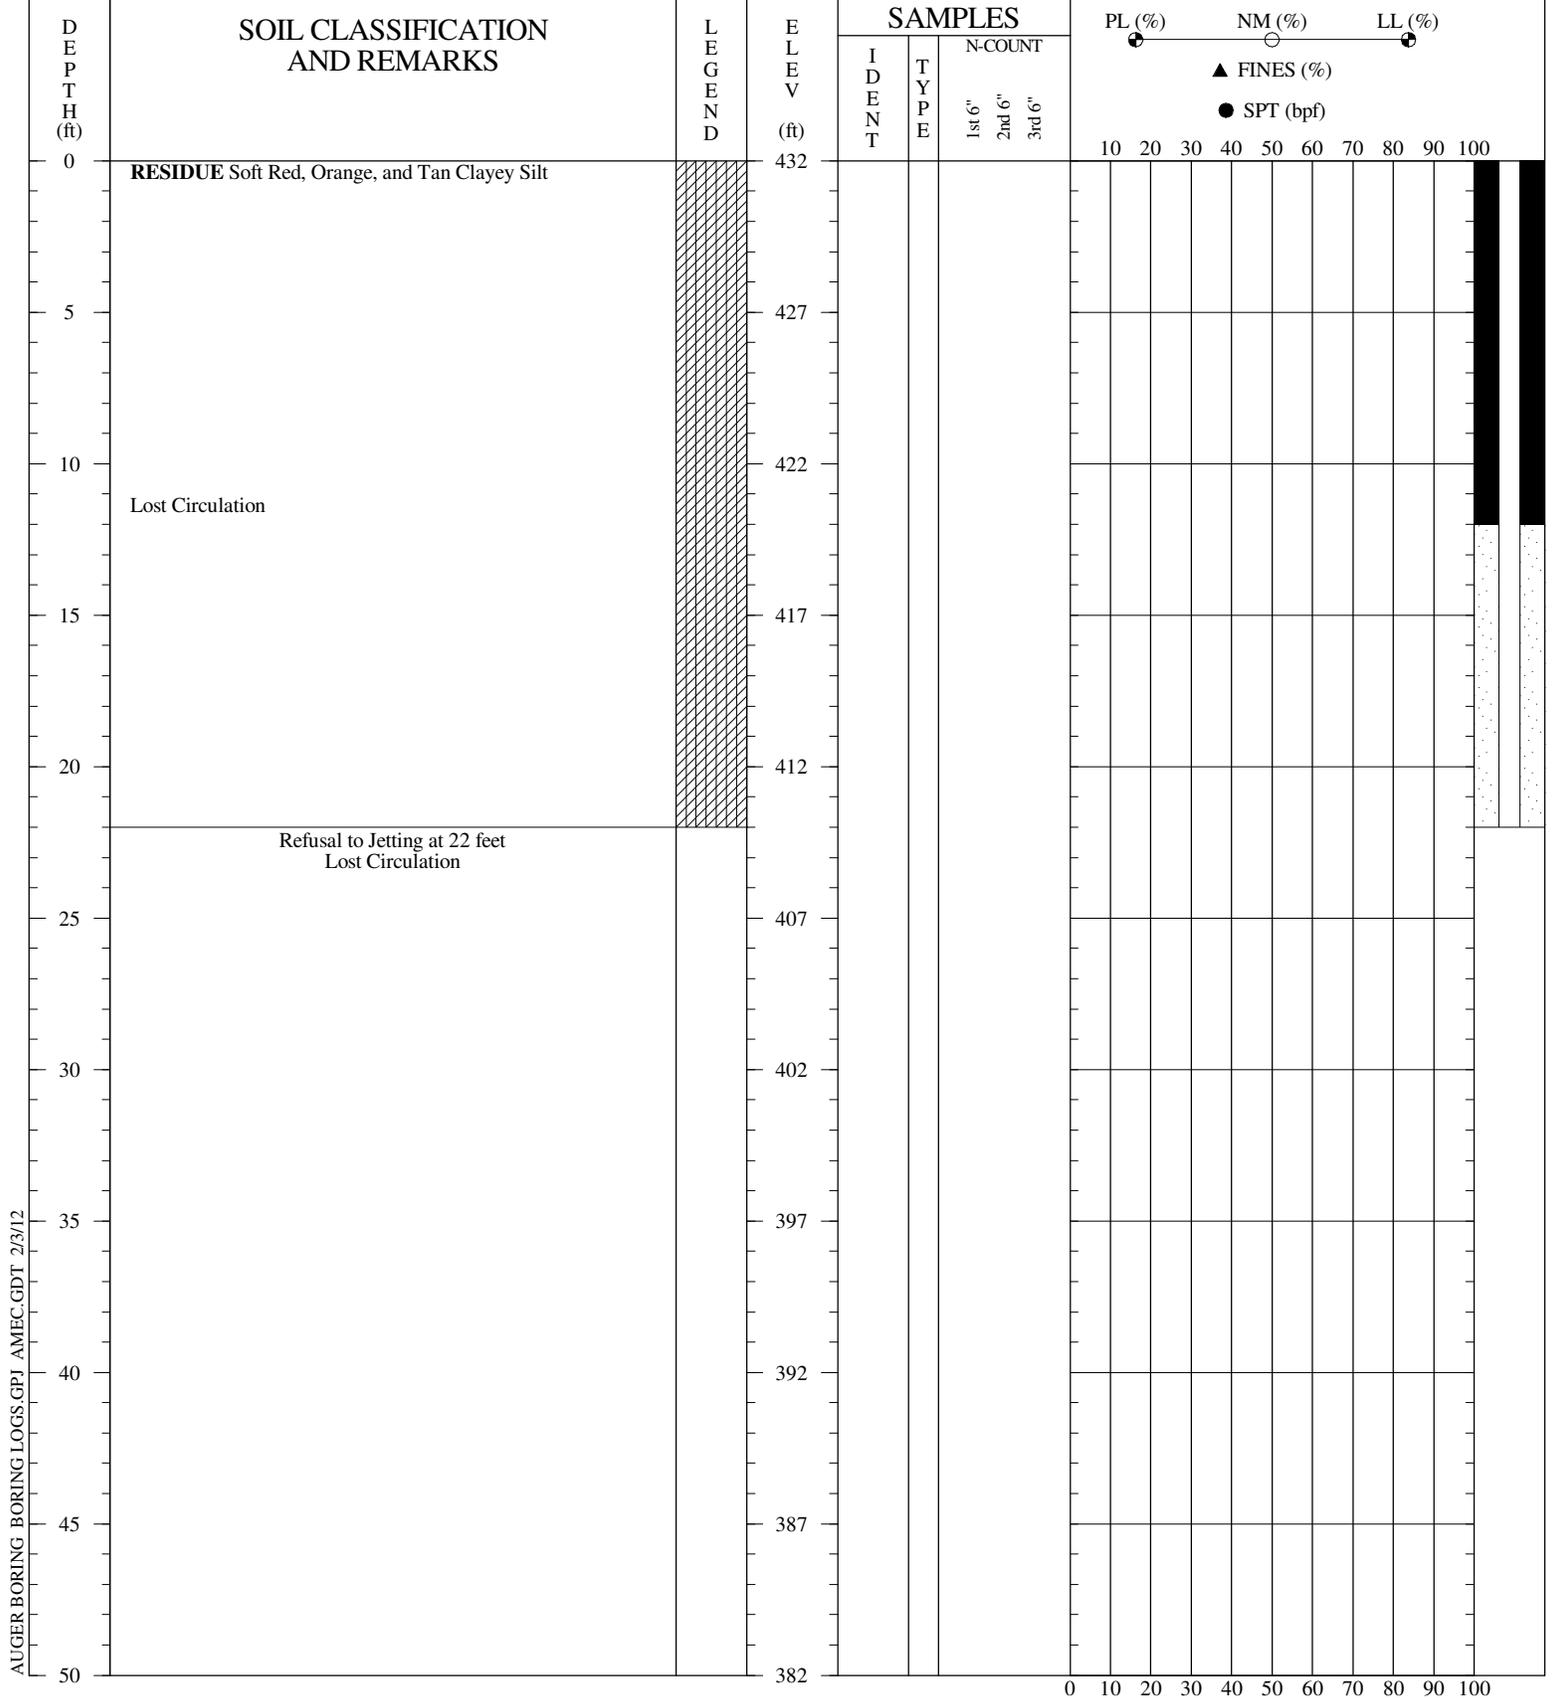
**DRILLER:** Piet DePree (AMEC)  
**EQUIPMENT:** Pump  
**METHOD:** Advanced by Hand with Jetting Water with 1 inch PVC  
**HOLE DIA.:** pipe  
**REMARKS:** 1.5 inches  
 No Sampling.
