**PRE-DESIGN INVESTIGATION REPORT  
PROPOSED SOLAR REDEVELOPMENT PROJECT  
FORMER BAUXITE RESIDUE DISPOSAL AREAS  
Operable Unit 1, North Alcoa Site**

East St. Louis, Illinois

**Restoration Land Development Company, LLC**  
Wellesley, MA

**AMEC Environment & Infrastructure, Inc.**  
800 N. Bell Avenue, Suite 200  
Pittsburgh, Pennsylvania 15106  
(412) 279-6661

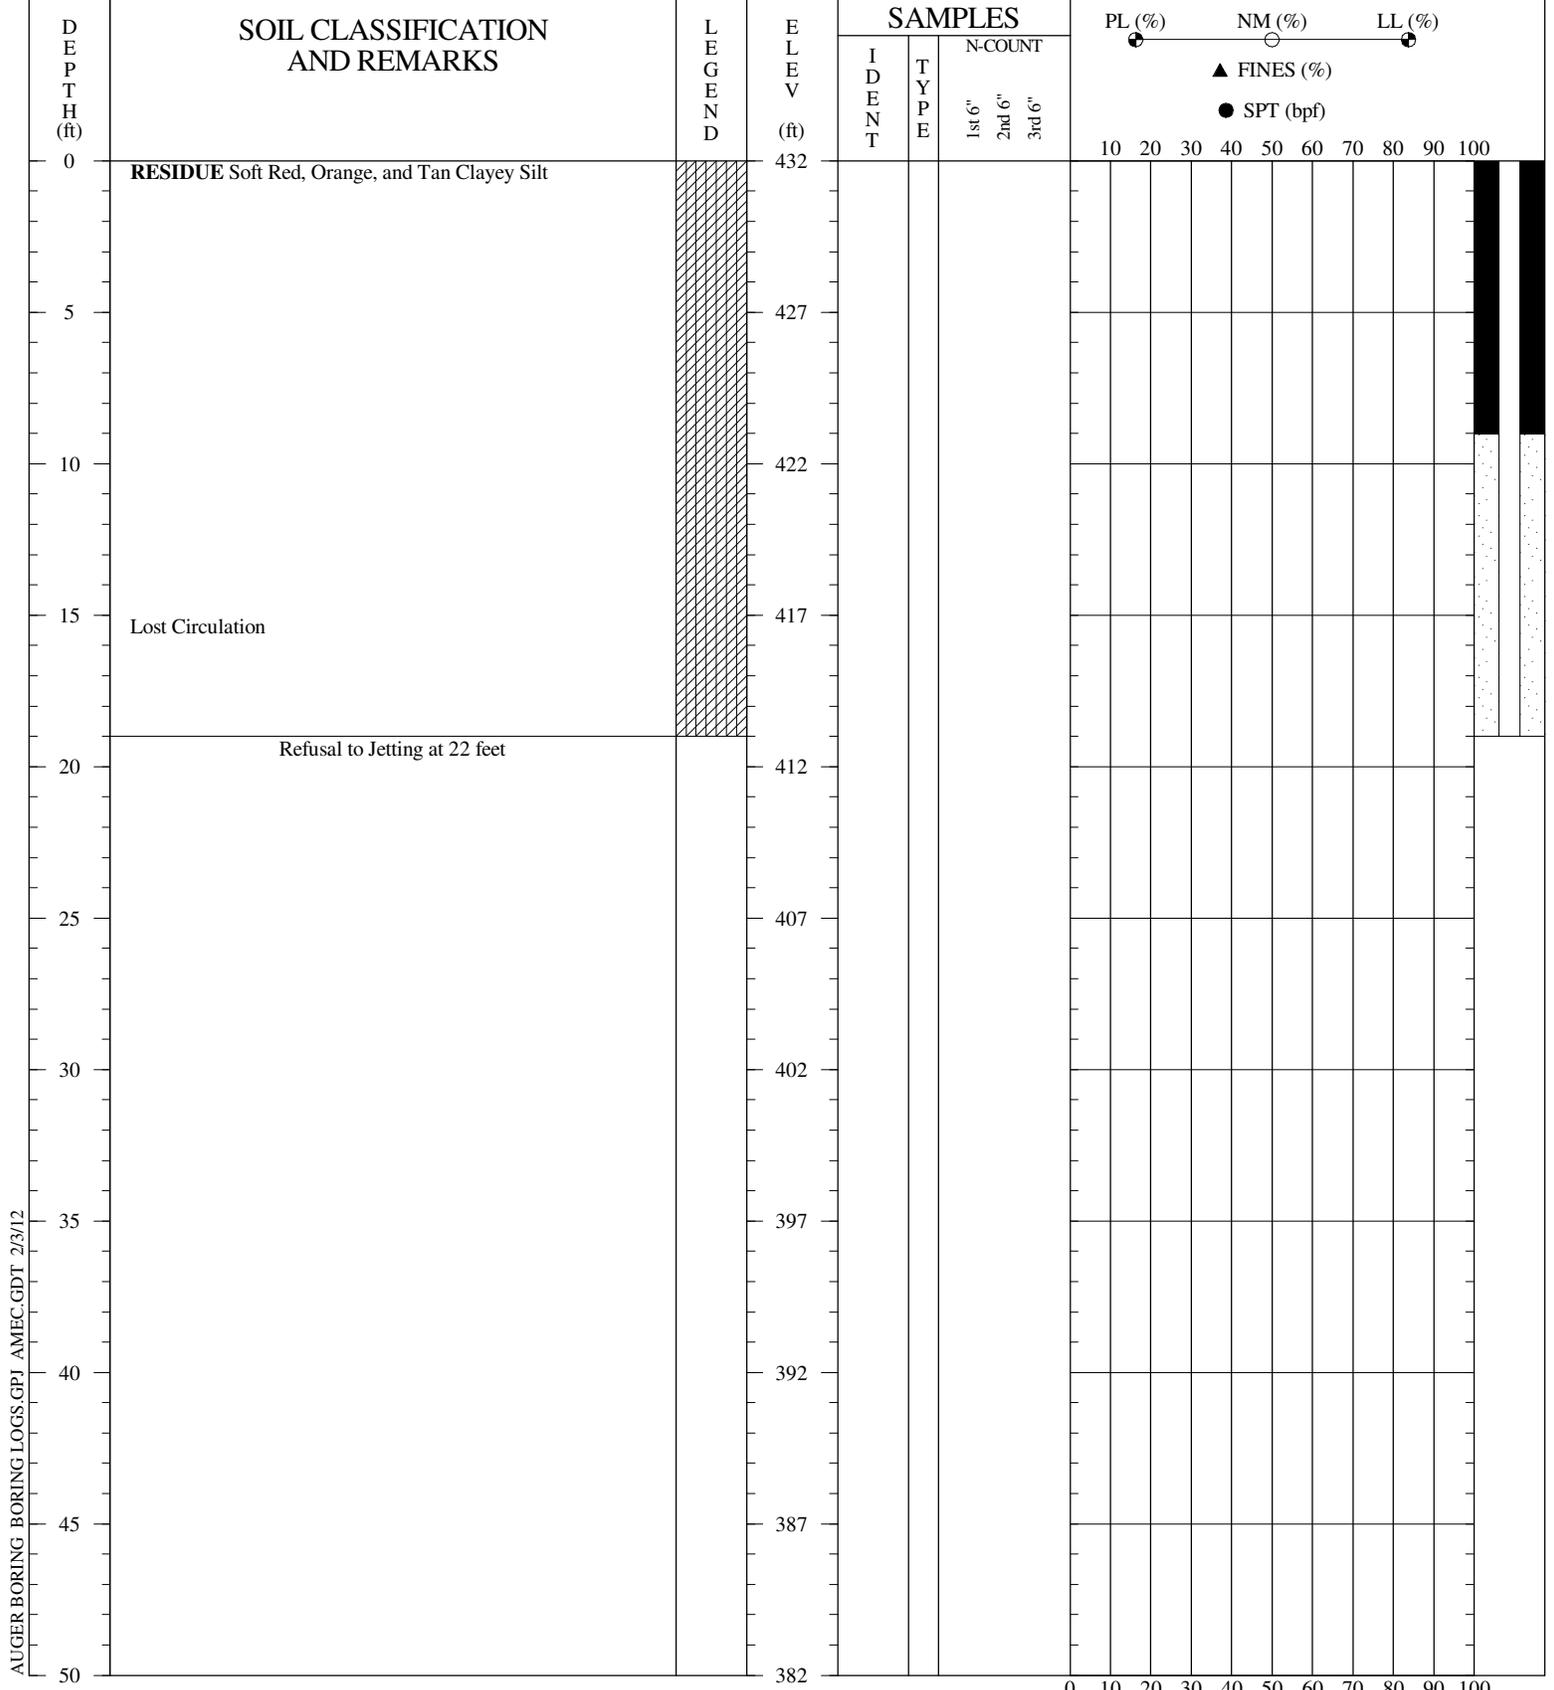
**DRILLER:** Piet DePree (AMEC)  
**EQUIPMENT:** Pump  
**METHOD:** Advanced by Hand with Jetting Water with 1 inch PVC  
**HOLE DIA.:** pipe  
**REMARKS:** 1.5 inches  
 No Sampling.

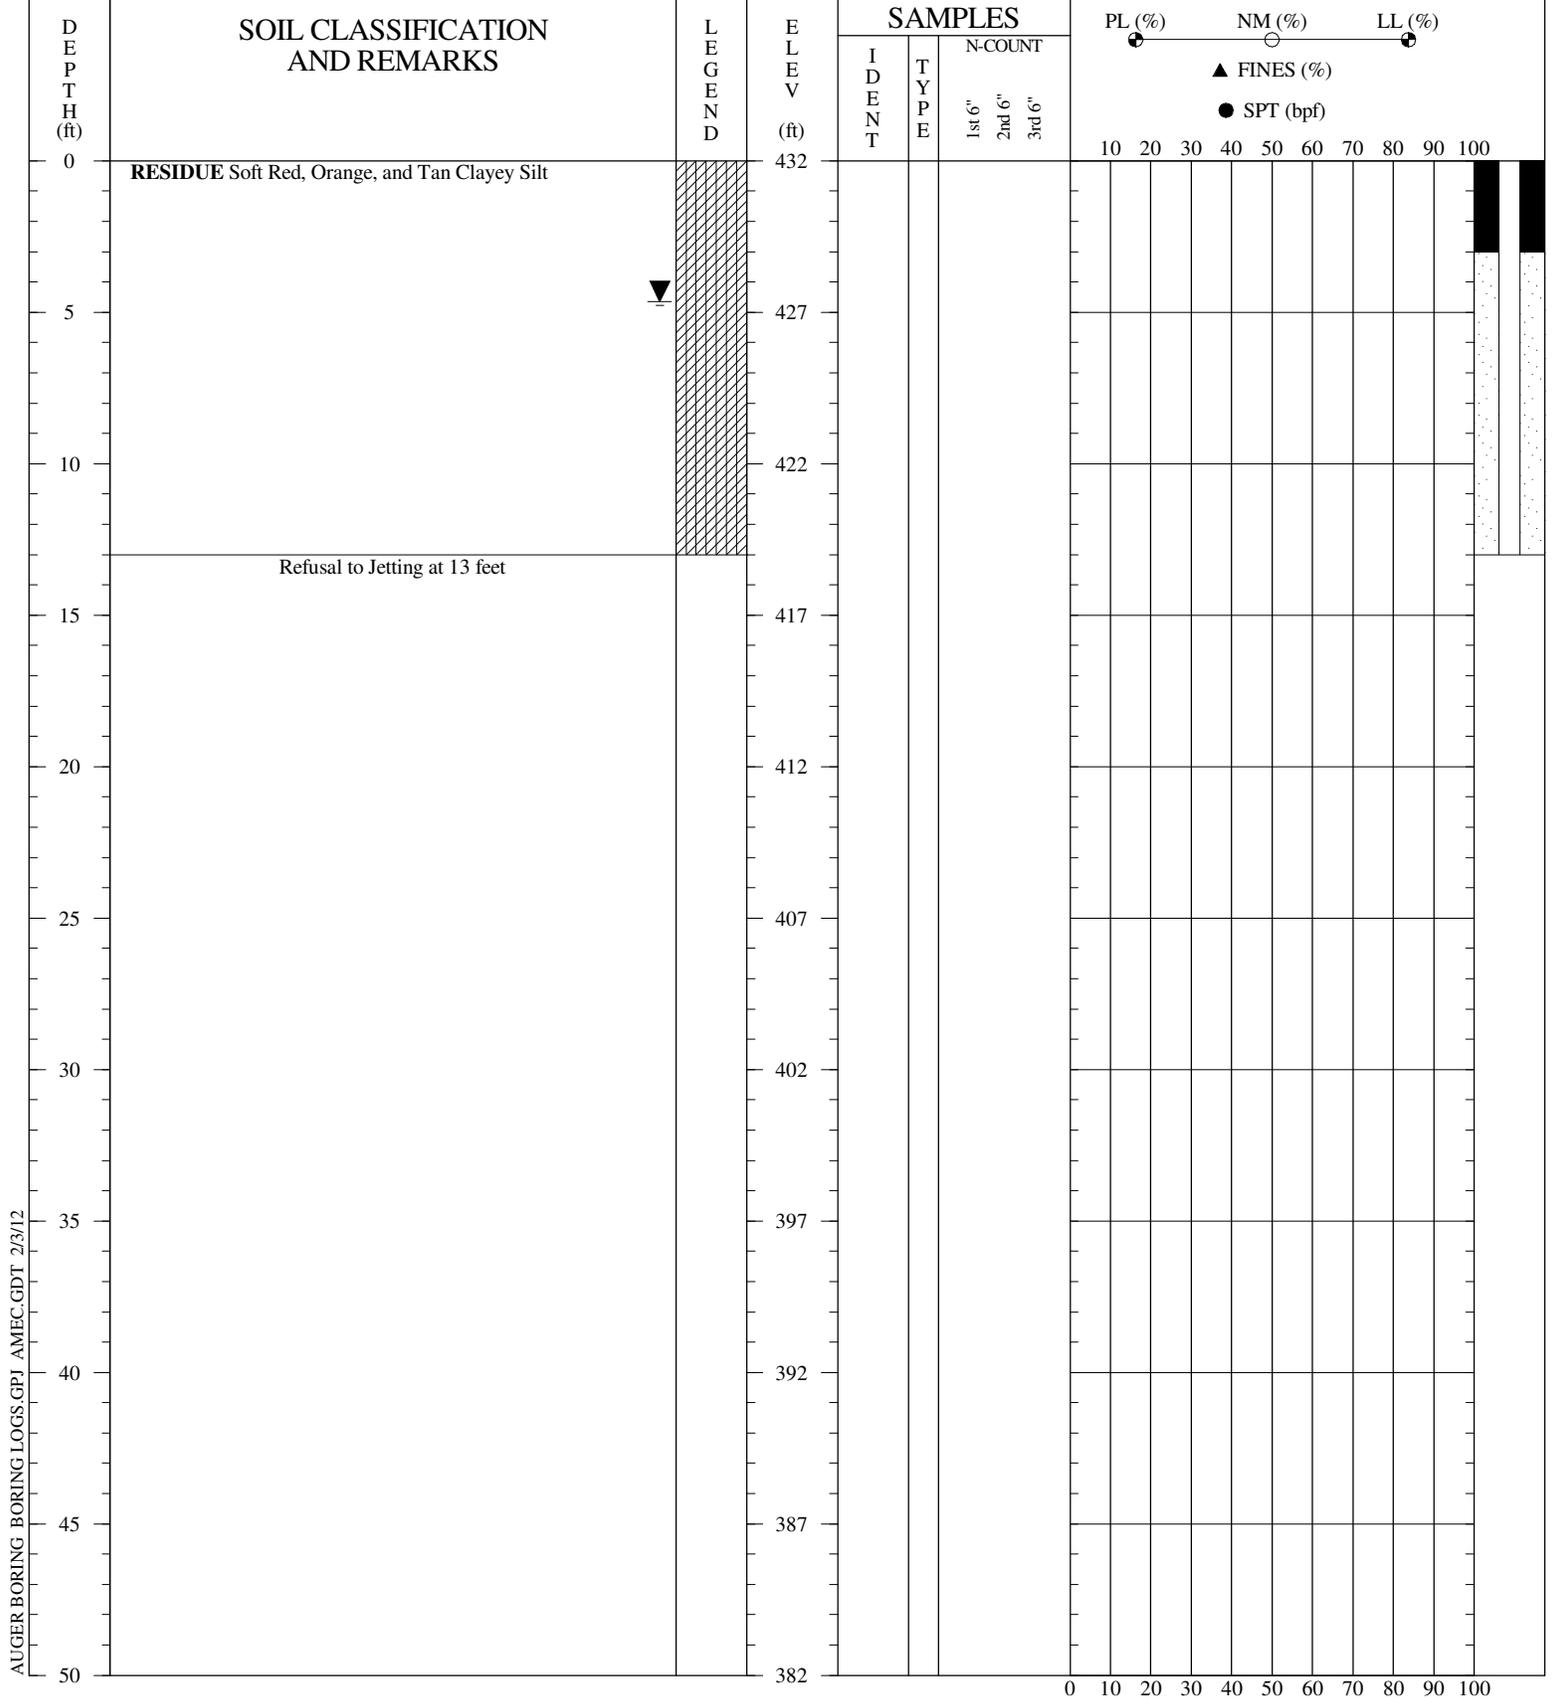
**DRILLER:** Piet DePree (AMEC)  
**EQUIPMENT:** Pump  
**METHOD:** Advanced by Hand with Jetting Water with 1 inch PVC  
**HOLE DIA.:** pipe  
**REMARKS:** 1.5 inches  
 No Sampling.

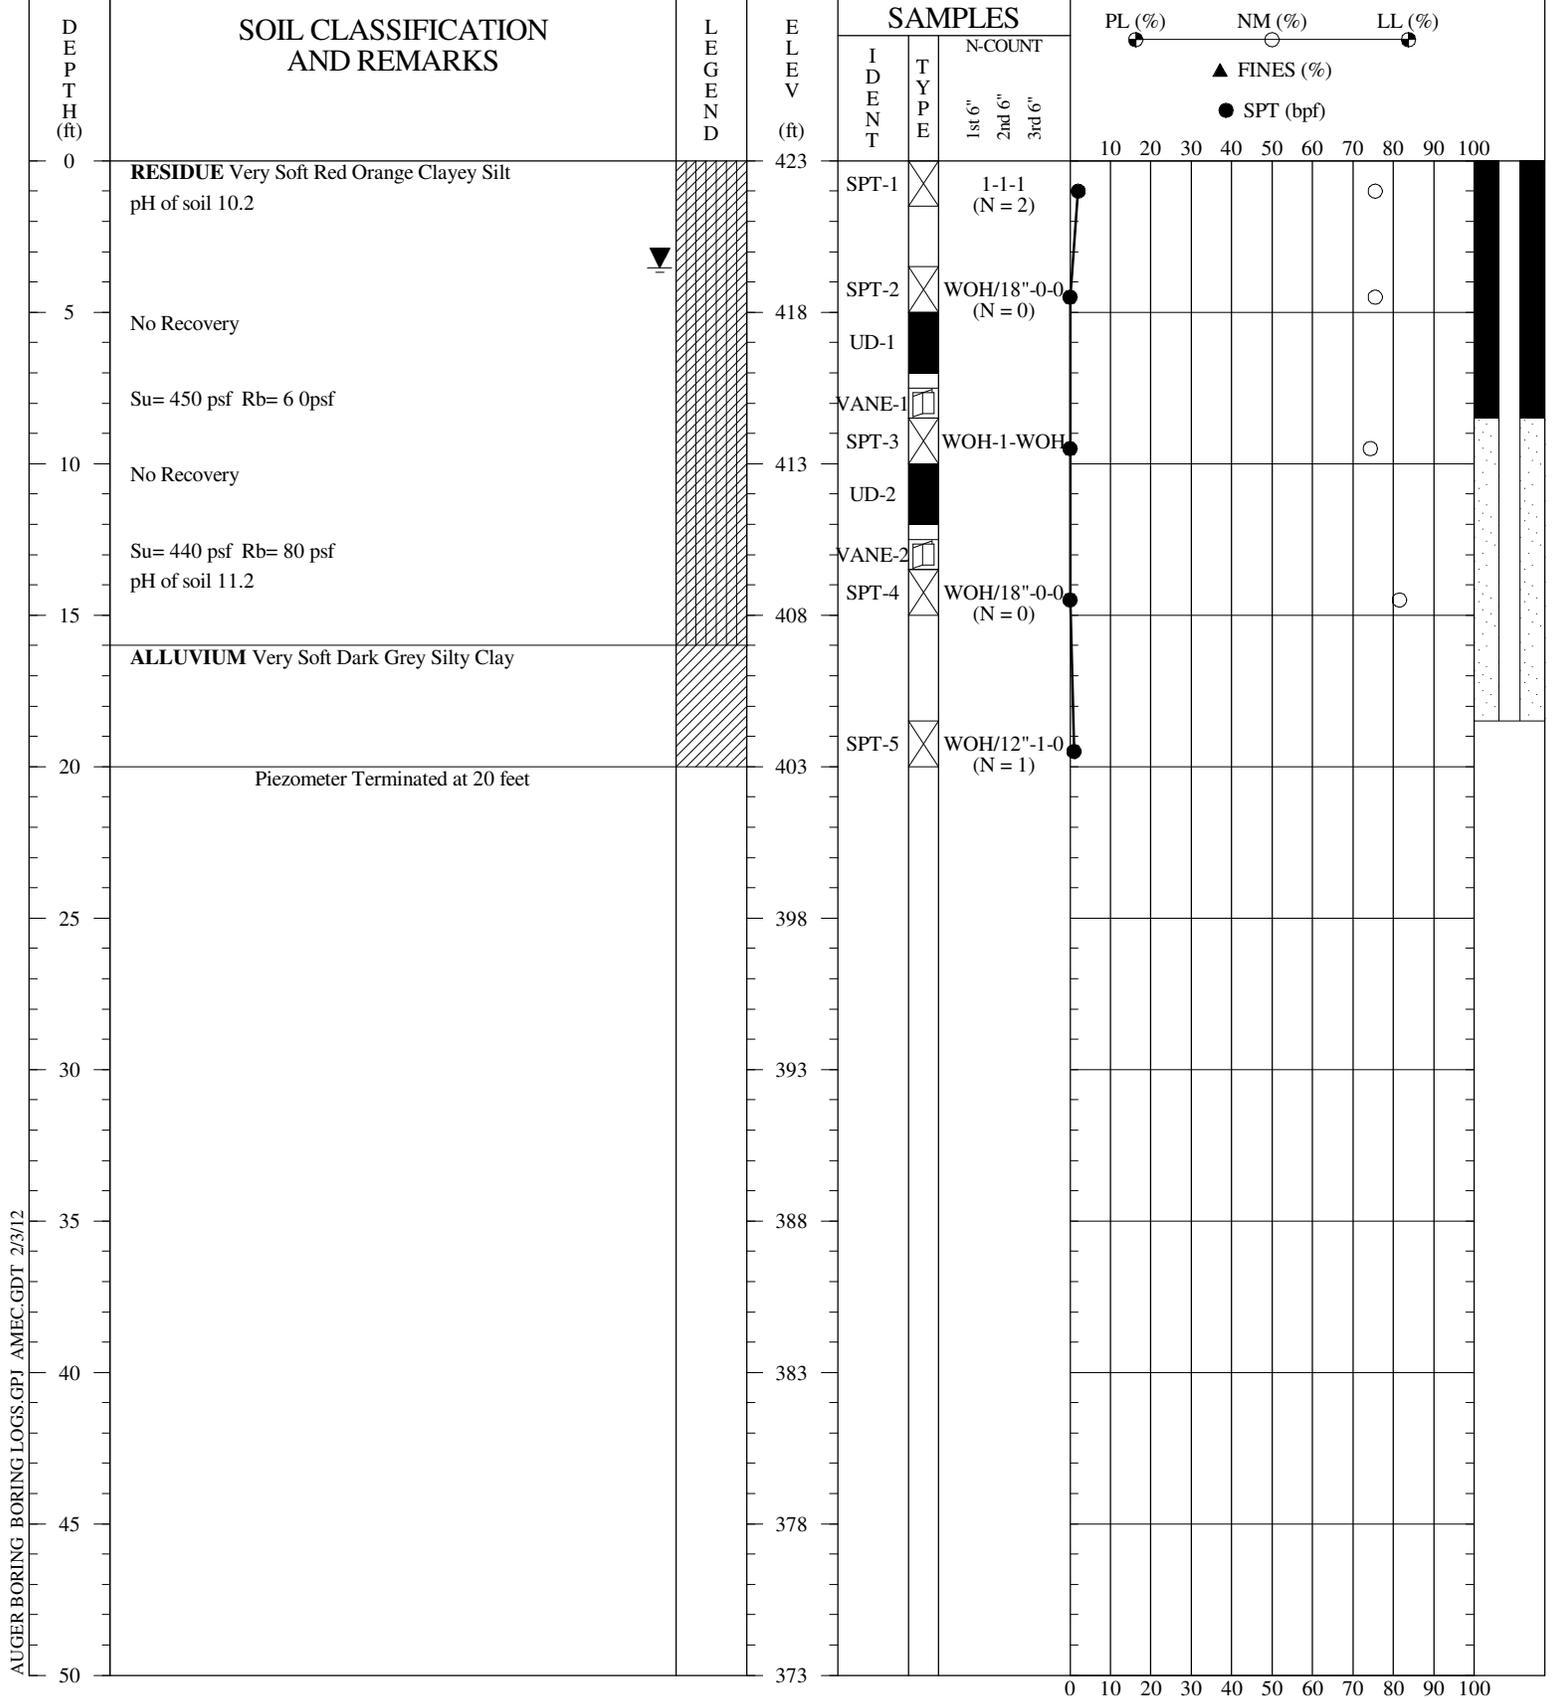
**DRILLER:** Ruben Landeros (AMEC)  
**EQUIPMENT:** CME-55 (Auto-Hammer)  
**METHOD:** Rotary Wash with Mud  
**HOLE DIA.:** 6 inches  
**REMARKS:** Piezometer backfilled to 8.5 feet using sand. Backfilled to surface using residue and bentonite.

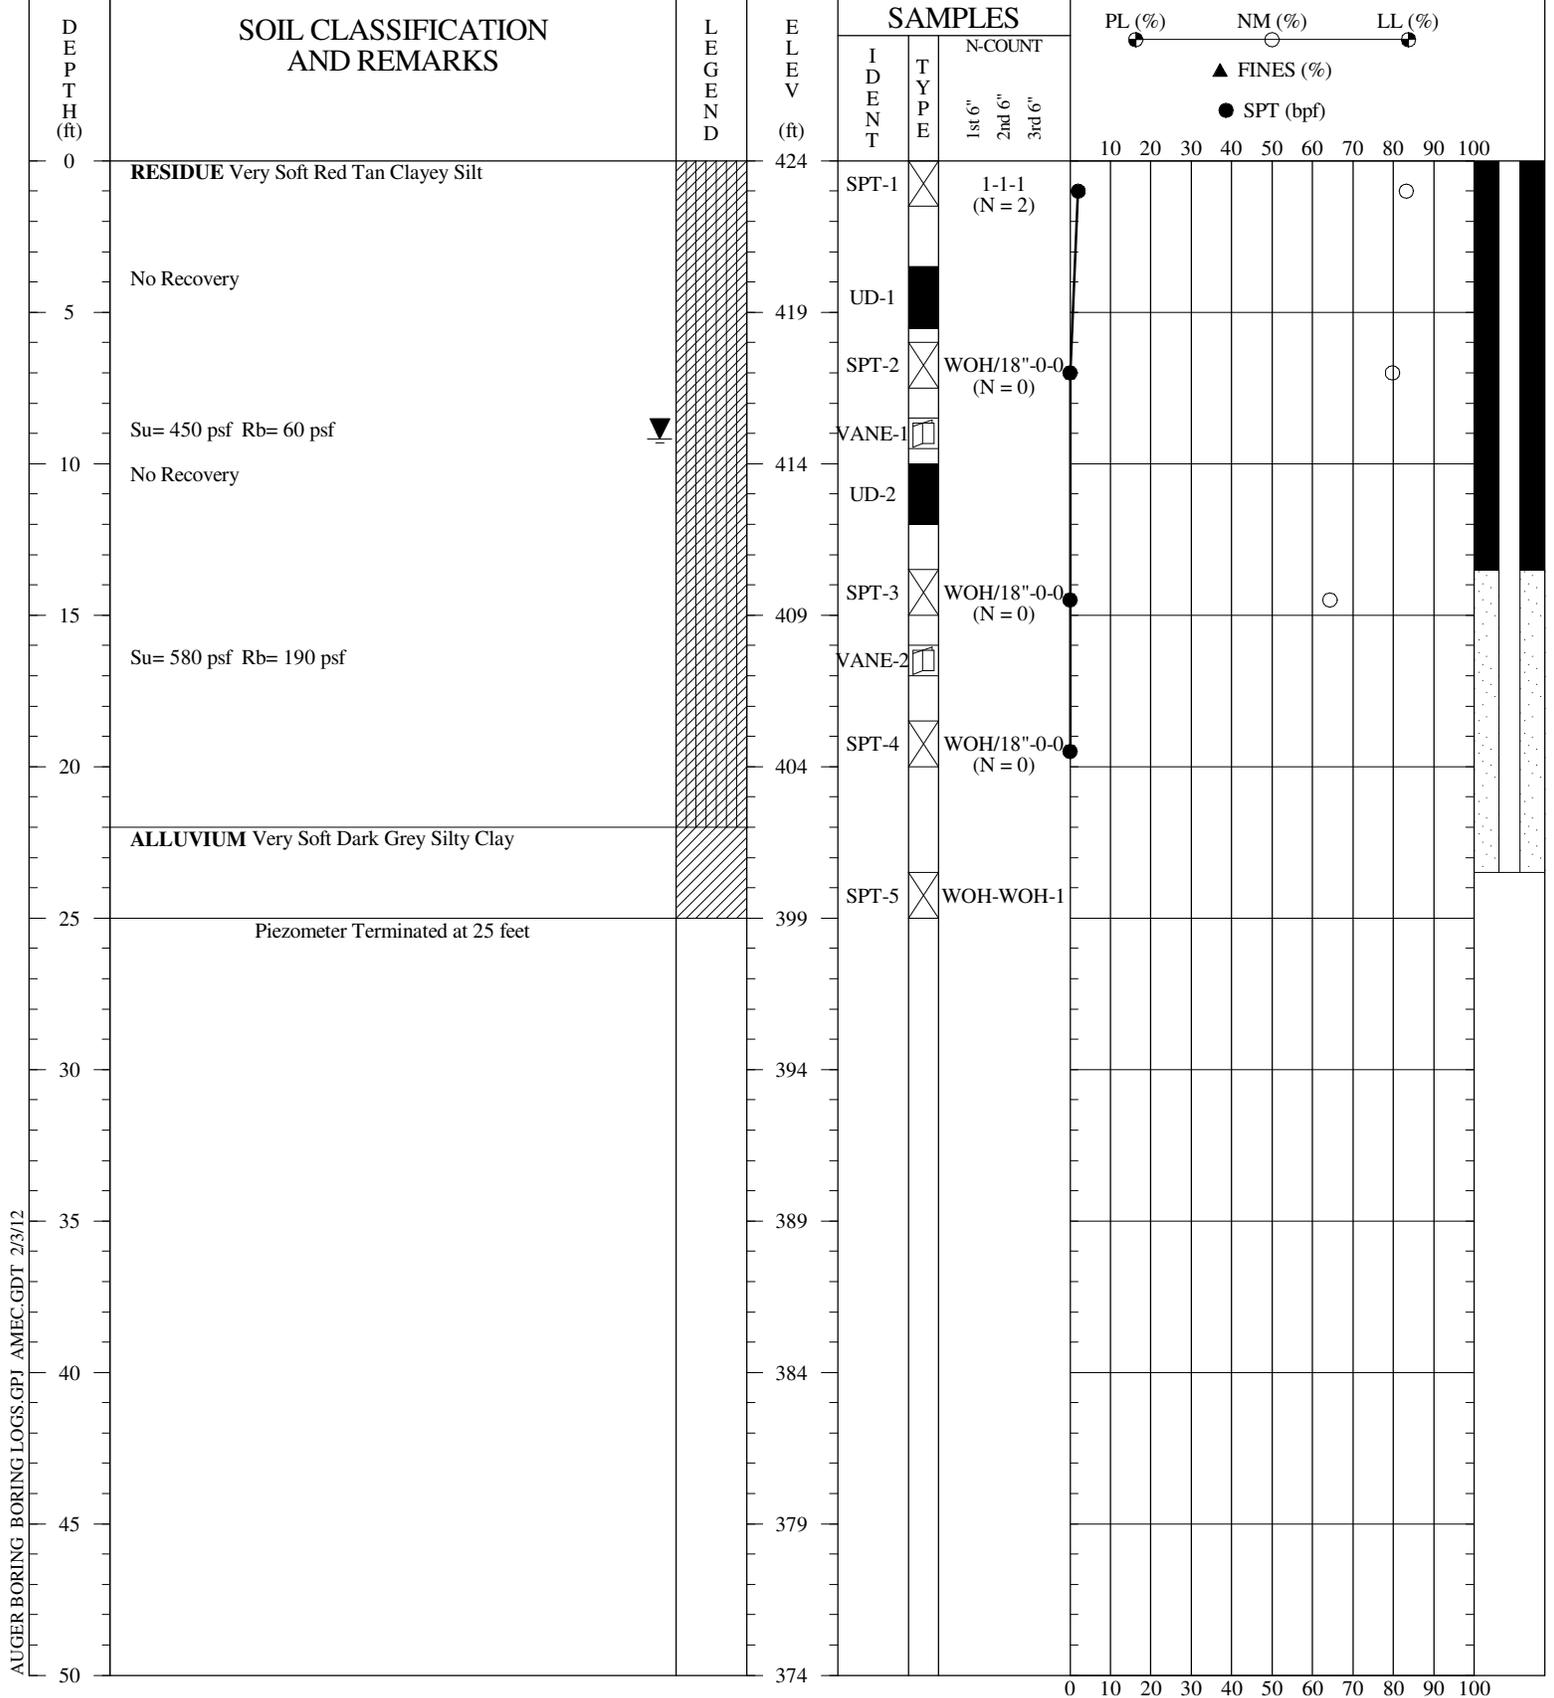
**DRILLER:** Ruben Landeros (AMEC)  
**EQUIPMENT:** CME-55 (Auto-Hammer)  
**METHOD:** Rotary Wash with Mud  
**HOLE DIA.:** 6 inches  
**REMARKS:** Piezometer backfilled to 13.5 feet using sand. Backfilled to surface using residue and bentonite.

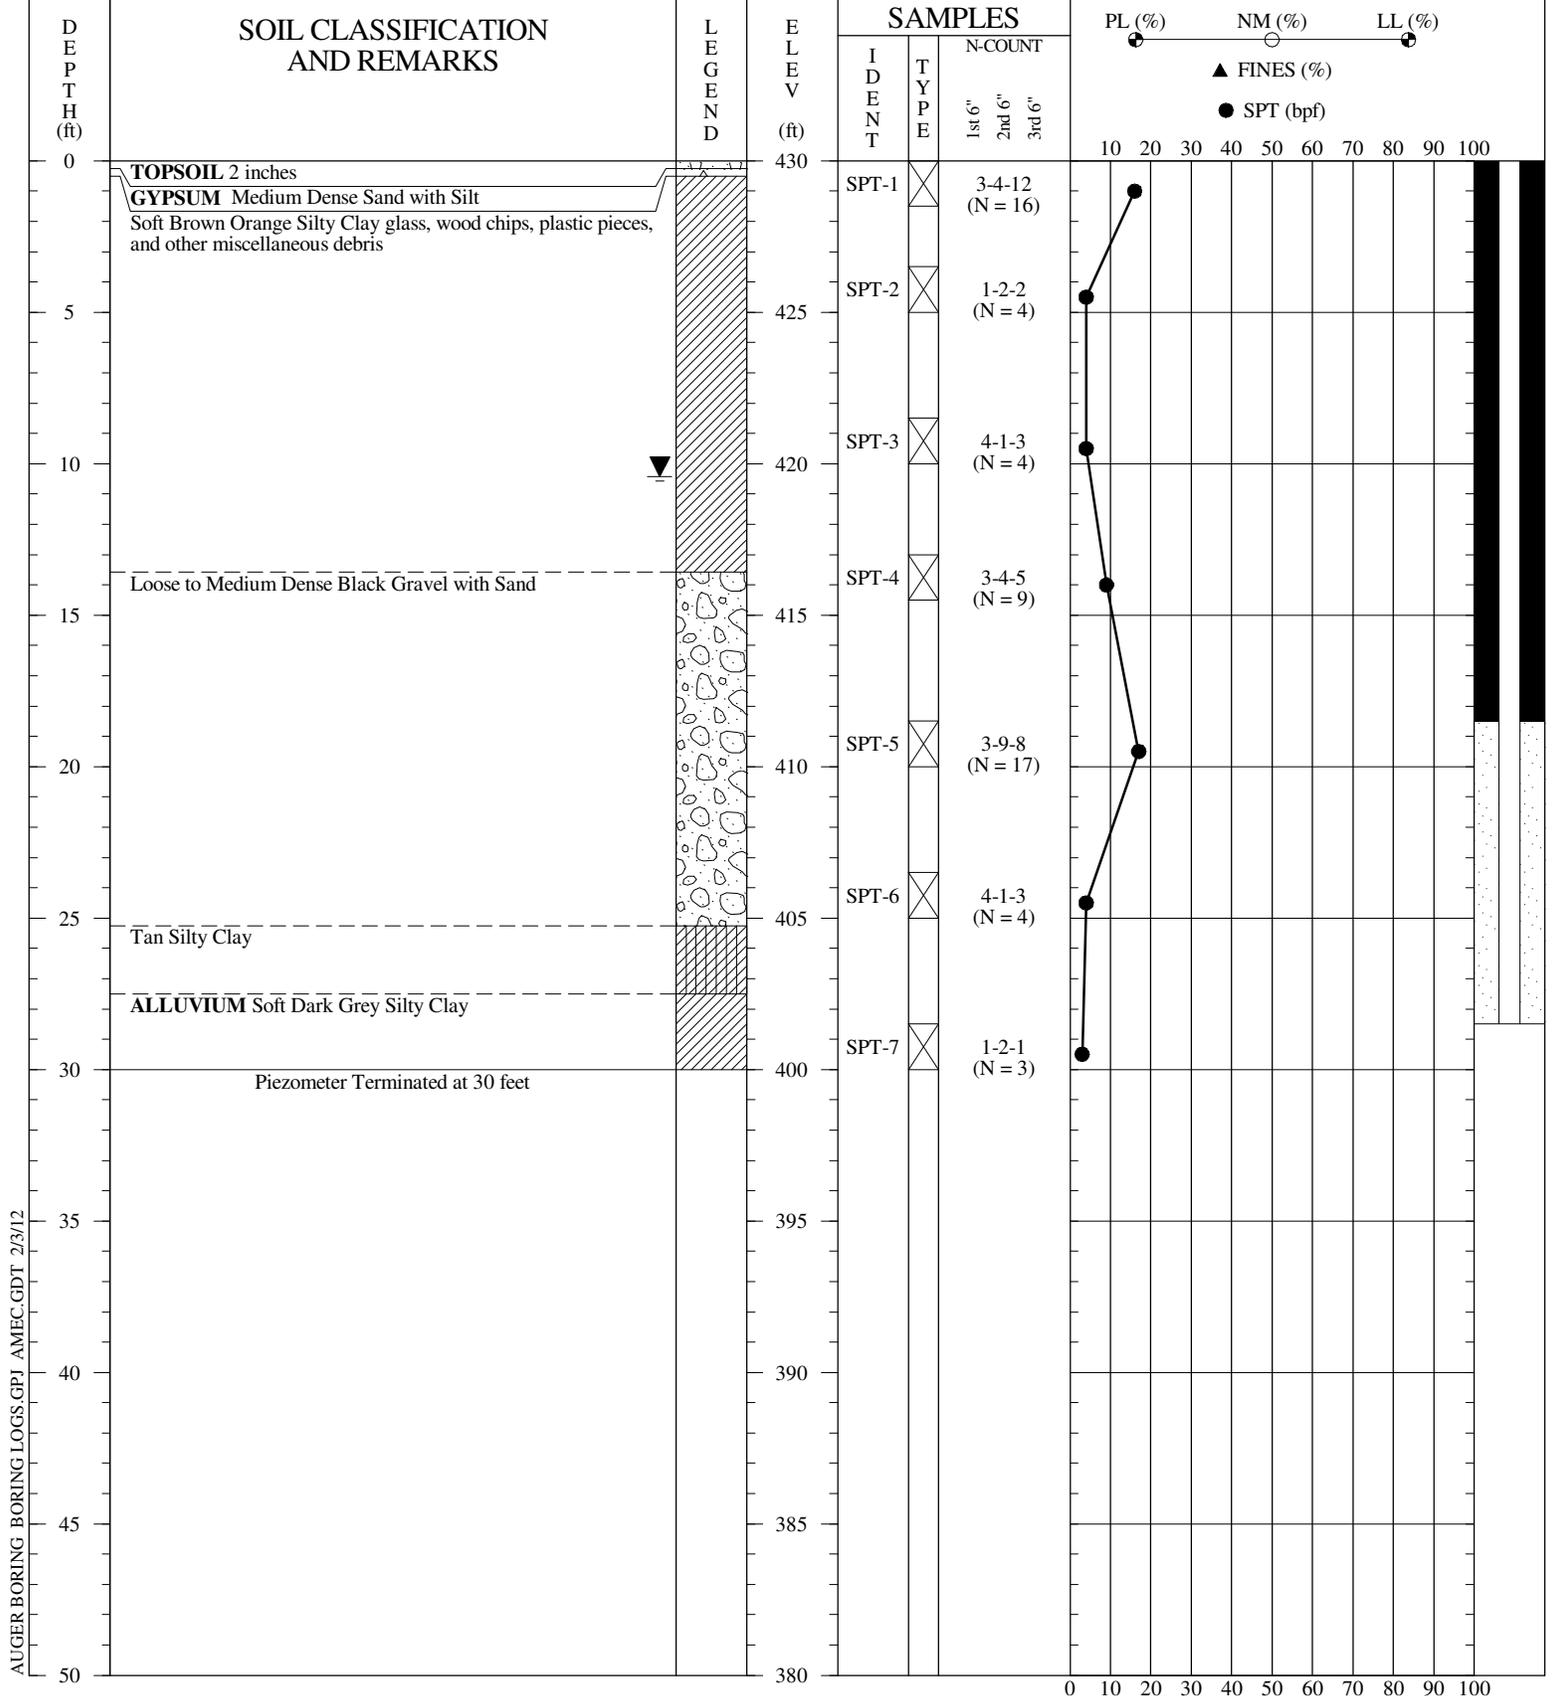
**DRILLER:** Ruben Landeros (AMEC)  
**EQUIPMENT:** CME-55 (Auto-Hammer)  
**METHOD:** Rotary Wash with Mud  
**HOLE DIA.:** 6 inches  
**REMARKS:** Piezometer backfilled to 18.5 feet using sand. Backfilled to surface using residue and bentonite.

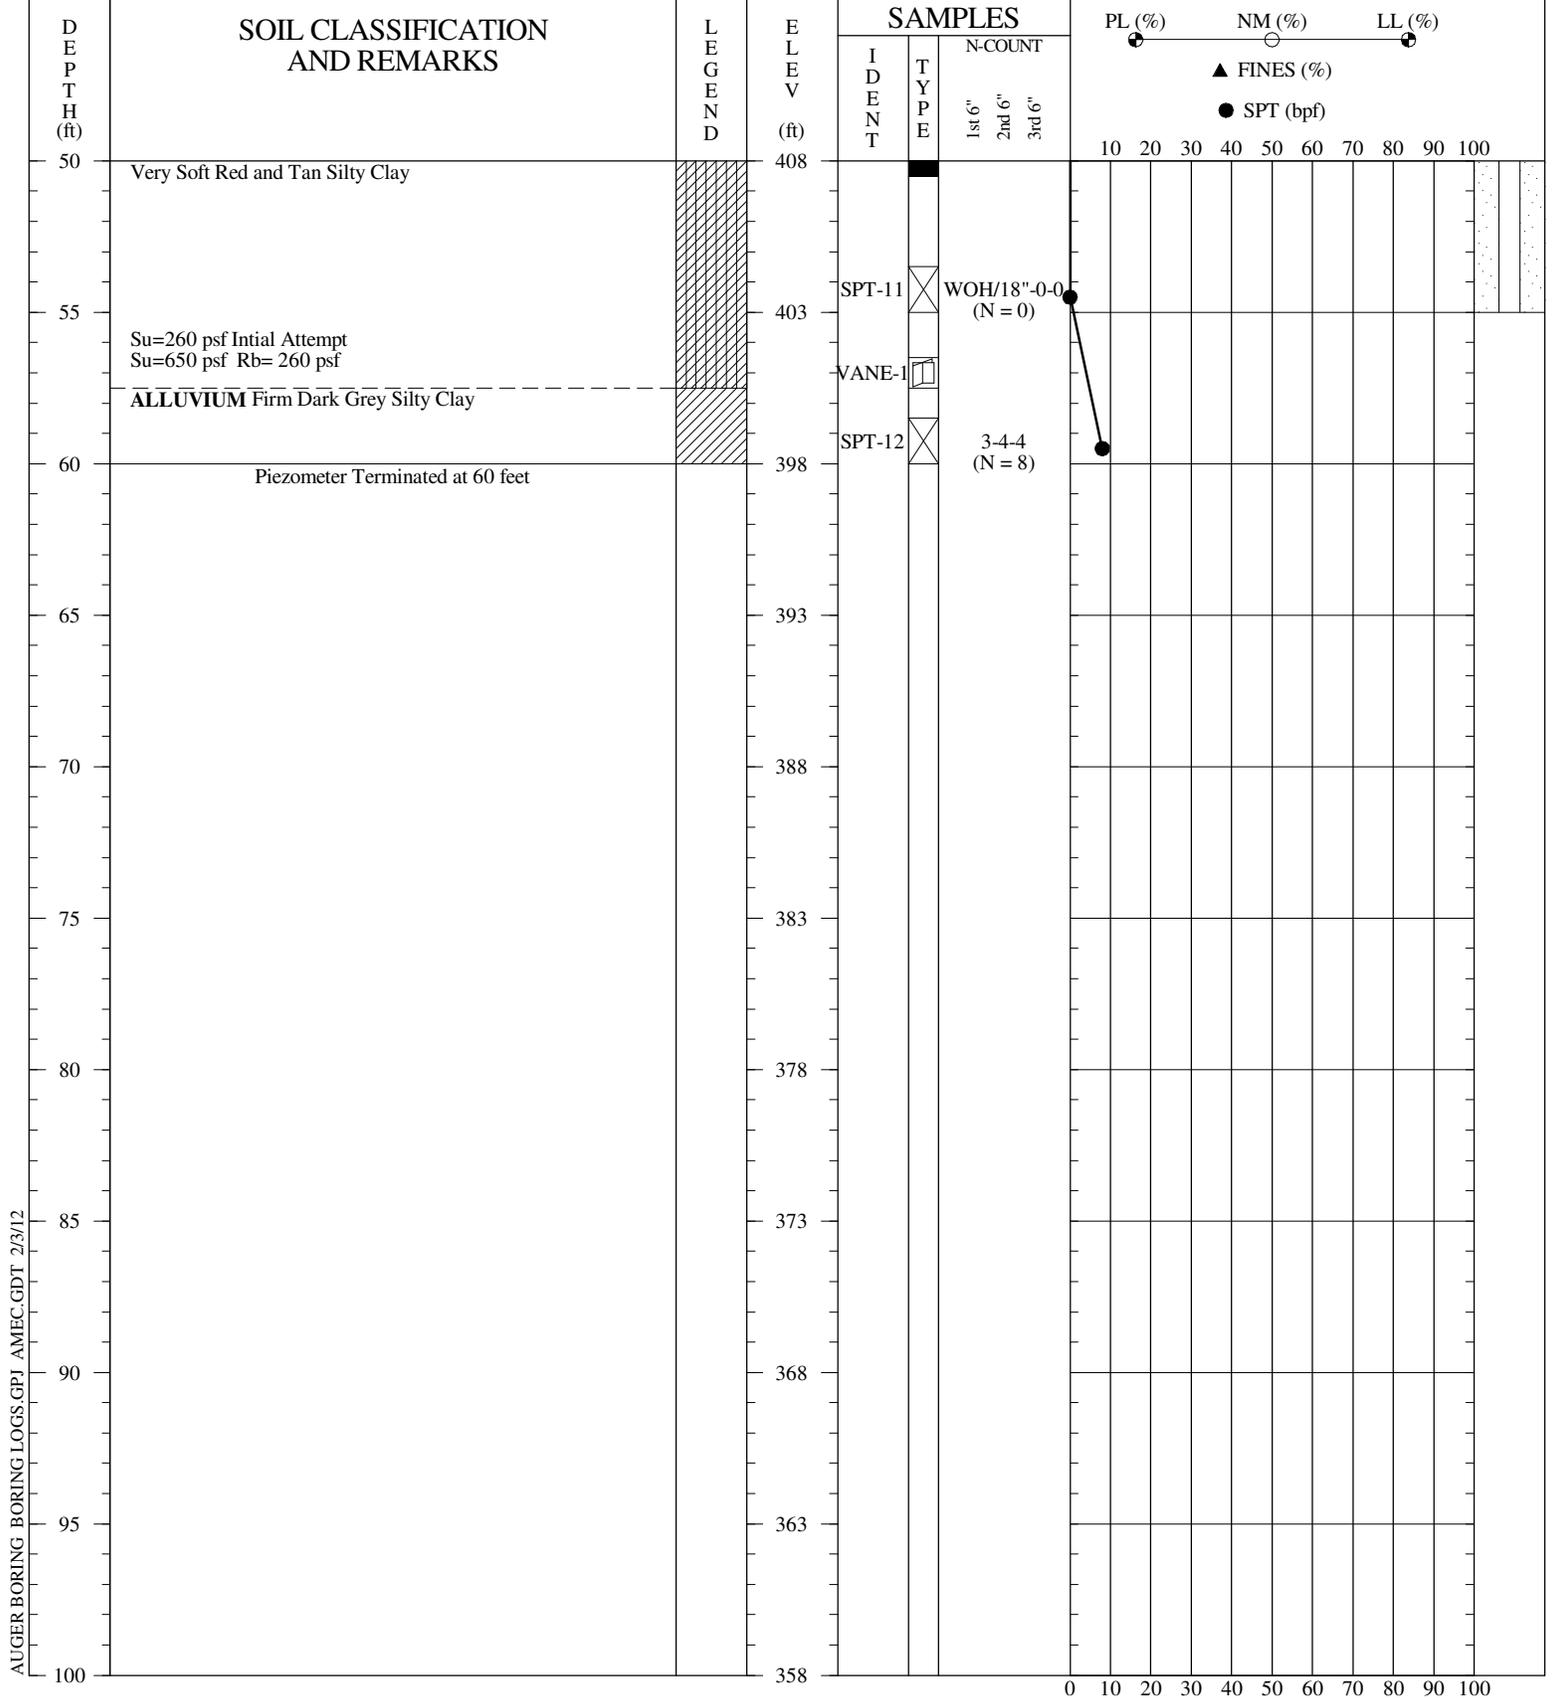
**DRILLER:** Ruben Landeros (AMEC)  
**EQUIPMENT:** CME-55 (Auto-Hammer)  
**METHOD:** Rotary Wash with Mud  
**HOLE DIA.:** 6 inches  
**REMARKS:** Piezometer backfilled to 42 feet using sand. Backfilled to surface using residue and bentonite.

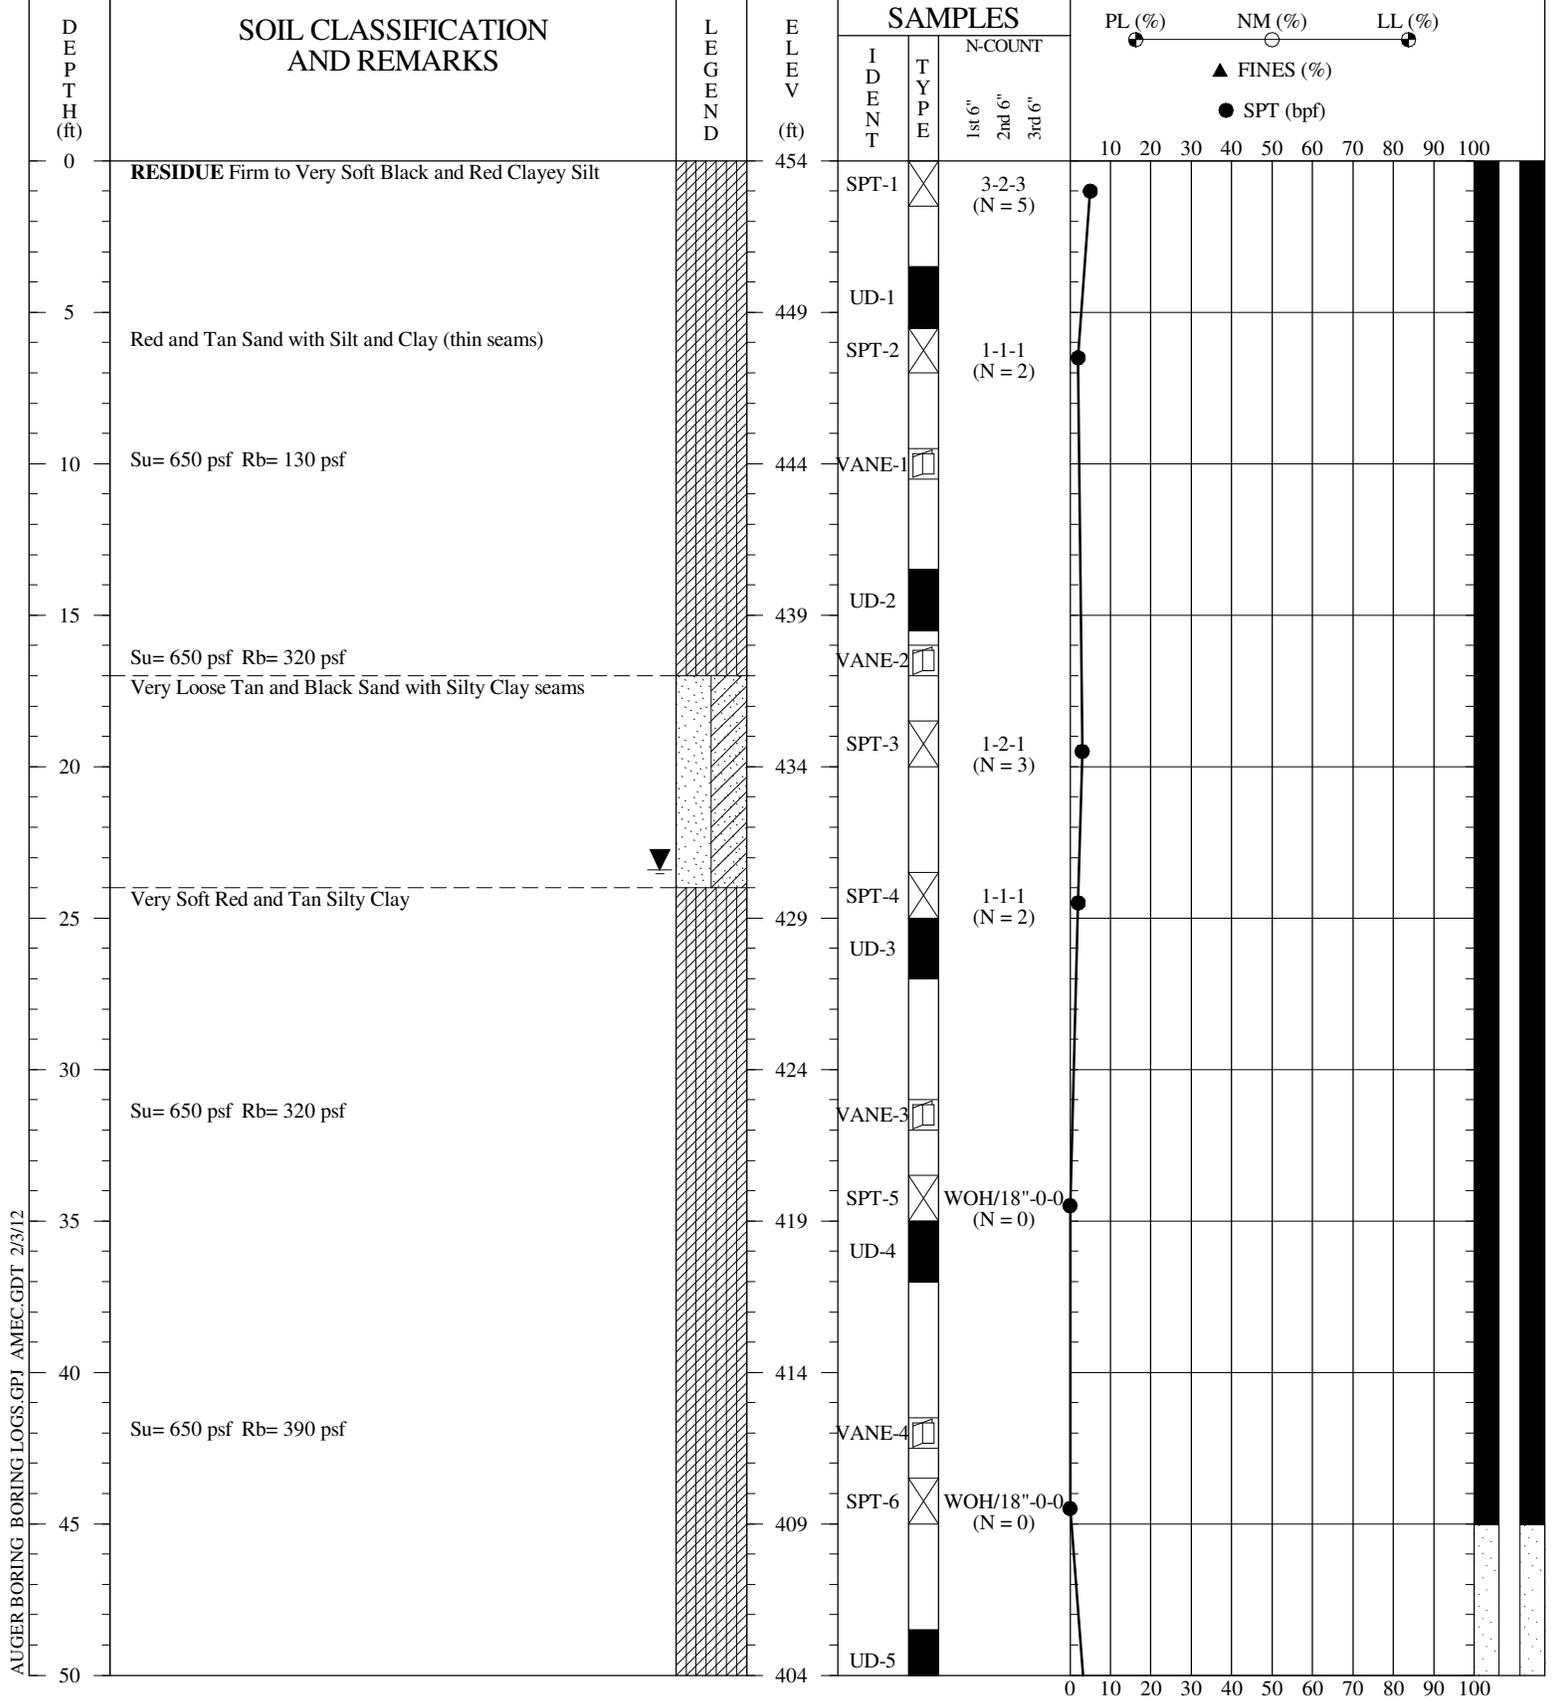
**DRILLER:** Ruben Landeros (AMEC)  
**EQUIPMENT:** CME-55 (Auto-Hammer)  
**METHOD:** Rotary Wash with Mud  
**HOLE DIA.:** 6 inches  
**REMARKS:** Piezometer backfilled to 33 feet using sand. Backfilled to surface using residue and bentonite.

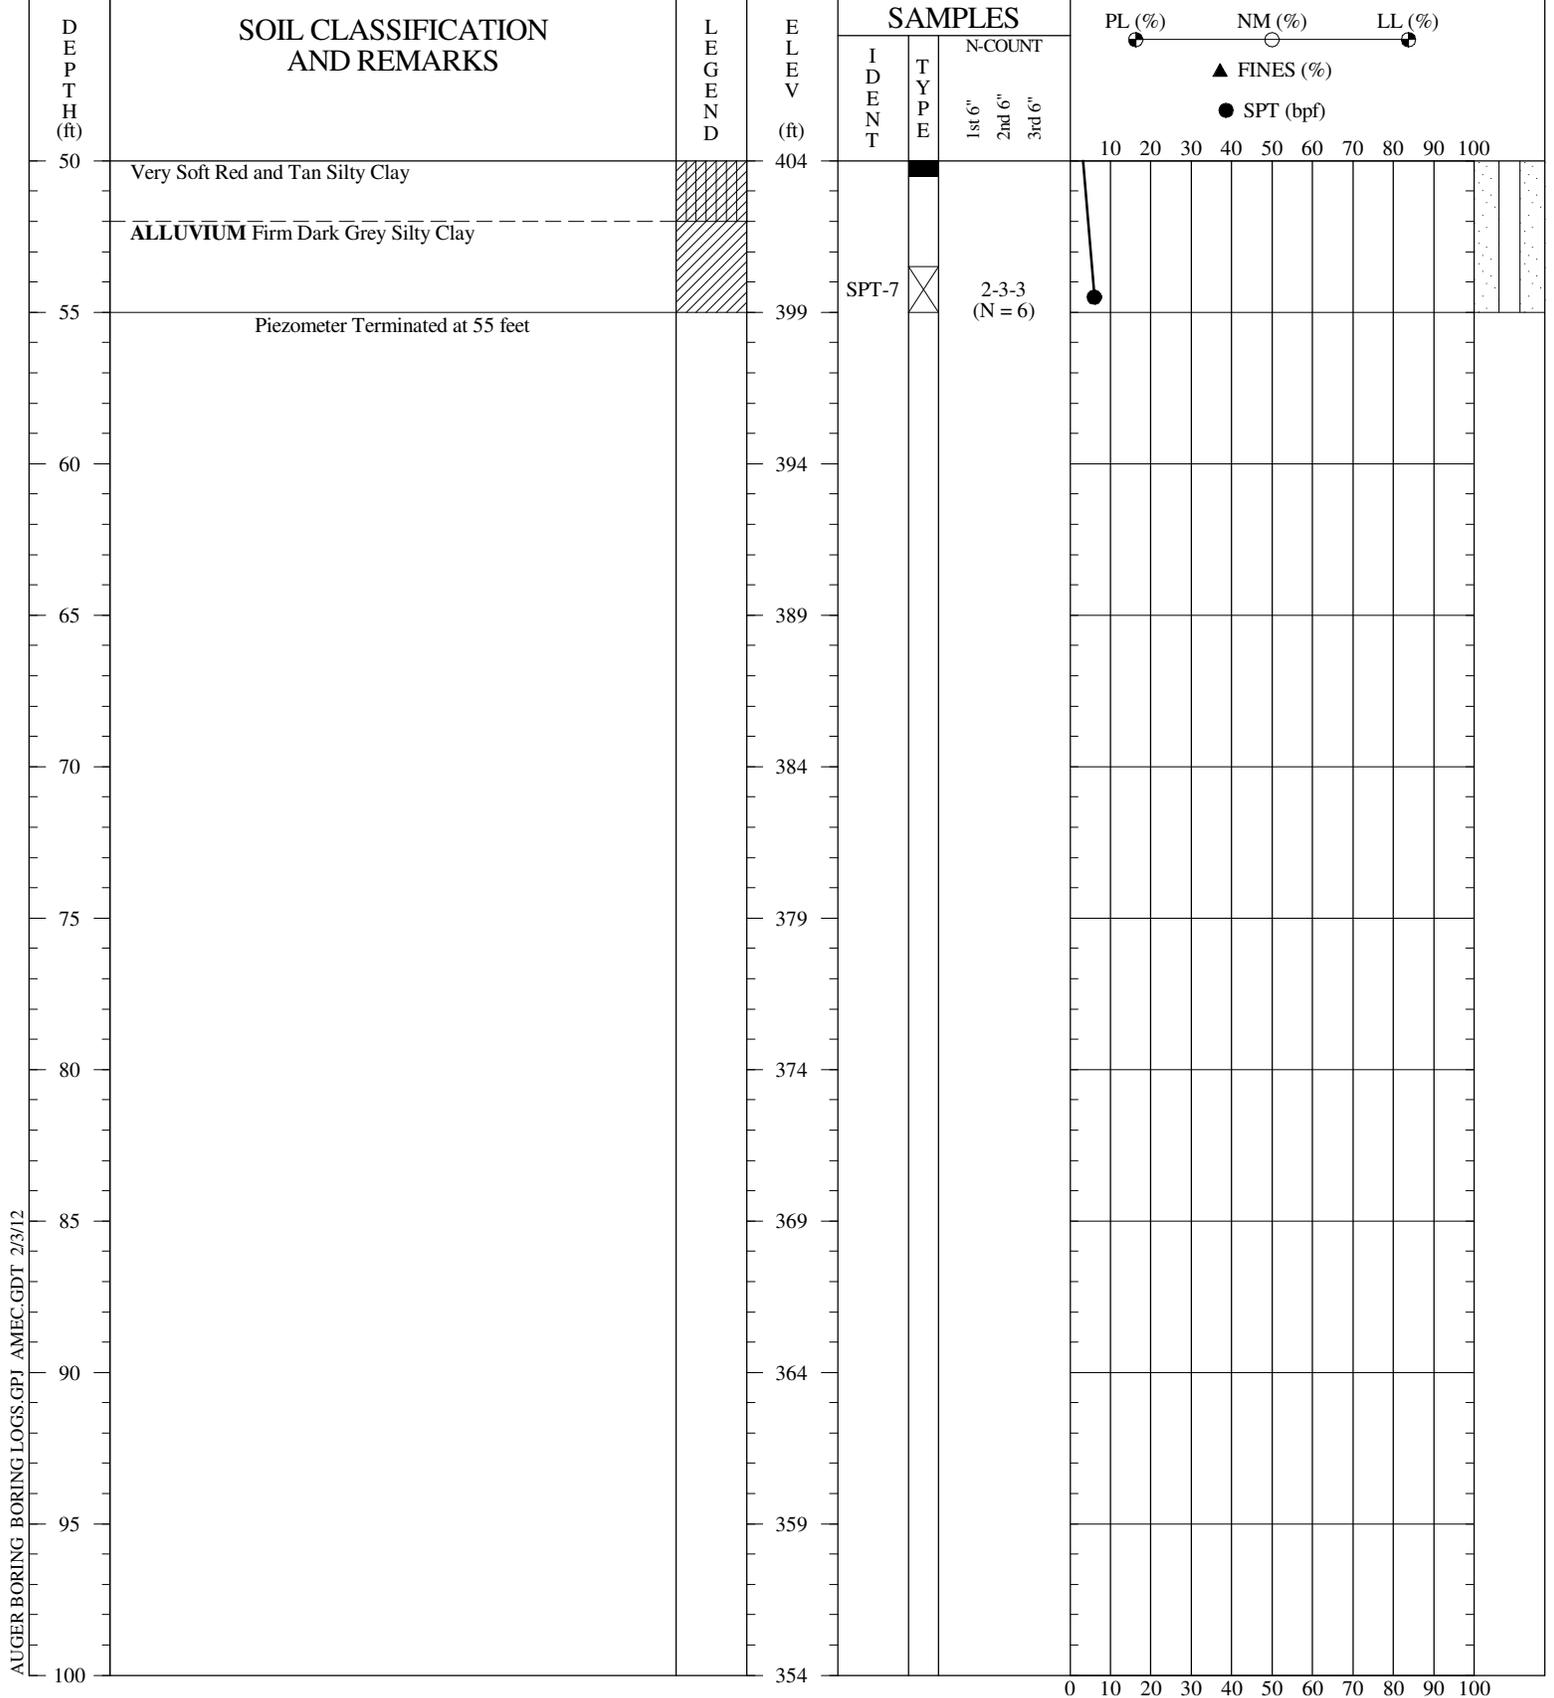
**DRILLER:** Ruben Landeros (AMEC)  
**EQUIPMENT:** CME-55 (Auto-Hammer)  
**METHOD:** Rotary Wash with Mud  
**HOLE DIA.:** 6 inches  
**REMARKS:** Piezometer backfilled to 33 feet using sand. Backfilled to surface using residue and bentonite.
