**PRE-DESIGN INVESTIGATION REPORT  
PROPOSED SOLAR REDEVELOPMENT PROJECT  
FORMER BAUXITE RESIDUE DISPOSAL AREAS  
Operable Unit 1, North Alcoa Site**

East St. Louis, Illinois

**Restoration Land Development Company, LLC**  
Wellesley, MA

**AMEC Environment & Infrastructure, Inc.**  
800 N. Bell Avenue, Suite 200  
Pittsburgh, Pennsylvania 15106  
(412) 279-6661

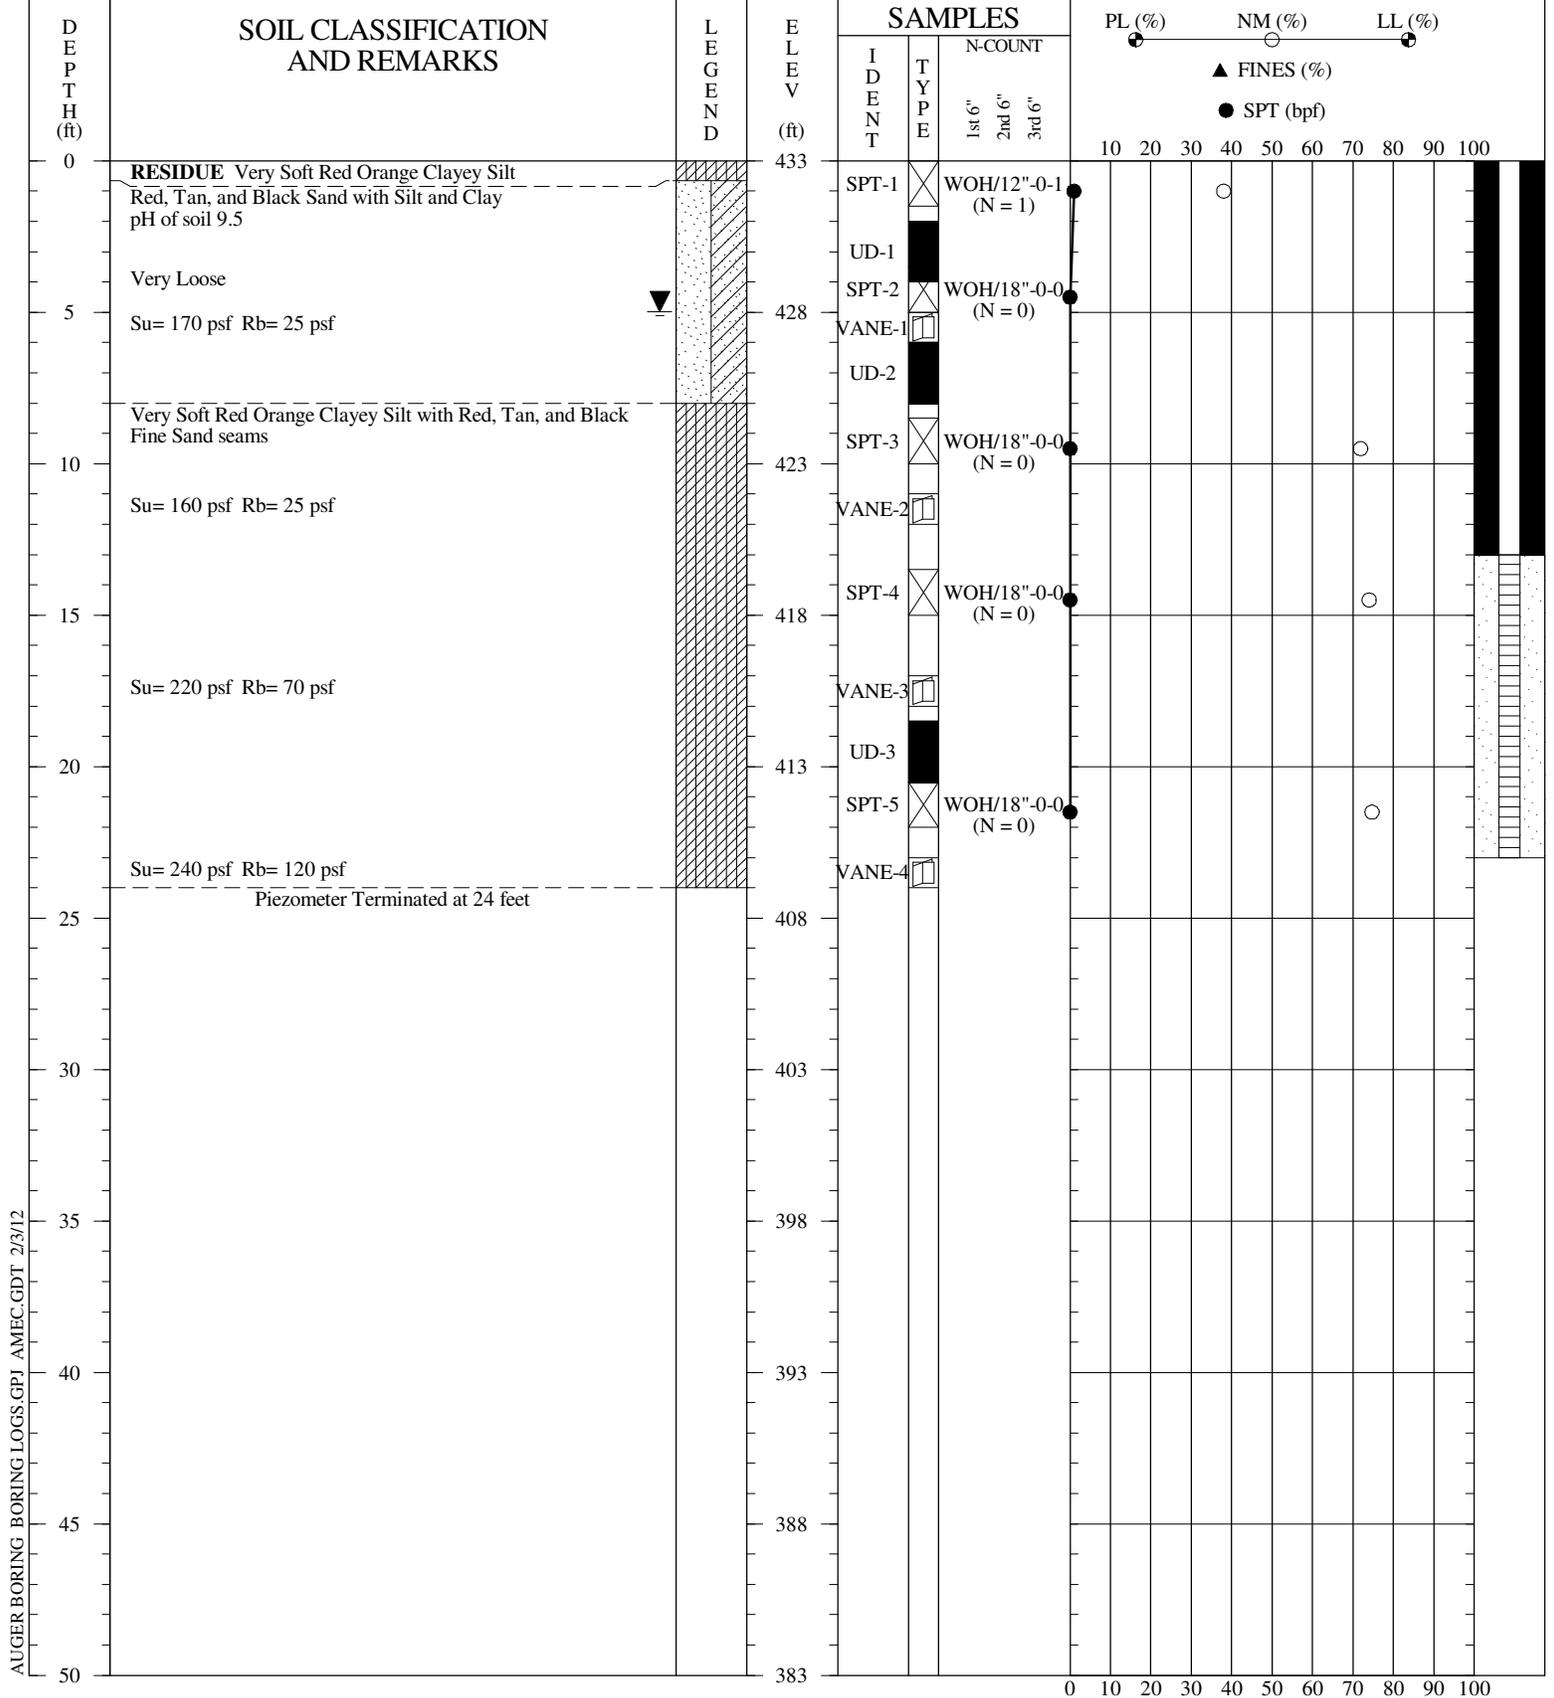
**DRILLER:** Ruben Landeros (AMEC)  
**EQUIPMENT:** CME-55 (Auto-Hammer)  
**METHOD:** Rotary Wash with Mud  
**HOLE DIA.:** 6 inches  
**REMARKS:** Piezometer backfilled to 13 feet using sand. Backfilled to surface using residue and bentonite.

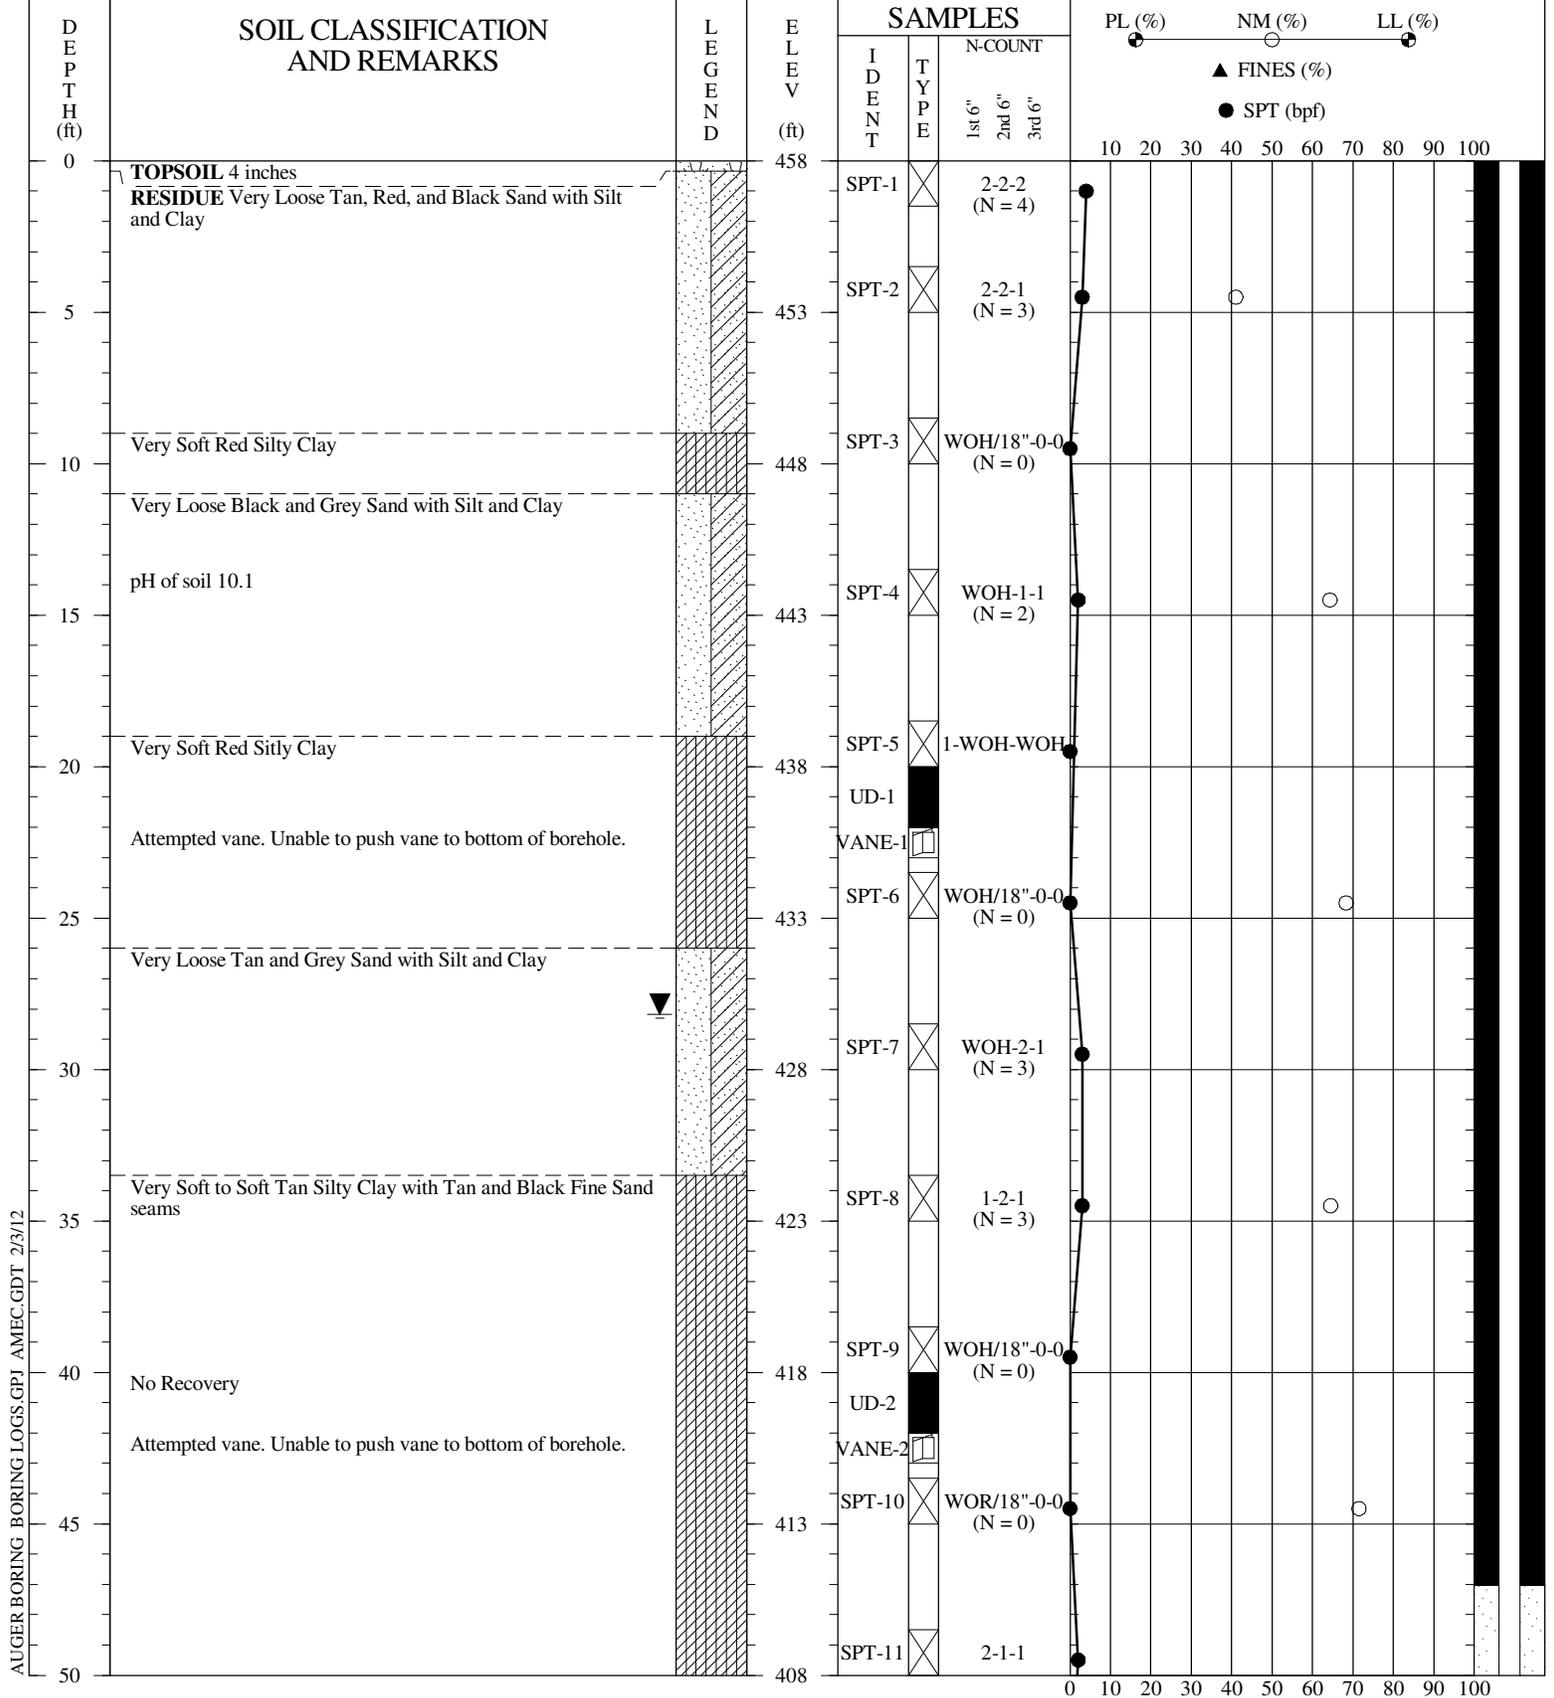
**DRILLER:** Ruben Landeros (AMEC)  
**EQUIPMENT:** CME-55 (Auto-Hammer)  
**METHOD:** Rotary Wash with Mud  
**HOLE DIA.:** 6 inches  
**REMARKS:** Piezometer backfilled to 40 feet using sand. Backfilled to surface using residue and bentonite.

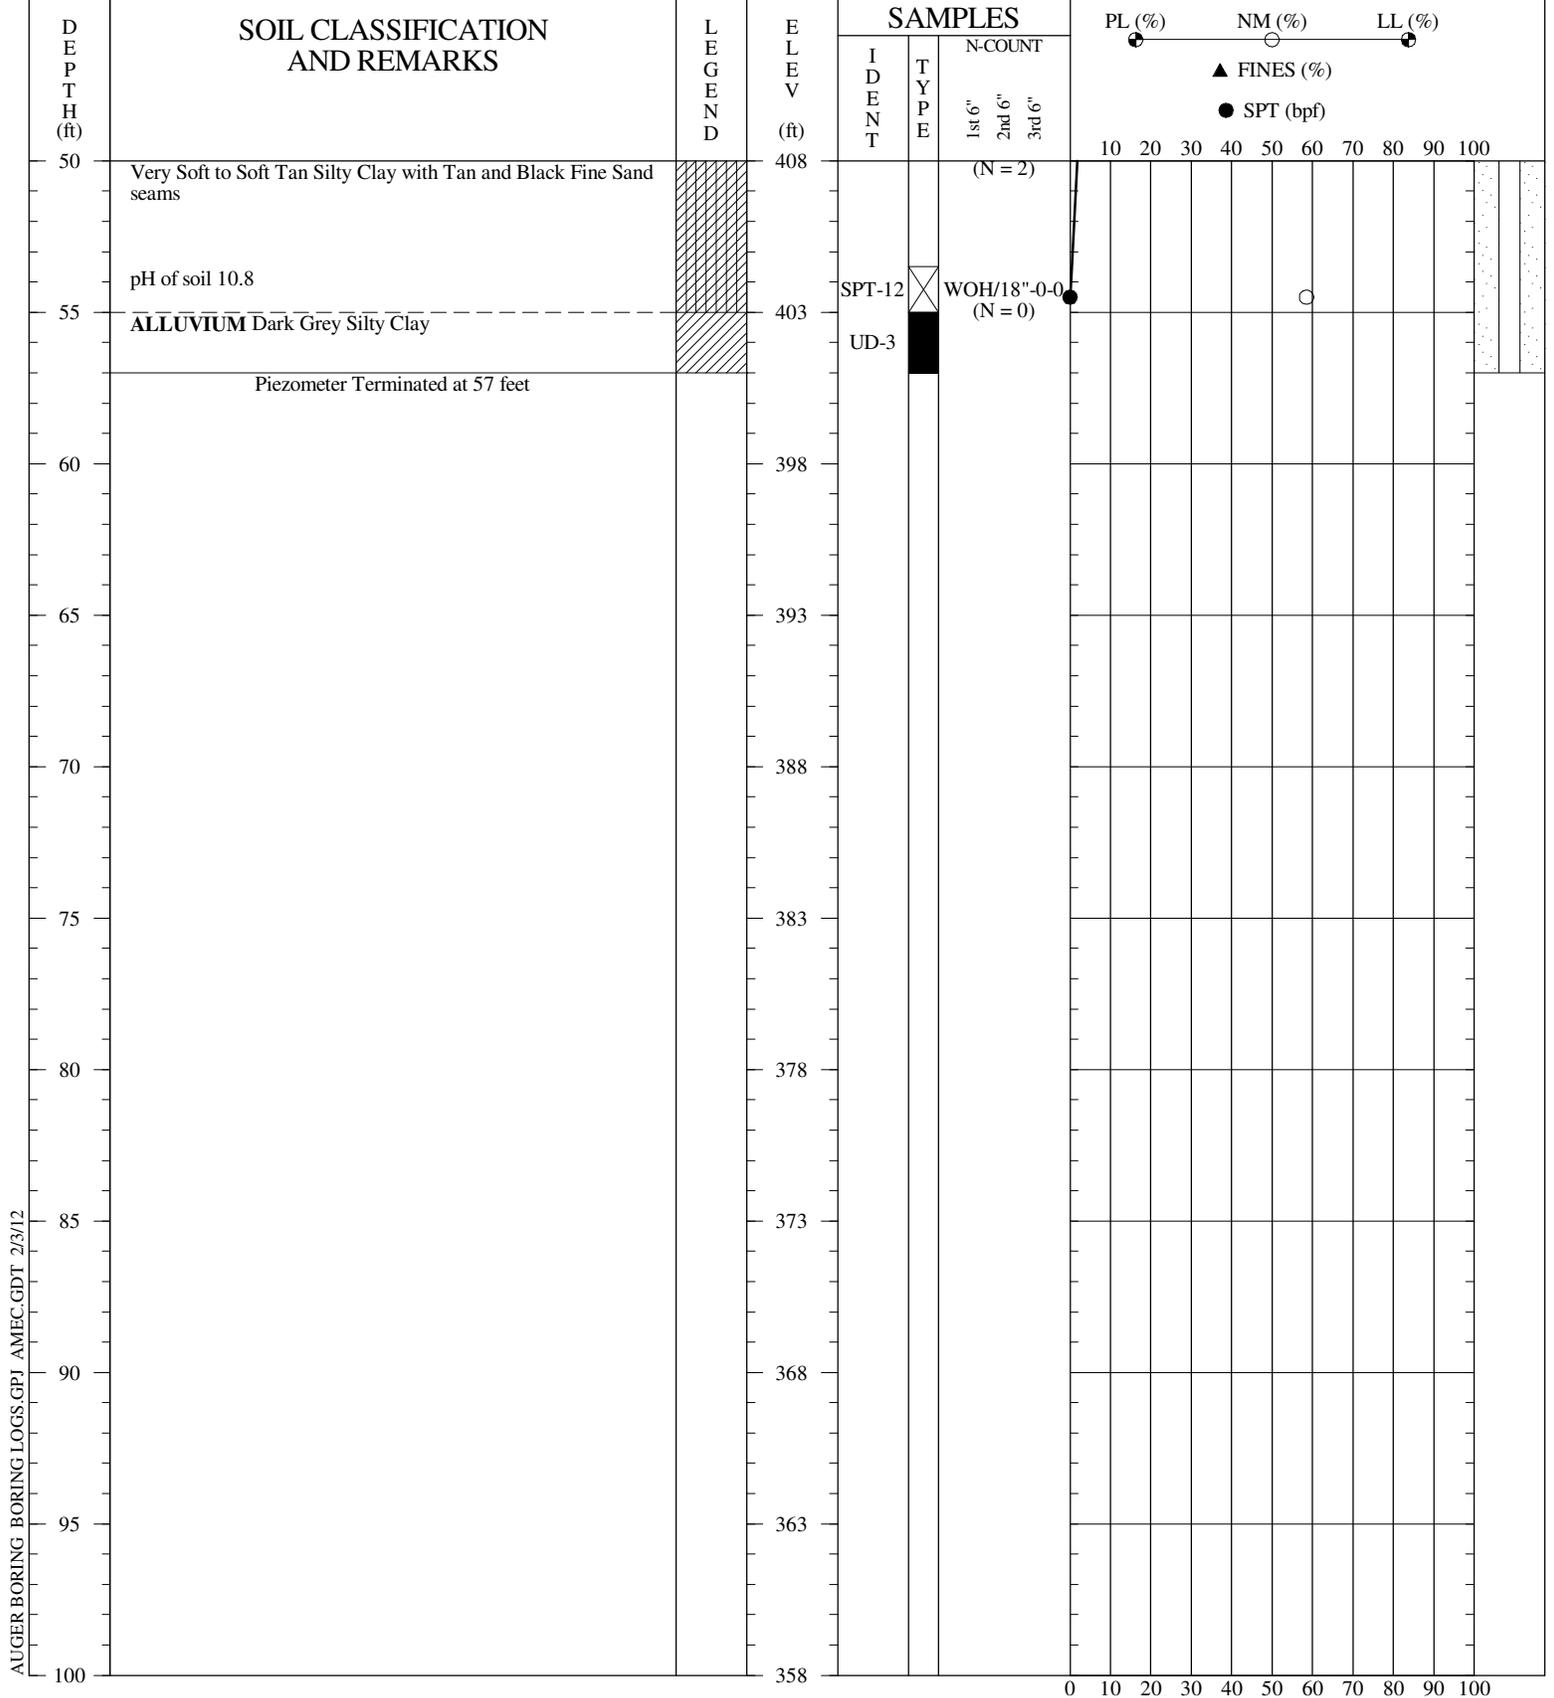
**DRILLER:** Ruben Landeros (AMEC)  
**EQUIPMENT:** CME-55 (Auto-Hammer)  
**METHOD:** Rotary Wash with Mud  
**HOLE DIA.:** 6 inches  
**REMARKS:** Piezometer backfilled to 40 feet using sand. Backfilled to surface using residue and bentonite.

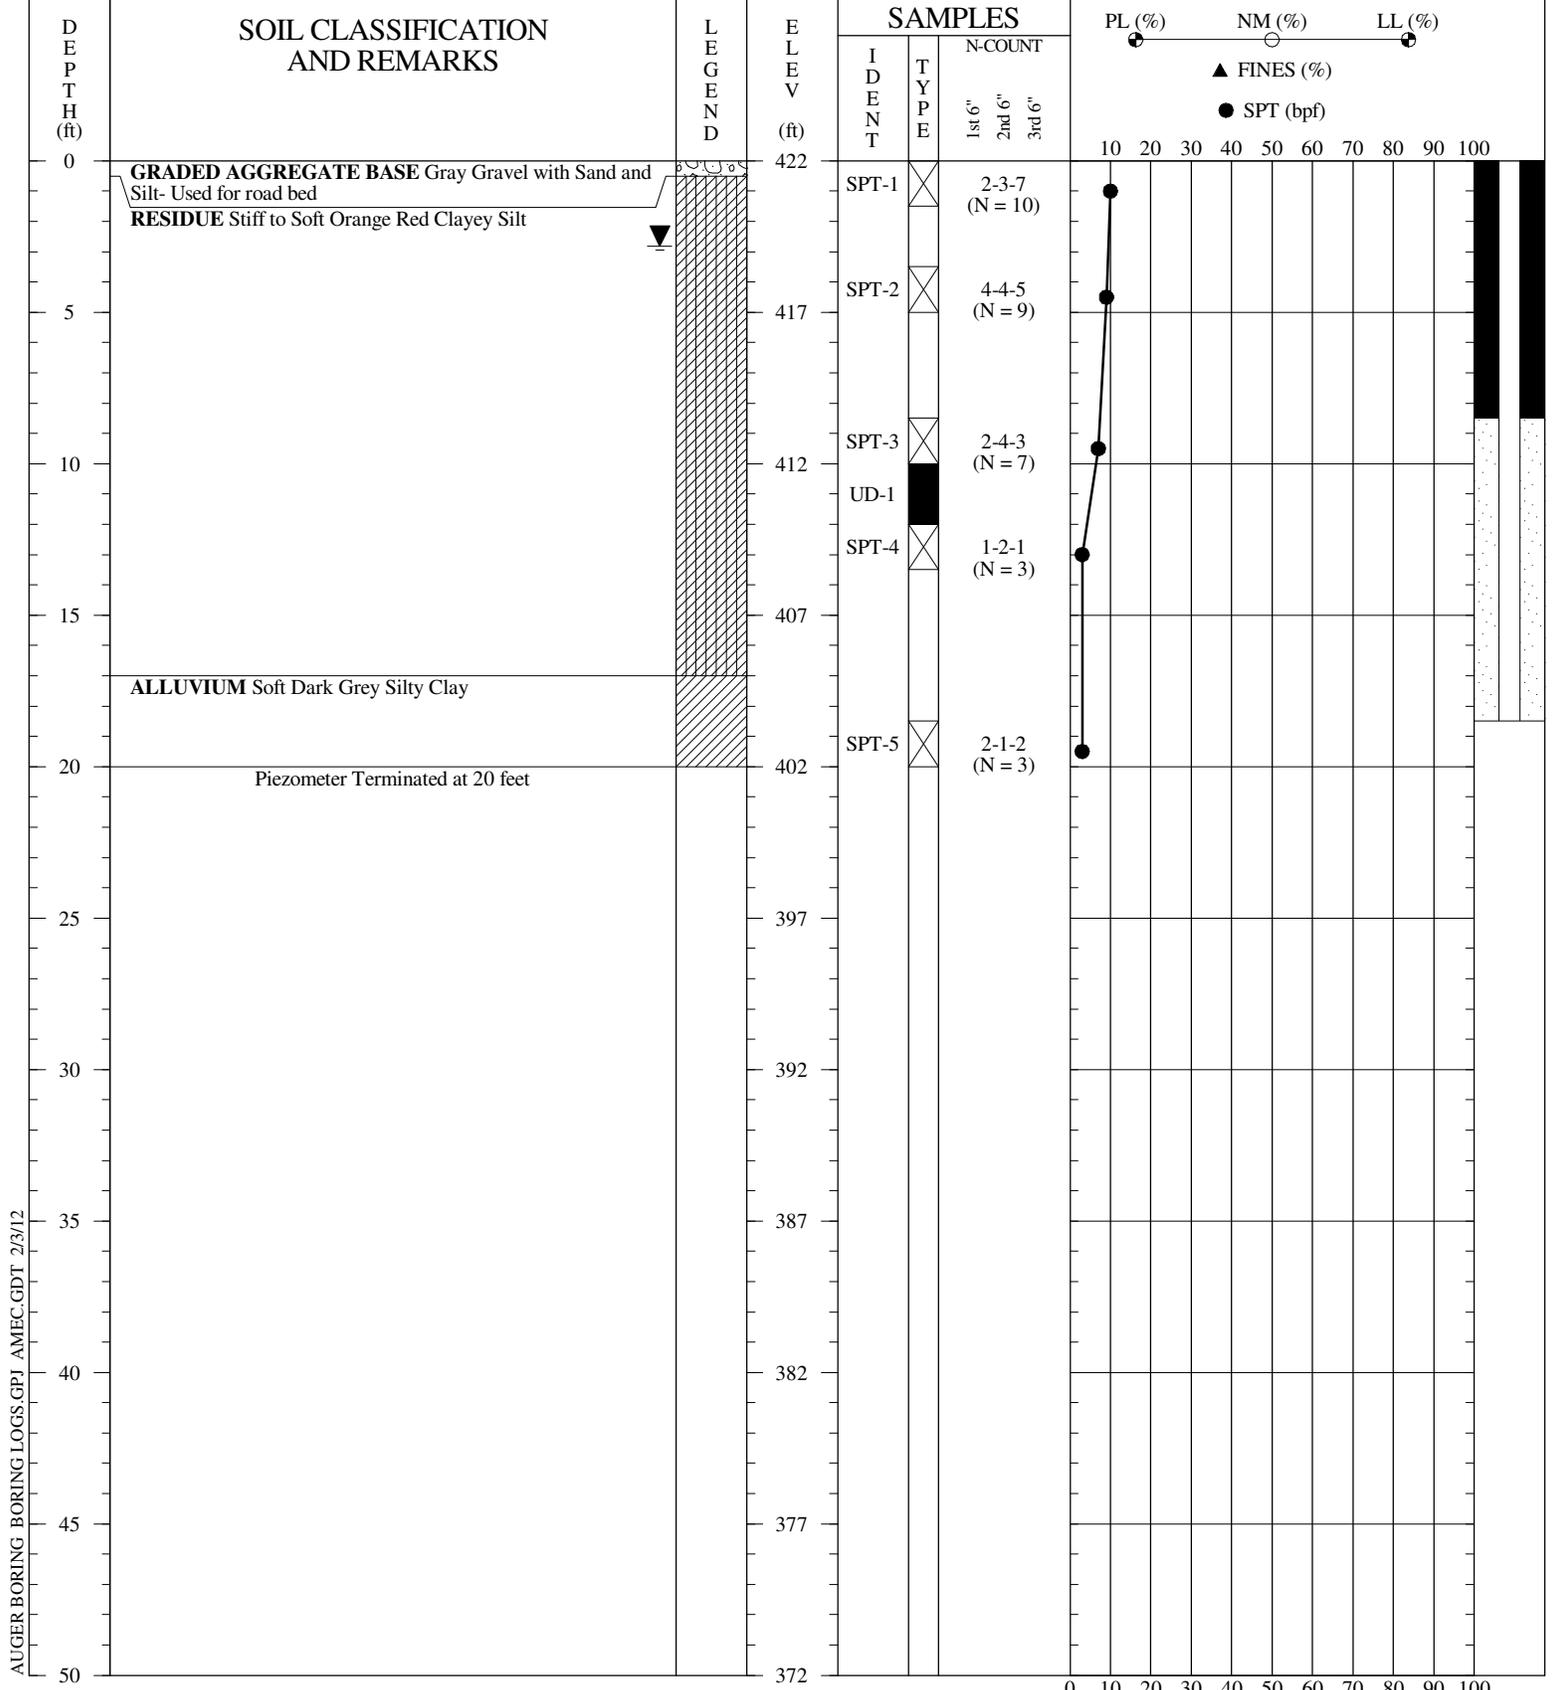
**DRILLER:** Ruben Landeros (AMEC)  
**EQUIPMENT:** CME-55 (Auto-Hammer)  
**METHOD:** Rotary Wash with Mud  
**HOLE DIA.:** 6 inches  
**REMARKS:** Piezometer backfilled to 6 feet using sand. Backfilled to surface using residue and bentonite.

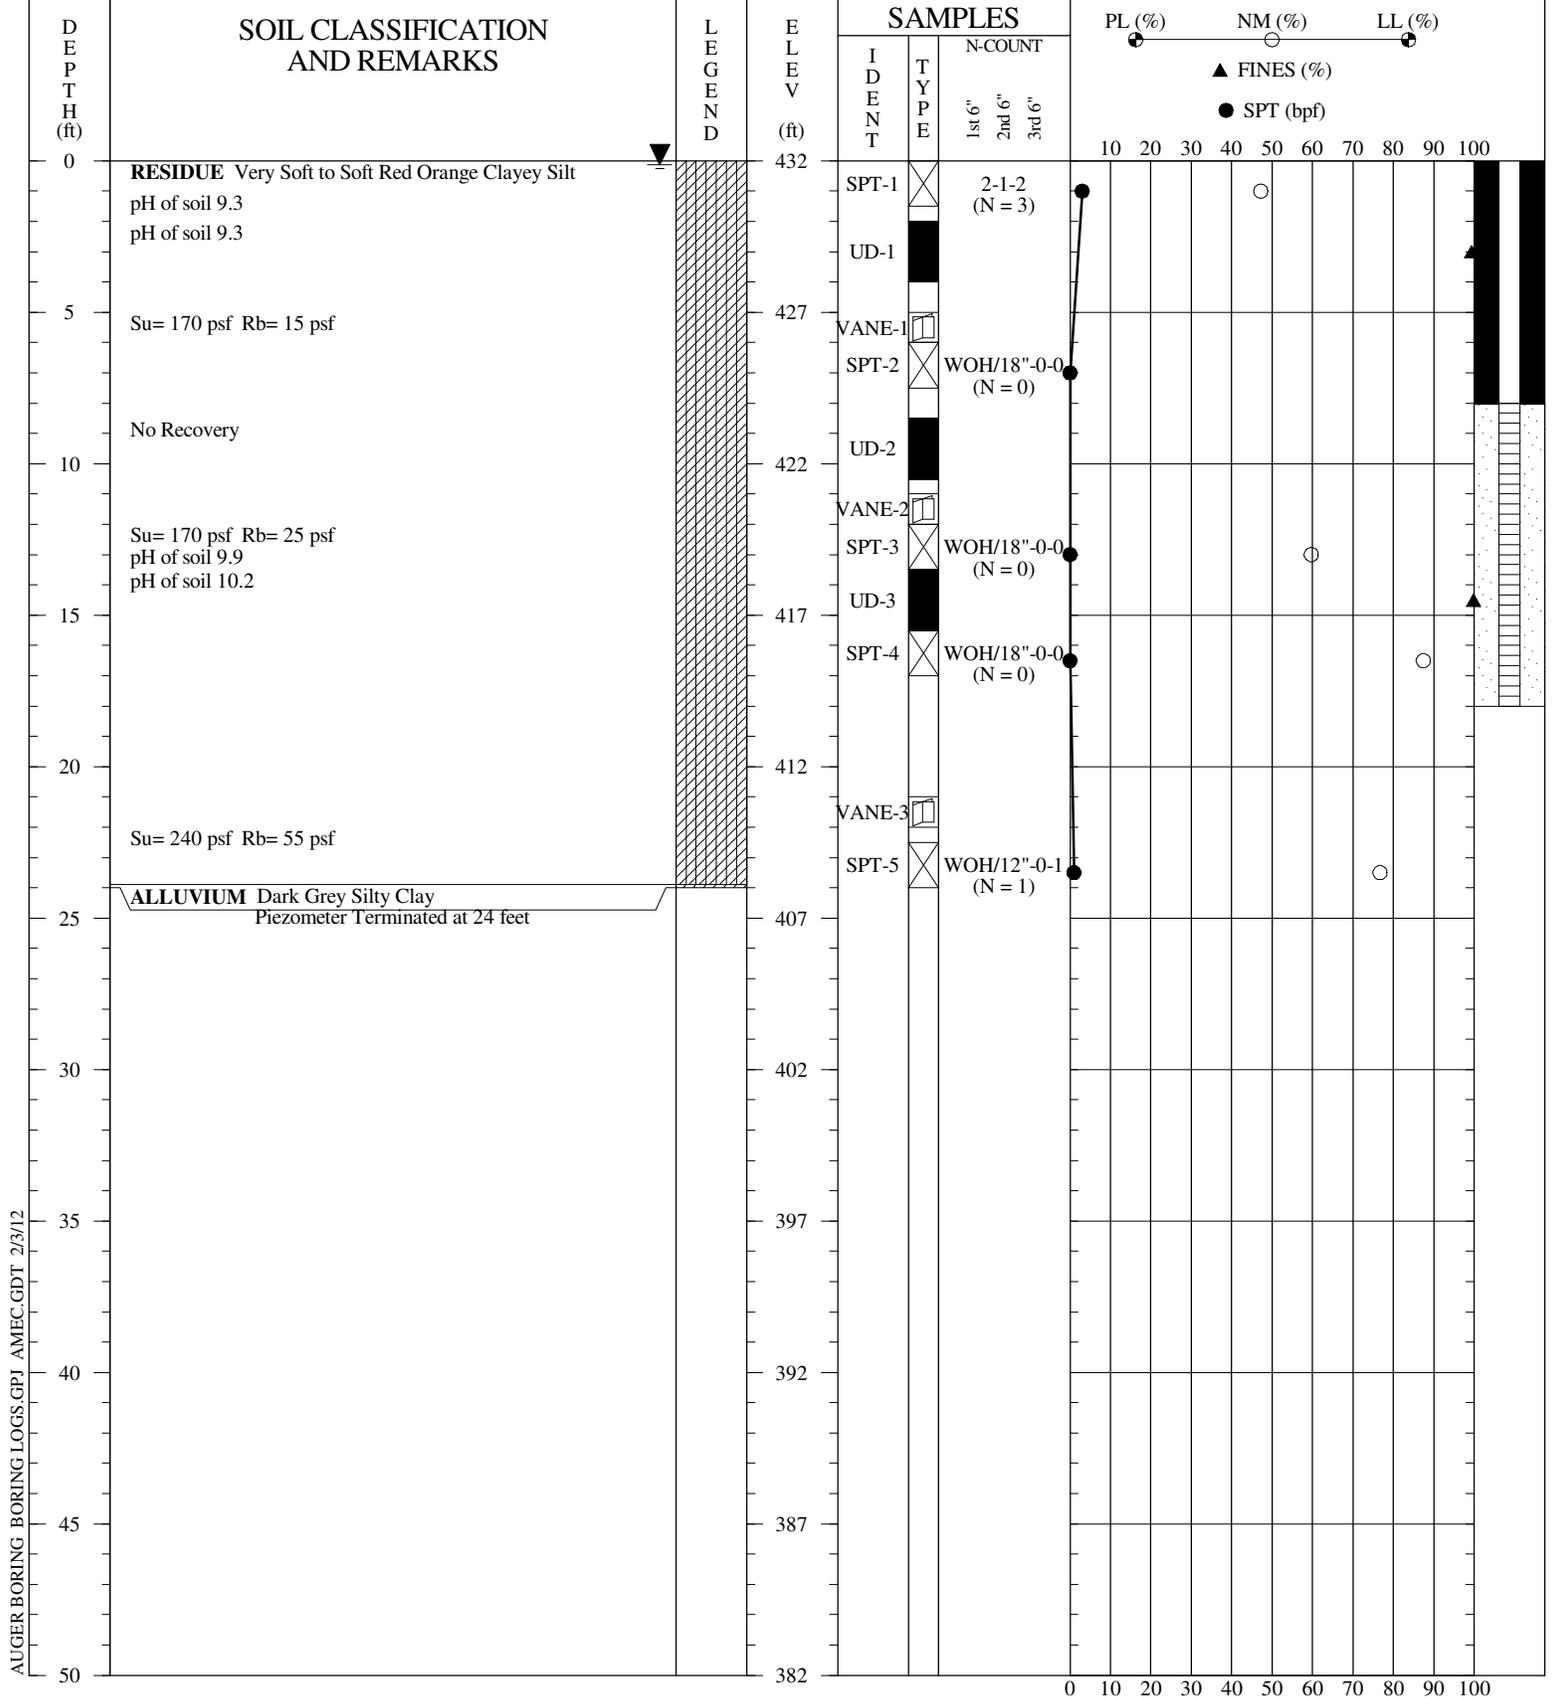
**DRILLER:** Ruben Landeros (AMEC)  
**EQUIPMENT:** CME-55 (Auto-Hammer)  
**METHOD:** Rotary Wash with Mud  
**HOLE DIA.:** 6 inches  
**REMARKS:** Piezometer backfilled to 8 feet using sand. Backfilled to surface using residue and bentonite.

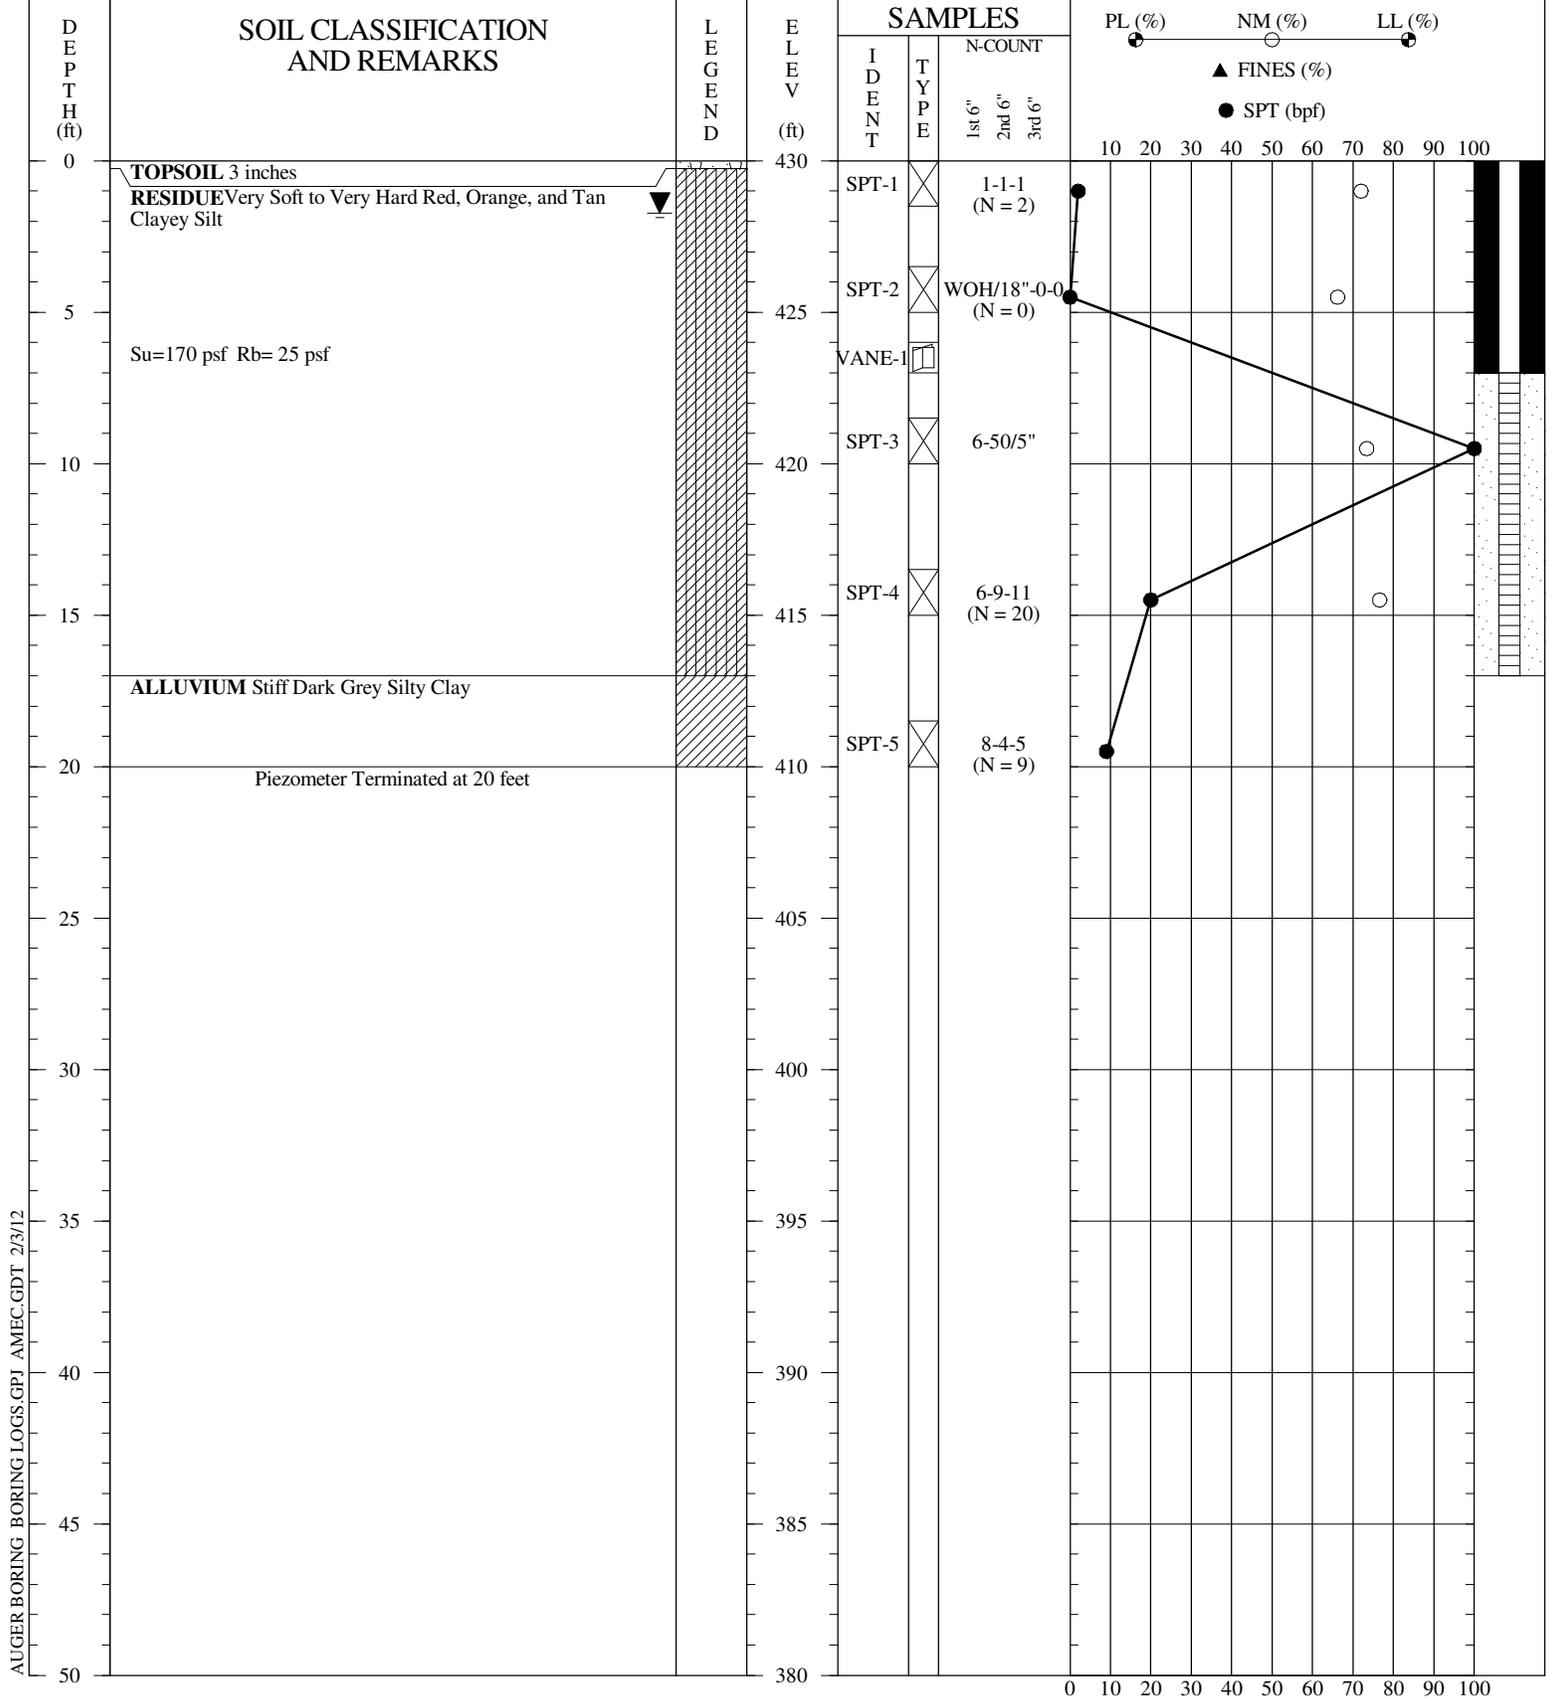
**DRILLER:** Ruben Landeros (AMEC)  
**EQUIPMENT:** CME-55 (Auto-Hammer)  
**METHOD:** Rotary Wash with Mud  
**HOLE DIA.:** 6 inches  
**REMARKS:** Piezometer backfilled to 7 feet using sand. Backfilled to surface using residue and bentonite.

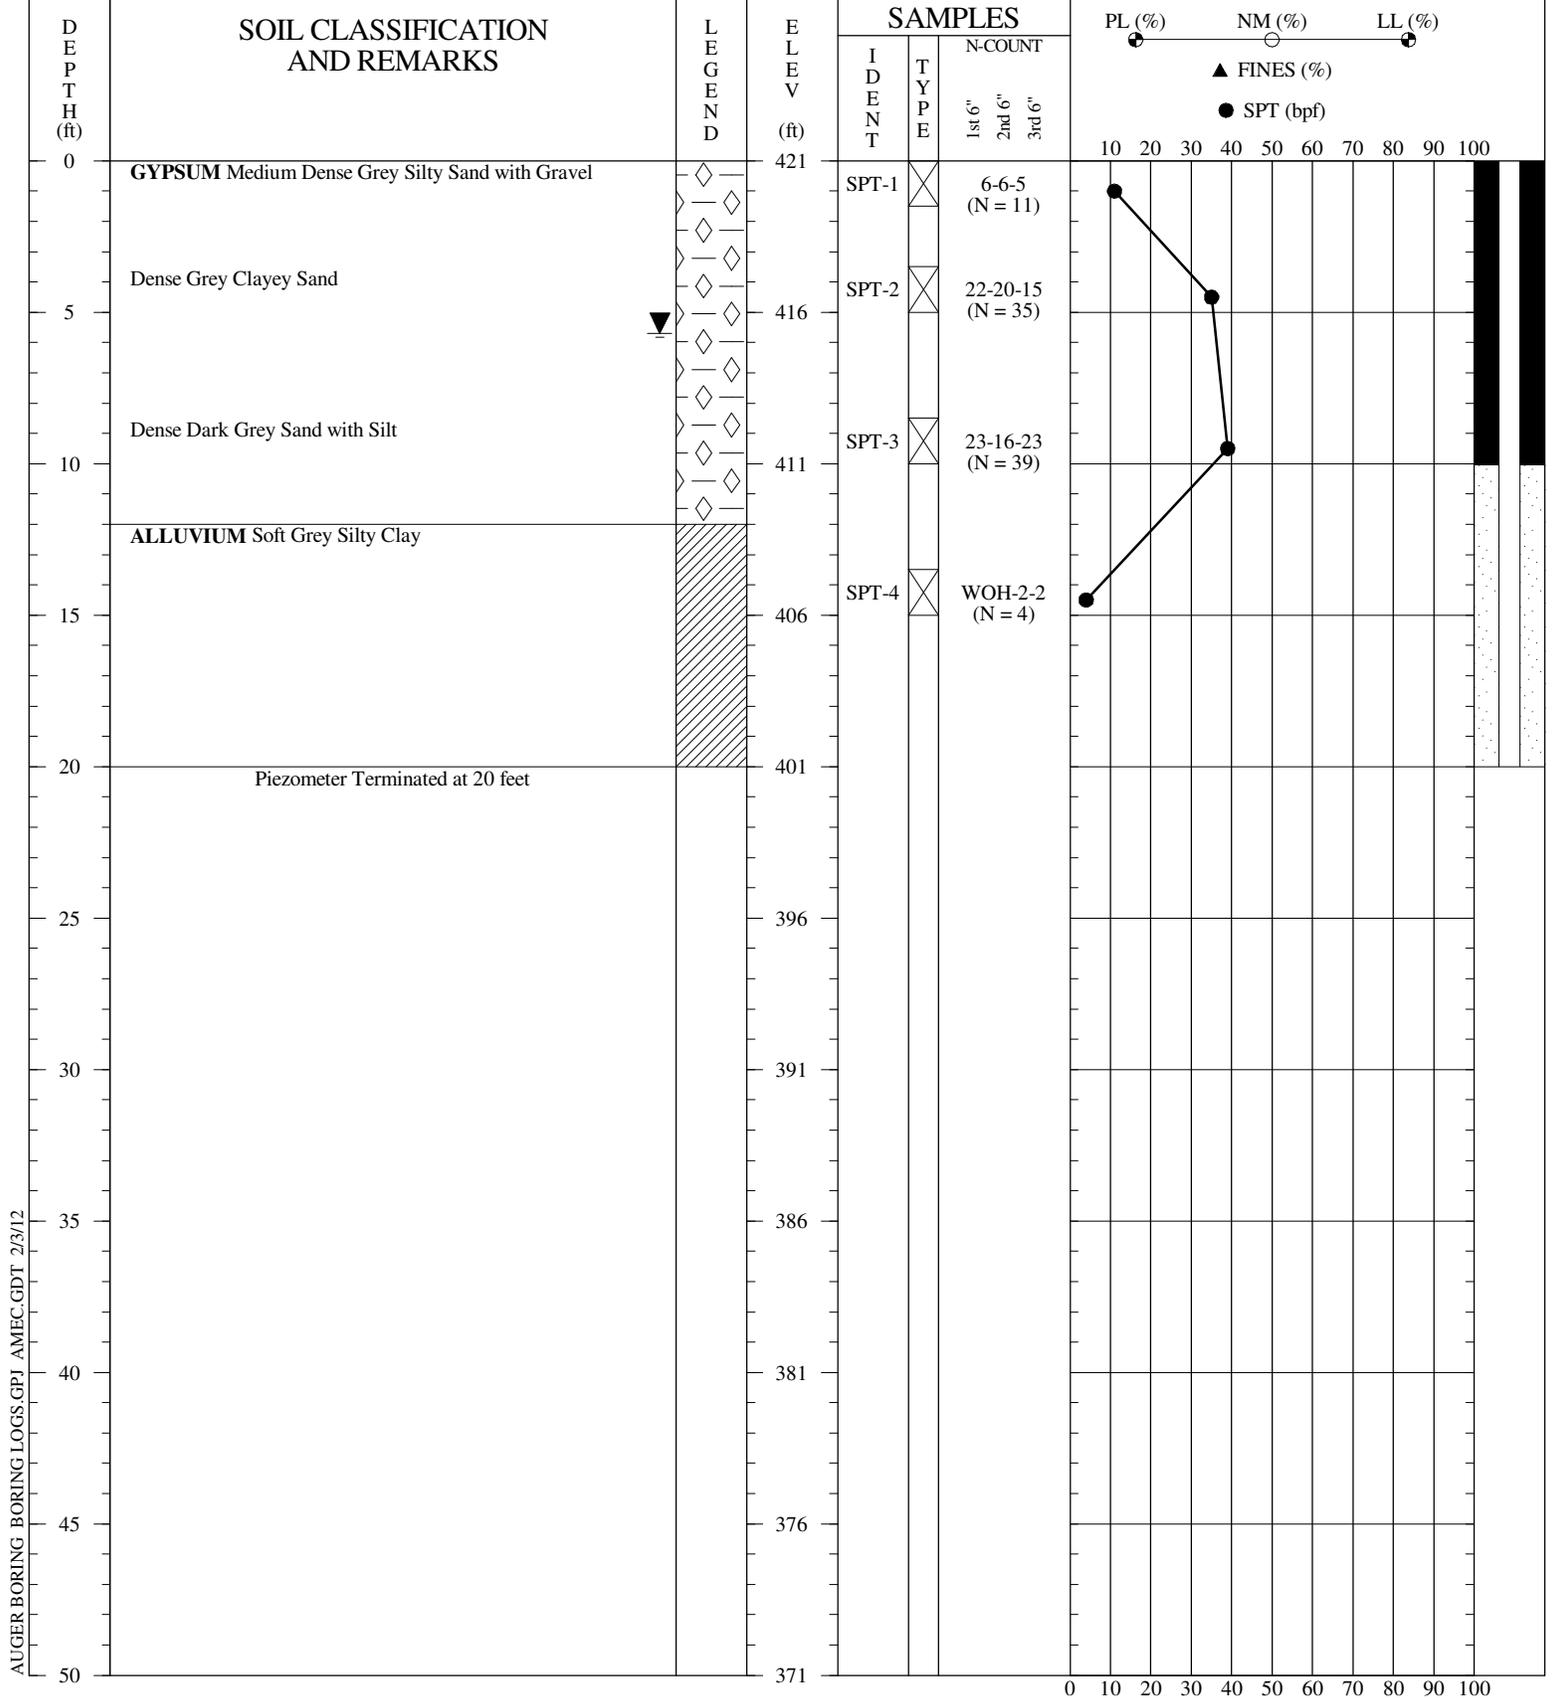
**DRILLER:** Ruben Landeros (AMEC)  
**EQUIPMENT:** CME-55 (Auto-Hammer)  
**METHOD:** Rotary Wash with Mud  
**HOLE DIA.:** 6 inches  
**REMARKS:** Piezometer backfilled to 4 feet using sand. Backfilled to surface using residue and bentonite.

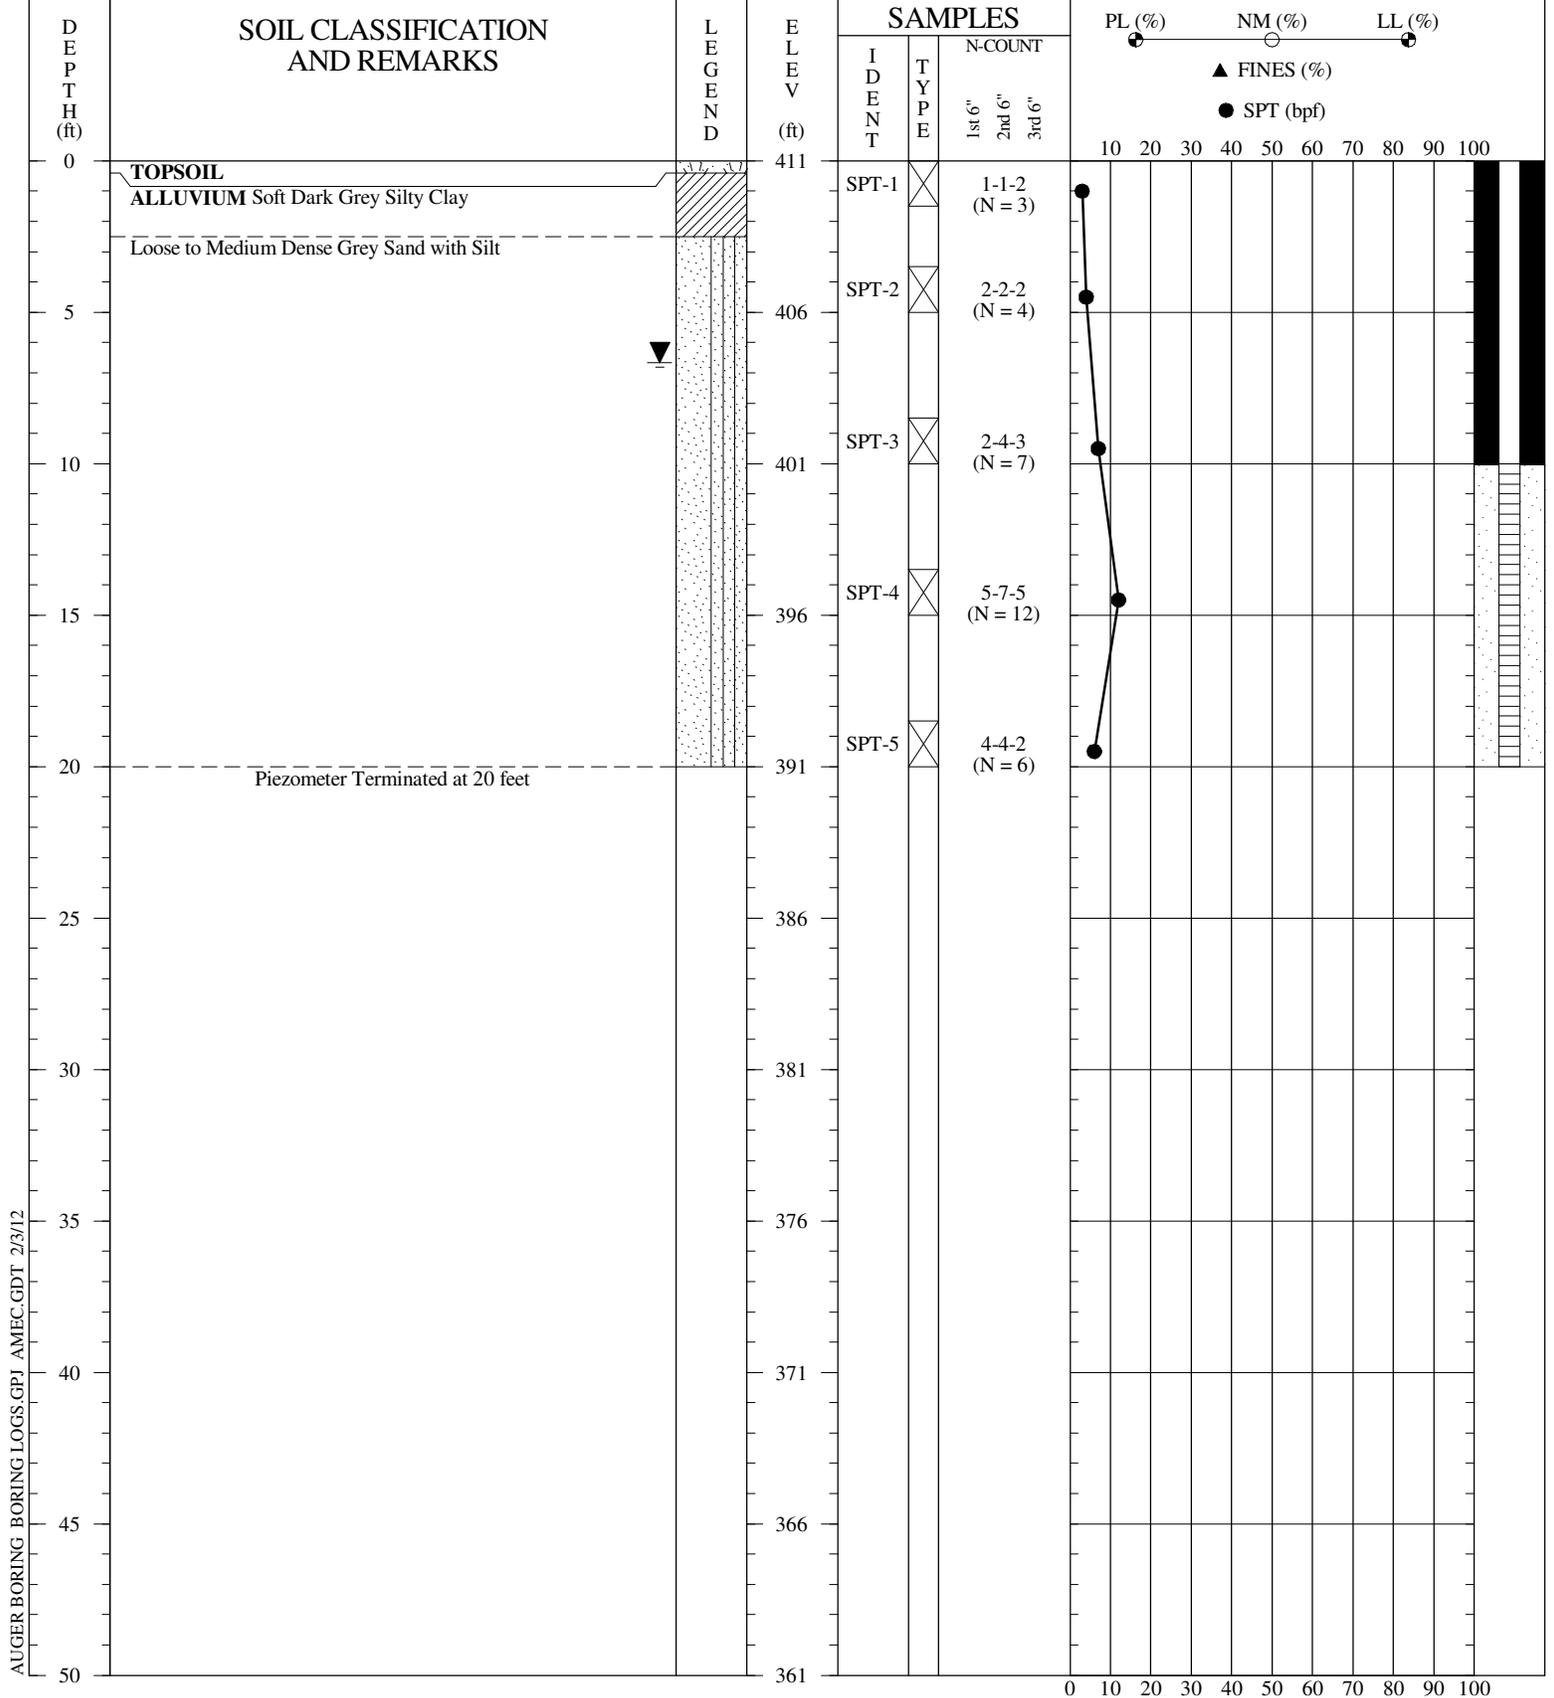
**DRILLER:** Ruben Landeros (AMEC)  
**EQUIPMENT:** CME-55 (Auto-Hammer)  
**METHOD:** Rotary Wash with Mud  
**HOLE DIA.:** 6 inches  
**REMARKS:** Piezometer backfilled to 10 feet using sand. Backfilled to surface using drilling spoils and bentonite.

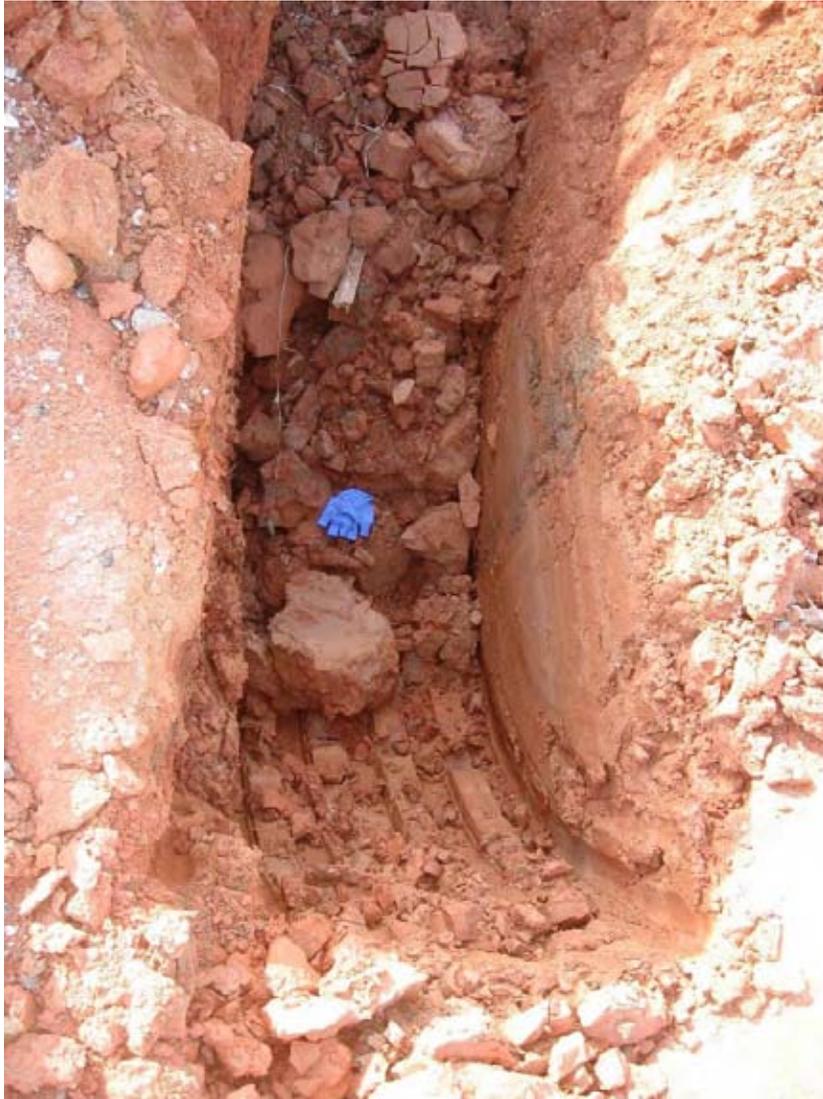
### TP-1, Ground Elevation: ~451 feet

Depth (feet)	Description
0- 5	<b>RESIDUE</b> – Tan Red Clayey Silt, Softer and Moister with Depth Test pit terminated at 5 feet No Groundwater Observed
