**PRE-DESIGN INVESTIGATION REPORT  
PROPOSED SOLAR REDEVELOPMENT PROJECT  
FORMER BAUXITE RESIDUE DISPOSAL AREAS  
Operable Unit 1, North Alcoa Site**

East St. Louis, Illinois

**Restoration Land Development Company, LLC**  
Wellesley, MA

**AMEC Environment & Infrastructure, Inc.**  
800 N. Bell Avenue, Suite 200  
Pittsburgh, Pennsylvania 15106  
(412) 279-6661

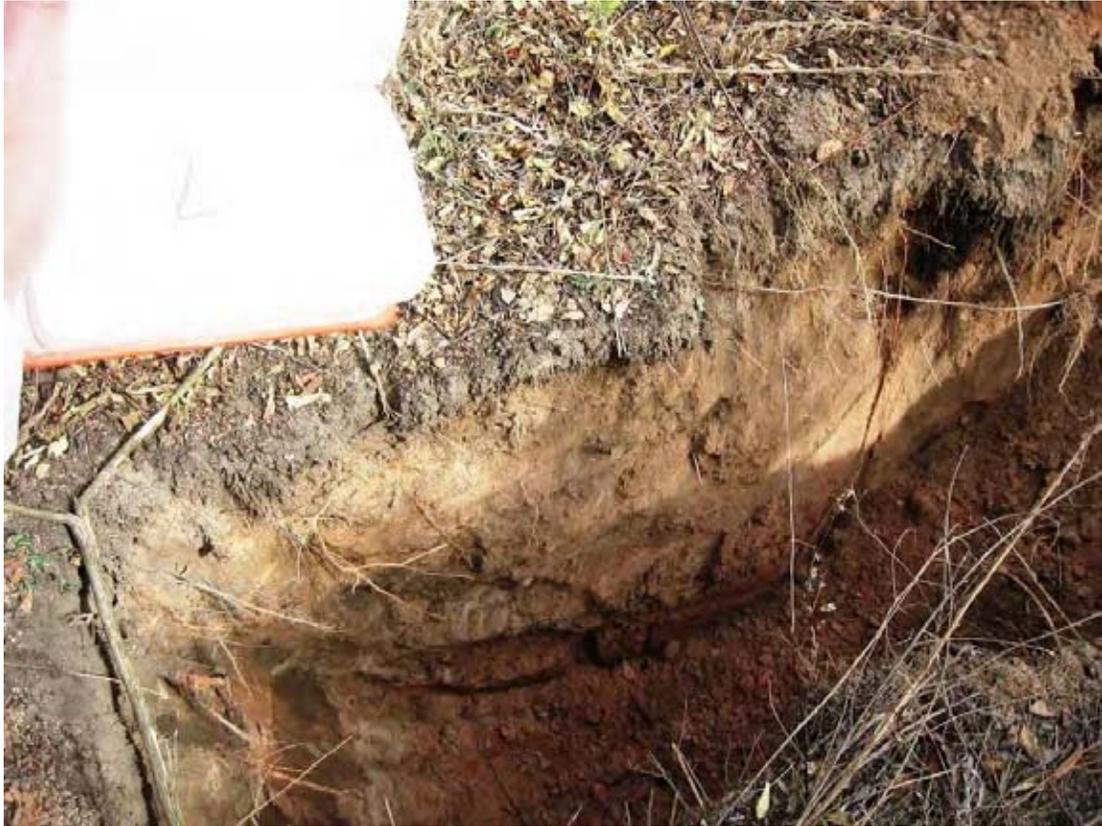
### TP-2, Ground Elevation: ~457 feet

Depth (feet)	Description
0-0.5	<b>TOPSOIL</b> – Gray Silty SAND w/roots and litter
0.5-3	Tan Silty SAND
3 - 5	<b>RESIDUE</b> - Red Tan Sandy Silty CLAY
	Test pit terminated at 5 feet No Groundwater Observed

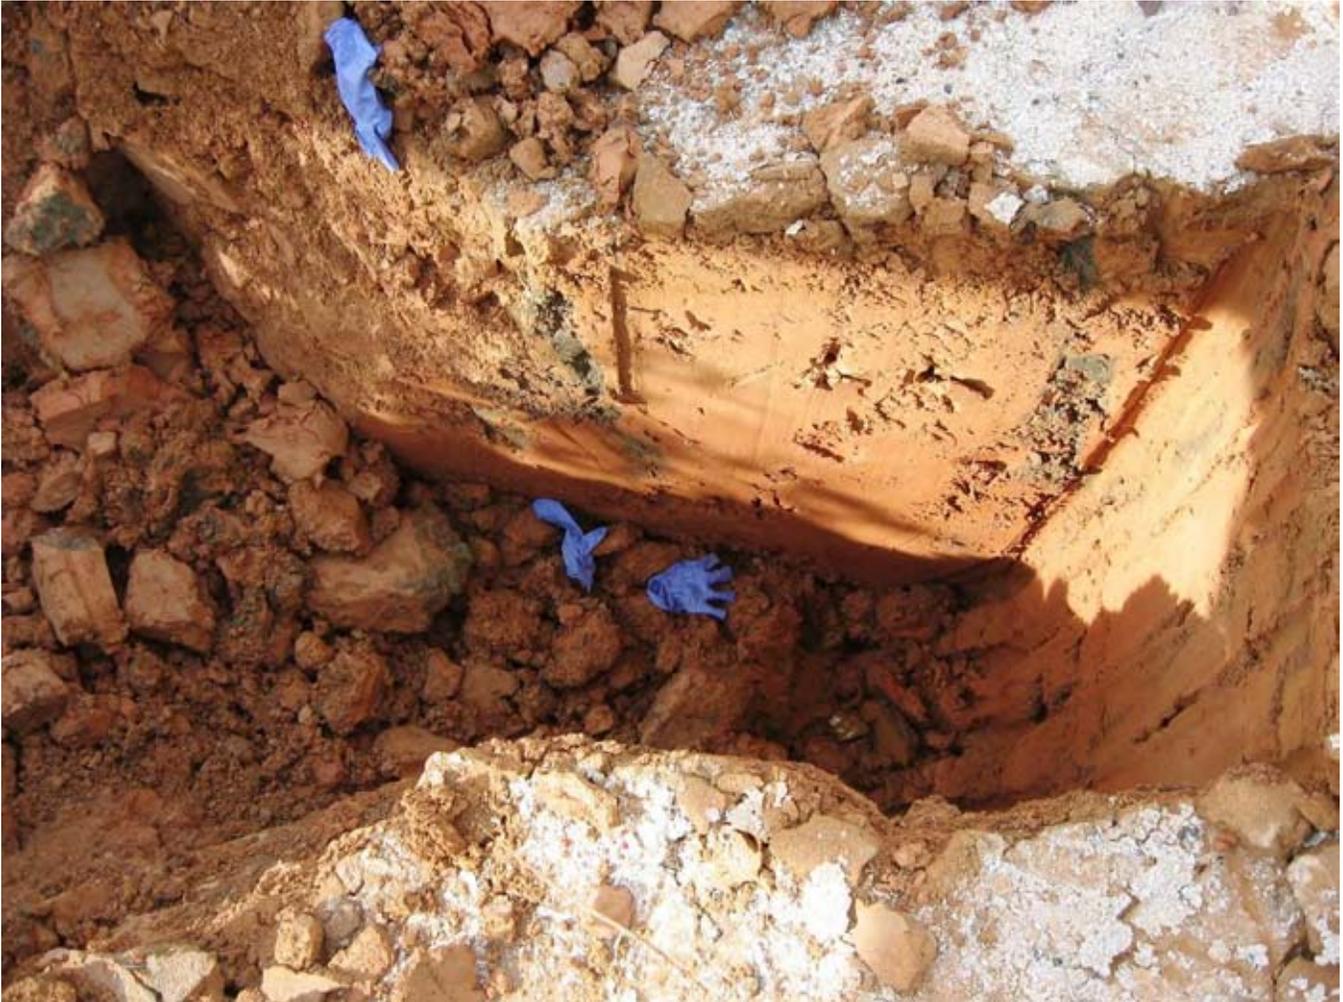
### TP-3, Ground Elevation: ~454 feet

Depth (feet)	Description
0- 5	<b>RESIDUE</b> – Dry White Gray Crust with Tan Red Clayey Silt beneath, Softer and Moister with Depth Test pit terminated at 5 feet No Groundwater Observed

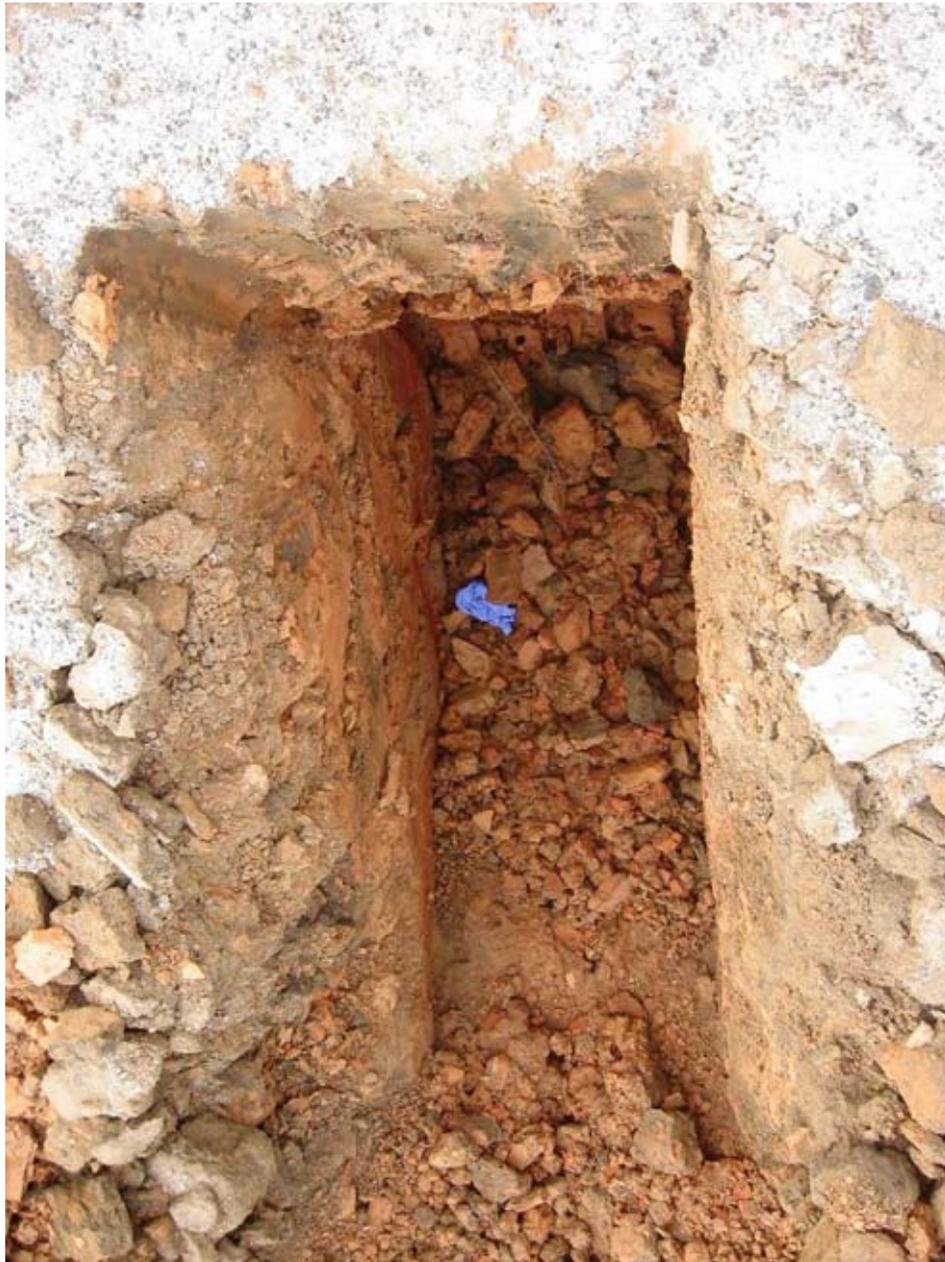
### TP-4, Ground Elevation: ~451 feet

Depth (feet)	Description
0- 5	<b>RESIDUE</b> – Dry White Gray Crust with Tan Red Clayey Silt beneath, Softer and Moister with Depth Test pit terminated at 5 feet No Groundwater Observed

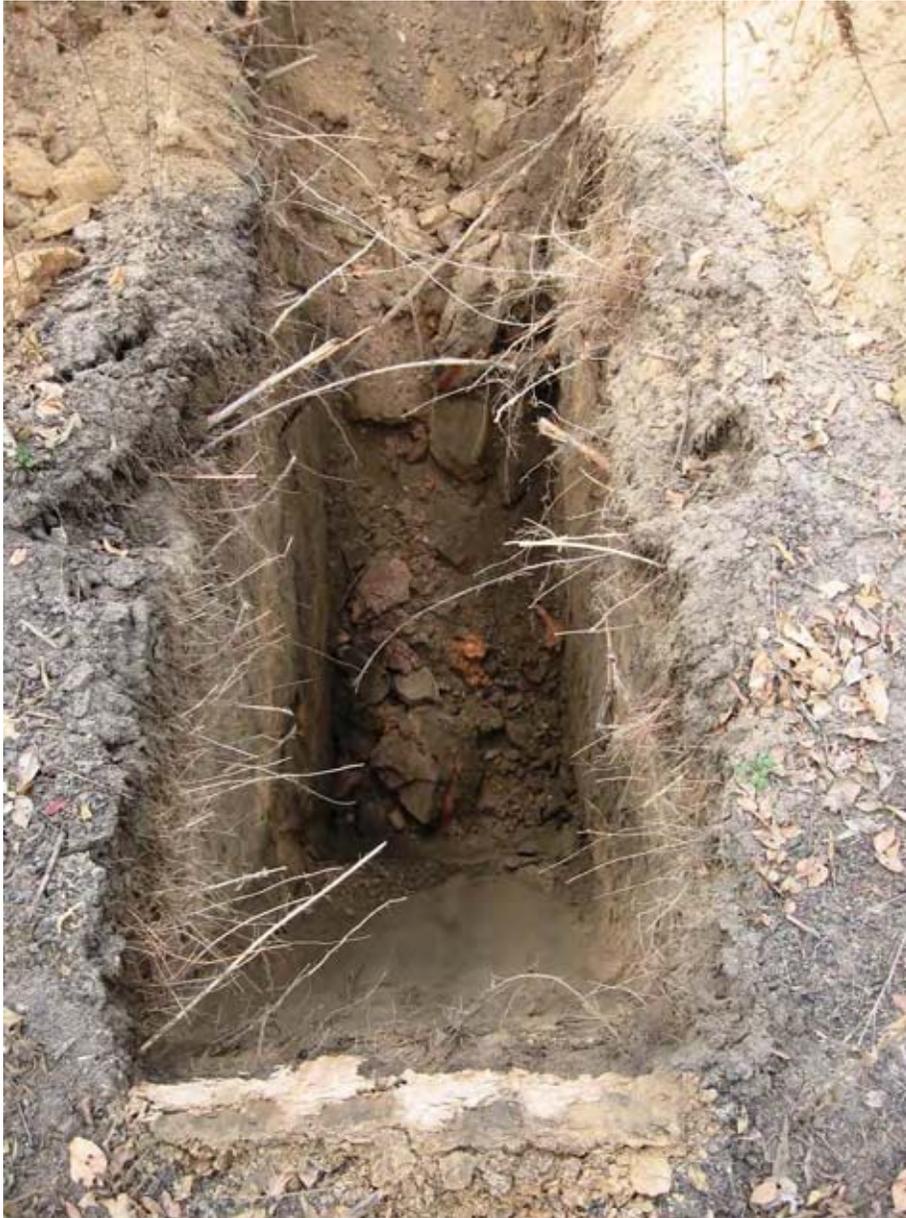
### TP-5, Ground Elevation: ~459 feet

Depth (feet)	Description
0-0.5	<b>TOPSOIL</b> – Gray Silty SAND w/roots and litter
0.5-4	Tan Silty SAND
4 - 5	<b>RESIDUE</b> - Red Tan Sandy Silty CLAY
	Test pit terminated at 5 feet No Groundwater Observed

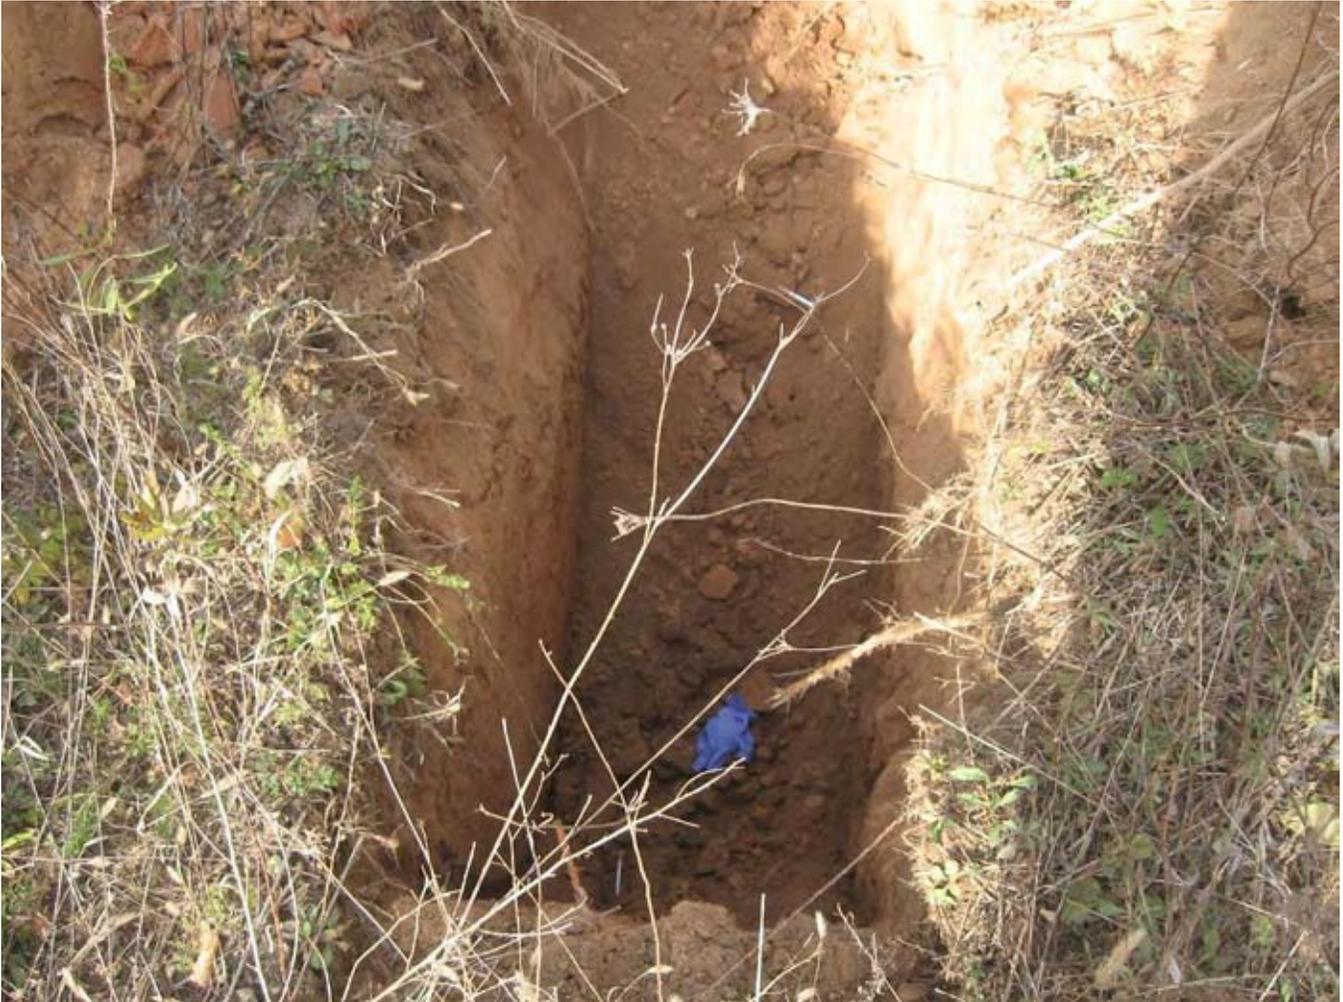
### TP-6, Ground Elevation: ~456 feet

Depth (feet)	Description
0-0.3	<b>TOPSOIL</b> – Tan Silty SAND w/roots and litter
0.3-2	<b>RESIDUE</b> – Tan Red Silty SAND
2 - 5	Red Tan Sandy Silty CLAY
	Test pit terminated at 5 feet No Groundwater Observed

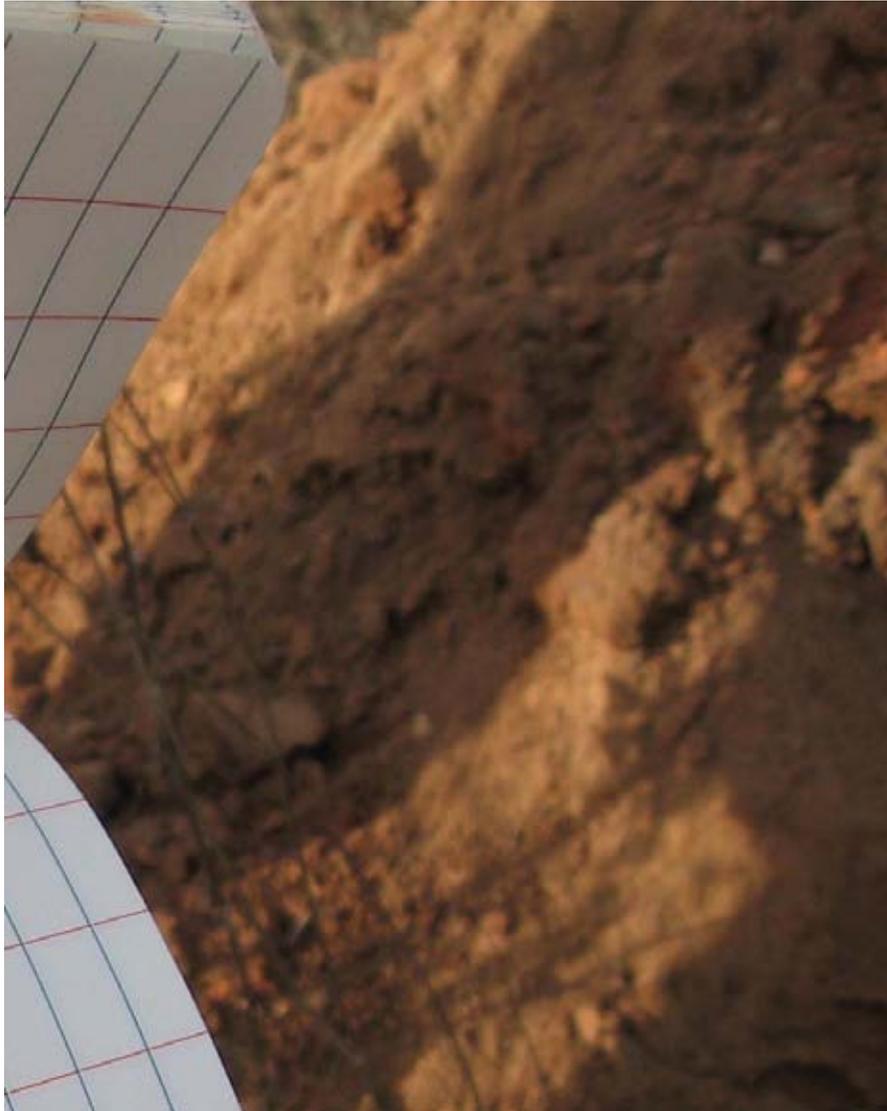
### TP-7, Ground Elevation: ~457 feet

Depth (feet)	Description
0-0.3	<b>TOPSOIL</b> – Tan Silty SAND w/roots and litter
0.3-2	<b>RESIDUE</b> – Tan Red Clayey Silty SAND
2 - 5	Red Tan Sandy Silty CLAY
	Test pit terminated at 5 feet No Groundwater Observed

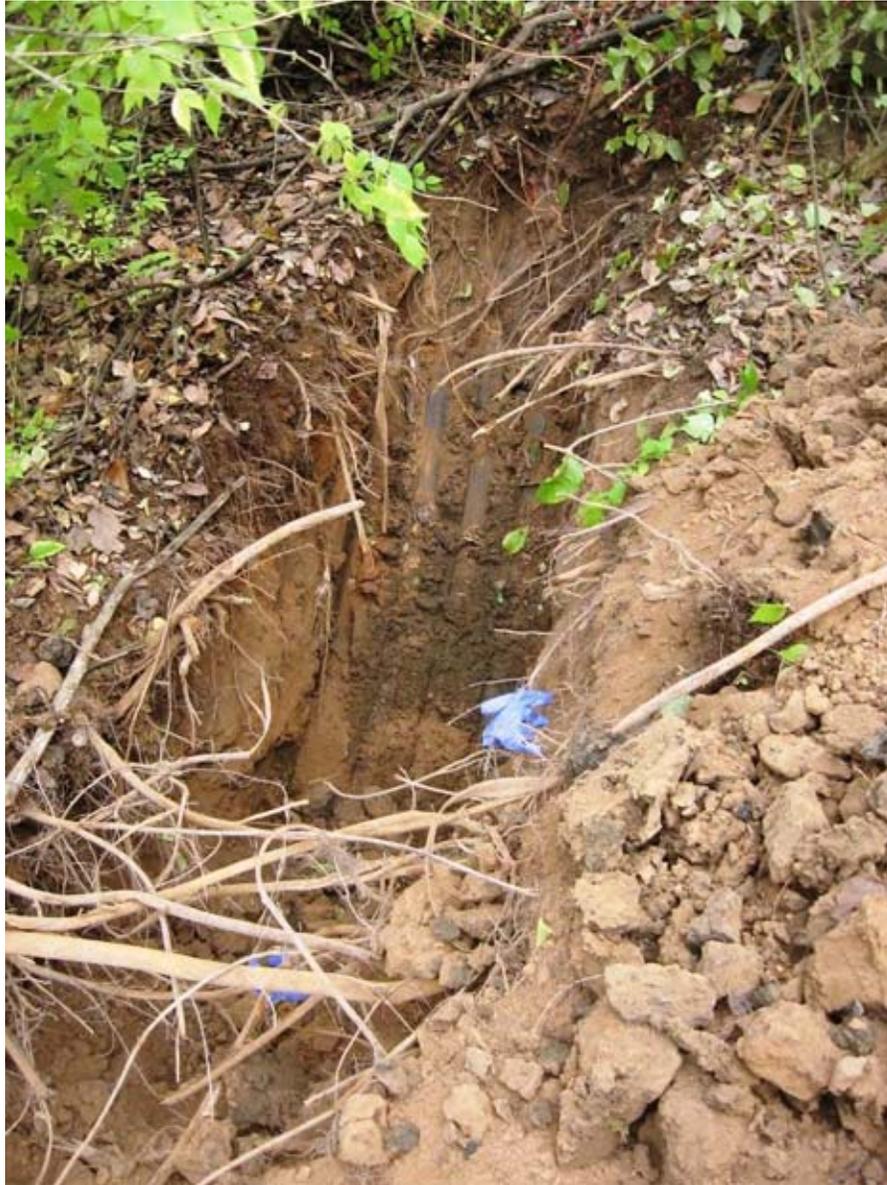
### TP-8, Ground Elevation: ~417 feet

Depth (feet)	Description
0-0.5	<b>TOPSOIL</b> – Tan Silty SAND w/roots and litter
0.5-2	<b>ALLUVIUM</b> – Tan Silty SAND
2 - 5	Dark Gray Silty CLAY
	Test pit terminated at 5 feet No Groundwater Observed

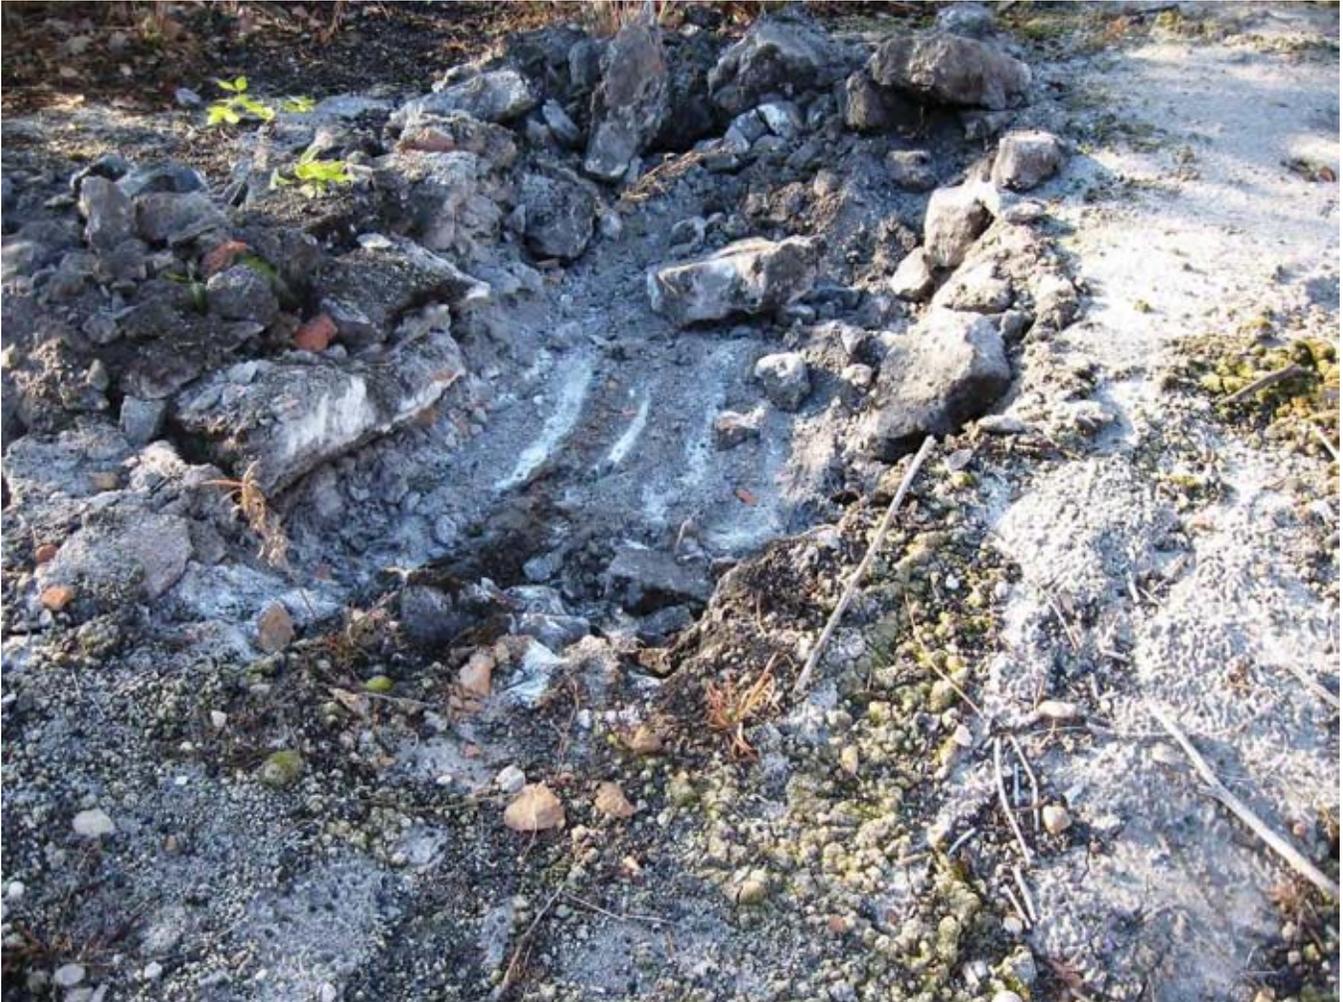
### TP-9, Ground Elevation: ~423 feet

Depth (feet)	Description
0-0.5	<b>GYPSUM</b> -Dark Gray Weakly Cemented Fine Sandy SILT
0.5-1.5	White Gray Strongly Cemented Fine Sandy SILT
	Test pit terminated at 1.5 feet (refusal) No Groundwater Observed

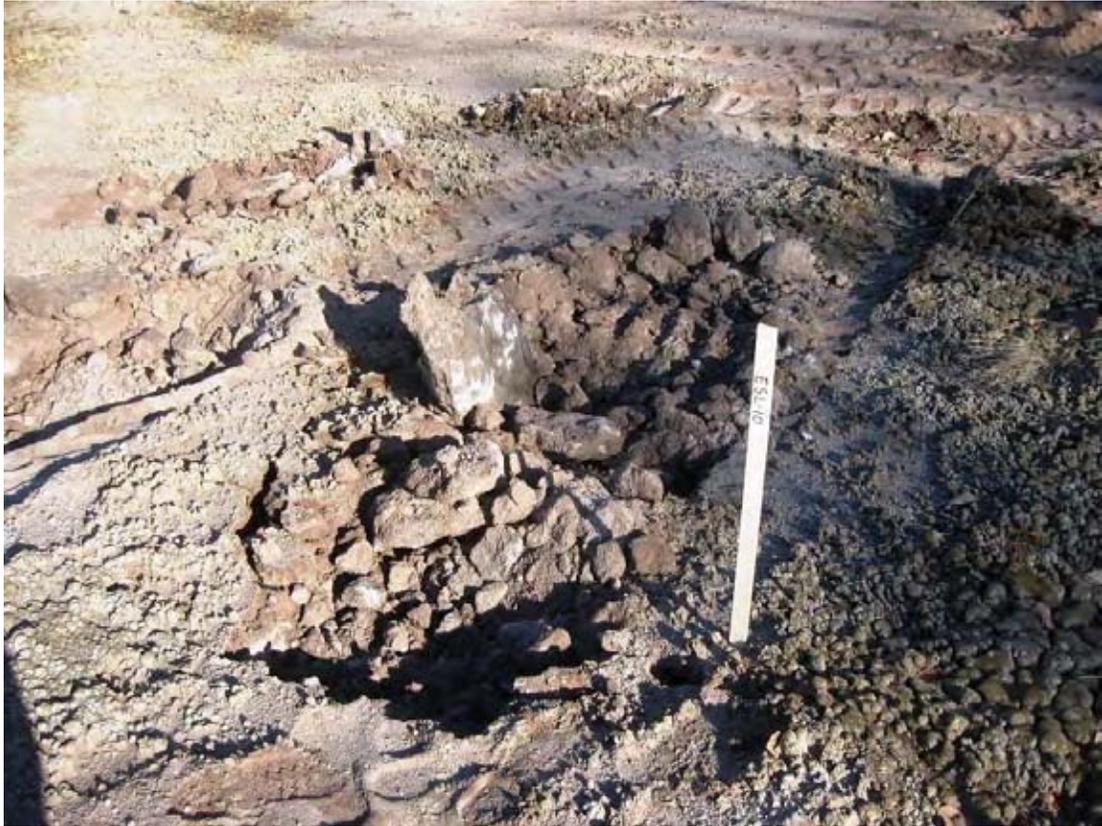
### TP-10, Ground Elevation: ~424 feet

Depth (feet)	Description
0-0.5	<b>GYPSUM</b> -Dark Gray Weakly Cemented Fine Sandy SILT
0.5-1.5	White Gray Strongly Cemented Fine Sandy SILT
	Test pit terminated at 1.5 feet (refusal) No Groundwater Observed

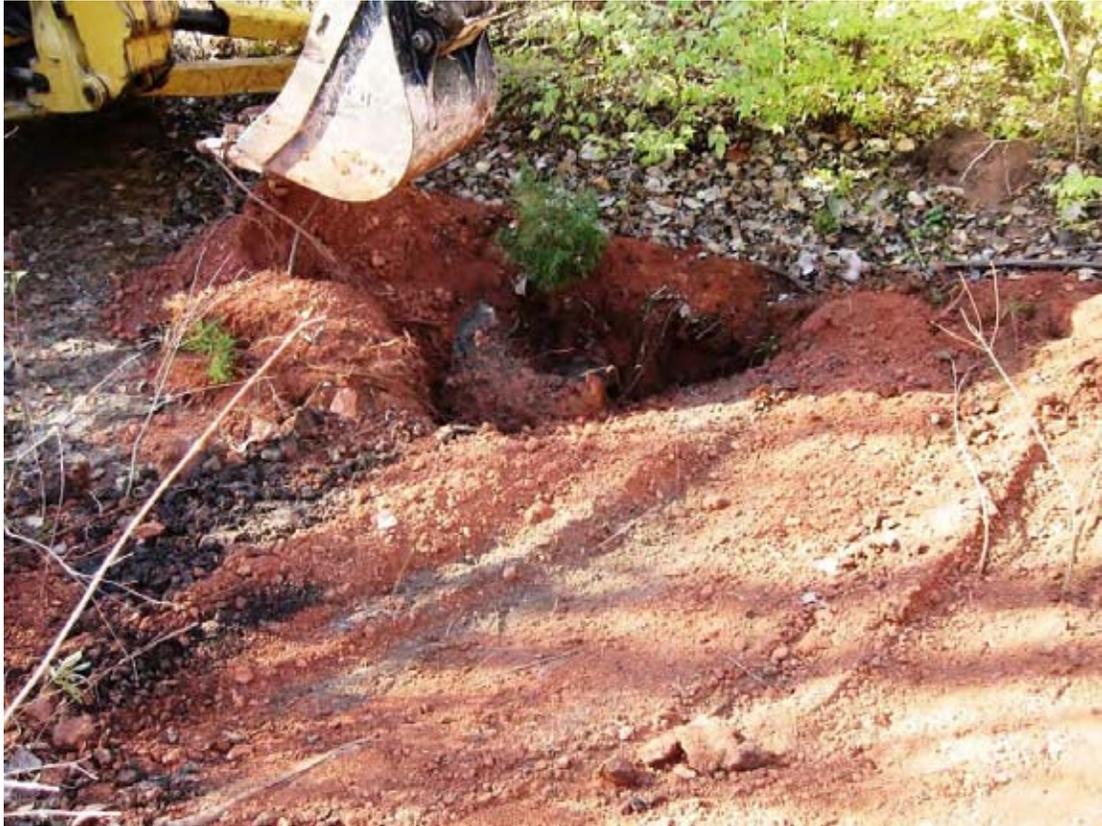
### TP-11, Ground Elevation: ~415 feet

Depth (feet)	Description
0 - 0.5	<b>TOPSOIL</b> –Red Brown Clayey SILT with roots and litter
0.5 - 2	Red Brown Clayey SILT
2 - 5	<b>ALLUVIUM</b> – Dark Gray Silty CLAY
	Test pit terminated at 5 feet No Groundwater Observed

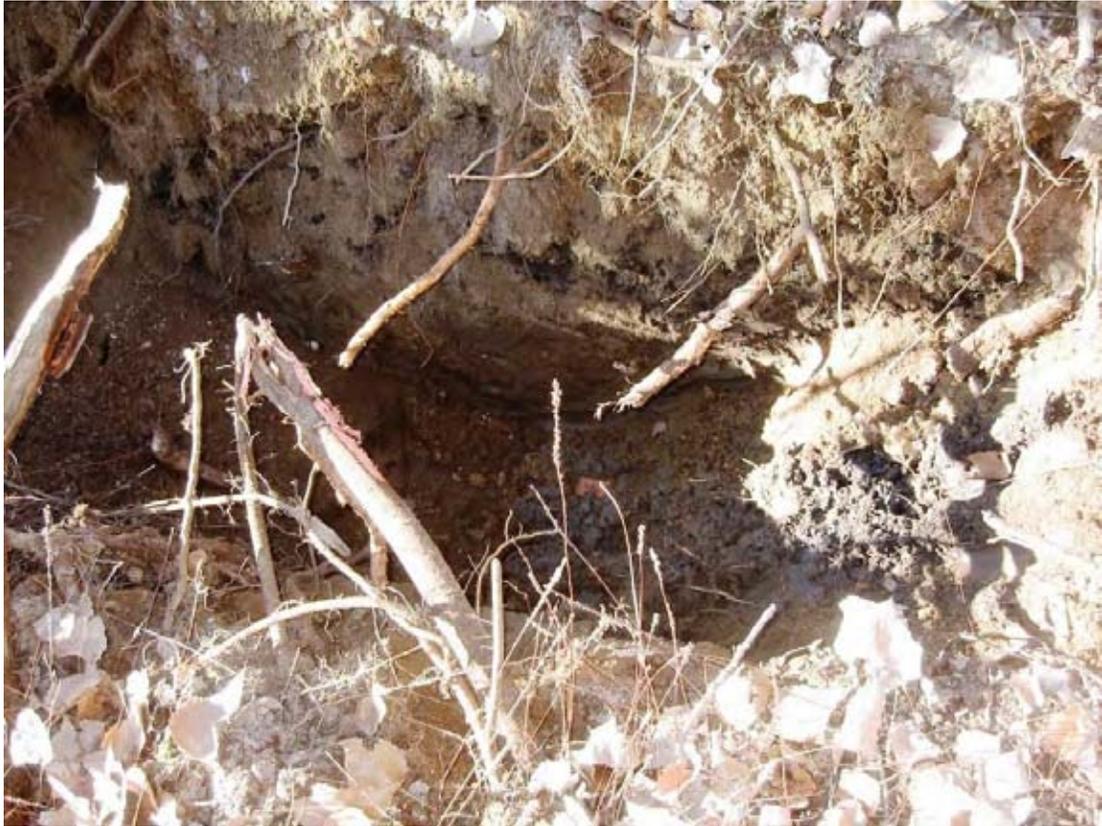
### TP-12, Ground Elevation: ~410 feet

Depth (feet)	Description
0 - 1	<b>TOPSOIL</b> – Tan Silty SAND with roots and litter
1 - 3	<b>ALLUVIUM</b> – Tan Silty SAND
3-5	Dark Gray Silty CLAY
	Test pit terminated at 5 feet No Groundwater Observed

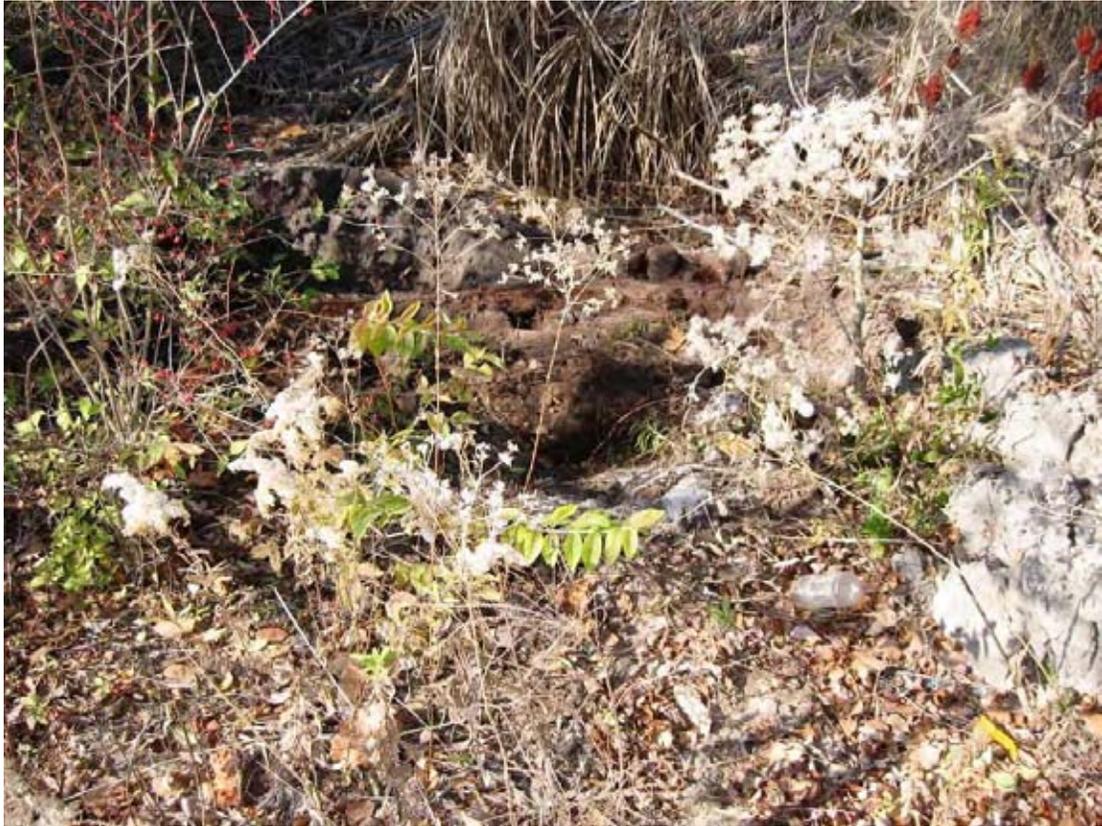
### TP-13, Ground Elevation: ~435 feet

Depth (feet)	Description
0 – 1	<b>GYPSUM</b> – Gray Silty Gravel mixed with red clayey silt, roots, and trash
	Test pit terminated at 1 foot (refusal) No Groundwater Observed

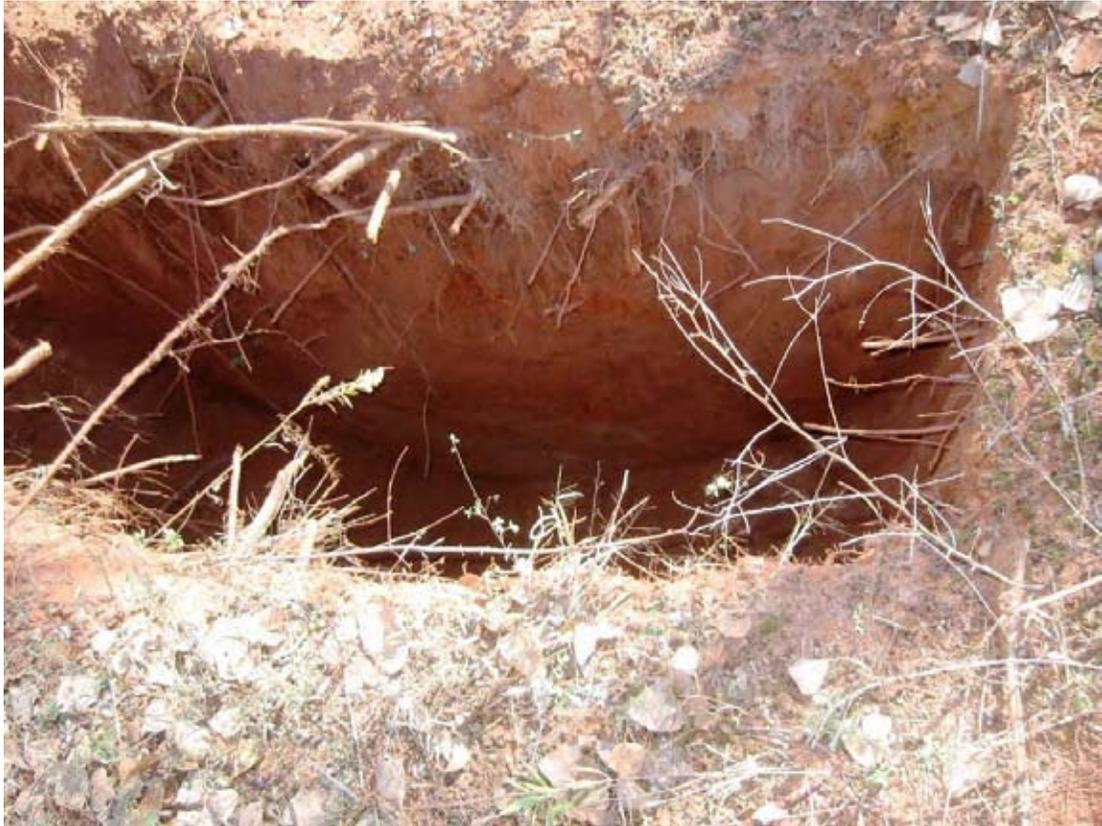
### TP-14, Ground Elevation: ~440 feet

Depth (feet)	Description
0 - 1	<b>TOPSOIL</b> – Red Brown Clayey SILT with roots and litter
1 - 5	<b>RESIDUE</b> – Red Brown Clayey SILT
	Test pit terminated at 5 feet No Groundwater Observed

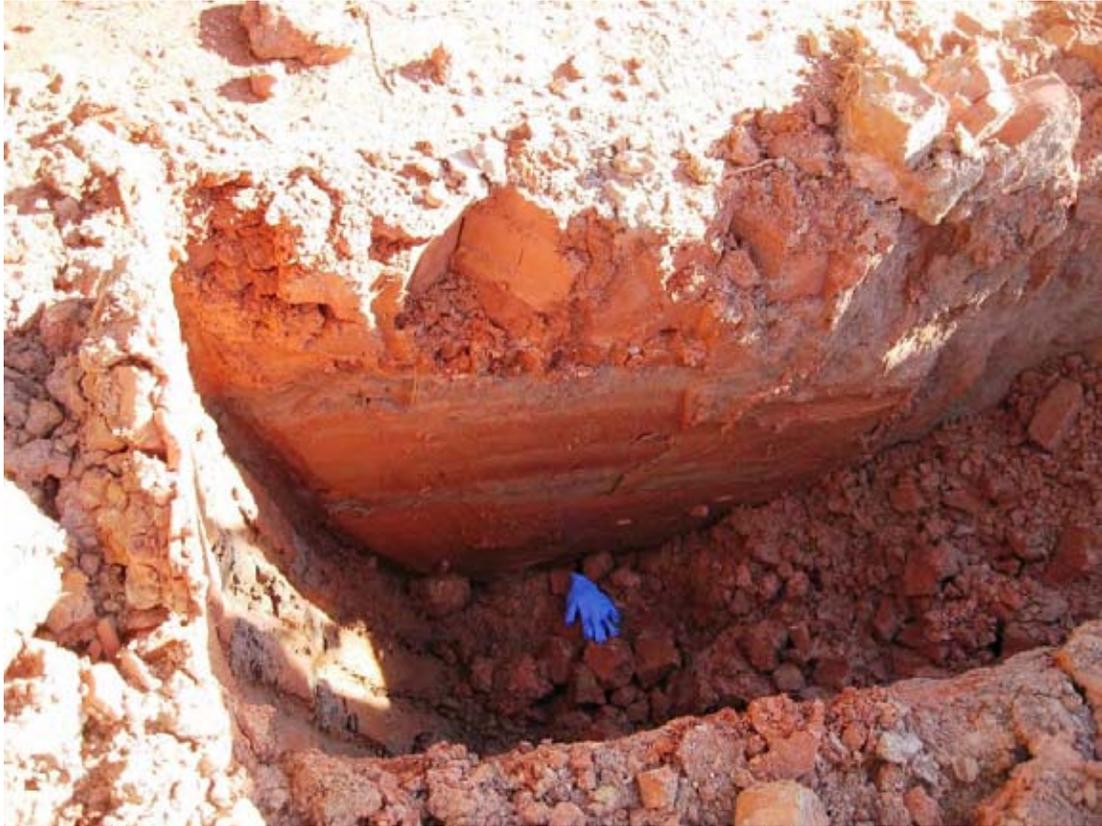
### TP-15, Ground Elevation: ~432 feet

Depth (feet)	Description
0 – 3	<b>RESIDUE</b> –Red Brown Clayey SILT, Dry at Surface, Increasing Moisture with Depth
3-3.3	Tan Sand Seam
3.3-5	Red Brown Clayey SILT
	Test pit terminated at 5 feet No Groundwater Observed

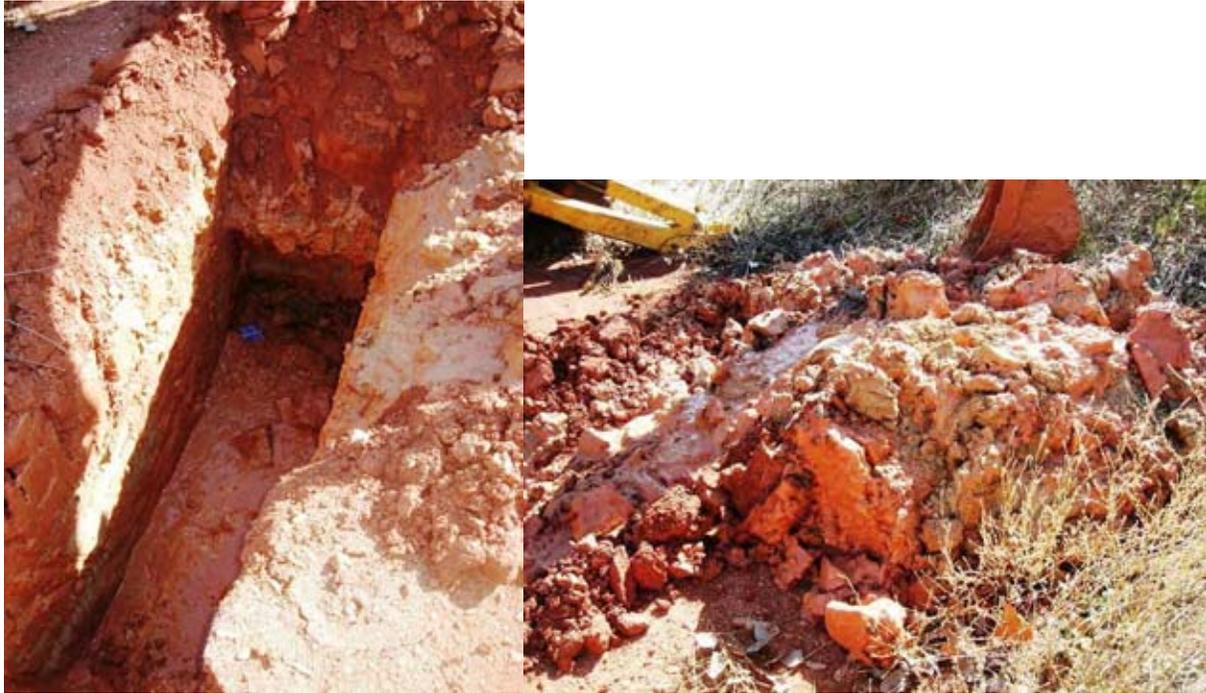
**TP-16, Ground Elevation: ~433 feet**

Depth (feet)	Description
0 – 6.0	<b>RESIDUE</b> –Red Brown Clayey SILT, Dry at Surface, Increasing Moisture with Depth
	Test pit terminated at 6 feet Groundwater Observed at 5 feet

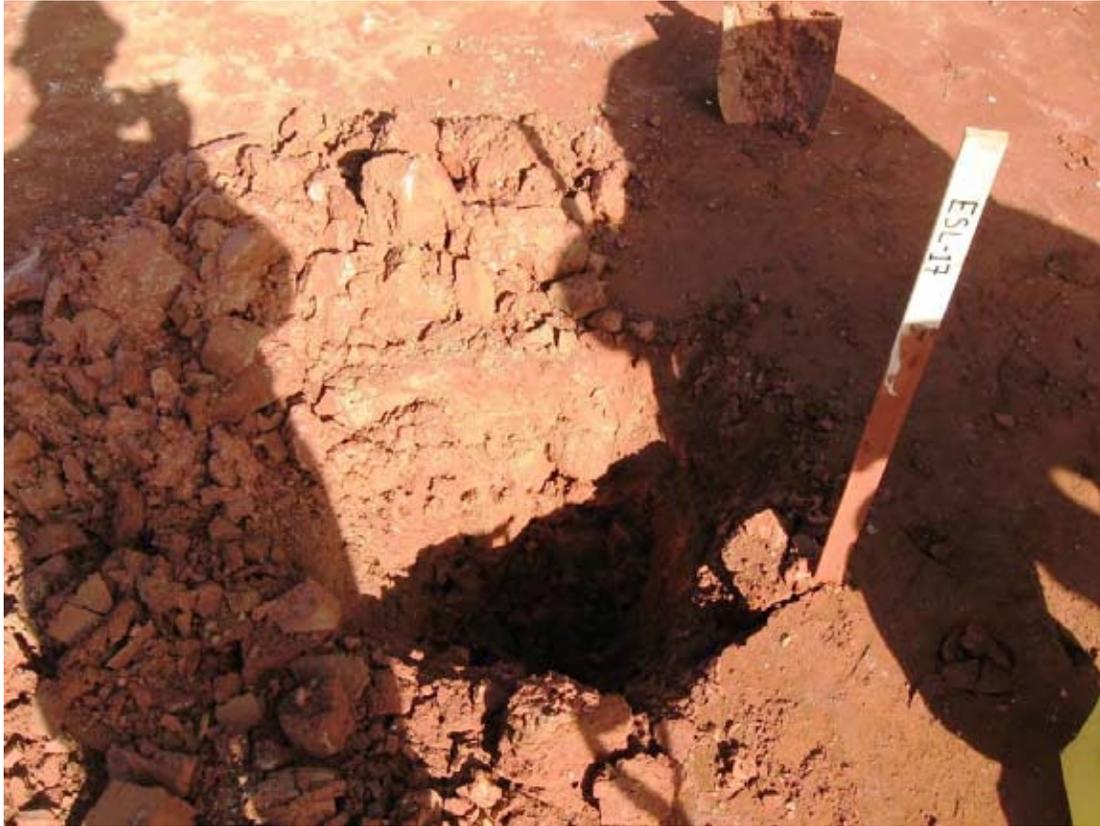
### TP-17, Ground Elevation: ~434 feet

Depth (feet)	Description
0 – 1.5	<b>RESIDUE</b> –Red Brown Clayey SILT, Dry at Surface, Increasing Moisture with Depth
	Test pit terminated at 1.5 feet No Groundwater Observed

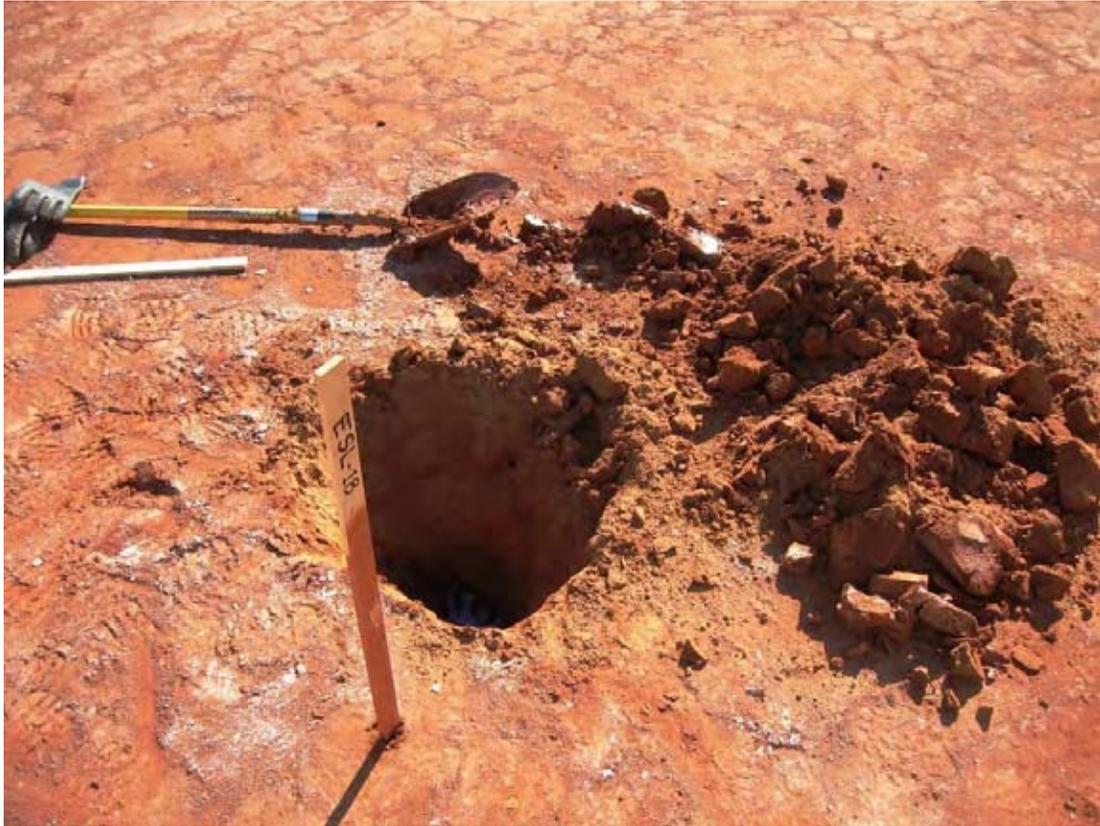
### TP-18, Ground Elevation: ~434 feet

Depth (feet)	Description
0 – 1.4	<b>RESIDUE</b> –Red Brown Clayey SILT, Dry at Surface, Increasing Moisture with Depth
	Test pit terminated at 1.4 feet No Groundwater Observed

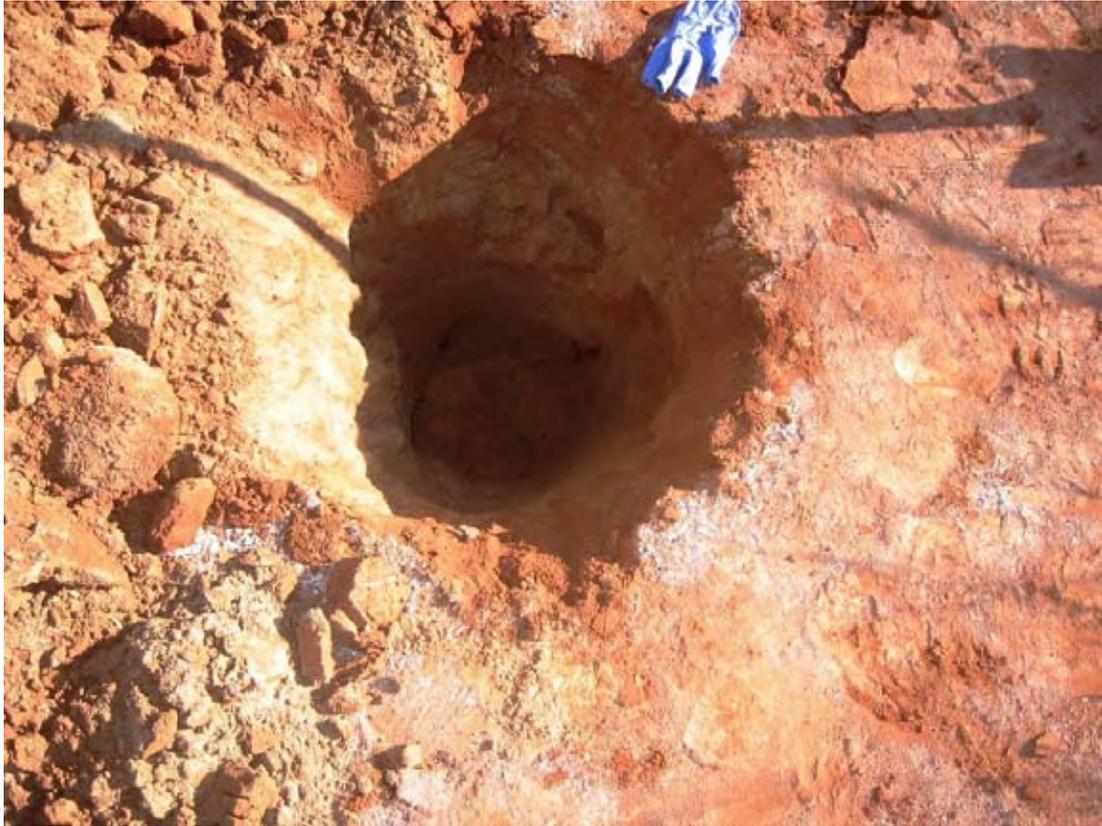
**TP-19, Ground Elevation: ~436 feet**

Depth (feet)	Description
0 – 1.1	<b>RESIDUE</b> –Red Brown Clayey SILT, Dry at Surface, Increasing Moisture with Depth
	Test pit terminated at 1.1 feet No Groundwater Observed

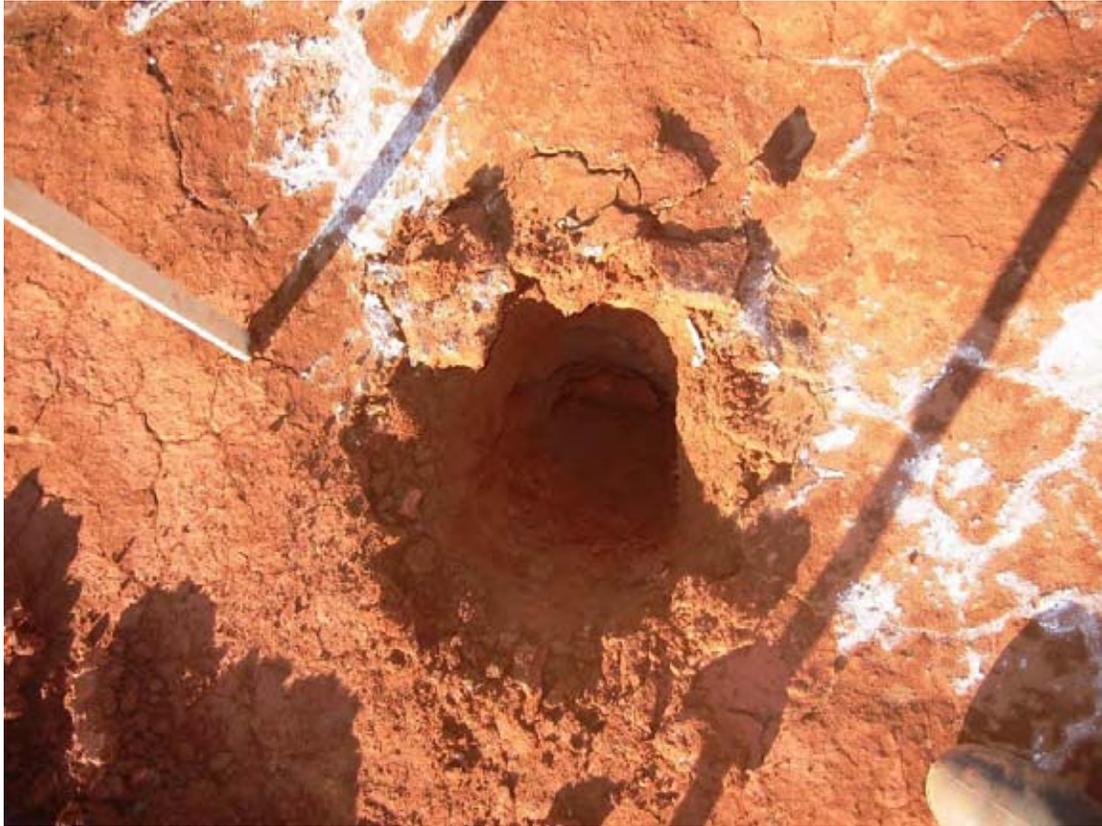
**TP-20, Ground Elevation: ~433 feet**

Depth (feet)	Description
0 – 1.0	<b>RESIDUE</b> –Red Brown Clayey SILT, Dry at Surface, Increasing Moisture with Depth
	Test pit terminated at 1.0 feet No Groundwater Observed

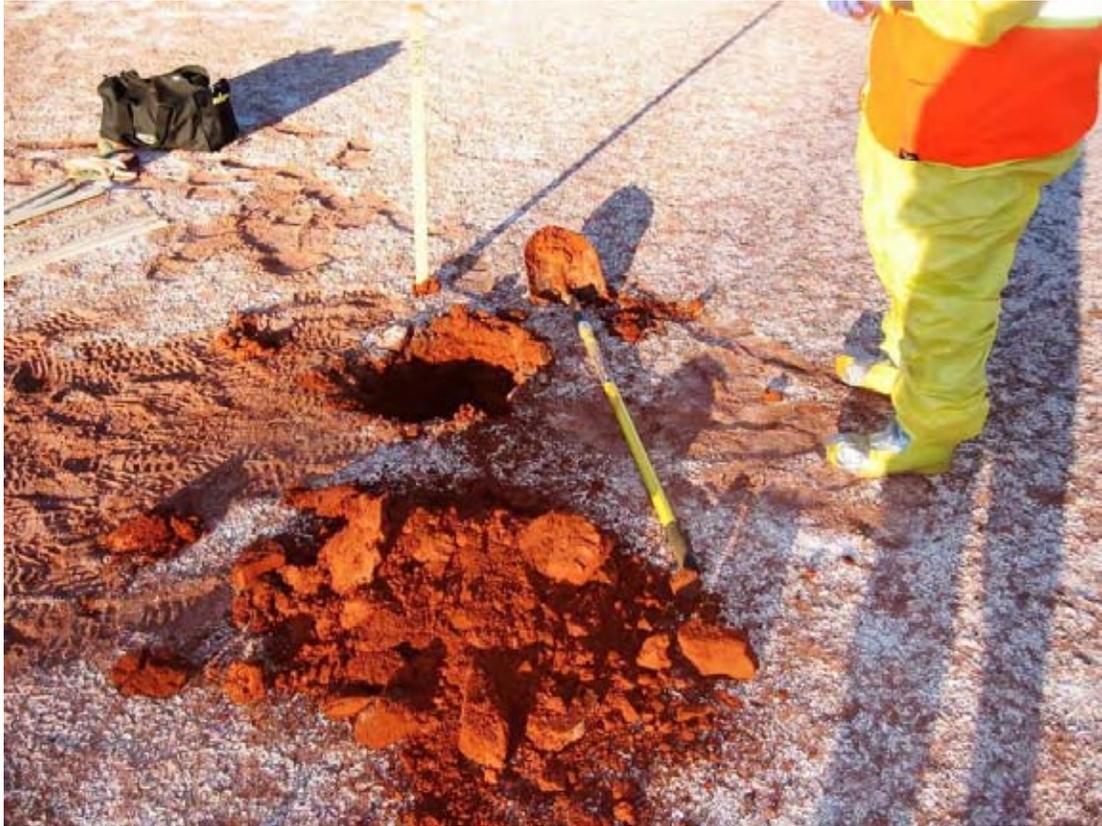
### TP-21, Ground Elevation: ~433 feet

Depth (feet)	Description
0 – 1.2	<b>RESIDUE</b> –Red Brown Clayey SILT, Dry at Surface, Increasing Moisture with Depth
	Test pit terminated at 1.2 feet No Groundwater Observed

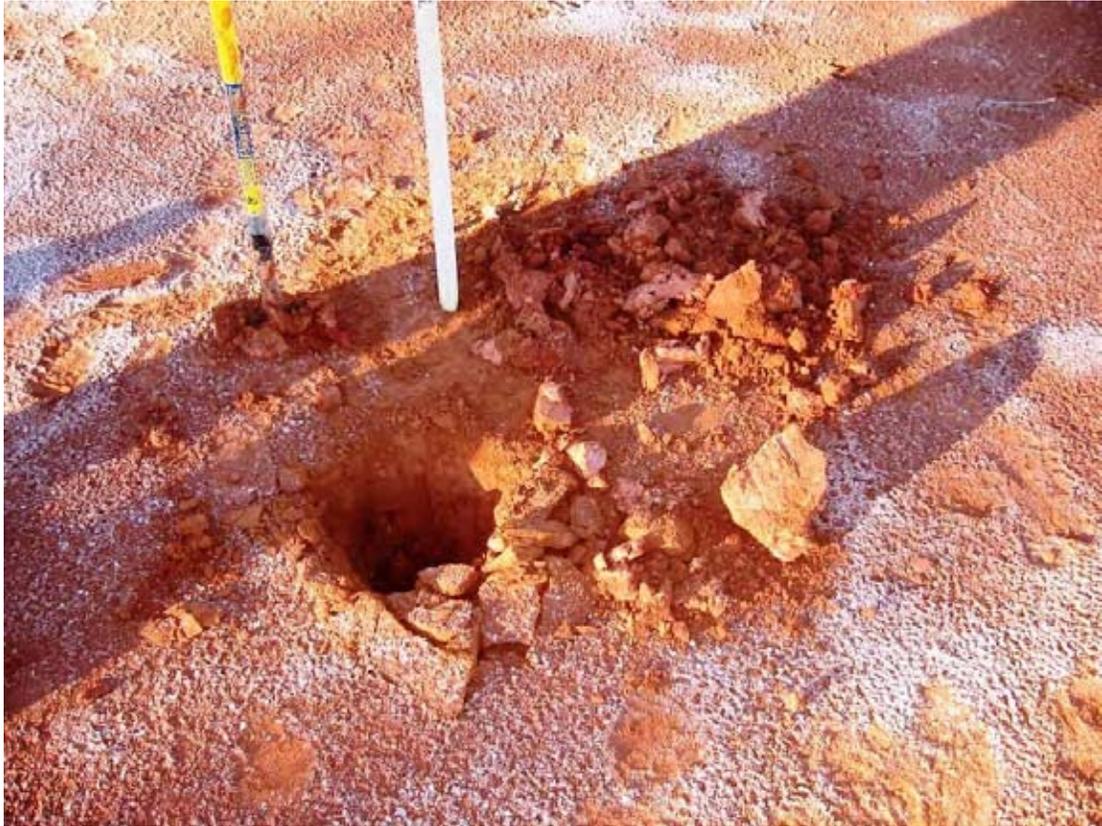
**TP-22, Ground Elevation: ~433 feet**

Depth (feet)	Description
0 – 1.0	<b>RESIDUE</b> –Red Brown Clayey SILT, Dry at Surface, Increasing Moisture with Depth
	Test pit terminated at 1.0 feet No Groundwater Observed

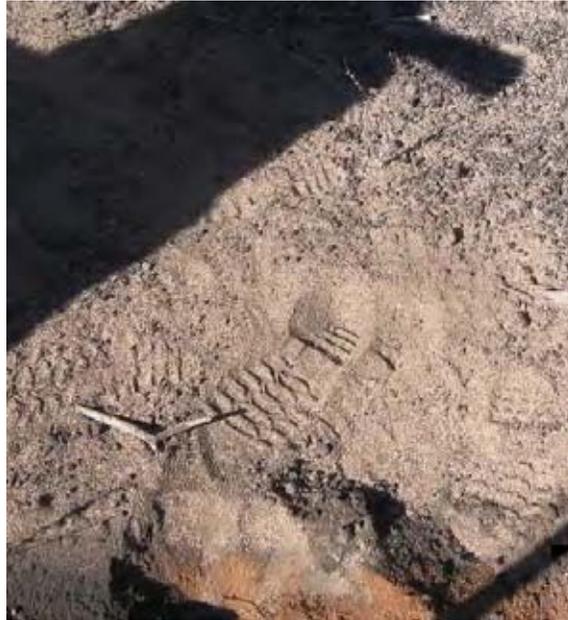
**TP-23, Ground Elevation: ~425 feet**

Depth (feet)	Description
0 – 0.2	Tan Black Fine to Medium SAND
0.2-1.2	<b>RESIDUE</b> –Red Brown Clayey SILT
	Test pit terminated at 1.2 feet No Groundwater Observed

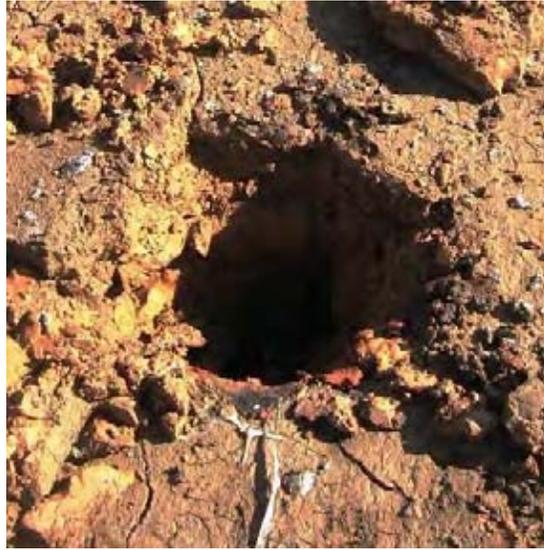
**TP-24, Ground Elevation: ~425 feet**

Depth (feet)	Description
0 - 1	<b>RESIDUE</b> -Red Tan Clayey SILT Test pit terminated at 1.0 feet No Groundwater Observed
