**PRE-DESIGN INVESTIGATION REPORT  
PROPOSED SOLAR REDEVELOPMENT PROJECT  
FORMER BAUXITE RESIDUE DISPOSAL AREAS  
Operable Unit 1, North Alcoa Site**

East St. Louis, Illinois

**Restoration Land Development Company, LLC**  
Wellesley, MA

**AMEC Environment & Infrastructure, Inc.**  
800 N. Bell Avenue, Suite 200  
Pittsburgh, Pennsylvania 15106  
(412) 279-6661

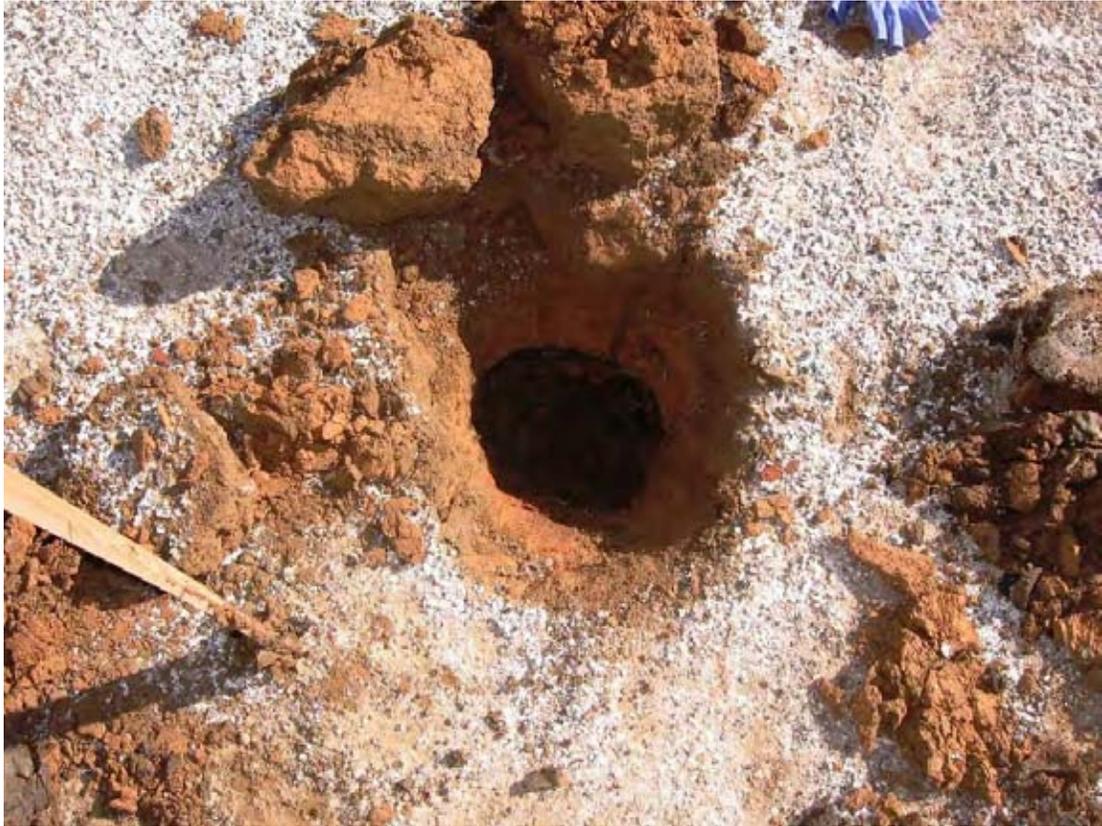
### TP-25, Ground Elevation: ~425 feet

Depth (feet)	Description
0 – 0.1	<b>RESIDUE</b> –Red Brown Clayey SILT w/Lime Precipitate
0.1-1	Red Clayey SILT
1 – 1.2	Tan Brown Silty Fine SAND
	Test pit terminated at 1.2 feet No Groundwater Observed

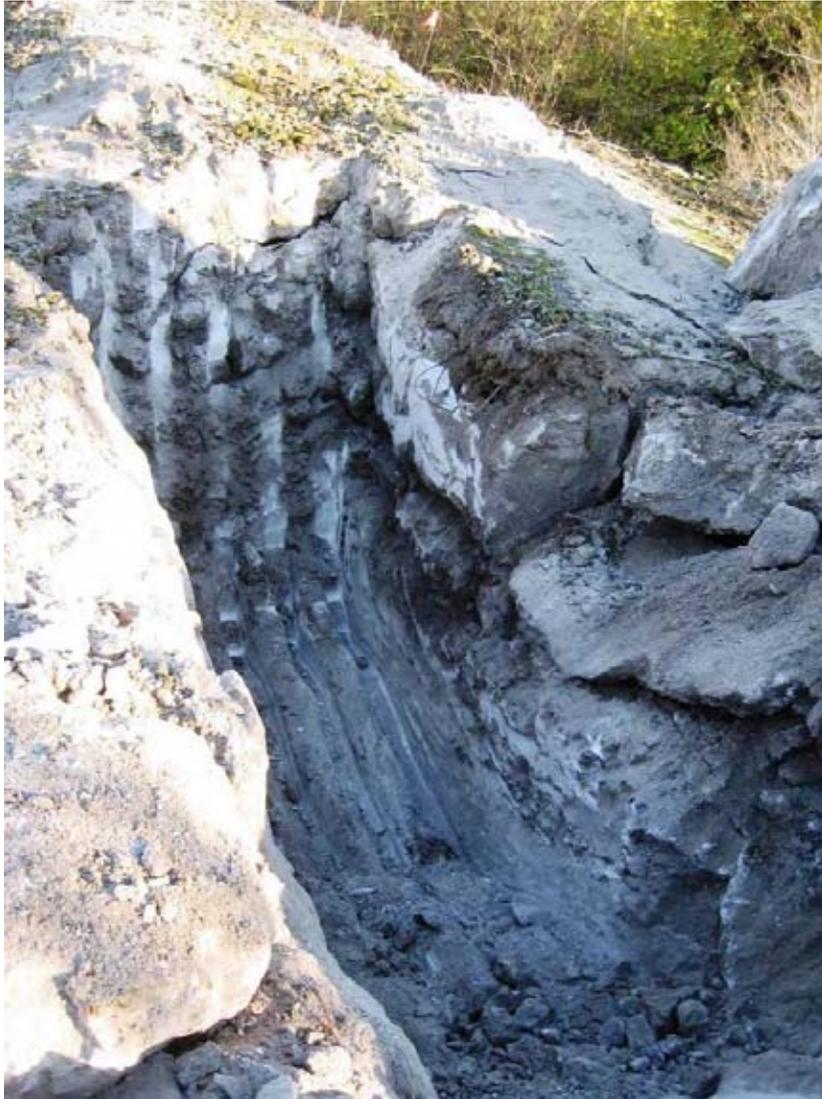
**TP-26, Ground Elevation: ~440 feet**

Depth (feet)	Description
0-6	<b>GYPSUM-White Gray Strongly Cemented, Fractured Fine Sandy SILT</b> Test pit terminated at 6 feet (refusal) No Groundwater Observed

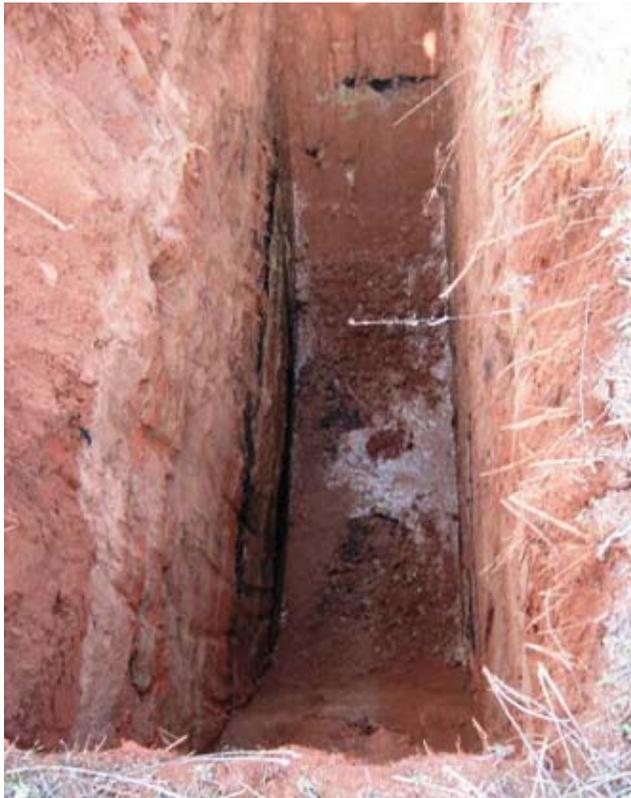
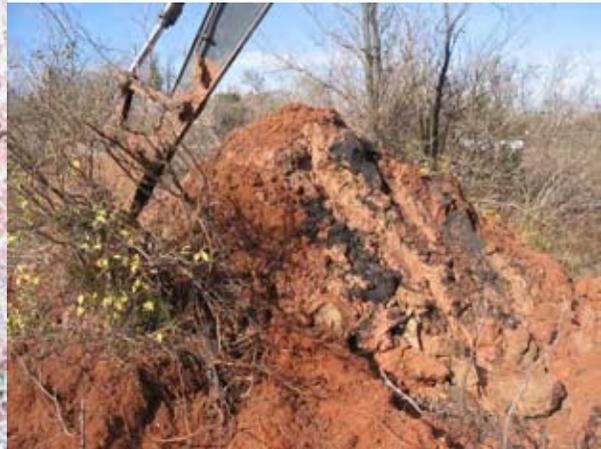
**TP-27, Ground Elevation: ~439 feet**

Depth (feet)	Description
0 - 1	<b>TOPSOIL</b> – Red Silty Fine SAND with Roots
1-2	<b>RESIDUE</b> –Red Thixotropic Clayey SILT w/Sand Seams
2 - 9	Tan Red SAND with Clayey Silt Seams
9-10	Black Clayey SILT w/Sand Seams
10-12	Tan Red SAND with Clayey Silt Seams
12-14	Black Clayey SILT w/Sand Seams
	Test pit terminated at 14 feet Groundwater (or Liquefied Material) observed at 13 feet

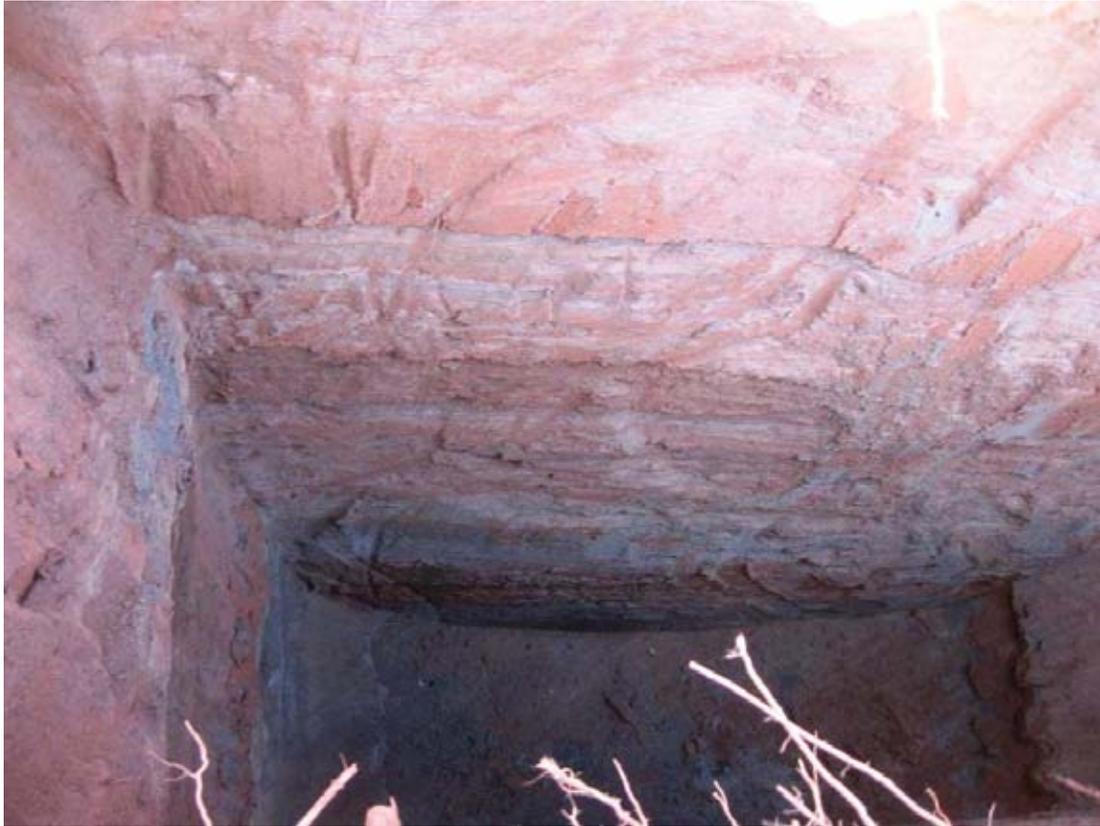
### TP-28, Ground Elevation: ~439 feet

Depth (feet)	Description
0-0.5	<b>TOPSOIL</b> – Red Sandy Clayey SILT with Roots
0.5-1	<b>GYPSUM</b> -Dark Gray Cemented Fine Sandy SILT
1-3	<b>RESIDUE</b> – Red Thixotropic Clayey SILT
3-6	Red Tan Silty Fine SAND
6-17	Gray Silty Fine SAND
	Test pit terminated at 17 feet No Groundwater Observed

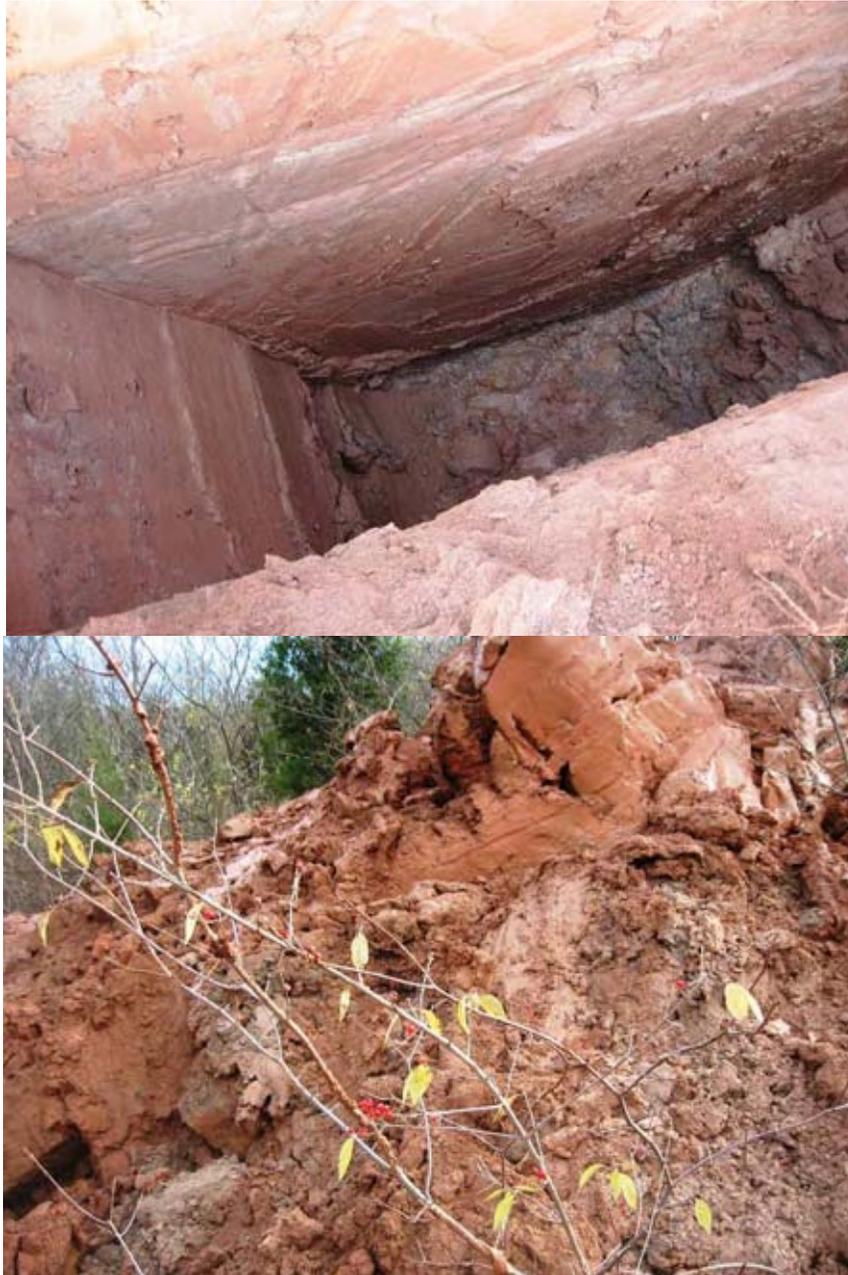
### TP-29, Ground Elevation: ~436 feet

Depth (feet)	Description
0-15	<b>RESIDUE</b> – Red Thixotropic Clayey SILT w/1 Inch Sand Seams at 2 and 4 feet
	Test pit terminated at 15 feet (caving) Groundwater Observed at 13 feet

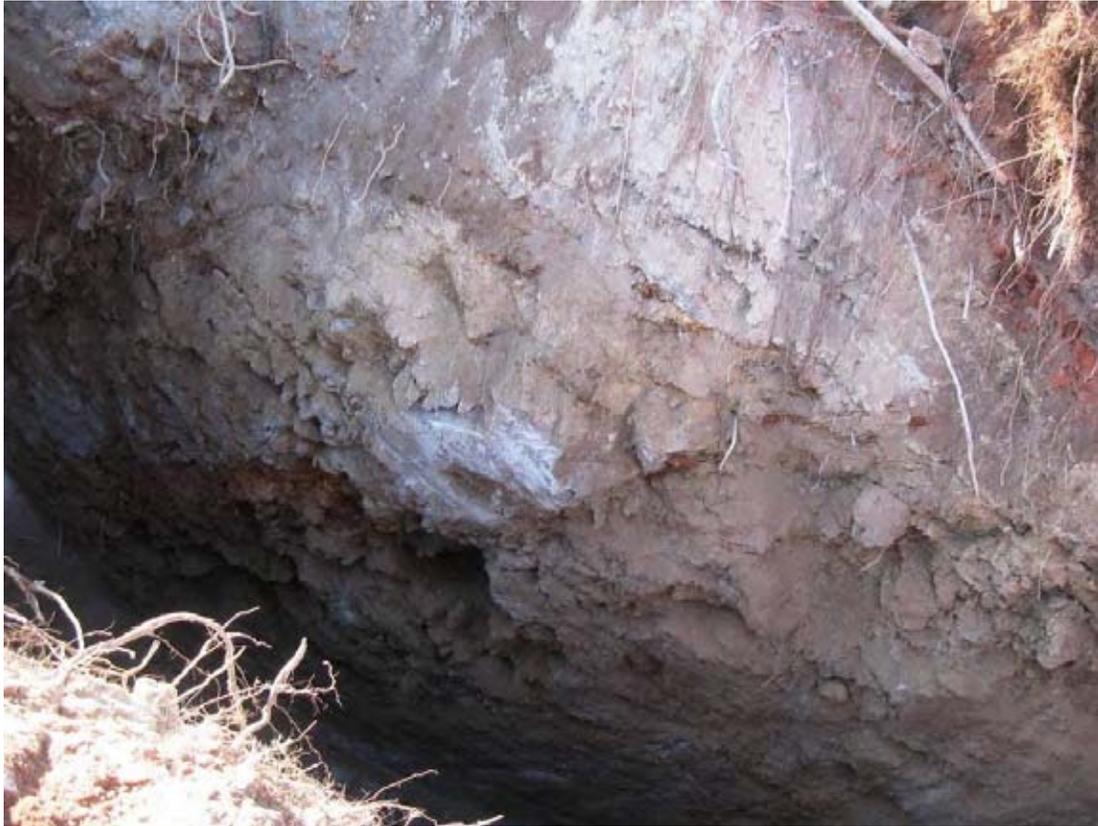
**TP-30, In Side of Dike, Top of Dike ~441, base ~ 432**

Depth (feet)	Description From Top of Dike	Description From Base
0-3	<b>GYPSUM</b> -Dark Gray Cemented Fine Sandy SILT	
3-7	Black Cemented Material	
7-10	<b>GYPSUM</b> -Dark Gray Cemented Fine Sandy SILT	
10-11	<b>TOPSOIL</b> – Red Brown Silty Sand with Roots, Rising toward base	
12-20	Tan Silty Fine SAND w/Gypsum Inclusions	<b>RESIDUE</b> – Red Clayey SILT
20-22	<b>GYPSUM</b> -White Cemented Fine Sandy SILT	
	Test pit terminated at 22 feet (from Top of Dike) No Groundwater Observed

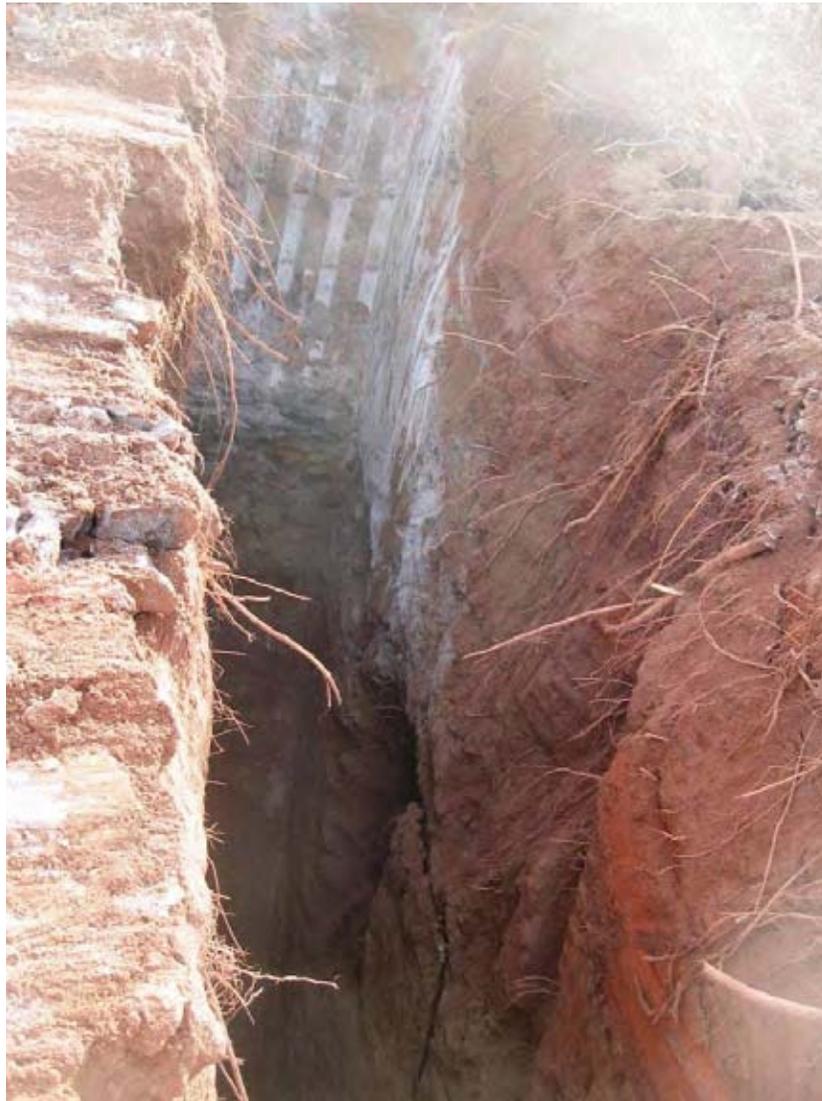
**TP-31, Ground Elevation: ~442 feet**

Depth (feet)	Description Near Dike	Description Away from Dike
0-2	GYPSUM-Gray White Cemented Fine Sandy SILT (apparent Step-In Dike)	TOPSOIL – Red Sandy Clayey SILT with Roots
2-9		RESIDUE – Red Brown Black Sandy Clayey SILT, Thixotropic Seams
9-20	Tan Sandy Clayey SILT, Thixotropic Seams	
Test pit terminated at 20 feet No Groundwater Observed

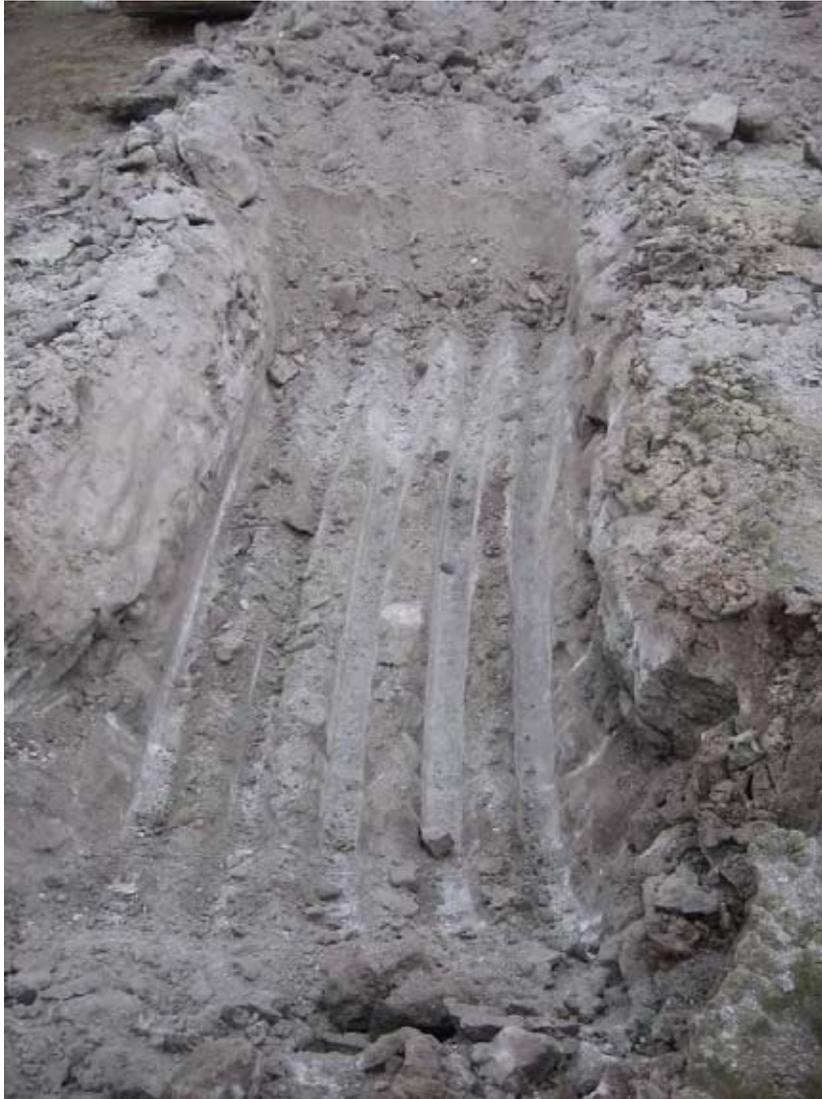
**TP-32, Ground Elevation: ~447 feet**

Depth (feet)	Description
0-0.5	<b>GYPSUM</b> -Dark Gray Weakly Cemented Fine Sandy SILT
0.5-2	White Gray Strongly Cemented Fine Sandy SILT
	Test pit terminated at 2 feet (refusal) No Groundwater Observed

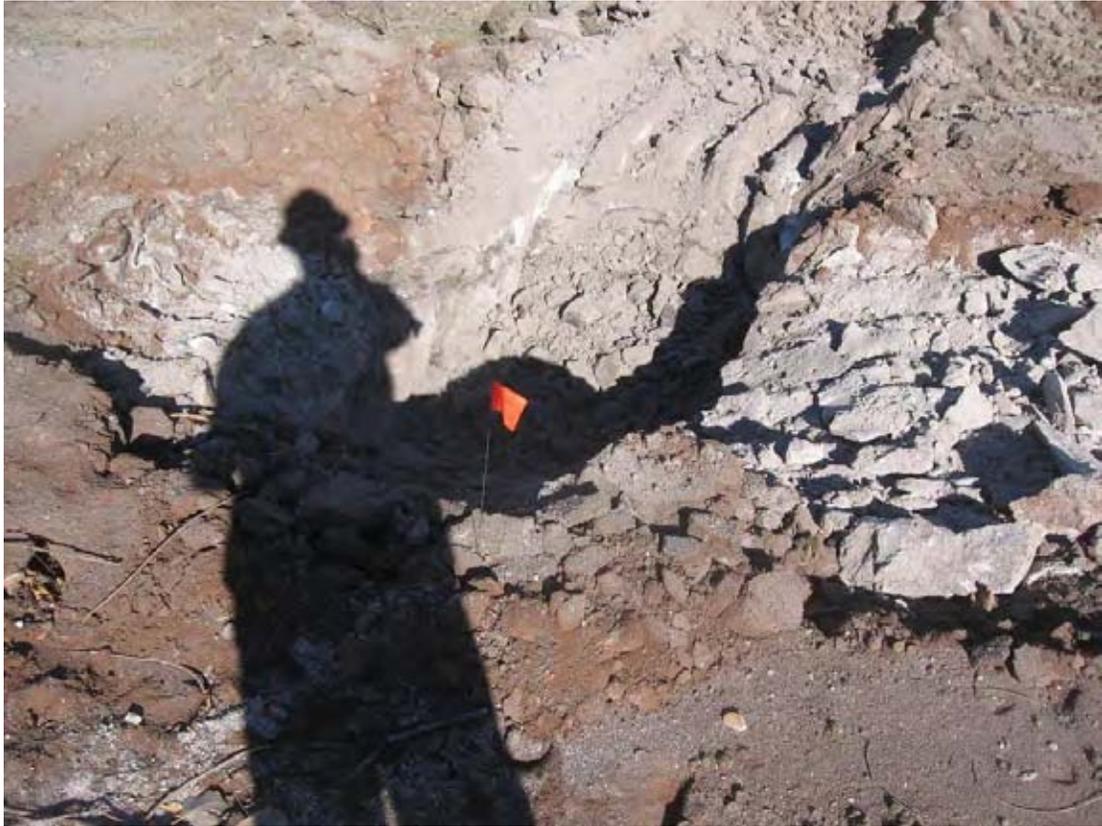
### TP-33, Ground Elevation: ~440 feet

Depth (feet)	Description
0-0.5	<b>GYPSUM</b> -Dark Gray Weakly Cemented Fine Sandy SILT w/Red Fine Sandy Silt
0.5-2	White Gray Strongly Cemented Fine Sandy SILT
	Test pit terminated at 2 feet (refusal) No Groundwater Observed

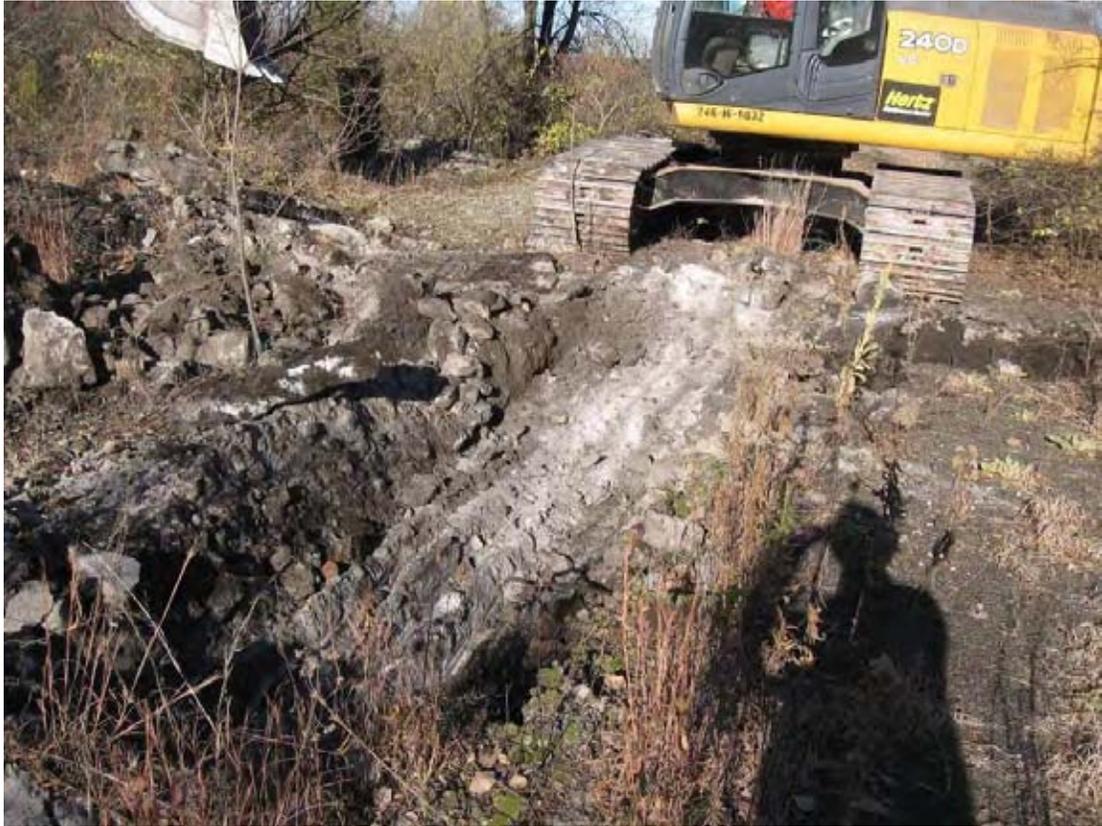
### TP-34, Ground Elevation: ~421 feet

Depth (feet)	Description
0-0.5	<b>GYPSUM</b> -Dark Gray Weakly Cemented Fine Sandy SILT
0.5-2	White Gray Strongly Cemented Fine Sandy SILT
	Test pit terminated at 2 feet (refusal) No Groundwater Observed

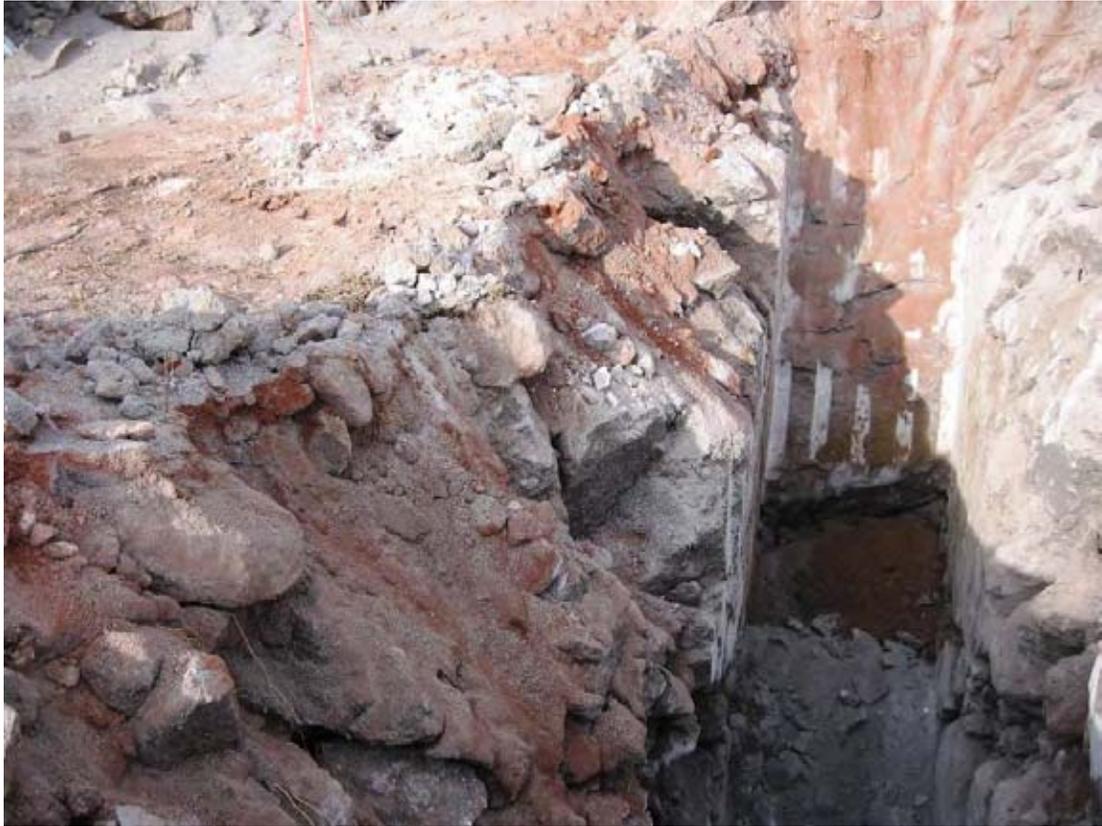
**TP-35, Ground Elevation: ~441 feet**

Depth (feet)	Description
0-14	<b>GYPSUM-White Gray Strongly Cemented and Fractured Fine Sandy SILT</b>
	Test pit terminated at 14 feet (refusal) No Groundwater Observed

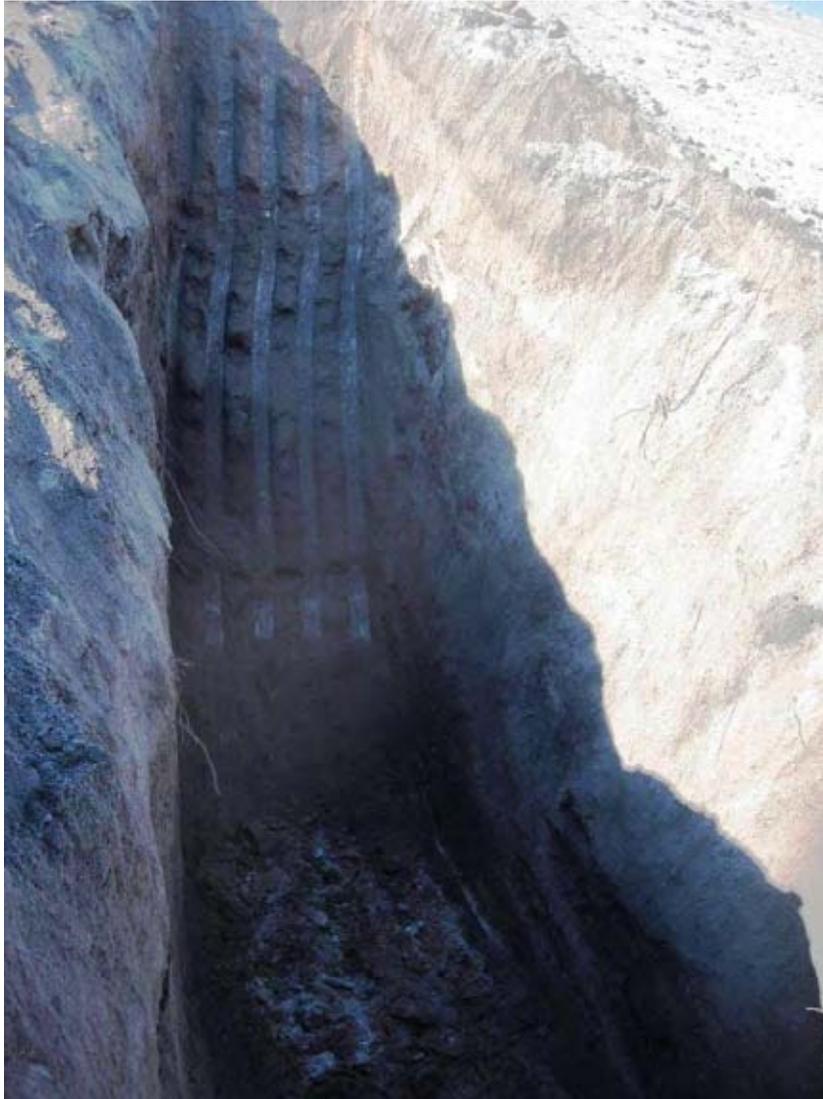
**TP-36, Into Bank, Top Elevation ~436, Bottom ~420**

Depth (feet)	Description
0-15	<b>GYPSUM</b> -Gray Uncemented Silty Fine SAND Test pit terminated at 15 feet No Groundwater Observed

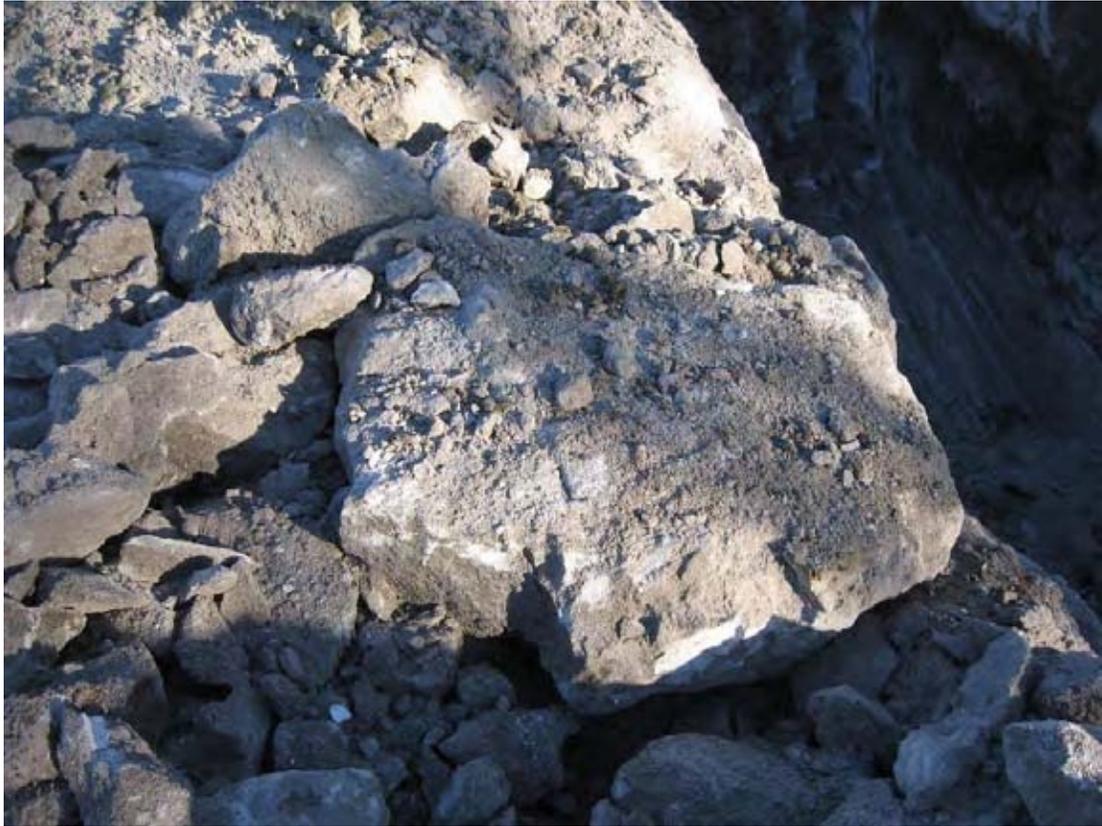
**TP-37, Ground Elevation: ~436 feet**

Depth (feet)	Description
0-1	<b>TOPSOIL</b> -Dark Gray Silty Sand w/4 Inch Slabs of Cemented Fine Sandy SILT
1-2	<b>GYP SUM</b> -White Gray Strongly Cemented Fine Sandy SILT
	Test pit terminated at 2 feet (refusal) No Groundwater Observed

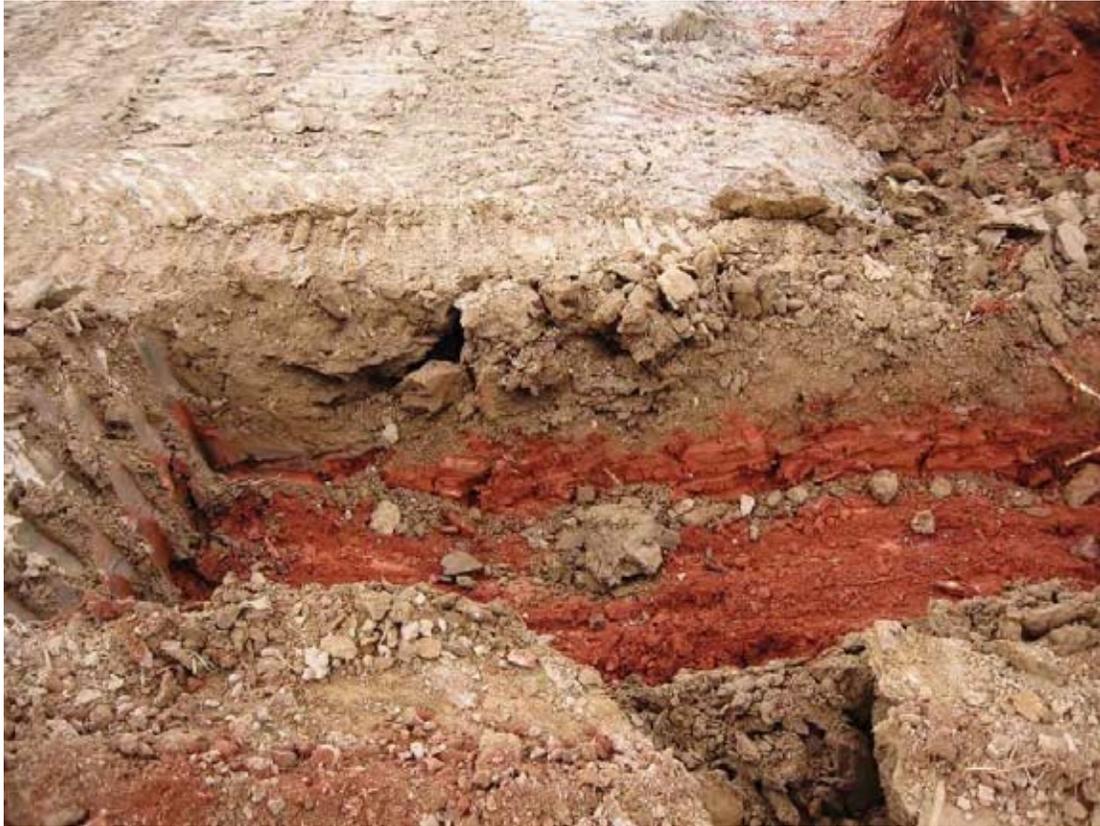
### TP-38, Ground Elevation: ~436 feet

Depth (feet)	Description
0-1.8	<b>TEST STRIP –Tan SILT</b>
1.8-2.6	<b>RESIDUE</b> – Red Clayey SILT, w/Phragmites Roots (No evidence of disturbance/subsidence at fill/residue interface)
	Test pit terminated at 2.6 feet No Groundwater Observed

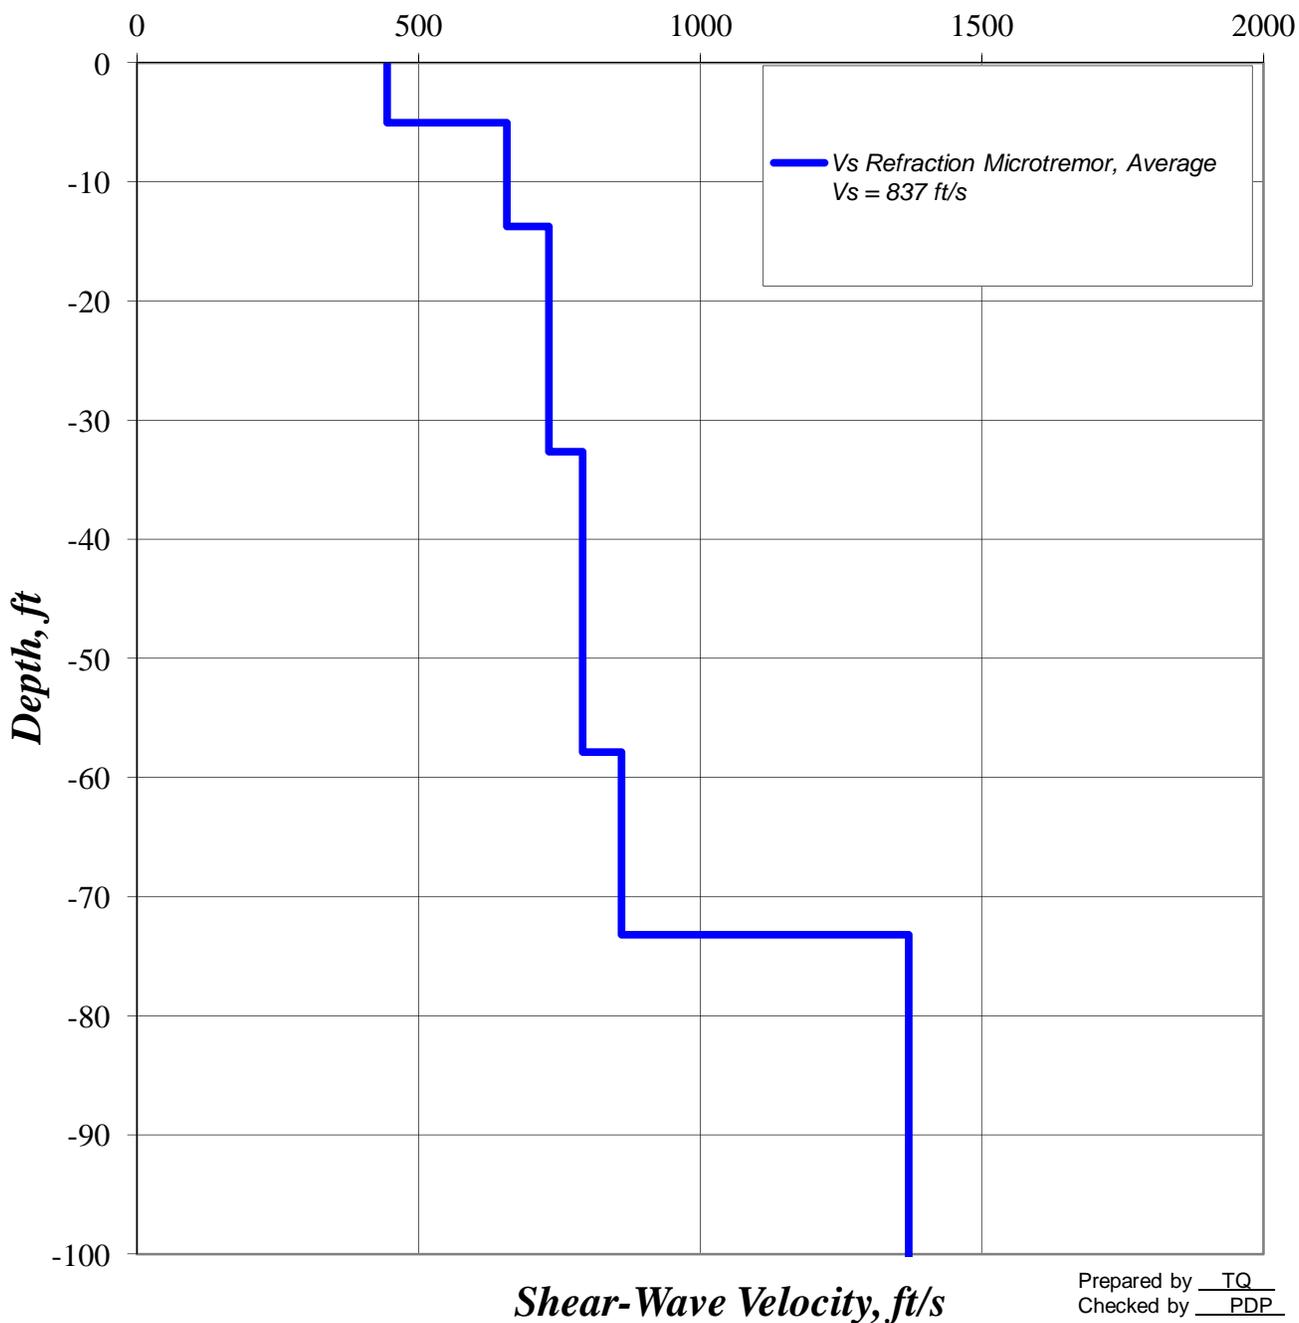
North Alcoa Site - East St Louis, IL  
Shear Wave Velocity Profile for ReMi Array 1  
AMEC Project No. 3410-10-0782

*Shear-Wave Velocity Profile from SeisOpt ReMi Software Analysis*

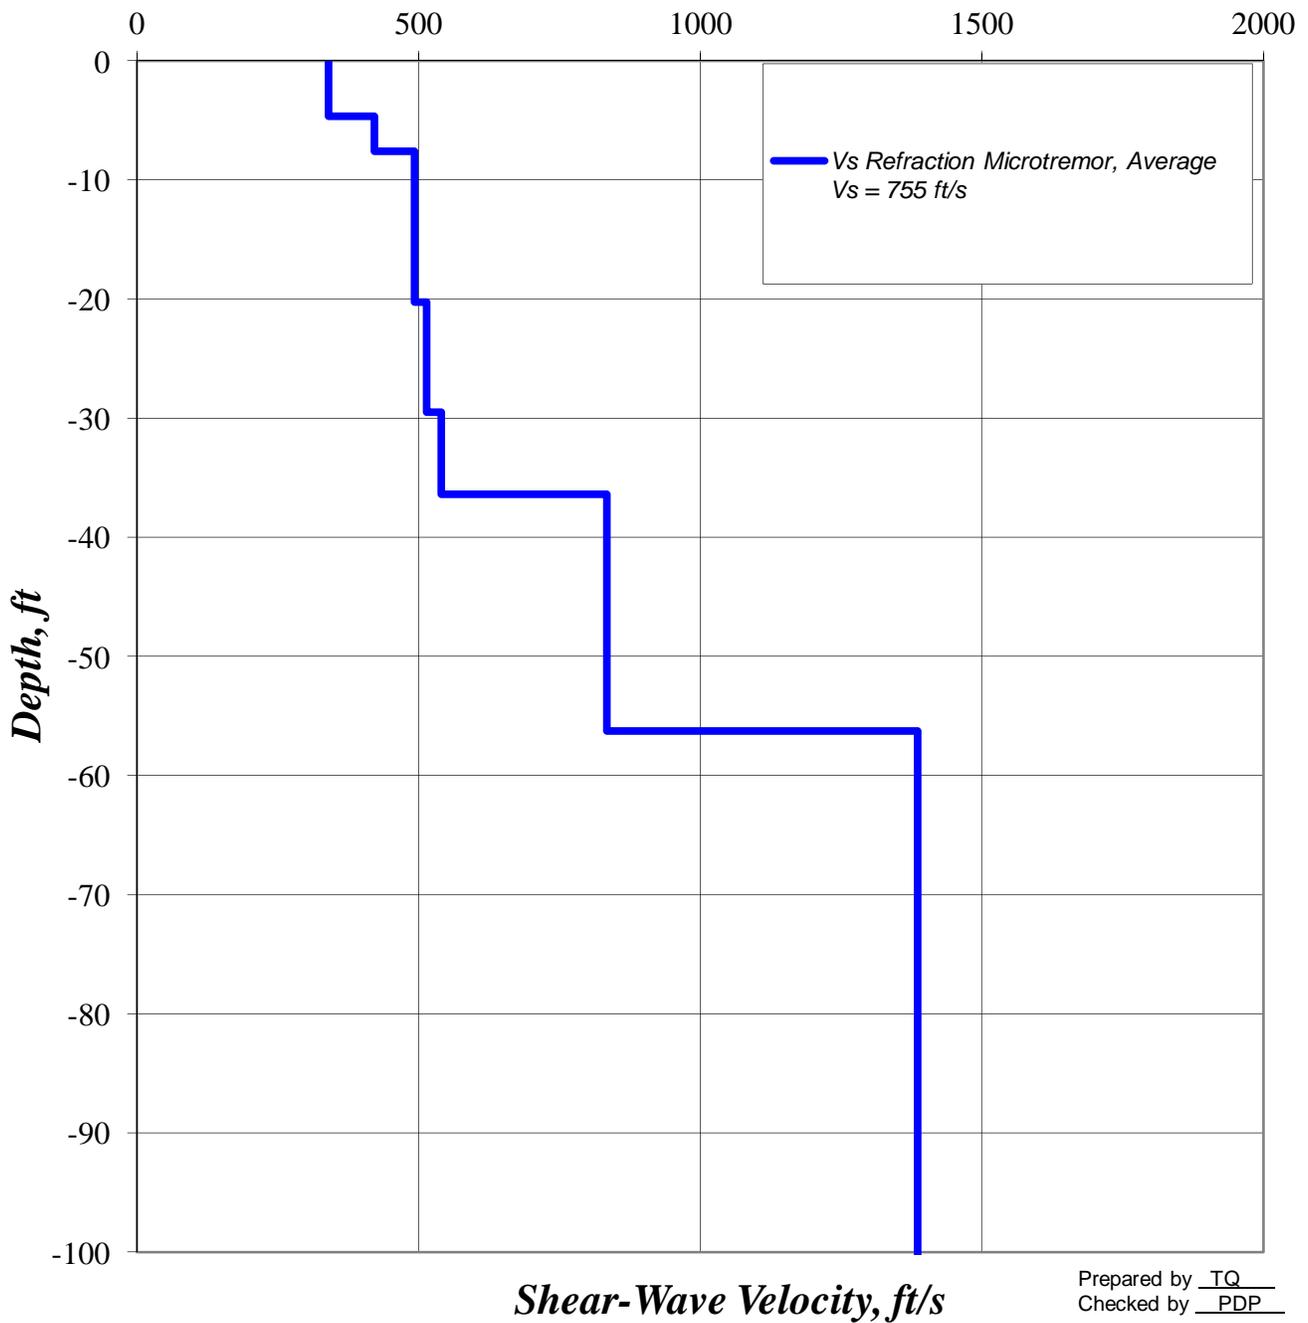
North Alcoa Site - East St Louis, IL  
Shear Wave Velocity Profile for ReMi Array 2  
AMEC Project No. 3410-10-0782

*Shear-Wave Velocity Profile from SeisOpt ReMi Software Analysis*

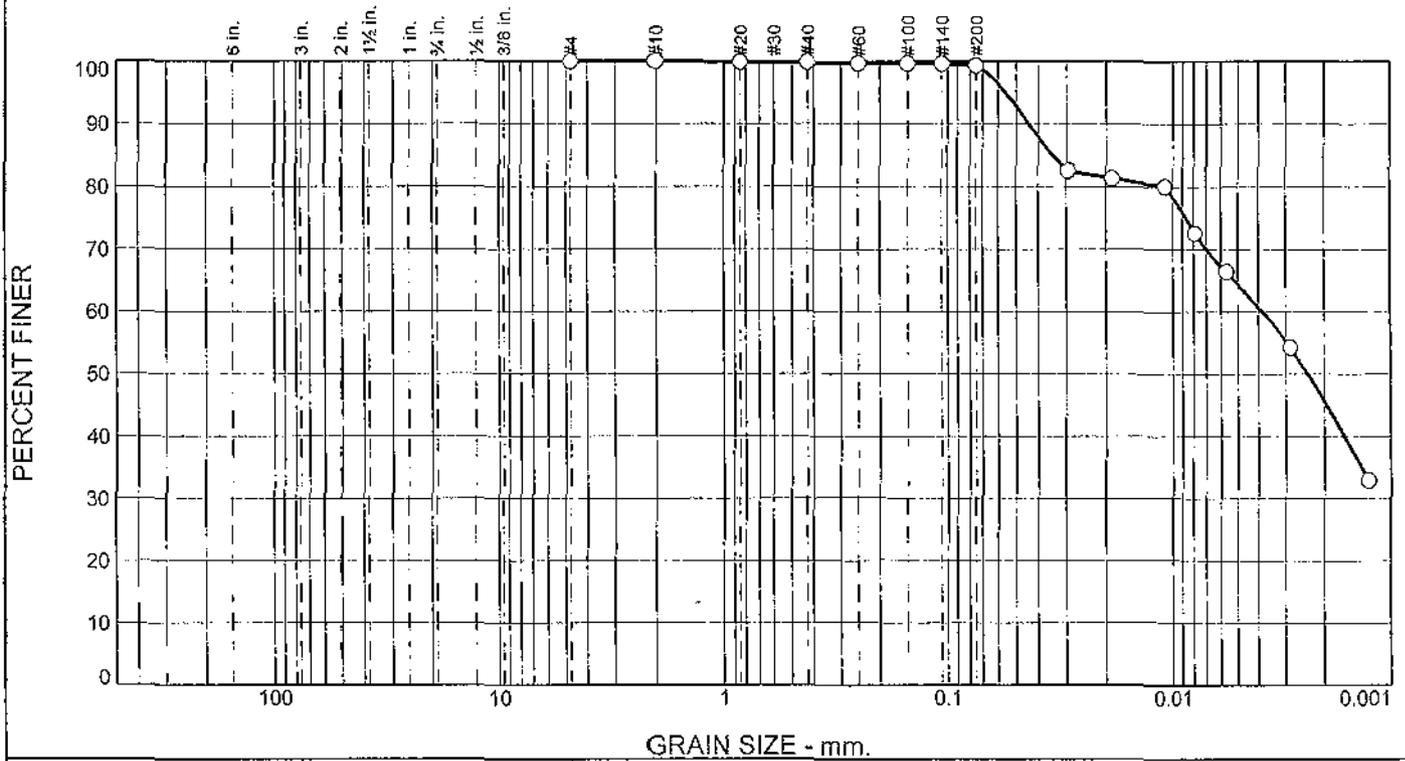
# Particulate Size Distribution (ASTM D422-63 (2007))

% +3"	% Gravel		% Sand			% Fines	
	Coarse	Fine	Coarse	Medium	Fine	Silt	Clay
0.0	0.0	0.0	0.0	0.2	0.5	35.0	64.3

TEST RESULTS			
Opening Size	Percent Finer	Spec.* (Percent)	Pass? (X=Fail)
#4	100.0		
#10	100.0		
#20	99.8		
#40	99.8		
#60	99.7		
#100	99.6		
#140	99.6		
#200	99.3		
0.0295 mm.	82.5		
0.0187 mm.	81.3		
0.0109 mm.	80.1		
0.0079 mm.	72.6		
0.0057 mm.	66.4		
0.0029 mm.	54.3		
0.0013 mm.	32.9

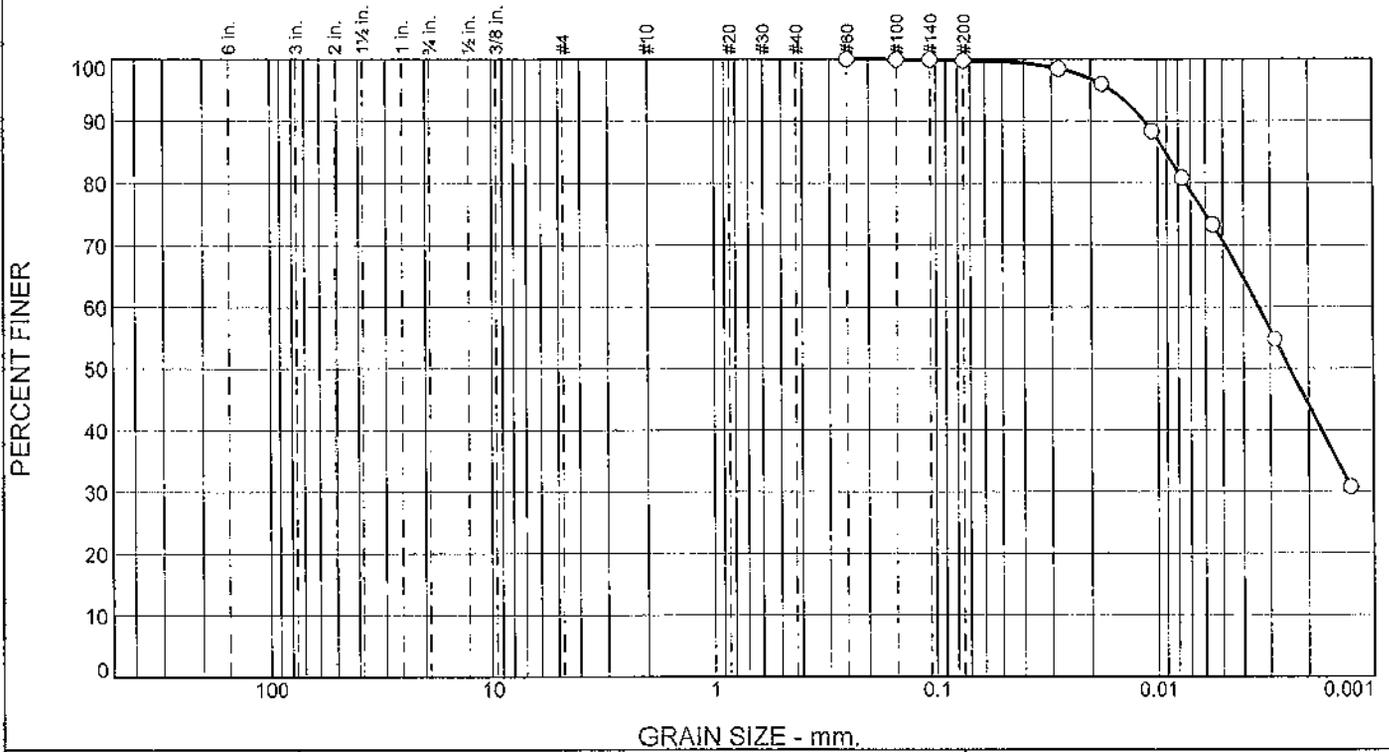
# Particulate Size Distribution (ASTM D422-63 (2007))

% +3"	% Gravel		% Sand			% Fines	
	Coarse	Fine	Coarse	Medium	Fine	Silt	Clay
0.0	0.0	0.0	0.0	0.0	0.2	29.2	70.6

TEST RESULTS			
Opening Size	Percent Finer	Spec.* (Percent)	Pass? (X=Fail)
#60	100.0		
#100	99.9		
#140	99.9		
#200	99.8		
0.0280 mm.	98.4		
0.0179 mm.	95.9		
0.0106 mm.	88.4		
0.0077 mm.	80.8		
0.0056 mm.	73.3		
0.0029 mm.	54.8		
0.0013 mm.	30.7

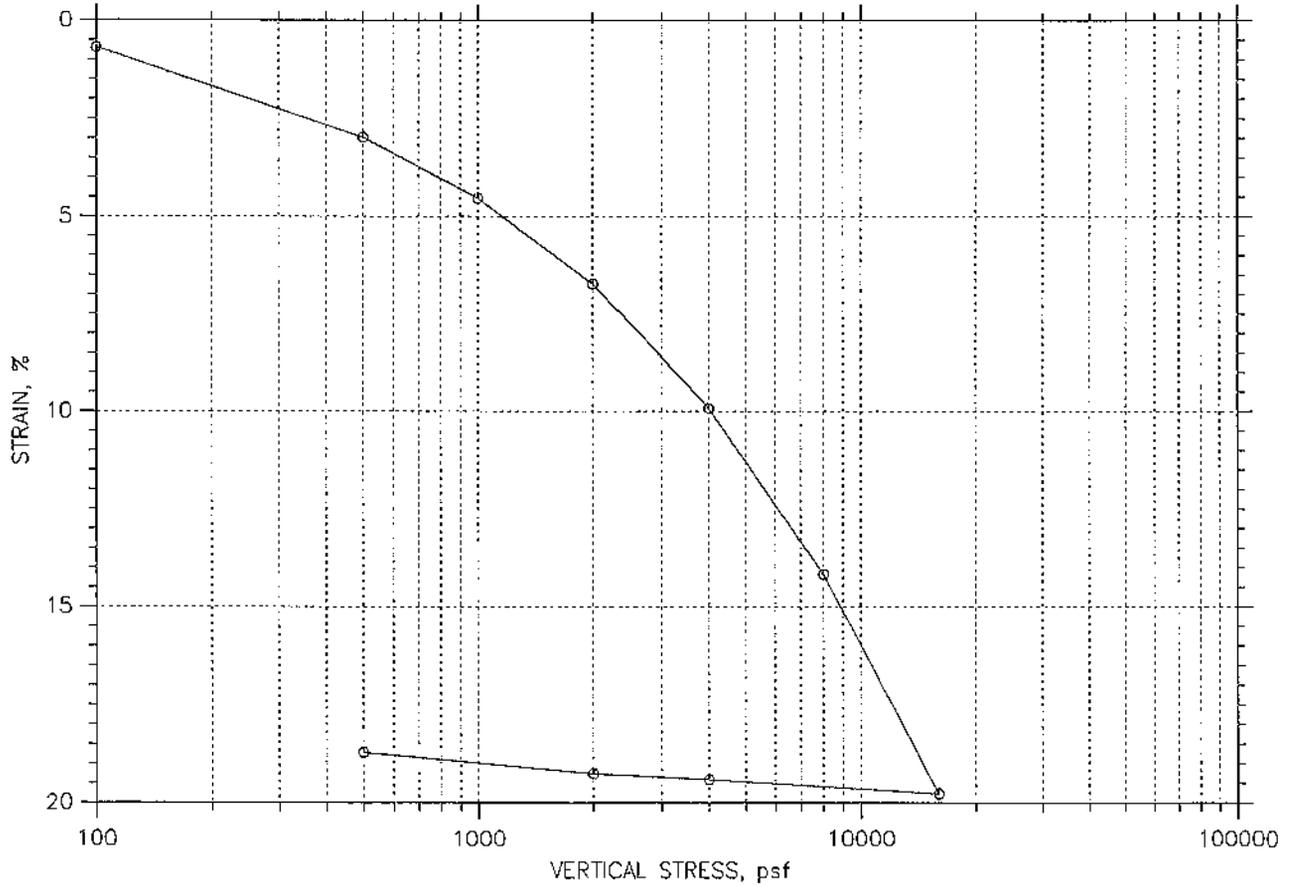
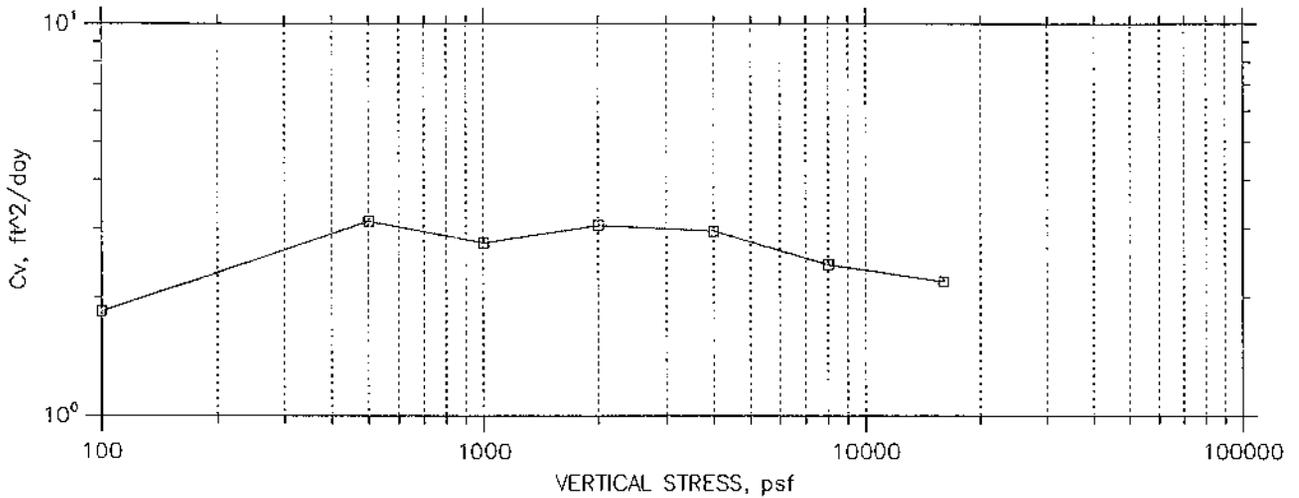
## CONSOLIDATION TEST DATA SUMMARY REPORT

Project: N Alcoa Site-E. St. Louis	Location: PZ-13	Project No.: 3410100782
	Boring No.: PZ-13	Tested By: JW	Checked By:
	Sample No.: UD	Test Date: 11/28/11	Depth: 2-4 ft
	Test No.: 11133	Sample Type: UD	Elevation: N/A
	Description: Yellowish Red Silt		
	Remarks: ASTM D2435-04

**Consolidation Test:** The one-dimensional or oedometric consolidation test involves placing an undisturbed sample in a smooth sided, stainless steel ring and then applying load in increments. The sample may be saturated by inundation or tested at other moisture contents as representative of field conditions. At each load increment, the vertical strain is measured over time. Based on the time measurements, an estimate of the end of primary consolidation is made. The time/strain curves provide a coefficient of consolidation ( $C_v$ ) from which the time rate of settlement due to consolidation can be calculated. A stress-strain curve based on the end of primary consolidation strains for each load increment allows calculation of the magnitude of expected settlement related to additional load.
