**PRE-DESIGN INVESTIGATION REPORT  
PROPOSED SOLAR REDEVELOPMENT PROJECT  
FORMER BAUXITE RESIDUE DISPOSAL AREAS  
Operable Unit 1, North Alcoa Site**

East St. Louis, Illinois

**Restoration Land Development Company, LLC**  
Wellesley, MA

**AMEC Environment & Infrastructure, Inc.**  
800 N. Bell Avenue, Suite 200  
Pittsburgh, Pennsylvania 15106  
(412) 279-6661

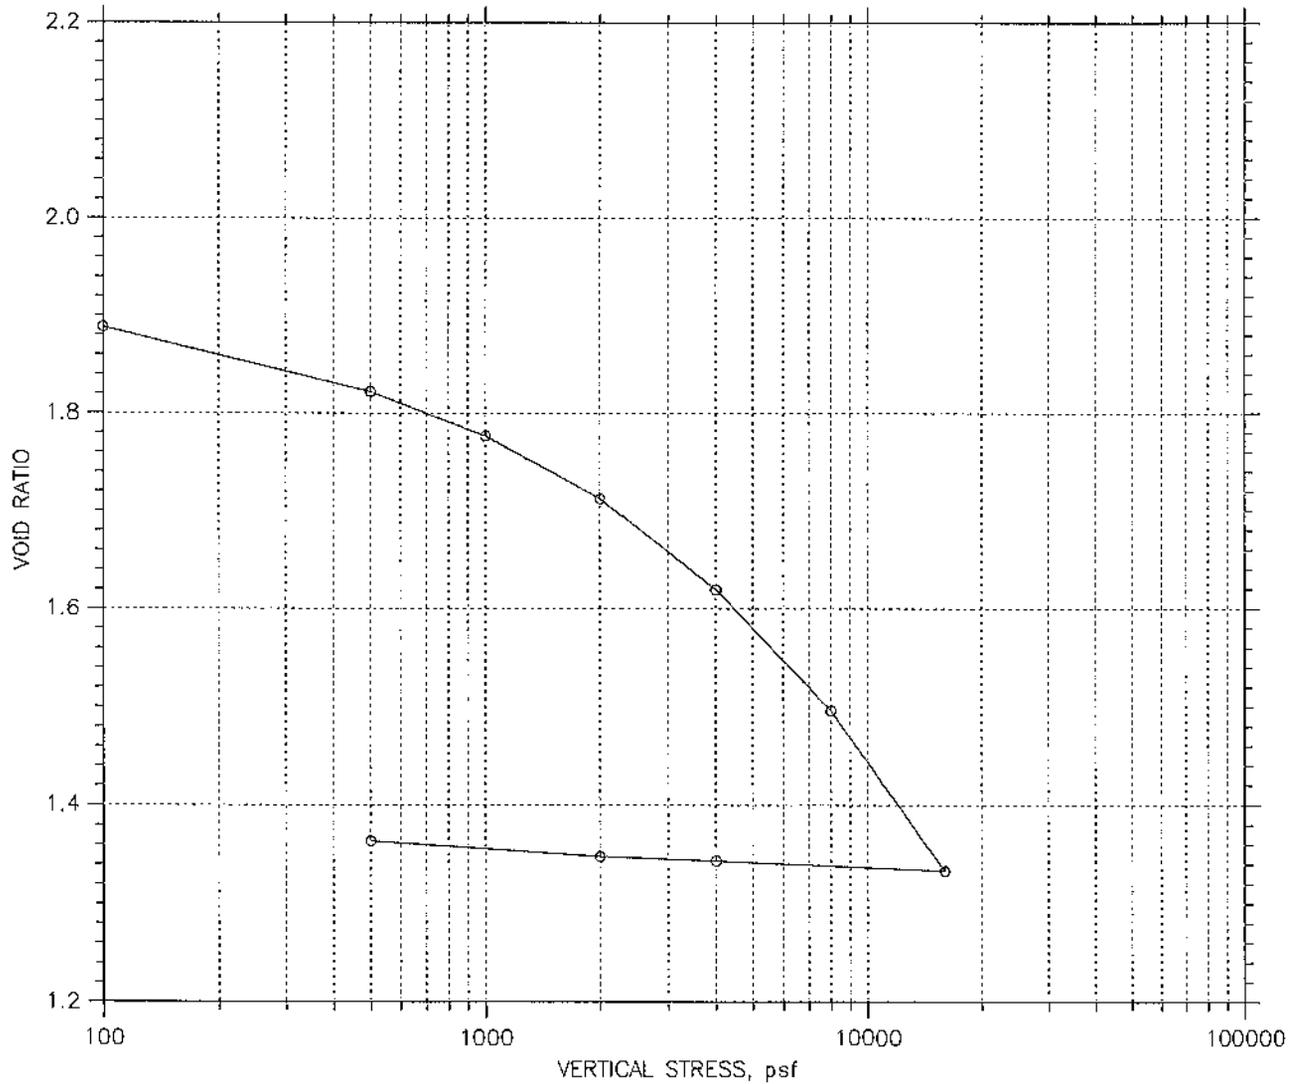
# CONSOLIDATION TEST DATA SUMMARY REPORT

Before Test	After Test
Overburden Pressure: 0 psf		72.26	58.91
Preconsolidation Pressure: 0 psf		56.88	69.98
Compression Index: 0		100.34	114.46
Diameter: 2.499 in	Height: 1.004 in	1.91	1.36
LL: ---	PL: ---	PI: ---	GS: 2.65

Project: N Alcoa Site-E. St. Louis	Location: PZ-13	Project No.: 3410100782
	Boring No.: PZ-13	Tested By: JW	Checked By:
	Sample No.: UD	Test Date: 11/28/11	Depth: 2-4 ft
	Test No.: 11133	Sample Type: UD	Elevation: N/A
	Description: Yellowish Red Silt		
	Remarks: ASTM D2435-04

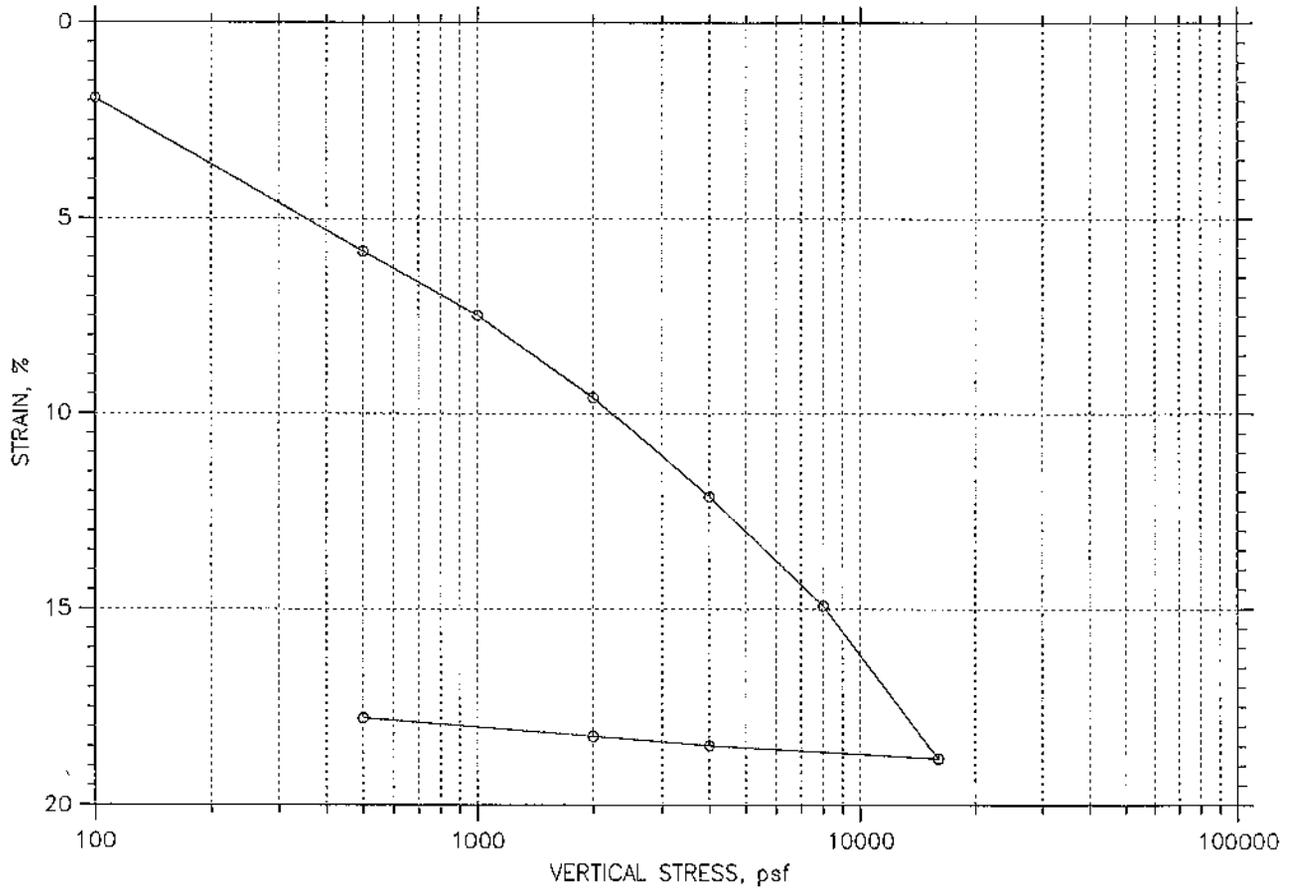
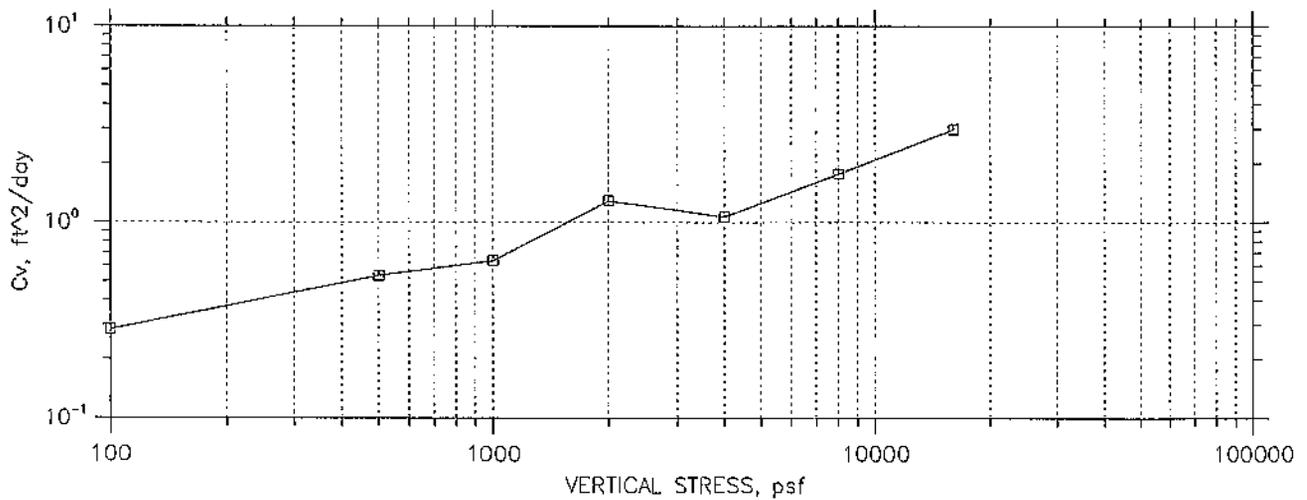
## CONSOLIDATION TEST DATA SUMMARY REPORT

<b>amec</b>	Project: N Alcoa Site-E. St. Louis	Location: PZ-13	Project No.: 3410100782
	Boring No.: PZ-13	Tested By: JW	Checked By:
	Sample No.: UD	Test Date: 11/28/11	Depth: 13.5-15.5ft
	Test No.: 11134	Sample Type: UD	Elevation: N/A
	Description: Brown Silt		
	Remarks: ASTM D2435-04

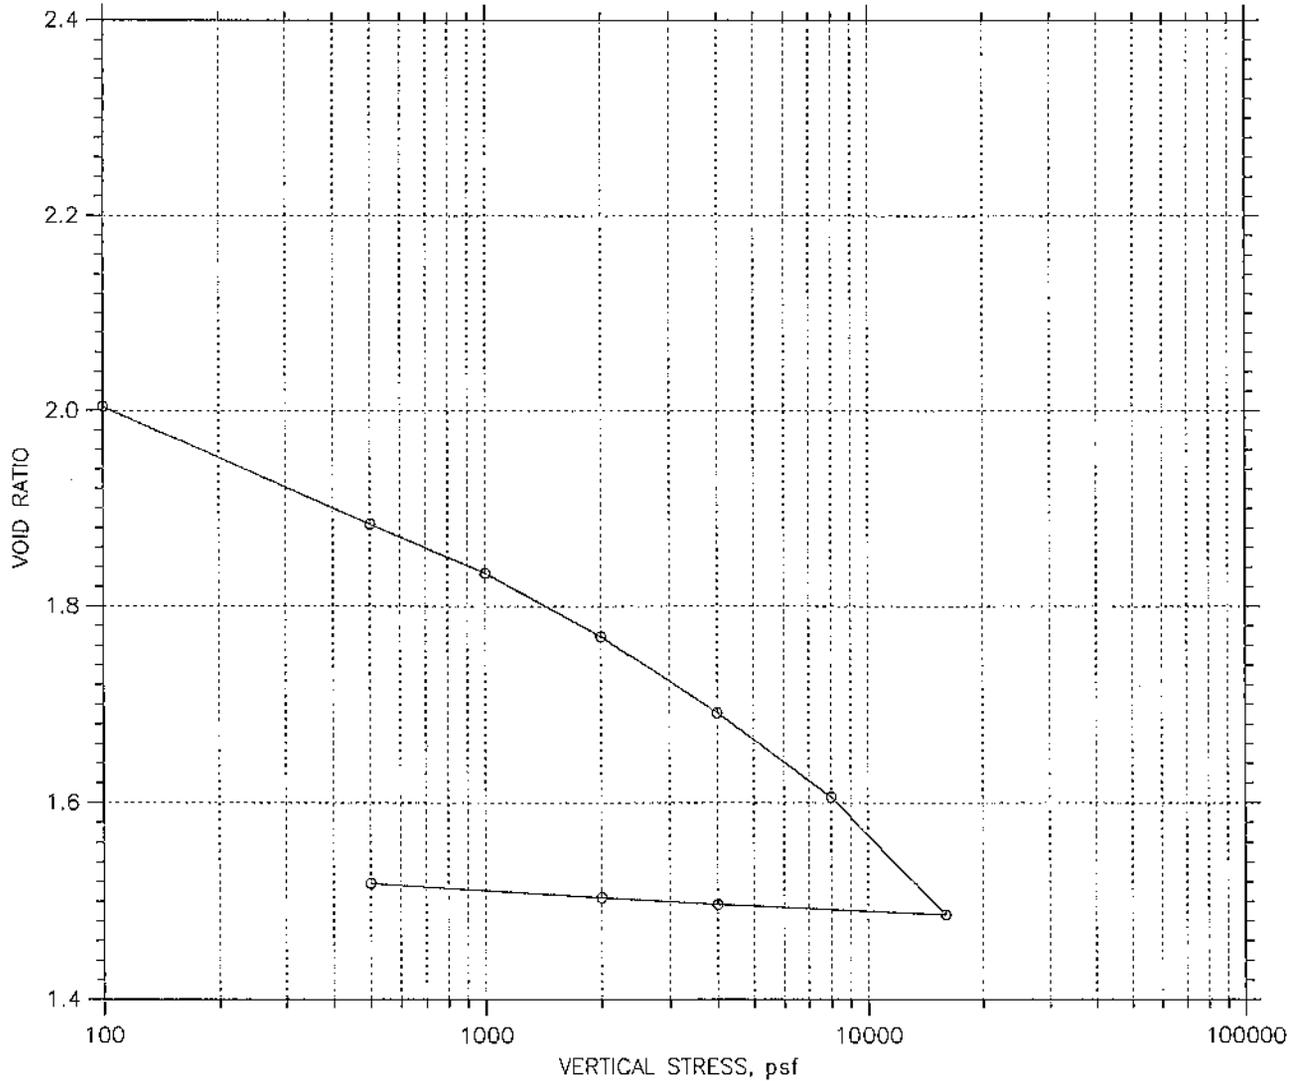
# CONSOLIDATION TEST DATA SUMMARY REPORT

Before Test	After Test
Overburden Pressure: 0 psf				84.54	59.96
Preconsolidation Pressure: 0 psf				54.02	65.69
Compression Index: 0				108.61	104.64
Diameter: 2.5 in		Height: 1 in		2.06	1.52
LL: ---	PL: ---	PI: ---	GS: 2.65

Project: N Alcoa Site-E. St. louis		Location: PZ-13	Project No.: 3410100782
	Boring No.: PZ-13		Tested By: JW	Checked By:
	Sample No.: UD		Test Date: 11/28/11	Depth: 13.5-15.5ft
	Test No.: 11134		Sample Type: UD	Elevation: N/A
	Description: Brown Silt			
	Remarks: ASTM D2435-04

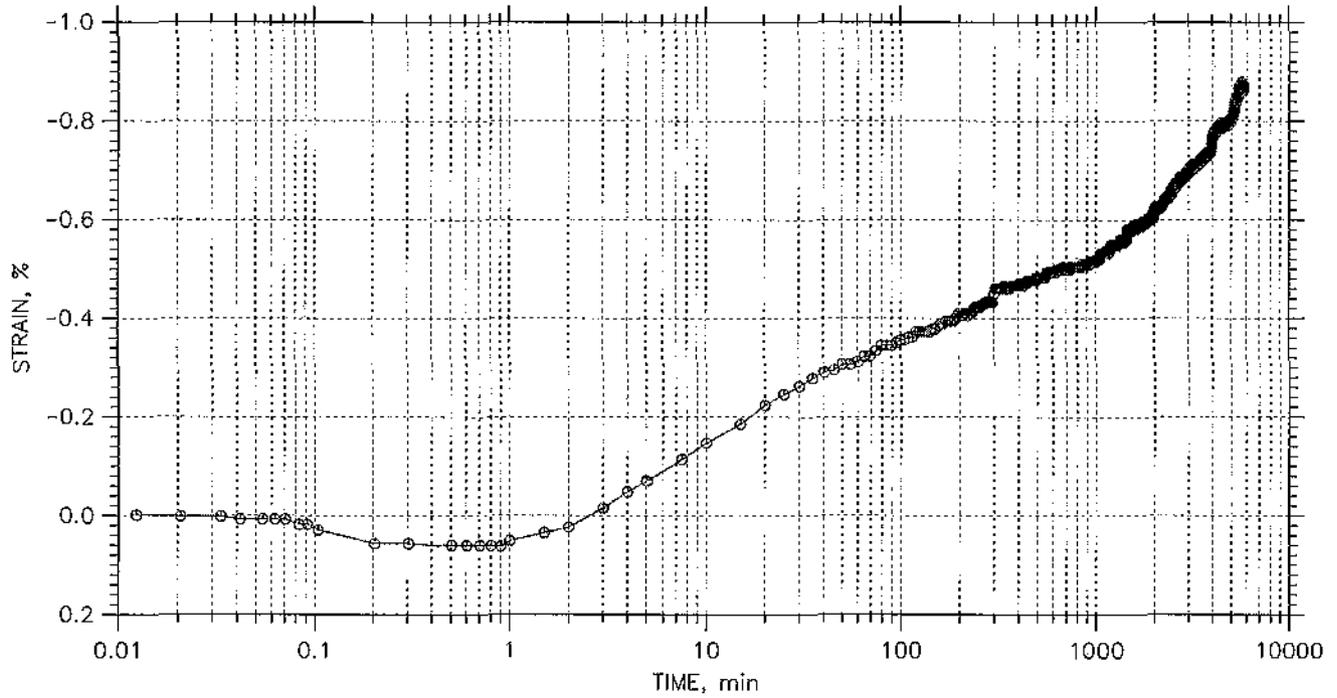
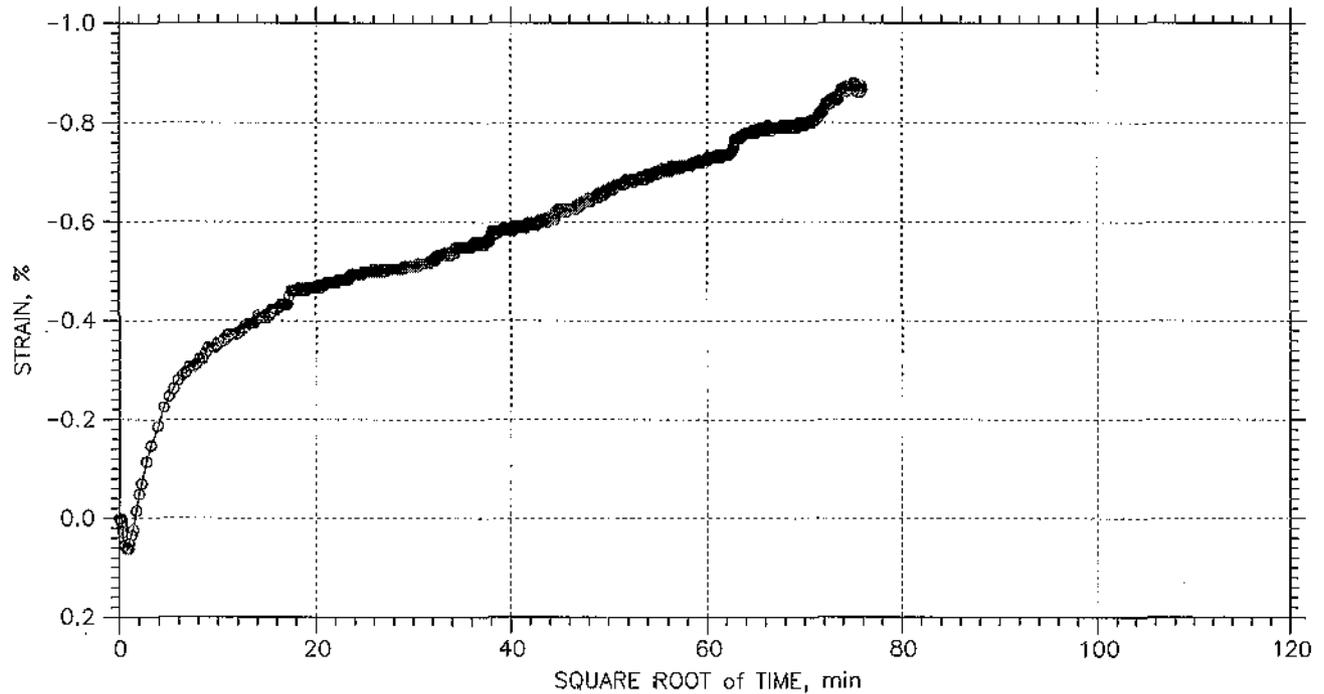
Constant Load Step: 1 of 2

Stress: 100. psf

Project: North Alcoa Site	Location: Composite	Project No.: 3410100782
	Boring No.: Composite	Tested By: JW	Checked By:
	Sample No.: B	Test Date: 1/20/12	Depth: N/A
	Test No.: N/A	Sample Type: N/A	Elevation: N/A
	Description:		
Remarks: composite of four samples

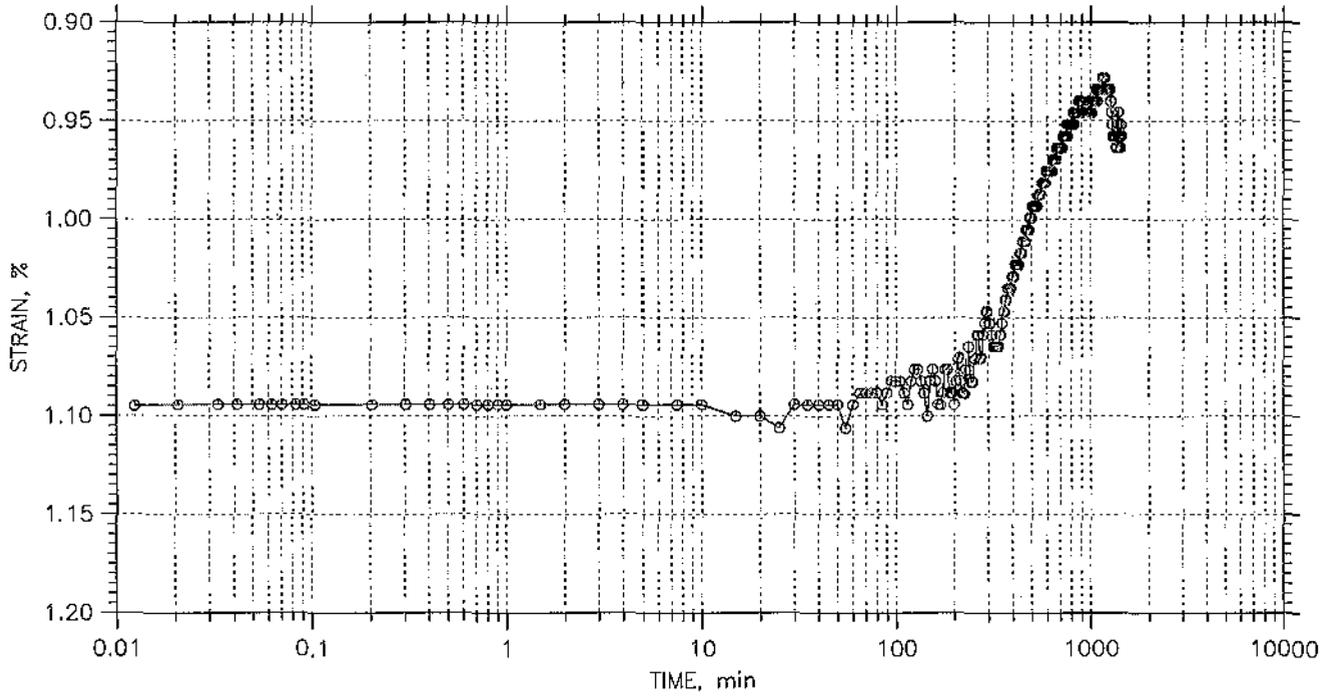
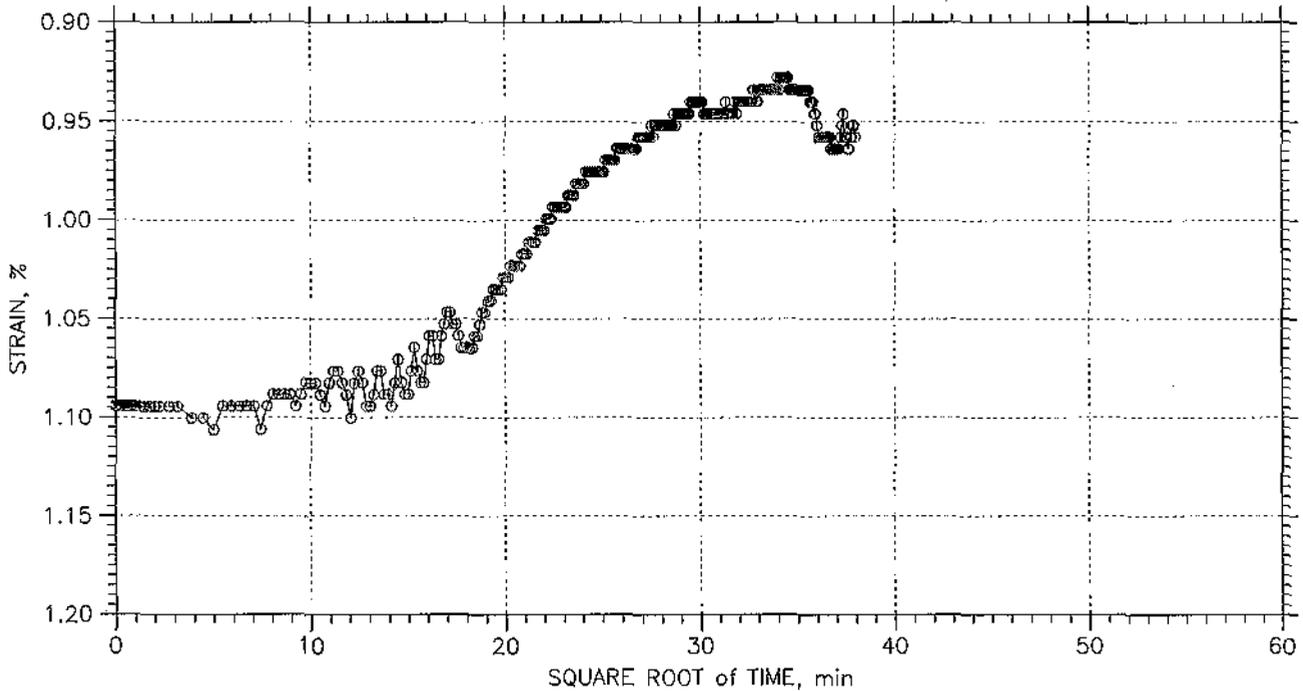
Constant Load Step: 2 of 2

Stress: 100. psf

Project: North Alcoa	Location: B-12	Project No.: 3410100782
	Boring No.: B-12	Tested By: JW	Checked By:
	Sample No.: Bulk	Test Date: 1/20/12	Depth: Surface
	Test No.: 11129CL	Sample Type: Remolded	Elevation: N/A
	Description:		
	Remarks:

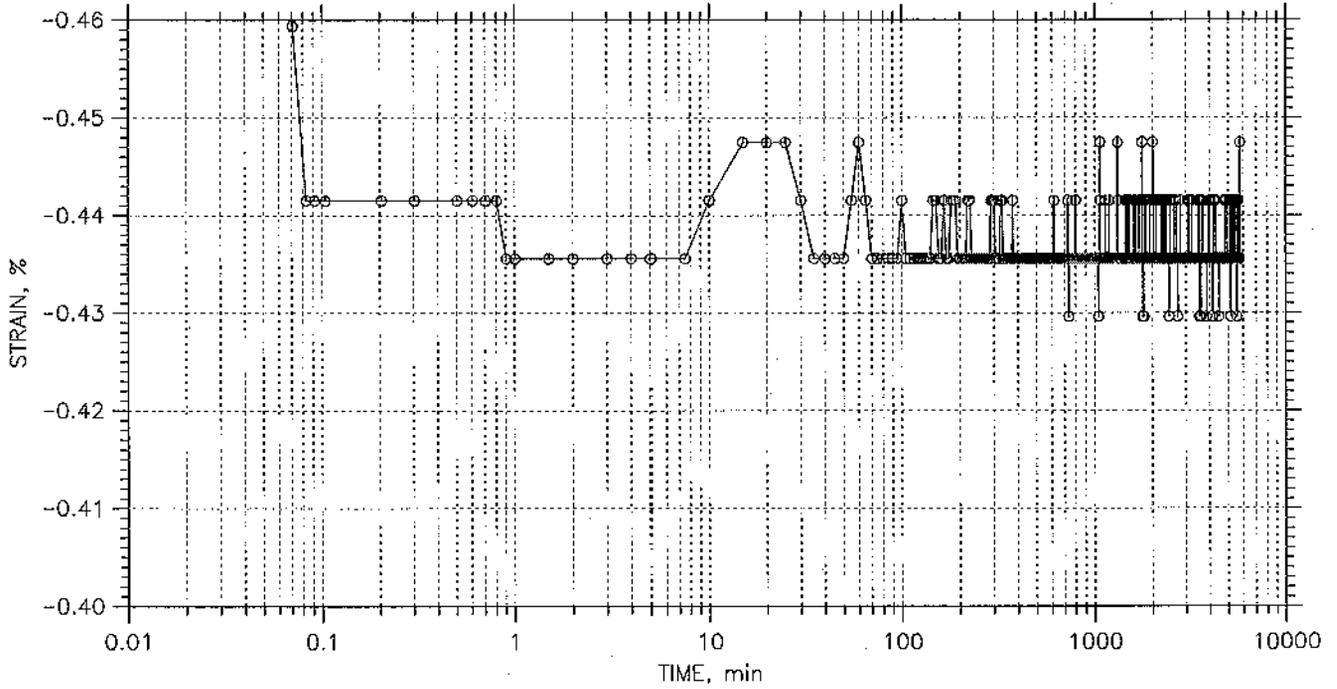
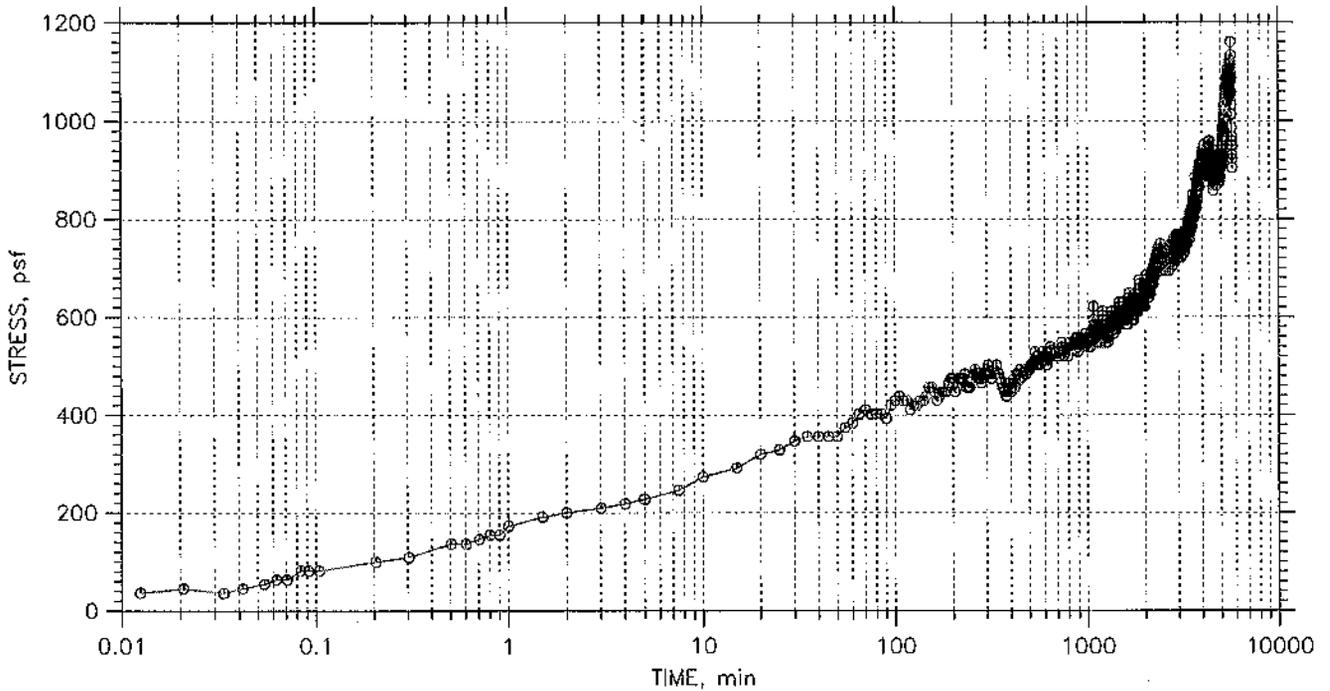
Constant Volume Step: 2 of 2

Stress: 100. psf

Project: North Alcoa Site	Location: Composite	Project No.: 3410100782
	Boring No.: Composite	Tested By: JW	Checked By:
	Sample No.: A	Test Date: 1/20/2012	Depth: N/A
	Test No.: N/A	Sample Type: Remolded	Elevation: N/A
	Description:		
	Remarks: Composite of four samples

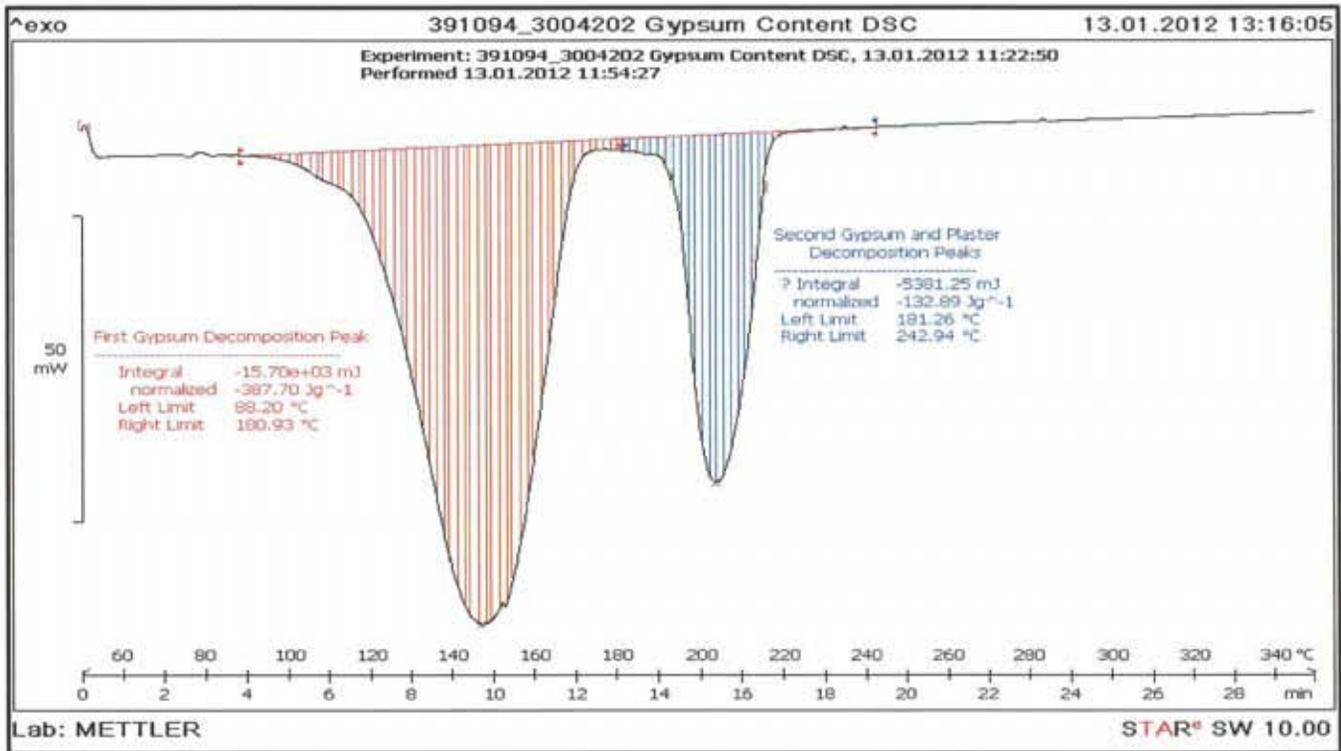
Client ID  
TP-33A

Material  
Gypsum

<u>Sulfate Form</u>	<u>Weight %</u>
Gypsum	85.354
Plaster	1.675
Syngenite	--

Chemistry Testing: X-Ray Fluorescence and Thermal Analysis were used to assess the relatively proportions of gypsum, anhydrite, and other materials in various gypsum samples.

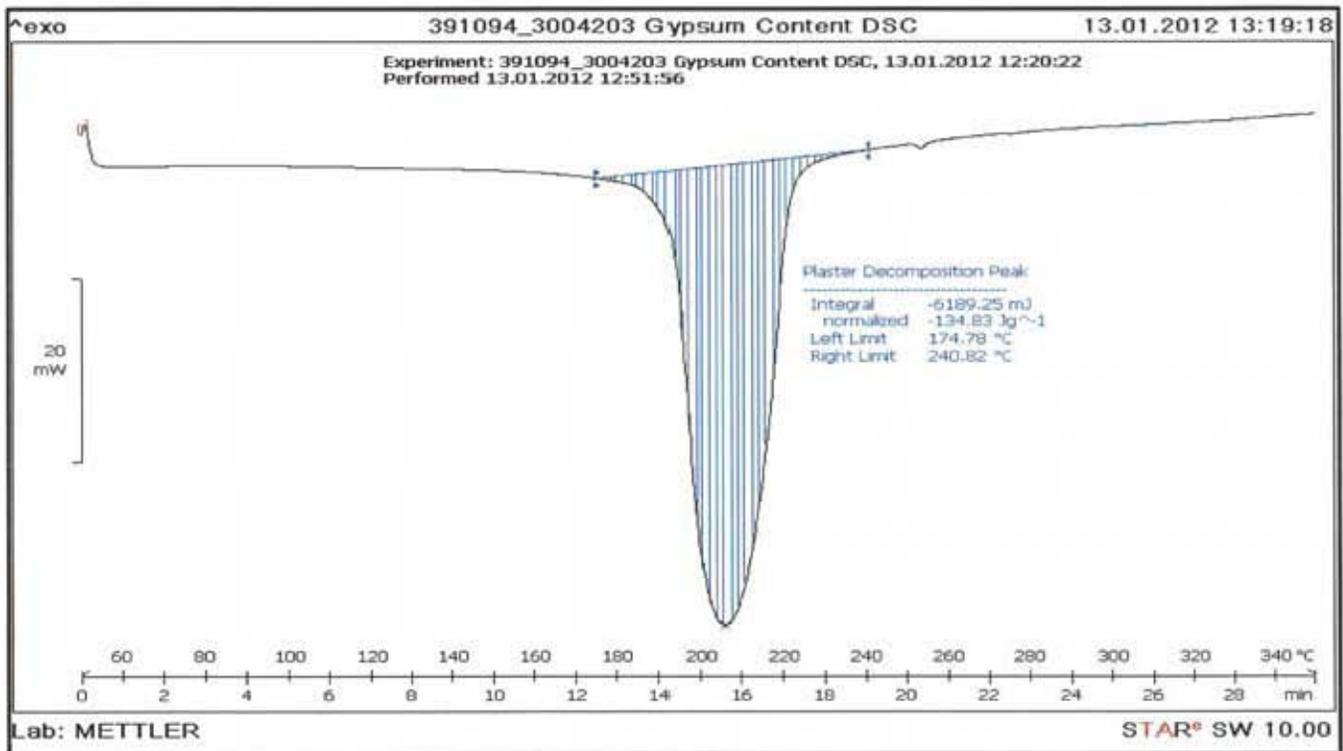
Client ID  
B-12-D

Material  
Gypsum

Sulfate Form	Weight %
Gypsum	--
Plaster	64.638
Syngenite	--

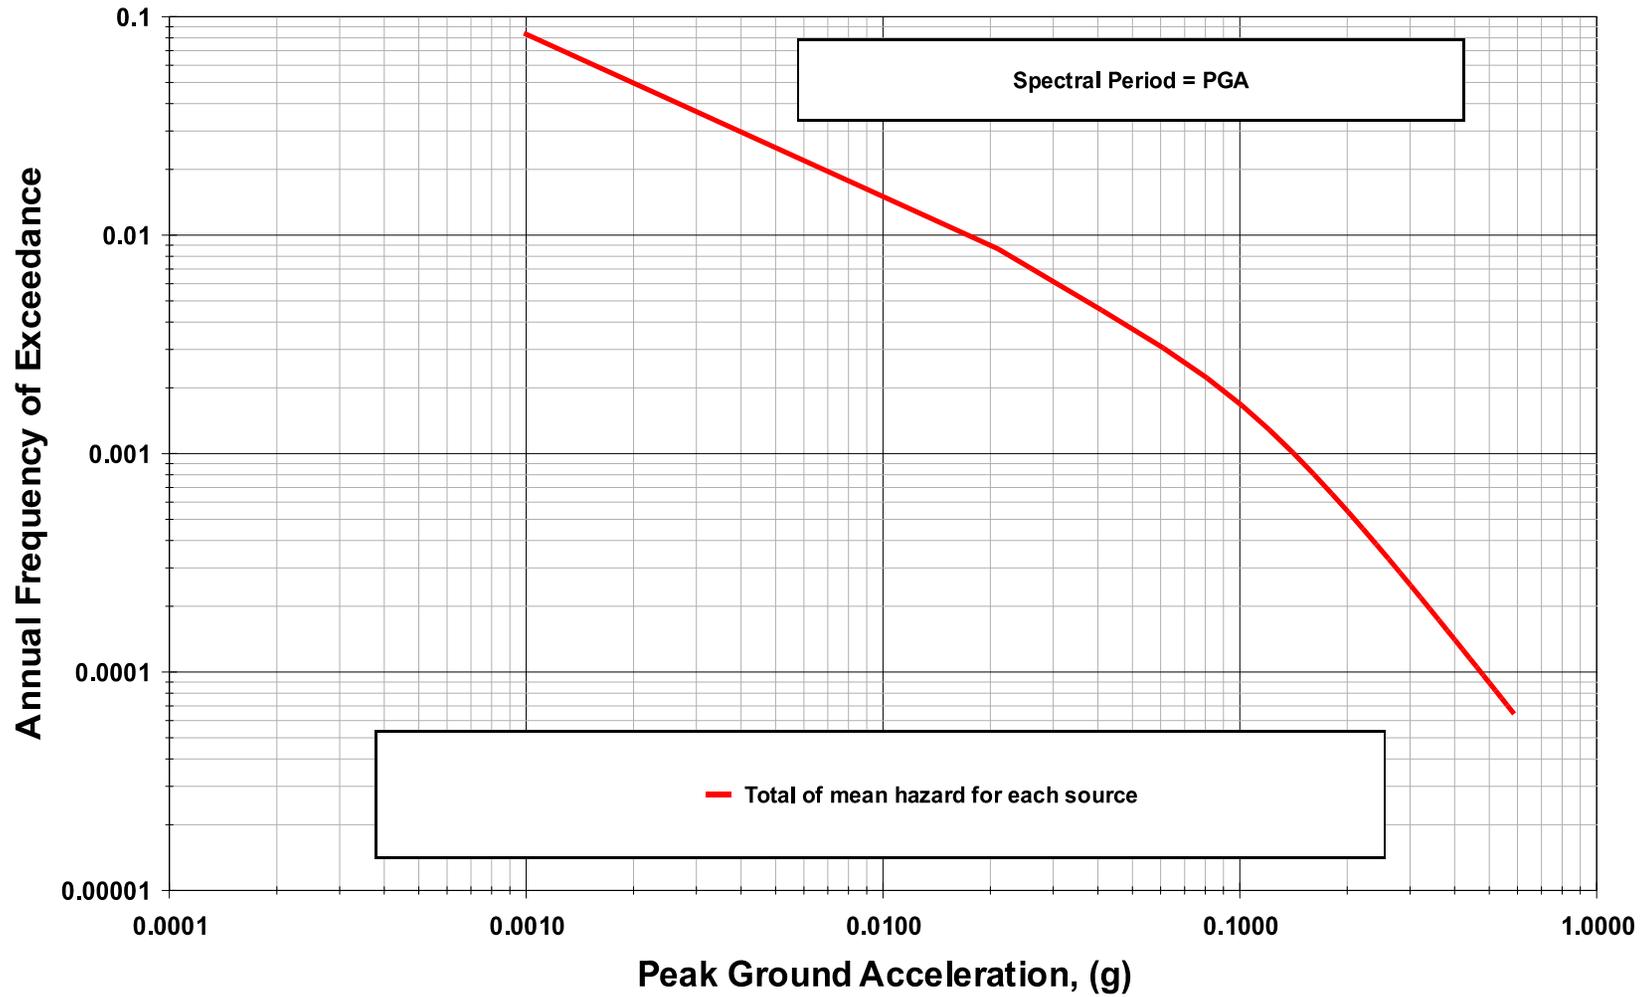
### Total Hazard Spectral Response @ 5% Damping - Average Horizontal Component

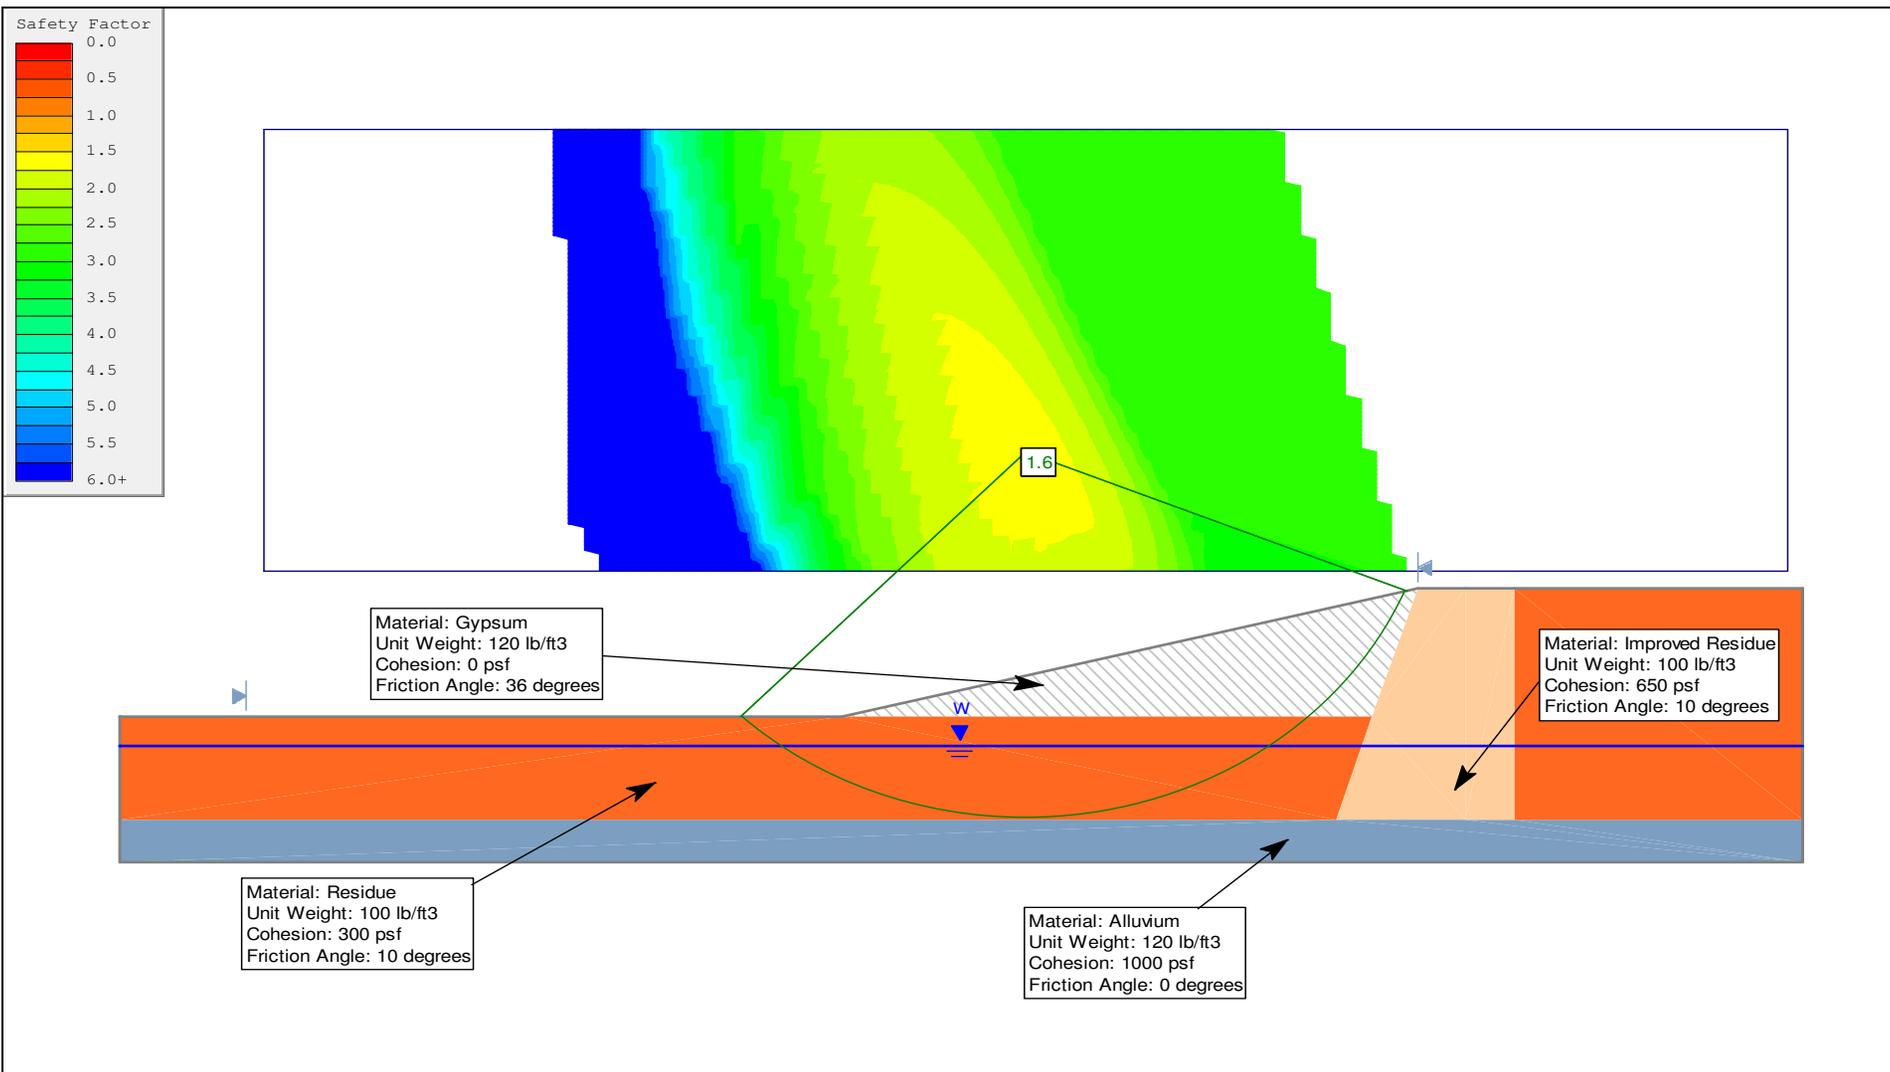
**Slope Stability Analysis**

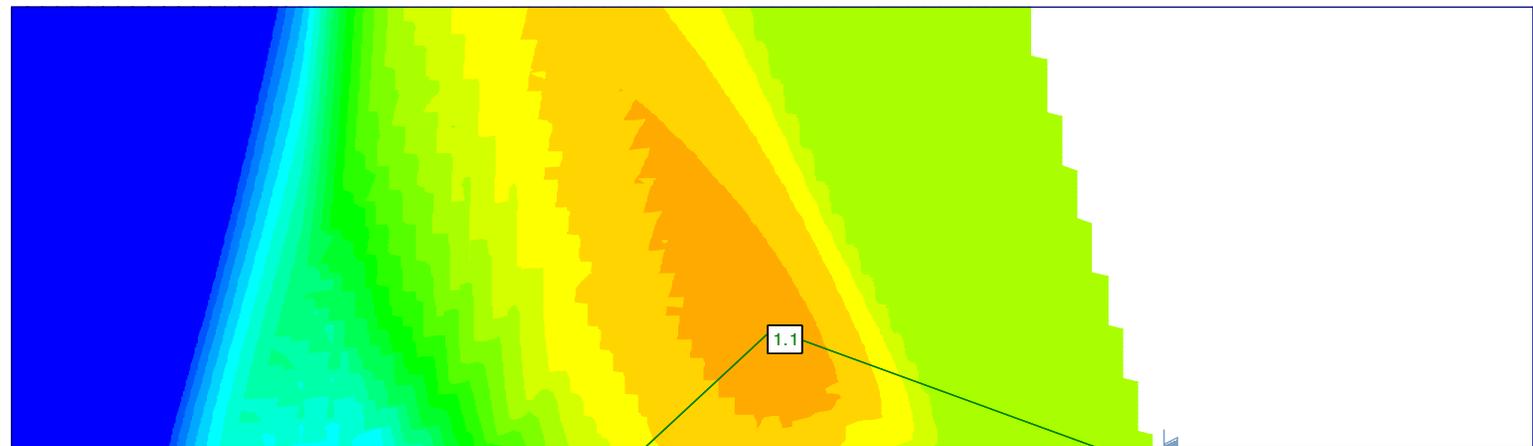
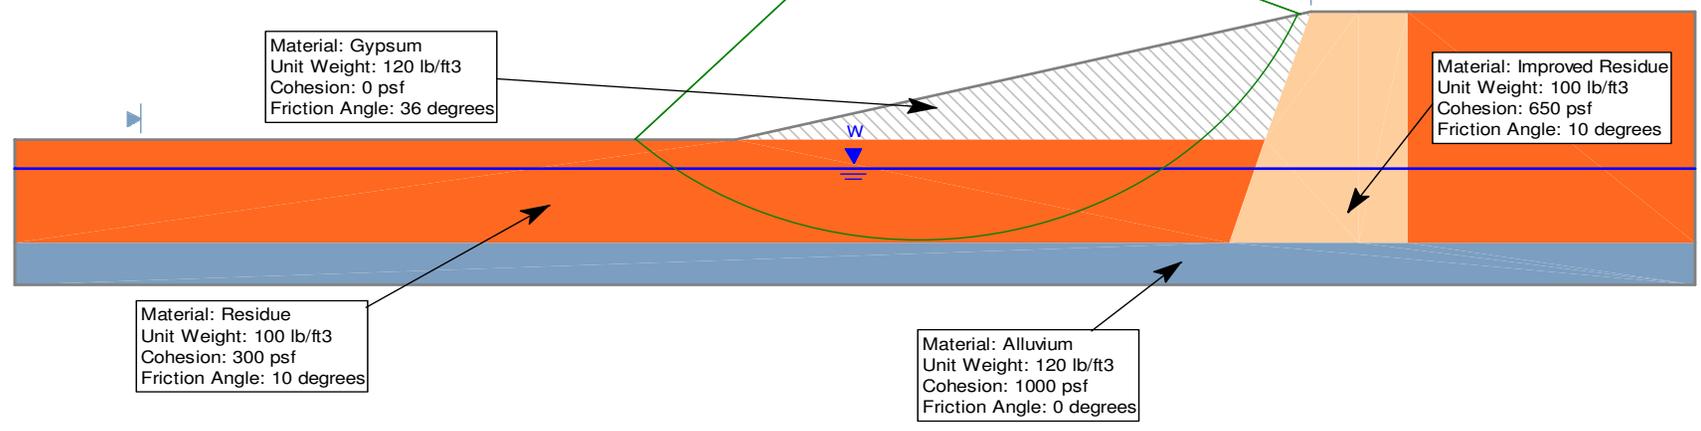
**Slope Stability Analysis  
 with 0.1g Seismic Event**
