Green Infrastructure Webcast Series:

Retrofits: Green Streets and Operation & Maintenance

Seattle Public Utilities

Natural Drainage Systems (NDS)
Maintenance Manual

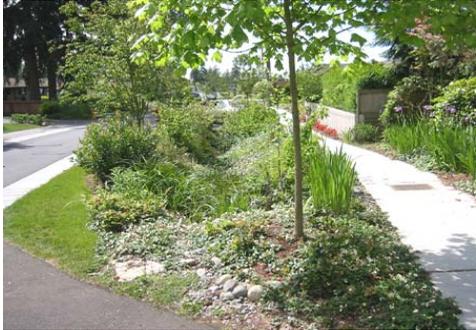
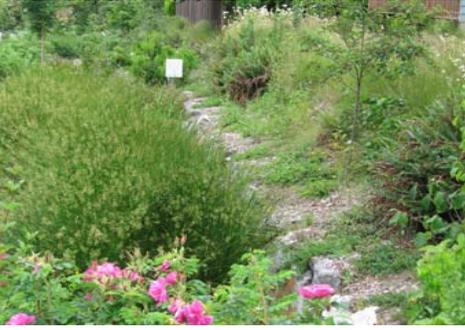
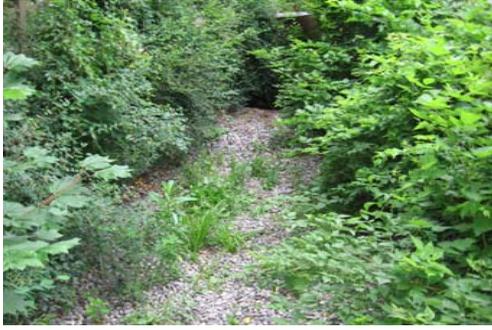
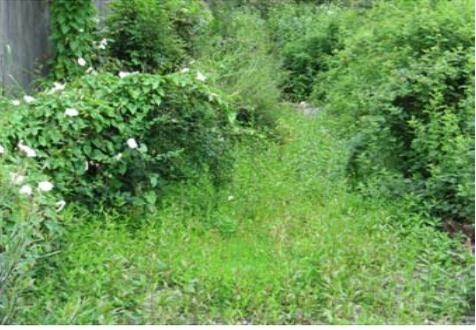
| <p>Planted vegetation coverage, health and appearance</p> | <p>Lush vegetation; excellent appearance</p> | <p>Mostly healthy vegetation with good appearance</p> | <p>Mostly healthy vegetation with neglected appearance</p> | <p>Poorly planted vegetation health and neglected appearance</p> |

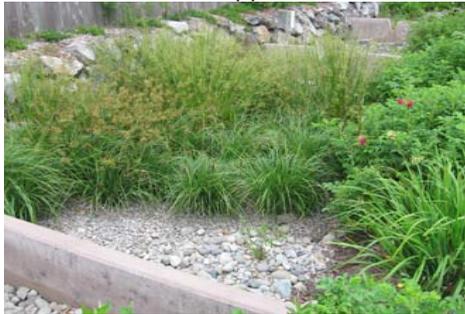
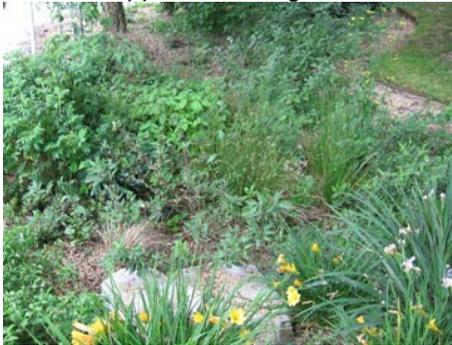
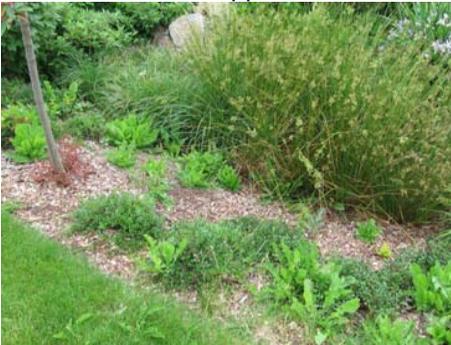
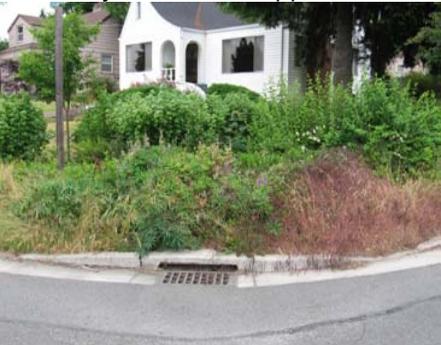
| | <p>Healthy, well-maintained vegetation; excellent appearance</p> | <p>Appearance is good</p> | <p>Moderate appearance</p> | <p>Poorly maintained appearance</p> |

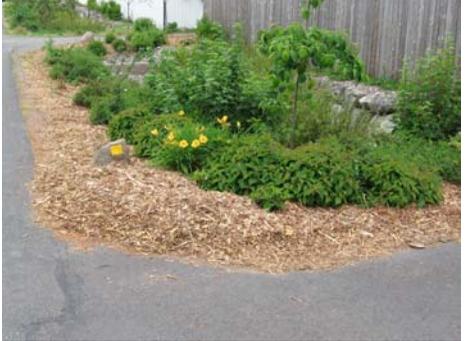
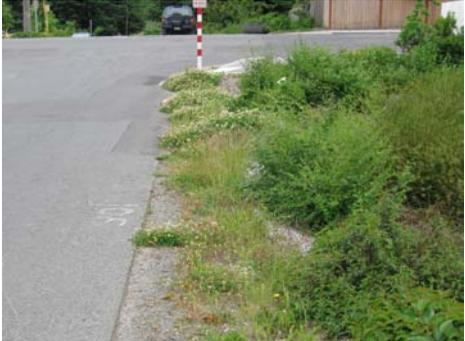
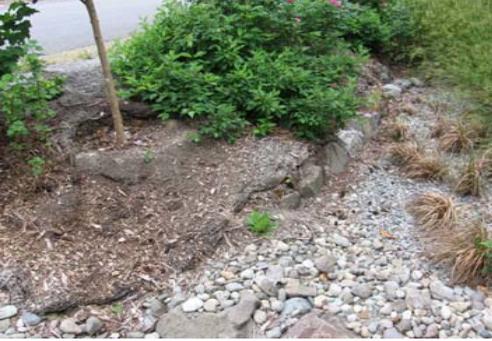
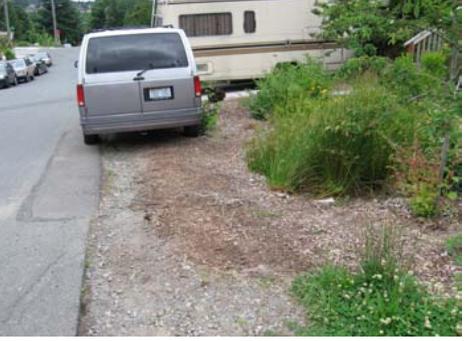
| <p>Organic matter (mulch layer), edges, shoulder compaction</p> | <p>Deep mulch layer, clean edges, limited compaction</p> | <p>Some mulch, loose edges, some compaction</p> | <p>Little mulch, no defined edge, shoulder compaction</p> | <p>No mulch, no defined edge, shoulder compaction</p> |

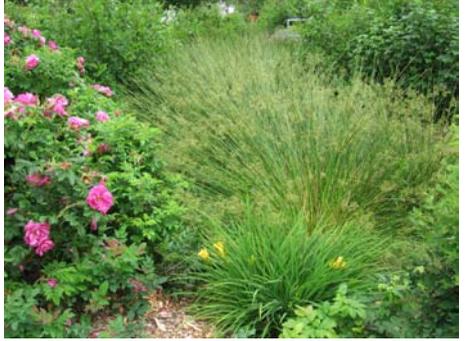
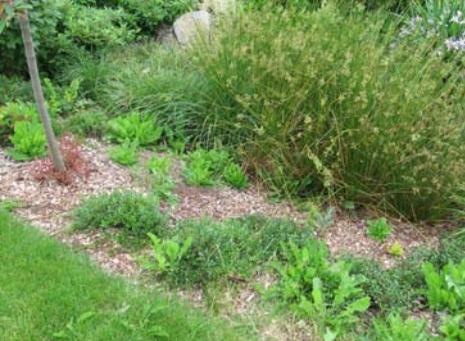
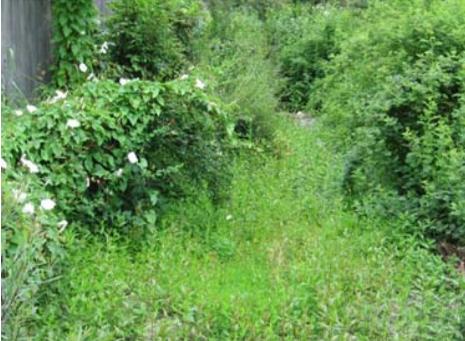
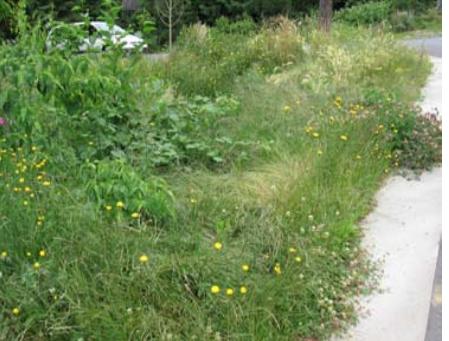
| <p>Presence of weeds</p> | <p>No weedy species present</p> | <p>Occasional weedy species</p> | <p>Lots of Weedy species</p> | <p>Weedy species predominant</p> |

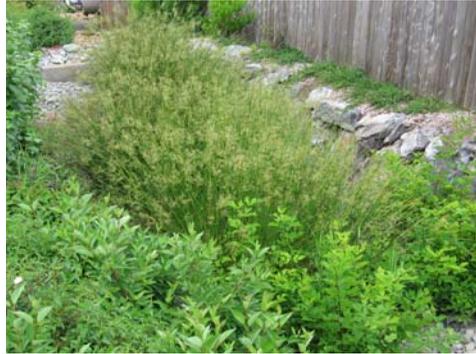
No erosion or bare spots

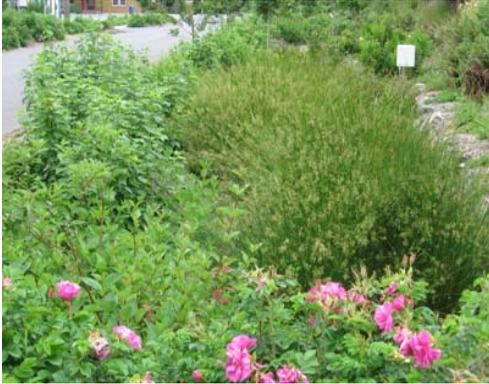
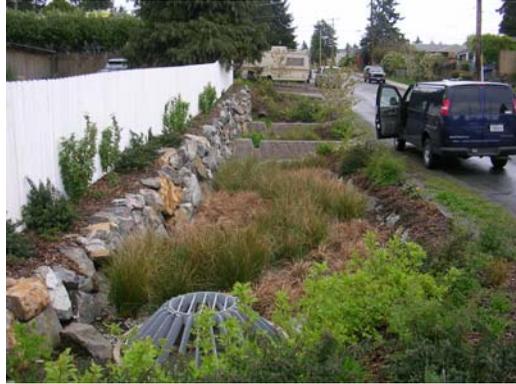
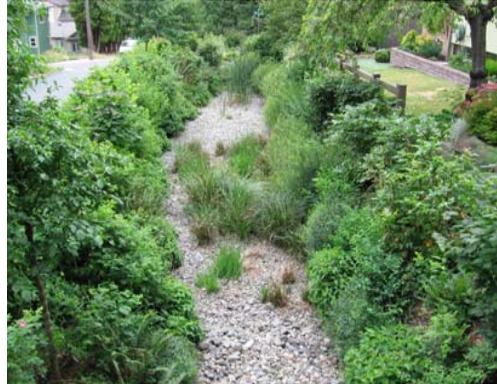
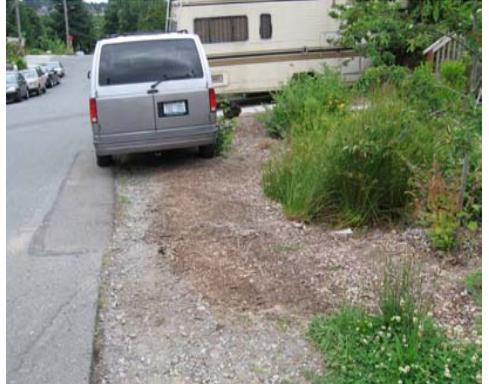
| Service Category | Service Level A (Excellent Effort) | Service Level B (Good Effort) | Service Level C (Moderate Effort) | Service Level D (Poor Effort) |
|---|---|---|--|---|
| Swale bottom vegetation | | | | |

| Service Category | Service Level A (Excellent Effort) | Service Level B (Good Effort) | Service Level C (Moderate Effort) | Service Level D (Poor Effort) |
|---|---|---|--|---|
| | <ul style="list-style-type: none"> • No erosion, channelization or scouring • Water drains within 24 hours • Minimal bare spots • Acceptable level of sediment or debris accumulation | <ul style="list-style-type: none"> • Some erosion, channelization or scouring • Most water drains within 24 hours, minimal long-term ponding • A few bare spots • Acceptable level of sediment or debris accumulation | <ul style="list-style-type: none"> • The presence of long-term ponding (> 72 hours) • Many bare spots • Significant build up of sediment or debris | <ul style="list-style-type: none"> • scouring • The presence of long-term ponding (> 72 hours) • Many bare spots or noxious weeds/grass • Significant build up of sediment or debris |

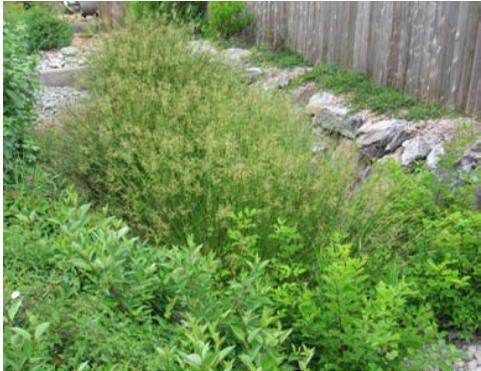
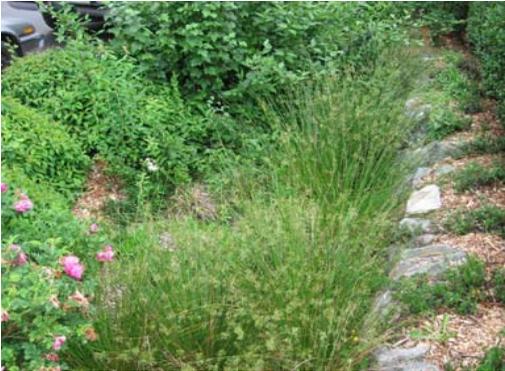
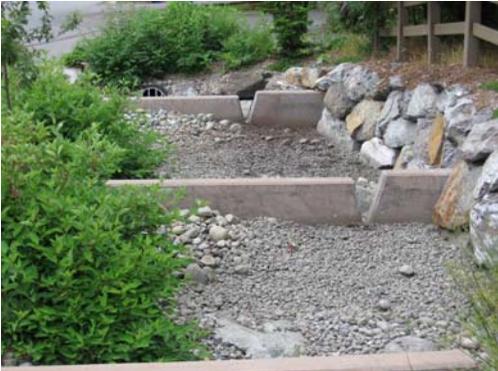
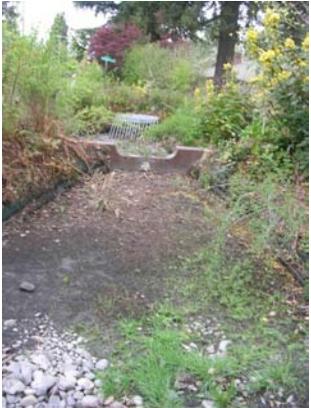
| Service Category | Service Level A (Excellent Effort) | Service Level B (Good Effort) | Service Level C (Moderate Effort) | Service Level D (Poor Effort) |
|---|---|---|--|---|
| Conveyance | <ul style="list-style-type: none"> • Healthy vegetation | <ul style="list-style-type: none"> • Mostly healthy vegetation | <ul style="list-style-type: none"> • Some vegetation | <ul style="list-style-type: none"> • Poor or no vegetation |

| Service Category | Service Level A (Excellent Effort) | Service Level B (Good Effort) | Service Level C (Moderate Effort) | Service Level D (Poor Effort) |
|---|---|--|--|--|
| (vegetation & soils/substrate) | <ul style="list-style-type: none"> • No erosion, channelization or scouring • Minimal bare spots • No build up of sediment or debris • No non-designed obstructions to flow | <ul style="list-style-type: none"> • Some erosion, channelization or scouring • A few bare spots • Some build up of sediment or debris • Minimal non-designed obstructions to flow (over-grown vegetation, trash rack blockages) | <ul style="list-style-type: none"> • Erosion, channelization or scouring • Many bare spots • Significant build up of sediment or debris • Significant non-designed obstructions to flow (over-grown vegetation, trash rack blockage) | <ul style="list-style-type: none"> • Erosion, channelization or scouring • Many bare spots • Significant build up of sediment or debris • Significant non-designed obstructions to flow (over-grown vegetation, trash rack blockage) |

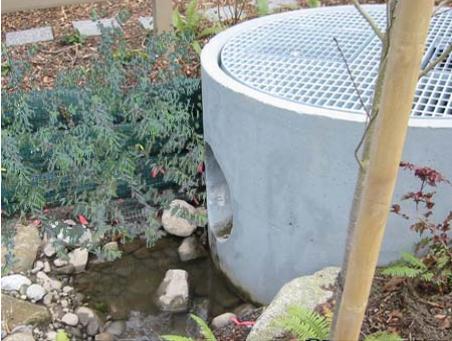
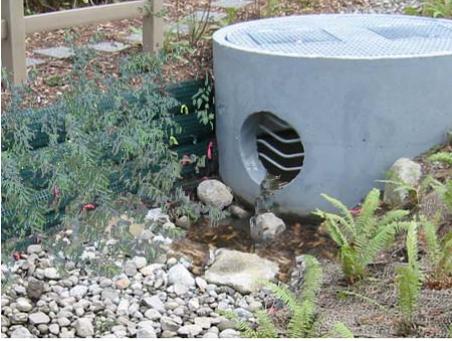
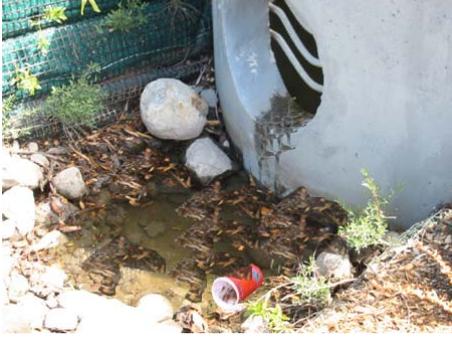
| Service Category | Service Level B (Good Effort) | Service Level C (Moderate Effort) | Service Level D (Low Effort) | Recommended Maintenance Activities |
|--|--|---|--|--|
| <input type="checkbox"/> Sedimentation structures— TYPE 2 | <p>Sediment is blocking 10% of structure</p> | <p>Sediment is blocking 30% of structure</p> | <p>Sediment is blocking 50% of structure</p> | <input type="checkbox"/> if sediment present, remove trash and unwanted organic debris <input type="checkbox"/> muck out / vacuor structure and dispose of waste properly |

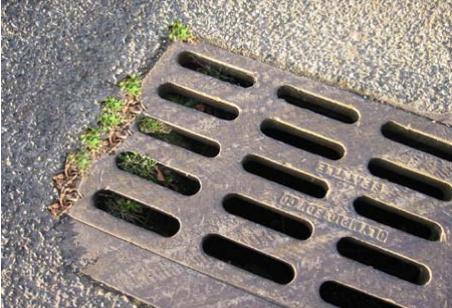
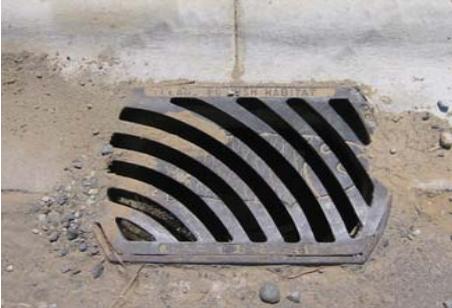
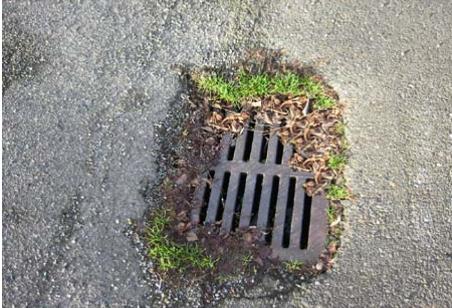
| Service Category | Service Level B (Good Effort) | Service Level C (Moderate Effort) | Service Level D (Low Effort) | Recommended Maintenance Activities |
|--|---|--|--|---|
| <input type="checkbox"/> Grates and debris screens on catch basins (CBs) | Accumulation of organic debris covers 10% of structure | Accumulation of organic debris covers 30% of structure | Accumulation of organic debris covers 50% of structure | <input type="checkbox"/> if present, muck out / vector catch basins and dispose of waste properly. Clear debris and vegetation growth around intakes. |

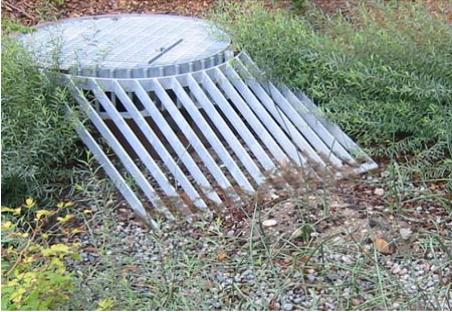
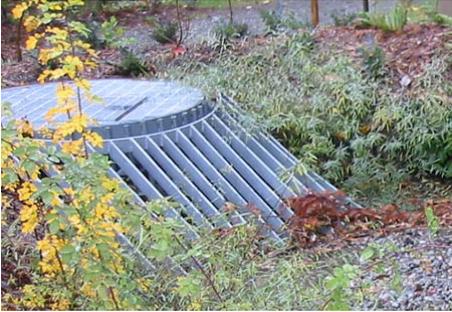
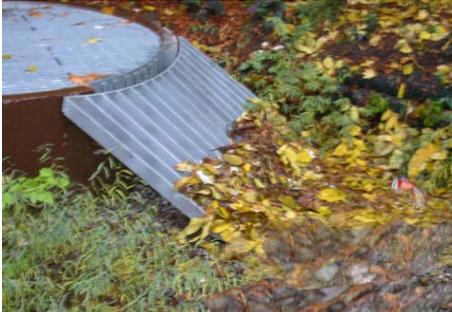
| Service Category | Service Level B (Good Effort) | Service Level C (Moderate Effort) | Service Level D (Low Effort) | Recommended Maintenance Activities |
|--|---|--|--|---|
| <input type="checkbox"/> Outlet structures—TYPE 2 | Accumulation of organic debris covers 10% of structure | Accumulation of organic debris covers 30% of structure | Accumulation of organic debris covers 50% of structure | <input type="checkbox"/> Remove debris and dispose of waste properly |

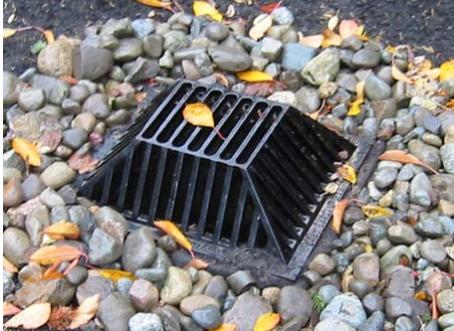
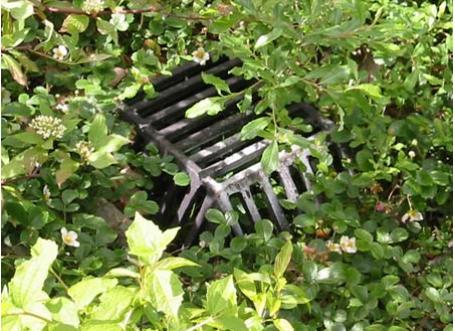
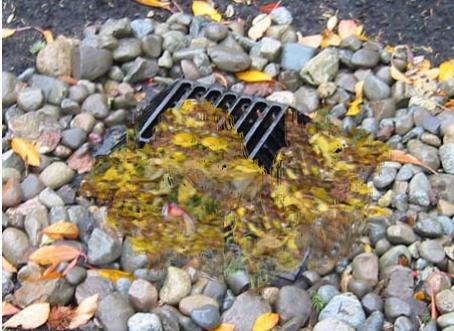
| Service Category | Service Level B (Good Effort) | Service Level C (Moderate Effort) | Service Level D (Low Effort) | Recommended Maintenance Activities |
|--|---|--|--|---|
| Flow control structures and overflow structures or pipes | Accumulation of organic debris covers 10% of structure | Accumulation of organic debris covers 30% of structure | Accumulation of organic debris covers 50% of structure | <input type="checkbox"/> remove debris and vegetation growth and dispose of waste properly |

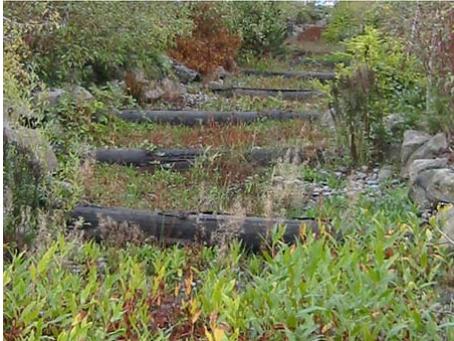
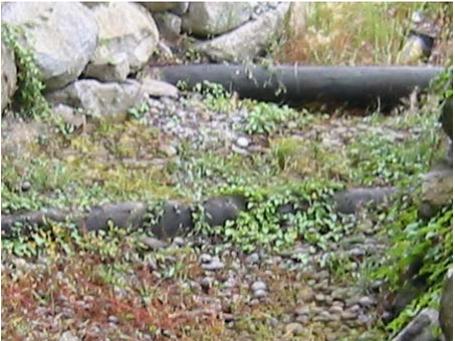
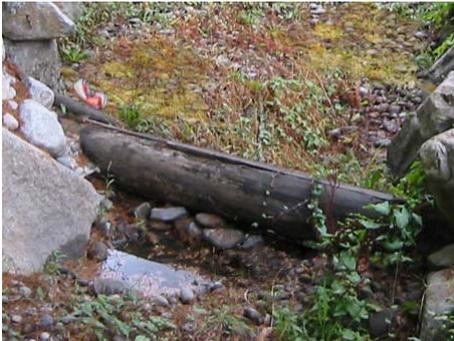
| Service Category | Service Level B (Good Effort) | Service Level C (Moderate Effort) | Service Level D (Low Effort) | Recommended Maintenance Activities |
|---|---|---|---|---|
| <input type="checkbox"/> Log weirs and check dams | <p>Sediment deposit of check dams or log weirs is about 10%</p> | <p>Sediment deposits of check dams or log weirs is about 30%</p> | <p>Sediment deposits of check dams or log weirs is about 50% or more</p> | <input type="checkbox"/> add splash-pool (rocks) to reduce scouring of swale-bottom for undercutting or eroding <input type="checkbox"/> remove sediment, debris, and trash if ponding upstream of check-dam |

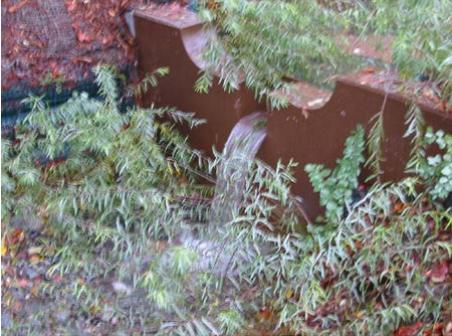
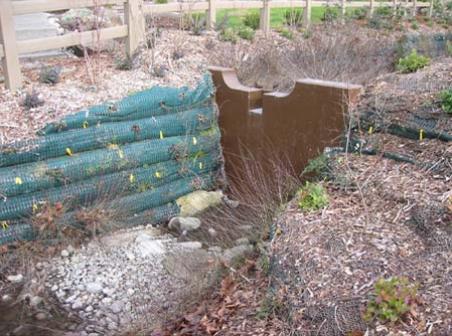
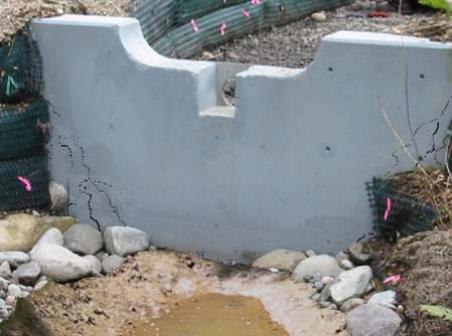
| Service Category | Service Level B (Good Effort) | Service Level C (Moderate Effort) | Service Level D (Low Effort) | Recommended Maintenance Activities |
|---|---|---|---|---|
| <input type="checkbox"/> Weir walls w/ flow control notch | <p>Sediment deposit downstream of check dams or log weirs is about 10%</p> | <p>Sediment deposit downstream of check dams or log weirs is about 30%</p> | <p>Sediment deposit downstream of check dams or log weirs is about 50% or more</p> | <input type="checkbox"/> add rocks to splash-pool to prevent scouring <input type="checkbox"/> reinforce weir wall (<i>non-routine</i>) if leakage occurs at structure edges |

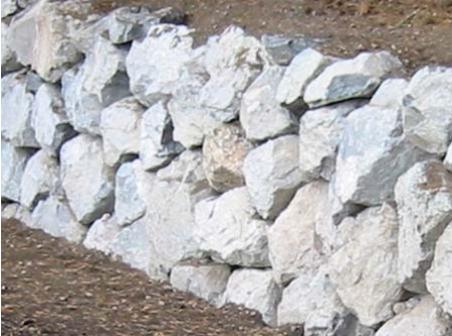
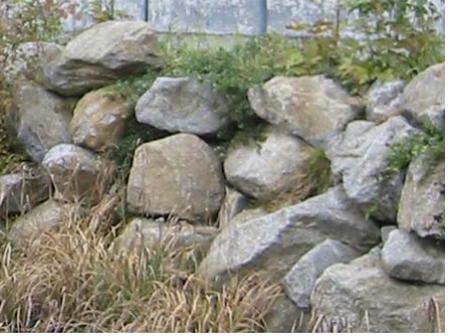
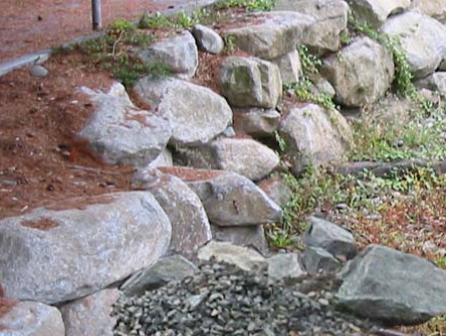
| Service Category | Service Level B (Good Effort) | Service Level C (Moderate Effort) | Service Level D (Low Effort) | Recommended Maintenance Activities |
|---|--|---|---|--|
| <input type="checkbox"/> Rockery / boulders PHOTOS TO BE UPDATED (shown here with little vegetative cover, but rocks may become covered in plant growth in well- established projects) | 10% of rocks or walls are unsecured | 30% of rocks or walls are unsecured | 50% of rocks or walls are unsecured | <input type="checkbox"/> ensure large rocks and boulders are stable |

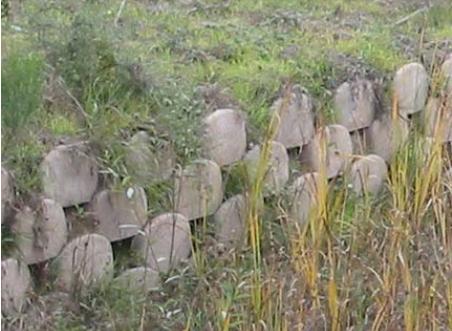
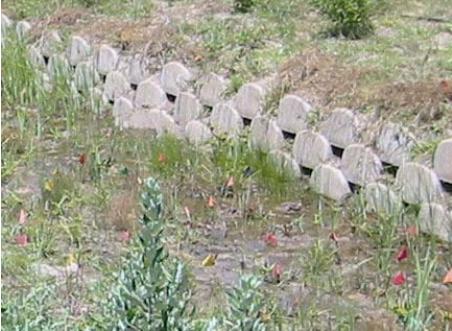
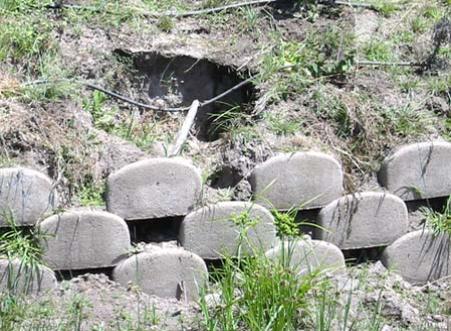
| Service Category | Service Level B (Good Effort) | Service Level C (Moderate Effort) | Service Level D (Low Effort) | Recommended Maintenance Activities |
|---|--|---|---|--|
| Manufactured block sidewalls | 10% of rocks or walls are unsecured | 30% of rocks or walls are unsecured | 50% of rocks or walls are unsecured | <input type="checkbox"/> ensure blocks and bricks are stable |

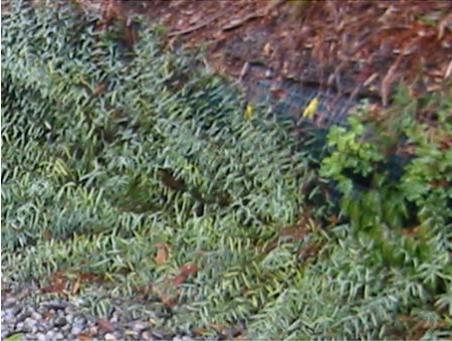
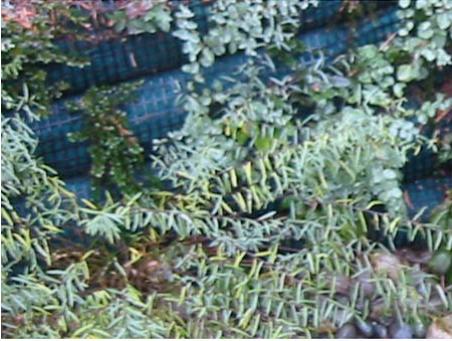
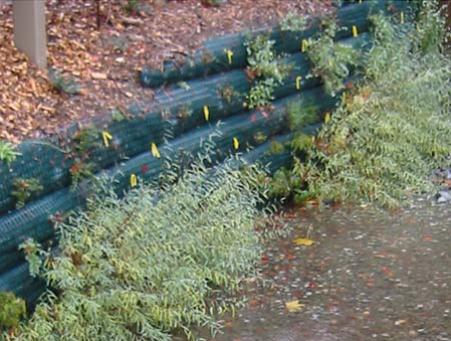
| Service Category | Service Level B (Good Effort) | Service Level C (Moderate Effort) | Service Level D (Low Effort) | Recommended Maintenance Activities |
|---|--|---|---|--|
| Soil-wrap walls ("green walls") | <p>Erosion or undercutting of 10% is walls visible around rockery, walls and weirs</p> | <p>Erosion or undercutting of 30% is visible around rockery, walls and weirs</p> | <p>Erosion or undercutting of 50% is walls visible around rockery, walls and weirs</p> | <ul style="list-style-type: none"> □ repair as needed stabilize loose soil-bricks, notify vegetation crew if weeds present, water needed, or re-planting required |

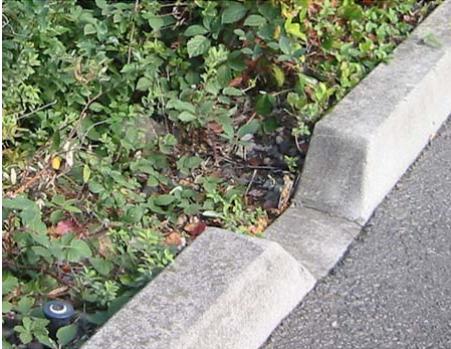
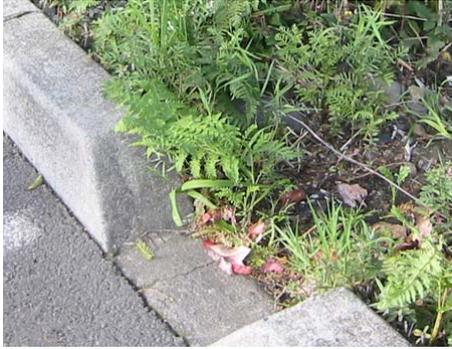
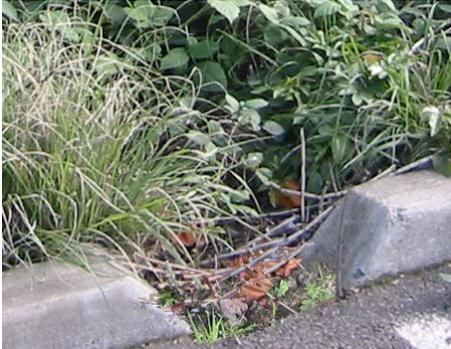
| Service Category | Service Level B (Good Effort) | Service Level C (Moderate Effort) | Service Level D (Low Effort) | Recommended Maintenance Activities |
|---|---|---|--|--|
| <p><input type="checkbox"/> Curb cuts</p> | <p>Curb is up to 10% blocked</p> | <p>Curb is between 10-40% blocked</p> | <p>Curb is above 40% blocked</p> | <p><input type="checkbox"/> remove trash and organic debris and dispose properly</p> |

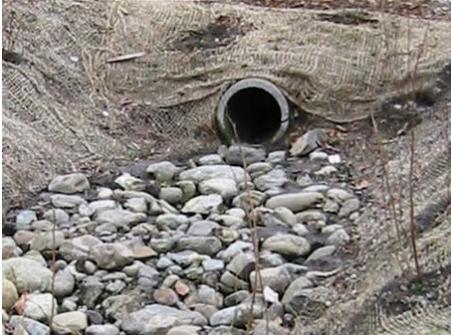
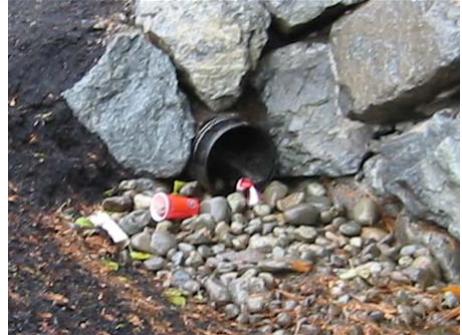
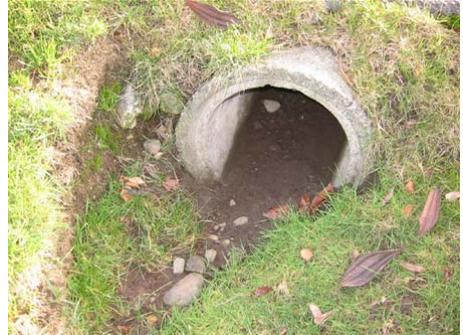
| Service Category | Service Level B (Good Effort) | Service Level C (Moderate Effort) | Service Level D (Low Effort) | Recommended Maintenance Activities |
|---|---|---|--|--|
| <p><input type="checkbox"/> Culverts</p> | <p>Culvert is up to 10% blocked</p> | <p>Culvert is between 10-40% blocked</p> | <p>Culvert is more than 40% blocked</p> | <p><input type="checkbox"/> remove trash and organic debris and dispose properly</p> |

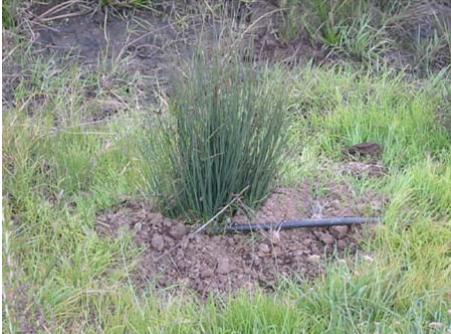
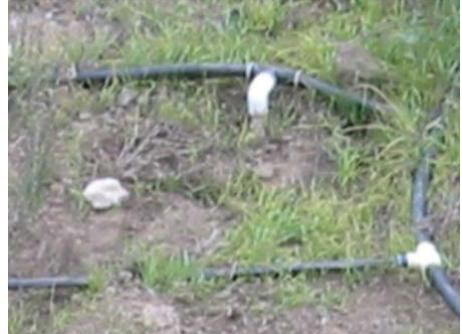
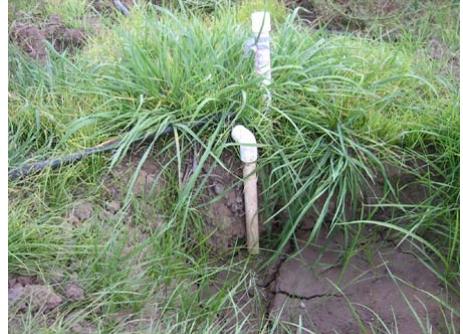
| Service Category | Service Level B (Good Effort) | Service Level C (Moderate Effort) | Service Level D (Low Effort) | Recommended Maintenance Activities |
|---|--|---|---|---|
| <input type="checkbox"/> Irrigation systems (for establishing vegetation) | <p>holes in drip irrigation correspond with plant locations; nozzles have no breaks, leaks, or blocks</p> | <p>plants and drip holes mostly aligned minimal seeping of water when system is off; no breaks or blockages</p> | <p>system has breaks or leaks; vegetation is not being adequately watered; complaints of ponding</p> | <input type="checkbox"/> repair as needed (for establishing vegetation 0-3 years old) |

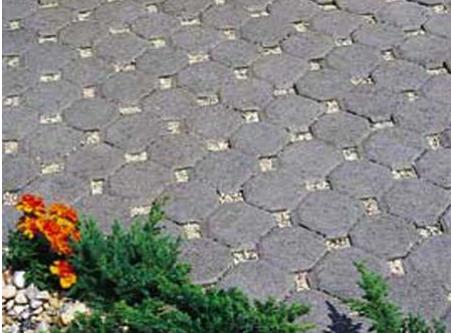
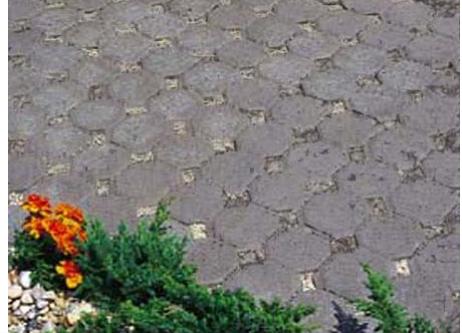
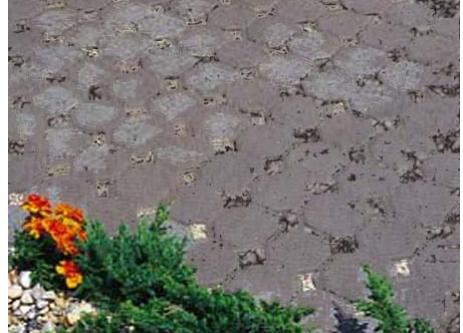
| Service Category | Service Level B (Good Effort) | Service Level C (Moderate Effort) | Service Level D (Low Effort) | Recommended Maintenance Activities |
|---|--|---|---|---|
| <input type="checkbox"/> Porous/pervious pavers | <p>water infiltrates well, pavers are up to 10% clogged or minimal ponding is observed</p> | <p>water infiltrates well, pavers are between 10-40% clogged and minimal ponding is observed</p> | <p>water does not infiltrate well, pavers are more than 40% clogged</p> | <input type="checkbox"/> vactor debris |

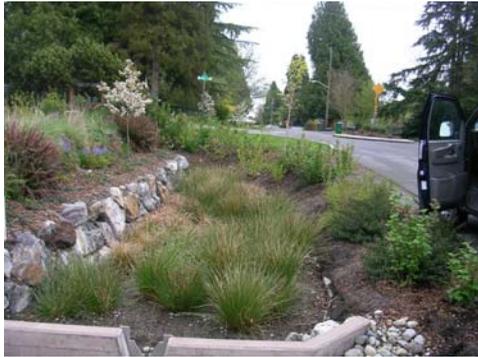
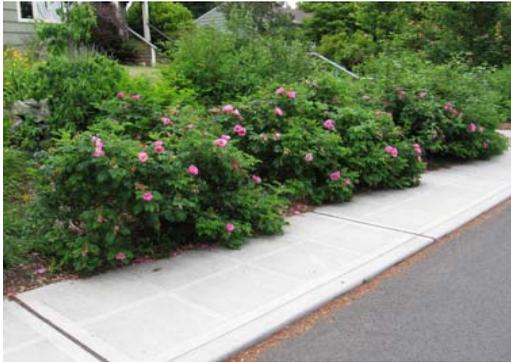
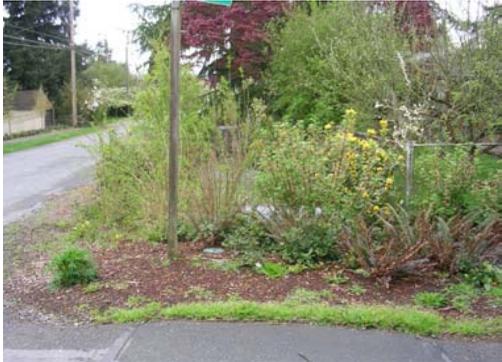
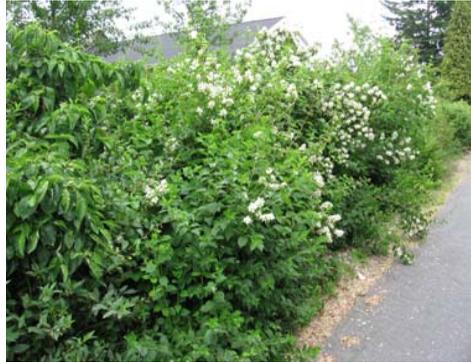
| Service Category | Service Level A (Excellent Effort) | Service Level B (Good Effort) | Service Level C (Moderate Effort) | Service Level D (Low Effort) |
|---|---|---|--|--|
| SAFETY, MOBILITY, ACCESS | <ul style="list-style-type: none"> • Vegetation causes no visibility (line of sight) or driver safety issues • Infrastructure is always accessible • Vegetation around infrastructure is maintained at height to prevent damage during routine maintenance | <ul style="list-style-type: none"> • Vegetation causes minimal visibility (line of sight) or driver safety issues • Infrastructure is mostly accessible • Most vegetation around infrastructure is maintained at height to prevent damage during routine maintenance | <ul style="list-style-type: none"> • Vegetation causes visibility (line of sight) or driver safety issues • Infrastructure is not accessible • Vegetation around infrastructure is will be damaged during routine maintenance | <ul style="list-style-type: none"> • Vegetation causes visibility (line of sight) or driver safety issues • Infrastructure is not accessible • Vegetation around infrastructure is will be damaged during routine maintenance |
