Tyco Electronics (AMP Inc.)

**Rural Delivery 2, Box 248B
Glen Rock, PA 17327-9550
Congressional District 19
EPA ID #: PAD041421223
Last Updated: 04/12/2010**

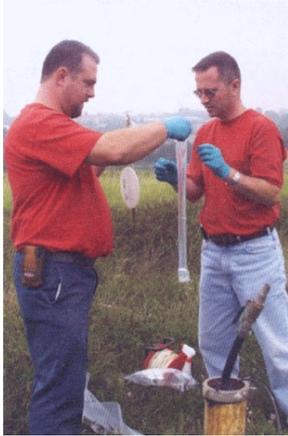
Figure 1: A stainless steel wire is attached to the diffusion bag and lowered into the well.

The facility is currently using a new method for acquiring groundwater samples called diffusion sampling. This method replaces the conventional purge and bail method for future groundwater monitoring. Diffusion sampling is a relatively new technology designed to use passive sampling techniques that eliminate the need for well purging. A diffusive-membrane capsule is filled with deionized distilled water, sealed, mounted in a suspension device, and lowered to a specified depth in a monitoring well. Over time the VOCs in the groundwater diffuse across the capsule membrane, and contaminant concentrations in the water inside the sampler attain equilibrium with the ambient groundwater. The diffusion bag sampler is subsequently removed from the well, and the water within the sampler is transferred to a sample container and submitted for analysis. Below are pictures taken during the deployment and retrieval of the diffusion bags.

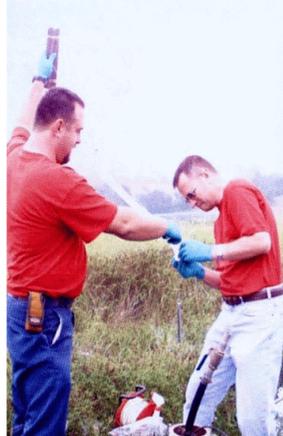
Figure 2: A weight is attached to the bottom of the bag to stabilize the deployment of the bag.

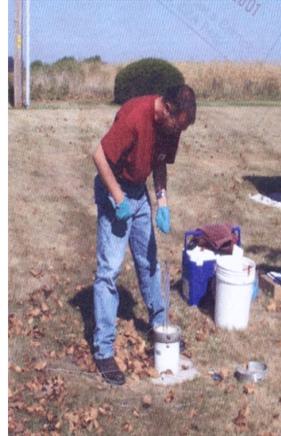
Figure 3: Retrieving the diffusion bag from the well.
