Re: City of Santa Paula Municipal Separate Storm Sewer System (MS4) Compliance Audit Report

**MUNICIPAL SEPARATE STORM
SEWER SYSTEM (MS4)
COMPLIANCE INSPECTION**

**CITY OF SANTA PAULA,
CALIFORNIA**

INSPECTION REPORT

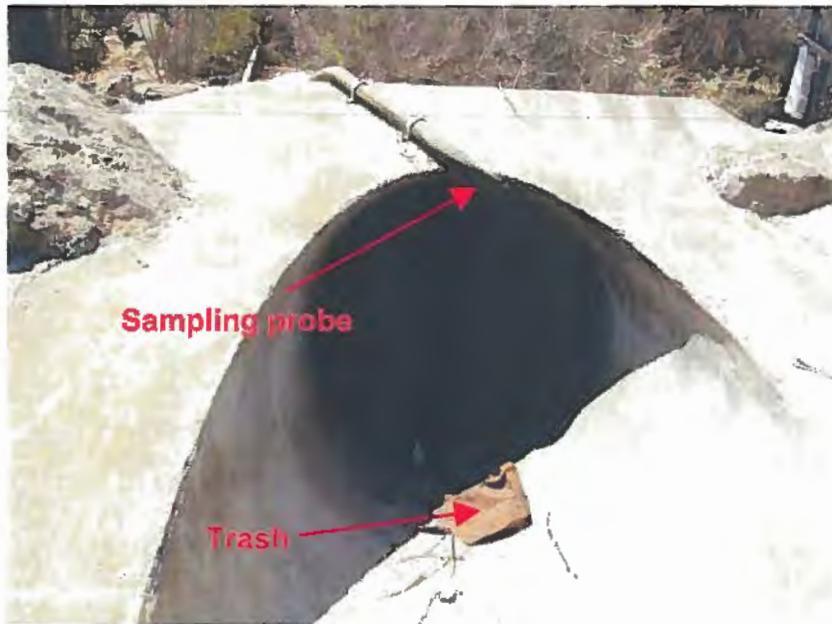
The City Monitoring Outfall consisted of a roughly 36-inch diameter culvert (Photograph 1). The City Engineering Technician stated that stormwater flowed through the natural area to the south of the outfall and then flowed to the Santa Clara River. The City Engineering Technician and City Consultant stated that the Ventura County Watershed Protection District conducted all monitoring activities for the City

- A homeless encampment was located in the area just below the outfall and articles of trash were observed in the City Monitoring Outfall (Photographs 1 and 2).
- The Ventura County Watershed Protection District monitoring box was located directly uphill north of the City Monitoring Outfall (Photograph 3).

Photograph 1. City Monitoring Outfall – View of the 36-inch diameter culvert outfall. Note the sampling probe which had been installed at the outfall and trash within the outfall.

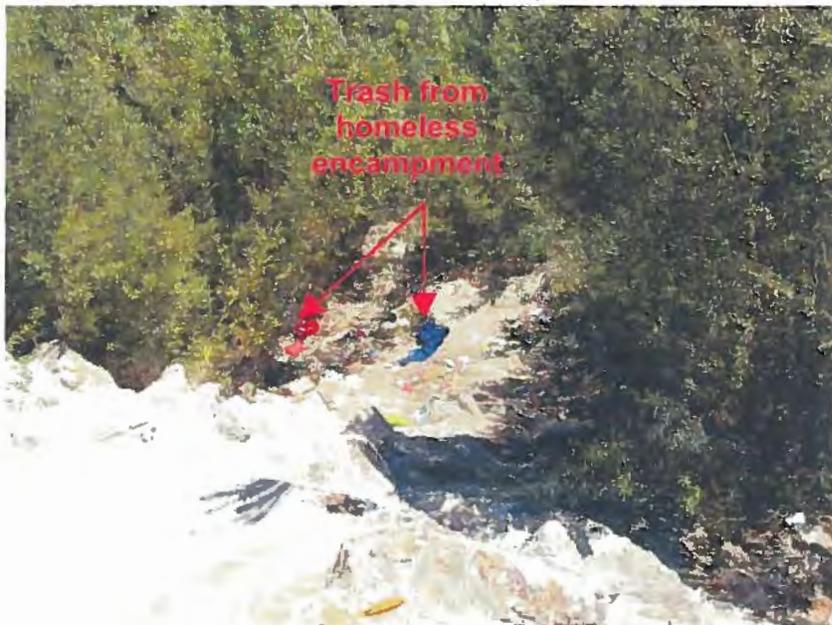
Photograph 2. City Monitoring Outfall – View of trash associated with the homeless encampment located directly below the City Monitoring Outfall to the south.

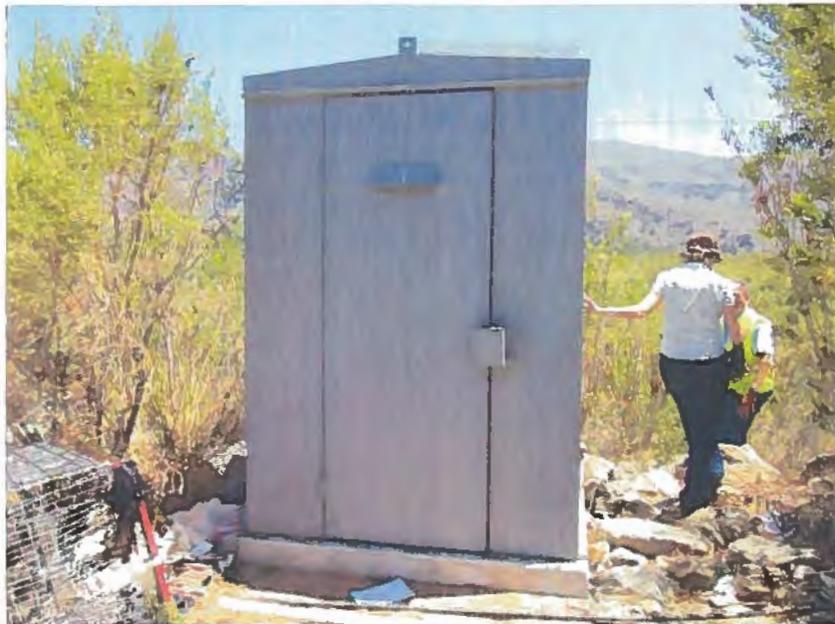
Photograph 3. City Monitoring Outfall – View of VCWPD monitoring box located north of the City Monitoring Outfall.

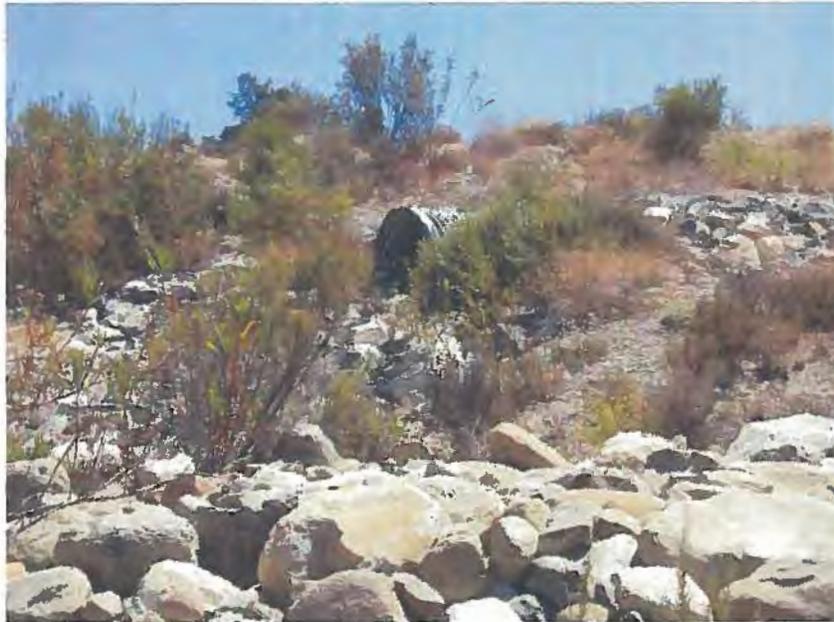
The outfall from the City's MS4 consisted of a 54-inch corrugated metal pipe (Photograph 1). The outfall discharged runoff from an area of the City that had a varied land use including small horse farming activities. The City Engineering Technician stated that an additional 34-inch corrugated metal pipe outfall was also present near this location; however, it was not viewed during this site visit.

Photograph 1. City MS4 Outfall East of Ojai Road – View of the 54-inch CMP outfall.

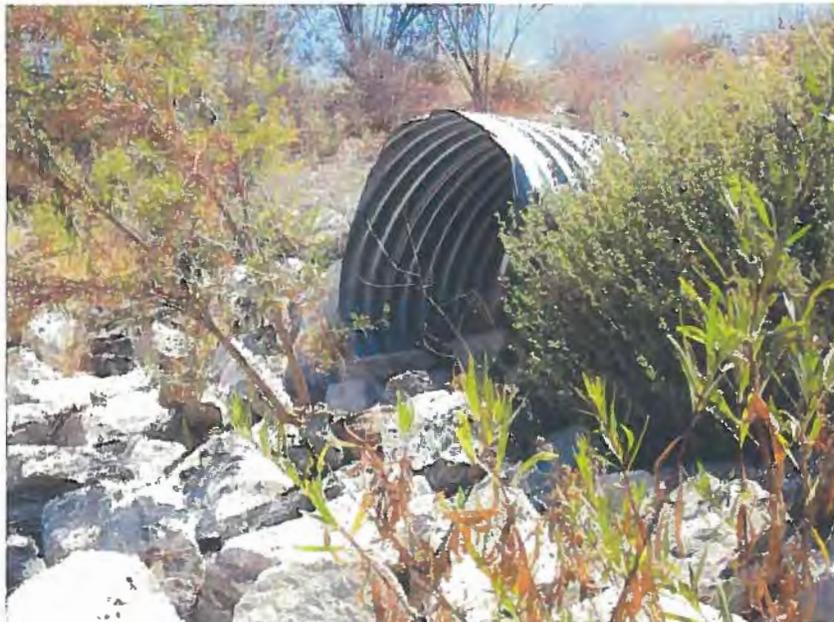
- The 54-inch corrugated metal pipe outfall was dry at the time of the site visit and the outfall pipe was clean of debris and sediment (Photograph 2).

Photograph 2. City MS4 Outfall East of Ojai Road – Closer view of the outfall shown in Photograph 1. The outfall was dry and the outfall pipe was clean of debris and sediment at the time of the site visit.

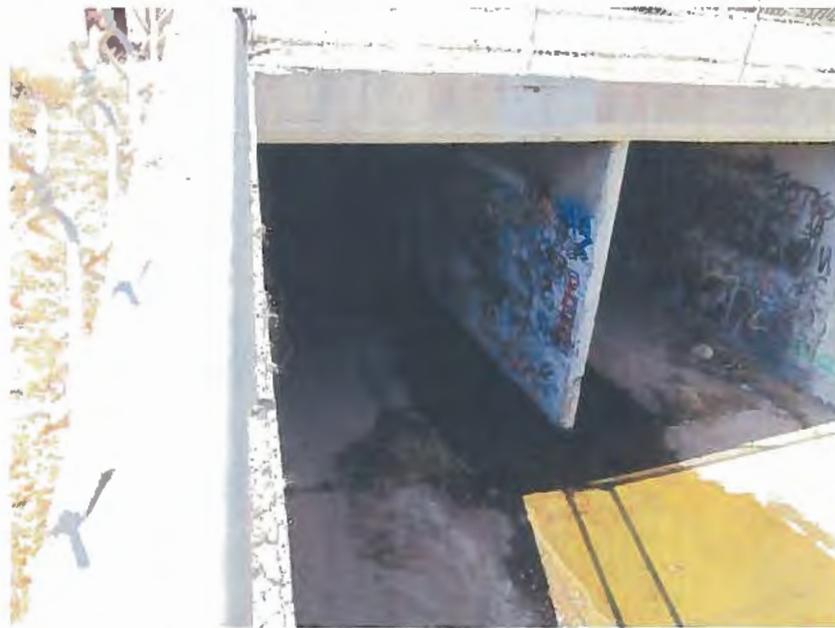
This outfall consisted of two large concrete box culverts (Photograph 1). Discharges from the City MS4 Outfall flowed through a trapezoidal concrete channel and eventually to the Santa Clara River.

Photograph 1. City MS4 Outfall to VCWPD MS4 – View of the two large concrete box culverts through which discharges from the City MS4 would enter a channel owned and operated by the VCWPD.

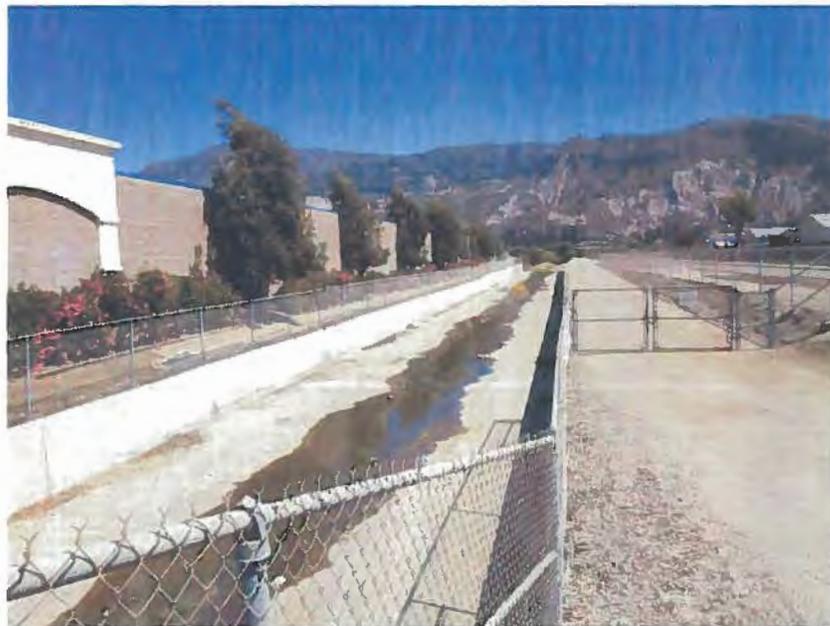
- A small quantity of water was flowing from the outlet into the concrete VCWPD channel (Photograph 2).

Photograph 2. City MS4 Outfall to VCWPD MS4 – View of VCWPD channel looking south from the box culverts shown in Photograph 1. Note that water was flowing in the channel at the time of the site visit.
