CORRECTIVE MEASURES STUDY COLUMBIA MANUFACTURING COMPANY RESTORATION PROJECT WESTFIELD, MASSACHUSETTS		
DISTRIBUTION OF COPPER SOUTH END GROUNDWATER - MAY 2009		
DRAWN BY: TLH	SCALE AS NOTED	PROJECT NO.: 71360.27
CHECKED BY: BCB	APPROVED BY: MAM	DATE: 2009
RMT		<i>Patewood Plaza One, Suite 100 30 Patewood Drive Greenville, SC 29615-3535 Phone: 864-281-0030 FAX: 864-281-0288</i>

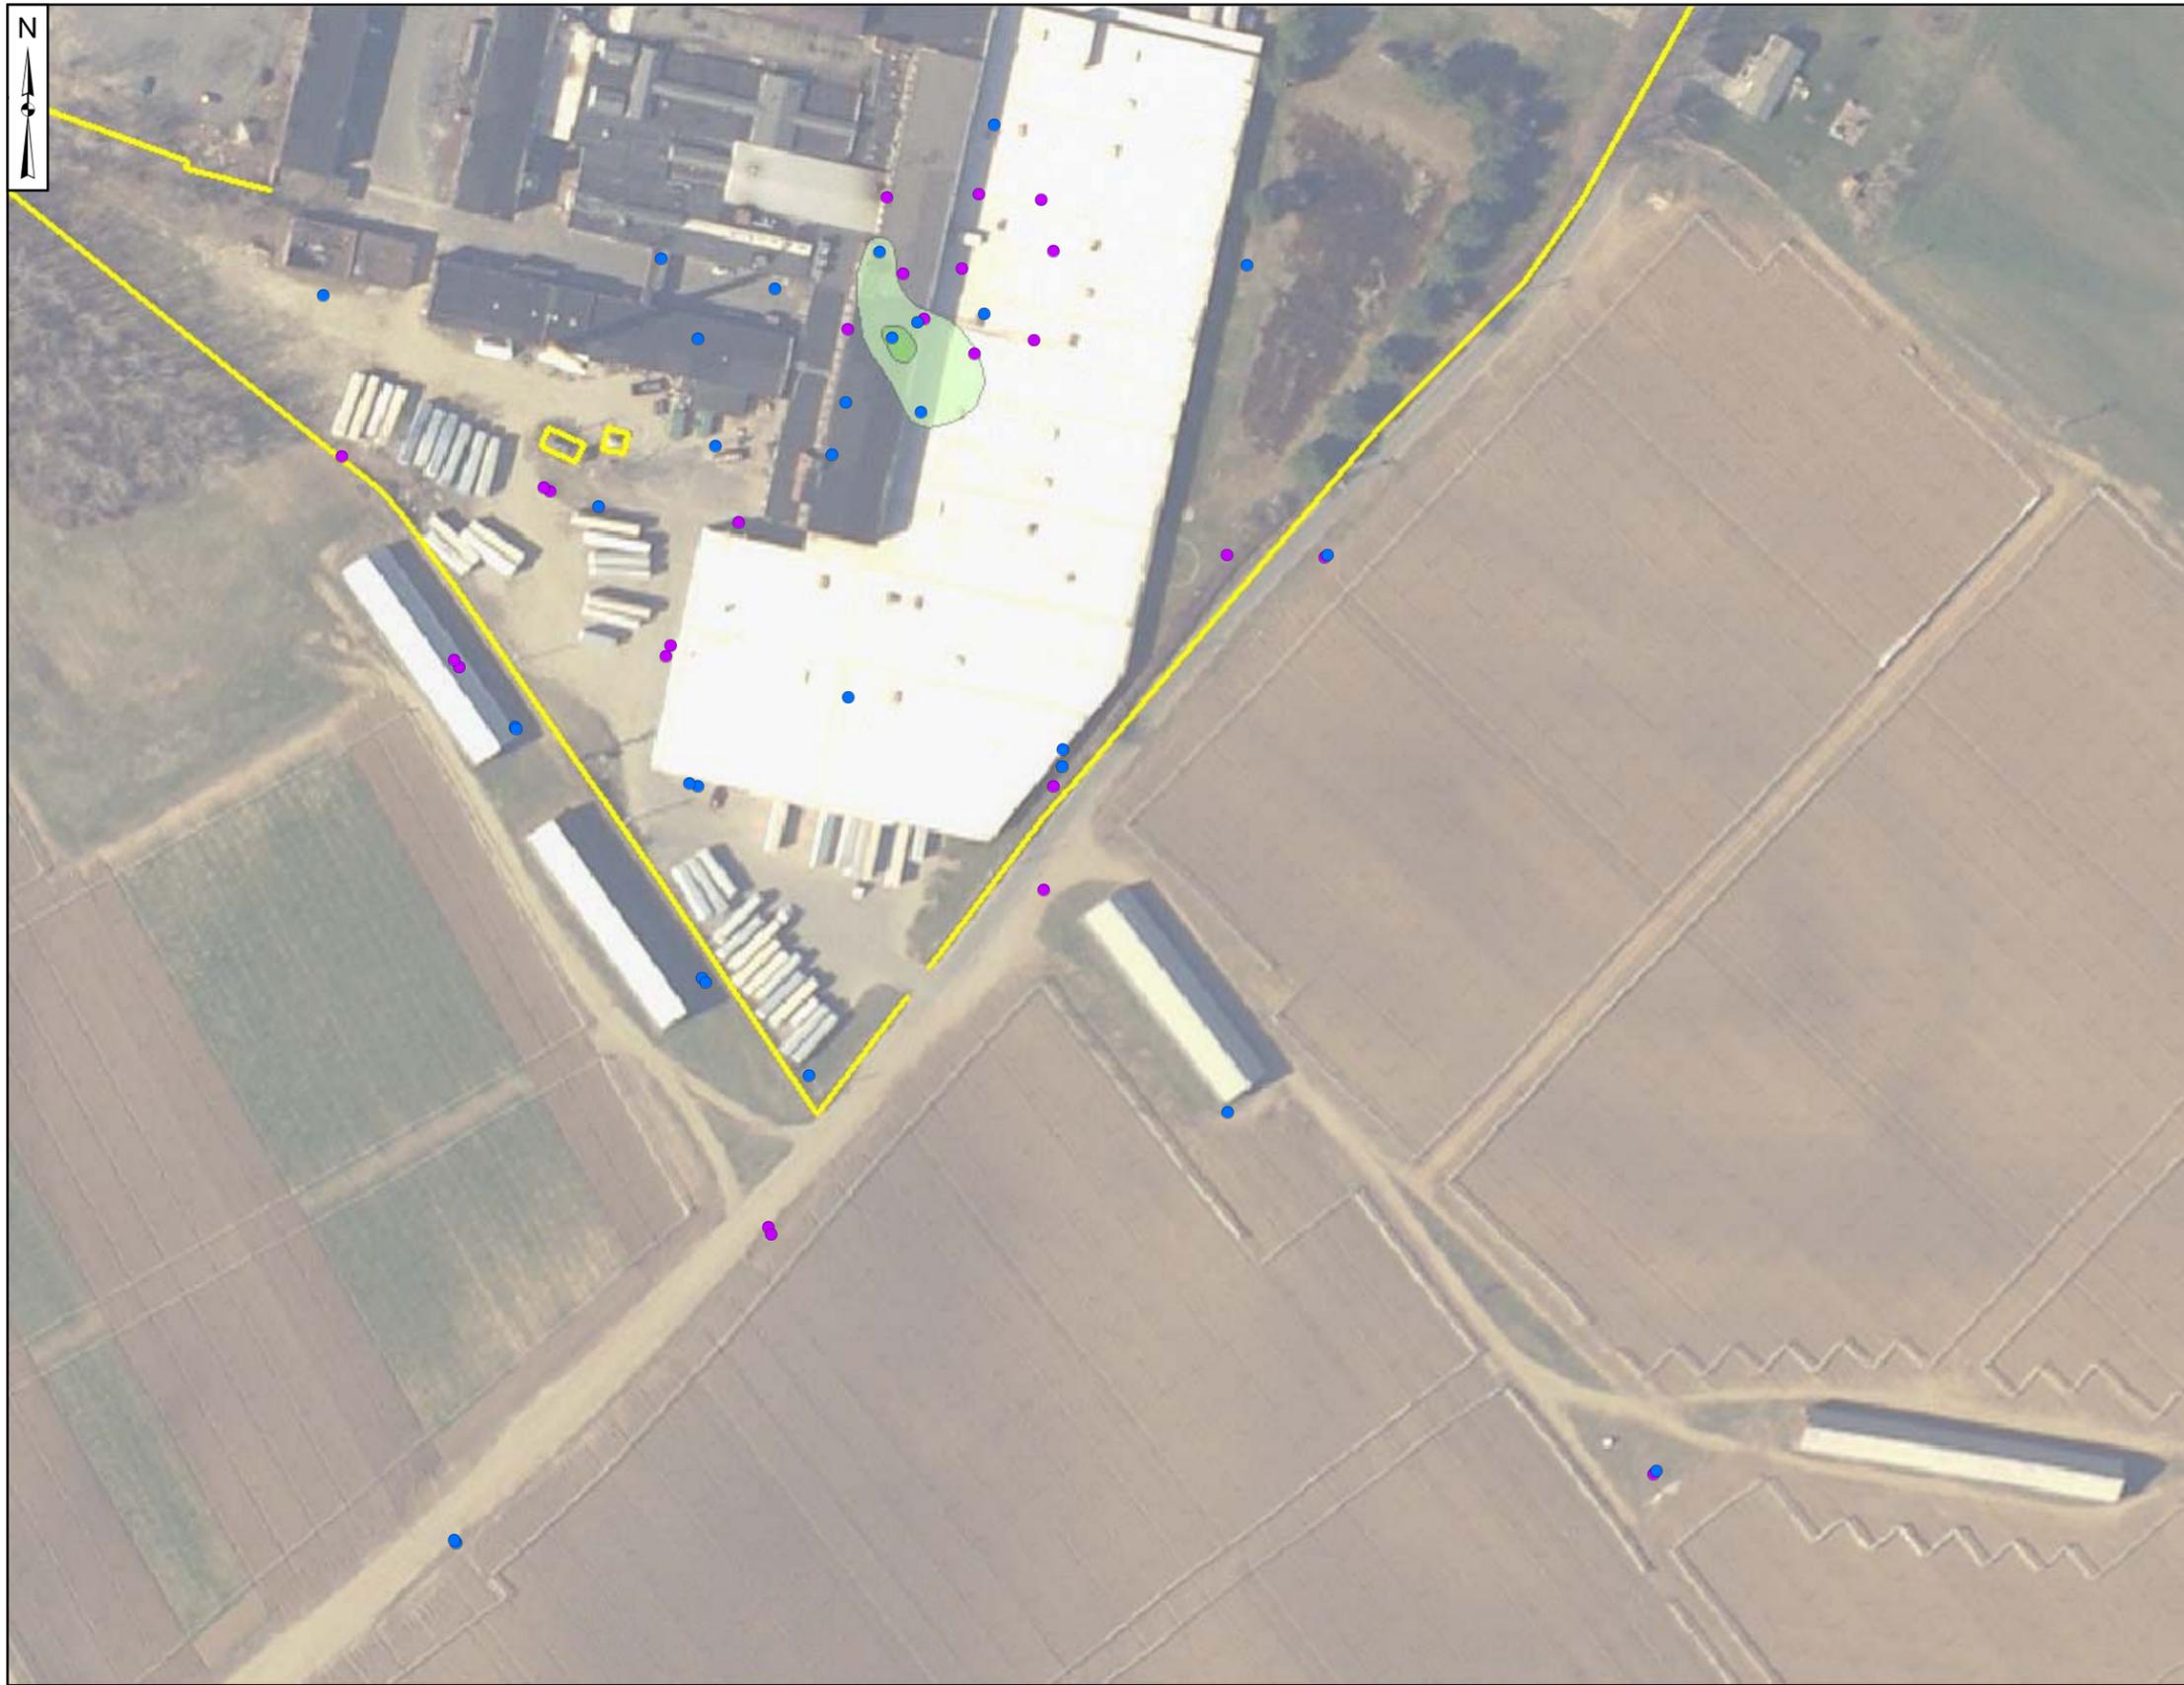
- Monitoring Well - GW Quality and Water Levels
 - Monitoring Well - Water Levels Only
 - Site Boundary and Fence Line
- Copper Concentration (mg/L)
- 1 - 5
 - >5

Aerial photograph taken ca. 2004.
 Multiple structures have been deconstructed since the aerial photograph was taken.
