Corrective Measures Study (CMS)
Columbia Manufacturing Company (CMC) Restoration Project
Westfield, Massachusetts
Site Location and History

Site Location and History

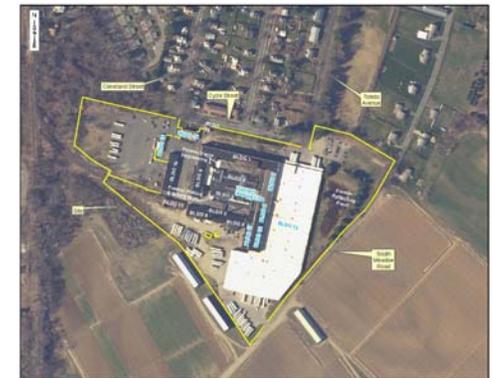
Historical Building Location Map

These basic operations have not changed significantly throughout the history of the site. Different methods may have been used; however, for different workpieces to maintain production. The locations of the former site buildings are shown on the [Historical Building Location Map](#).

Wastewater generated in the plant which contained or may have contained heavy metals was piped to the WWTP where treatment vessels precipitated metal hydroxide sludges. The clarified liquid was discharged to the Little River outfall and the bottom slurry of metal hydroxide sludge was pumped to two lagoons (AOC 29) constructed for the purpose of dewatering this sludge (see [Historical Building Location Map](#)).

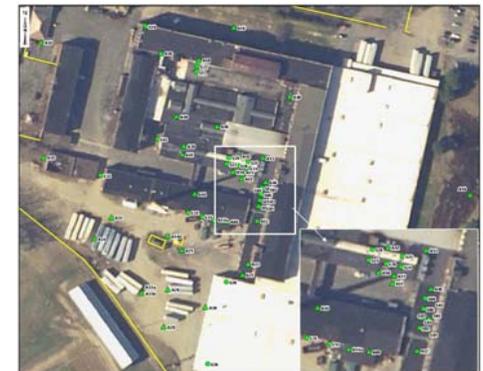
SWMU and AOC Location Map

- CMC originally identified four SWMUs: the sludge roll-off box (AOC 9), the former lagoons (AOC 29), the former hazardous waste drum storage area (AOC 14b), and satellite storage of hazardous waste in the degreasing room in Building IA (SWMU 13). The location of these SWMUs and AOCs are shown on the [SWMU and AOC Location Map](#).

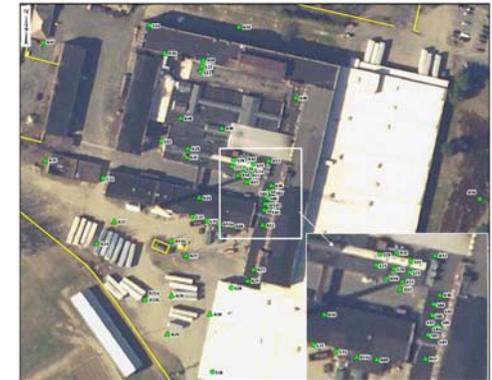
SWMU and AOC Location Map

A total of 52 SWMUs and/or AOCs have been identified at the site through numerous environmental studies. Earlier investigations, prior to the development of the RFI Proposal and as a result of the RCRA facility assessment (RFA) report identified 47 SWMUs. Two additional SWMUs were identified during the development of the RFI Proposal. Of the 52 SWMUs, 30 AOCs were identified for further investigation. Two of those AOCs were further subdivided during Phase I of the RFI to account for differences in location or use. Two separate areas were identified for the storage of hazardous waste drums, the current area (AOC 14a) and the former area (AOC 14b). Additional information regarding the former incinerator (AOC 33b) indicated that the unit was not located at the former strap metal fill area (AOC 33b). The locations of all SWMUs and AOCs are shown on the [SWMU and AOC Location Map](#). [Table 1 \(Status of SWMUs and AOCs\)](#) summarizes the SWMUs and AOCs and their current status.
