# **Fish Protection at Cooling Water Intake Structures**

*A Technical Reference Manual – 2012 Update*

Technical Update, February 2013

**Alden Research Laboratory, Inc.**

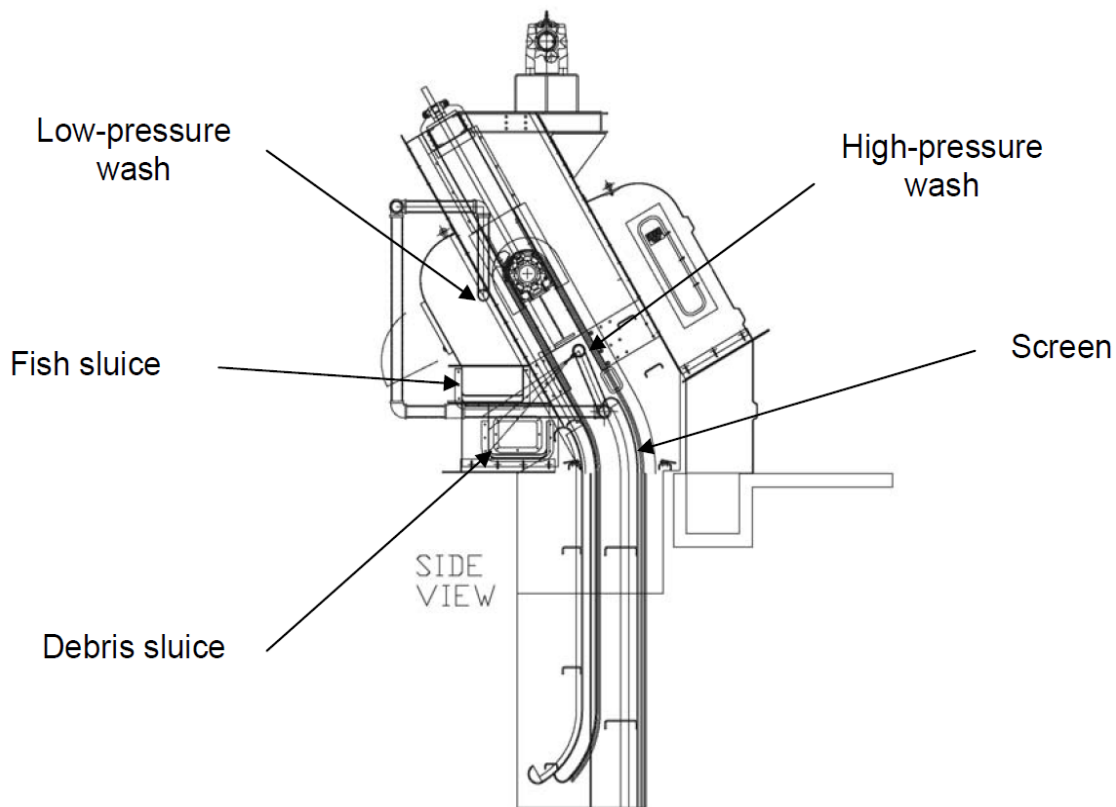
**Figure 2-20**  
**Hydrolox™ screen installed at the Barrett Generating Station, 2007**

The study was conducted at the Unit 2 intake bays, one bay equipped with a Hydrolox screen and the other equipped with a conventional vertical travelling screen. The collection system was comprised of three devices, transitioning through the fish return system. Organisms and debris impinged on the screens were first collected in an aluminum collection bucket with 0.79-cm (0.31-in.) mesh drains, inserted in the fish sluice. A custom-fitted 0.64-cm (0.25-in.) soft net was installed behind the fish sluice, in the Hydrolox debris sluice, and locked into place at the transition between the stainless sluice and the concrete below deck sluice. A standard collection basket for the convention travelling screen modified with an aluminum insert to hold 10.2 cm (4 in.) of water was the final collection device in the system.

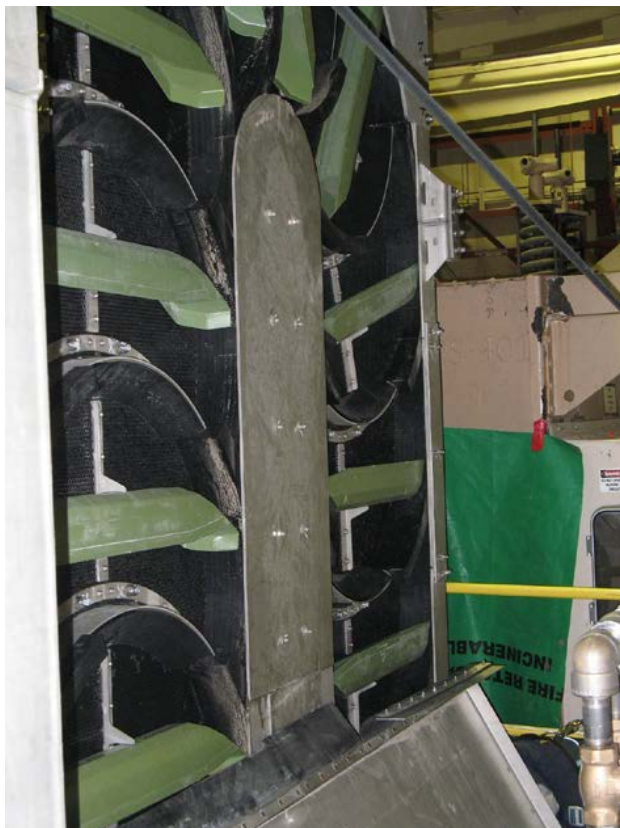
**Figure 2-23**  
**Image of Geiger screen installed at Fort Calhoun Station**

Omaha Public Power District installed the Geiger screen on all six intake bays at Fort Calhoun Station. The Geiger screen, unlike conventional traveling screens, moves up and down on one plane, eliminating debris carryover from overtopping (Figure 2-23). The main components of the Geiger screen are the sickle-shaped mesh panels, one central chain guide-way integrated in the supporting structure, one revolving chain, one lower guide, low-pressure and high-pressure spraywashes, debris/fish buckets, a debris/fish collection/return trough, a drive unit, and a splash guard. The round screen opens are 9.5 mm (3/8 in.) in diameter and are arranged in a hex pattern.

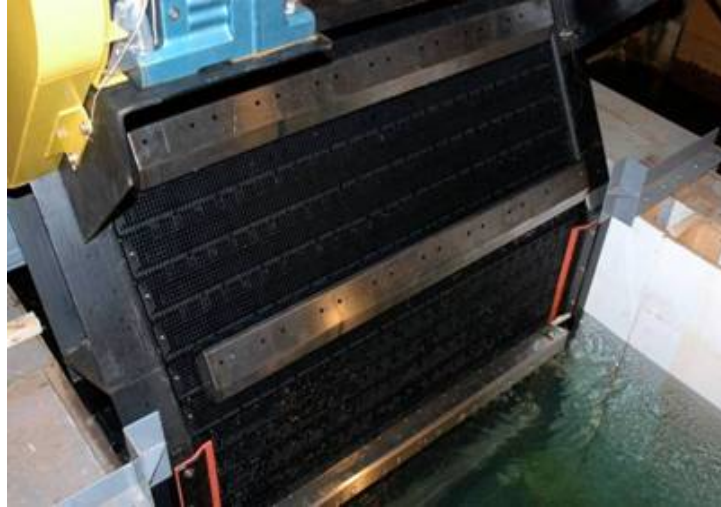
**Figure 2-25**  
**Hydrolox Screen™ installed in fish testing flume**

In 2006, a Hydrolox screen was tested at Alden Research Laboratory using five species of freshwater fish: golden shiner (*Notemigonus crysoleucas*), common carp (*Cyprinus carpio*), bluegill (*Lepomis macrochirus*), striped bass (*Morone saxatilis*), and channel catfish (*Ictalurus punctatus*). Tests were conducted in Alden’s Fish Testing Flume using a 1.22 m (4 ft) wide by 3.66 m (12 ft) high, fully operational Hydrolox screen installed perpendicular to the flow (Figure 2-25). Screening material was made of molded plastic with slot openings of 0.64 cm by 0.76 cm (0.25 in. by 0.30 in.). Testing procedures were similar to those used previously to evaluate modified traveling screens (EPRI 2006a). Fish were impinged at 0.31 or 0.61 m/sec (1.0 or 2.0 ft/sec) approach velocity. During testing, the screen was rotated at either 1.5 or 3.1 m/min (5.0 ft/min or 10.0 ft/min).

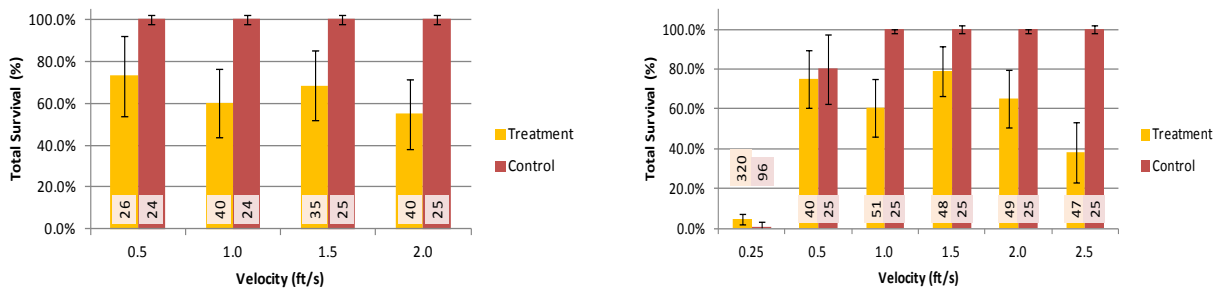
**Figure 2-30**  
**Golden shiner total survival on the OVIVO screen (left) and WIP screen (right). The total number of fish held for LM evaluation is presented at the base of each bar. 95% confidence intervals (shown as error bars) were calculated using the normal approximation of the binomial distribution.**

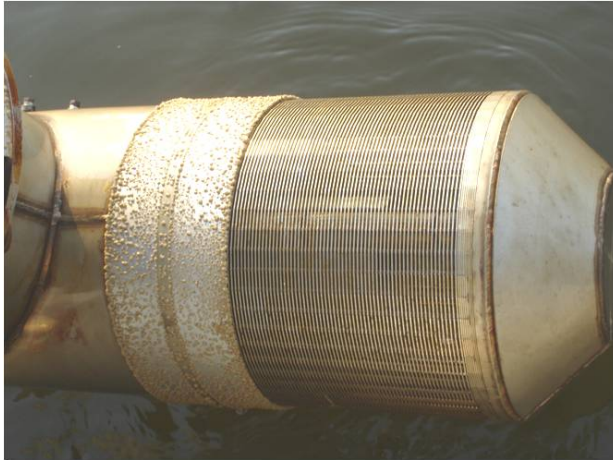
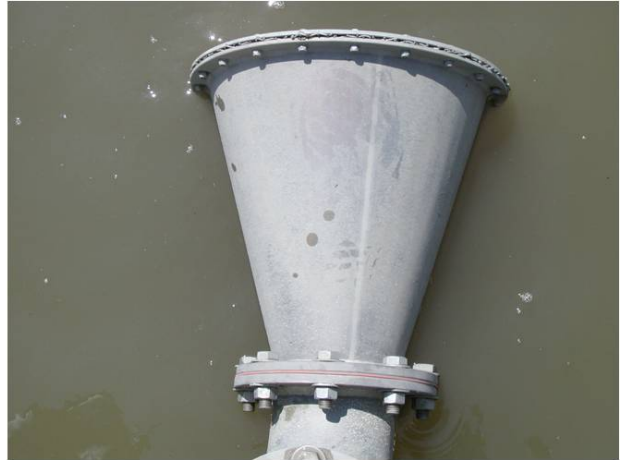
**Figure 5-15**  
Photographs showing the aluminum sleeve used to decrease the open area of the 2.0-mm wedgewire screen (left) and the geometry of the control intake cone (Alden 2010).

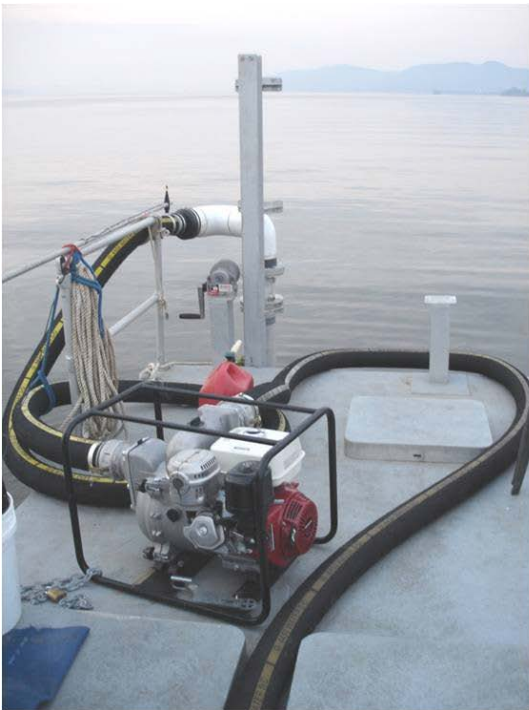
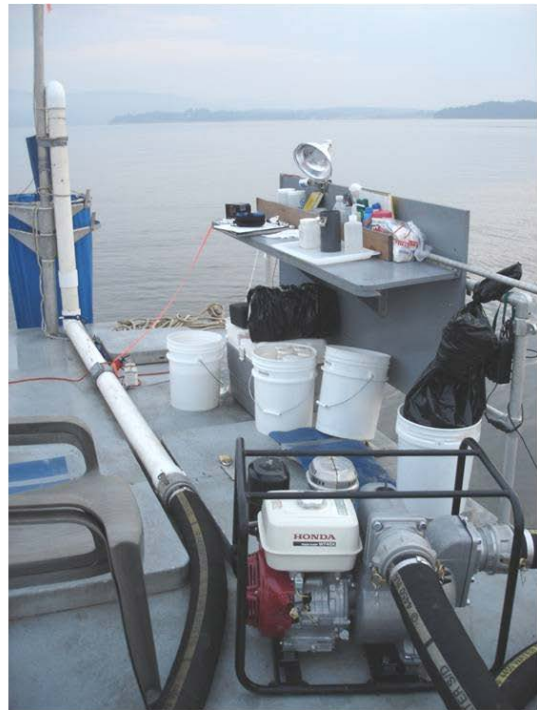
**Figure 5-16**  
Floating test facility (barge) with alternative sampling equipment. Left image show intake side of barge and right image shows discharge side of barge (Alden 2010).

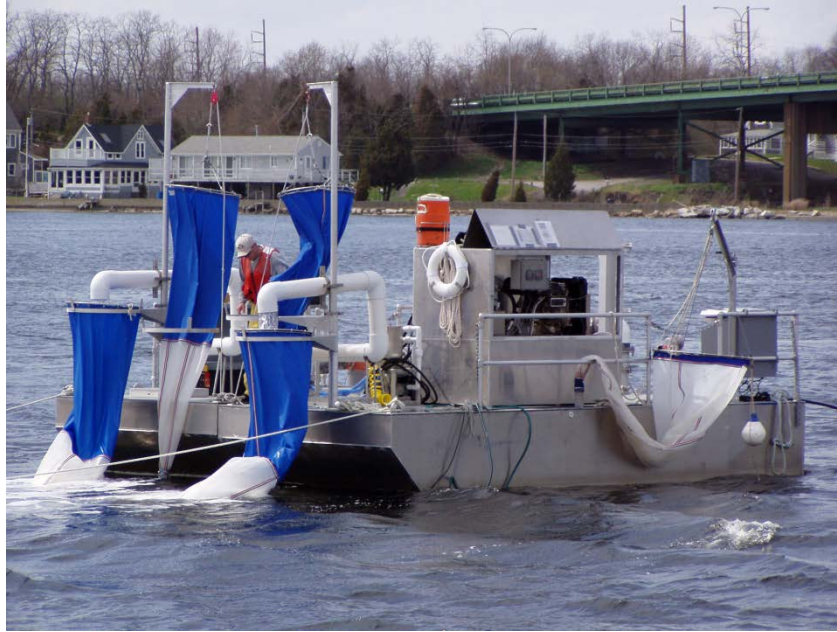
**Figure 5-17**  
**Floating test facility (barge with standard sampling equipment) (Alden 2010)**

Paired samples were collected from a floating test barge, which consisted of two separate aluminum sections (2.3 by 6.1 m [7.5 by 20 ft]) pinned together to make a 4.6 by 6.1 m (15 by 20 ft) test platform (Figure 5-13). The starboard side intake was capped with a stainless steel T-12 (30.5 cm [12 in.] diameter) 2.0-mm (0.08-in.) slot width wedgewire screen supplied by Johnson Screen (Figure 5-15). A flow distributor was located nearer the center of the screen was used to achieve an average through-slot velocity of 0.15 m/sec (0.5 ft/sec) across the screen face. The control intake was conical-shaped (flaring outward), constructed of aluminum, and capped with a 9.5-mm (.37-in.) mesh screen to prohibit entrainment of large debris (Figure 5-15). Its cone shape was designed such that through-screen velocity would approximate the test screen. Two fish pumps located within the hull of the barge withdrew approximately 100 m<sup>3</sup> (3531.5 ft<sup>3</sup>) samples, over a duration of approximately 90 min per sample (Figure 5-14).

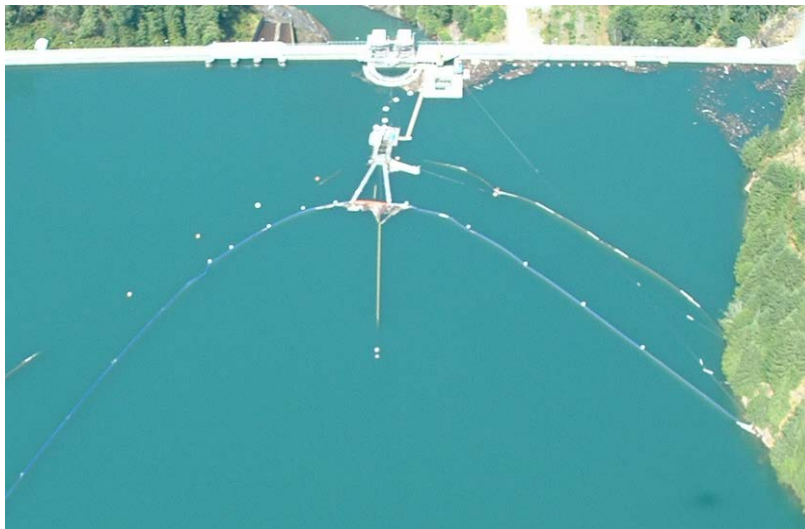
**Figure 6-5**  
**Baker River aerial photograph of barrier net**

day [BGD]) (Puget Sound Energy 2002)). A barrier net is used to guide sockeye (*Oncorhynchus nerka*) and coho salmon (*Oncorhynchus kisutch*) to the entrance of a surface collector where they pass to a fish trap and holding facility (Puget Sound Energy 2002). An aerial photograph of the net installation is shown on Figure 6-5.

In 2001, a full depth net was installed at the Lower Baker River section reaching a depth of 72 m (236 ft), extending from shore to shore. The net is supported by cork floatation across the top and 0.5-kg (1-lb) weights at the bottom sewn at 0.3 m (1 ft) spacing. The net is removed during off-migration period beginning in August and redeployed in February. The manufacturer for both nets is Redden Marine (Puget Sound Energy 2002).

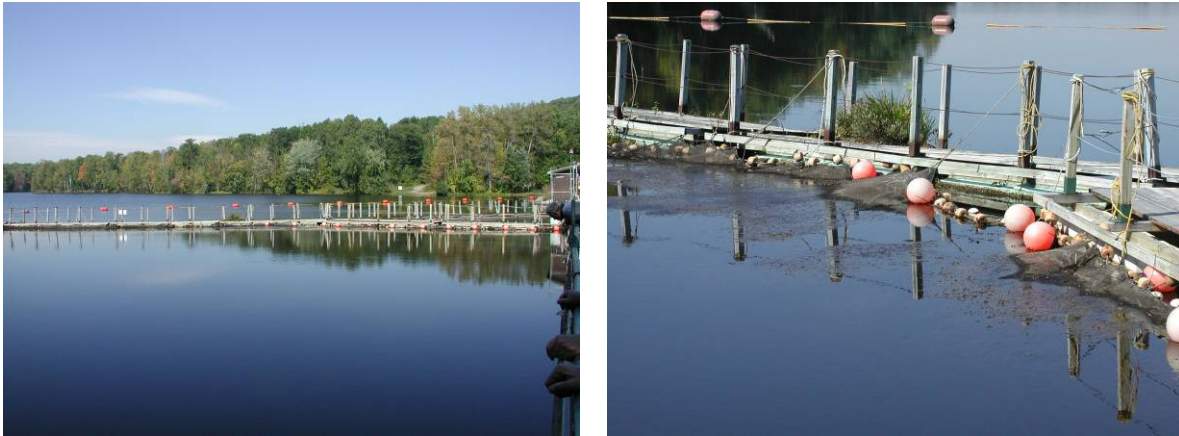
**Figure 6-7**  
**Pine barrier net**

In the summer of 1990, Wisconsin Electric (WE) installed and tested a prototype barrier net system at the Pine Hydroelectric Project (Pine) on the Pine River in Wisconsin (Stone and Webster 1991). The 25-mm (1-in.) nylon mesh (stretch) barrier net was 79.2 m (260 ft) in length, ranged in depth from 0.6 to 10.7 m (2 to 35 ft), and was placed along an angled log boom located directly upstream of the power canal intake, as shown on Figure 6-7. Table 6-2 provides pertinent project information. The top of the net was set 30.5 to 45.7 cm (12 to 18 in.) below the water surface to avoid entanglement of floating debris. Pine has a flow capacity of approximately 18 m<sup>3</sup>/s (640 cfs/414 mgd), equivalent to the flow of a moderately sized CWIS. Average approach velocities ranged from 0.03 to 0.15 m/sec (0.1 to 0.5 ft/sec).

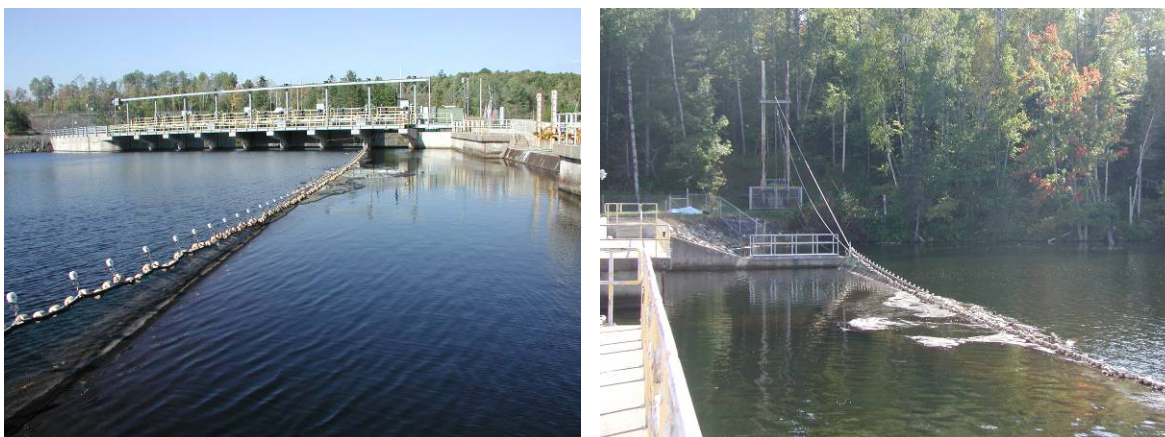
**Figure 6-8**  
**Brule barrier net**

Wisconsin Electric (WE) installed a barrier net system at the Brule Hydroelectric Project on the Brule River in Wisconsin in 1999. The barrier net spanned 217 ft across the front of the hydroelectric project forebay and was suspended by a cable. The 9.7- by 13-mm (0.38- by 0.5-in.) knotless nylon mesh barrier net extended about 6.1 m (30 ft) below the water surface and the bottom of the net was attached to weights to hold the net vertical. The net was attached to the top cable by clevises and nylon pulleys. This unique deployment system allows that net to be installed and removed in a similar manner to operating a clothes line, as shown on Figure 6-8. The top cable support is anchored to the dam at one end and the other end by a suspended concrete block to maintain a constant tension on the cable. This system limits tension on the cable resulting from debris loading on the net. Brule has a flow capacity of approximately 39 m<sup>3</sup>/s (1,377 cfs/890 mgd). Average approach velocity to the net is 0.06 m/sec (0.2 ft/sec).

The Brule net experiences heavy biogrowth (Figure 6-8) which, on at least one occasion, has caused the net to lift to the water surface rendering it ineffective. The pictures on Figure 6-8 were taken in September 2004, about one month after the net was cleaned by divers and just before the net was removed for winter storage. The net is stored for the winter in the hanging position from an onshore tower (see right picture, Figure 6-8).

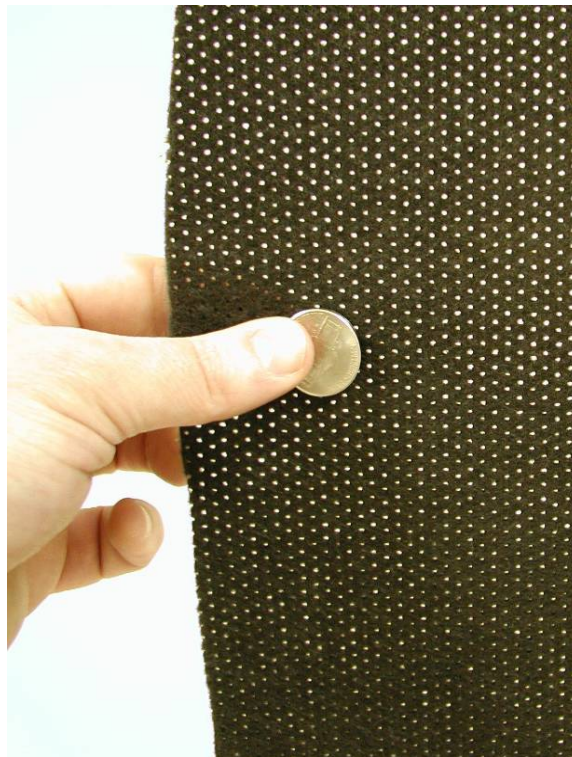
**Figure 7-1**  
**Close-up of perforated AFB material (courtesy of Alden)**

There are limited data available on the deployment of aquatic filter barrier (sold commercially as Gunderboom® Marine Life Exclusion System™ – MLES) for the protection of fish at water intakes. The AFB consists of polyester fiber strands that are pressed into a water-permeable fabric mat (Figure 7-1). This material can be perforated to allow greater flow rates. In addition, Gunderboom also developed a woven material with greater opening sizes than the original fabric mat.

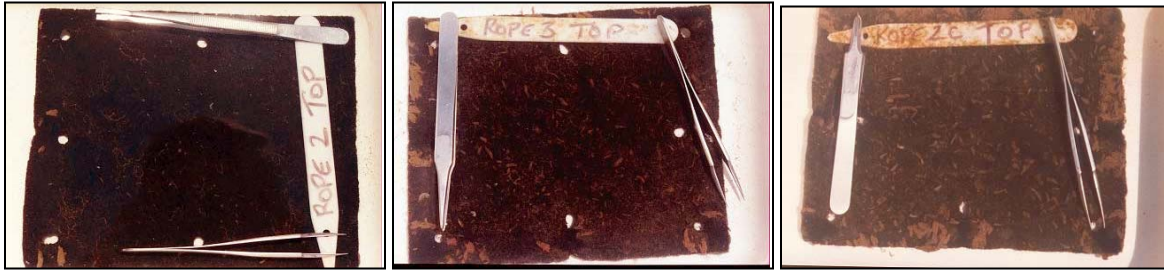
**Figure 7-5**  
Appearance of AFB pieces after 11, 20 and 29 days of exposure (moving from left to right) to water in Bowline Pond at a depth of 3 ft (Henderson et al. 2001).

Results indicated that there was a significant difference in permeability among the three depths tested. In the no flow/no air burst treatments, there was a significant decrease in permeability over time. There was no change in permeability after 11 days, a 49% decrease in permeability after 20 days, and a 62% decrease in permeability after 29 days (Figure 7-5). In the treatments exposed to flow and airbursting, there was an even greater reduction in permeability. After 29 days, the flow was reduced to 4% that of clean fabric. The authors linked the decrease in permeability to the development of a diverse biofouling community. Additionally, it was hypothesized that the biofouling community was comprised of a number of potentially predatory species that could prey upon the eggs and larvae occurring near the AFB.

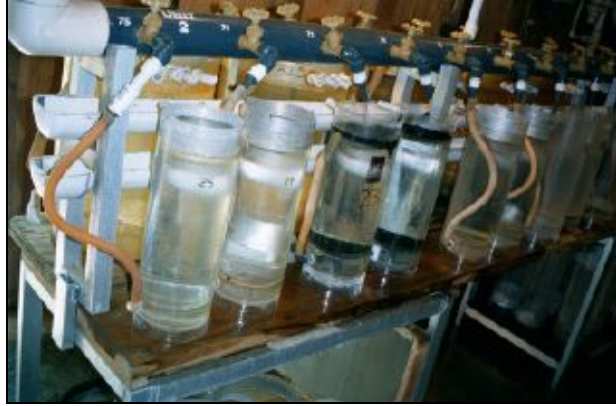
**Figure 7-6**  
**Hatching jars used in American shad egg impingement trials at the New York State Department of Environmental Conservation (NYSDEC) (photo courtesy Ed Radle, NYSDEC).**

A small-scale laboratory study was conducted by NYSDEC to evaluate the survival of American shad (*Alosa sapidissima*) eggs impinged on AFB and to observe the swimming behavior of American shad larvae in the laboratory at a typical AFB approach velocity. For the impingement survival trials, eggs were placed in a hatching jar that had a disc of AFB mounted on one end (Figure 7-6). Uni-directional flow was initiated such that all eggs were impinged on the AFB surface. Eggs were impinged for 1, 2, or 4 hrs and then held for 24 hrs to assess latent mortality. Swimming observations of day-old larvae were conducted in a 0.3- by 1.1-m (1- by 3.5-ft) test channel with a piece of AFB at the downstream end. Flow in the channel was such that the through-*AFB* velocity was 5 gpm/ft<sup>2</sup>.

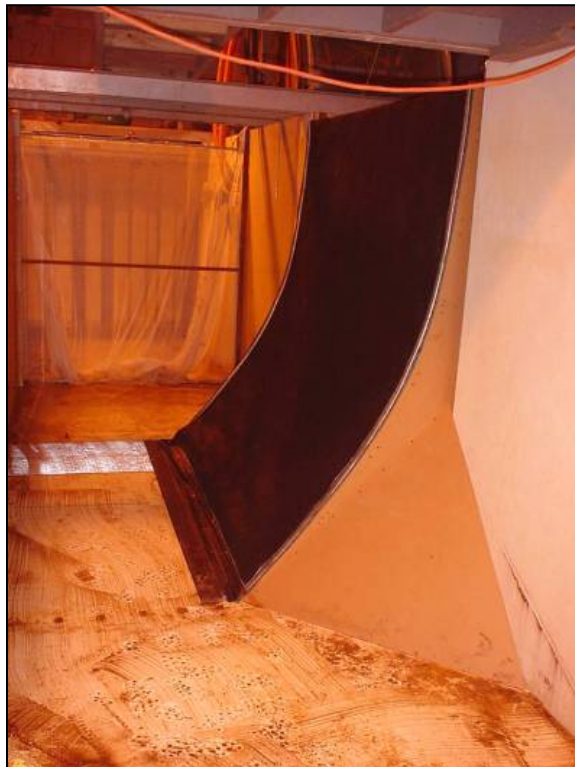
**Figure 7-8**  
Large flume used in the investigation of the effects of ambient sweeping currents on headloss. AFB is installed to simulate the bottom portion of a floating anchored deployment oriented parallel to the ambient flow (EPRI 2004).

Headloss and debris loading testing was conducted in a small acrylic test flume to develop a headloss coefficient (Figure 7-7). Investigation of the effects of ambient sweeping currents on the headloss of the various fabrics was conducted in a large test flume (Figure 7-8). Four simulated AFB intake configurations were evaluated in this study:

Two intake flow rates (10 gpm/ft<sup>2</sup> and 20 gpm/ft<sup>2</sup>) and two ambient sweeping velocities (7.62 and 30.5 cm/s [0.25 and 1.0 ft/s]) were tested during the engineering evaluation. Airburst testing was conducted in the large flume and evaluated the effectiveness of the airburst system in clearing the AFB after 85% blockage with simulated debris (Mylar sheets).

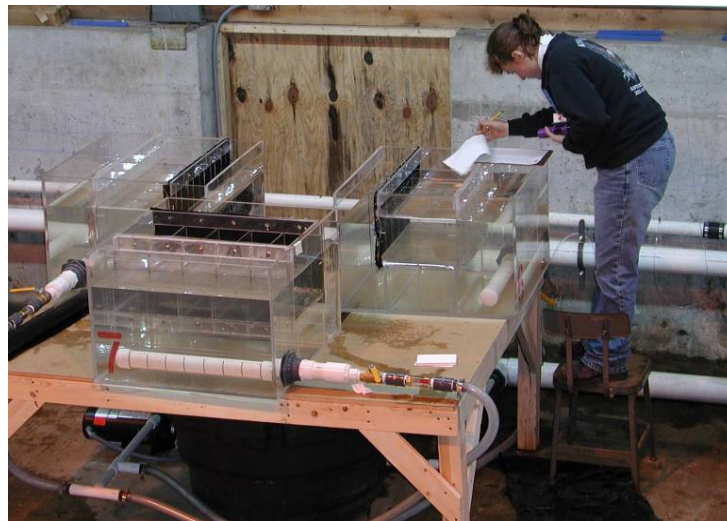
**Figure 7-9**  
**Biological testing facility comprised of 14 small acrylic test flumes (EPRI 2004)**

Biological evaluation of the AFB was conducted in a recirculating testing facility comprised of 14 small acrylic test flumes (Figure 7-9). Each small flume contained 5 individual testing channels with AFB covering the downstream end of each channel. The two objectives of the biological testing were to determine the effect of flow rate and perforation size on the survival and retention of eggs and larvae. Flow rates tested during the biological evaluation included 0, 10, and 20 gpm/ft<sup>2</sup>. Perforation sizes of 0.5, 1.0, and 1.5 mm were used in the biological testing as well. Species tested during this study included common carp (*Cyprinus carpio*), rainbow smelt (*Osmerus mordax*), striped bass (*Morone saxatilis*), bluegill (*Lepomis macrochirus*), yellow perch (*Perca flavescens*), walleye (*Sander vitreus*), and white sucker (*Catostomus commersonii*). Trials were run for 6 hrs and post-test fish were held for 48 hrs to assess latent mortality.

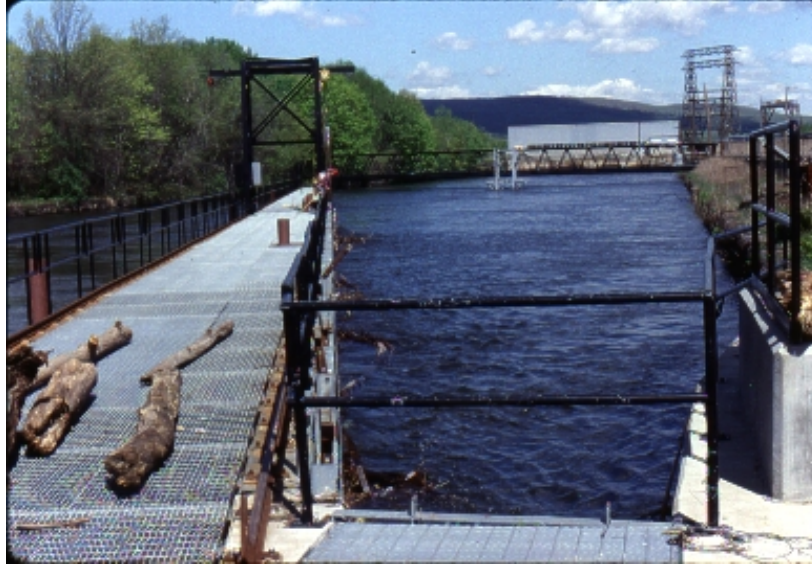
**Figure 12-7**  
**Holyoke louver system (photo courtesy of Alden)**

Northeast Utilities Service Company conducted a major research effort evaluating the use of louvers for diverting juvenile and adult clupeids and Atlantic salmon smolts in the Holyoke Canal (part of the Holyoke Hydroelectric Project; Figure 12-6 and Figure 12-7) on the Connecticut River (Harza and RMC 1992; Harza and RMC 1993; Stira and Robinson 1997). An evaluation of louver effectiveness was performed with juvenile clupeids (American shad [*Alosa sapidissima*] and blueback herring [*Alosa aestivalis*]) at various canal flows. The study found that 76% of marked and recaptured test fish were guided, and 86% of naturally migrating fish were guided to a bypass that returned fish to the mainstem river (Harza and RMC 1993). A separate evaluation performed with Atlantic salmon (*Salmo salar*) smolts indicated an overall guidance effectiveness of between 85 and 90% (Harza and RMC 1992).

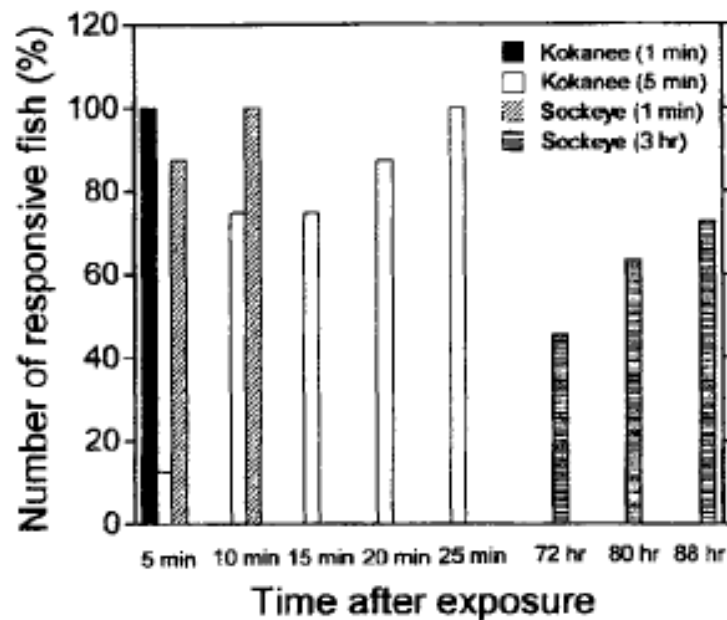
**Figure 13-6**  
**Percentage of Kokanee and sockeye salmon that responded to an overhead shadow after strobe light exposure for various amounts of time as a function of time after exposure. Note that 3 sockeye salmon in the 3-hr-exposure group died before any reaction was detected; hence, the cumulative bar graph never attains 100% from this treatment (Flamarique et al. 2006).**

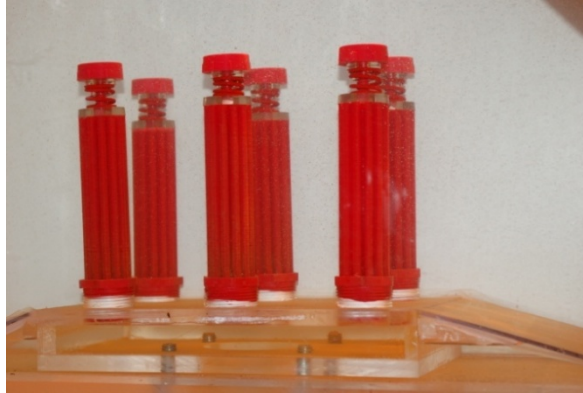
**Figure 17-3**  
**Six individual Filtrex filter candles installed in the laboratory test facility.**

A laboratory study was conducted by Inima/Aquaria to investigate the impingement and subsequent survival of early life stages of fishes contacting Filtrex Filter Candles (FFS). This evaluation was a step in determining whether the FFS was an appropriate intake technology for a desalination facility. The FFS is composed of individual filter candles (Figure 17-3). The candles are designed with a pore size of 40 µm, a through-pore velocity of 0.06 m/sec (0.2 ft/sec), and a flow rate of approximately 35 lpm (9.25 gpm) (Alden 2007).
