Fish Protection at Cooling Water Intake Structures

A Technical Reference Manual – 2012 Update

3002000231

Technical Update, February 2013

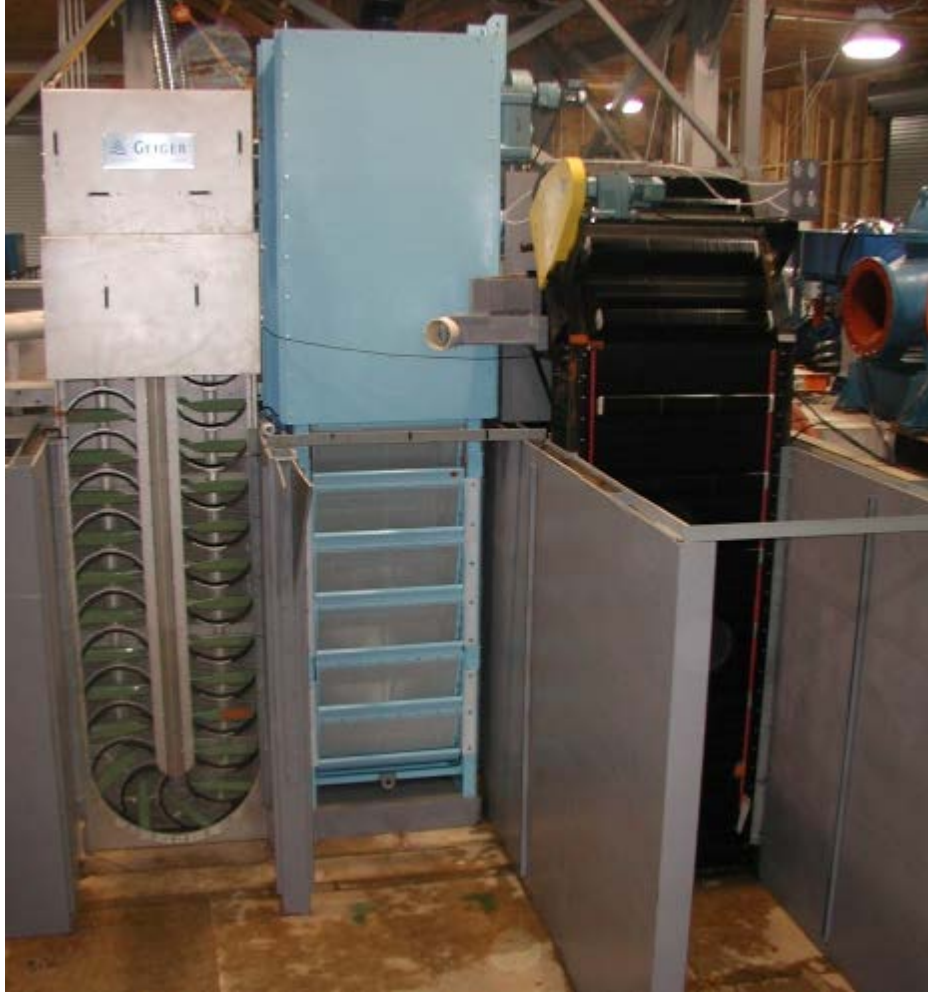
Figure 2-27
Test flume for prototype-scale screen testing showing the three test screens (EPRI 2009b).

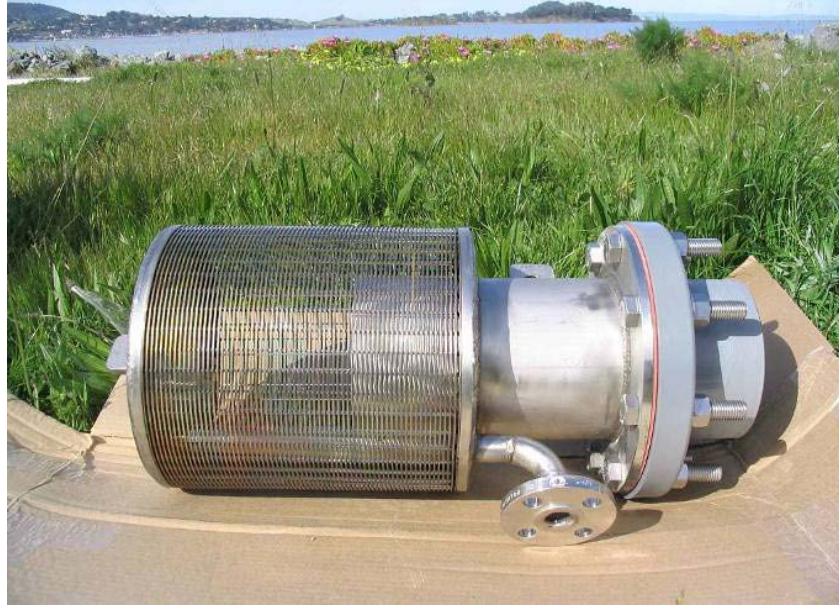
Figure 5-19
MMWD pilot plant cylindrical narrow slot intake

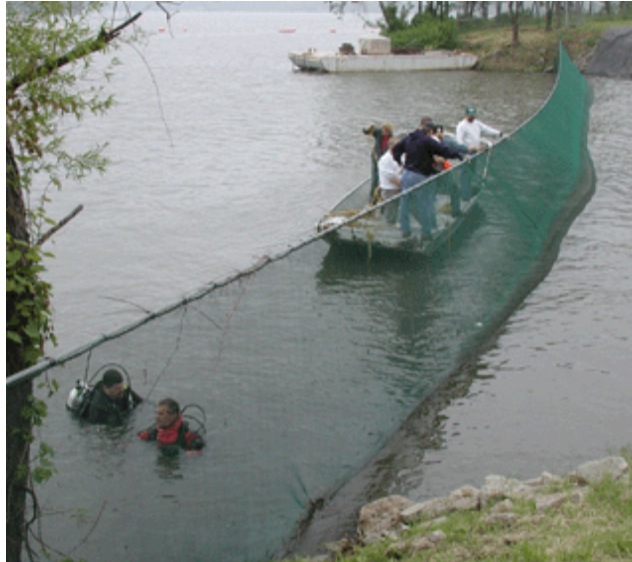
Figure 6-1
Dallman barrier net installation 2003

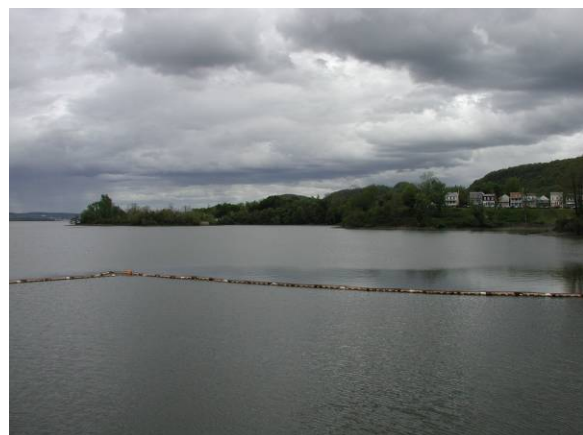
Figure 6-2
Bowline Point barrier net configuration (LMS 1978)

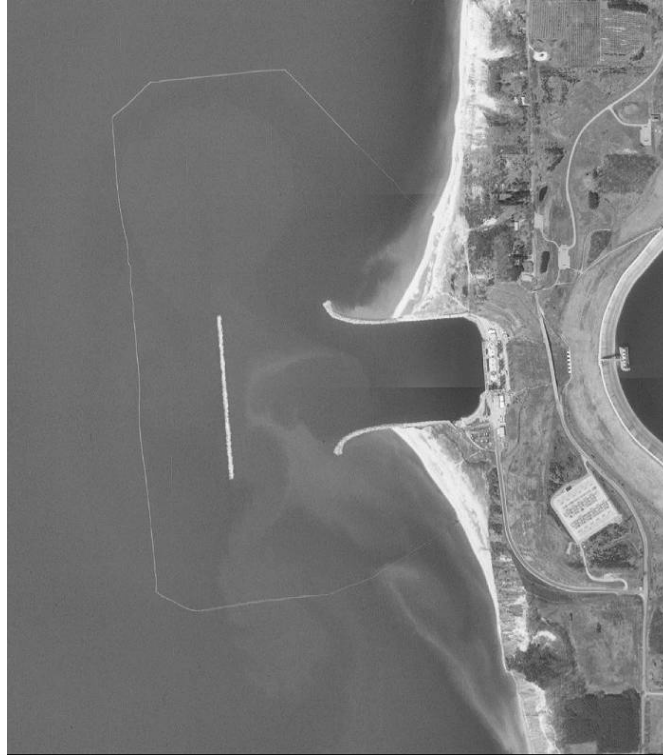
Figure 6-6
Ludington aerial photograph of barrier net

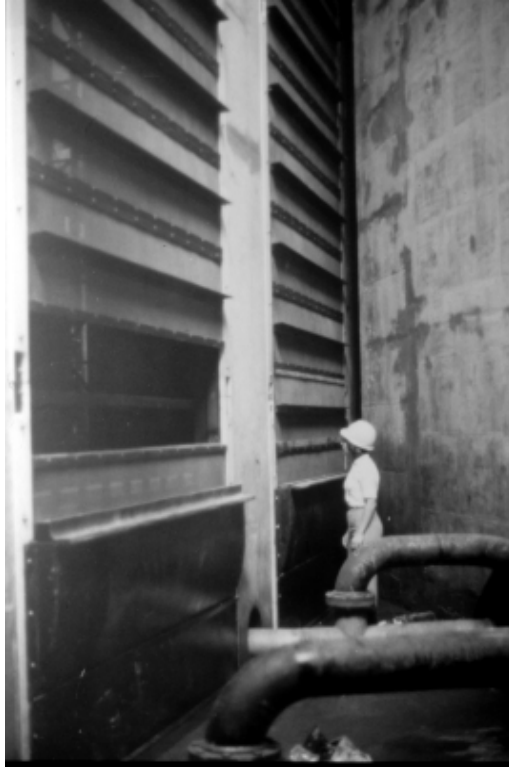
Figure 10-2
Oswego angled screen intake system dewatered (courtesy of Alden Research Laboratory, Inc.)

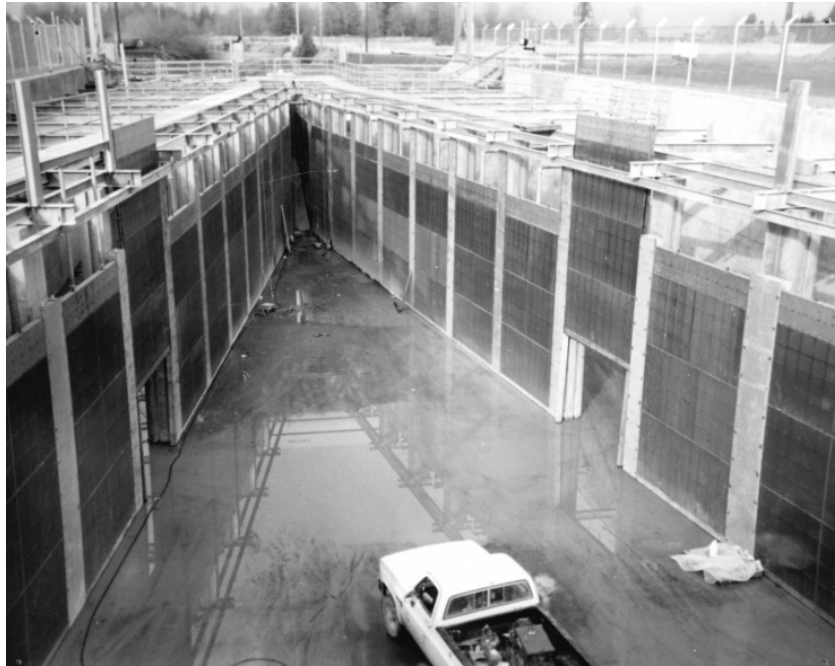
Figure 10-7
White River angled screen diversion system (courtesy of U.S. Filter — Johnson Screen)

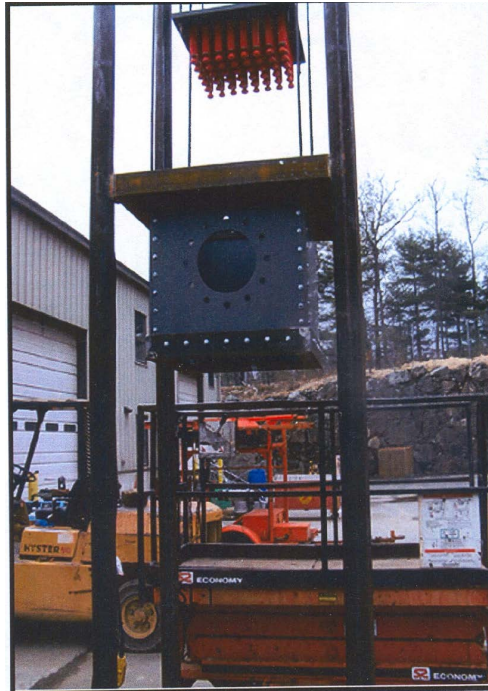
Figure 17-2
Filtrex receiver box of IMOD (Normandeau 2007)
