Subject: Final Five-Year Review Report
Naval Air Station South Weymouth, Weymouth, Massachusetts

Five-Year Review Report

**Naval Air Station South Weymouth
Weymouth, Massachusetts**

FIVE-YEAR REVIEW REPORT

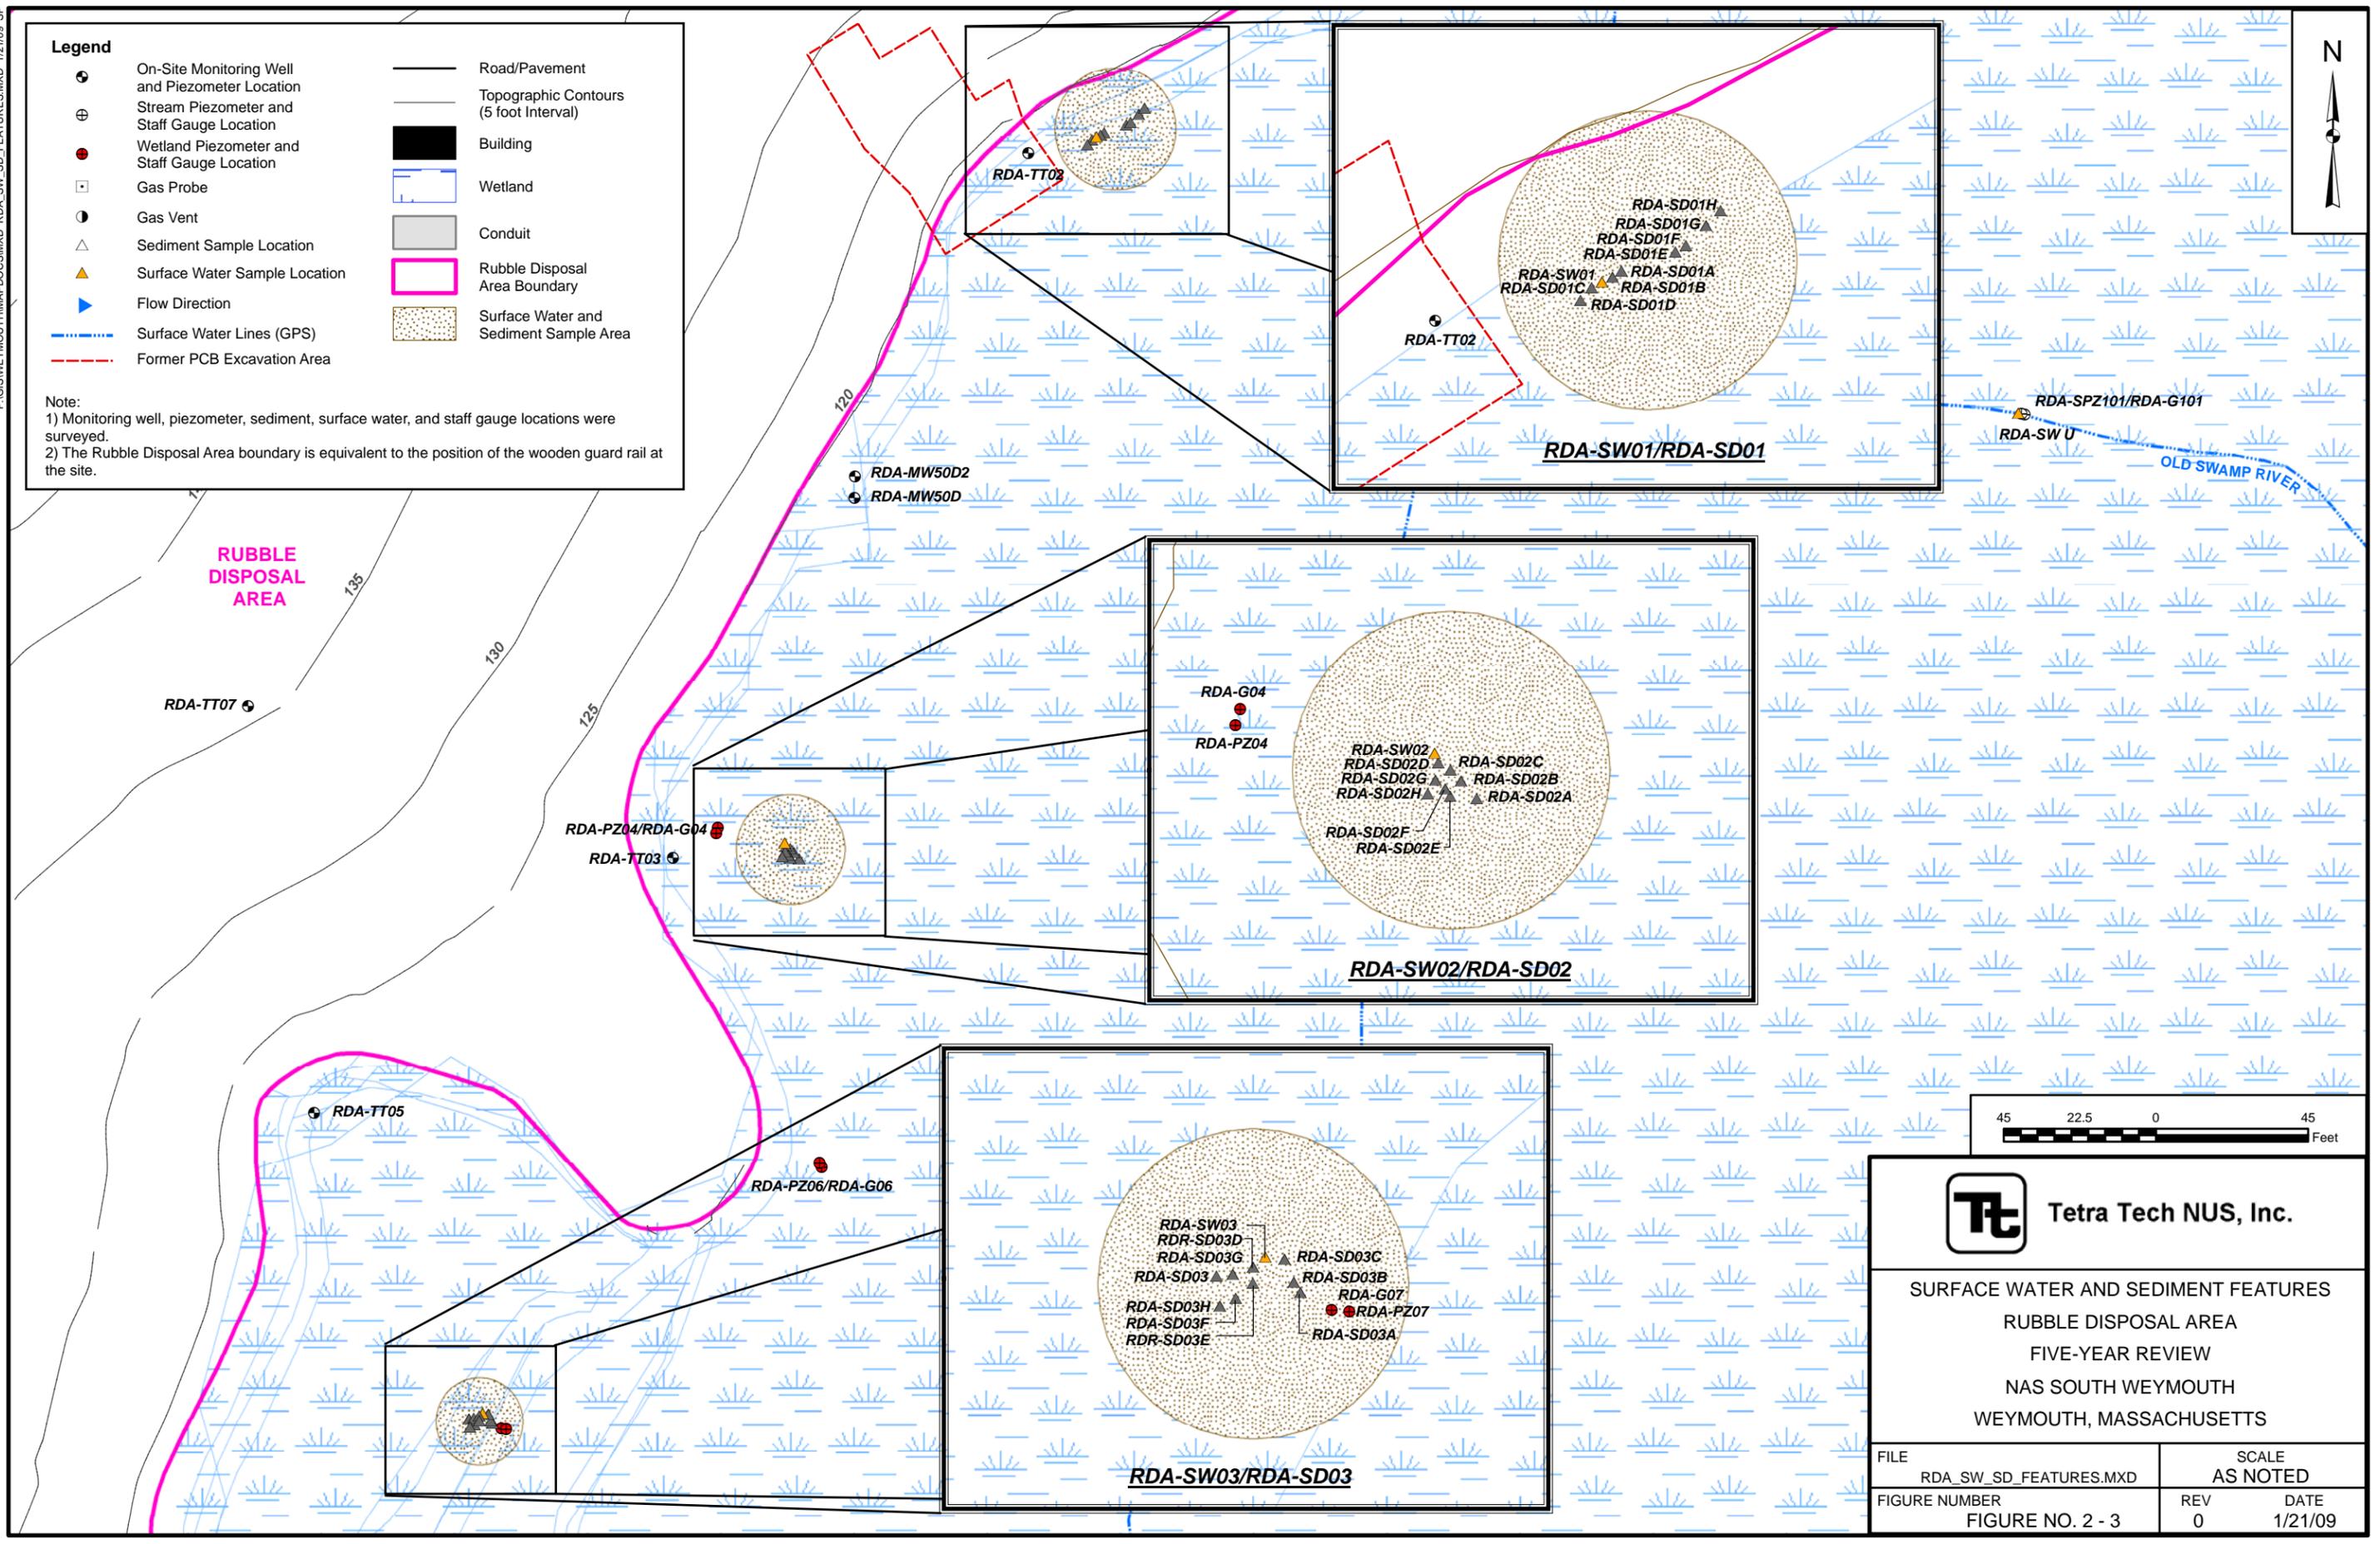
SURFACE WATER AND SEDIMENT FEATURES
 RUBBLE DISPOSAL AREA
 FIVE-YEAR REVIEW
 NAS SOUTH WEYMOUTH
 WEYMOUTH, MASSACHUSETTS

Note:
 1) Monitoring well, piezometer, sediment, surface water, and staff gauge locations were surveyed.
 2) The Rubble Disposal Area boundary is equivalent to the position of the wooden guard rail at the site.

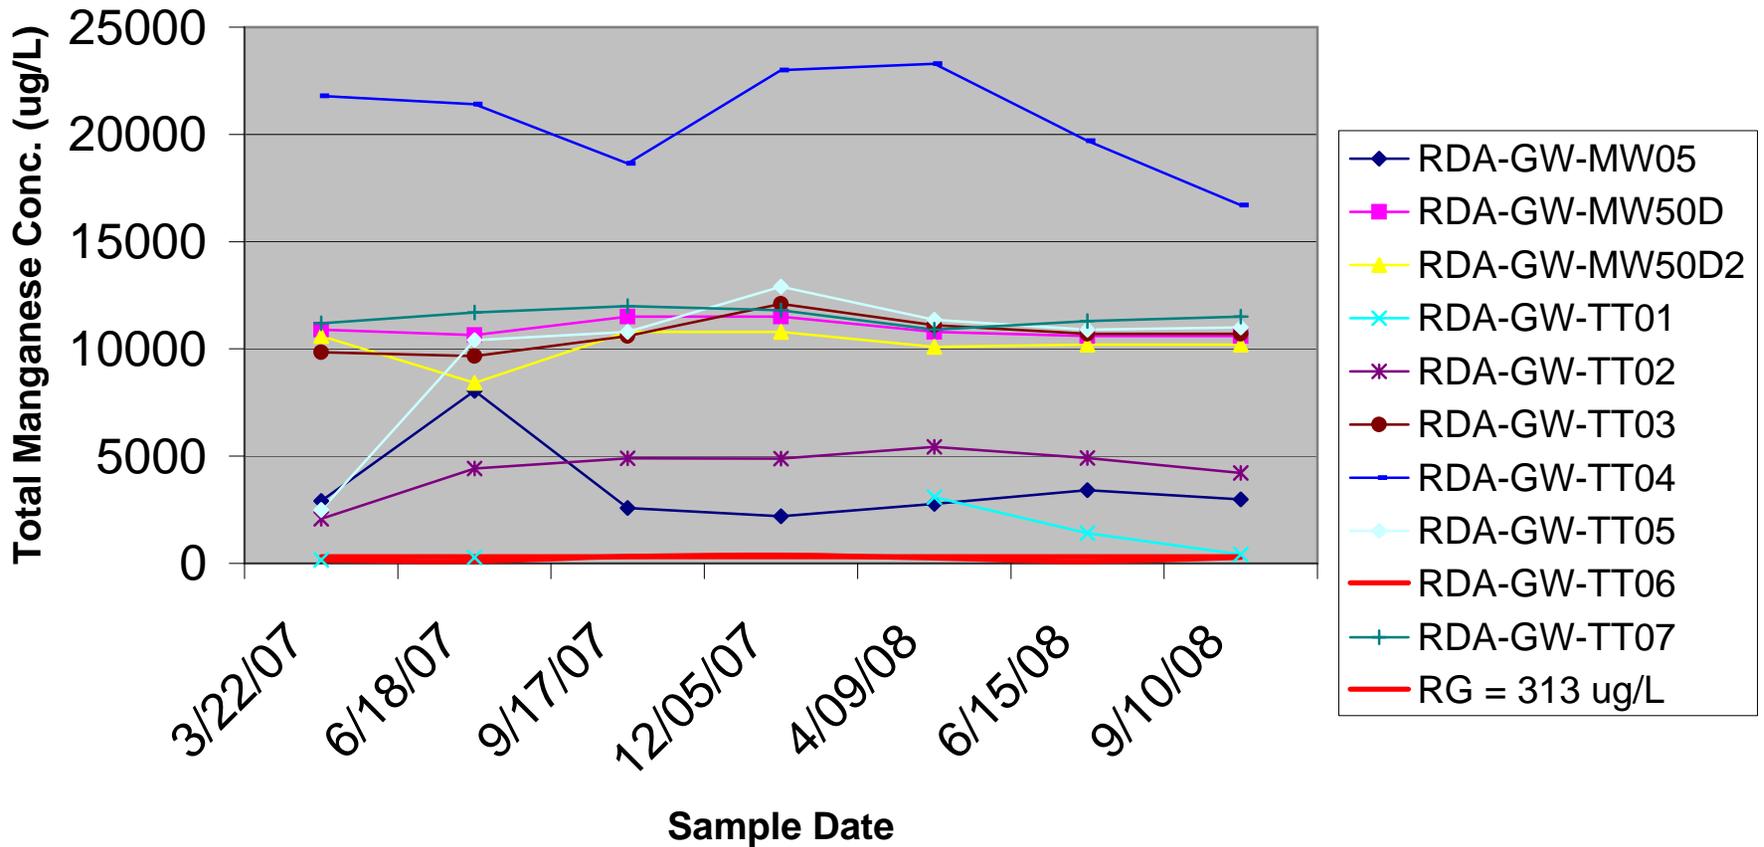
Figure 2-5
RDA Manganese Concentrations in Groundwater
Five Year Review
NAS South Weymouth
Weymouth, Massachusetts

In 2007, an upward trend in manganese concentrations was noted in downgradient wells TT02 and TT05, while concentrations appeared to remain fairly stable at TT07, within the landfill. The data suggest that concentrations of manganese in groundwater in the eastern area of the Site generally appear to decrease from south to north. Overall, trends in manganese concentrations in 2007 indicate either upward trends, or no definitive trends; downward trends in manganese concentrations were not observed. In contrast, in 2008 a downward trend in manganese concentrations was noted in the downgradient well TT04; a slight downward trend was noted at downgradient well TT02. Trends in concentrations will continue to be evaluated after additional data are acquired during future sampling events. Total manganese concentrations at each monitoring well for each monitoring round are graphically presented in Figure 2-5.

Note:
 MW05 and TT01 are upgradient/background wells.
 RG: Remedial Goal

obvious trend in manganese concentrations in 2007; a decrease in concentrations was seen at TT04 in 2008. The monitoring wells north of TT04 exhibit fairly consistent, high manganese concentrations. Further north, manganese concentrations in bedrock wells MW50D and MW50D2 were fairly stable (see trend graph in Figure 2-5). It should be noted, the data set is not yet robust enough to make definitive statements regarding trends or statistically significant interpretations.

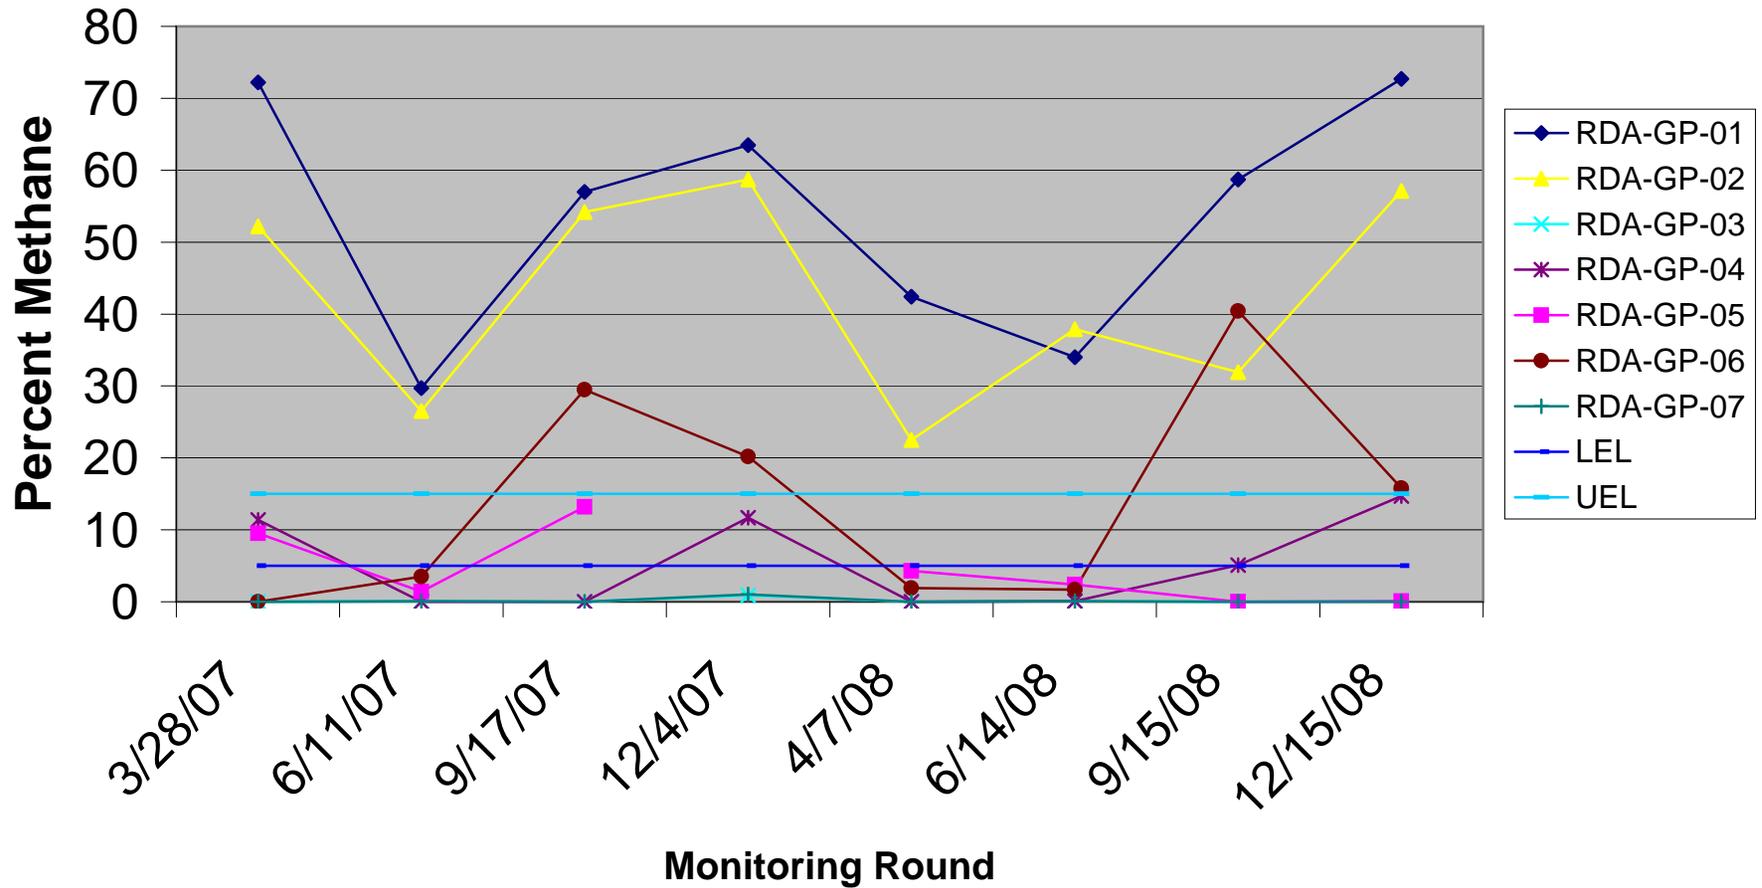
Figure 2-7
RDA Gas Probes Percent Methane - 2007 & 2008
Five Year Review
NAS South Weymouth
Weymouth, Massachusetts

Note:
 LEL: lower explosive limit (5%)
 UEL: upper explosive limit (15%)

Combustible gases all have a lower explosive limit (LEL) and an upper explosive limit (UEL). The LEL and the UEL are measures of the percent of gas in the air by volume. At concentrations below the LEL and above the UEL, a gas is not considered explosive. An explosion hazard may be present if a gas level is measured between the LEL and the UEL, oxygen is present, and an ignition source is available. The explosive limits of methane are 5 percent to 15 percent by volume in air under normal atmospheric conditions. Five percent methane is approximately equivalent to 100 percent LEL.

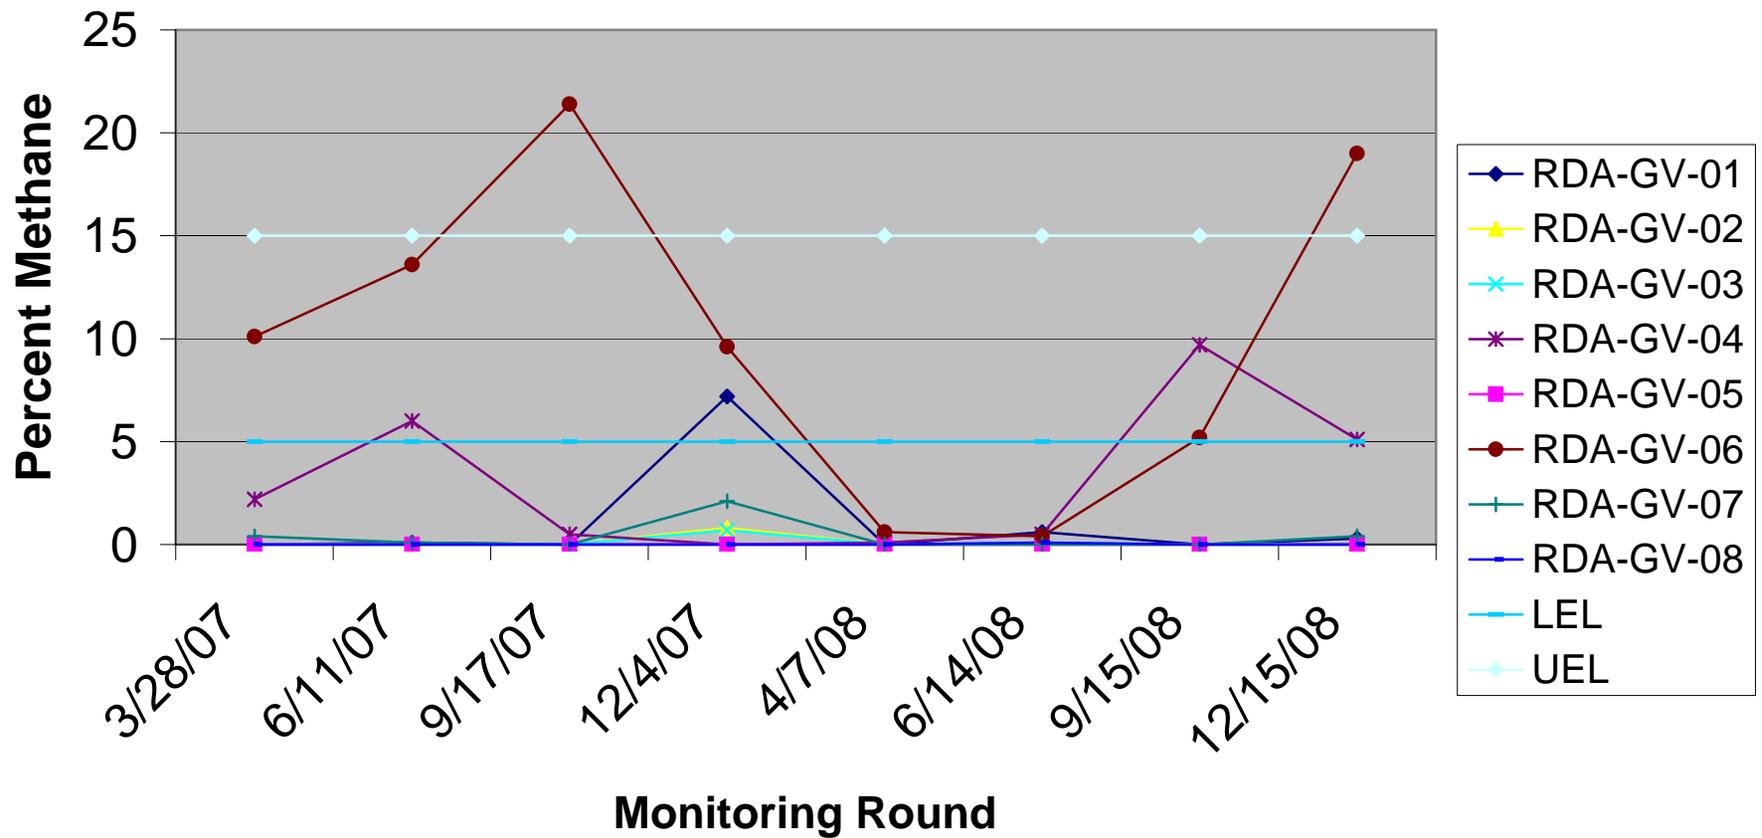
Figure 2-8
RDA Gas Vents Percent Methane - 2007 & 2008
Five Year Review
NAS South Weymouth
Weymouth, Massachusetts

Note:
 LEL: lower explosive limit (5%)
 UEL: upper explosive limit (15%)

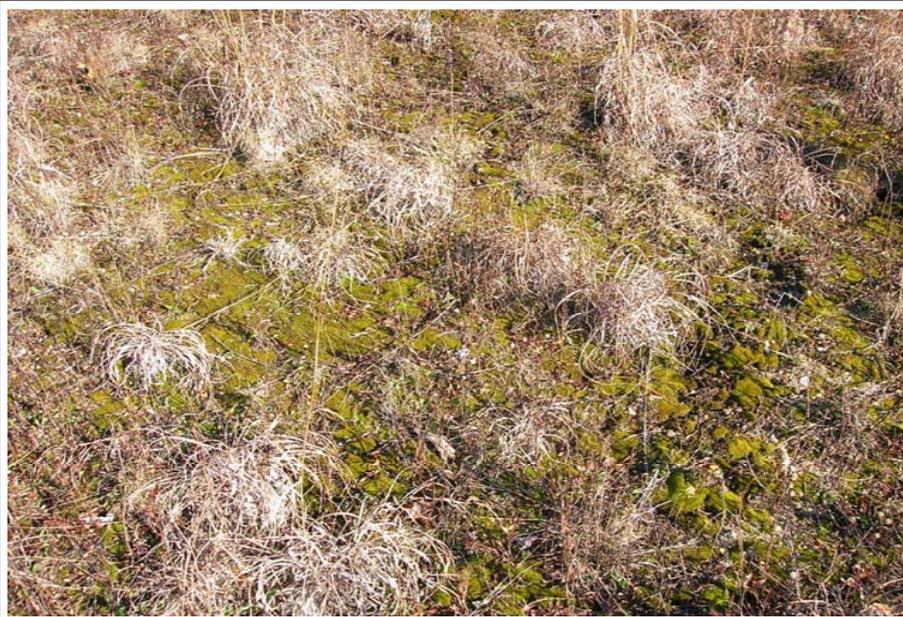
Date: 11/21/2008 Picture No. 5 Location: RDA

Comment: Moss area on southern portion of landfill cap

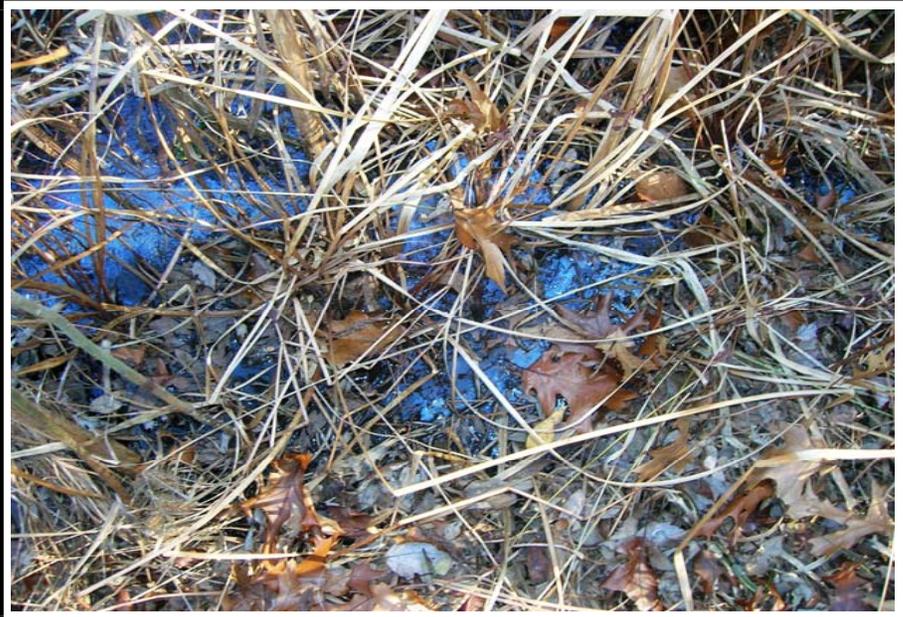
Date: 11/21/2008 Picture No. 6 Location: RDA

Comment: Unidentified sheen located in south wetland area

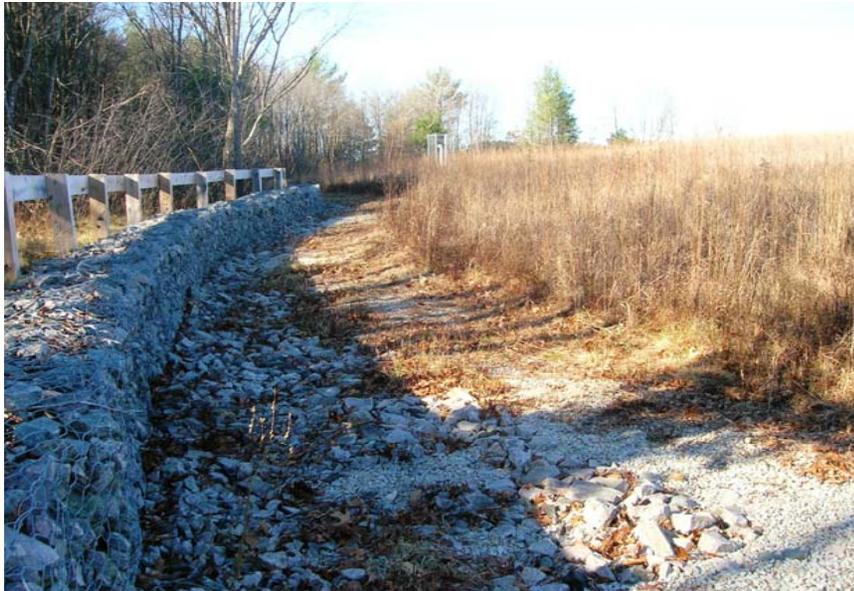
Date: 11/21/2008 Picture No. 7 Location: RDA

Comment: View of gabion basket located along western boundary of landfill cap

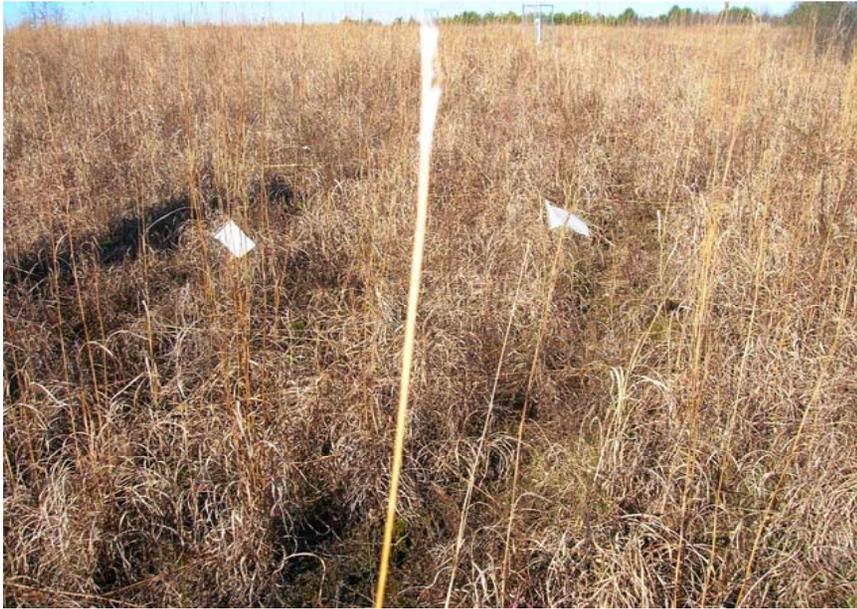
Date: 11/21/2008 Picture No. 9 Location: RDA

The capped landfill was well vegetated; no major erosion or damage to the cap was noted. Minor areas of erosion and vehicle ruts were observed. Signs were posted at two locations along the perimeter of the landfill warning presence of a capped landfill. Monitoring wells and gas vents appeared to be in good condition and secured with locks.

Comment: View of tire ruts on the southern portion of the landfill cap

The landfill inspections conducted in 2007 and 2008 concluded that overall the landfill cap is in good condition and functioning according to the design, including the vegetative cover, storm water drainage system, gas vents and probes, and perimeter road, fence and signage. The inspections noted vehicle ruts from the monitoring well drilling equipment; repairs were recommended. There was some evidence of possible trespassing along the access road and in the parking area by the vehicle gate. Animal burrows and small areas of erosion were noted; additional monitoring was recommended. In addition, a settling monument survey needs to be conducted. Vegetation and shrubs established in the stormwater drainage channel were removed in November 2008. Mowing of the vegetated cap and rut repair and reseeded are planned for Spring 2009.

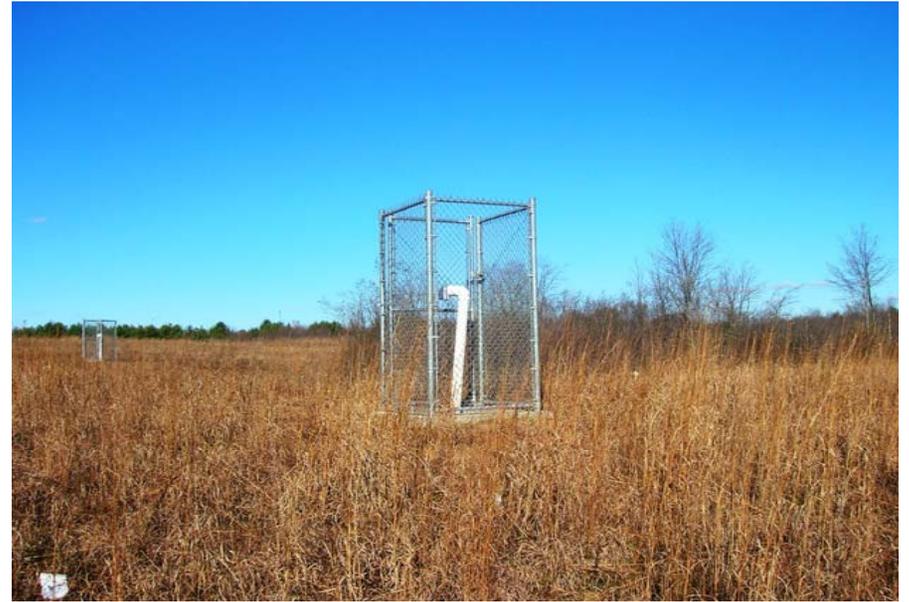
Date: 11/21/2008 Picture No. 10 Location: RDA

Comment: View of gas vent (GV-02) located on southern landfill cap

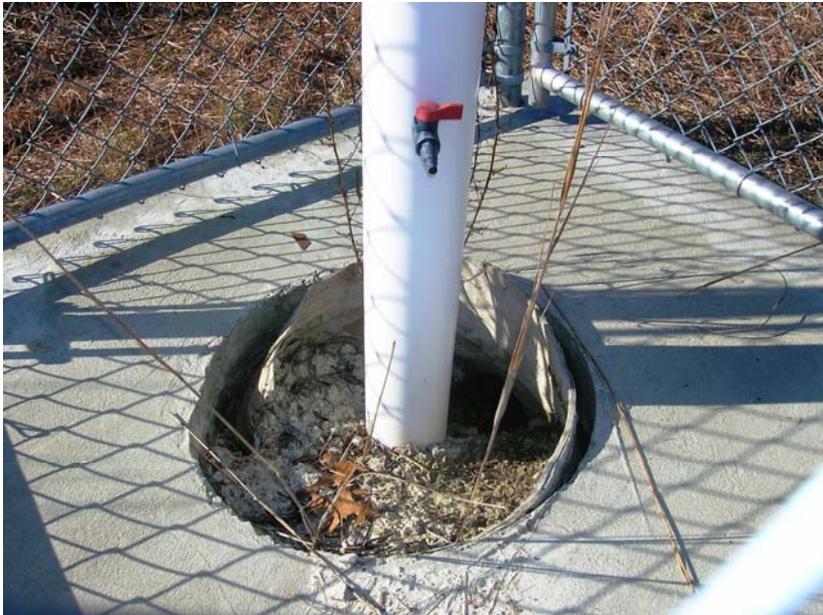
Date: 11/21/2008 Picture No. 11 Location: RDA

Comment: View of animal burrow in base of gas vent GV-02

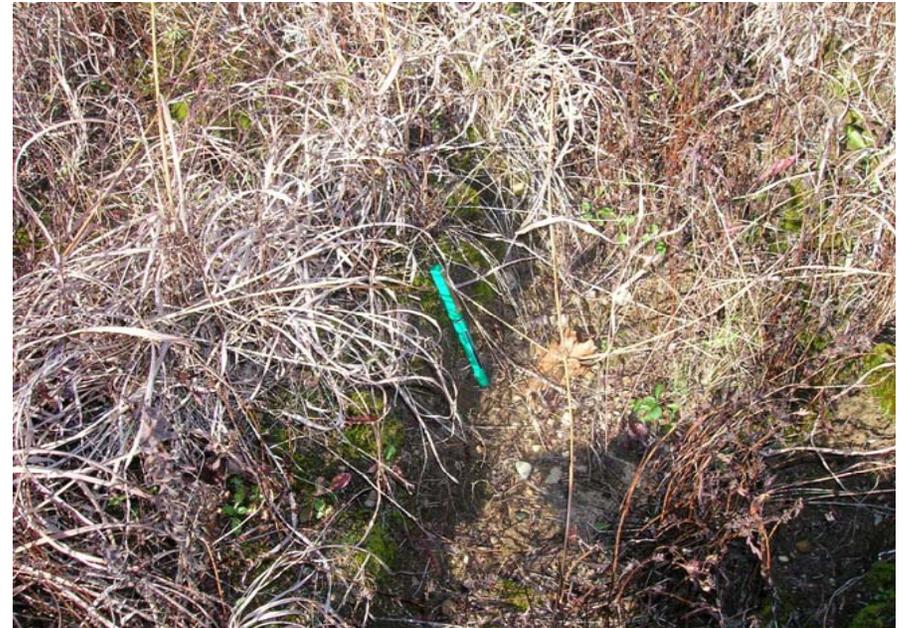
Date: 11/21/2008 Picture No. 12 Location: RDA

Comment: View of erosion ruts on southern portion of cap (see pen for size reference)

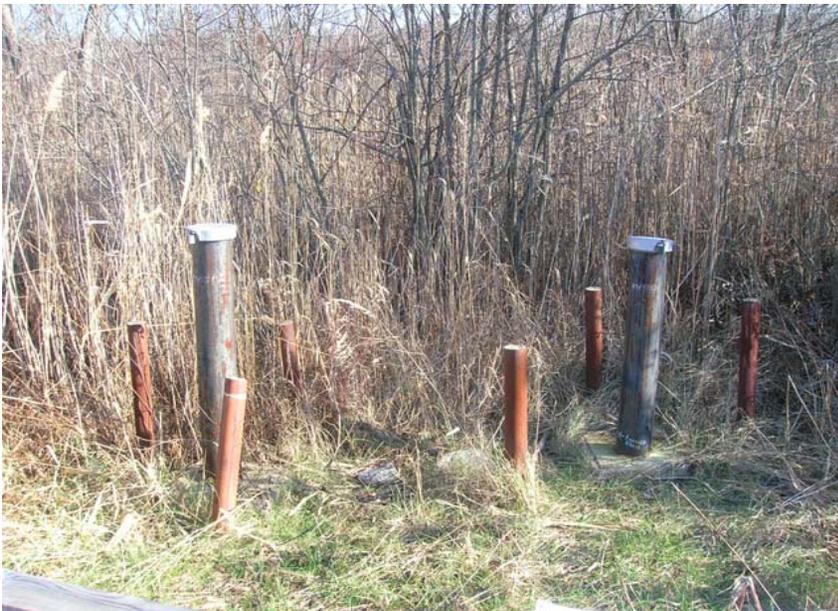
Date: 11/21/2008 Picture No. 15 Location: RDA

Comment: View of monitoring wells MW-50D and MW-50D2 along eastern landfill boundary

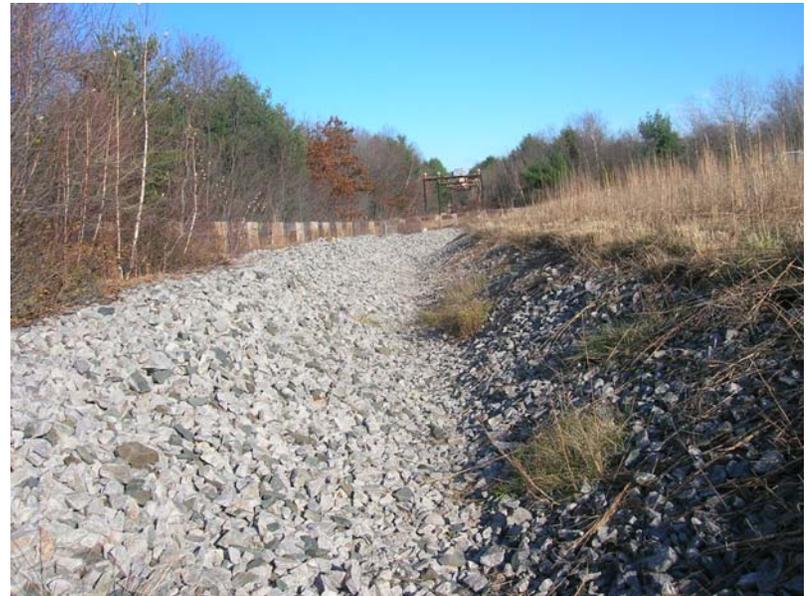
Date: 11/21/2008 Picture No. 20 Location: RDA
Comment: View of northern drainage swale looking north

along the north side of the landfill appeared in good condition, but contained some low-lying vegetation and several bushes. As recommended, the vegetation in the swale was removed in November 2008. Minor areas that require continued monitoring but no repairs and do not affect the performance of the remedial action include: small sections of exposed geotextile fabric along the boundary of the landfill, with the largest section visible along the northern landfill boundary; several small areas of erosion along the landfill boundary; and vehicle ruts associated with LTM activities on the landfill cap.
