EPA Completes First Part of Study to Define Contaminants at Formosa Mine Superfund Site

Operable Unit #1

Douglas County, Oregon

February 2012

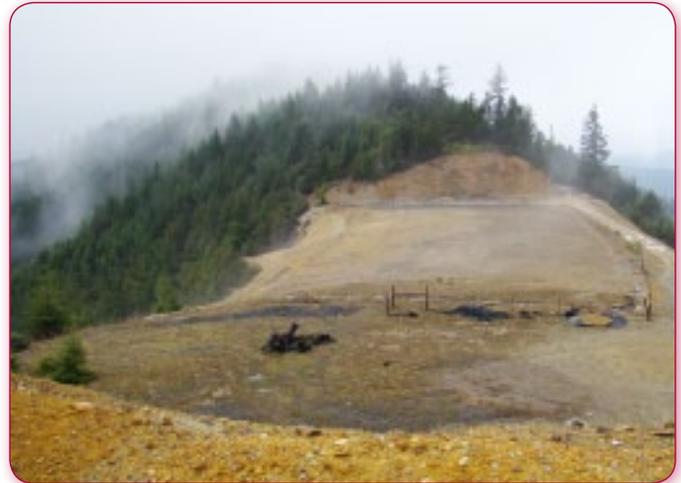
Formosa Mine site: looking south from Silver Butte over the former processing area and waste encapsulation pond. Acid-generating waste prevents vegetation from growing.

The sampling effort identified about 317,000 cubic yards of mine materials located on the surface of the site. These need to be addressed to protect people's health and the environment. The materials are spread over about 25 acres at depths ranging from 1 foot to about 40 feet. They contain sulfide minerals and high levels of contaminants like arsenic, cadmium, copper, and zinc. These metals leach out of mine materials and contaminate surface water and groundwater, generating acidic water called acid rock drainage.
