**THIRD FIVE-YEAR REVIEW REPORT FOR
TULALIP LANDFILL SUPERFUND SITE
Snohomish County, Washington**

U.S. Environmental Protection Agency
Region 10
Seattle, Washington

Photos Documenting Site Conditions

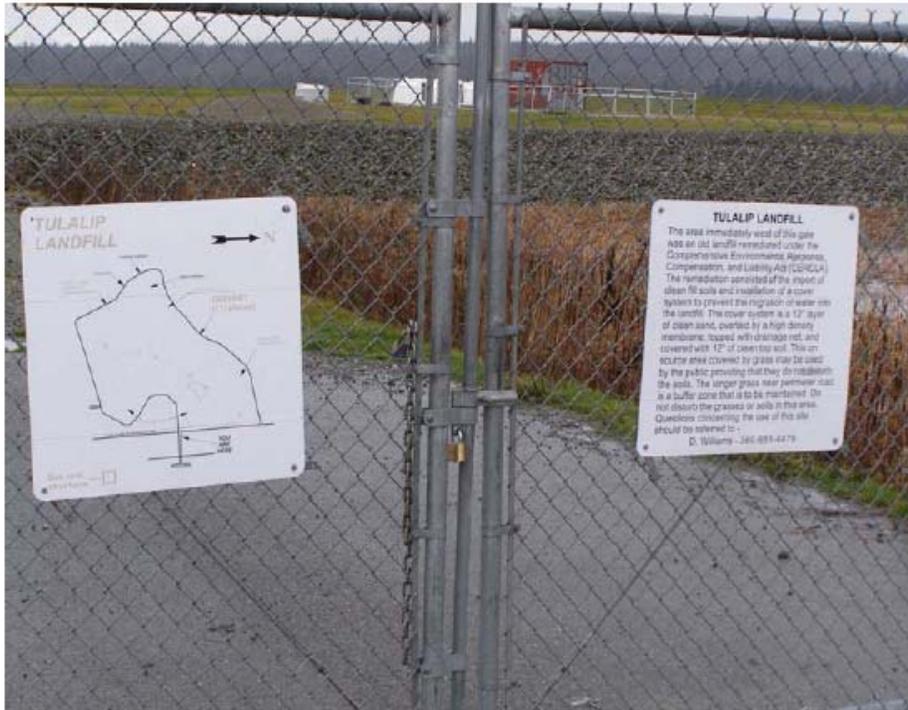
Figure 1. Entrance gate

V. ACCESS AND INSTITUTIONAL CONTROLS <input checked="" type="checkbox"/> Applicable <input type="checkbox"/> N/A					
A. Fencing					
1.	Fencing damaged	<input type="checkbox"/> Location shown on site map	<input checked="" type="checkbox"/> Gates secured	<input type="checkbox"/> N/A	
Remarks: <i>Fencing only at the gates. The landfill is surrounded by wetlands and 2 sloughs so accessibility by automobile is only through the access gates. Gate locks were in good working order and fencing intact during site inspection.</i>

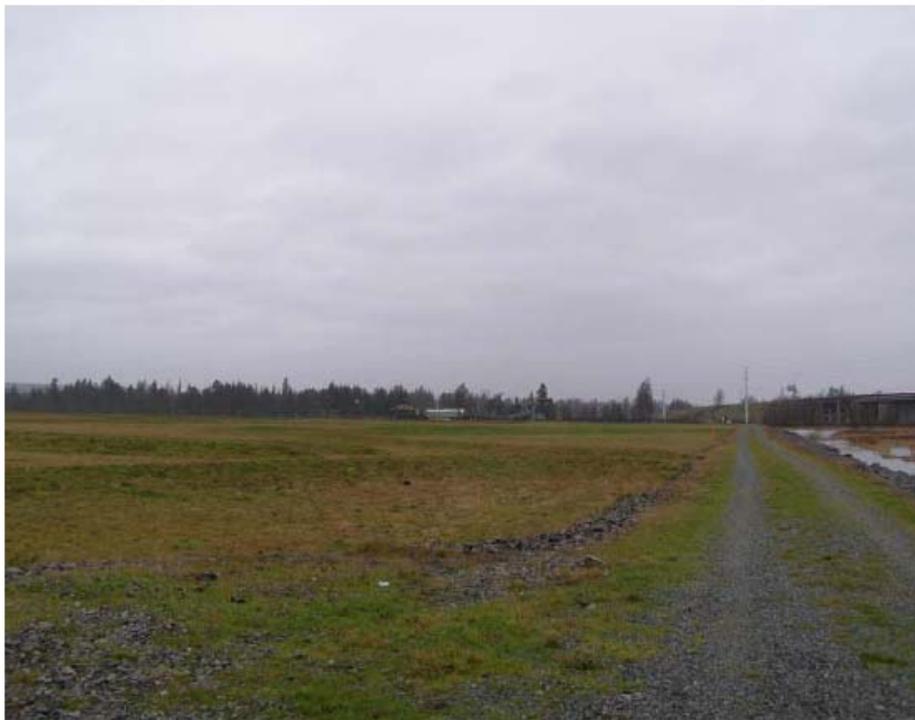
Figure 2. Landfill cover facing northwest

- Signs surrounding the landfill were intact.
- The access gate and lock were intact.
- The landfill cover appeared to be in good condition. The vegetative cover was intact and ponding was not observed.
- The seeps and seep location markers were observed.
- Drainage piping appeared to be in good condition with no or little silting.
- Mr. Cleveland stated there are still a few drainage pipe branches with no cleanout ports.

The site inspection confirmed that the condition of the cap is operating as intended by the ROD. Attachment 4 provides photo documentation of existing conditions.

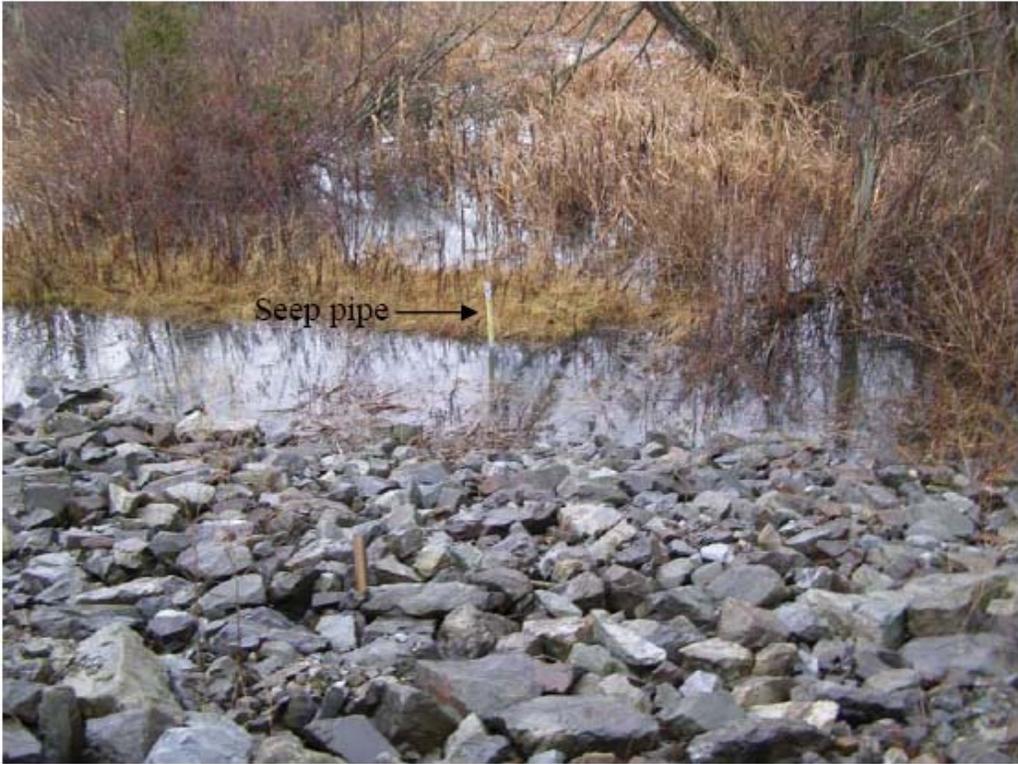
Figure 7. Typical seep pipe

During the 2008-2013 FYR reporting period, only seep locations SP-13, SP-14 and SP-16 showed any measurable amounts of seepage during monitoring cycles. The rest of the 13 seeps on the site are dry. In 2012, only seep SP-14 showed any measurable amount of seepage, flowing at a rate of .25 gallons per minute (gpm). In all cases, the seepage was observed to be clear water based on visual checks. These results represent about a 98-99% reduction in total site flow rates of the seeps. Leachate Seep Monitoring Locations are shown in Figure #3, "Site Plan with Post Closure Monitoring Locations."

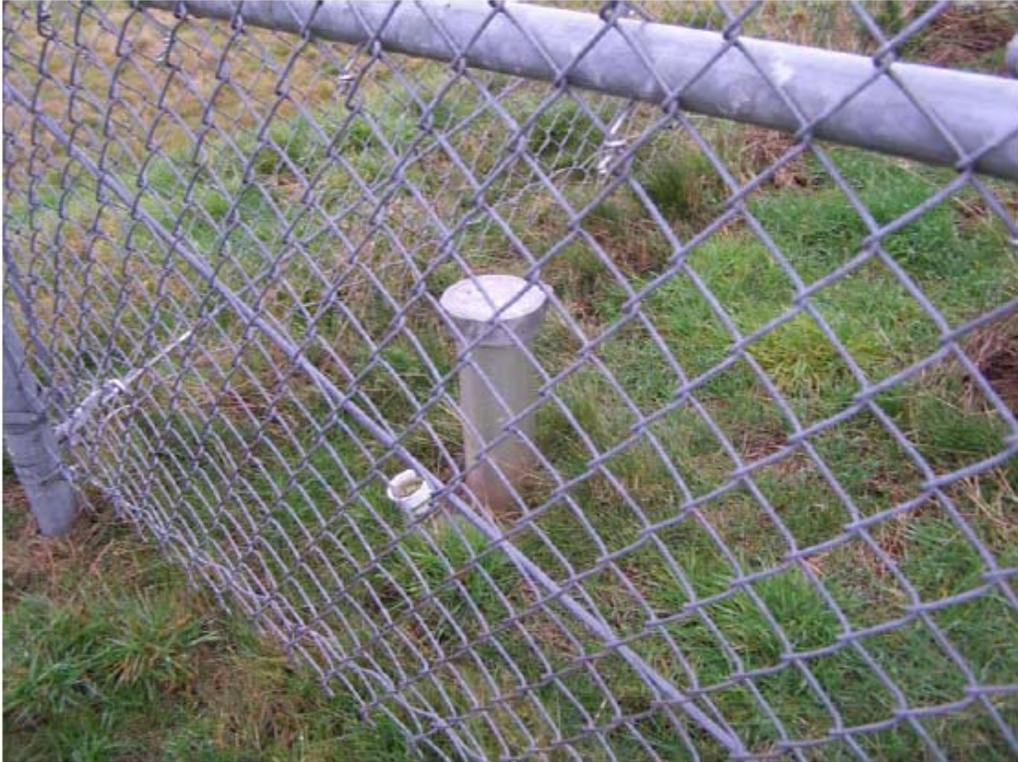
Figure 8. Typical piezometer

During conversation with Baker-Kircher on 3/13/2013, Tom McKinsey, the Tulalip Tribes’ Big Water Project Manager, reported that he observed the installation of piezometers on the site in 1998, 1999 and 2000. McKenzie confirmed that the cap penetrations (landfill vents and piezometers) were installed in a casing wrapped in a geomembrane “boot.” The boots were sealed to the geomembrane over the landfill.

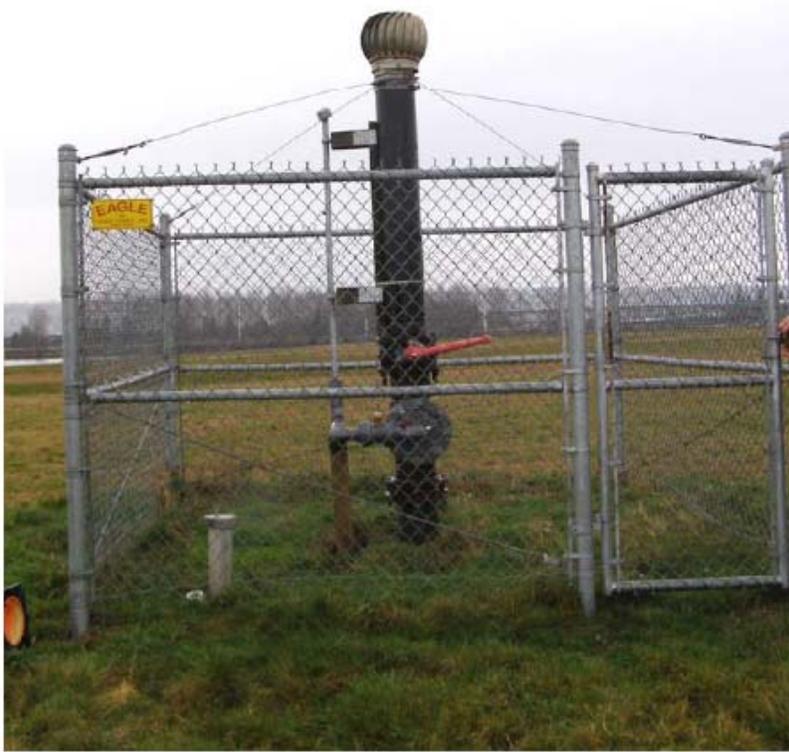
Figure 9. Typical gas vent structure

Issues	Action Taken and Outcome	Date of Action
The gas collection system rotor vanes on all the vents were showing signs of age and were not functioning as they should.	The vanes were replaced on all venting structures (GVS-1 through GVS-6). The system is now working correctly. All gas flows remained within the historical ranges associated with this passive landfill gas system.	Fall 2009
The handle on the GVS-4 valve needed to be replaced.	The PVC valve on GVS-4 was replaced; could not find a source for handle so the entire valve was replaced. Valve working great now.	Fall 2009
Line in the infiltration collection system blocked.	Repair was completed on line L-3 east of SM-03. The blockage in the line was located by removing the soil cap, and then digging the last six inches by hand so as not to damage the cover. The blockage in the pipe appeared to be caused by mineral deposits and not by something foreign or damage to the pipe. The repaired area was about 250 feet long. Line L-3 works fine now.	Fall 2010

During the last five years, contractors for the Tulalip Tribes continued to monitor landfill gas by obtaining monthly field measurements of primary gas composition, temperature, pressure, and flow from each of the landfill gas vent structures installed at the landfill (GVs-1 through GVS-6). Landfill Gas Monitoring Locations are shown in Figure #3, “Site Plan with Post Closure Monitoring Locations.” Select trace gas compounds were monitored once per quarter concurrent with one of the monthly monitoring events. This information was used to provide an assessment of the landfill gas conditions at the site.

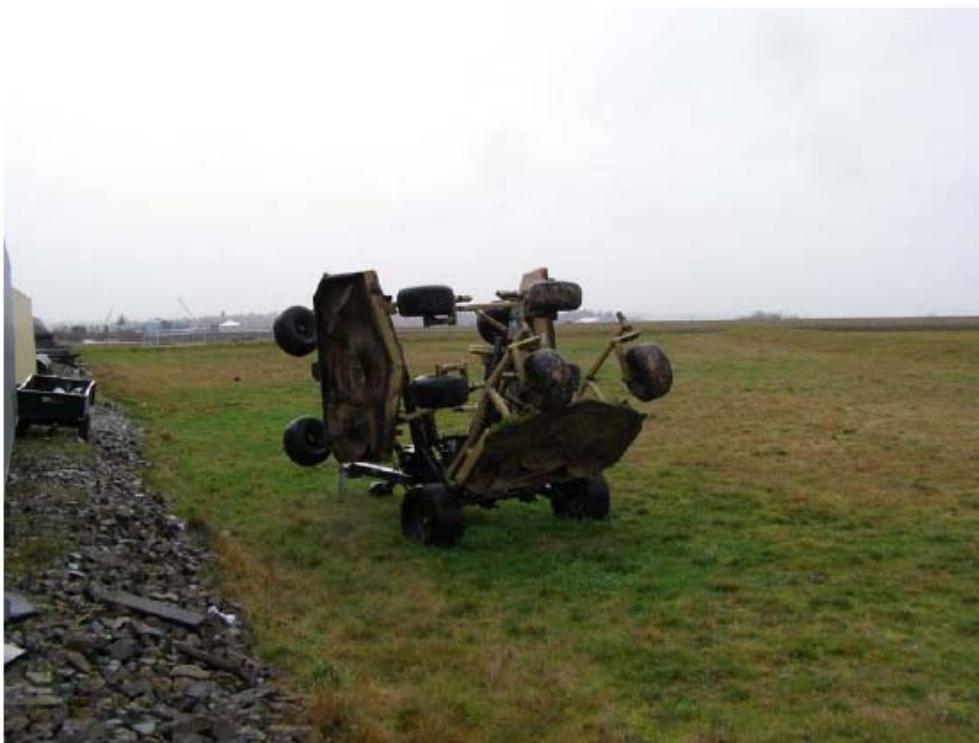
Figure 10. Mower used to maintain vegetative cover

Heavy rain during spring and early summer seasons has caused grass to grow at an accelerated rate, and has made mowing the site a bit challenging. One year, the grass on the landfill could not be mowed down until the first part of August. [The landfill is not mowed when landfill soils are saturated and the cap geomembrane is more prone to damage from the use of mowing equipment.] Large mowers that can more effectively cut down high grass on the site are not used on the site until the landfill soils are dry. High grass provides places for animals to hide and burrow. There is some evidence of minor problems with burrowing animal(s) that will need to be watched. Very few deep-rooted plants have established themselves on the cap. These weeds will be mowed down as soon as mowers can recommence operation this spring/early summer.

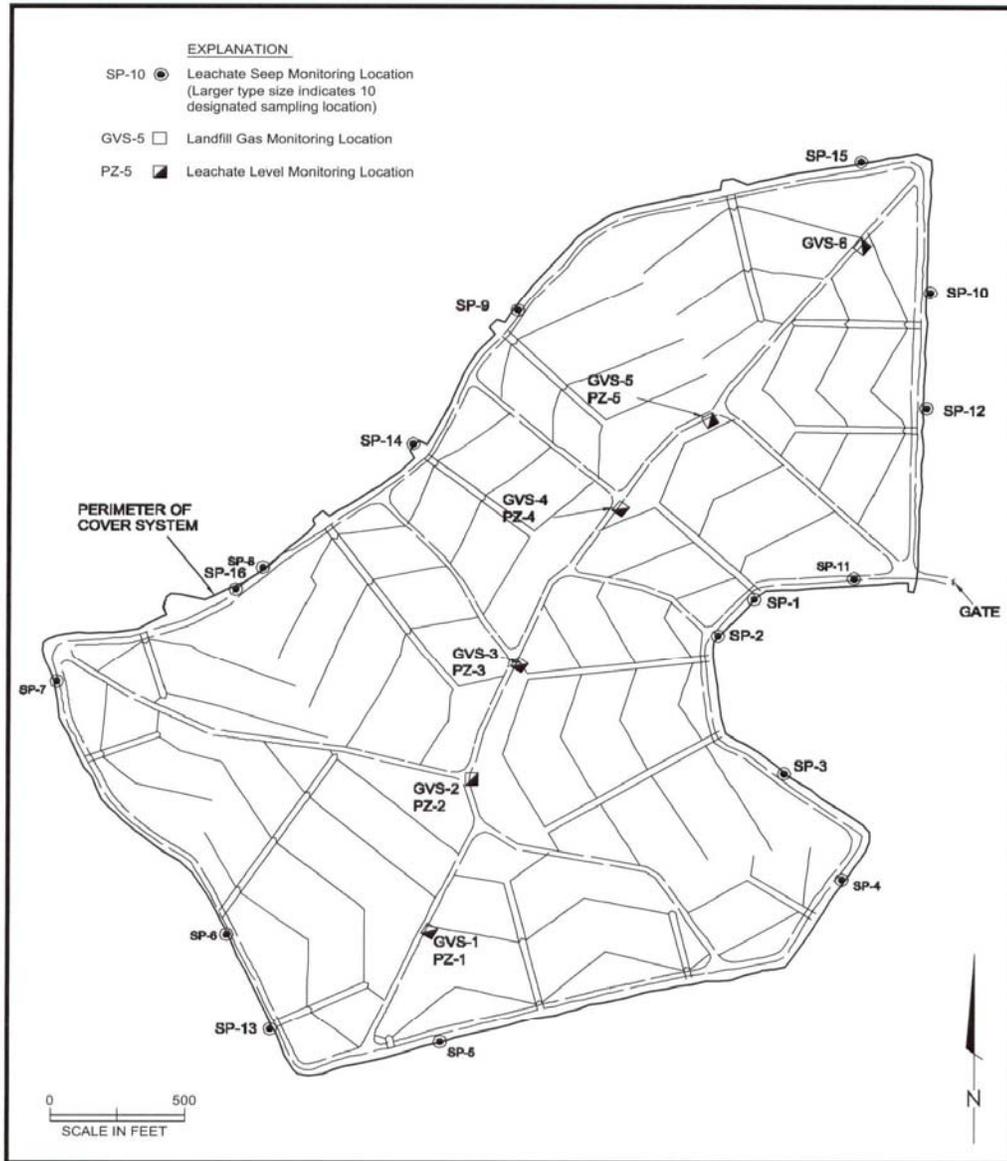
Figure #3: Site Plan with Post Closure Monitoring Locations

Site Plan with Post Closure
Monitoring Locations
Tulalip Landfill - Environmental Monitoring Plan
Post Closure Care
Marysville, Washington

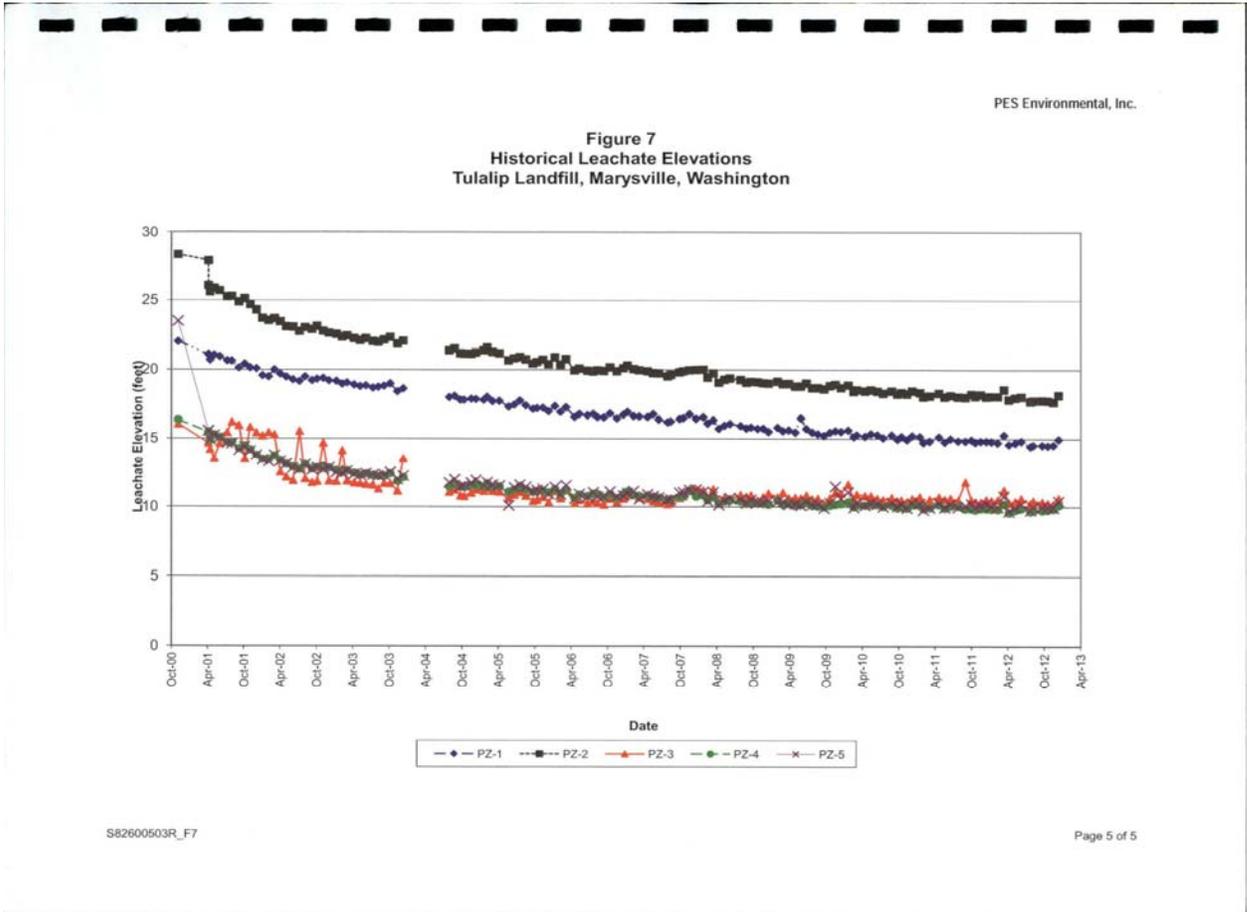
Figure #4: Historical Leachate Elevations

The results of the leachate level monitoring indicate that leachate elevations in the landfill piezometers were consistent with the historical trends, which have generally decreased since monitoring began in November 2000. The results are consistent with an overall decrease in storm water infiltration into the waste materials since the construction of the cover system.

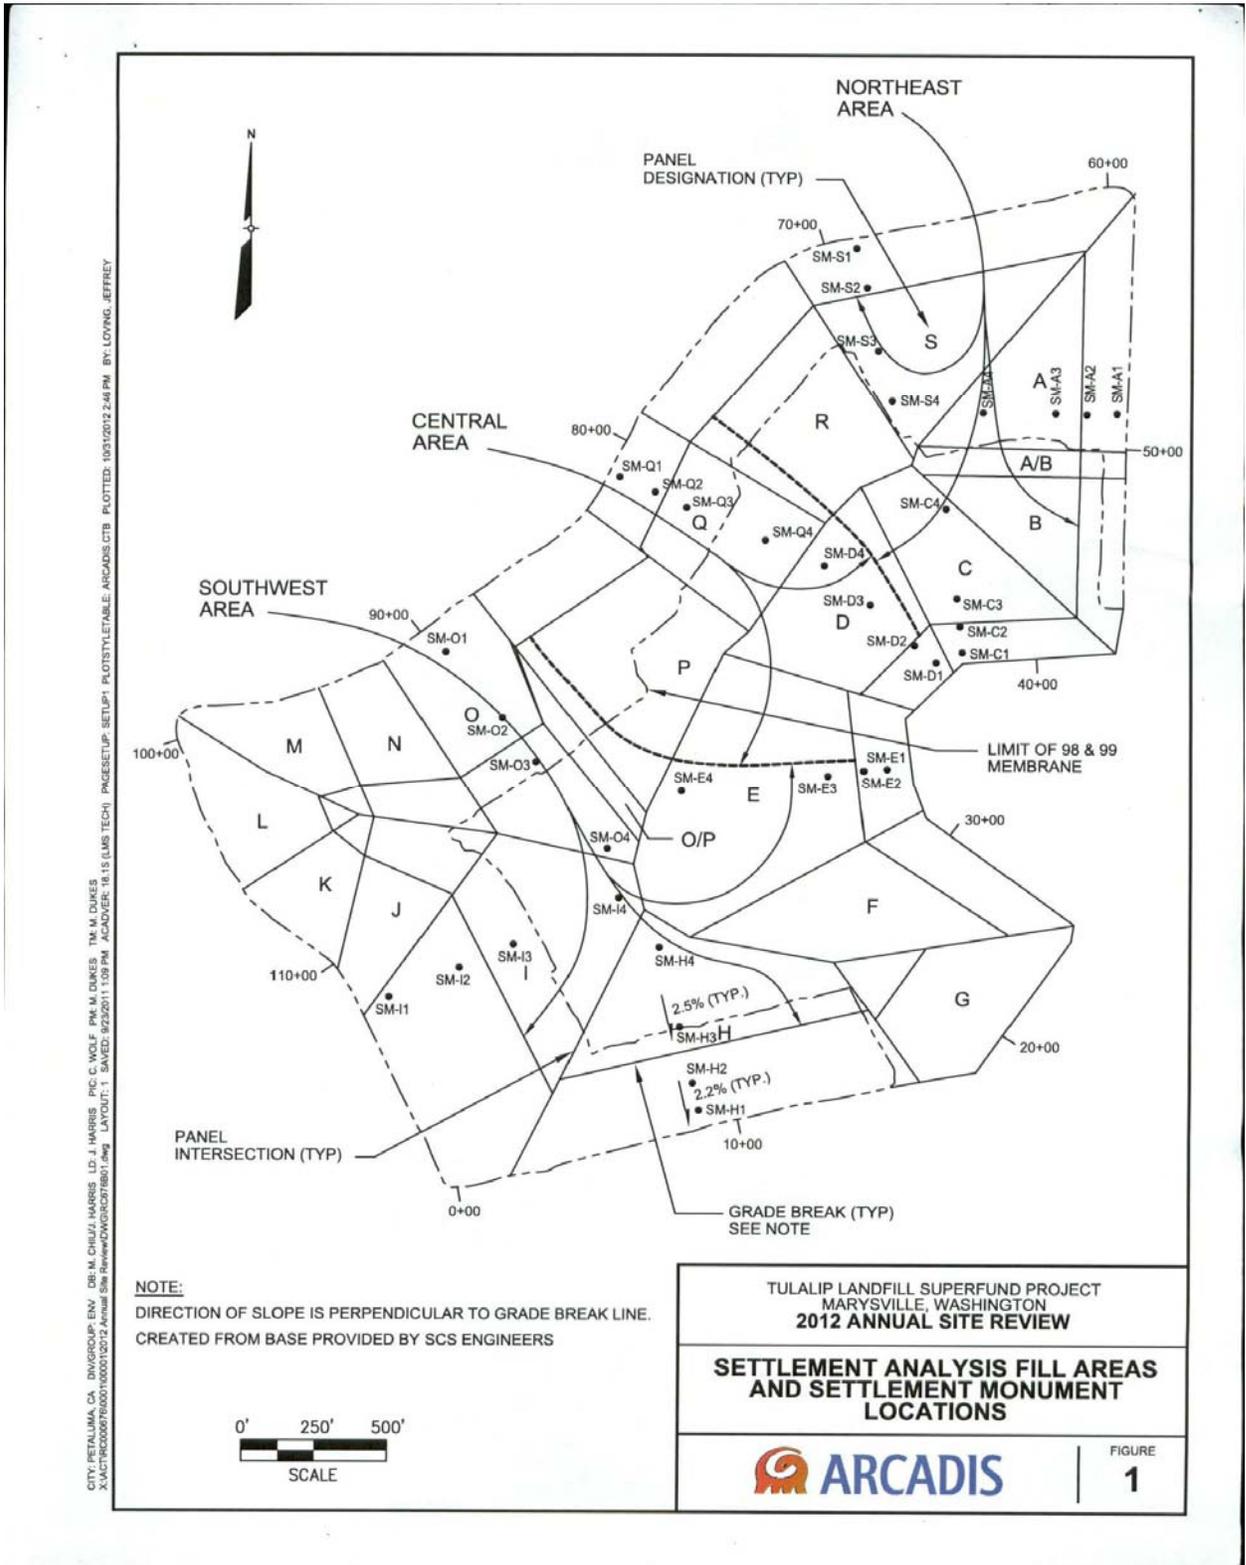
Figure #5: Settlement Analysis Fill Areas and Settlement Monument Locations

Fill areas: Except for the measured slopes in Panels O and S, all slopes are within the predicted settlement range. The slopes on Panels O and S are unchanged from the previous survey, and both panels are flatter than the minimum 2 percent as described in Washington State Landfill Regulations (WAC-173-304, which has been replaced by WAC-173-351).

The slopes on the landfill were all constructed with a greater than 2 percent slope and most were around 2.5 percent. A minimum slope was required by WAC 173-304 MFS regulations that were in force at the time. A minimum slope is still required under the revised Washington State Landfill Closure regulations (WAC-173-351), which replaced the MFS described under WAC-173-304. The intent of these landfill regulations are that slopes be initially constructed with a minimum of a 2% slope so they can accommodate drainage as the landfill settles over time. Therefore, if the flatter slopes that are present still allow runoff, a massive construction effort is not warranted to rebuild the slopes to greater than 2 percent. However, it is recommended that a monitoring and maintenance program be continued to look for localized ponding, to fill any areas where ponding has occurred and to grade the filled areas to promote drainage off the cap.

There is no evidence of differential settlement leading to cracks or degradation.

Based on review of the 2012 survey data, the rate of settlement increase slightly over the last year and it is recommended that the survey continue to be performed annually. Also during periods of heavy rainfall, special inspections should be made on Panels A and S to review the performance of the landfill surface and to determine if any local ponding is occurring.
