**Subject: Tuchman Cleaners Site Assessment Report, Revision 01  
Indianapolis, Marion County, Indiana  
Technical Direction Document No.: S05-0001-1012-034  
WESTON START Contract No.: EP-S5-06-04  
Document Control No.: 1323-2A-AXEY**

**SITE ASSESSMENT REPORT, REVISION 01  
FOR THE  
TUCHMAN CLEANERS SITE  
INDIANAPOLIS, MARION COUNTY, INDIANA  
SITE ID NO. B5ZU**

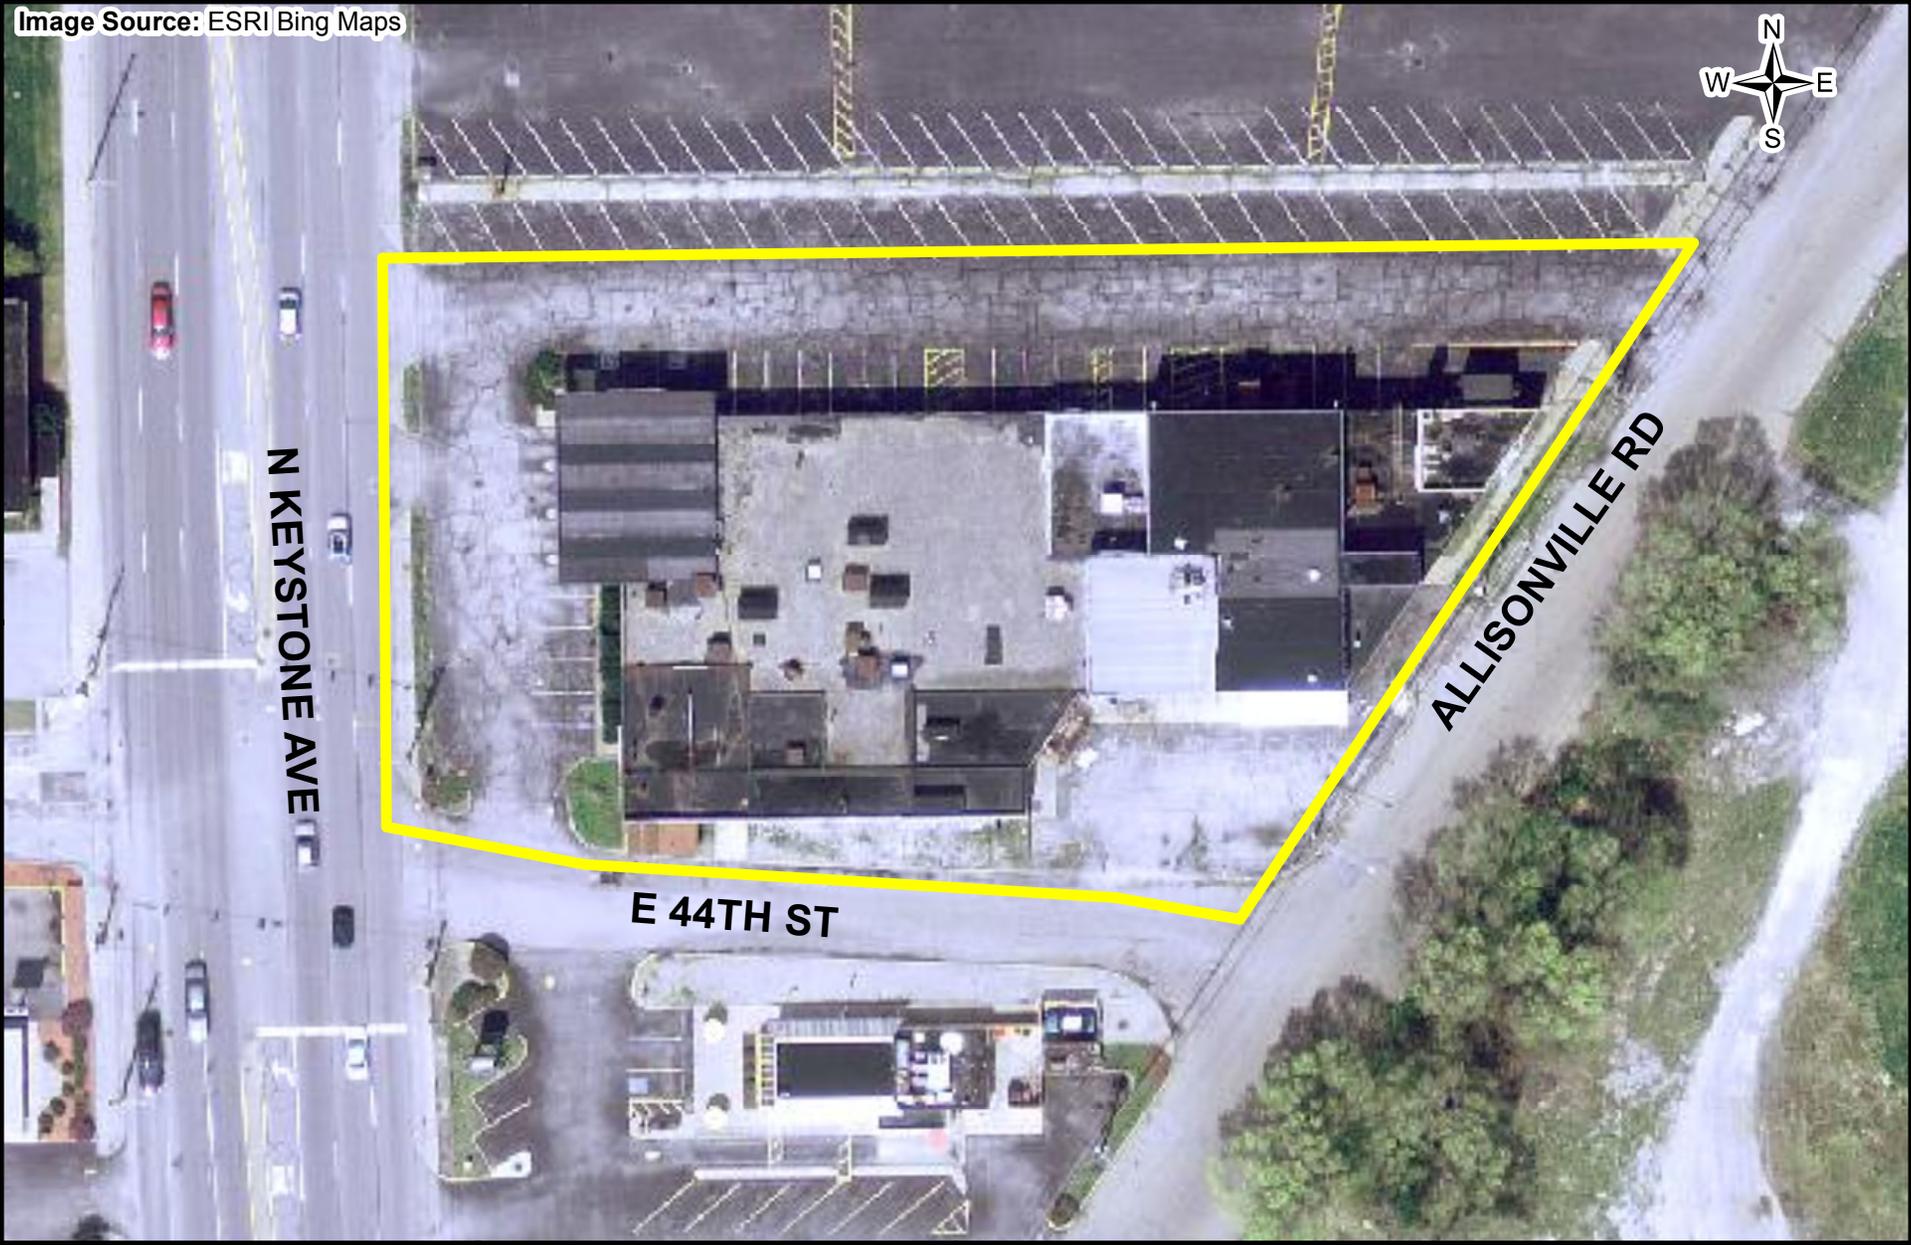
The Site sits on a 2.2-acre lot and until November 2011 contained an approximately 37,000-square-foot facility building (see **Figure 2-1**). In November 2011, the City of Indianapolis demolished the facility building (see **Figure 2-2**).

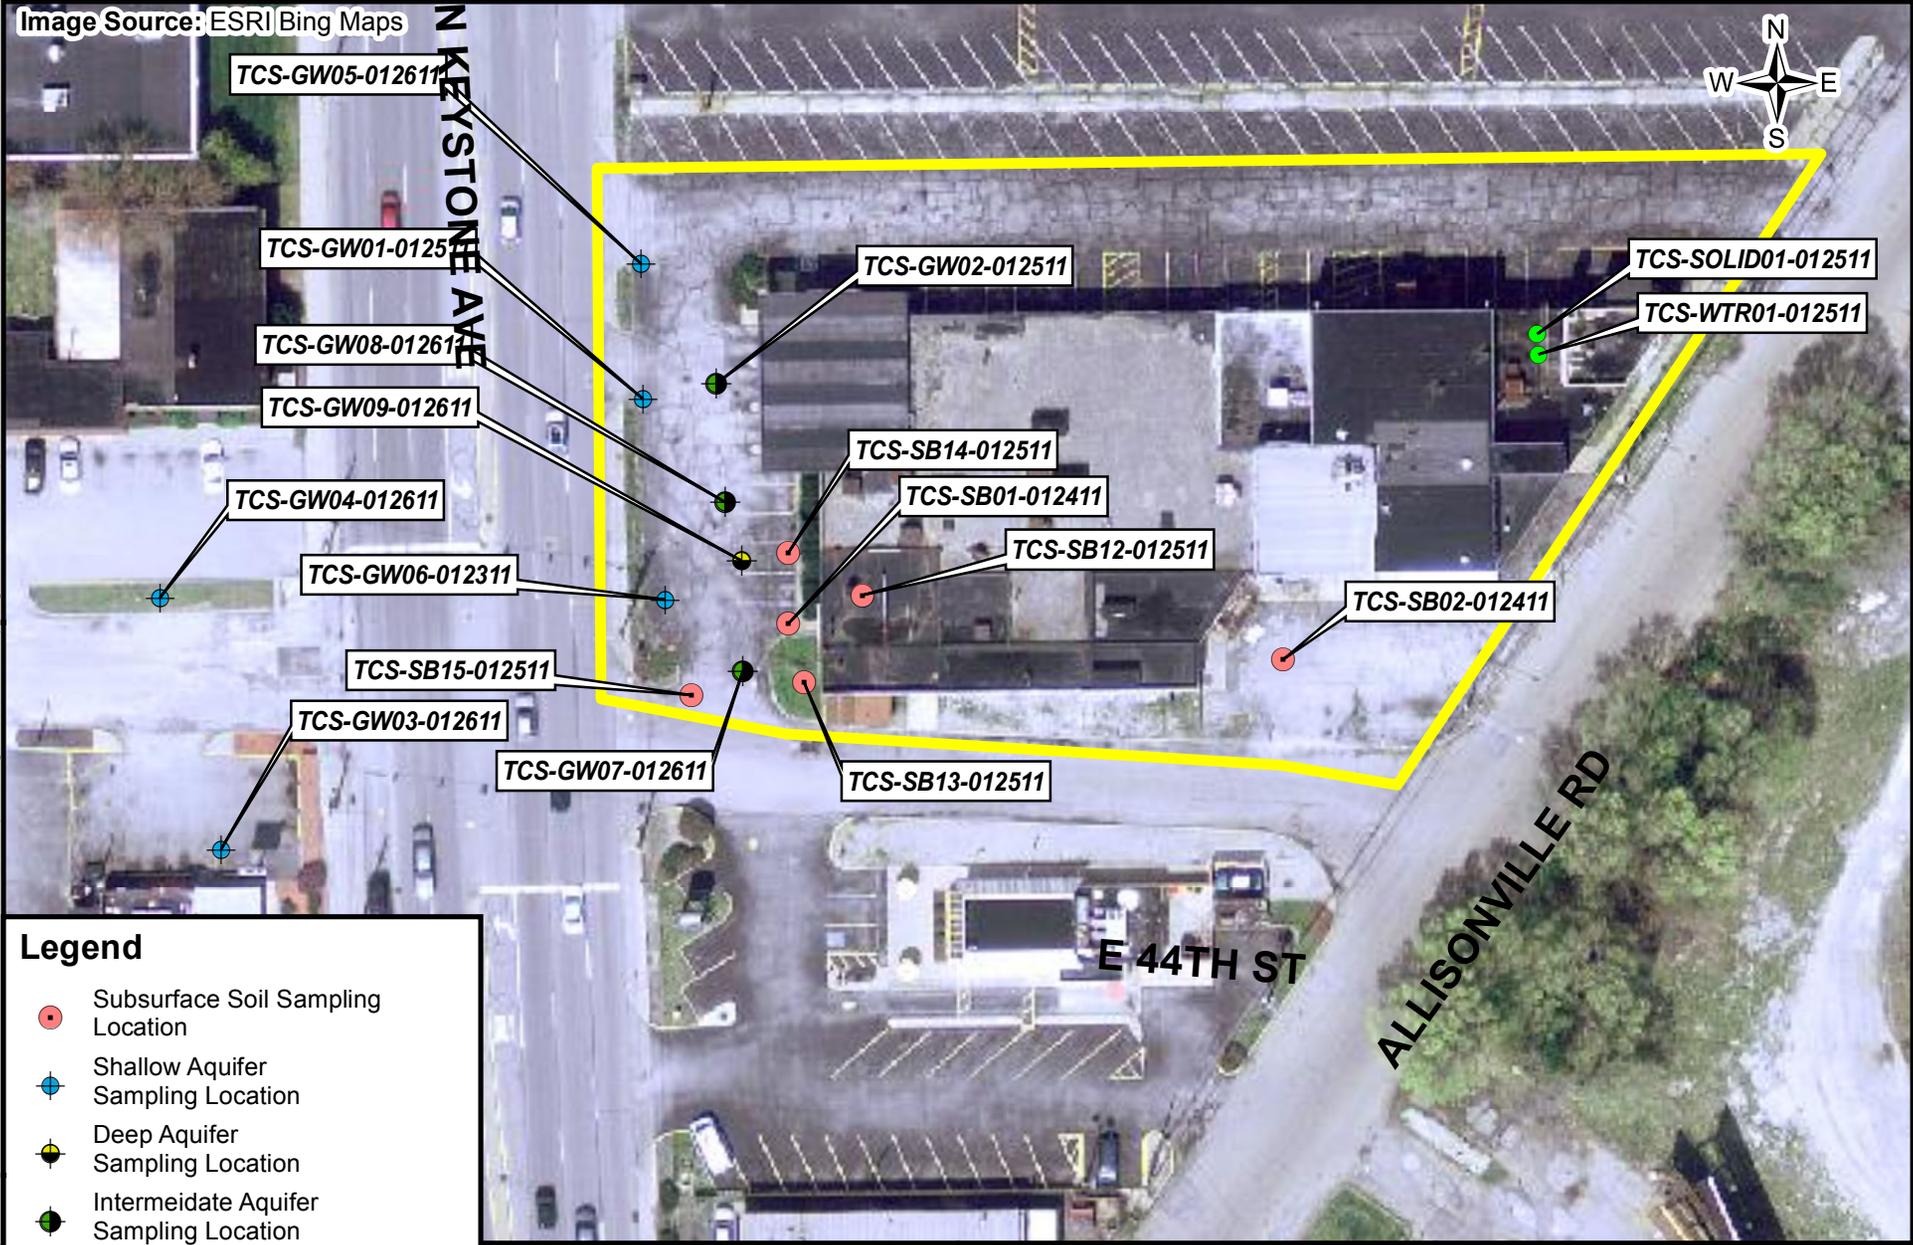
- Subsurface Soil Sampling Location
- ⊕ Shallow Aquifer Sampling Location
- ⊕ Deep Aquifer Sampling Location
- ⊕ Intermediate Aquifer Sampling Location
- Bulk Waste Sampling Location
- Site Boundary

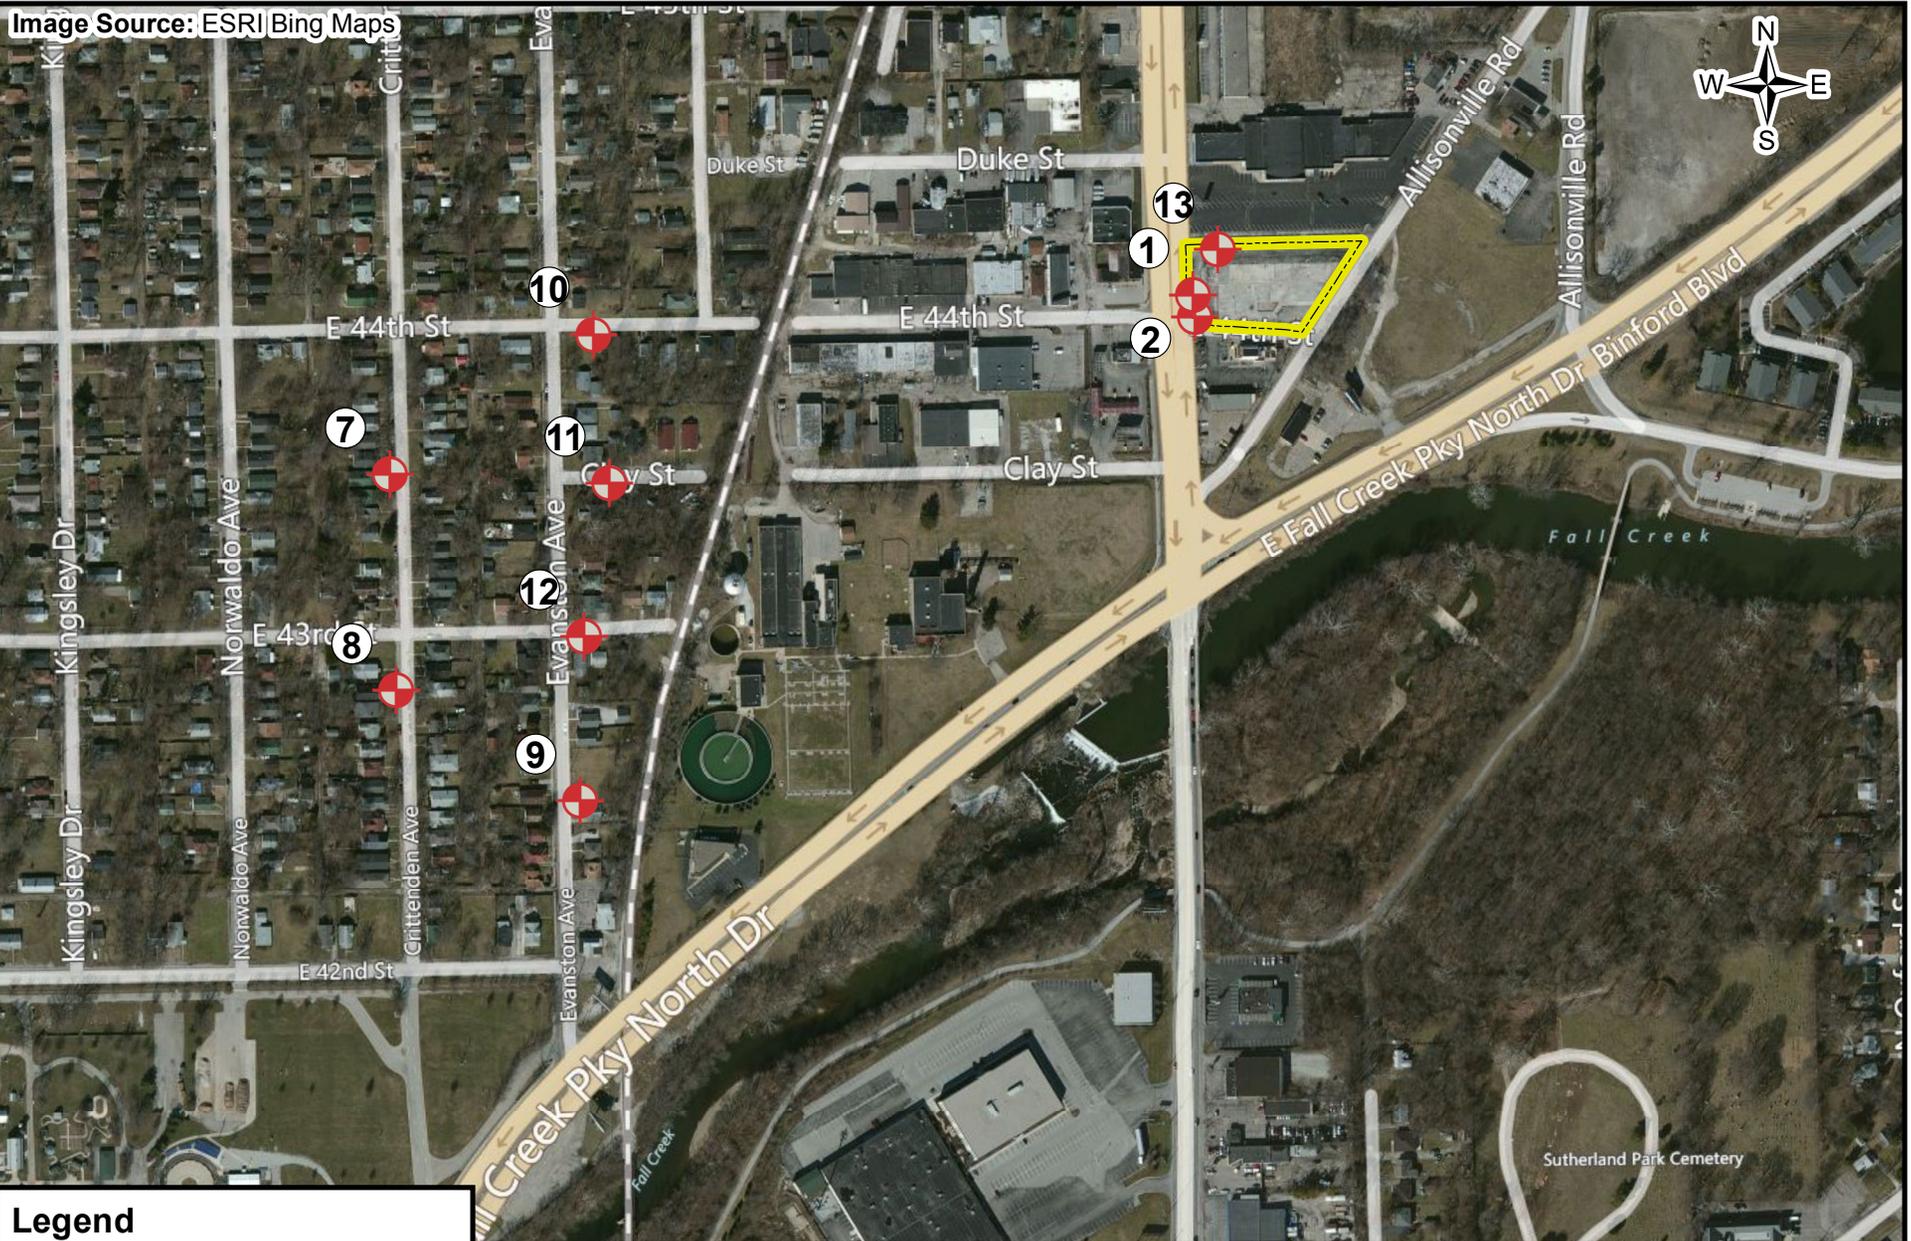
On May 9, 2012, U.S. EPA and WESTON START installed nine soil gas probes on the Site and in a public right-of-way in the neighborhood west of the Site. **Figure 3-2** shows the soil gas sampling probe locations. The following nine soil gas samples were collected: TCS-G01-051012, TCS-G02-051012, TCS-G07-051012 through TCS-G09-051012, and TCS-G10-051012, through TCS-G13-051012. A subcontractor drilling firm, IEGS, Inc., used a truck-mounted Geoprobe<sup>®</sup> unit to install each 2-inch-diameter borehole to approximately 16 to 20 feet bgs at 4-foot-long intervals. After each 4-foot core was advanced, the sleeve was removed from the core and opened. The soil core was inspected, and observations were recorded in a logbook. Each soil core was screened for VOCs by passing a ppbRAE 3000<sup>®</sup> PID over the length of the core and collecting a small aliquot of soil from each section of the core with suspected contamination into a Ziploc-style bag. Each aliquot was allowed to equilibrate, and then the headspace in each bag was screened for VOCs using the PID.

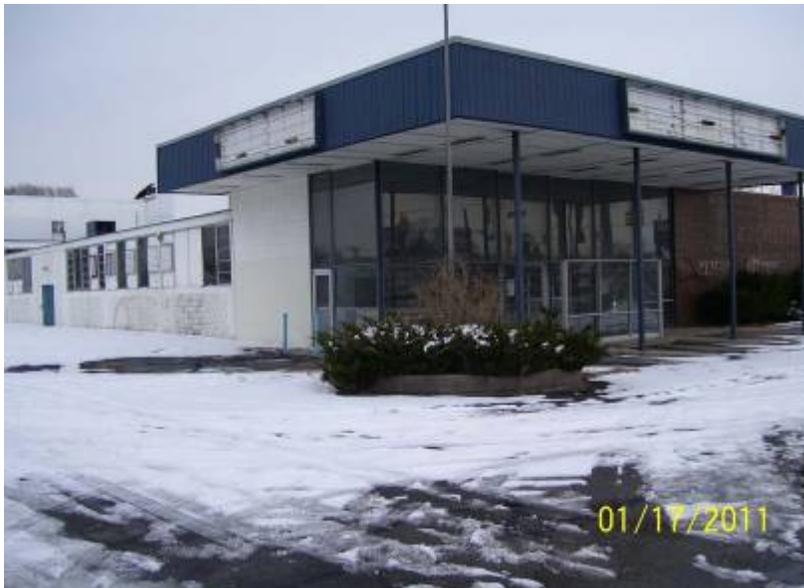
**Site:** Tuchman Cleaners Site  
**Photograph No.:** 1  
**Direction:** Southeast  
**Subject:** Front of main facility building

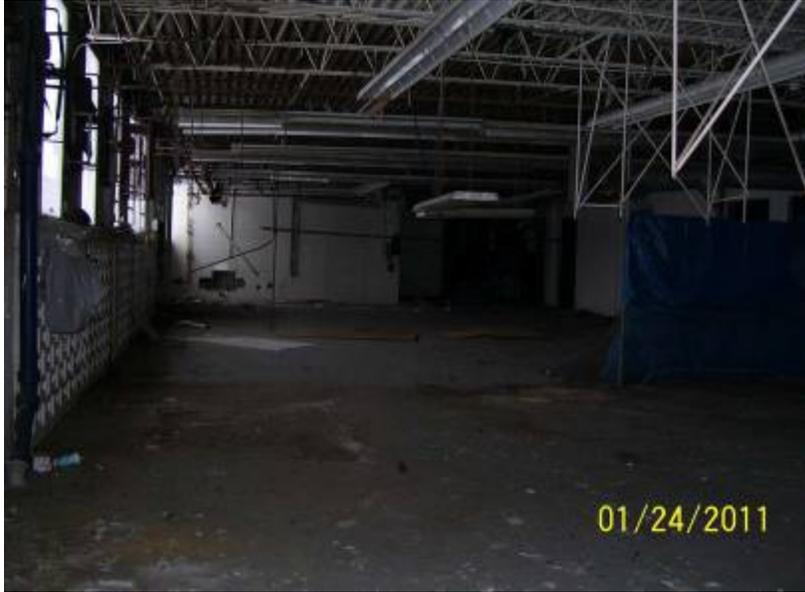
During the site assessment, WESTON START observed that the interior of the facility had an open floor plan with rooms along the periphery. The front office was located on the west side of the building, the maintenance and parts rooms were located on the south side, and the operations and storage areas were located on the north side. The facility contained two catch basins, both with inlet pipes but no outlet pipes. A wastewater treatment room in the northeast area of the facility held a sump suspected to drain to the City of Indianapolis' sanitary sewer system (see **Photograph No. 11** in **Appendix A**). Two self-contained subsurface vaults were observed in the facility, one in a west-central area and the other in a southwest area. The facility had a partial second floor that contained offices.

**Site:** Tuchman Cleaners Site  
**Photograph No.:** 3  
**Direction:** East  
**Subject:** Inside of main facility building

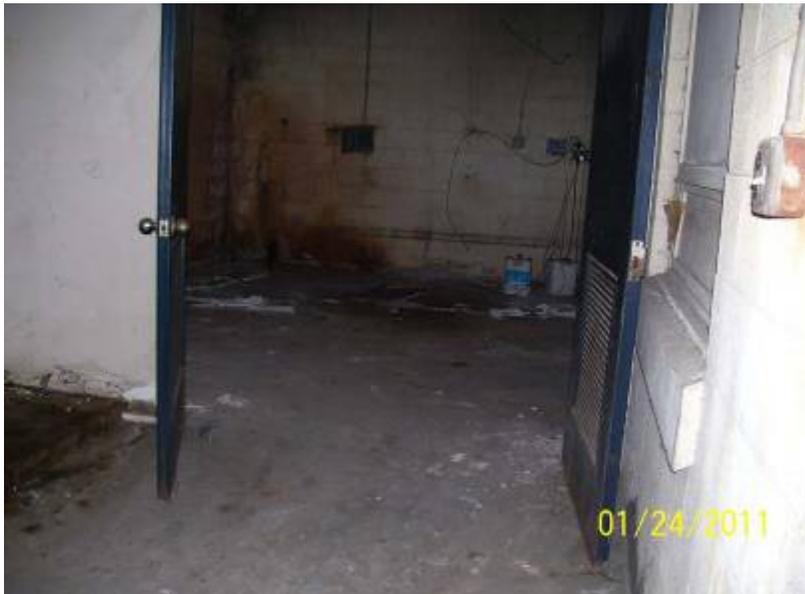
**Site:** Tuchman Cleaners Site  
**Photograph No.:** 4  
**Direction:** West  
**Subject:** Room from which subsurface soil sample TCS-SB12-012511 was collected

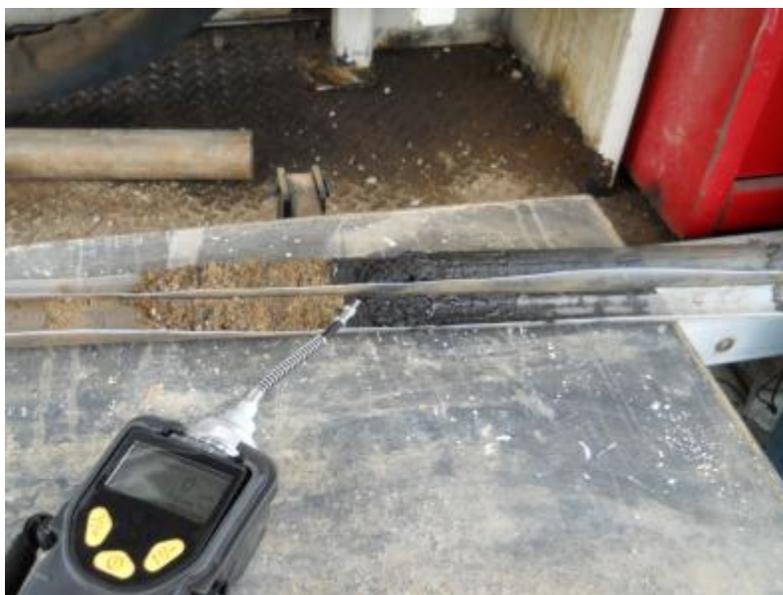
After the soil gas probes equilibrated for a minimum of 24 hours, WESTON START returned to collect the soil gas samples. Soil gas was screened using a RAE Systems, Inc., ppbRAE detector. The ppbRAE was attached to the end of the Teflon tubing, and when the VOC concentration had stabilized, the reading was recorded and the ppbRAE removed. The soil gas sample was collected using an evacuated, 6-liter SUMMA stainless-steel canister. The canister was attached to the soil gas probe, and then the shut-off valve was slowly opened to collect a “grab” sample. When the canister was 80 to 90 percent full, the valve was shut, the system was disassembled, and the canister was tightly capped for shipment to the laboratory. The samples were submitted under chain of custody to Air Toxics, Ltd., in Folsom, California, on May 10, 2012, under analytical TDD No. S05-001-1012-035, for analysis for VOCs using U.S. EPA Method TO-15.

**Site:** Tuchman Cleaners Site  
**Photograph No.:** 15  
**Direction:** Down  
**Subject:** ppbRAE analyzing soil core

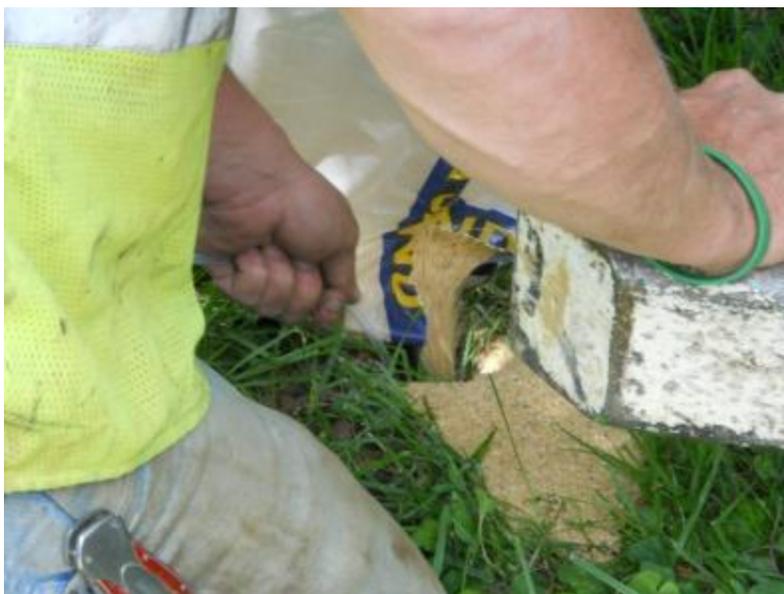
The soil gas probes were set in each boring at approximately 1 to 2 feet above the static water level near the depth of the core area with the highest VOC reading (if present). Each probe had a 0.5-foot-long screened section and was connected to 0.25-inch-diameter Teflon tubing that rose to the surface. Each boring then was backfilled with sand extending approximately 1 foot above the probe, and the remaining borehole volume was filled with bentonite to the surface. The Teflon tubing was capped at the surface with a plastic cap.

**Site:** Tuchman Cleaners Site  
**Photograph No.:** 16  
**Direction:** Down  
**Subject:** Setting of soil gas probe in boring

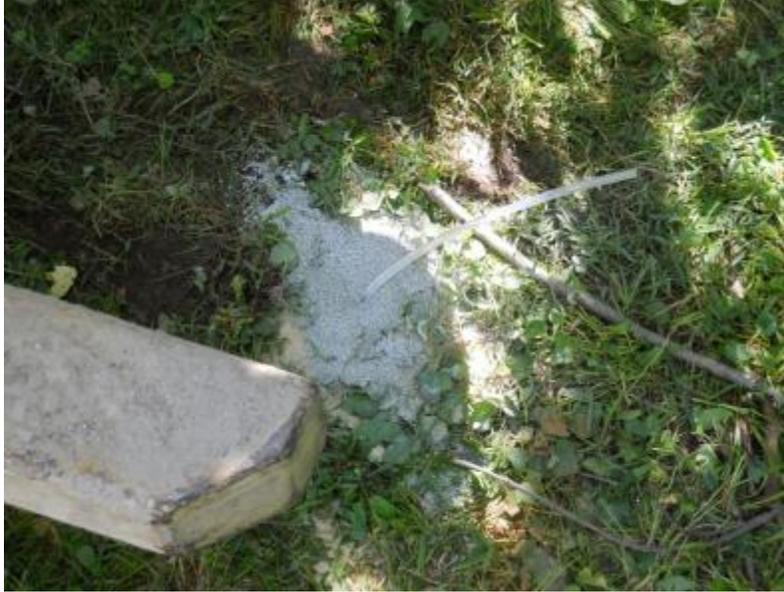
**Site:** Tuchman Cleaners Site  
**Photograph No.:** 17  
**Direction:** Down  
**Subject:** Top of soil gas probe
