Volume V - WDI Operating License Application Master Cells VI F & G

*Environmental Assessment Report
Wayne Disposal, Inc. - Site No. 2*

NTH Project No. 13-060921-03

**Environmental Assessment Report (Rule 299.9504(1)(e))
Wayne Disposal, Inc., Site No. 2
Master Cell VI – F & G Development (Woodlot)
NTH Project No. 13-060921-03**

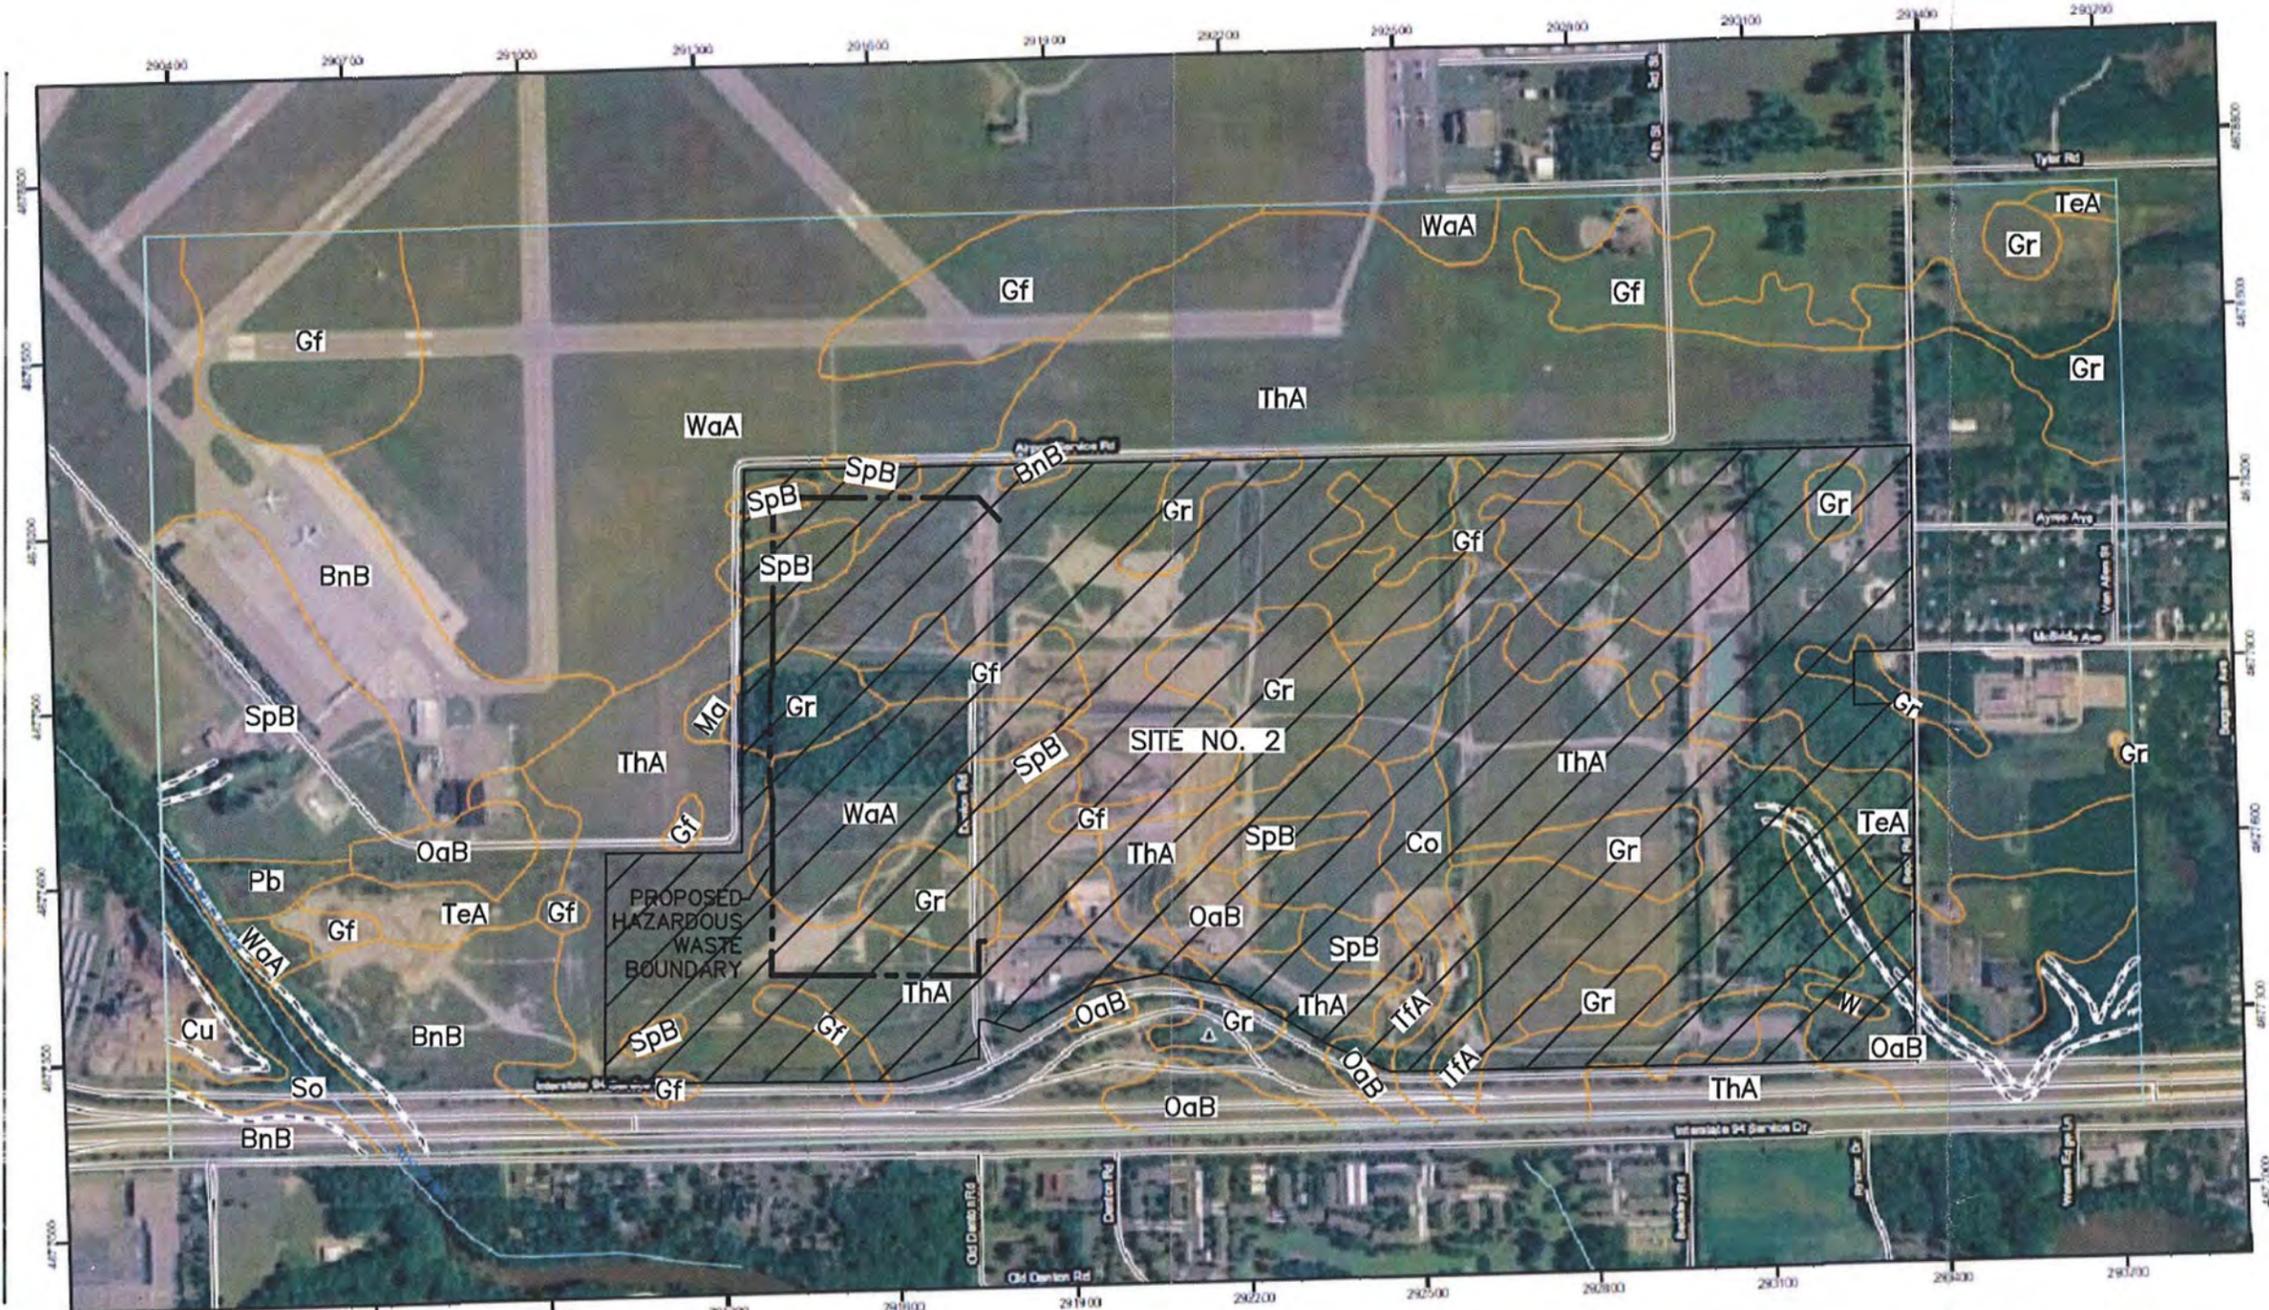
1. THE SOIL MAP WAS PROVIDED BY THE USDA-NRCS WEB SOIL SURVEY VERSION 2.2. THE SOIL SURVEY AREA IS IN WAYNE COUNTY, MICHIGAN (MAPPED IN 1973). THE SURVEY AREA DATA IS VERSION 7, JUNE 22, 2009.
2. SOIL TYPES MAPPED PRIOR TO LANDFILL DEVELOPMENT.

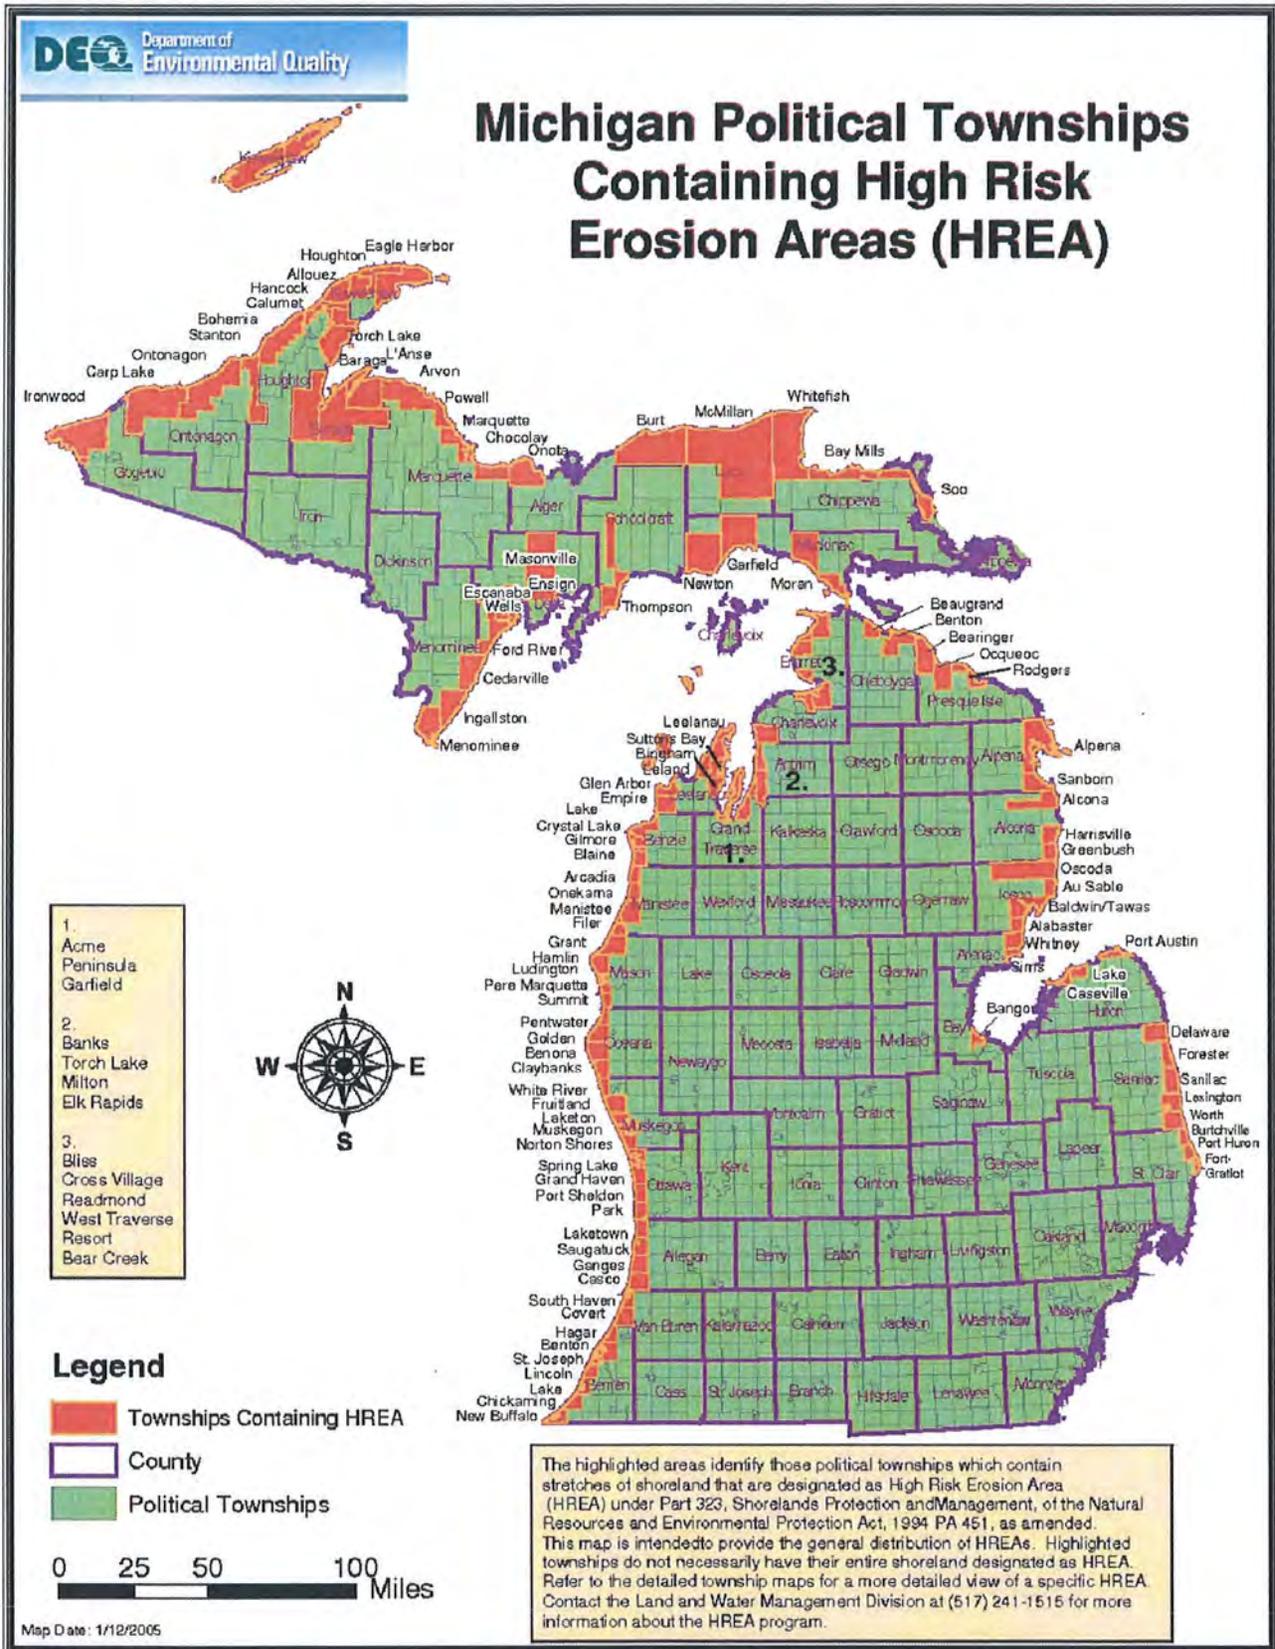
FIGURE:
8

MICHIGAN POLITICAL TOWNSHIPS CONTAINING HIGH RISK EROSION AREAS (HREA)
WAYNE DISPOSAL, INC. SITE NO. 2 - MC VI F&G VAN BUREN TWP., WAYNE COUNTY, MICHIGAN
