Rain Garden

Broadway Avenue Broken Arrow, Oklahoma

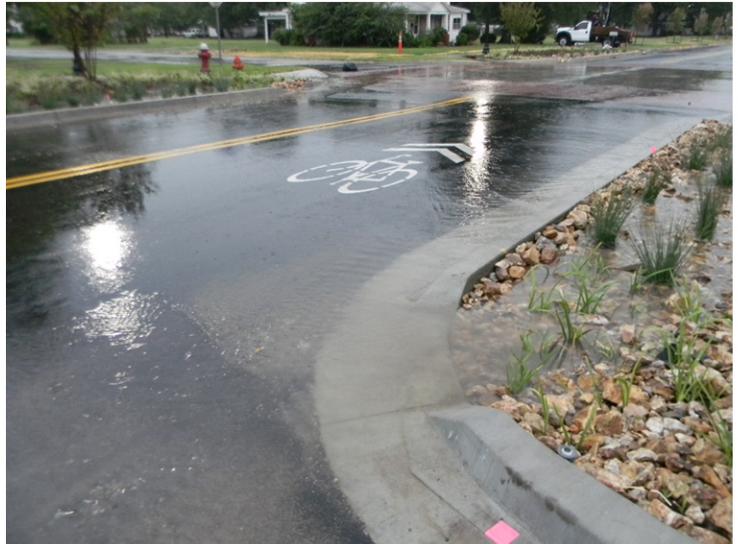
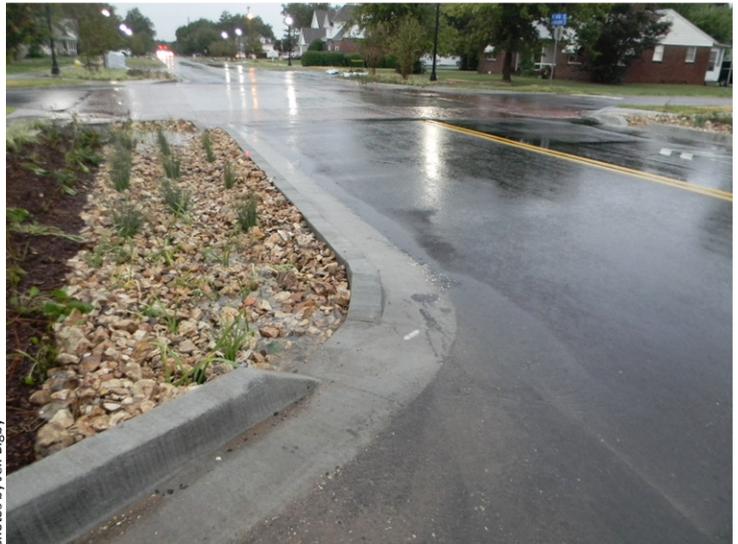
Outflow curb openings at two different rain gardens created along Broadway Avenue in Broken Arrow, Oklahoma.

Broadway Avenue is in an older part of town where there are no storm sewer inlet systems. The rain gardens were designed with an inflow curb opening to direct the rain water runoff into the gardens, allow the runoff to infiltrate into the ground, and support the native plants within the gardens. Each garden also has an outflow curb opening that allows excess runoff from large rainfall events to flow back into the street and into a series of streams several blocks away.
