**U.S. Environmental Protection Agency  
Region 9  
Clean Water Act Compliance Office**

**Industrial User Inspection Report**

**Industrial User:** Air Louvers/Samson Products, Inc.  
**Industrial User Address:** 6285 Randolph St., Commerce, CA 90040

**Inspection Date:** August 24, 2010

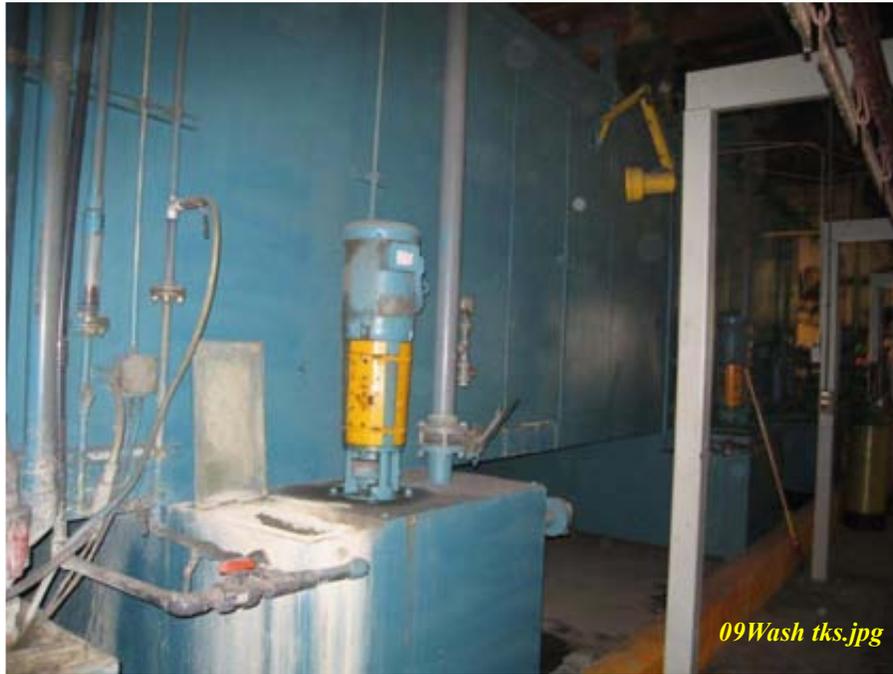
**Photo 1**

Parts hanging on rods are conveyed to a four-tank wash/phosphating system (*see Photo 1 in Attachment 1*) before being painted. At Tank #1, phosphating occurs during which an iron phosphate coating is applied to the part. This phosphating solution not only degreases the part but also prepares the part so that the paint will more readily stick to the part. At Tanks #2 and #3, the part is rinsed with tap water. At the final tank, the part is rinsed with deionized (DI) water.

Countercurrent rinses are employed in all rinse tanks. The used DI water from the final tank is circulated to Tank #3, the used rinse water from Tank #3 is circulated to Tank #2, and the used rinse water from Tank #2 is circulated to Tank #1 to mix with a phosphoric acid-based solution for the phosphating step.

Four-Tank Wash/Phosphating System  
*Taken by Anna Yen on August 24, 2010*

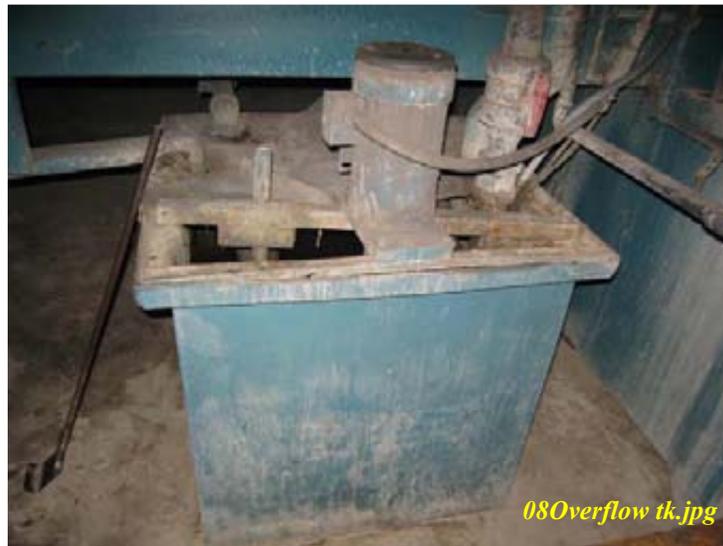
**Photo 2**

An overflow tank is located next to the four-tank wash/phosphating system. *See Photo 2 in Attachment 1*. Air Louvers stated that it is hardly ever used. For example, when the facility cleans the tanks, it just adds water to the system, the excess water overflows into the overflow tank. At the time of the inspection, it was three-fourths full. Air Louvers stated that this liquid is pumped to the onsite wastewater treatment system. Air Louvers could not remember when it was last pumped. Air Louvers stated that it does not use much water. When pressed for an estimate, Air Louvers gave a rough estimate of much less than 100 gallons per week of water that has to be put into the system. This estimate is much less than the amount currently stated in Air Louvers' pretreatment permit. In a follow-up phone call, Air Louvers confirmed that it has made operational changes to decrease the amount of wastewater it sends to the local sewer system.

Overflow Tank  
*Taken by Anna Yen on August 24, 2010*

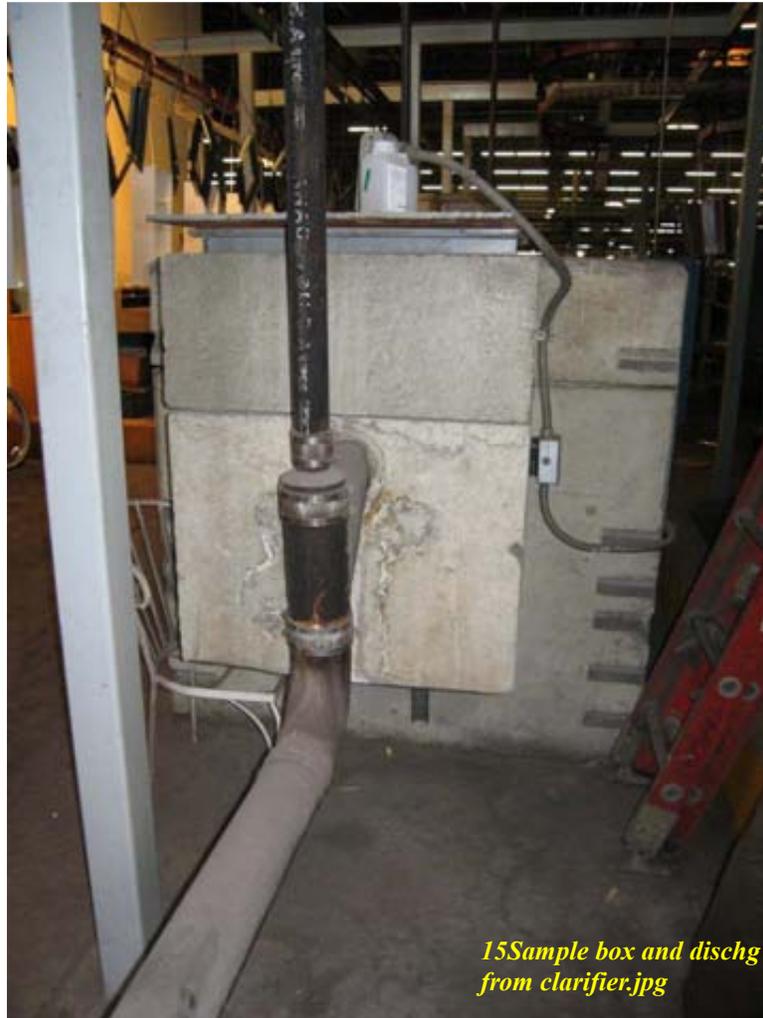
**Photo 3**

The facility's wastewater treatment system consists of a pH adjustment tank and a three-stage clarifier, with a sample box directly downstream of the clarifier. *See Photo 3 in Attachment 1.* The pH adjustment, through the addition of acid or caustic, occurs automatically. The pH is recorded continuously and is also logged manually. Discharge from the clarifier flows to the local sewer system. *See Photos 4 & 5 in Attachment 1.*

Sample Box at Discharge End of Clarifier  
*Taken by Anna Yen on August 24, 2010*

Air Louvers has the clarifier cleaned every six months. Air Louvers hires an outside company to pump the clarifier out and dispose of the contents.

Based on the facility's written responses and follow-up sampling and analysis, it appears that the facility's compliance problems are resolved when the clarifier is cleaned out. In a follow-up conversation with Air Louvers on October 27, 2010, EPA learned that Air Louvers has been working with LACSD to find a solution to the compliance issues. Air Louvers has implemented a more frequent schedule for cleaning its clarifier and has been taking monthly samples for analysis to report to LACSD. Air Louvers now cleans its clarifier every three months instead of every six months. Air Louvers stated that it has not violated its copper and zinc limits since April 2010 and is confident that this more frequent cleaning schedule will prevent future violations of the copper and zinc limits.

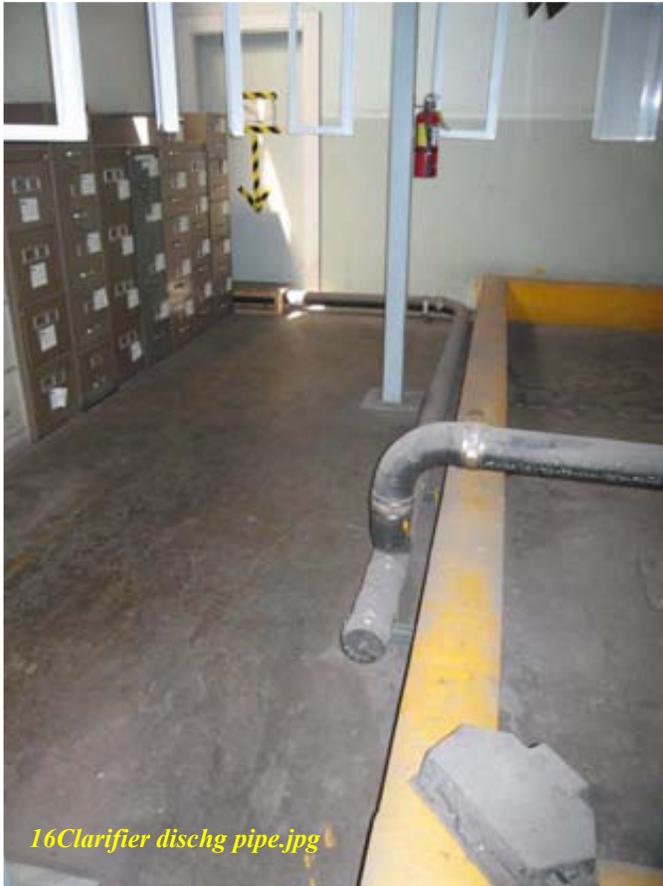
**Photo 4**  
Discharge pipe from clarifier to outside  
building  
*Taken by Anna Yen on August 24, 2010*

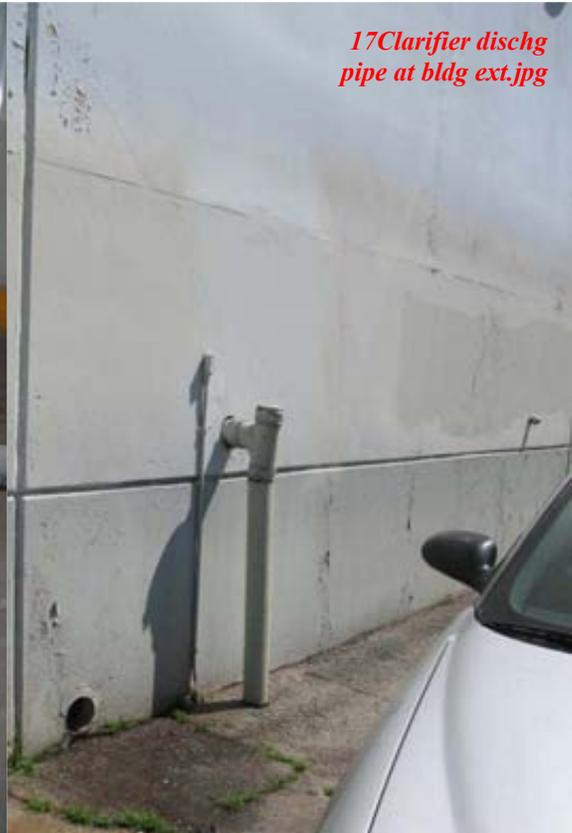
**Photo 5**  
Clarifier discharge pipe outside of building  
- leading down to local sewer system  
*Taken by Anna Yen on August 24, 2010*
