**NPDES COMPLIANCE EVALUATION INSPECTION**

NPDES Permittee: American Samoa Power Authority

Facility: Satala Power Plant  
P.O. Box PPB, Pago Pago, Tutuila Island, American Samoa  
(NPDES Permit No. AS0020044)

Date of Inspection: April 1, 2008

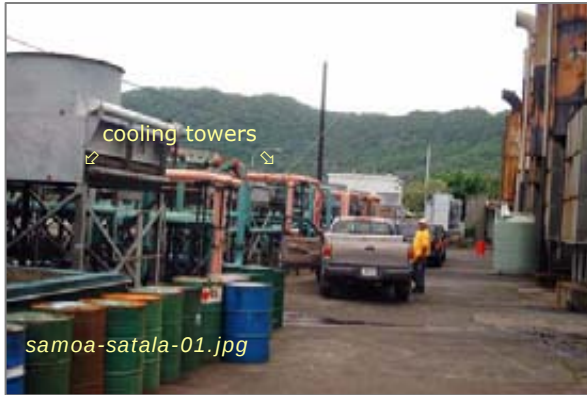
Cooling Towers – Twelve individual cooling towers are used to water-jacket cool the engines. The cooling towers are located outside on the paved access road in front of the engine building between the highway and the building. ASPA does not add corrosion inhibitors or biocides to the cooling tower contents. Each cooling tower is drained every four months to the underlying cement pad. See Photo #1 in Section 1.6 on page 6.

Photo #1: Cooling Towers and Paved Access Areas  
Taken By: Greg V. Arthur  
Date: 04/01/08

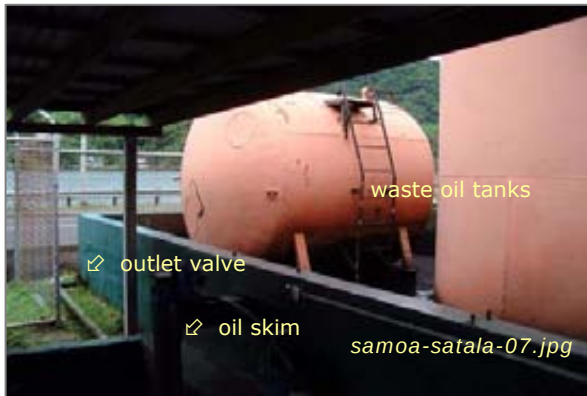
Waste Oil Tanks – Two waste oil tanks, with capacities of 7,300 and 5,000 gallons, are installed behind concrete block secondary containment walls adjacent to NPDES Sump #1. Oil spills, skimmed oil, oily wastewaters, and slop are conveyed manually to these waste oil tanks for off-site hauling to the Tafuna Power Plant for reprocessing. The waste oil storage containment is outfitted with a valved drain line to NPDES Sump #1. The drain line valve was found in the open position during this inspection. See Photos #3 and #4 in Section 1.6 on page 7.

Photo #3: NPDES Sump #1 – Waste Oil Tanks  
Taken By: Greg V. Arthur  
Date: 04/01/08

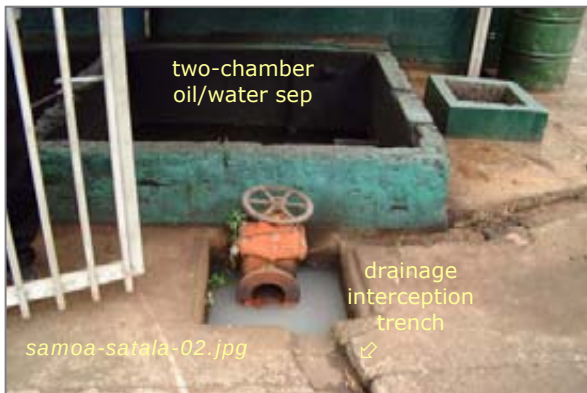
Truck Wash – Cloudy wastewater that was said by ASPA to be from truck washing was observed in the interceptor trench. The pollutants in the truck wash are unknown at this time although it is likely to include alkaline soap and the resulting emulsified oils. Truck wash drains uncontrolled into the interceptor trench to the oil water separator irrespective of storm events.

Photo #5: NPDES Sump #1 – Soapy Drainage  
Taken By: Greg V. Arthur  
Date: 04/01/08

- The NPDES permit should require impoundment of the process wastewaters (*cooling water spents, fuel farm wash down, truck wash down*) for discharge during storm events.
