**Re: April 30, 2009 Clean Water Act Inspection  
and Modification of EPA Administrative Order CWA-309(a)-09-011**

**NPDES COMPLIANCE EVALUATION INSPECTION**

Facility: American Samoa Terminal  
(Utulei Petroleum Terminal, Fuel Dock, and Tank Farm)  
P.O. Box 488, Pago Pago, Tutuila Island, American Samoa

Date of Inspection: April 30, 2009

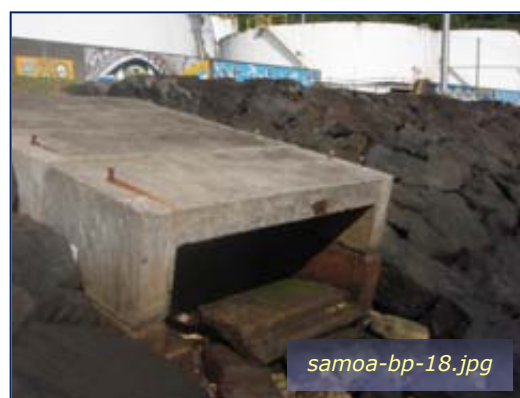
Photo #4: NPDES-002 Outfall – Low Tide  
Taken By: Nick King, Assistant Terminal Manager  
Date: 06/22/09

Loading Rack Drainage – The bottom fill loading rack is used to load tanker trucks. It is underlain by floor drains which lead beyond the rack perimeter to a 6,000 gallon blind sump tank which after visual inspection is pumped to a pre-filler surge tank for the Area B oil water separator. The bottom fill loading rack is covered, and surrounded by berms and raised contouring to minimize storm water run-off into the floor drains. The top fill loading rack is now decommissioned. Spills, wash-downs, and drainages would be expected to contain fluctuating levels of free and emulsified petroleum distillates. See Photos #3 and #4 in Section 1.5 of this report on page 8.

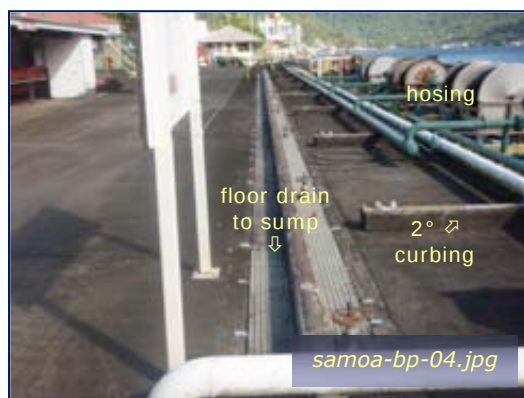
Photo #5: Fueling Dock – looking west  
Taken By: Nick King, Assistant Terminal Manager  
Date: 06/22/09

Fuel Dock Drainage – The fore dock is bermed and sloped to drain to an interceptor trench which leads to the Area F oil water separator. The filler hose reels on the fore dock are also within their own berms with valving as normally closed. Fuel dock drainage would be expected to contain low levels of free and emulsified petroleum distillates. See Photos #5 and #6 in Section 1.5 of this report on page 8.

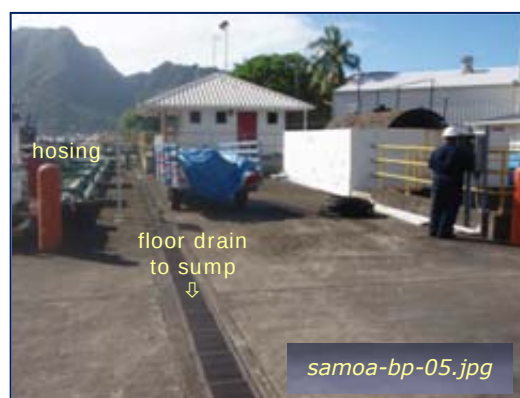
Photo #6: Fueling Dock – looking east  
Taken By: Nick King, Assistant Terminal Manager  
Date: 06/22/09

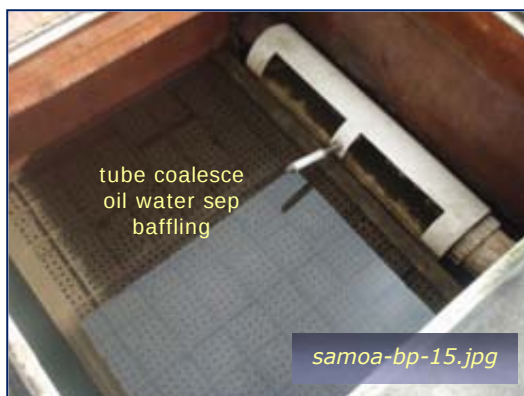
Photo #7: Area B Oil Water Separator  
Taken By: Nick King, Assistant Terminal Manager  
Date: 06/22/09

all valved normally closed. Finally, the four oil water separators are each surrounded by secondary containment. See Photo #7 in Section 1.5 of this report on page 9.

Area B Drainage – Spills, washdown, and drainage from the bottom fill loading rack collect into a blind sump tank through floor drains. The sump contents are pumped into a pre-filler surge tank. Storm water run-off from the surrounding paved areas also drain into the surge tank, which is operated to release through an oil water separator. There is normally closed valving into and out of the oil water separator and out through a bypass line. The Area B oil water separator discharges to a storm water culvert leading to the harbor, which is designated in the permit and here as NPDES-002. The oil water separator effluent is designated in this report as NPDES-002B. The oil water separator bypass line is designated in this report as NPDES-002BX. See Photos #7, #8 and #9 in Section 1.5 of this report on page 9.

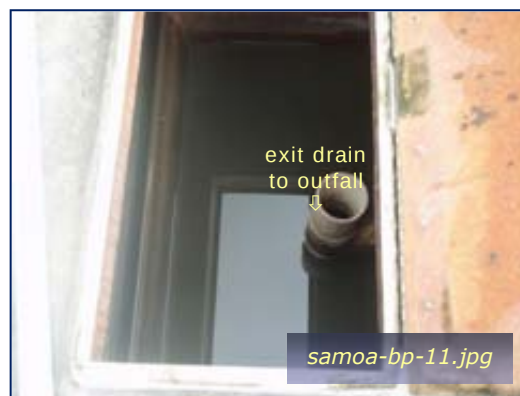
Photo #8: NPDES-002B Discharge Point  
Taken By: Nick King, Assistant Terminal Manager  
Date: 06/22/09

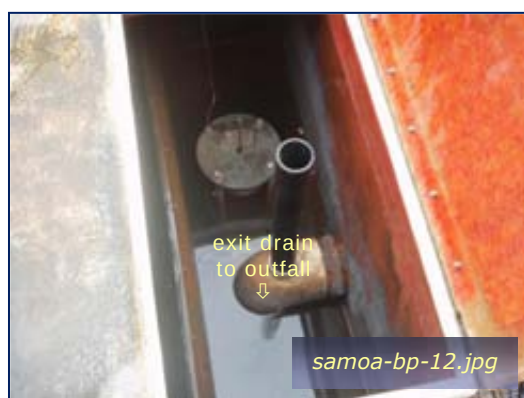
Photo #11: NPDES-002D Discharge Point  
Taken By: Nick King, Assistant Terminal Manager  
Date: 06/22/09

Area D Drainage – Spills, tank bottoms, storm water run-off, and drainage from Area D collect within secondary containment. The wastewaters from Area D and the top fill loading rack drain through a tube coalescing oil water separator, with normally closed valving in and out, to a storm water culvert leading to the harbor. The oil water separator effluent is designated in this report as NPDES-002D. See Photo #11 in Section 1.5 of this report on page 9.

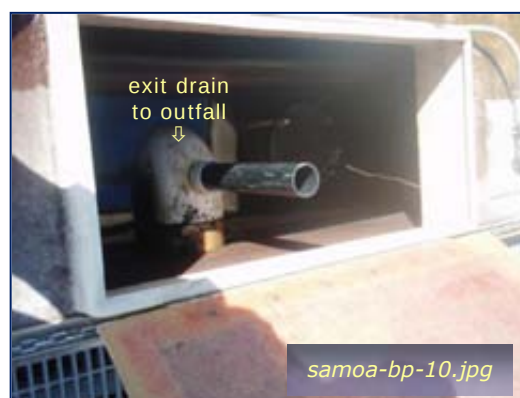
Photo #12: NPDES-003 Discharge Point  
Taken By: Nick King, Assistant Terminal Manager  
Date: 06/22/09

Area F Drainage – Spills, storm water run-off, and drainage from the fore dock collect within secondary containment to an interceptor trench. The wastewaters are released through a tube coalescing oil water separator, with normally closed valving in and out, to the harbor. The oil water separator effluent is the NPDES discharge point, designated in the permit and here as NPDES-003. See Photo #12 in Section 1.5 of this report on page 9.
