Re: August 16, 2011 Clean Water Act Inspection

**Industrial User Inspection Report**

**Industrial User:** Arnold's Metal Finishing  
**Industrial User Address:** 805 Aldo Ave., Suite 104, San Jose, CA 95054

**Inspection Date:** August 16, 2011

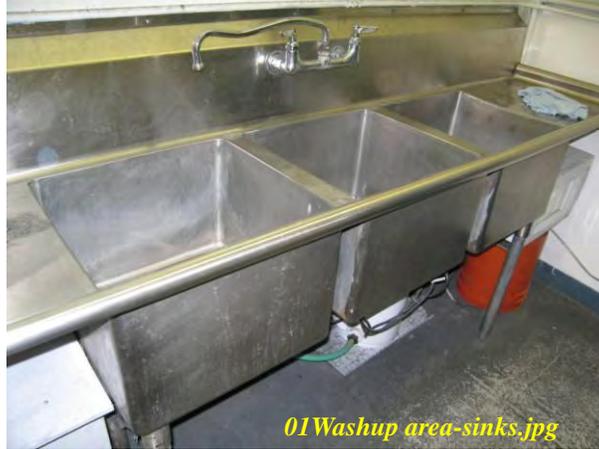
**Photo 1**

Wash-up area near the metal polishing machines  
*Taken by Anna Yen on August 16, 2011*

Arnold's has bead glass sandblast machines and performs some sanding. Arnold's also has metal polishing machines. None of these machines use any water, for the function of the machine or for cooling purposes. A wash-up area is located near the metal polishing machines. Drainage from the sinks flows to a holding tank, the contents of which are then pumped to a central sump and then to the onsite wastewater treatment system. *See Photos 1-4 in Attachment 1.*

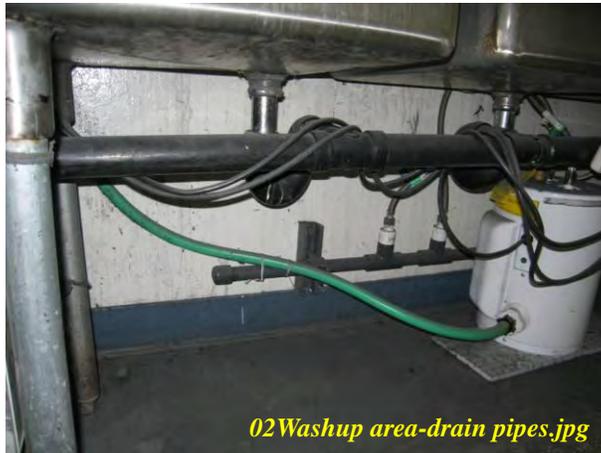
**Photo 2**

Drain pipes below the sinks of wash-up area  
*Taken by Anna Yen on August 16, 2011*

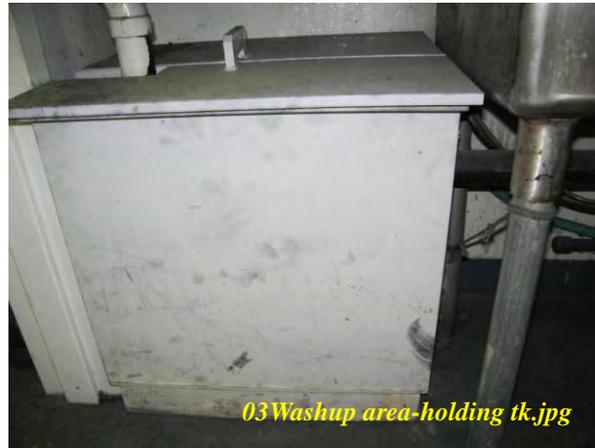
**Photo 3**

Holding tank of wash-up area  
*Taken by Anna Yen on August 16, 2011*

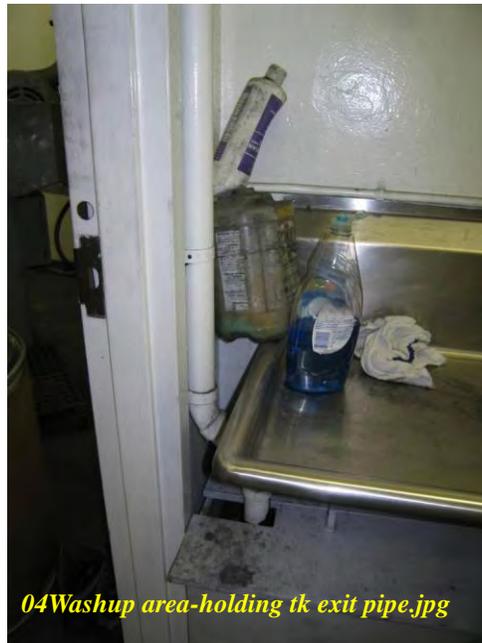
**Photo 4**

Discharge pipe from holding tank  
*Taken by Anna Yen on August 16, 2011*

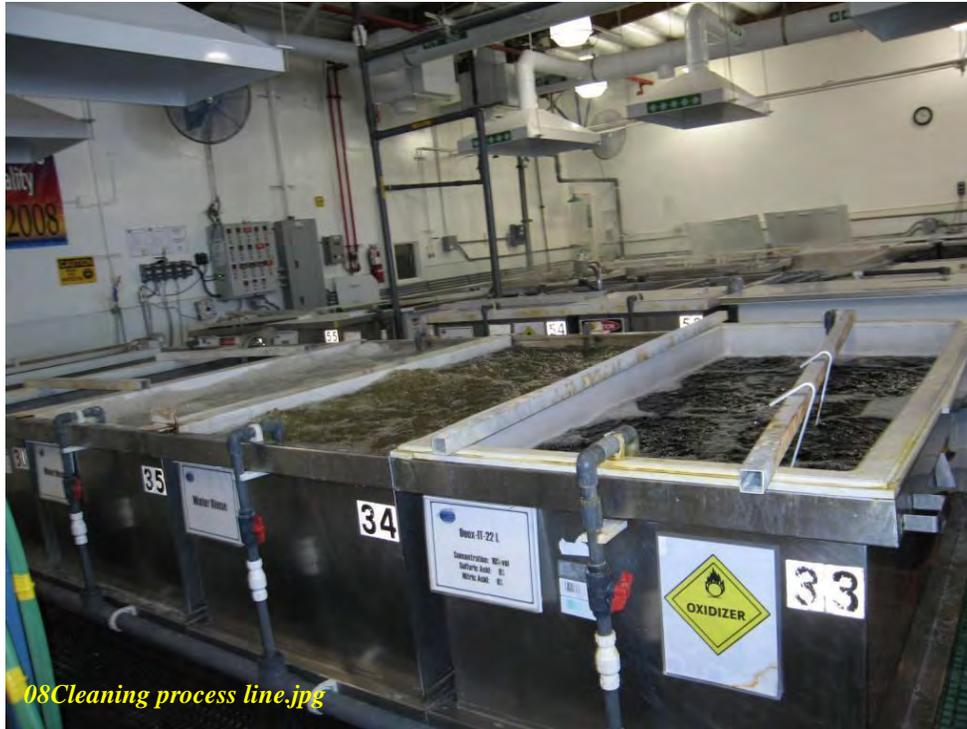
**Photo 5**

Arnold's employees place metal parts on custom-made racks, and manually dip the parts into the tanks of a process line. The metal finishing area starts with a cleaning line, consisting of a soap tank, rinse tank, caustic etch tank, two rinse tanks, and a deoxidizer tank. After the parts go through this cleaning line, the parts are dipped in a rinse tank and spray rinsed. *See Photo 5 in Attachment 1.*

Cleaning process line in metal finishing area  
*Taken by Anna Yen on August 16, 2011*

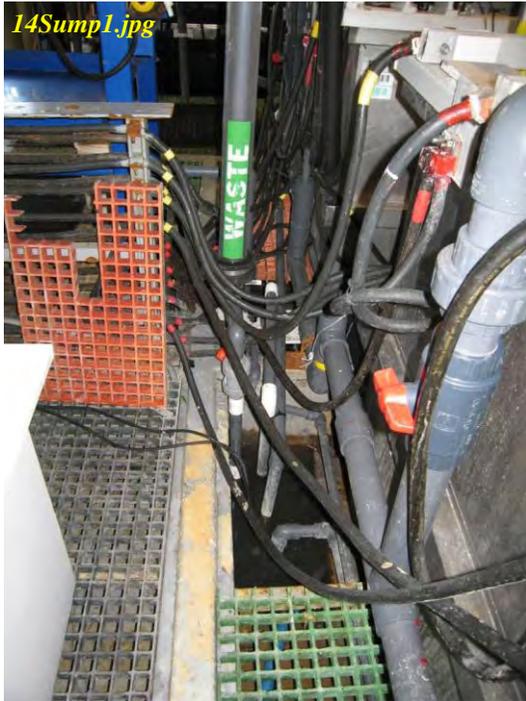
**Photo 6**

All tanks in the metal finishing area sit on top of floor grating. Dragout from the metal finishing process lines collect in the secondary containment below the floor grating. The secondary containment is separated into a few sections by berms. The floor of each section slopes to one point where a sump pump pumps the liquid to a central sump from which the liquid is then pumped to the onsite wastewater treatment system. This central sump is the same one to which drainage from the wash-up area for metal polishing is conveyed. Arnold's also transfers by bucket air compressor condensate to this sump. *See Photos 6-7 in Attachment 1.*

Central sump

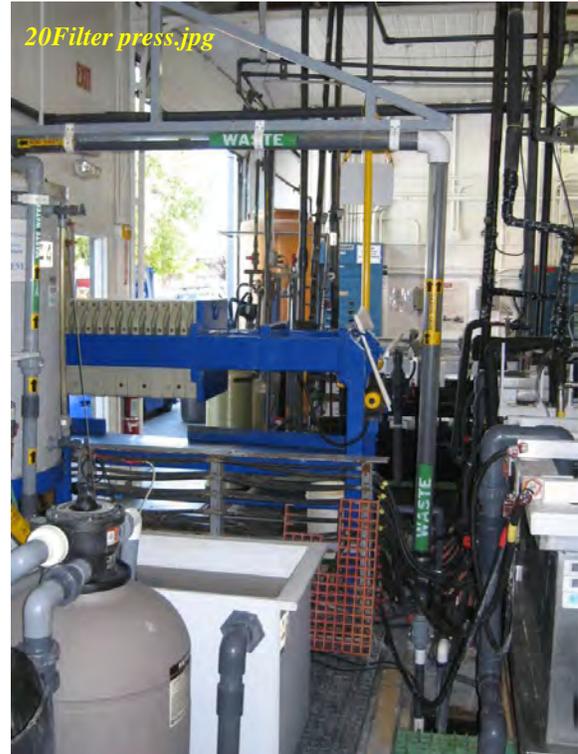
**Photo 7**

View of central sump adjacent to  
the wastewater treatment system

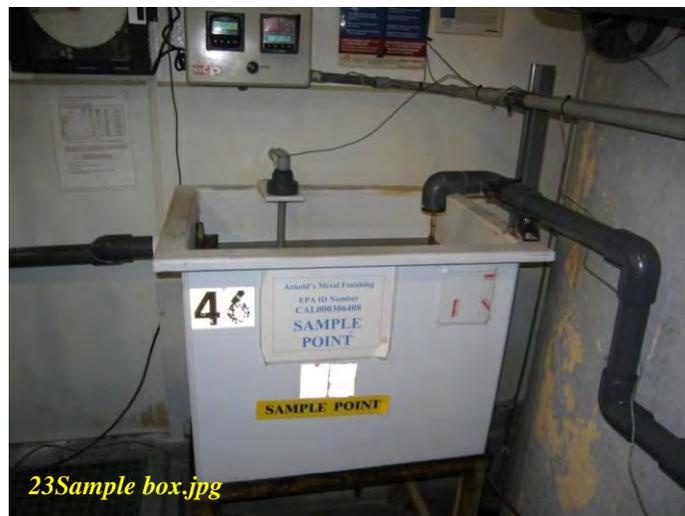
**Photo 8**

The above listed wastewaters, except for the second and last item of the list, are all sent to an onsite wastewater treatment system. See Section 1.1 above for a description of how other spent metal finishing baths are handled. Lab sink drainage is collected and sent offsite for appropriate disposal. Once the wastewaters are processed through the onsite wastewater treatment system, the treated wastewater collects in a sample box before discharging to the local sewer system. *See Photo 8 in Attachment 1.*

Sample box

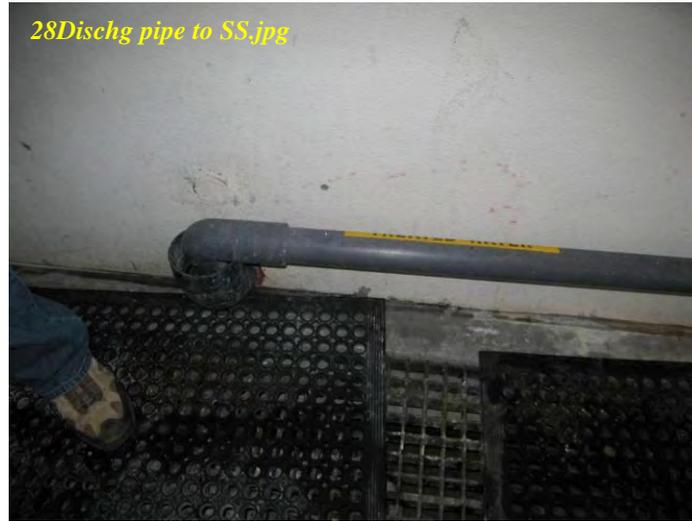
**Photo 9**

The discharge pipe from the sample box eventually ends at an open elbow which is of a larger diameter than the discharge pipe. This elbow runs through the wall of the metal finishing room near the floor and leads to piping through the floor eventually connecting to the local sanitary sewer system. When asked why the line from the sample box discharged into this elbow configuration, Arnold's stated that the City had required this configuration in the past. The City inspector that was present during this inspection was not aware of this requirement by the City. This type of configuration does not seem necessary and facilitates potential illegal discharges downstream of the sample point. *See Photos 9-10 in Attachment 1.*

Discharge pipe from sample box to local sanitary sewer system  
*Taken by Anna Yen on August 16, 2011*

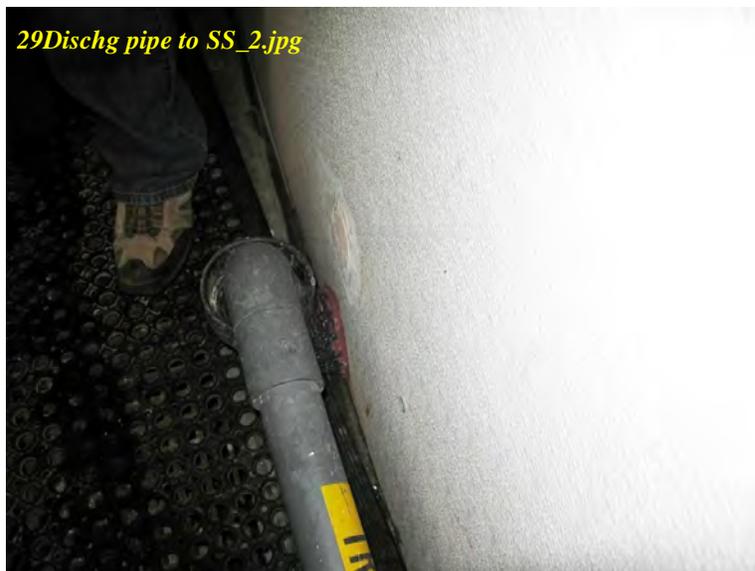
**Photo 10**

Discharge pipe to local sanitary sewer system –  
view of pipe entering elbow configuration  
*Taken by Anna Yen on August 16, 2011*

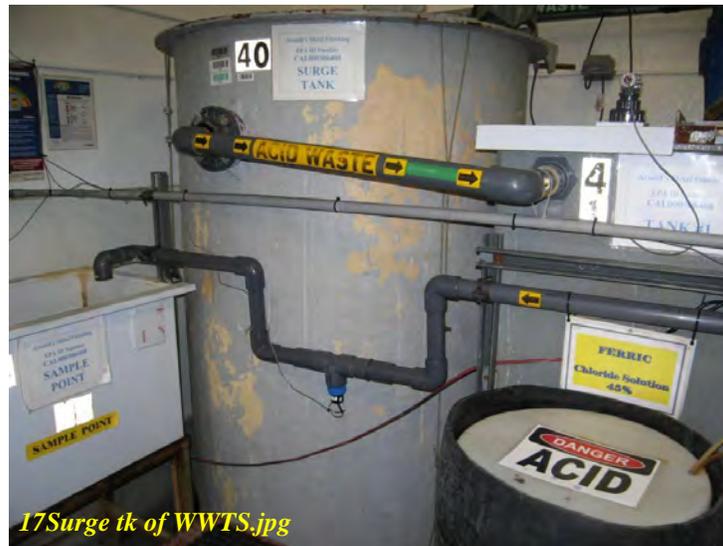
**Photo 11**

From the central sump to which metal finishing process wastewaters drain from the secondary containment area, wastewater is pumped to the Surge Tank of the onsite wastewater treatment system. The wastewater then flows by gravity to Tank #1. Arnold's adds ferric chloride and sulfuric acid to this tank. Their setpoint for pH is 3 to 4. At the time of the inspection, the pH meter read 3.70. The wastewater is then sent to Tank #2. Arnold's adds sodium hydroxide and flocculant to this tank. The pH setpoint is 10 to 11. At the time of the inspection, the pH meter read 10.18. The wastewater then flows to a clarifier. Clarifier bottoms are pumped to a thickener tank and subsequently to a filter press. The filter cake is hauled away for offsite disposal. The filtrate is sent back to the central sump. *See Photos 11-13 in Attachment 1.*

Surge tank of wastewater treatment system  
*Taken by Anna Yen on August 16, 2011*

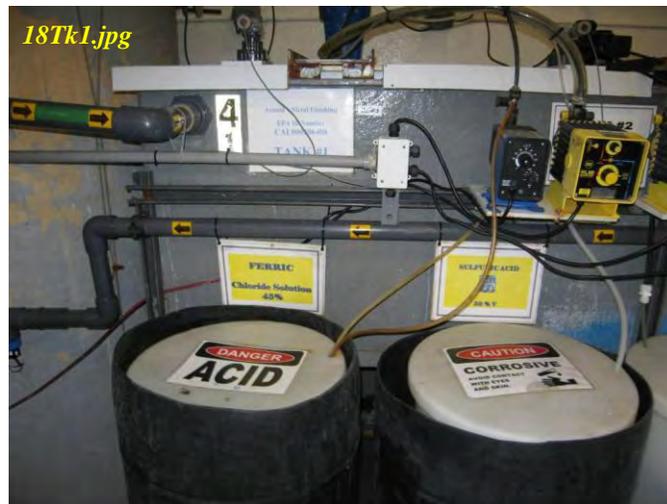
**Photo 12**

Tank 1 of the wastewater treatment system  
*Taken by Anna Yen on August 16, 2011*

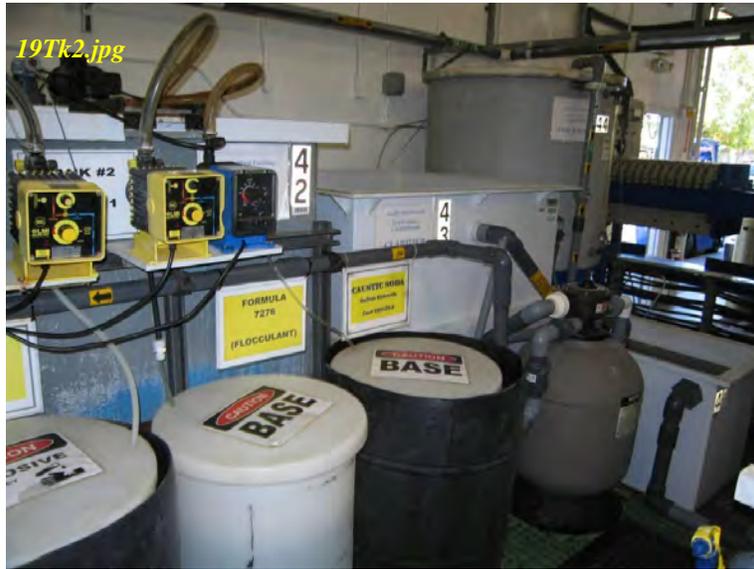
**Photo 13**

Wastewater treatment system  
*Taken by Anna Yen on August 16, 2011*

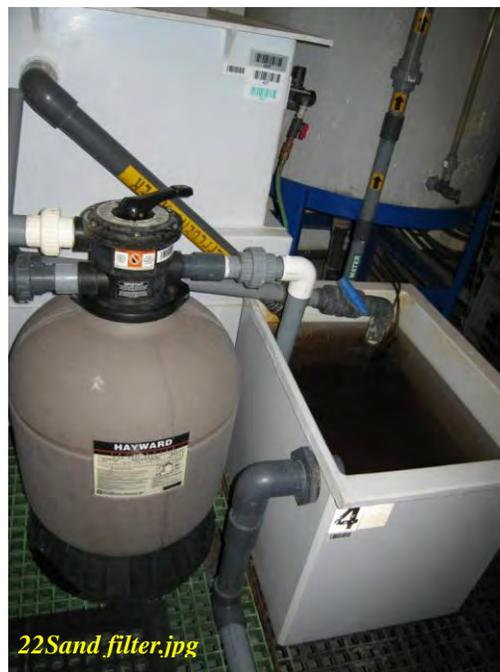
**Photo 14**

Clarifier effluent is sent to a holding tank and subsequently to a sand filter. The filtered effluent is conveyed to the sample point and then to the local sewer system. At the time of the inspection, the pH meter at the final sample point read 9.44. *See Photo 14 in Attachment 1.*

Holding tank and sand filter  
of the wastewater treatment system  
*Taken by Anna Yen on August 16, 2011*
