Re: August 17, 2011 Clean Water Act Inspection

**Industrial User Inspection Report**

**Industrial User:** Kion Technology, Inc.  
**Industrial User Address:** 2190 Oakland Rd., San Jose, CA 95131

**Inspection Date:** August 17, 2011

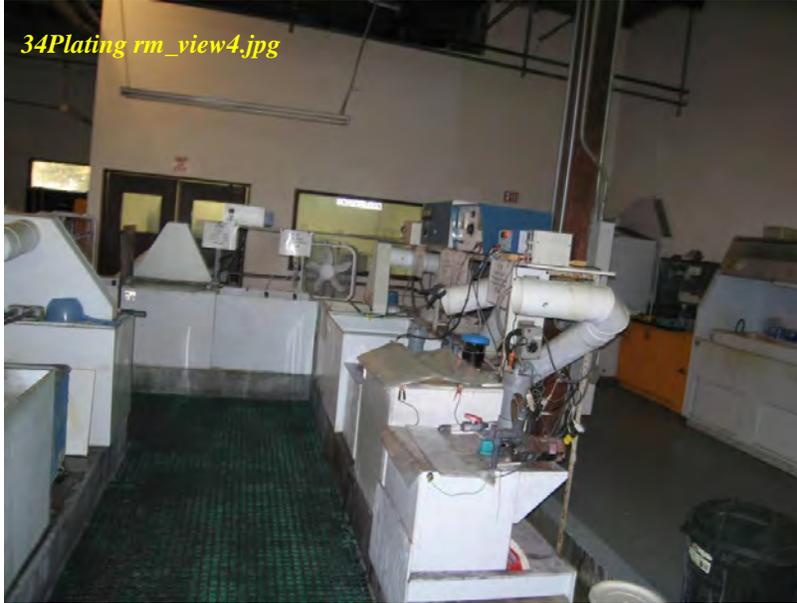
**Photo 1**

All tanks except the rinse tanks are dual-contained tanks. In addition, all of the metal finishing tanks sit on top of floor grating, below which is the secondary containment. *See Photo 1 in Attachment 1.* During the inspection, the secondary containment was dry with no standing liquid. Kion stated that, if any liquid were to collect in the secondary containment area, Kion would vacuum it out and send the liquid to the onsite wastewater treatment system.

Metal finishing room

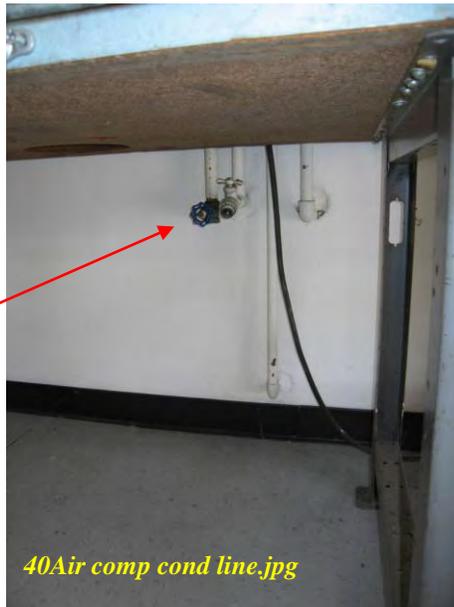
**Photo 2**

The treated wastewater is sent in a 300-gallon batch to a holding tank. The contents, once released, flow through a sample box and on to the local sanitary sewer system. Kion discharges a 300-gallon batch per day. Kion stated that the air compressor condensate is collected in two locations and then manually transferred to the onsite wastewater treatment system, approximately two gallons every week. One of the locations is simply a pipe with the valve closed. No container for collecting the condensate was observed. *See Photo 2 in Attachment 1.* Kion stated that it would double-check that staff were collecting the condensate on a weekly basis.

Air compressor  
condensate line

Air compressor condensate line

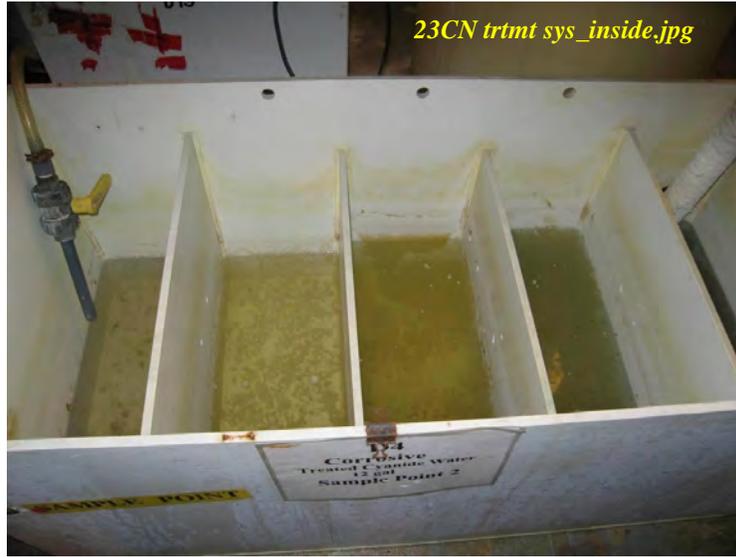
**Photo 3**

After Kion's cyanide violations in late 2010, Kion decided not to use its cyanide treatment system and instead have the cyanide-contaminated wastewaters hauled offsite for hazardous waste disposal. The cyanide treatment system is no longer connected to the process lines or to the rest of the wastewater treatment system. The City of San Jose required that Kion empty the contents of the cyanide treatment tank. Kion did so, sending the contents offsite as hazardous waste. However, Kion subsequently refilled the tank with water, stating that the tank, which is of non-metal construction, would crack at the joints if not filled with liquid. During the inspection, the tank was full of an opaque liquid. It did not appear to be clean water. *See Photo 3 in Attachment 1.*

Cyanide treatment system –  
currently not in operation  
*Taken by Anna Yen on August 17, 2011*

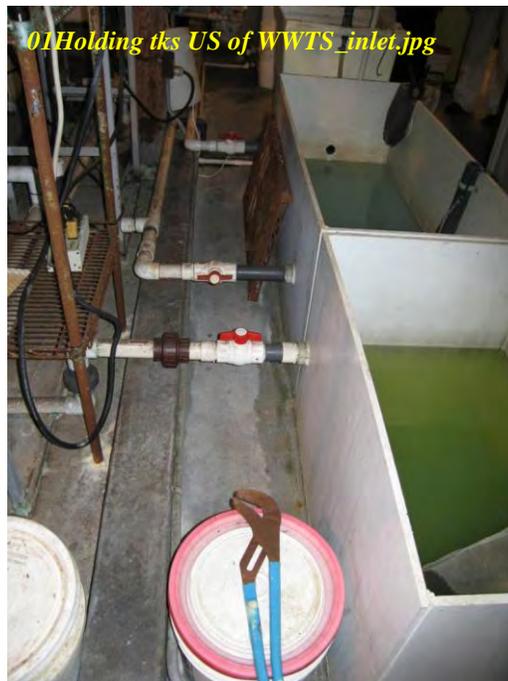
**Photo 4**

Wastewater from the process area gravity flows to a two-compartment holding tank: one compartment for cyanide-contaminated wastewater and the other compartment for wastewater without cyanide. The compartment containing cyanide-contaminated wastewater used to be pumped to the cyanide treatment system. However, now that Kion is not using its cyanide treatment system, it pumps out the compartment containing cyanide wastewater and has the contents hauled offsite for hazardous waste disposal. Kion pumps the contents of the other compartment to a treatment tank equipped with a mixer. The pH is adjusted automatically with the addition of sodium hydroxide. During the inspection, Kion's pH meter read 10.6. Ferrous sulfate is added for coagulation/flocculation. After some time for precipitation, the contents are sent to one of two filter presses. The filter cake is hauled away for offsite disposal, and the filtrate is sent to a 2000-gallon clarifier. Approximately 300 gallons of effluent from the clarifier are allowed to flow to a final holding tank for each batch discharge. Once released, the contents of the holding tank flow through a sample box and ultimately to the local sanitary sewer system. *See Photos 4-13 in Attachment 1.*

Holding tanks immediately prior to treatment  
*Taken by Anna Yen on August 17, 2011*

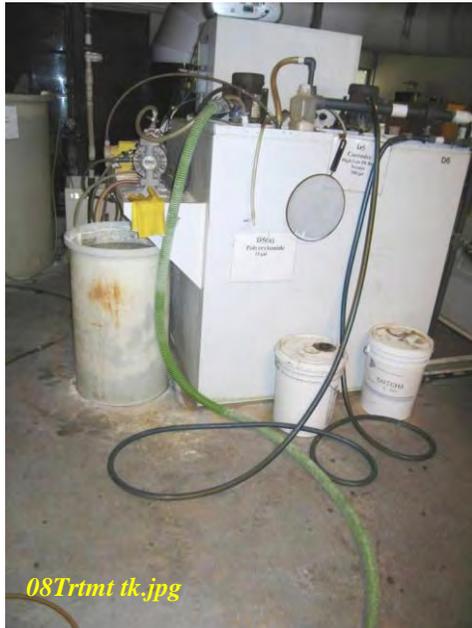
**Photo 5**

EPA noted that Kion was leaving open drums of chemicals out on the floor: drums of chemicals for addition to the wastewater treatment system as well as the 5-gallon containers used for batch treatment. *See Photos 5 and 16 in Attachment 1.* Though these drums and containers are all located in the bermed area of the wastewater treatment system, these open containers pose a safety hazard to employees working in this area.

Treatment tank

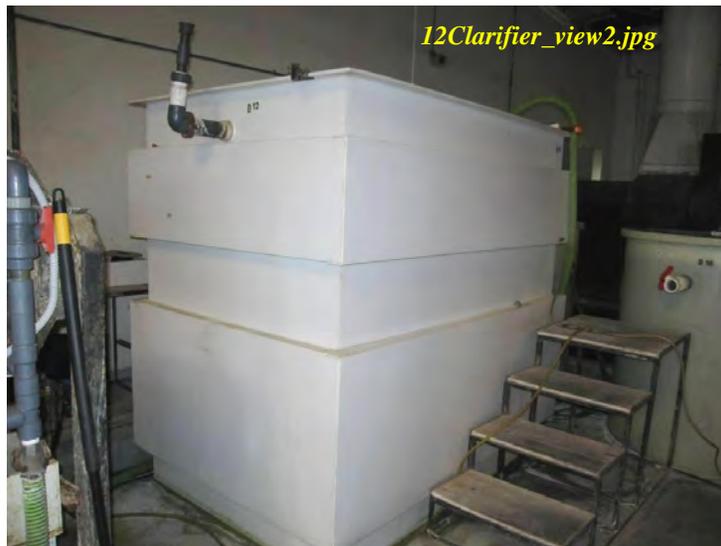
**Photo 6**

EPA also noted that most of the components of the wastewater treatment system were connected by hoses. We recommend a design in which components are hard-piped to each other, as excessive use of hoses potentially facilitates improper operation of the wastewater treatment system.

Clarifier

Inlet line –  
connected to a  
hose

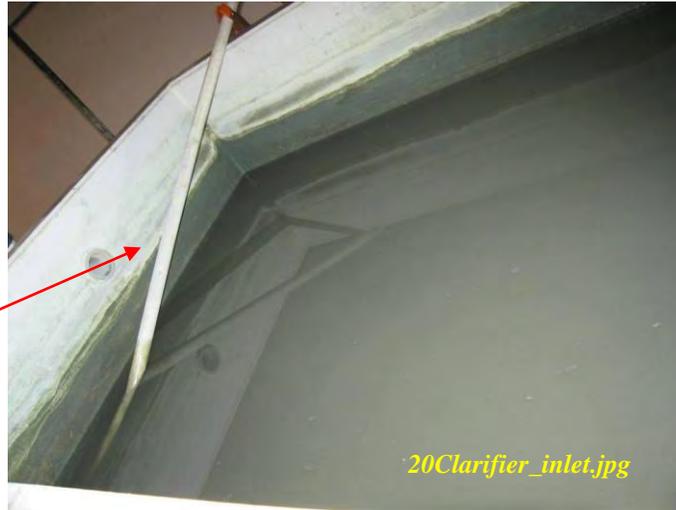
**Photo 7**

Inside of clarifier – view from top  
*Taken by Anna Yen on August 17, 2011*

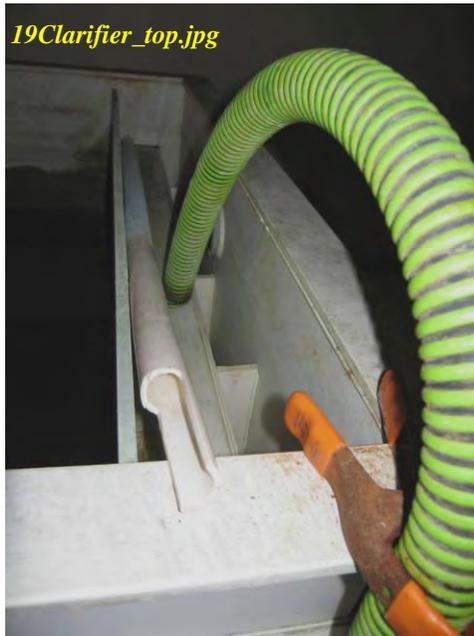
**Photo 8**

Discharge line

Top of clarifier  
*Taken by Anna Yen on August 17, 2011*

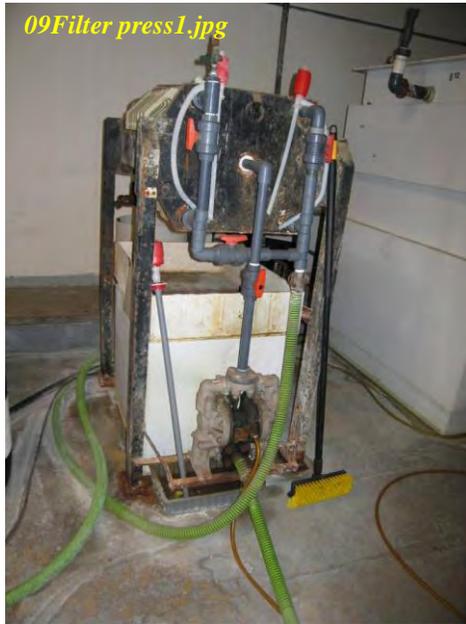
**Photo 9**

Filter press

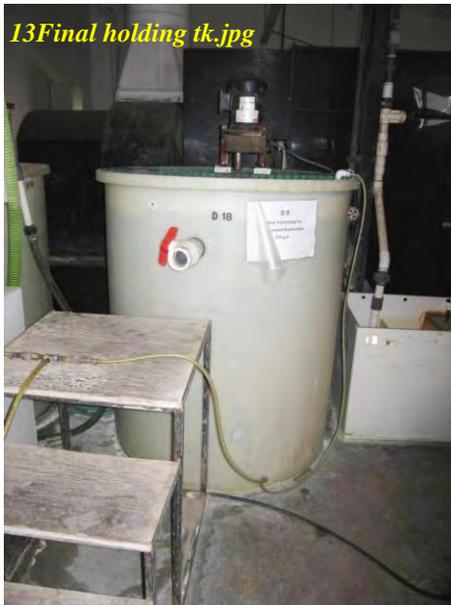
**Photo 10**

The final holding tank is also used as a batch tank when treating spent solution from the alodine process bath. In this case, sulfuric acid is added first to drop the pH to 2. After approximately one hour, sodium hydroxide is added to bring the pH up to 10. After 3-4 hours, Kion tests the wastewater with a test kit for copper, nickel, and cyanide. Kion also tests the pH. If the test results are unsatisfactory, the process is repeated. Kion then transfers the wastewater to the clarifier for overnight settling. Kion tests the wastewater again the next day. If the test results are satisfactory, Kion pumps the wastewater to the final holding tank and discharges the wastewater through the sample box and to the local sanitary sewer system.

Final holding tank/batch tank  
*Taken by Anna Yen on August 17, 2011*

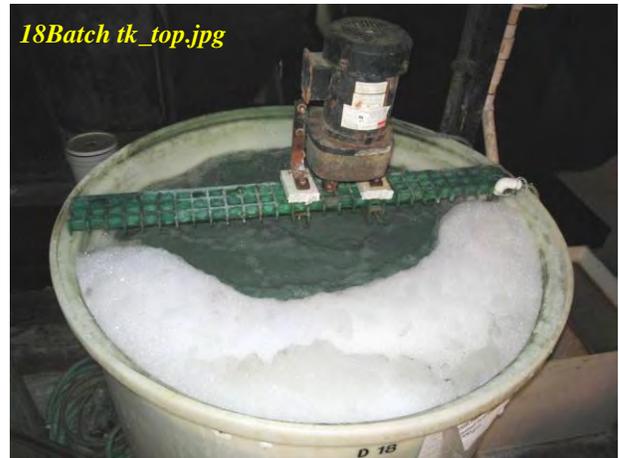
**Photo 11**

Top of final holding tank  
*Taken by Anna Yen on August 17, 2011*

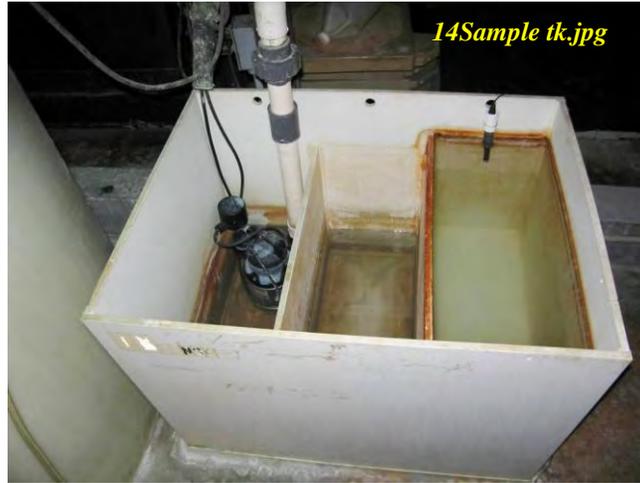
**Photo 12**

Sample box – view of inside  
*Taken by Anna Yen on August 17, 2011*

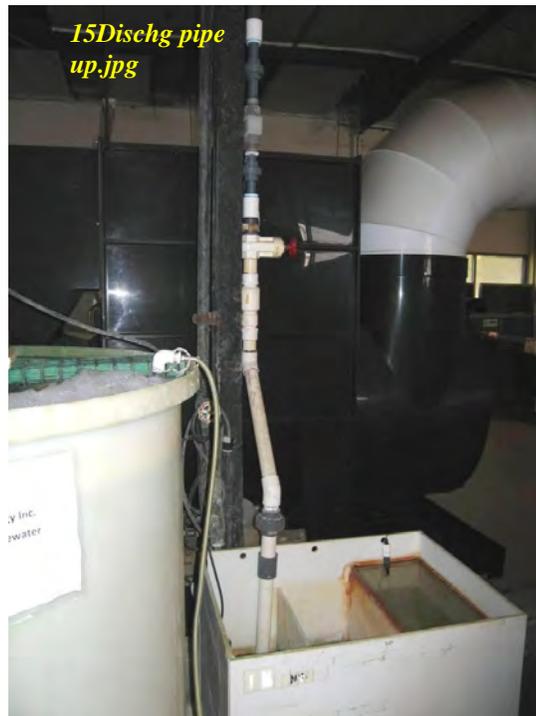
**Photo 13**

Discharge pipe – extending up from sample box  
*Taken by Anna Yen on August 17, 2011*

Treated effluent  
from wastewater  
treatment system

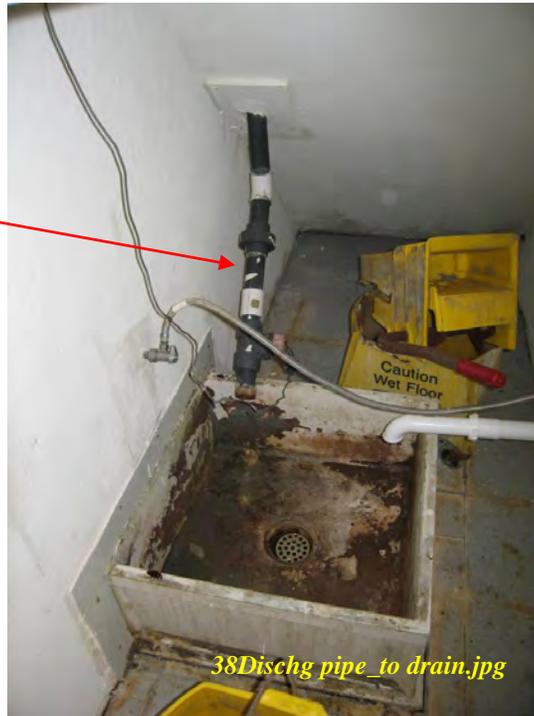
**Photo 14**

The effluent pipe from the sample box, however, first conveys the treated wastewater to a room outside the process area. The treated wastewater exits the pipe into a floor drain which leads to the local sewer system. A nearby sink which is also outside of the process area drains to this same floor drain. *See Photos 14-15 in Attachment 1.*

Drain line from  
sink on other  
side of wall (see  
Photo 15)

Discharge pipe from wastewater treatment system –  
to floor drain to sewer system  
*Taken by Anna Yen on August 17, 2011*

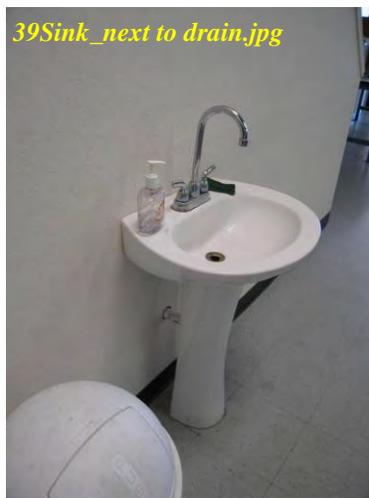
**Photo 15**

Sink – outside of metal finishing process area  
- on other side of wall from discharge pipe end point  
*Taken by Anna Yen on August 17, 2011*

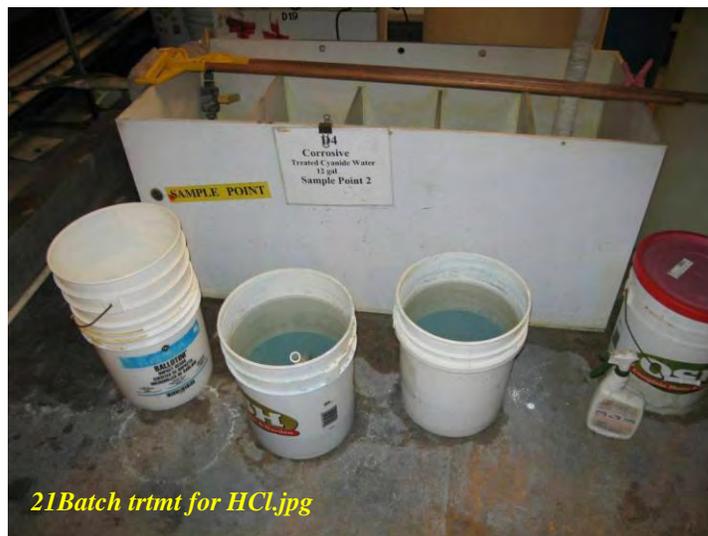
**Photo 16**

Two 5-gallon containers sitting on the floor are used for batch treatment of spent hydrochloric acid. *See Photo 16 in Attachment 1.* Lime, for pH adjustment, and metabisulfite are added to the containers of hydrochloric acid. After a few hours, the contents are pumped through one of two filter presses for solids removal. The filtrate is sent to a 2000-gallon clarifier, while the filter cake is hauled away for offsite disposal.

Batch treatment of hydrochloric acid –  
in 5-gallon containers  
*Taken by Anna Yen on August 17, 2011*
