Re: November 27, 2007 Clean Water Act Inspection

NPDES Compliance Evaluation Inspection Report

Industrial User: PolyPhaser Corporation
Industrial User Address: 2225 Park Place, Minden, NV 89423
Inspection Date: November 27, 2007

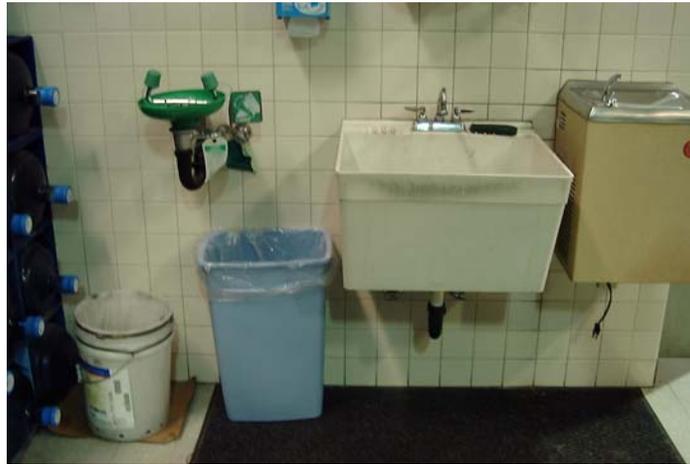
After machining, each part is rinsed off with water and mild soap. The water-soap solution is collected in a bucket. The buckets are manually transported over to a sink and emptied into the sink. A cloth placed over the bucket acts as a filter. Approximately thirty gallons per day are emptied into the sink. *See Photo 1 in the Appendix.*

Photo #1: Sink into which facility disposes used water-soap solution from cleaning of machined parts

Since the facility has low-flow discharges, EPA recommends that the facility consider the use of an evaporator. Implementing this relatively simple alternative would result in zero discharge, subjecting the facility to fewer monitoring requirements once Douglas County begins to issue discharge permits to industrial users.

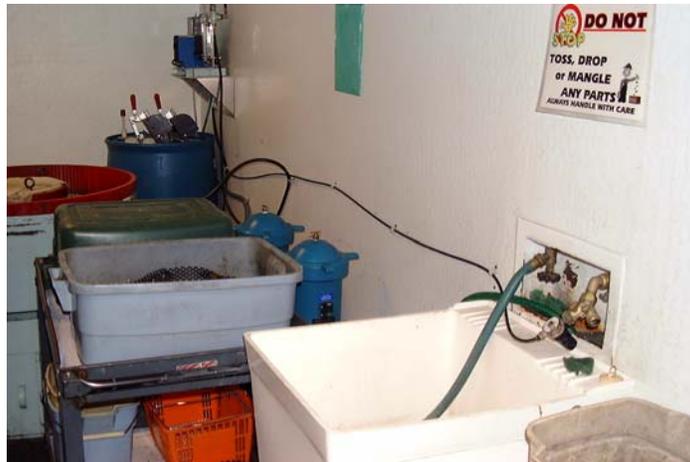
Polishing of metal parts is performed by a vibratory machine in a separate room. The machine is filled with steel media, and the parts are vibrated within this media combined with a water-mild soap solution. The water-soap solution drains out of the bin, is sent through cartridge filters, and flows to a floor drain which leads to the sewer system. A sink which drains to the sewer system is also located in this room. *See Photo 2 in the Appendix.*

Photo #2: Room containing the vibratory machine for polishing metal parts
