Re: April 1, 2008 Clean Water Act Inspection

NPDES COMPLIANCE EVALUATION INSPECTION

NPDES Permittee: American Samoa Power Authority
Facility: Satala Power Plant
P.O. Box PPB, Pago Pago, Tutuila Island, American Samoa
(NPDES Permit No. AS0020044)
Receiving Water: Pago Pago Harbor
Date of Inspection: April 1, 2008

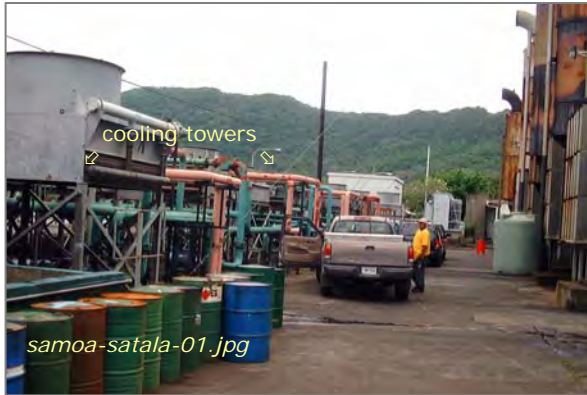
Cooling Towers – Twelve individual cooling towers are used to water-jacket cool the engines. The cooling towers are located outside on the paved access road in front of the engine building between the highway and the building. ASPA does not add corrosion inhibitors or biocides to the cooling tower contents. Each cooling tower is drained every four months to the underlying cement pad. See Photo #1 in Section 1.6 on page 6.

Cooling Tower Spents – Approximately three-hundred gallons of spents are drained from each of 12 cooling towers every four months to the underlying cement pad. ASPA indicates that because they do not use them, the cooling tower spents do not contain corrosion inhibitors (*molybdates, phosphates, zinc*) or biocides (*bromides, bleach, quaternary ammonium salts*). If this is so, the cooling tower spents would be expected to contain only trace levels of

zinc and iron from the corrosion of galvanized metal. The cooling water spents drain uncontrolled into the interceptor trench to the oil water separator irrespective of storm events.

Photo #1: Cooling Towers and Paved Access Areas
Taken By: Greg V. Arthur
Date: 04/01/08

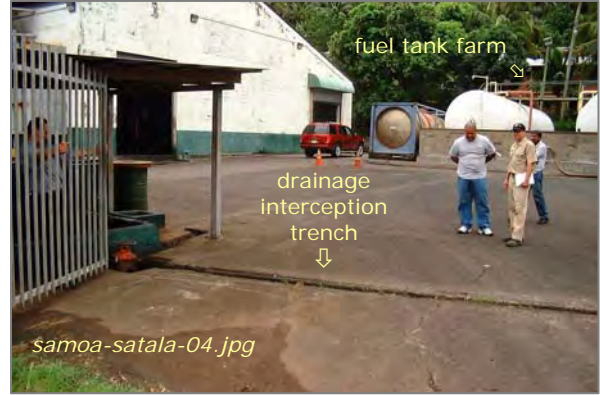
Fuel Tank Farm – Two 24,000 gallon diesel tanks are installed behind concrete block secondary containment walls. The fuel tanks are power washed every three weeks. Storm water run-off and wastewaters captured within the secondary containment drain to a small sump located in the center, inside, and against the front wall. This sump drains by buried line to a central sump drain located at the edge of the truck unloading area outside of the fuel farm. The central sump drain discharges by gravity through underground pipe to NPDES Sump #1. The buried drain line from the sump inside of the fuel tank farm containment is valved, and was found in the open position during this inspection. A lube oil tank is located outside of and adjacent to the fuel farm, without secondary containment but housed within a steel framework super-structure. See Photos #2 and #4 in Section 1.6 on pages 6 and 7.

Fuel Farm Tank Wash – ASPA indicates that the diesel tanks are power washed every three weeks with the tail waters drained through the valved drain to the main sump to the oil water separator irrespective of storm events. This tank wash water would be expected to entrain diesel, grime, and organic material.

Photo #2: Fuel Tank Farm – Paved Access Areas
Taken By: Greg V. Arthur
Date: 04/01/08

- The valved drain line from the fuel tank farm containment sump to the drain lines leading to the eastern oil water separator should be operated in the normally closed position.
- The valved drain line from the waste oil storage containment to the eastern oil water separator should be operated in the normally closed position.
- The unvalved drain line from the curbed transformer platform to the western oil water separator should be retrofitted with a valve then operated in the normally closed position.
- Copper and zinc sources into the drainages should be identified and for each source, and additional best management practices and/or pollution prevention should be proposed.
- Contaminated groundwater seepages should be pretreated through a dedicated package oil water separator for discharge through the eastern oil water separator.

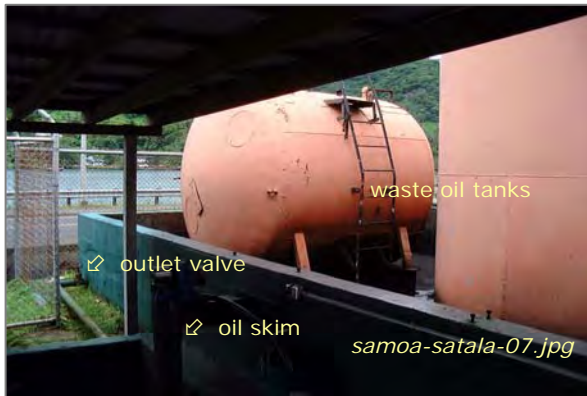
Waste Oil Tanks – Two waste oil tanks, with capacities of 7,300 and 5,000 gallons, are installed behind concrete block secondary containment walls adjacent to NPDES Sump #1. Oil spills, skimmed oil, oily wastewaters, and slop are conveyed manually to these waste oil tanks for off-site hauling to the Tafuna Power Plant for reprocessing. The waste oil storage containment is outfitted with a valved drain line to NPDES Sump #1. The drain line valve was found in the open position during this inspection. See Photos #3 and #4 in Section 1.6 on page 7.

Waste Oil Storage Decant – The water fractions from oily wastewaters, spills, and slop, collected into the two waste oil storage tanks, periodically are pumped to the oil water separator irrespective of storm events. The waste oil tank decant would be expected to contain low concentrations of free and emulsified oils, diesel, and grime.

Photo #3: NPDES Sump #1 – Waste Oil Tanks
Taken By: Greg V. Arthur
Date: 04/01/08

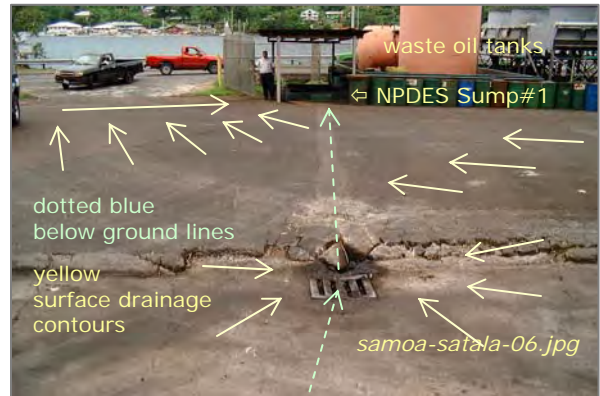
Photo #4: Fuel Farm Sump Drain Lay-out
Taken By: Greg V. Arthur
Date: 04/01/08

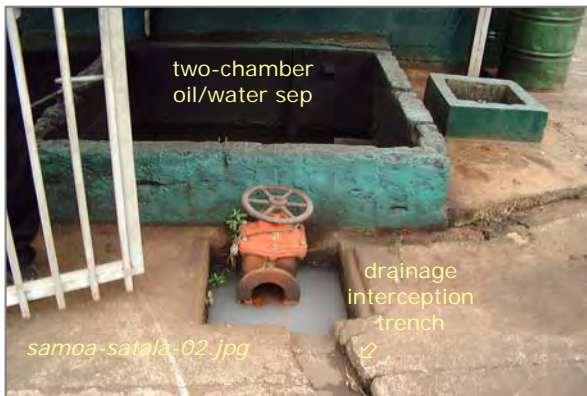
Truck Wash – Cloudy wastewater that was said by ASPA to be from truck washing was observed in the interceptor trench. The pollutants in the truck wash are unknown at this time although it is likely to include alkaline soap and the resulting emulsified oils. Truck wash drains uncontrolled into the interceptor trench to the oil water separator irrespective of storm events.

Photo #5: NPDES Sump #1 – Soapy Drainage
Taken By: Greg V. Arthur
Date: 04/01/08

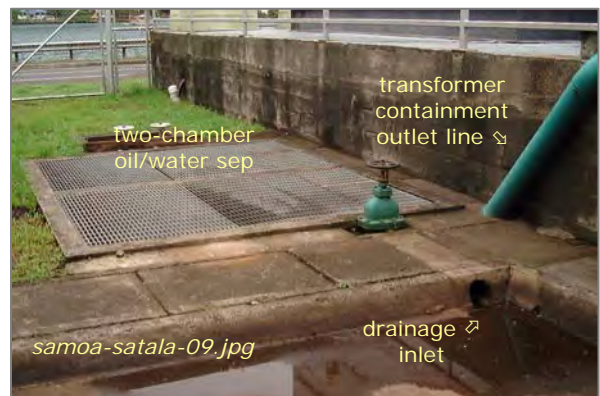
Transformer Platform – Transformers are installed over a vault box, adjacent to NPDES Sump #2. The platform is curbed to provide secondary containment around the transformers. However the containment is outfitted with an unvalved (and thus always open) drainage line into NPDES Sump #2. See Photo #6 in Section 1.6 on page 7.

NPDES Sump #2 – Storm water drainage from non-contact areas of the property and the transformer platform are discharged to the harbor through the western oil water separator. It is equivalent in design to the eastern oil water separator except it does not have a small contact oil film skimmer to remove trace sheen.

Photo #6: NPDES Sump #2 – Transformer Inlet
Taken By: Greg V. Arthur
Date: 04/01/08
