NPDES COMPLIANCE EVALUATION INSPECTION

NPDES Permittee: Pacific Energy, South-West Pacific, Limited
(NPDES Permit No. AS0020028)

Facility: American Samoa Terminal
(Utulei Petroleum Terminal, Fuel Dock, and Tank Farm)
P.O. Box 488, Pago Pago, Tutuila Island, American Samoa

Date of Inspection: September 27, 2010

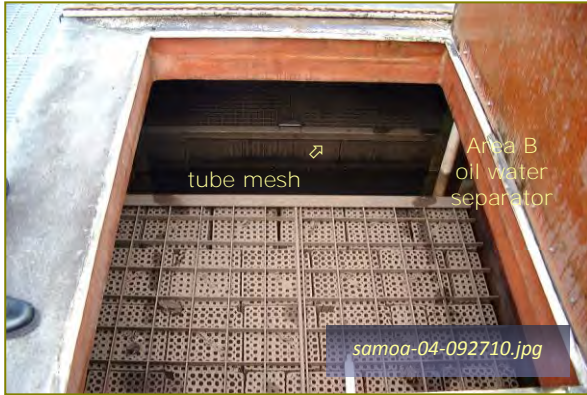
Photo #1-1: Mesh Tube Coalescing Oil Water Sep
Taken By: Greg V. Arthur
Date: 09/27/10

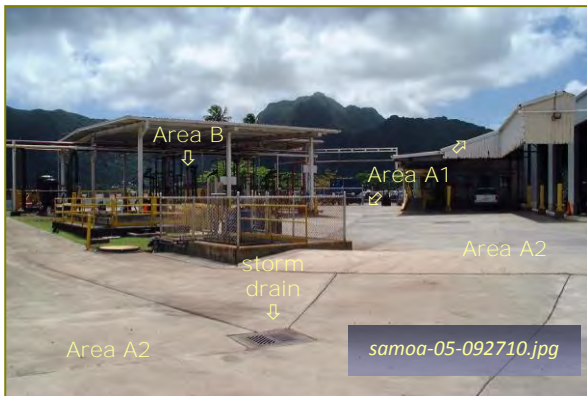
Area A1 Drainage (Non-Contact) – Storm water run-off from the parking lot and other non-operational paved areas on the east side of the property, including the building roof drainage, discharges through a storm water culvert to the harbor, designated in the previous NPDES permit and here as NPDES-001. Area A1 non-contact drainages are not regulated under the current permit. Raised pavement serves as the “continental divide” between the unregulated non-contact Area A1 and the permit regulated bottom fill loading rack in Area B. See Photos #1-2 and #1-3 in Section 1.5 of this report on page 9.

Area A2 Drainage (Non-Contact) – Storm water run-off from the paved access roadways between the Area B bottom fill loading rack and the Area C and D tank farms, discharges through the facility storm water culvert leading to the harbor, which is designated in the permit as NPDES-002. Drainage from this area is considered non-contact and discharges without treatment. See Photos #1-3, #1-4, and #1-5 in Section 1.5 of this report on page 9.

Photo #1-3: Areas A1/A2 - Non-Contact Drainage
Taken By: Greg V. Arthur
Date: 09/27/10

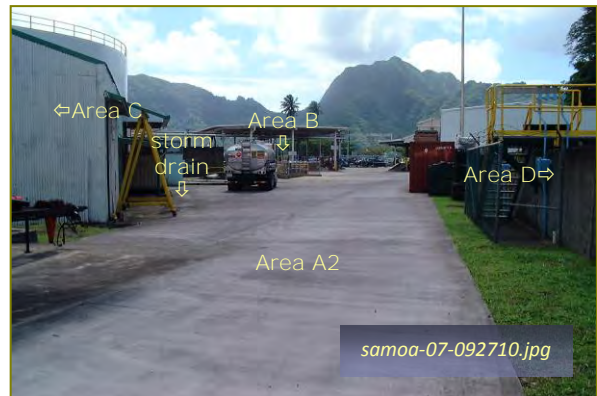
Photo #1-4: Area A2 - Non-Contact Drainage
Taken By: Greg V. Arthur
Date: 09/27/10

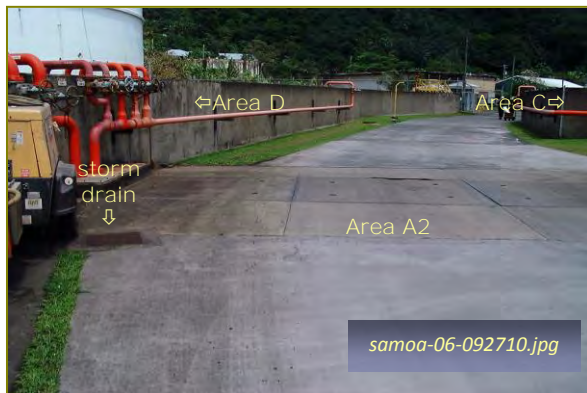
Photo #1-5: Area A2 - Non-Contact Drainage
Taken By: Greg V. Arthur
Date: 09/27/10

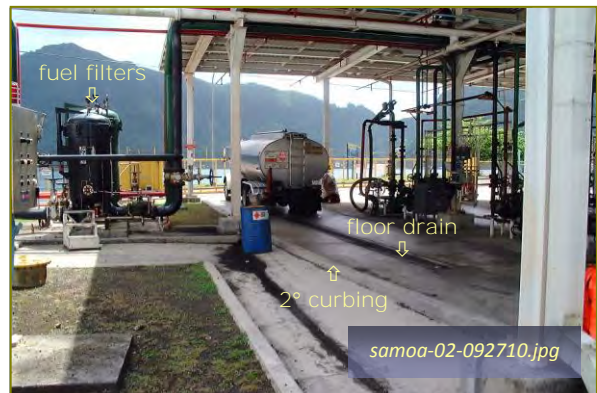
Area B Drainage – Spills, wash down, and drainage from the bottom fill loading rack collect into a blind sump tank through floor drains. The sump contents are pumped into a pre-filler surge tank. Storm water run-off from the surrounding paved areas also drain into the surge tank, which is operated to release through an oil water separator. There is normally closed valving into and out of the oil water separator and out through a bypass line. The Area B oil water separator discharges to the facility storm water culvert leading to the harbor, which is designated in the permit as NPDES-002. The Area B oil water separator effluent is designated in the permit as NPDES-002B and the bypass line is designated as NPDES-002BX. See Photos #1-6 on page 9 and #1-7 on page 10 in Section 1.5 of this report.

Photo #1-6: Area B - Bottom Fill Loading Rack
Taken By: Greg V. Arthur
Date: 09/27/10

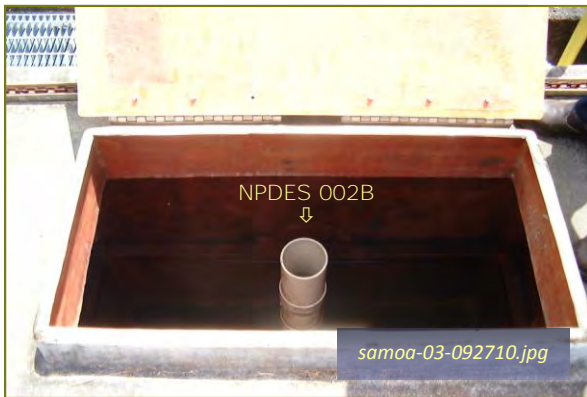
Photo #1-7: Area B - NPDES 002B Sample Point
Taken By: Greg V. Arthur
Date: 09/27/10

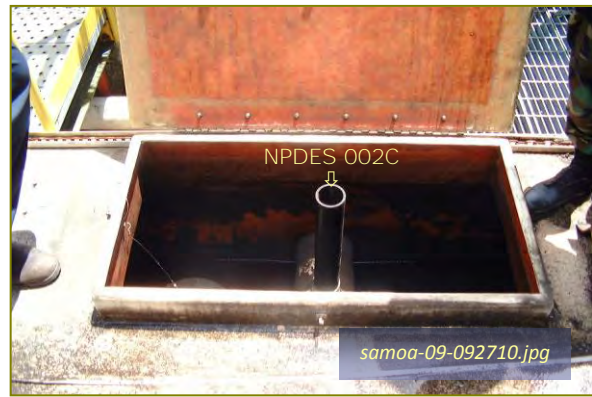
Area C Drainage – Spills, tank bottoms, storm water run-off, and drainage from Area C collect within secondary containment. The flows drain through a tube coalescing oil water separator, with normally closed valving in and out, to the facility storm water culvert leading to the harbor, which is designated in the permit as NPDES-002. The Area C oil water separator effluent is designated in this report as NPDES-002C. See Photo #1-8 in Section 1.5 of this report on page 10.

Photo #1-8: Area C - NPDES 002C Sample Point
Taken By: Greg V. Arthur
Date: 09/27/10

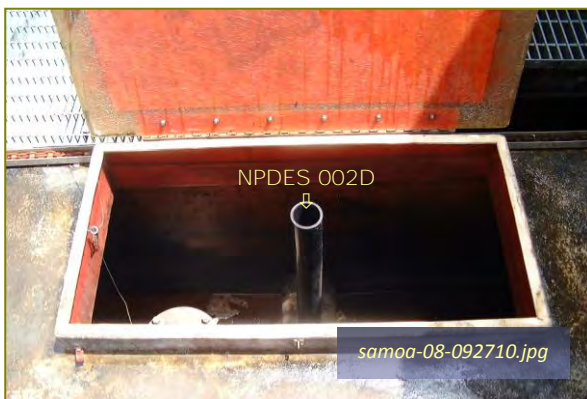
Area D Drainage – Spills, tank bottoms, storm water run-off, and drainage from Area D collect within secondary containment. The wastewaters from Area D drain through a tube coalescing oil water separator, with normally closed valving in and out, to the facility storm water culvert leading to the harbor, which is designated in the permit as NPDES-002. The Area D oil water separator effluent is designated in the permit as NPDES-002D. See Photo #1-9 in Section 1.5 of this report on page 10.

Photo #1-9: Area D - NPDES 002D Sample Point
Taken By: Greg V. Arthur
Date: 09/27/10

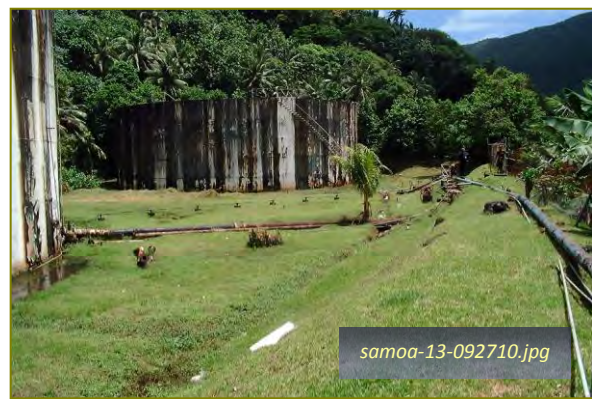
Area E Drainage (Non-Contact) – Storm water run-off from the decommissioned Area E tank farm discharges to a stream leading to the harbor. The discharge point was designated as NPDES-005 in an old permit but no longer is referenced in the NPDES permit since non-contact drainages are unregulated. See Photo #1-10 in Section 1.5 of this report on page 10.

Photo #1-10: Area E - Decommissioned Tanks
Taken By: Greg V. Arthur
Date: 09/27/10

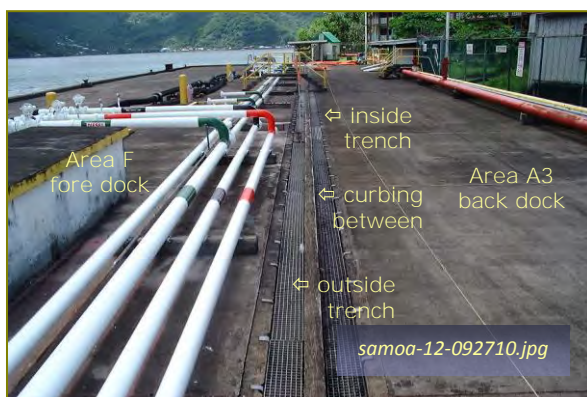
Area A3 Drainage (Non-Contact) – The fueling dock consists of a fore dock and a back dock, separated by a curbing with interceptor drains on either side. The Area A3 back dock does not discharge through the NPDES 003 outfall. Instead, the back dock encompasses the paved access to the fueling dock, with the storm water run-off from the back dock draining into the inside interceptor trench for direct discharge to the harbor. Area A3 drains unregulated by the NPDES permit and without treatment because it is considered non-contact. See Photo #1-11 in Section 1.5 of this report on page 10.

Photo #1-11: Area F/A3 - Fueling Dock
Taken By: Greg V. Arthur
Date: 09/27/10
