**HUDSON RIVER PCBs SUPERFUND SITE  
ARCHAEOLOGICAL DATA RECOVERY OF  
UNDERWATER RESOURCE U-2**

*Prepared for:*  
General Electric Company  
Albany, New York

URS Corporation  
200 Orchard Ridge Drive, Suite 101  
Gaithersburg, Maryland 20878  
301-258-9780

SEPTEMBER 2011

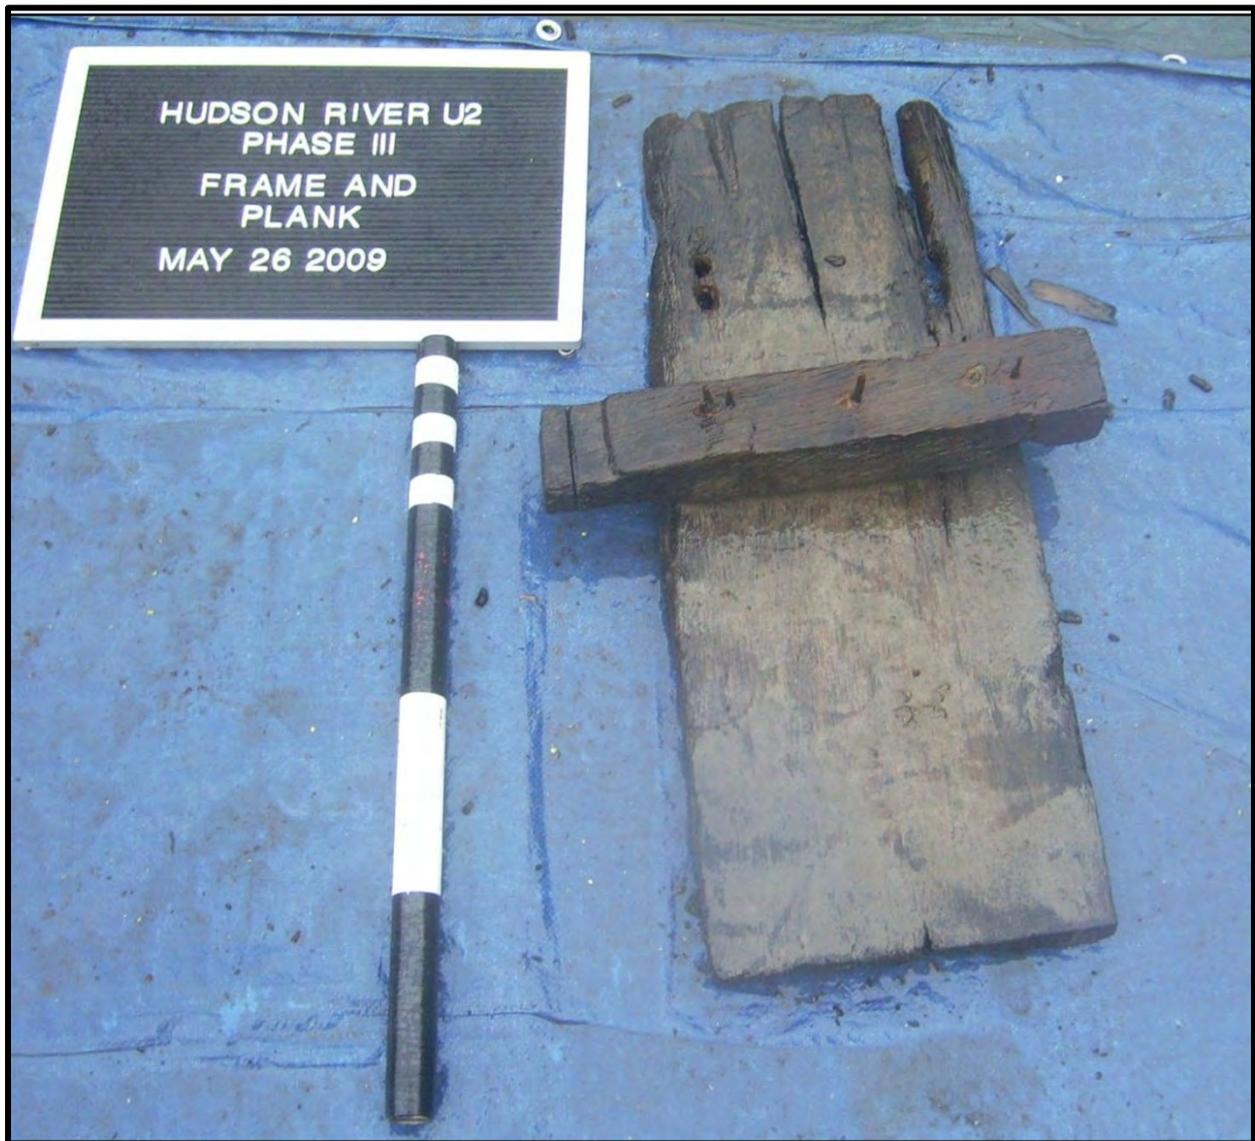
Figure 6-11. Planking Sample with Attached Floor.

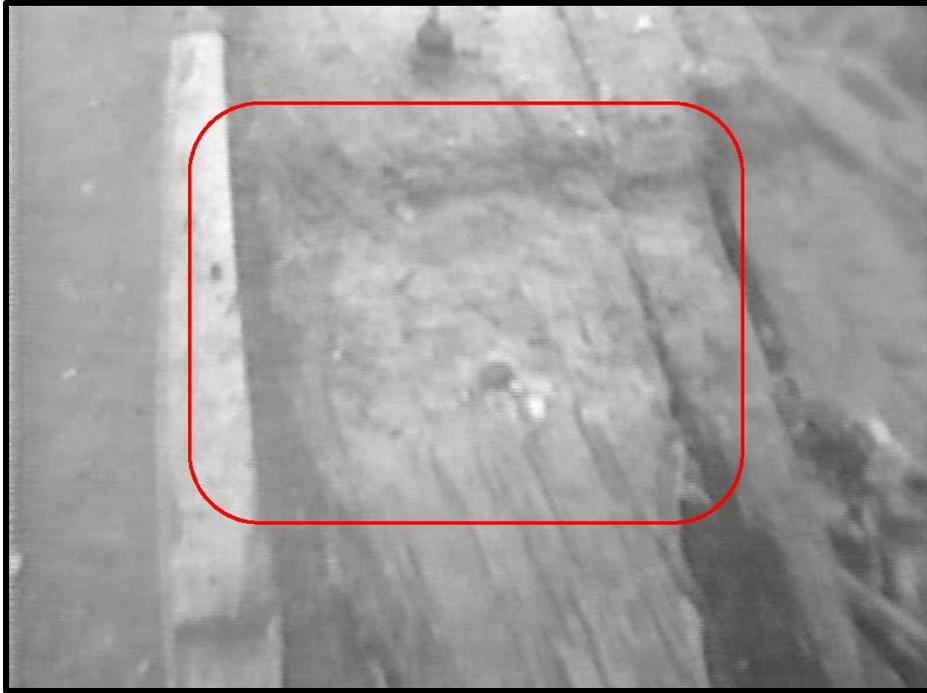
Figure 6-17. Video Image of a Limber Hole in Plan View, Frame 11, Facing East.

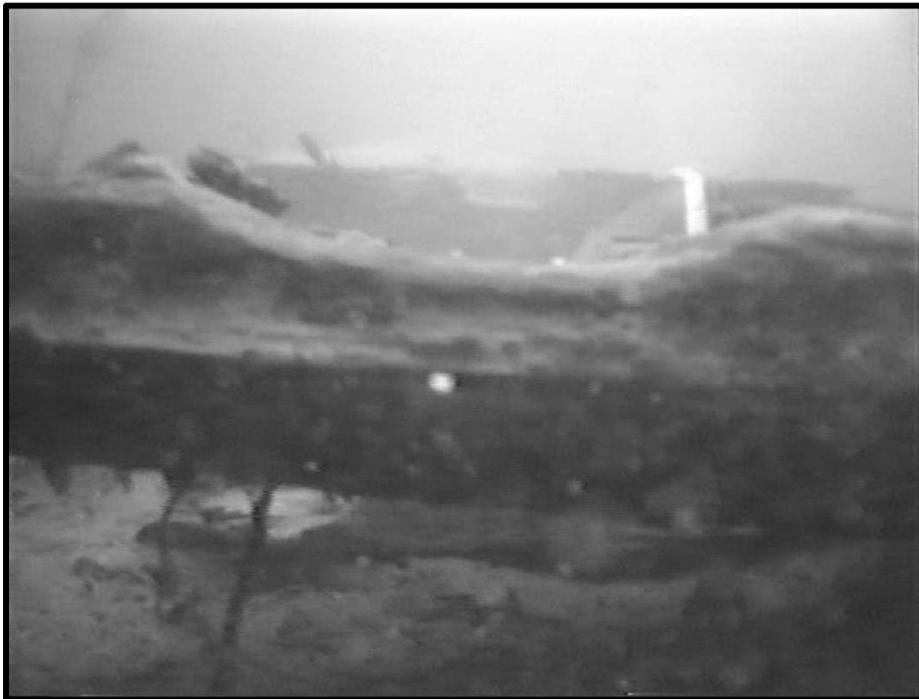
Figure 6-18. Video Image of Limber Holes in Profile, Frames 11 and 12, Facing North.
