# Assessment of Dam Safety

## Coal Combustion Surface Impoundments (Task 3)

Pleasants Power Station

McElroys Run Dam

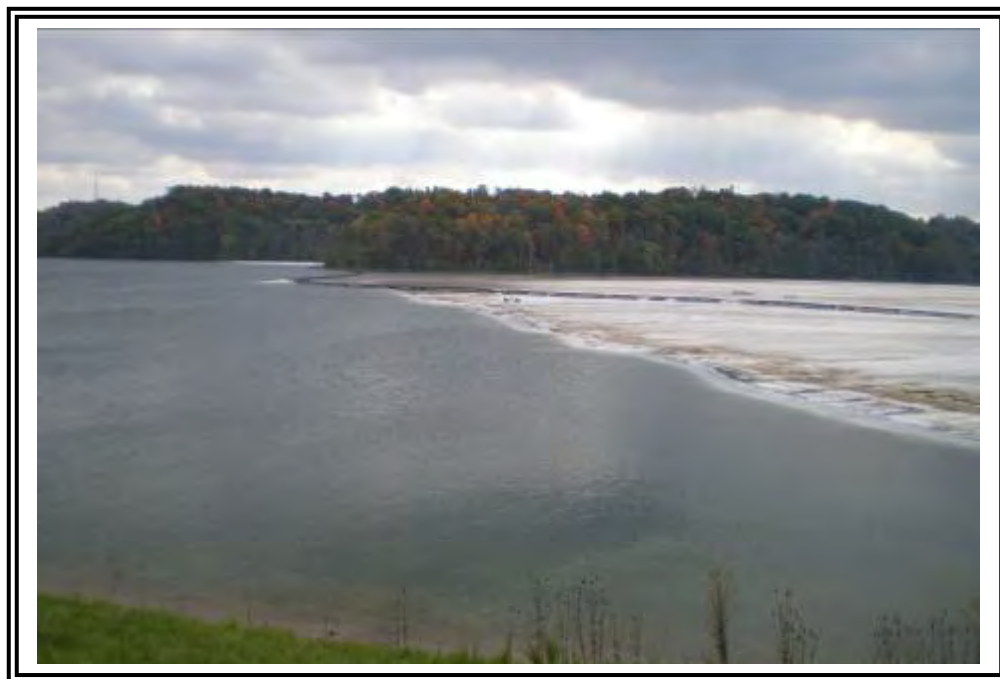
6

Sluice lines and ash within the McElroy Run impoundment (looking south).

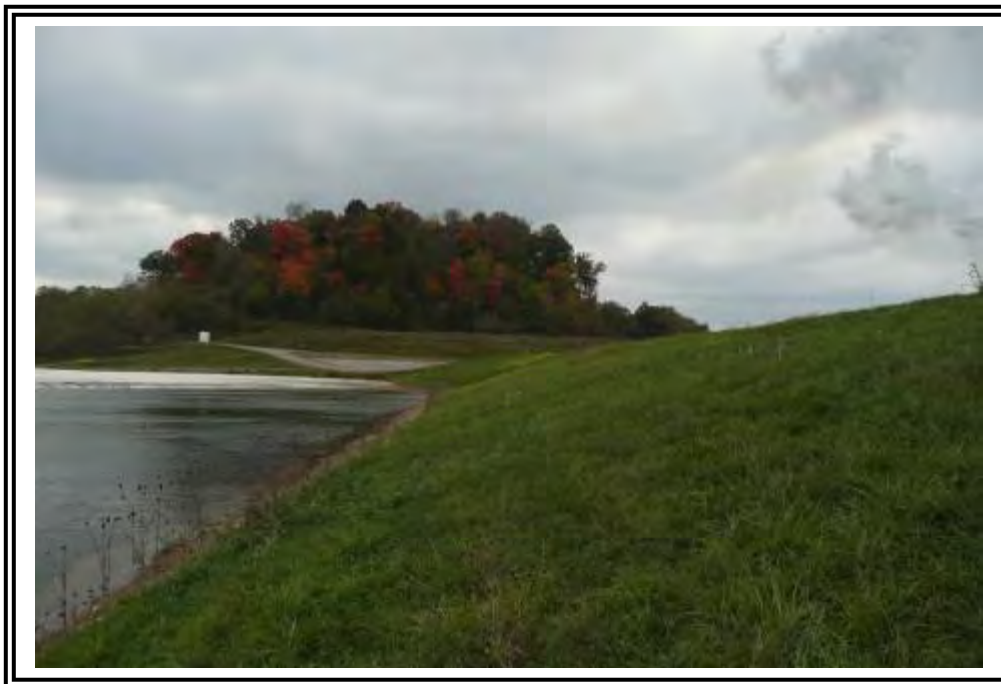
7

Looking west along upstream slope with emergency spillway invert in background at left (west) abutment contact.

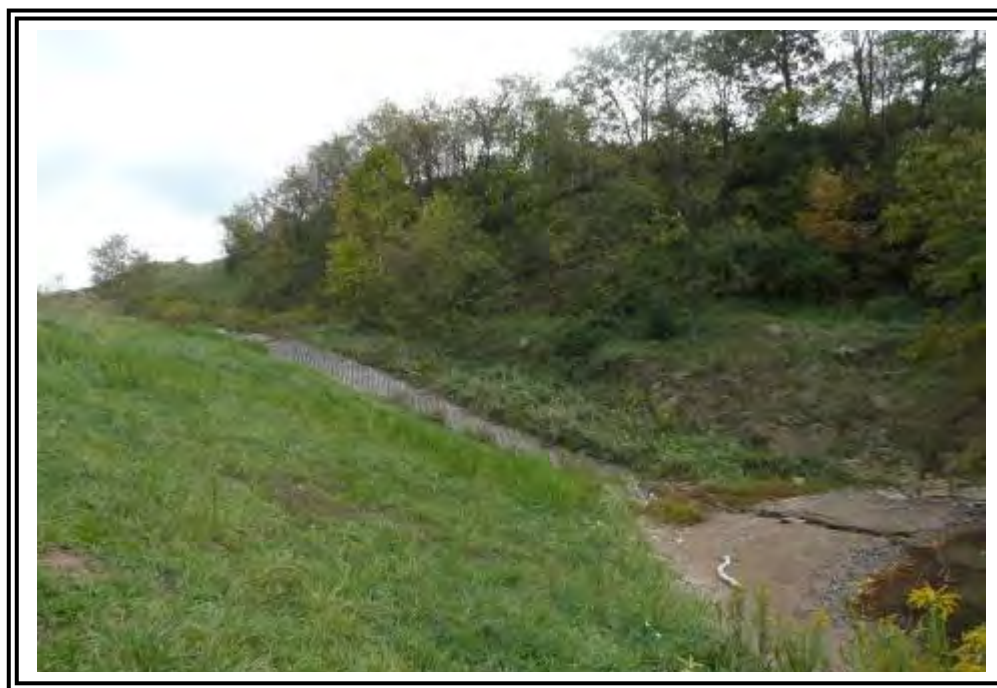
14

Upstream slope at right (east) abutment contact, looking east. Break in tree line above slope is location of upstream core trench at the right abutment contact. Note Fabriform lined groin at abutment contact.

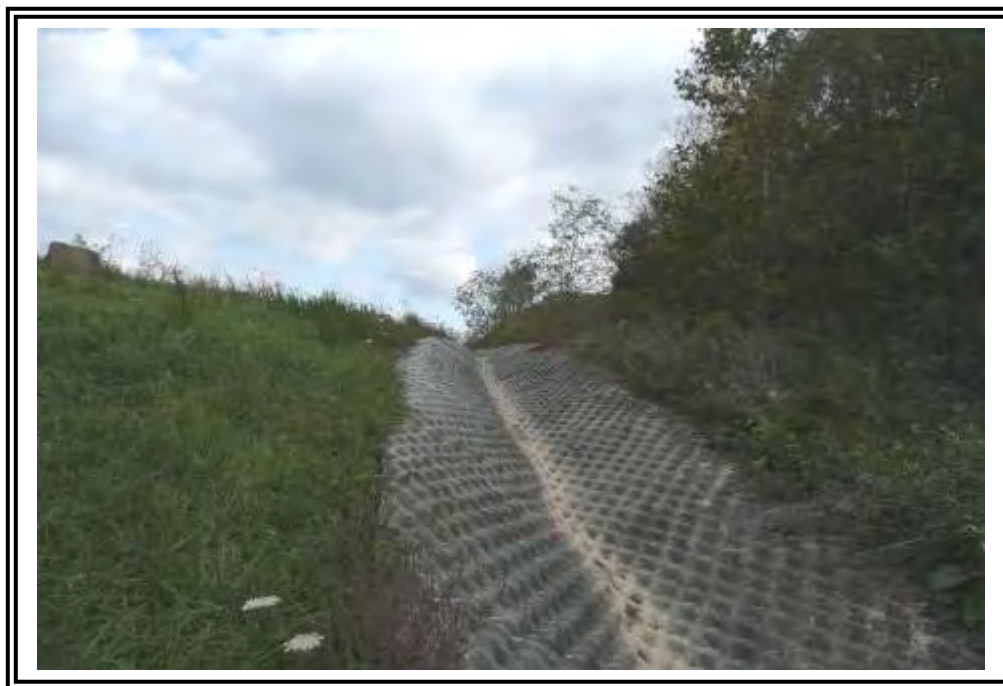
15

Close up view of the upstream slope right abutment groin looking toward crest.

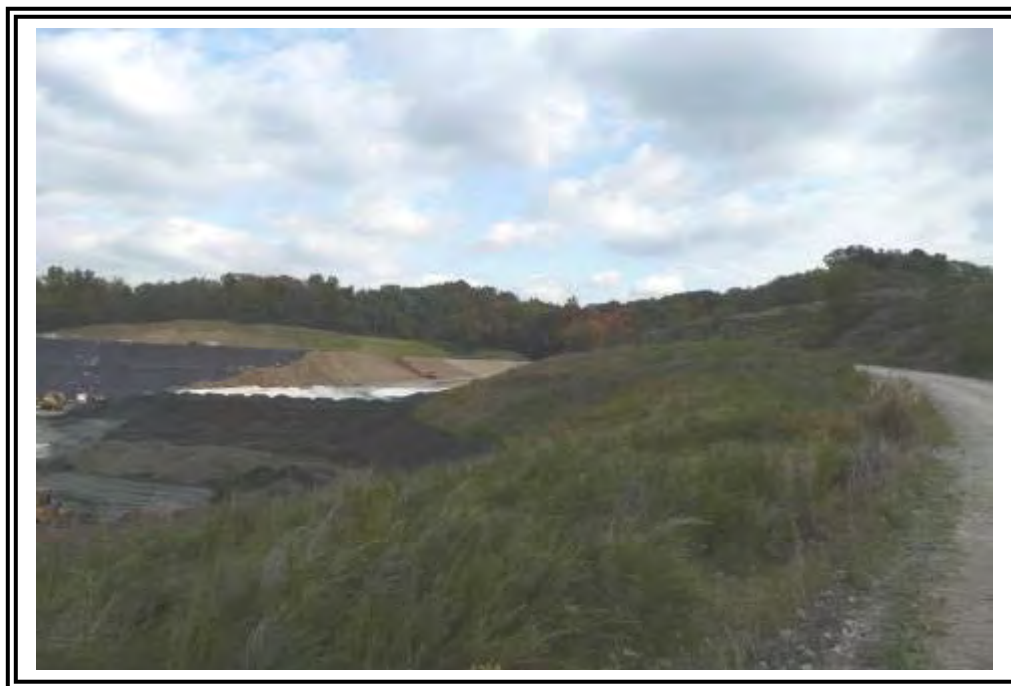
19

Downstream slope face, looking east, showing part of crest and access drive.

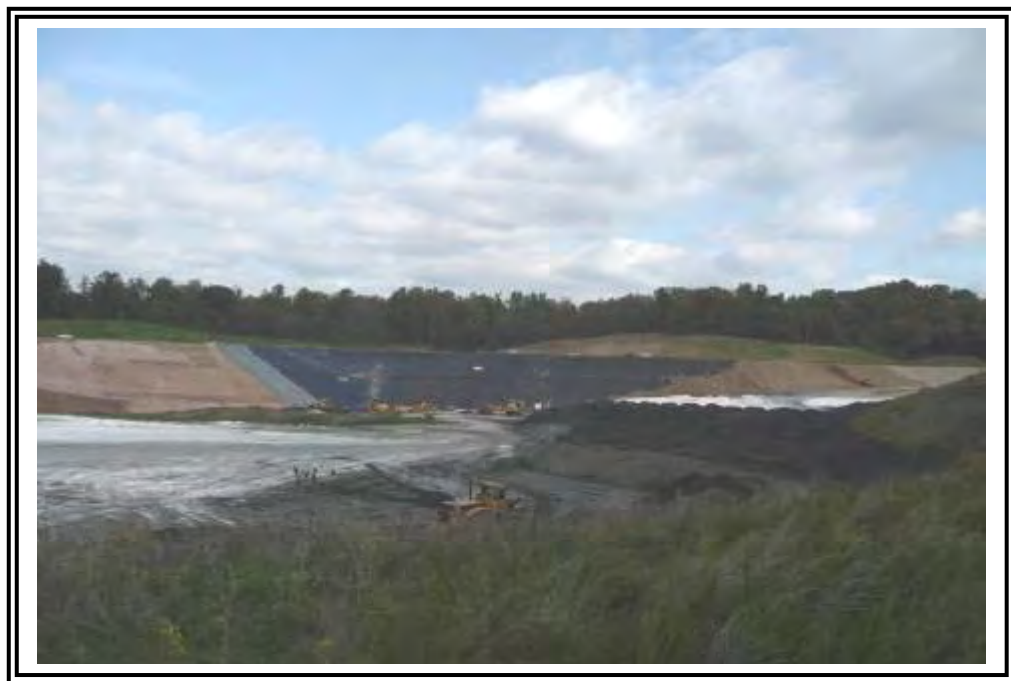
20

Looking northeast from crest at active buttress landfill operations on downstream face and landfill expansion area in the background.

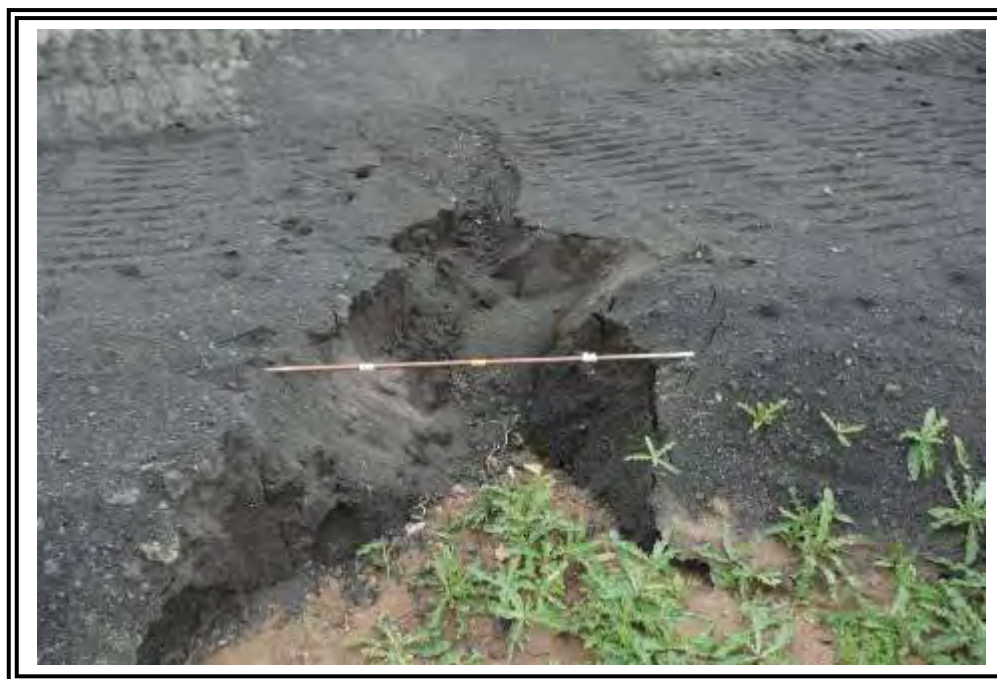
26

Landfill benches below the bench currently under construction are grass covered with occasional isolated woody vegetation. Occasional loss of grass cover and rutting from mowing equipment, and occasional active and repaired rodent burrows were observed. There were some deep (6 to 10 inches) erosion rills in the area where recent re-grading for the recently constructed access road has occurred on the east side and in the recently placed bottom ash blanket drain as shown in Photos 37 and 26, respectively.

Erosion gully at top of the bottom ash drainage blanket being placed on the active buttress landfill bench.

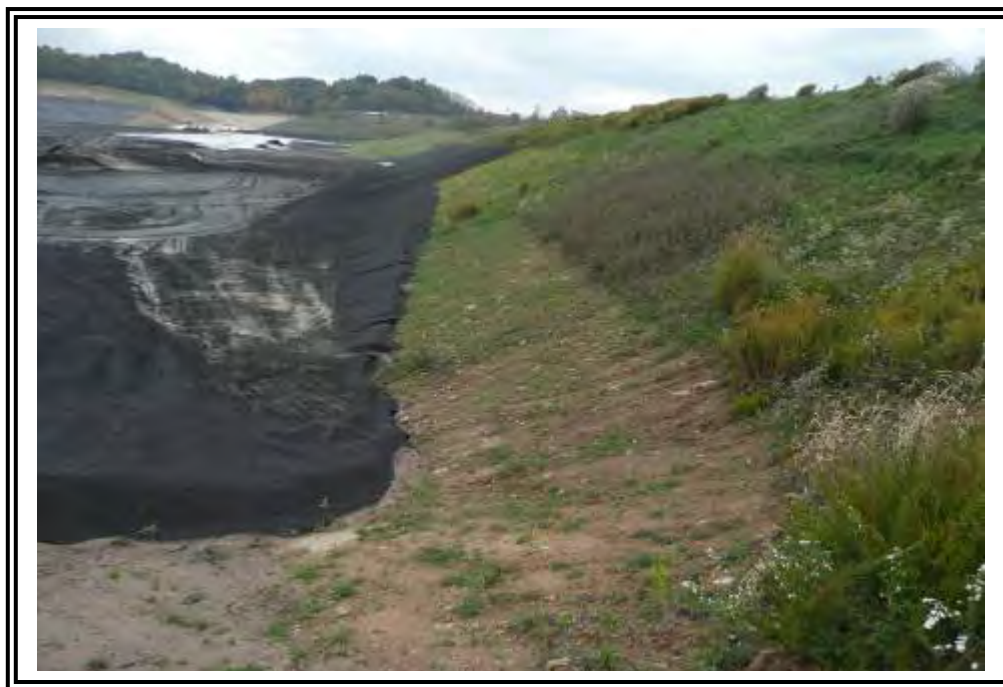
27

Looking east along the downstream slope face showing slope vegetation and present stage of the bottom ash drainage blanket placement.

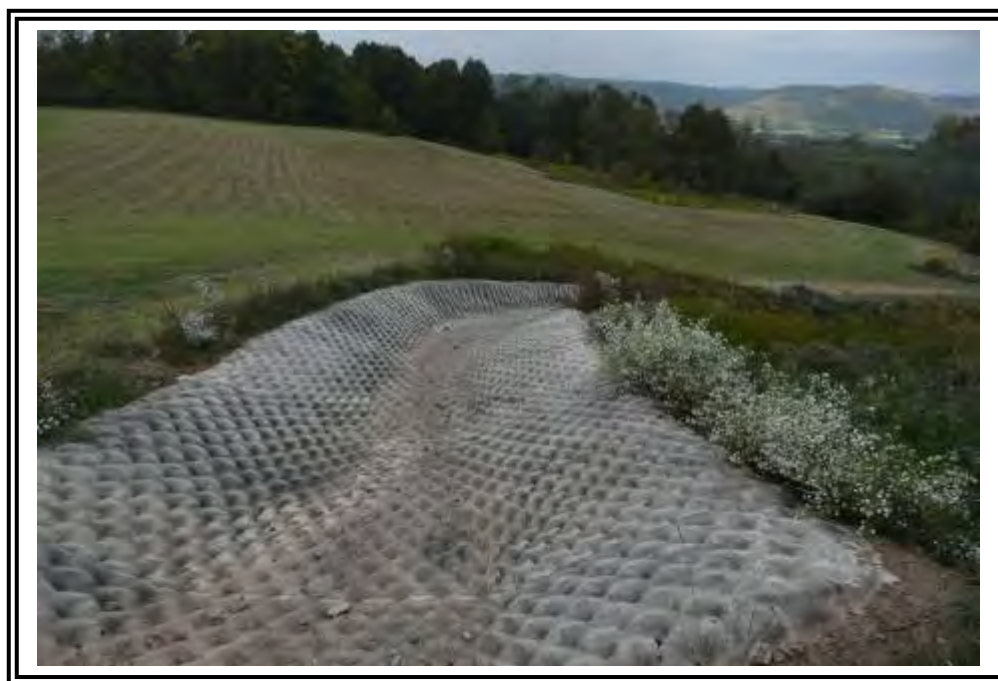
28

Looking downstream (north) at Fabriform concrete lined groin near west (left) abutment.

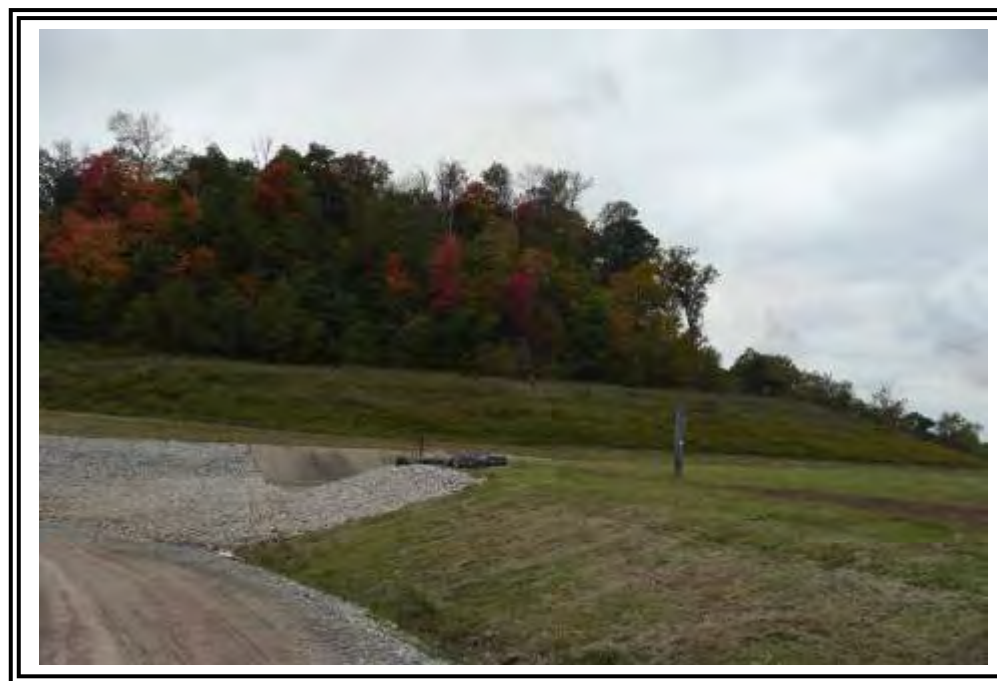
30

Looking west along upstream slope at emergency spillway entrance.

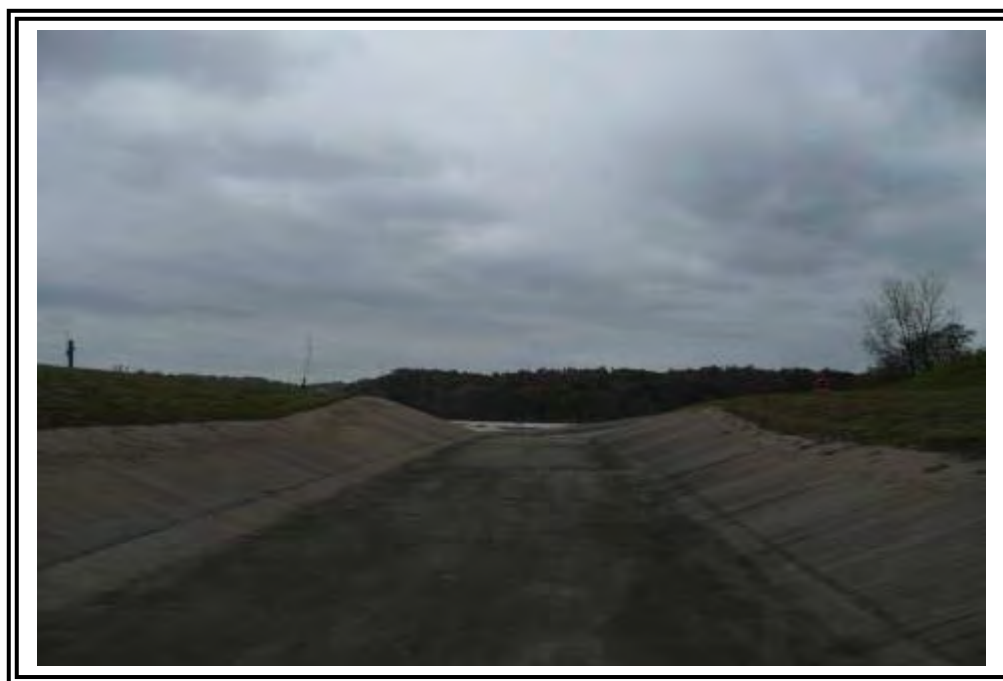
32

Emergency spillway, looking upstream at the control section.

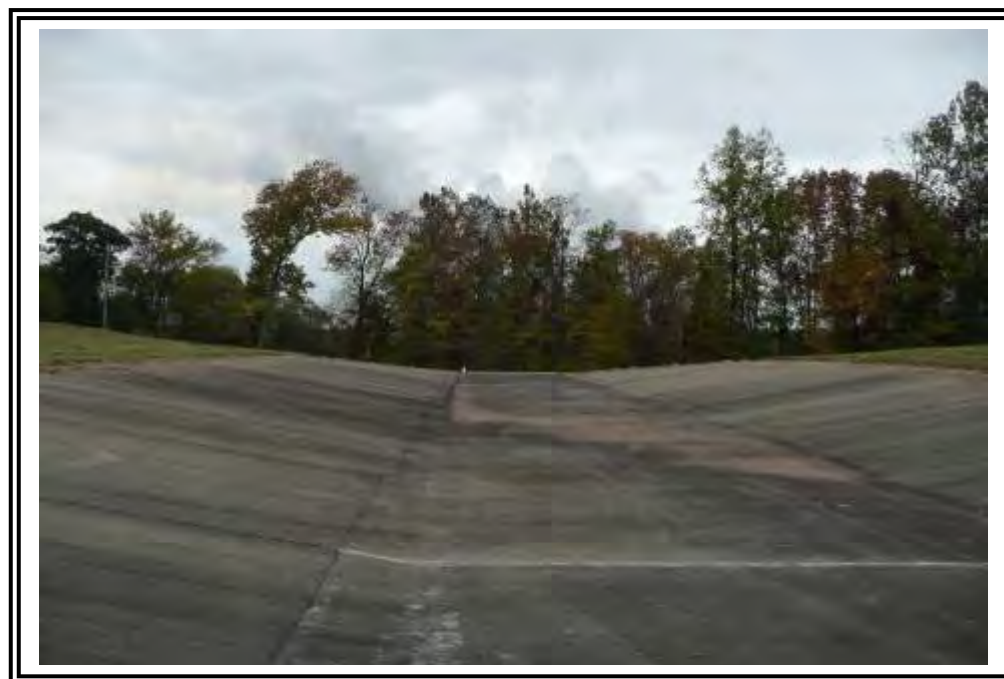
34

Looking downstream at emergency spillway outlet.

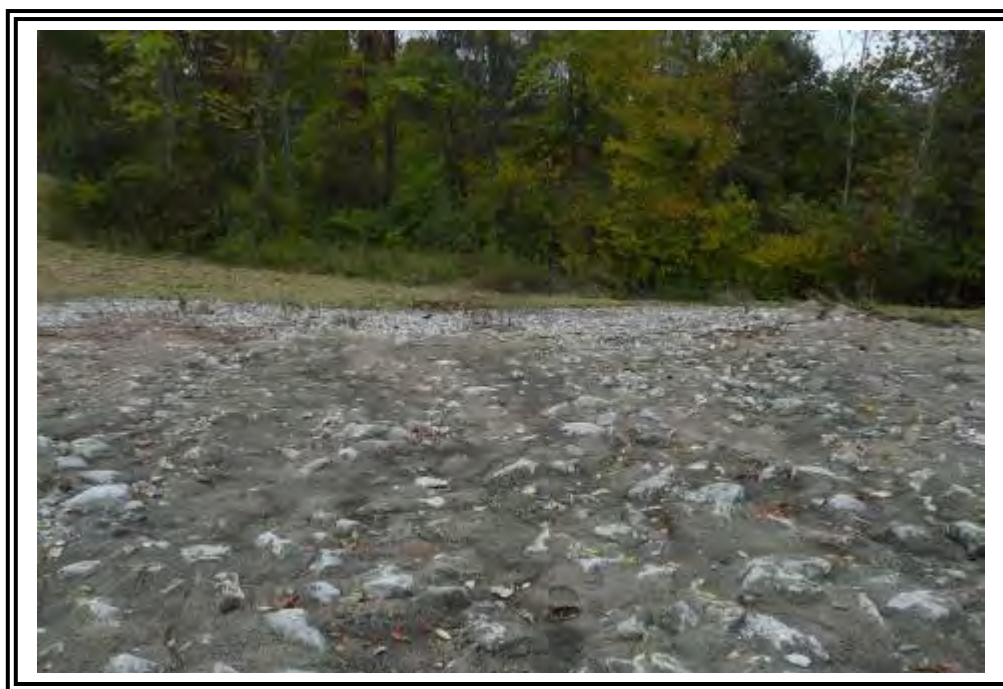
35

Grouted rip rap outlet protection at emergency spillway.

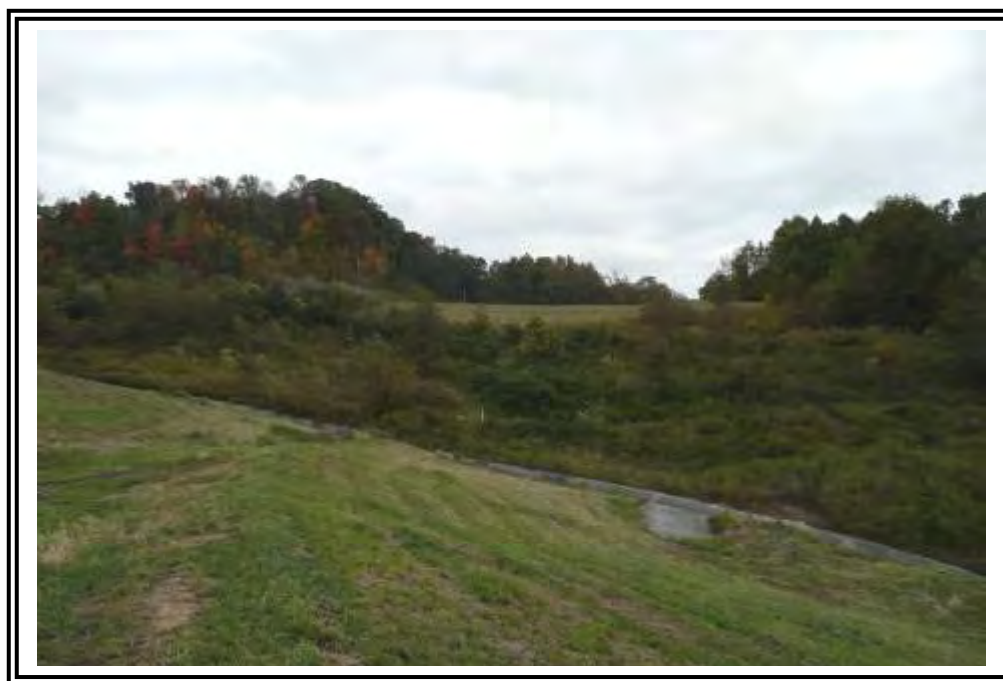
40

Looking west at the hillside above the left abutment contact with the buttress landfill slope.

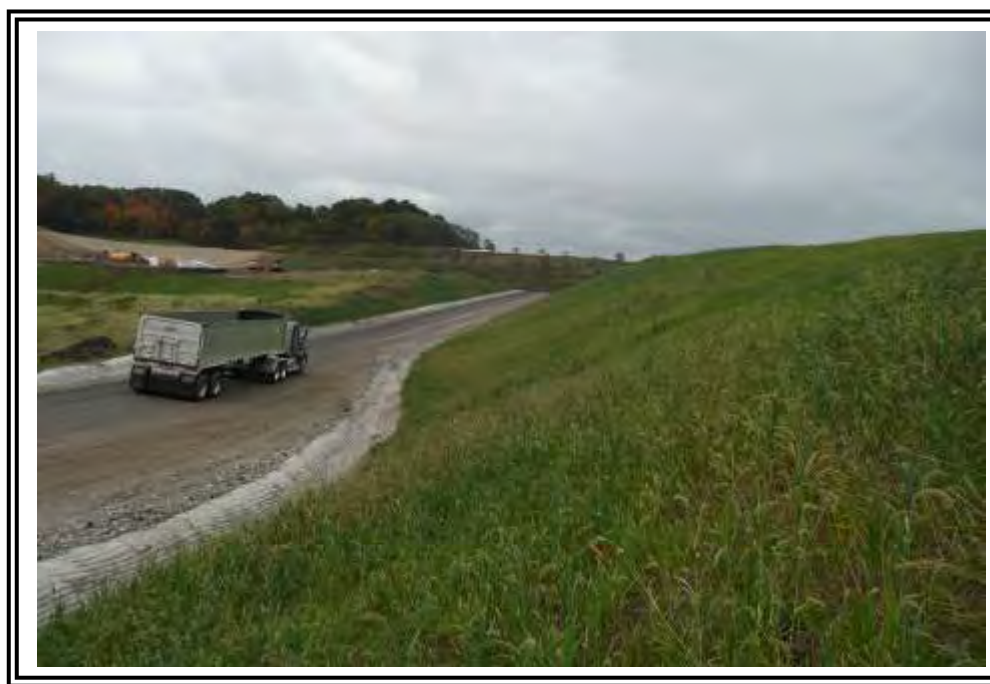
46

Looking southeast along the landfill buttress slope adjacent to active haul road. Slope is steeper adjacent to road.

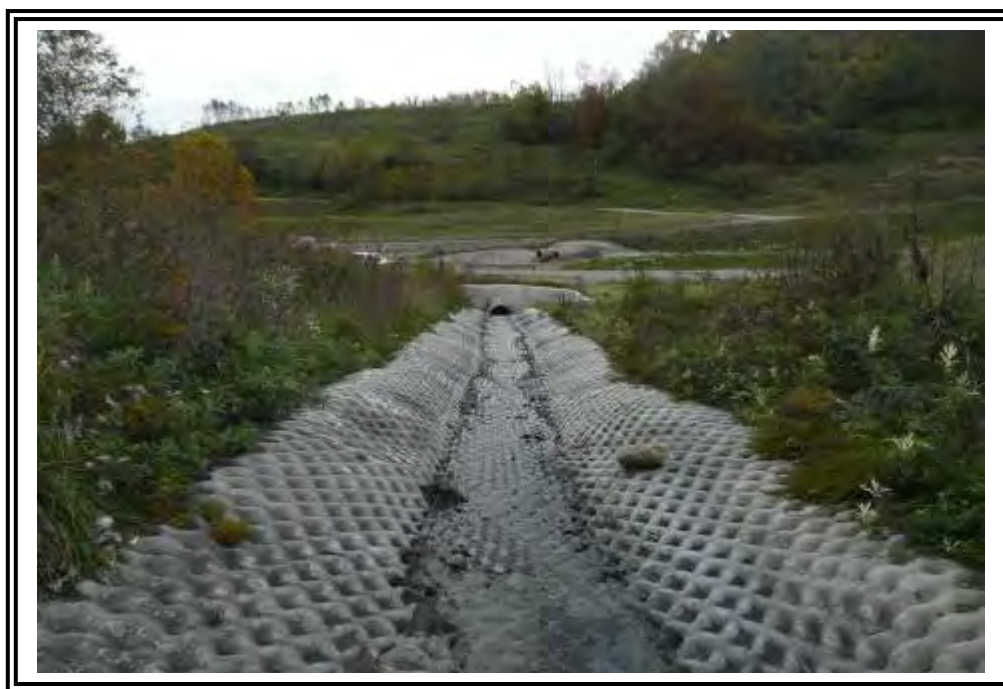
57

Looking down-slope at fabric formed concrete groin on west (left) buttress landfill abutment.

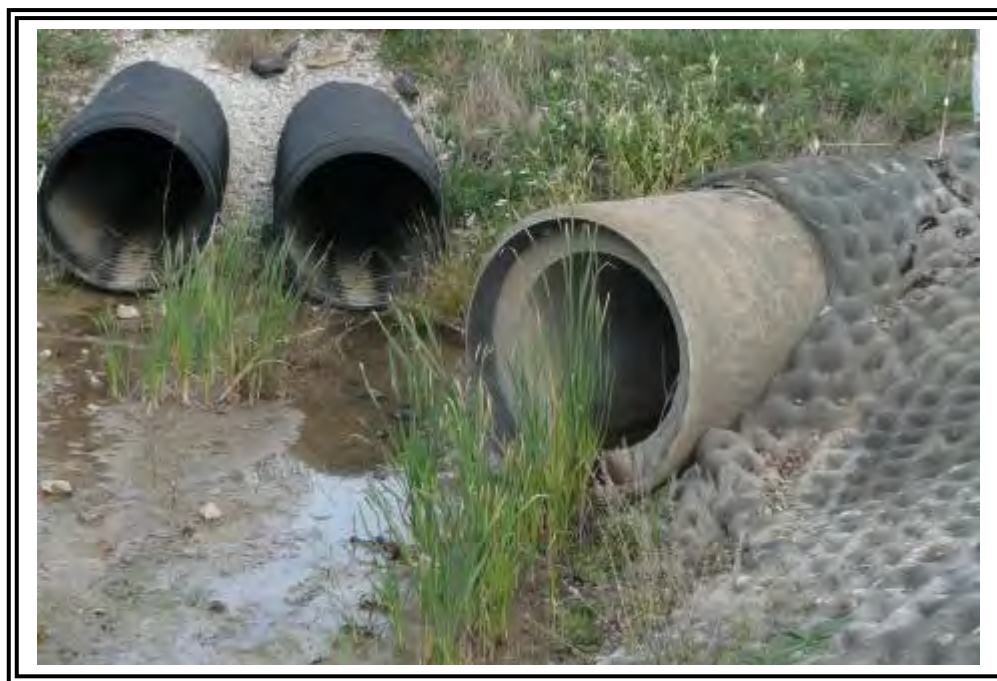
60

Concrete spillway outlet. Water does not normally flow through outlet.  
Water leaves outlet via a siphon with an outfall in the Ohio River.

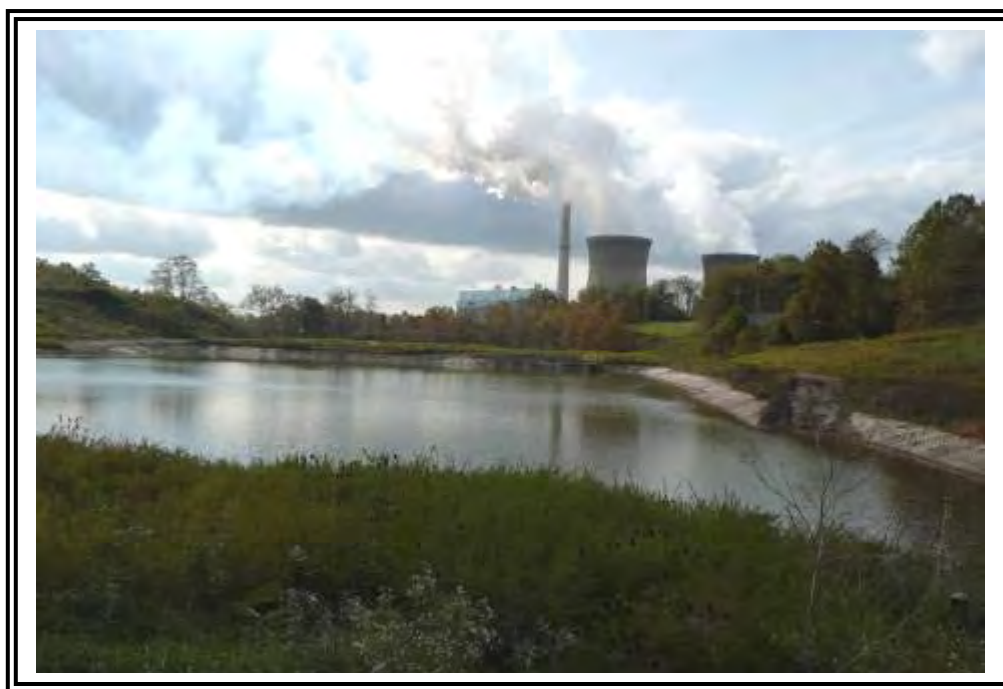
61

Sedimentation Basin No.1 for landfill and storm water runoff. Predominantly incised.

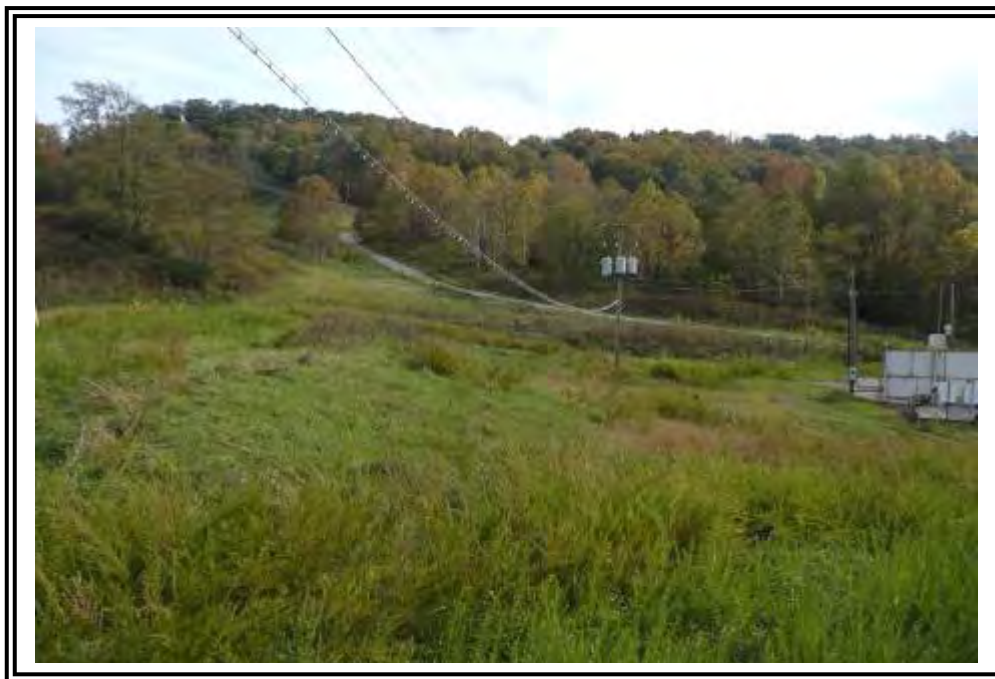
64

Downstream slope of Sedimentation Basin No. 2 showing pump house structure (right side of photo). Pump house conveys effluent from Sedimentation Basin No. 2 back up to the McElroy's Run Impoundment.
