# Assessment of Dam Safety Coal Combustion Surface Impoundments (Task 3) Draft Report

American Electric Power

Cardinal Power Plant

Brilliant, Ohio

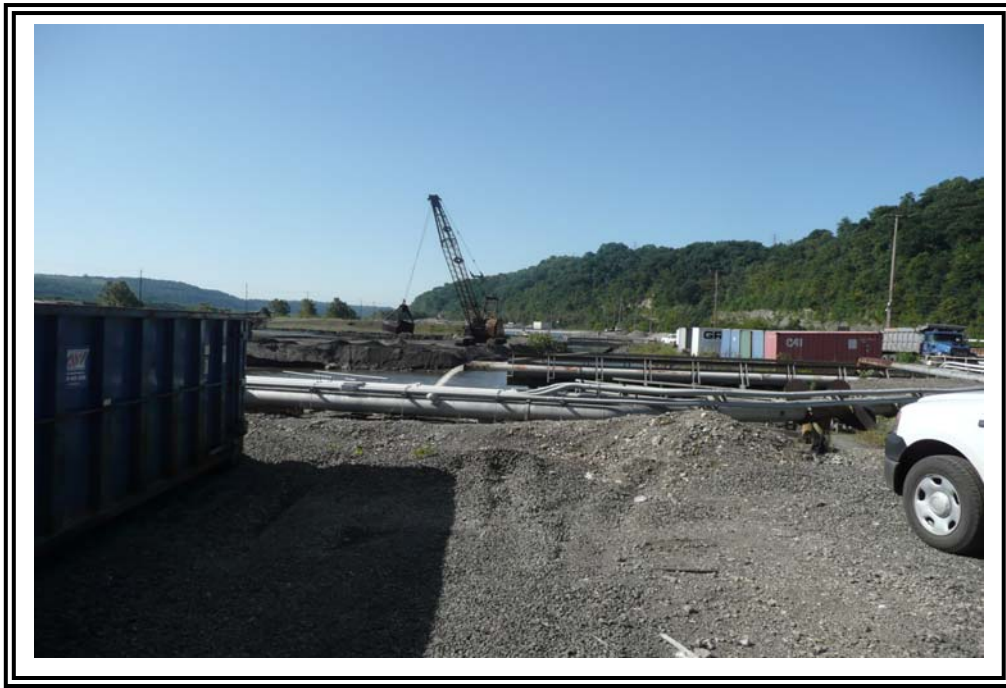
1

North rim of bottom ash pond at ash lines looking south. Note crane on ash delta platform.

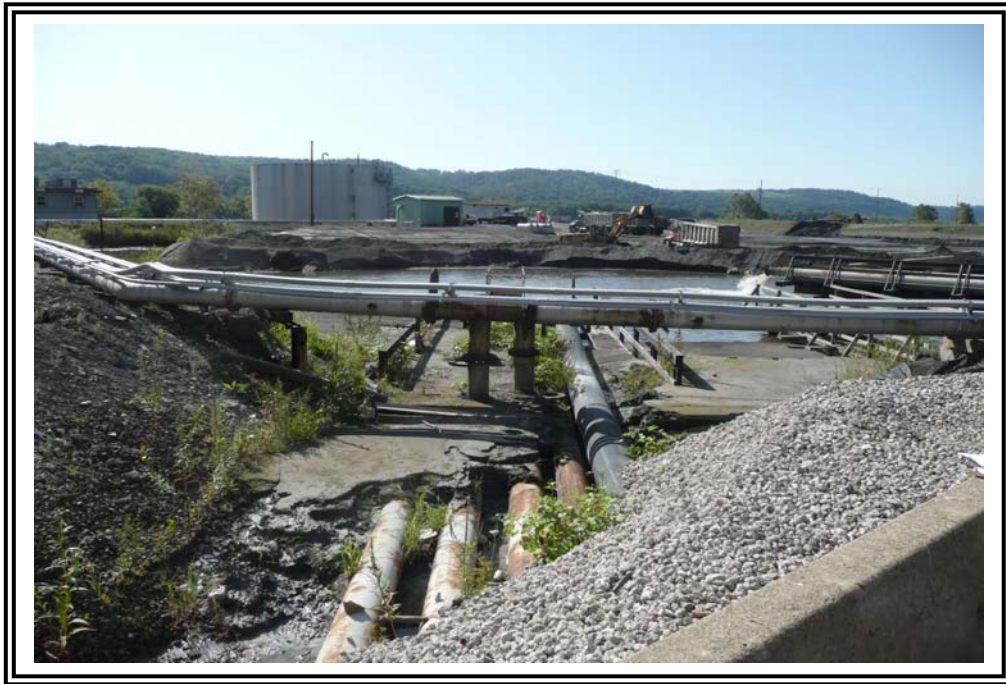
2

View of ash delta working platform from north dike. Note dredge spoil dike in background.

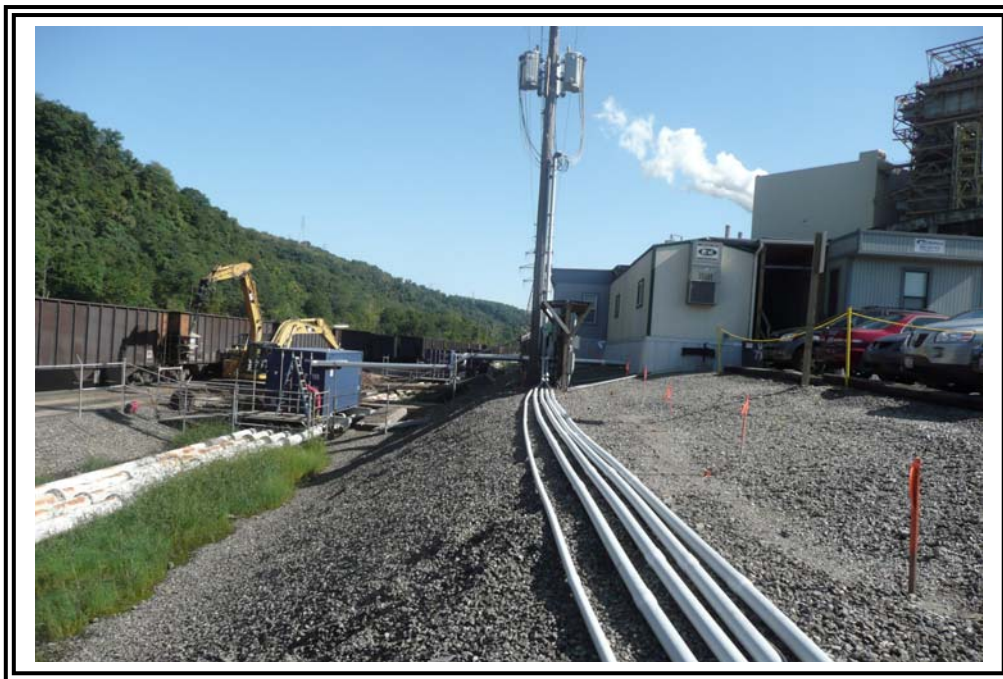
4

Downstream slope of the west dike, looking north. Note gravel surface and grass in drainage swale.

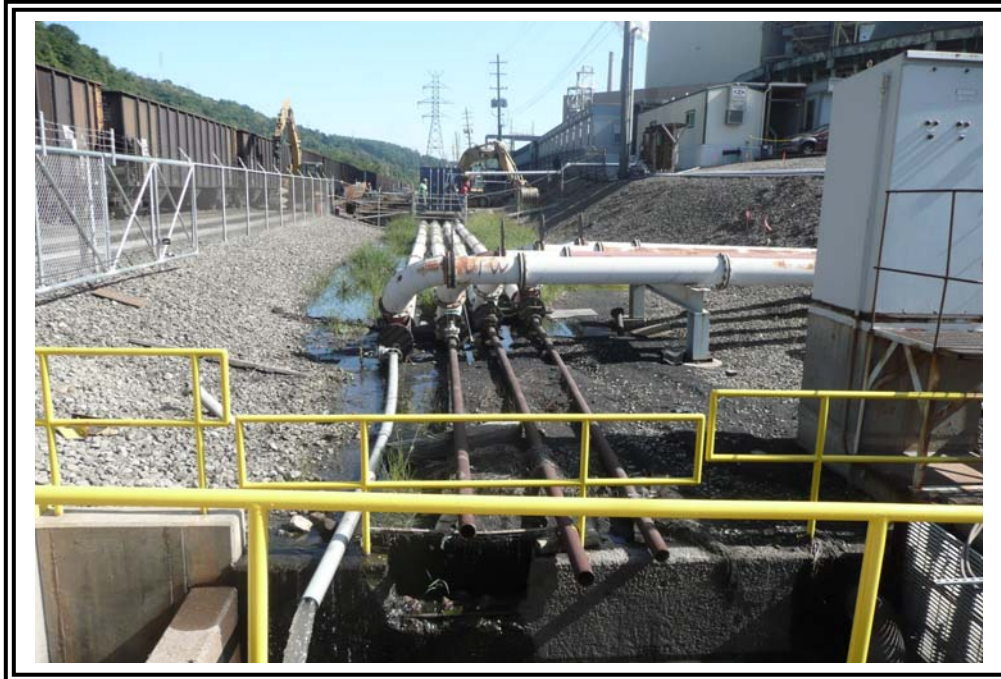
5

Looking north from the yard sump at the drainage swale along the downstream toe of the west dike.

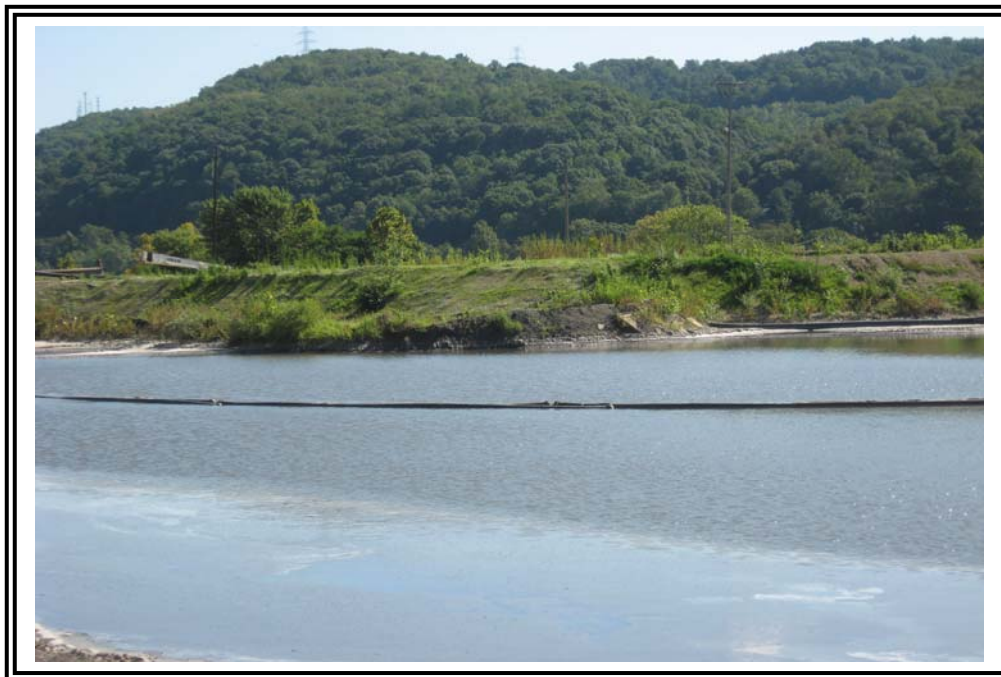
6

Looking east from west dike at interior dike structure used for temporary bottom ash dredge spoil storage.

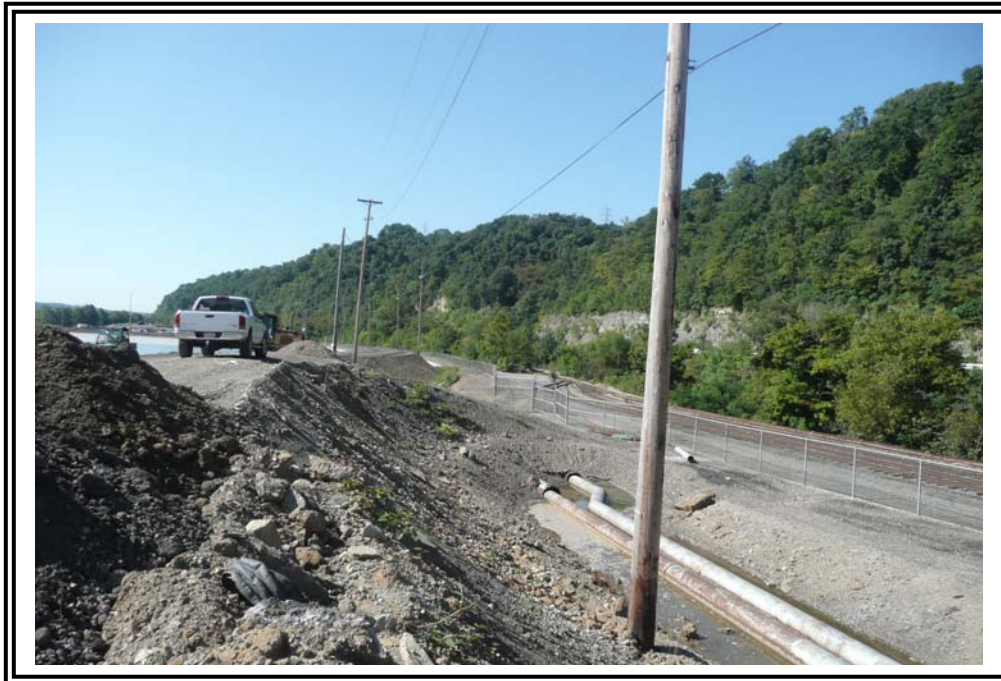
Photos 9 through 12 show the granular surface and erosion rills at the crest-slope interface and slope surface.

Downstream slope of the west dike looking south. Note water collecting around pipes in swale at slope toe which drains to the stormwater/wastewater and drainage sump in Photo # 9

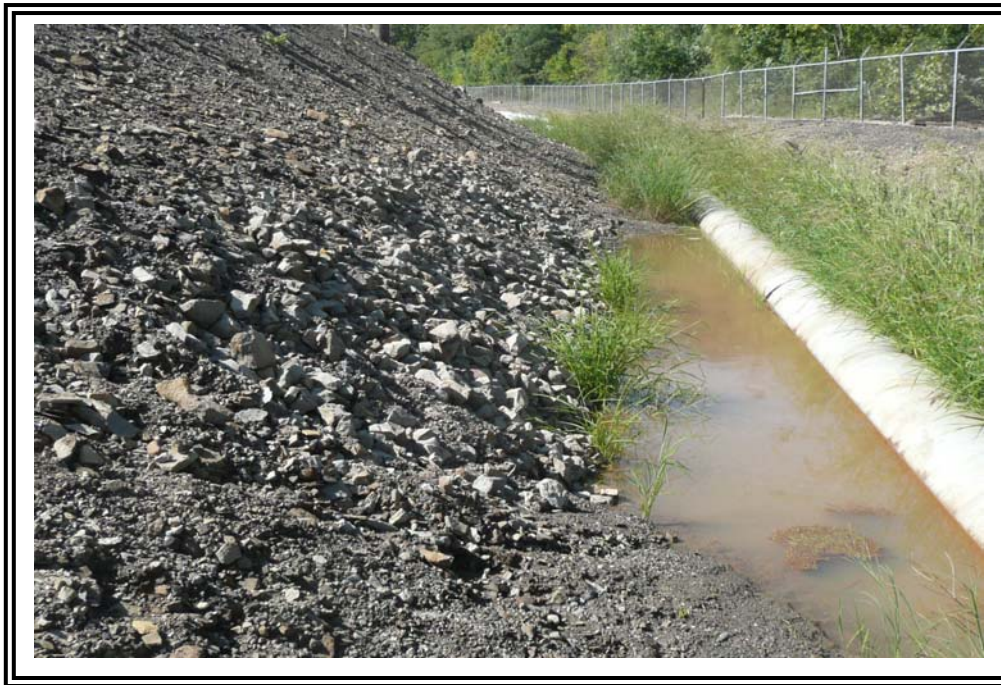
The dike toe area terminates in a drainage swale that also functions as a pipe trace for the recirculation pipes. This drainage swale conveys runoff and other facility surface flow into the site sump located at the north end of the Bottom Ash Pond and pumps that water into the pond. During the site visit, standing water was observed in the drainage swale along approximately 2/3 of the dike length. This water had a reddish brown color in some areas where the pipes had been partially submerged, however it was difficult to determine if the water coloration was due to corrosion or loss of pipe coating. An attempt to probe the toe area in the standing water indicated firm conditions. Given the 30-foot width of the dike and the fairly low head differential of about 5 feet, the water in the swale is not likely hydraulically connected to the pond. However, the grass growth in the swale at that area does suggest that water collects there and stands for a period time. Photos 12 and 13 show the water collected in this area of the toe swale.

Toe of west dike where drainage has collected in pipe swale, looking south. Soil difficult to probe more than a few inches.

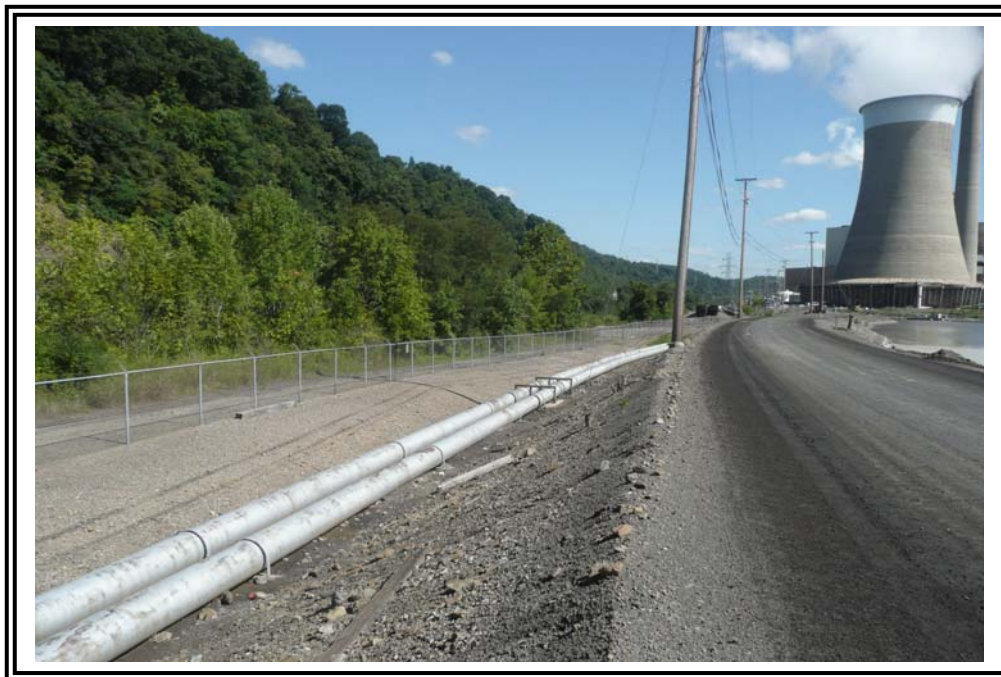
14

Downstream slope and crest of west dike, looking north.

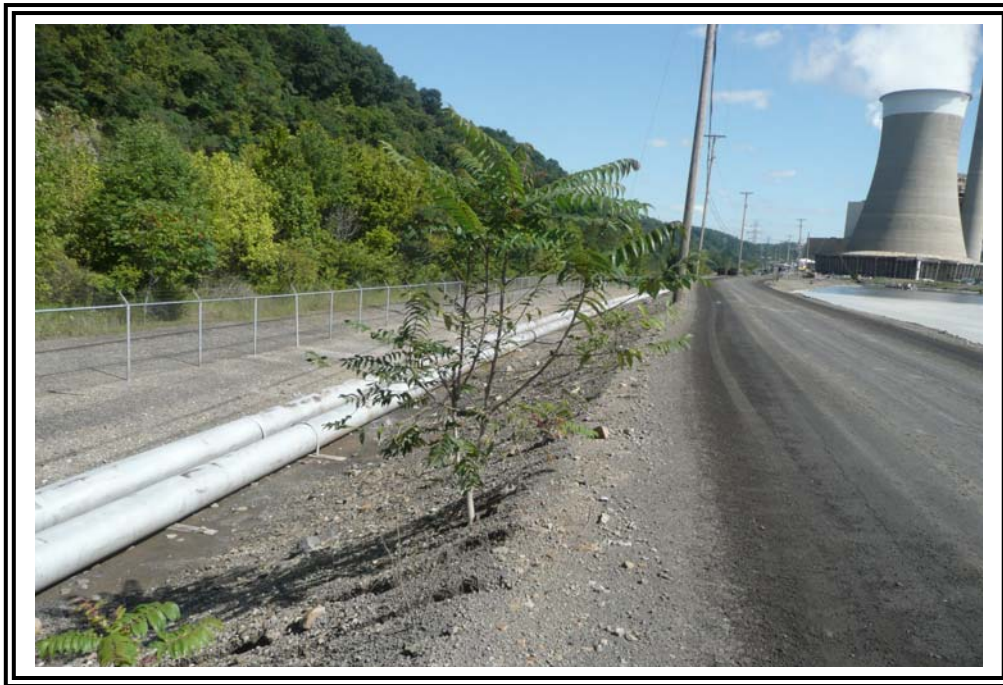
Isolated woody vegetation was observed along the west dike. Photo 15 shows an example of this plant growth.

Wooded vegetation becoming established on downstream slope of west dike, looking north.

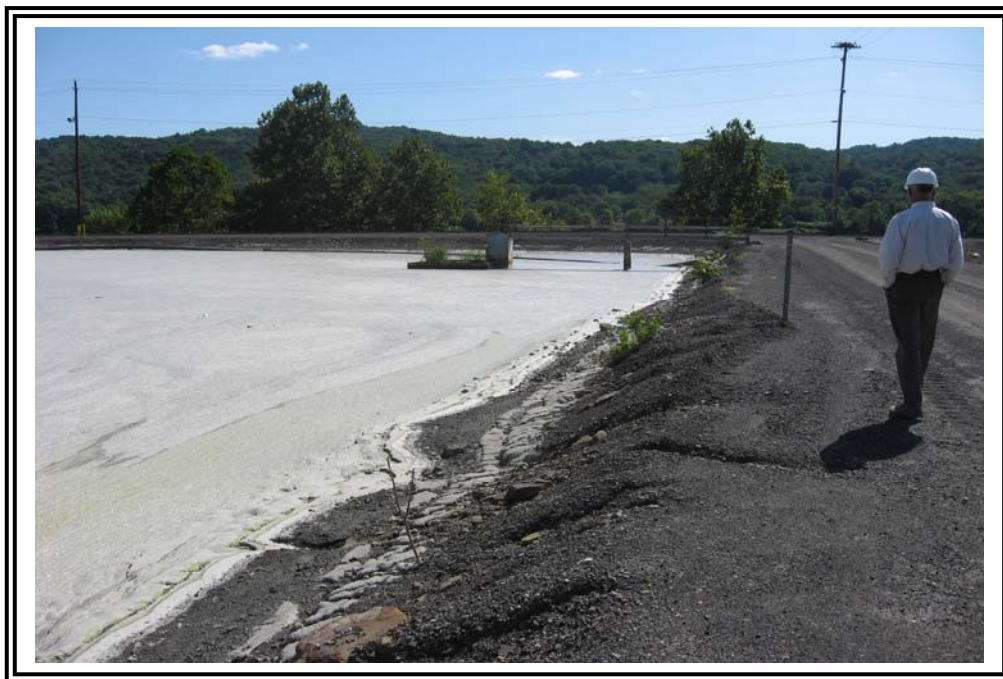
The separator dike has a general granular surface and is sparsely vegetated in similar fashion to the west dike as shown in Photos 16 and 34. Erosion features typical of the west dike are evident on this dike which is also about 10 feet wider at the crest than shown in the original site drawings (total measured width of approximately 31 feet). No unusual slumps or bulges were observed in the upstream or downstream slope.

Upstream slope of separator dike, looking east. Sparse vegetation and erosion rills evident.

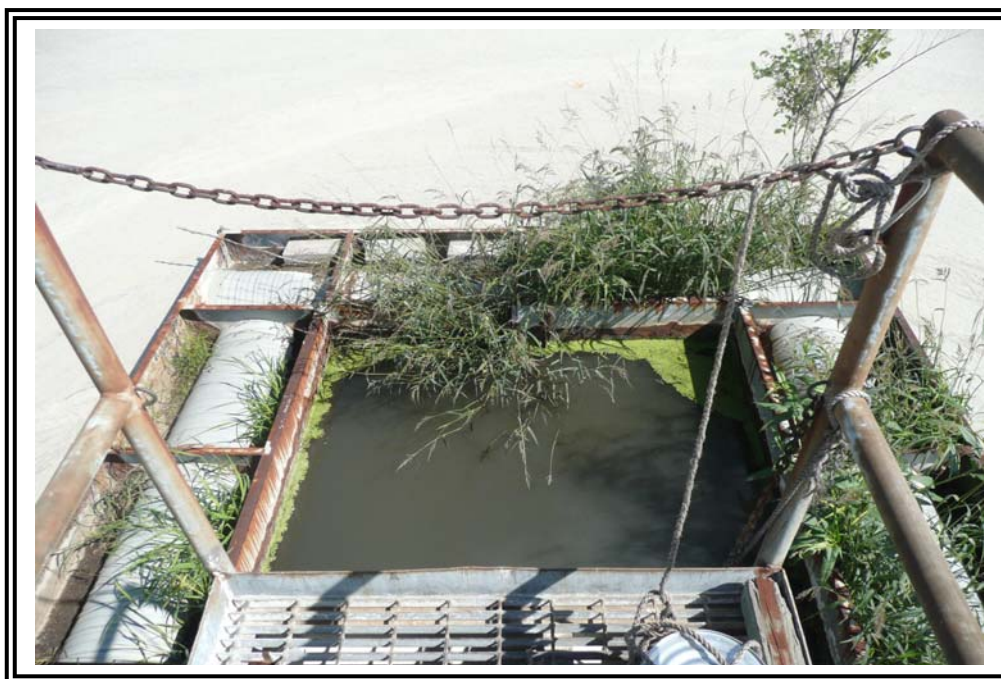
18

Closer view of skimmer at spillway tower and vegetation beginning to establish itself.

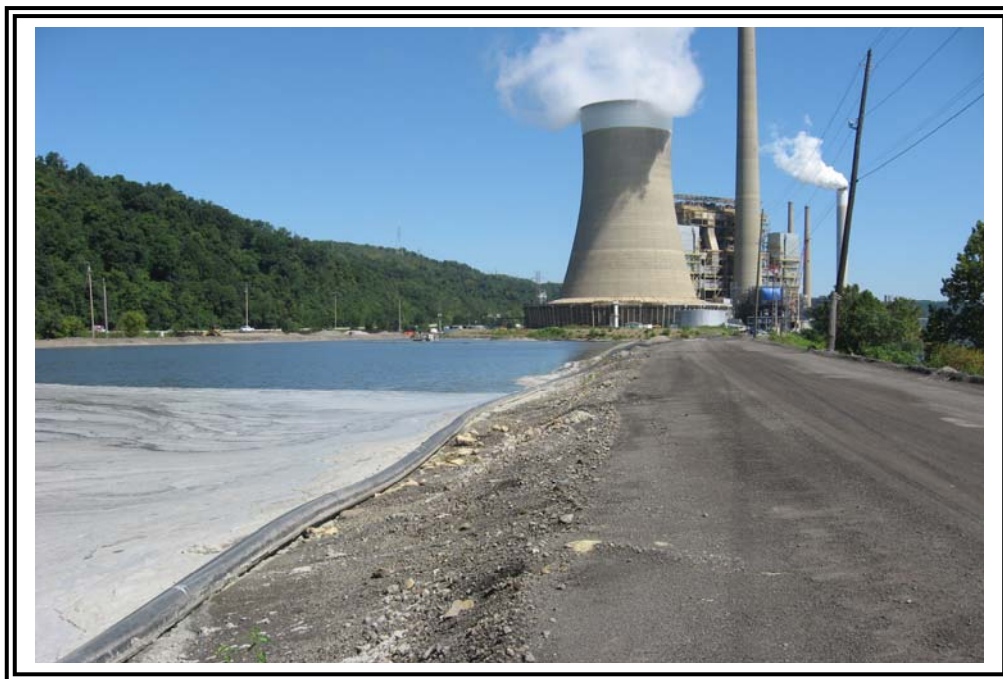
20

Upstream slope and crest alignment of east dike, looking north.

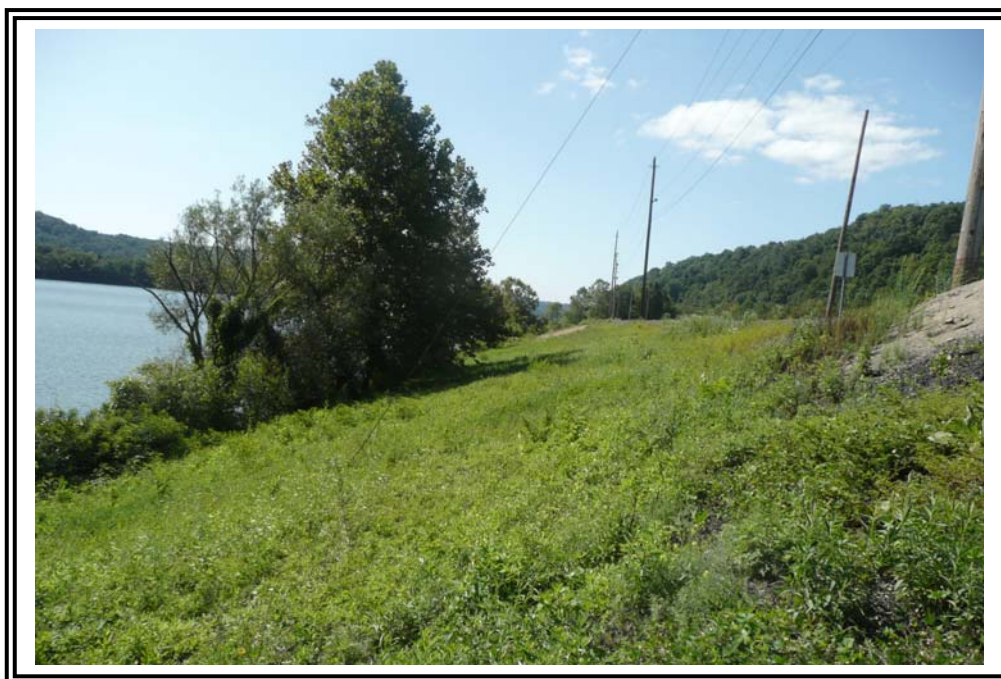
22

Downstream slope on east dike, looking south showing typical moderate, weedy vegetation cover on the slope face and larger brush with isolated trees at river bank.

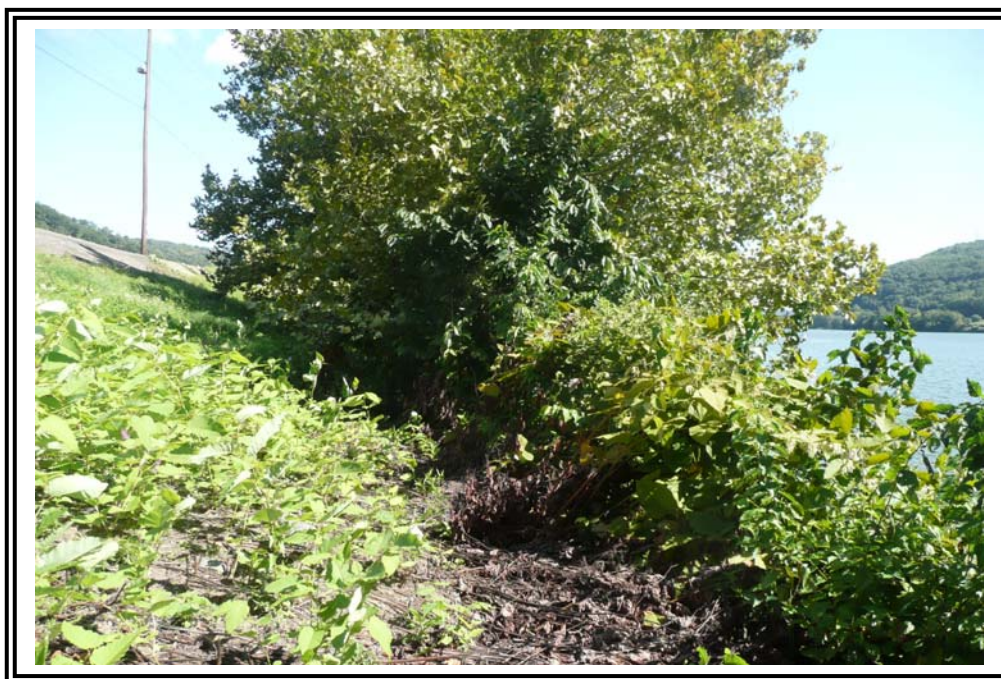
24

Downstream toe of east dike showing change in vegetation at slope toe-river bank contact.

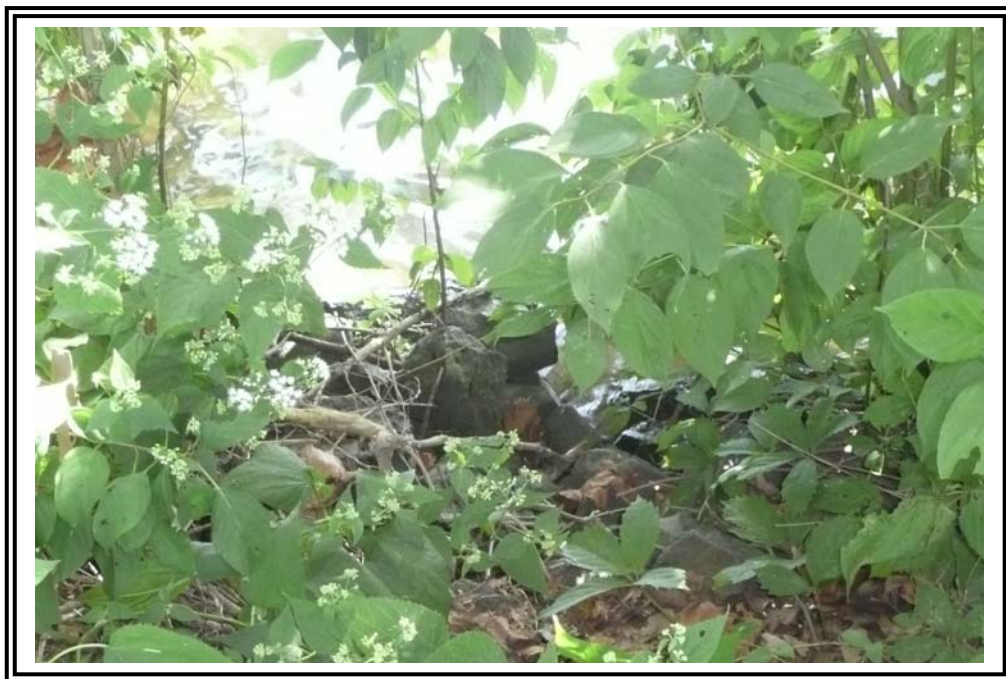
26

Close-up of stone at river bank adjacent to tree in Photo #23.

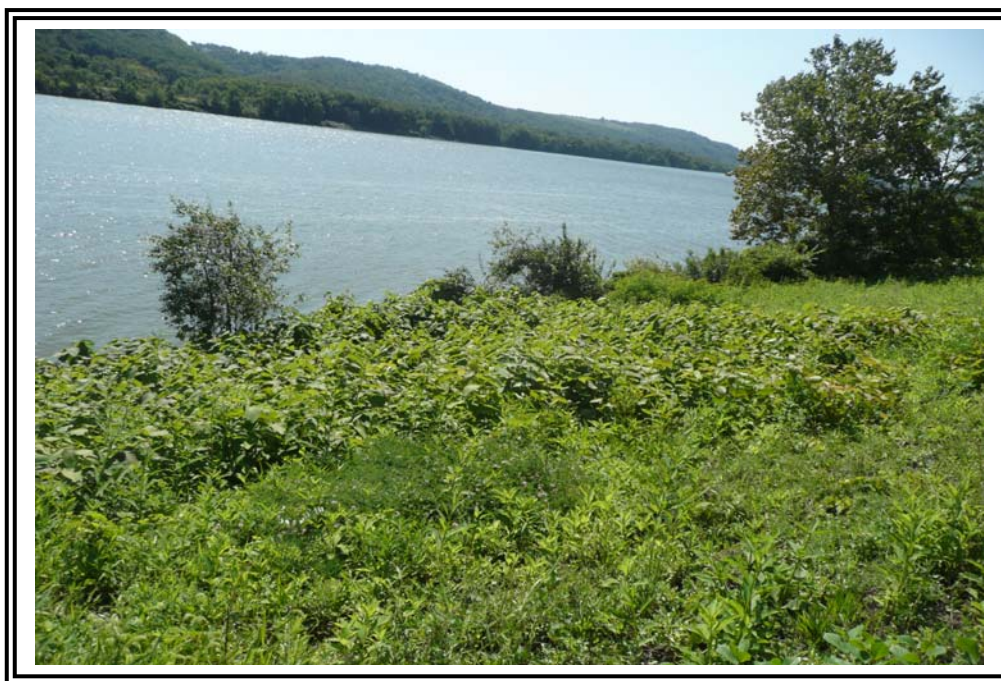
28

Closer view of change to leafy vegetation at river bank. Soils were firm and dry to touch in this area.

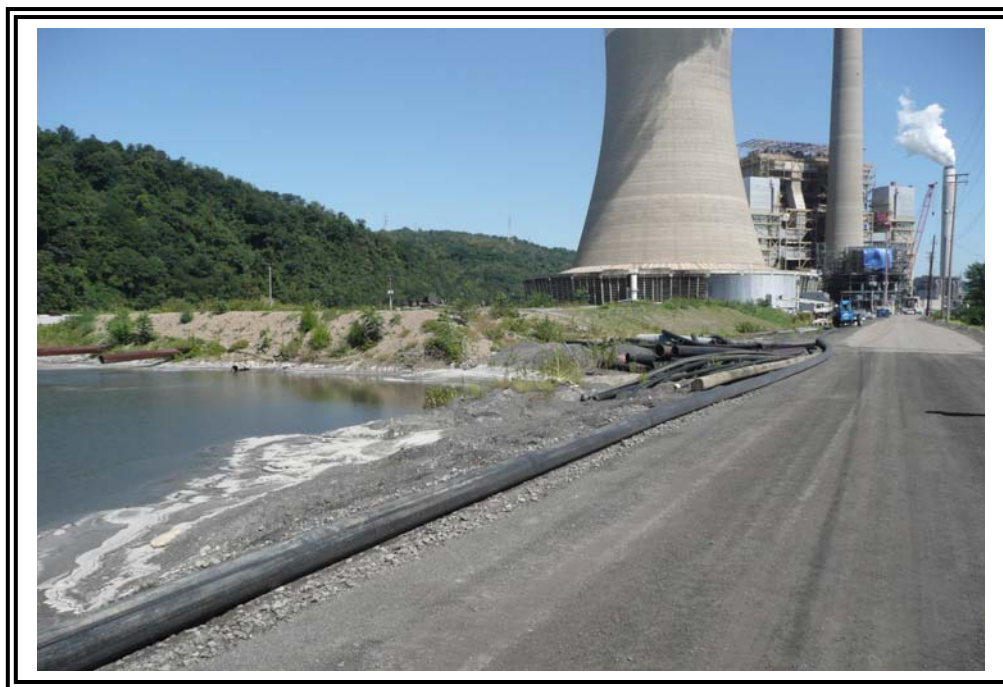
29

East dike crest alignment, pond surface, interior dike, chemical tank (in background) looking north.

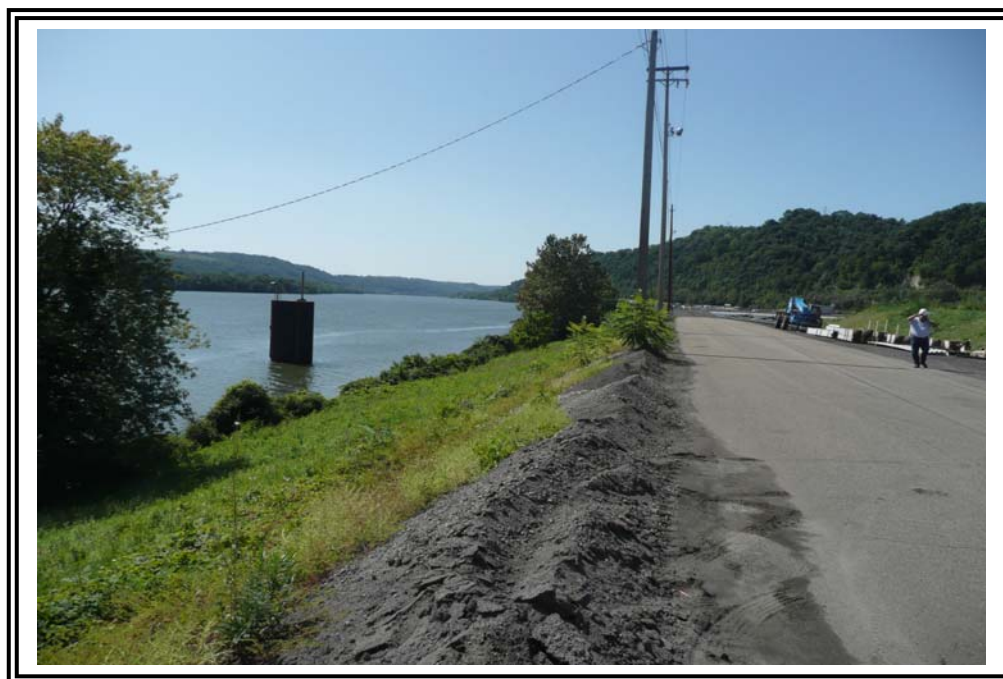
30

East dike crest alignment, looking south, showing ash build up at road edge due to grading activities.

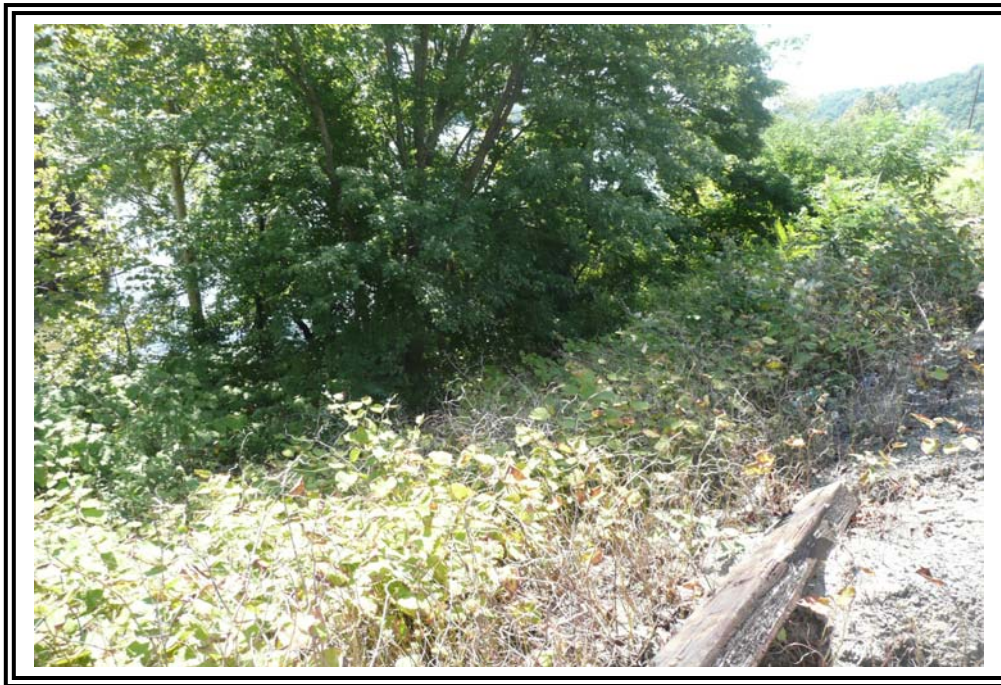
31

Downstream slope of east dike at northern extent of pond showing heavy vegetation and debris.

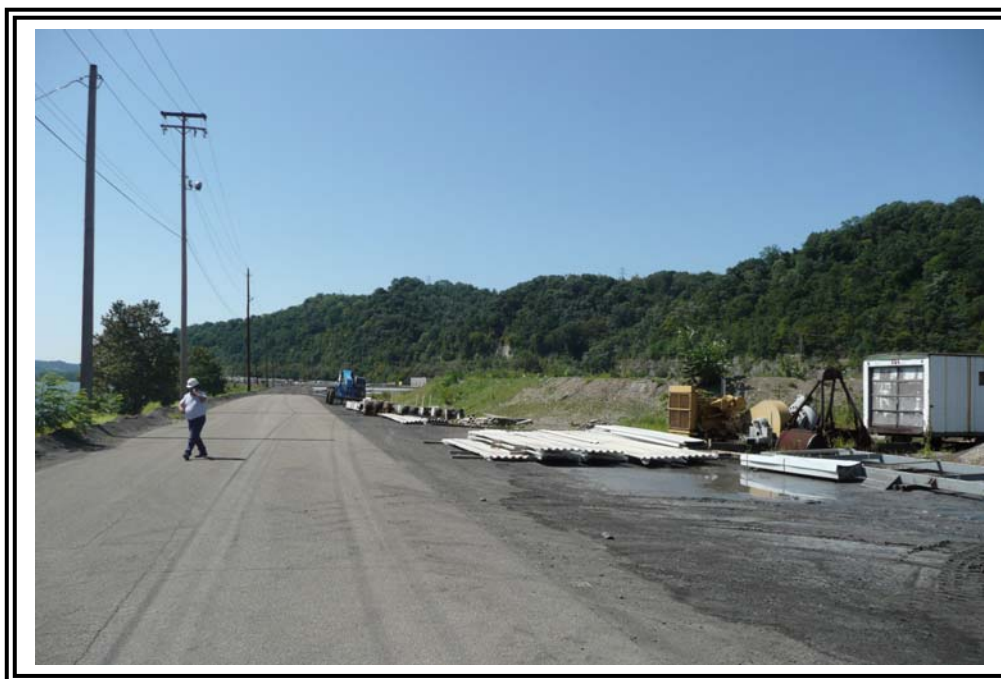
32

East dike crest alignment and portion of interior dike, looking south.

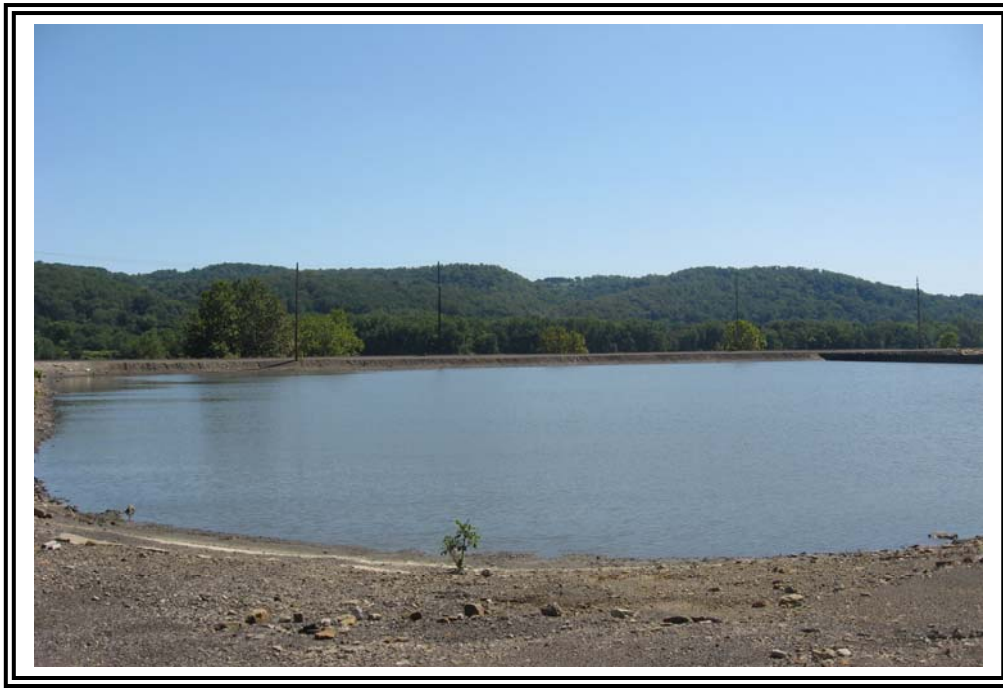
33

Pond surface, looking east

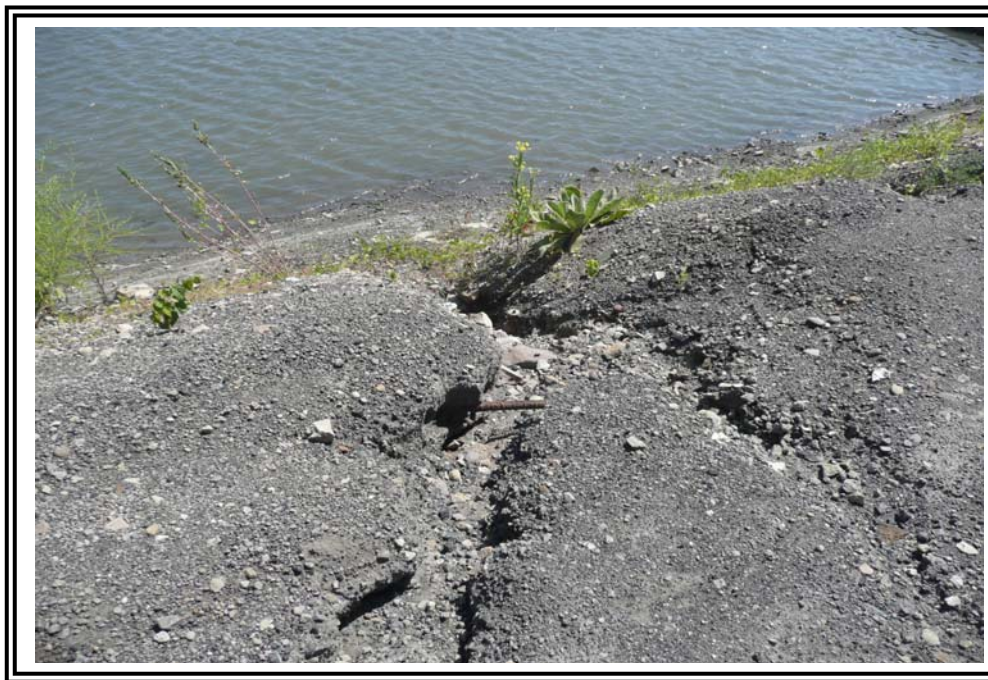
38

Closer look at erosion feature in Photo #36. Note exposed rebar debris in erosion gully.

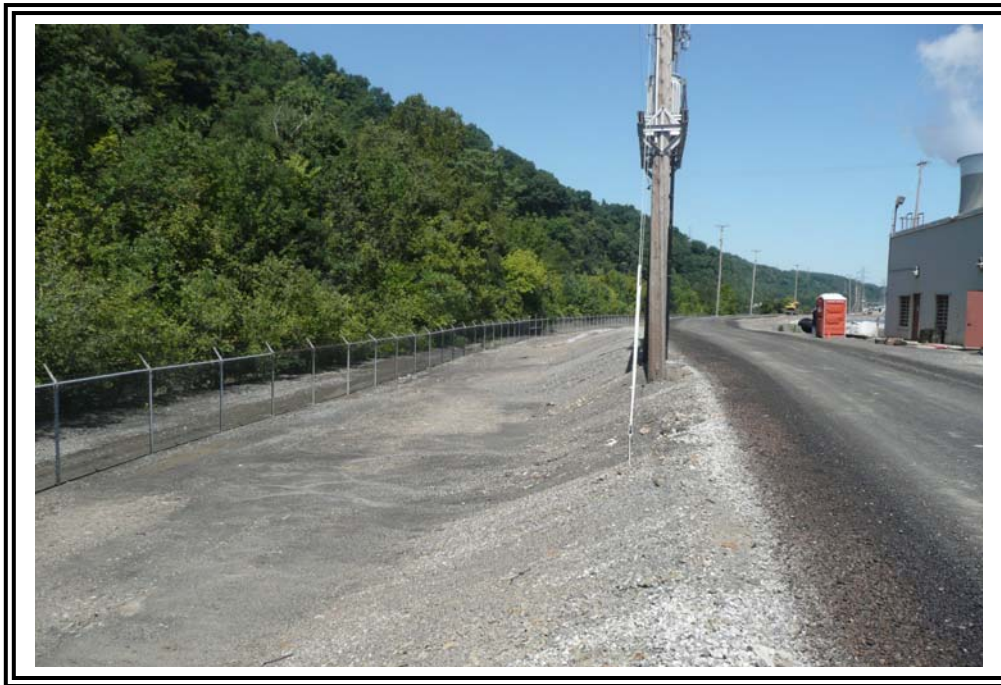
39

Downstream slope of west dike, looking north. Note fairly low height (about 5 feet tall) at this point.

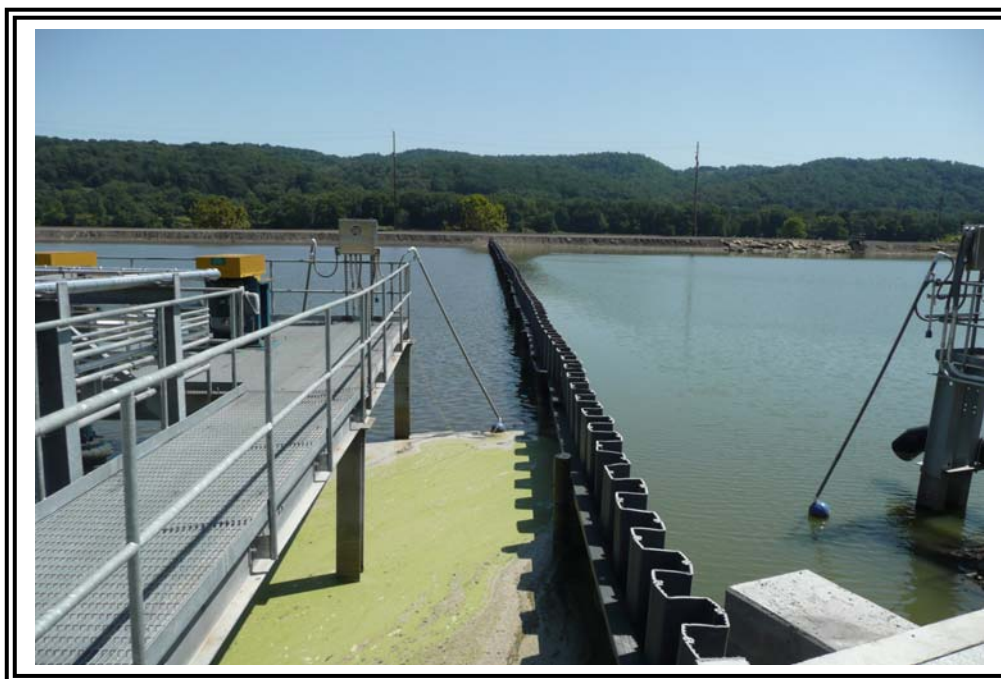
40

Vinyl sheet pile wall dividing recirculation pond to reduce treated water volume prior to discharge.

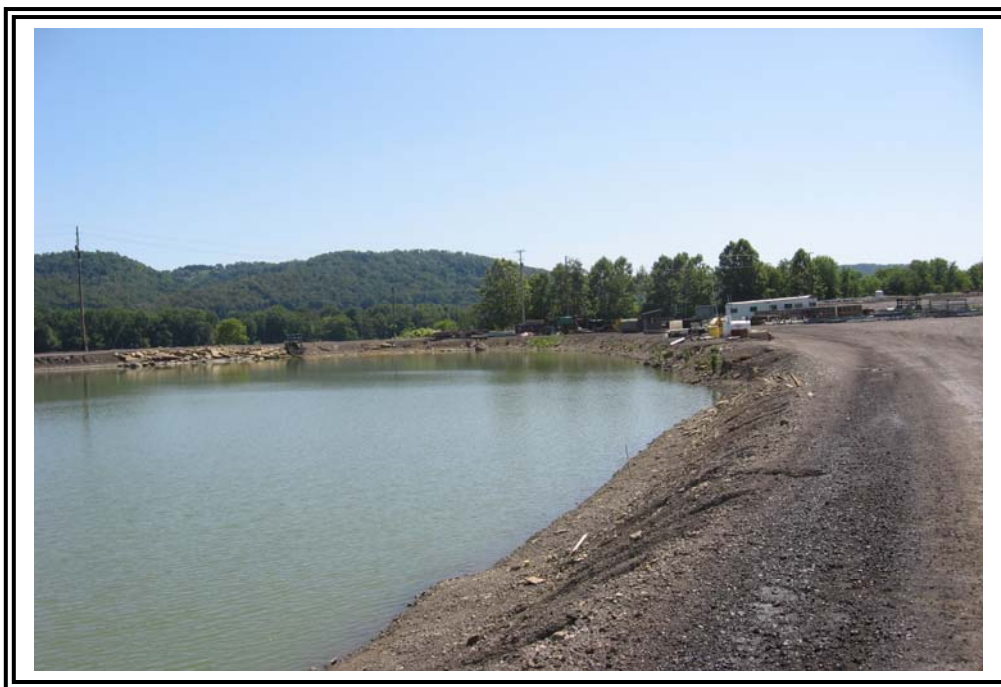
41

Inboard face at south wall, looking east. Pond is essentially incised in this location.

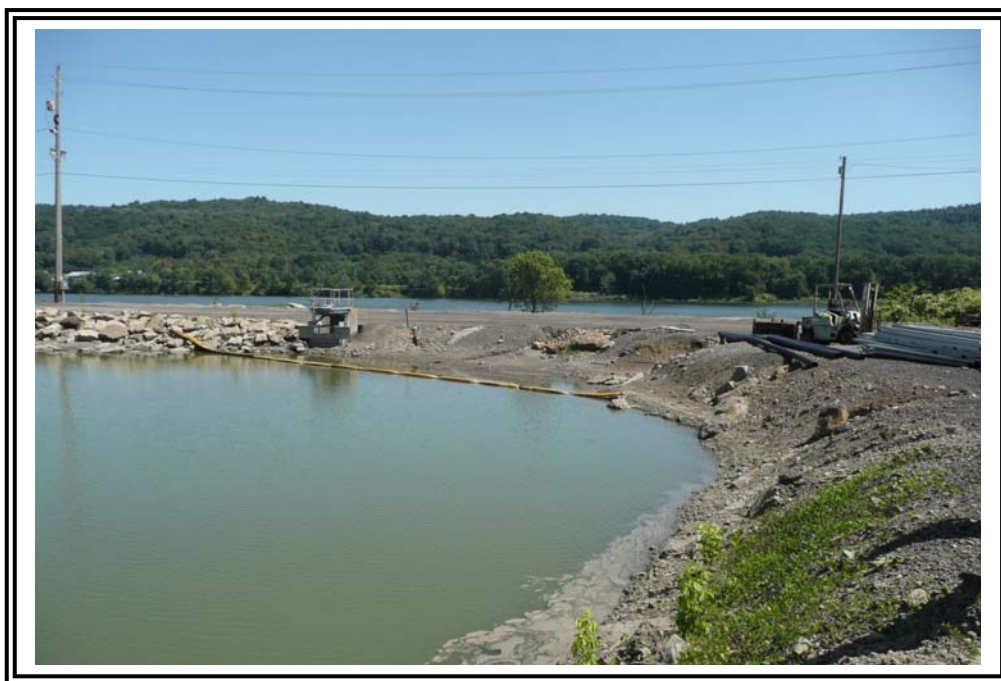
42

Looking east at upstream face of east dike. Note large armor stone adjacent to outlet structure and large erosion gullies adjacent to equipment at south wall - east dike interface.

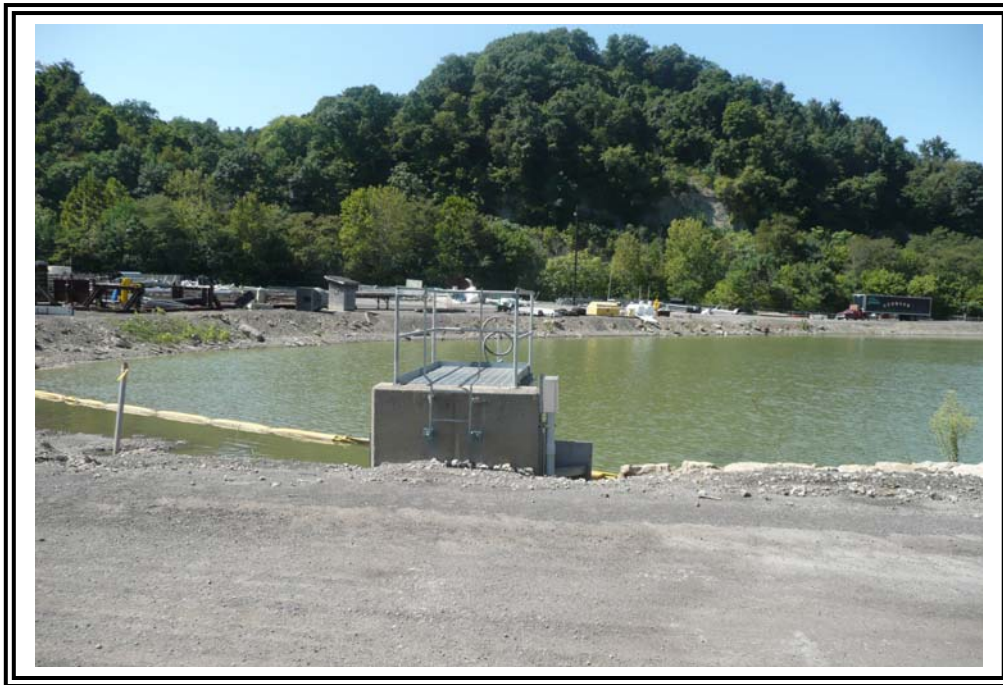
43

Recirculation pond outlet structure from east dike crest, looking west.

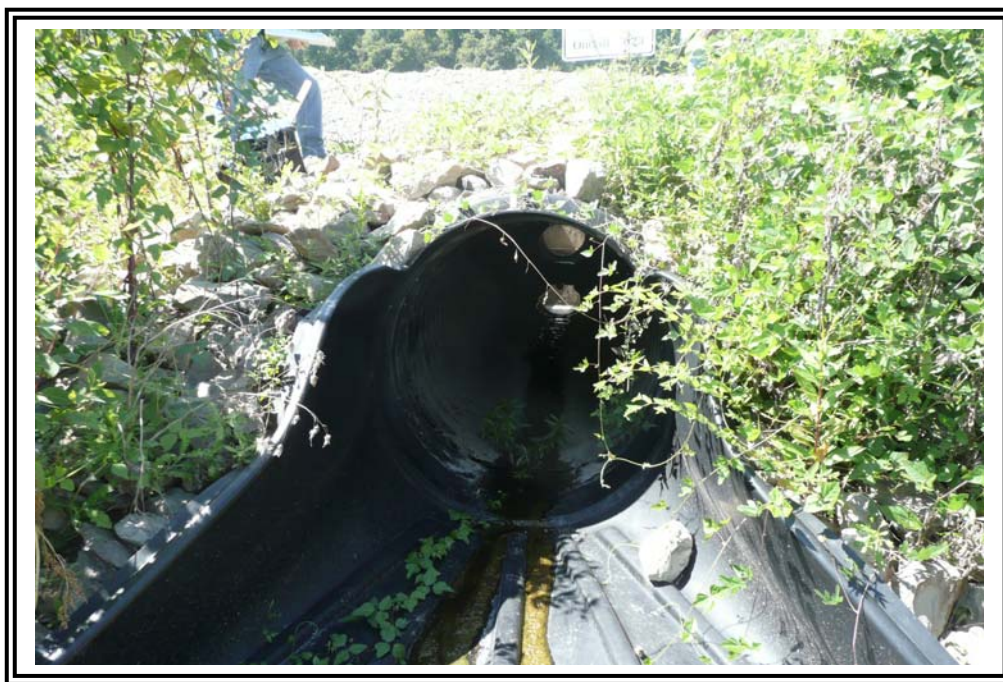
44

36" diameter Recirculation Pond outfall.

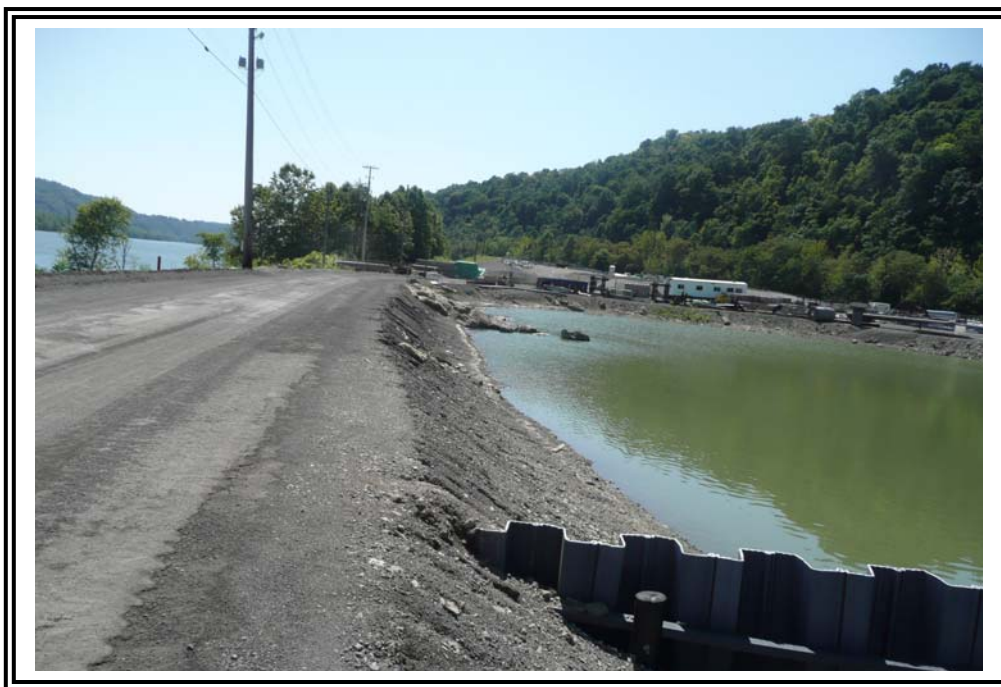
47

Crest and upstream slope of east dike at vinyl wall, looking south.

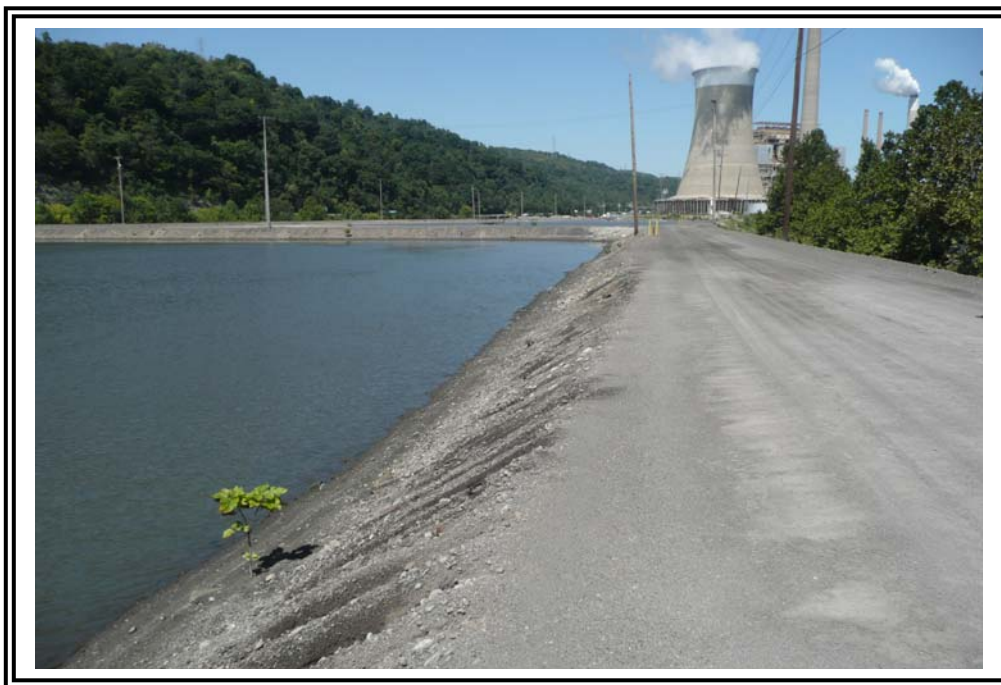
48

Crest and upstream slope of east dike at vinyl wall, looking north. Note typical erosion and sparse vegetation.

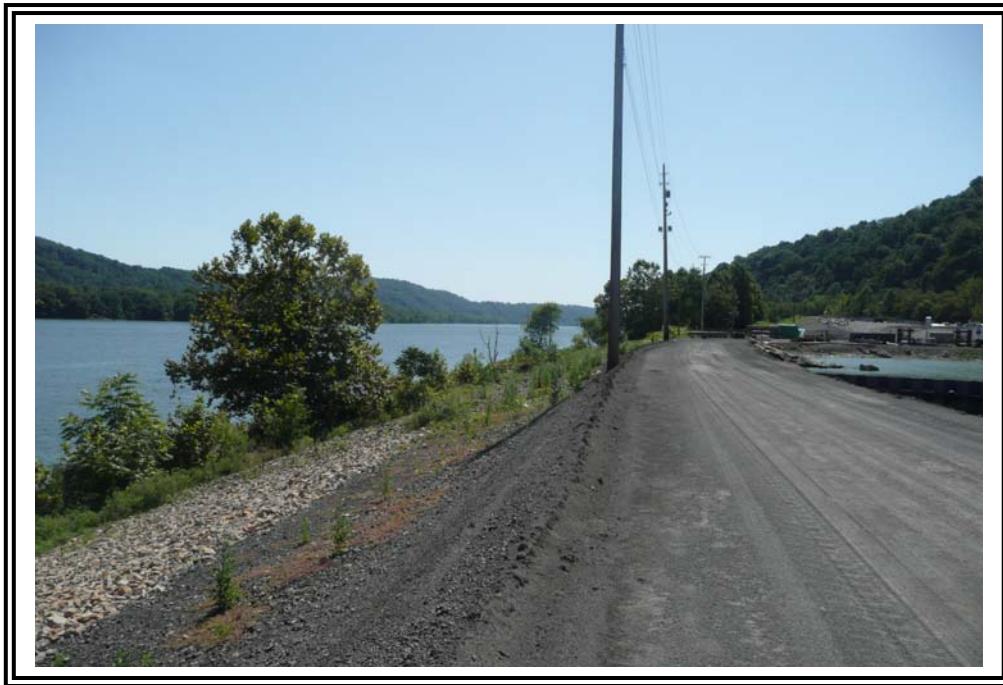
49

Crest and downstream slope of east dike, looking south. Note vertical limit of stone facing.

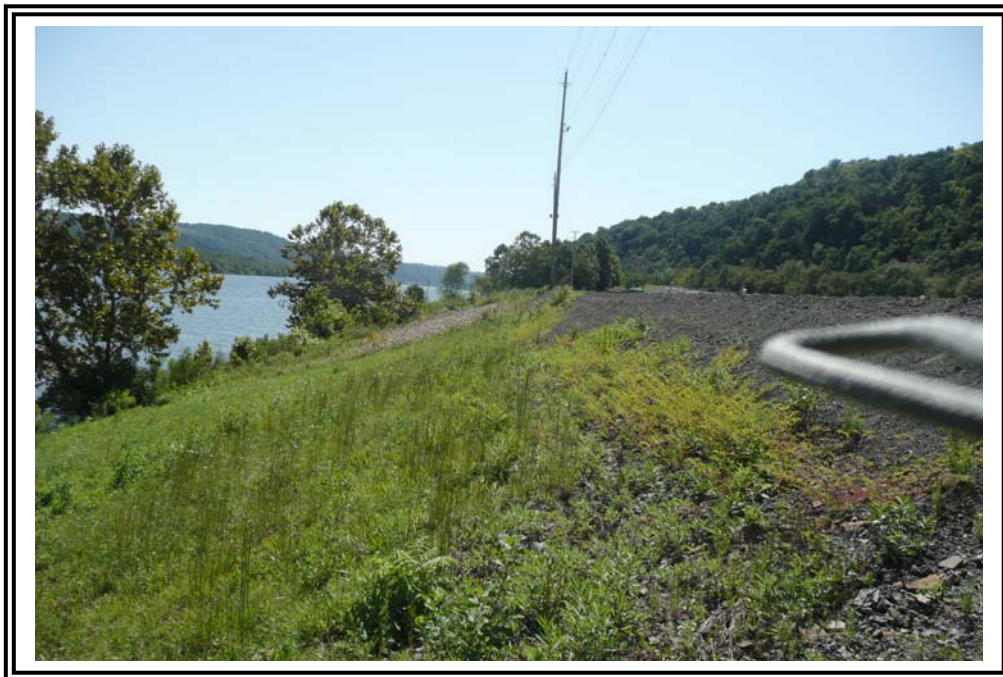
50

Downstream slope of east dike, looking south showing typical vegetation cover.
