# Assessment of Dam Safety Coal Combustion Surface Impoundments (Task 3) Draft Report

American Electric Power

Cardinal Power Plant

Brilliant, Ohio

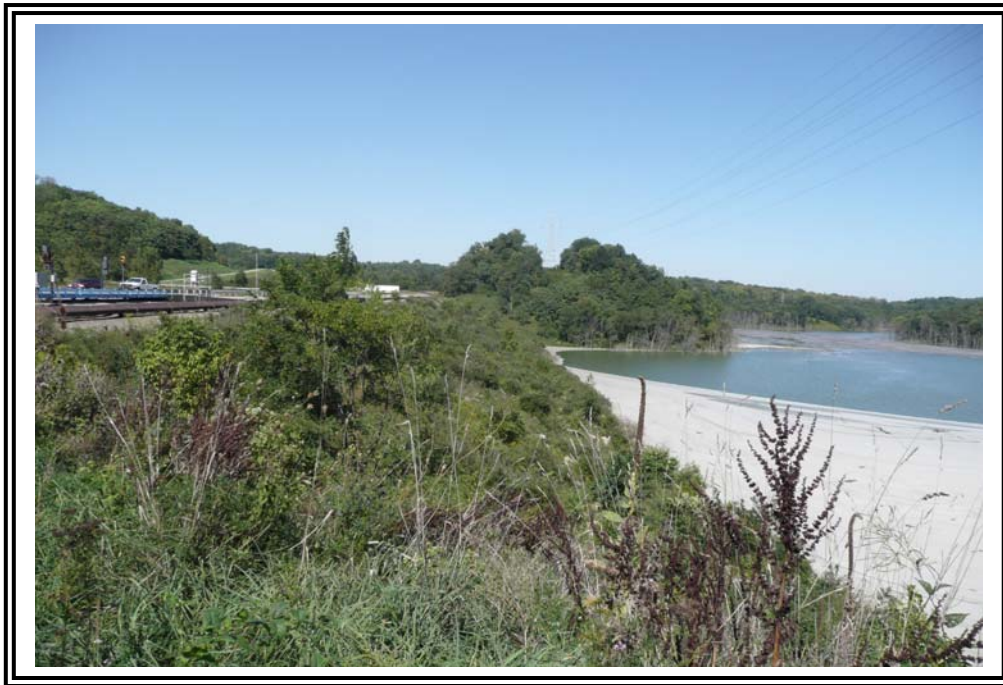
51

Downstream slope from right (south) abutment near crest. Note heavy wooded vegetation.

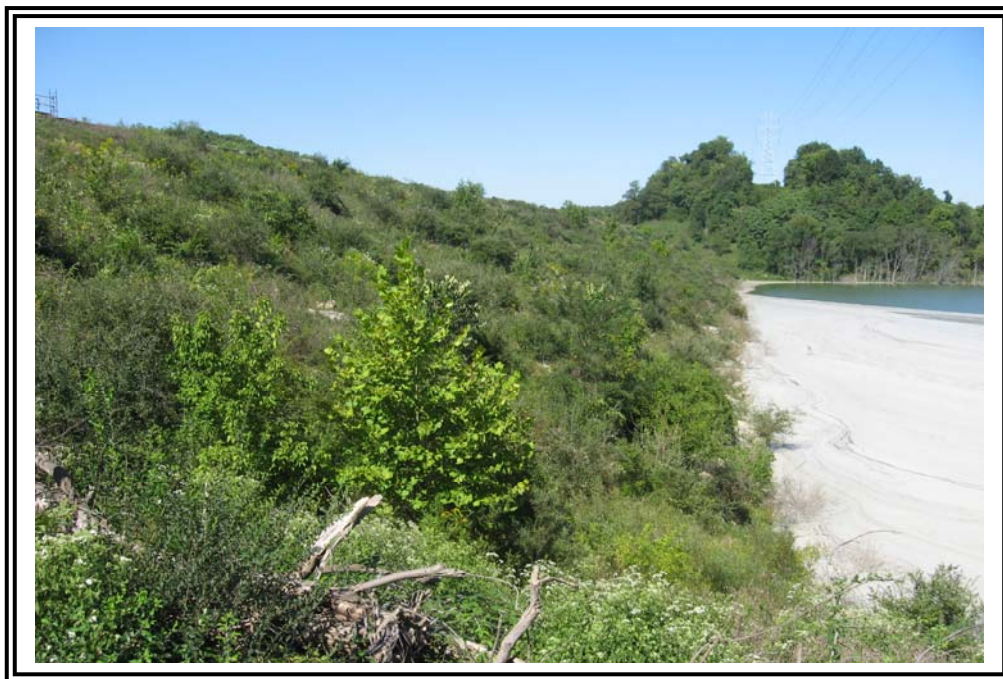
52

Downstream slope from right (south) abutment, closer to Fly Ash Reservoir No. 2 water surface.

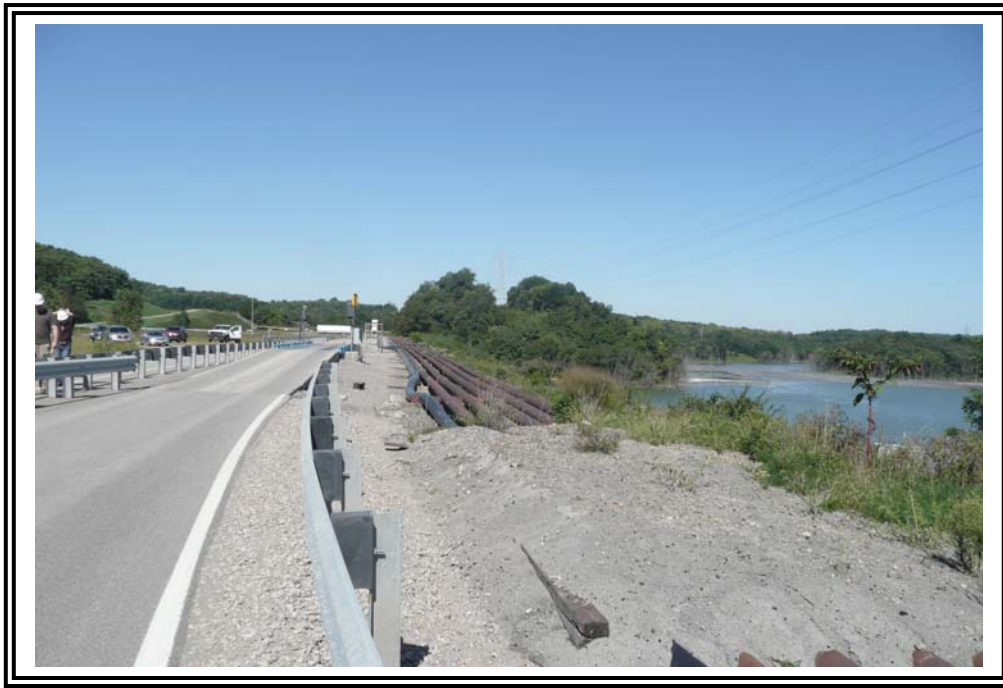
53

Looking north at crest area showing landfill truck scales and sluice lines to Fly Ash Reservoir No.2

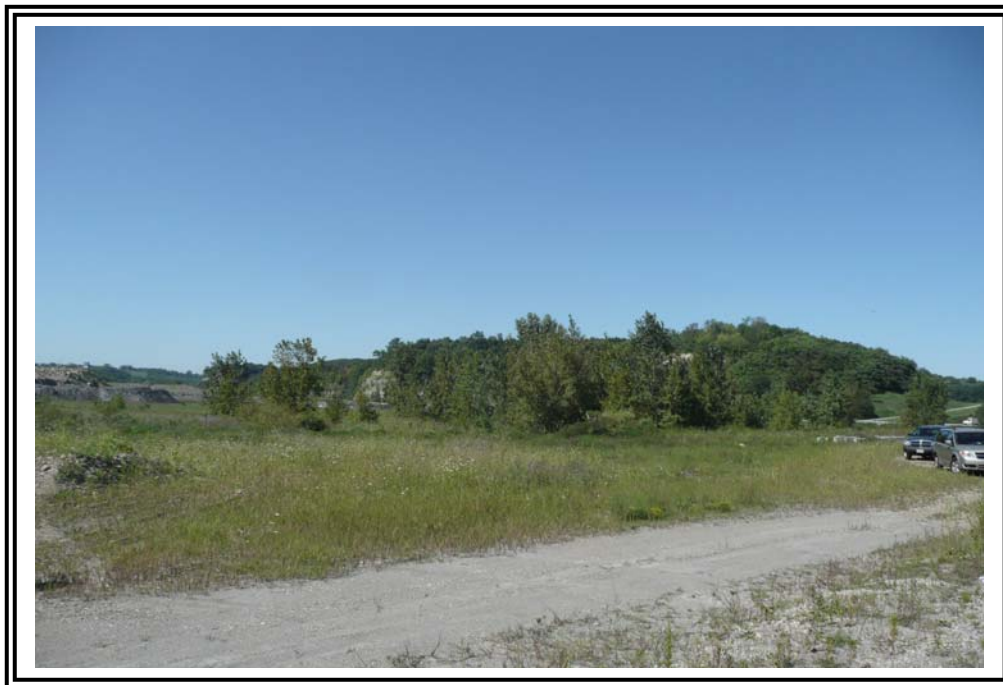
54

Another view of the crest, looking north. Crest is in excess of 100 feet in width.

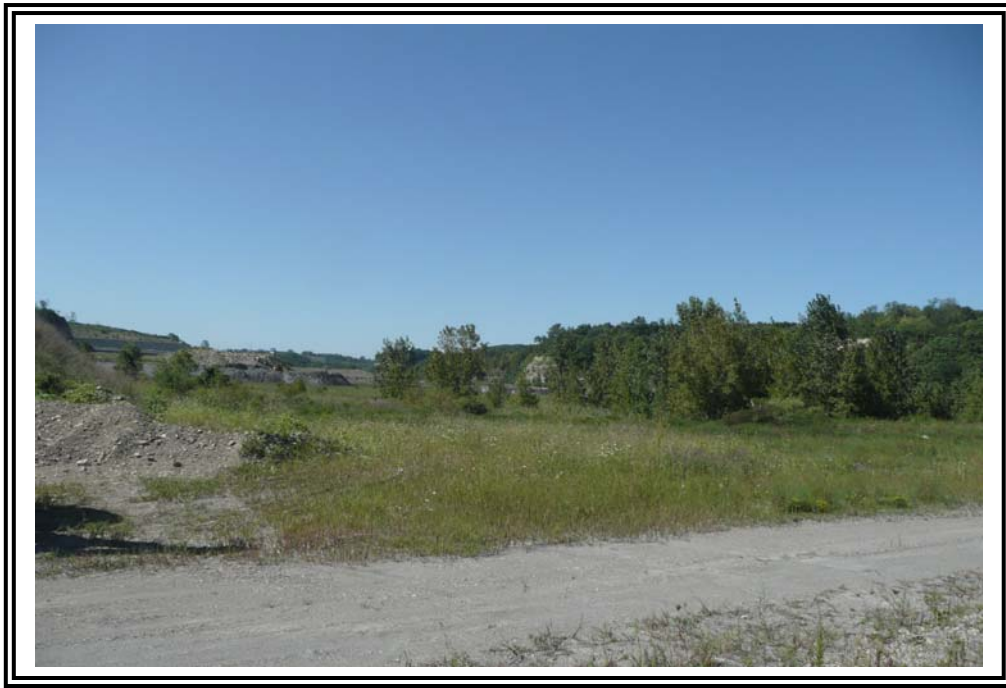
55

Looking west from crest area into former basin toward active landfill operations.

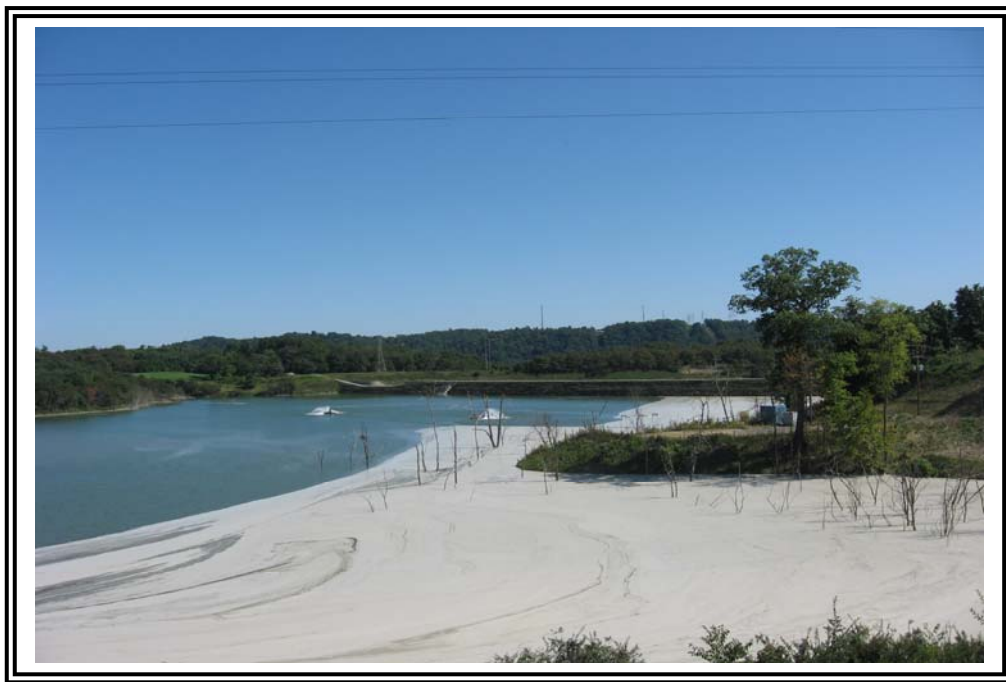
56

Looking east from crest across Fly Ash Reservoir No. 2 at Fly Ash Dam No. 2.

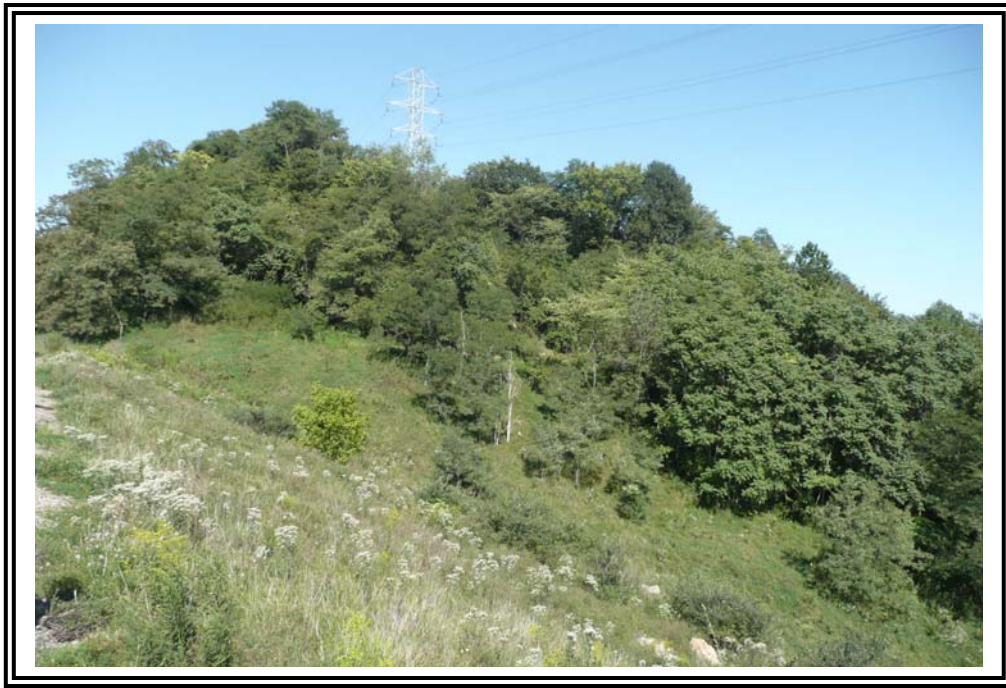
57

Looking north at downstream slope and left (north) abutment contact.

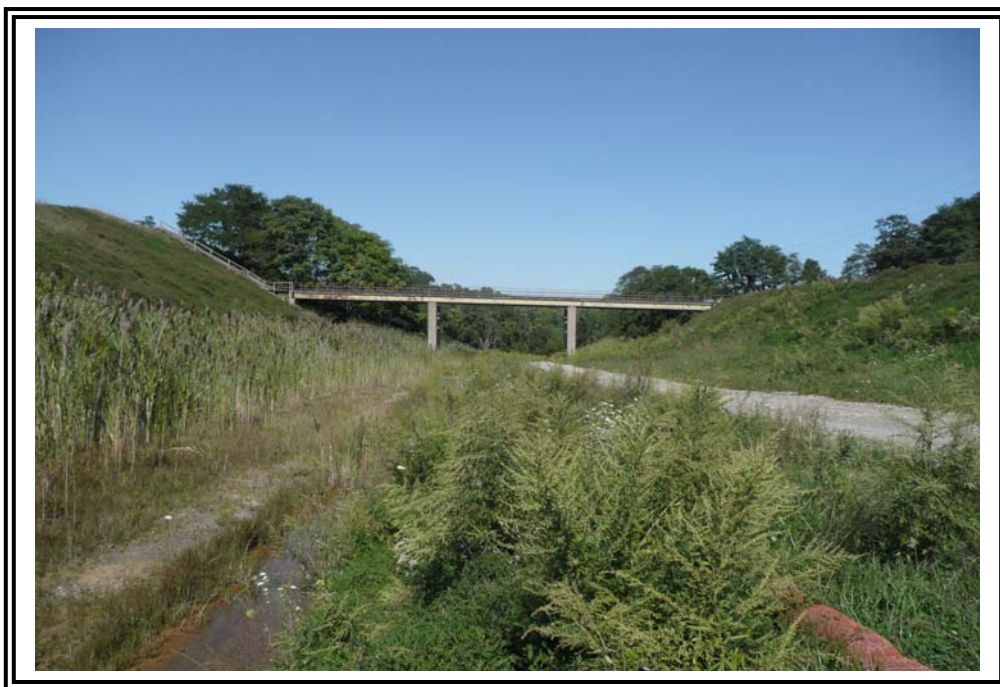
61

Emergency spillway, looking north from old basin area.

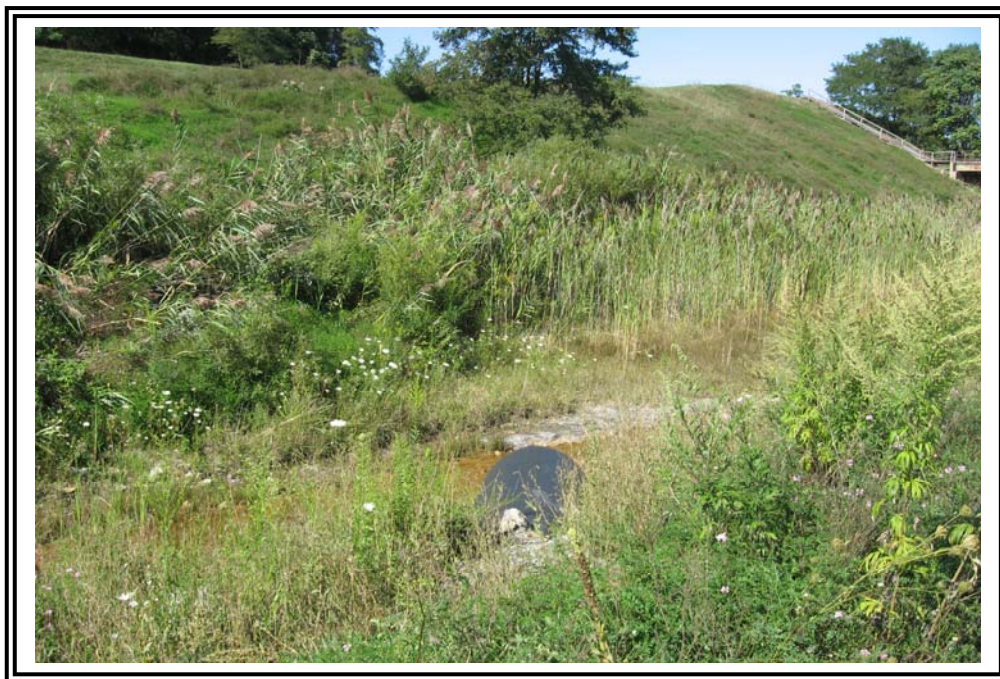
62

Storm runoff and site drainage outlet from landfill operation and old basin surface to emergency spillway.

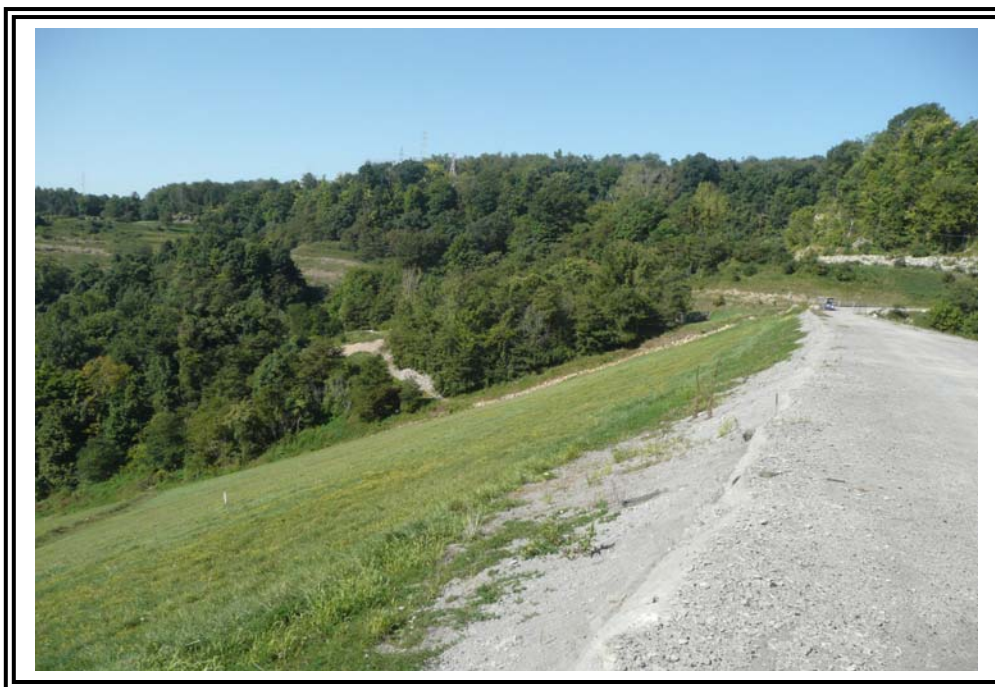
63

Downstream slope at crest looking west toward right abutment.

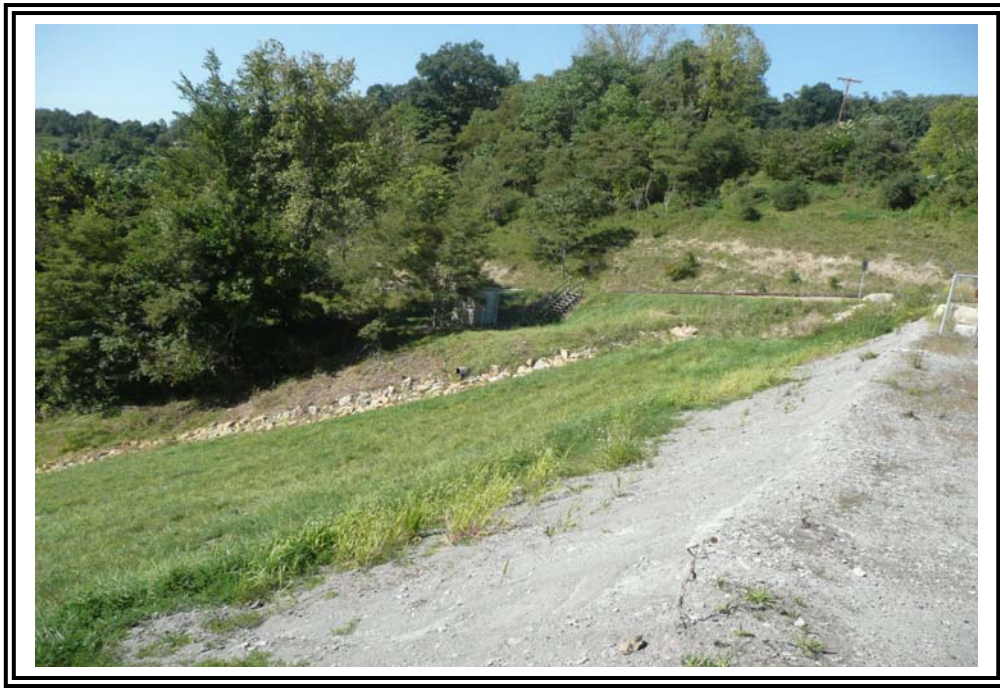
65

Rock lined groins and drainage ditches along the abutment contacts and on the slope face were varied in their conditions. The upper rock groin along the west (right) embankment was generally dry and fairly clear of vegetation (Photo 65). Fairly low vegetation was also evident in the east groin near the toe drain area (Photo 91). This is in contrast to the rock groin in the upper elevation of the east (left) abutment and the downstream slope (Photos 85, 86, and 104). At lower elevations, the abutment groins began to intercept and convey seepage toward the toe drain area (Photos 89, 90, and 106). One of the more prominent seeps on the right abutment is actually drainage from a trench drain in the natural hillside (Photo 88). Another active drain was observed at the east abutment contact. This drain appeared to be conveying flow from the embankment rather than the hillside (Photo 87). Seepage in these areas was clear.

Closer view of rock groin at right (west) abutment hillside contact from crest.

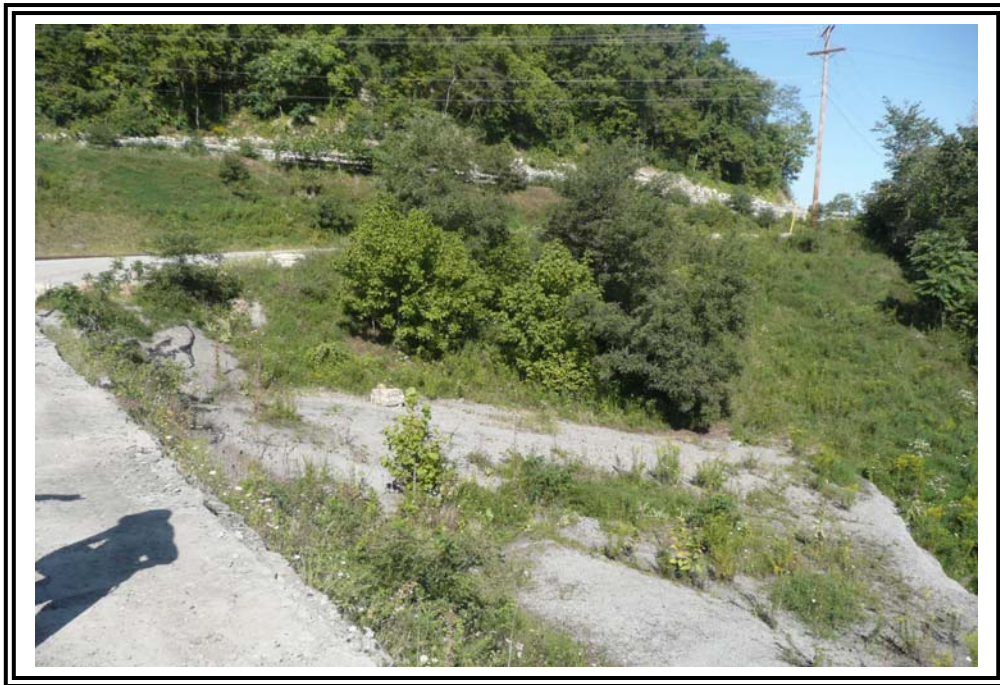
67

On crest looking west at abutment on upstream side.

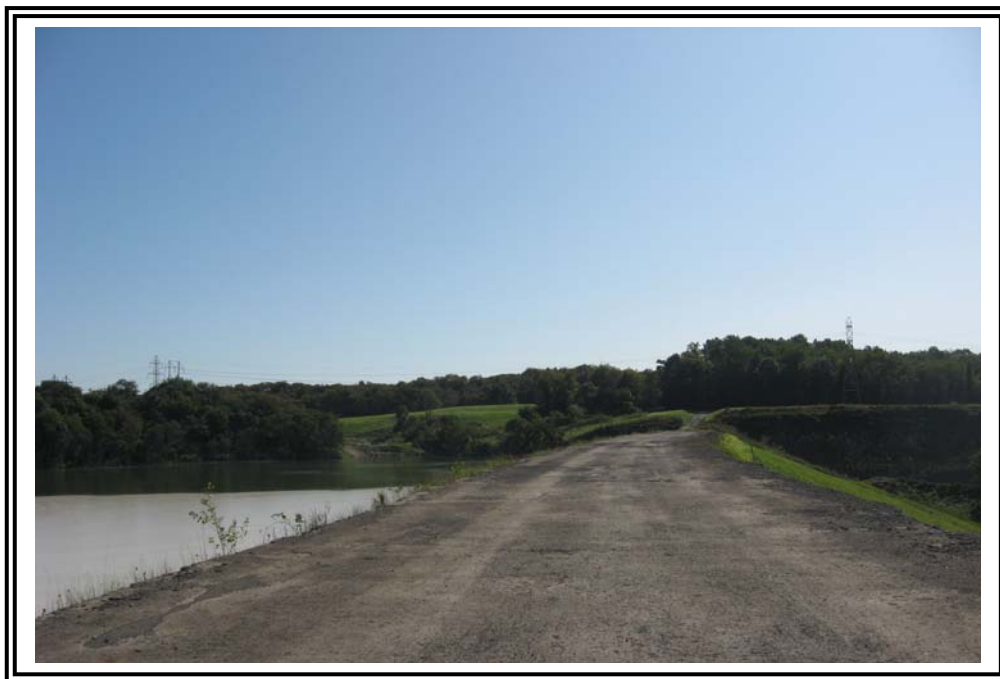
68

On crest looking east toward left abutment and emergency spillway.

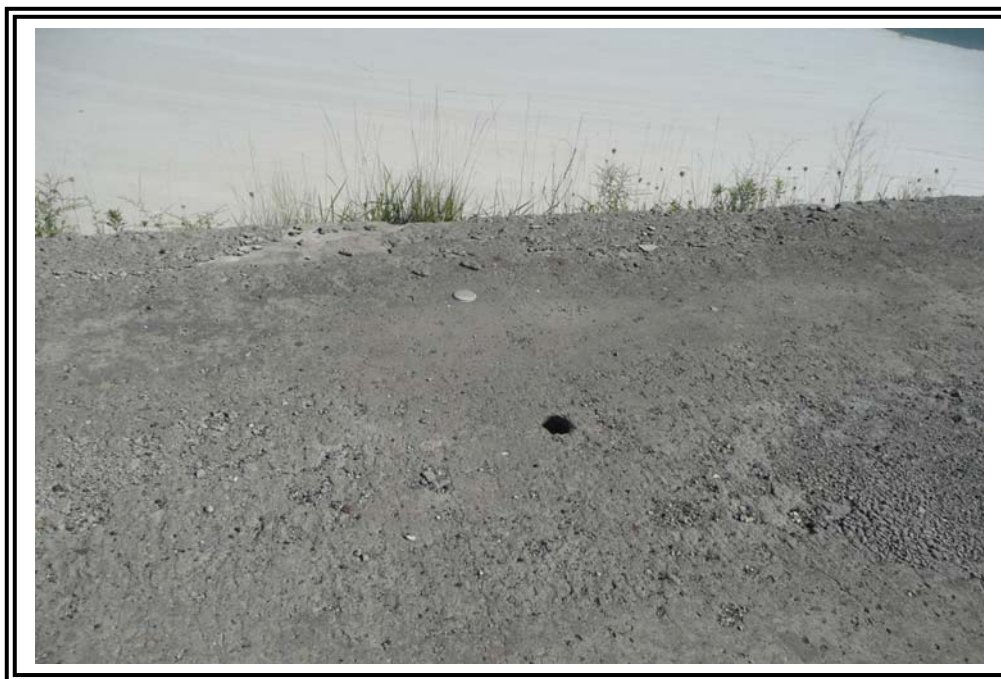
70

Open observation borehole and deformation monument on crest (typical).

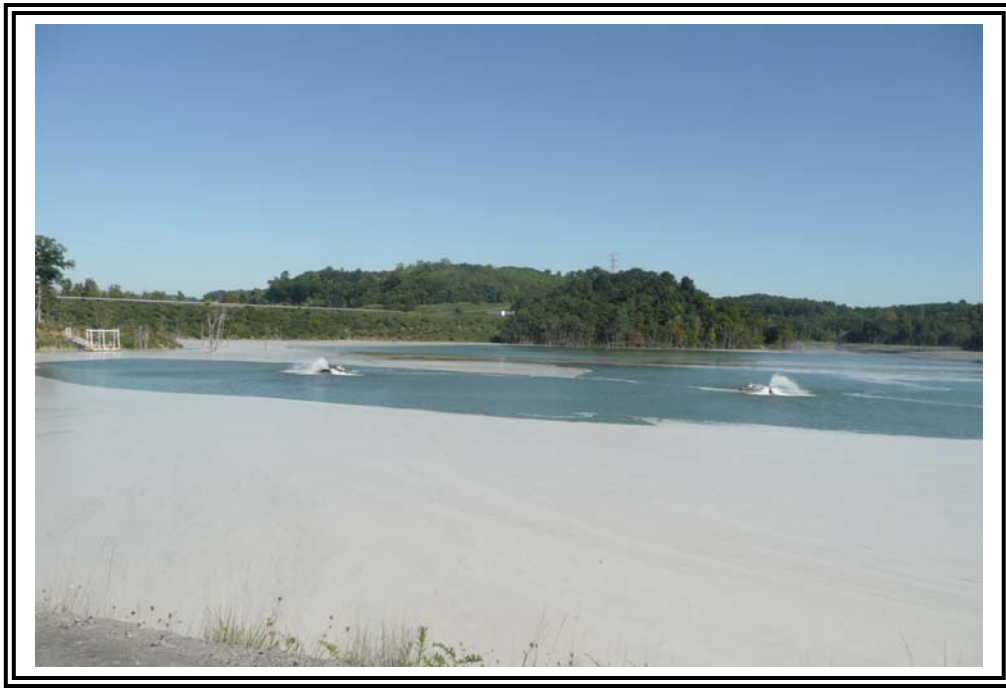
71

Looking north from crest across the reservoir at Fly Ash Dam No. 1

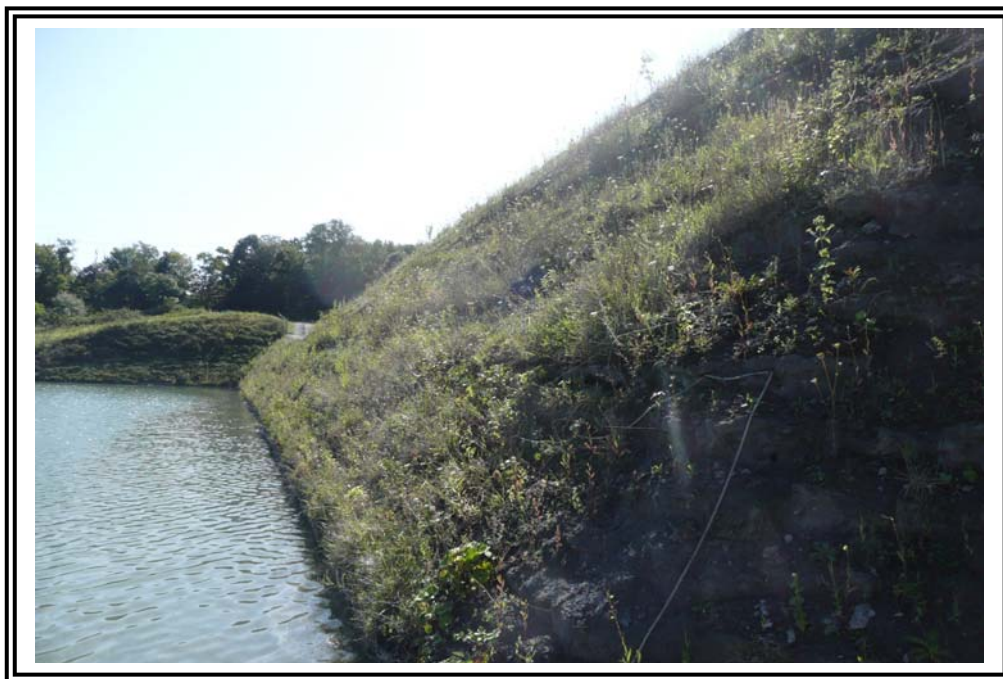
The upstream slope of the roller compacted concrete (RCC) crest is fairly steep and generally appears to be in good condition. Sparse vegetation has slowly started to establish itself (Photos 76 and 77). Due to the nature of the upstream slope, only a limited portion could be directly viewed during the site visit.

Upstream slope looking east from spillway.

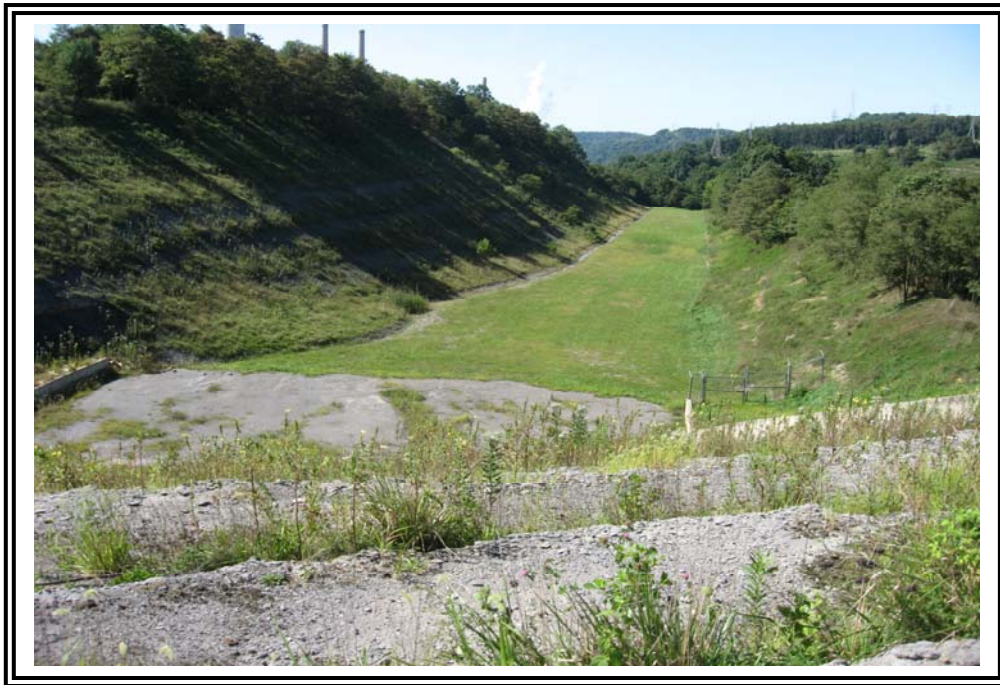
79

Emergency spillway, looking south from crest. Note that this spillway is excavated through hillside.

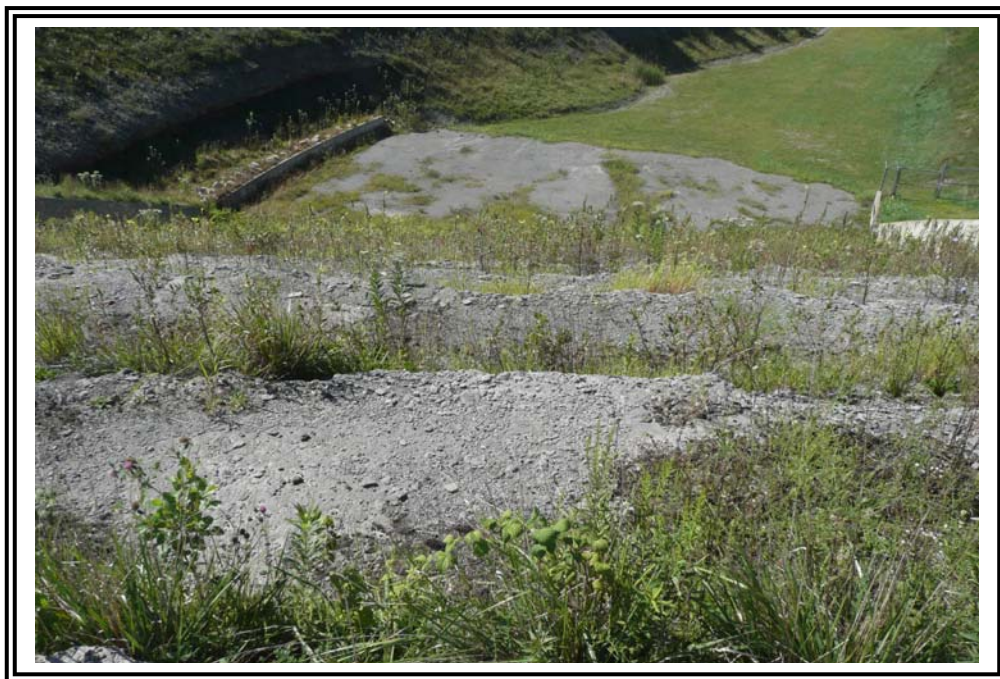
80

Close-up view of emergency spillway showing RCC steps for energy dissipation, vegetation, and weathering.

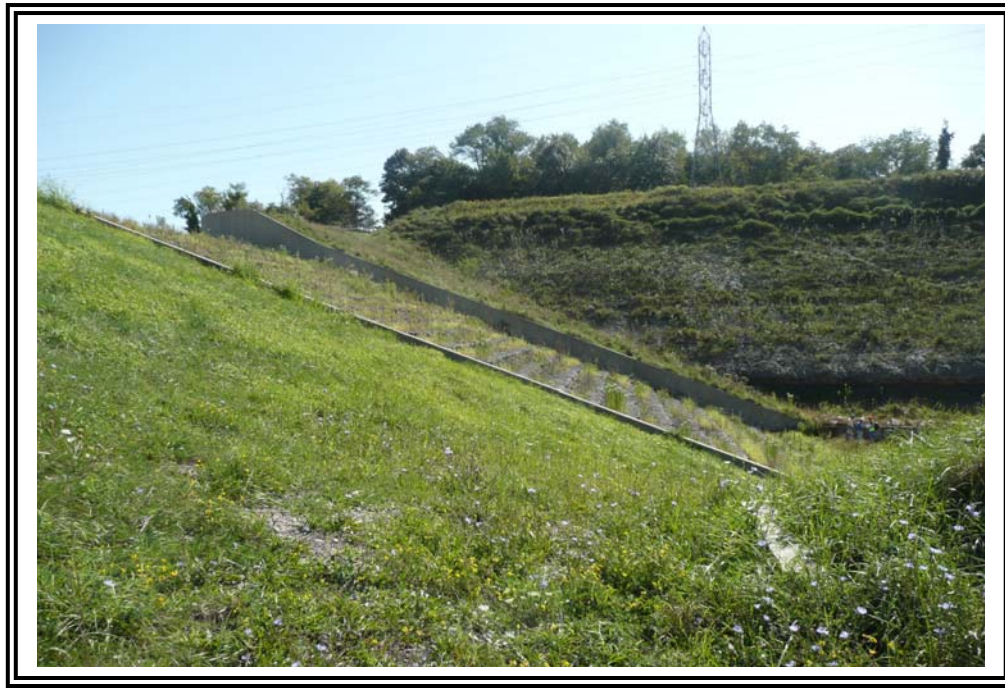
81

Downstream slope on RCC portion looking toward emergency spillway and left (east) abutment. Bedrock is exposed in far slope.

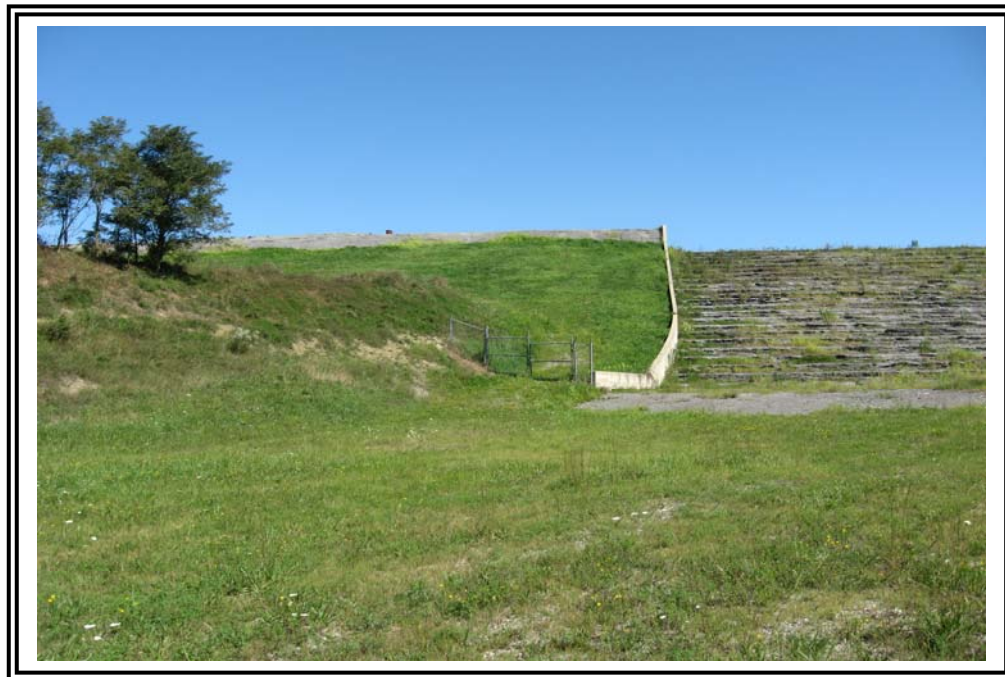
82

Looking north at dam crest and emergency spillway from downstream channel.

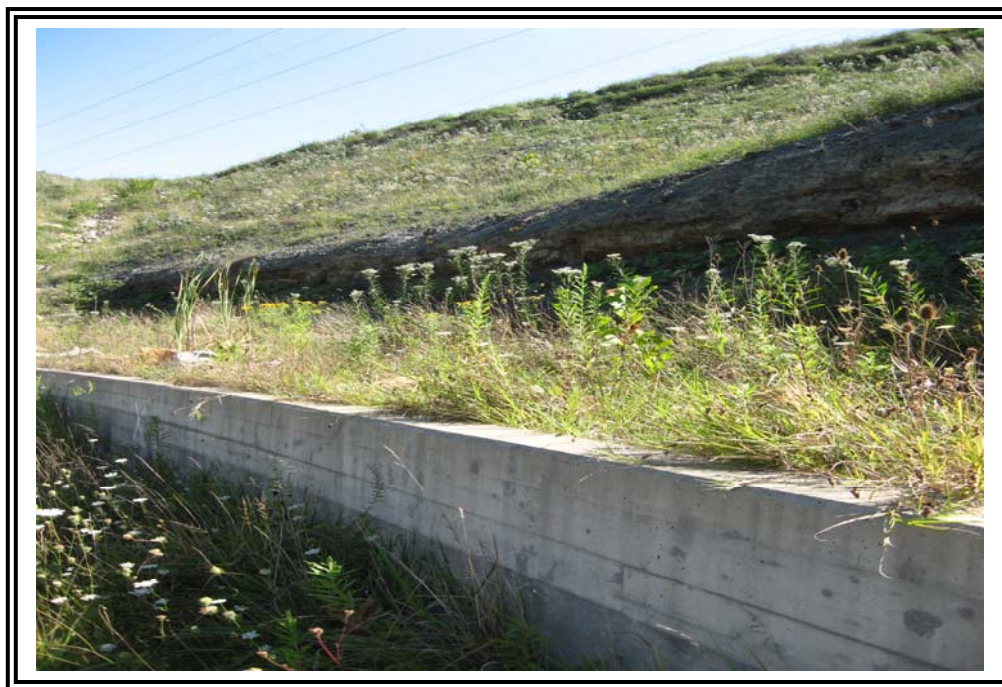
83

Left (east) concrete training wall at emergency spillway outfall channel. Note exposed bedrock.

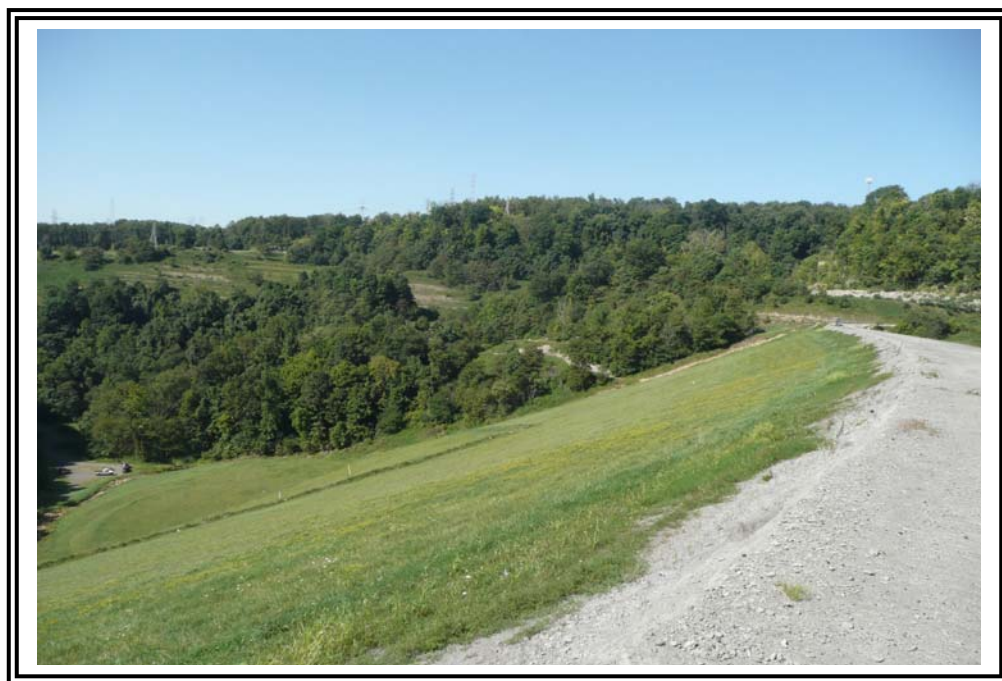
84

Overall downstream slope showing lower benches looking west from crest adjacent to spillway.

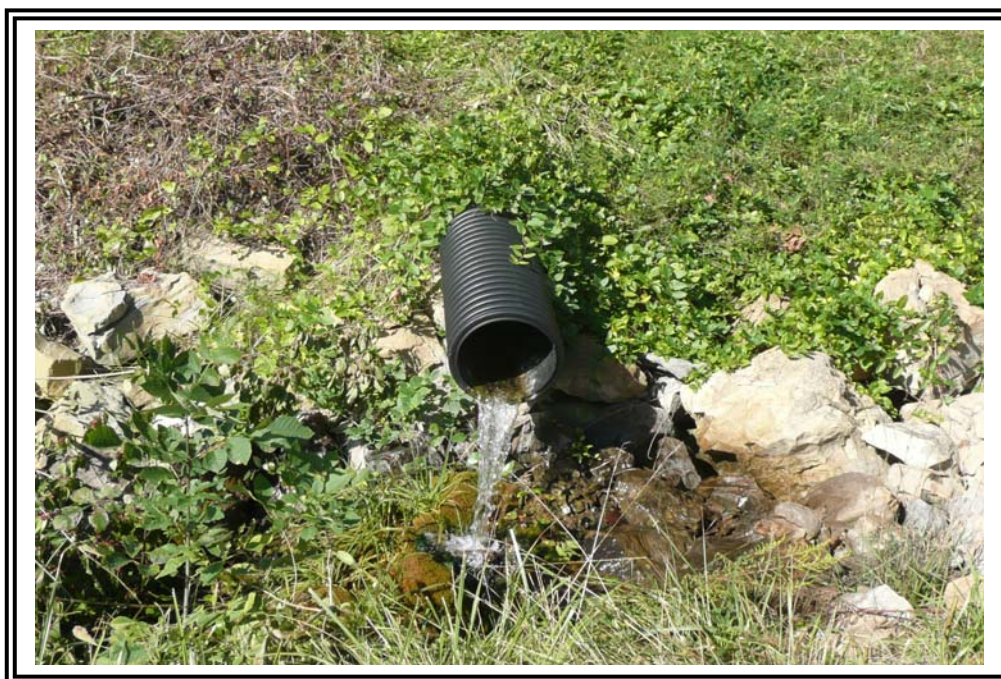
88

Active outlet from 12" pipe into west abutment rock groin from trench drain in natural hillside. Appears to supply most of the water flowing in the groin below about elevation 900.

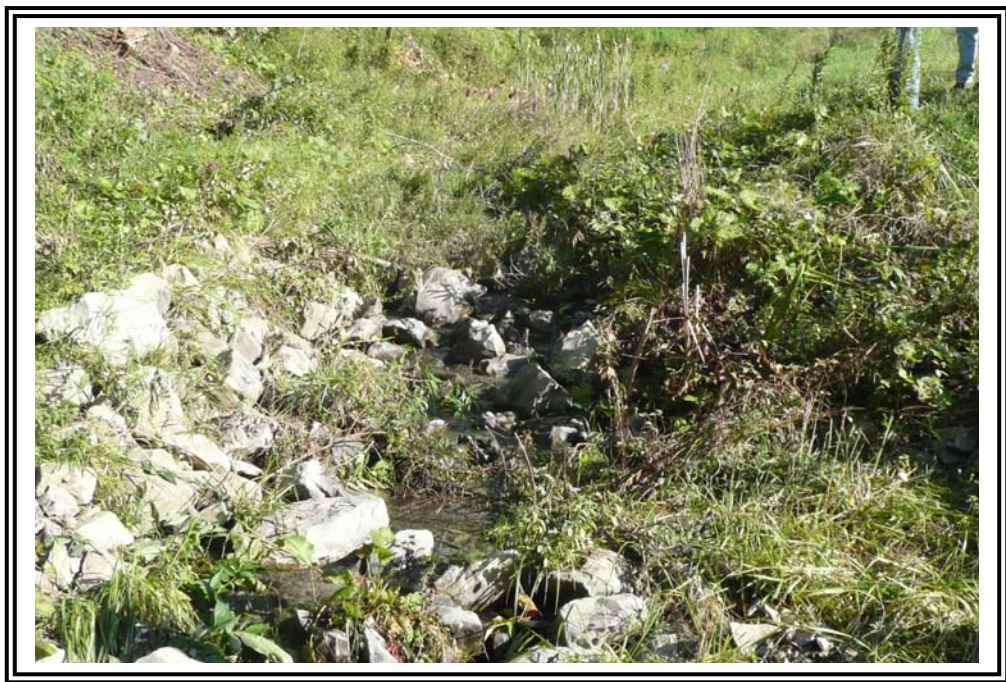
90

Water in right (west) groin adjacent to lower benches flowing toward toe drain.

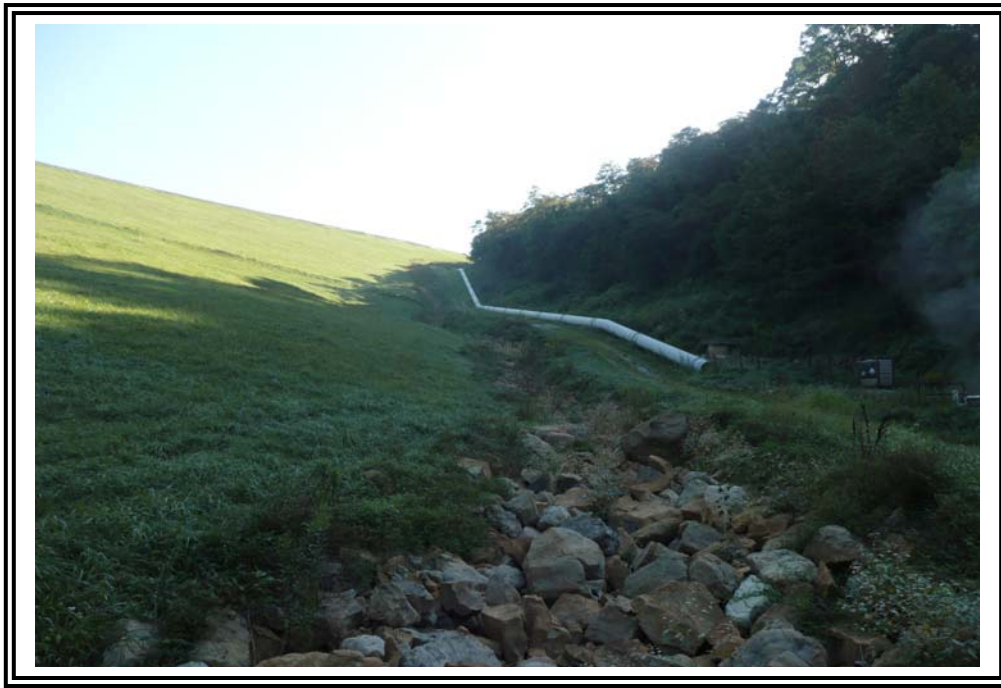
91

Looking upslope at left (east) rock groin and 42" diameter spillway outlet from toe drain

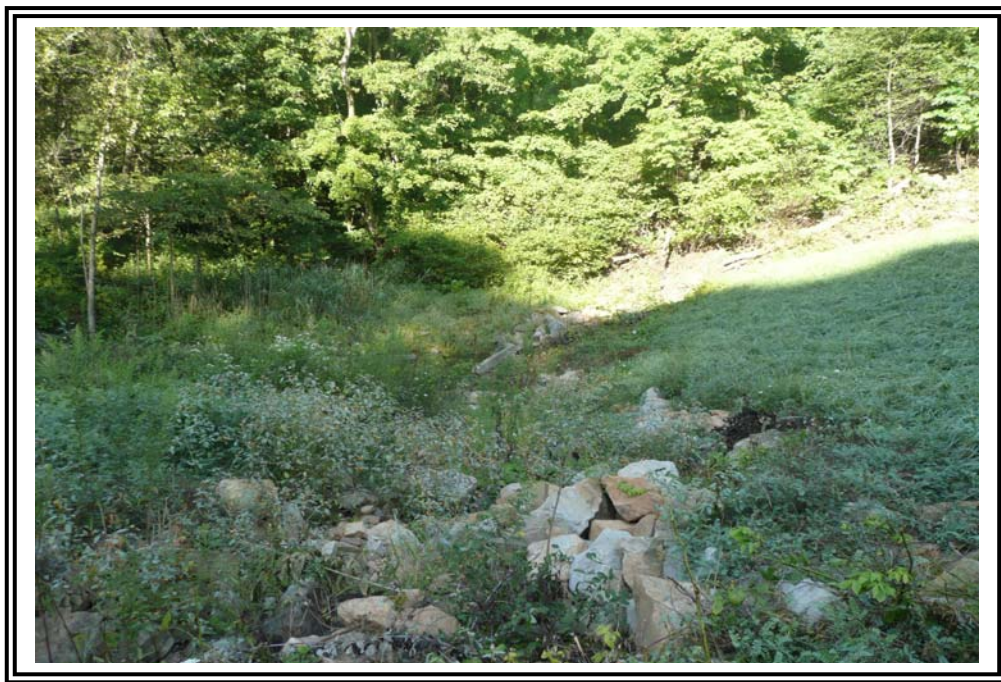
92

The toe drain is armored with 18-inch diameter rip rap, roughly 5 to 6 vertical feet of which is exposed at the slope toe (Photo 92). This toe terminates in a collection pool where additional drainage pipes actively convey water to the pool (Photos 93 and 94) which in turn empties into a

Looking west at rock toe and seepage pool in background. Note rip rap placement and vegetation.

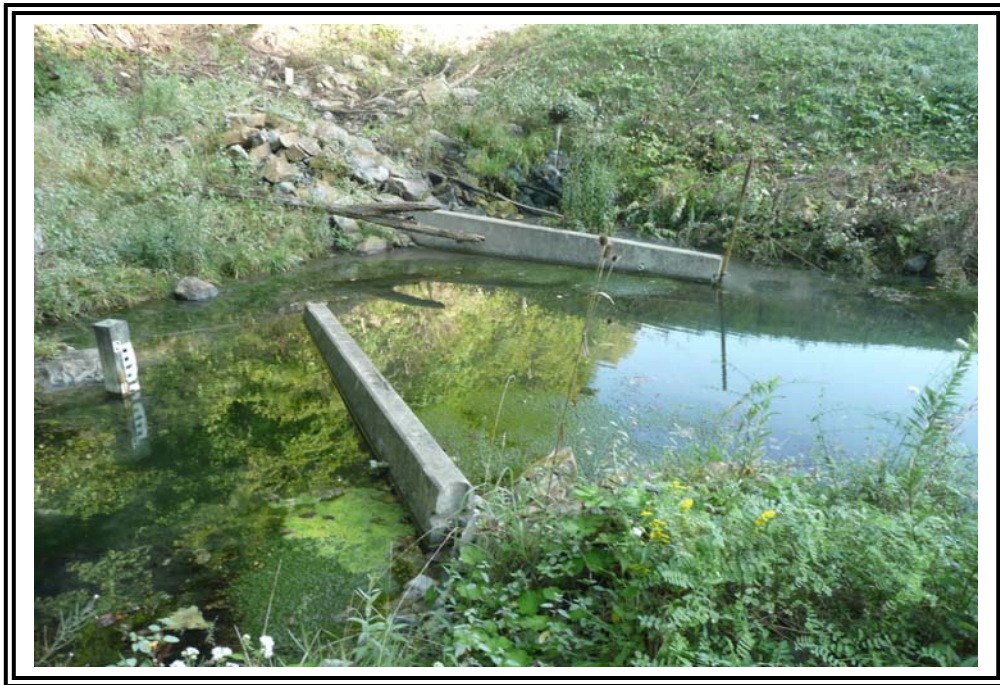
93

View of active toe drain discharge, seepage collection pool, and concrete baffles.

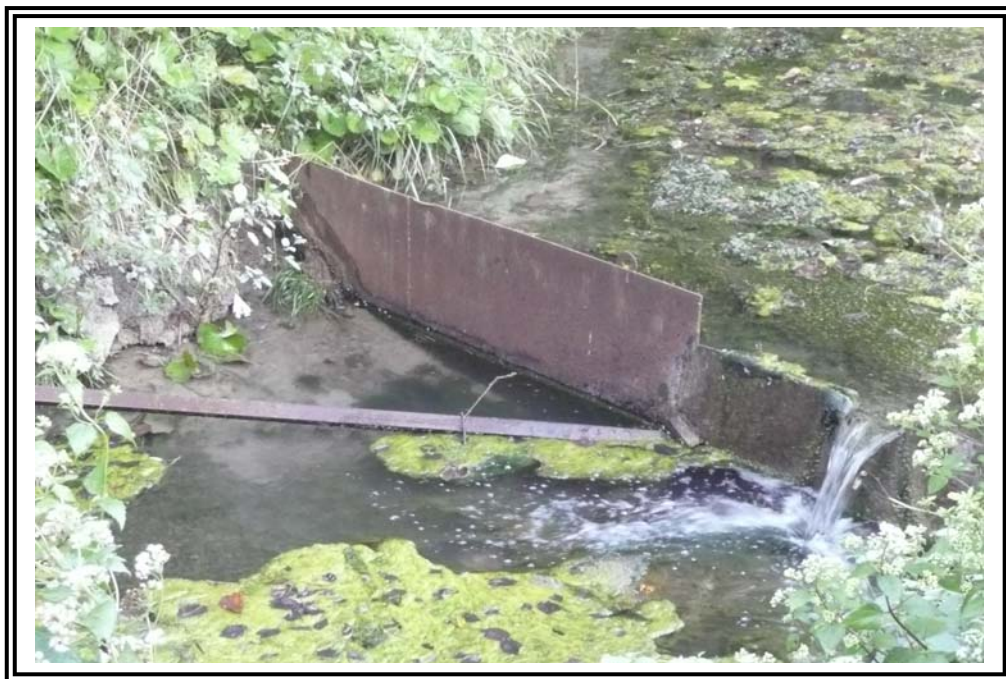
96

Steel V-Notch weir (typical) noted downstream of concrete weir shown in Photo No. 93

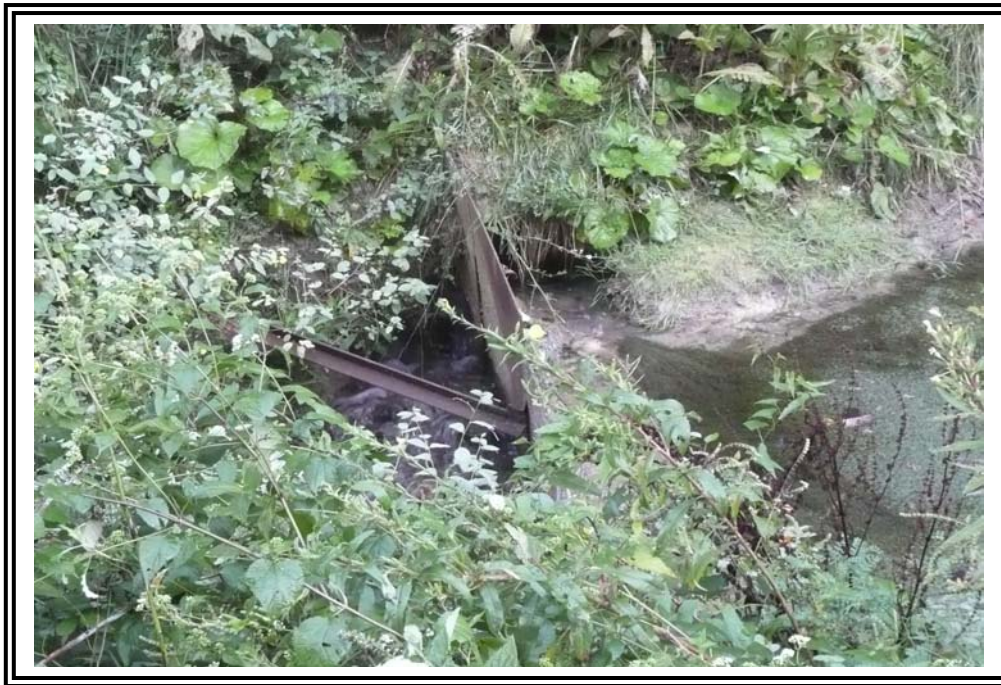
97

Ineffective steel V-notch weir where water flows along seepage path around weir.

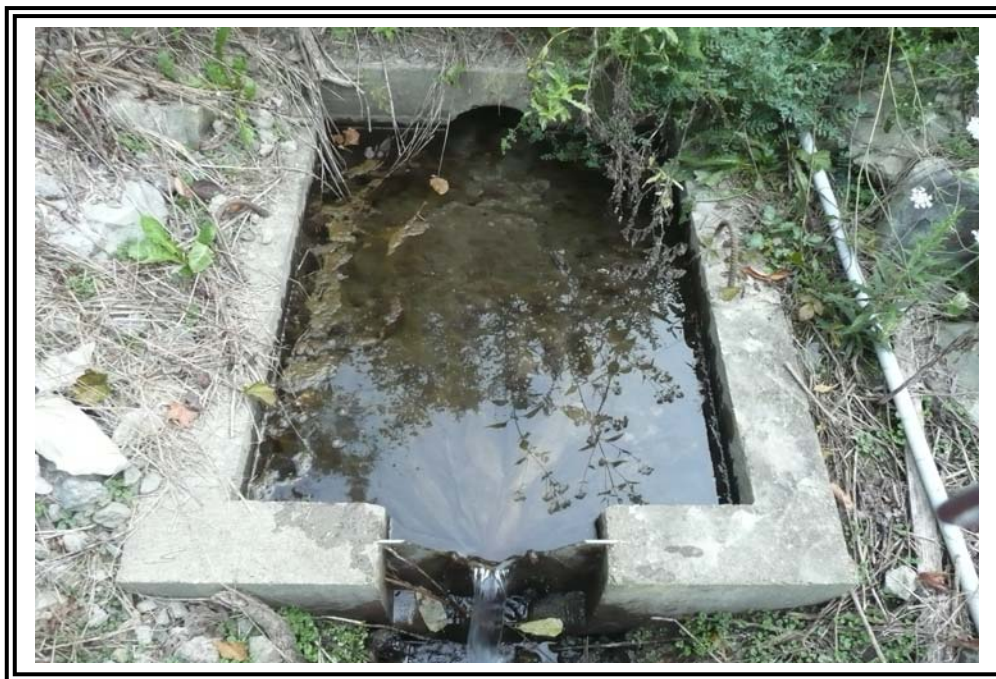
98

V-notch weir at original (Pre RCC) toe drain.

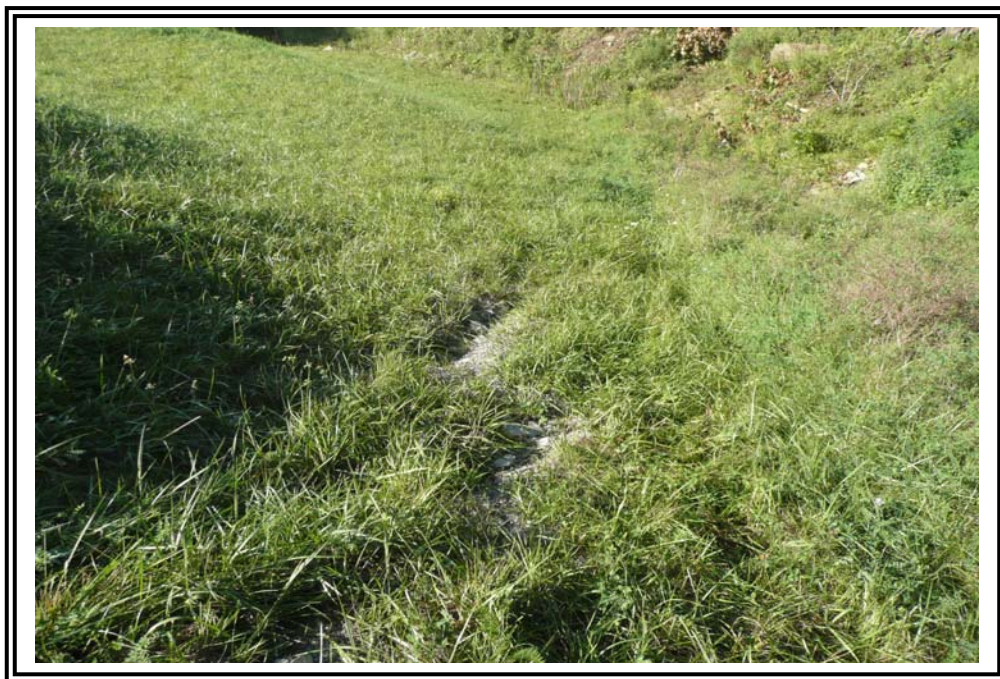
100

Erosion feature on downstream slope next to west groin at upper bench.

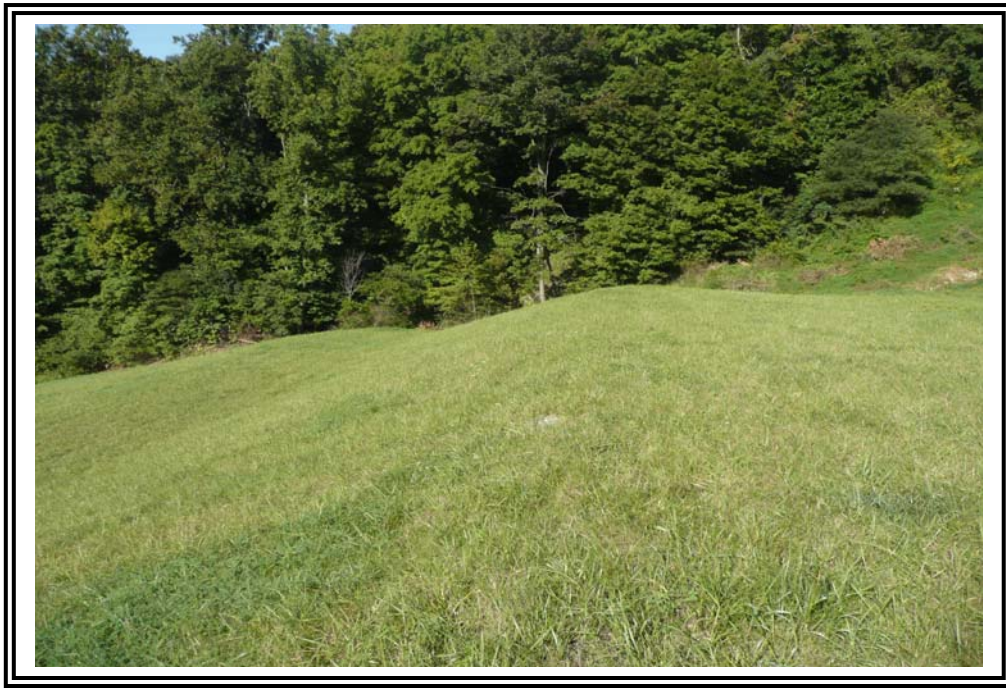
101

Downstream slope looking west at crest of upper bench.
