# Assessment of Dam Safety Coal Combustion Surface Impoundments (Task 3) Draft Report

American Electric Power

Cardinal Power Plant

Brilliant, Ohio

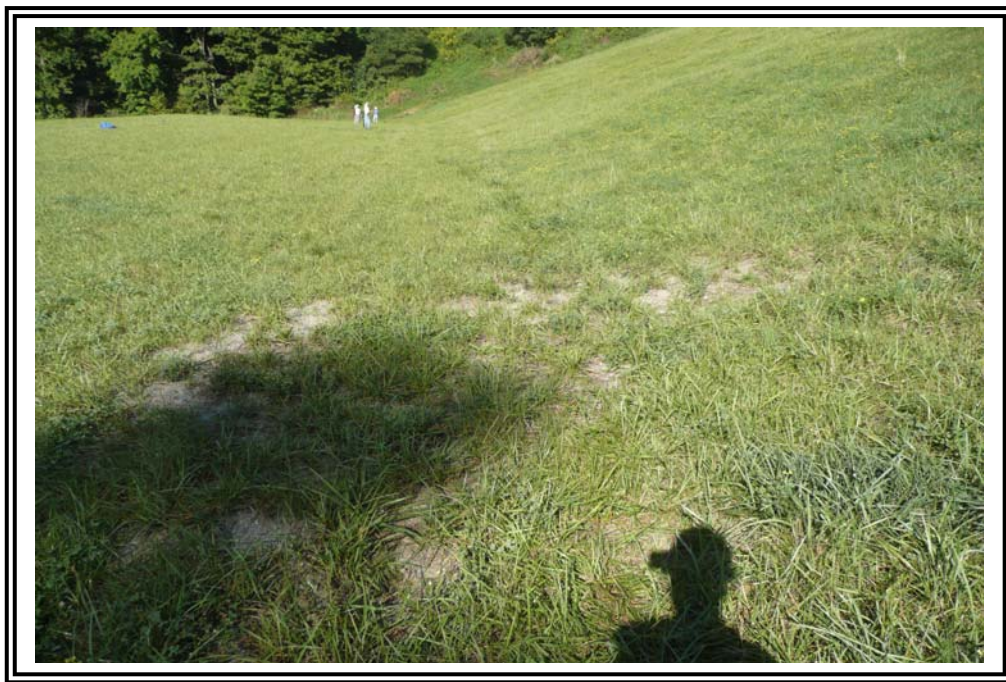
102

Sporadic loss of grass cover on upper bench adjacent to left (east) abutment

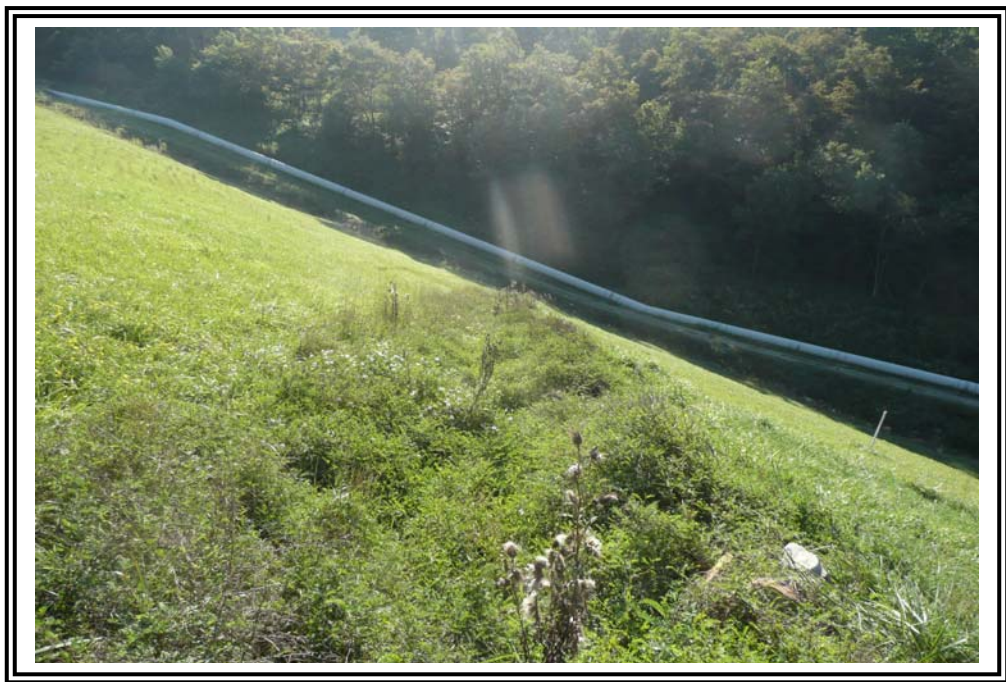
104

Looking east at slope drainage groin. Vegetation obscures rip rap

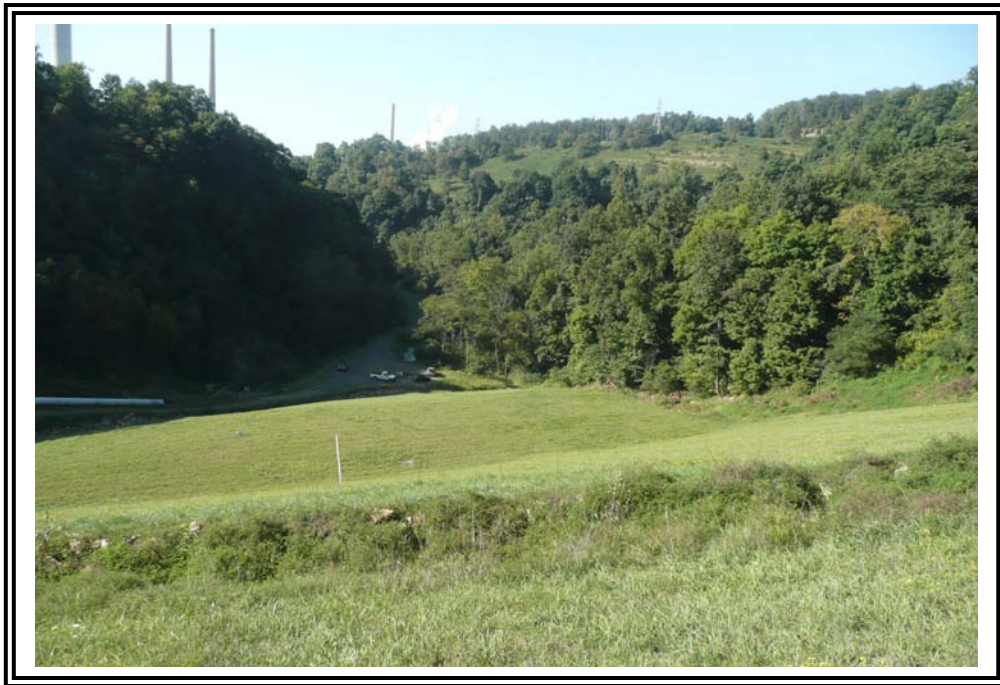
105

Another view of slope groin and general slope grass cover, looking downstream.

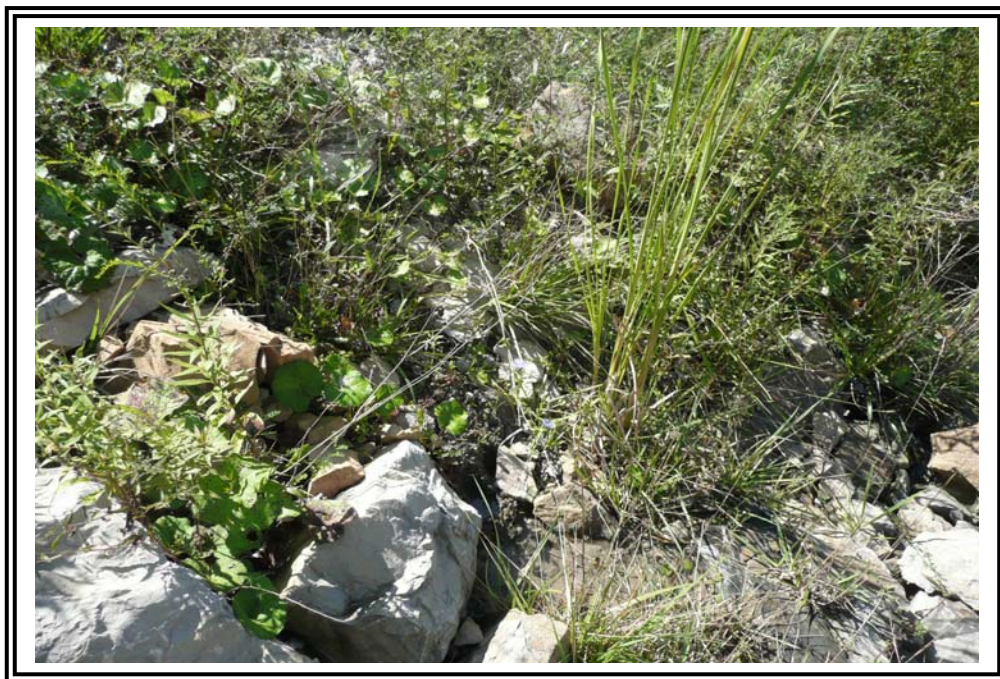
106

Area of small seep in left (east) abutment groin at approximate intersection with slope groin.
