**Coal Combustion Residue Impoundment  
Round 9 - Dam Assessment Report**

*Glen Lyn Power Plant  
Ash Pond Management Units  
Appalachian Power  
d/b/a American Electric Power  
Glen Lyn, VA*

Dewberry & Davis, LLC  
Fairfax, Virginia

Under Contract Number: EP-09W001727  
**April 2011**

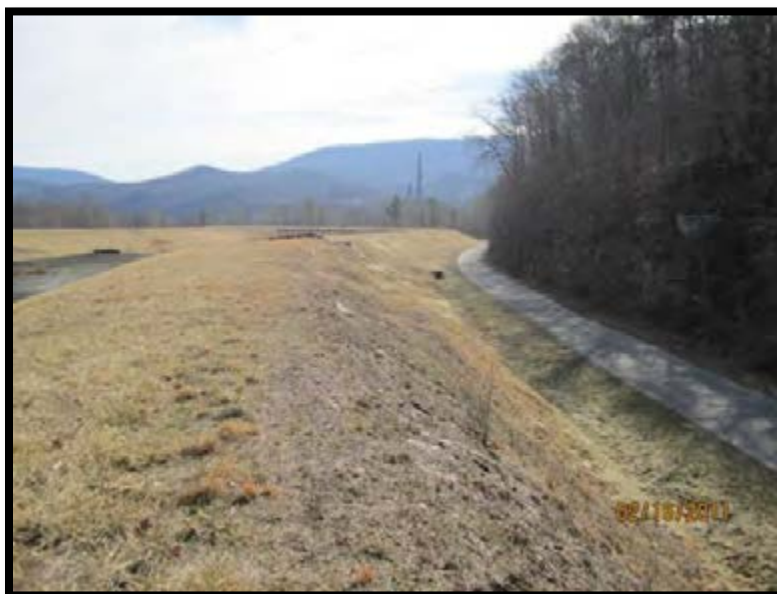
The crest of the perimeter dike had no significant signs of depressions, tension cracks or other indications of settlement or shear failure. Figure 5.2.1-1 and Figure 5.2.1-2 shows the typical crest conditions along the perimeter dike.

**Figure 5.2.1-2:** Crest, Southeast. Route 649 to the right.

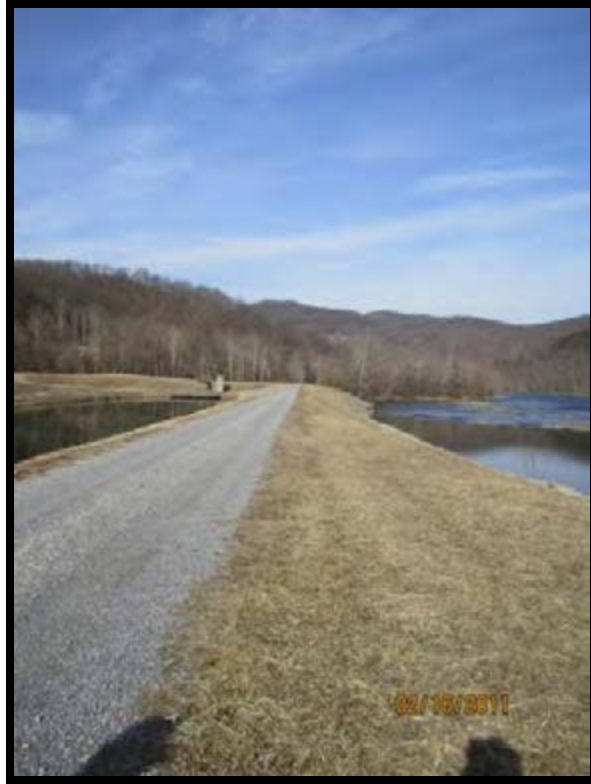
The crest of the perimeter dike had no significant signs of depressions, tension cracks or other indications of settlement or shear failure. Figure 5.3.1-1 and Figure 5.3.1-2 shows the typical crest conditions along the perimeter dike.

**Figure 5.3.1-2:** Crest, Northwest. New River to the right.

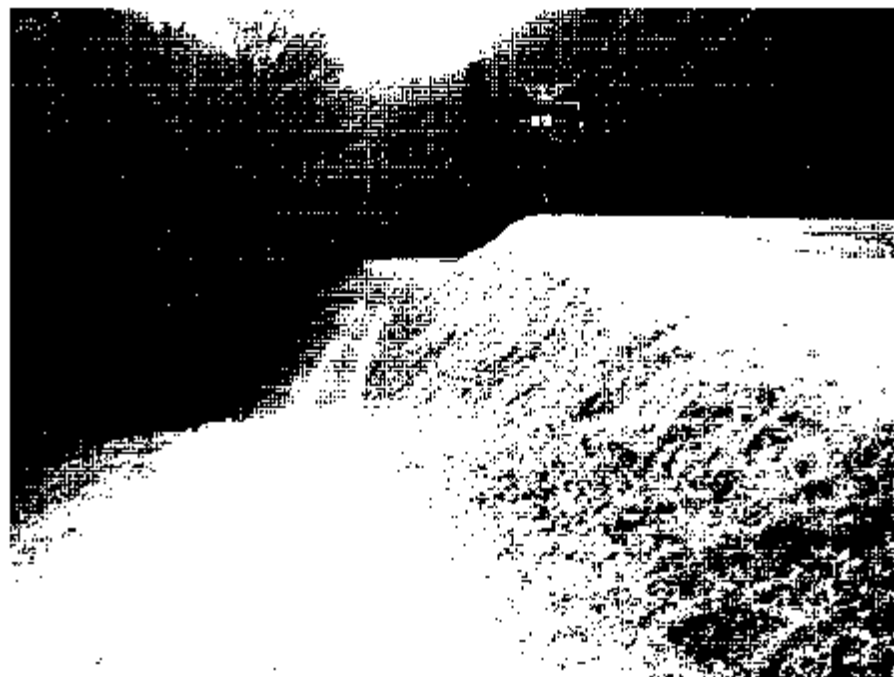
5. The exterior slope of the east dike appeared satisfactory with no signs of apparent instability. This section of dike had been mowed recently. There were no signs of rodent holes or erosion gullies. As noted in other reports, the exterior slopes are steeper than the north dike. (Photo 2)

Photo #2 – View of east dike, looking south

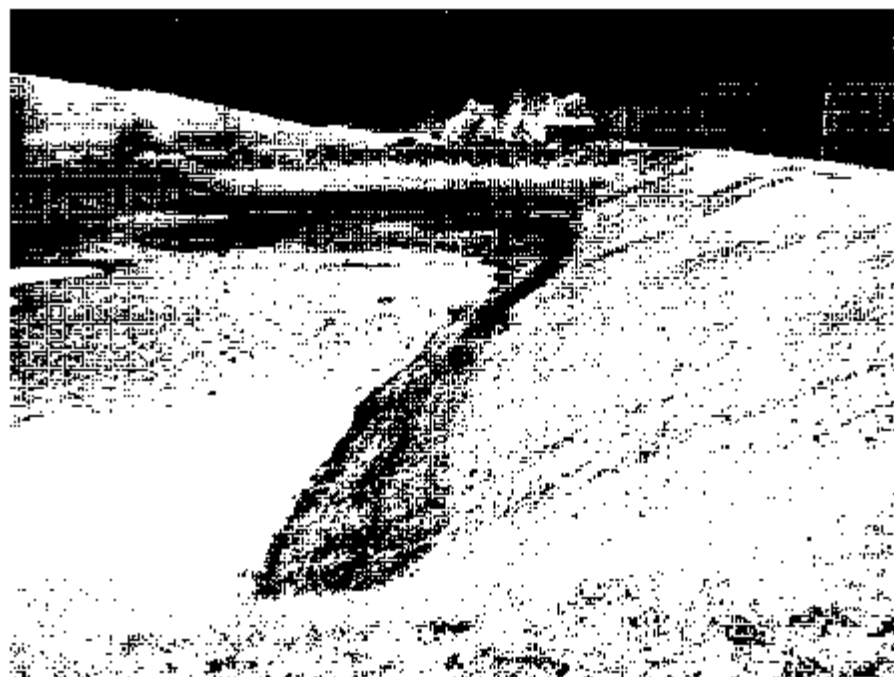
Photo #4 – View of interior slopes and water level

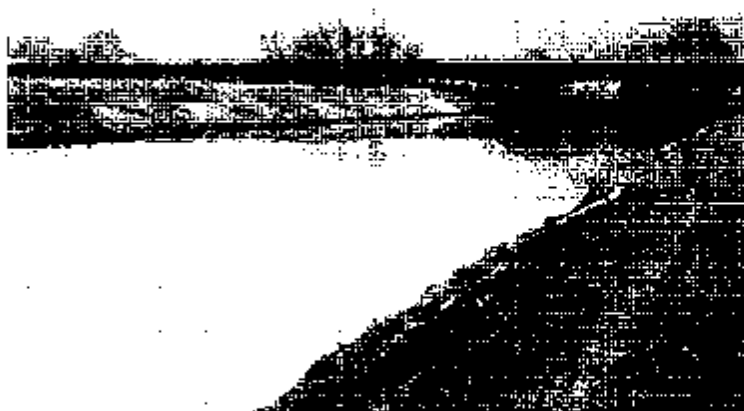
Photo # 2

South pond - dewatered.

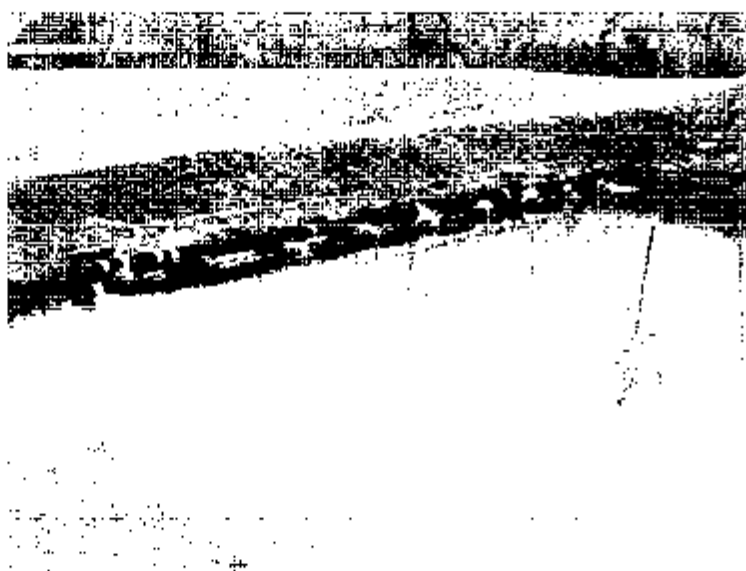
Photo # 6

7. Visible portions of the Clearwater Pond concrete discharge structure, wood steps, wood railing, platform, and intake structure were in satisfactory condition. Lower portions of the interior slope adjacent to this area are very steep, however, there are no other signs of instability or sloughing. (Photo 6)

Steep internal slopes of Clearwater Pond near the outlet structure.
