CCW IMPOUNDMENTS INSPECTION REPORT

**MITCHELL POWER PLANT
MARSHALL COUNTY,
WEST VIRGINIA**

**PROJECT NO. 09-4157
DECEMBER 2009**

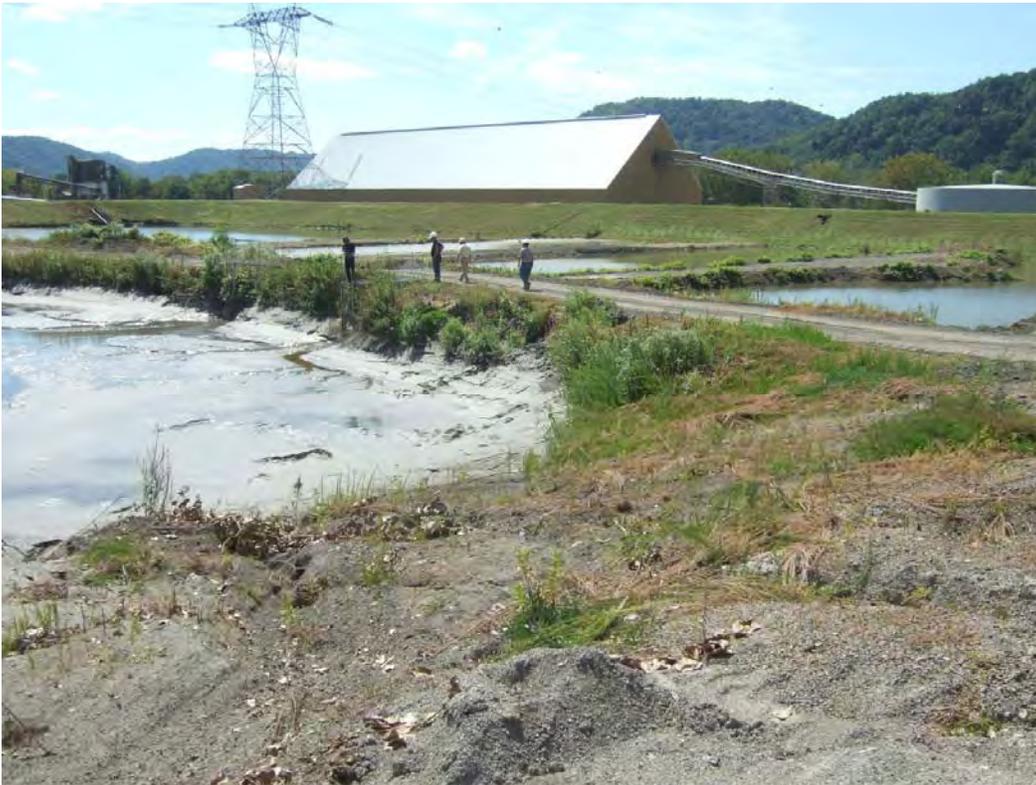
Vegetation control along the upstream and downstream slopes was considered to be good. Some heavier vegetation was observed along the waterline of the pond and at the overflow structure located on the upstream slope of the south embankment (**Photographs 25, 26 and 32**). Significant vegetation and signs of erosion were observed along the center berm and fingers within the impoundment, but are not considered a hazard to the safety of the impoundment. A small wet zone was found at the toe of the northwest corner of the impoundment (**Photographs 28 and 29**). The source of the water is unknown and could just be ponded surface water. No other seepage was observed. A line of trees exists along the downstream slope of east embankment (**Photograph 19**). This slope exists well above the normal pool elevation, and the trees do not pose a hazard to the safety of the impoundment. The upstream slope of the eastern bank (area where the pond is incised) is quite steep, with some more significant erosion in the northeast corner (**Photograph 20**). Though we do not think this is a stability problem for the upstream slope, it could be safety hazard for the equipment operators handling the ash removal in the area.

PHOTO 25: NORTHWEST CORNER OF BOTTOM ASH POND

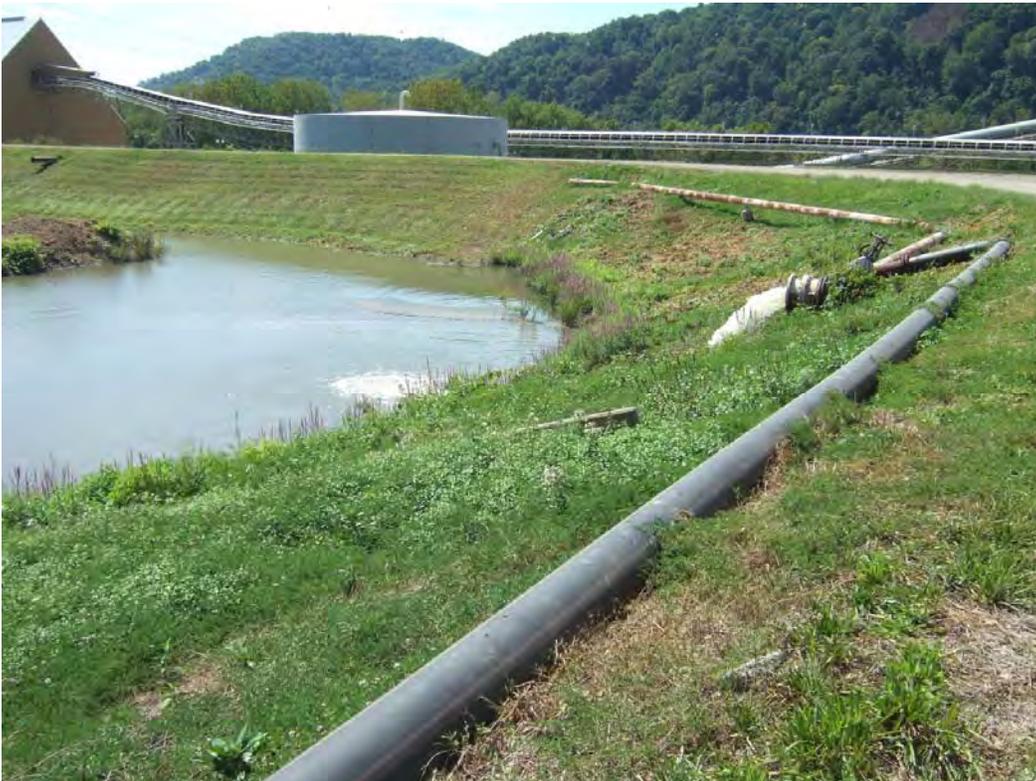
PHOTO 26: INLET INTO BOTTOM ASH POND

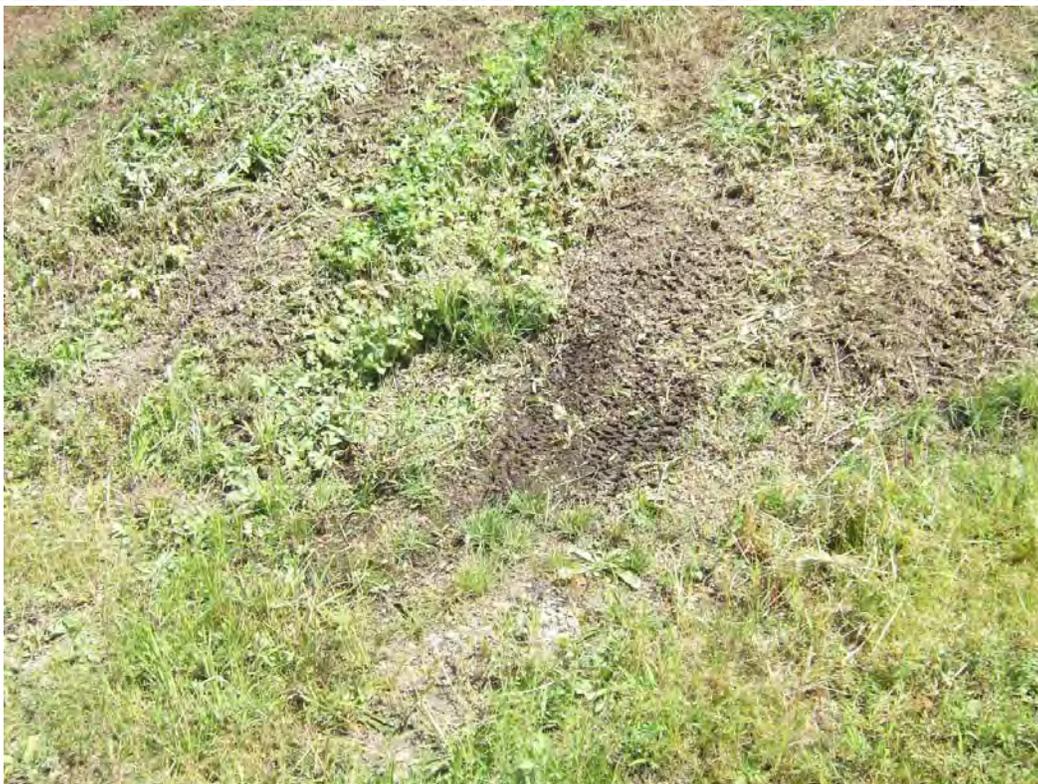
The dikes containing the metal cleaning tank secondary containment basin were looked at as well (**Photograph 30**). The vegetation around the secondary containment basin was little heavier, but the embankment looked in good condition, with no signs of erosion or sliding. The exposed PVC liner on the upstream slope looked to be in good condition.

PHOTO 30: METAL CLEAN TANK CONTAINMENT BASIN

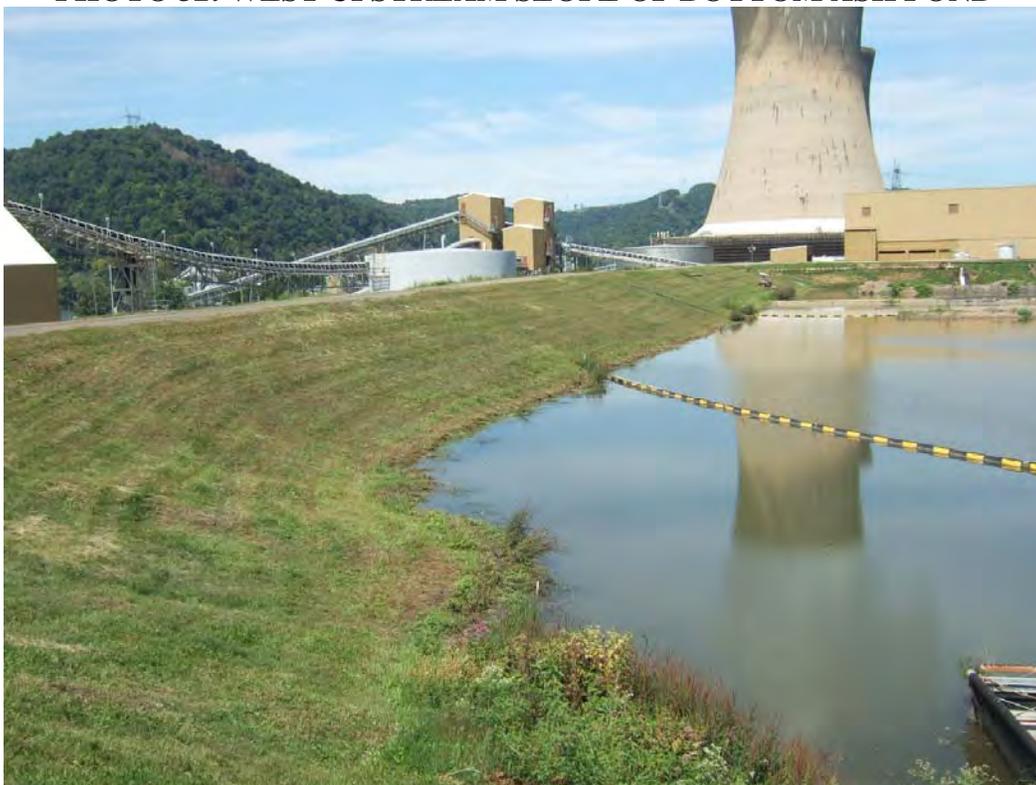
PHOTO 32: WEST UPSTREAM SLOPE OF BOTTOM ASH POND

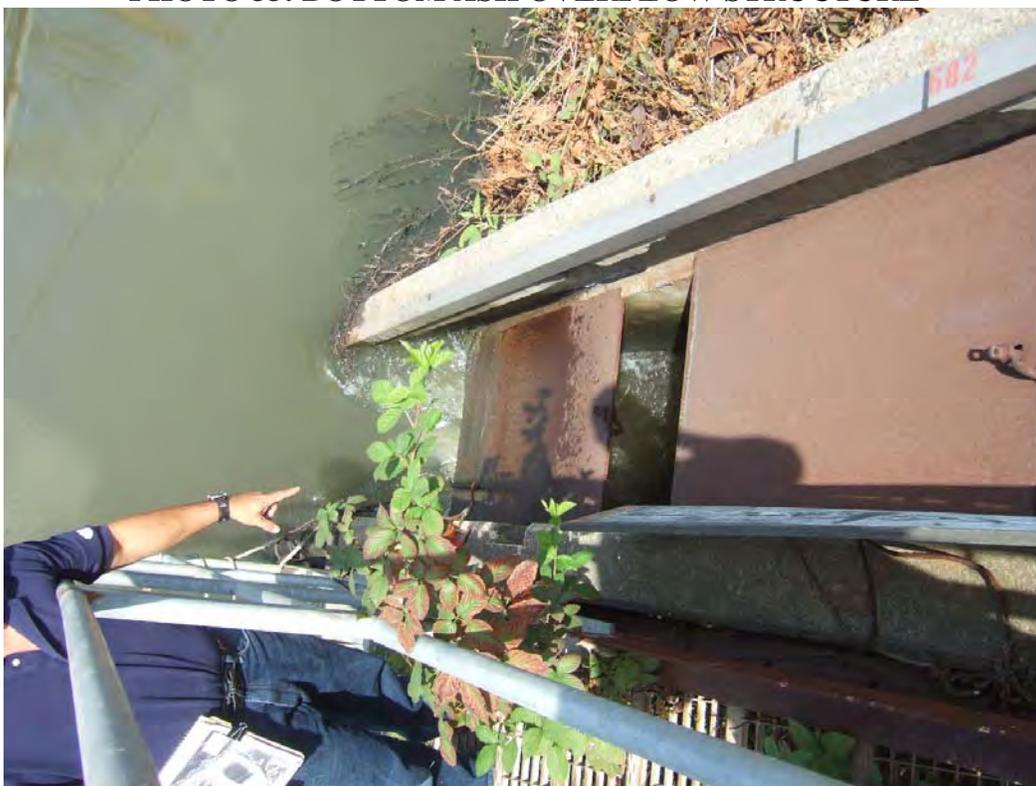
The only inflows to the impoundment include the slurry, which is pumped in from the plant, and storm runoff. The overflow structure and skimmer was in good to fair condition (**Photograph 33**). The concrete showed no signs of cracking, and the water was free-flowing. Some rust and corrosion were present on the stop log components.

PHOTO 33: BOTTOM ASH OVERFLOW STRUCTURE

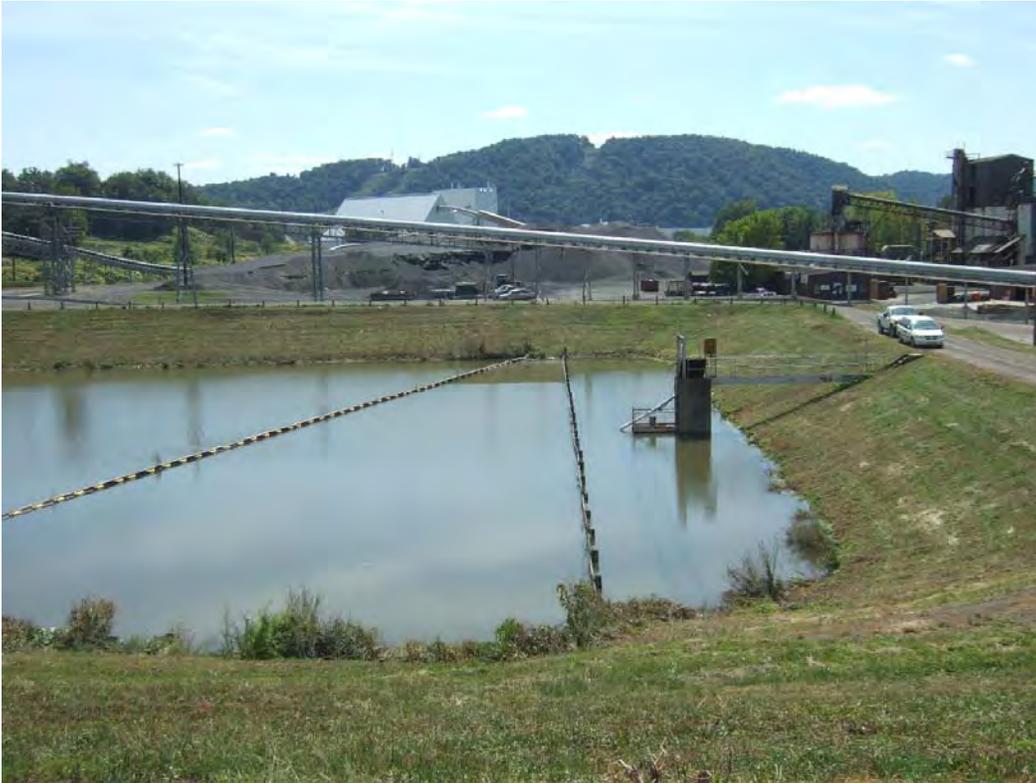
PHOTO 36: CLEAR WATER POND LOOKING SOUTH

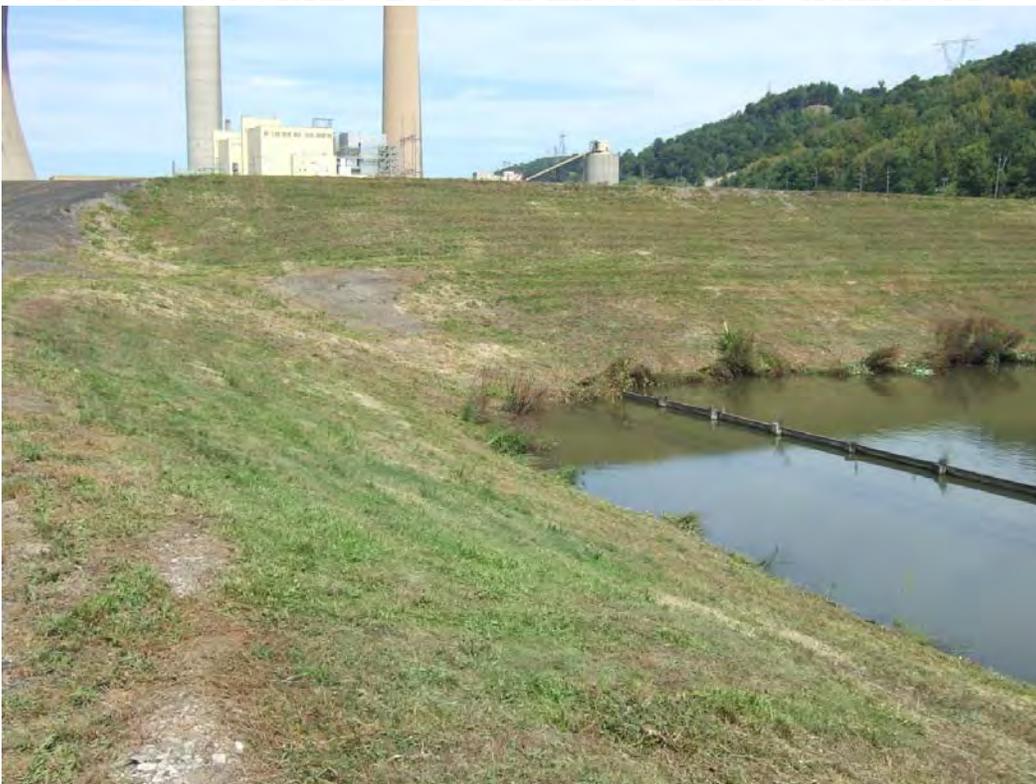
PHOTO 37: NORTH WEST CORNER OF CLEAR WATER POND

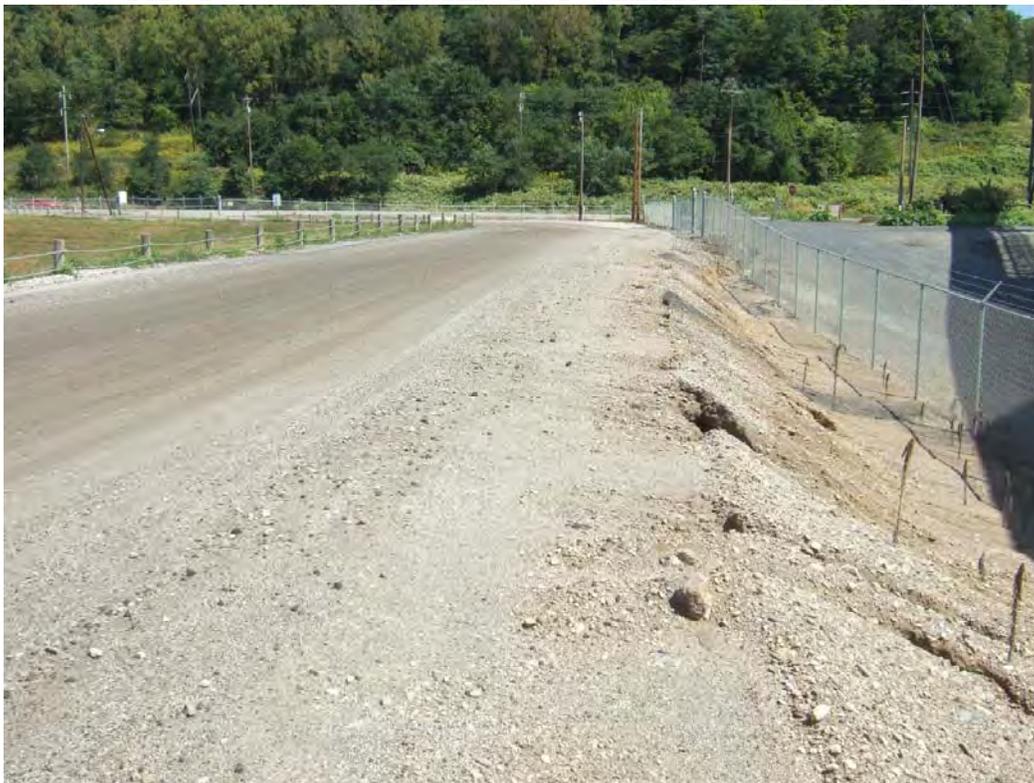
PHOTO 38: SOUTH CREST OF CLEAR WATER POND

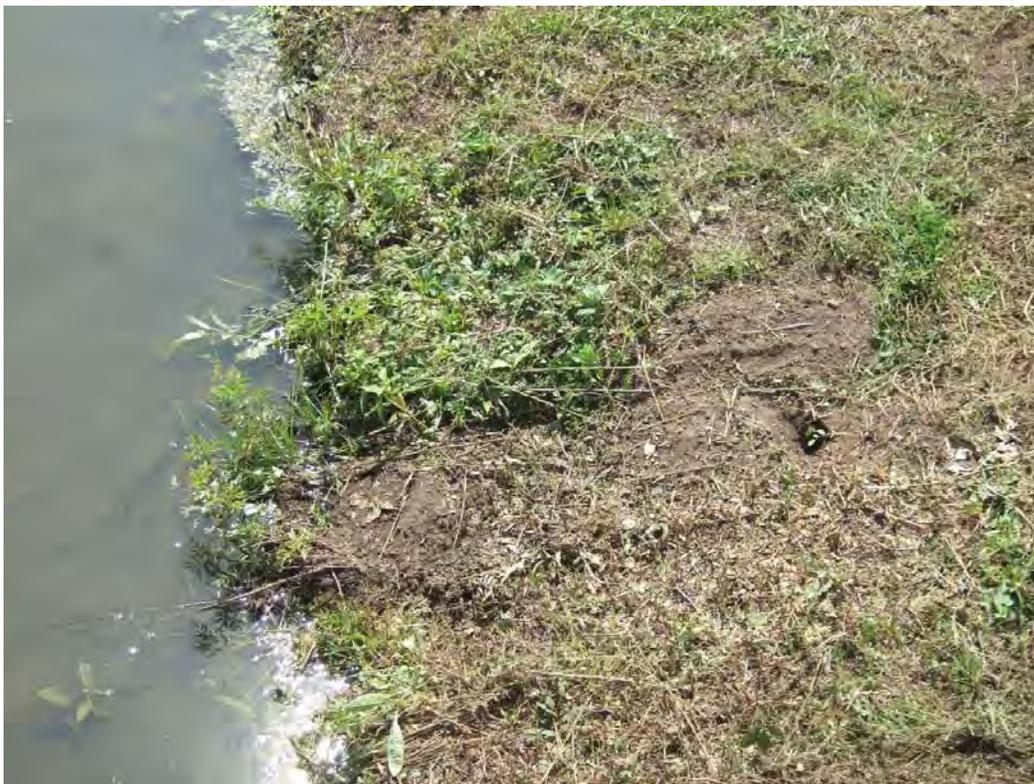
Vegetation control along the upstream and downstream slopes was considered to be good. Some heavier vegetation was observed along the waterline of the pond. No seepage was observed along the toe or along the downstream slope. A small animal borrow was discovered along the west upstream embankment about five feet from the water line that should be taken care of (**Photograph 39**).

PHOTO 39: ANIMAL BURROW ALONG WEST UPSTREAM SLOPE

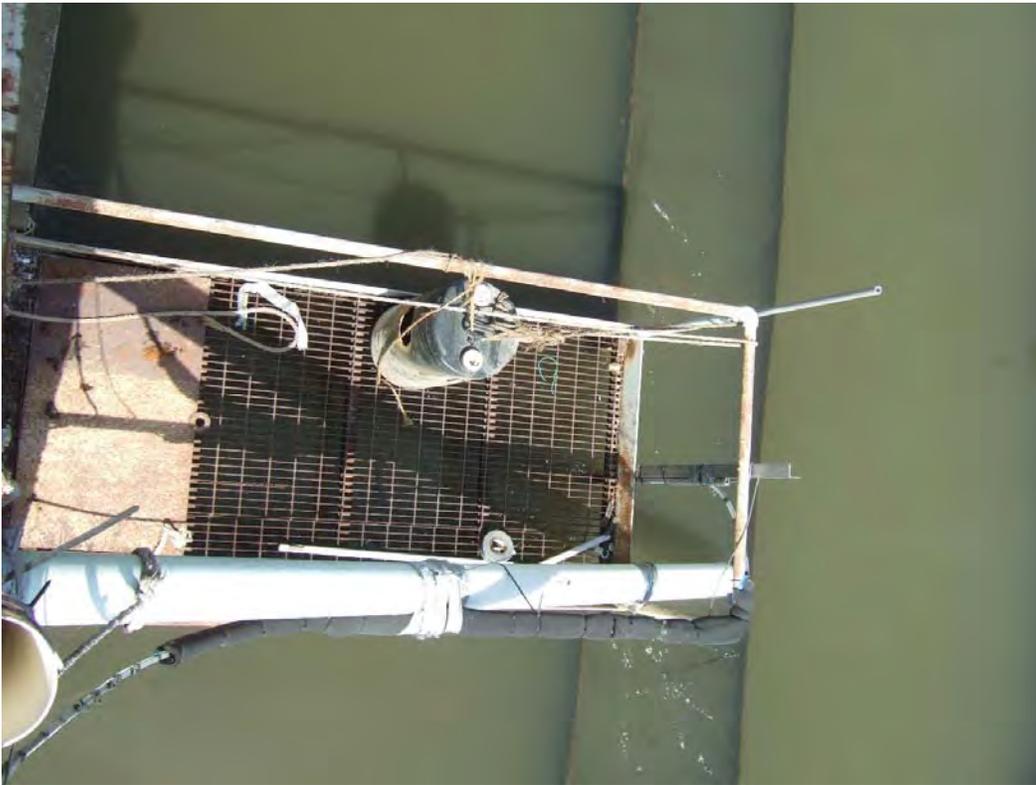
The only inflows to the impoundment include the waste water that flows in from the Bottom Ash Pond and storm runoff. The overflow structure was in good condition (**Photograph 40**). The concrete showed no signs of cracking or distress, and the water was free-flowing. Water was observed at the outlet discharging into the Ohio River. Some corrosion was observed along the metal walkway to the outlet structure. It appears to be about the same as was previously reported in past inspections.

PHOTO 40: OVERFLOW STRUCTURE FOR CLEAR WATER POND

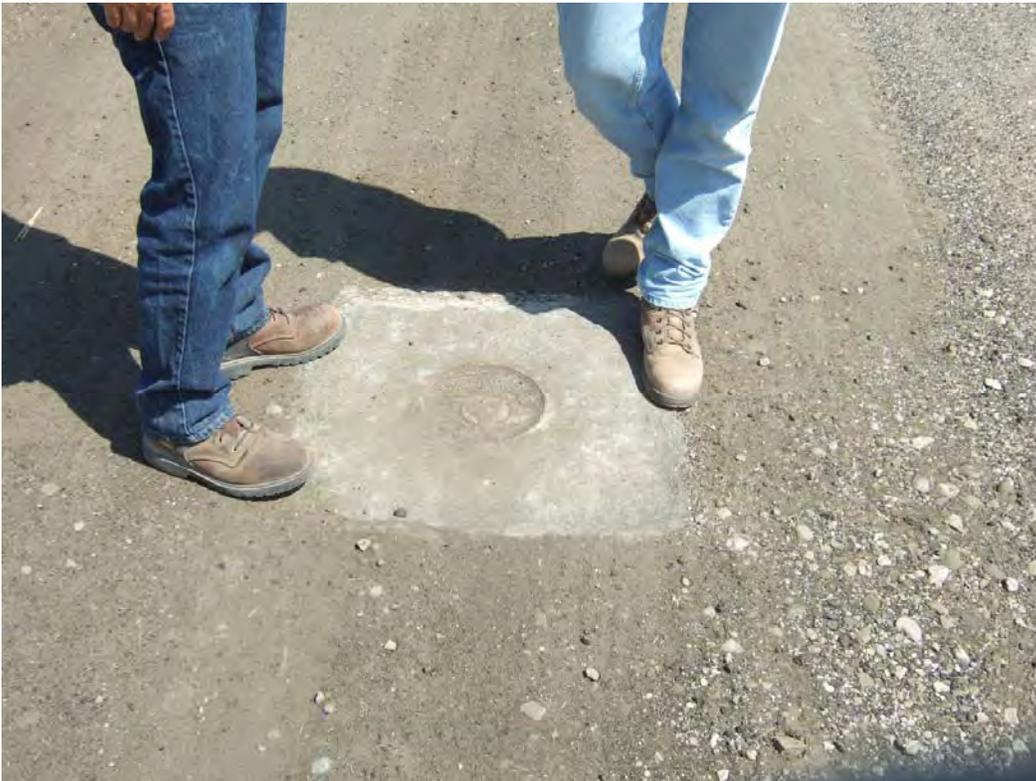
PHOTO 41: PIEZOMETER ALONG SHARED NORTH/SOUTH BERM

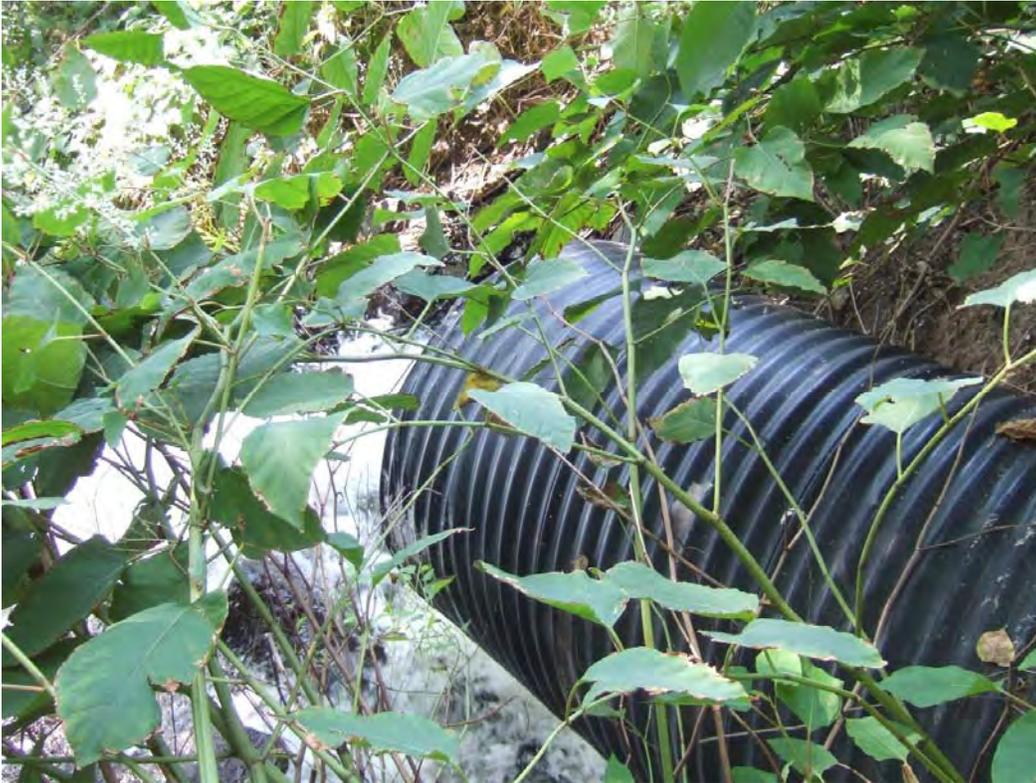
PHOTO 42: OUTFLOW FROM CLEAR WATER POND TO OHIO RIVER
