**Coal Combustion Waste Impoundment
Round 7 - Dam Assessment Report**

Meramec Power Station (Site #002)

***AmerenUE
St. Louis, Missouri***

Dewberry & Davis, LLC
Fairfax, Virginia

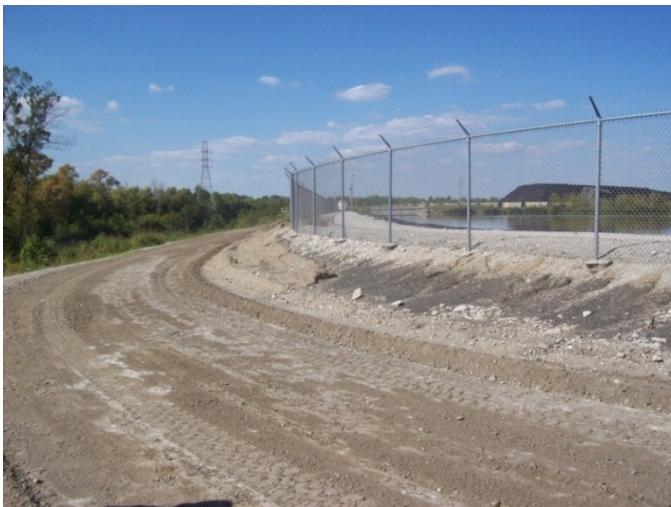
1. Looking west from access road at levee embankment at Pond 2.

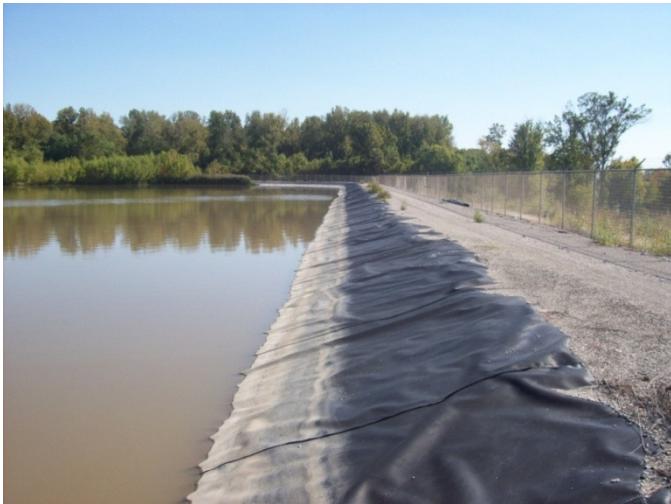
2. Looking east along internal side slope and crest of levee embankment of Pond 2. Note – liner in place.

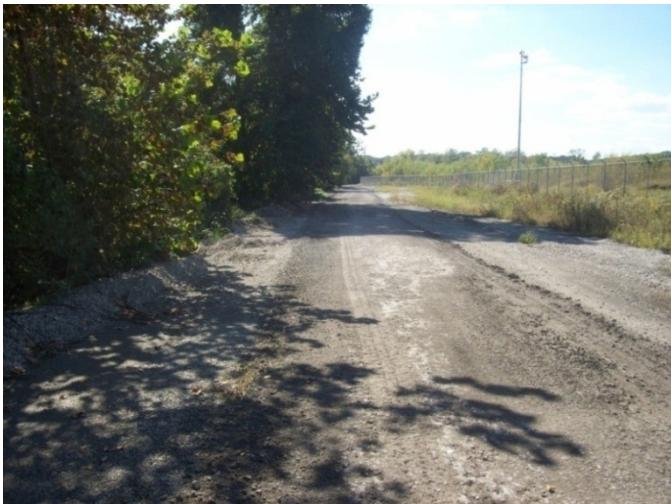
3. Looking south along embankment between railroad and Pond 2 (#489).

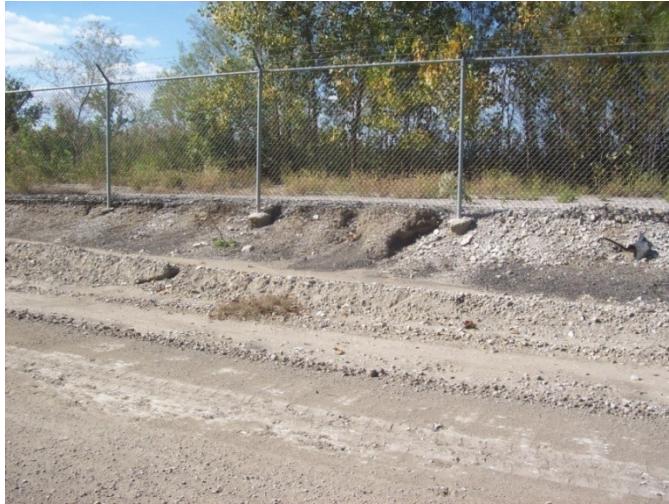
4. Looking Southwest at top of levee embankment of Pond 2 from access road.

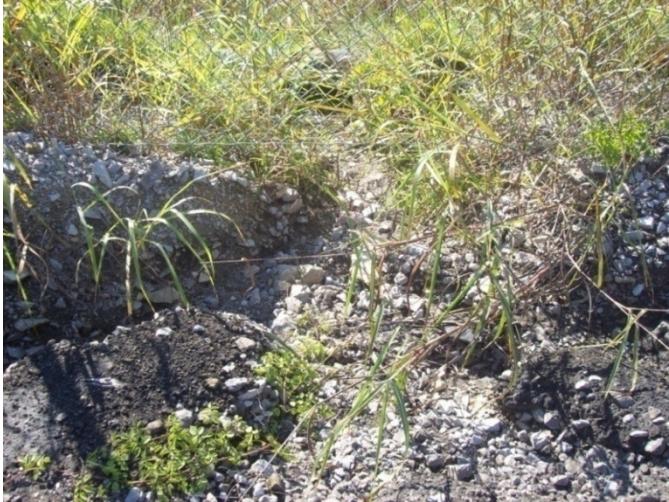
7. Runoff erosion from edge of crest of access road at Pond 2.

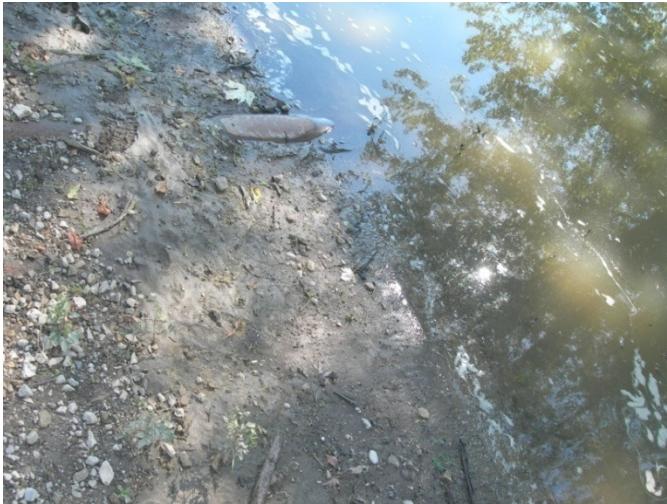
- 10. Outside slope of levee embankment at Pond 2. An unknown pipe was observed at the location, see Photo 14.**

14. Looking at unknown pipe at the outside toe of Pond 2 levee embankment.

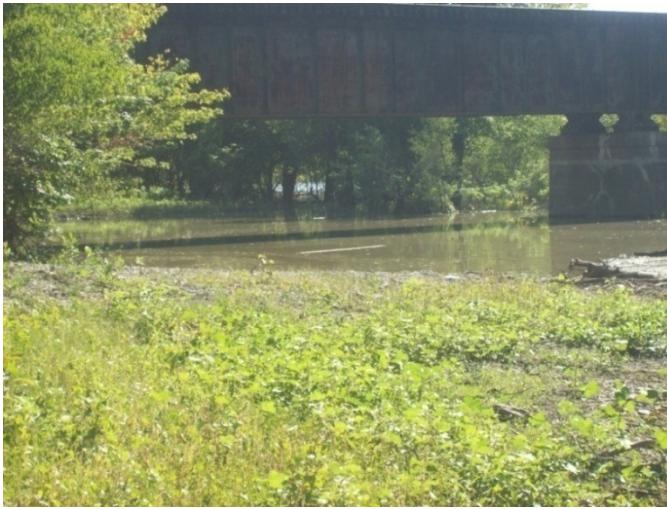
15. Looking southeast at railroad bridge. Location of submerged perimeter access road.

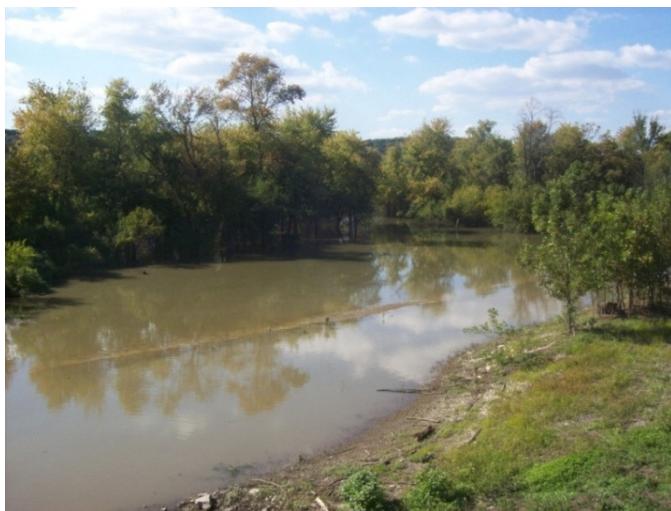
18. Looking southwest along toe of levee embankment where floodplain is flooded.

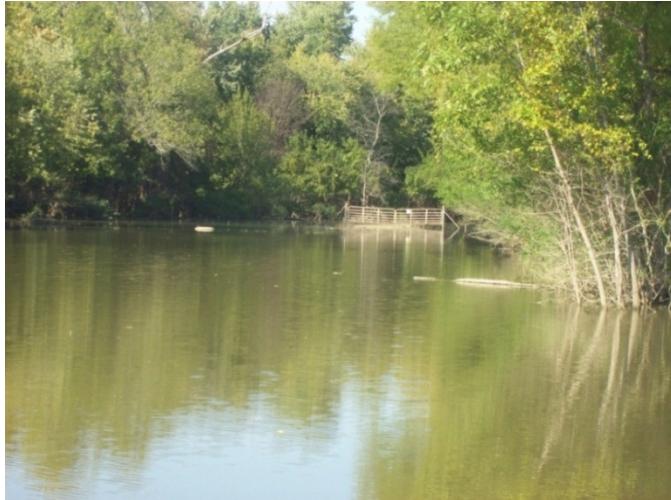
19. Looking north at perimeter access road gate. Road under water.

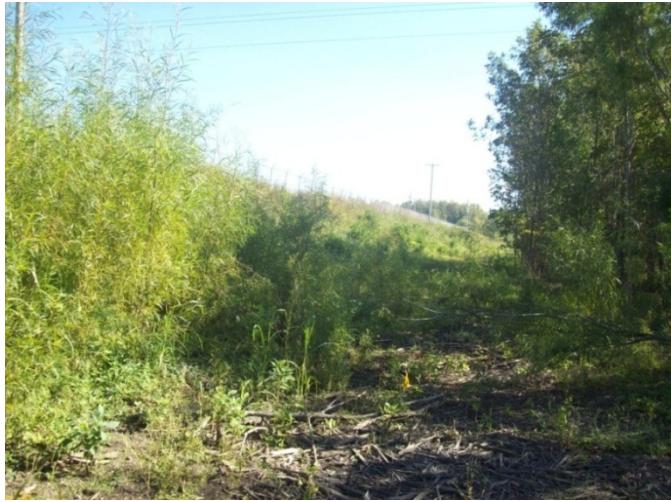
20. Looking south along outside toe of Pond 7.

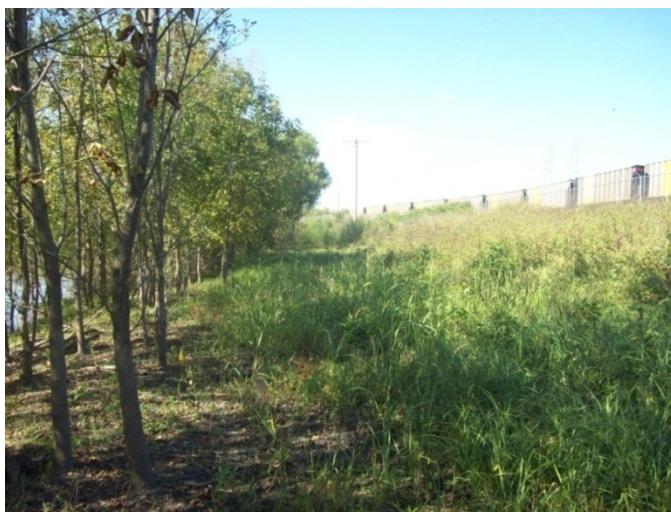
21. Looking northwest along outside toe and slope of levee embankment of Pond 7. Note - railroad tracks adjacent to top of embankment.

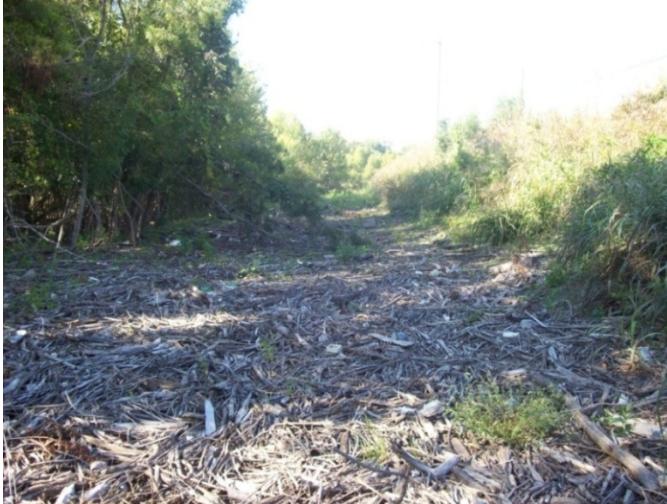
22. Looking northwest along outside toe of levee embankment at Pond 7.

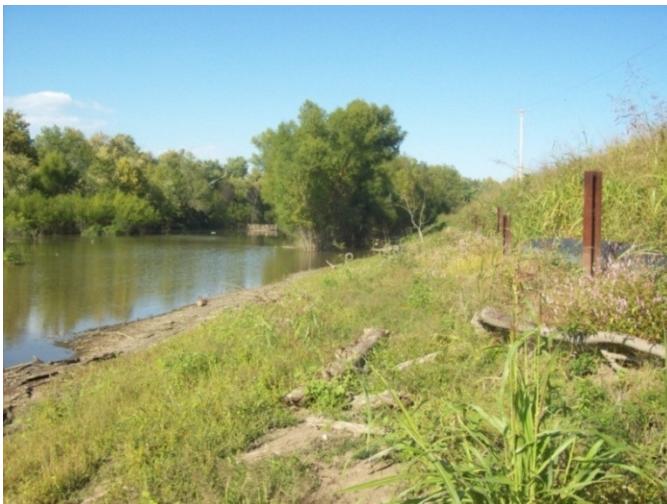
23. Looking north along outside toe of levee embankment at Pond 7.
Note - gate for perimeter access road is submerged.

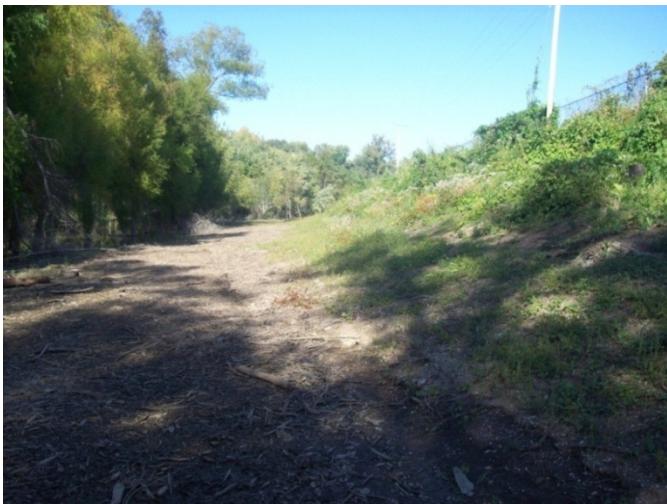
24. Looking northeast along outside toe of levee embankment at Pond 7.

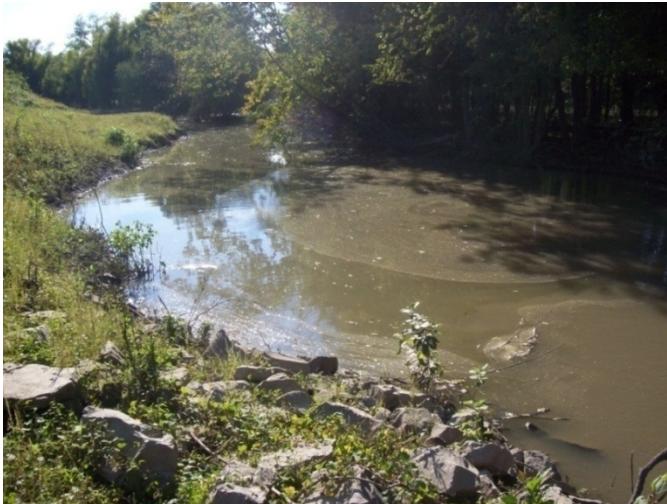
25. Looking southwest along Meramec River just outside from Pond 1 (retention pond) outlet.

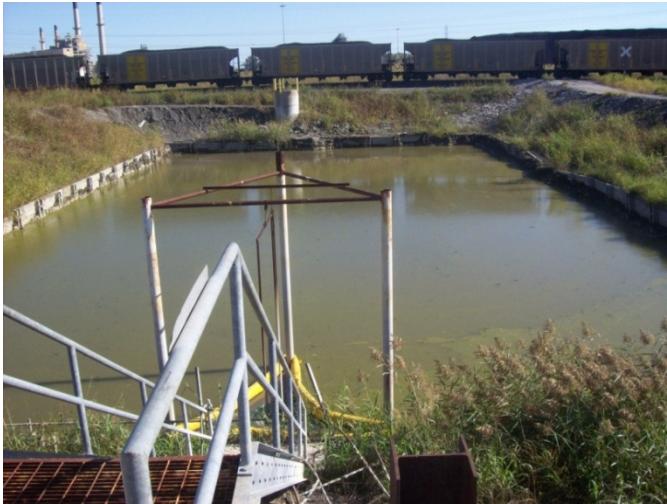
28. Looking southeast at Pond 1
(retention pond).

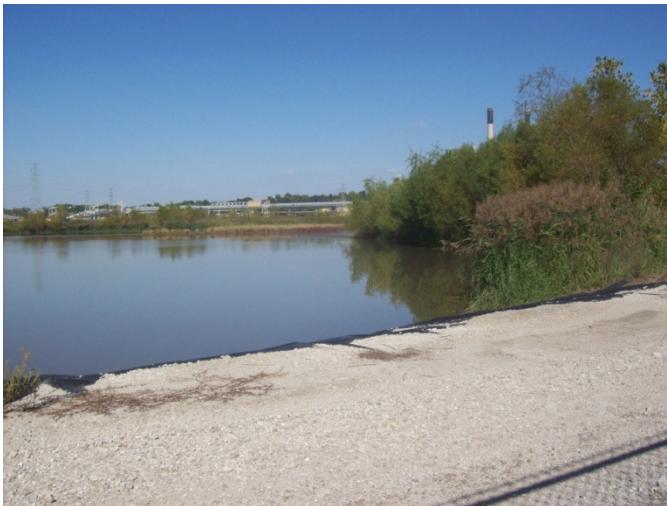
29. Looking northwest at Pond 2. Note
– Unit has a slope liner.

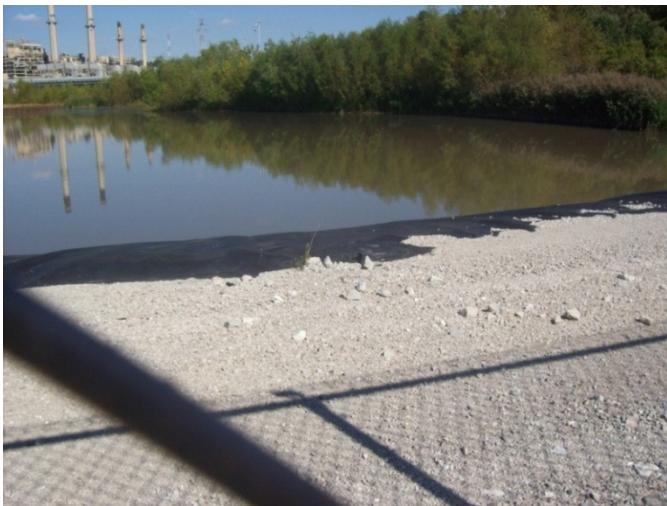
30. Looking north at Pond 2. Note –
Unit has a slope liner.

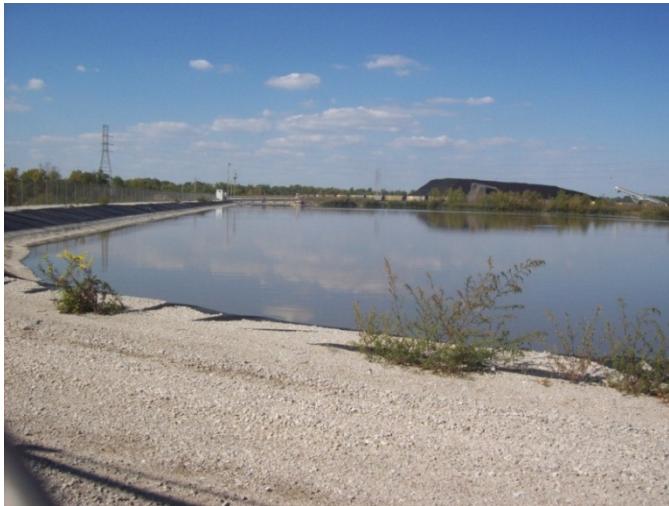
31. Looking at Pond 2 toward coal storage area. Note - liner with some vegetation.

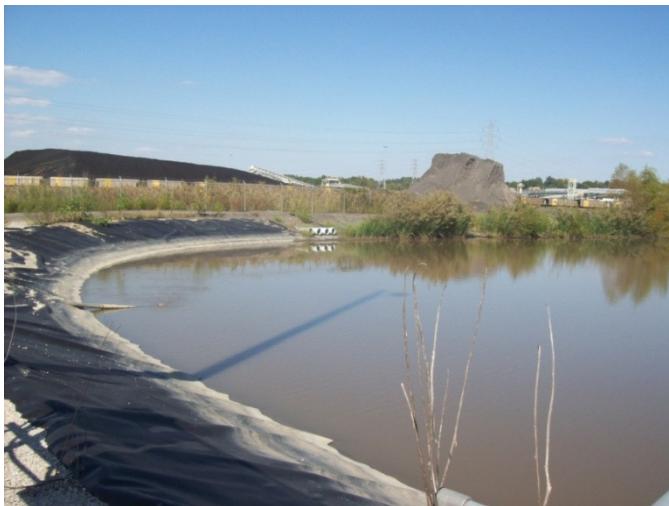
32. Looking north at overflow pipes and coal storage area. Note - pipe in water for taking water samples.

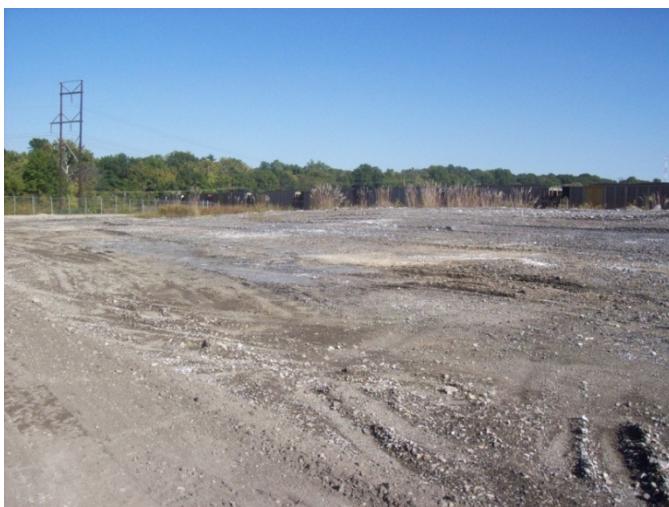
33. Looking at the Pond 3 (“New” Fly Ash Pond) area in the distance and the fill Fly Ash area to the northeast of Pond 1.

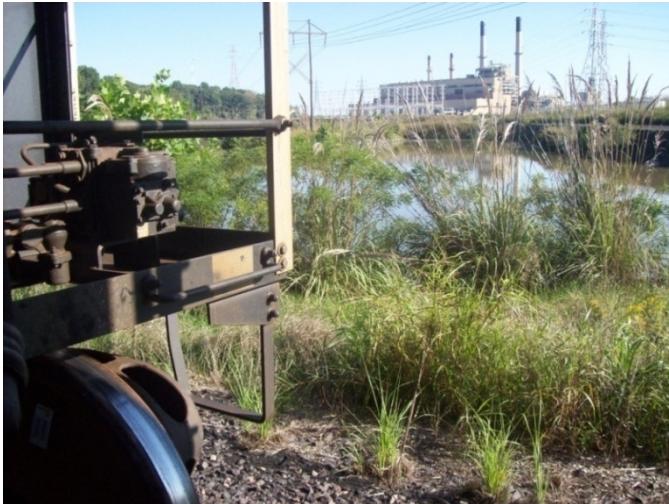
34. Looking through railroad track at southeast side of Pond 4 (Bottom Ash Pond).

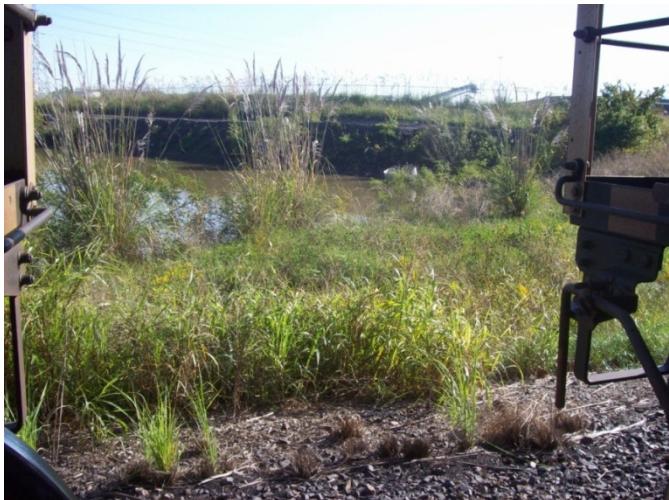
35. Looking through railroad tracks at southeast side of pond area of Pond 4.

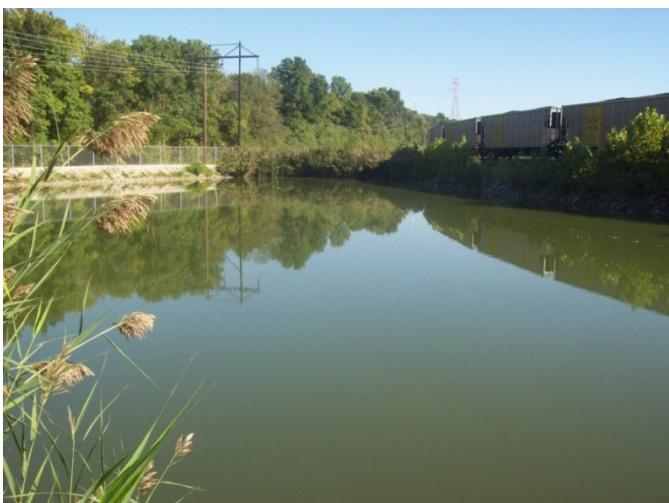
36. Looking north at northwest side of Pond 4.

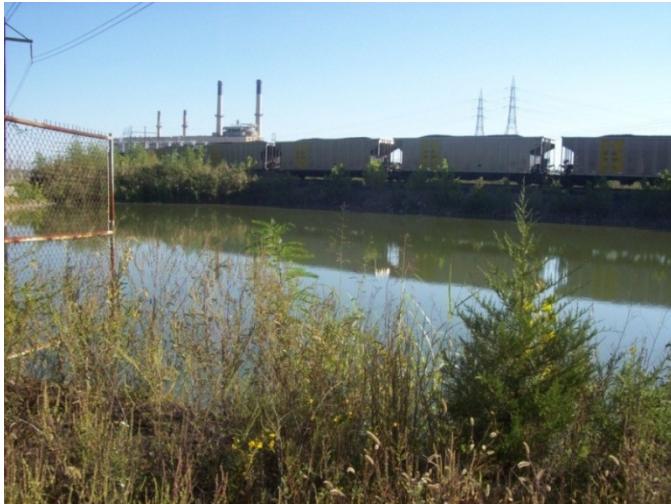
37. Looking southeast at railroad tracks between northwest & southeast Pond 4.

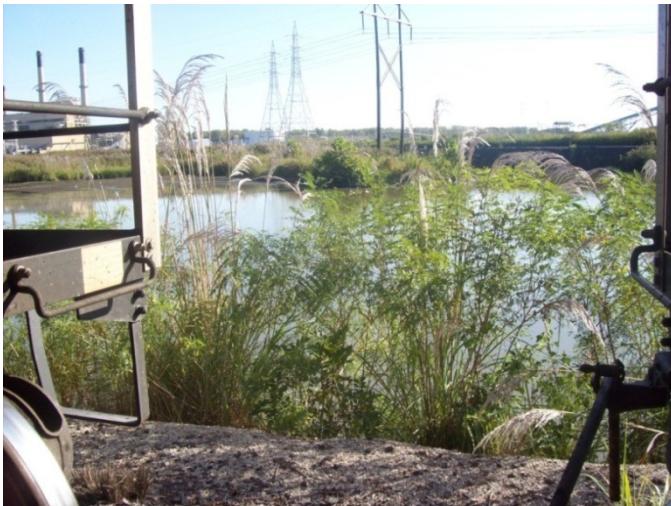
38. Looking southwest from railroad track at northwest Pond 4.

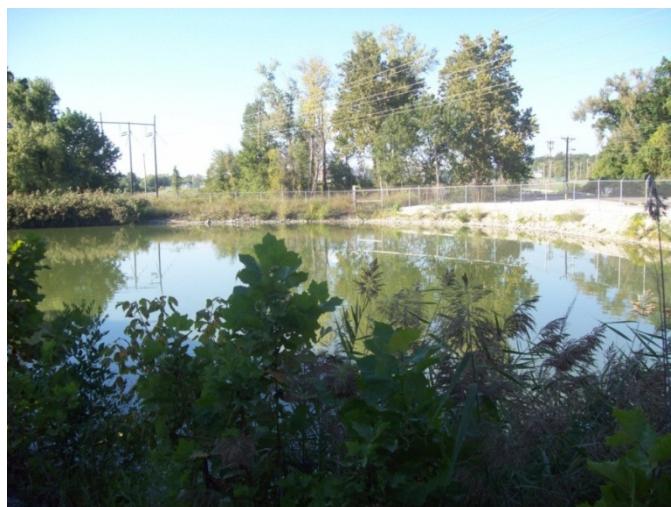
39. Looking north at southeast Pond 4 from railroad tracks.

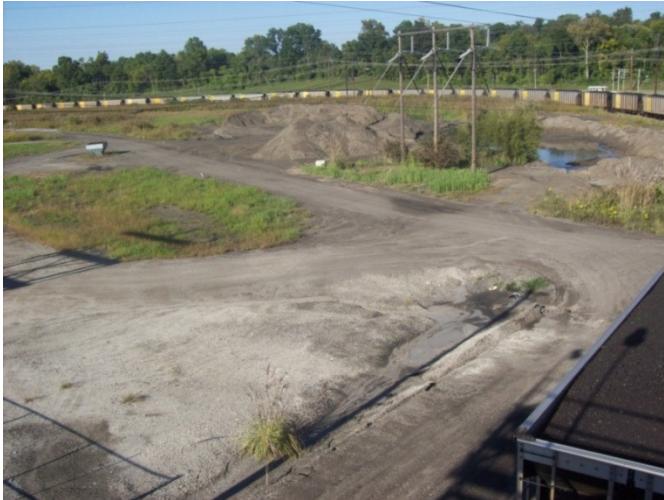
40. Looking towards Pond 5 and 6
(Bottom Ash Pond).

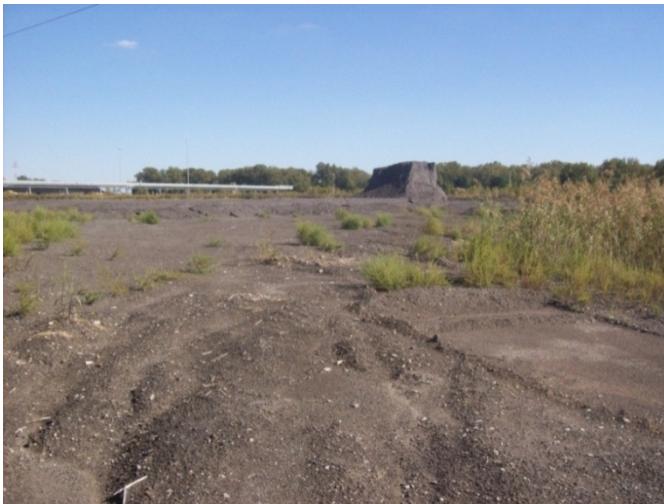
41. Looking northeast at completely
filled and deactivated Pond 8 (Fly
Ash Pond #495).

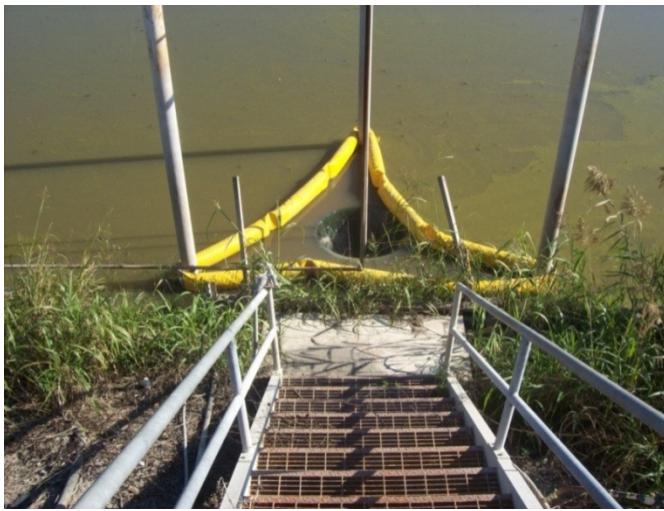
42. Looking at retention pond inlet.

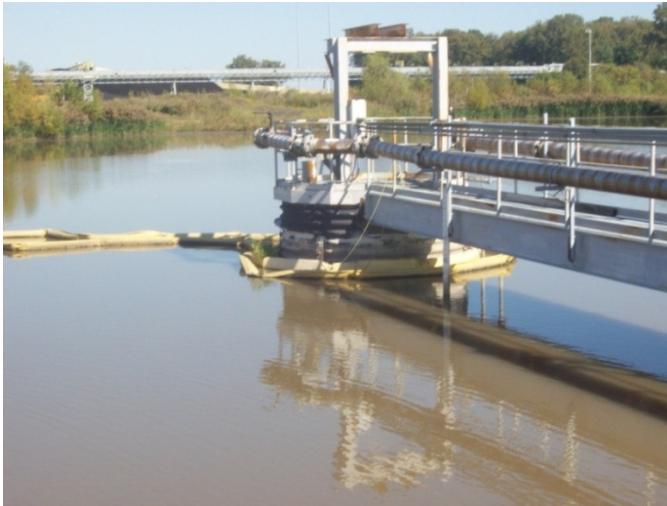
43. Looking at Pond 2 (#489) inlet structure.

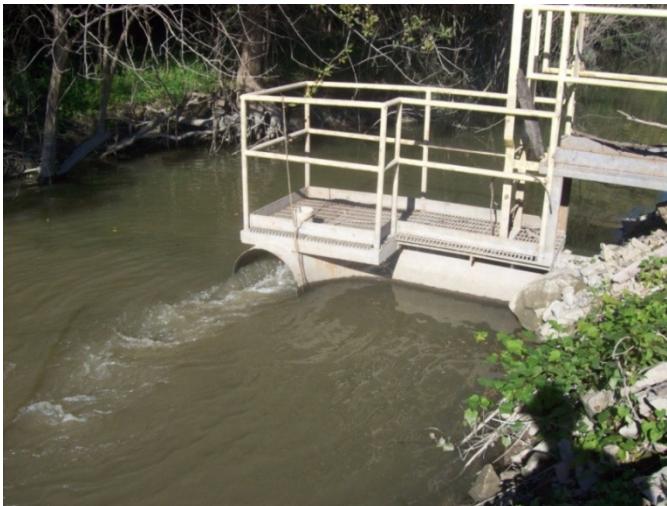
44. Looking northeast at outfall pipe from Pond 1.

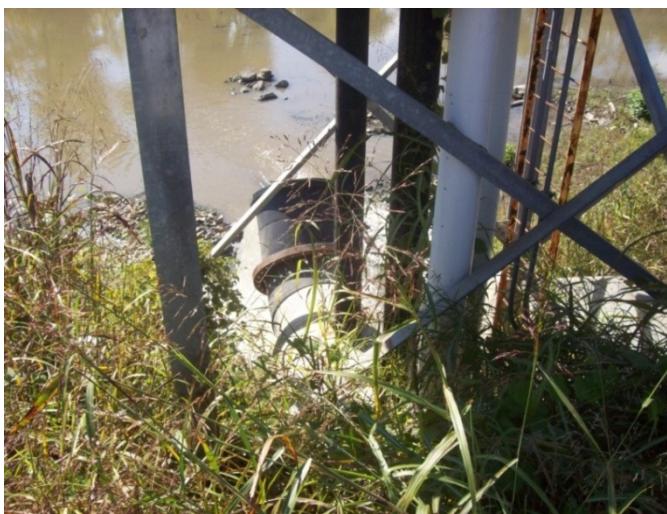
45. Looking west at outfall #009 at Pond 2 toward Meramec River.

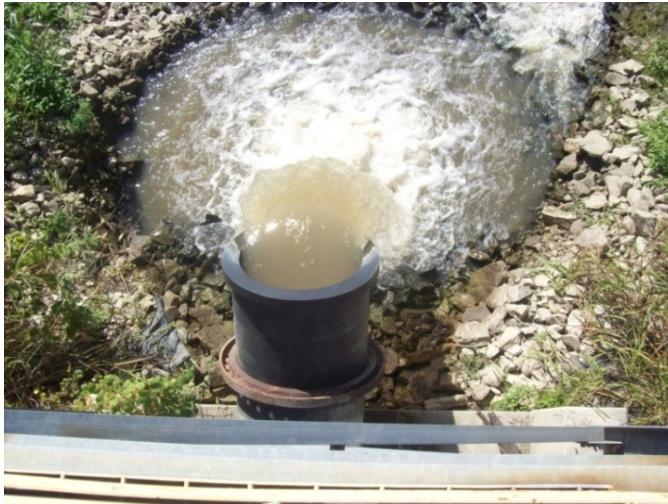
46. Outfall #009 from Pond 2.

The outlet structures appear to be in sound and stable condition with no visual evidence of significant deterioration; they should be satisfactory for continued service.

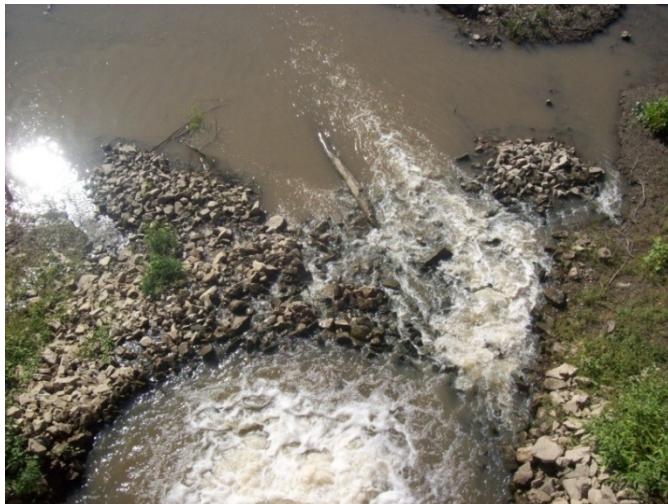
47. Plunge pool at outfall #009.
