**Coal Combustion Waste Impoundment**

**Round 7 - Dam Assessment Report**

***Rush Island Power Station (Site #003)***

***AmerenUE***  
**Festus, Missouri**

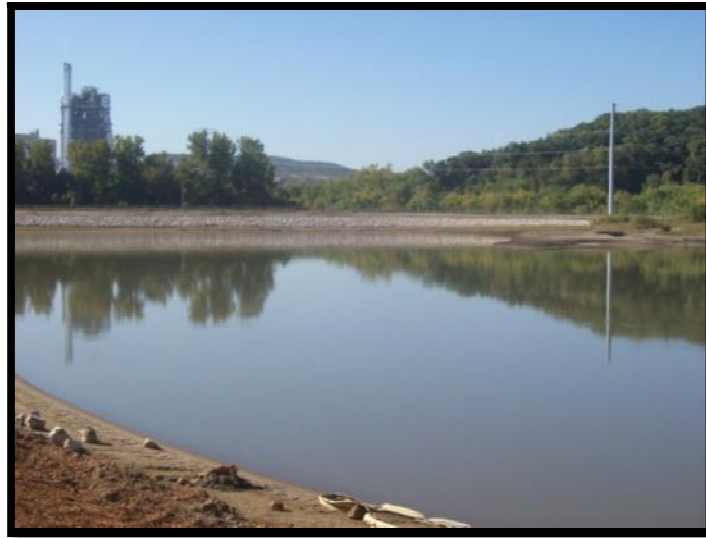
The inside embankment of the ash pond was under rehabilitation during the site assessment. Riprap armor was placed along inside slopes of pond to protect against wave action erosion. Figure 5.2.2-1 and Figure 5.2.2-2 show completed rehabilitation along interior slopes and groins on the south end of ash pond.

**Figure 5.2.2-1:** Riprap armored interior slopes of ash pond protected against wave action erosion, Southwest.

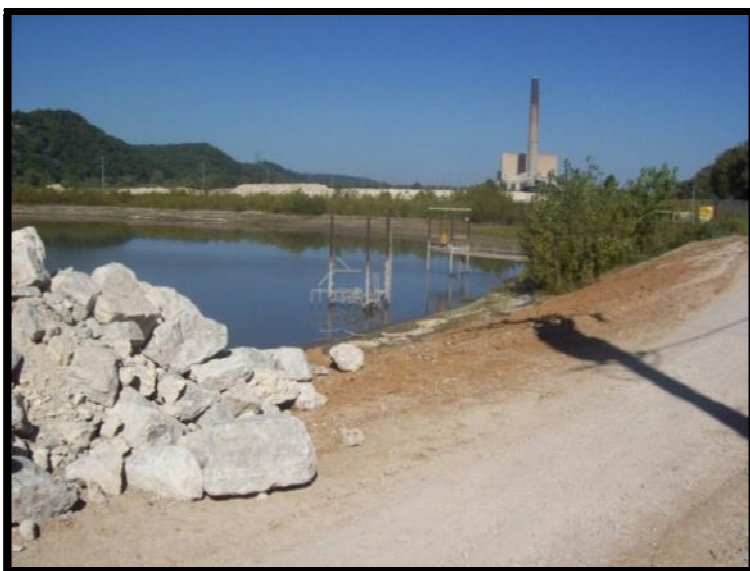
The pond outlet structure is located in the northeast corner of the ash pond. The ash pond discharges to the Mississippi River through an overflow structure consisting of a vertical riser and 24 inch HDPE outlet pipe. A skimmer boom is located around the riser and the structure is made accessible through a metal platform. The overflow structure was not completely visible at the time of the site assessment. Figure 5.3.1-1 shows both the active and inactive outlet structures for the ash pond.

**Figure 5.3.1-1:** Ash pond inactive (left) and active (right) overflow structures, Northwest.

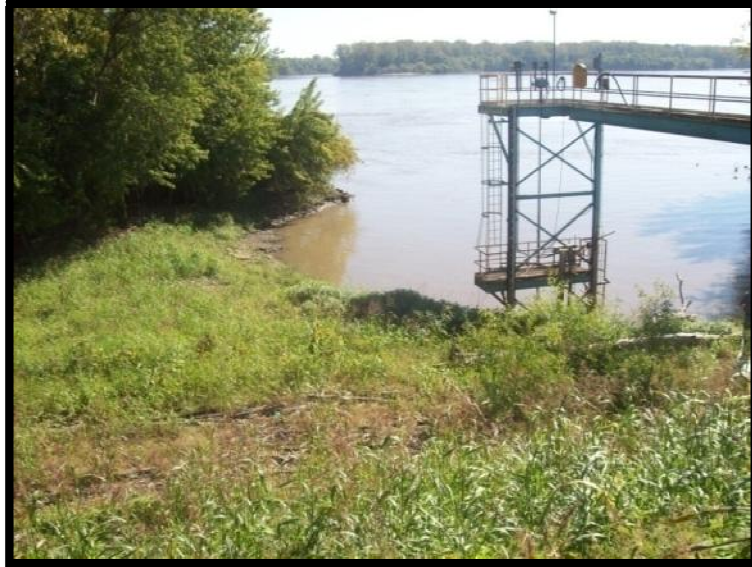
The outlet conduit for the ash pond is a 24 inch diameter HDPE pipe. This HDPE pipe is contained within the previous outlet pipe, a 36 inch diameter CMP, and is held in place by filling voids between pipes with grout/flowable fill. The outlet pipe has two CO<sub>2</sub> control valves and a sampling pump that regulates discharge water. Site plans indicate a design inlet invert of 382.54 feet and a maximum design outlet invert of 372.49 feet. Staff gages at both the inlet and outlet ends of the conduit monitor waters levels. Neither end of conduit could be seen as it was fully submerged. Figure 5.3.2-1 shows the discharge area of ash pond outlet conduit.

**Figure 5.3.2-1:** Ash pond outlet to Mississippi River.

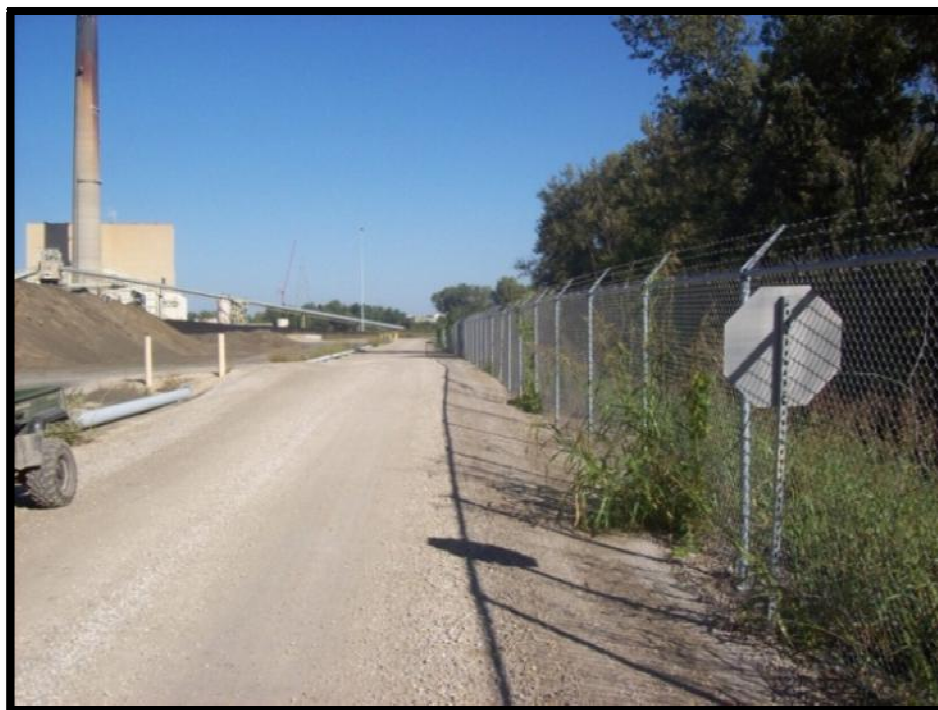
**Figure 1:** Perimeter road near ash disposal area, Northwest.

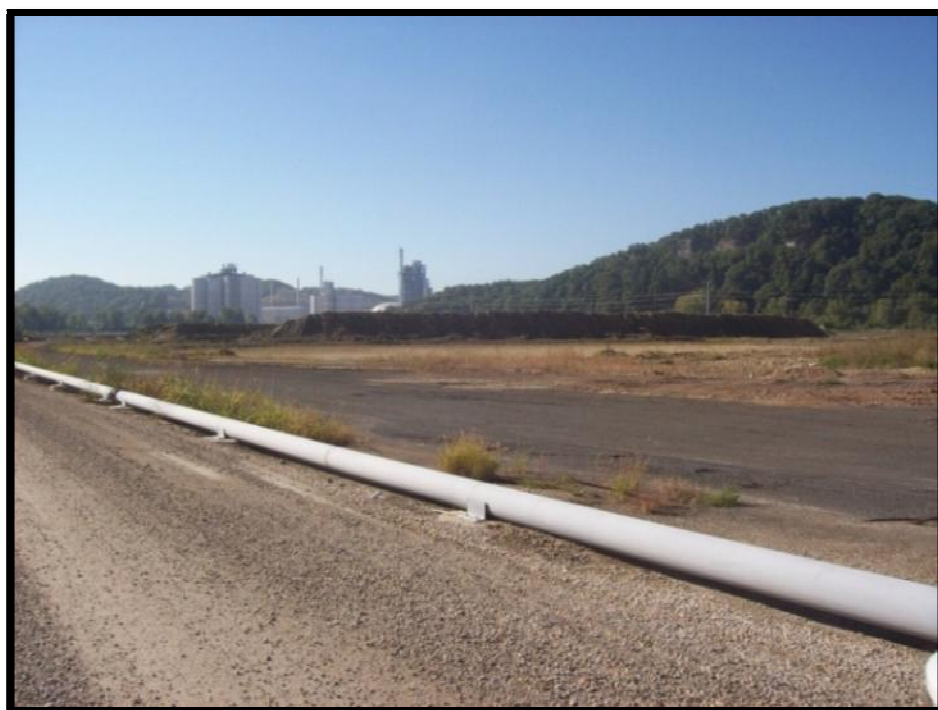
**Figure 2:** Ash disposal area, South.

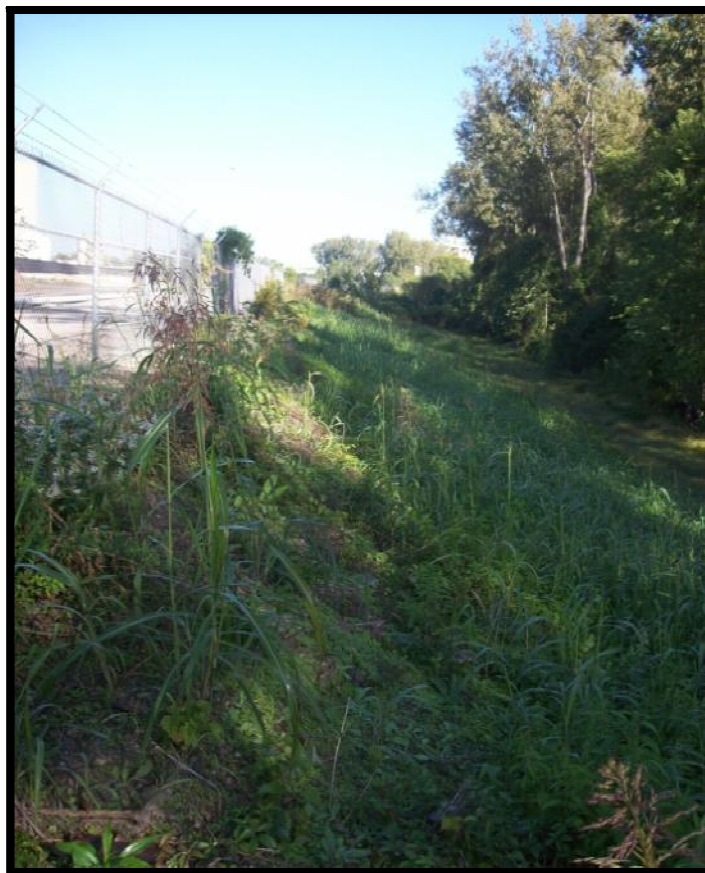
**Figure 3:** Ash pond external embankment with medium vegetation, Northwest.

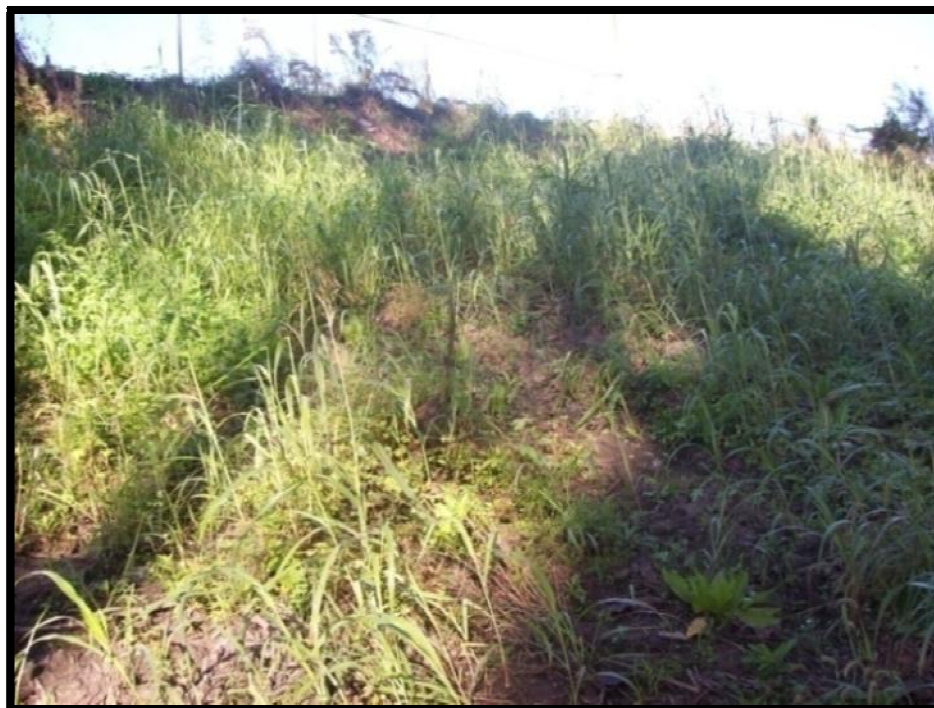
**Figure 4:** Ash pond external embankment with minimal ground cover and minor erosion from roadway runoff.

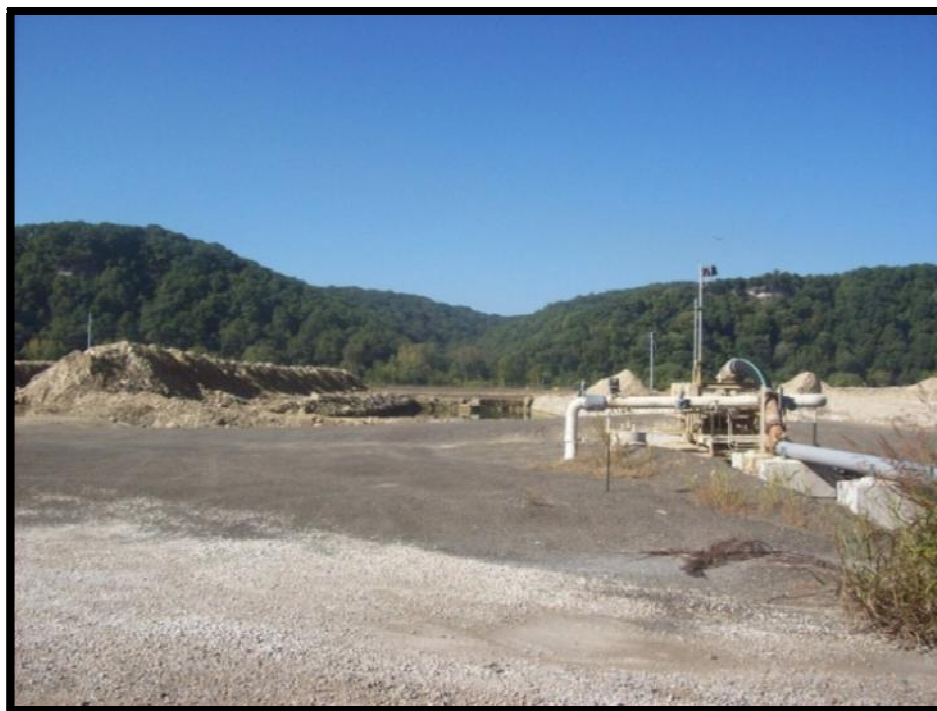
**Figure 5:** Ash disposal area near discharge to ash pond.

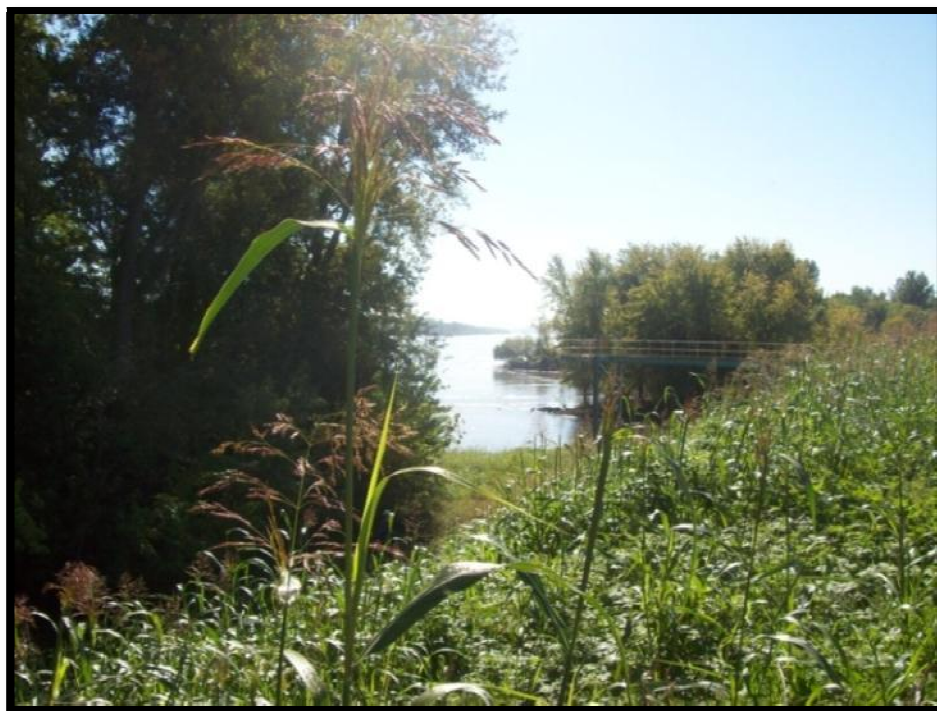
**Figure 6:** Ash pond outlet to Mississippi River, Southeast.

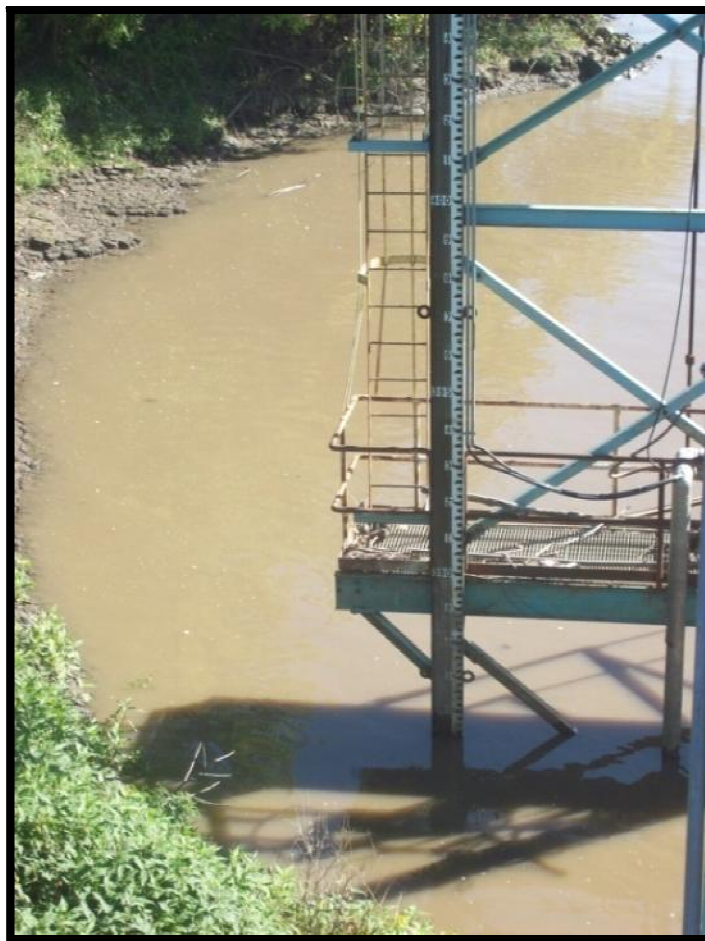
**Figure 7:** Staff gage at ash pond discharge area, Mississippi River. Outlet fully submerged.

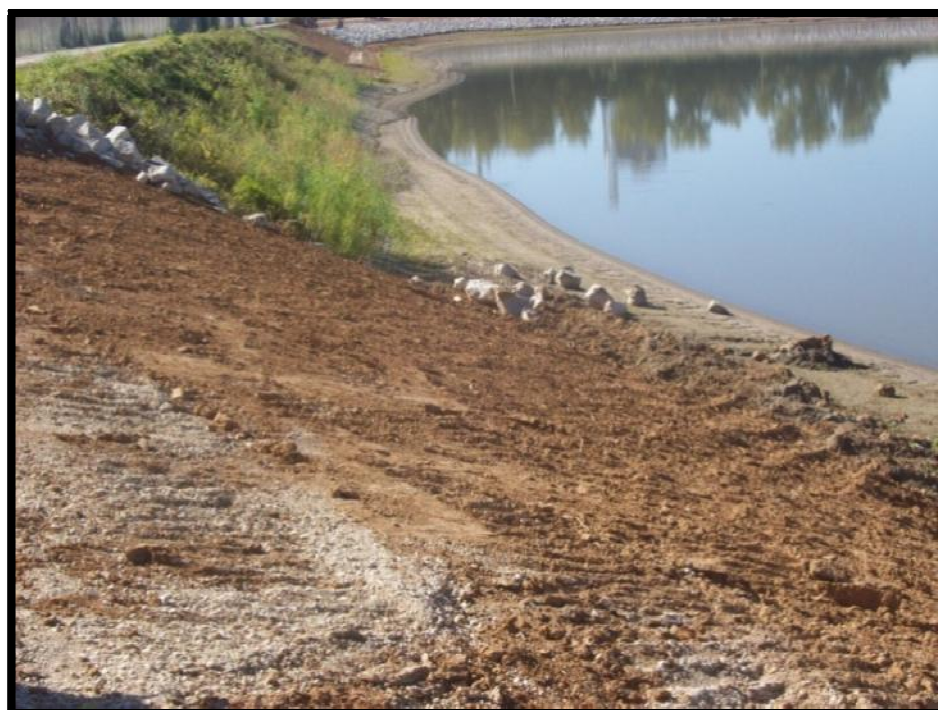
**Figure 8:** Interior slopes of ash pond currently under rehabilitation, South.

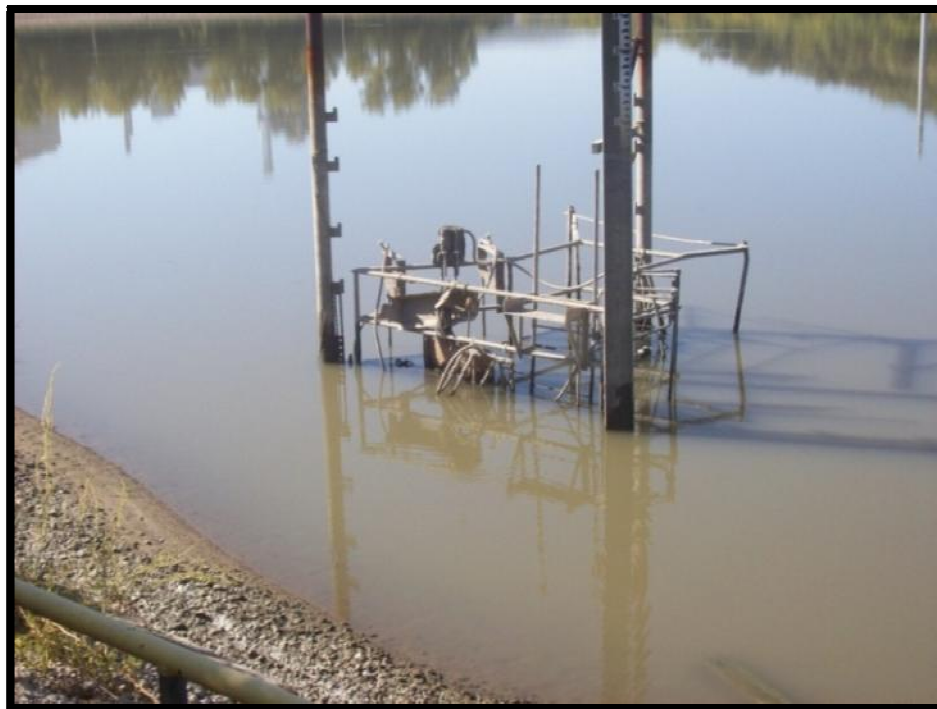
**Figure 9:** Inactive ash pond overflow structure.

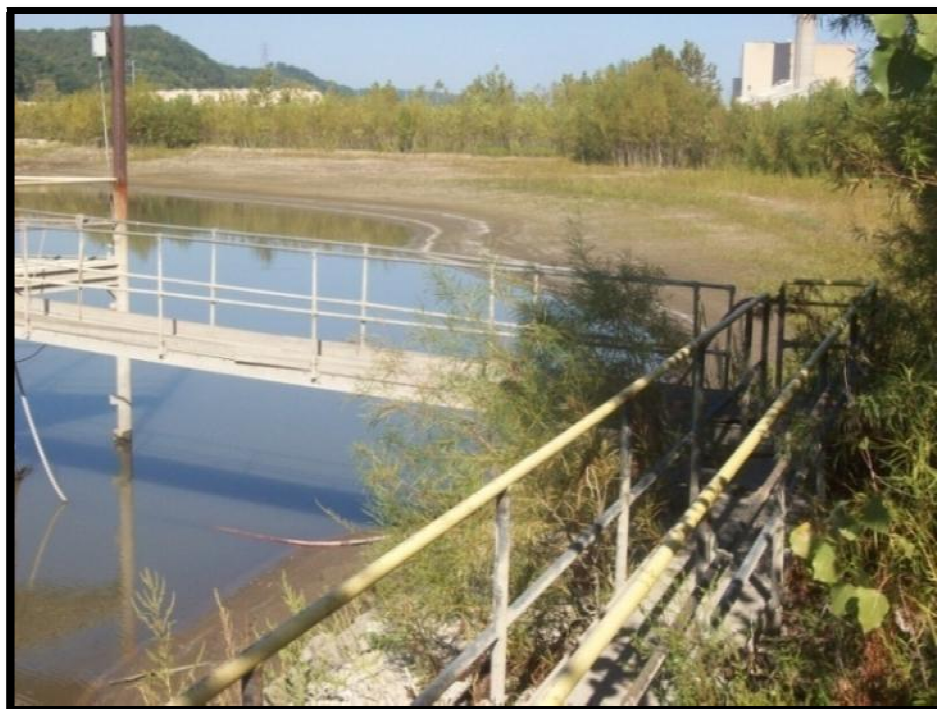
**Figure 10:** Access platform to ash pond overflow structure, Northwest.

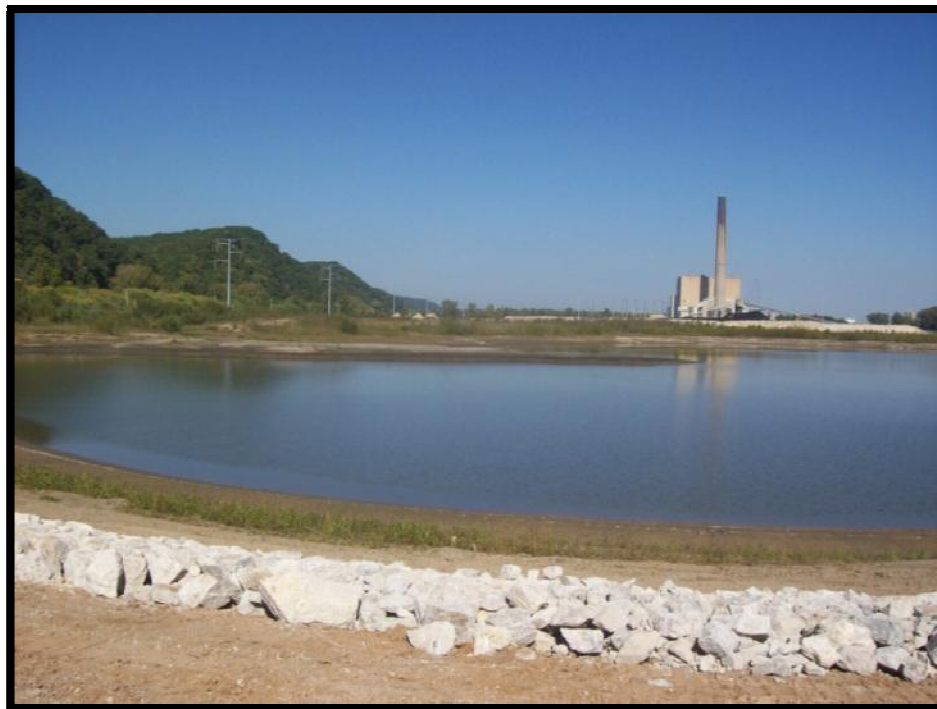
**Figure 11:** Ash pond, Northwest.

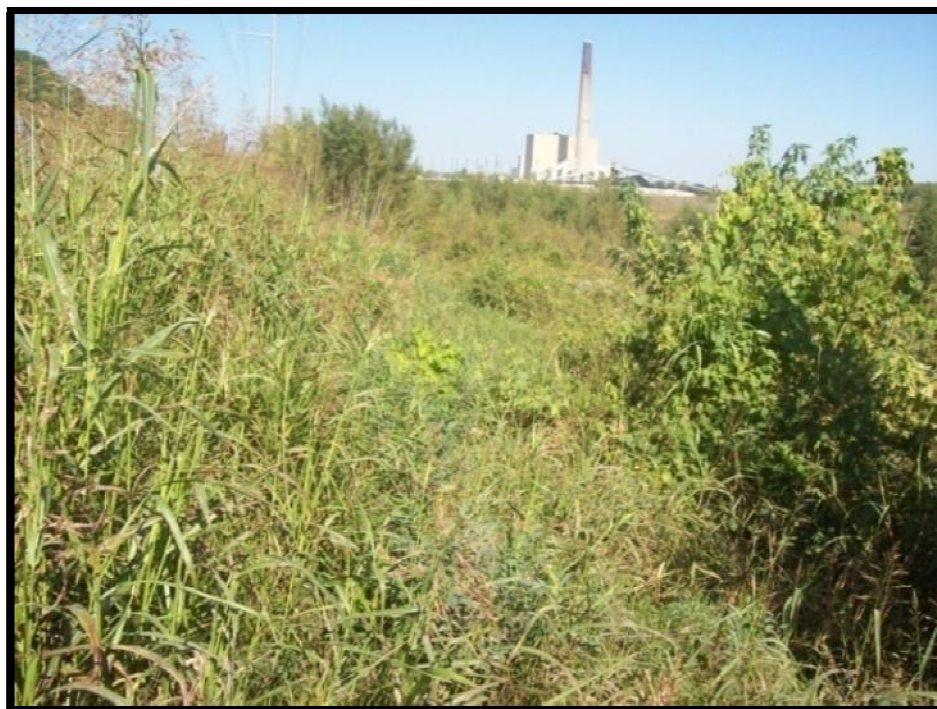
**Figure 12:** Ash pond exterior embankment with heavy vegetation, Northwest.

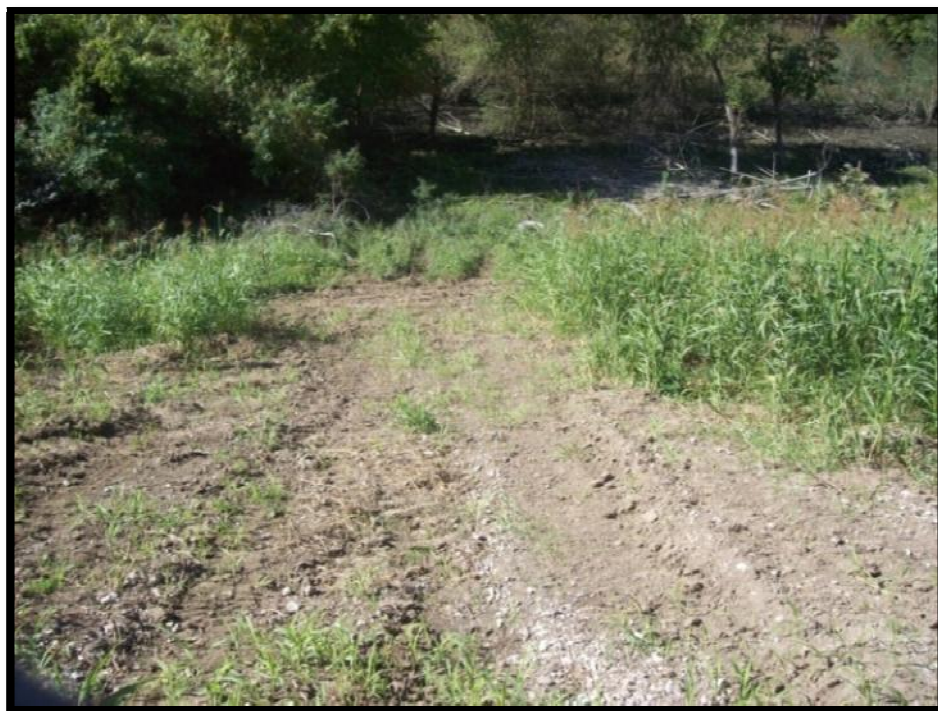
**Figure 14:** Heavily eroded area along exterior embankment of ash pond.

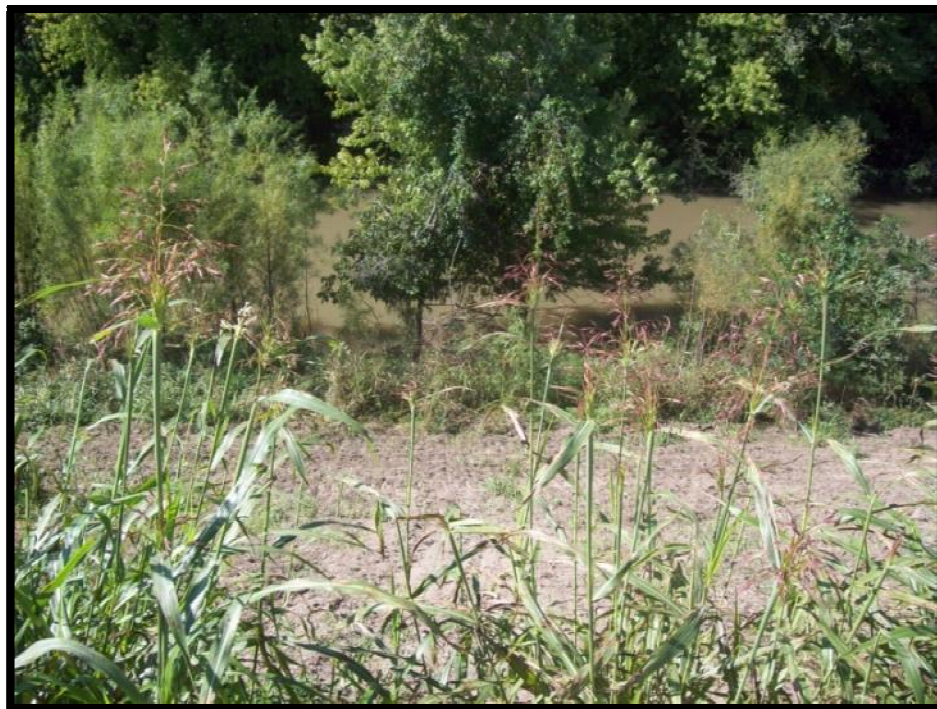
**Figure 17:** Exterior embankment of ash pond along the tributary to Isle du Boise Creek.

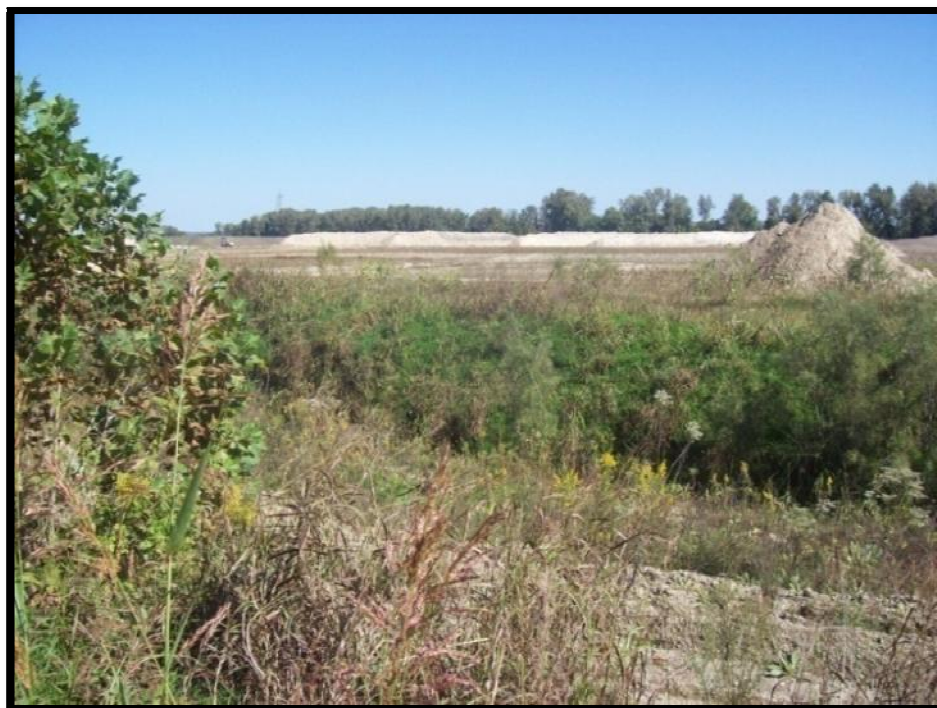
**Figure 18:** Ash disposal area, Northeast.

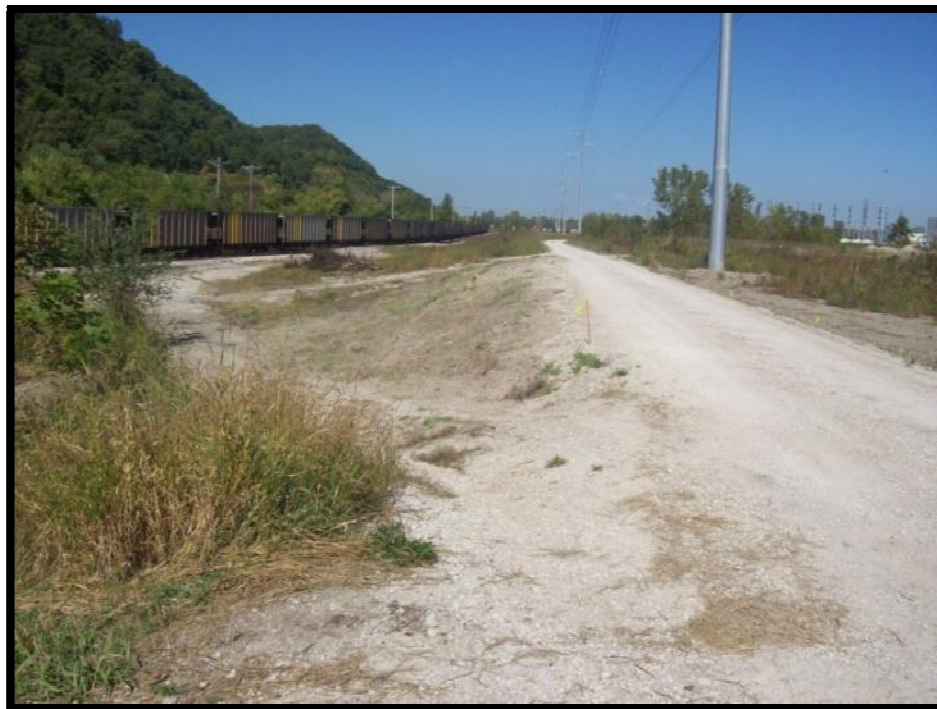
**Figure 19:** Perimeter road near ash disposal area, Northwest.

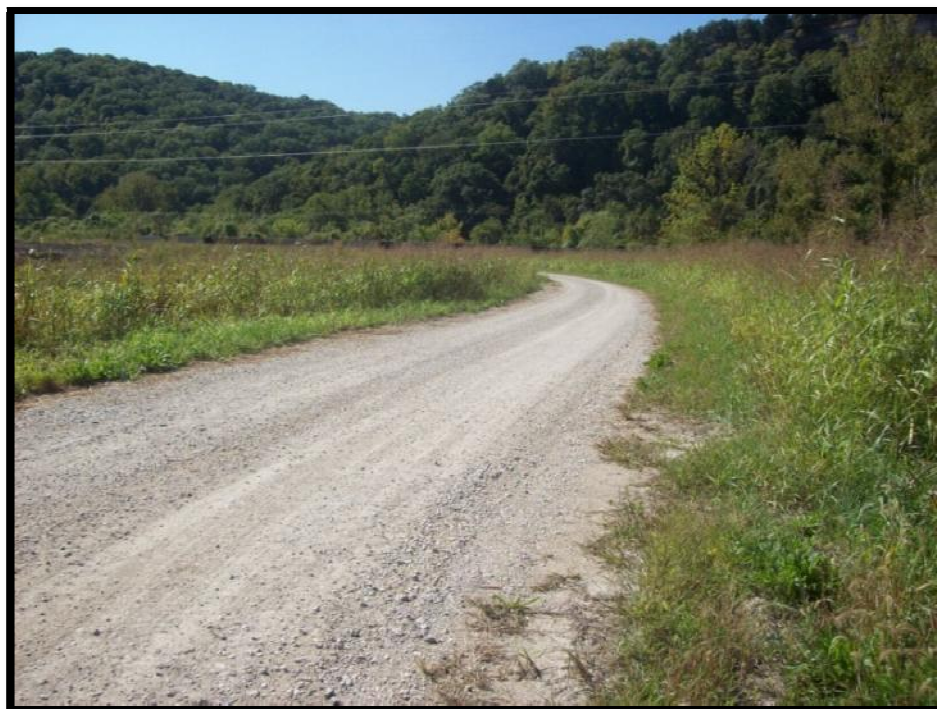
**Figure 20:** Perimeter road at top of the ash pond embankment, Southwest.
