**Coal Combustion Waste Impoundment
Round 6 - Dam Assessment Report**

East Bend Station

Coal Combustion Surface Impoundment
Duke Energy
Boone County, KY

March 2011

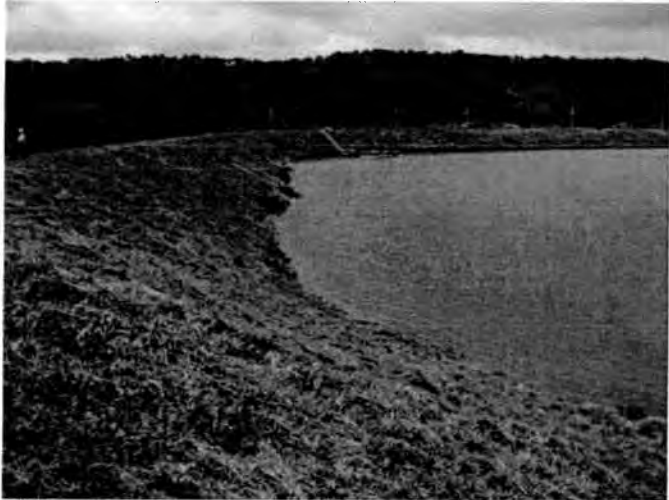
1. Light poles on downstream slope along the crest of south and west embankments;
2. Minor to excessive erosion from wave action was observed along the east and south embankment upstream slopes (see Photos 4, 14 and 18);

<p>Photo 4 Inboard slope of east embankment, photo facing south.</p>

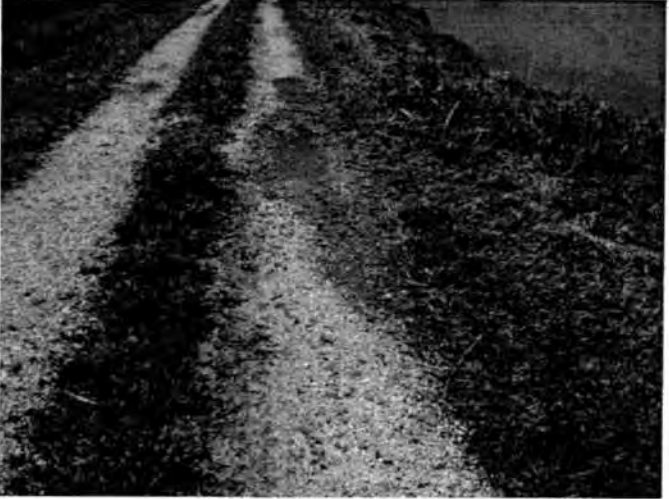
3. Minor low areas observed in gravel areas on the embankment crest (see Photo 5);
4. Approximately 350 linear feet of rip rap placed as wave action armor on upstream slope of the east embankment (see Photo 6);

<p>Photo 5 Low area along crest of east embankment.</p>

- Repair low area along the crest to prevent ponding
- Clear excess vegetation from areas within 15 feet of the down-gradient embankment toe
- Grade observed wet areas along the toe of the east embankment to promote positive drainage, and monitor areas after re-grading

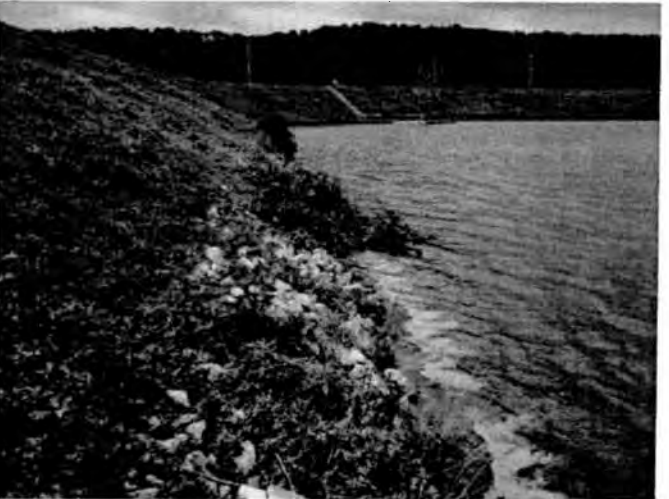
<p>Photo 6 Rip rap placed to remediate wave action erosion on the inboard slope of the east embankment, photo facing south.</p>

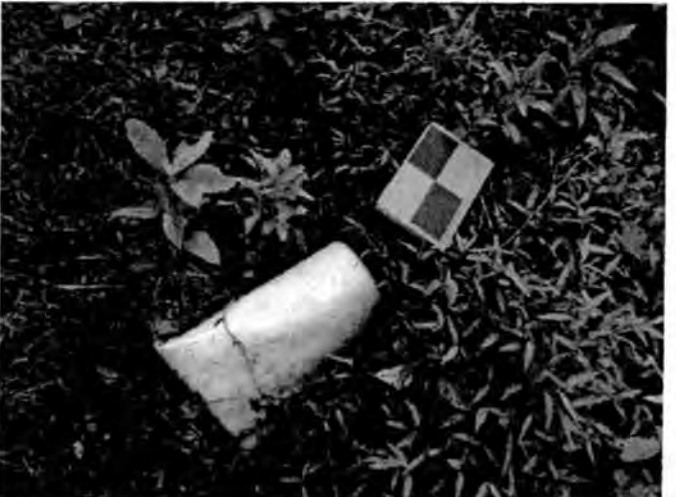
6. Marsh area was observed beyond the toe of the east embankment (see Photo 8);
7. Scrap pipe located along the toe of the east embankment (see Photo 9);

<p>Photo 9 Existing scrap pipe located near toe of the east embankment.</p>

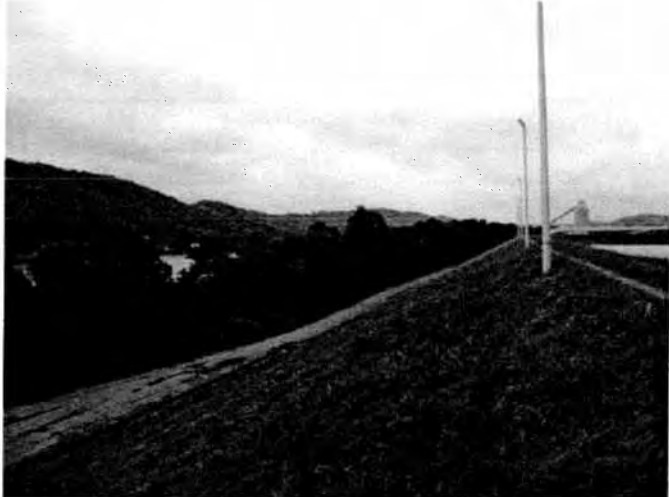
5. Excessive vegetation beyond the toe of the east embankment (see Photo 7) and on the downstream slope below the access road running along the toe of the south embankment (see Photos 16 and 17);

<p>Photo 16</p> <p>Downstream slope of south embankment, photo facing west.</p>

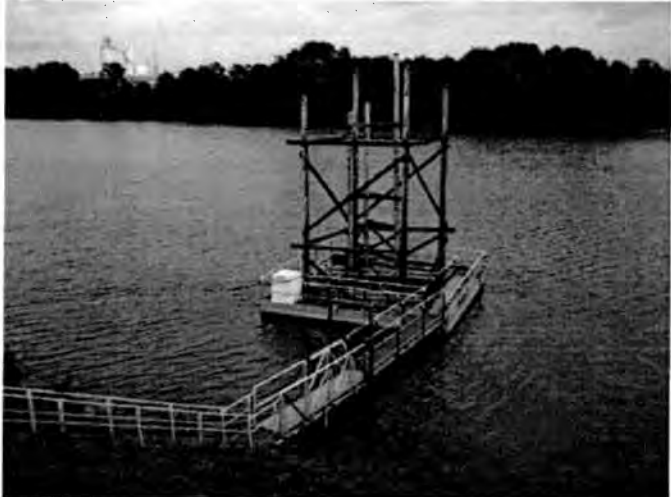
<p>Photo 19</p> <p>Outlet structure located near southeast corner of ash pond, photo facing north.</p>

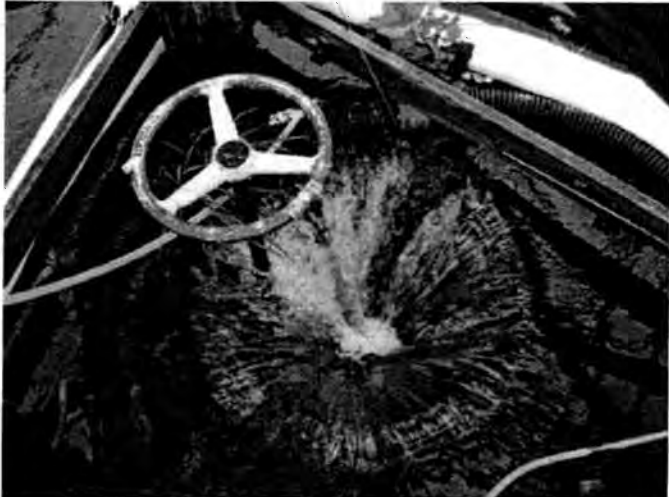
<p>Photo 20</p> <p>Outlet structure located near southeast corner of ash pond.</p>

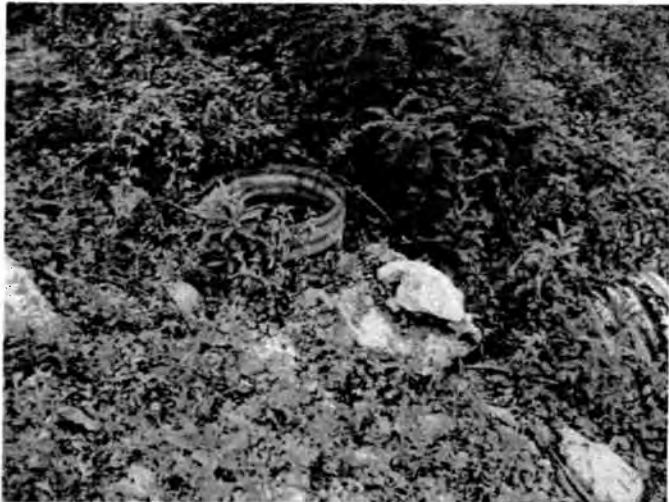
<p>Photo 21</p> <p>Vertical riser in the outlet pipe located beyond and downstream of the toe.</p>

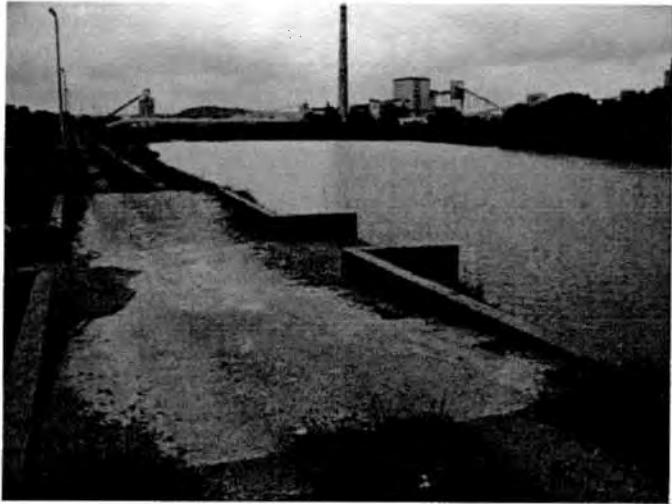
<p>Photo 22</p> <p>Emergency spillway on crest of south embankment, photo facing west.</p>

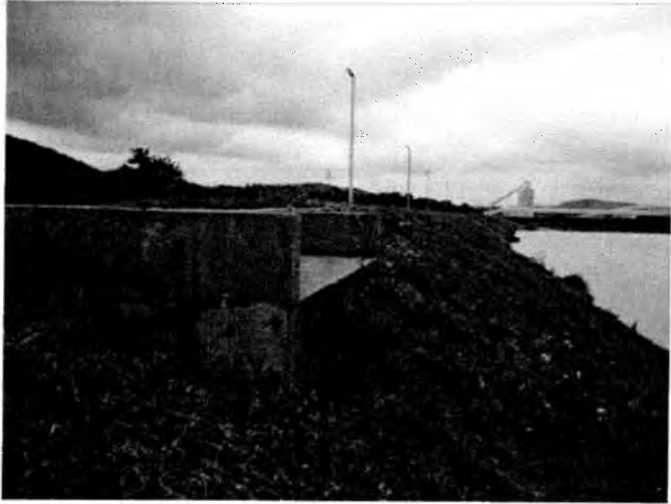
<p>Photo 23</p> <p>Emergency spillway on crest of south embankment, photo facing west.</p>

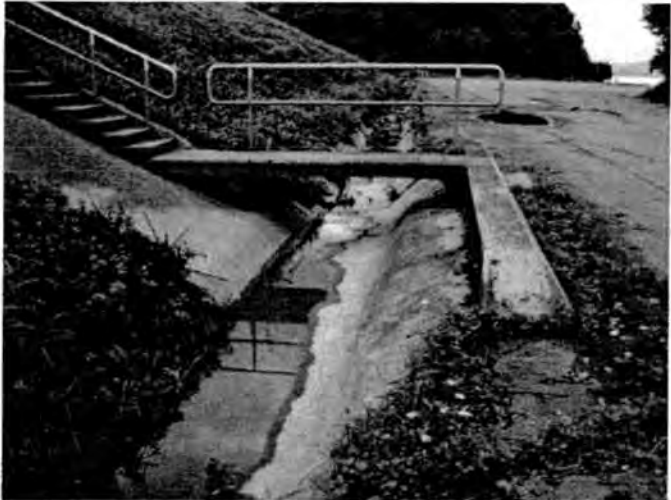
<p>Photo 25</p> <p>Emergency spillway channel along toe of south embankment, photo facing east.</p>

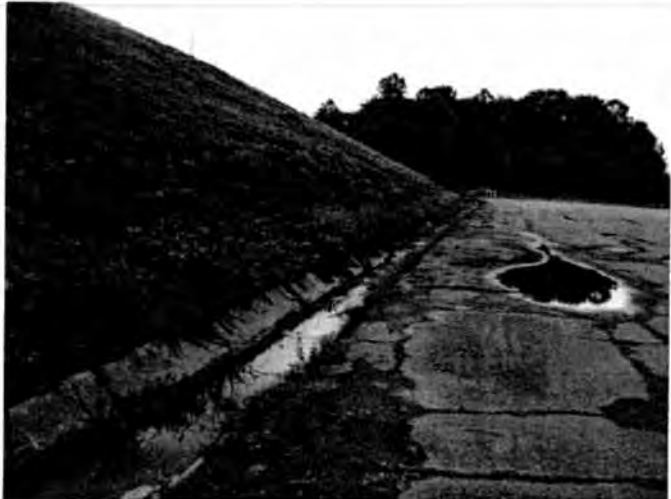
8. Minor vegetation within the concrete drainage channel and emergency spillway (see Photos 24 and 26);
9. Excessive vegetation at the mouth of the concrete channel located along the toe of the south embankment (see Photo 27);

<p>Photo 26</p> <p>Emergency spillway channel along toe of south embankment, photo facing east.</p>

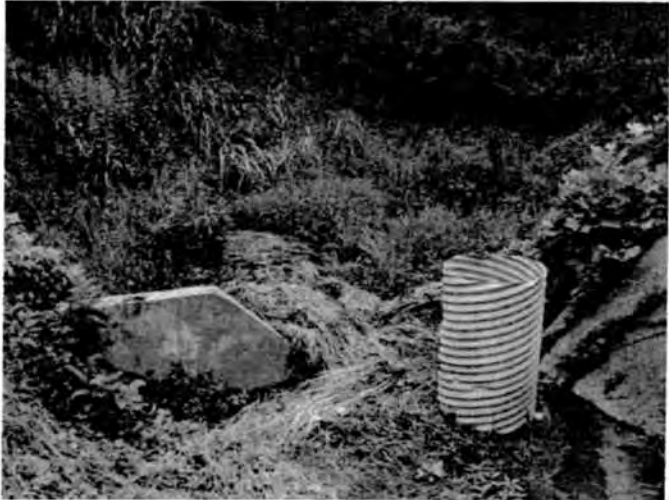
<p>Photo 27</p> <p>Emergency spillway channel mouth and vertical riser for the outlet pipe along toe of south embankment, photo facing east.</p>

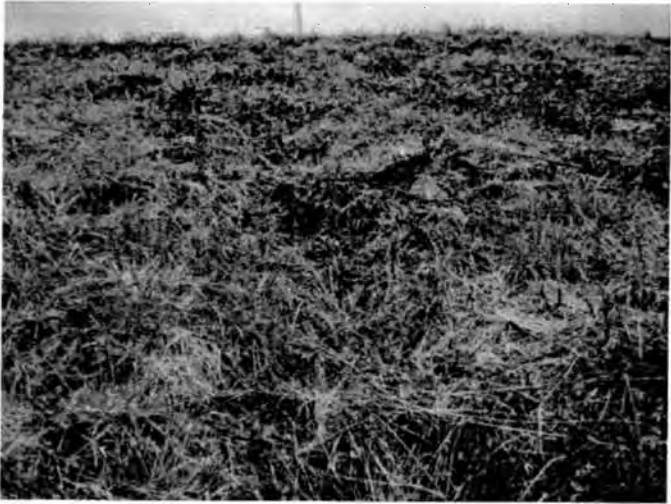
10. Minor erosion channels were observed on the upstream slopes of the east and south embankments (see Photo 31);
11. Inlet channel flowing adjacent to the south embankment (see Photo 33);
12. Rip rap placed on upstream slope of the west embankment (see Photos 40, 42 and 45);
13. Low area on the downstream slope of the west embankment, adjacent to the crest (see Photo 44).

<p>Photo 31</p> <p>Erosion channel on the upstream slope of the south embankment, photo facing south.</p>

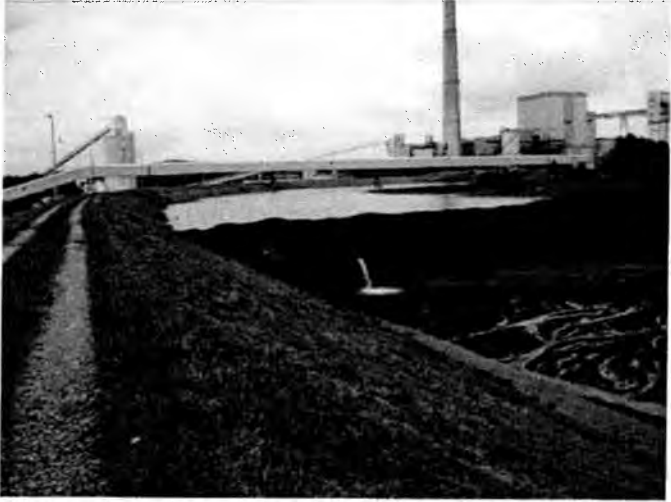
<p>Photo 32</p> <p>Ash divider dike with pipe through the ash dike, photo facing west.</p>

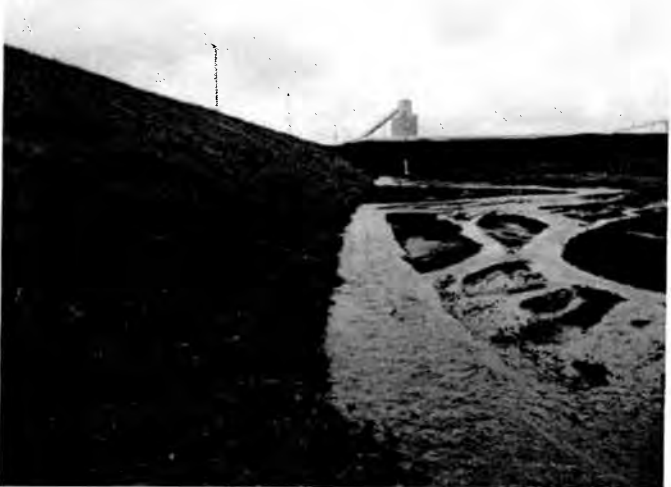
<p>Photo 33</p> <p>Inlet channel flowing through the ash along the south embankment, photo facing west.</p>

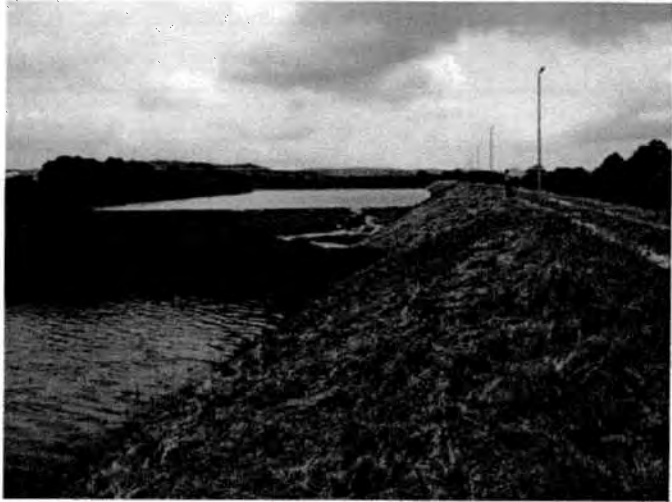
<p>Photo 34</p> <p>Upstream slope of south embankment, west of ash dike, photo facing east.</p>

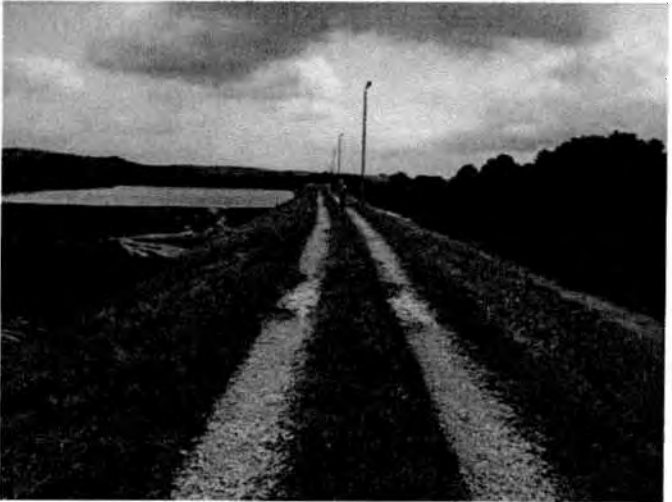
<p>Photo 35</p> <p>Crest of south embankment, west of ash dike, photo facing east.</p>

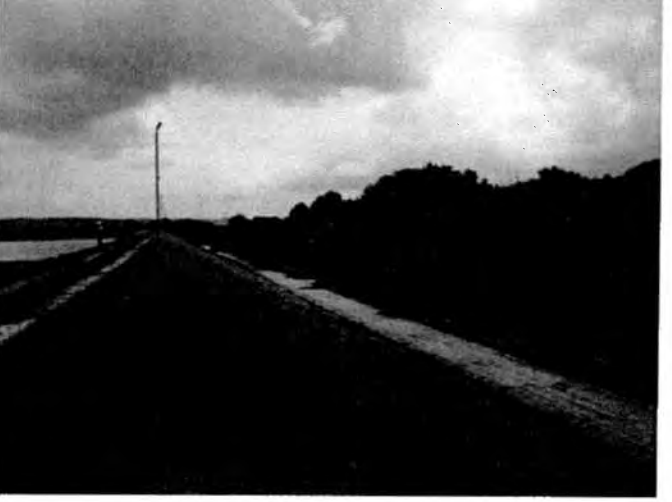
<p>Photo 36</p> <p>Downstream slope of south embankment, west of ash dike, photo facing east.</p>

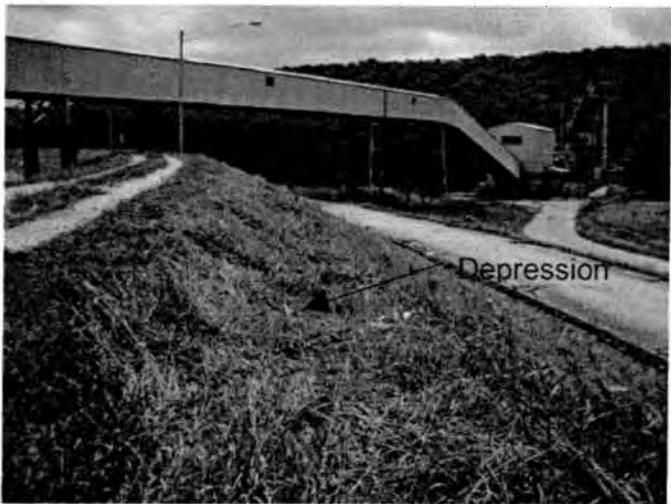
<p>Photo 41</p> <p>Depression on the downstream slope of the west embankment, photo facing southeast.</p>

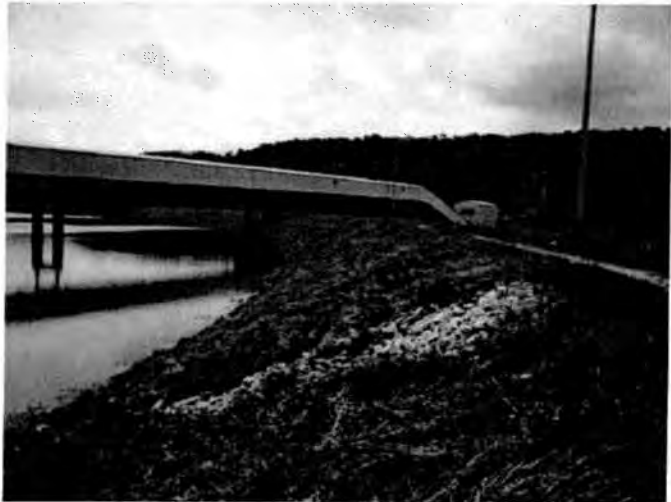
<p>Photo 42</p> <p>Upstream slope of west embankment, photo facing southeast.</p>

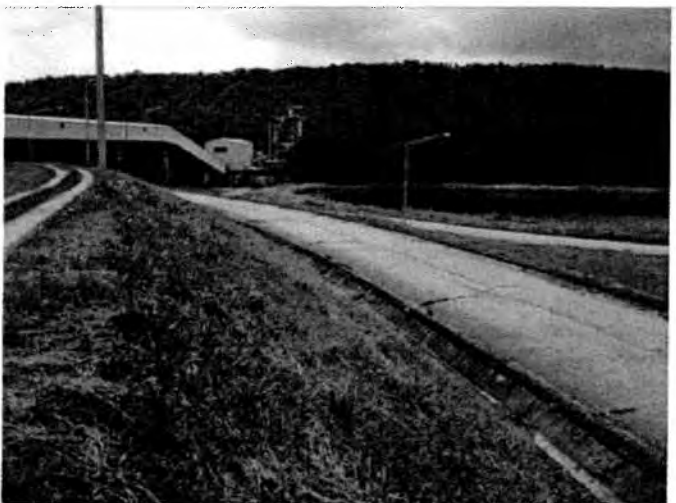
<p>Photo 44 Low area on the downstream slope of west embankment, photo facing southeast.</p>

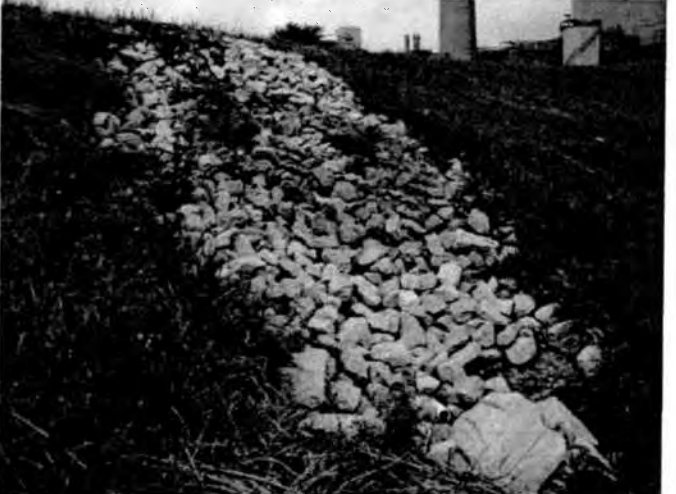
<p>Photo 45 Rip rap placed on the upstream slope of the west embankment at the inlet from the wastewater structure, photo facing west.</p>
