Assessment of Dam Safety Coal Combustion Surface Impoundments (Task 3) Final Report

Louisville Gas &
Electric Company
(A subsidiary of E.ON U.S.)

Cane Run Power Station
Louisville, Kentucky

April 16, 2010

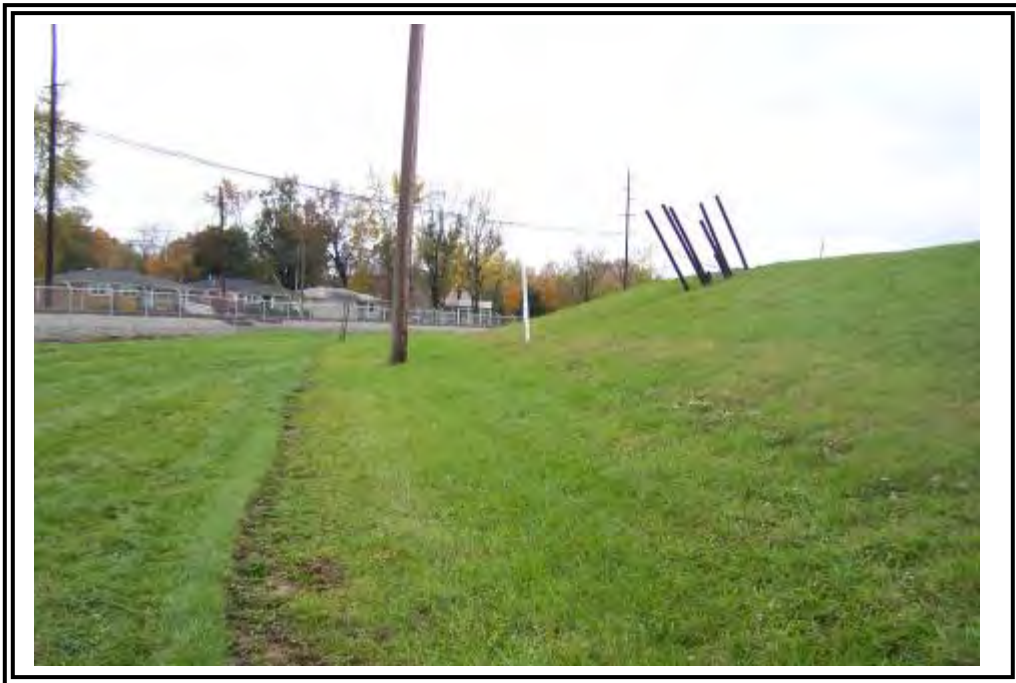
14

Downstream slope of ATB east dike looking south. White markers indicate the location of a high pressure gas line installed in 2005.

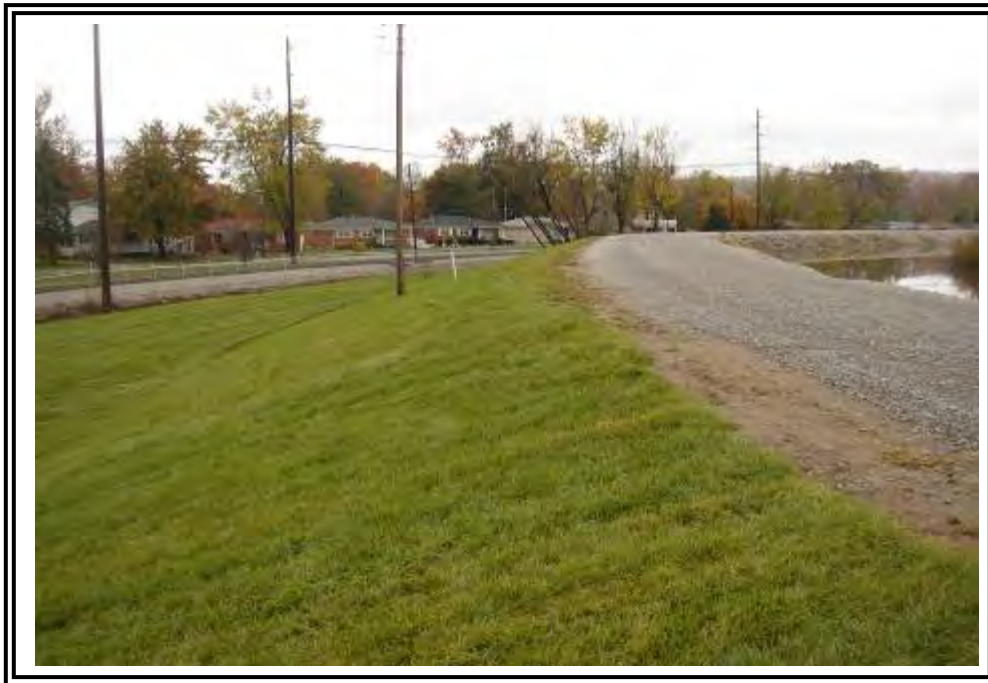
16

Crest of ATB east dike looking south.

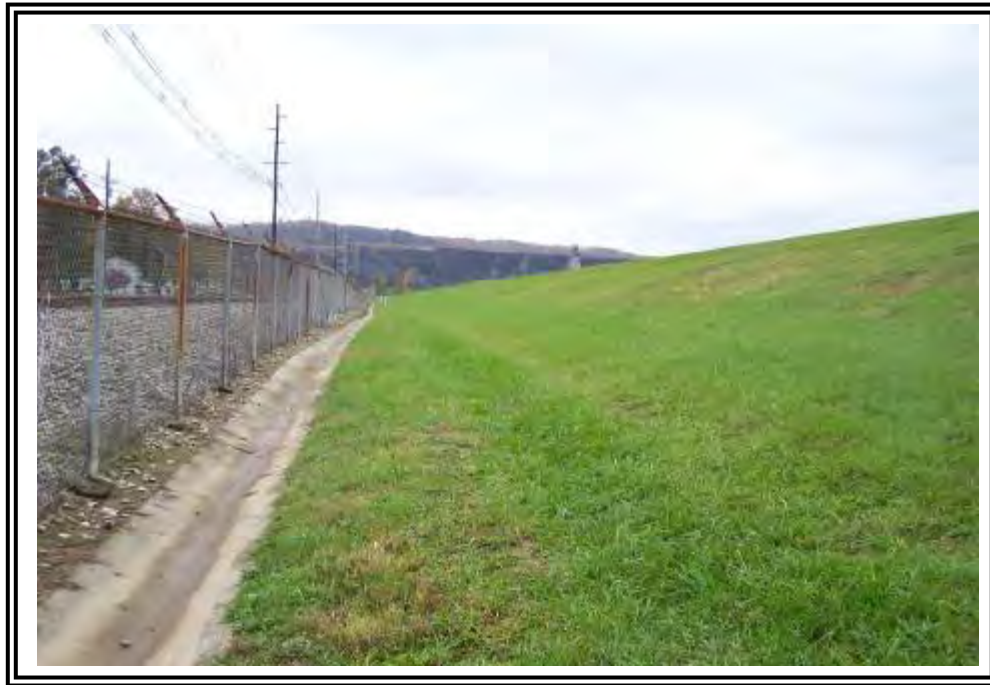
19

Downstream slope of ATB south dike looking west.

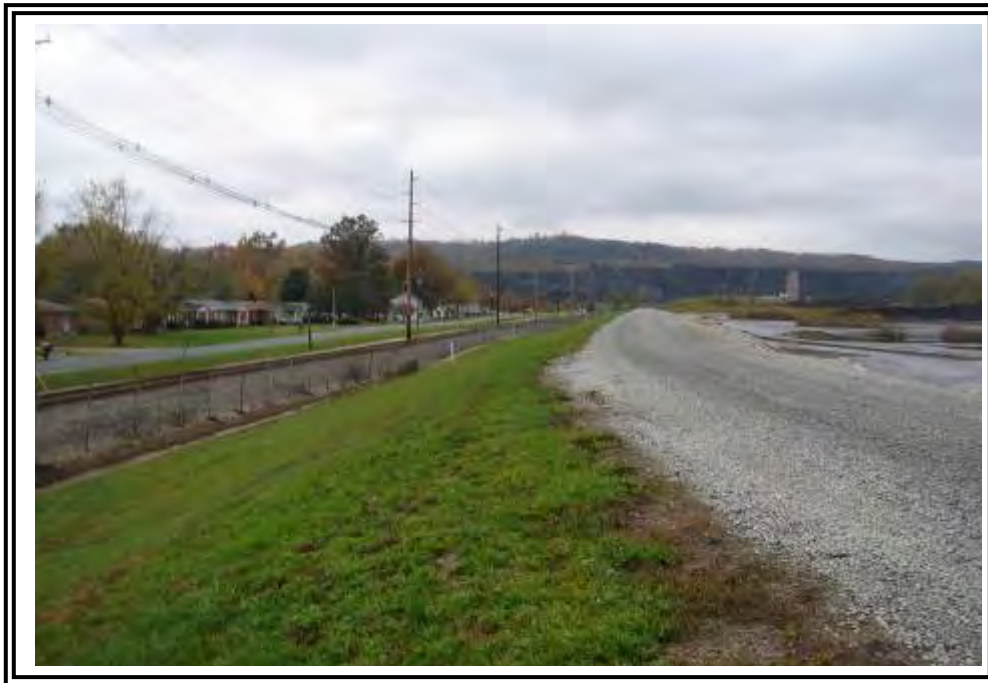
22

Crest of ATB south dike looking west.

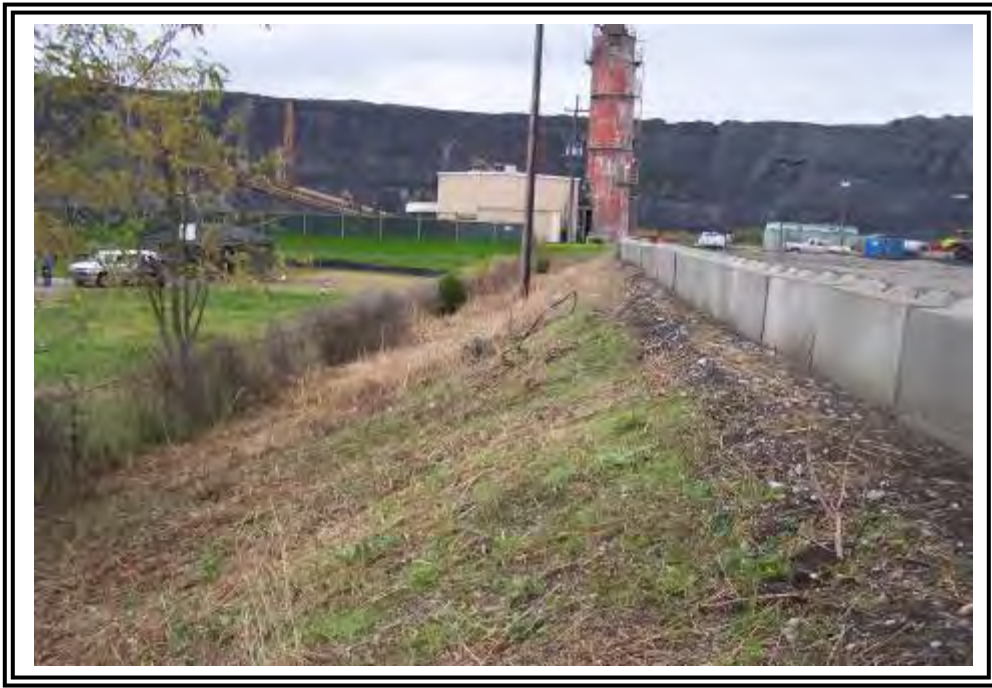
27

The ATB south dike continues along the E-Pond. The downstream embankment of the western 420 feet of the south dike, as shown in Photos 26 through 30, becomes over-steepened and irregular, and vegetation appears predominantly weedy. Surface probing indicated soft conditions, with up to 18" of penetration observed. A concrete barrier runs between the crest and the downstream face. Photo 29 shows several erosion rills which have developed under this barrier. Photo 31 shows the E-Pond which was excavated within previously deposited ash slightly to the northeast of the E-Pond location indicated on a 1972 proposed site plan. Storm

Downstream slope of west end of ATB south dike. Note tree at the toe is on the adjacent property looking west.

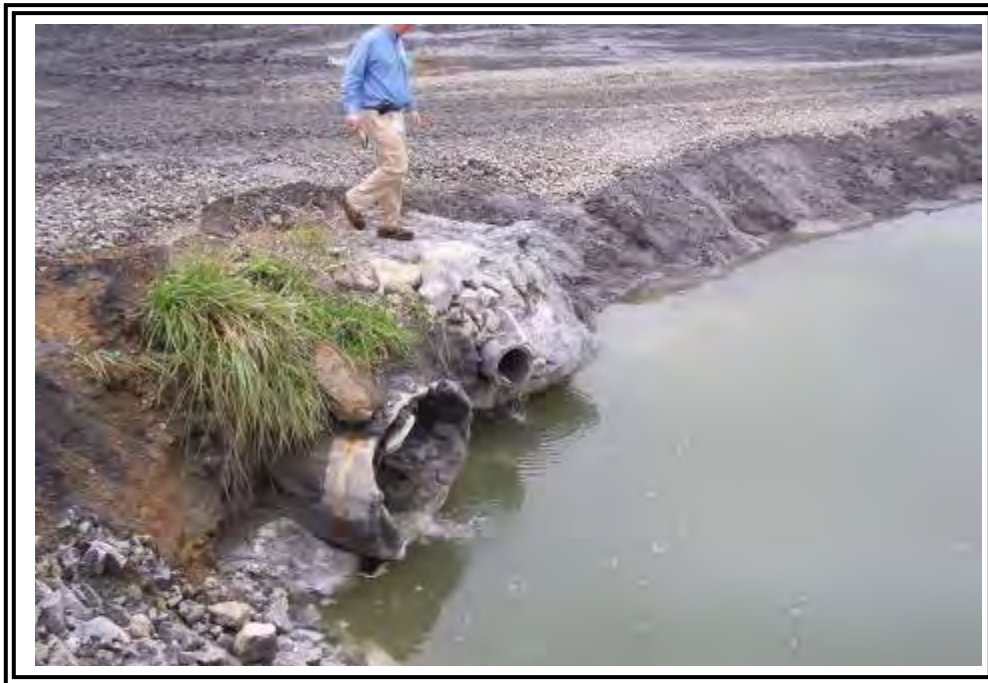
32

Stormwater flows from landfill (capped and uncapped) areas and discharges into E-Pond within the ATB.

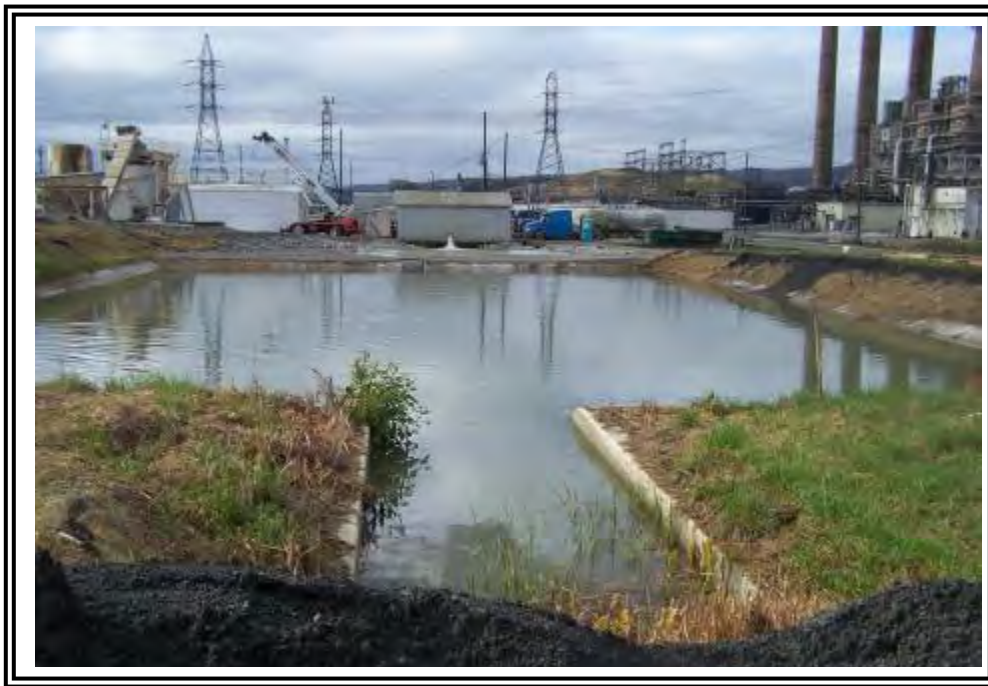
56

The location of these ponds is shown on Figure 2. This report focuses on the ATB/E-Pond Complex and the Basin Pond/Dead Storage Pond Complex because these ponds are impounded by earthen dikes and they receive coal combustion waste (CCW) products. While the Clearwell Pond has the potential to receive CCW, it is incised and therefore it is not discussed further in this report.

Clearwell Pond west of Basin/ Dead Storage Pond is incised.
