Assessment of Dam Safety Coal Combustion Surface Impoundments (Task 3) Final Report

Kentucky Utilities

Ghent Generating Station

February 25, 2010

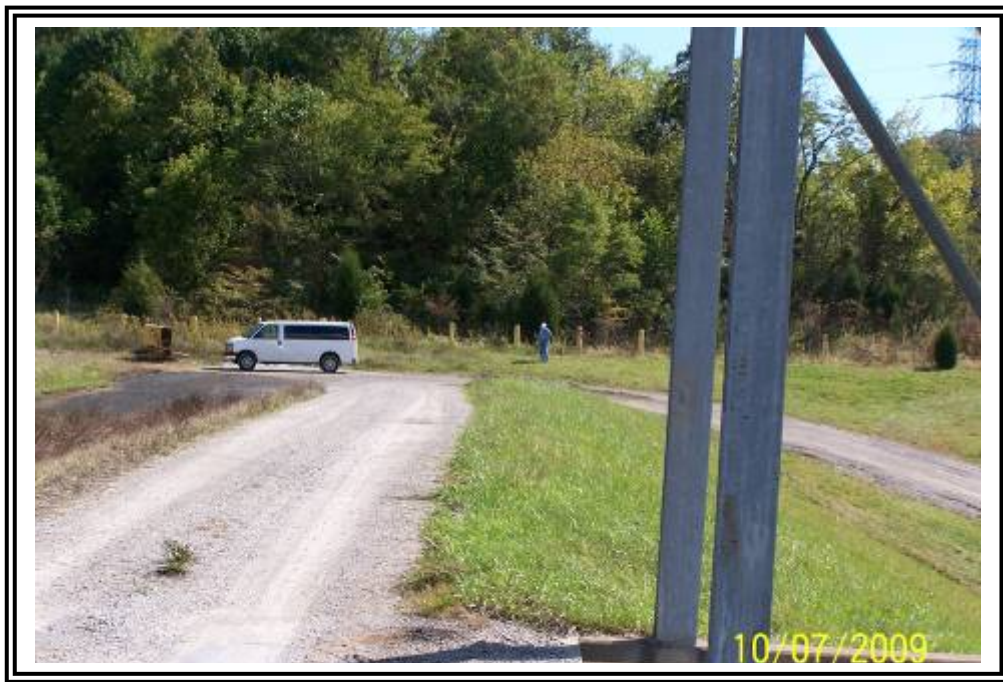
2

West abutment of ATB #1 looking south.

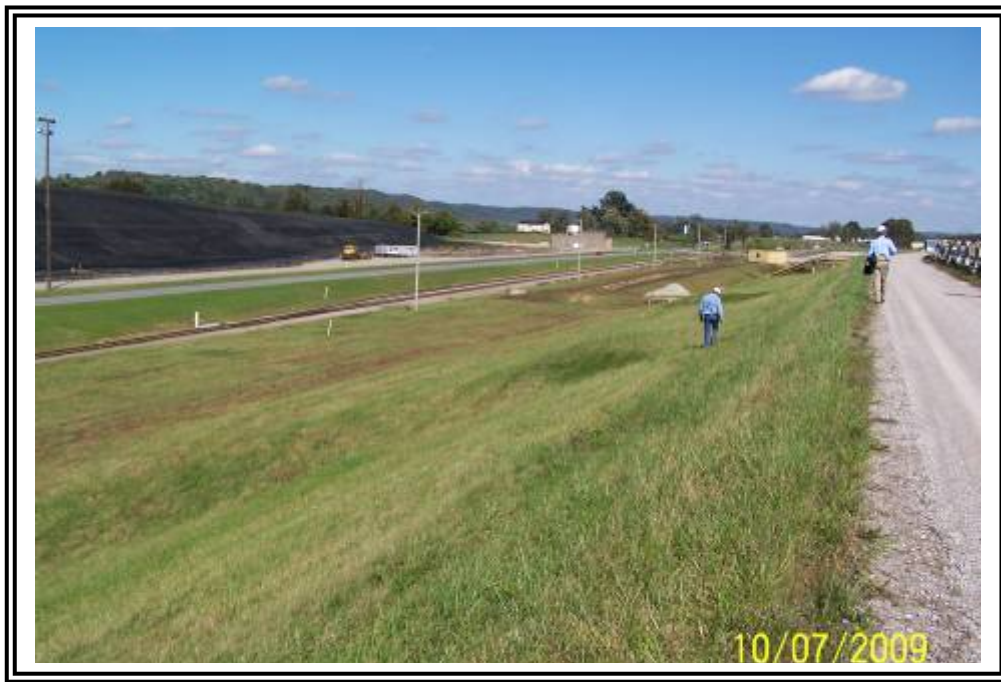
At the northeast corner of the embankment there is a bench about halfway down the slope as shown in Photos 16 and 22. A depression was observed in the bench near the northeast corner as shown in Photo 17. Occasional shallow erosion rills were also noted.

Start of bench around northeast corner of ATB #1 dike.

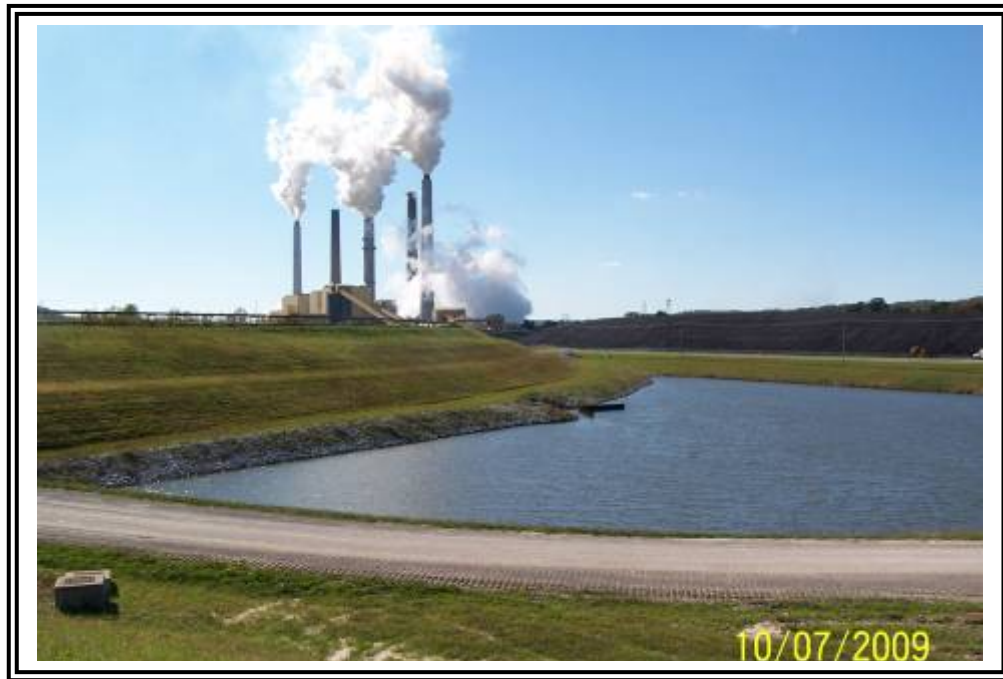
22

Downstream slope of ATB #1 northeast corner looking northwest.

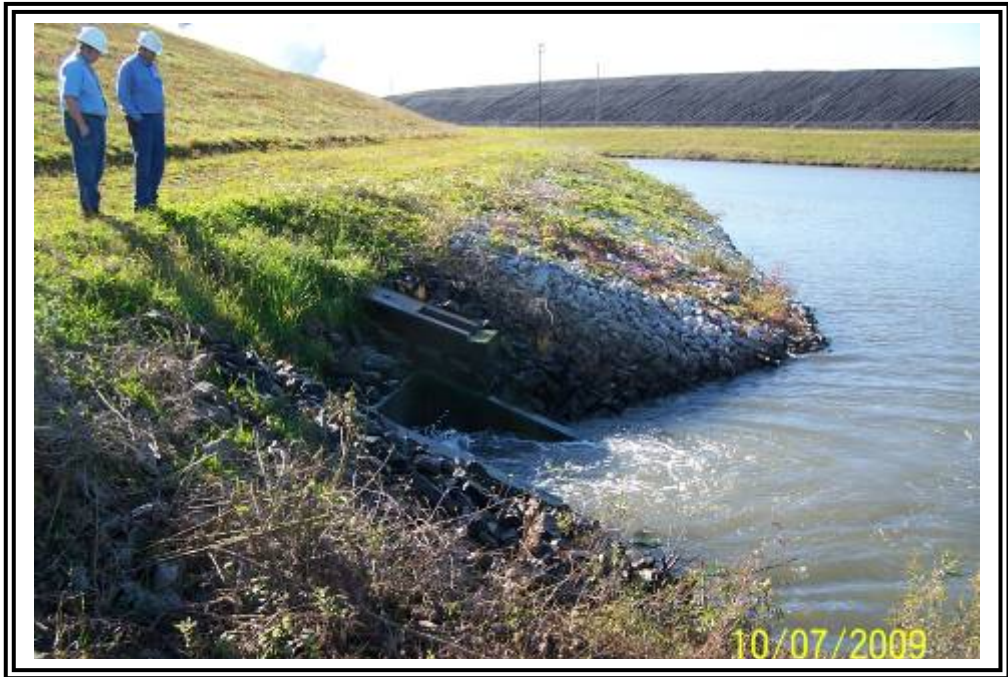
26

Outlet pipe discharge into secondary Ash Treatment Basin.

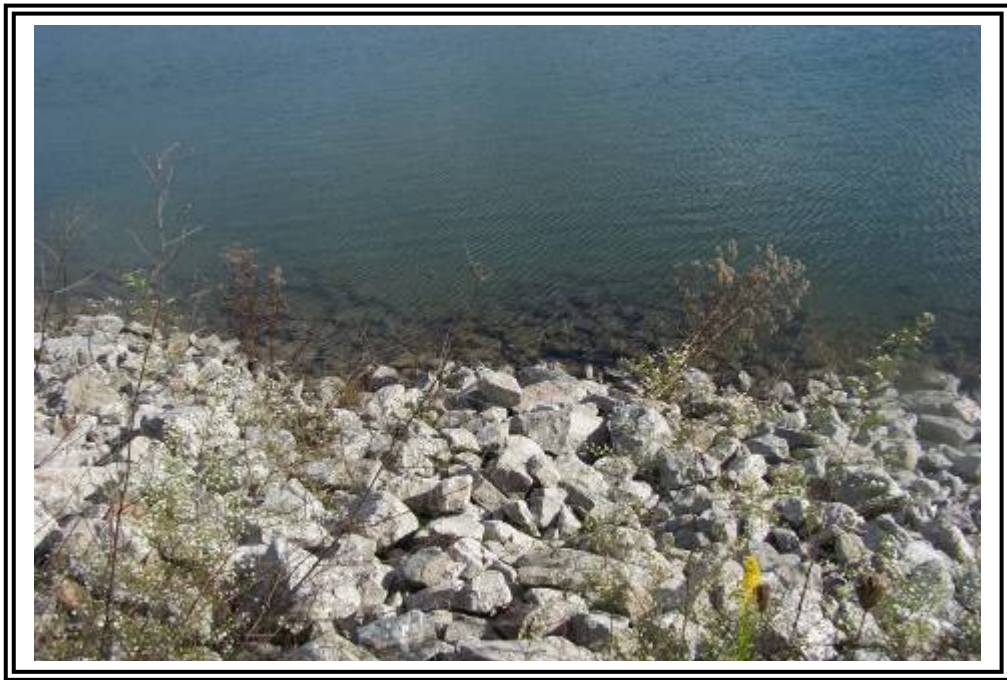
28

Rip rap protection on upstream slope of ATB #2 extends below the normal pool elevation.

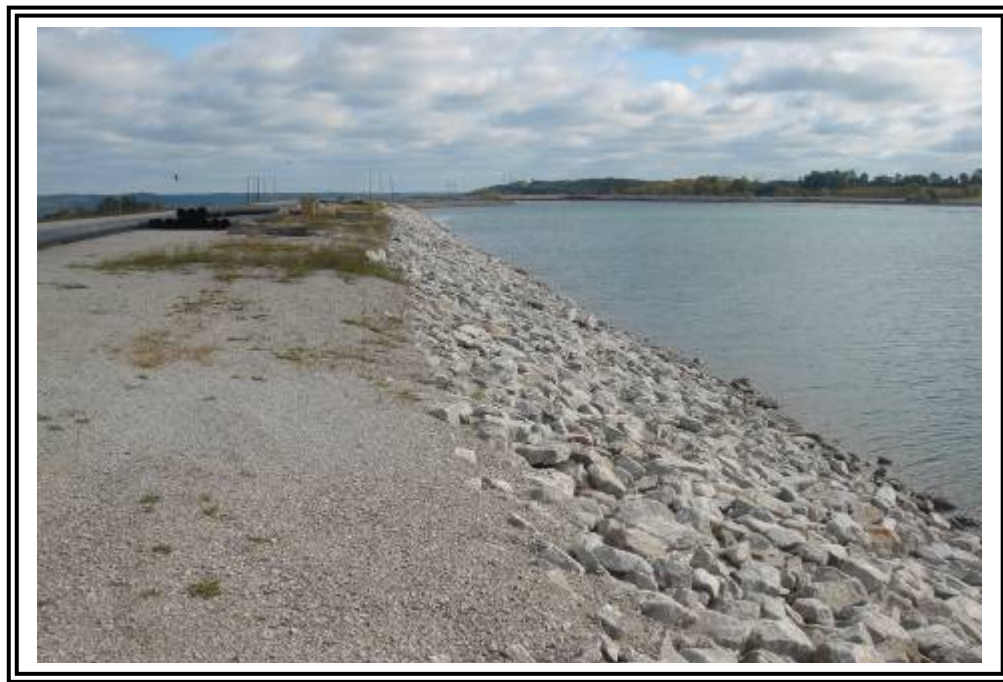
32

Upstream slope of ATB #2 looking east.

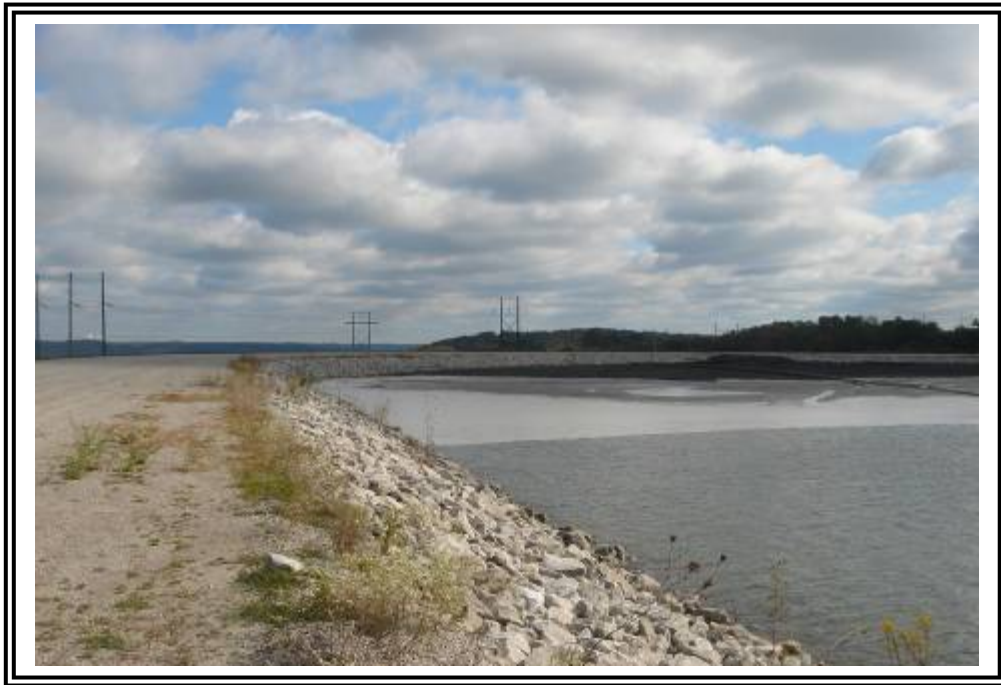
33

Upstream slope of ATB #2 looking east.

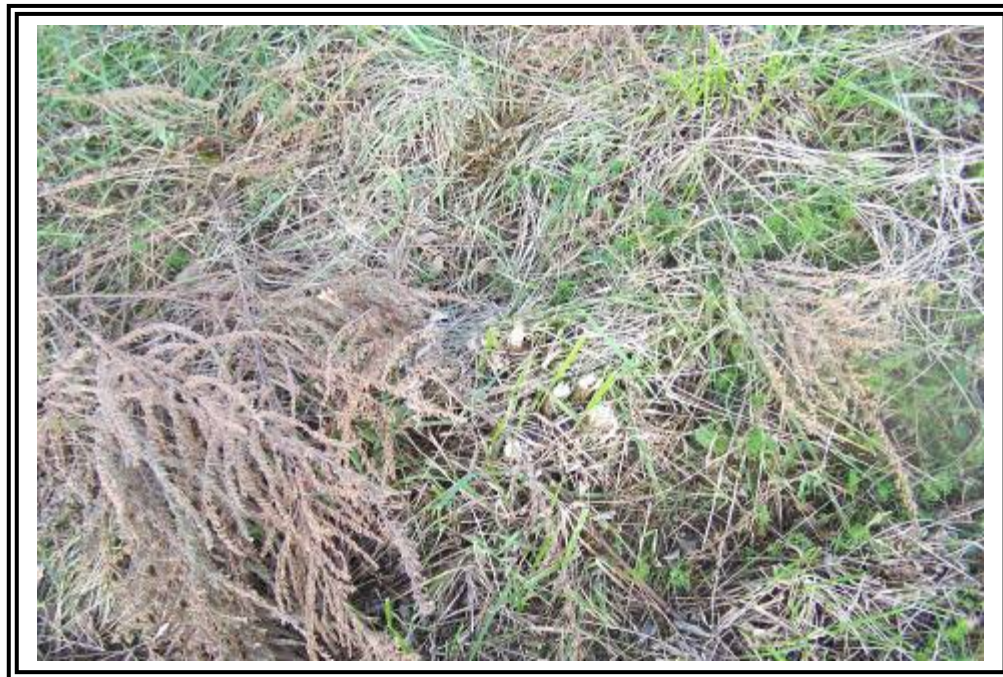
42

Maintenance includes removal of woody brush.

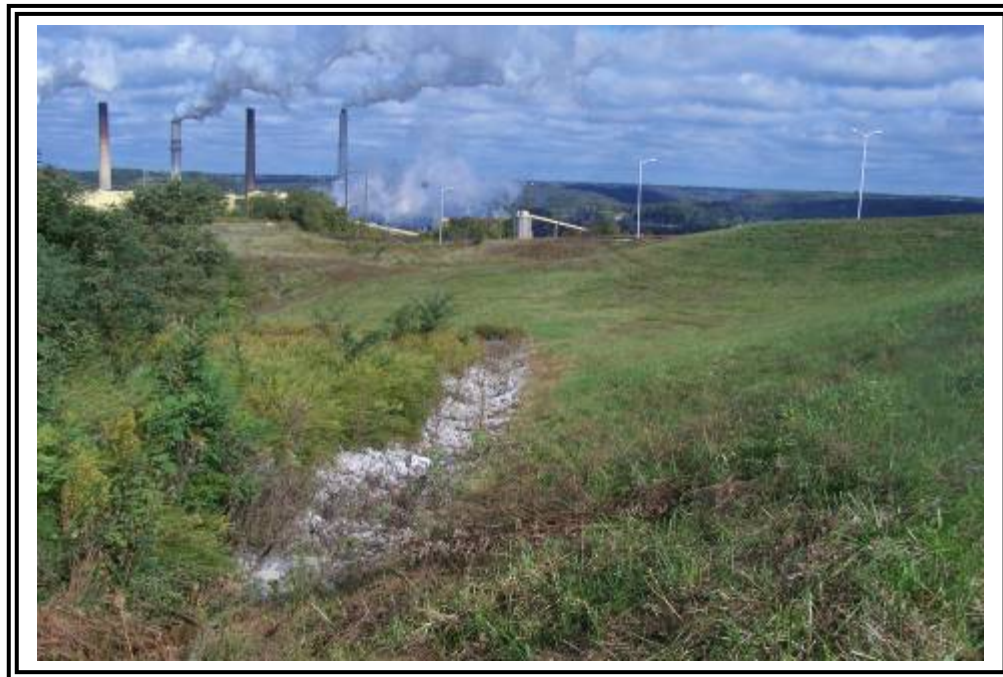
44

East groin at western knoll looking northeast.

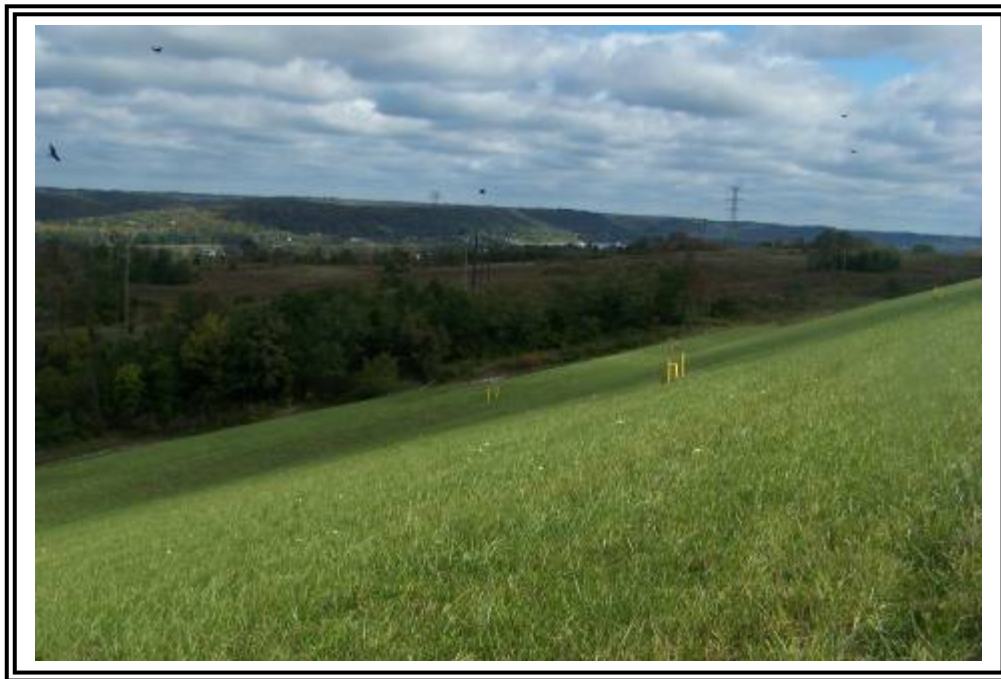
48

Upper portion of downstream slope of ATB #2 looking northeast. Instrumentation marked with yellow bollards, horizontal benched in main section of Dike at 50 vertical foot increments.

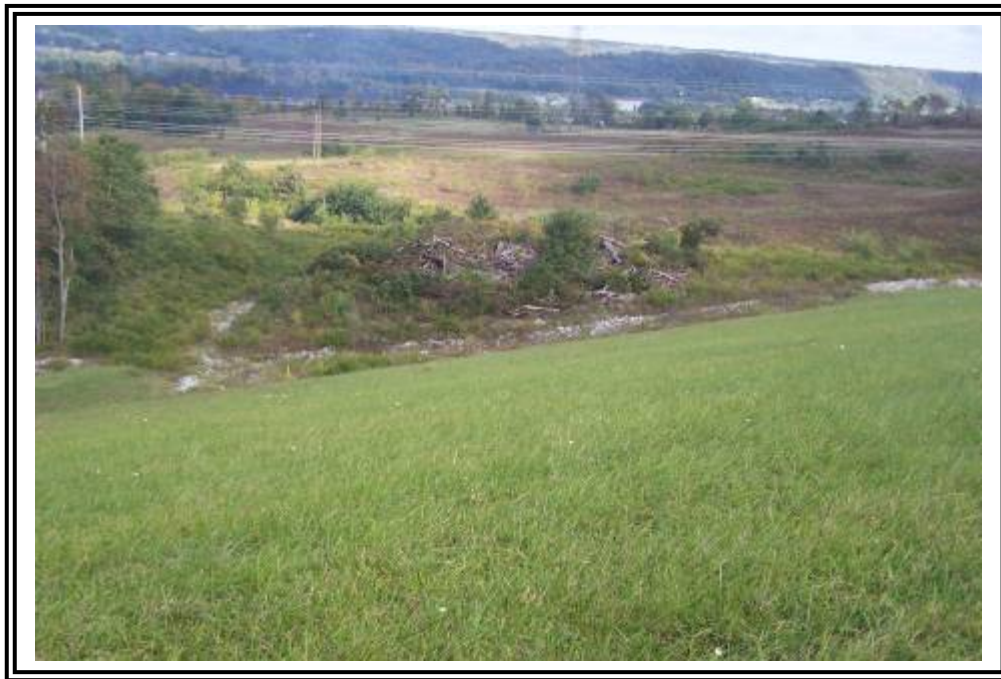
50

Downstream slope of ATB #2 at eastern knoll looking northeast.

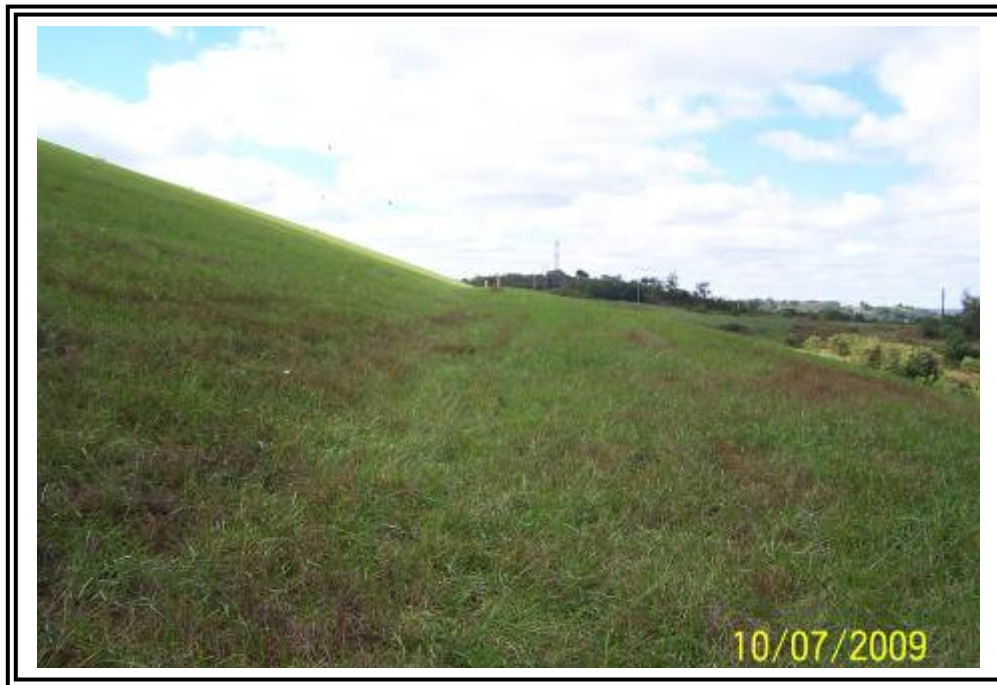
63

Upper bench on main fill.

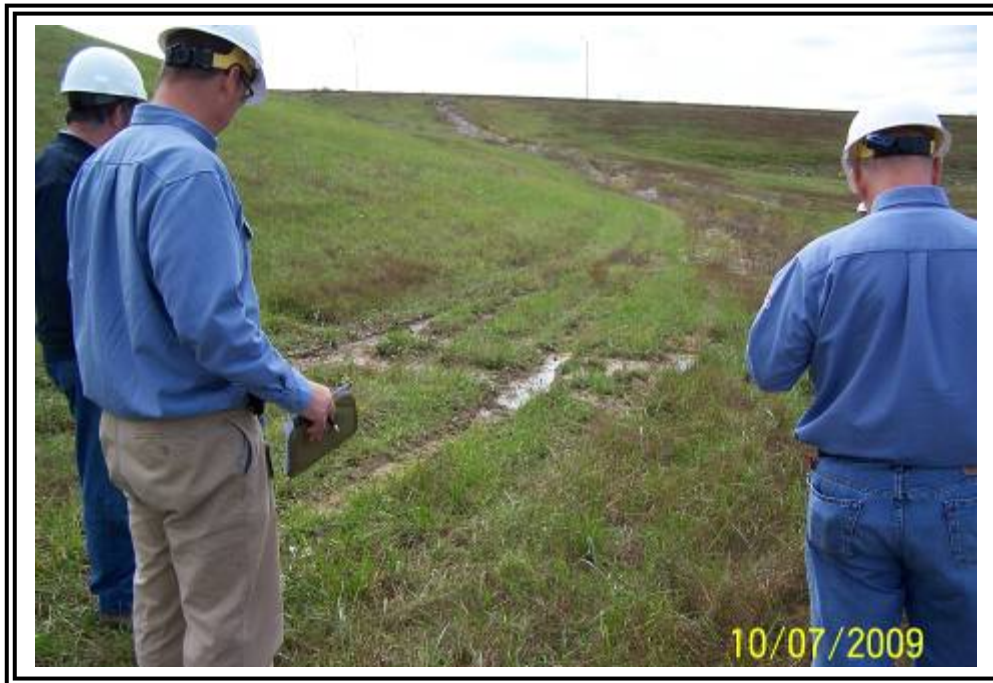
72

Standing water on west end of upper bench.

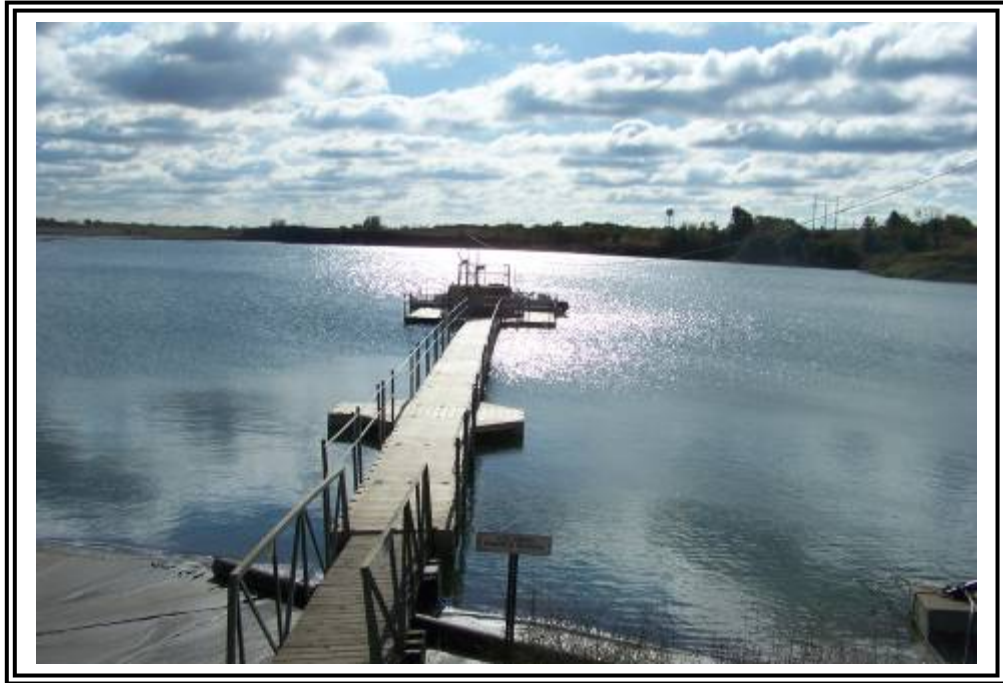
75

Outlet structure.

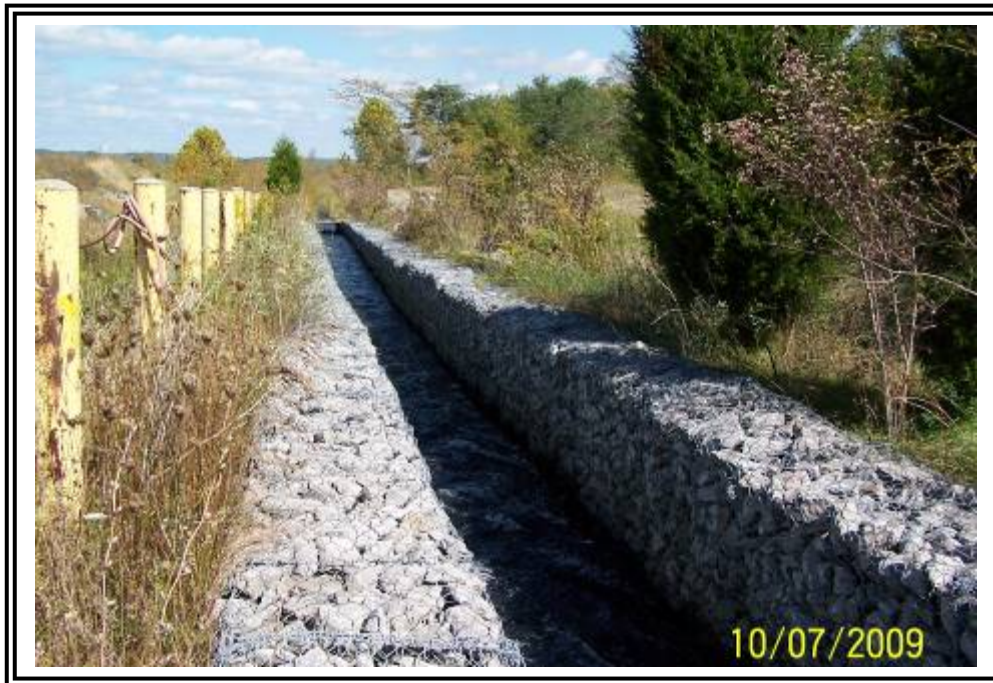
80

Sluiceway from ATB #2 discharge into ATB #1.

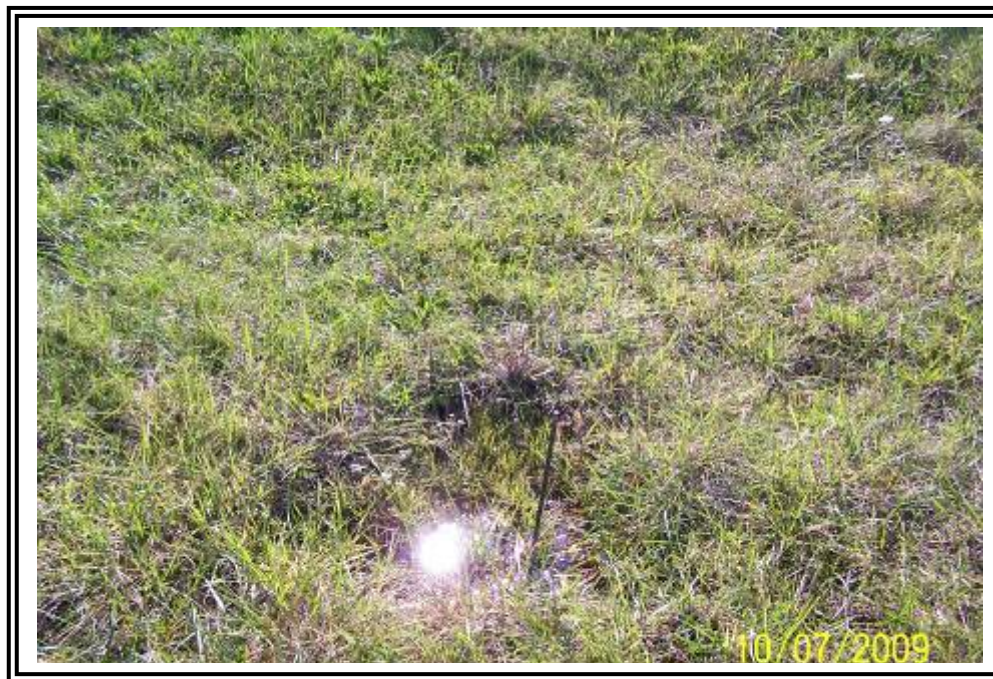
98

Standing water at the toe along the east side of the gypsum stacking facility starter dike.
Ground is firm, appears to be surface water drainage.

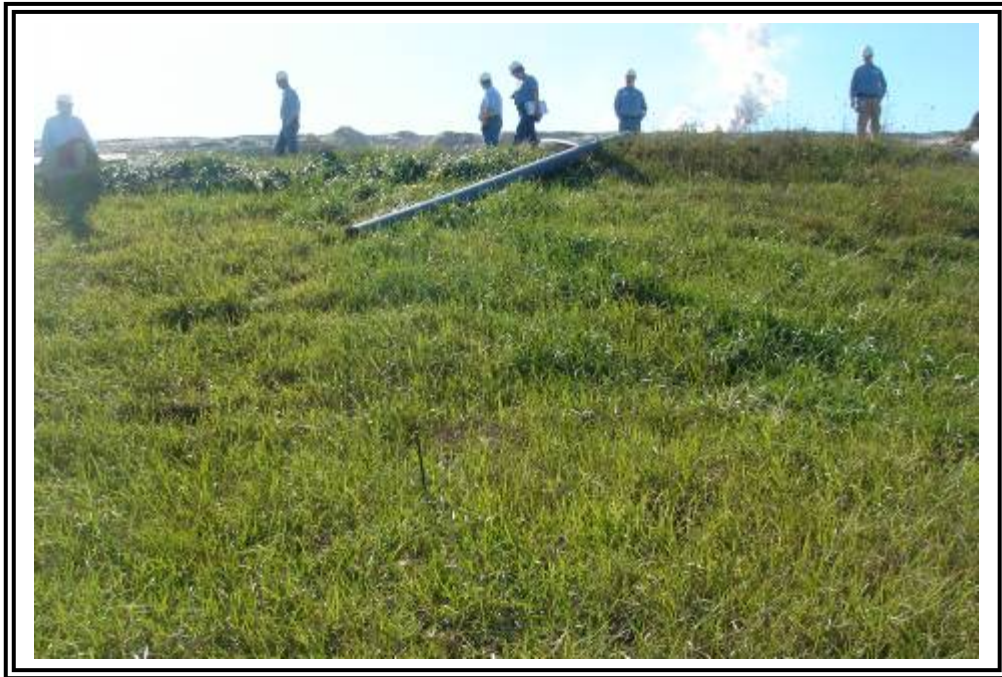
104

Area of seep near top of gypsum stacking facility east starter dike. Kentucky Utilities is working with Stantec (Engineer of Record) to resolve this issue. Seepage is at approximate elevation of current water surface in the pond.
