Report of Geotechnical Investigation
Dam Safety Assessment of Coal Combustion
Surface Impoundments
Georgia Power
Plant Scherer, Juliette, GA

AMEC Project No. 3-2106-0174.0200

June 2010

Southern Company, Georgia Power, Plant Scherer: Ash Pond and Settling Pond was assessed on May 12, 2010.

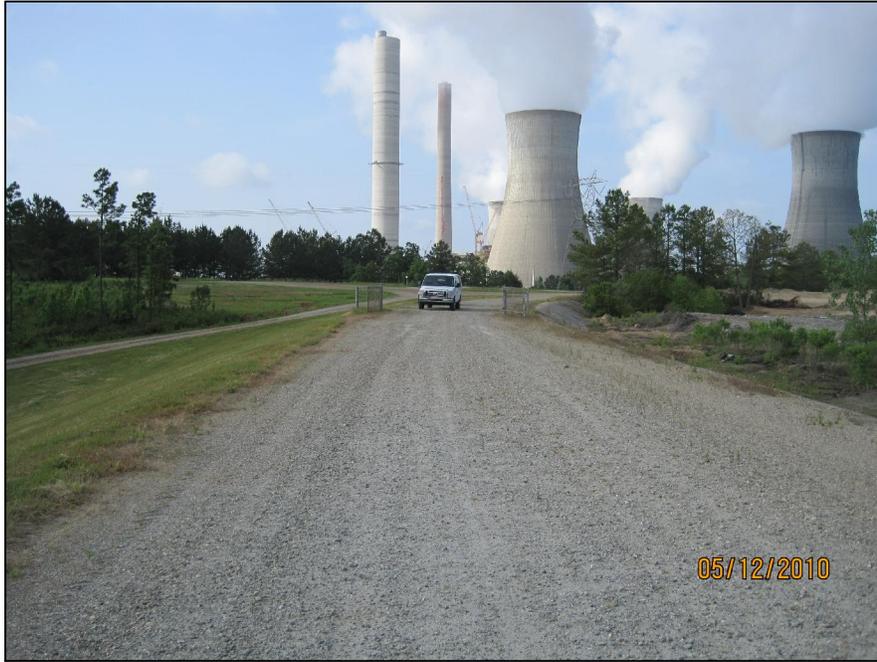
AP-1

CREST OF EAST DIKE, LOOKING SOUTH TOWARD TIE-IN WITH SOUTH DIKE

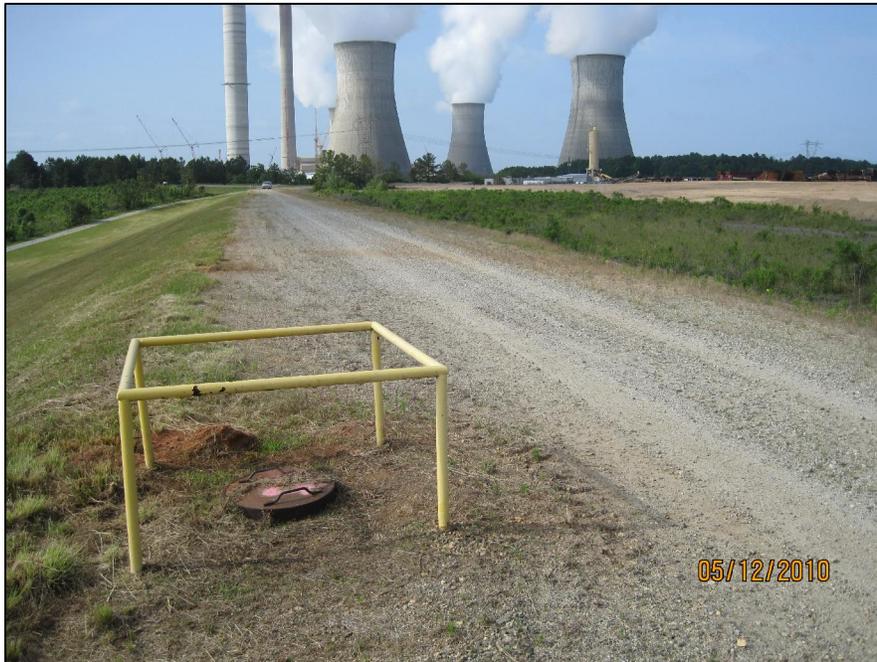
AP-2

CREST OF EAST DIKE, LOOKING SOUTH AT SETTLEMENT MONUMENT #4

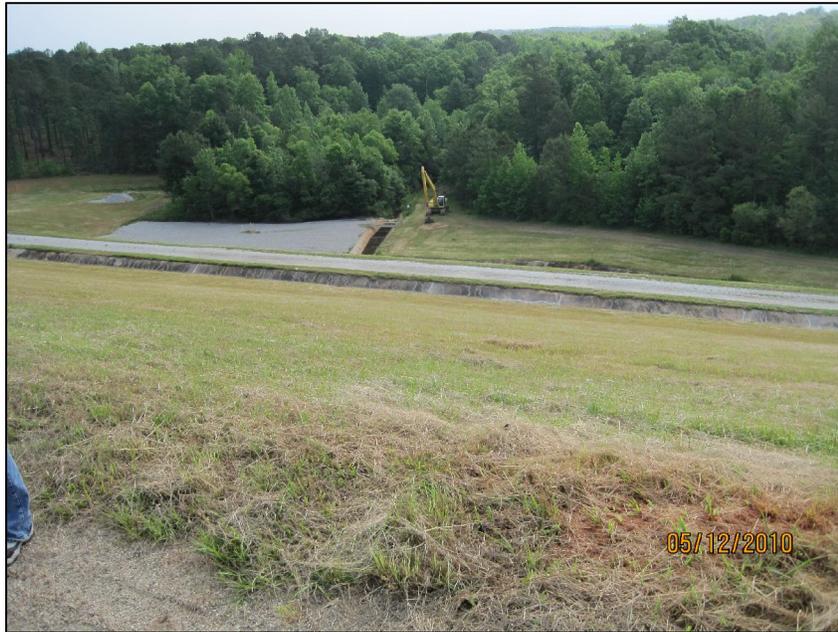
AP-3
CREST OF EAST DIKE, LOOKING EAST AT TOE DRAIN OUTLET

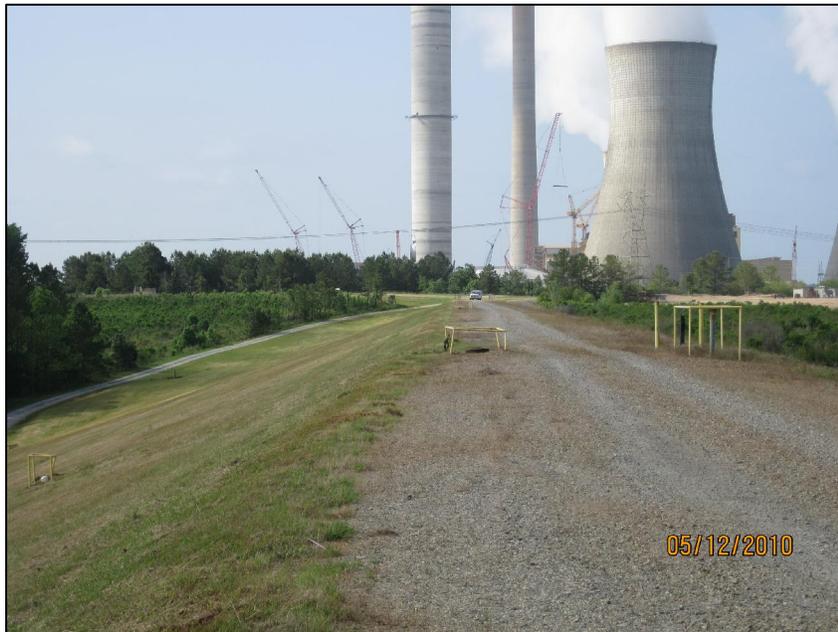
AP-4
CREST OF EAST DIKE, LOOKING SOUTH AT PZ'S AP-1R, AP2 AND SETTLEMENT MONUMENT #5

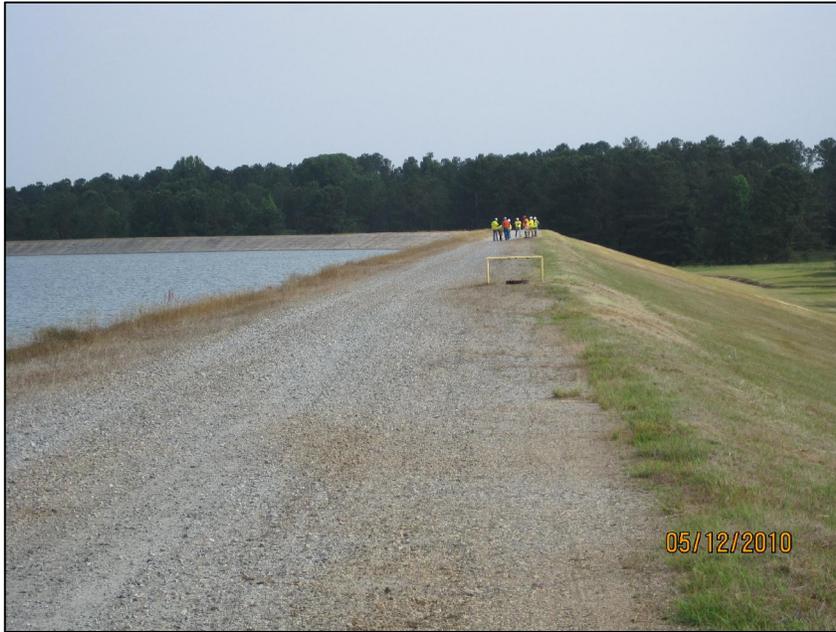
AP-5

CREST OF EAST DIKE, LOOKING NORTH AT SETTLEMENT MONUMENT #6 AND #7) LEFT:UPSTREAM FABRIFORM SLOPE OF SOUTH END OF NORTH DIKE, RIGHT:DOWNSTREAM SLOPE OF NORTH END OF EAST DIKE

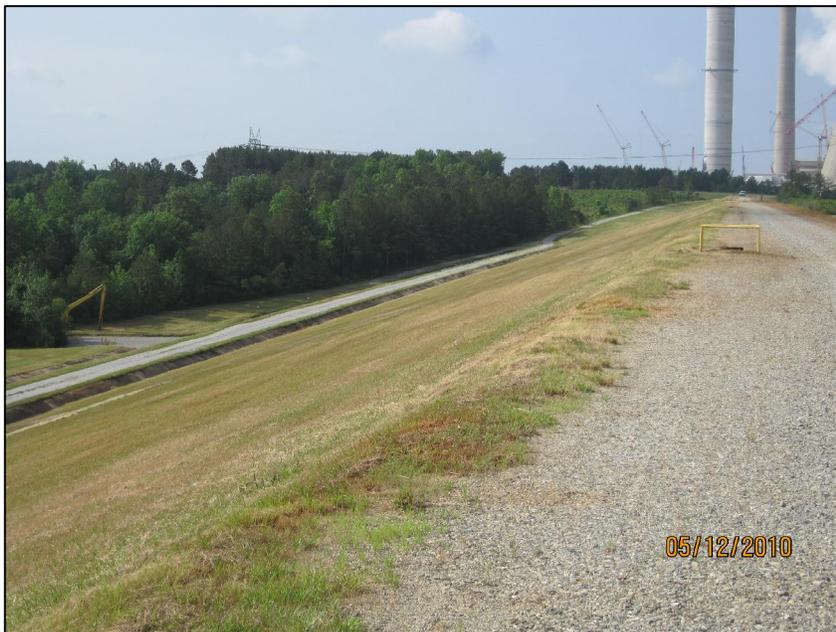
AP-6

CREST OF EAST DIKE, LOOKING SOUTH (SETTLEMENT MONUMENT #6) REPAIRED SURFACE SLOUGHING AREA (RESEEDED AND MATTED) ON DOWNSTREAM SLOPE AT FAR LEFT OF PHOTO

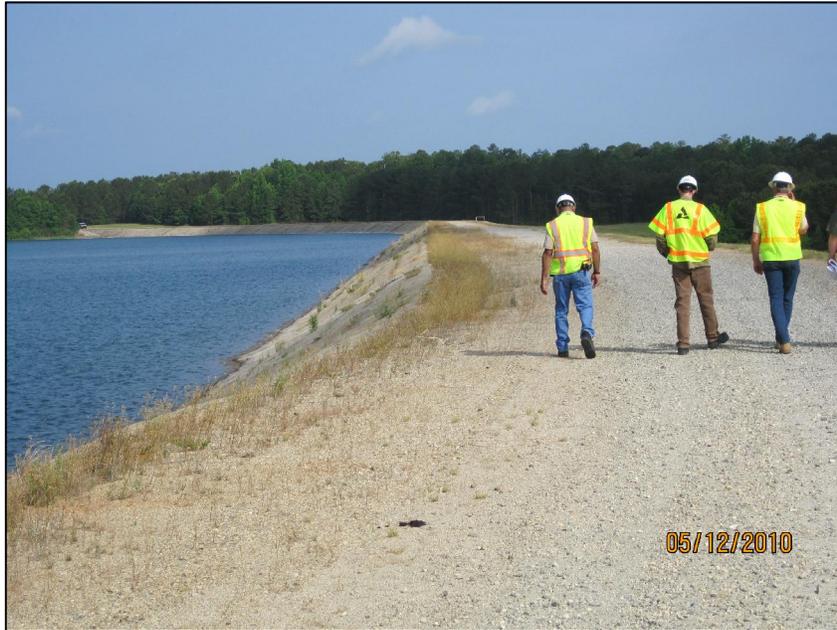
AP-7

INTERSECTION OF CREST OF EAST AND NORTH DIKE LOOKING NORTHWEST, LEFT: UPSTREAM FABRIFORM SLOPE OF NORTH DIKE, FAR LEFT: NORTH DIKE ABUTMENT TIE-IN

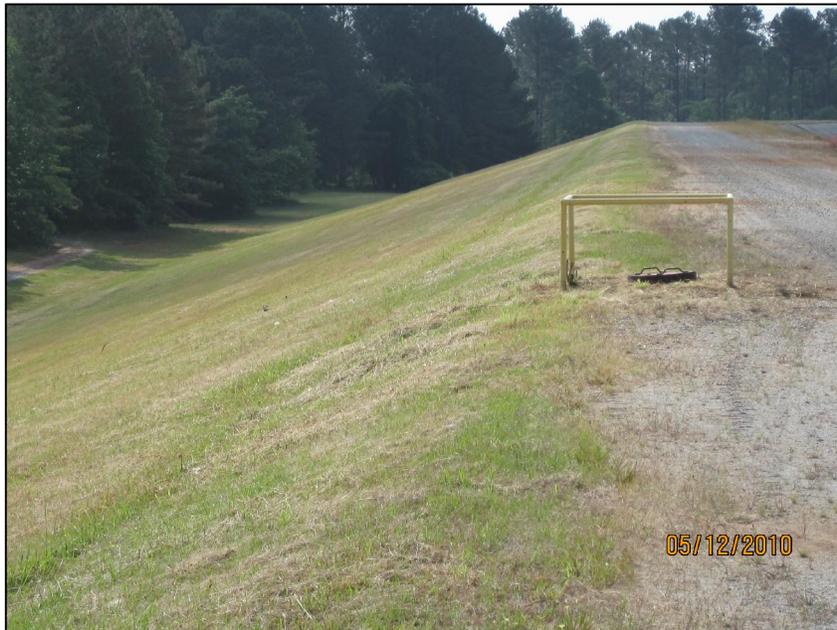
AP-8

CREST OF NORTH DIKE, LOOKING SOUTHEAST AT SETTLEMENT MONUMENT #8

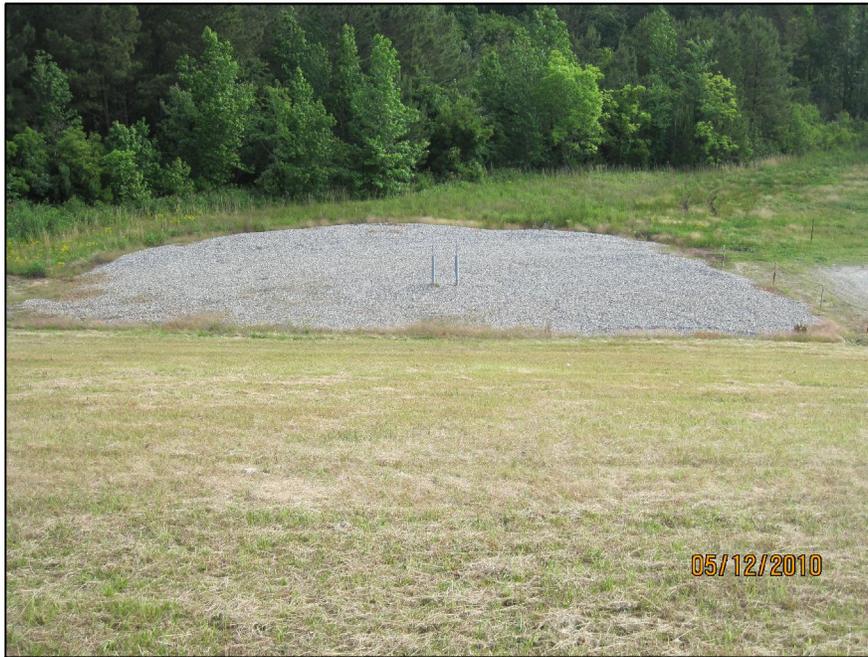
AP-9

CREST OF NORTH DIKE, LOOKING NORTH AT PZ'S AP-6 AND AP-7 (GPS POINT 10) AT TOE OF DOWNSTREAM SLOPE

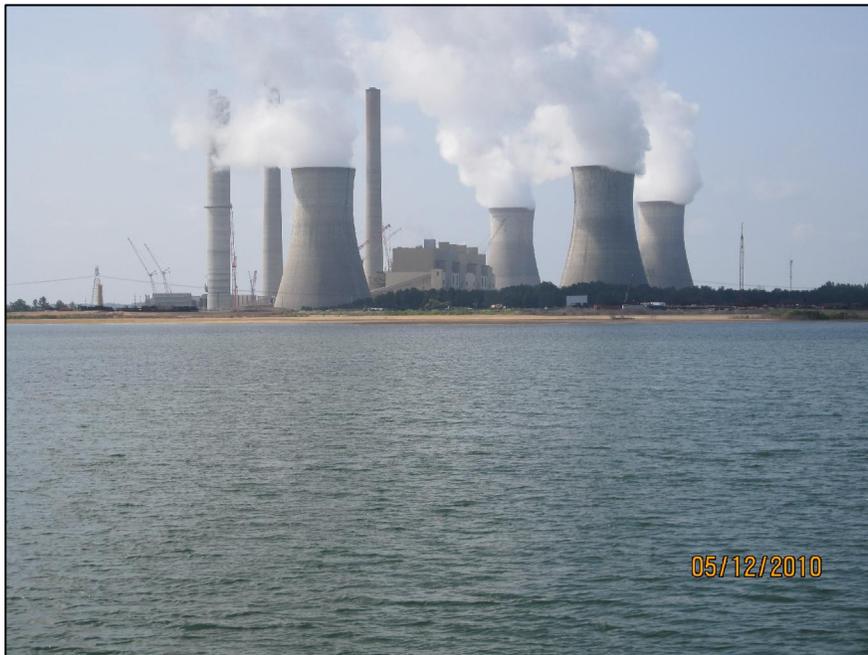
AP-10

CREST OF NORTH DIKE, LOOKING SOUTH AT PLANT SCHERER

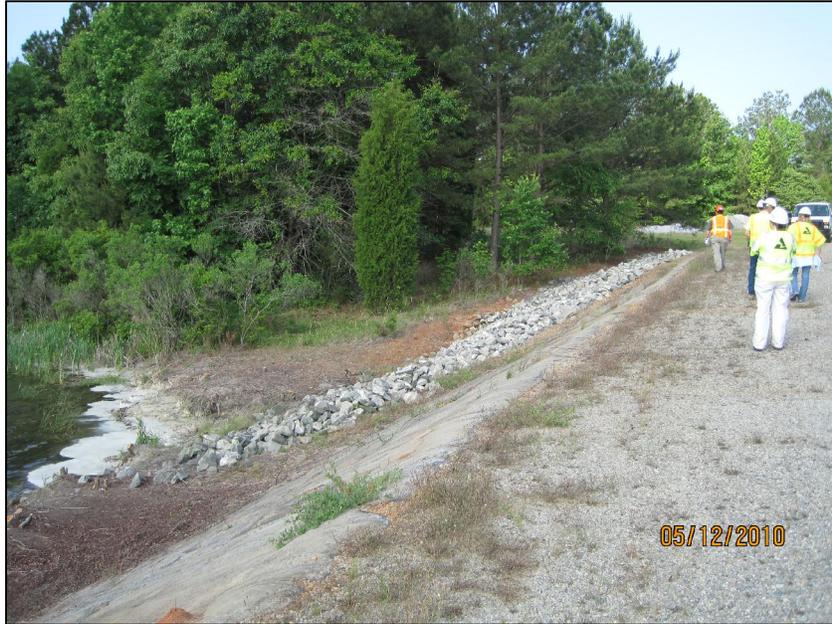
AP-11

CREST OF NORTH DIKE, LOOKING AT UPSTREAM SLOPE AT LEFT ABUTMENT TIE-IN

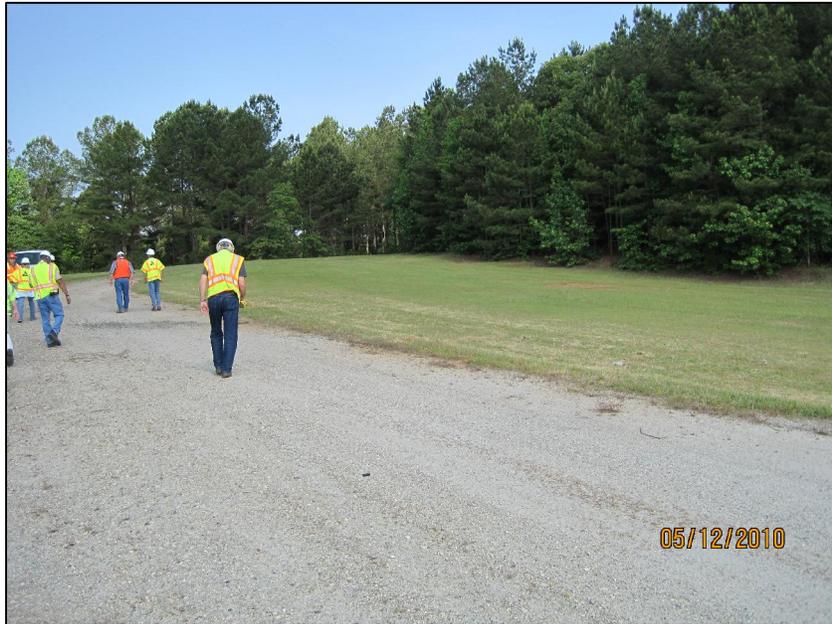
AP-12

CREST OF NORTH DIKE, LOOKING AT DOWNSTREAM SLOPE AT LEFT ABUTMENT TIE-IN

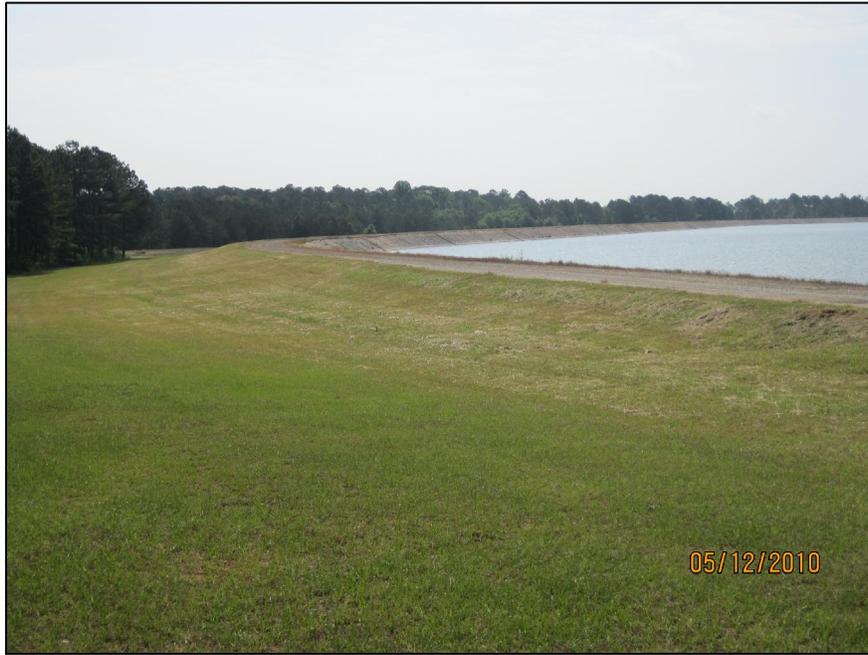
AP-13

NORTH DIKE FROM LT. ABUTMENT TIE-IN LOOKING EAST AT DOWNSTREAM SLOPE

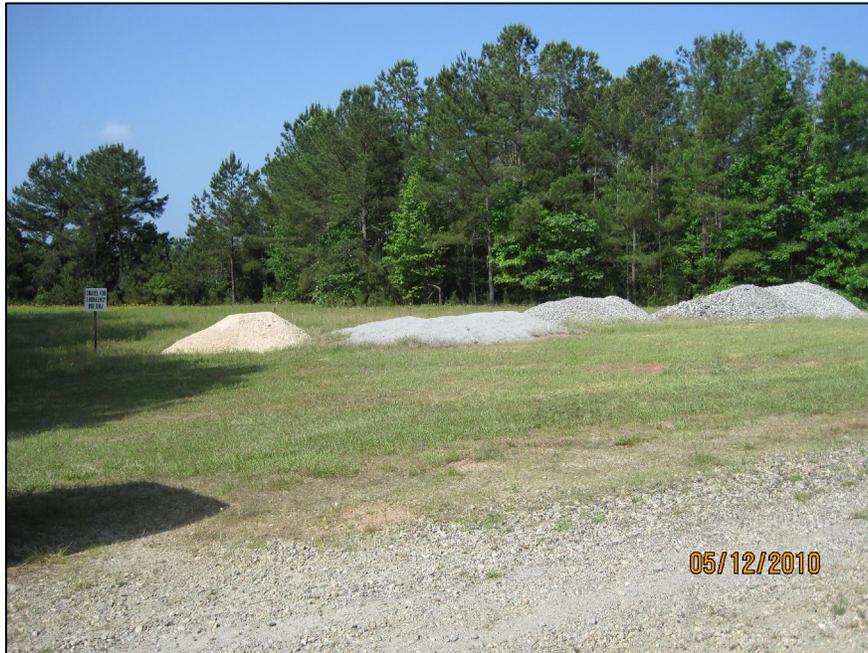
AP-14

NORTH DIKE, LT ABUTMENT TIE-IN, EMERGENCY SUPPLIES

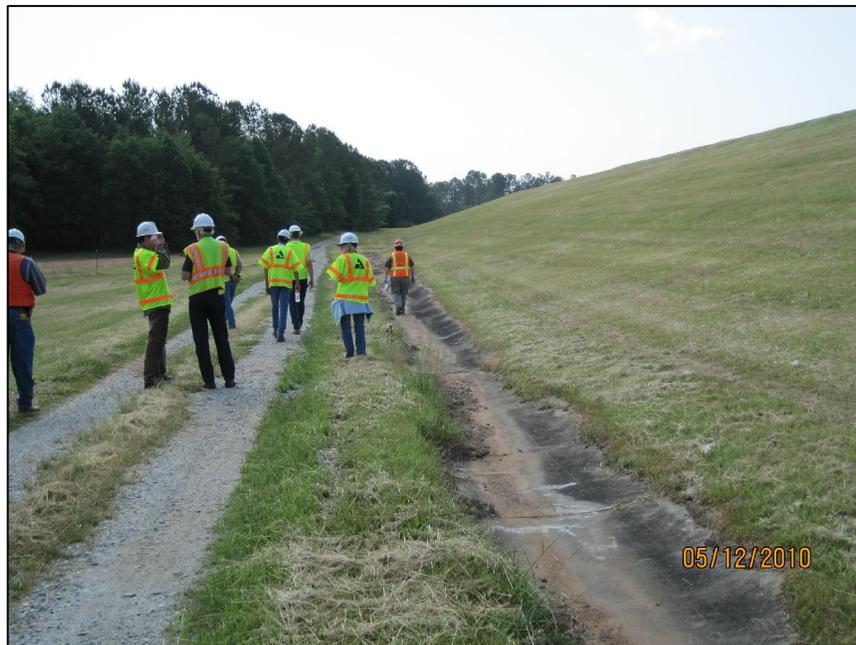
AP-16

**DOWNSTREAM TOE OF NORTH DIKE, LOOKING SOUTHEAST
AT GRAVEL ROAD AND CONCRETE DITCH AT TOE AND DOWNSTREAM SLOPE**

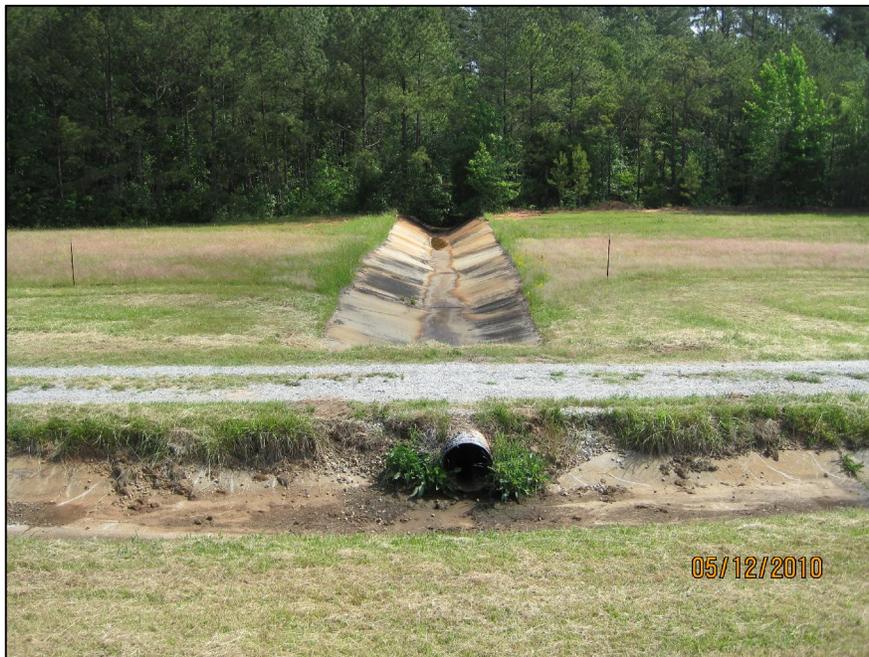
AP-18

DOWNSTREAM TOE OF NORTH DIKE, LOOKING NORTHEAST AT TOE DRAIN OUTLET

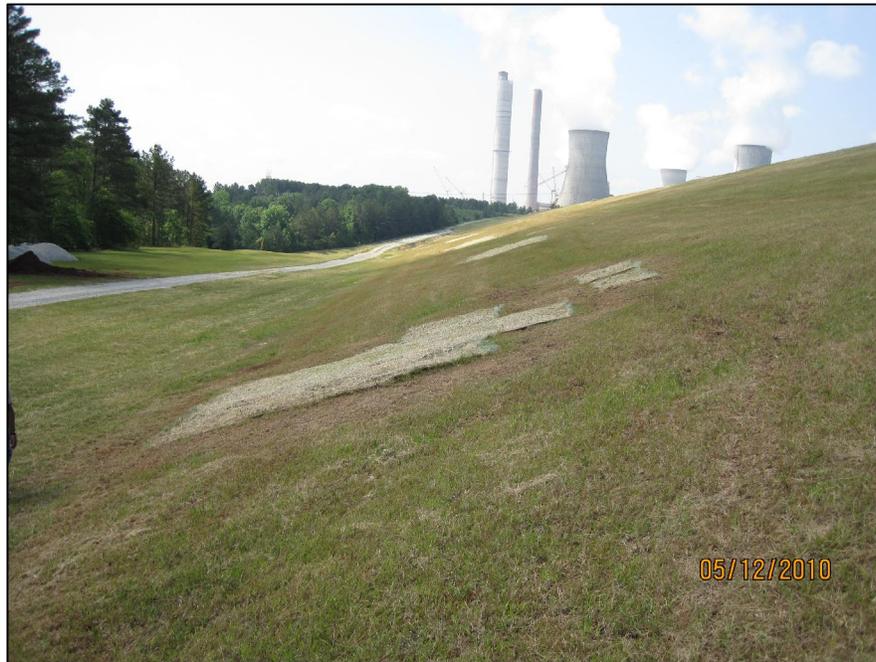
AP-20

DOWNSTREAM SLOPE OF EAST DIKE, LOOKING SOUTH AT REPAIRED AREAS ON SLOPE

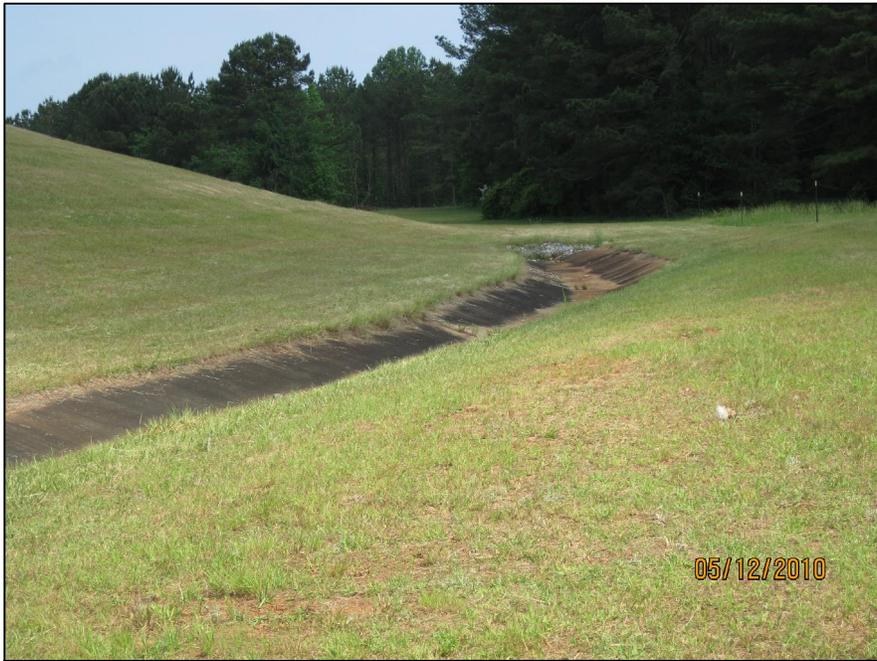
AP-21

DOWNSTREAM TOE OF EAST DIKE, LOOKING NORTHWEST AT BEGINNING OF CONCRETE DITCH

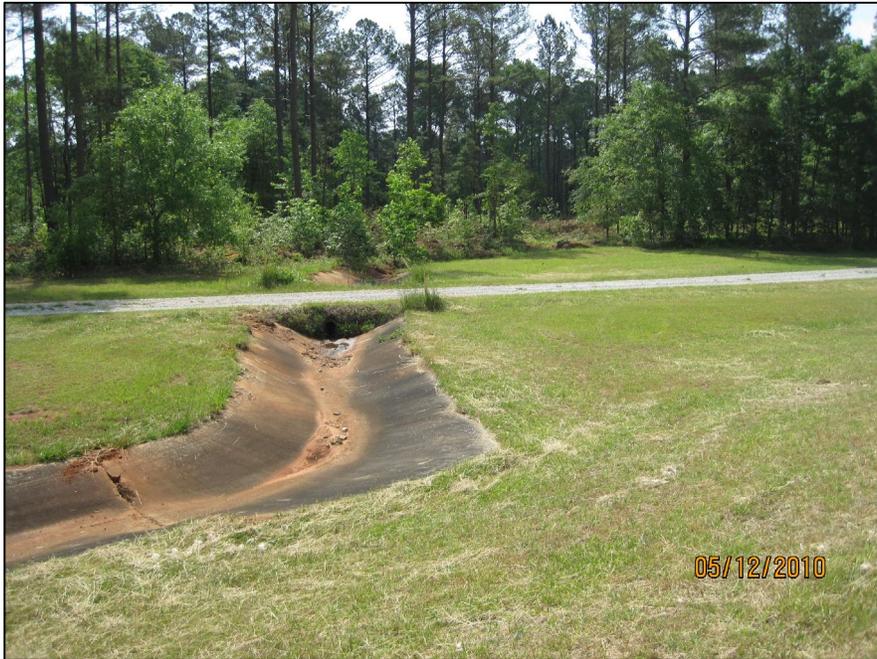
AP-22

DOWNSTREAM TOE OF EAST DIKE, LOOKING EAST AT TOE-DRAIN OUTLET

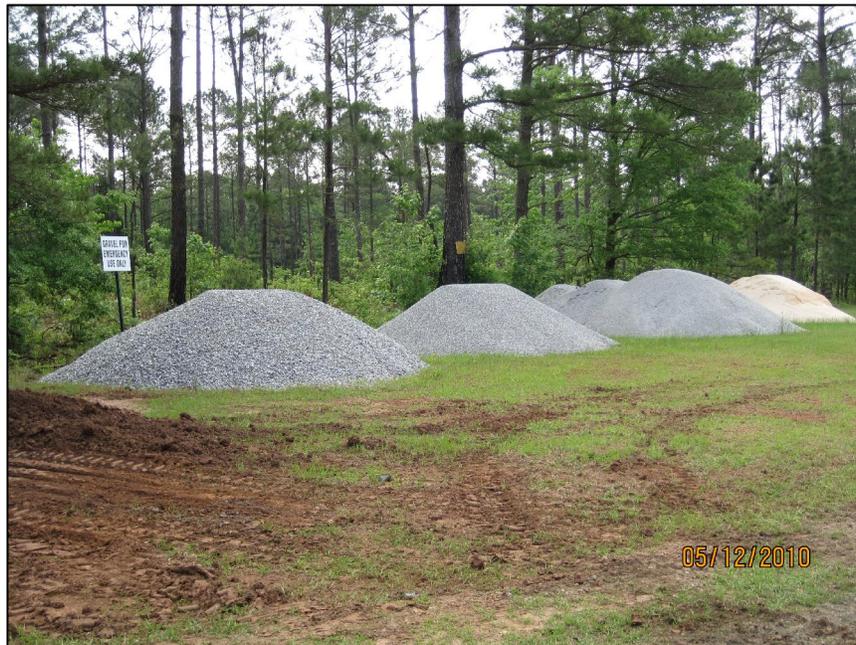
AP-23
EAST OF DOWNSTREAM TOE OF EAST DIKE, EMERGENCY SUPPLIES

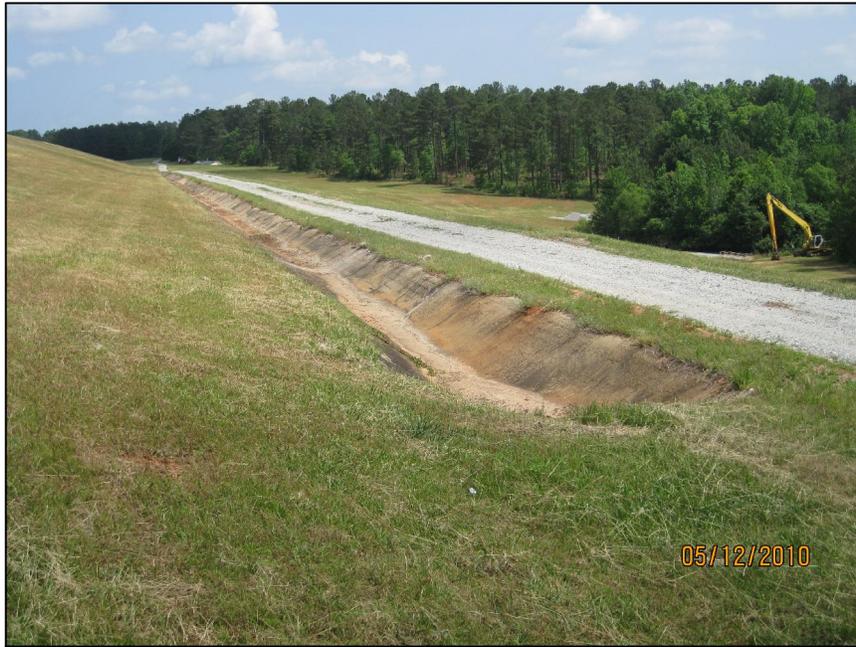
AP-25
DOWNSTREAM SLOPE OF EAST DIKE, LOOKING NORTH, END OF CONCRETE DITCH ABOVE GRAVEL ROAD

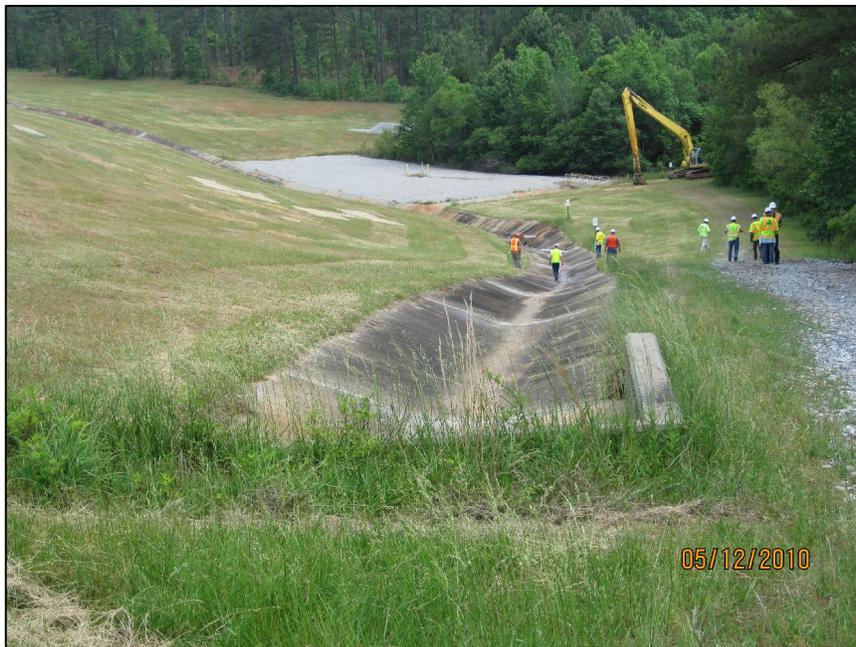
AP-26
DOWNSTREAM SLOPE OF EAST DIKE, LOOKING NORTHEAST, SOUTH END START OF SLOPE AND BLANKET DRAIN CONCRETE DITCH

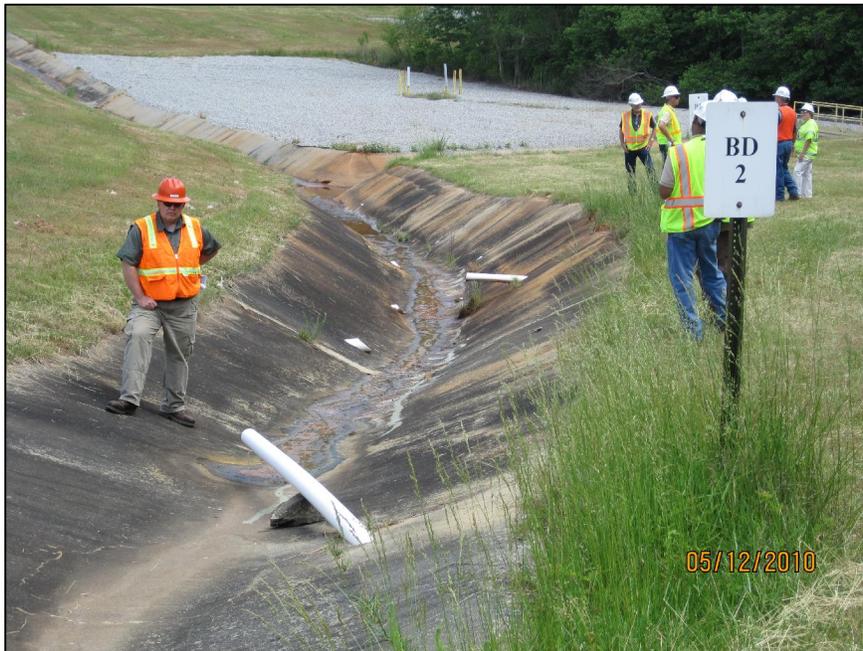
AP-28

DOWNSTREAM SLOPE OF EAST DIKE, LOOKING NORTH, WATER ENTERING CONCRETE DITCH FROM BD-2 AND BD-3

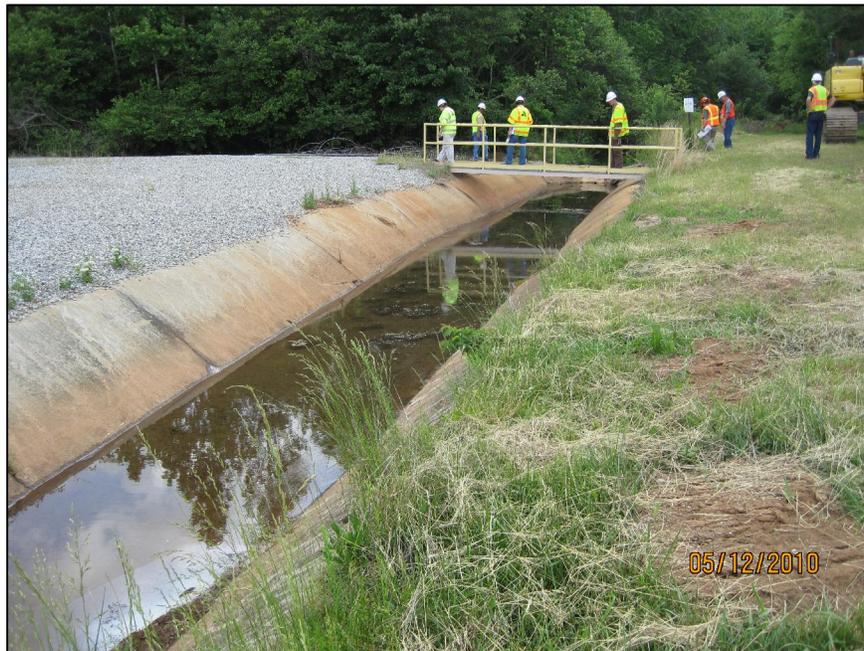
AP-29
 DOWNSTREAM TOE OF EAST DIKE, LOOKING EAST, BLANKET DRAIN OUTLET

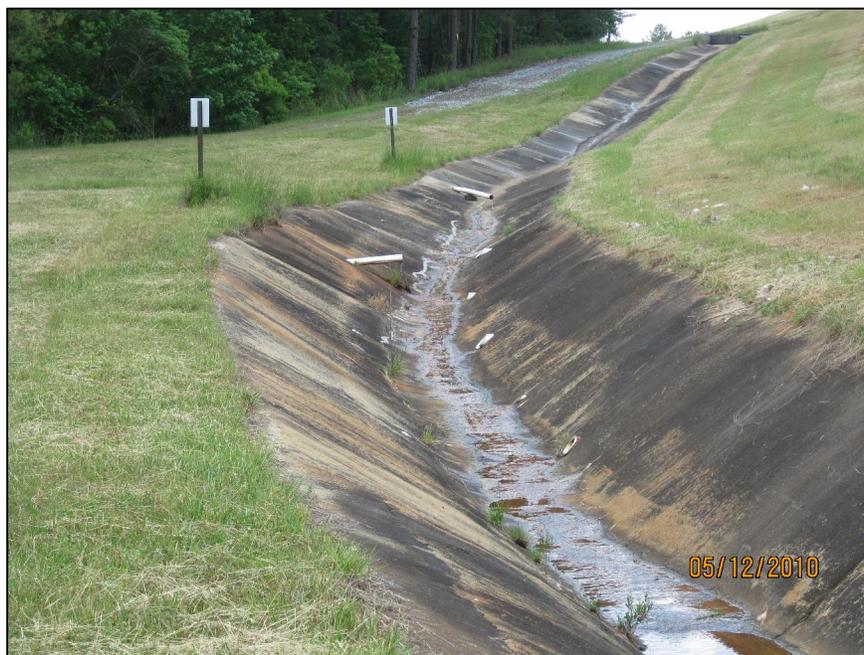
AP-30
 DOWNSTREAM TOE OF EAST DIKE, LOOKING SOUTHWEST AT BLANKET DRAIN DITCH

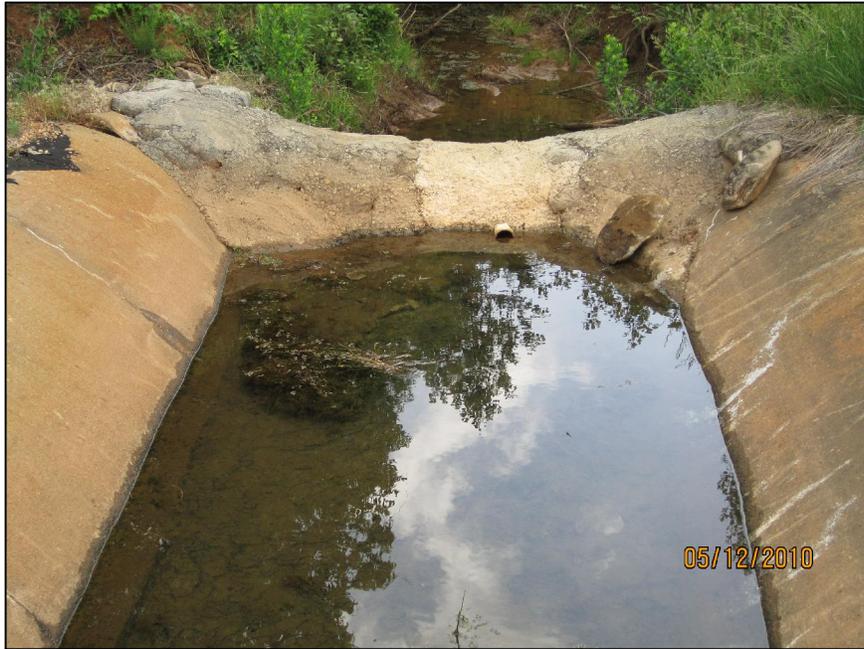
AP-31
 DOWNSTREAM TOE OF EAST DIKE, LOOKING EAST AT BLANKET DRAIN OUTLET WITH 4-INCH
 DIAMETER PIPE

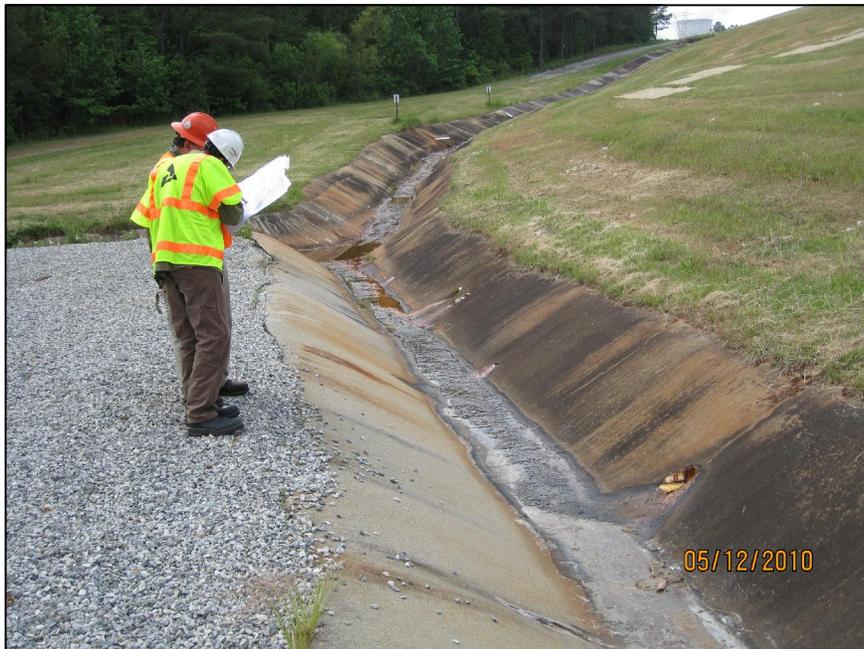
AP-32
 DOWNSTREAM TOE OF EAST DIKE, LOOKING SOUTH AT FLOWING BLANKET DRAIN ON NORTH
 SIDE OF BLANKET DRAIN OUTLET

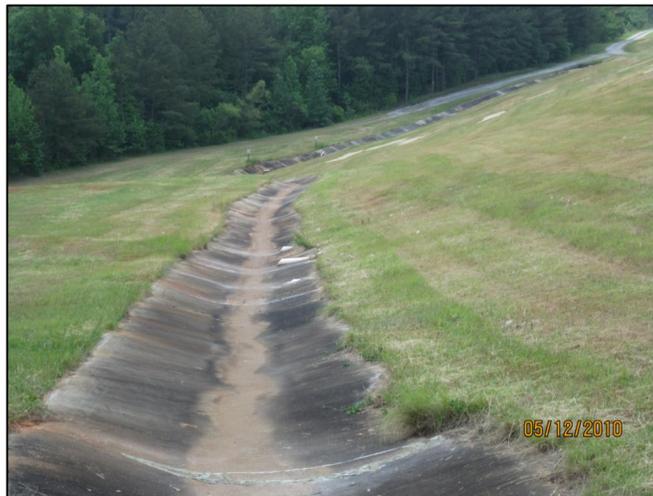
AP-34
 DOWNSTREAM SLOPE OF EAST DIKE, LOOKING SOUTHEAST, TOP OF NORTH END OF ROAD AND BLANKET DRAIN CONCRETE DITCH

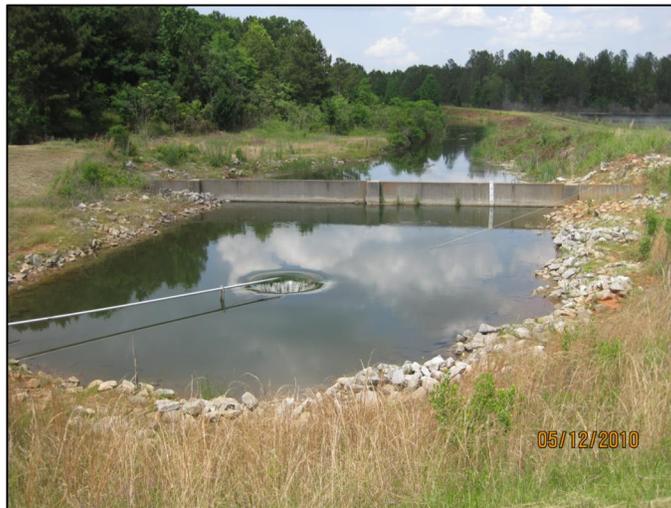
AP-36
 ASH POND OUTLET WEIR AND DECANT PIPE (TREATMENT PIPE ABOVE DECANT)

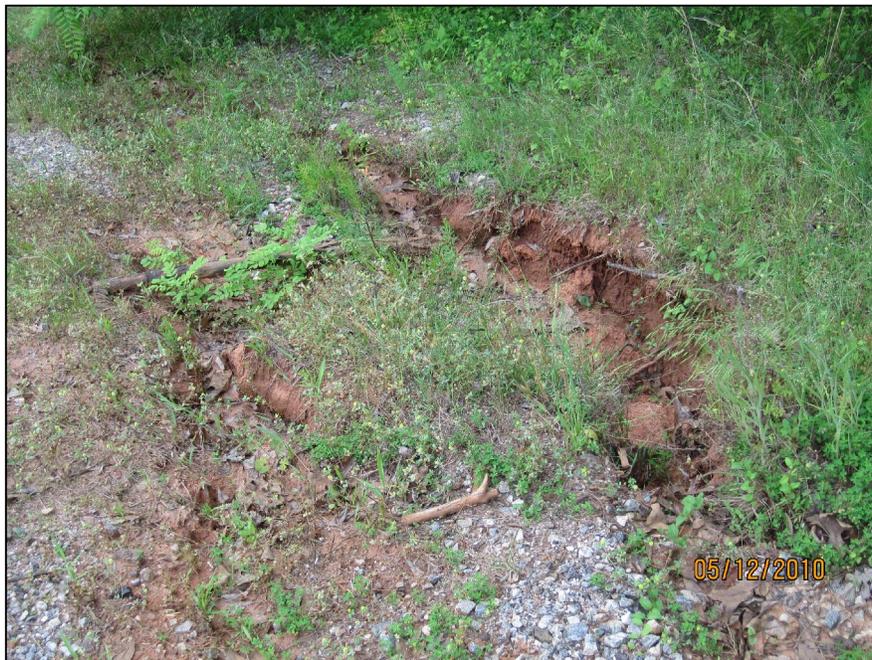
AP-48

EROSION ON DOWNSTREAM SLOPE IN GROIN OF LEFT ABUTMENT

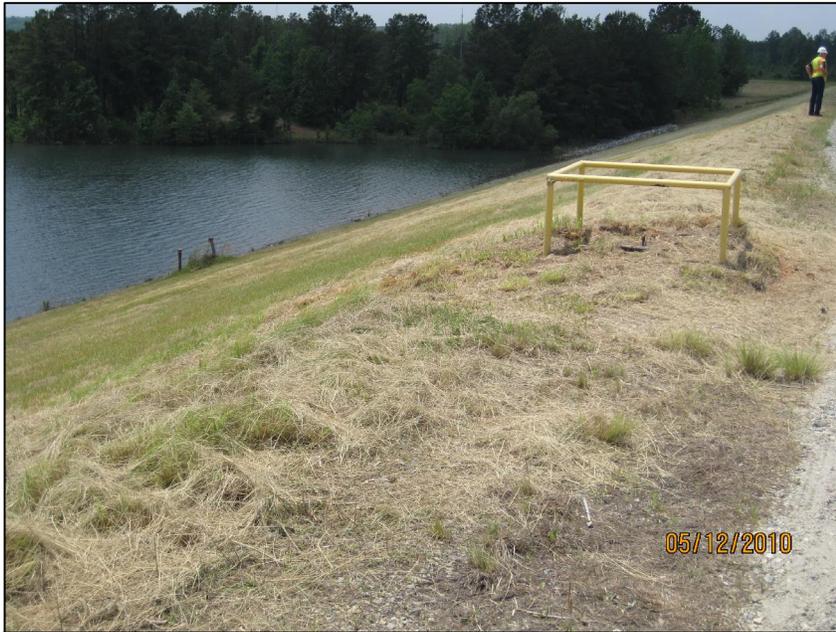
SP-3

CREST OF SETTLING POND, LOOKING SOUTHWEST AT SETTLEMENT MONUMENT ON CREST AND PZ'S AT DOWNSTREAM TOE (LAKE JULIETTE)

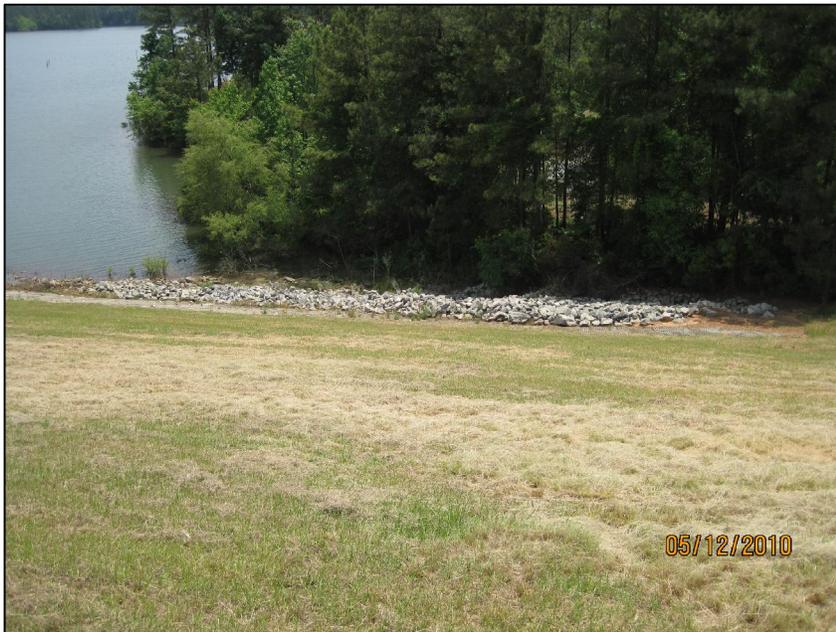
SP-4

CREST OF SETTLING POND, LOOKING SOUTH AT RIP RAP ON DOWNSTREAM TOE OF LEFT ABUTMENT

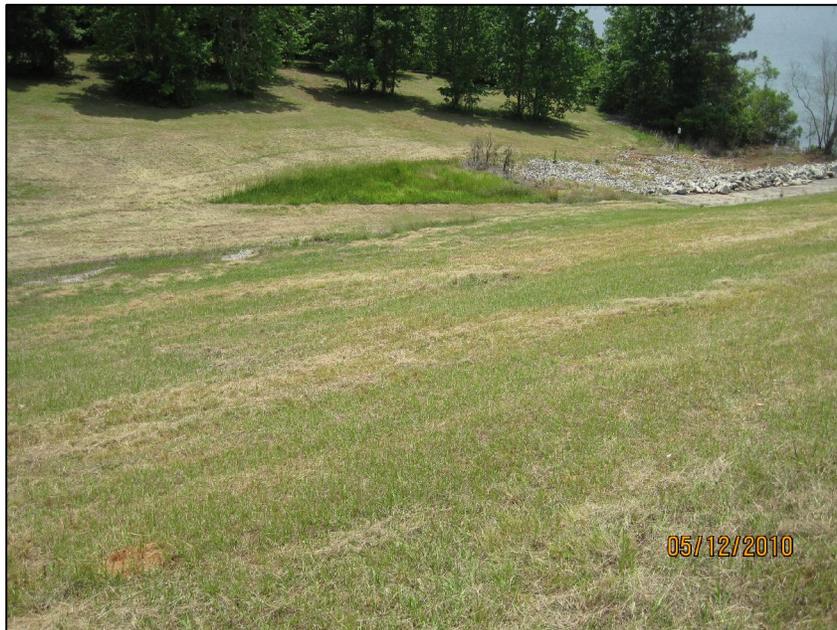
SP-8

**CREST OF SETTLING POND, LOOKING SOUTH AT TOE OF GROIN AREA AT RIGHT ABUTMENT,
OBSERVED LARGE ANIMAL BURROW AT TOE OF DOWNSTREAM SLOPE IN THIS AREA**
