Report of Dam Safety Assessment
of Coal Combustion Surface Impoundments
Georgia Power
Plant Scherer, Juliette, GA

AMEC Project No. 3-2106-0174.0200

December 2010

Southern Company, Georgia Power, Plant Scherer Ash Pond and Settling Pond
were assessed on May 12, 2010.

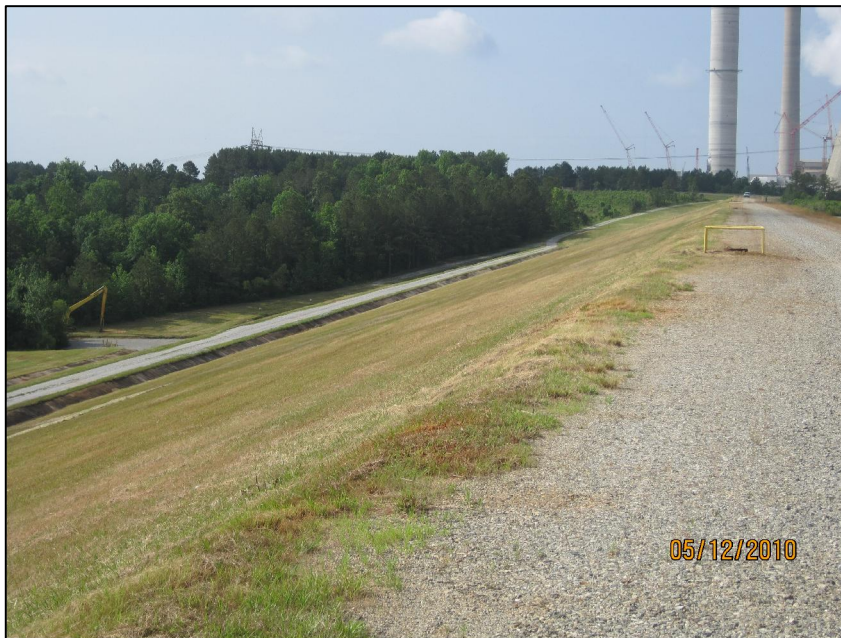
AP-6

CREST OF EAST DIKE, LOOKING SOUTH (SETTLEMENT MONUMENT #6) REPAIRED SURFACE EROSION AREA (RESEEDED AND MATTED) ON DOWNSTREAM SLOPE AT FAR LEFT OF PHOTO

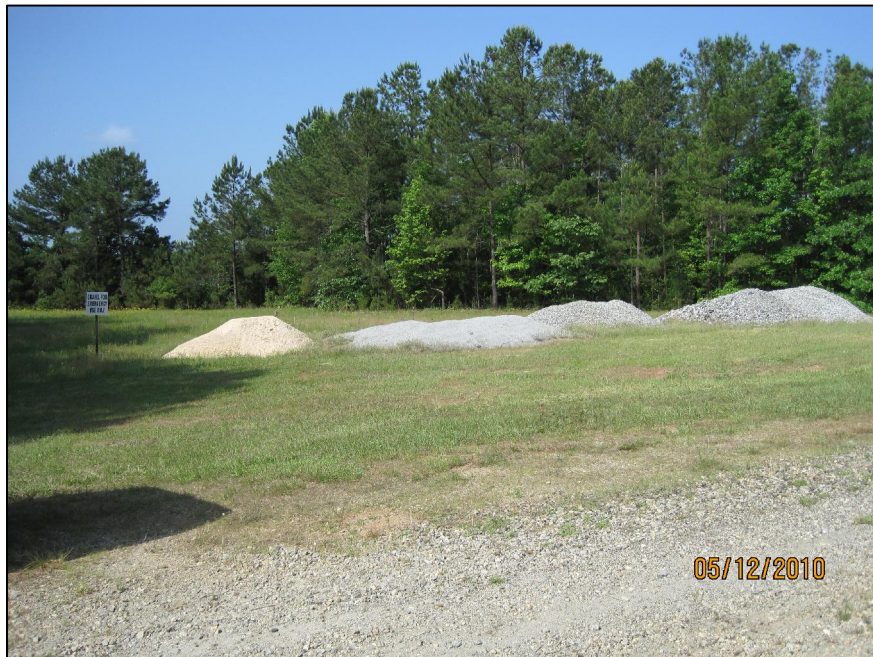
AP-14

No pronounced surface depressions or other deficiencies were noted on the upstream slope or crest of the Ash Pond. At the end of the north dike, a stockpile of emergency supplies was stored (photo AP-14). On the north dike of the embankment, a wet area was observed beyond the downstream slope from PZ's AP-6 and AP-7 (photo AP-15). A concrete ditch was observed at the toe of the downstream slope of the north dike. A broken area of concrete was observed in this ditch (photo AP-16 and AP-17). The outlet of this concrete ditch directed water away from the embankment (photo AP-18). A wet surface area at the toe extending about 125 feet was located beyond the east end of the concrete ditch (photo AP-19).

NORTH DIKE, LT ABUTMENT TIE-IN, EMERGENCY SUPPLIES

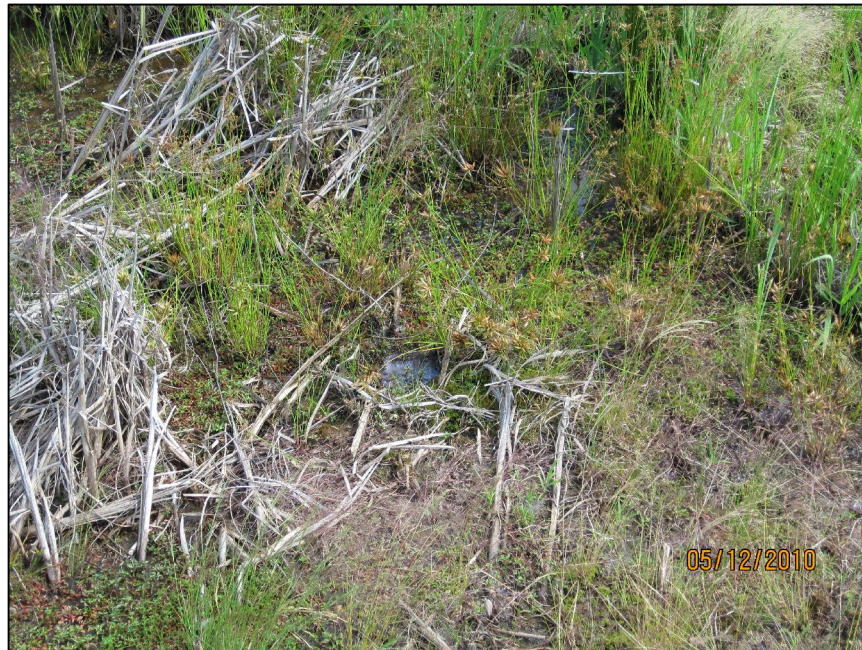
AP-15

DOWNSTREAM TOE OF NORTH DIKE, WET AREA NORTH OF PZ'S AP-6 AND 7

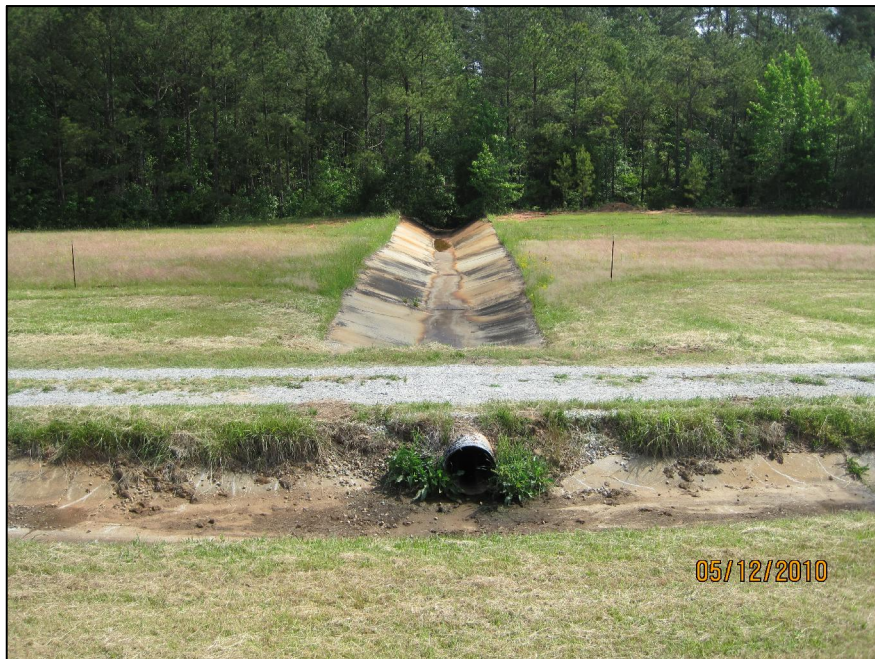
AP-18

DOWNSTREAM TOE OF NORTH DIKE, LOOKING NORTHEAST AT TOE DRAIN OUTLET

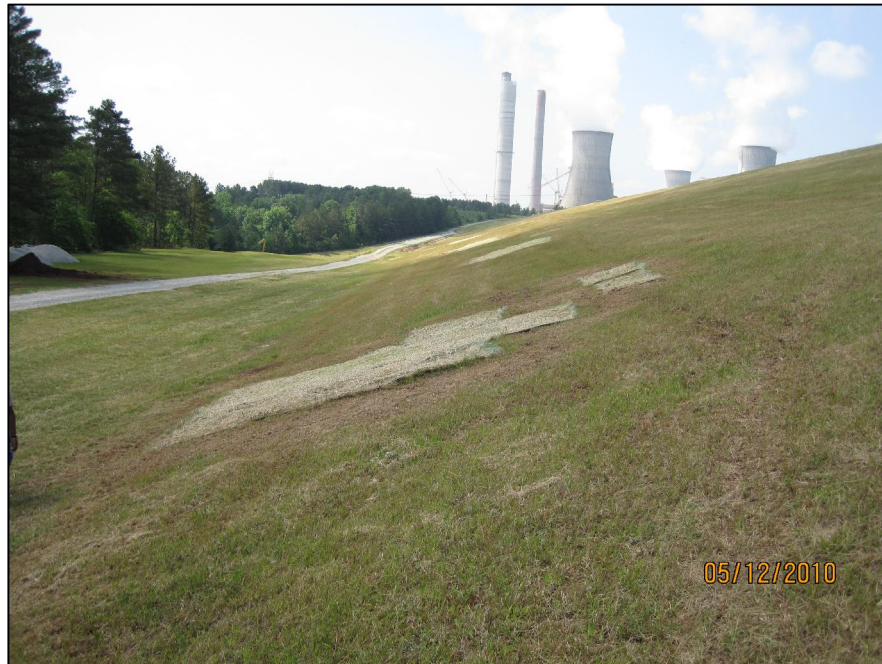
Repaired surficial areas were noted on the downstream embankment of the east dike (photos AP-20 and AP-24). A concrete ditch beginning at the intersection of the north and east dike extended south along the toe of the downstream slope and directed water away from the embankment (photos AP-21 and AP-22). An emergency stockpile of crushed stone and sand was located near this outlet (photo AP-23). The lower bench at the east dike extends the downstream embankment. A gravel access road crosses a middle bench in this area. A concrete ditch on the upstream side of this road is higher at the middle and directs water to each end (photo AP-24 and AP-25). The concrete ditch is piped beneath the road on both ends and extends down along the groin to the east (photo AP-26 and AP-34). On the south side of this groin ditch, water was observed entering and exiting the ditch at a joint (photo AP-27). Near the bottom of the ditch, water is entering from pipes at blanket drain outlets BD-2 and BD-3 (photos AP-28 and AP-30). Likewise, on the north groin ditch, water is entering the ditch at an upper damaged joint and two lower piped outlets from the blanket drain (photos AP-33 and AP-32). The two ditches combine at the toe into a concrete channel and outlet including a 4-inch diameter pipe and overflow weir (photo AP-31). A dry blanket drain outlet (BD-1) is located in the groin area above the road. Some minor surface scour/erosion was noted in this area(photo AP-35).

DOWNSTREAM SLOPE OF EAST DIKE, LOOKING SOUTH AT REPAIRED AREAS ON SLOPE

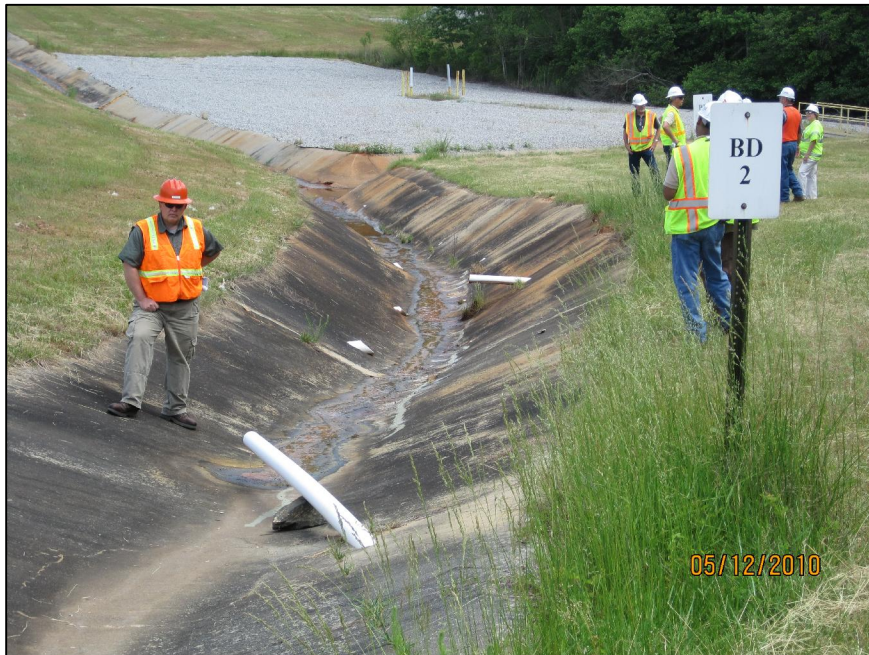
AP-28

DOWNSTREAM SLOPE OF EAST DIKE, LOOKING NORTH, WATER ENTERING CONCRETE DITCH FROM BD-2 AND BD-3

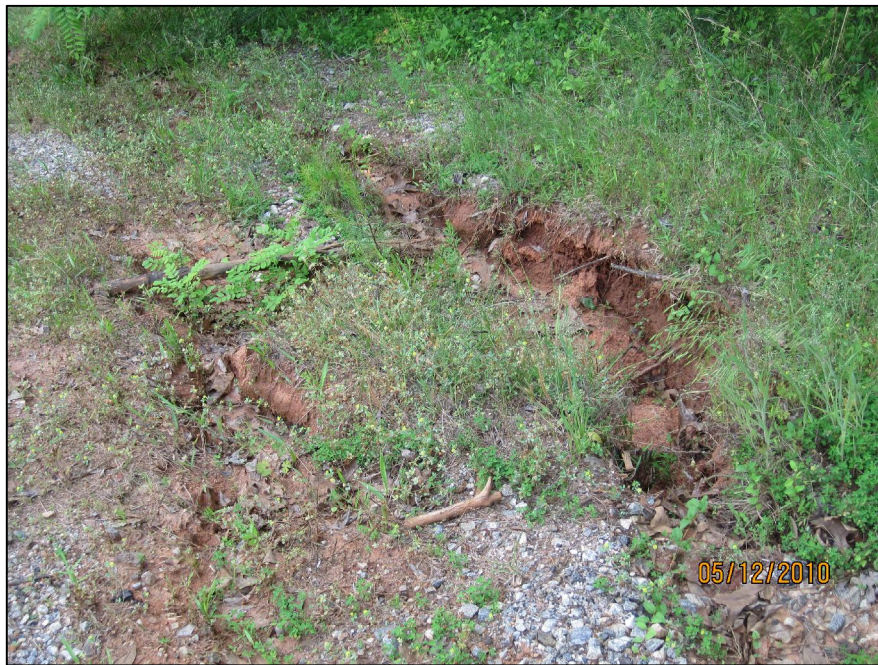
AP-48

EROSION ON DOWNSTREAM SLOPE IN GROIN OF LEFT ABUTMENT

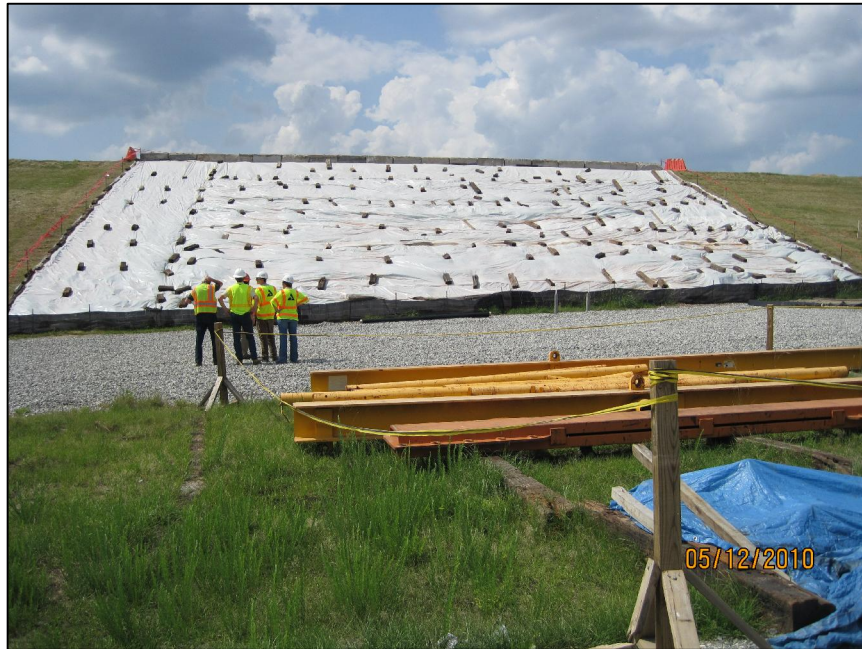
AP-52

**SOUTH OF SOUTH DIKE TOE LOOKING NORTH AT REPORTED SURFACE SLOUGH;
WAITING FOR DRY WEATHER TO COMPLETE SLOPE REPAIR**

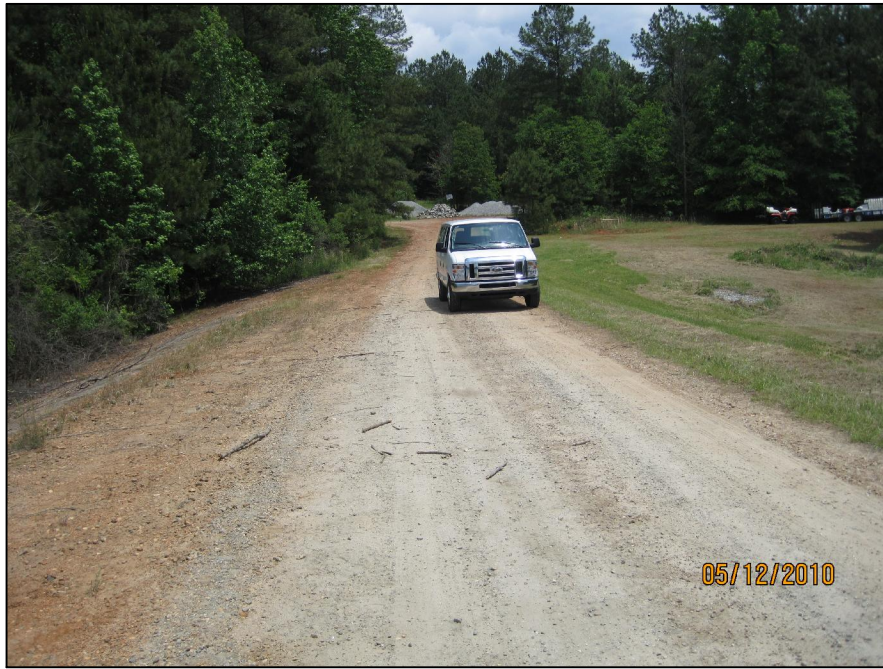
SP-1

CREST OF SETTLING POND, LOOKING EAST AT LEFT ABUTMENT TIE-IN

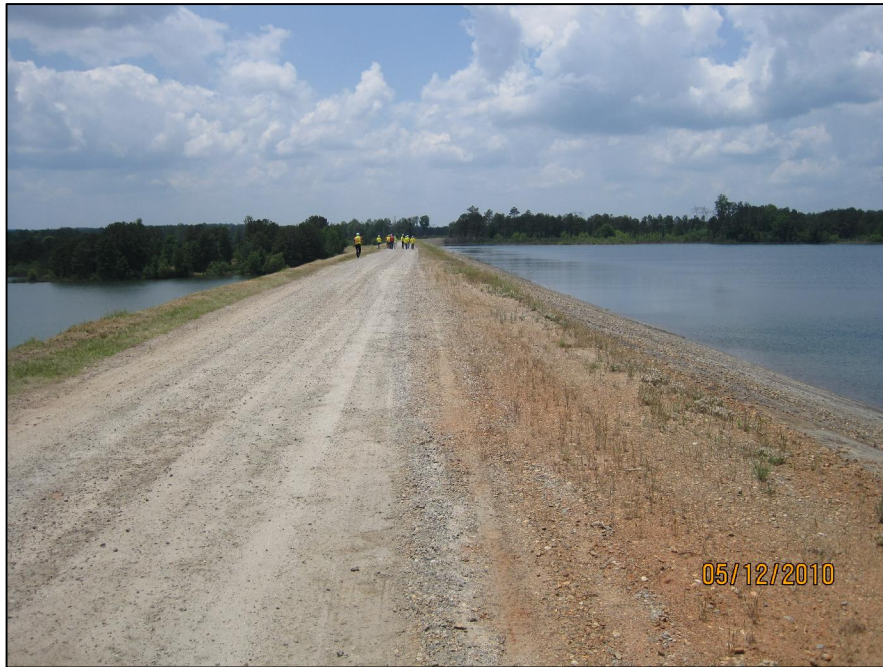
SP-2

CREST OF SETTLING POND, LOOKING EAST AT RIGHT ABUTMENT TIE-IN

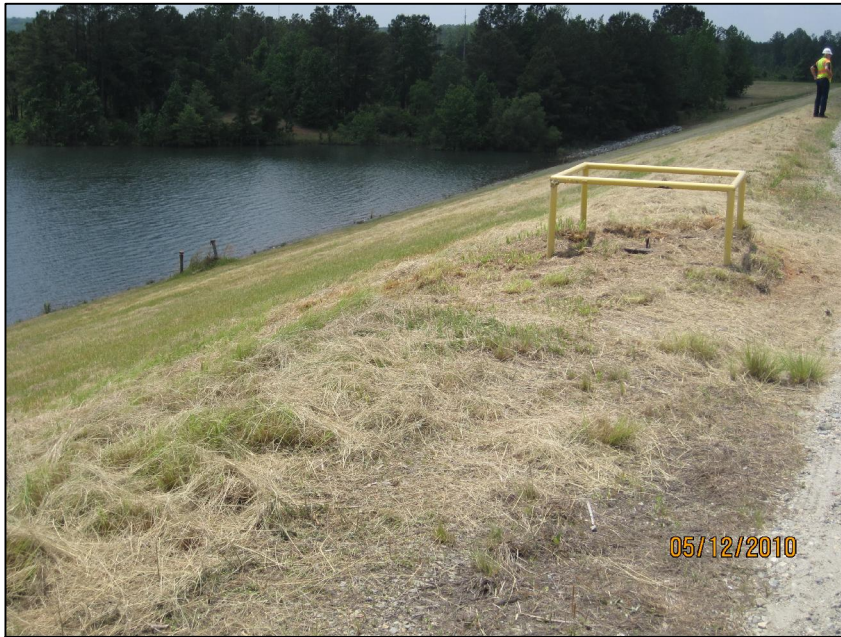
SP-3

CREST OF SETTLING POND, LOOKING SOUTHWEST AT SETTLEMENT MONUMENT ON CREST AND PZ'S AT DOWNSTREAM TOE (LAKE JULIETTE)

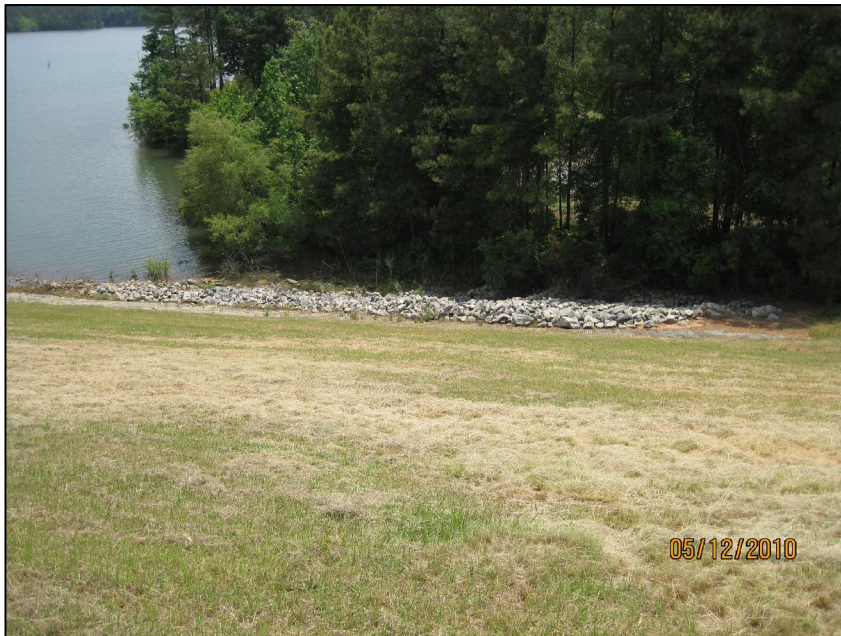
SP-4

CREST OF SETTLING POND, LOOKING SOUTH AT RIP RAP ON DOWNSTREAM TOE OF RIGHT ABUTMENT

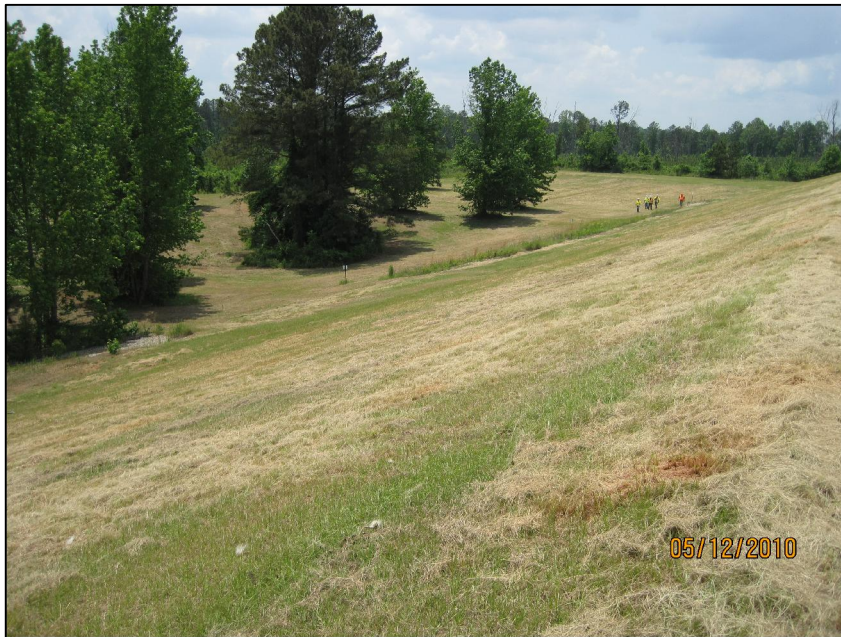
SP-5

CREST OF SETTLING POND, LOOKING SOUTHWEST AT BLANKET DRAIN AND GROIN AREA OF RIGHT ABUTMENT

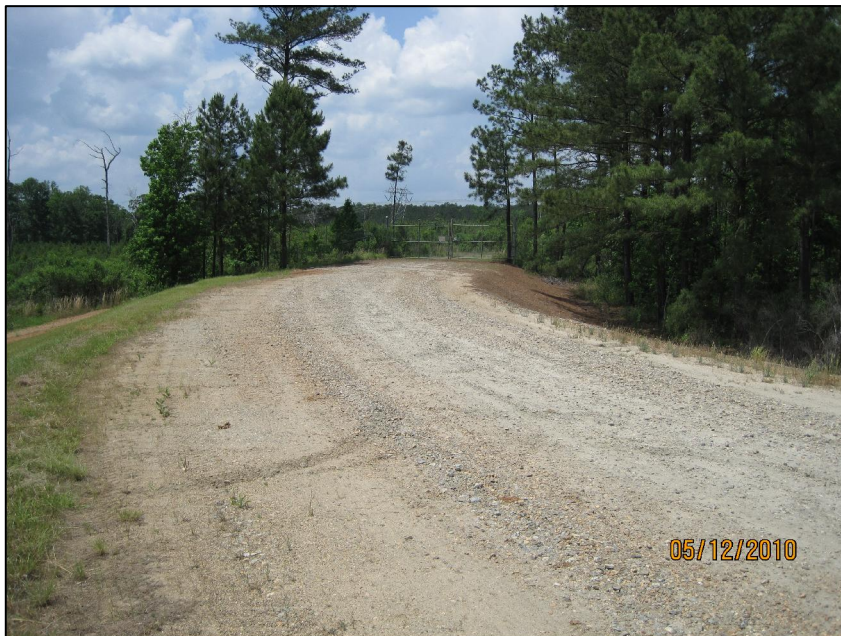
SP-6

CREST OF SETTLING POND, LOOKING WEST AT RIGHT ABUTMENT TIE-IN

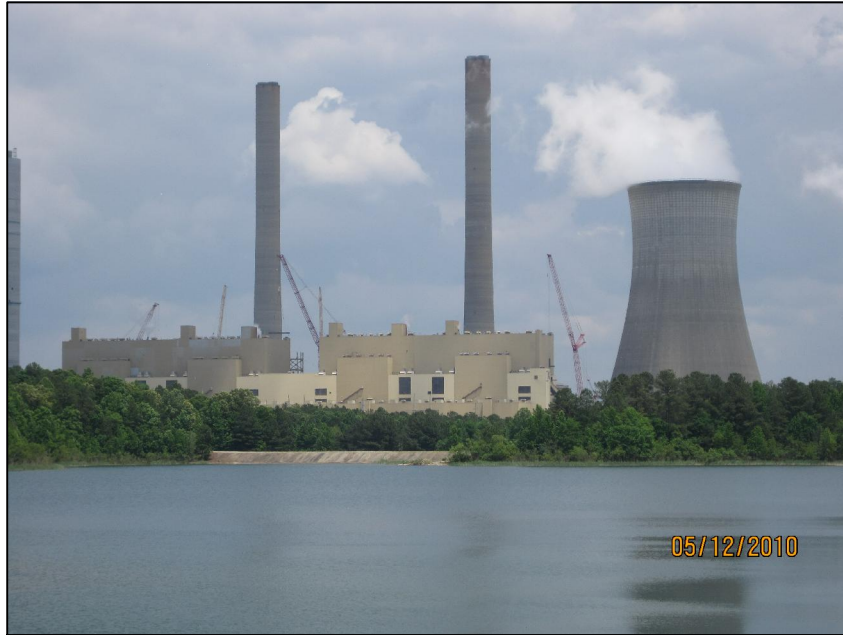
SP-7

CREST OF SETTLING POND, LOOKING NORTHEAST AT SADDLE BERM

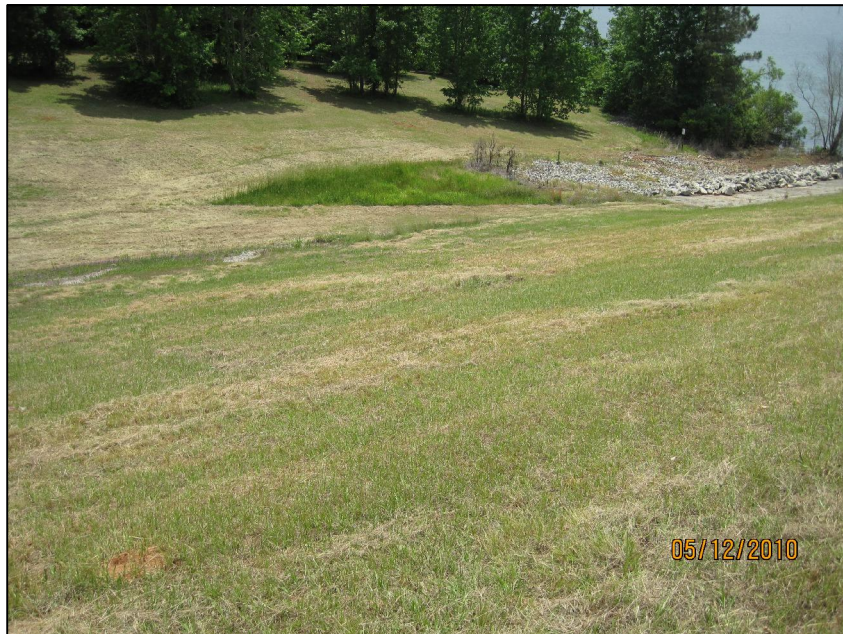
SP-8

CREST OF SETTLING POND, LOOKING SOUTH AT TOE OF GROIN AREA AT LEFT ABUTMENT, OBSERVED LARGE ANIMAL BURROW AT TOE OF DOWNSTREAM SLOPE IN THIS AREA

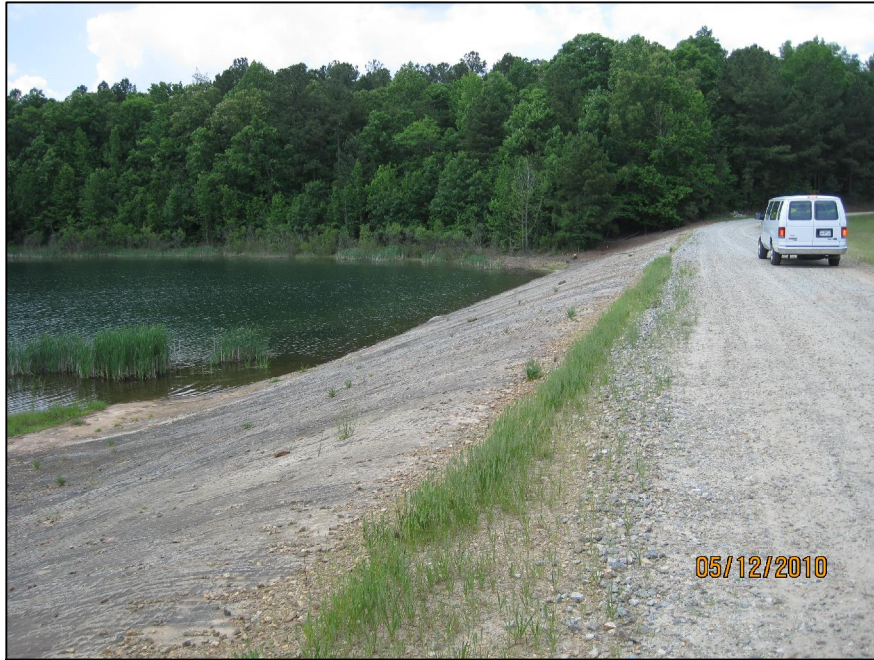
SP-9

SETTLING POND, LOOKING NORTH AT UPSTREAM FABRIFORM SLOPE AND CREST OF SADDLE BERM

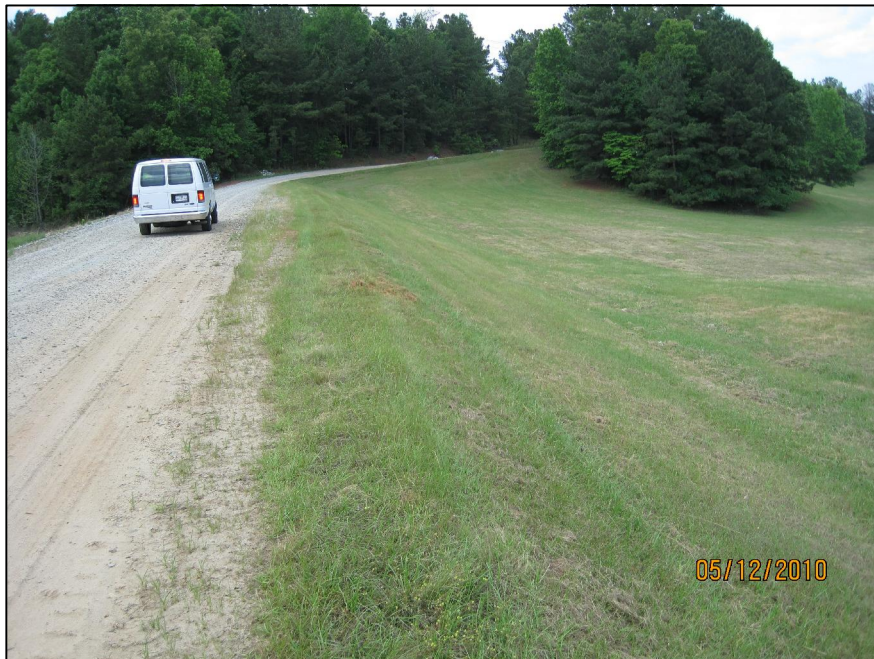
SP-10

SETTLING POND, LOOKING NORTH AT CREST AND DOWNSTREAM SLOPE OF SADDLE BERM

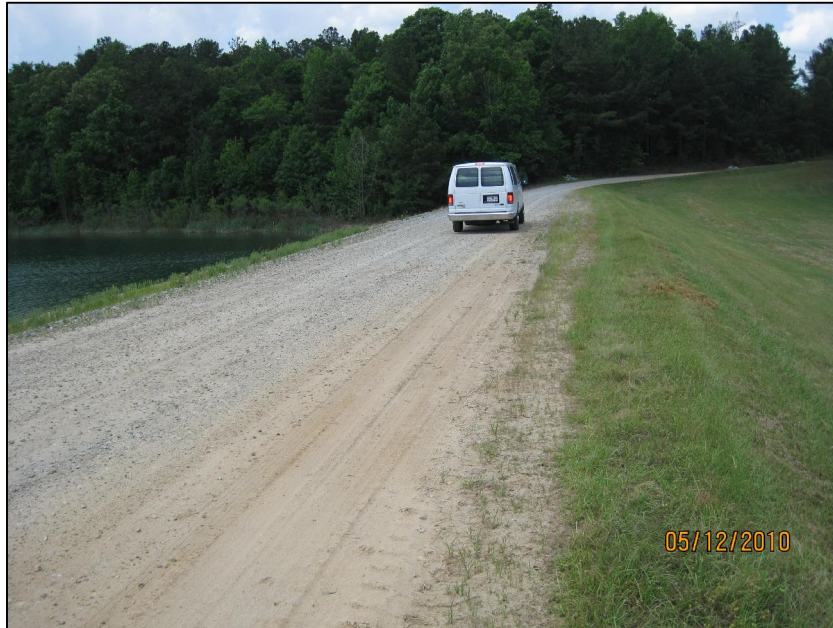
SP-11

SETTLING POND, LOOKING NORTH AT CREST OF SADDLE BERM
