# **Assessment of Dam Safety of Coal Combustion Surface Impoundments**

**Indianapolis Power & Light Company**

**Petersburg Generating Station**

**June 8, 2010**

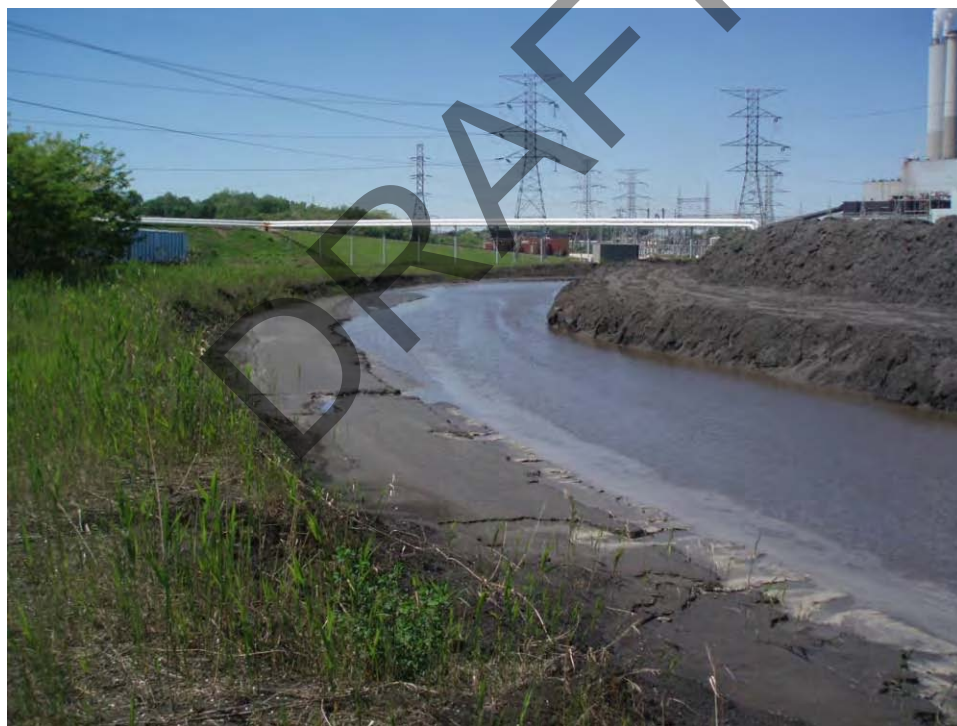
6. Pond A rim ditch, looking southeast.

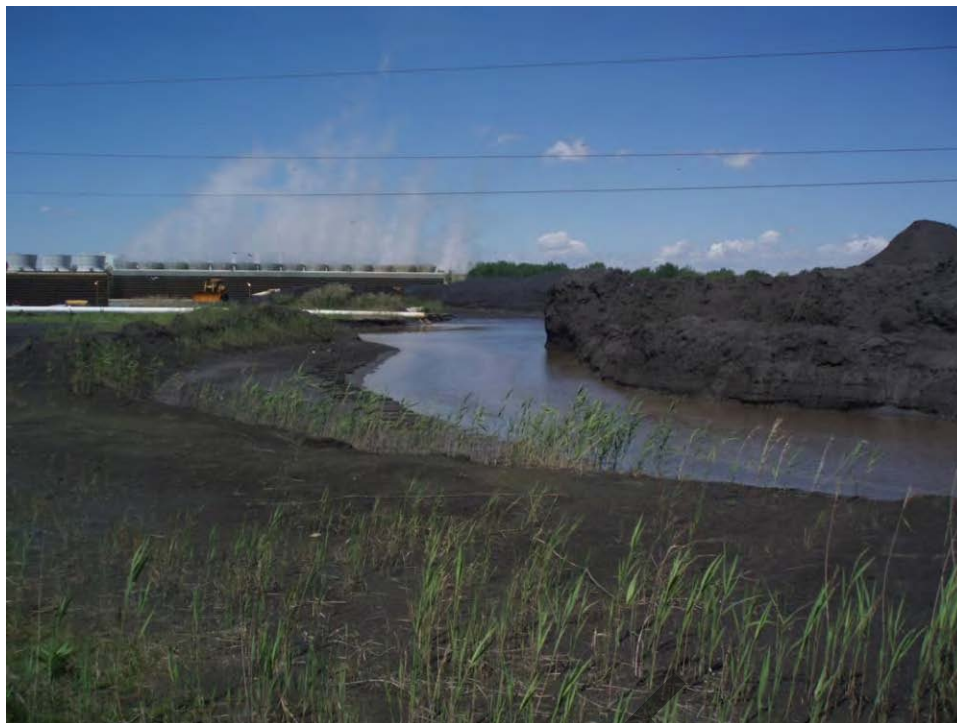
7. Pond A rim ditch looking west at sluice pipes.

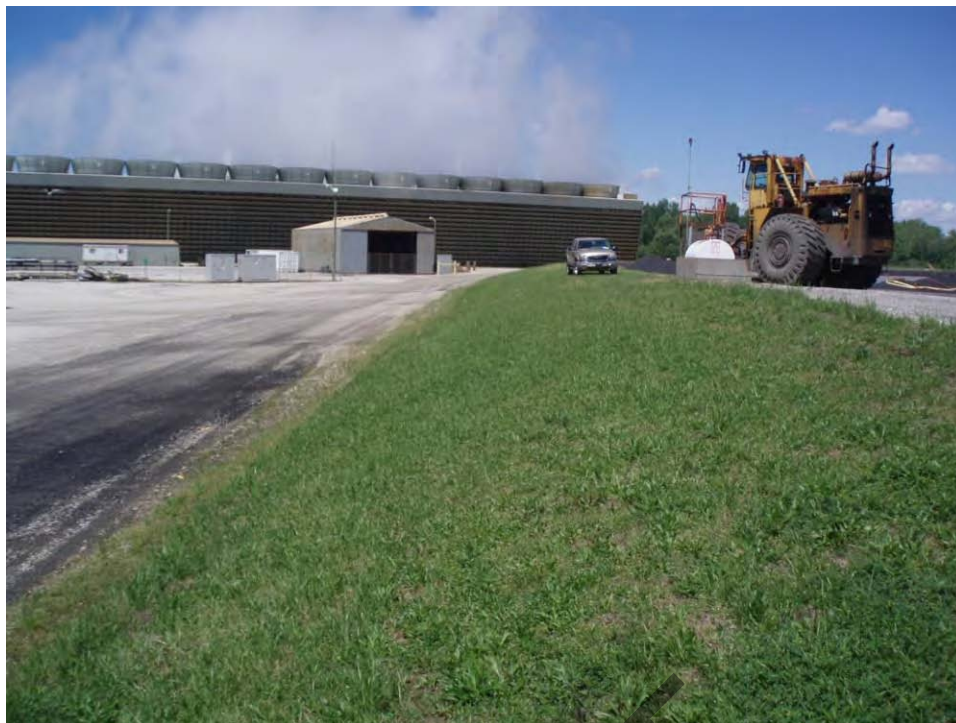
13. Pond A - South embankment exterior slope, looking northwest.

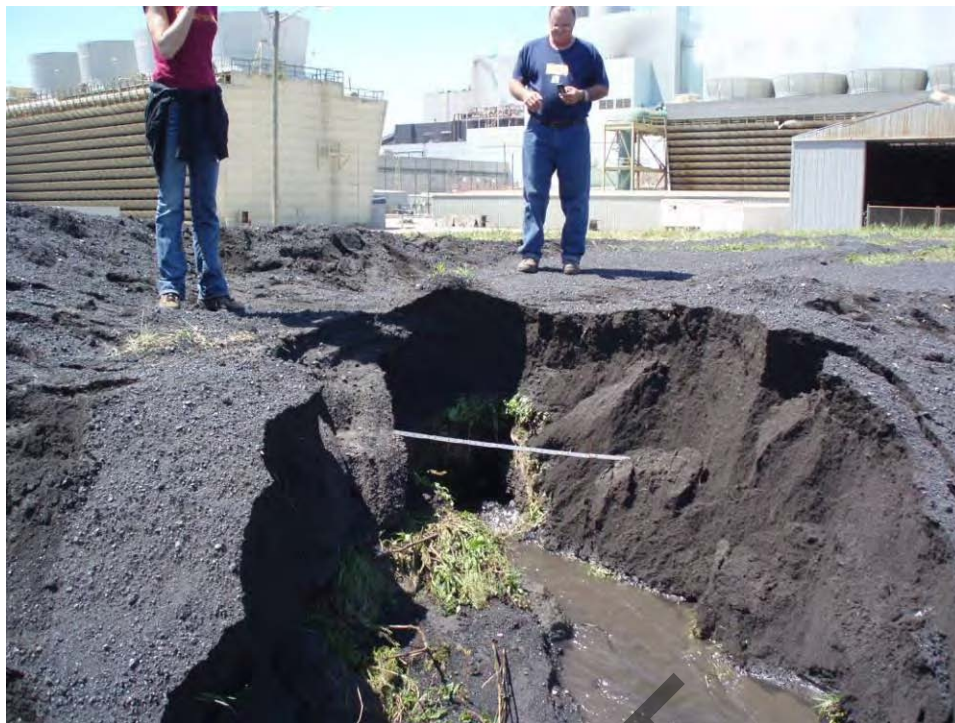
During the site visit, active piping/erosion of the crest was observed (Photo 15). The water had eroded the recently placed ash and formed an erosion cavity in the original embankment. The water was clear and had a constant estimated flow of 10 to 20 gpm. At the time of the site visit IPL staff did not know the source of the water (i.e., if it was an unmarked pipeline in the embankment). The staff was in the process of identifying the source and addressing the situation.

15. Pond A - Active erosion/piping of south embankment interior slope from unknown water source. Water was clear. Eroded area 5'Wx8'Lx3.5'D. IPL personnel were trying to determine source of flow.

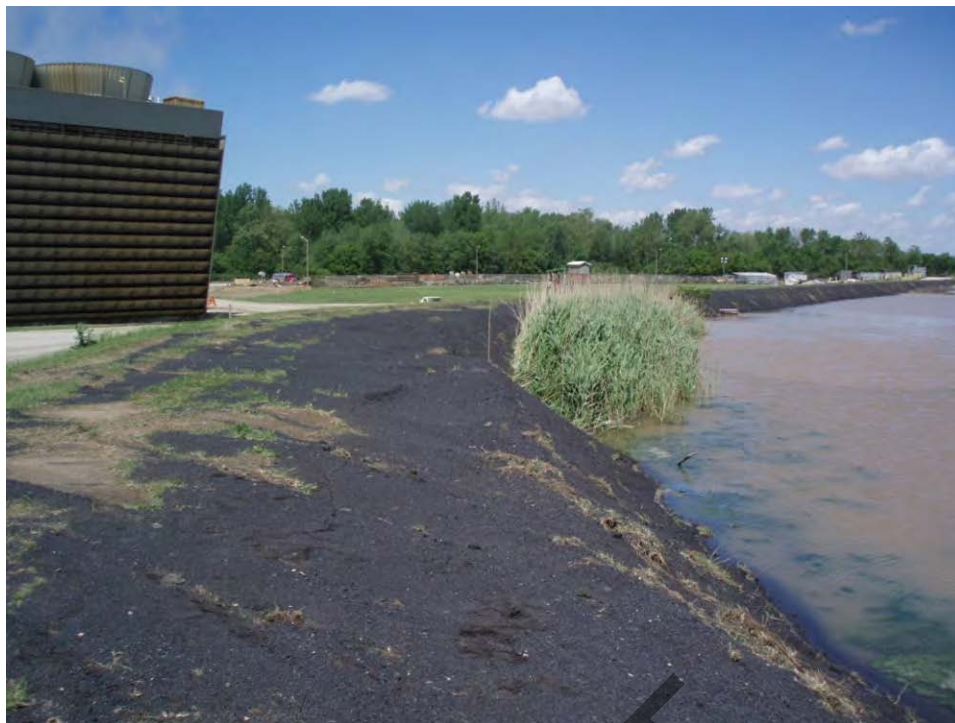
17. Pond A - South embankment crest, looking northwest at recently placed ash. Note existing embankment was not cleared or grubbed before placing material.

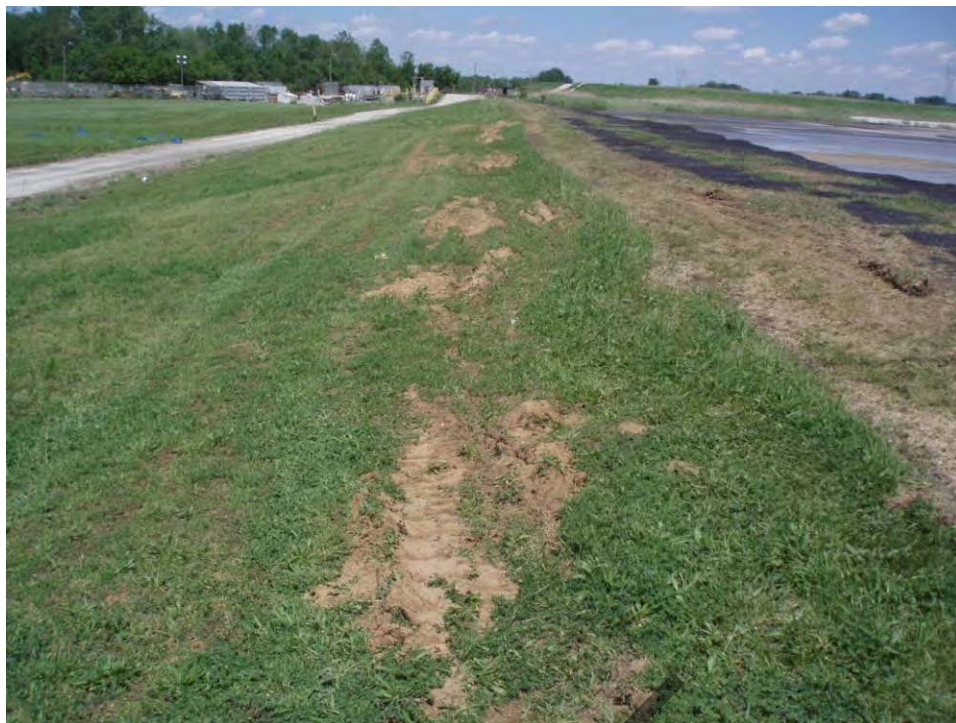
23. Pond A - West embankment exterior slope, looking north at tractor ruts.

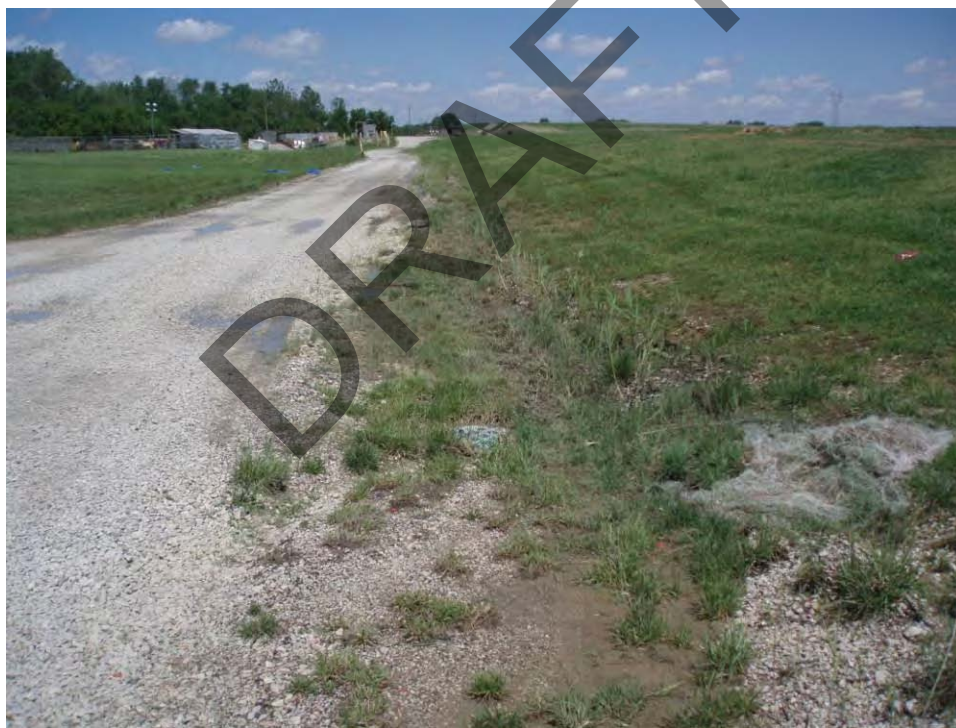
24. Drainage ditch at toe of Pond A west embankment. Note ditch has sparse vegetation.

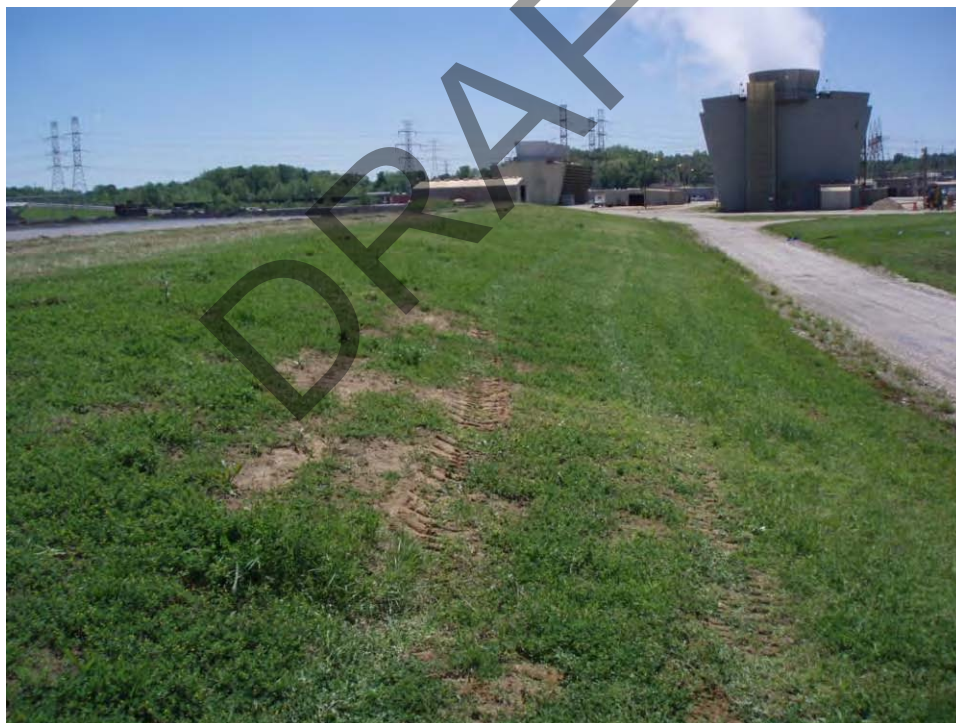
28. Pond A - West embankment exterior slope, looking south.

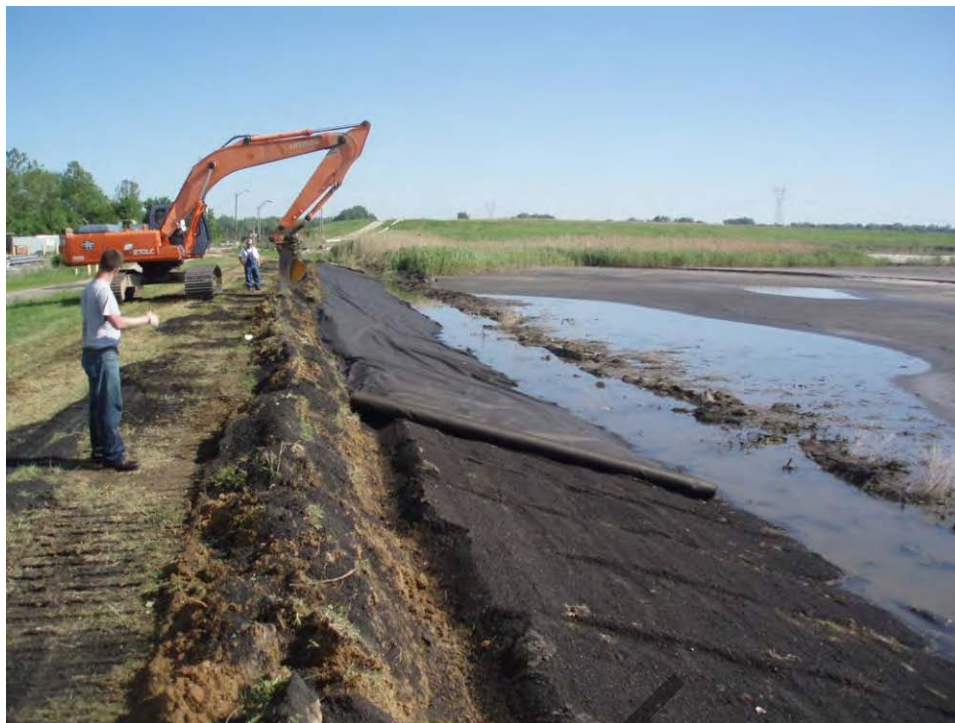
31. Pond A - West embankment interior slope, looking north at rough embankment grading. Note Mirafi geofabric does not extend to the toe of the slope.

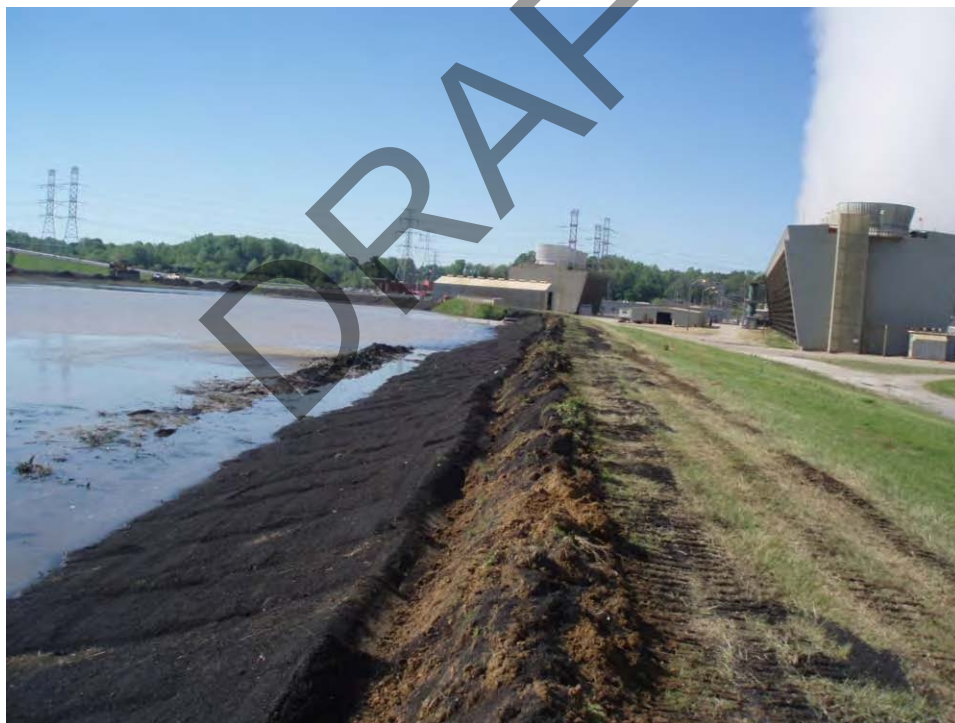
32. Pond A - West embankment interior slope, looking south at rough embankment grading

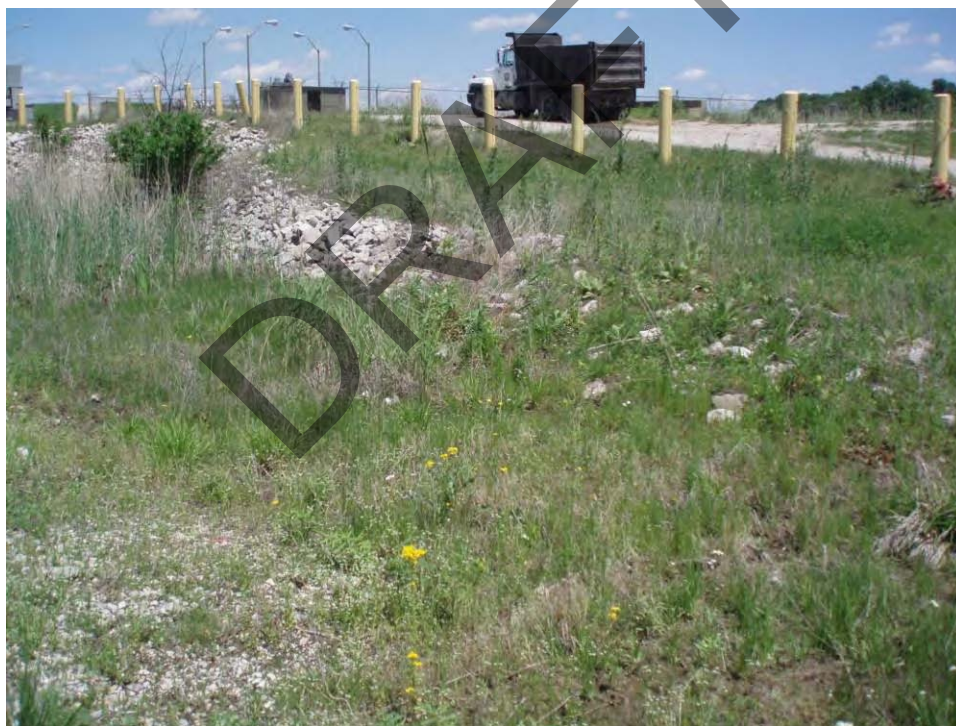
34. Pond A - Former location of Lick Creek at west embankment exterior toe.

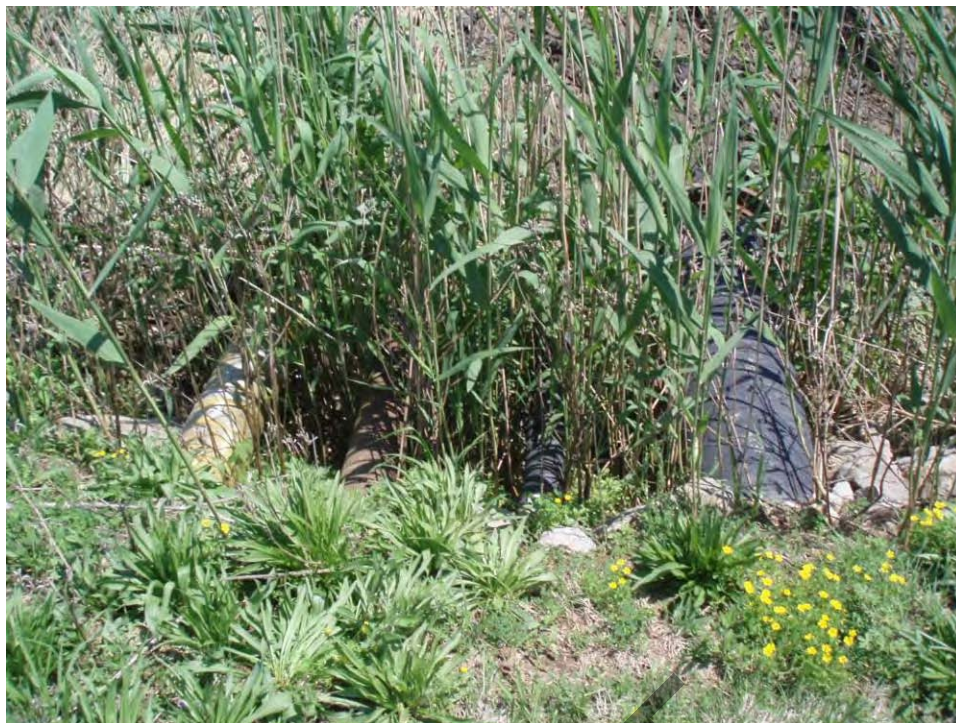
35. Pond A - Looking east at inactive 4-, 6-, 8-, and 15-inch-diameter sluice pipes from unknown origin. Use unknown.

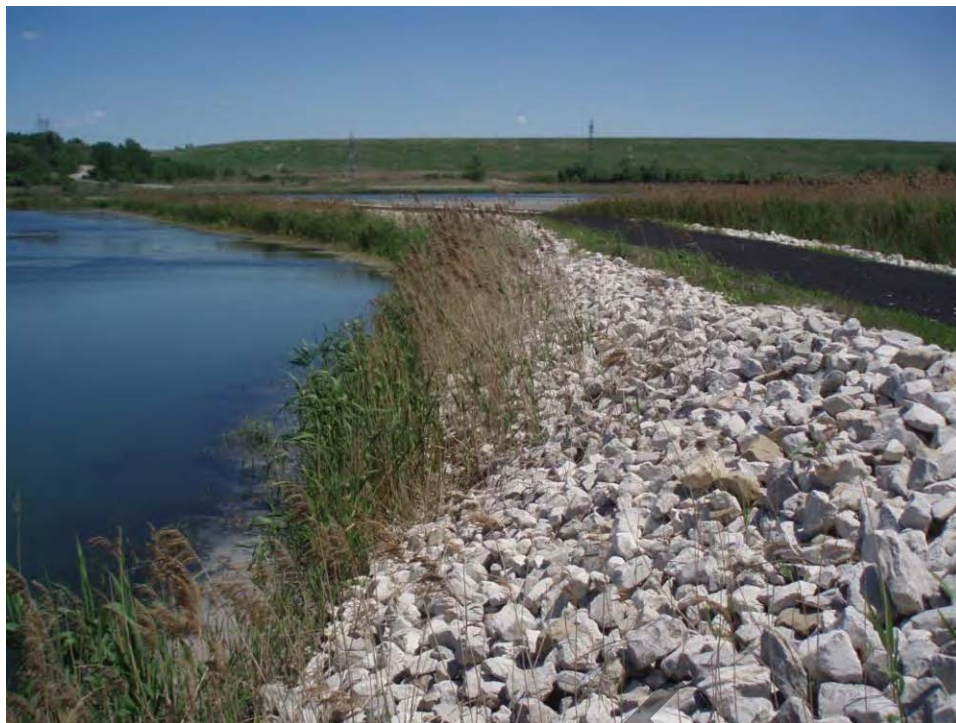
37. North slope of divider embankment between Pond A and Pond A - Discharge, looking east.

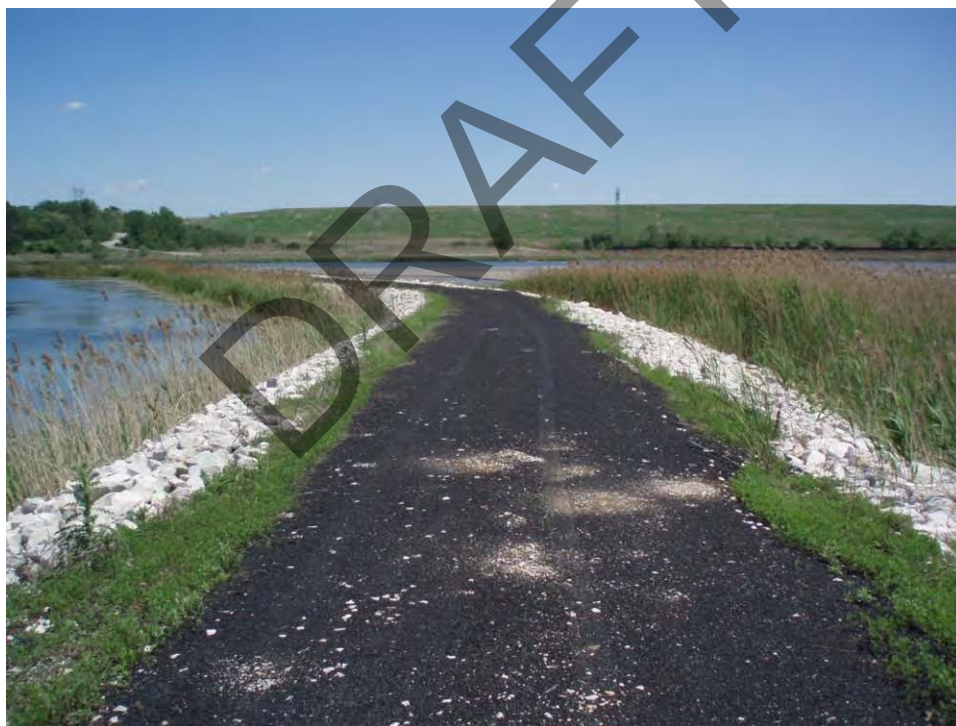
38. Crest of divider embankment between Pond A and Pond A - Discharge, looking east.

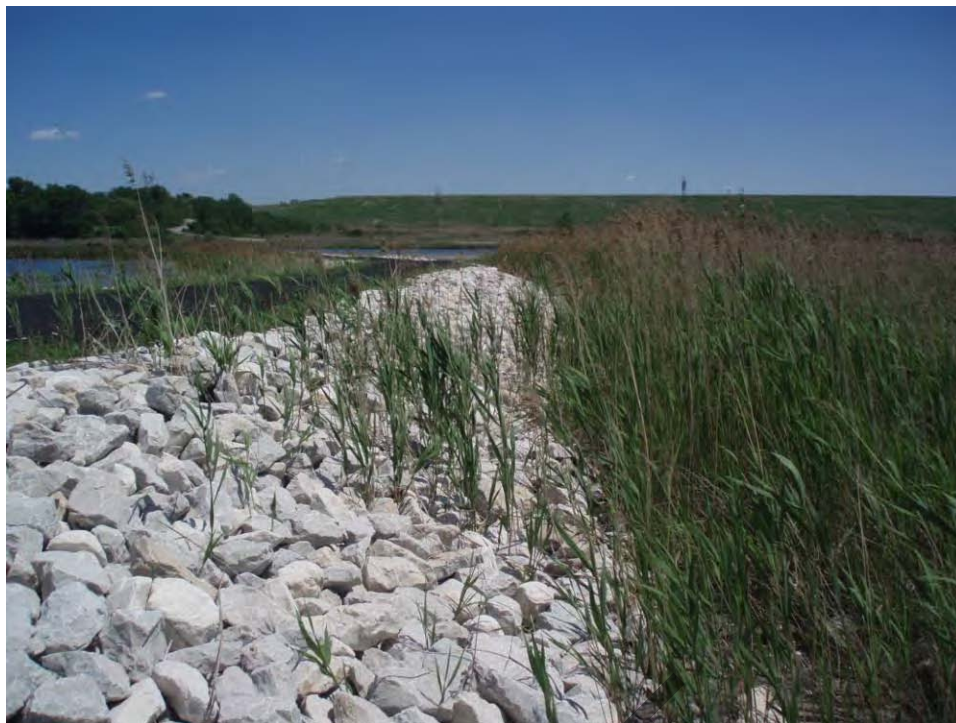
39. South slope of divider embankment between Pond A and Pond A - Discharge, looking east.

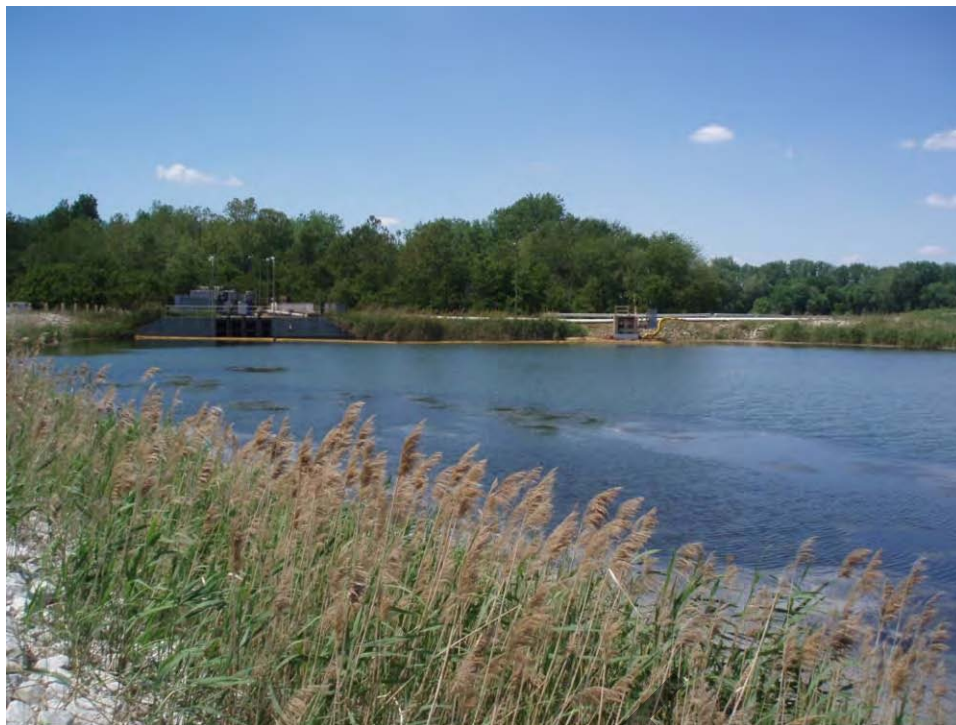
41. Overview of Pond A - Discharge recycle pump station and outlet structure, looking west

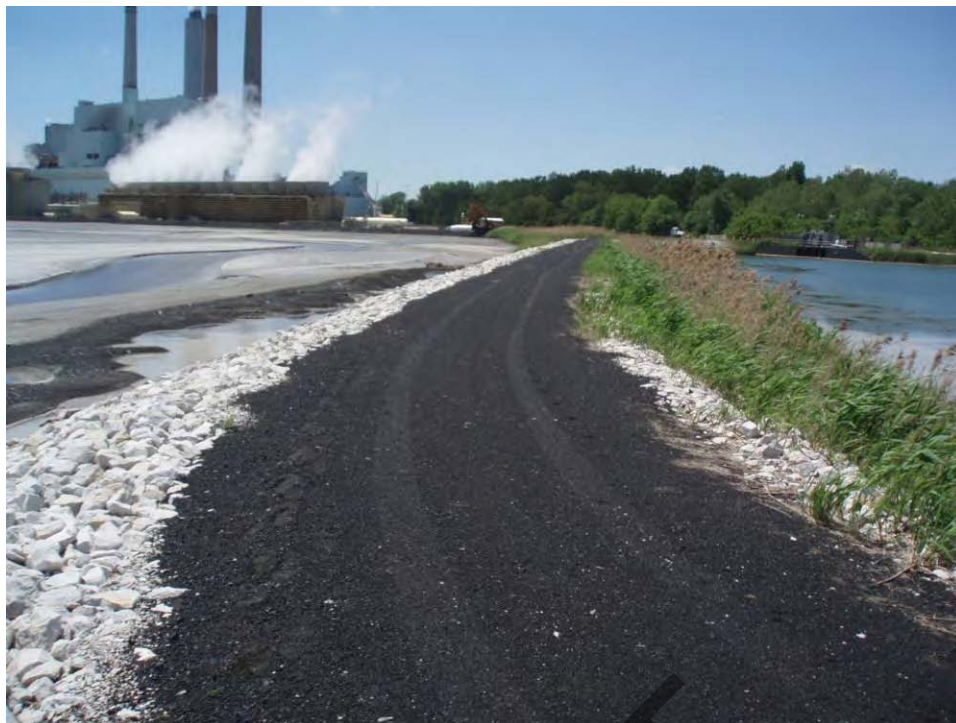
43. Crest of divider embankment between Pond A and Pond A - Discharge, looking southwest.

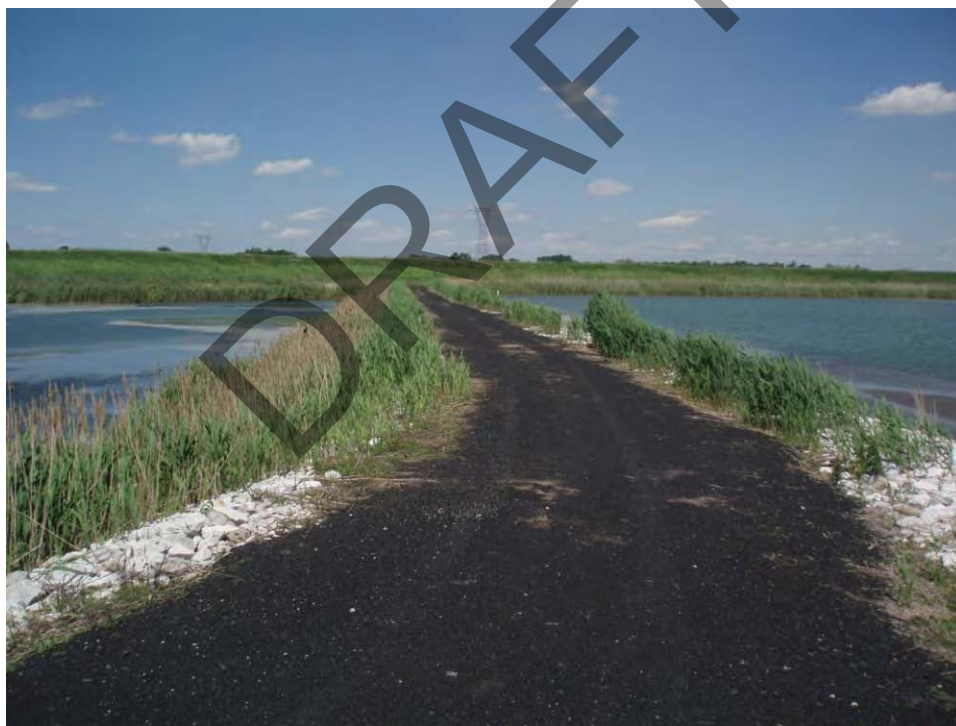
44. Crest of divider embankment between Pond A and Pond A - Discharge, looking northeast.

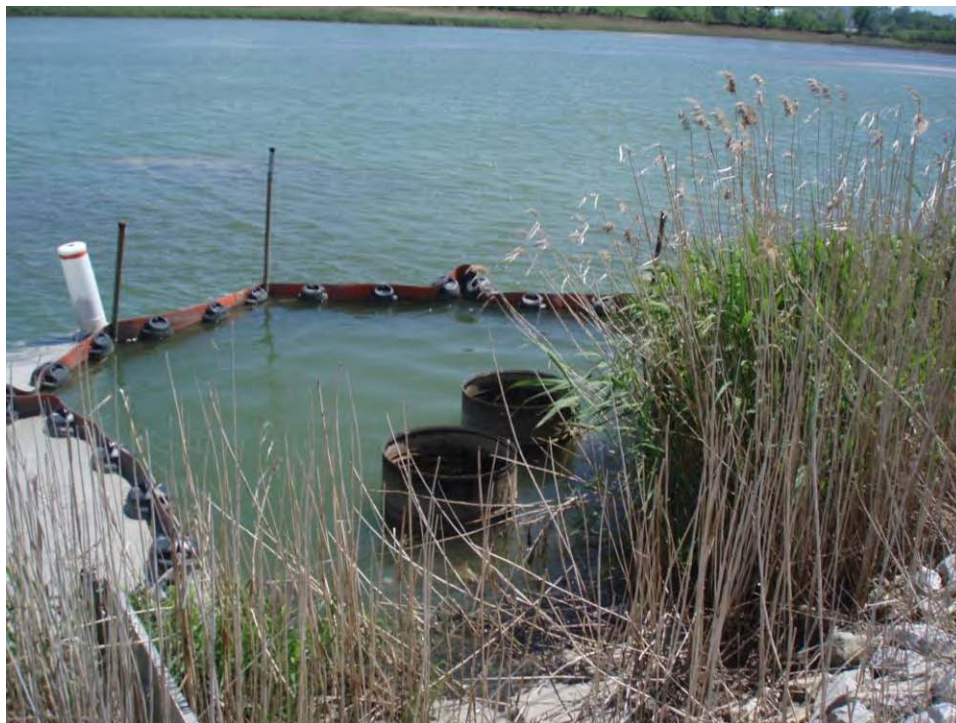
45. Inlet of two (2) 36-inch-diameter CM pipes from Pond A to Pond A - Discharge. Note pipes have T's at inlets and the floating boom to reduce the potential for surface debris from clogging pipes.

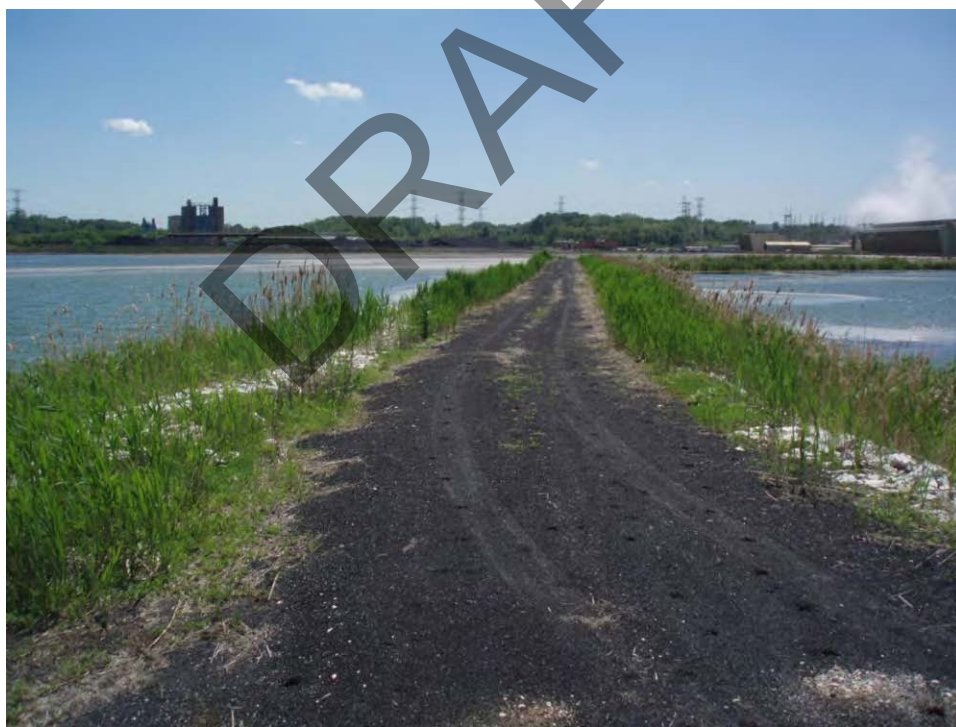
46. Crest of divider embankment between Pond A and Pond A - Discharge, looking southwest.

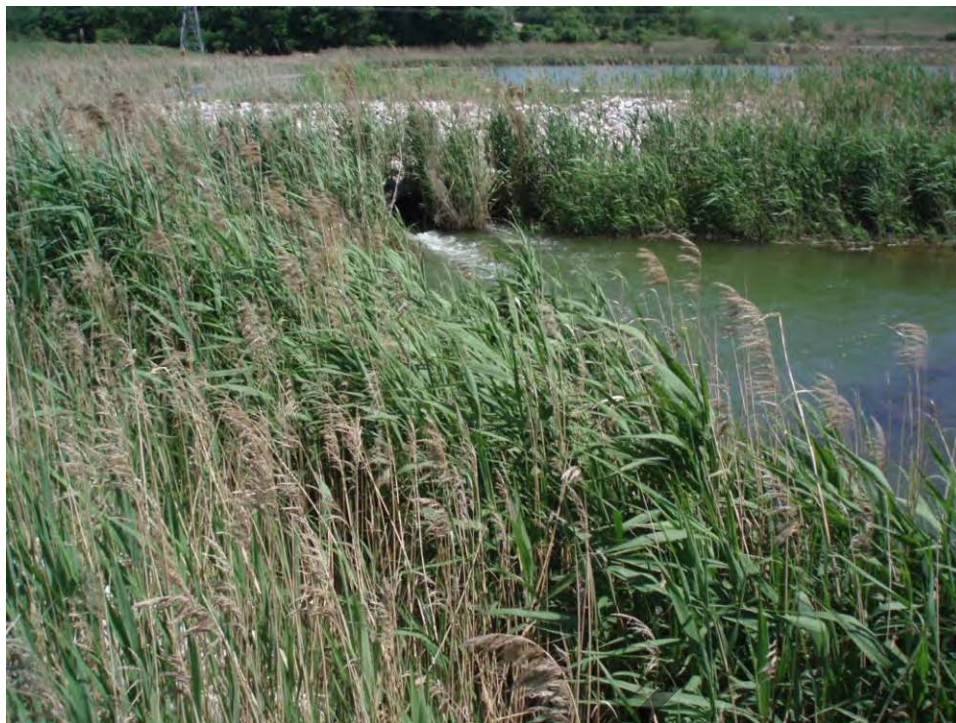
47. Outlet of two (2) 36-inch-diameter CMP outlet pipes from Pond A to Pond A – Discharge.

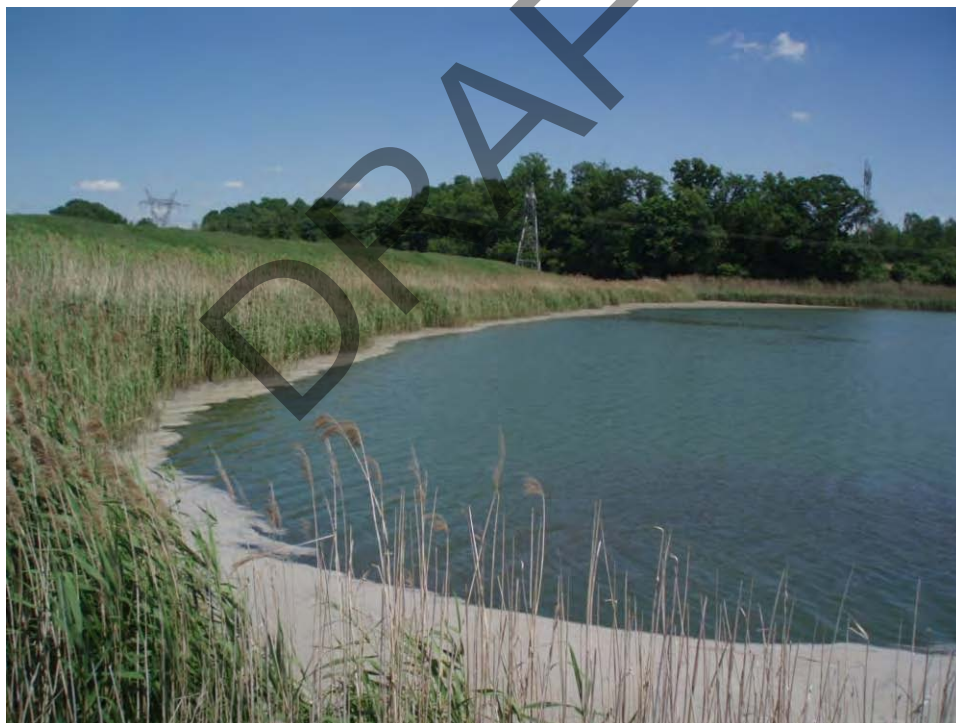
48. Overview of Pond A north interior slope, looking northeast.

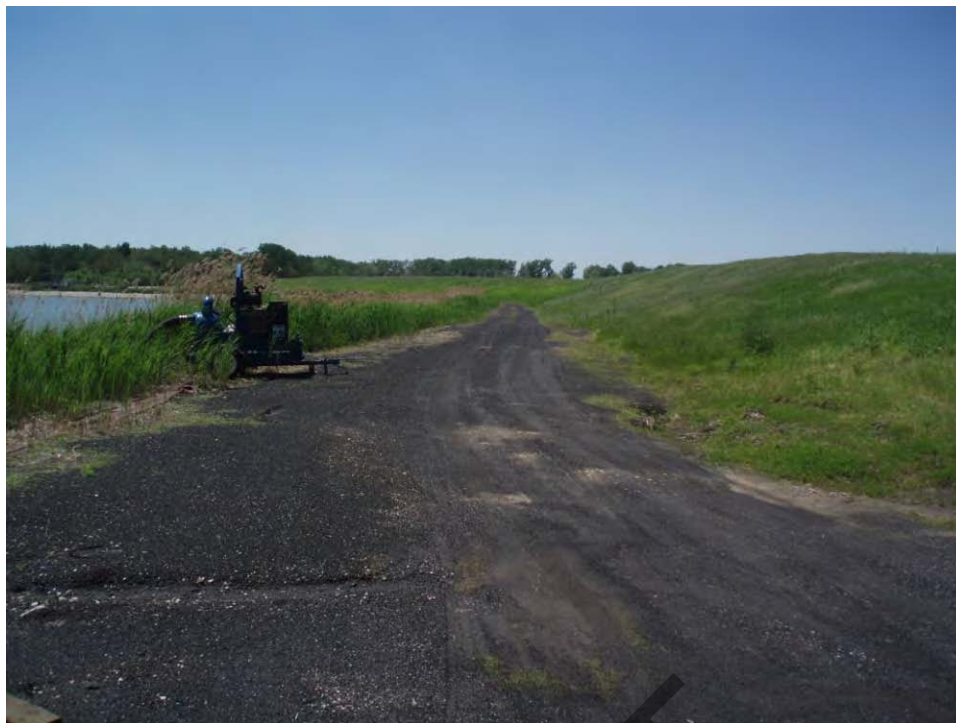
49. Pond A – North embankment crest and Pond B – South embankment exterior slope, looking west.

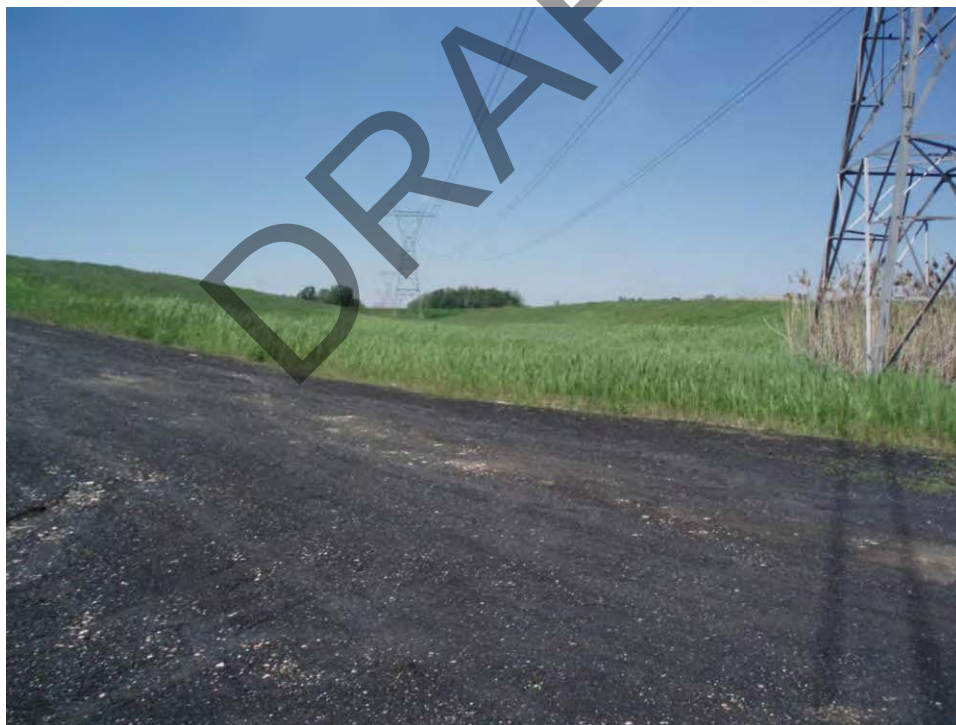
50. Pond B – North embankment exterior slope, looking northwest between Pond B and Pond C.

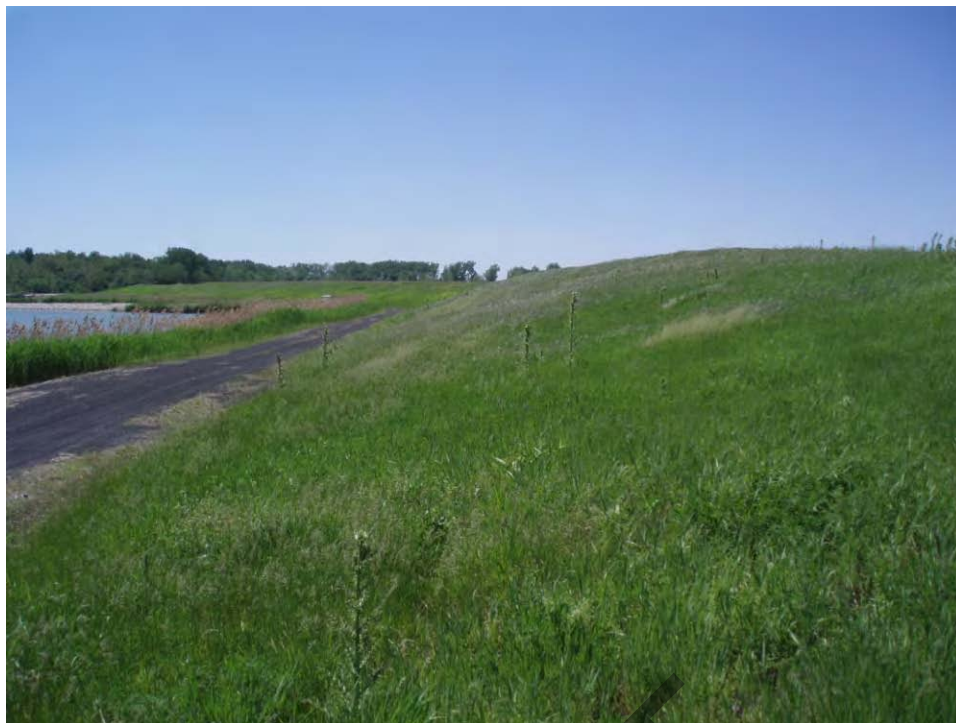
51. Pond B – South embankment exterior slope, looking west.

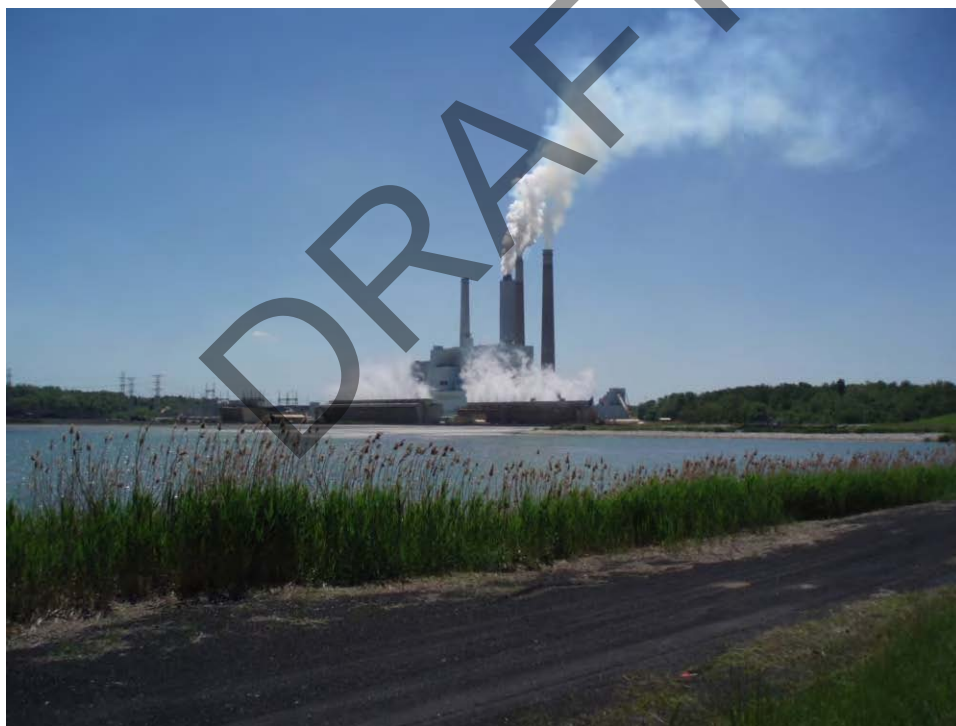
52. Overview of Pond A, looking southwest at Petersburg Generating Station.

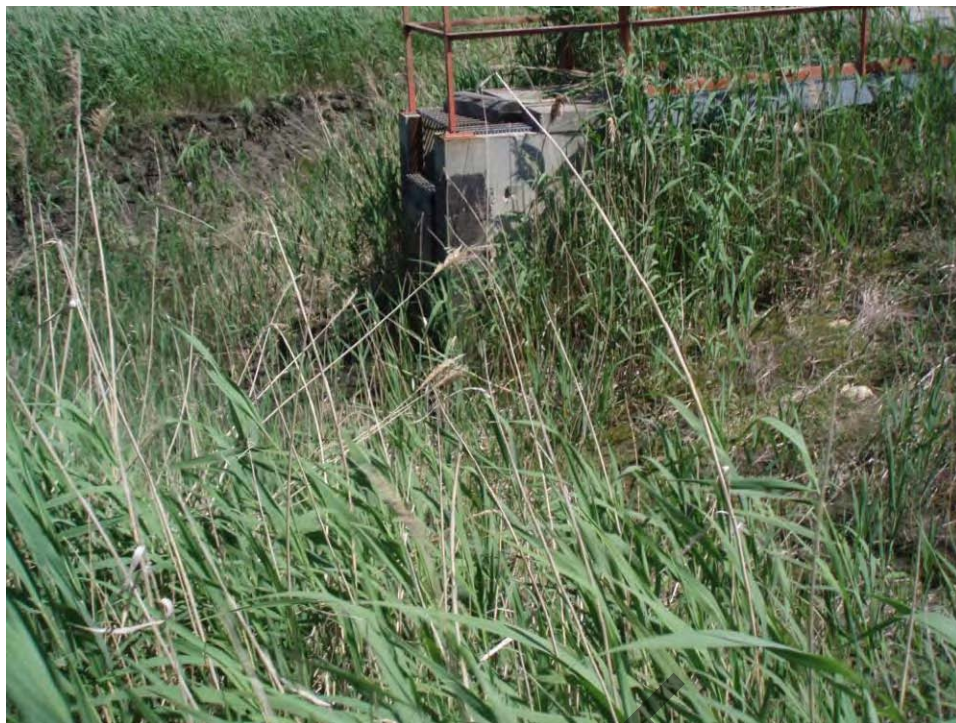
57. Pond B - Overview of outlet control structure with stoplogs, looking east.

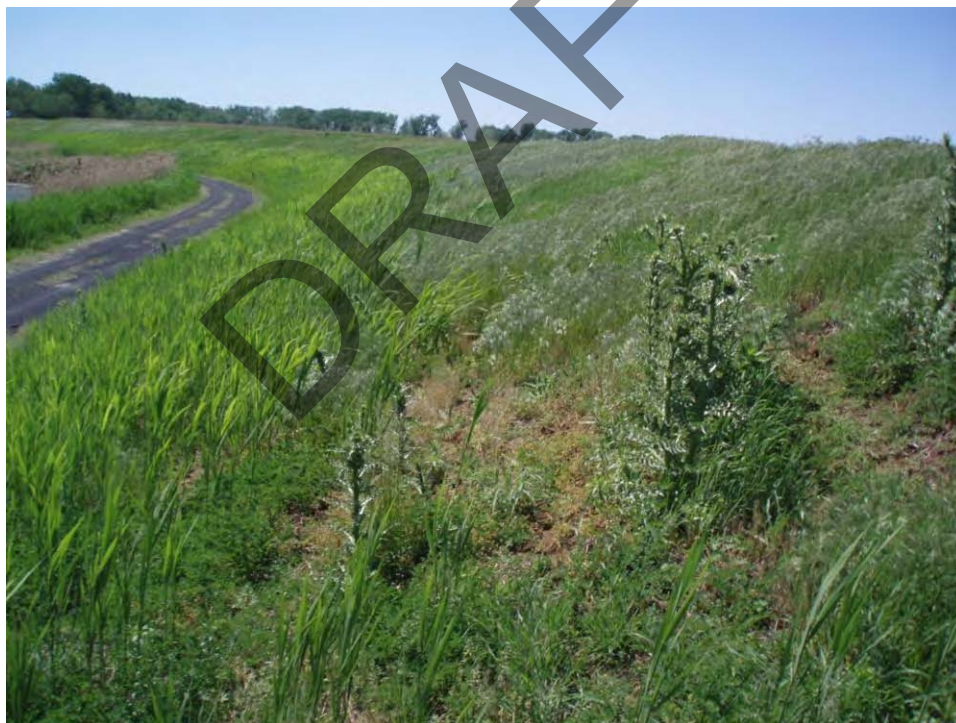
58. Pond B - South embankment exterior slope, looking west at tractor rutting and minor surficial erosion. Note change in vegetation at mid slope and stabilized FGD material very soft.

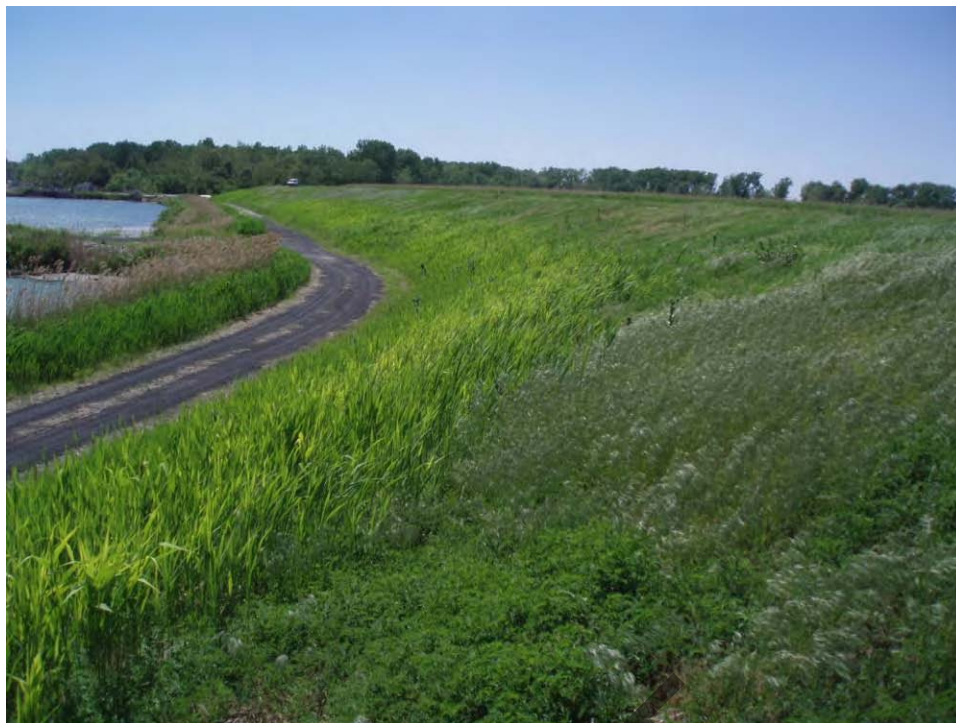
59. Pond B - South embankment exterior slope, looking west. Note change in vegetation at mid slope and stabilized FGD material is very soft.

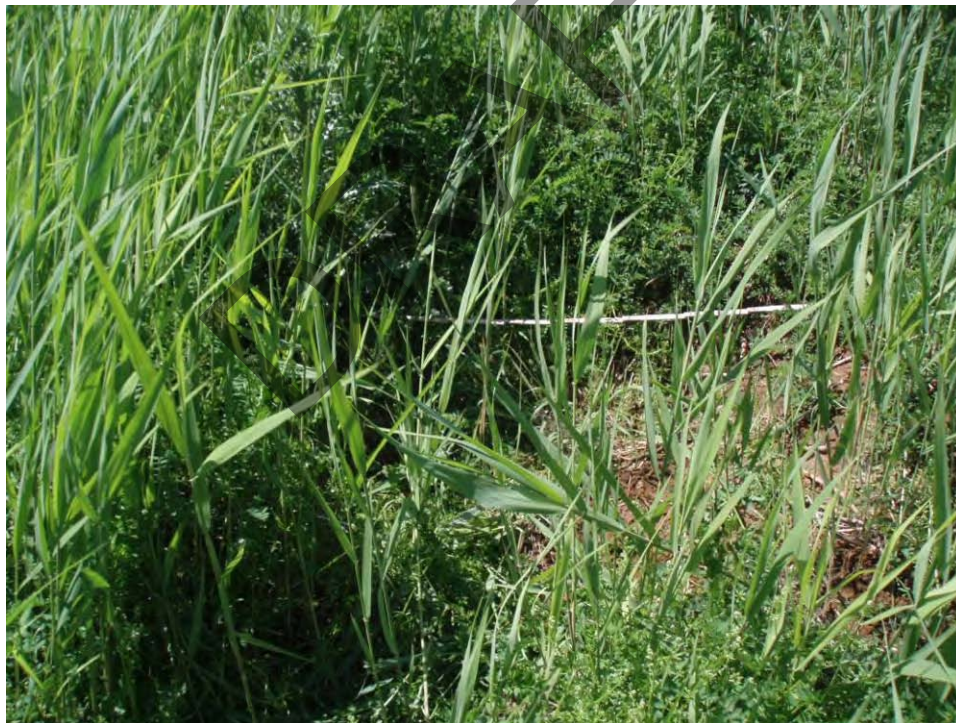
60. Pond B - South embankment exterior slope, looking north at 4'Wx1'D erosion feature.

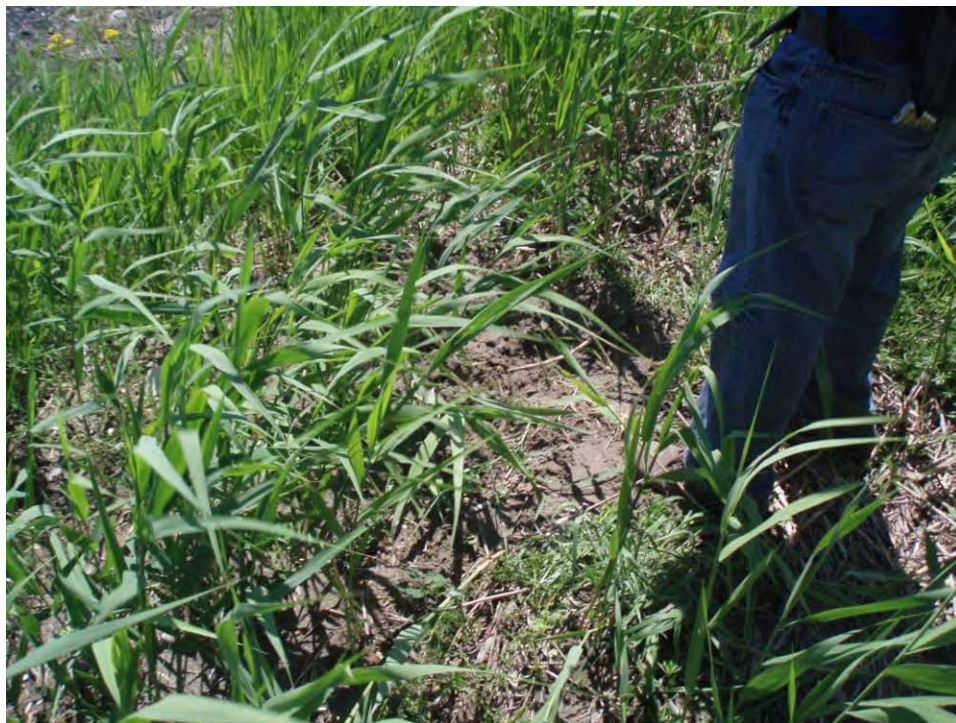
61. Pond B - South embankment exterior slope looking at bare spots of very soft, fine grained stabilized FGD.

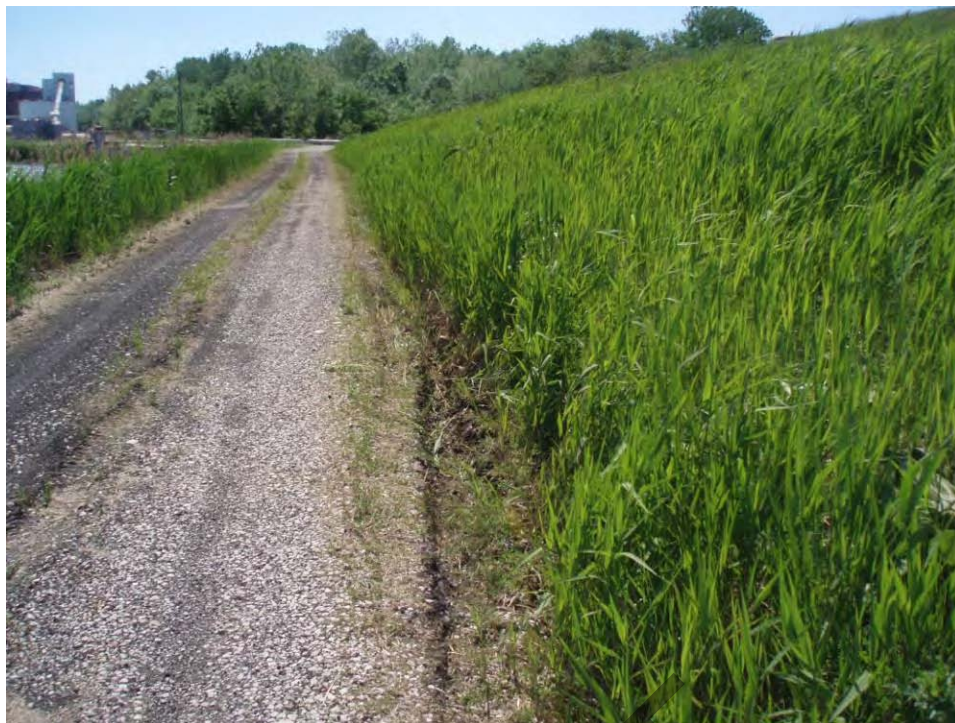
63. Pond B - South embankment exterior slope, looking southwest at possible seepage at toe.
